NC DEPARTMENT OF TRANSPORTATION
 DIVISION OF HIGHWAYS
 STRUCTURE MANAGEMENT UNIT

ATTENTION: **prompt action request; sketches revised; span 3 clearances revised**

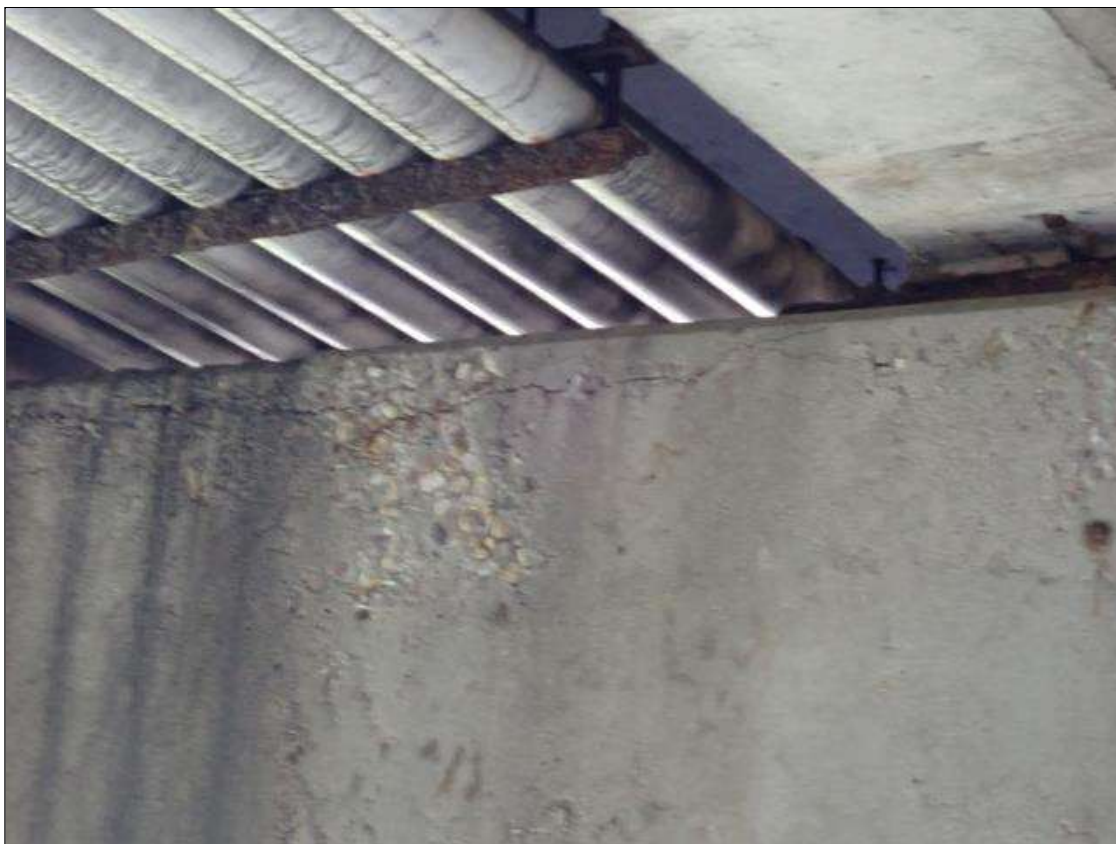
Bent 3 Cap 1: along the length of the cap, near top, longitudinal cracks (up to 1/8 inch x 8 foot) at random

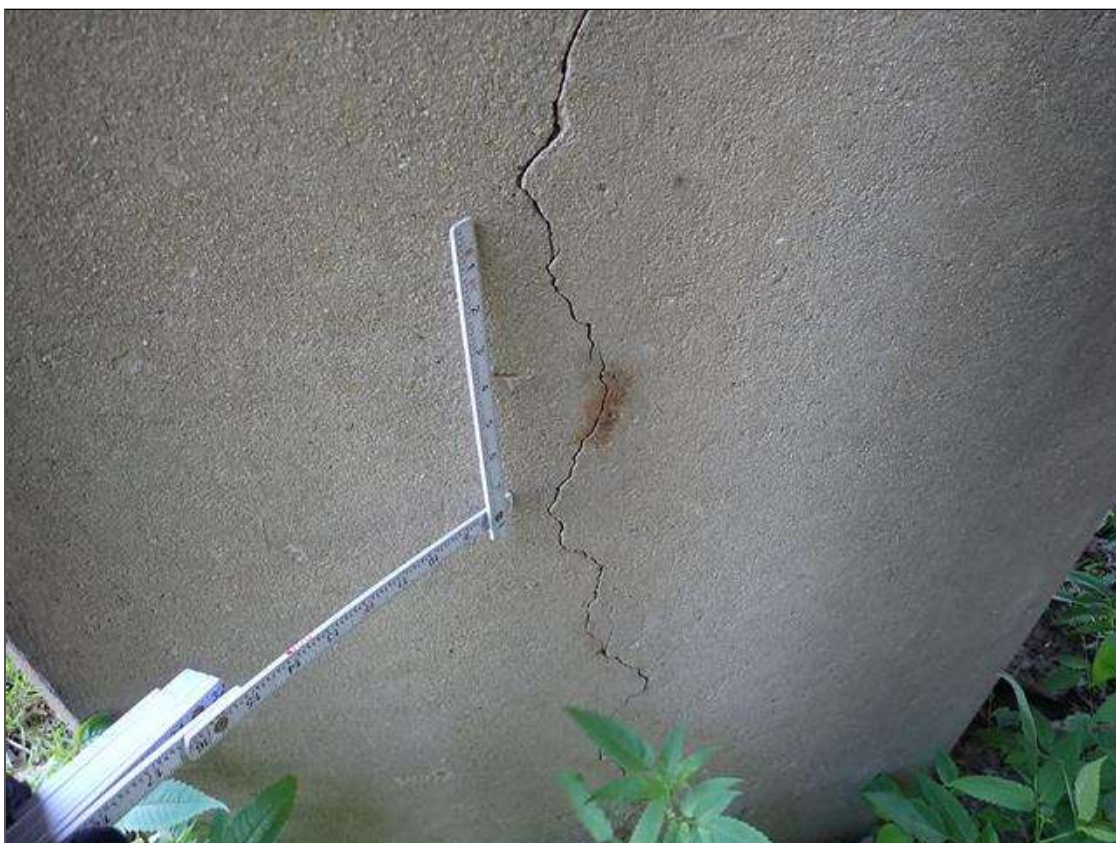
Bent 3 Pile 4: (PAR) MULTIPLE UP TO FULL HEIGHT X 1/16 INCH VERTICAL CRACKS WITH RUST STAINING, AT RANDOM THROUGHOUT.

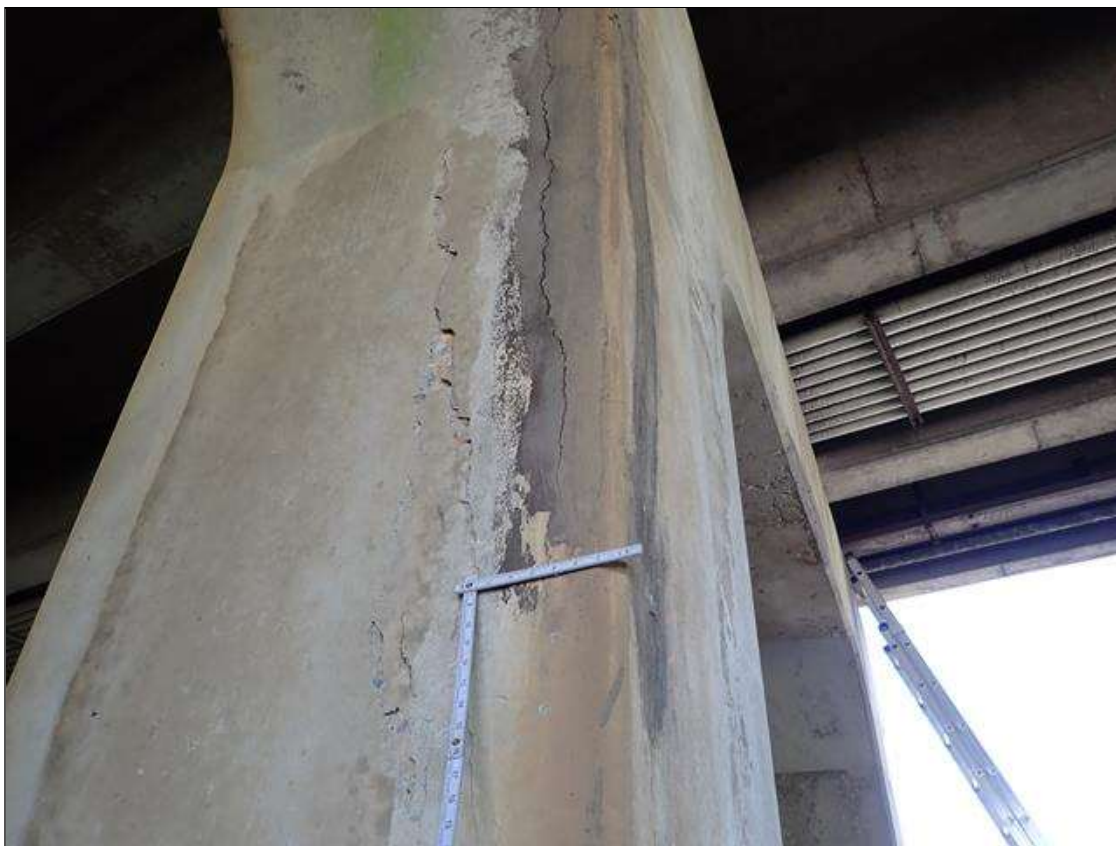
Bent 3 Pile 3: southwest corner, spall/delamination (6 foot x 11 inch x 5 inch x 1 inch deep) with cracks (up to 1/8 inch)

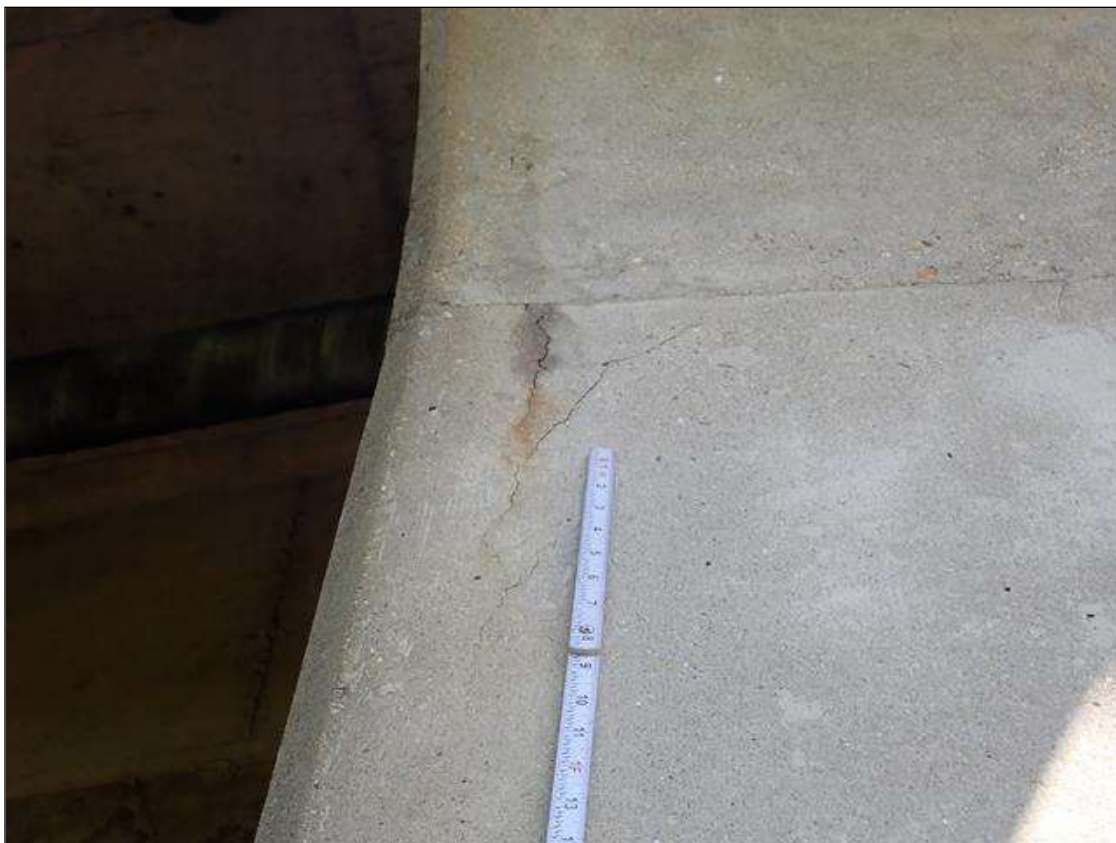
Bent 3 Pile 1: (PAR) MULTIPLE UP TO 3 FOOT X 1/16 INCH VERTICAL CRACKS WITH RUST STAINING, AT RANDOM THROUGHOUT.

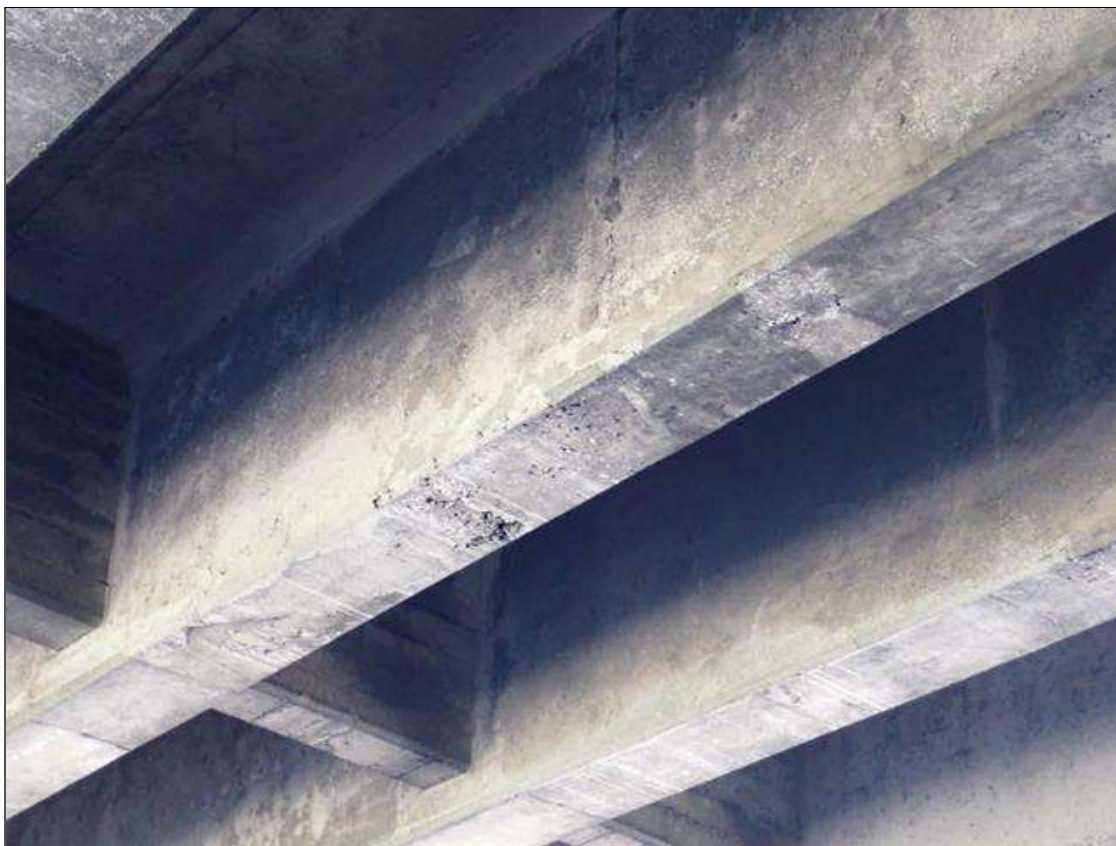
Span 3 Beam 6: (NOT FOUND 2023) SPAN 3 BEAM 6 BOTTOM AND EAST WEB OVER WEST BOUND RIGHT LANE. HAS A 4 FOOT X 1 FOOT X 1 FOOT PATCHED AREA WITH SCATTERED MAP CRACKING.

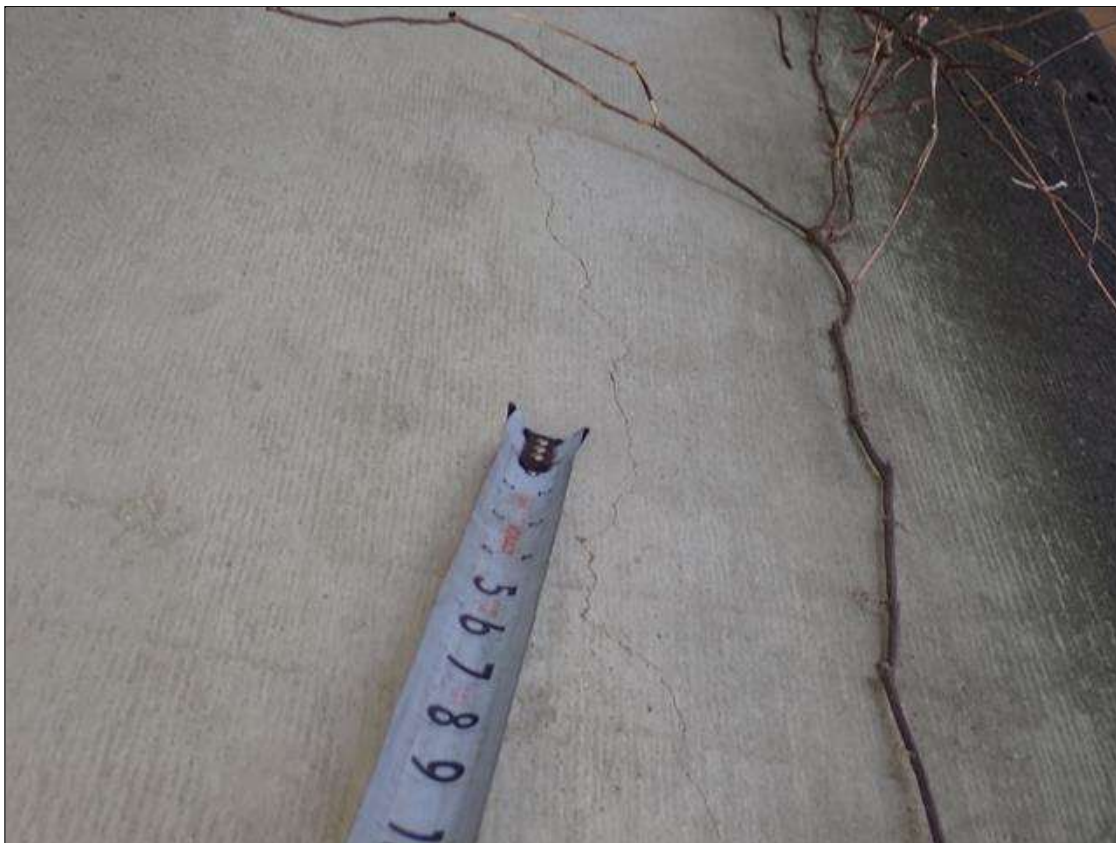
Bent 1 Pile 1: 7 FOOT X UP TO 1/32 INCH VERTICAL CRACK, EAST FACE, BEGINNING AT BOTTOM OF CAP

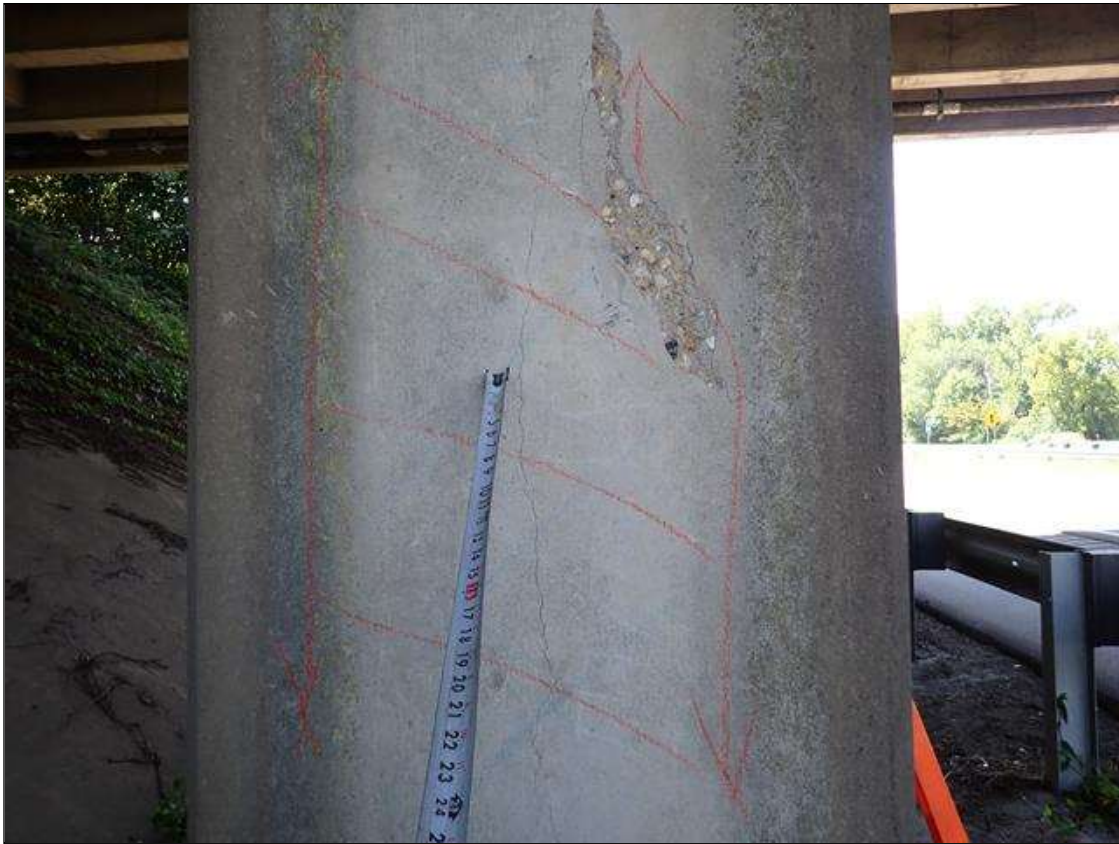
Bent 1 Pile 3: east and west faces, spall/delamination (21 inch x full height x 1/2 inch deep) with cracks (up to 1/32 inch)

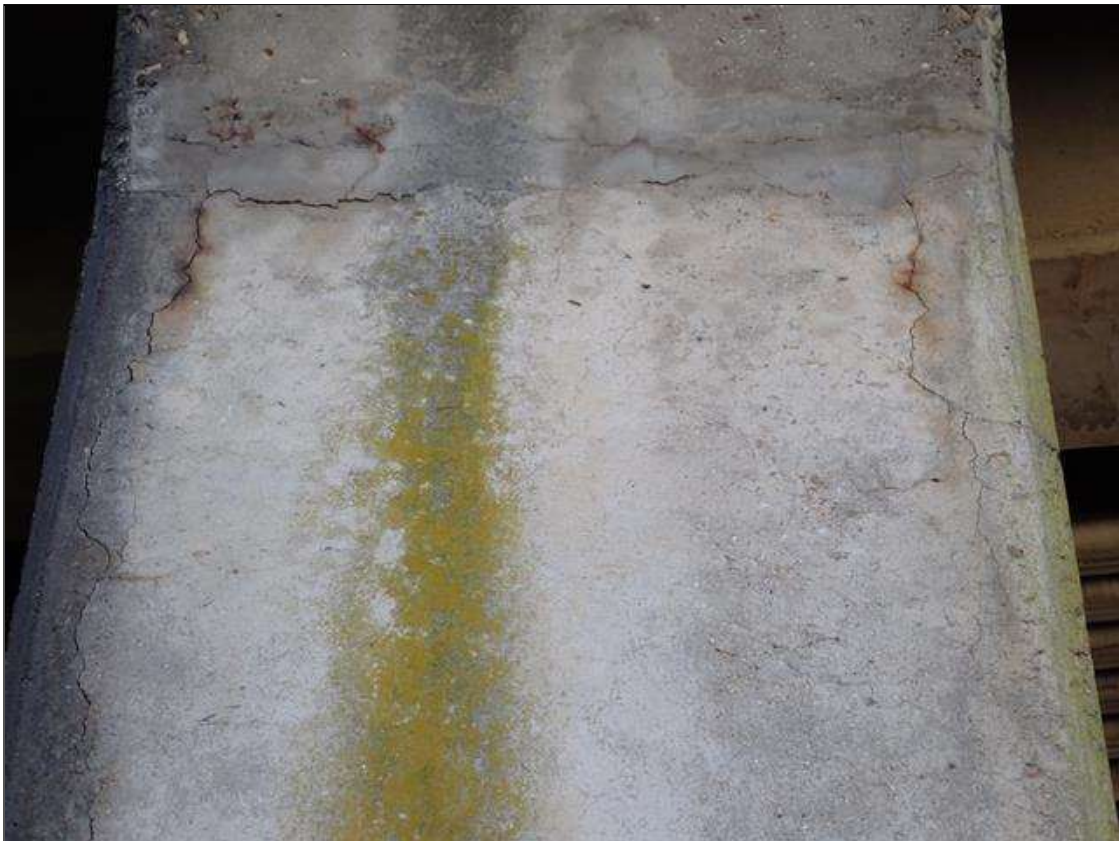
Bent 1 Pile 4: (PAR) (2)- UP TO 5 FOOT X 1/32 INCH VERTICAL CRACKS WITH RUST STAIN, EAST FACE, BEGINNING AT BOTTOM OF CAP.

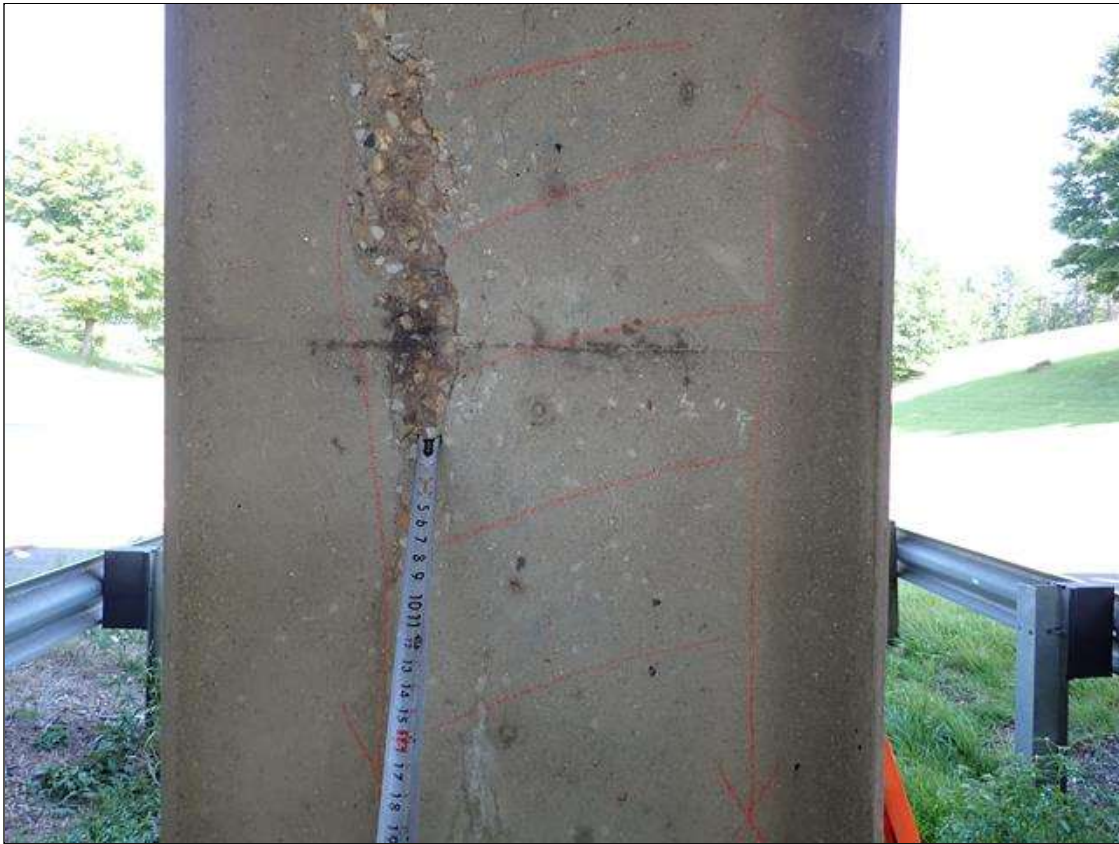
Bent 2 Pile 4: west face, spall/delamination (2 foot x full height x 1/2 inch deep) with cracks (up to 1/32 inch) some with efflorescence

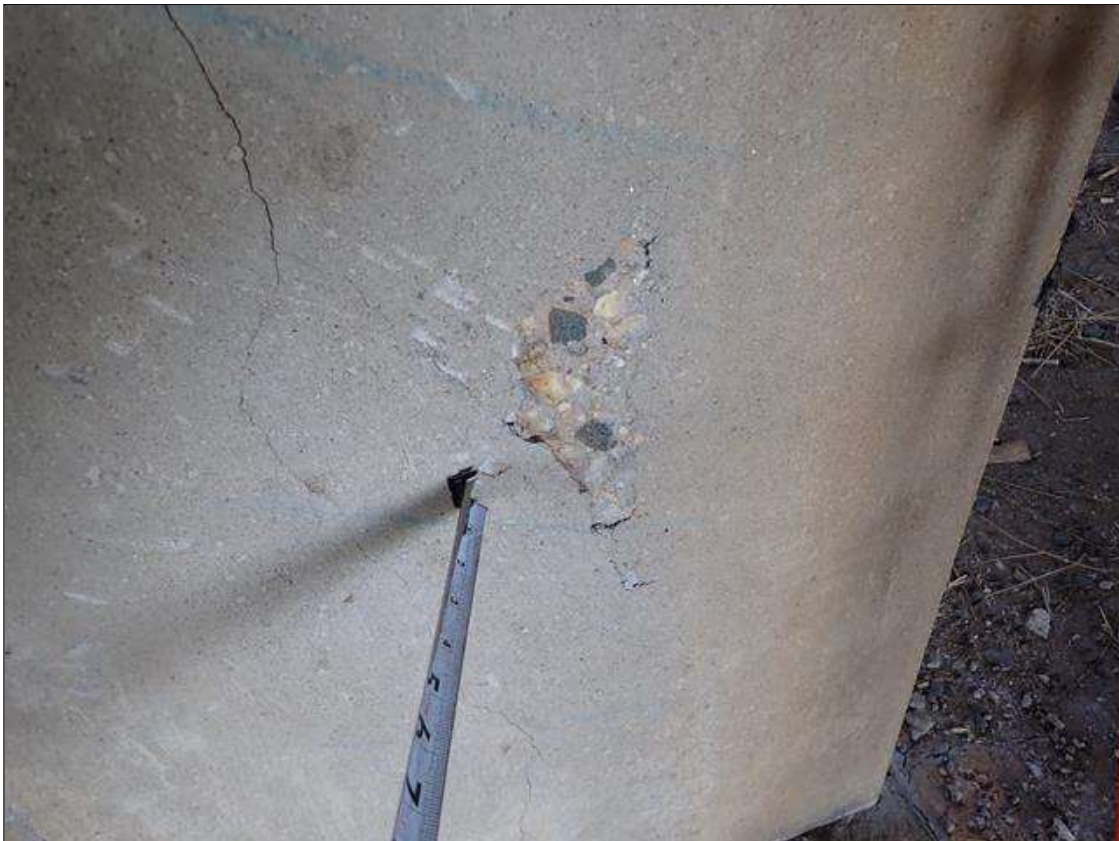
Bent 2 Pile 3: west face at base, delamination/spall (2 foot x 7 foot x 1/2 inch deep) with cracks (up to 1/32 inch)

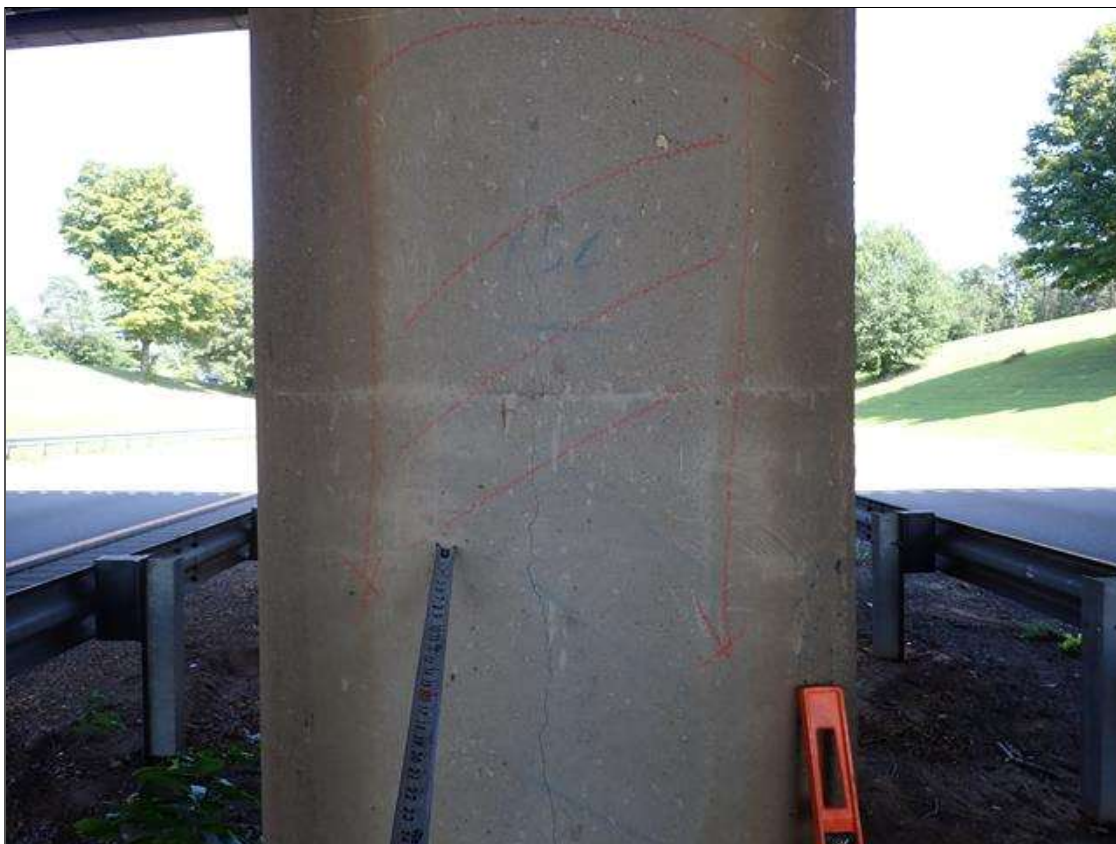
Bent 2 Pile 3: west face at base, delamination/spall (2 foot x 7 foot x 1/2 inch deep) with cracks (up to 1/32 inch)

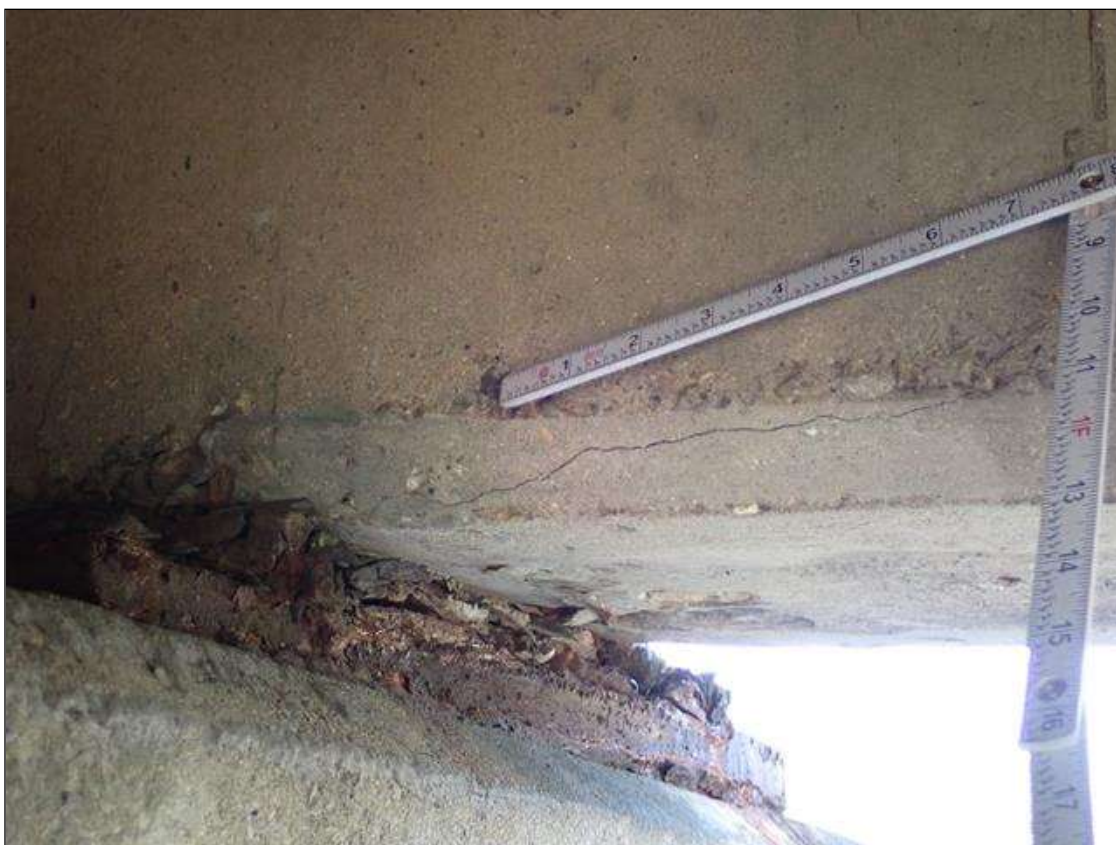
Span 3 Beam 1: at bent 2, east face at bottom, longitudinal crack (1/32 inch x 1 foot)

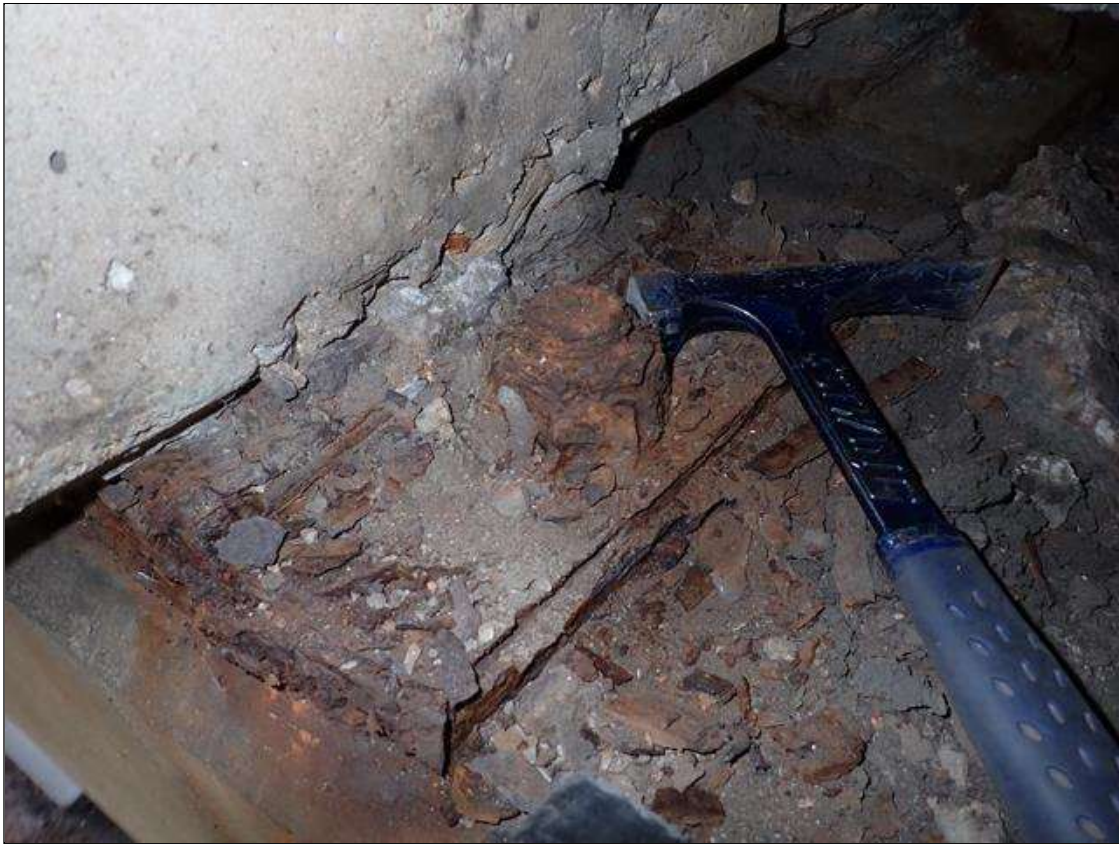
Span 3 Beam 2 - Near Bearing 2: active corrosion with section loss [up to 1/8 inch loss on plates]; anchor bolts, corrosion with section loss [approximately 75 percent remaining]

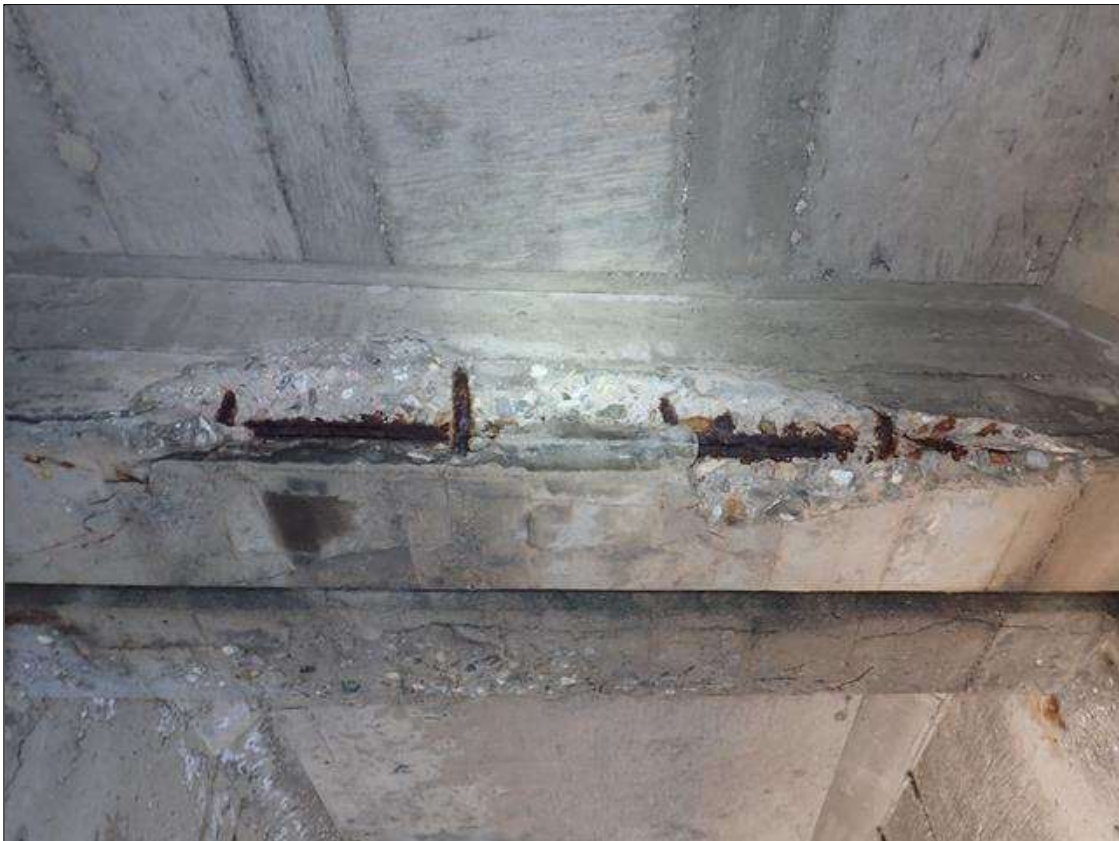
Span 3 Beam 2: (PAR) at bent 2, bay 2 end diaphragm, spall/delamination (full length x full width x 8 x 2 inch deep) with exposed rusted rebar (approximately 25 percent loss)

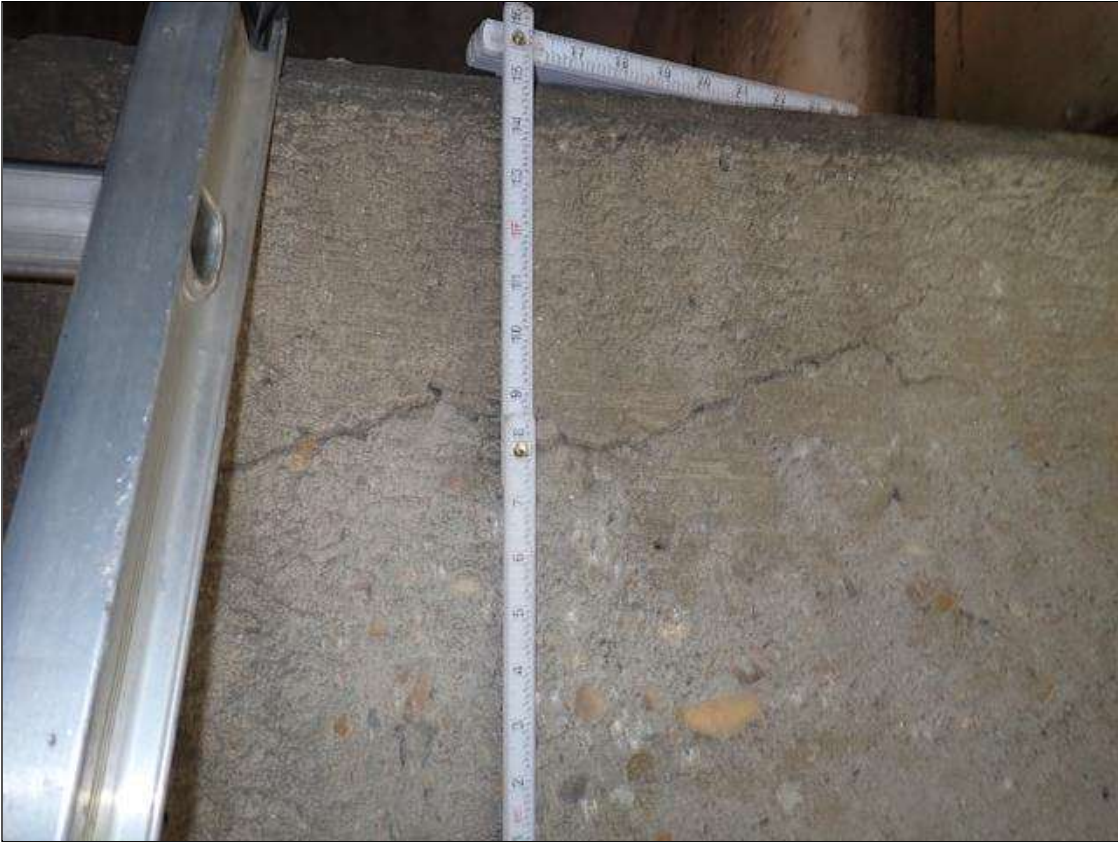
Bent 2 Cap 1: along the length of the cap, near top, longitudinal cracks (up to 1/16 inch x 8 foot) at random

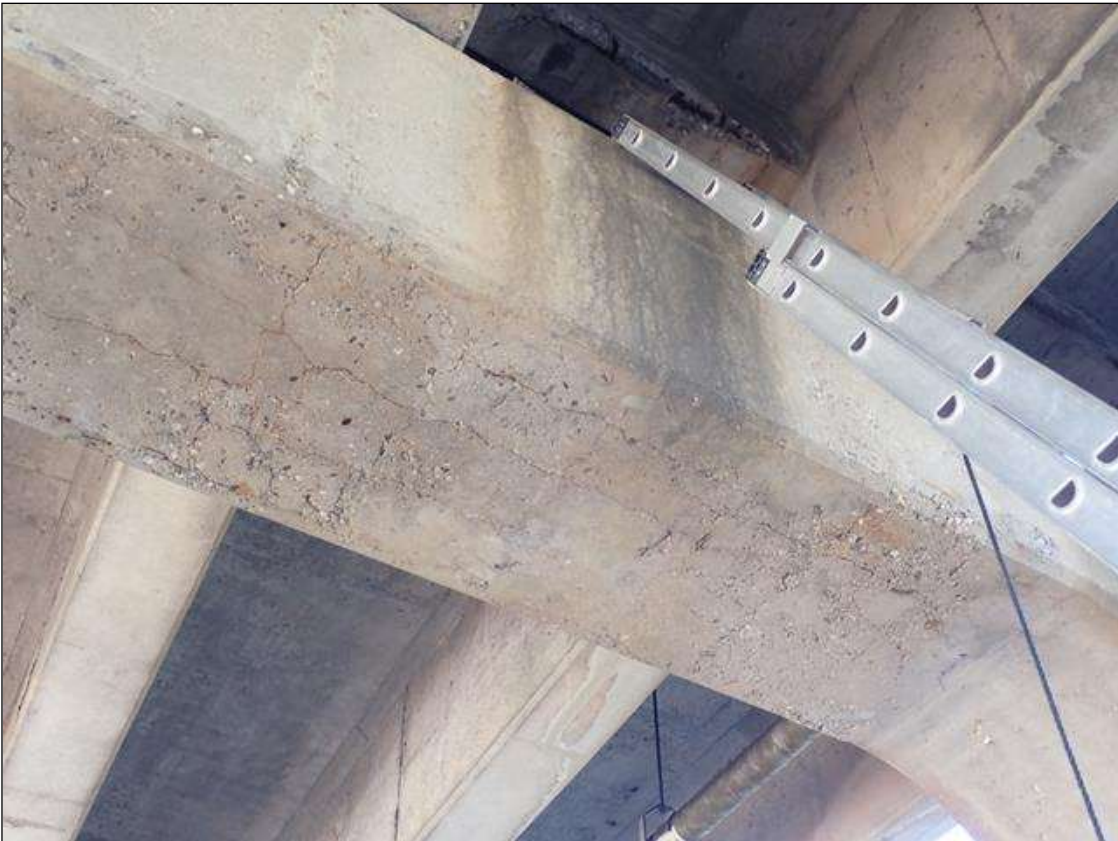
Bent 2 Cap 1: (PAR) 8 FOOT X 3 FOOT DELAMINATION WITH MAP CRACKING UP TO 1/16 INCH WITH RUST STAINS, BOTTOM FACE, BETWEEN PILES 1 AND 2.

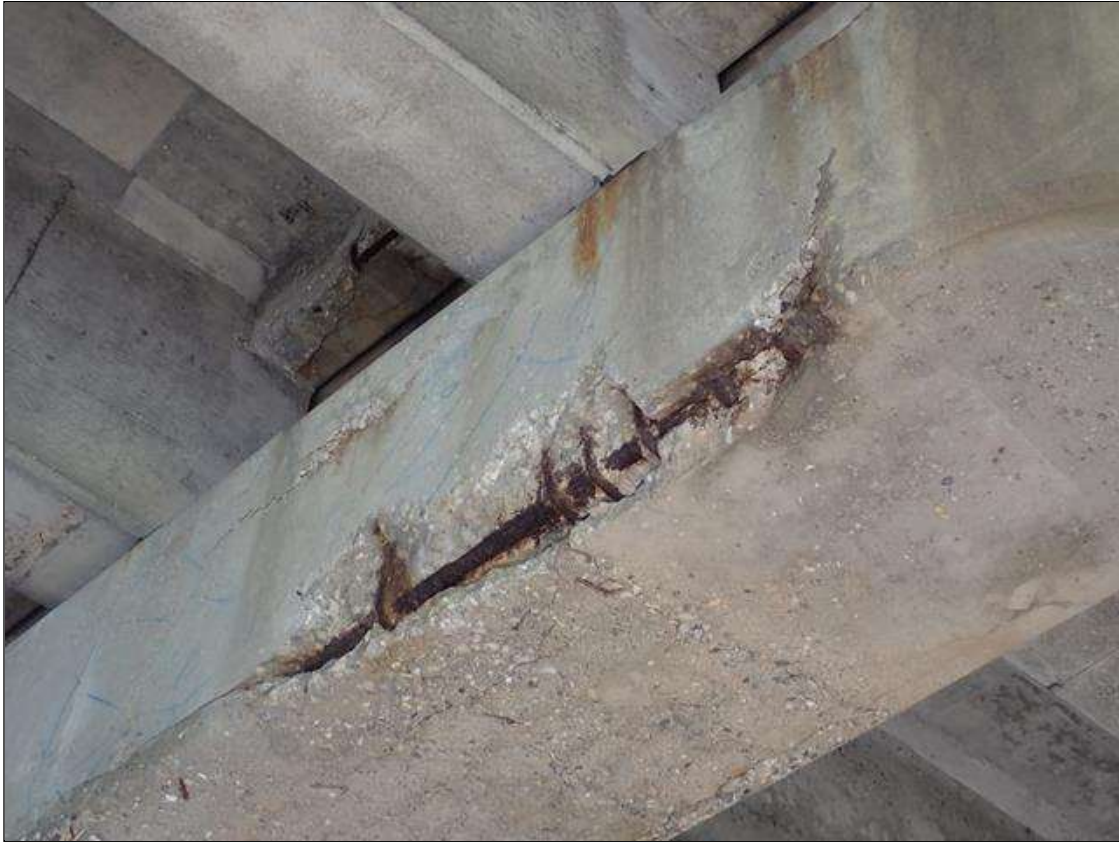
Bent 2 Cap 1: (PAR) 5 FOOT X 1 FOOT X UP TO 3 INCH DEEP SPALL WITH EXPOSED REINFORCING WITH APPROXIMATELY 25 PERCENT LOSS AND MULTIPLE DELAMINATIONS (UP TO 10 FOOT X FULL WIDTH OF BOTTOM X UP TO FULL HEIGHT) WITH CRACKS UP TO 1/8 INCH AND RUST STAINS, SOUTH, NORTH AND BOTTOM FACES, BETWEEN PILES 2 AND 3.

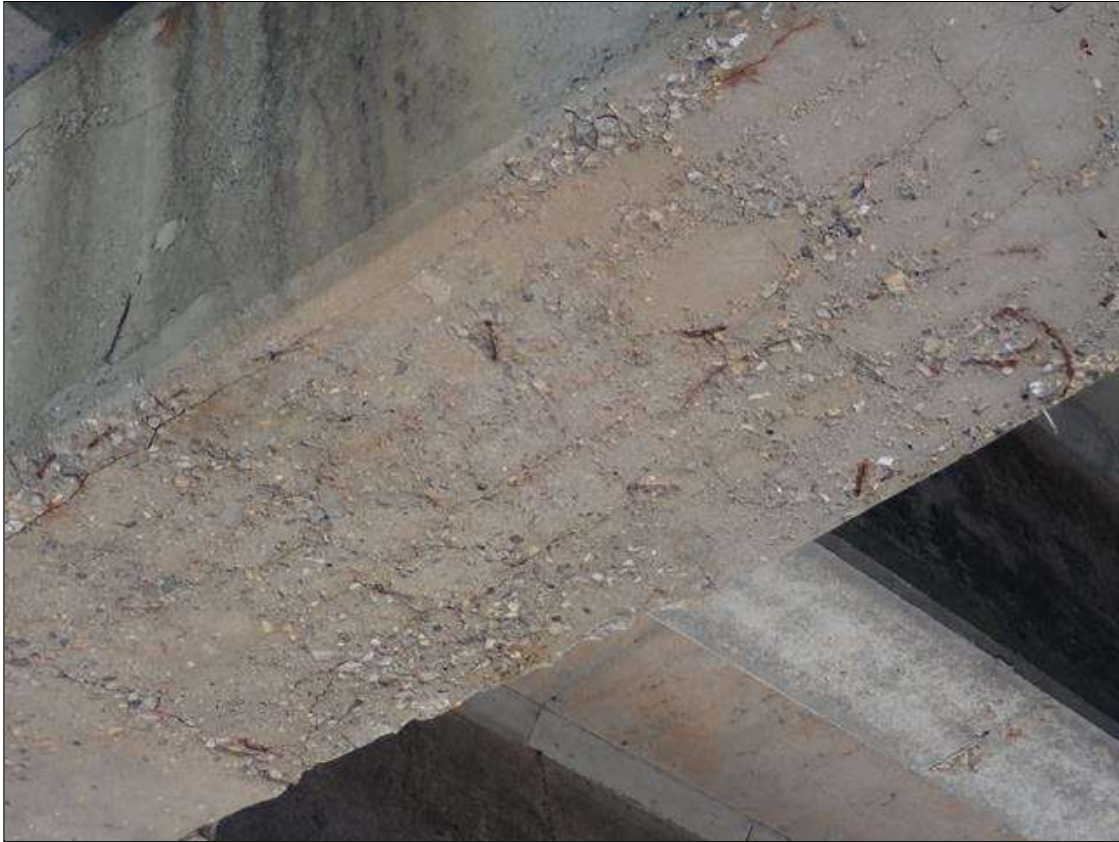
Bent 2 Cap 1: (PAR) 5 FOOT X 1 FOOT X UP TO 3 INCH DEEP SPALL WITH EXPOSED REINFORCING WITH APPROXIMATELY 25 PERCENT LOSS AND MULTIPLE DELAMINATIONS (UP TO 10 FOOT X FULL WIDTH OF BOTTOM X UP TO FULL HEIGHT) WITH CRACKS UP TO 1/8 INCH AND RUST STAINS, SOUTH, NORTH AND BOTTOM FACES, BETWEEN PILES 2 AND 3.

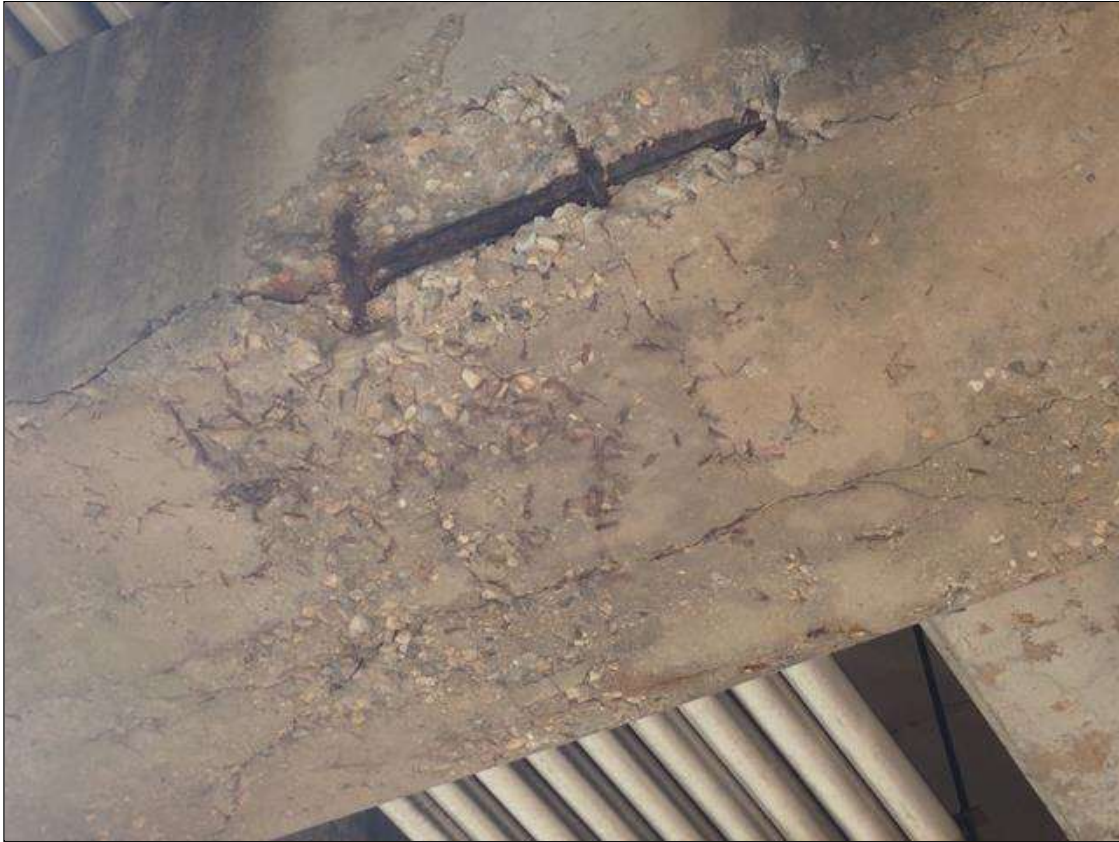
Bent 2 Cap 1: (PAR) [3 FOOT X UP TO 20 INCH X 5 INCH] DEEP SPALL WITH EXPOSED PRIMARY REINFORCING [SECTION LOSS UP TO 1/8 INCH], NORTH AND BOTTOM FACES, BETWEEN PILES 3 AND 4 WITH ADJACENT DELAMINATIONS [UP TO 10 FOOT X FULL WIDTH OF BOTTOM], EXTENDS UP TO FULL HEIGHT OF SOUTH FACE

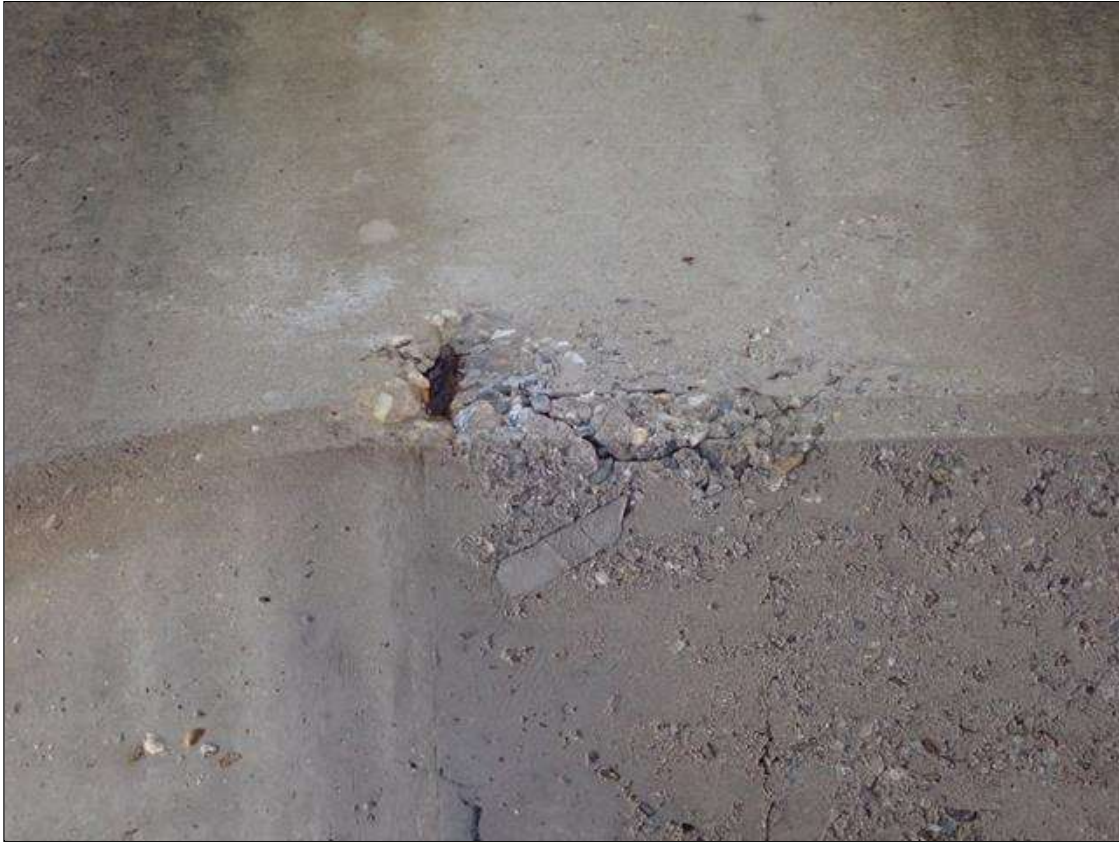
Bent 2 Cap 1: (PAR) 6 INCH DIAMETER X 1 INCH DEEP SPALL WITH EXPOSED REINFORCING WITH APPROXIMATELY 25 PERCENT LOSS, SOUTH FACE, UNDER BEAM 2.

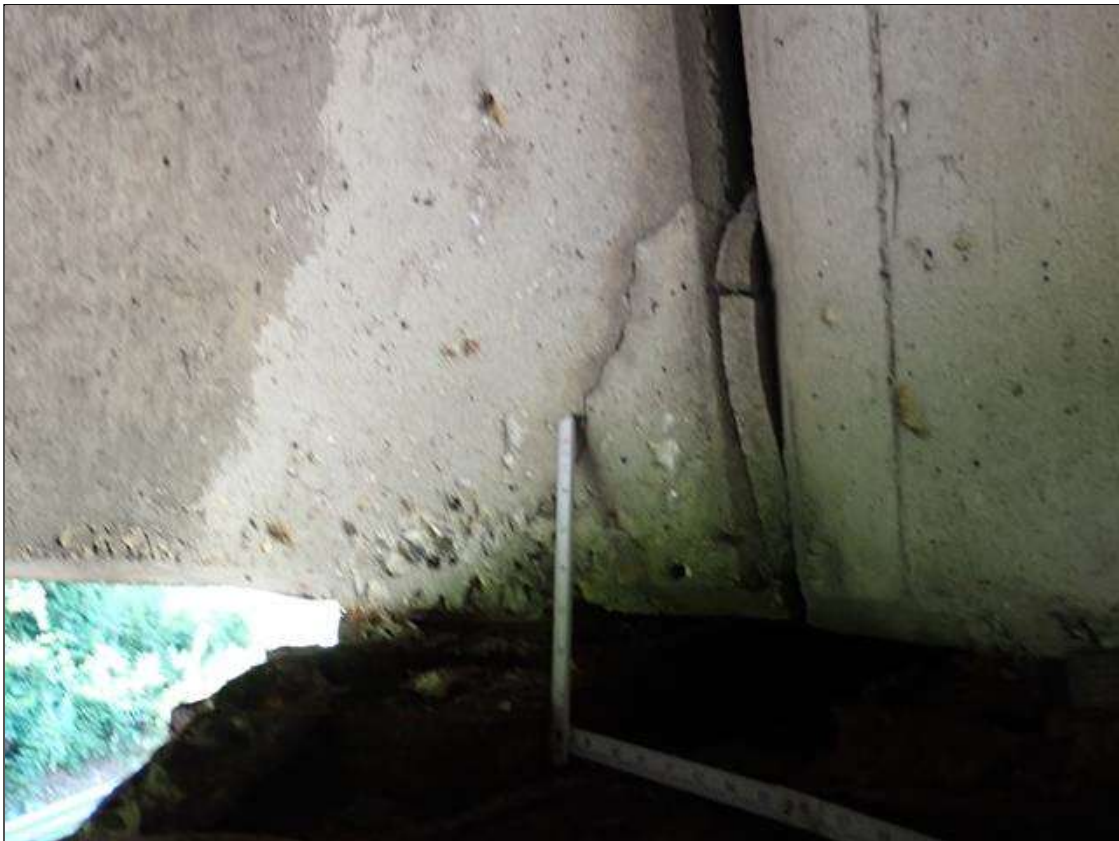
Span 2 Beam 3: at bent 2, east face, delamination (7 inch x 8 inch) with cracks (up to 1/16 inch)

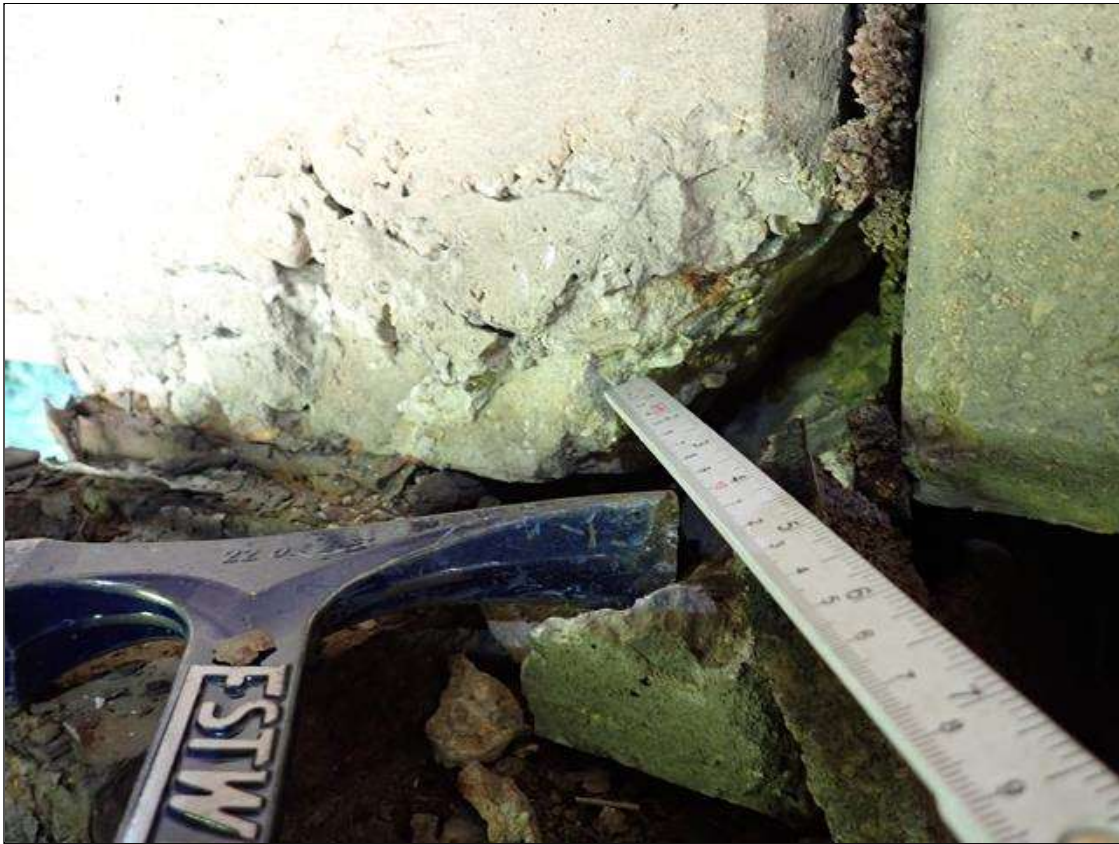
Span 2 Beam 5: at bent 2, east face bottom corner, spall (8 inch x 4 inch x 8 inch x 2 inch deep)

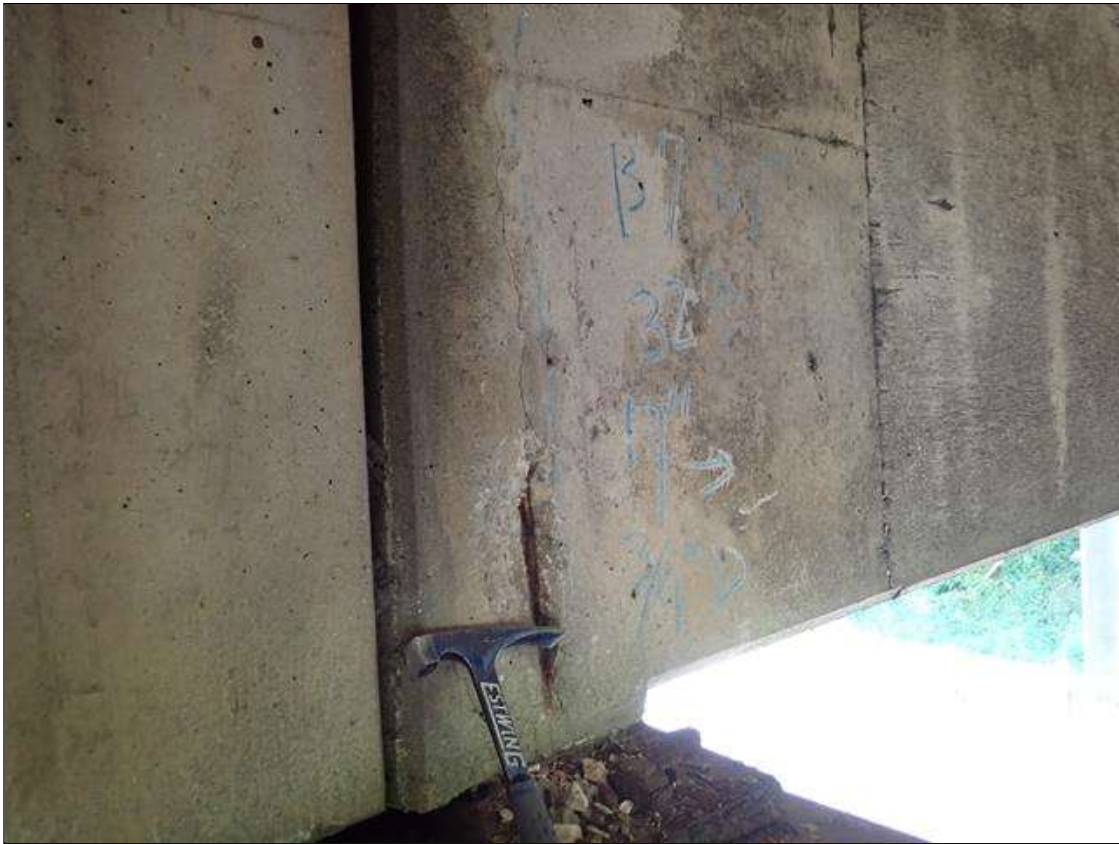
Span 2 Beam 7: (PAR) SPAN 2 BEAM 7 WEST WEB OVER BENT 2. HAS A CRACK/SPALL AND DELAMINATED AREA WITH REBAR EXPOSED. AREA IS: 7 INCH X 32 INCH X 3/4 INCH DEEP. WITH EXPOSED RUSTED REINFORCING WITH APPROXIMATELY 25 PERCENT LOSS
