NC DEPARTMENT OF TRANSPORTATION
 DIVISION OF HIGHWAYS
 STRUCTURE MANAGEMENT UNIT

ATTENTION: **prompt action request; sketches revised; span 3 clearances revised**

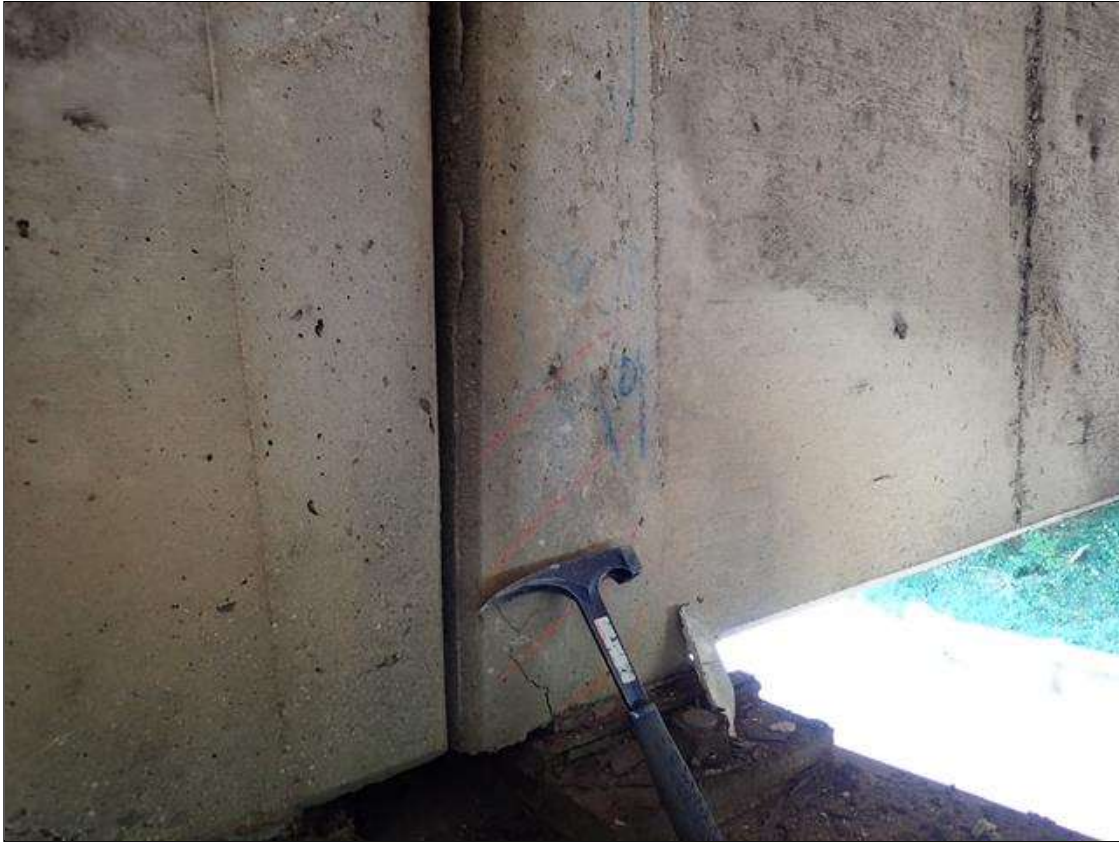
Span 2 Beam 8: West face at far end, delamination [10 inch x full height]

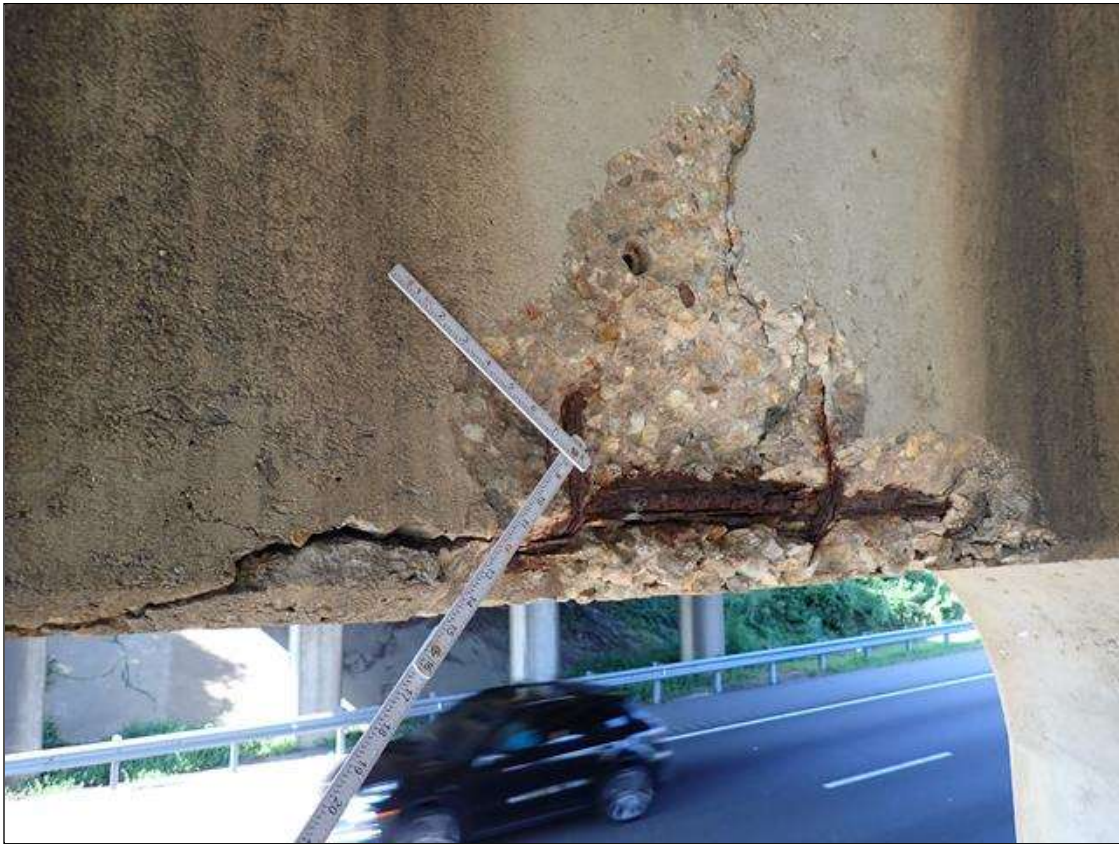
Bent 2 Cap 1: (PAR) [3 FOOT X UP TO 20 INCH X 5 INCH] DEEP SPALL WITH EXPOSED PRIMARY REINFORCING [SECTION LOSS UP TO 1/8 INCH], NORTH AND BOTTOM FACES, BETWEEN PILES 3 AND 4 WITH ADJACENT DELAMINATIONS [UP TO 10 FOOT X FULL WIDTH OF BOTTOM], EXTENDS UP TO FULL HEIGHT OF SOUTH FACE

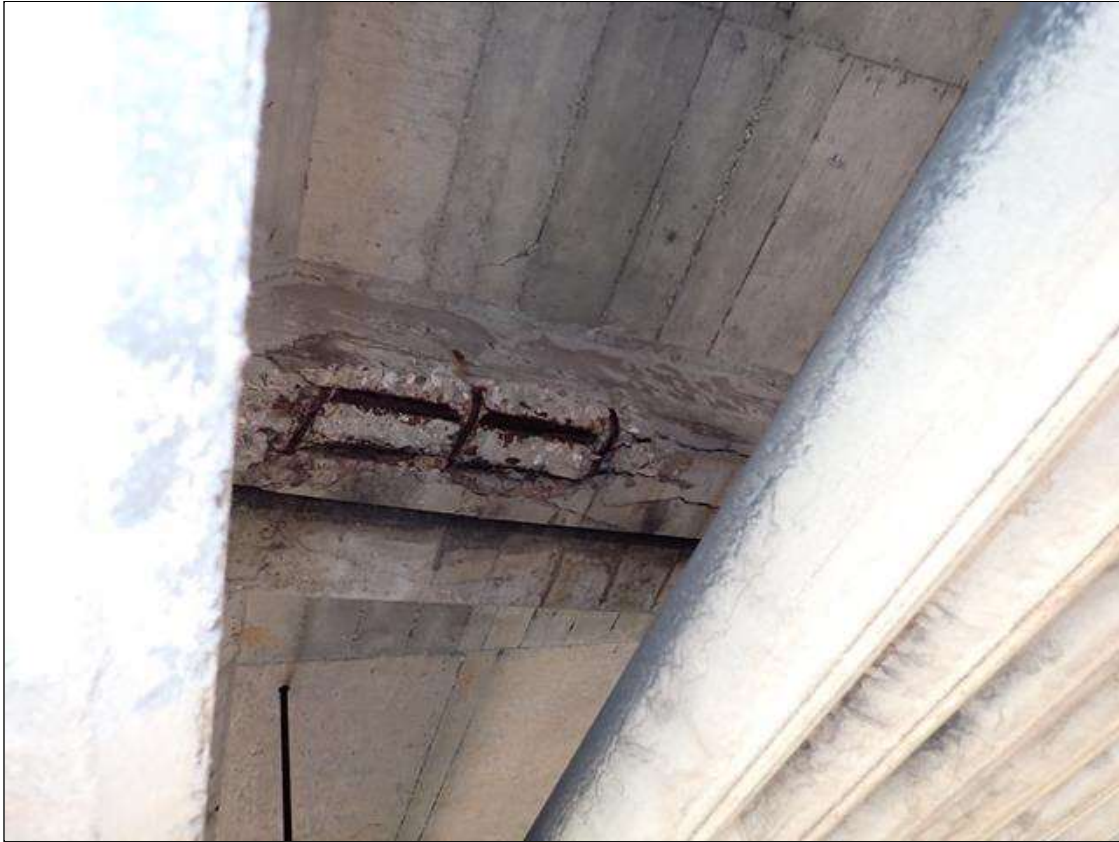
Span 3 Beam 8: (PAR) at bent 2, bay 8 end diaphragm, spall/delamination (full length x full width x 8 x 2 inch deep) with exposed rusted rebar (approximately 25 percent loss)

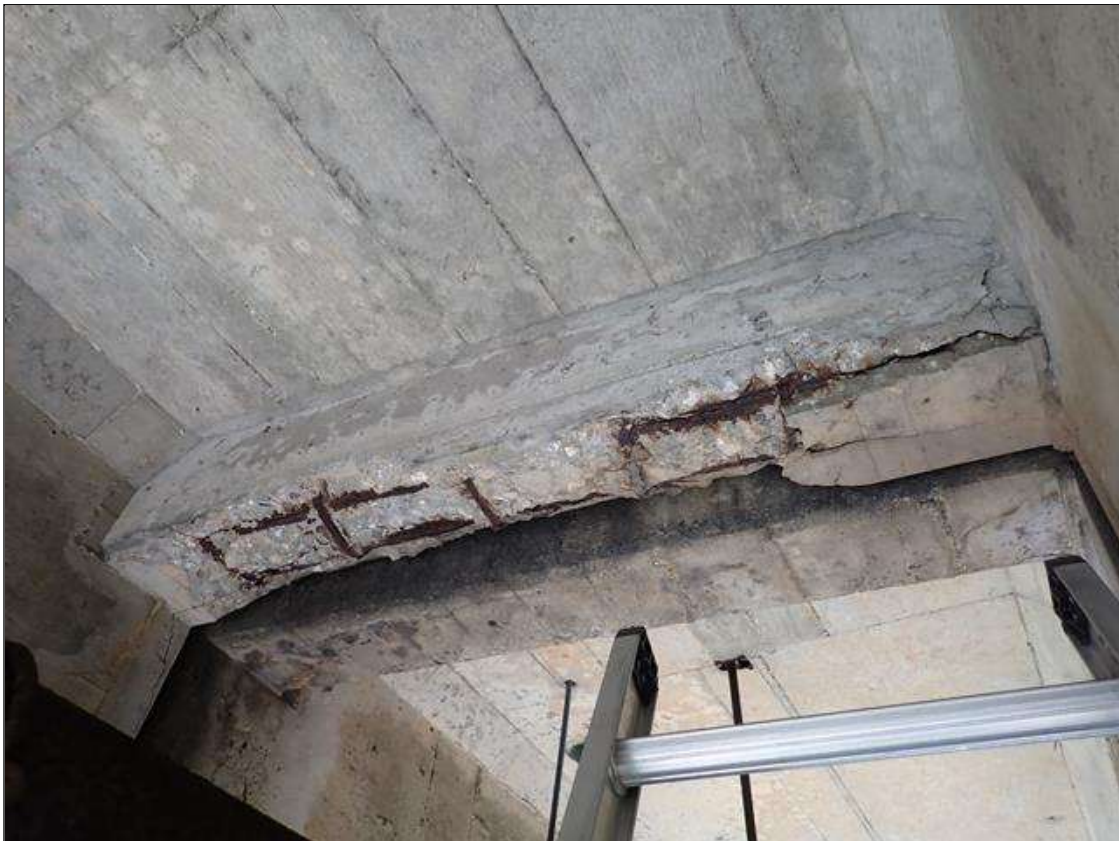
Span 3 Beam 9: (PAR) 6 FOOT X 1 FOOT X 8 INCH X 2 INCH DEEP SPALL WITH EXPOSED REINFORCING WITH APPROXIMATELY 25 PERCENT LOSS, IN BENT 2 DIAPHRAGM, BAY 9.

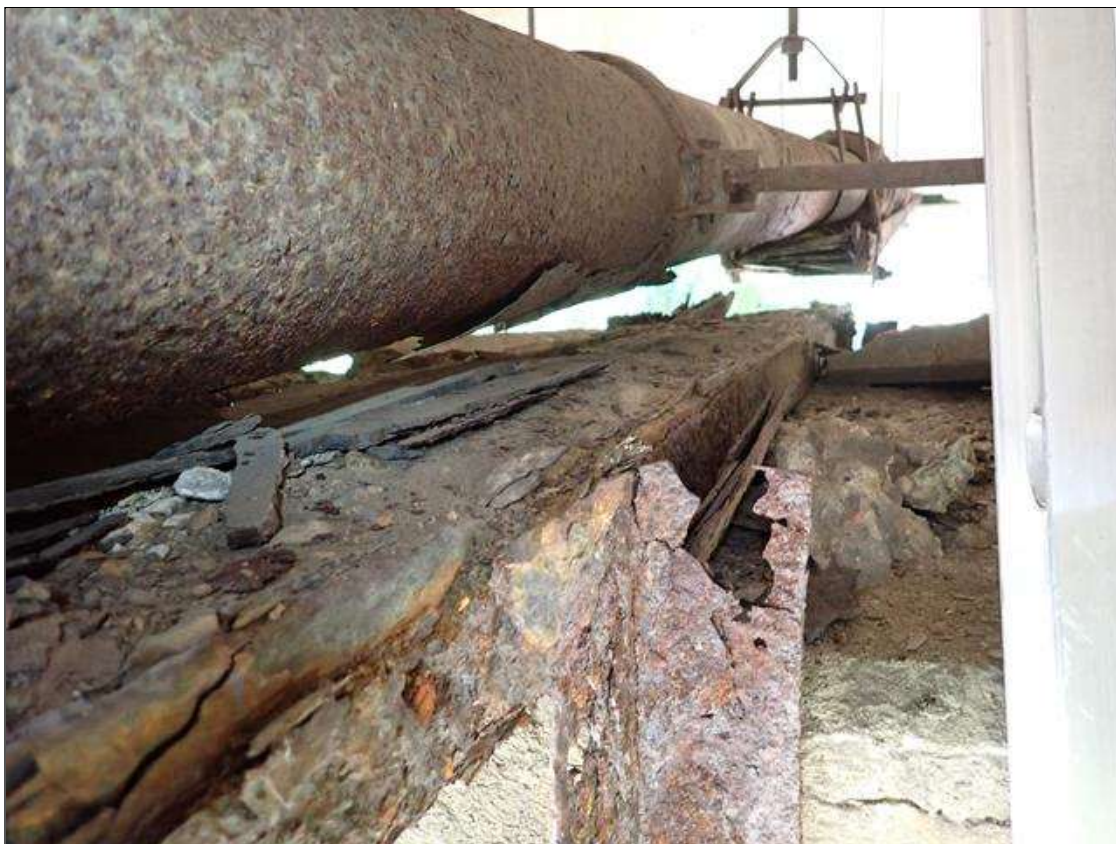
(PAR) at bent 2, bay 9 utility, metal platform, corroded and sheared

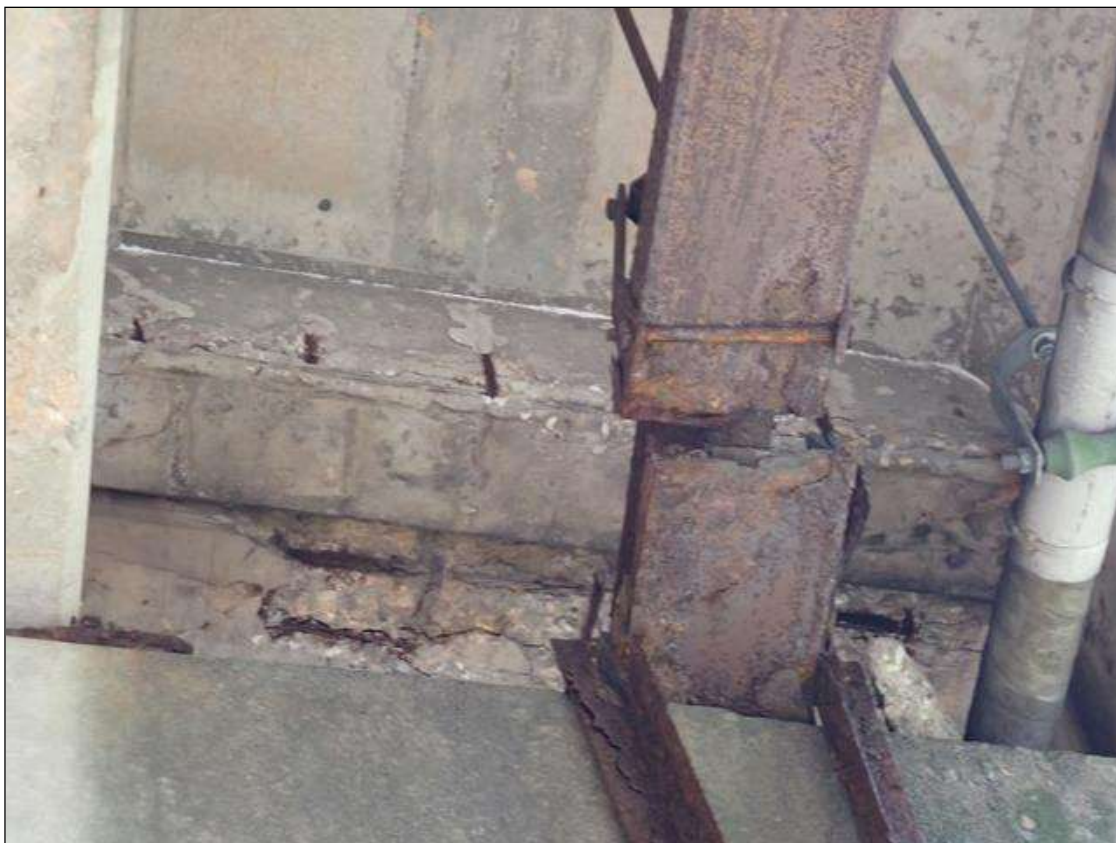
Span 2 Beam 9: FULL LENGTH X FULL WIDTH X 12 INCH X 1 INCH DEEP SPALL/DELAMINATION WITH EXPOSED REINFORCING, IN BENT 2 DIAPHRAGM, BAY 9.

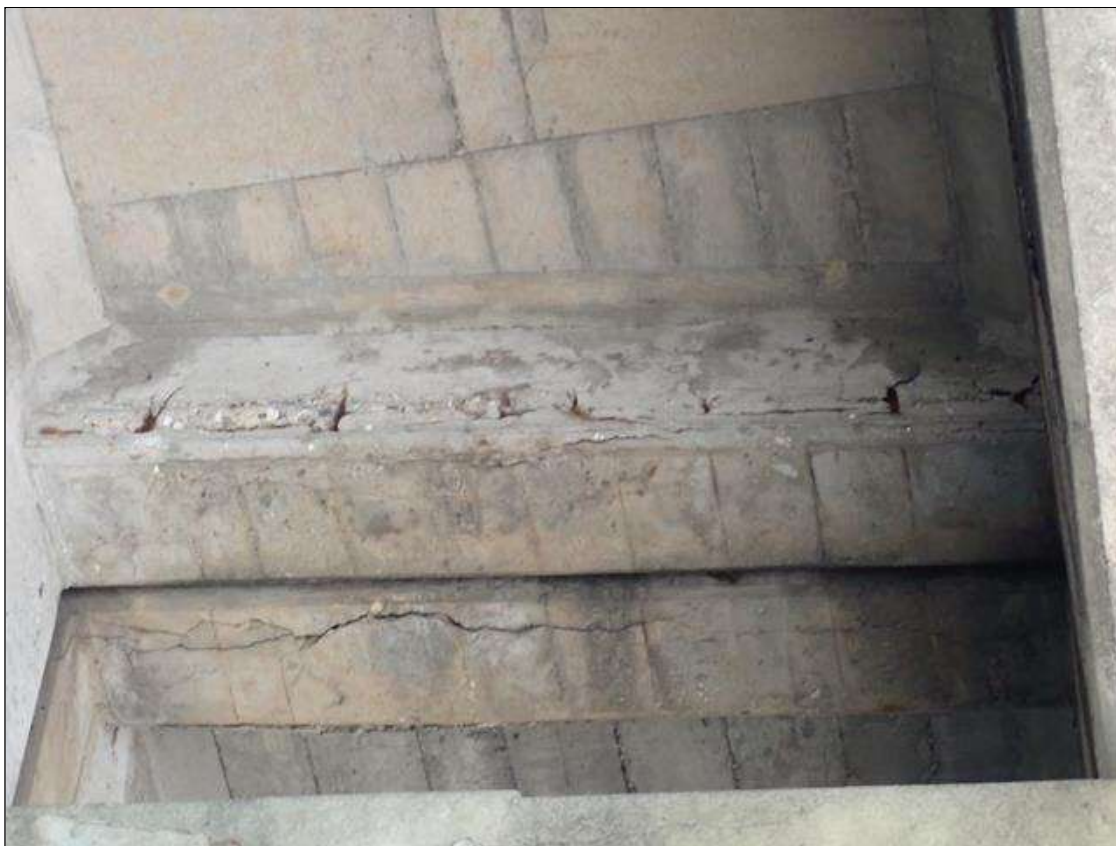
Span 2 Beam 6: FULL LENGTH X FULL WIDTH X 12 INCH X 2 INCH DEEP SPALL/DELAMINATION IN BAY 6 DIAPHRAGM AT BENT 2.

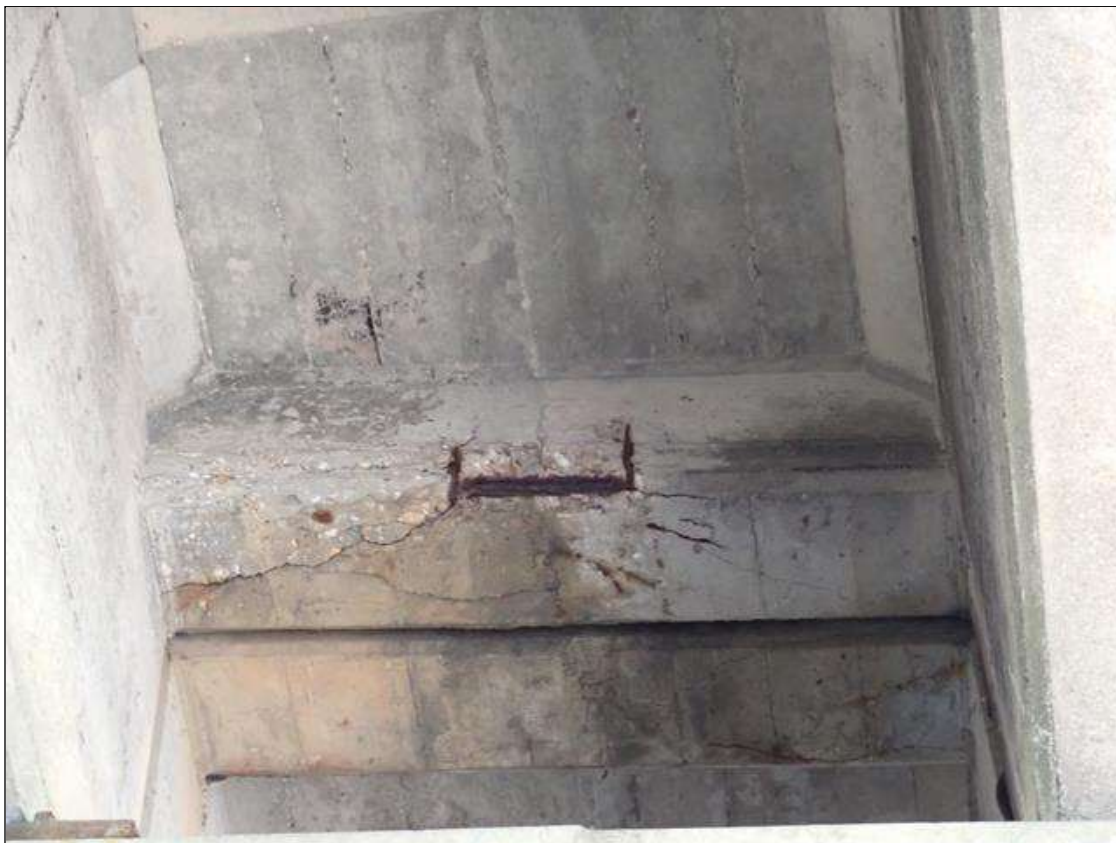
Span 2 Beam 5: (PAR) FULL LENGTH X FULL WIDTH X 10 INCH X 2 INCH DEEP SPALL/DELAMINATION WITH EXPOSED REINFORCING WITH APPROXIMATELY 25 PERCENT LOSS, IN BENT 2 DIAPHRAGM, BAY 5.

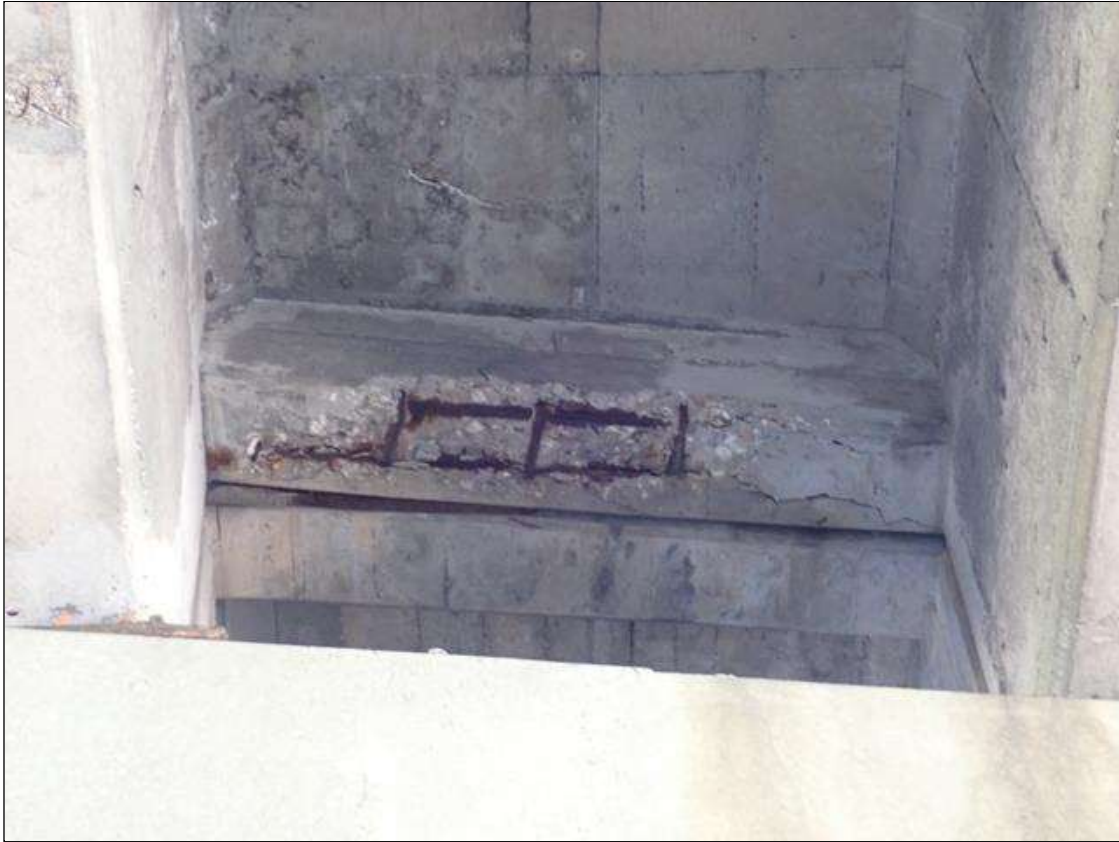
Span 2 Beam 3: (PAR) FULL LENGTH X FULL WIDTH X 4 INCH X 2 INCH DEEP SPALL/DELAMINATION WITH EXPOSED RUSTED REBAR WITH APPROXIMATELY 25 PERCENT LOSS IN BAY 3 DIAPHRAGM AT BENT 2.

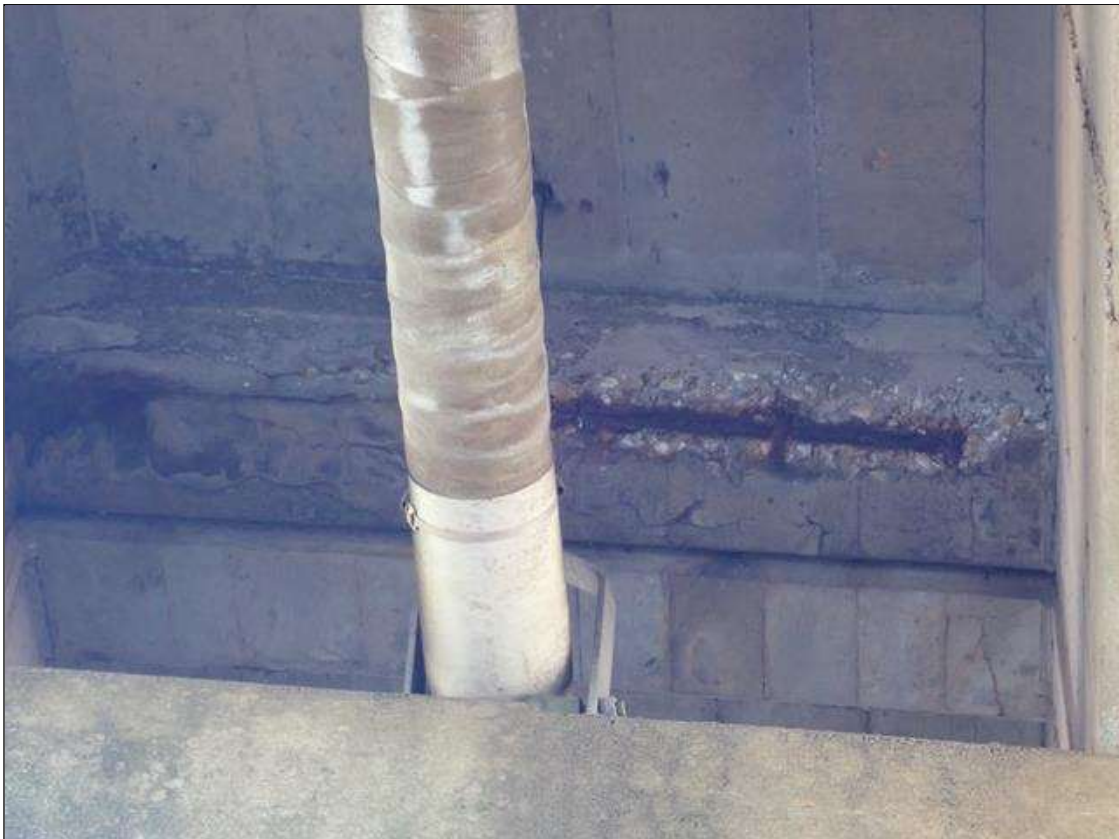
Span 2 Beam 1: (PAR) FULL LENGTH X FULL WIDTH X 4 INCH X 2 INCH DEEP SPALL WITH EXPOSED REINFORCING WITH APPROXIMATELY 25 PERCENT LOSS, IN BENT 2 DIAPHRAGM, BAY 1.

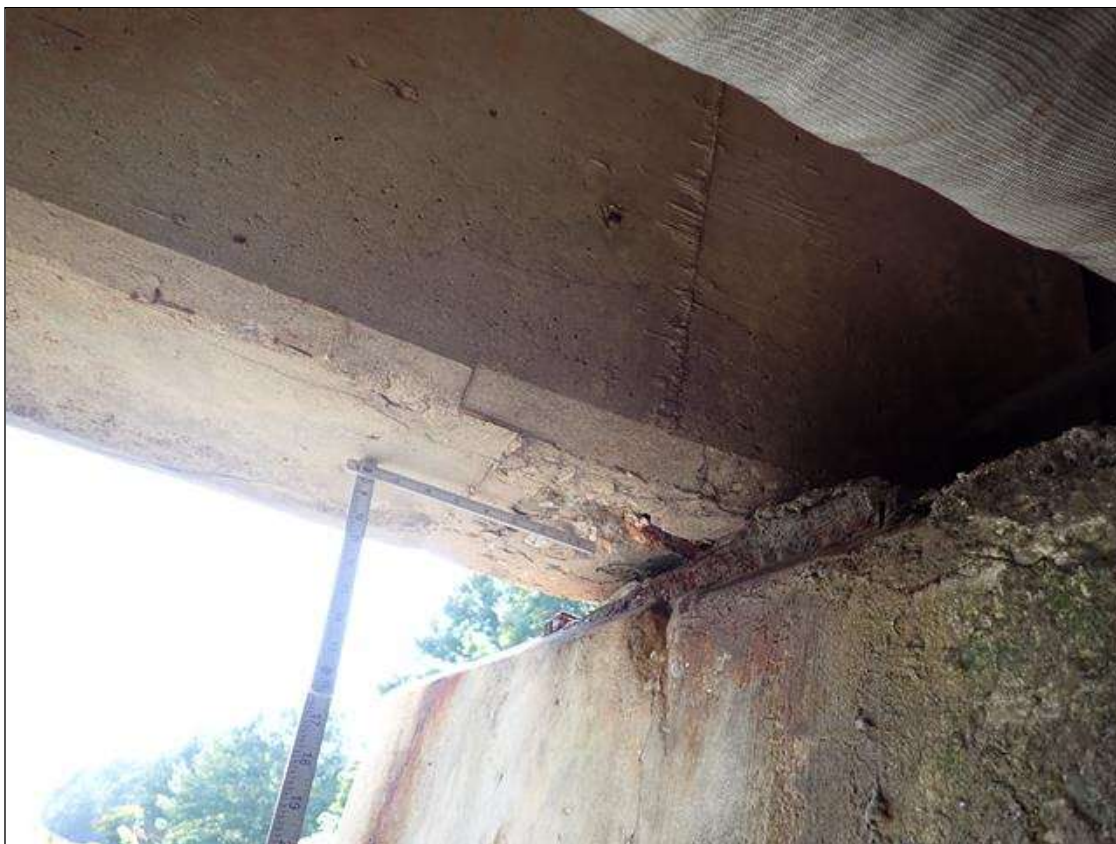
Span 2 Beam 10: underside at bent 1, spall/delamination [1.5 foot x full width x 1 inch deep] with exposed rusted rebar

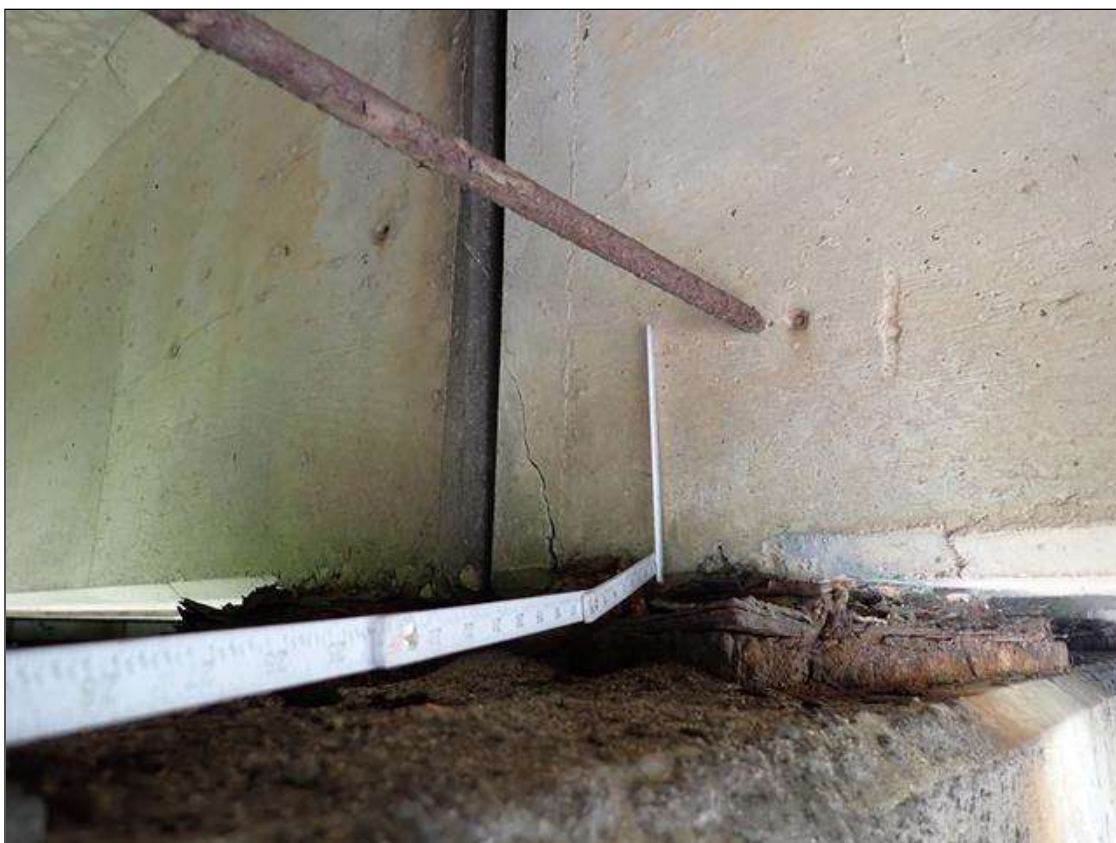
Span 2 Beam 9: at bent 1, delamination (9 inch x 3 inch) with cracks (up to 1/8 inch)

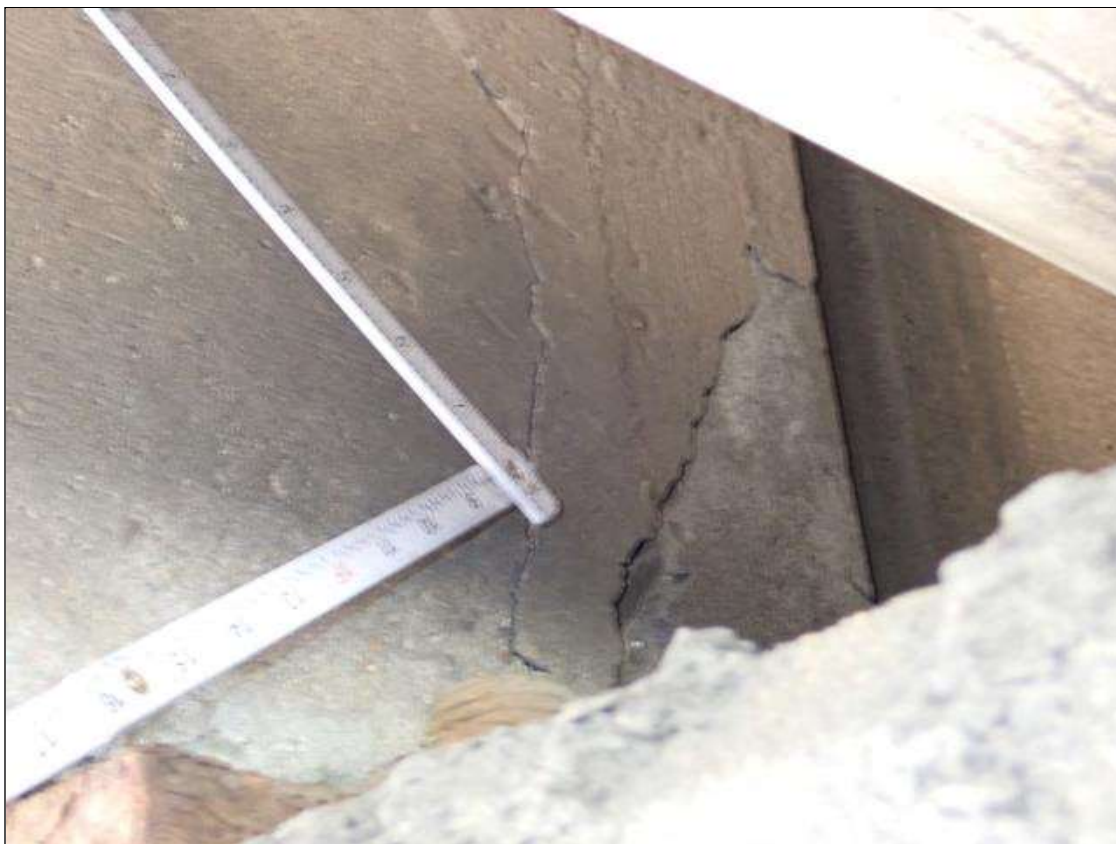
Span 2 Beam 9: at bent 1, west face, spall/delamination (8 inch x up to full height x 1 inch deep)

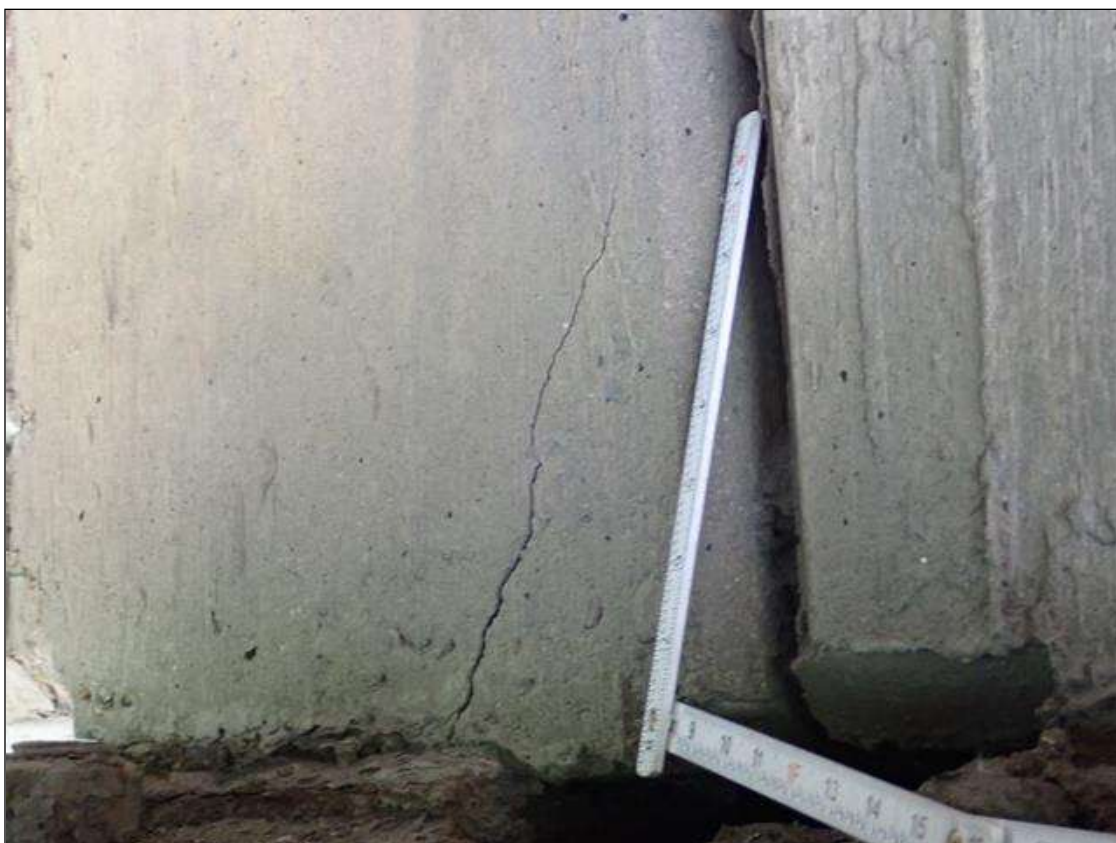
Span 1 Beam 7: at bent 1, both faces, delamination (up to 5 inch x 8 inch) with cracks (up to 1/8 inch)

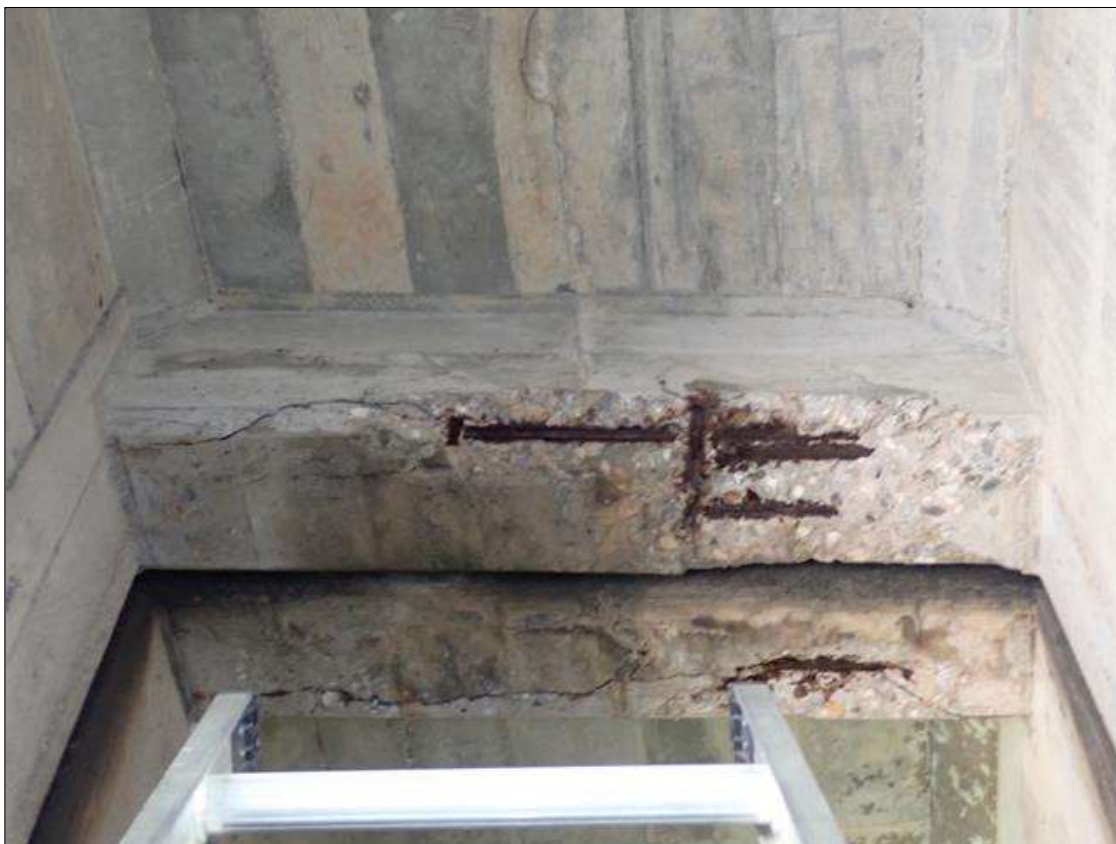
Span 2 Beam 5: (PAR) FULL LENGTH X FULL WIDTH X 8 INCH X 2 INCH DEEP SPALL WITH EXPOSED REINFORCING WITH APPROXIMATELY 25 PERCENT LOSS, IN BENT 1 DIAPHRAGM, BAY 5.

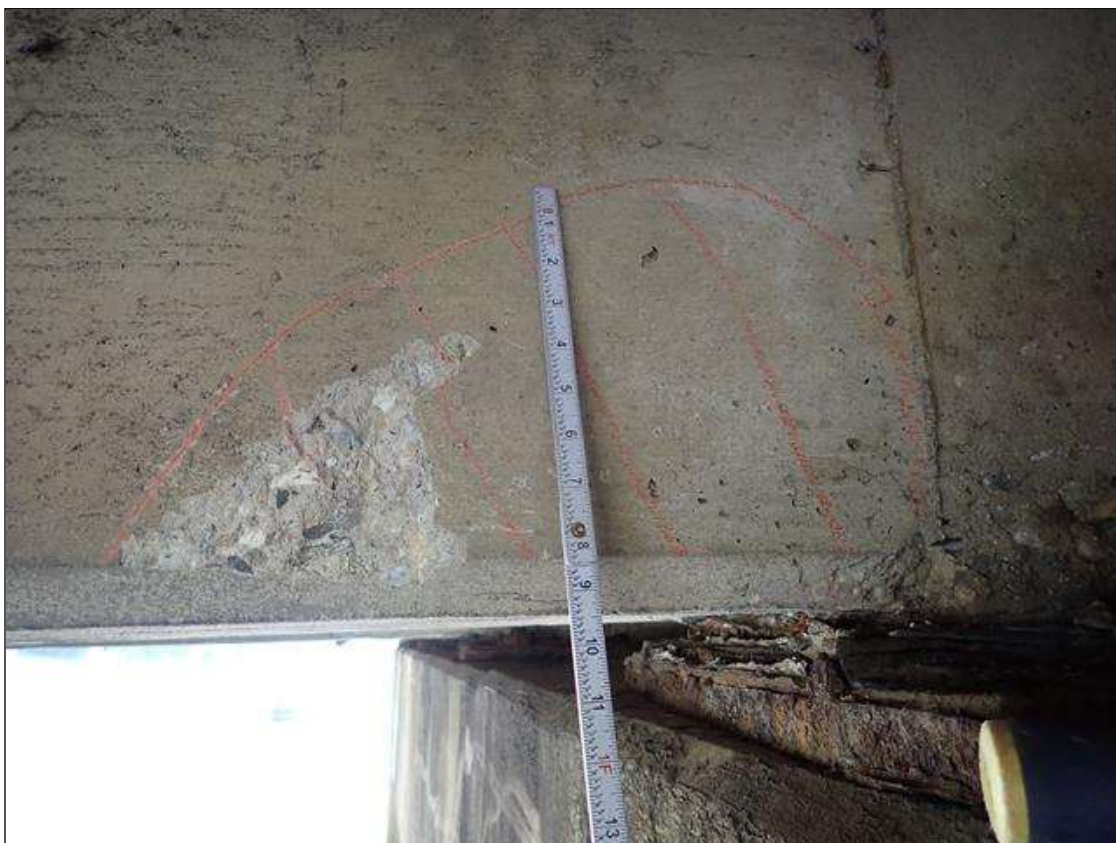
Span 2 Beam 6: at bent 1, west face, delamination/spall (18 inch x 9 inch x 1/2 inch deep)

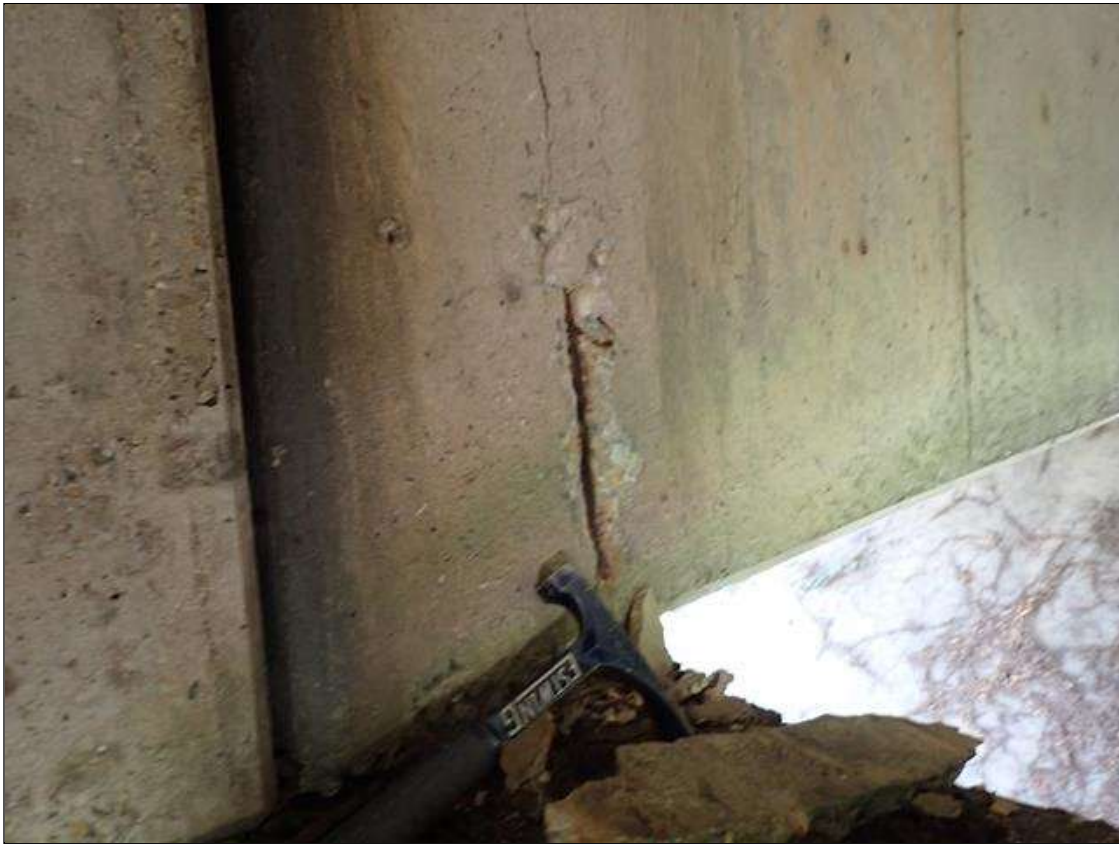
Span 1 Beam 6: (PAR) at bent 1, west face, spall/delamination (5 inch x 30 inch x 1/2 inch deep) with exposed rusted rebar (approximately 25 percent loss)

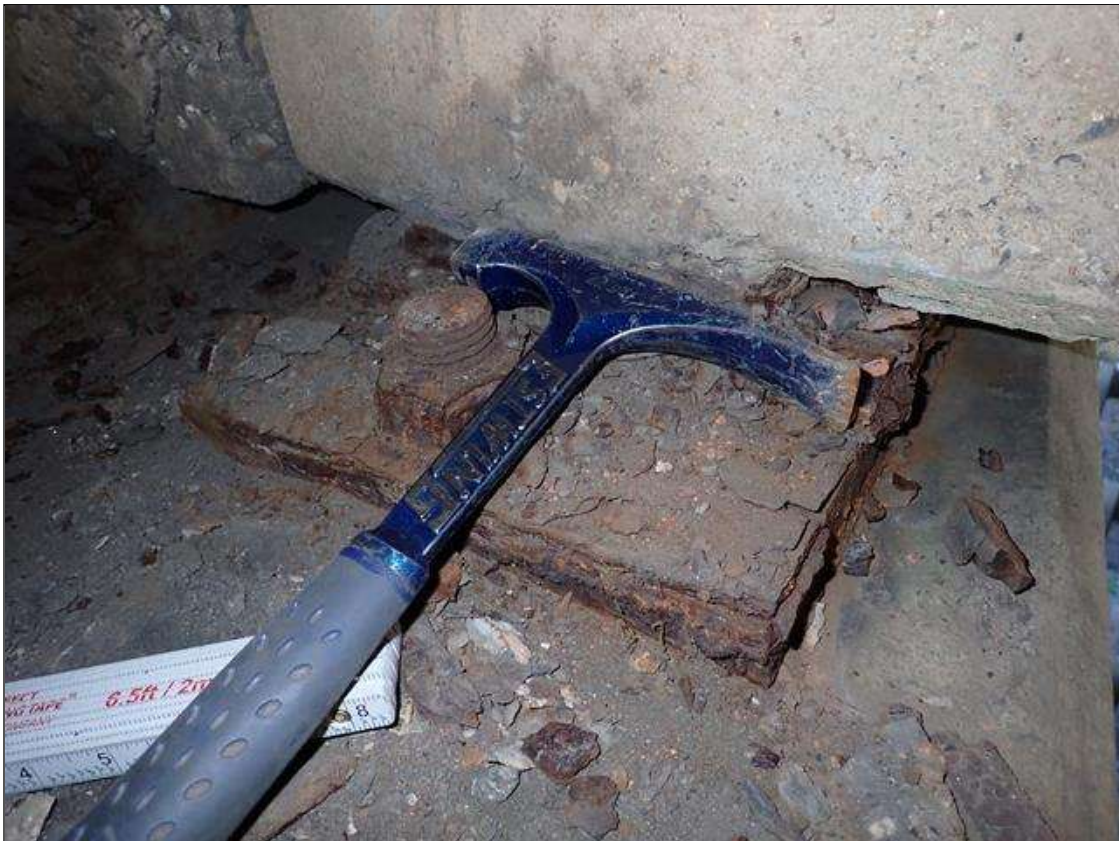
Span 2 Beam 5 - Near Bearing 5: active corrosion with section loss [up to 1/8 inch loss on plates]; anchor bolts, corrosion with section loss [approximately 75 percent remaining]

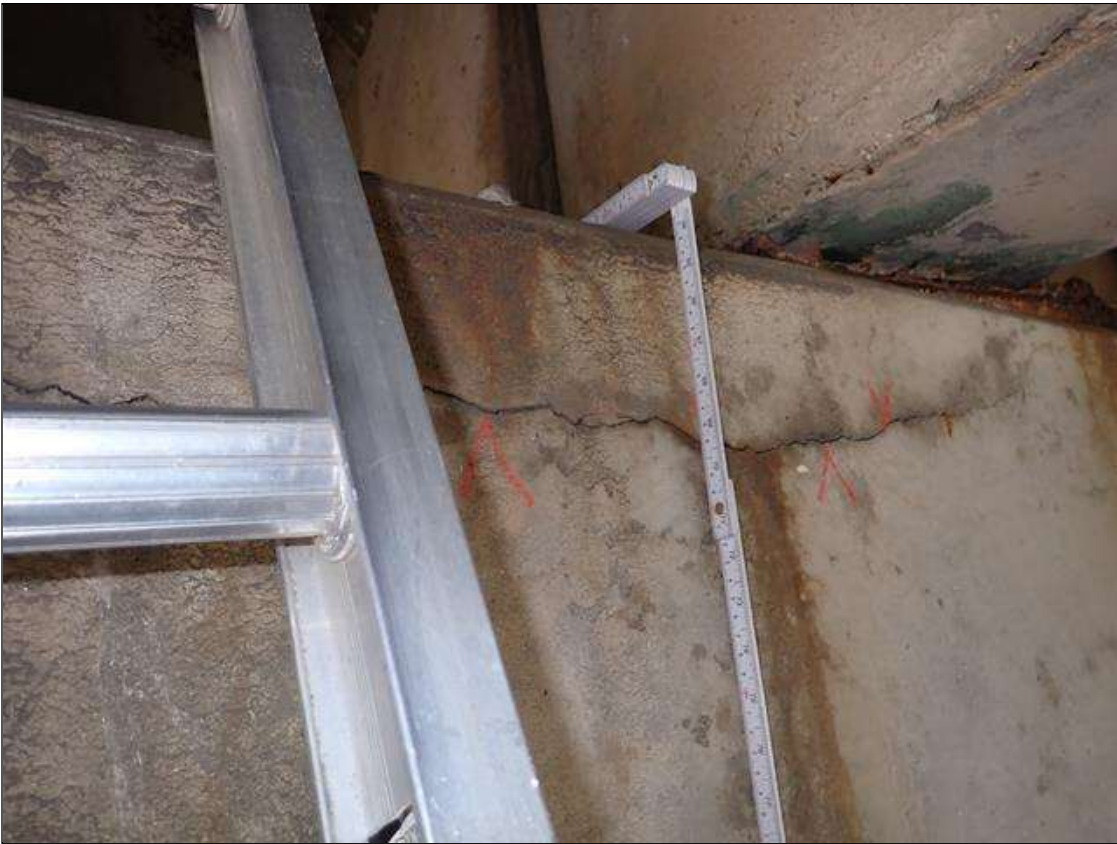
Bent 1 Cap 1: along the length of the cap, near top, longitudinal cracks (up to 1/16 inch x 8 foot) at random

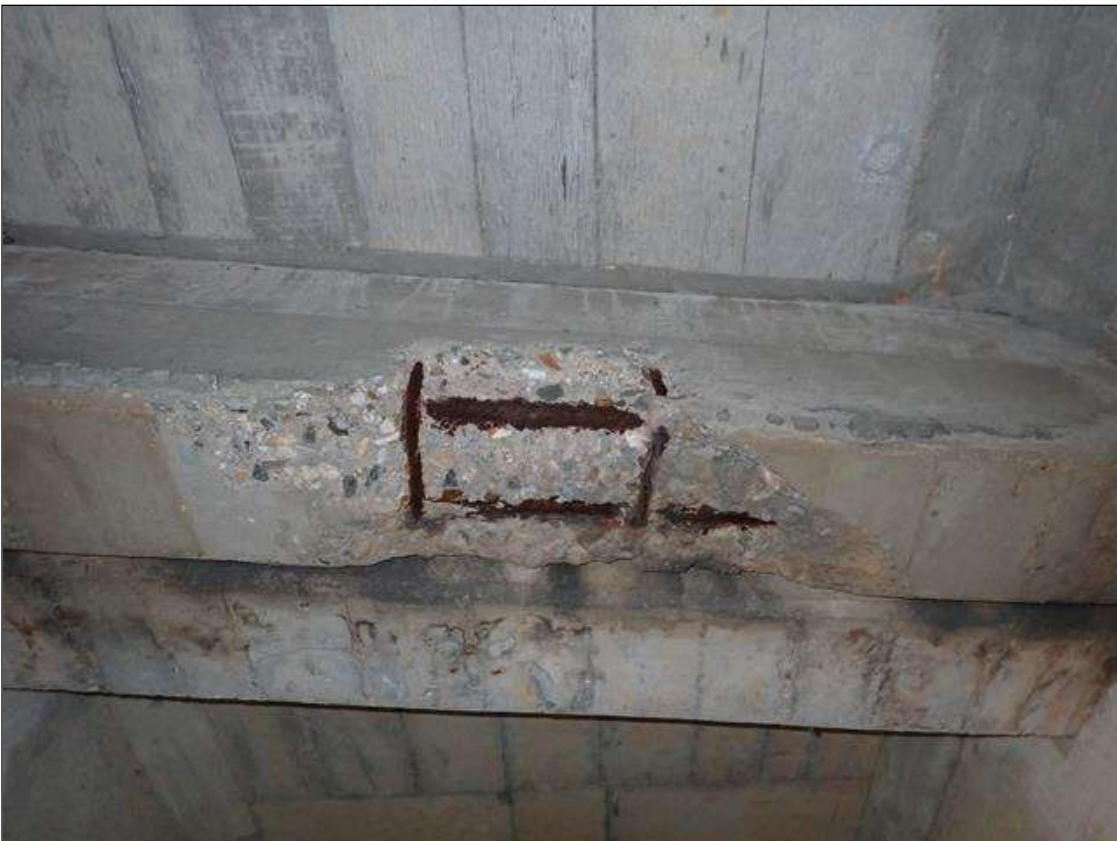
Span 2 Beam 3: (PAR) FULL LENGTH X FULL WIDTH X 8 INCH X 2 INCH DEEP SPALL/DELAMINATION WITH EXPOSED RUSTED REBAR WITH APPROXIMATELY 25 PERCENT LOSS IN BAY 3 DIAPHRAGM AT BENT 1.

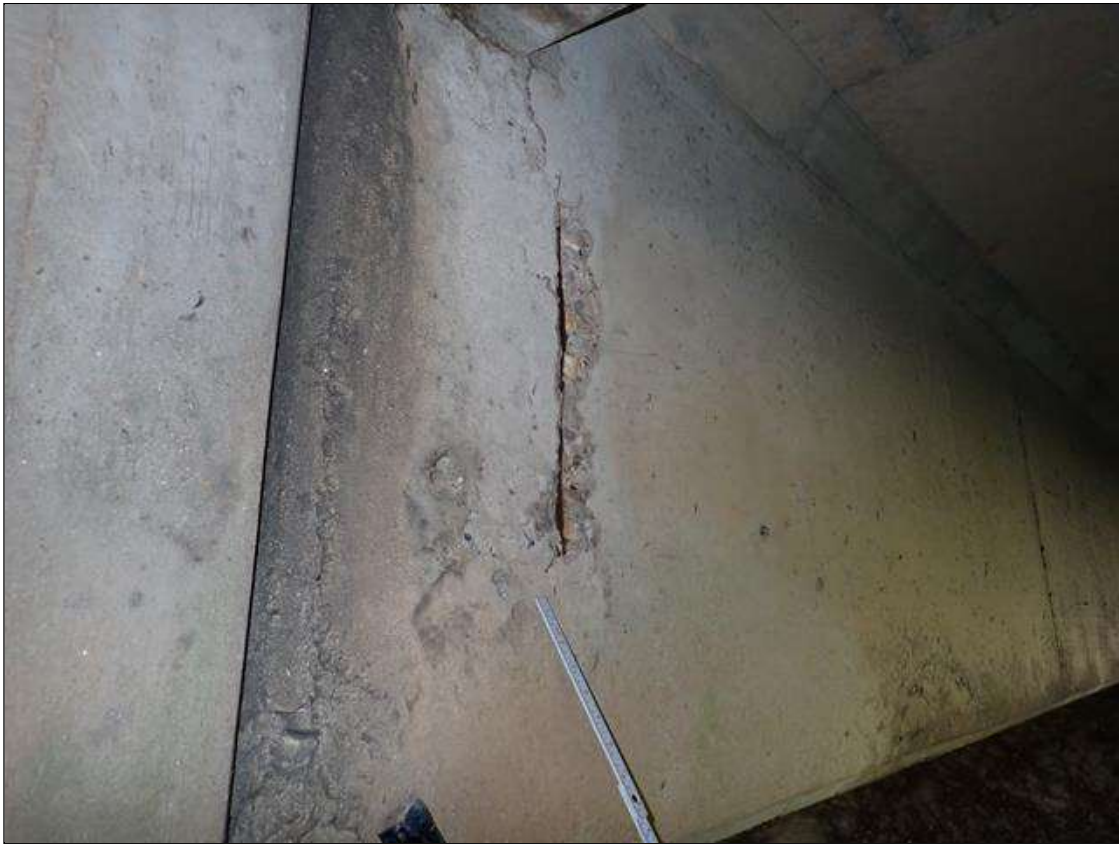
Span 1 Beam 3: (PAR) at bent 1, west face, spall/delamination (8 inch x 24 inch x 1/2 inch deep) with exposed rusted rebar with (approximately 25 percent loss)

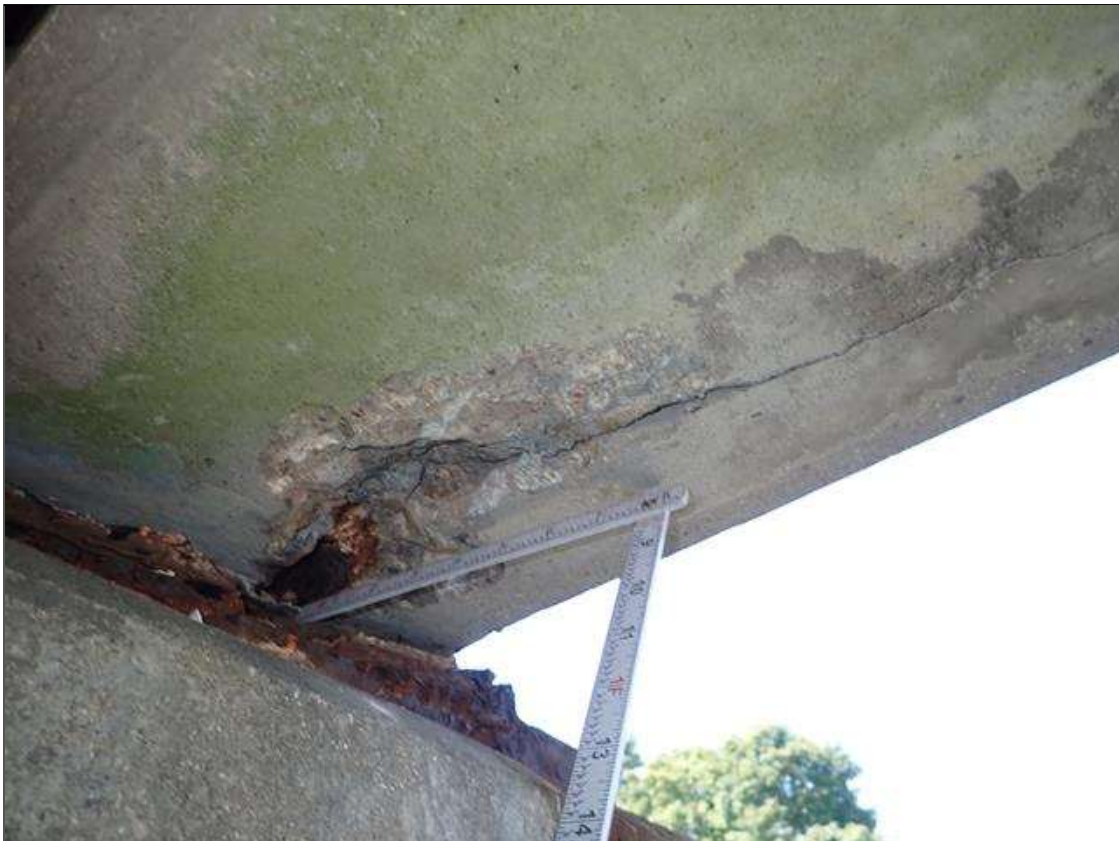
Span 2 Beam 1: at bent 1, underside, spall (9 inch x 4 inch x 1 inch deep) with exposed rusted rebar

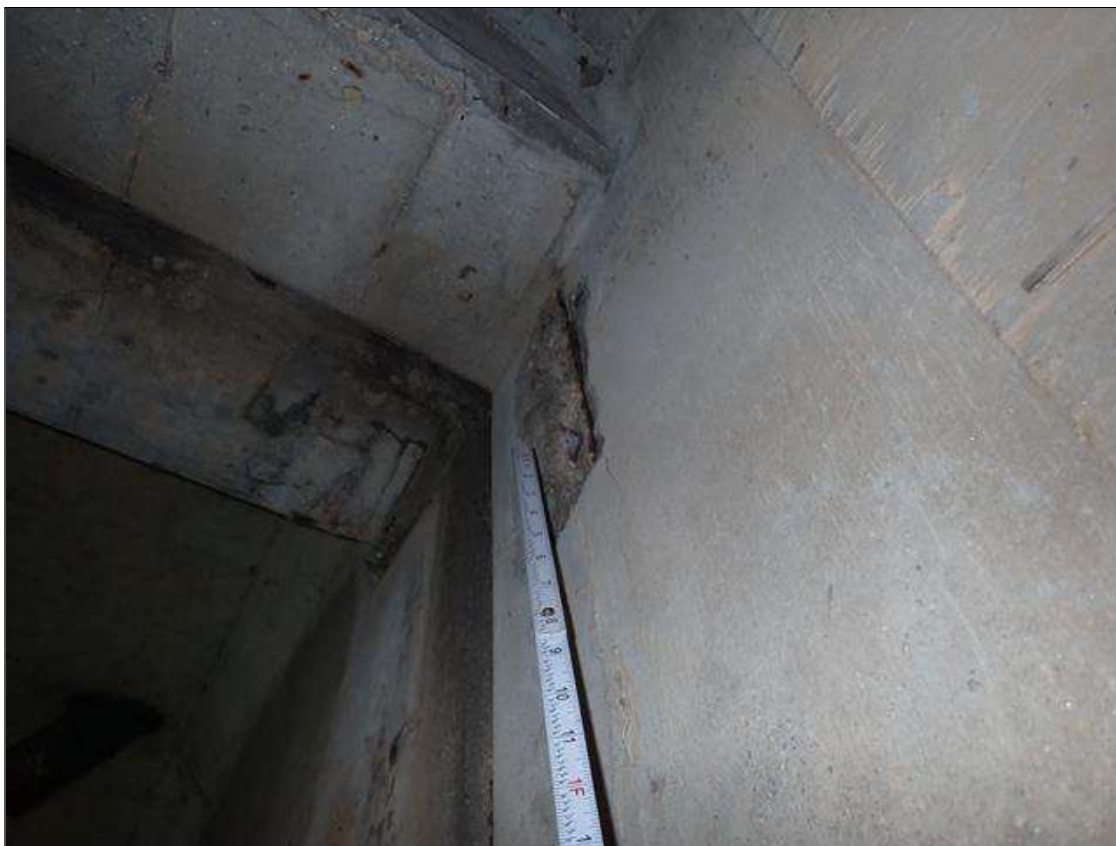
Span 2 Beam 1: at bent 1, east face, spall/delamination (6 inch x 11 inch x 1/2 inch deep) with exposed rusted rebar
