NC DEPARTMENT OF TRANSPORTATION
 DIVISION OF HIGHWAYS
 STRUCTURE MANAGEMENT UNIT

ATTENTION: **prompt action request; sketches revised; span 3 clearances revised**

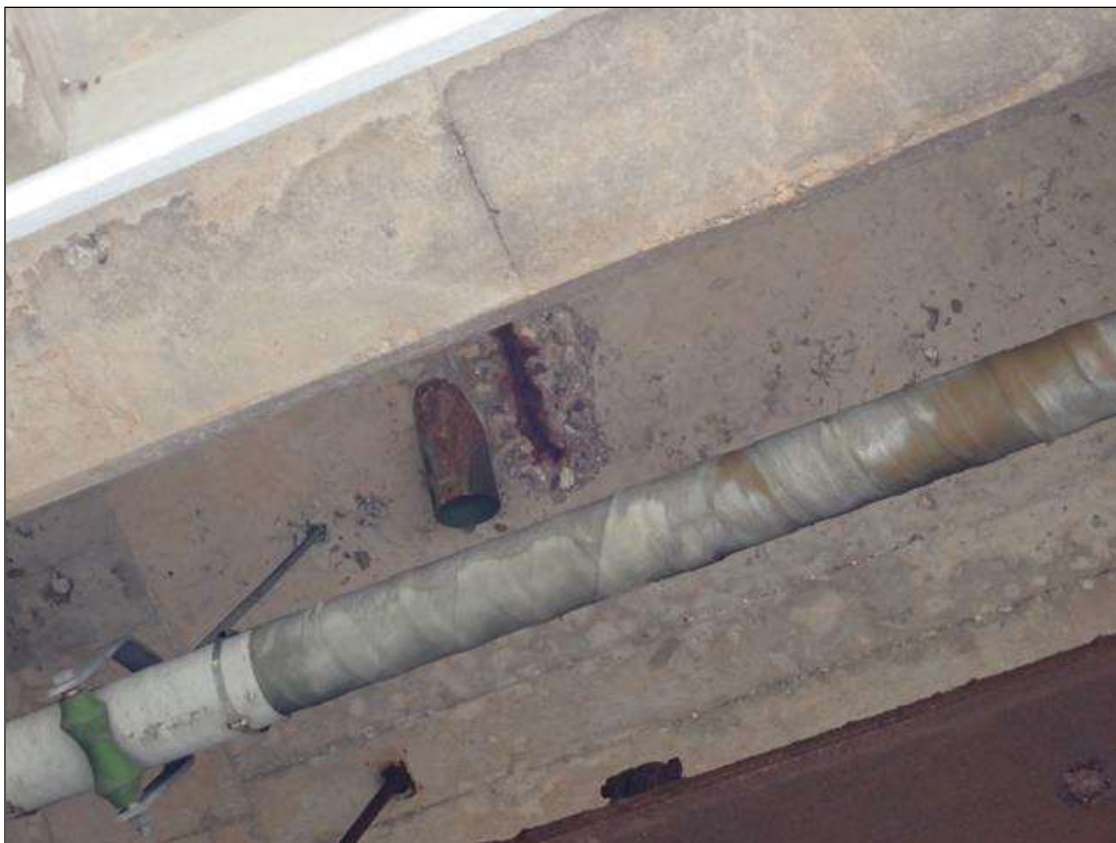
Span 2 Deck: (PAR) underside of deck in bay 9 near bent 1, (2) spalls (up to 18 inch x 1 foot x 1 inch deep) with exposed rusted rebar

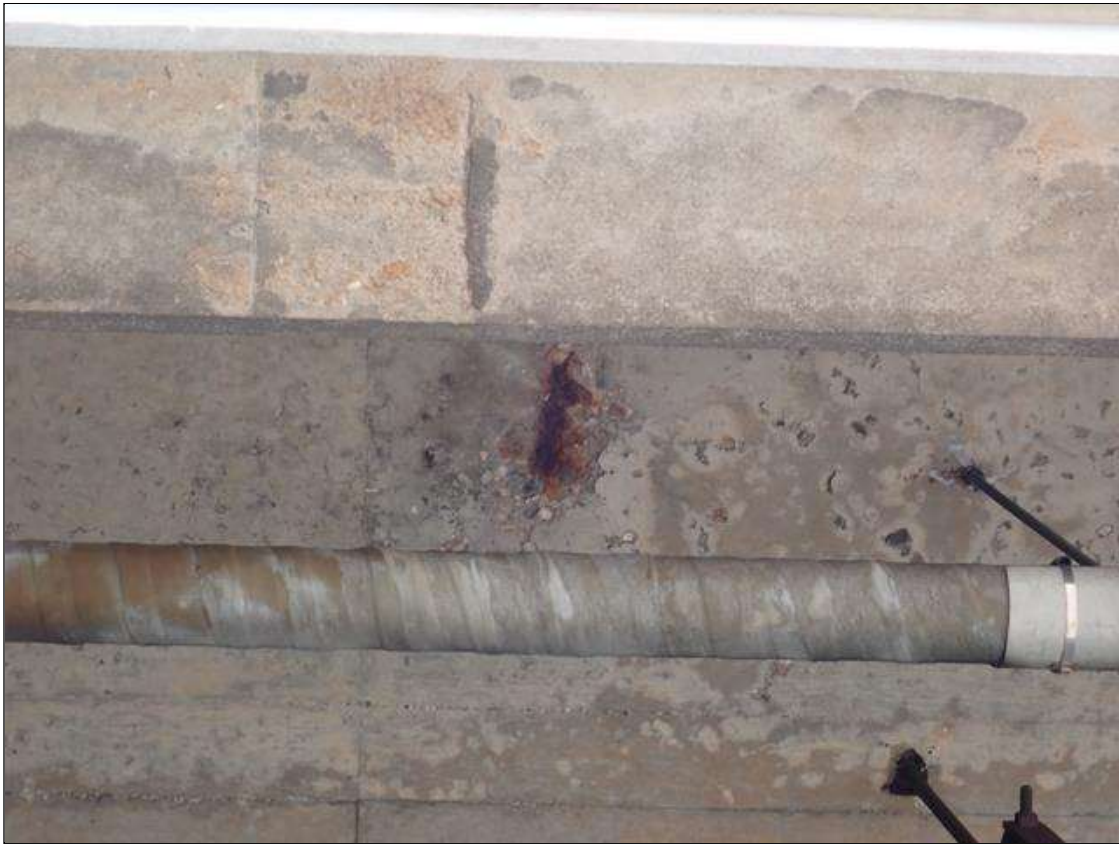
Span 2 Deck: (PAR) underside of deck in bay 9 near bent 1, (2) spalls (up to 18 inch x 1 foot x 1 inch deep) with exposed rusted rebar

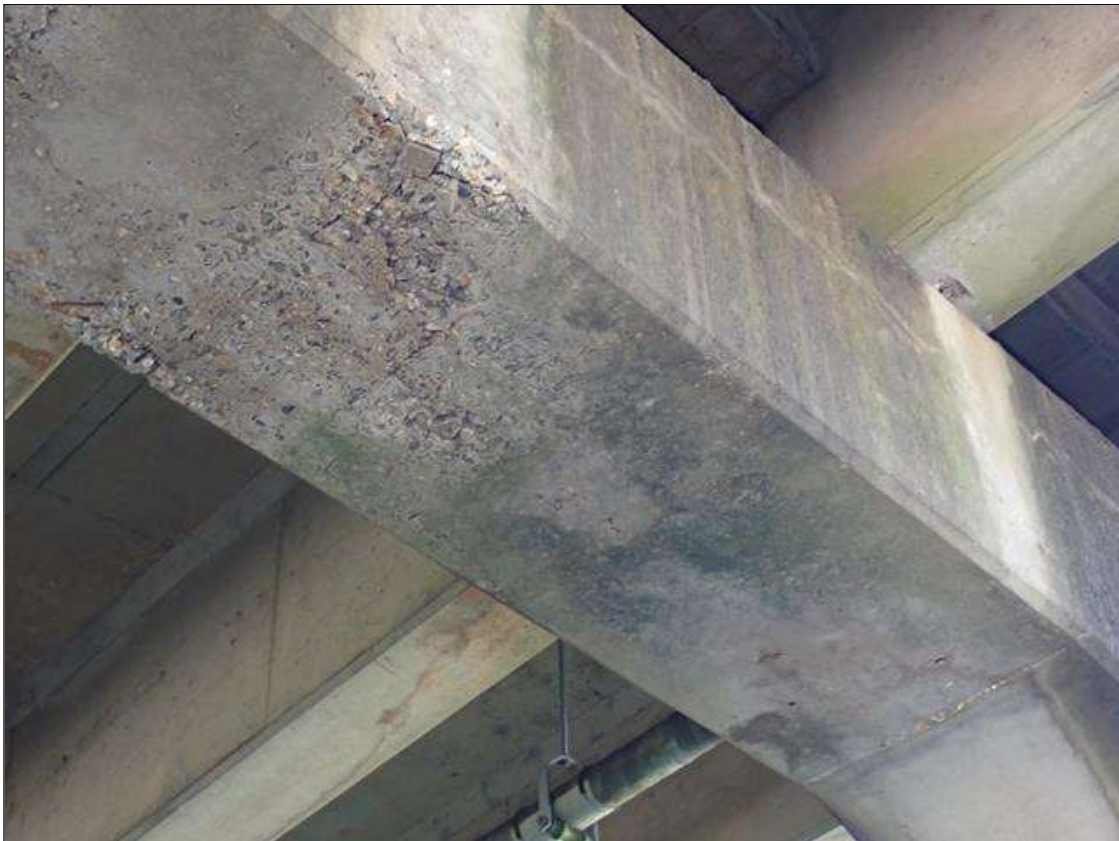
Bent 1 Cap 1: (PAR) underside of cap between columns, delaminations (up to 10 foot x full width) extending into vertical faces (up to 1 foot) with cracks (up to 1/8 inch) with rust stains

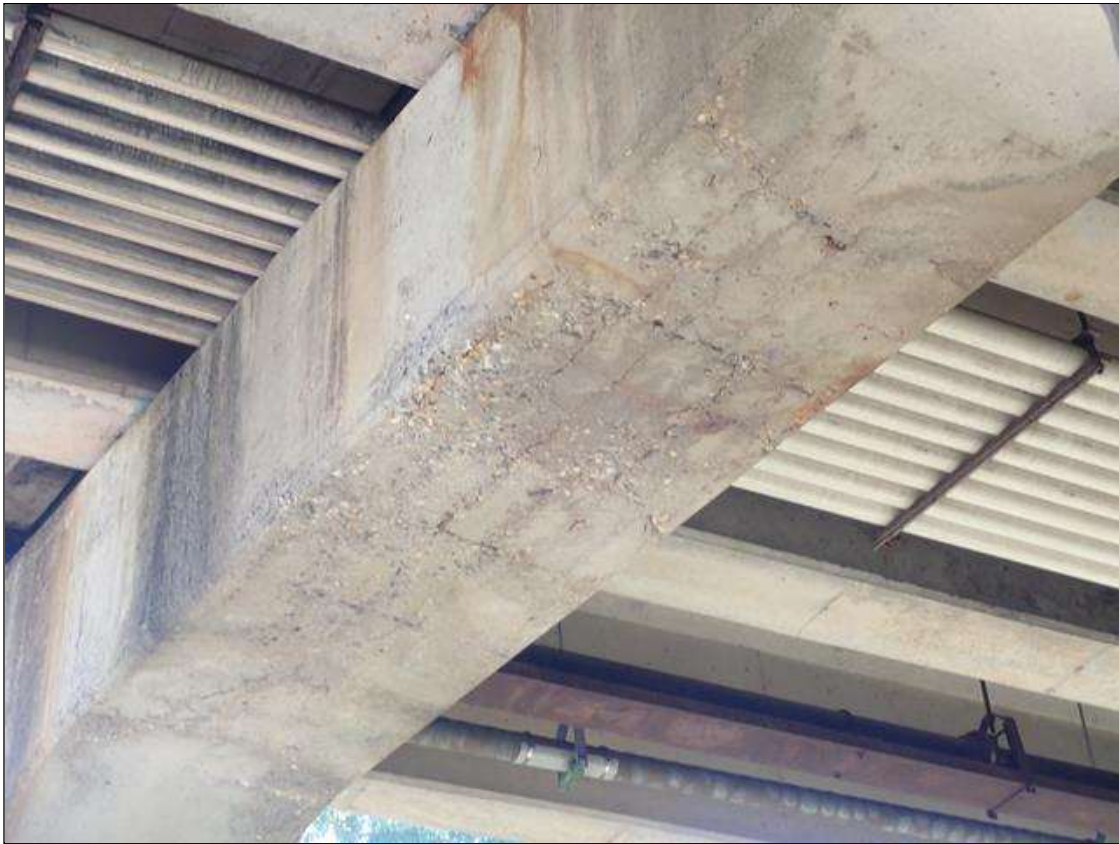
Bent 1 Cap 1: (PAR) underside of cap between columns, delaminations (up to 10 foot x full width) extending into vertical faces (up to 1 foot) with cracks (up to 1/8 inch) with rust stains

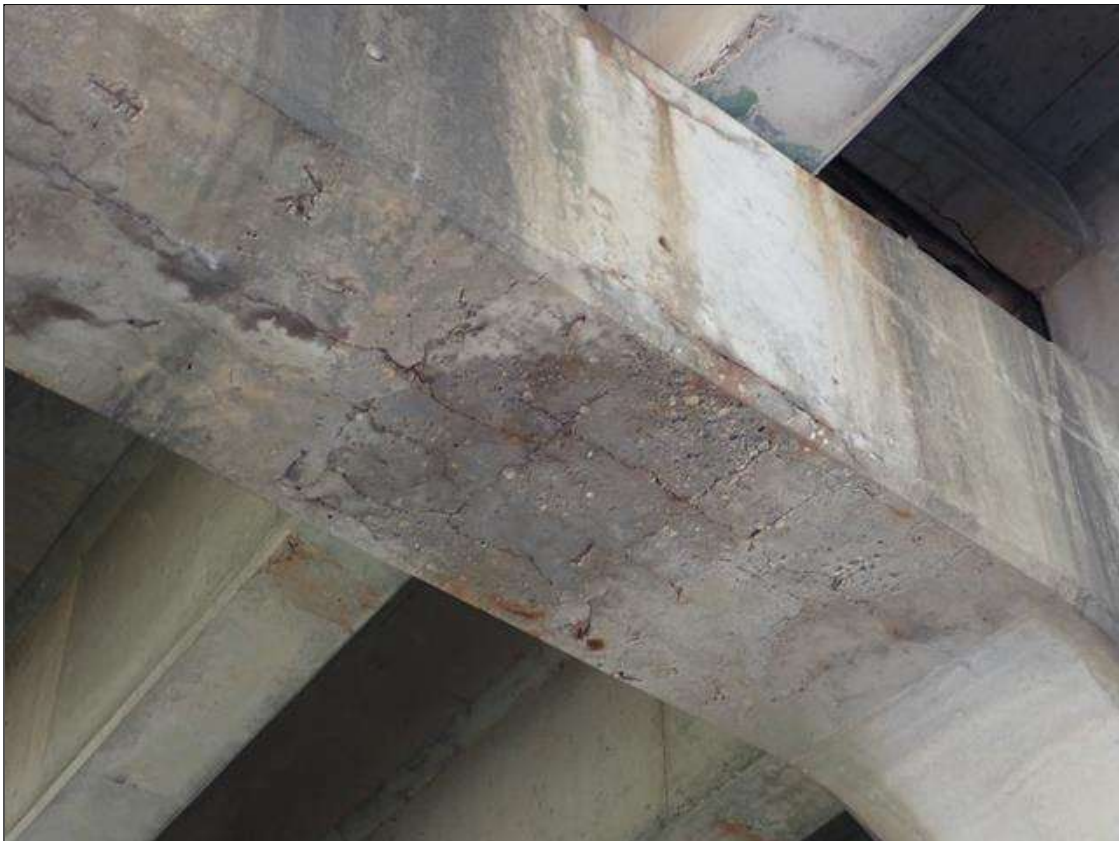
Bent 1 Cap 1: (PAR) underside of cap between columns, delaminations (up to 10 foot x full width) extending into vertical faces (up to 1 foot) with cracks (up to 1/8 inch) with rust stains

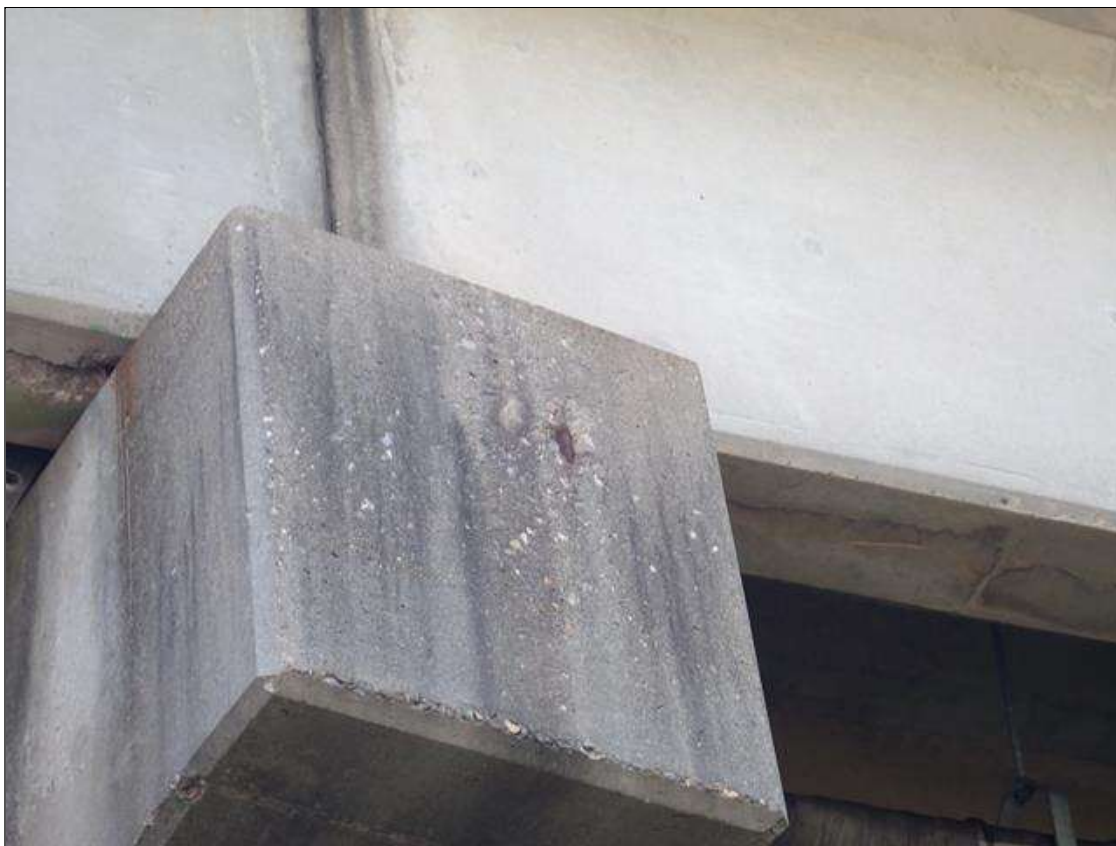
Bent 1 Cap 1: West face, spall [4 inch diameter x 1/2 inch] with exposed rusted reinforcing [no loss noted]

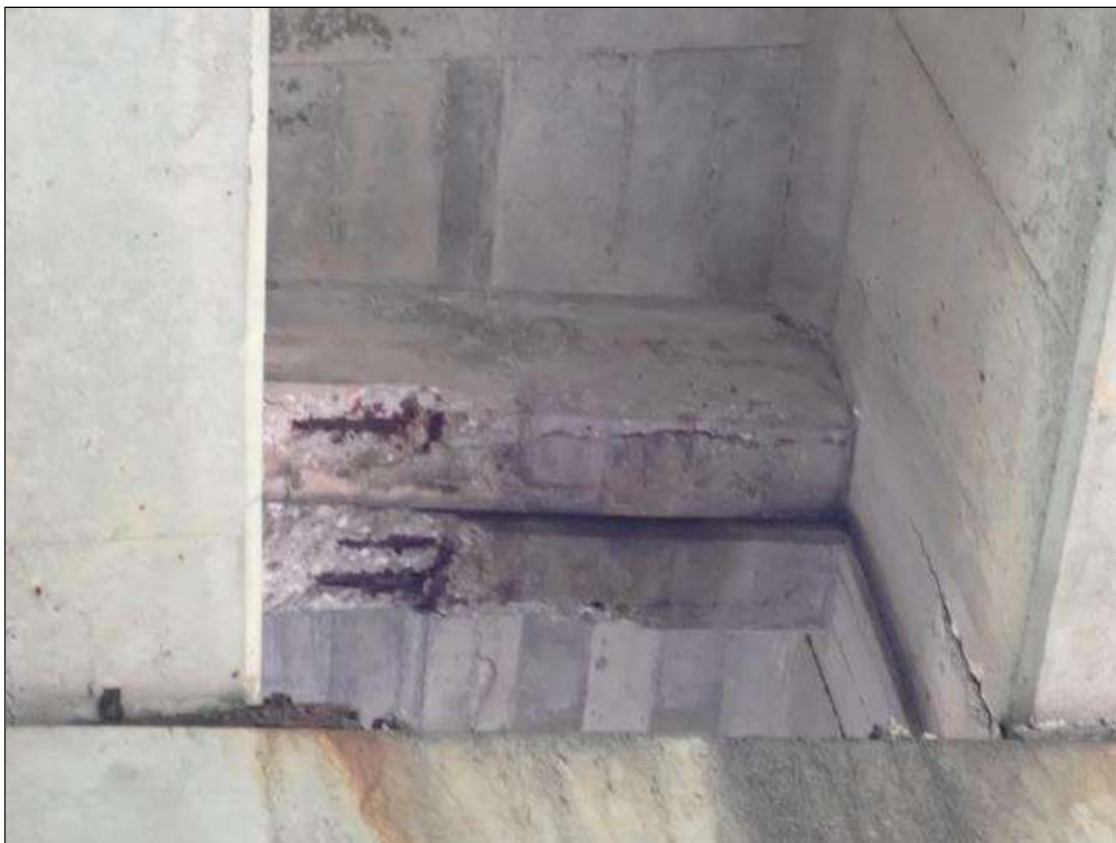
Span 1 Beam 5: (PAR) at bent 1, bay 5 end diaphragm, spall/delamination (full length x full width x up to full height x 1 inch deep) with exposed rusted rebar (approximately 25 percent loss)

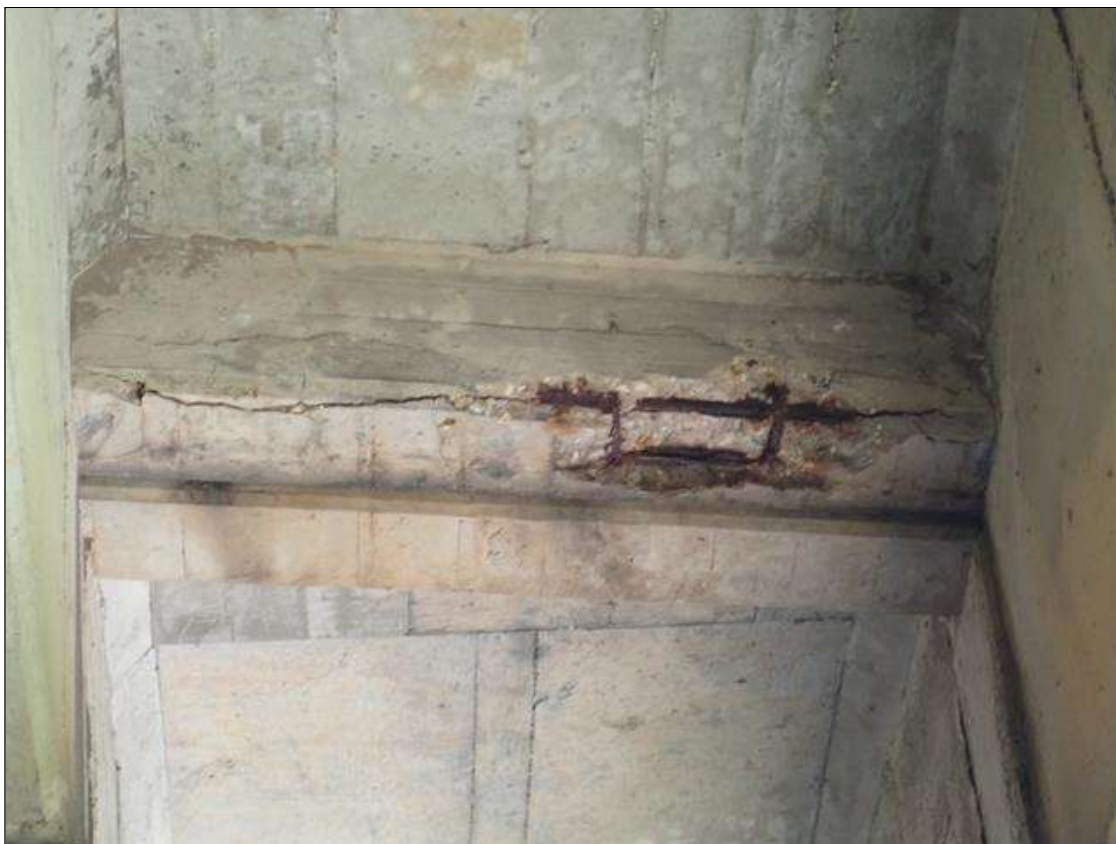
Span 1 Beam 7: (PAR) at bent 1, bay 7 end diaphragm, spall/delamination (full length x full width x up to full height x 1 inch deep) with exposed rusted rebar (approximately 25 percent loss)

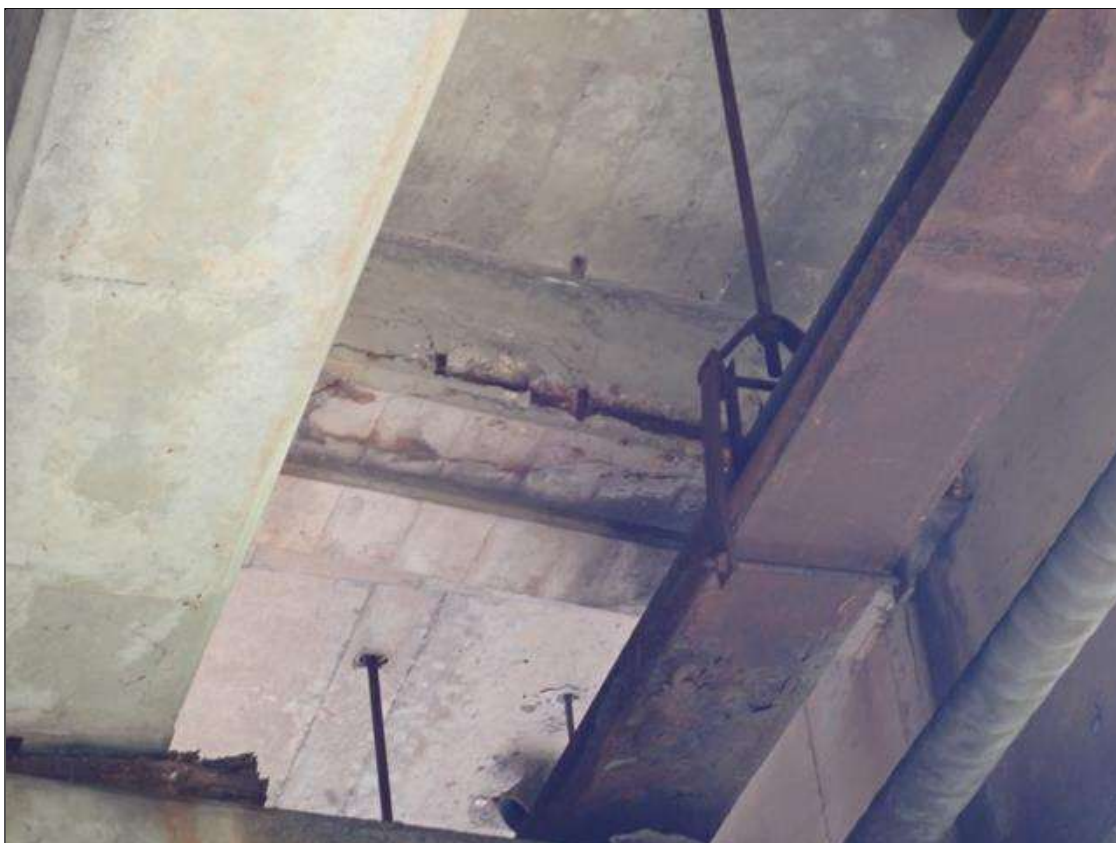
Span 1 Beam 9: (PAR) at bent 1, bay 9 end diaphragm, spall/delamination (full length x full width x up to full height x 1 inch deep) with exposed rusted rebar (approximately 25 percent loss)

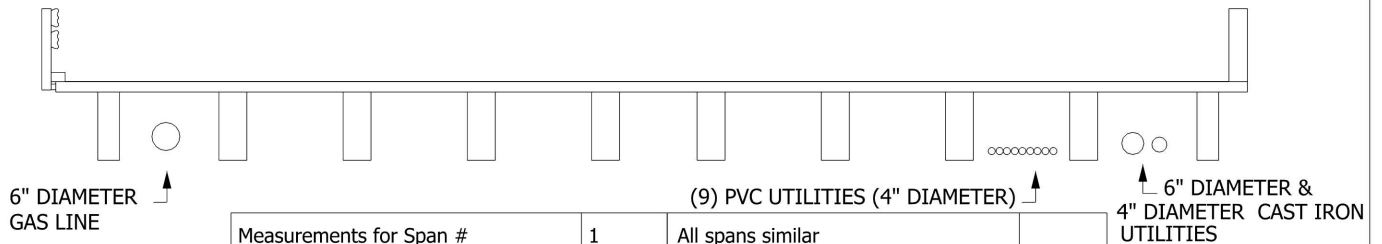
Measurements for Span #	1	All spans similar	
Deck Thickness	6.75in	Left Overhang	3.5ft
Top of Rail to Bottom of Beam (Avg)	8.146ft	Right Overhang	3.333ft

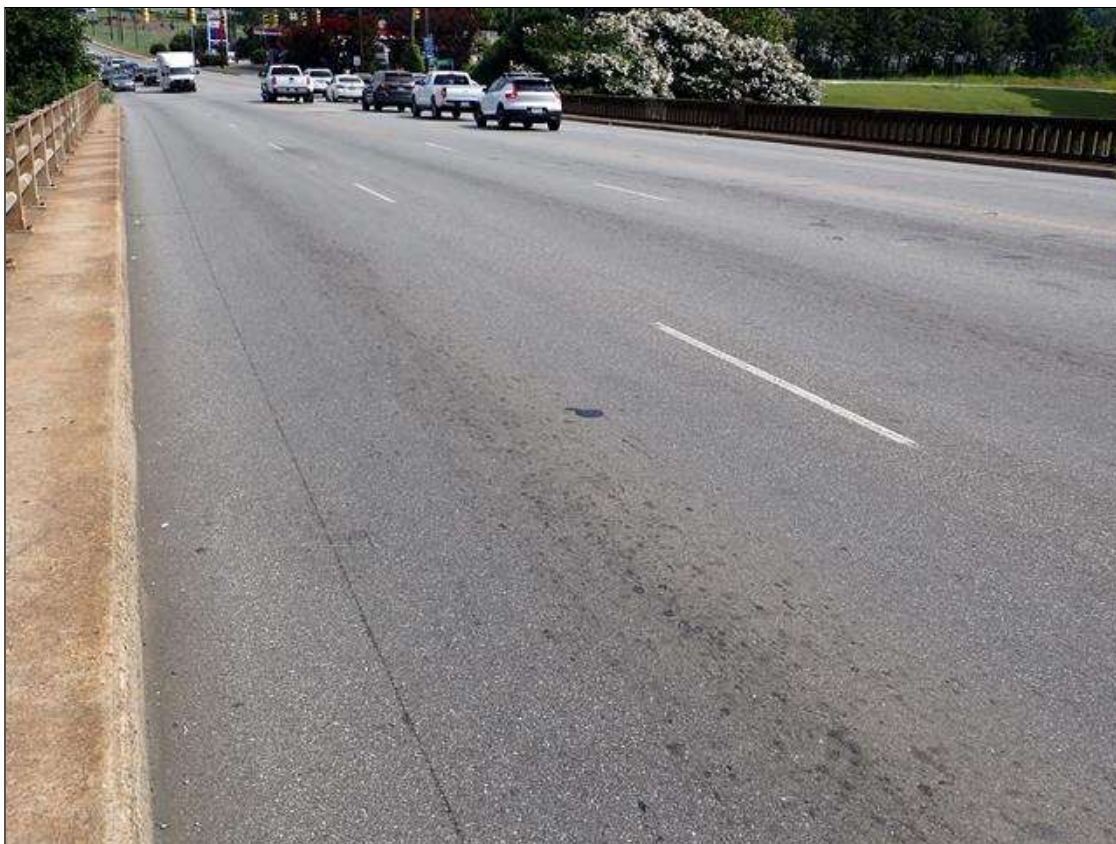
asphalt wearing surface

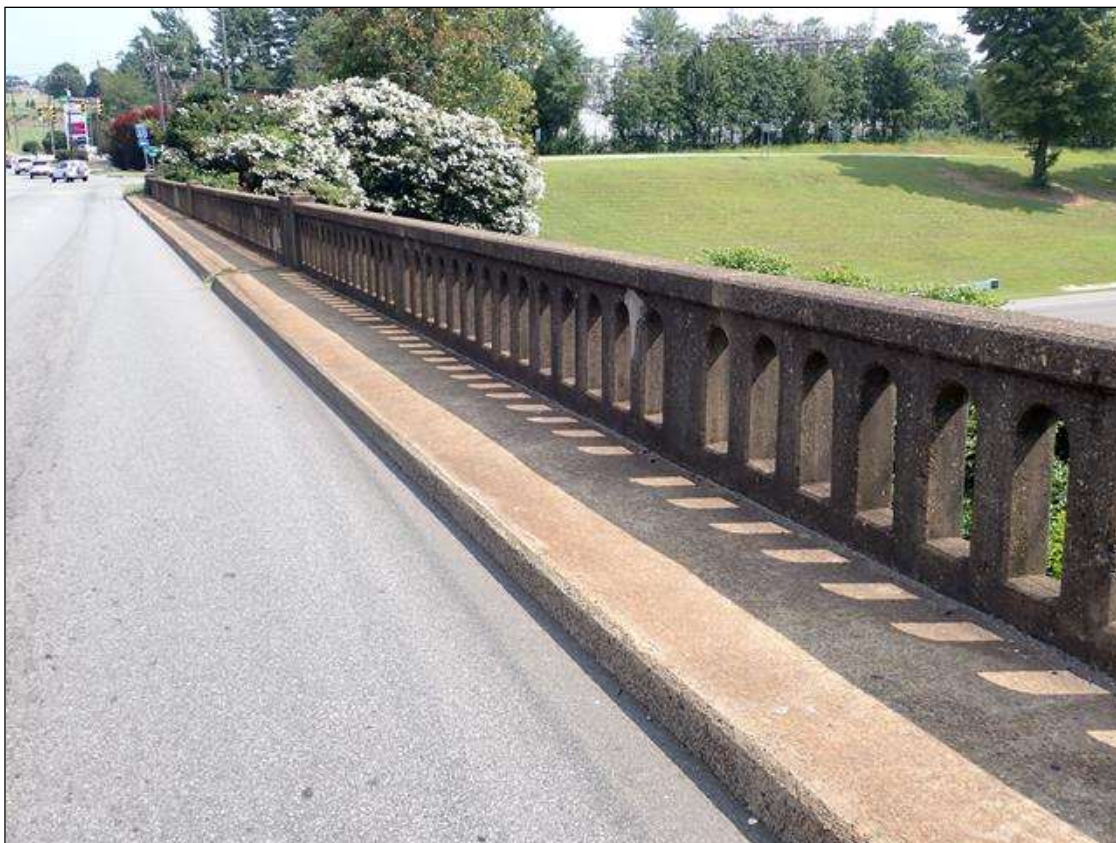
right bridge rail and sidewalk
