NC DEPARTMENT OF TRANSPORTATION
 DIVISION OF HIGHWAYS
 STRUCTURE MANAGEMENT UNIT

ATTENTION: prompt action request; sketches updated; clearance revised

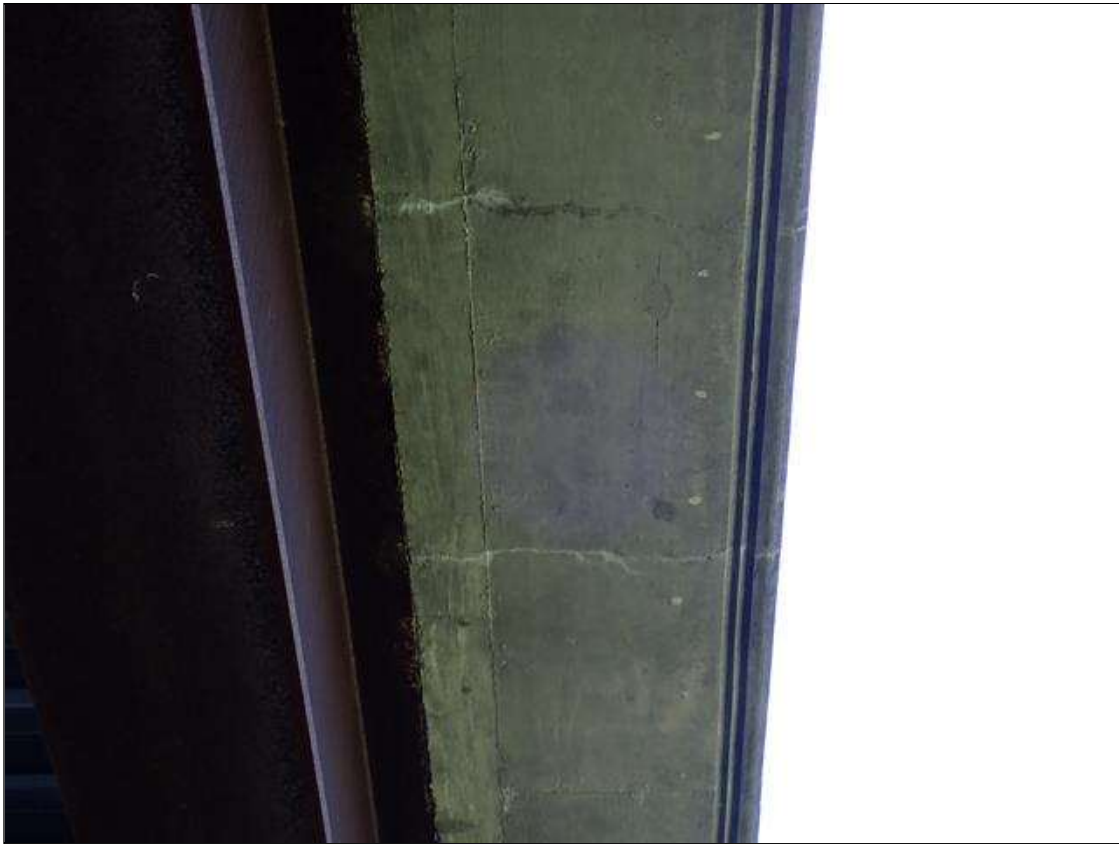
Span 2 Deck: underside of deck, both overhangs, transverse cracks (up to 1/32 inch x full width) some with efflorescence

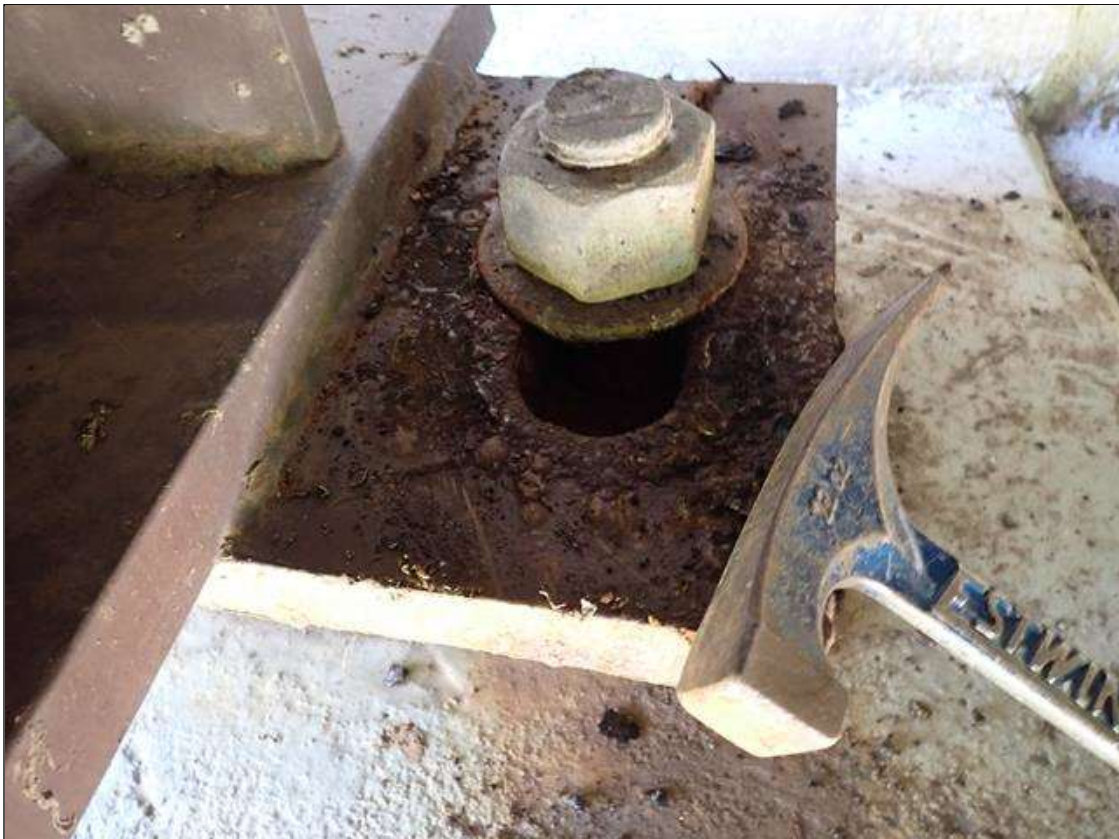
Span 1 Beam 1 - Far Bearing 1: rust scale (no measurable loss)

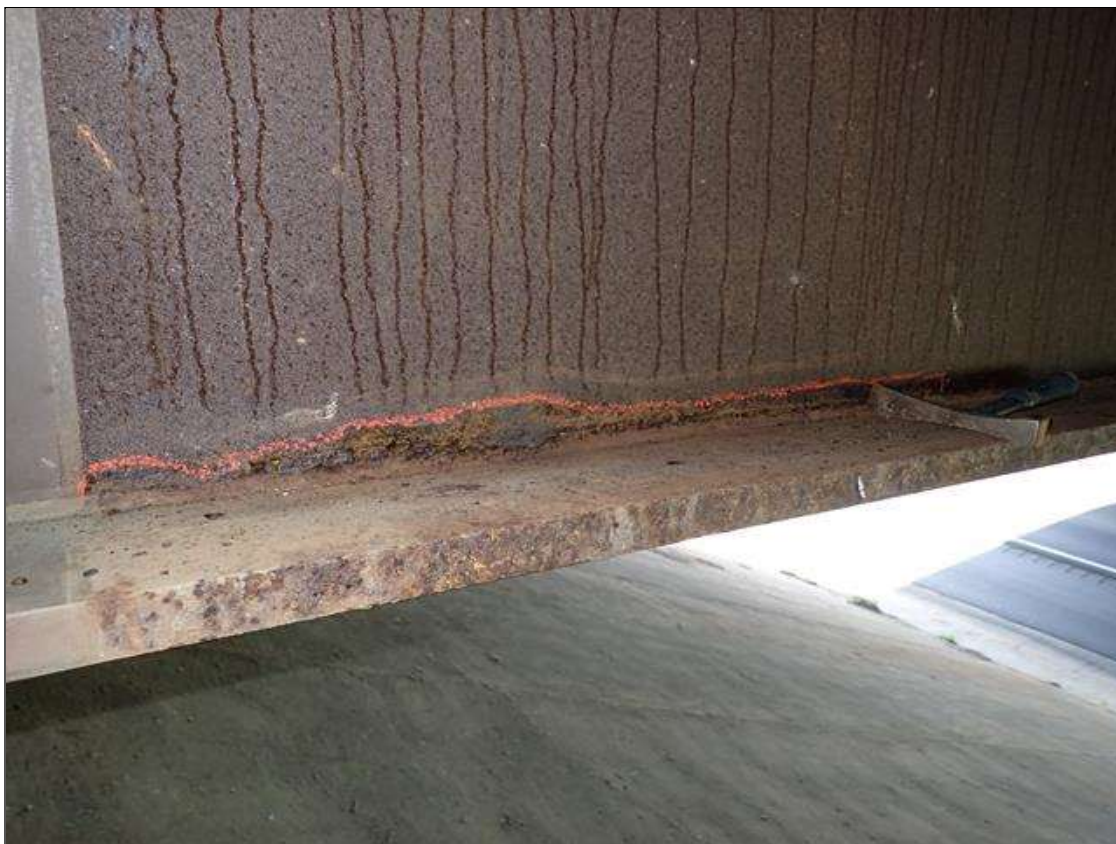
Span 1 Beam 2: (PAR) 6.5 foot from end bent 2, corrosion with section loss: lower web (3/8 inch average remaining x 34 inch x 2 inch); bottom flange, rust scale (9 foot)

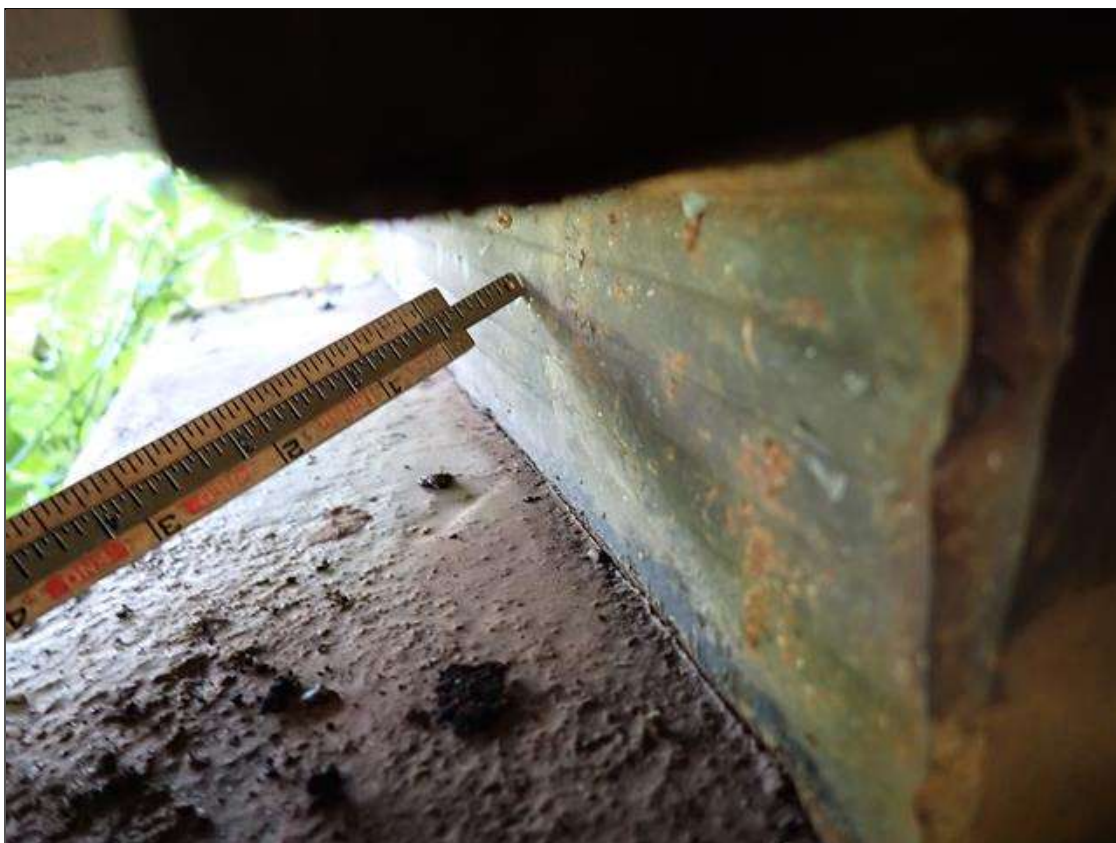
Span 1 Far Bearing 1: south face, bulging (up to 1/16 inch high)

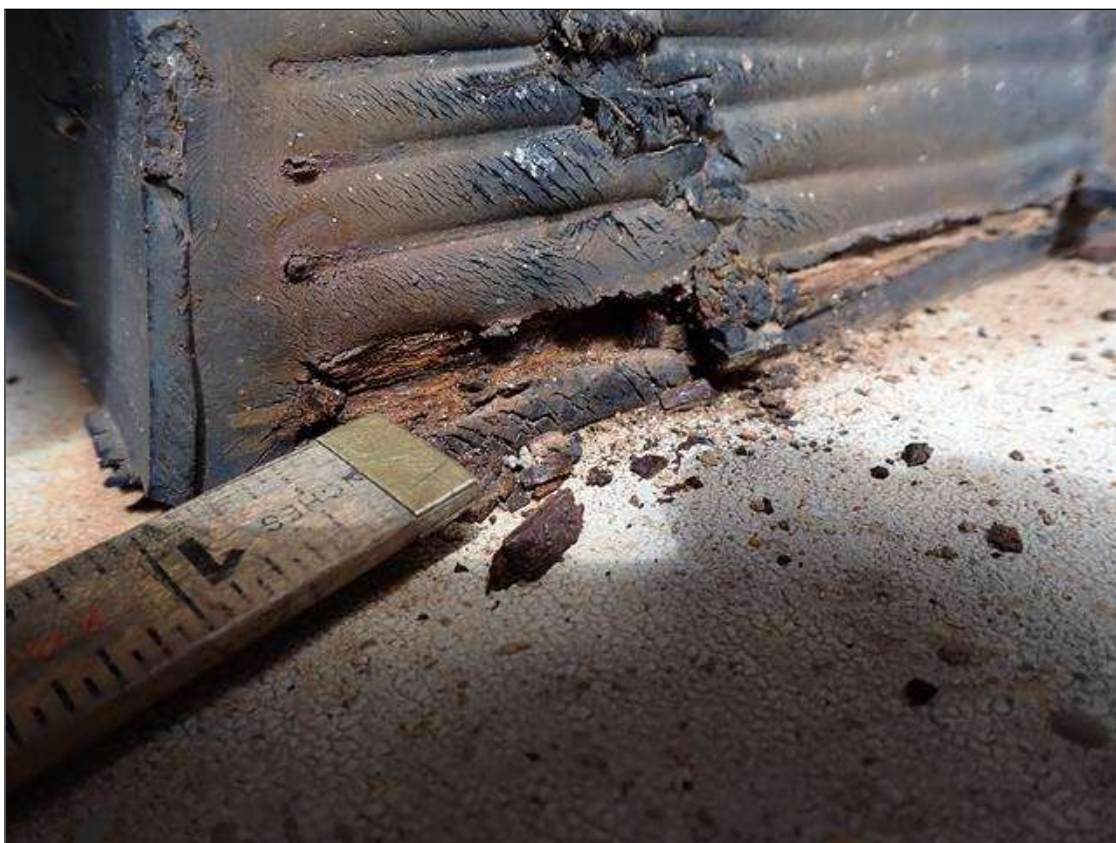
Span 1 Far Bearing 6: (PAR) east face, bulging (up to 1/8 inch high) with tear (10 inch x 1/4 inch wide) exposing steel plate; steel plate, rust scale; southeast corner, loss of bearing (1 inch x 1.5 inch)

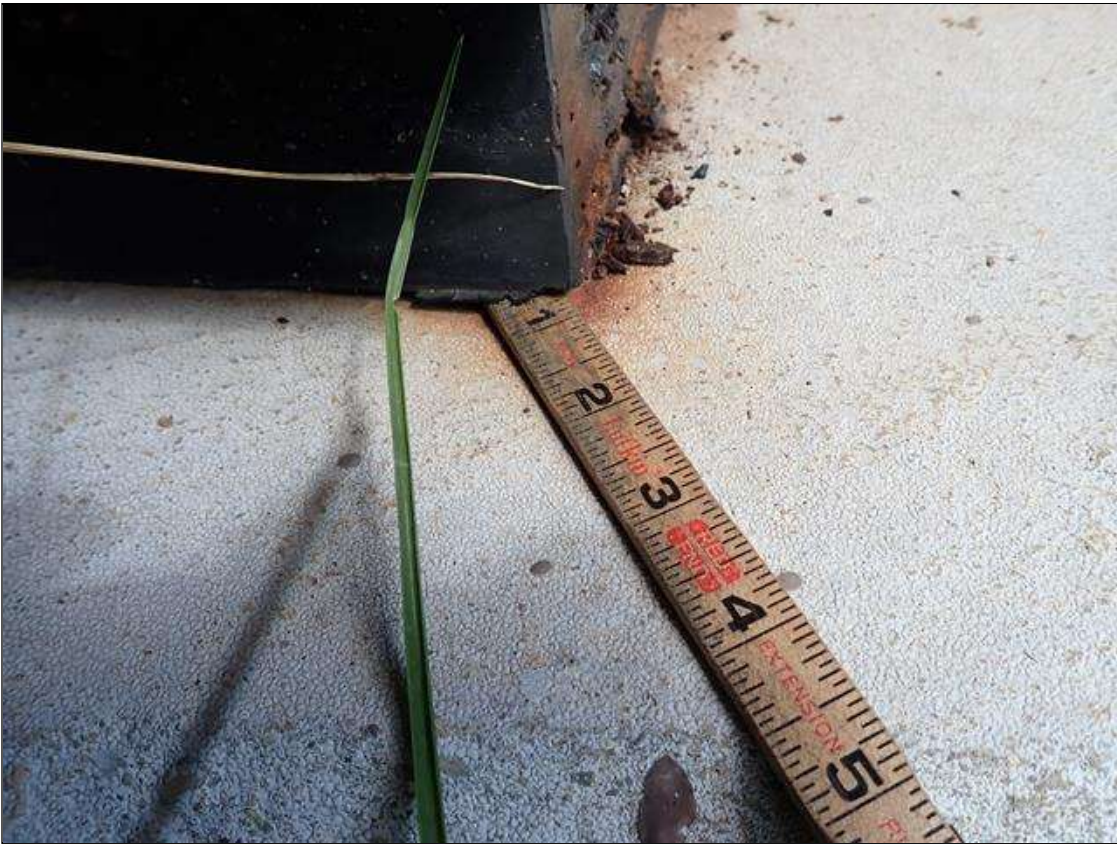
Span 1 Far Bearing 6: (PAR) east face, bulging (up to 1/8 inch high) with tear (10 inch x 1/4 inch wide) exposing steel plate; steel plate, rust scale; southeast corner, loss of bearing (1 inch x 1.5 inch)

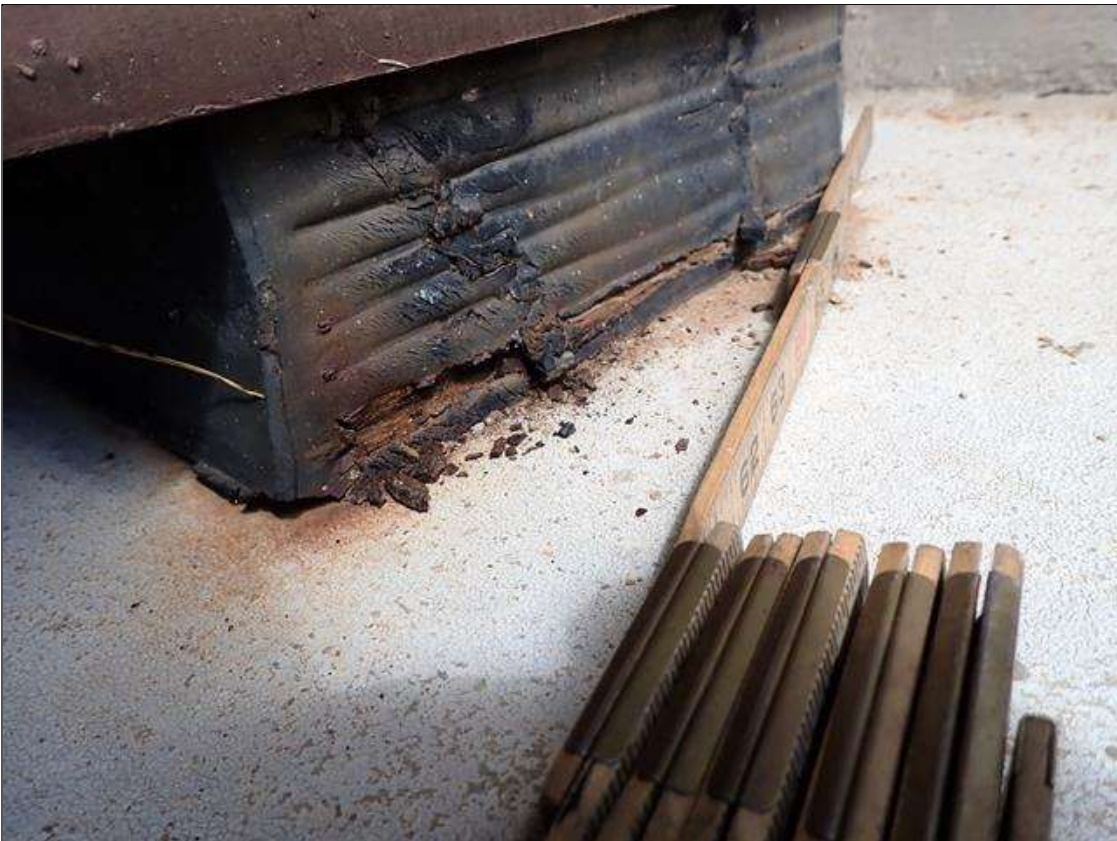
Span 1 Far Bearing 6: (PAR) east face, bulging (up to 1/8 inch high) with tear (10 inch x 1/4 inch wide) exposing steel plate; steel plate, rust scale; southeast corner, loss of bearing (1 inch x 1.5 inch)

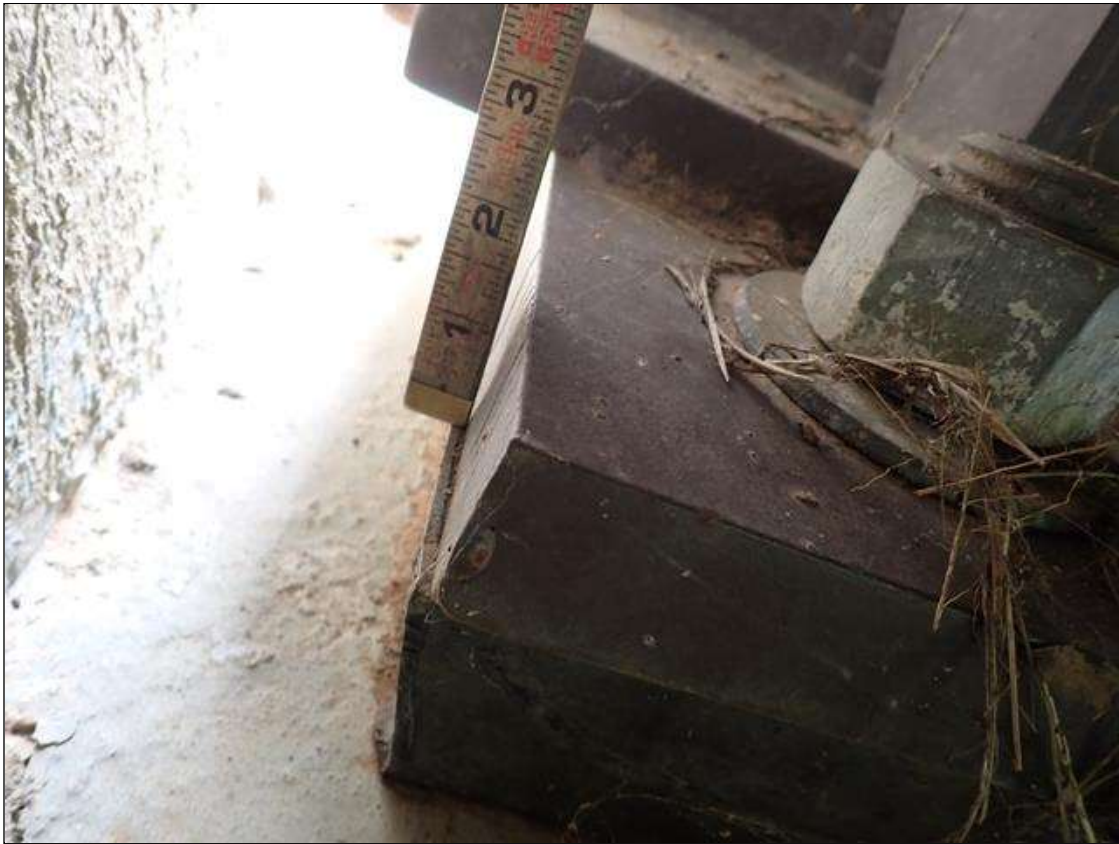
Span 1 Far Bearing 6: bearing is in expanded position (up to 1/2 inch); bearing pad, not flush with bearing plate (up to 1/8 inch)

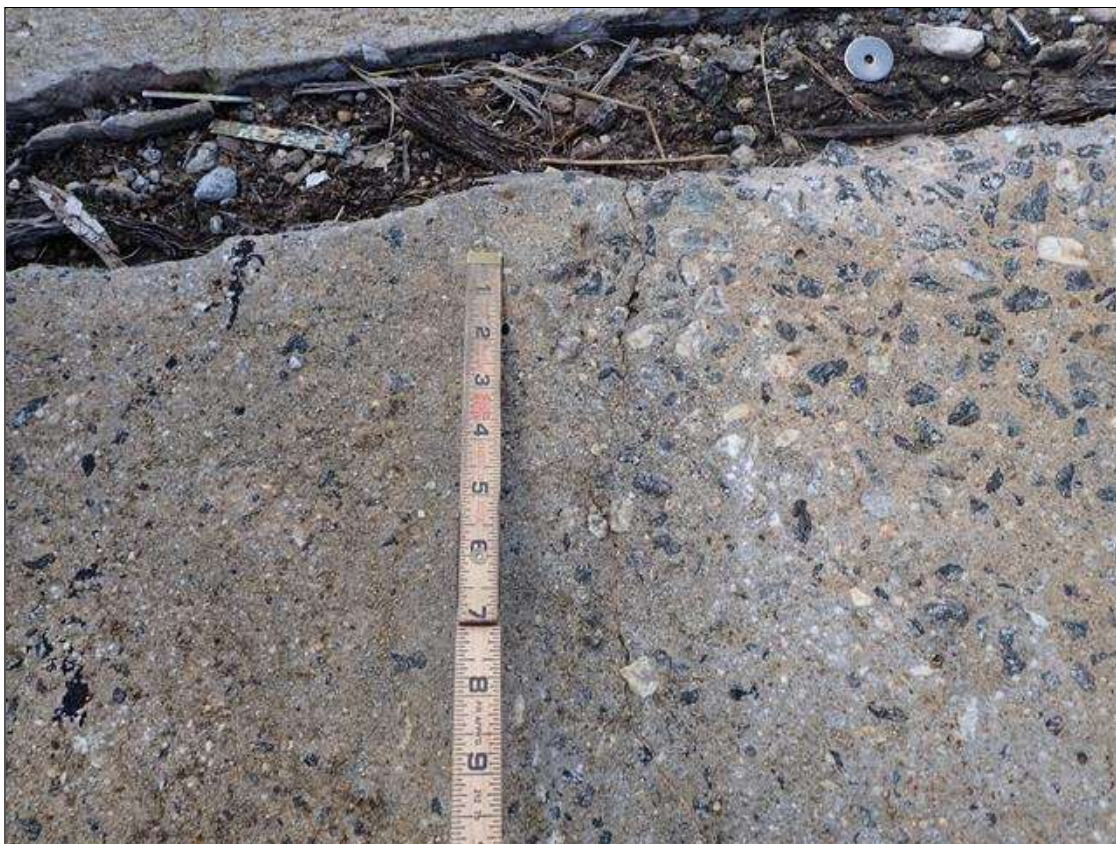
Approach 2 : SCATTERED LONGITUDINAL CRACKS THROUGH OUT [UP TO FULL WIDTH X 1/32 INCH]

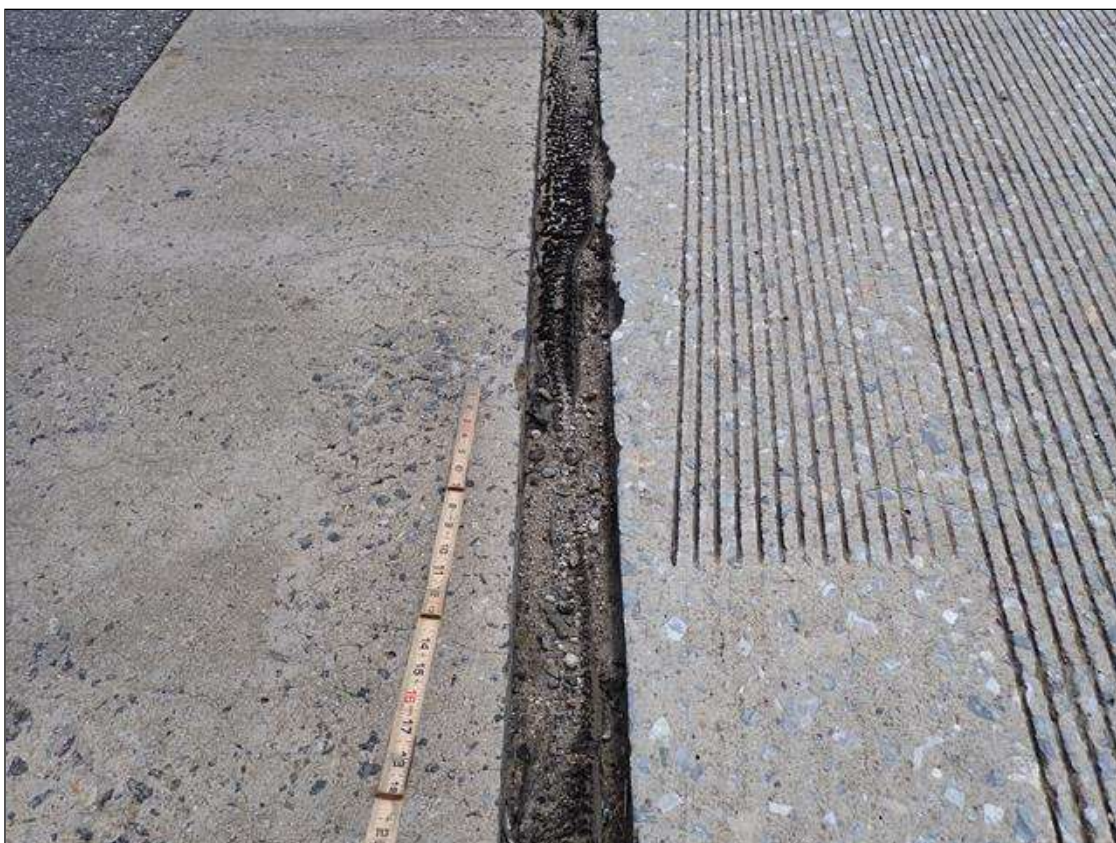
Span 2 Expansion Joint at End Bent 2: along the length of the joint, seal deteriorated/torn and adhesion loss (up to full length x full depth)

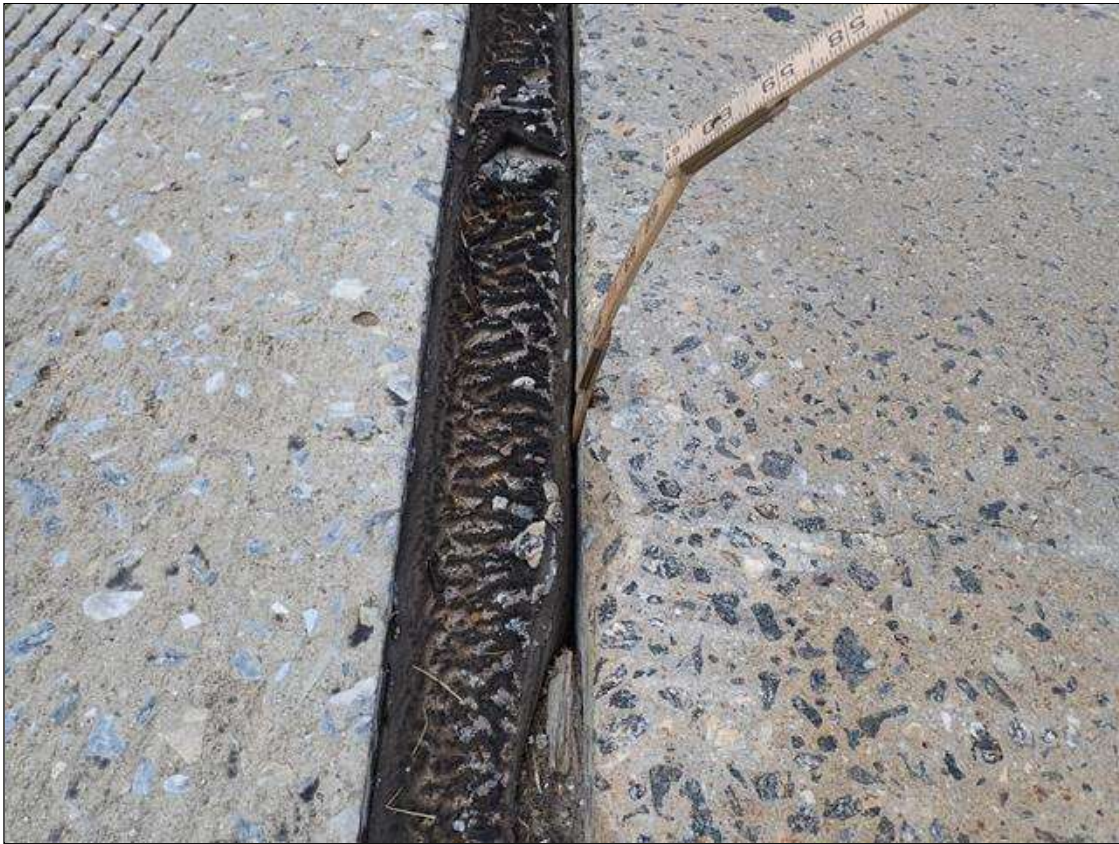
Span 2 Expansion Joint at End Bent 2: along the length of the joint, seal deteriorated/ torn and adhesion loss (up to full length x full depth)

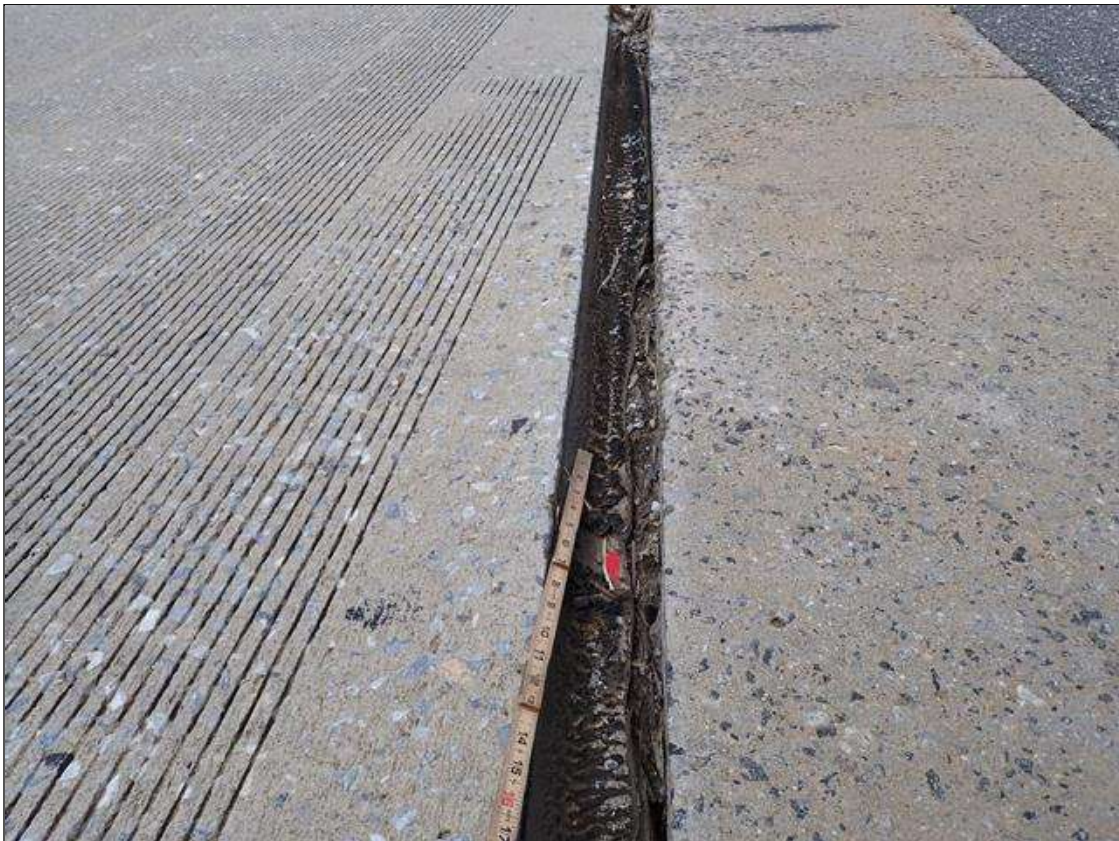
Span 2 Expansion Joint at End Bent 2: along the length of the joint, seal deteriorated/ torn and adhesion loss (up to full length x full depth)

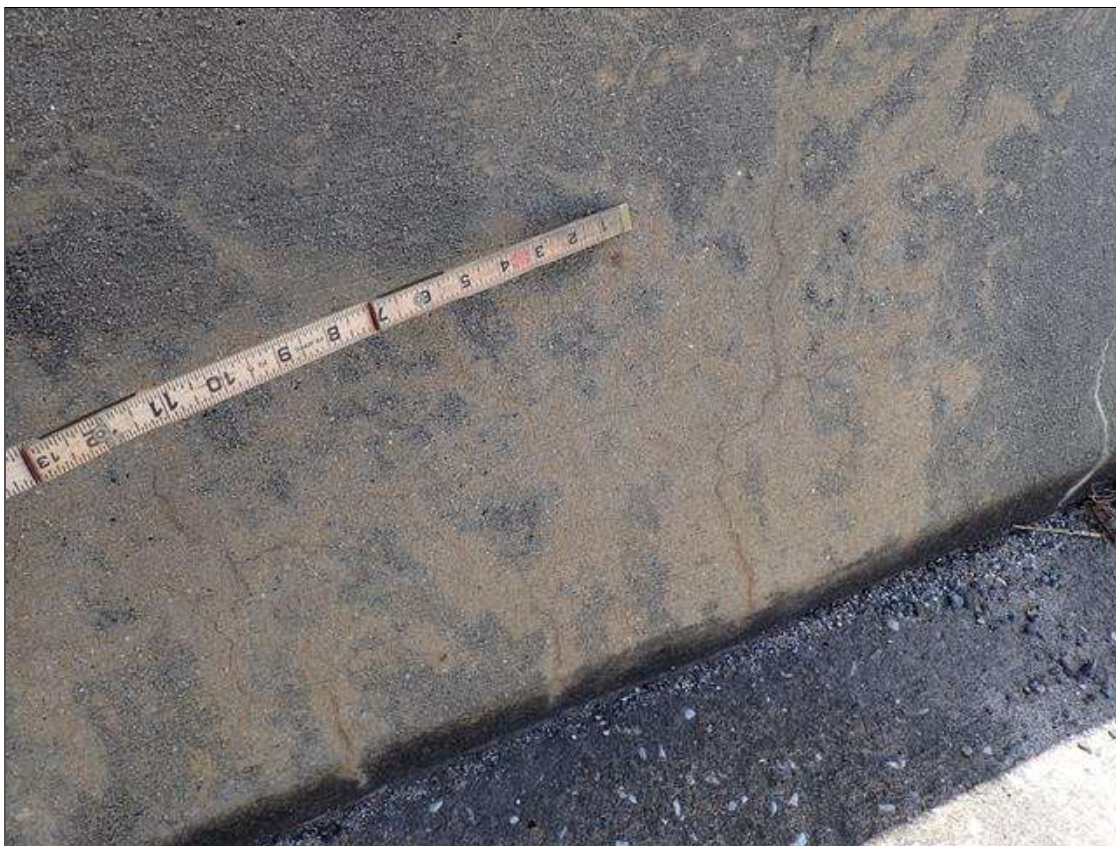
Span 2 Right Bridge Rail: along length of rail, map cracks [hairline] and multiple vertical cracks [up to full height x 1/32 inch], some wrap around, some with efflorescence

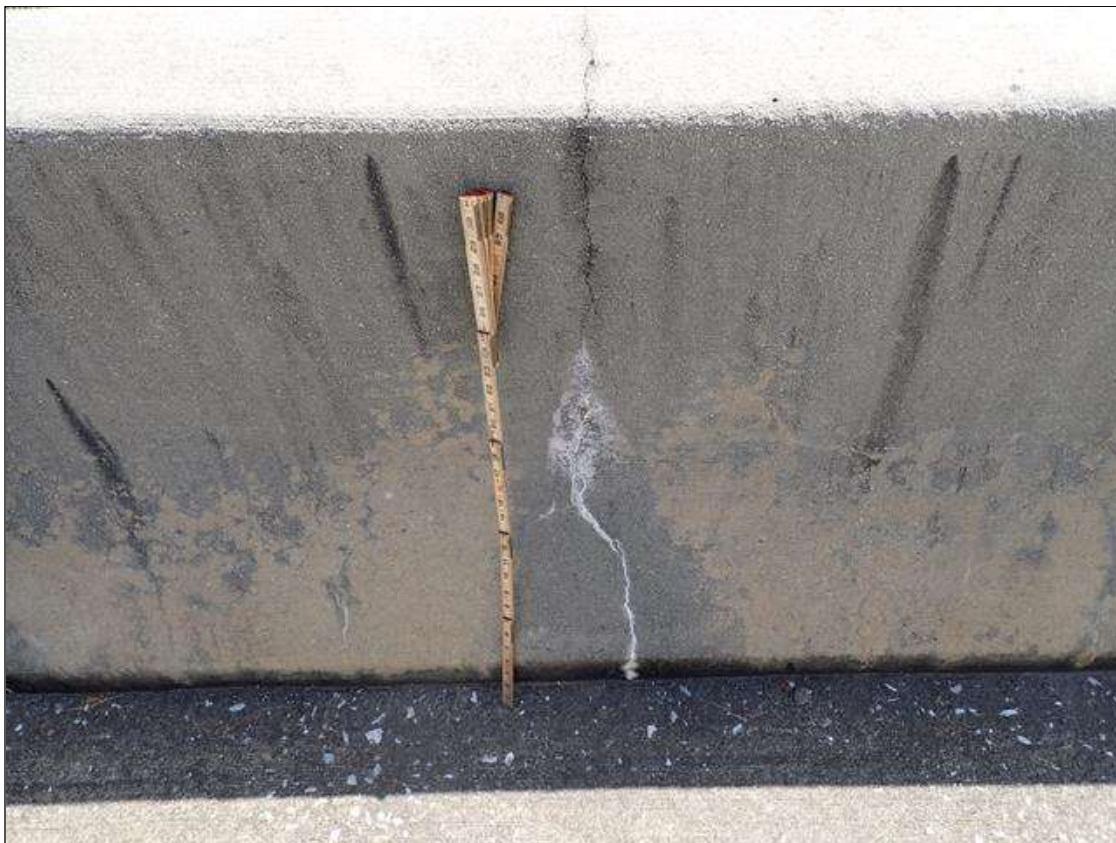
Span 2 Right Bridge Rail: along length of rail, map cracks [hairline] and multiple vertical cracks [up to full height x 1/32 inch], some wrap around, some with efflorescence

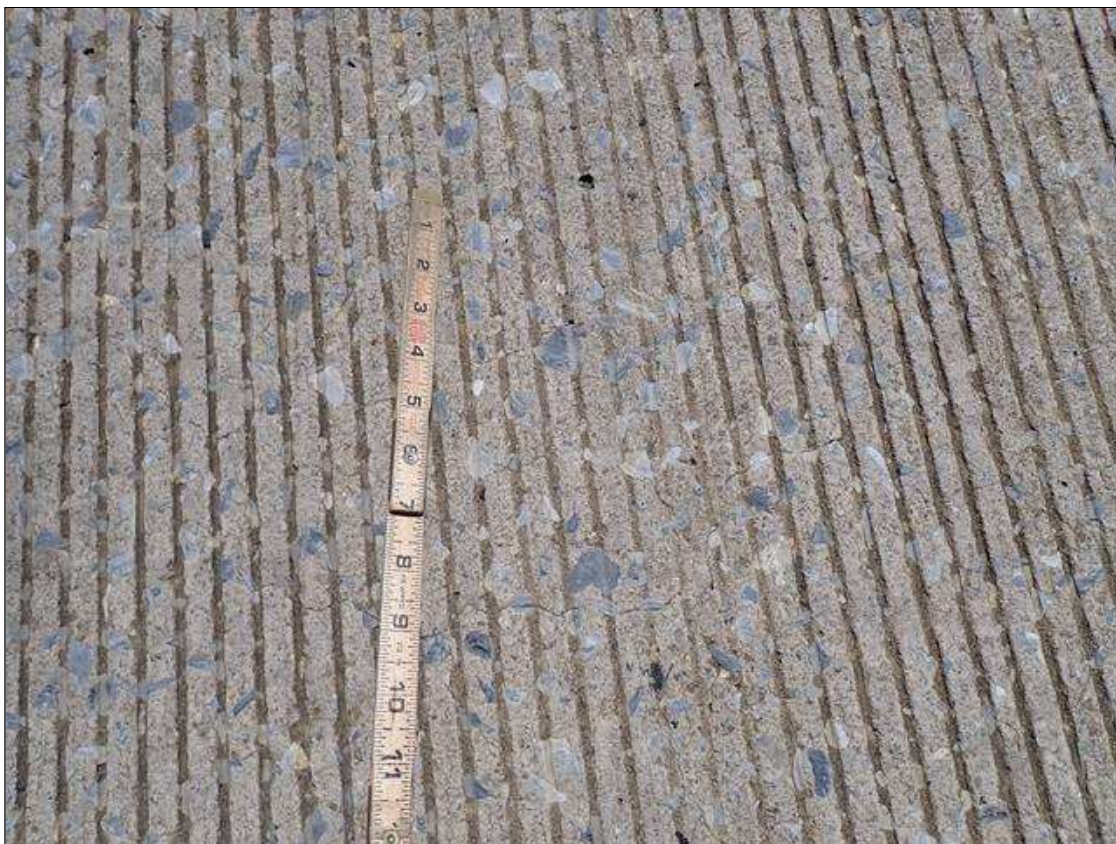
Span 2 Deck: throughout topside of deck, map cracks (hairline) and transverse/longitudinal cracks (up to 1/32 inch x 12 foot) at random

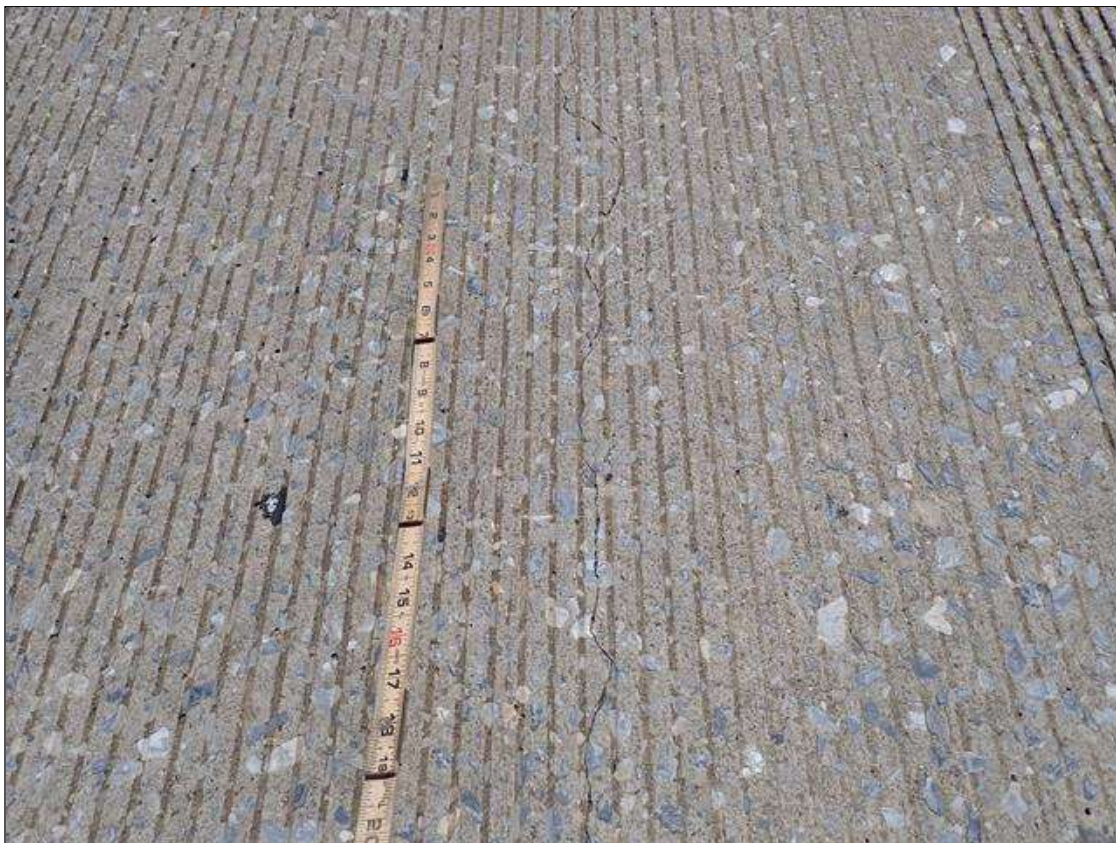
Span 2 Deck: throughout topside of deck, map cracks (hairline) and transverse/longitudinal cracks (up to 1/32 inch x 12 foot) at random

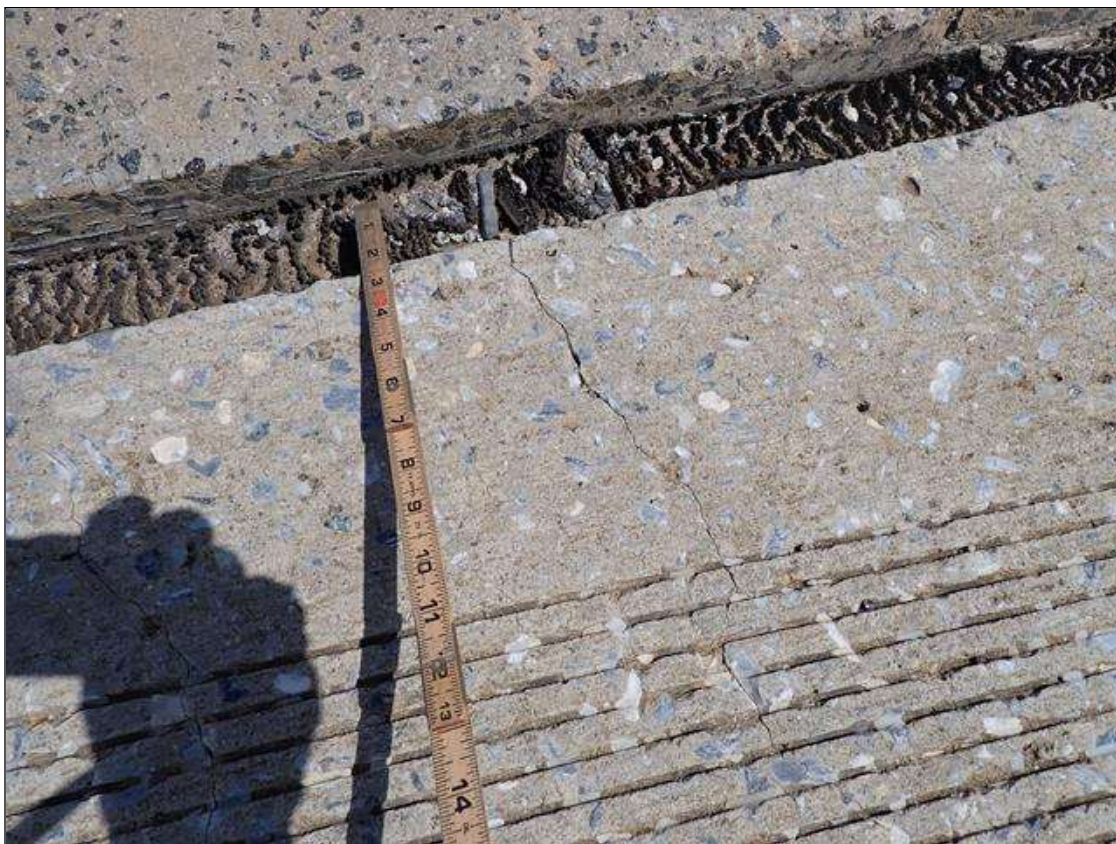
Span 2 Deck: throughout topside of deck, map cracks (hairline) and transverse/longitudinal cracks (up to 1/32 inch x 12 foot) at random

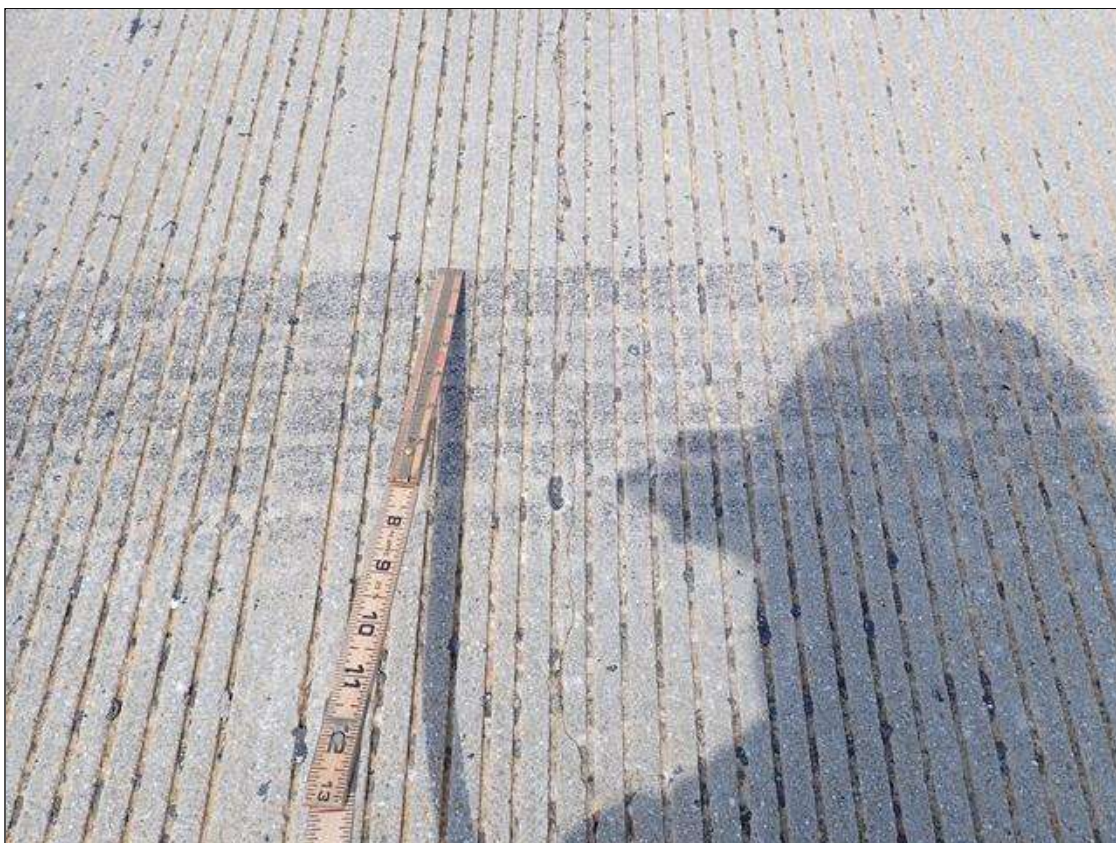
Span 1 Deck: throughout topside of deck, map cracks (hairline) and transverse/longitudinal cracks (up to 1/32 inch x 12 foot) at random

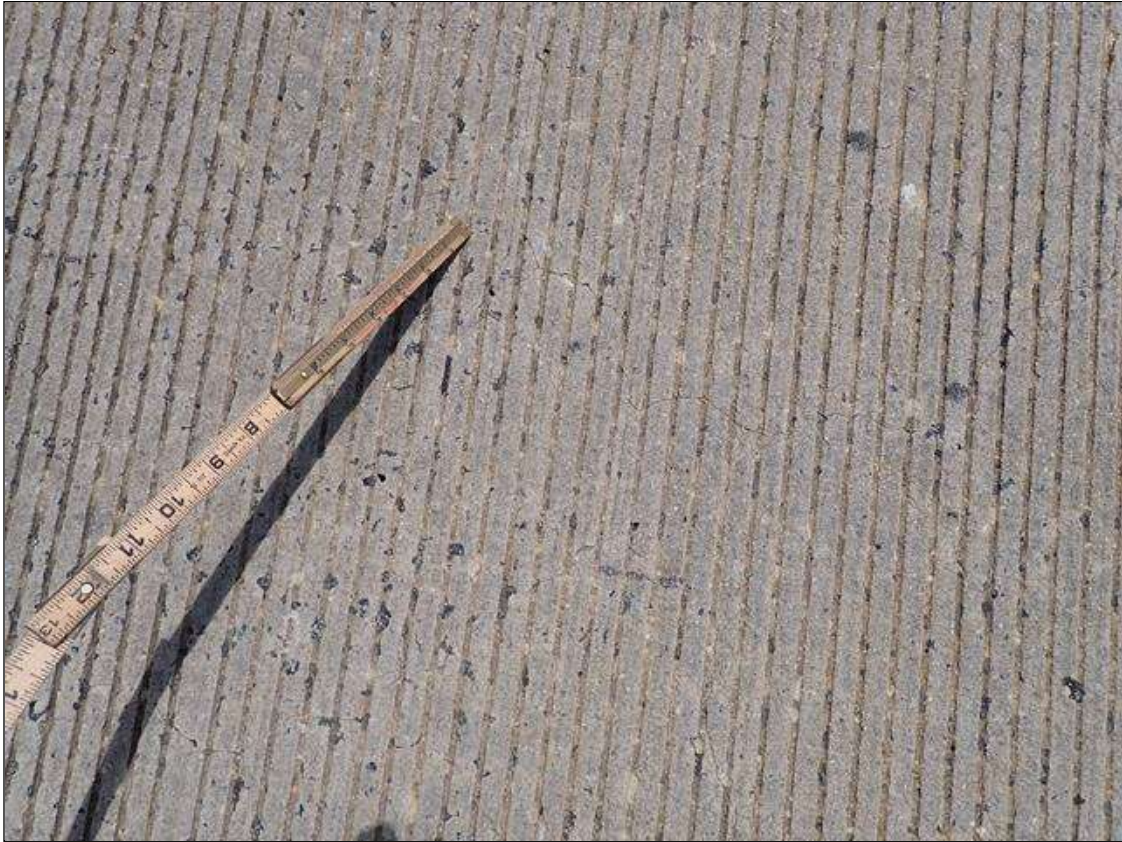
Span 1 Deck: throughout topside of deck, map cracks (hairline) and transverse/longitudinal cracks (up to 1/32 inch x 12 foot) at random

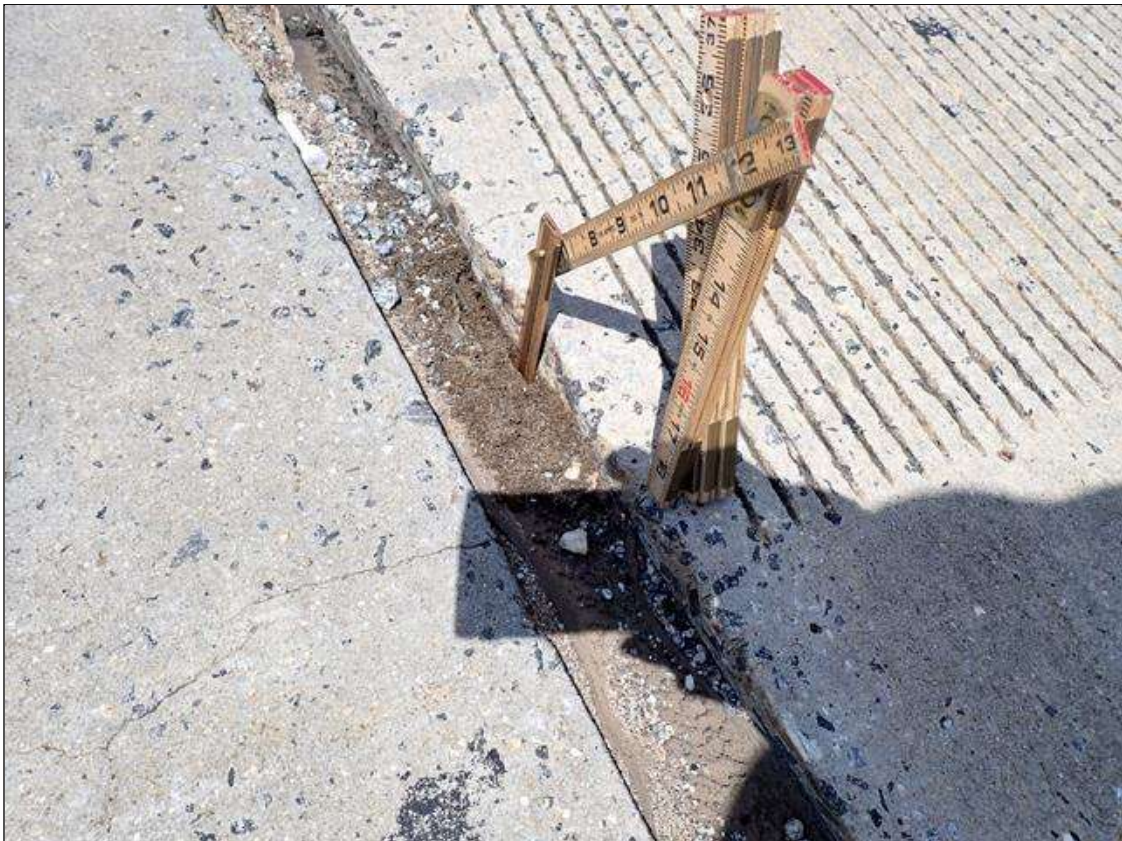
Span 1 Expansion Joint at End Bent 1: along the length of the joint, seal deteriorated/torn and adhesion loss (up to full length x full depth)

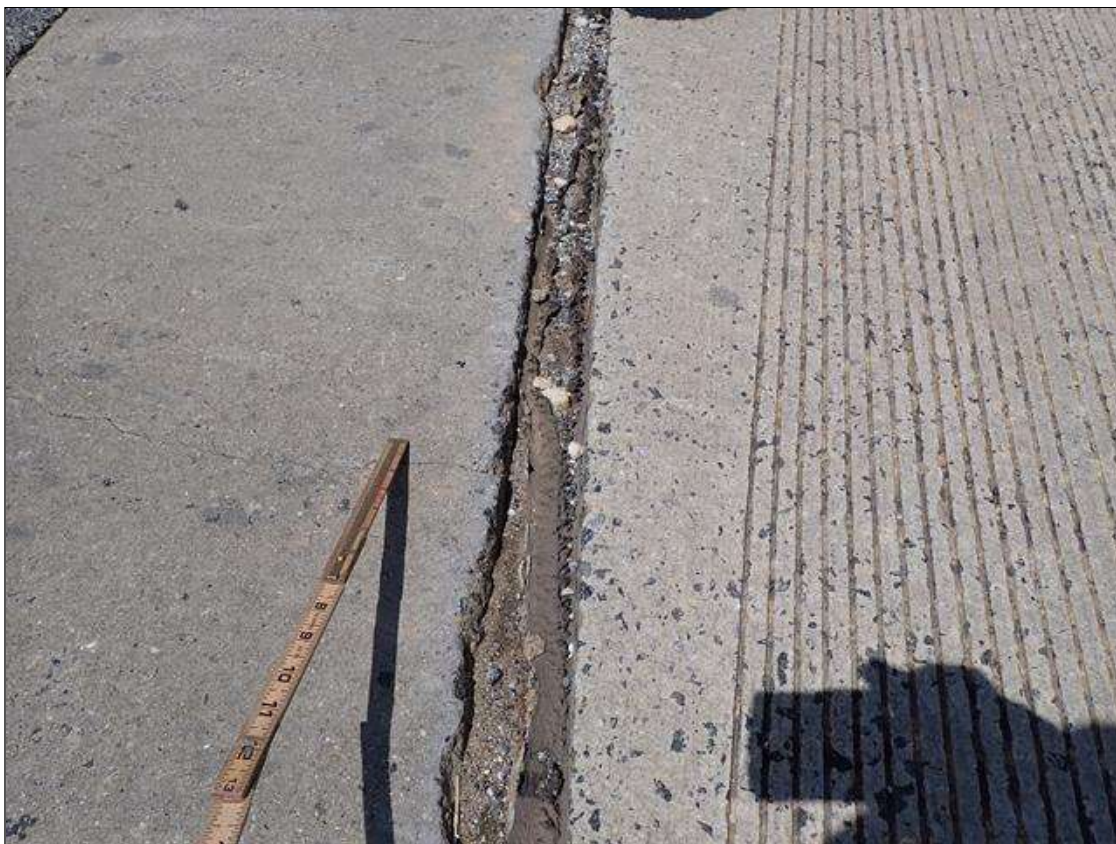
Span 1 Expansion Joint at End Bent 1: along the length of the joint, seal deteriorated/torn and adhesion loss (up to full length x full depth)

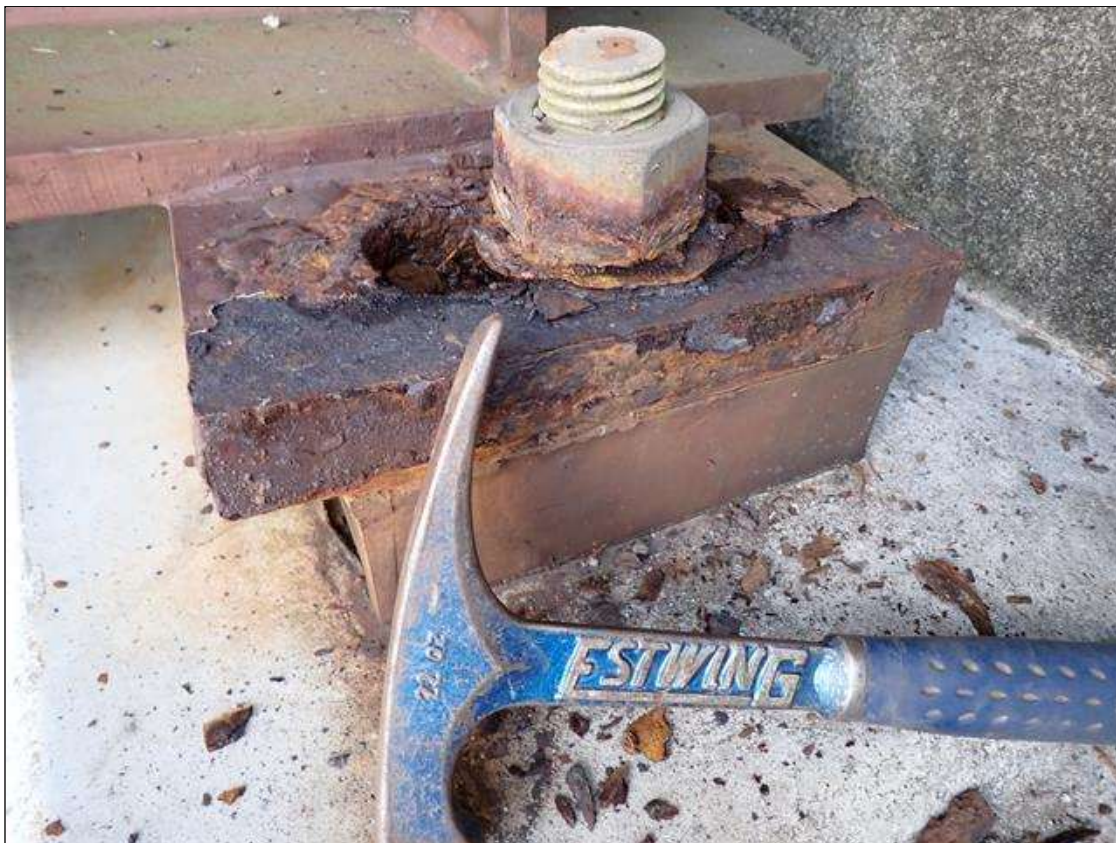
Span 1 Near Bearing 1: rust scale/corrosion with section loss (up to 1/16 inch loss)

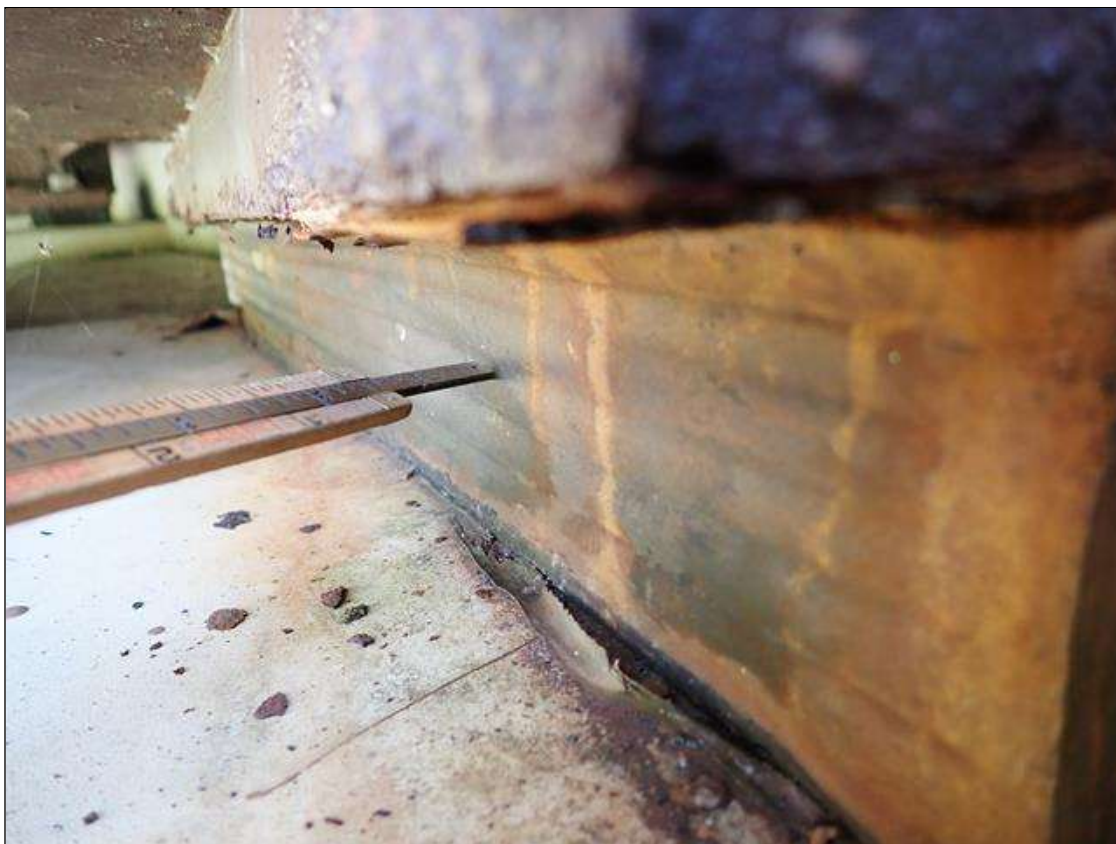
Span 1 Near Bearing 1: north face, bulging (up to 1/16 inch high)
