NC DEPARTMENT OF TRANSPORTATION
 DIVISION OF HIGHWAYS
 STRUCTURE MANAGEMENT UNIT

ATTENTION: prompt action request; sketches updated; clearance revised

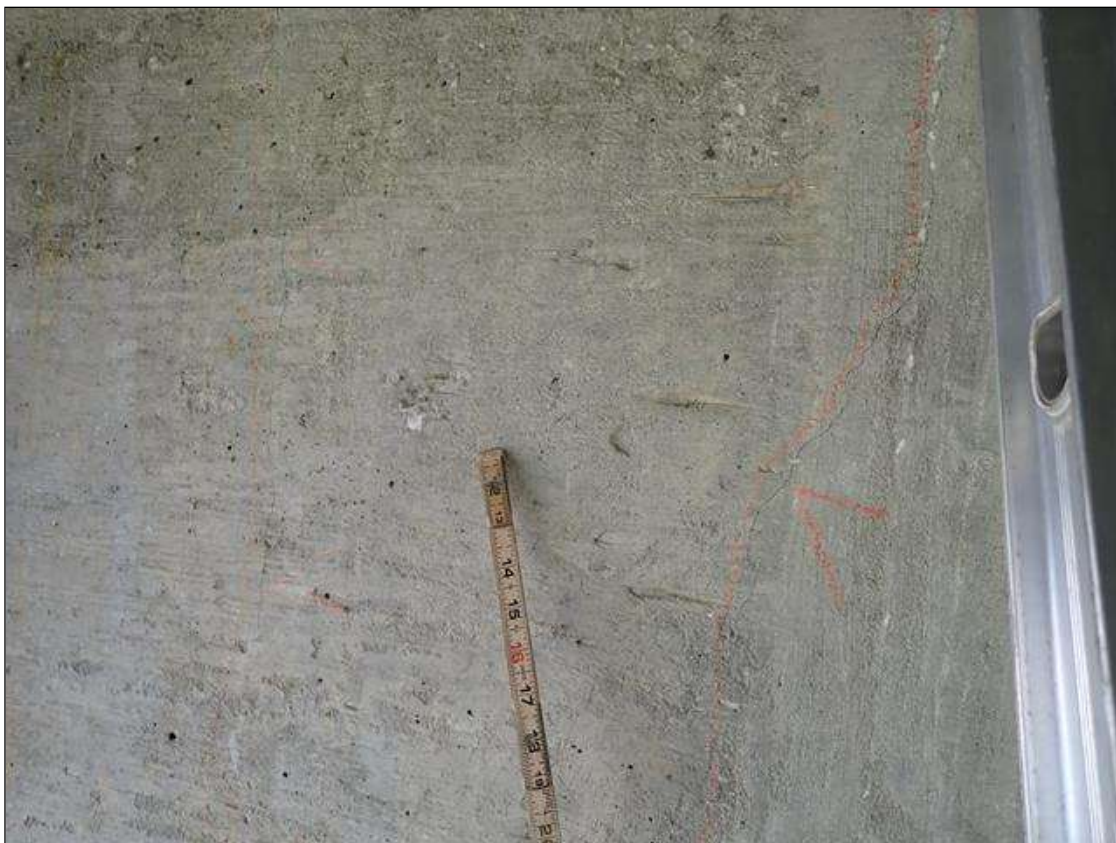
Bent 1 Cap 1: along the length of the cap, multiple vertical and diagonal cracks [up to full height x 1/32 inch] some extend across top

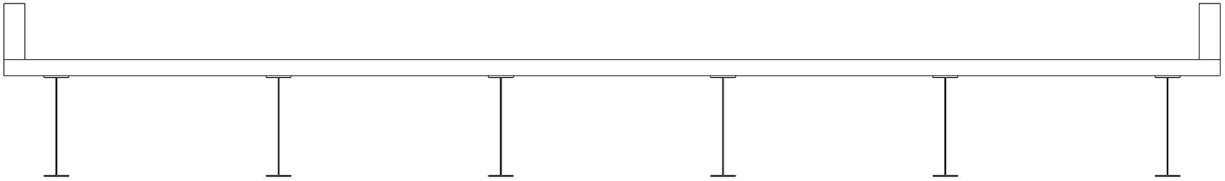
Measurements for Span #	1	ALL SPANS SIMILAR	
Deck Thickness	9.25in	Left Overhang	2.5ft
Top of Rail to Bottom of Beam (Avg)	8.23ft	Right Overhang	2.5ft
