NC DEPARTMENT OF TRANSPORTATION
 DIVISION OF HIGHWAYS
 STRUCTURE MANAGEMENT UNIT

ATTENTION: sketches revised, clearances revised

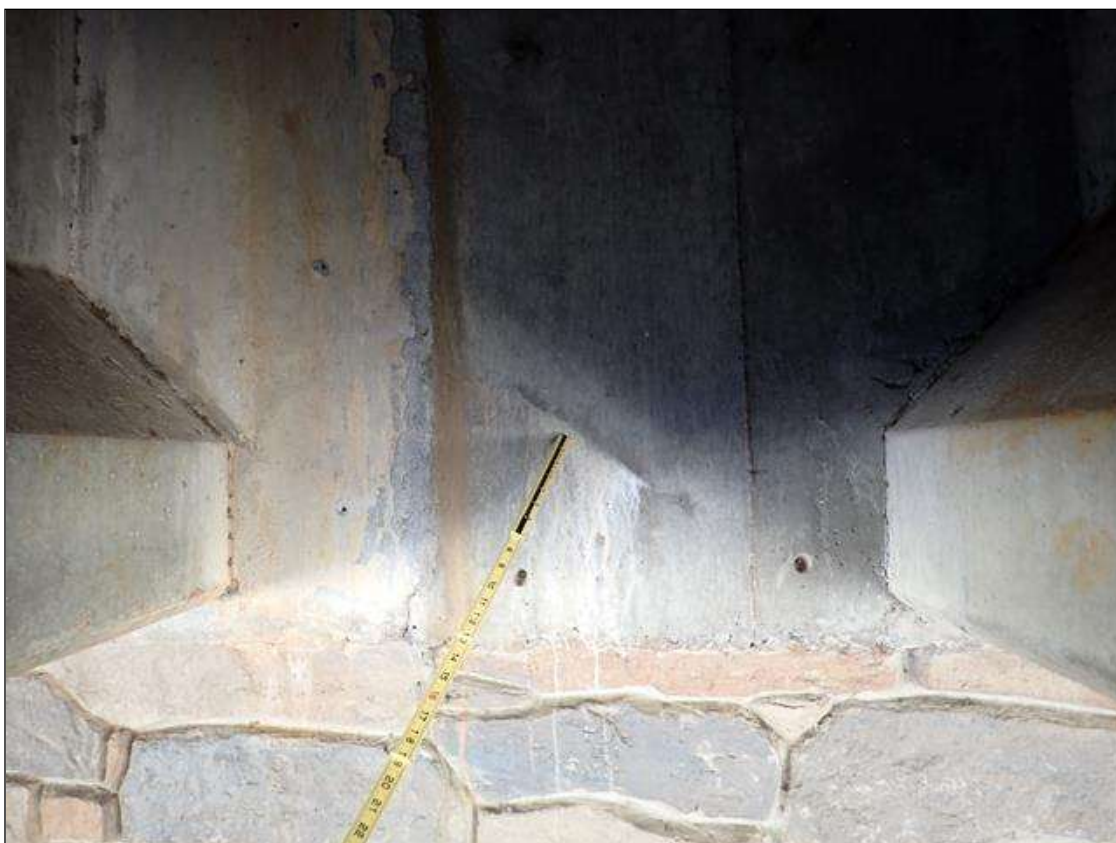
End Bent 1 Abutment: bay 6 closure pour, diagonal crack (hairline x 1 foot) with efflorescence

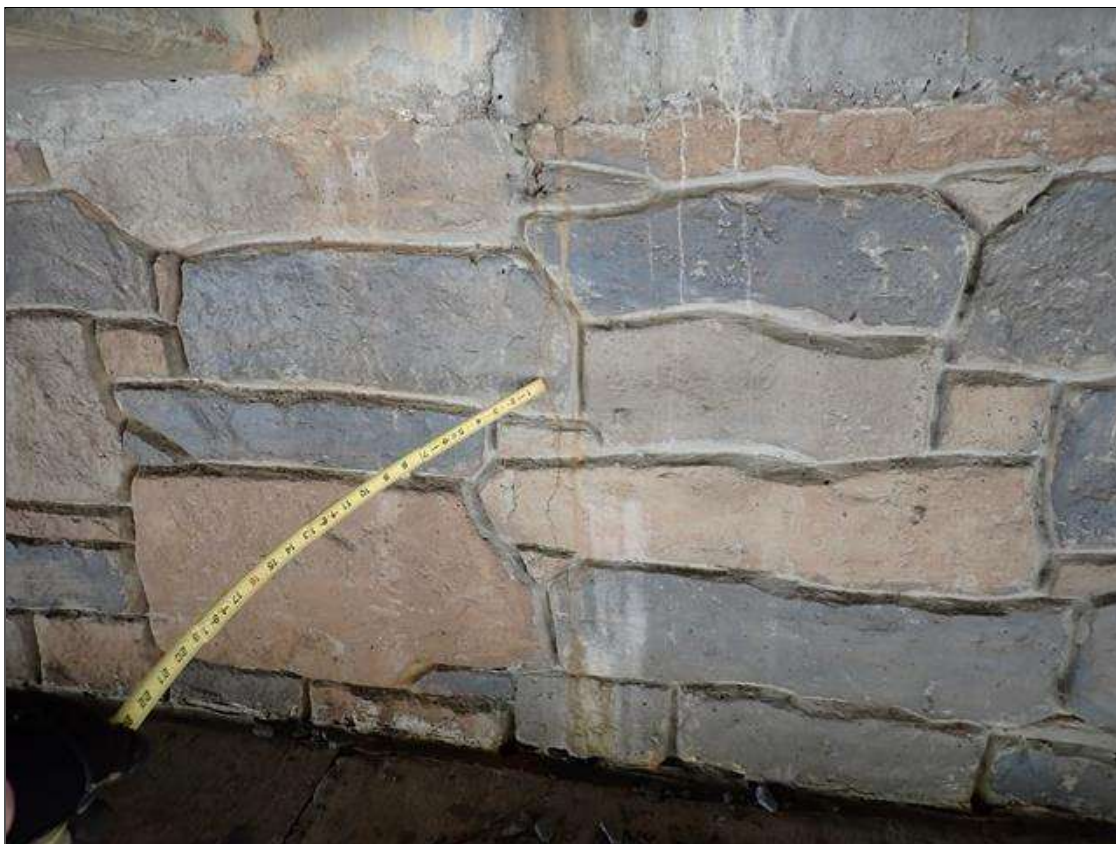
End Bent 1 Cap 1: below bay 6, vertical crack (1/64 inch x full height)

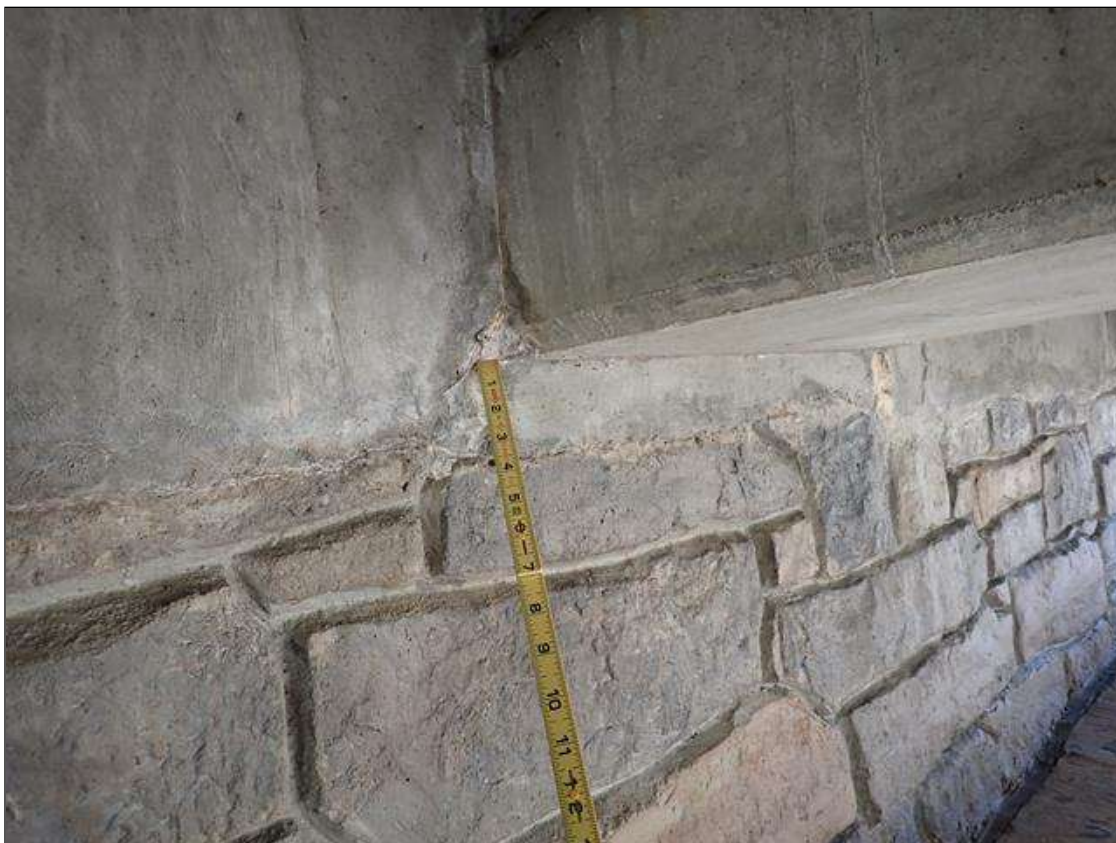
End Bent 1 Abutment: at multiple beams, at bottom flange, diagonal crack (hairline x 4 inch) with efflorescence

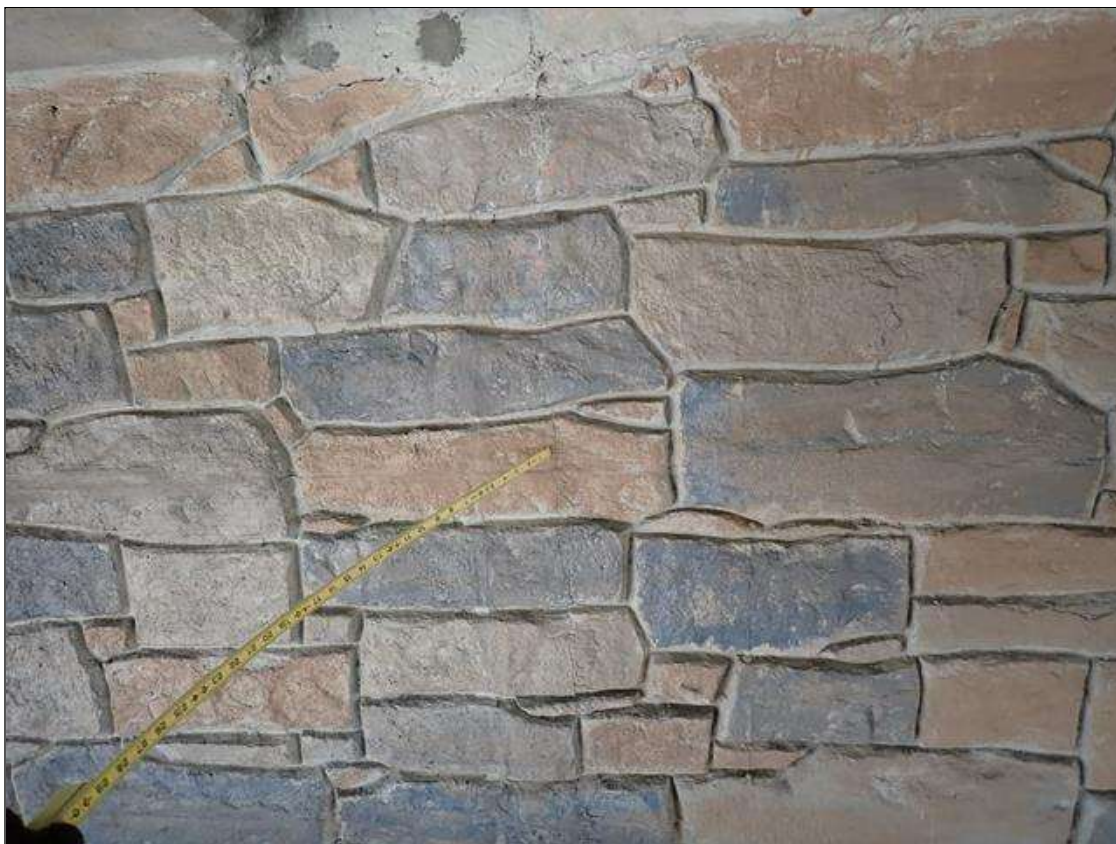
End Bent 2 Cap 1: vertical crack up to 1/32 inch wide, in front face, below bay 6.

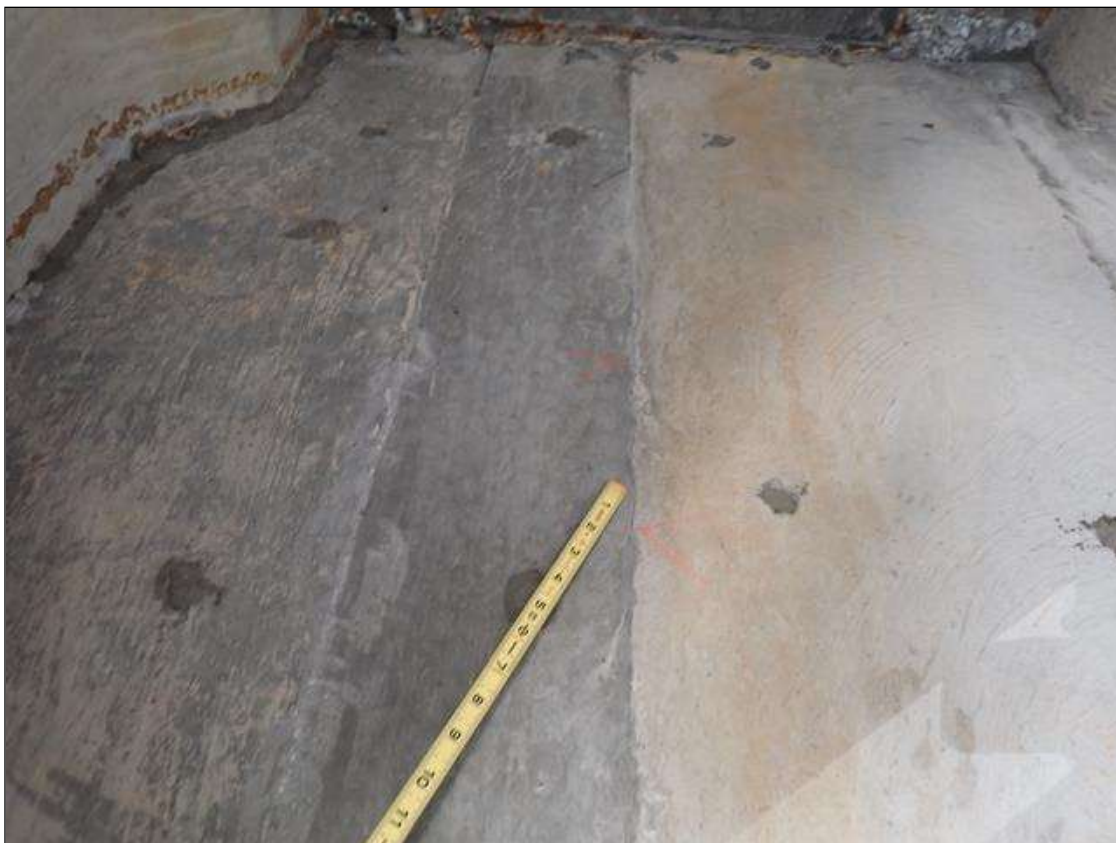
End Bent 2 Abutment: at bay 6, at construction joint, vertical crack, full height x up to 0.012 inch

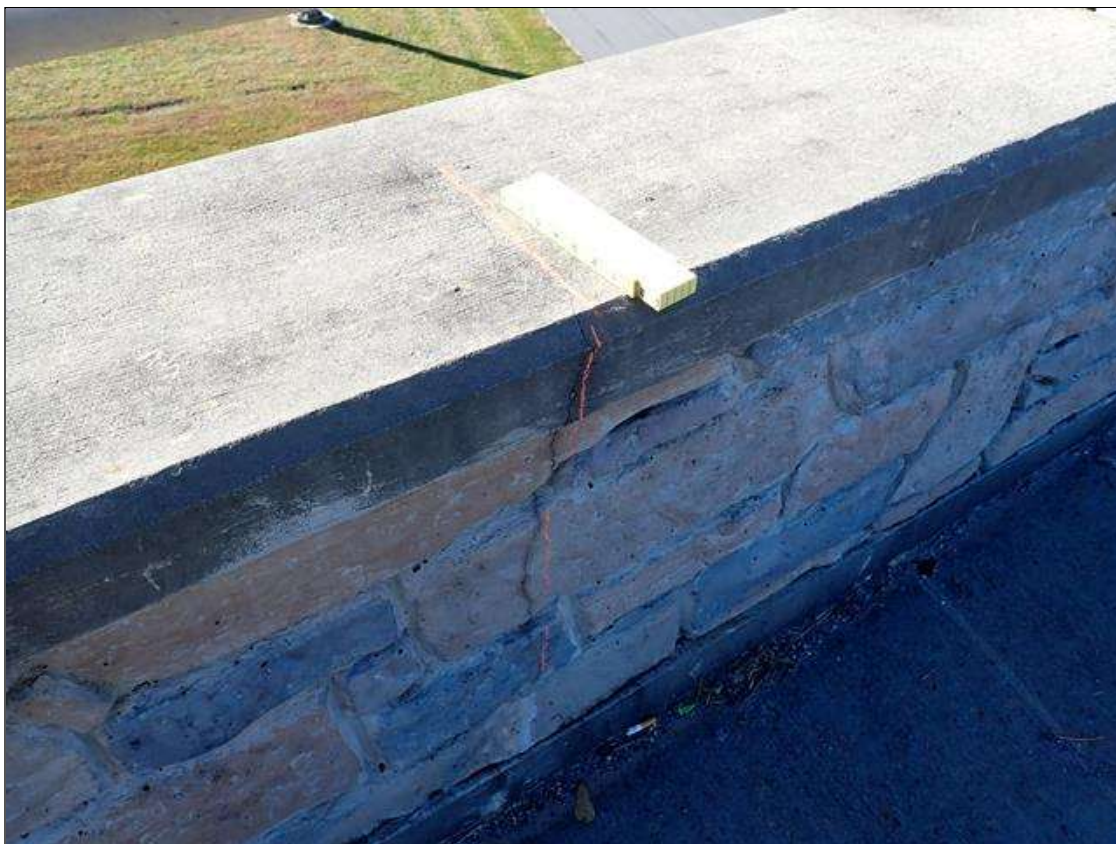
Span 1 Left Bridge Rail: up to full height x 1/64 inch vertical cracks in top of rail extending down face

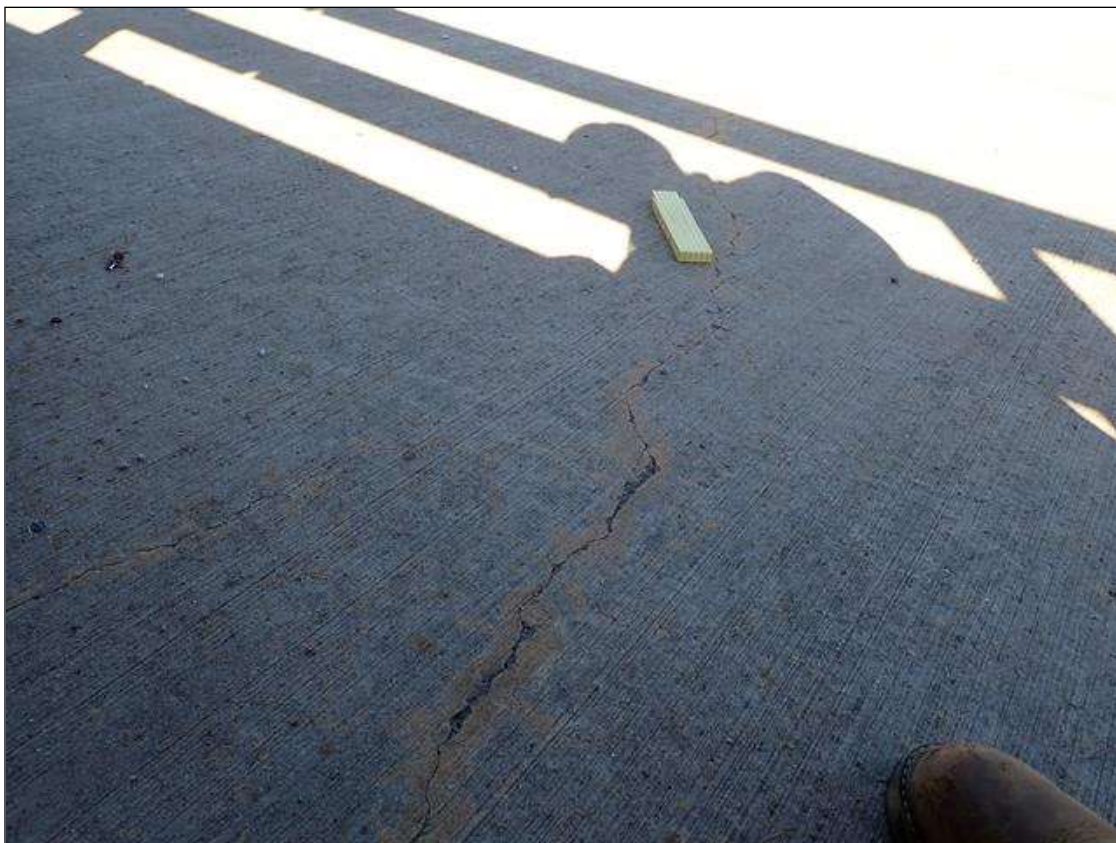
Span 1 Left Bridge Rail: sidewalk at random, transverse cracks (up to 1/16 inch x 9 feet)

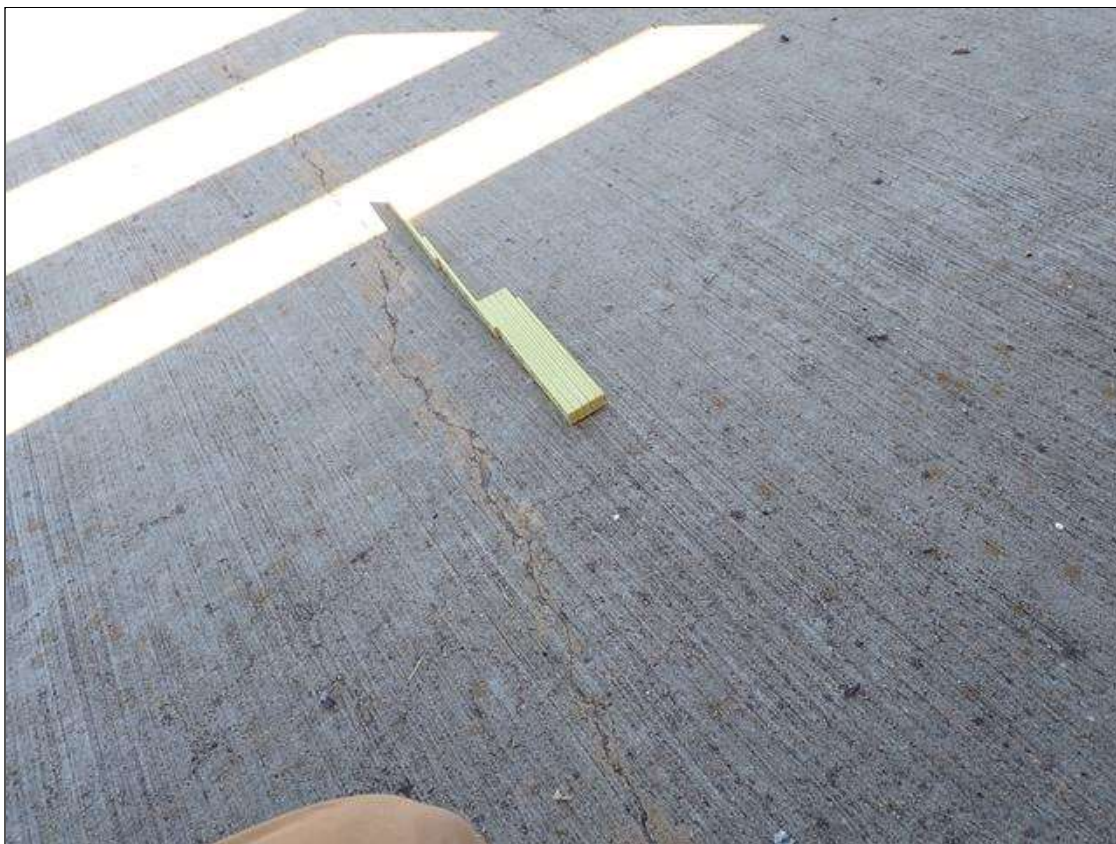
Span 2 Left Bridge Rail: sidewalk at random, transverse cracks (up to 1/16 inch x 9 feet)

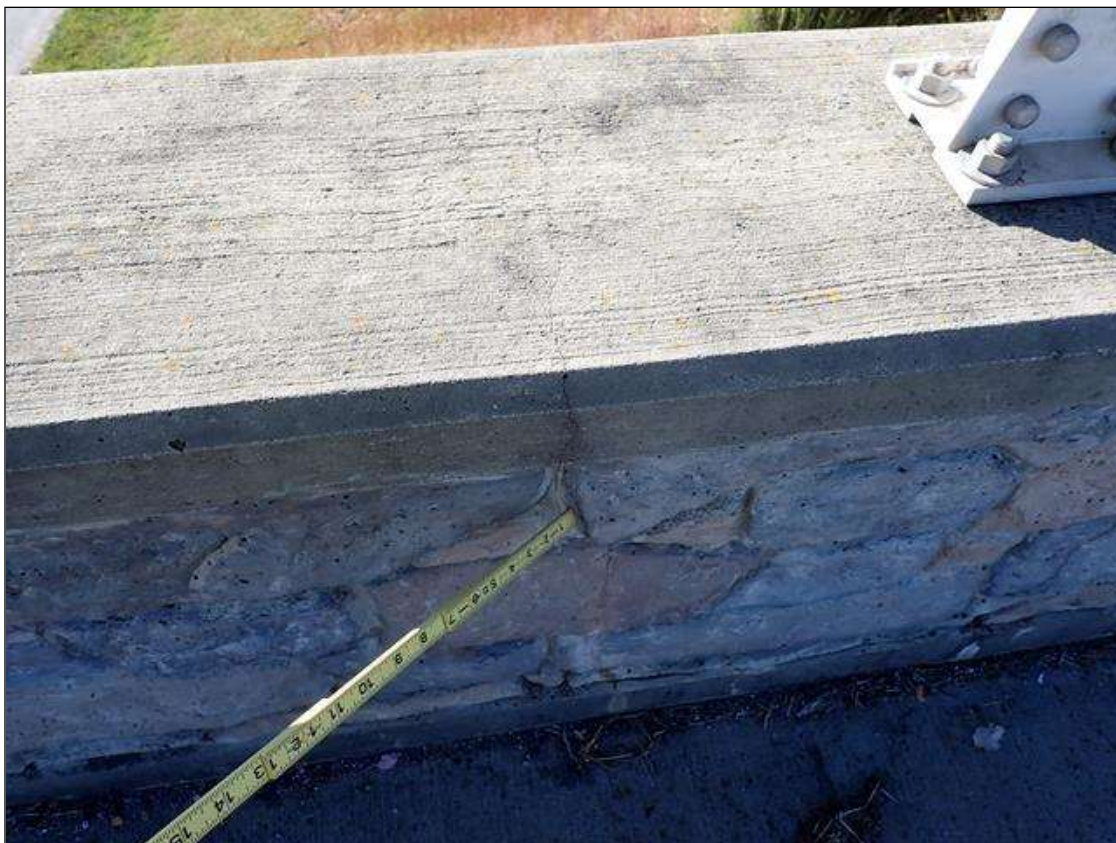
Span 2 Left Bridge Rail: up to full height x 1/64 inch in top of rail extending down face

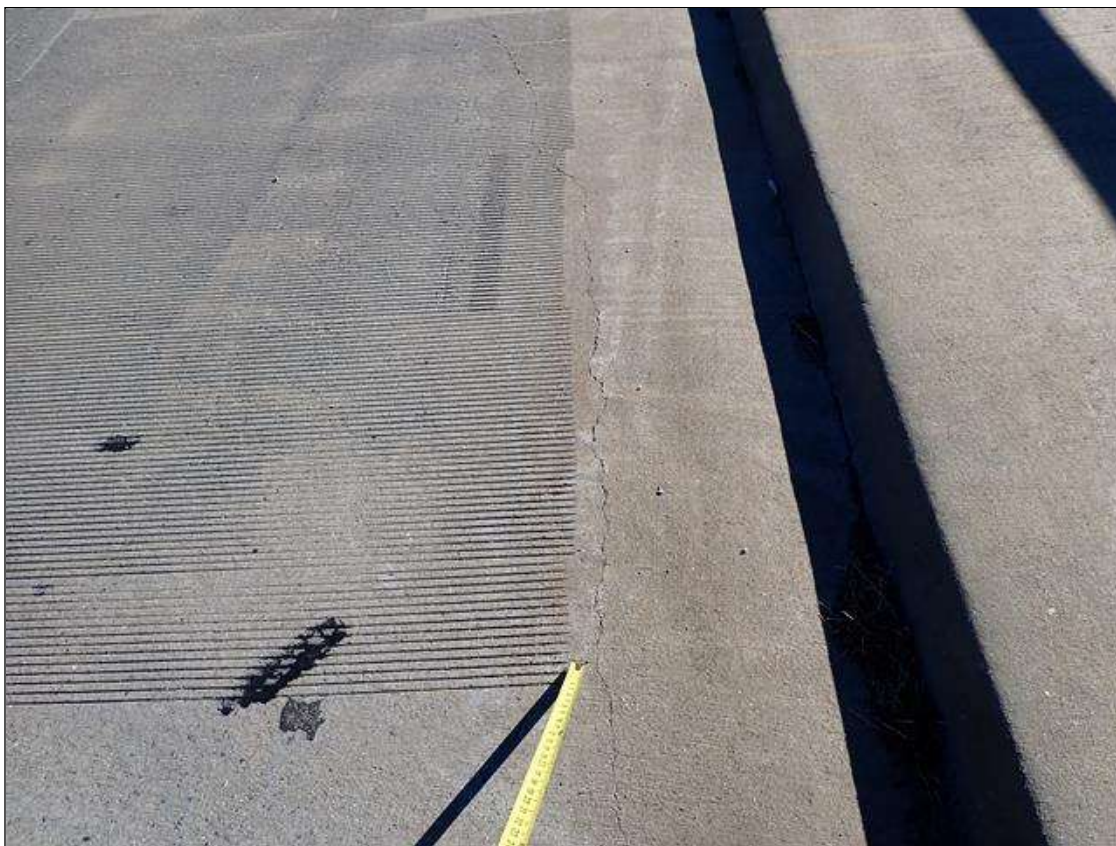
Approach 2 : full length longitudinal crack up to 1/16 inch wide in south bound lanes, near west shoulder.

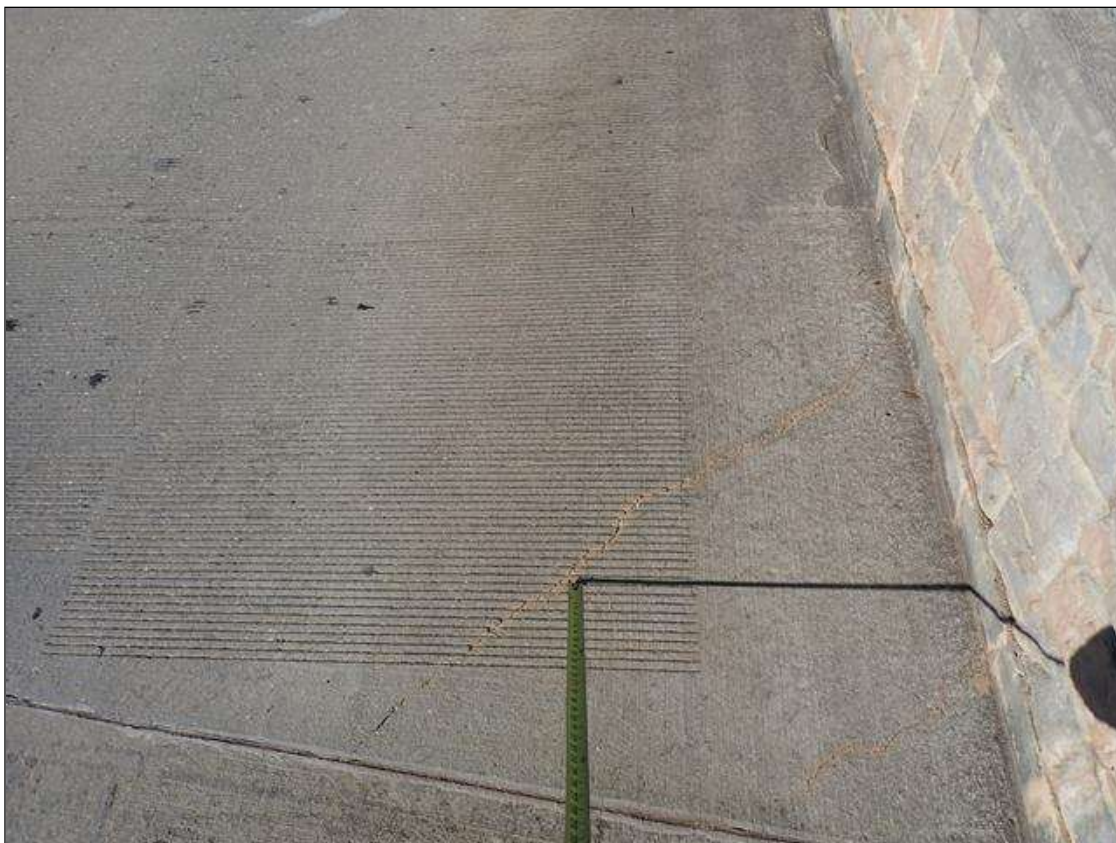
Approach 2 : 2 diagonal x 1/16 inch cracks in near right corner of approach slab, 58 inches long and 20 inches long

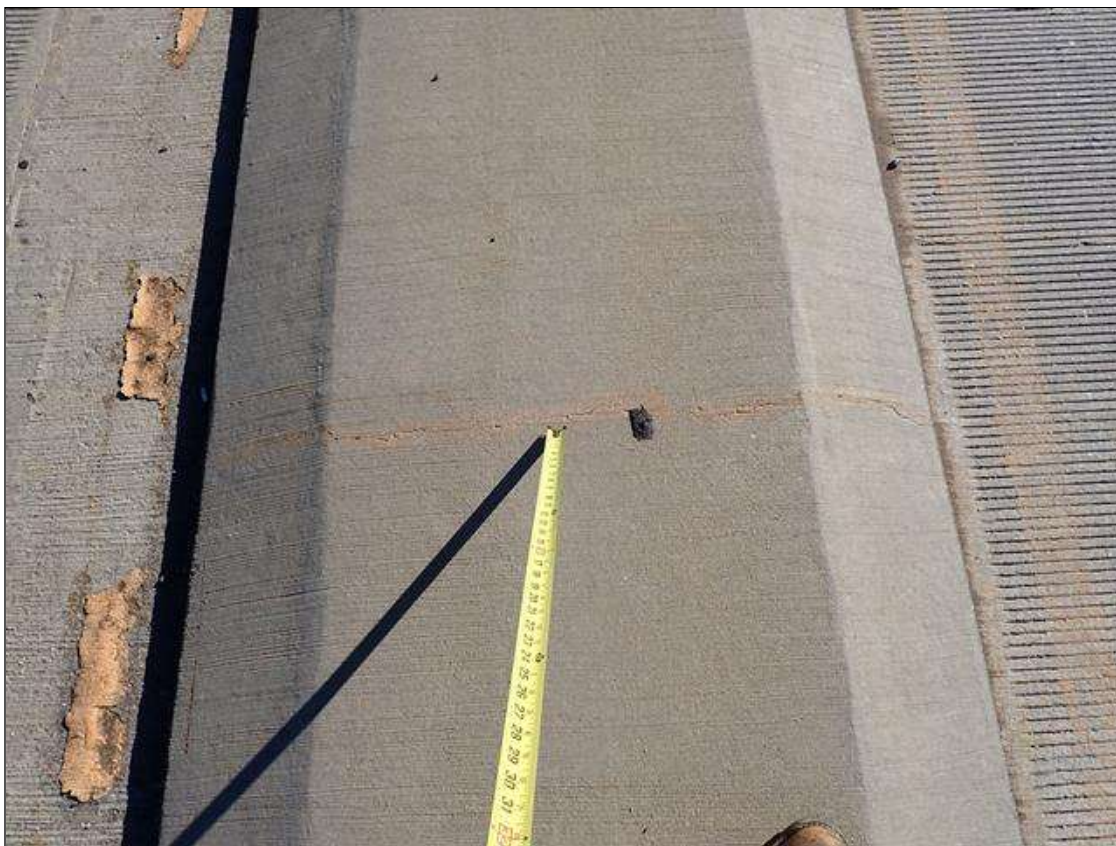
Span 2 Deck: throughout center mountable median, multiple transverse cracks [up to full width x up to 1/16 inch]

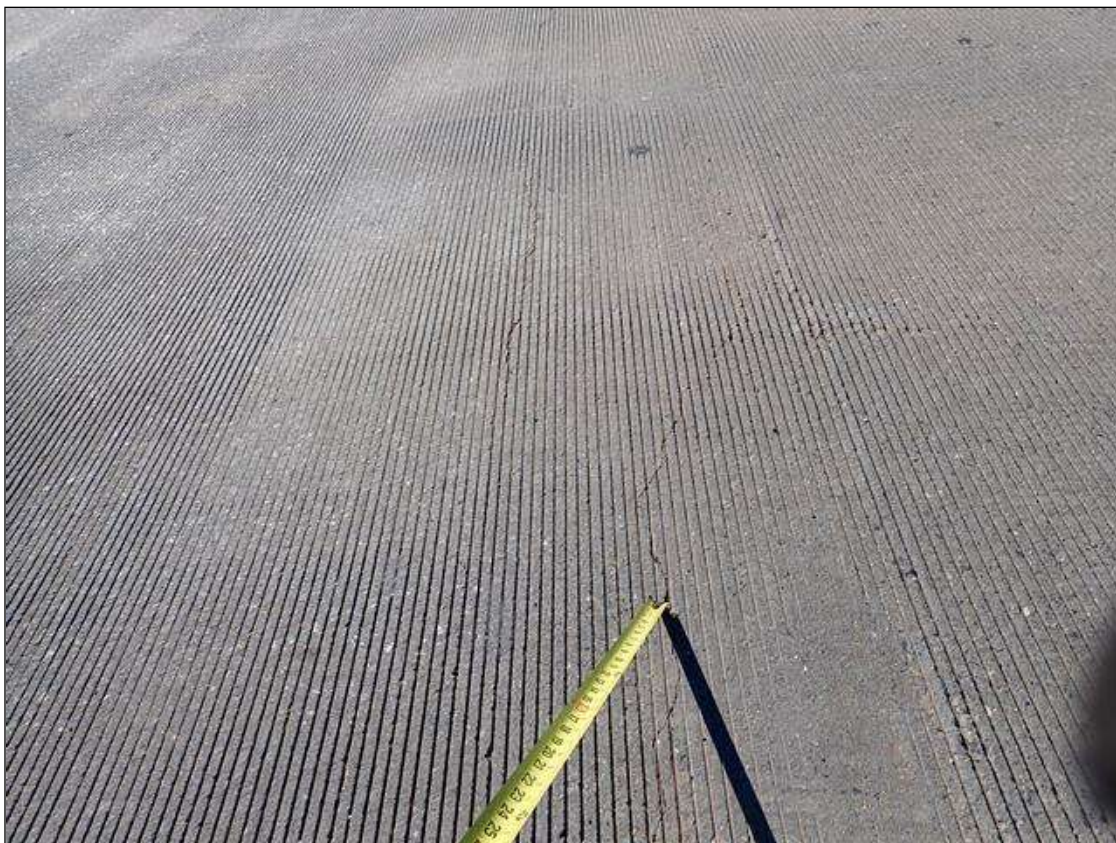
Span 2 Deck: multiple full width transverse cracks up to 1/16 inch wide, near bent 1, in south bound lanes.

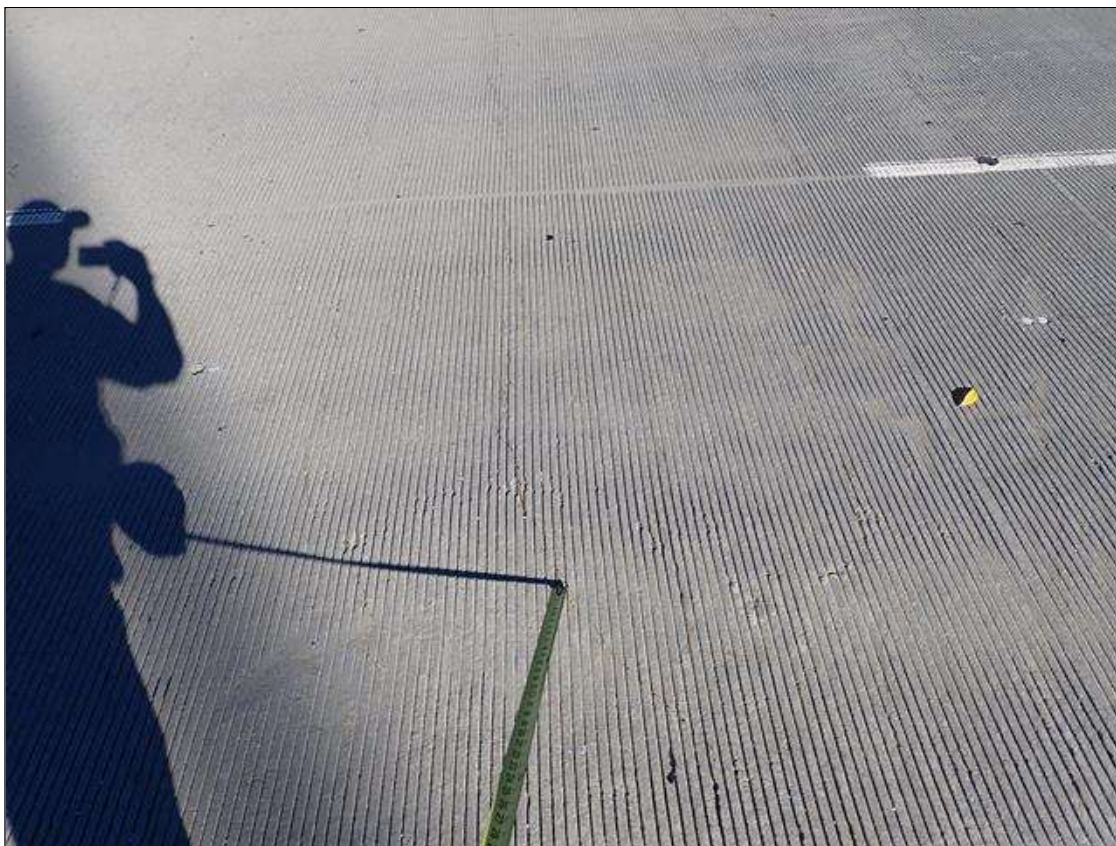
Span 2 Deck: 5 - full width transverse cracks up to 1/16 inch wide, in north bound lanes, near bent 1.

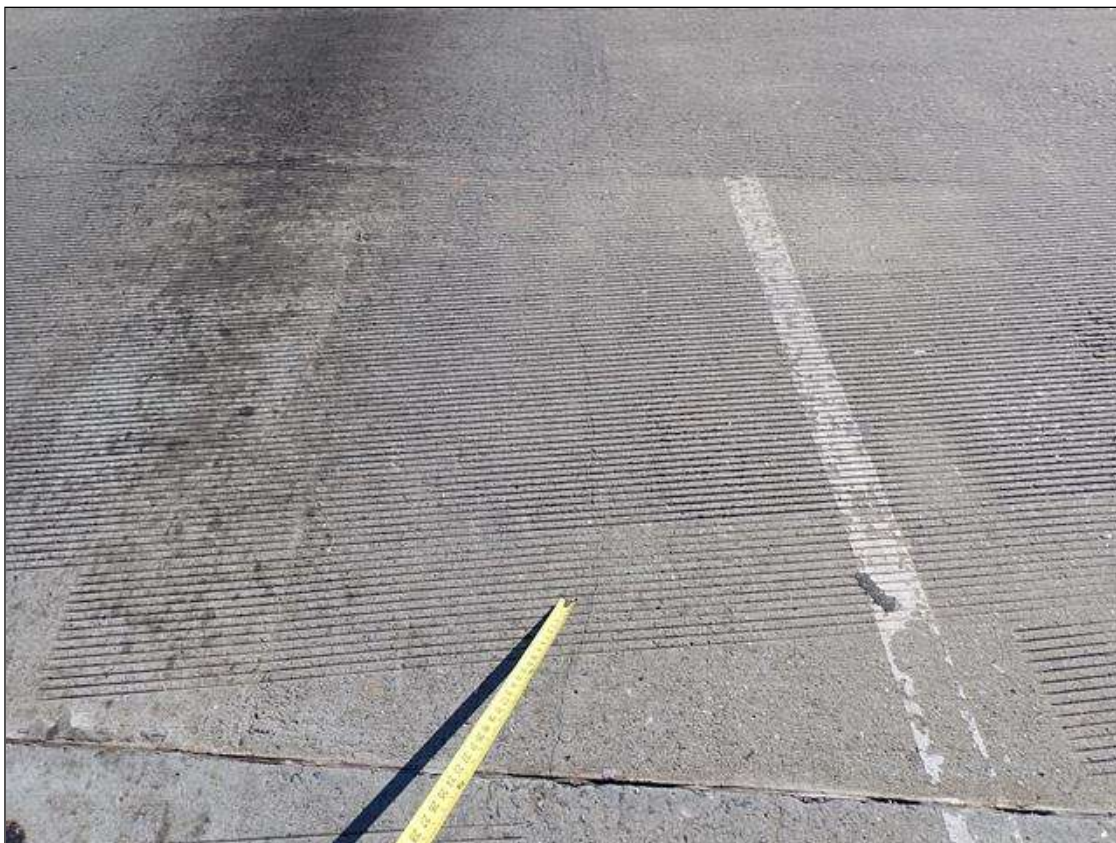
Span 2 Deck: 3 - longitudinal cracks up to 1/32 inch wide x up to 4 feet long, in south bound lanes, at end bent 2.

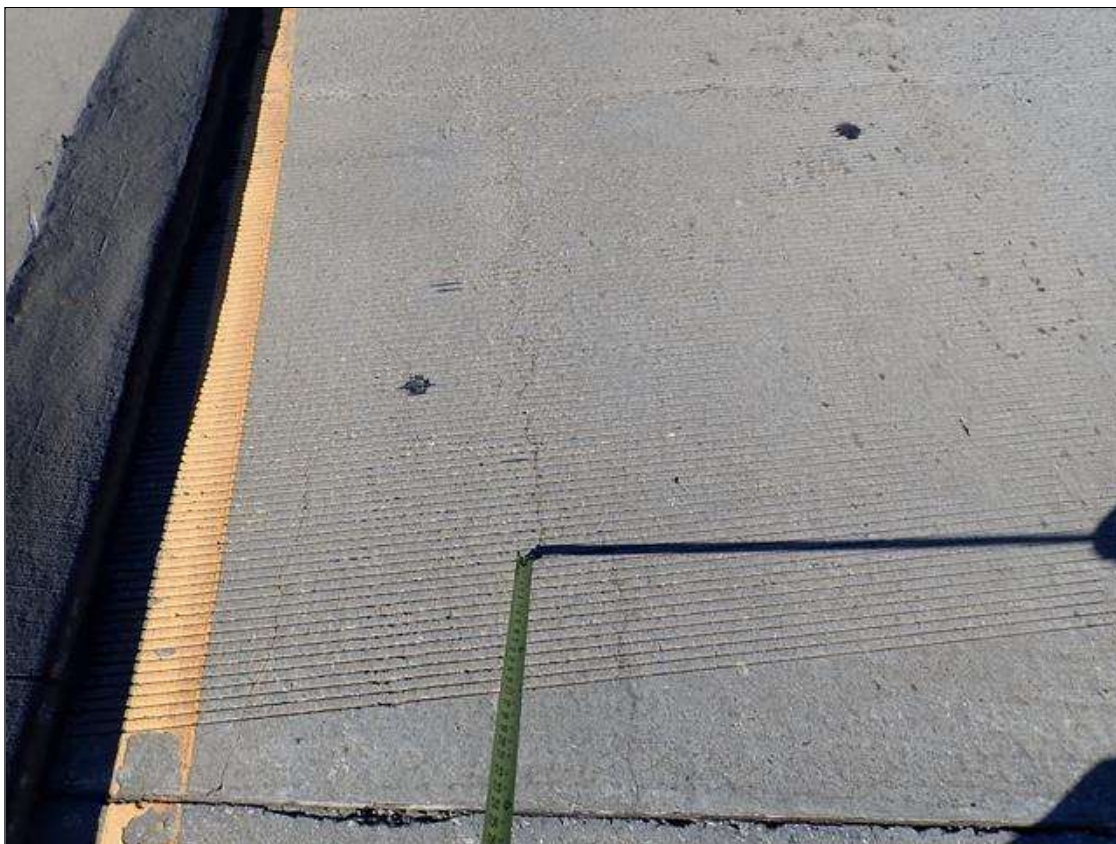
Span 1 Deck: 3 - longitudinal cracks up to 1/32 inch wide x up to 4 feet long, extending from end bent 1 joint, in northbound lanes.

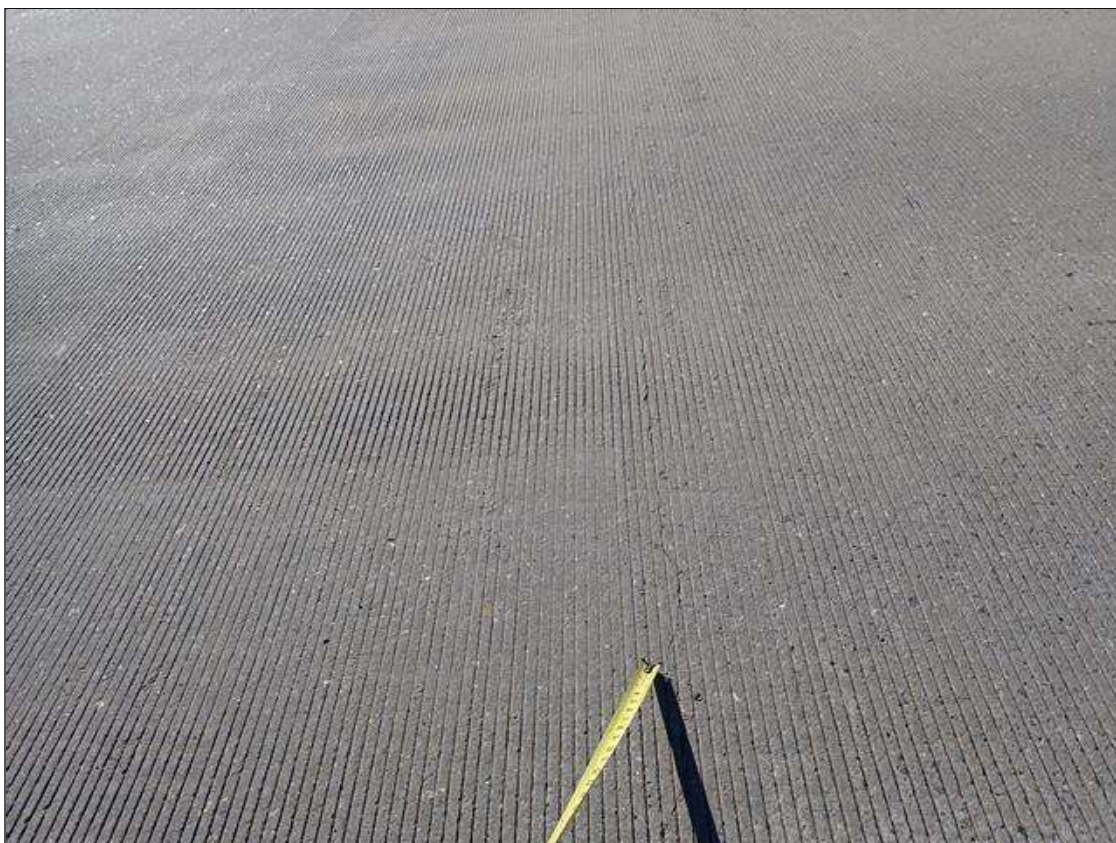
Span 1 Deck: multiple transverse cracks up to 1/16 inch wide, in top of deck, southbound lanes, near bent 1.

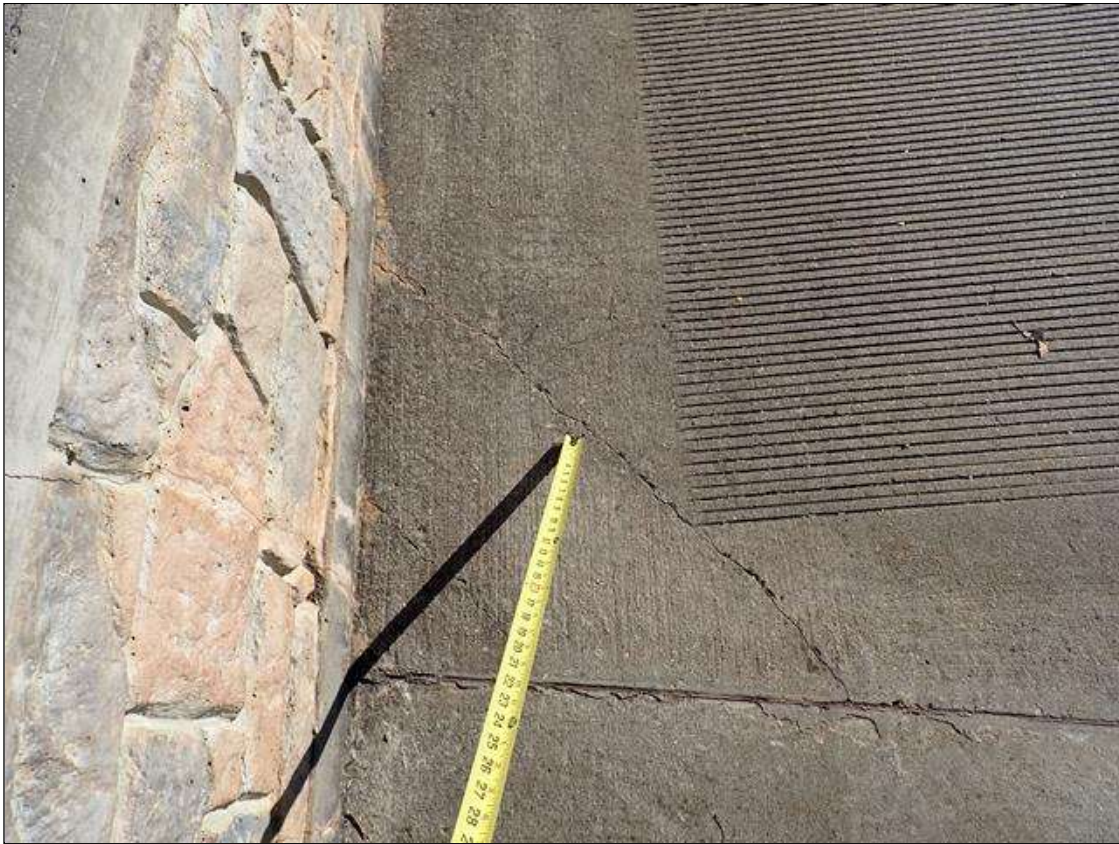
Approach 1 : 2 diagonal x 1/16 inch cracks in far right corner of approach slab, 40 inches long and 16 inches long
