NC DEPARTMENT OF TRANSPORTATION  
 DIVISION OF HIGHWAYS  
 STRUCTURE MANAGEMENT UNIT

ATTENTION: prompt action request, sketches revised, clearances revised

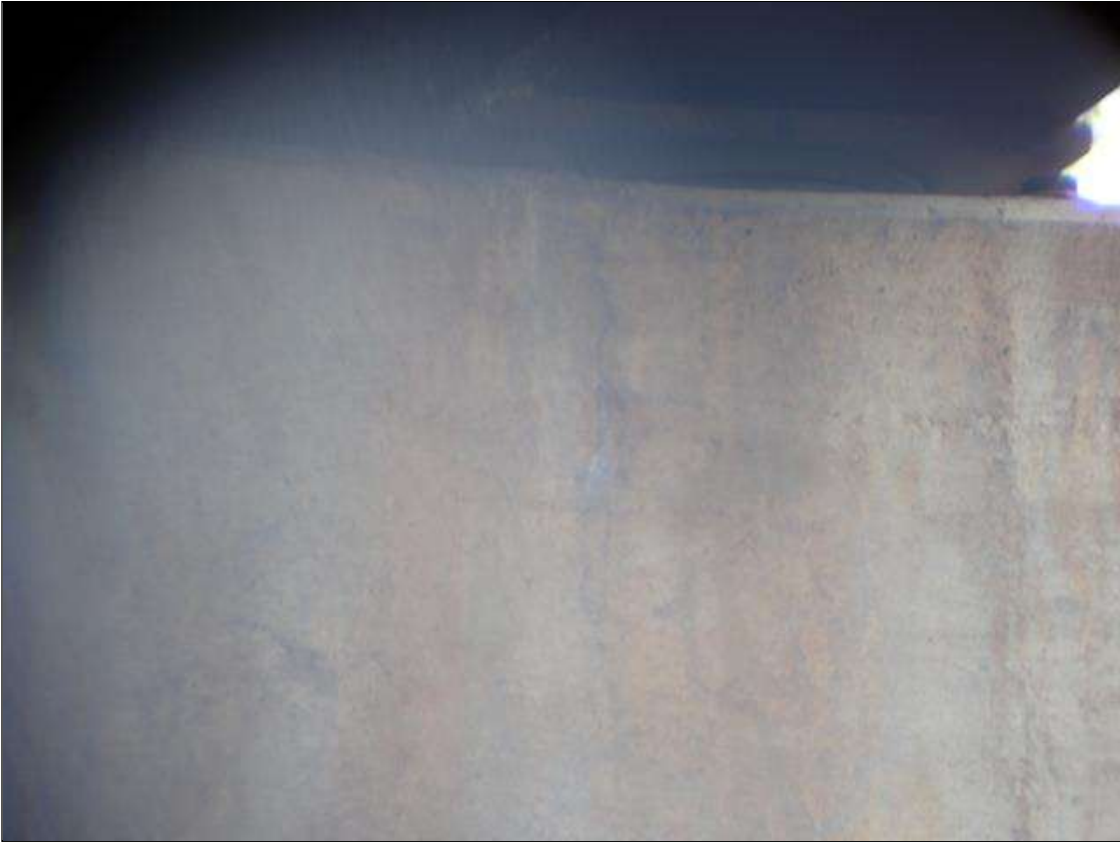
Bent 1 Cap 1: SCATTERED VERTICAL AND DIAGONAL CRACKS UP TO 1/32 INCH, SOME WITH EFFLORESCENCE, AT RANDOM THROUGHOUT ALL FACES.

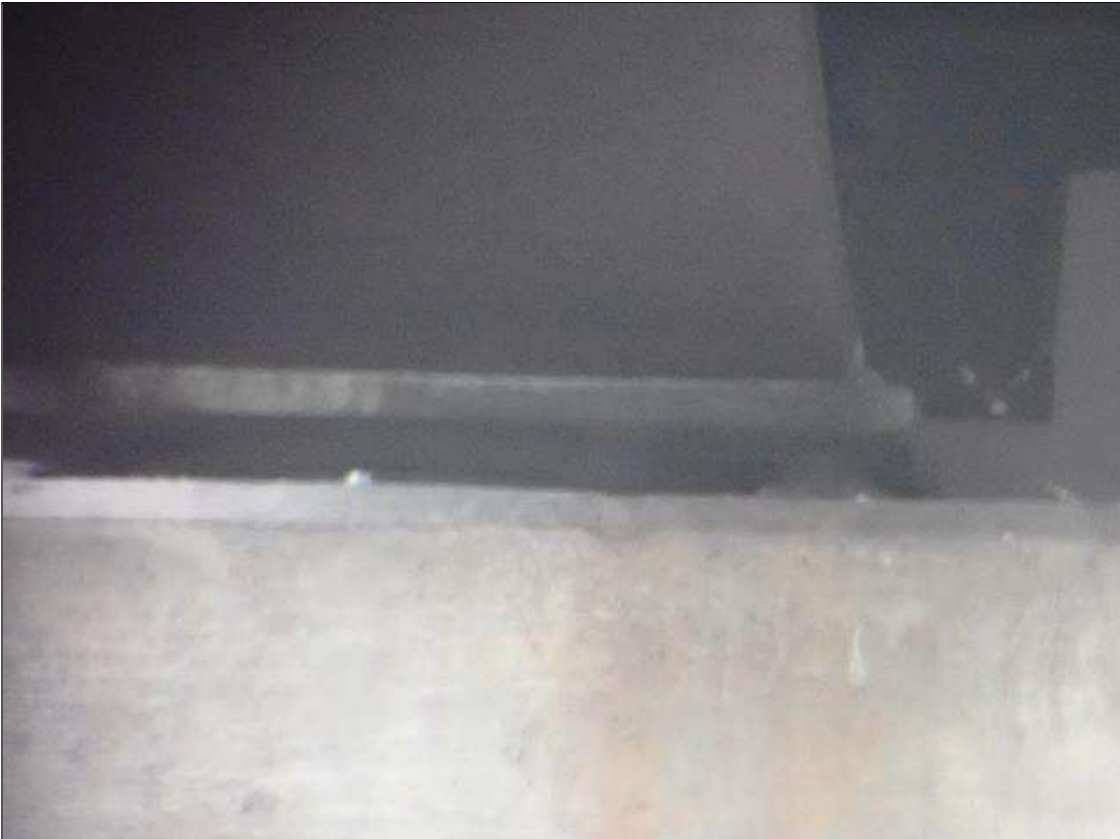
Span 1 Beam 4 - Intermediate Bearing 4: FRECKLED RUST

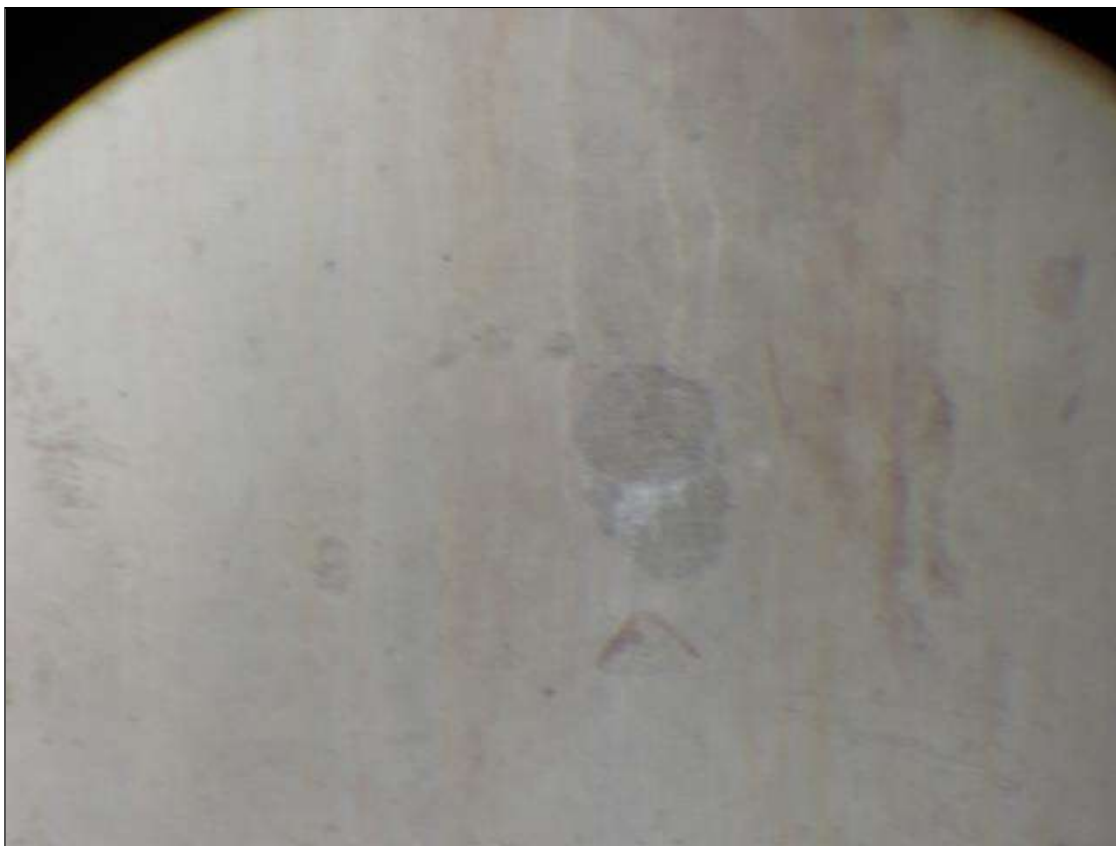
Bent 1 Pile 2: north face, near cap, efflorescence

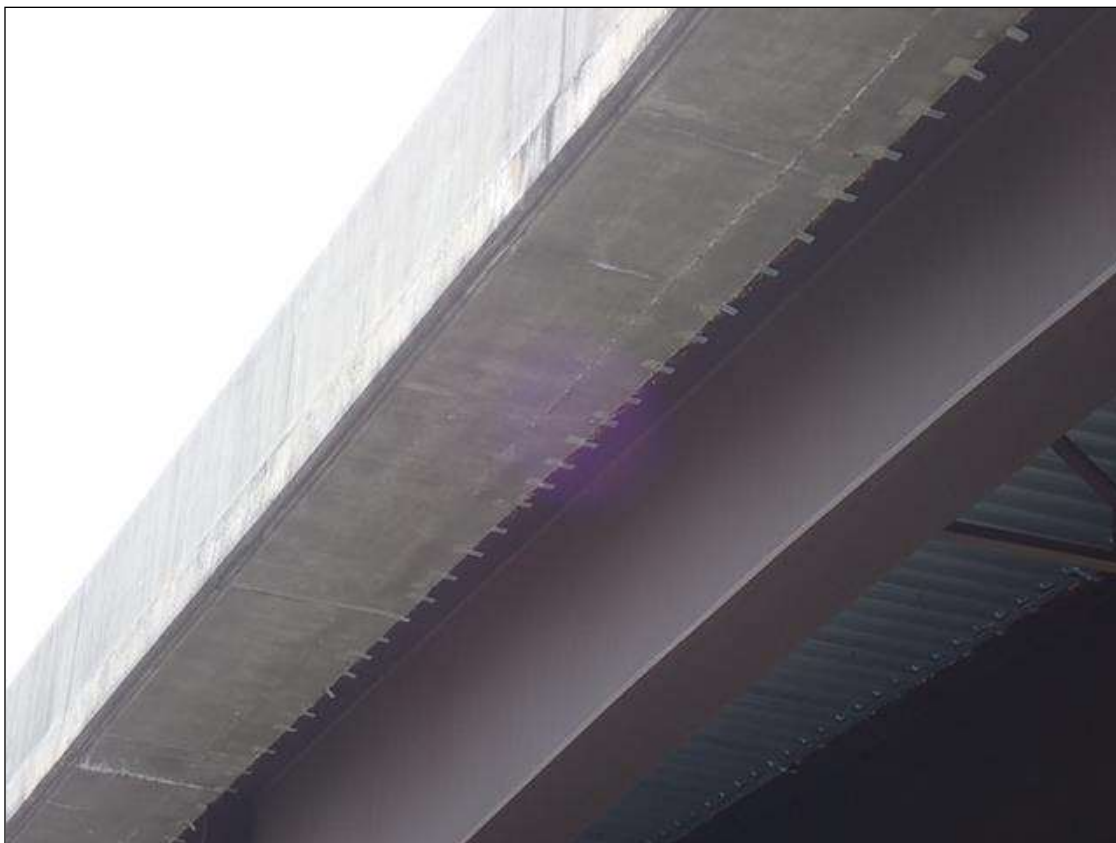
Span 2 Deck: TRANSVERSE CRACKS UP TO 1/64 INCH WITH EFFLORESCENCE UNDERSIDE OF EAST OVERHANG AT RANDOM THROUGHOUT.

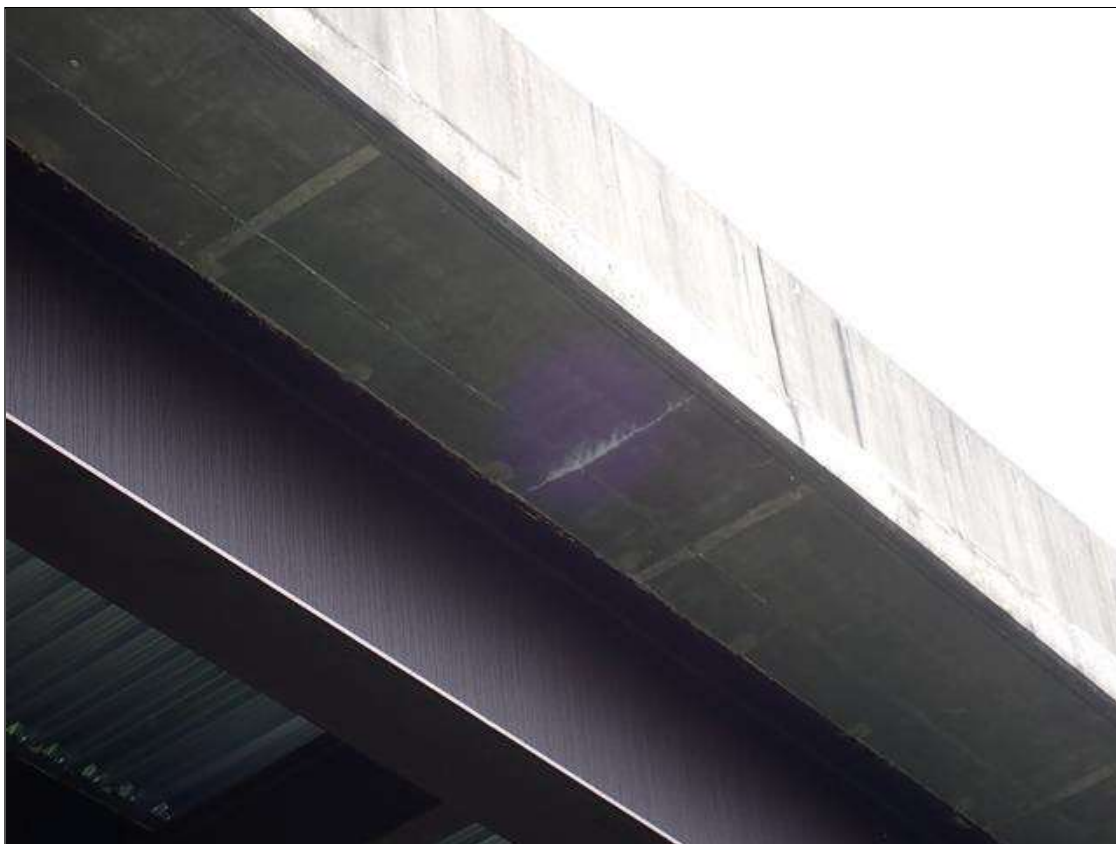
Span 1 Deck: TRANSVERSE CRACKS UP TO 1/64 INCH WITH EFFLORESCENCE UNDERSIDE OF WEST OVERHANG AT RANDOM THROUGHOUT.

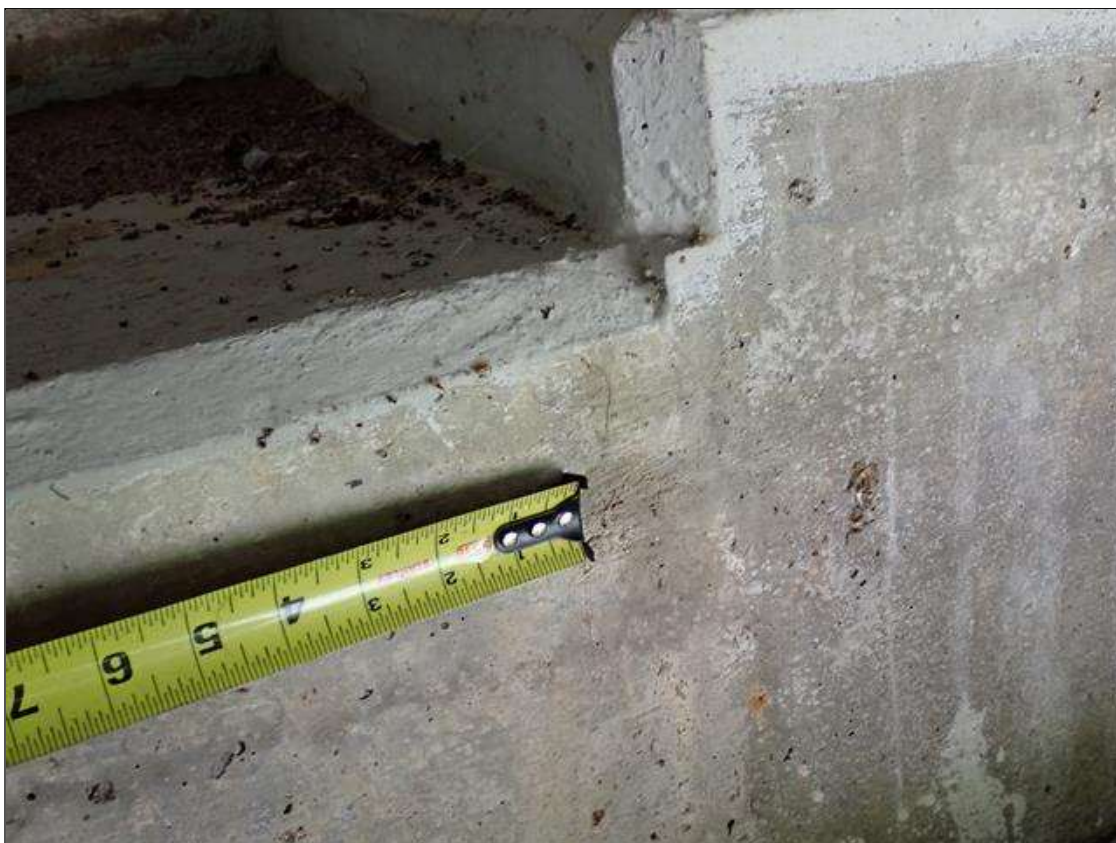
End Bent 1 Cap 1: along length, multiple vertical cracks, up to 8 inch x hairline

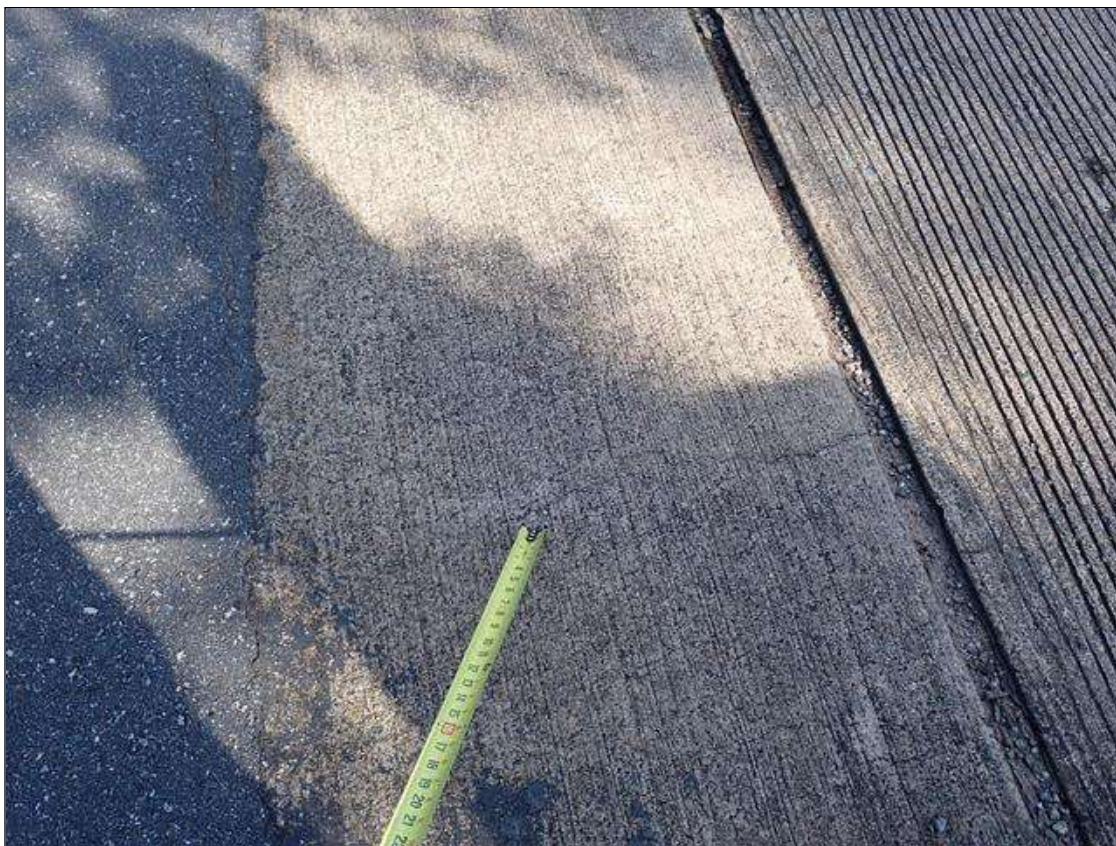
Approach 1 : throughout approach slab, longitudinal cracks (up to 1/32 inch x 2.5 feet) and areas of map cracks (hairline) at random

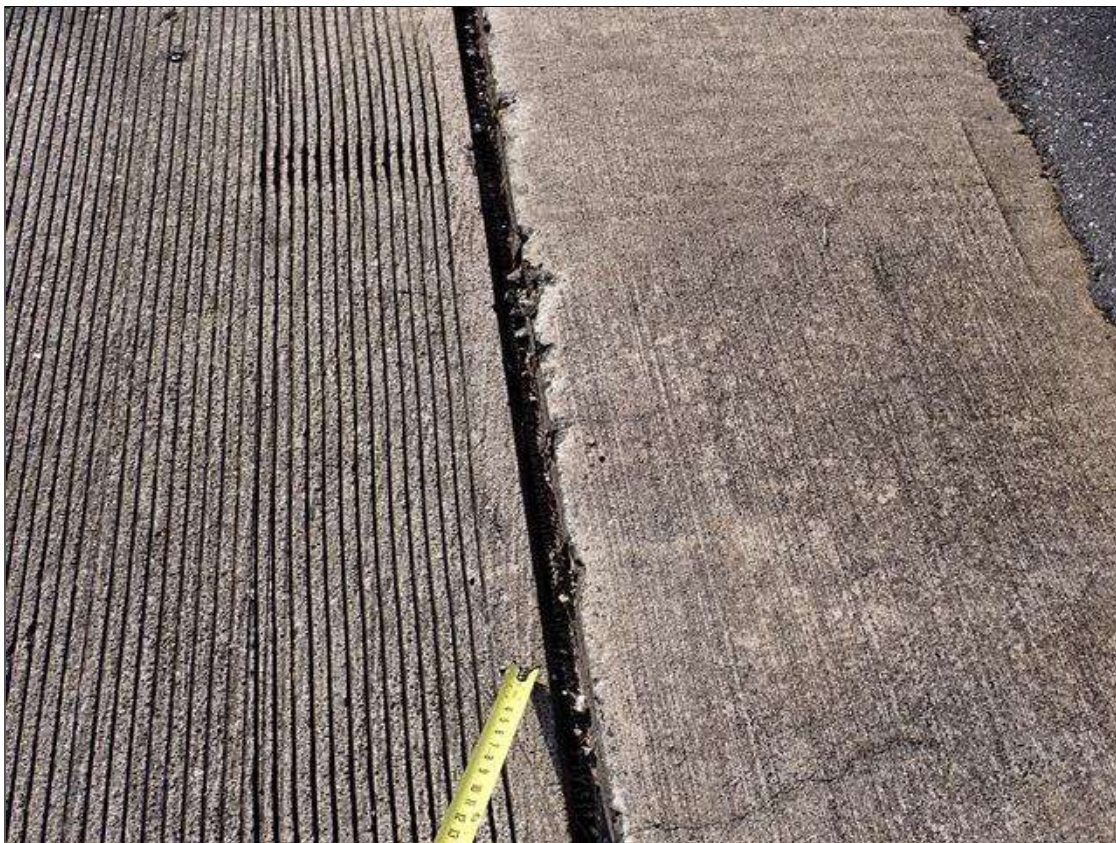
Span 1 End Bent 1 Joint: (not found 2023) along length of joint at random throughout, adhesion loss greater than 50 percent

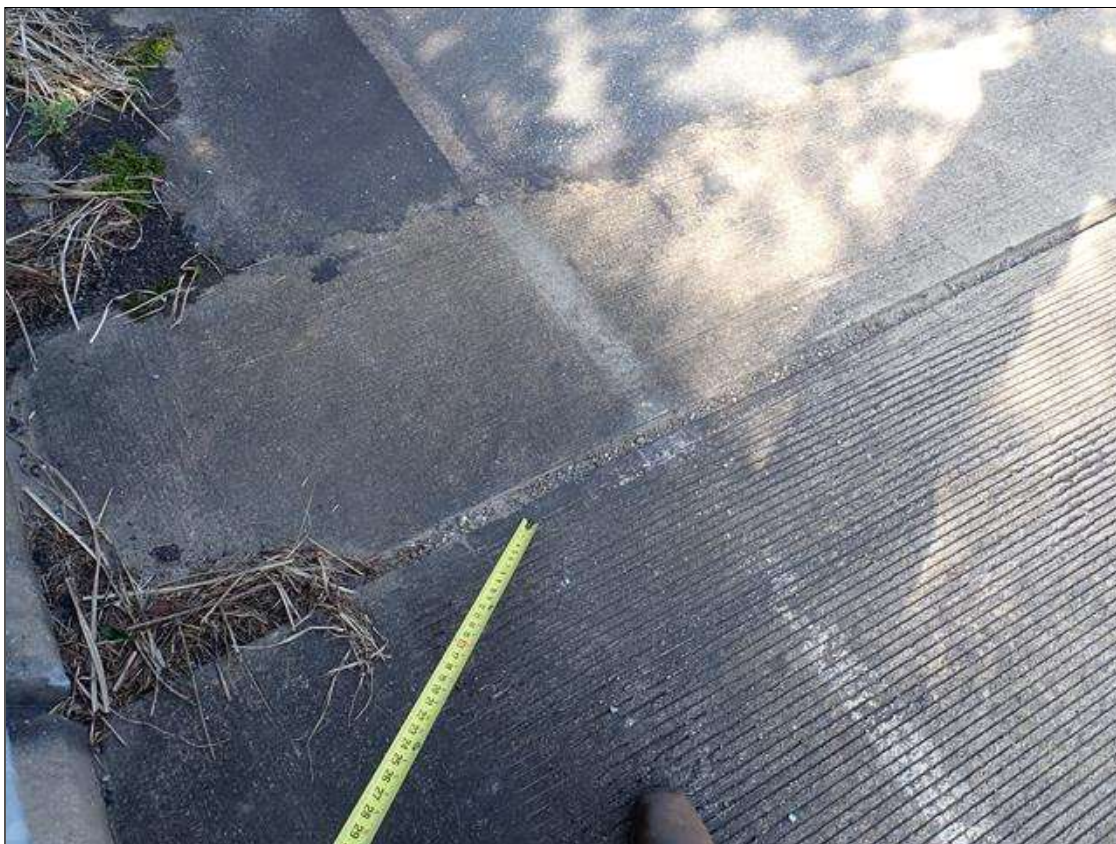
Span 1 End Bent 1 Joint: LOOSE GRAVEL DEBRIS AT RANDOM THROUGHOUT

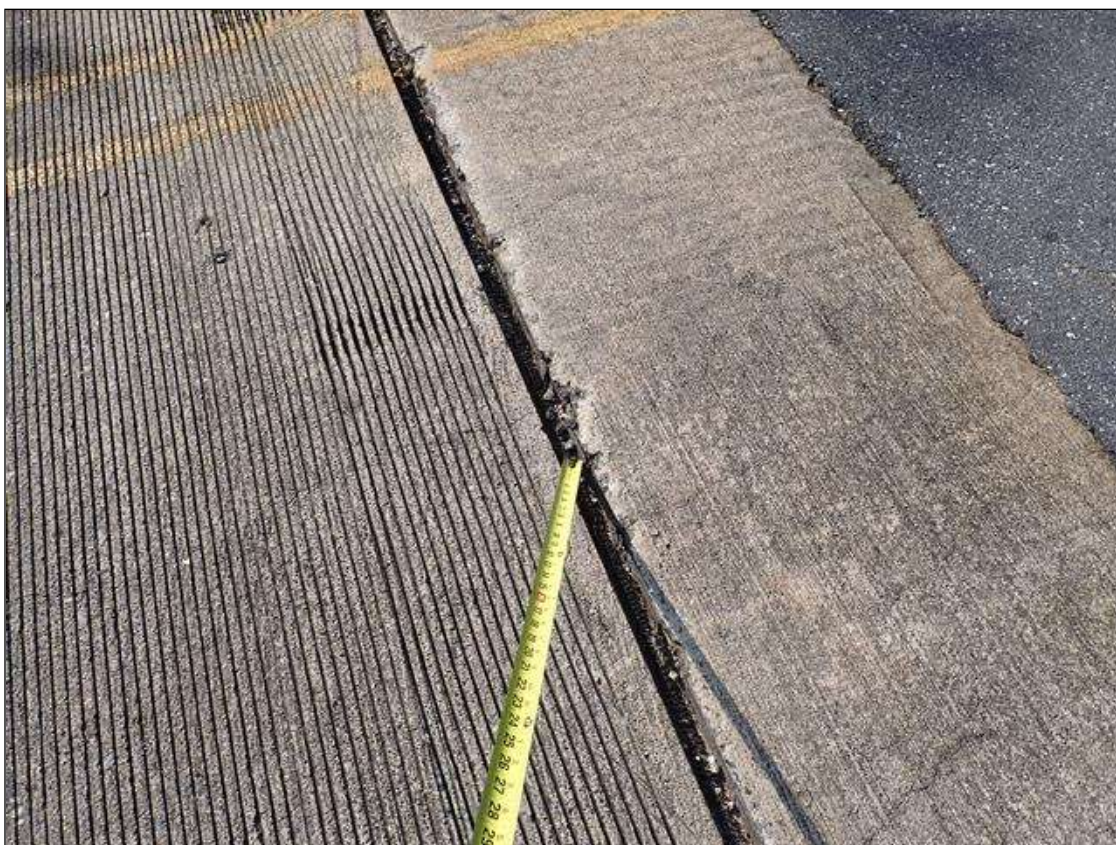
Approach 1 : along end bent 1 joint, edge spalls (up to 4 inch x 2 inch x 1 inch deep)

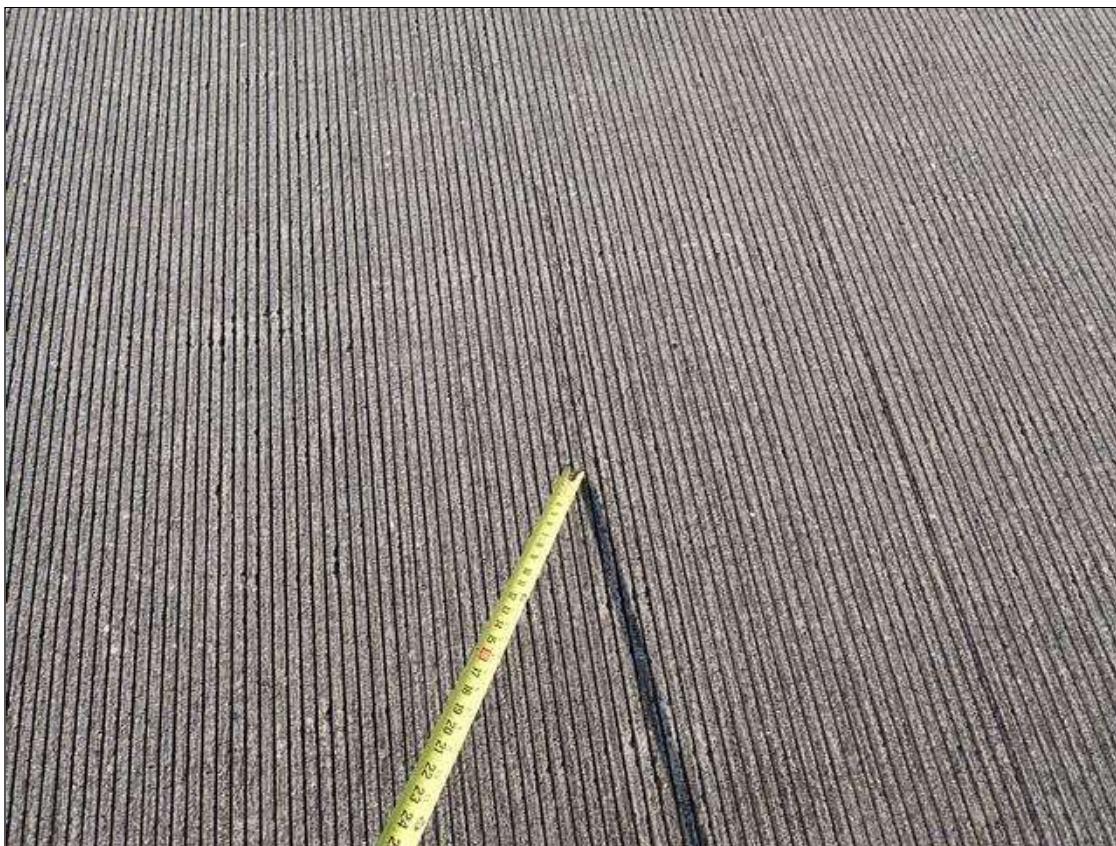
Span 1 Deck: southbound lane, near bent 1, transverse crack (1/32 inch x 6 feet)

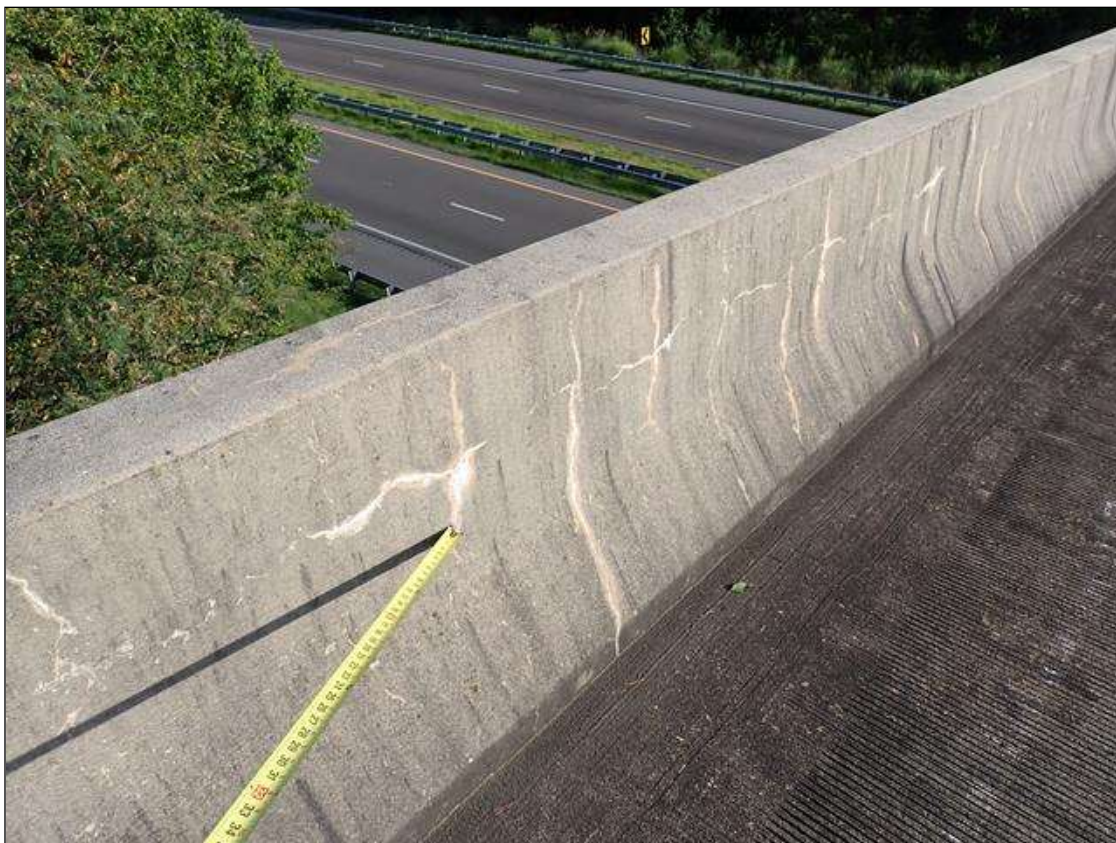
Span 1 Left Bridge Rail: (PAR) VERTICAL, horizontal AND WRAP AROUND CRACKS UP TO 1/32 INCH WITH EFFLORESCENCE AND EFFLORESCENCE BUILDUP AT RANDOM THROUGHOUT

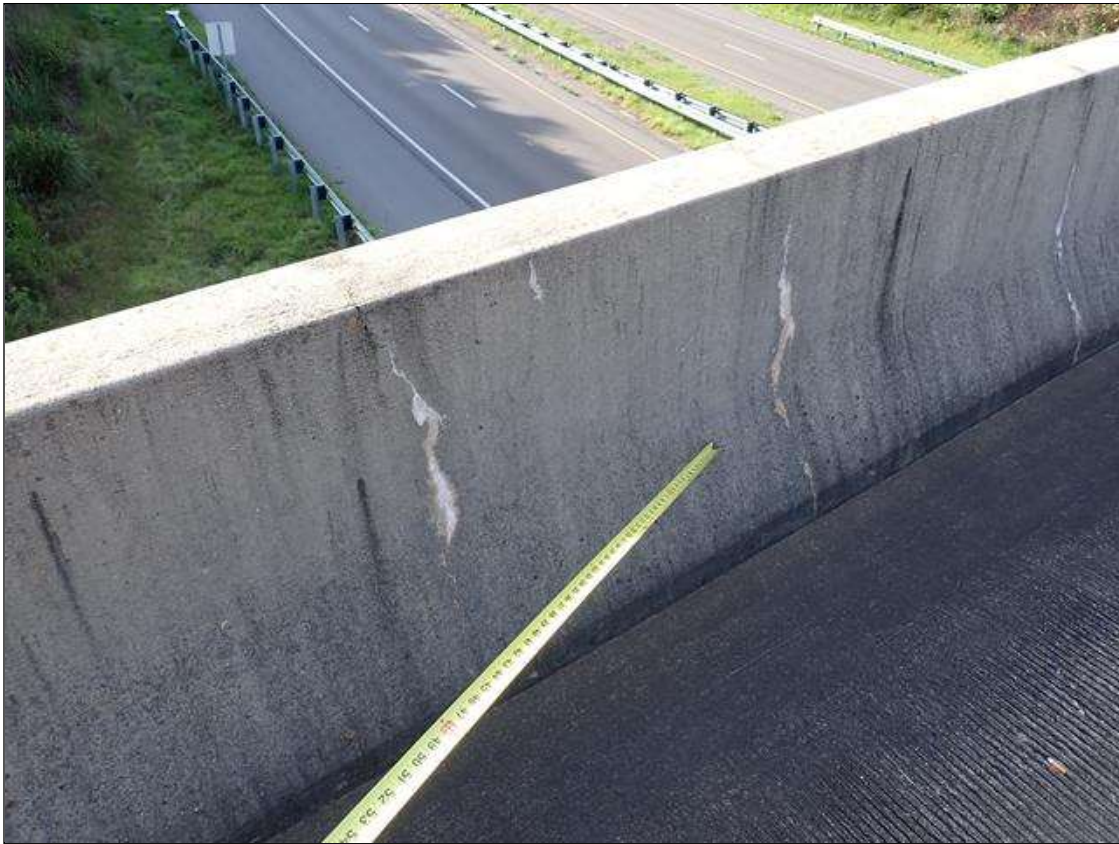
Span 2 Right Bridge Rail: 27 - VERTICAL, HORIZONTAL AND WRAP AROUND CRACKS UP TO 1/32 INCH WITH EFFLORESCENCE AT RANDOM THROUGHOUT

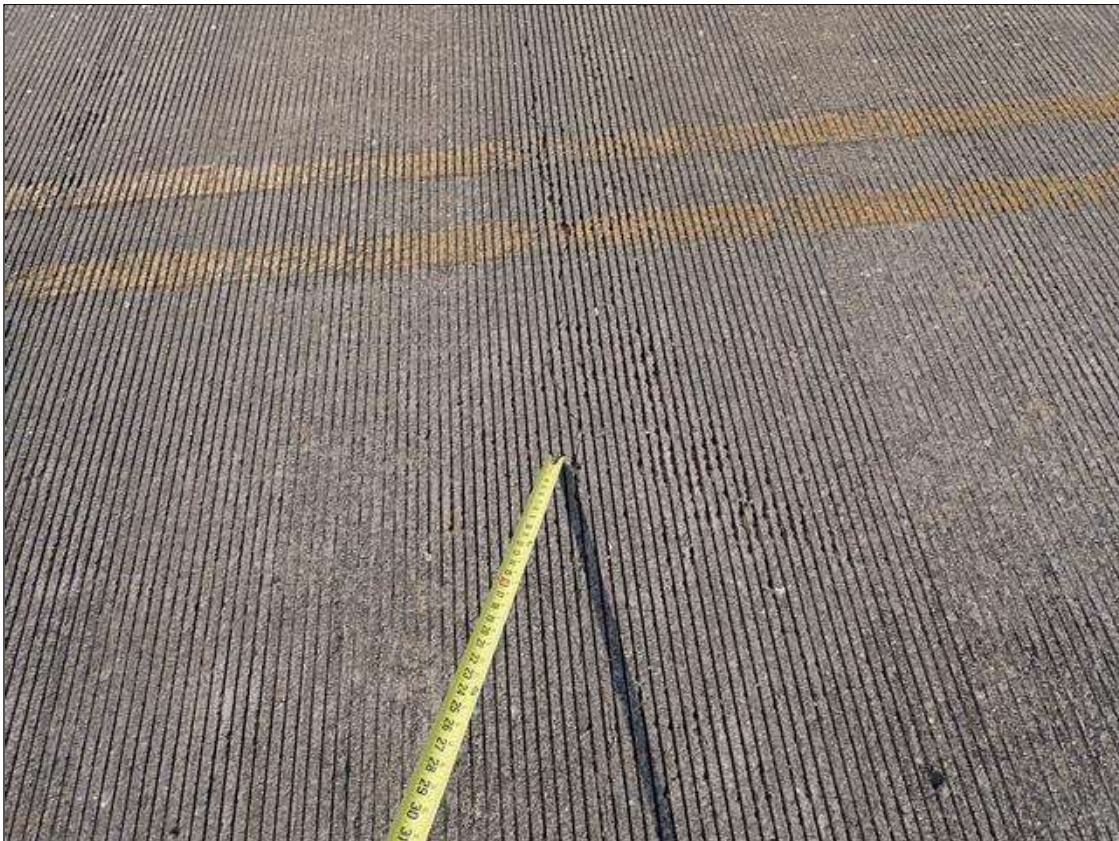
Span 2 Deck: SCATTERED TRANSVERSE CRACKS UP TO 1/32 INCH AT RANDOM THROUGHOUT top of deck

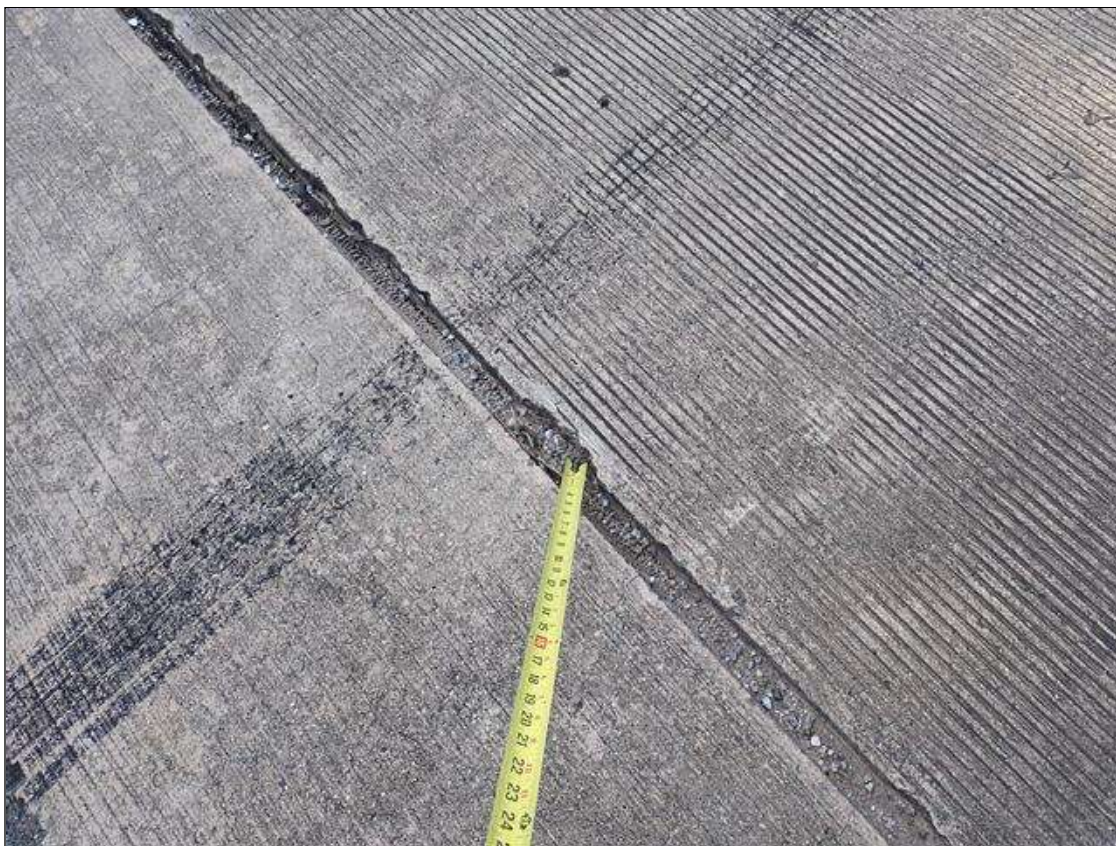
Span 2 End Bent 2 Joint: along the length of the joint, edge spalls (up to 8 inch x 1 inch x 1 inch deep)

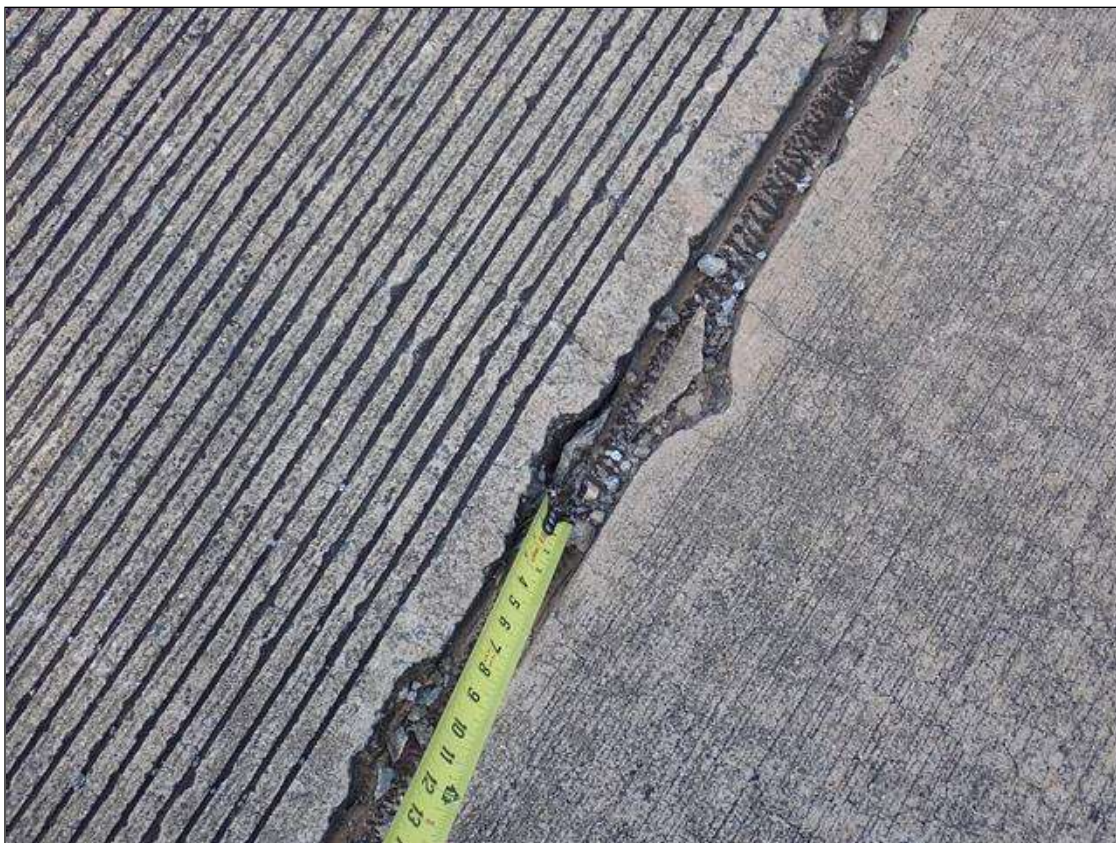
Span 2 End Bent 2 Joint: along length of joint at random throughout, adhesion loss greater than 50 percent

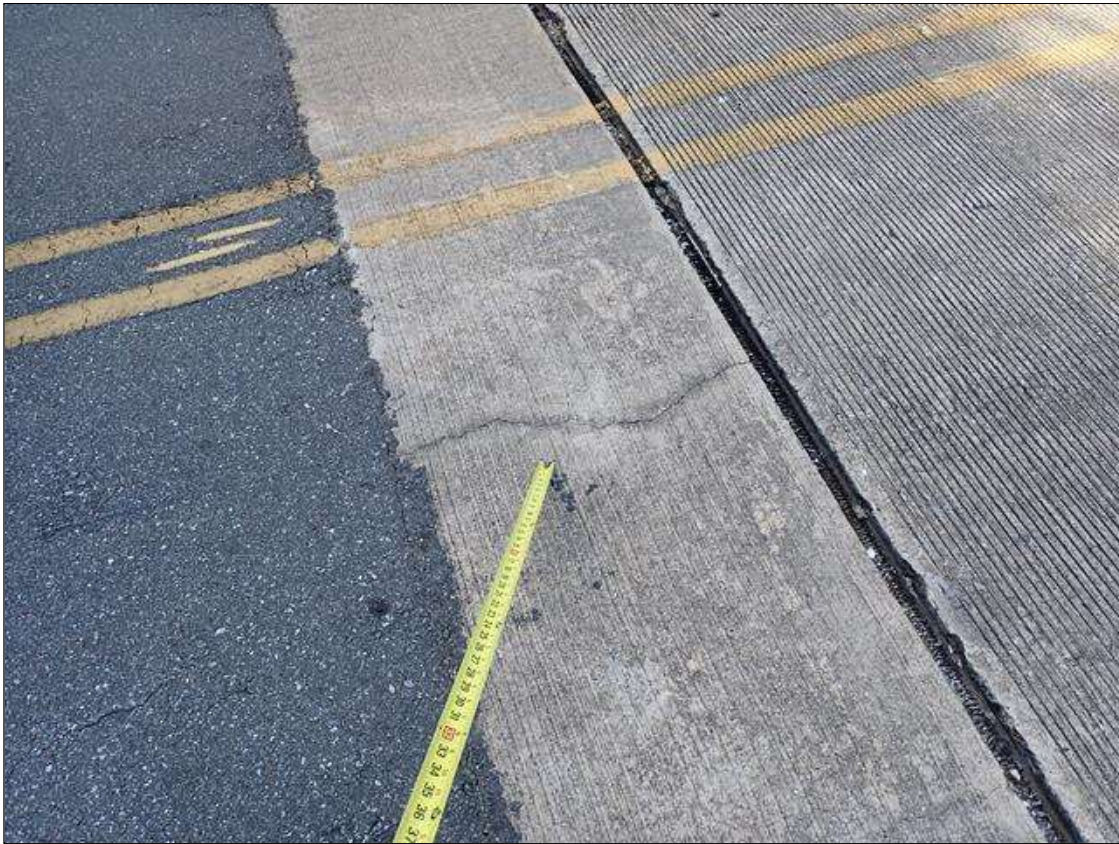
Approach 2 : throughout approach slab, longitudinal cracks (up to 1/32 inch x 2.5 feet) and areas of map cracks (hairline) at random

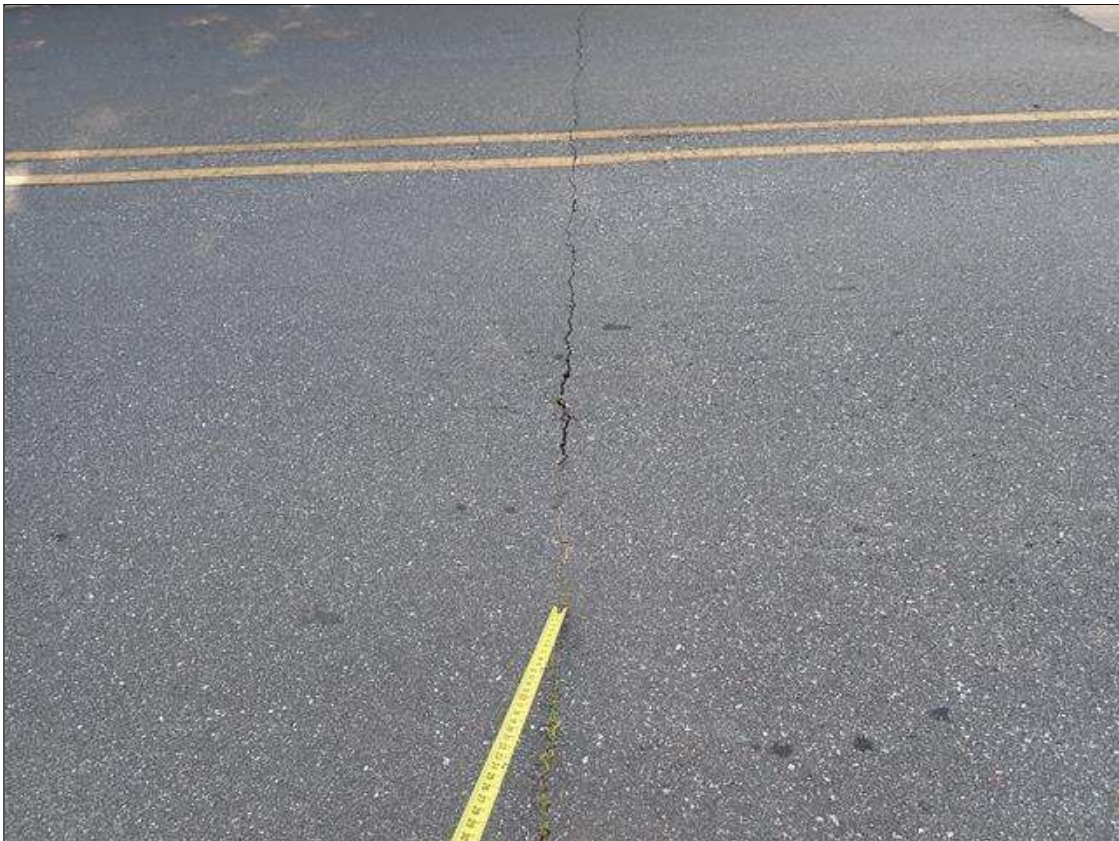
south and north approach asphalt, adjacent to approach slabs, transverse cracks (up to 1/4 inch x full width of roadway)

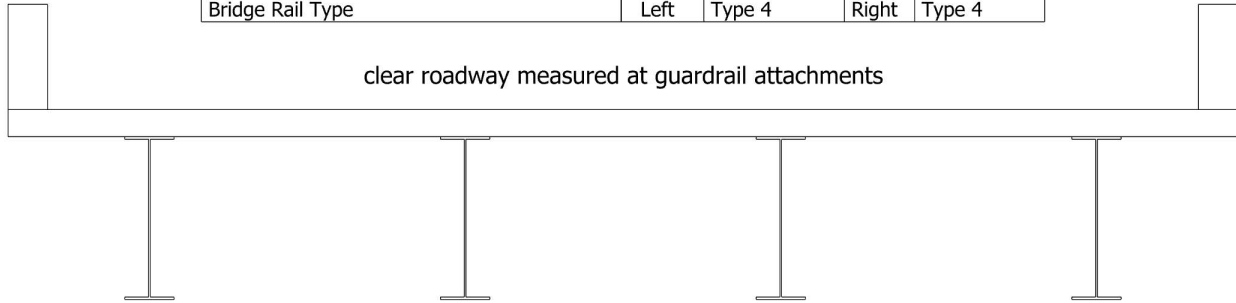
Measurements for Span #	1-2		
Deck Thickness	8.25in	Left Overhang	3.58ft
Top of Rail to Bottom of Beam (Avg)	7.483ft	Right Overhang	3.58ft
