NC DEPARTMENT OF TRANSPORTATION
 DIVISION OF HIGHWAYS
 STRUCTURE MANAGEMENT UNIT

ATTENTION: **PRIORITY ACTION REQUEST ISSUED; CHANGE TO LATERAL UNDERCLEARANCES**

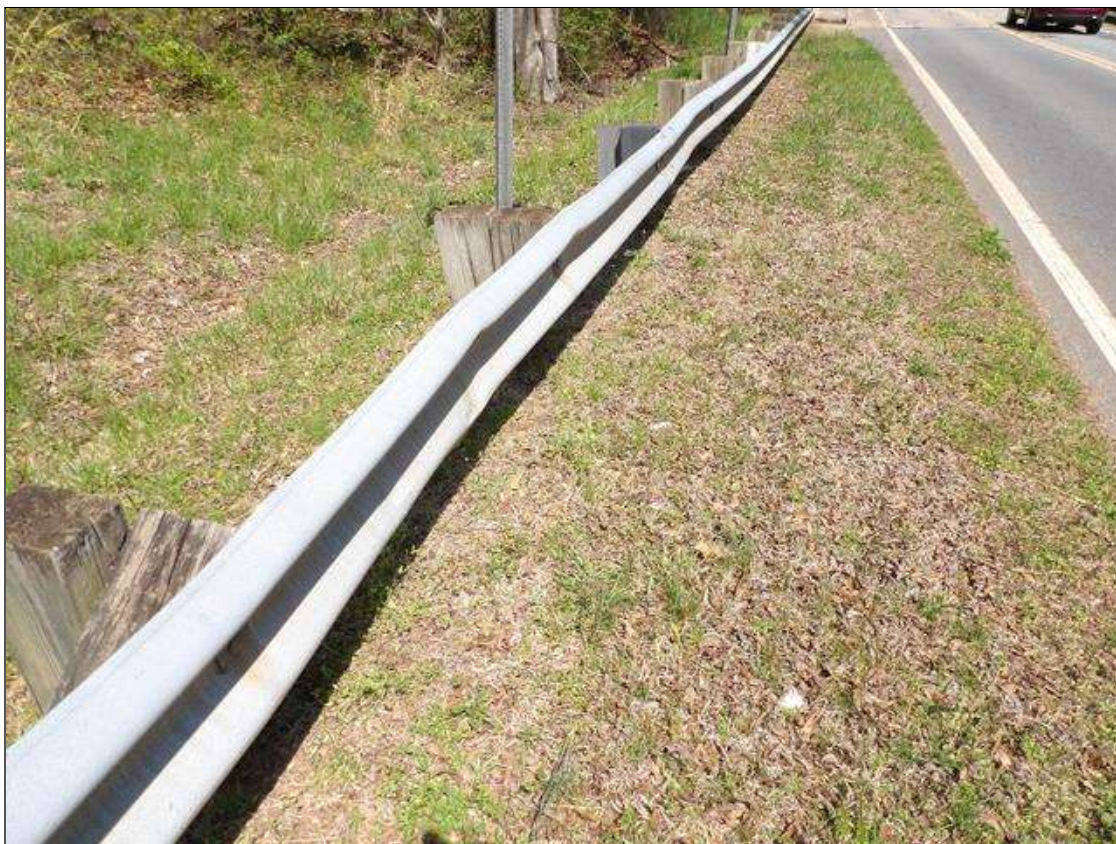
SOUTHWEST GUARDRAIL IMPACT DAMAGE 15 FEET LONG 20 FEET FROM TERMINAL END

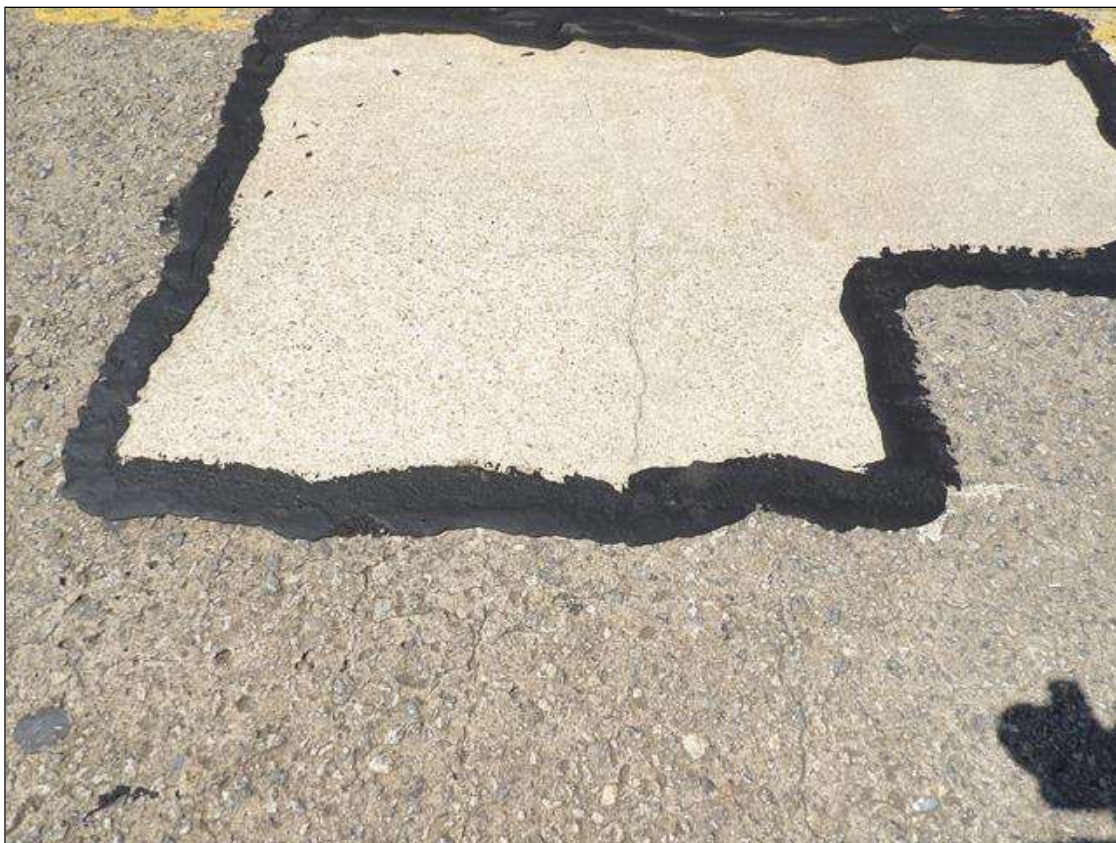
Span 4 Deck: SEVERAL SOUND DECK PATCHES UP TO 4.5 FEET X 3 FEET WITH CRACKING UP TO 1/32 INCHES WIDE

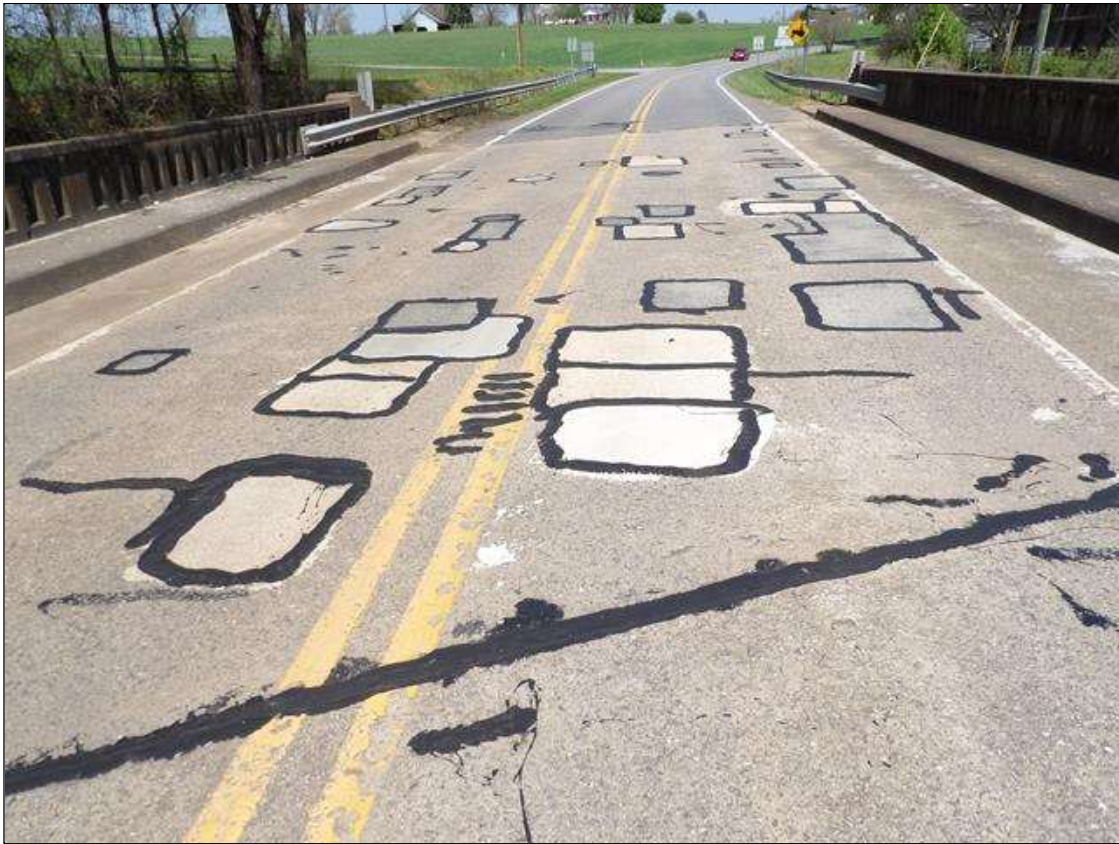
TYPICAL SOUND PATCHED AREAS IN SPAN 4 DECK

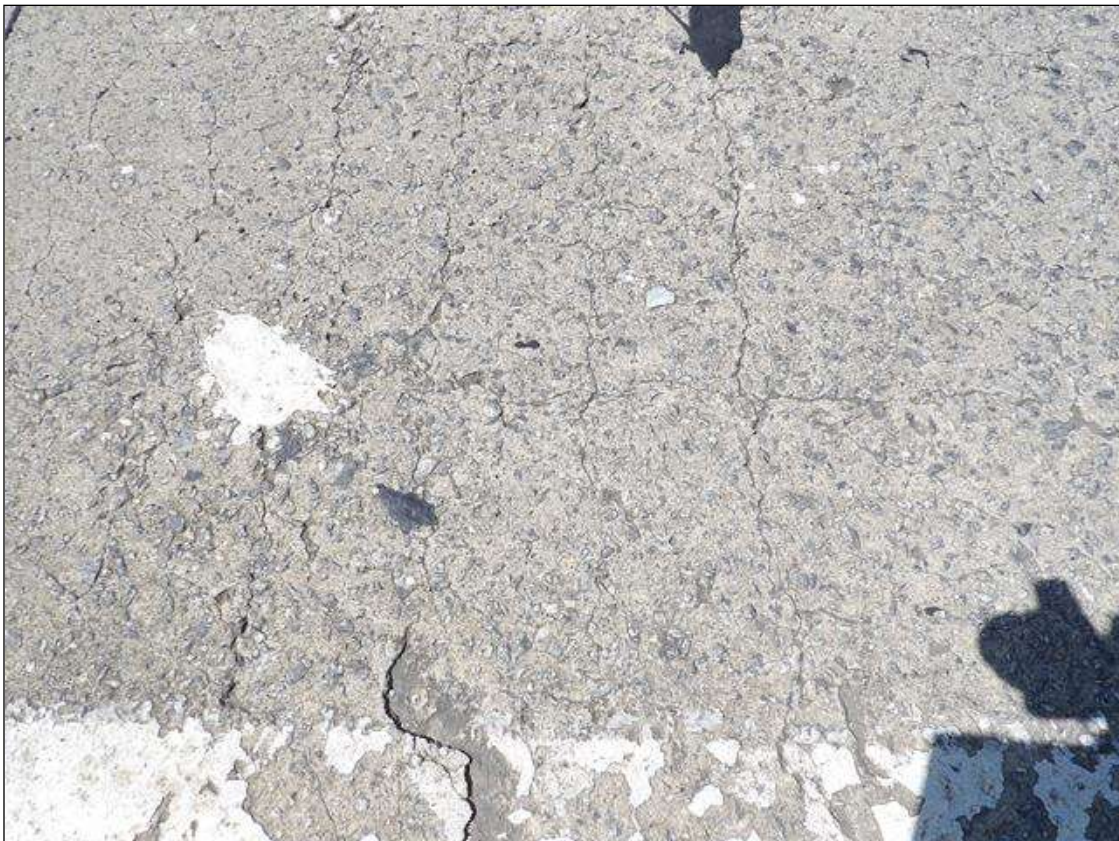
Span 4 Deck: UP TO 1/8 INCH WIDE TRANSVERSE CRACKS AT VARIOUS LOCATIONS IN TOP OF DECK

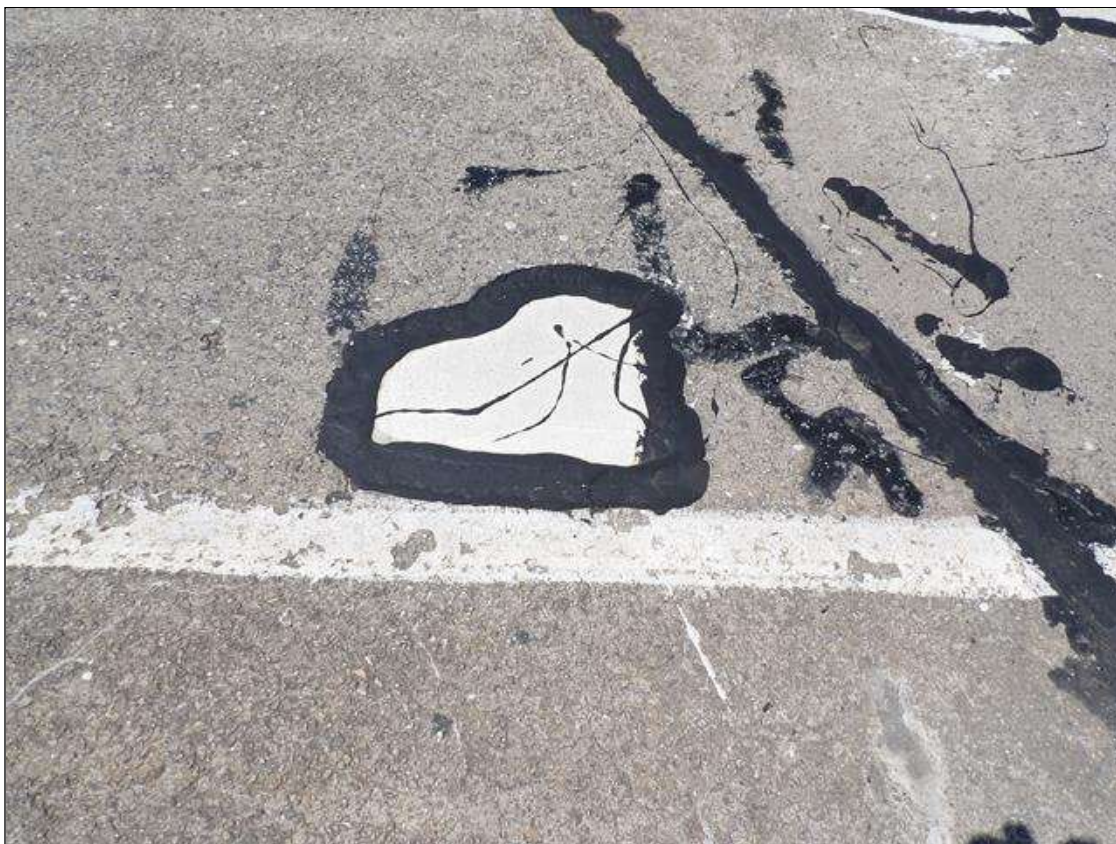
Span 3 Deck: SOUND PATCH TO FIX PREVIOUS PAR 18 INCHES LONG X 14 INCHES WIDE IN NORTHBOUND LANE 2 FEET FROM BENT 3 JOINT

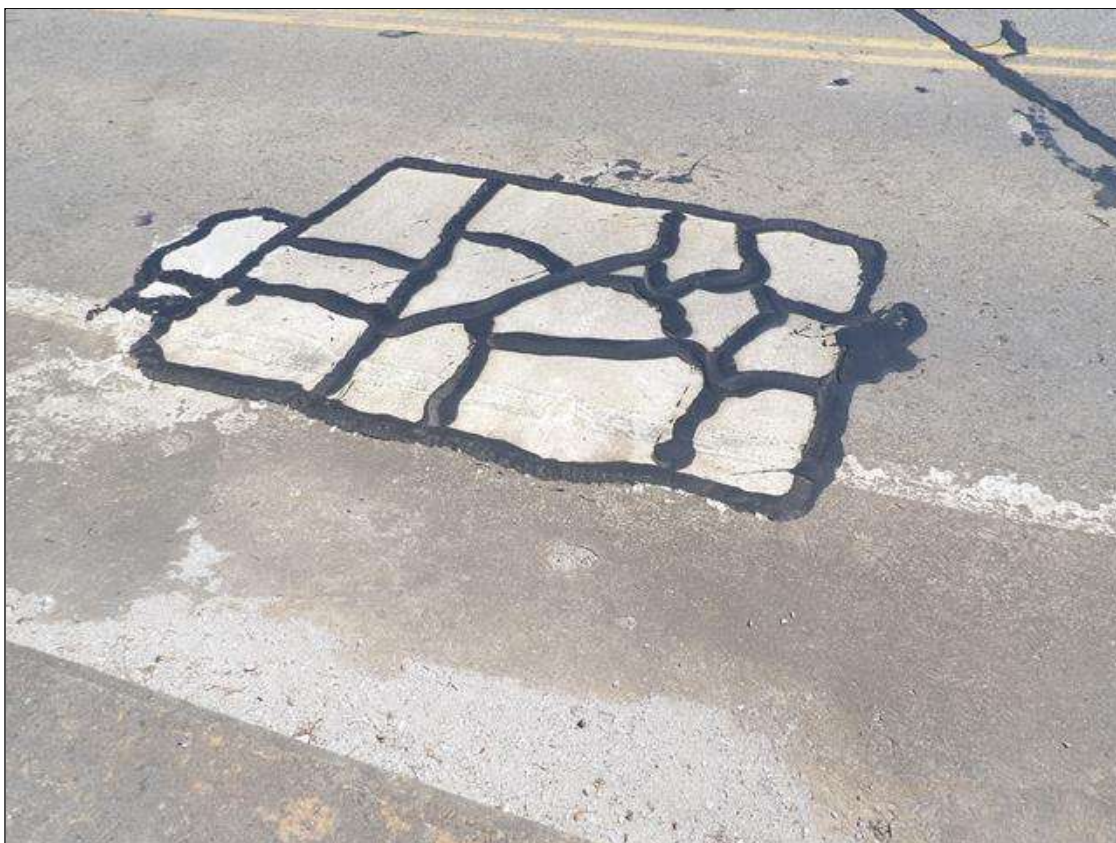
Span 3 Deck: 4.5 FEET WIDE X 7 FEET LONG SOUND PATCH WITH INTERMITTENT SEALED CRACKING IN SOUTHBOUND TRAVEL LANE NEAR BENT 2

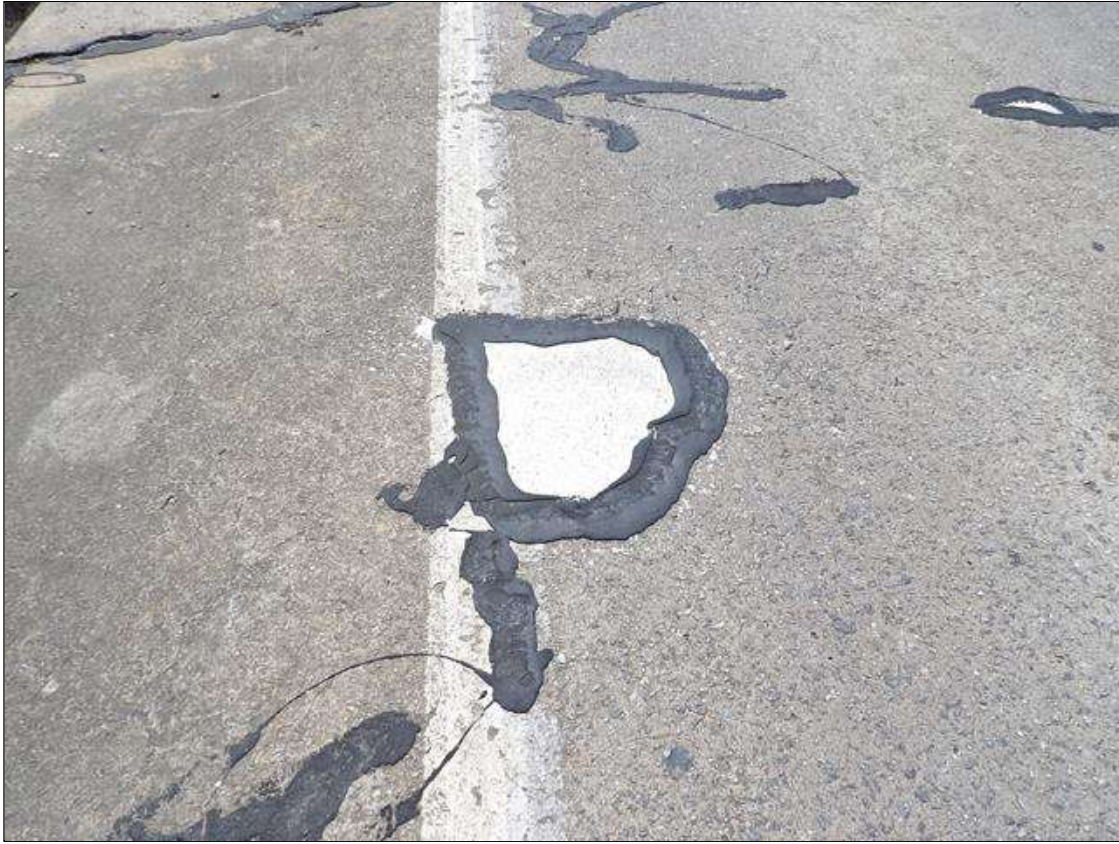
Span 3 Deck: SOUND PATCH TO FIX PREVIOUS PAR 18 INCHES DIAMETER LOCATED 6 FEET FROM BENT 2 IN THE NORTHBOUND TRAVEL LANE

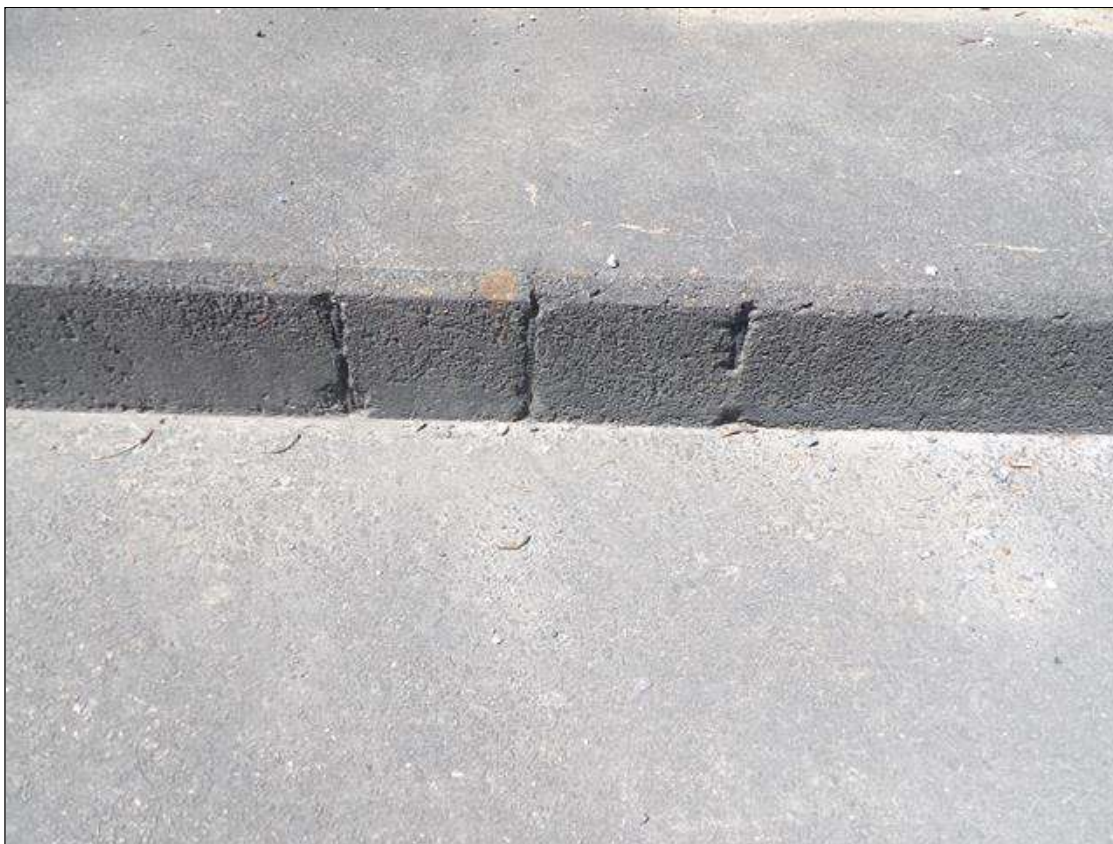
SPAN 2 LEFT SIDEWALK (3) 9 INCHES HIGH X 3/4 INCHES WIDE X 1/4 INCHES DEEP SPALLS WITH EXPOSED REBAR ON VERTICAL FACE OF LEFT SIDEWALK , APPROXIMATELY 15 FEET FROM BENT 1

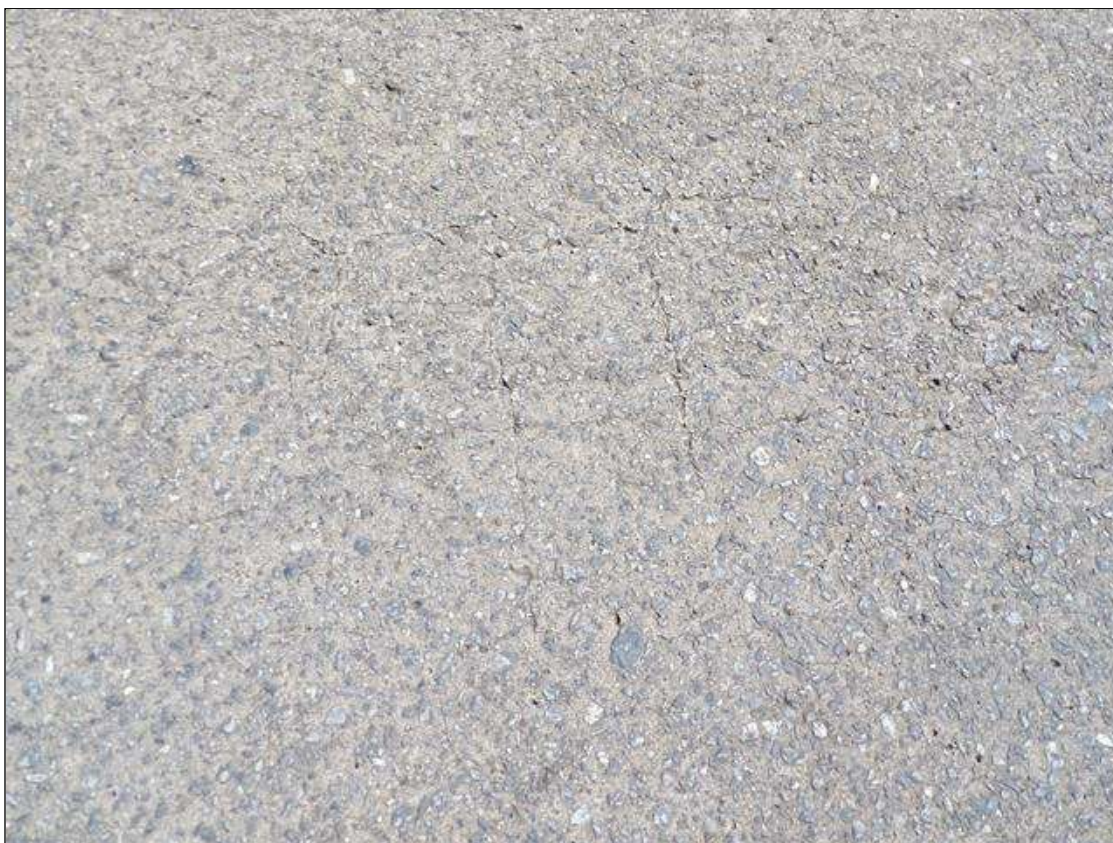
TYPICAL-- MAP CRACKING UP TO 1/16 INCHES WIDE INTERMITTENT THROUGHOUT BRIDGE DECK, SPAN 2 SHOWN

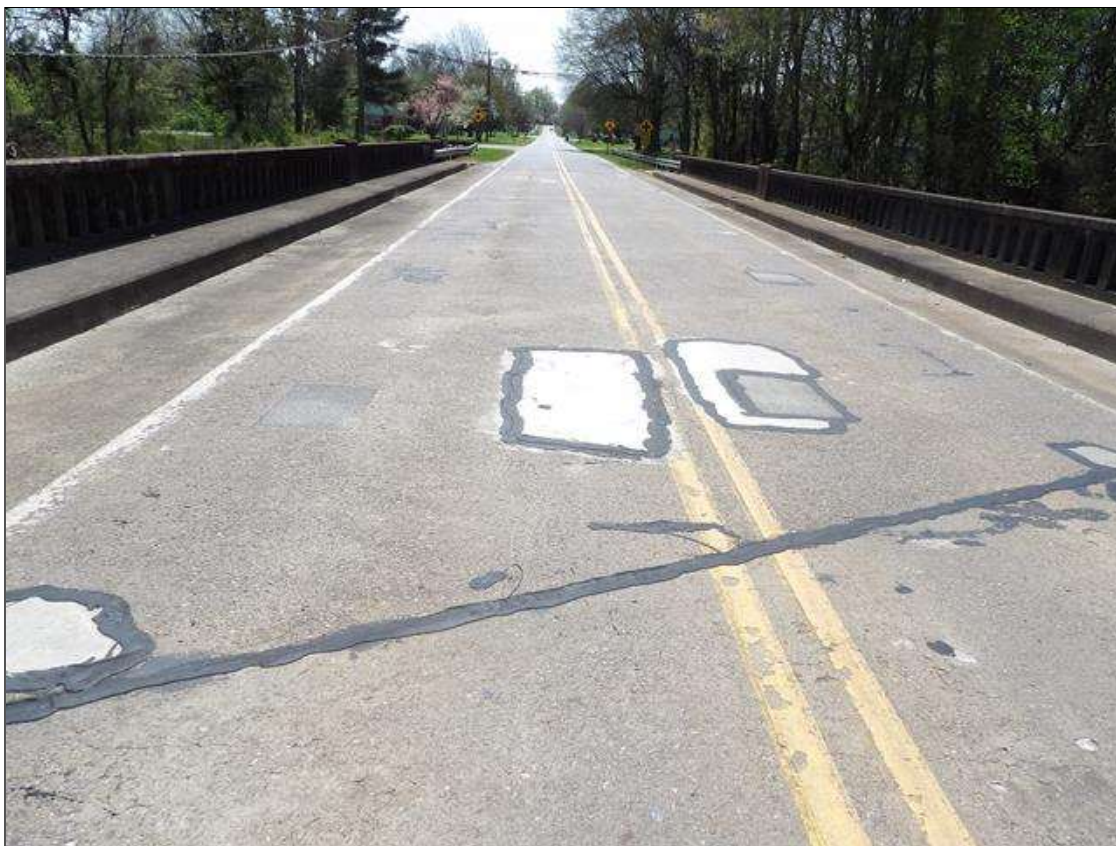
TYPICAL SOUND PATCHES IN SPAN 2 DECK

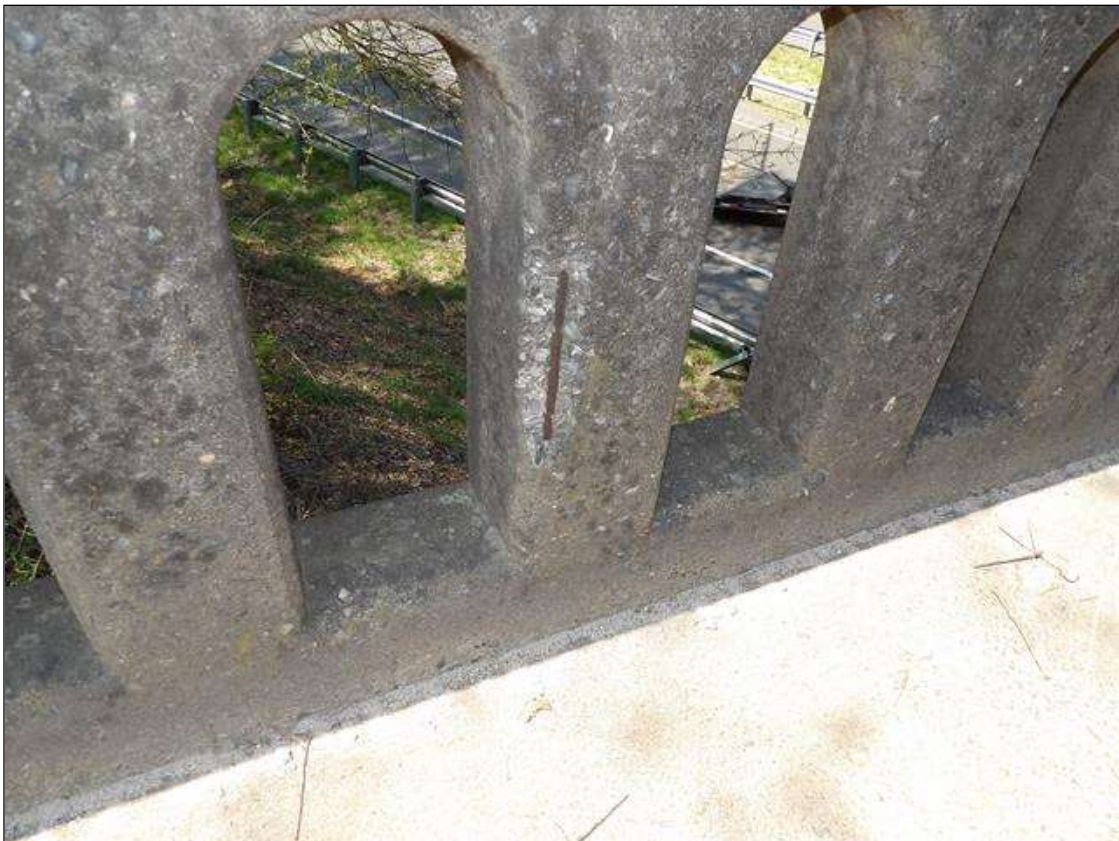
TYPICAL-- SPALLS UP TO 19 INCHES HIGH X 2 INCHES WIDE X 0.5 INCHES DEEP WITH EXPOSED REBAR THROUGHOUT FRONT AND BACK FACE OF BARRIER RAIL PEDESTALS SPAN 1 LEFT SHOWN

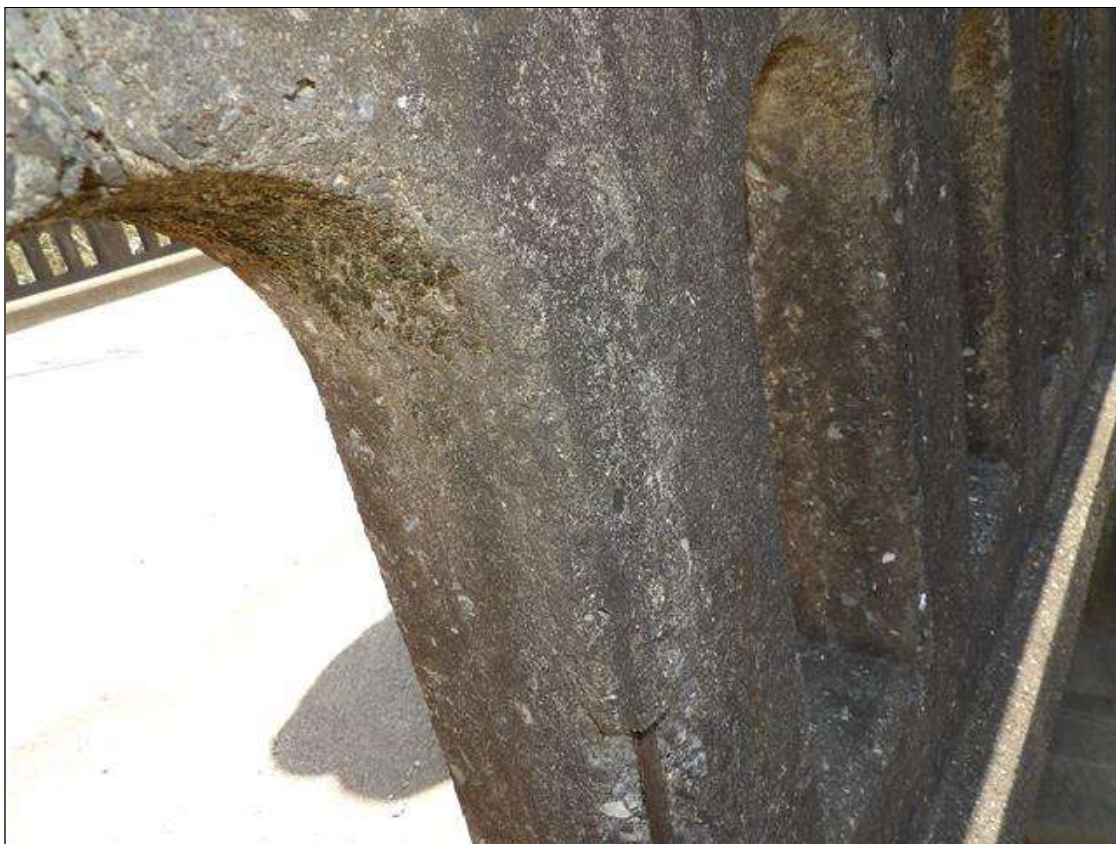
Span 2 Left Bridge Rail: PAR: (13) SPALLS AND DELAMINATED AREAS UP TO 2 FEET HIGH X 3 INCHES WIDE X 3 INCHES DEEP WITH EXPOSED REBAR INTERMITTENT THROUGHOUT FRONT AND BACK FACE OF BARRIER RAIL PEDESTALS, SOME AREAS ON BACK FACE ARE LOOSE AND OVER TRAFFIC

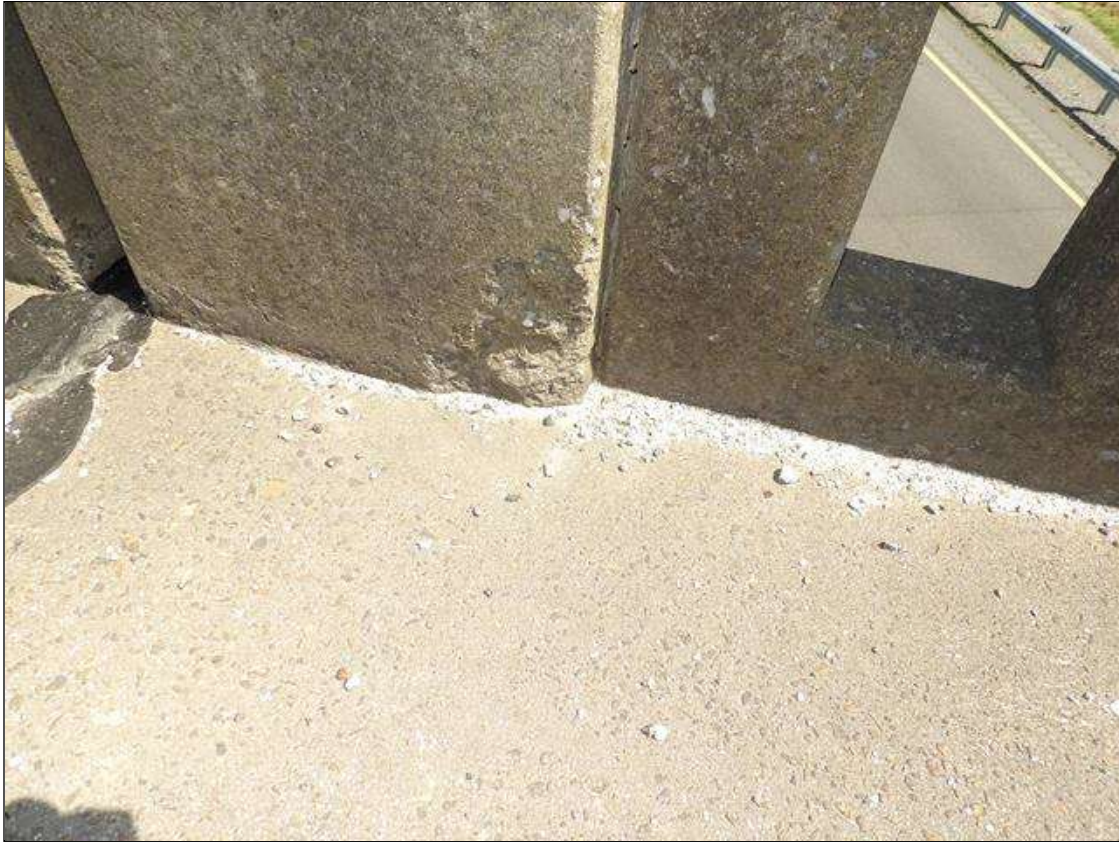
Span 3 Right Bridge Rail: SPALL 9 INCH X 6 INCH X 3/4 INCH DEEP ON INSIDE FACE OF END POSTS AT PIER 3
AT BOTTOM

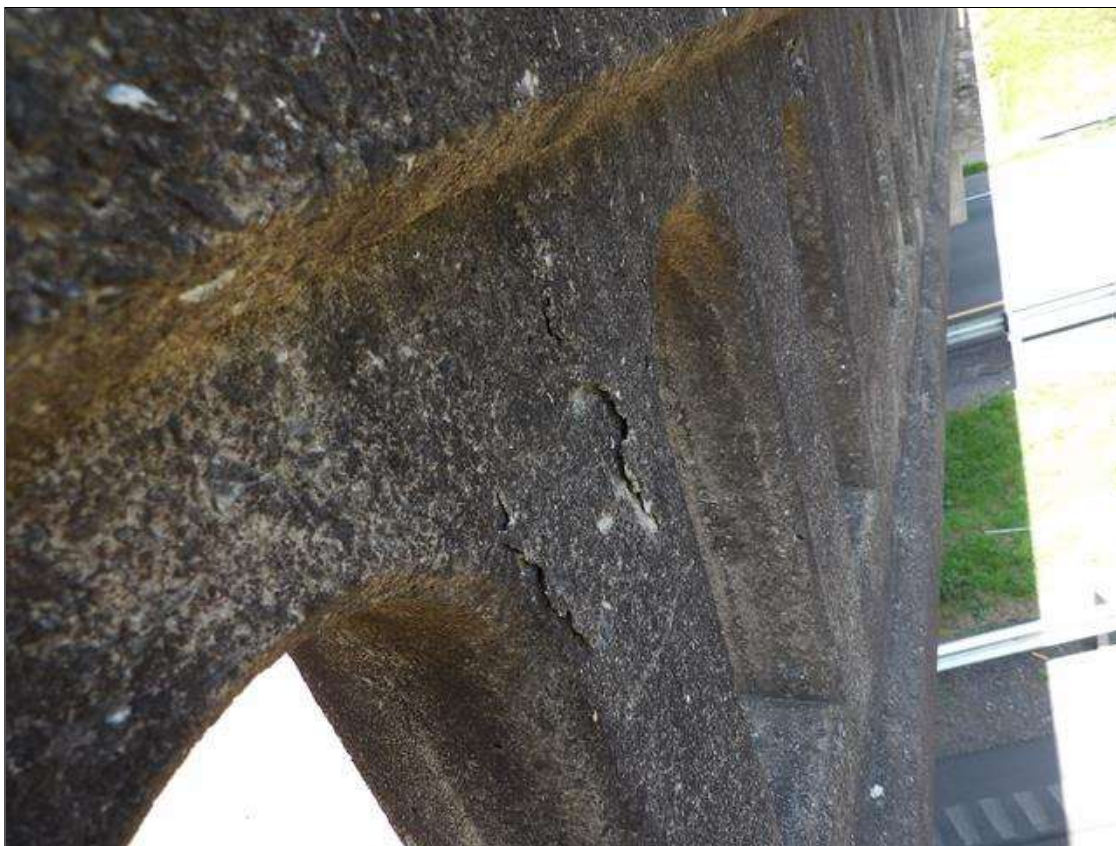
Span 2 Right Bridge Rail: PAR: (6) SPALLS AND DELAMINATED AREAS UP TO 8 INCHES HIGH X 5 INCHES WIDE X 0.5 INCHES DEEP WITH EXPOSED REBAR INTERMITTENT THROUGHOUT FRONT AND BACK FACE OF BARRIER RAIL PEDESTALS, SOME AREAS ON BACK FACE ARE LOOSE AND OVER TRAFFIC - NCDOT NOTIFIED

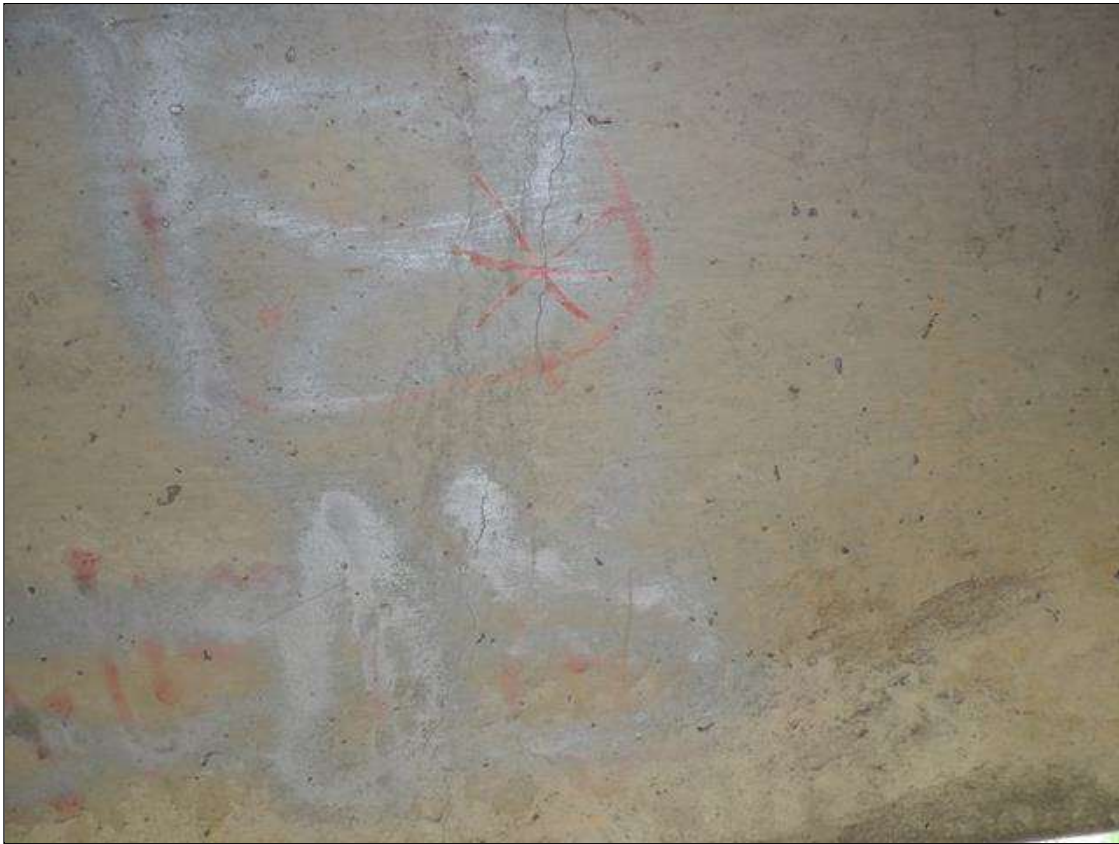
TYPICAL VERTICAL CRACKS UP TO 1/32 INCHES WIDE UP TO FULL-HEIGHT OF WEB SCATTERED THROUGHOUT BEAMS, BEAM 1 SPAN 1 SHOWN

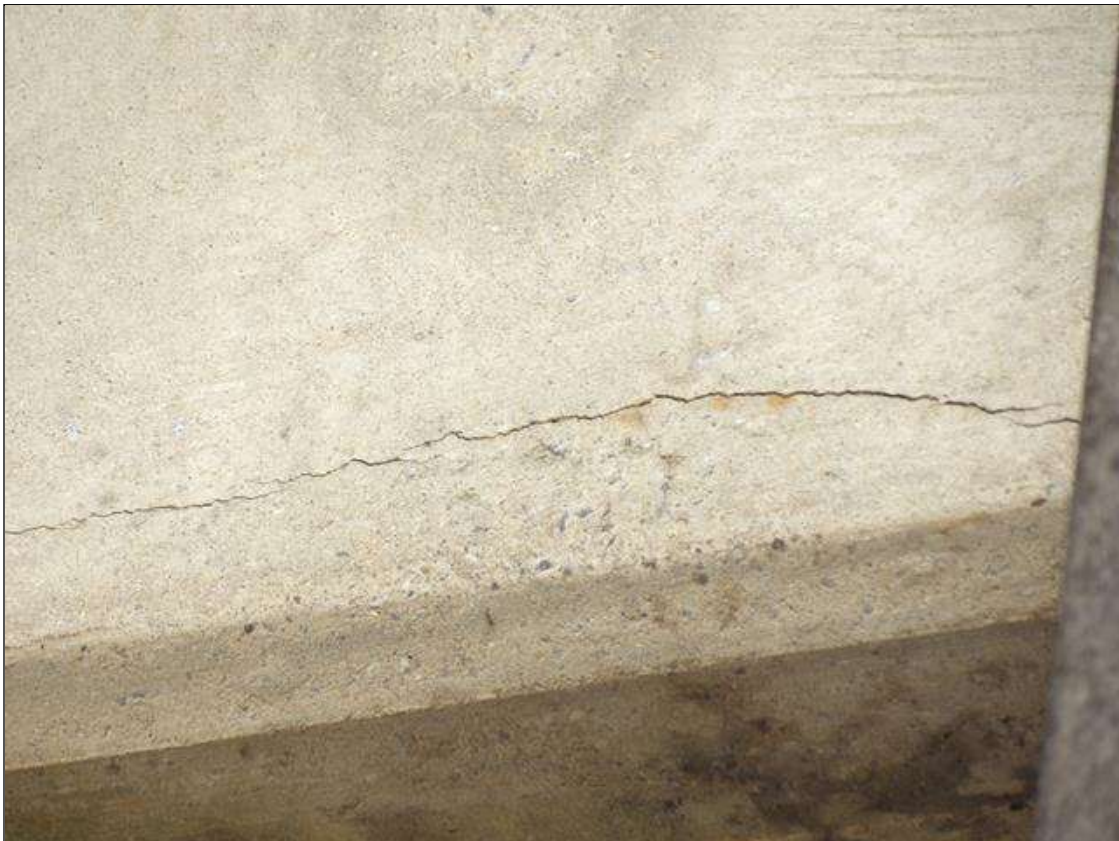
Span 2 Beam 1: AT BENT 1, UP TO 1/16 INCHES WIDE HORIZONTAL CRACK UP TO 3 FEET LONG IN LEFT FACE AT BOTTOM OF BEAM

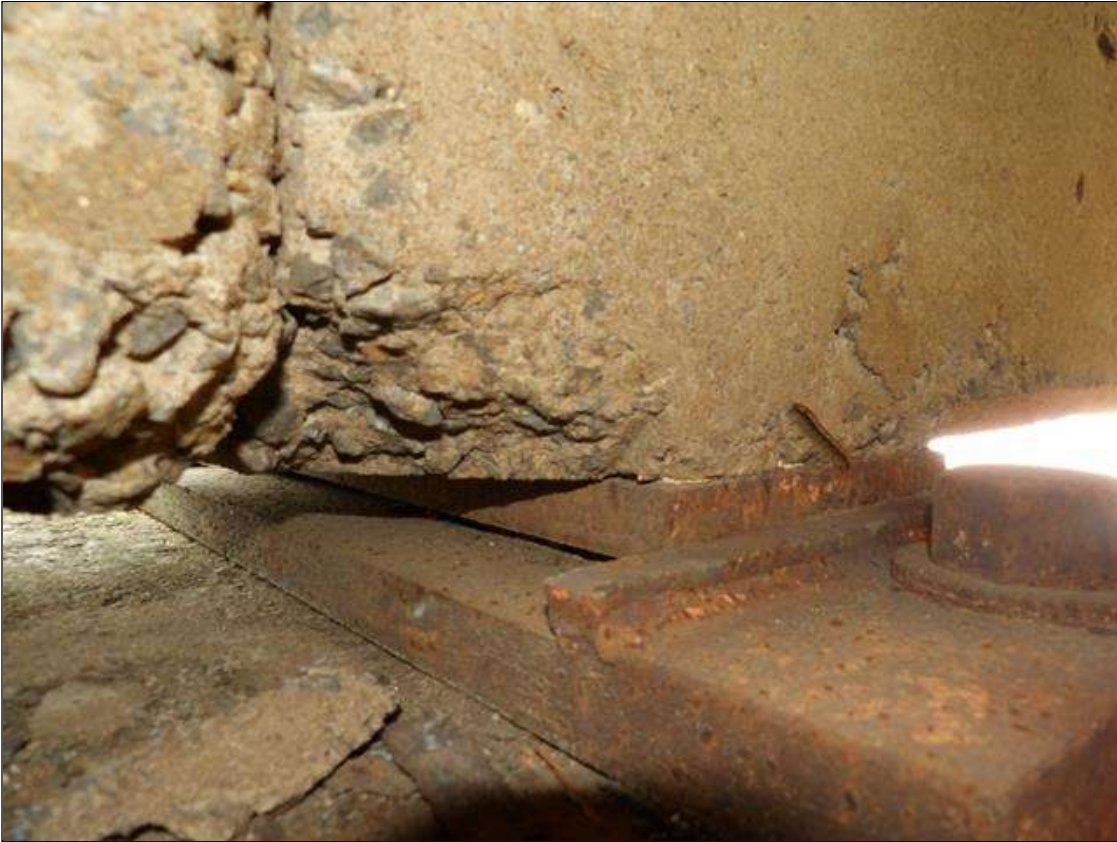
Span 2 Beam 1: 4 INCHES LONG X 3 INCHES WIDE X 1 1/2 INCHES DEEP SPALL ON BOTTOM RIGHT CORNER AT NEAR END, NO LOSS OF BEARING NOTED

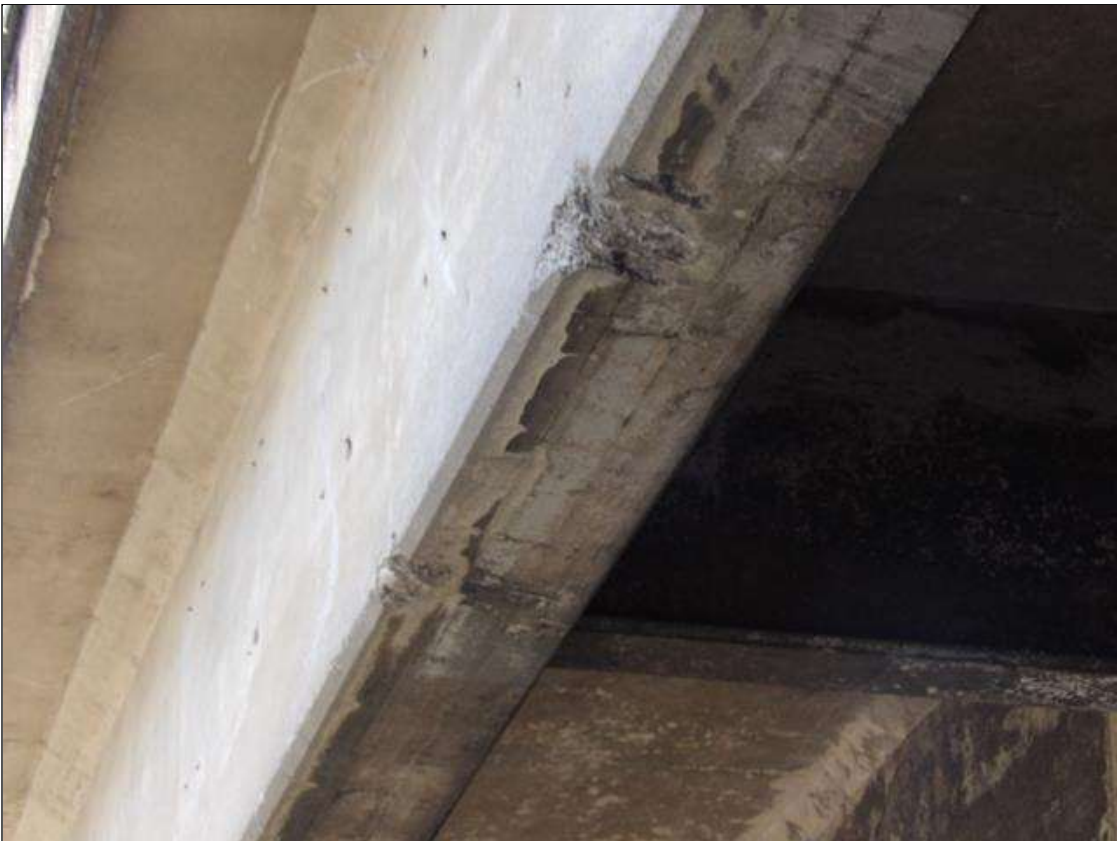
Span 2 Beam 1: (2) HIGH HIT SPALLS UP TO 18 INCHES LONG X 9 INCHES (BOTTOM FACE) X 4 INCHES (WEB) X 1 INCHES DEEP AT BOTTOM LEFT CORNER OF BEAM 1 NEAR MIDSPAN

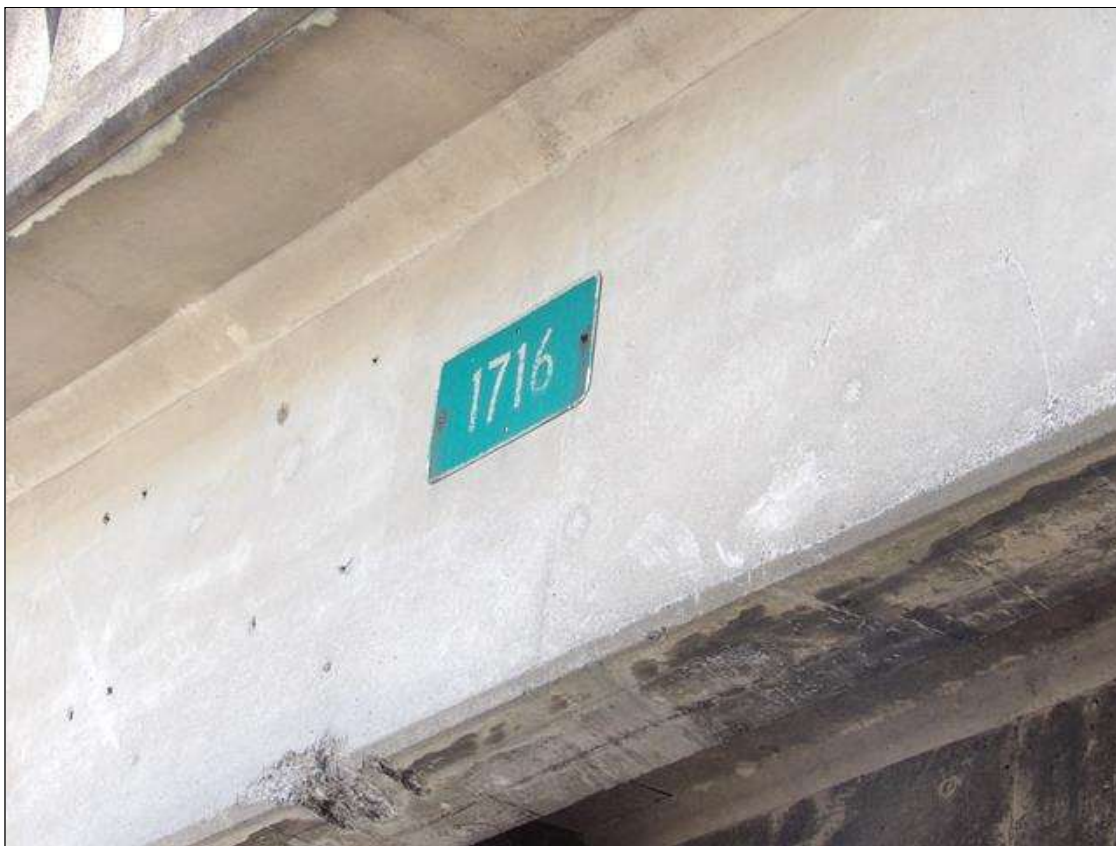
ROUTE 1716 SIGN REATTACHED TO SPAN 2 BEAM 1 WEST FACE TO FIX PREVIOUS PAR

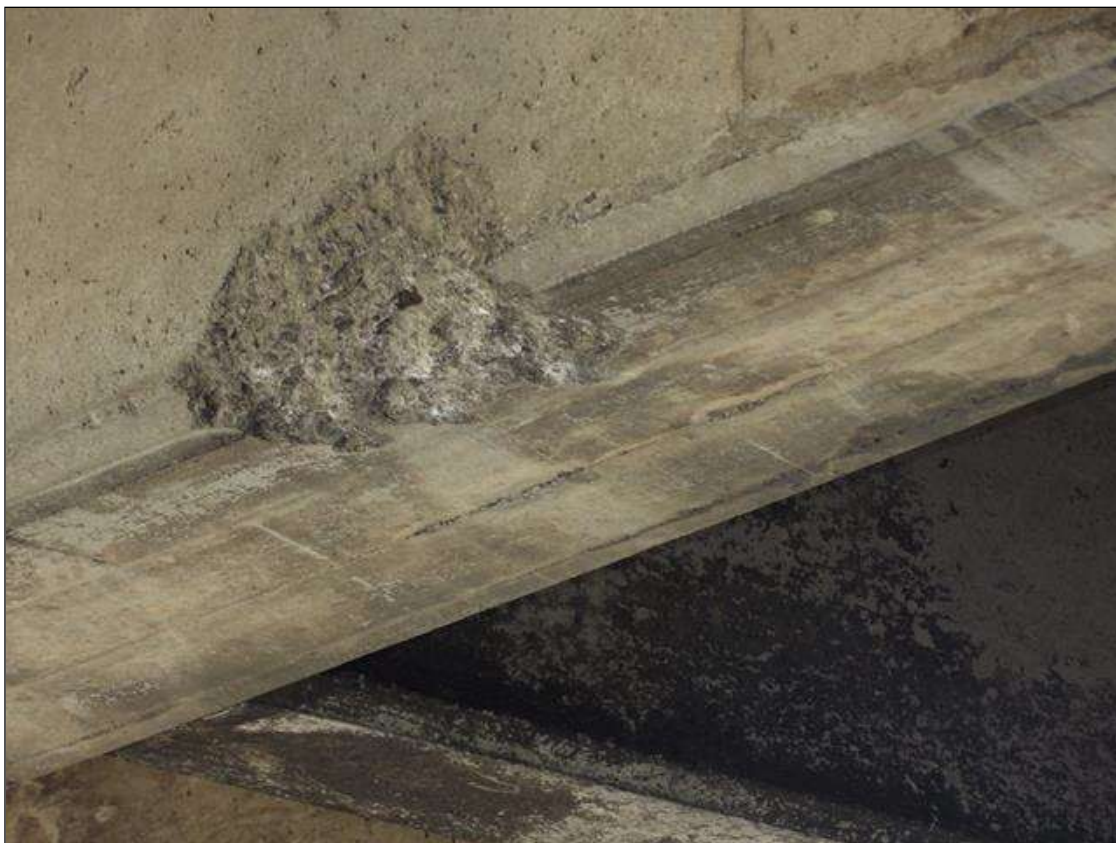
Span 2 Beam 2: IMPACT SPALL 15 INCHES LONG X 6 INCHES (BOTTOM FACE) X 6 INCHES (WEB) X 3 INCHES DEEP AT BOTTOM CORNER OF BEAM 2 NEAR MIDSPAN

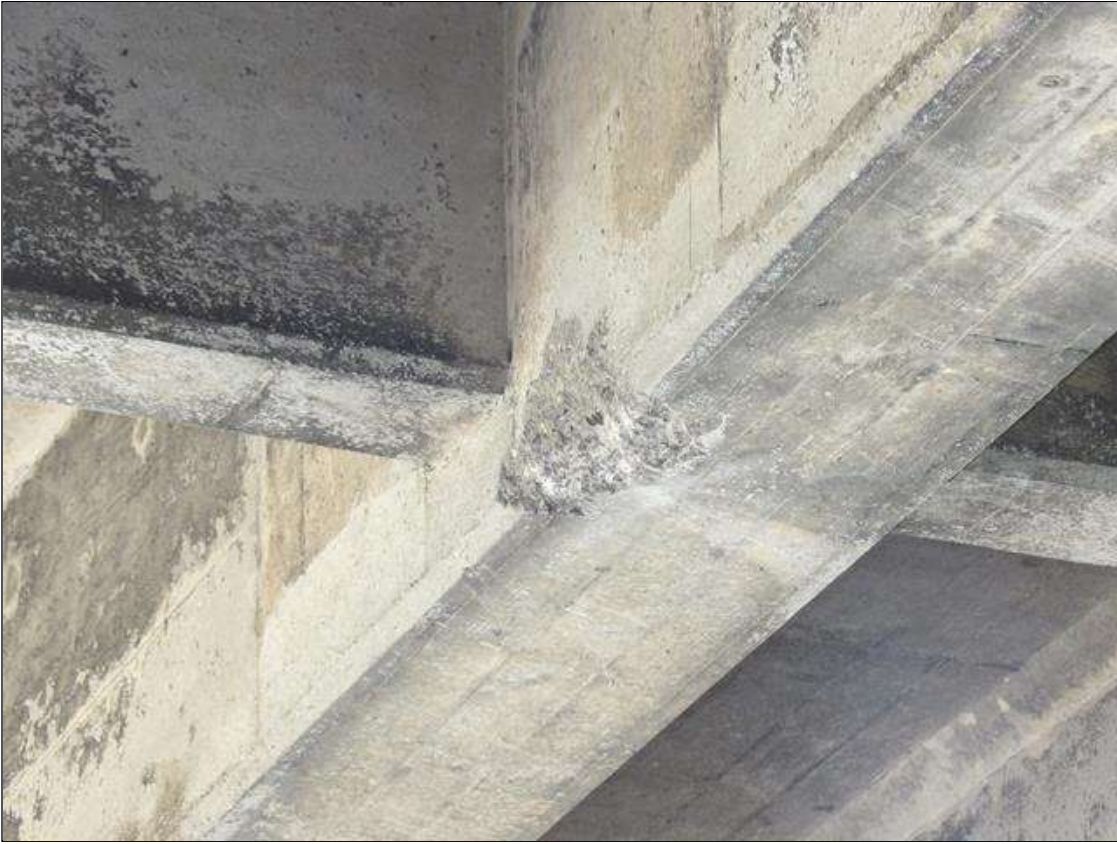
Span 2 Beam 3: IMPACT SPALL 15 INCHES LONG X 6 INCHES (BOTTOM FACE) X 6 INCHES (WEB) X 2 INCHES DEEP AT BOTTOM CORNER OF BEAM 3 NEAR MIDSPAN

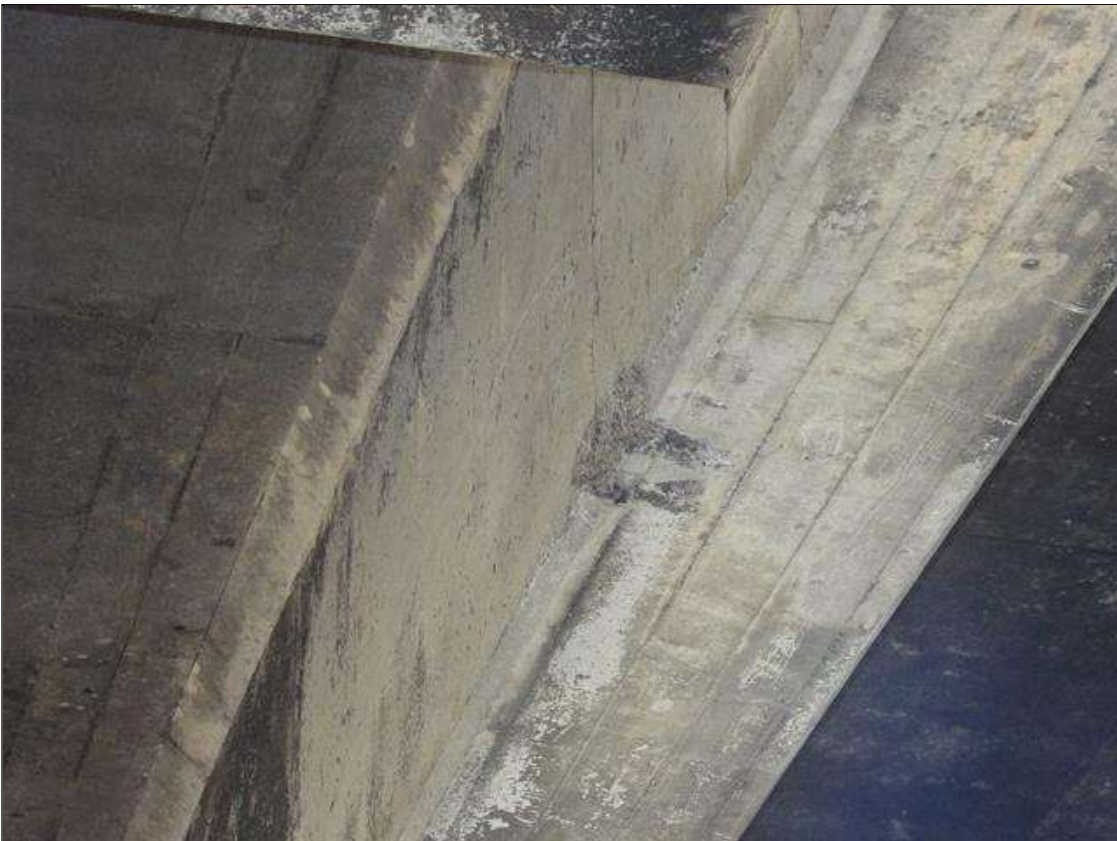
Span 2 Beam 4: IMPACT SPALL 8 INCHES LONG X 5 INCHES WIDE (BOTTOM FACE) X 3 INCHES HIGH (LEFT FACE) X 1 1/4 INCHES DEEP ON BOTTOM CORNER APPROXIMATELY MID-SPAN

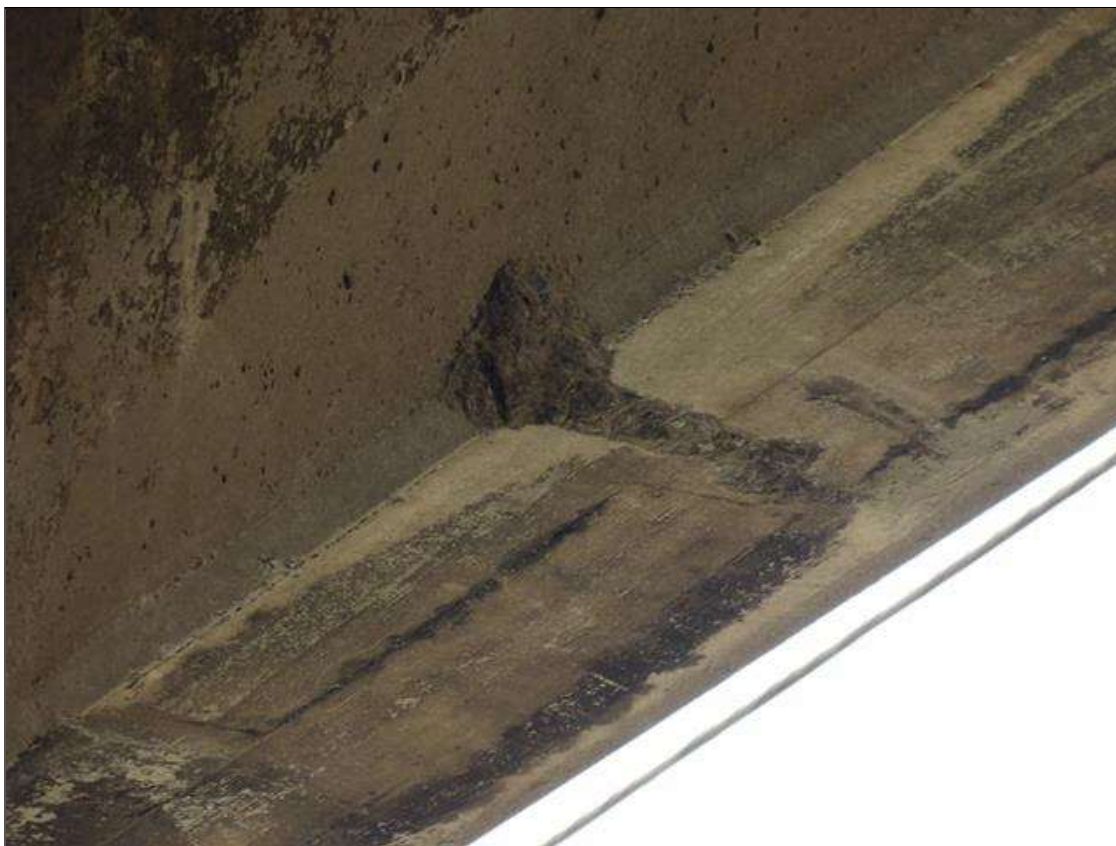
Span 2 Beam 5: IMPACT SPALL NEAR MIDSPAN, 6 INCHES X 4 INCHES X 2 INCHES DEEP AT BOTTOM OF BEAM
