NC DEPARTMENT OF TRANSPORTATION
 DIVISION OF HIGHWAYS
 STRUCTURE MANAGEMENT UNIT

ATTENTION: **PRIORITY ACTION REQUEST ISSUED; CHANGE TO LATERAL UNDERCLEARANCES**

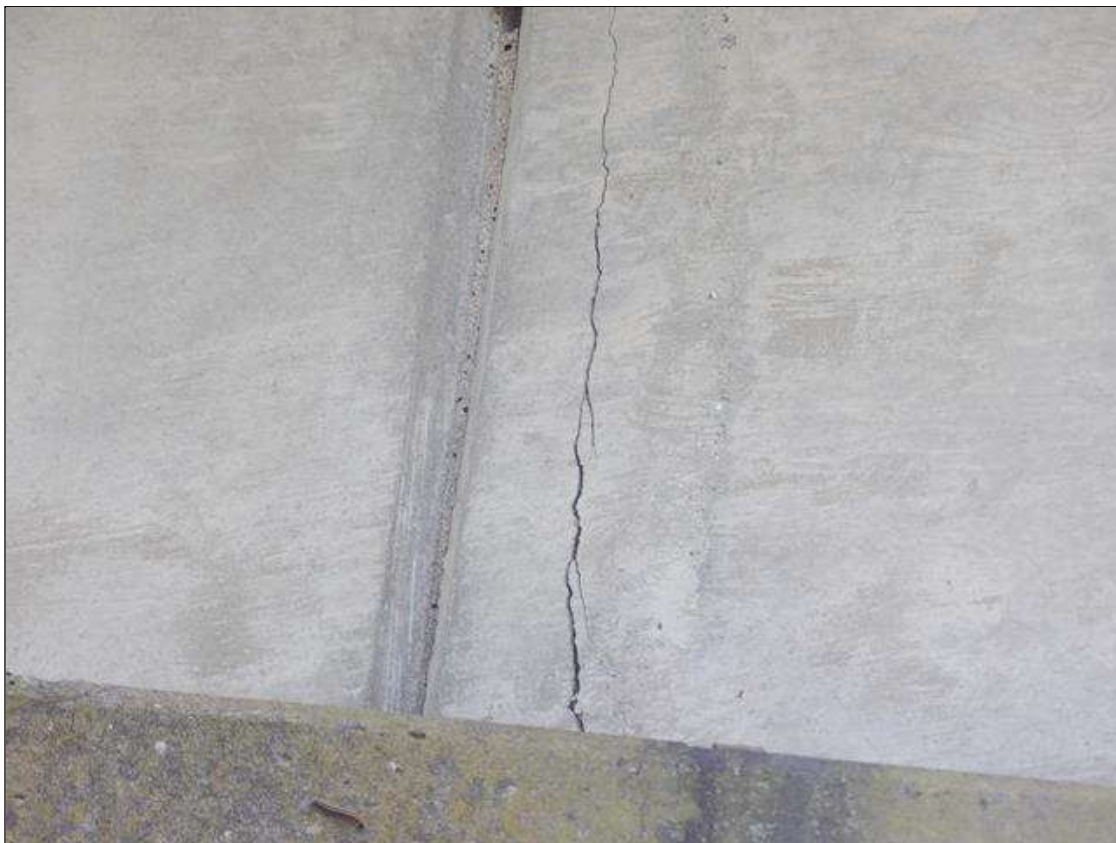
Span 2 Beam 5: AT BENT 1, 30 INCHES HIGH VERTICAL CRACK UP TO 1/8 INCHES WIDE EAST FACE

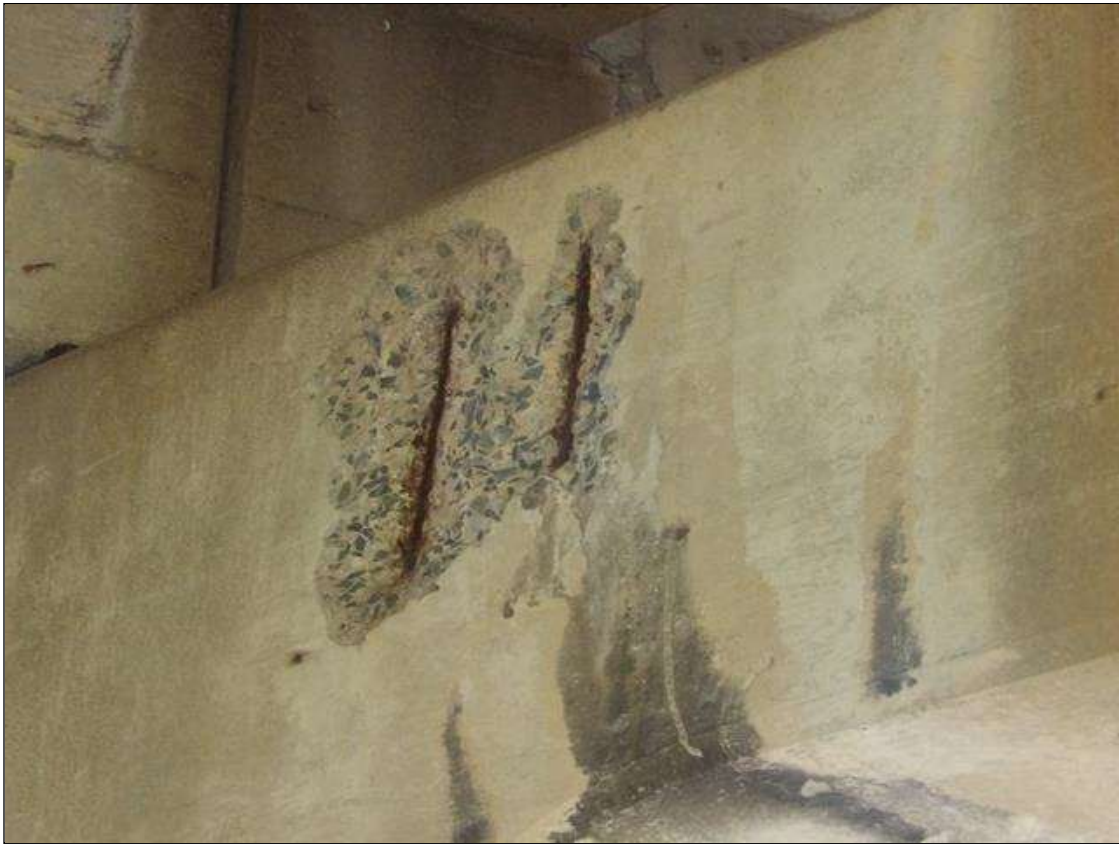
Bent 1 Cap 1: 20 INCHES HIGH X 20 INCHES WIDE X 1.5 INCHES DEEP SPALL WITH EXPOSED REBAR WITH ACTIVE CORROSION NO LOSS ON NEAR FACE IN BAY 1

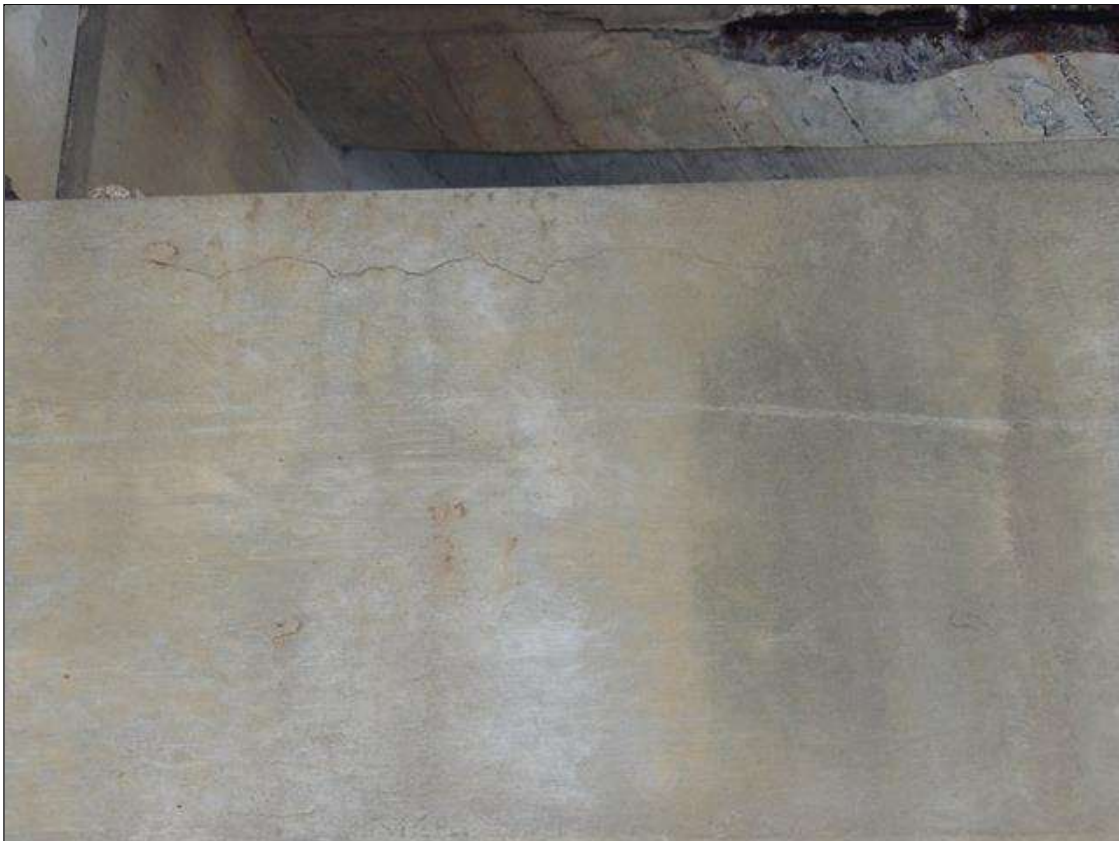
Bent 2 Cap 1: 2 FEET LONG HORIZONTAL CRACK 1/16 INCHES WIDE ON NEAR FACE IN BAY 2

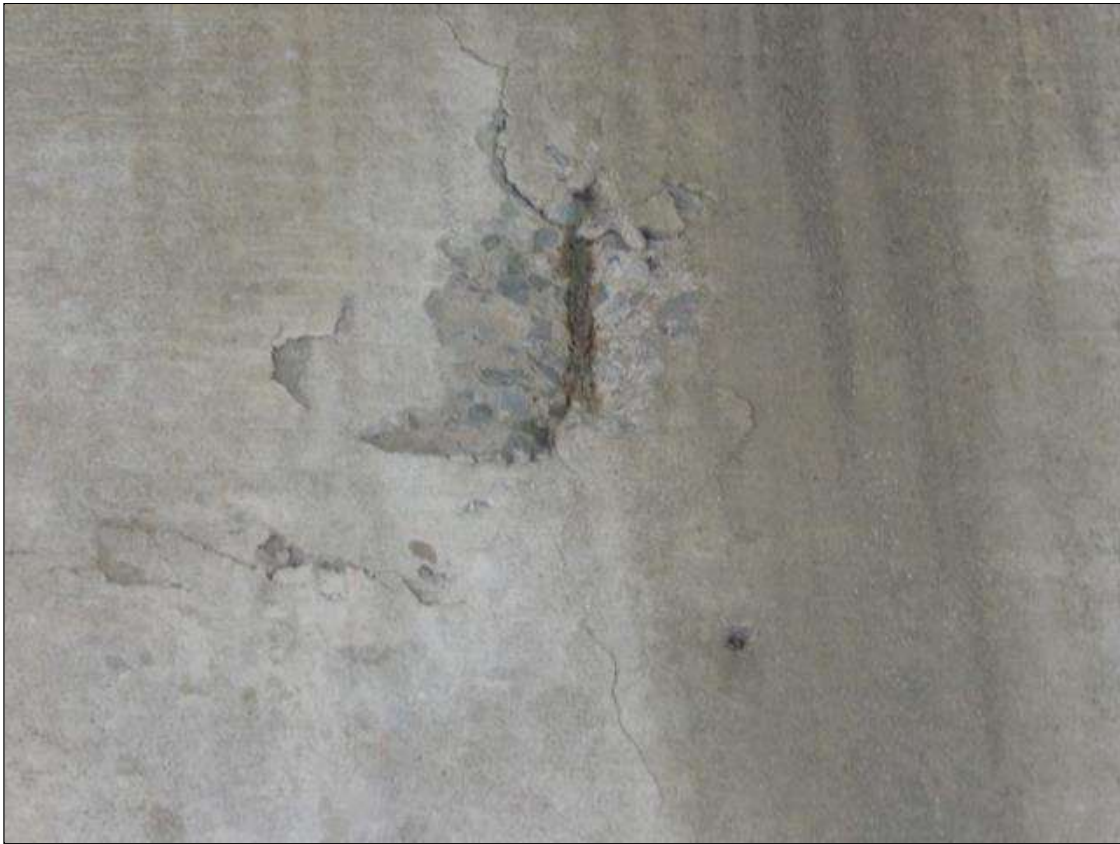
Bent 2 Cap 1: 2 FOOT-6 INCHES HIGH X 1 FOOT-6 INCHES WIDE X 1 1/4 INCHES DEEP SPALL WITH EXPOSED REBAR/AREA OF DELAMINATION WITH ACTIVE CORROSION NO LOSS ON NEAR FACE UNDER BEAM 3

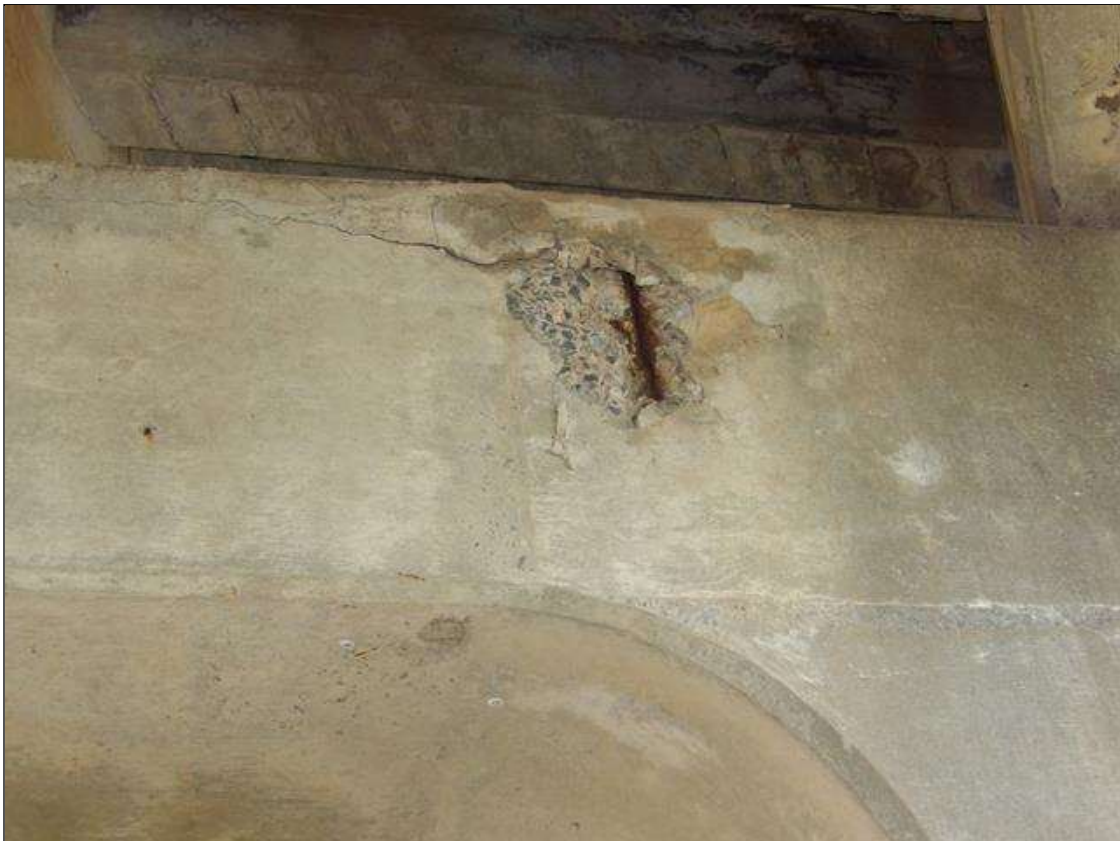
Bent 2 Cap 1: 4 FOOT-8 INCHES LONG X 1 FOOT-10 INCHES HIGH X 1 1/2 INCHES DEEP SPALL WITH EXPOSED REBAR/AREA OF DELAMINATION WITH ACTIVE CORROSION NO LOSS ON NEAR FACE IN BAY 4

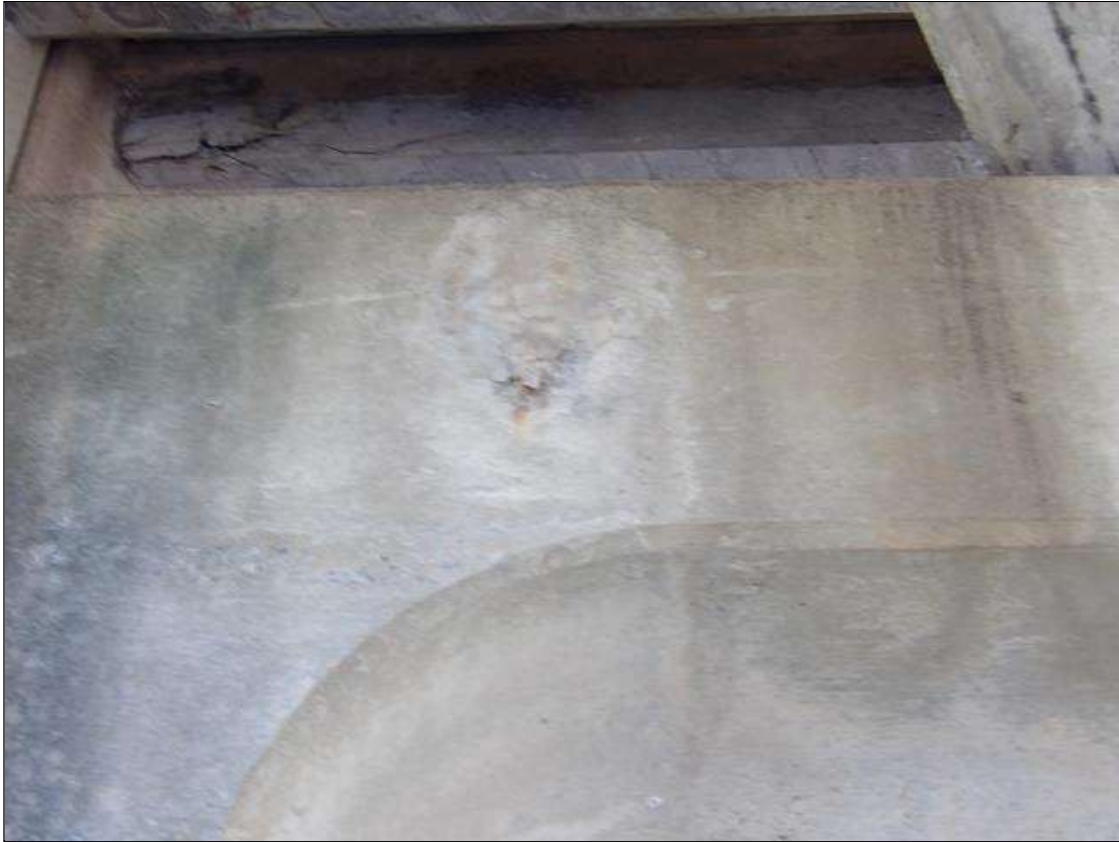
Bent 2 Cap 1: FAILED PATCHED AREA THAT IS 2 FEET DIAMETER X UP TO 3/4 INCHES DEEP ON FAR FACE UNDER BAY 4

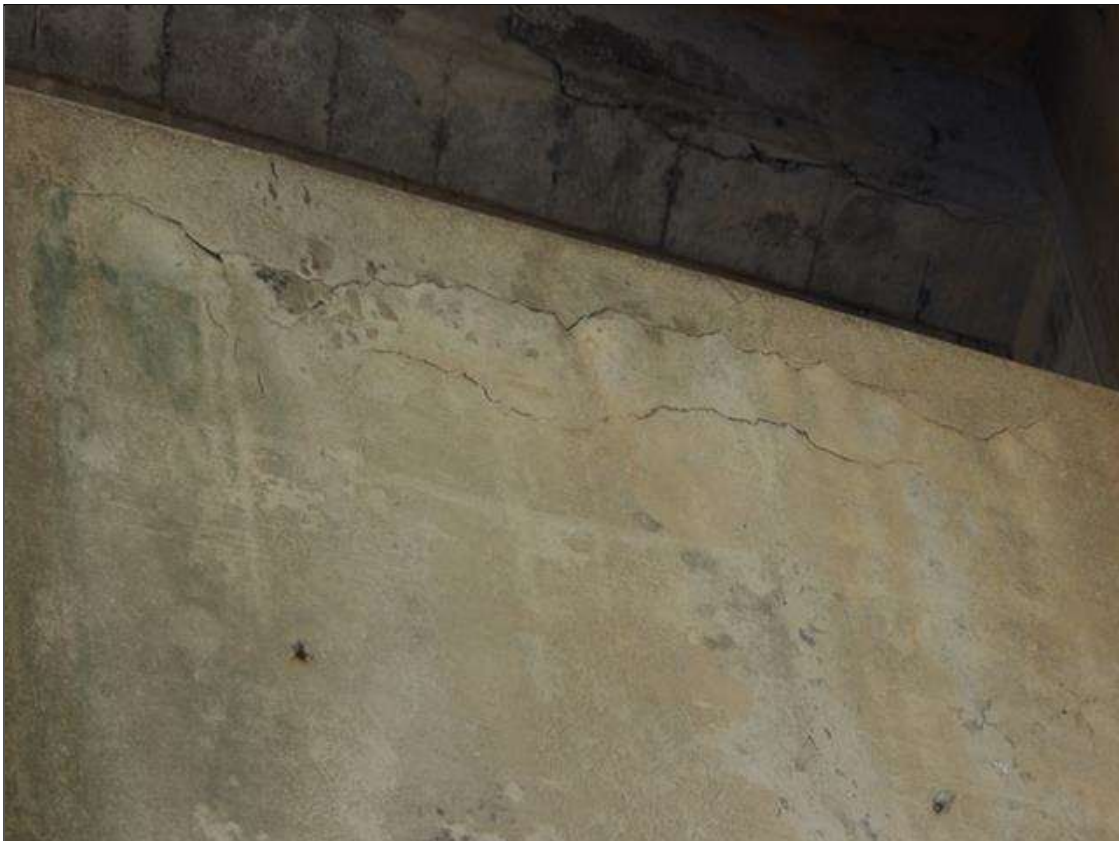
Bent 2 Cap 1: 4 FEET LONG X 10 INCHES HIGH DELAMINATION TOP OF FAR FACE WITH UP TO 1/8 INCHES WIDE CRACKING UNDER BAY 2

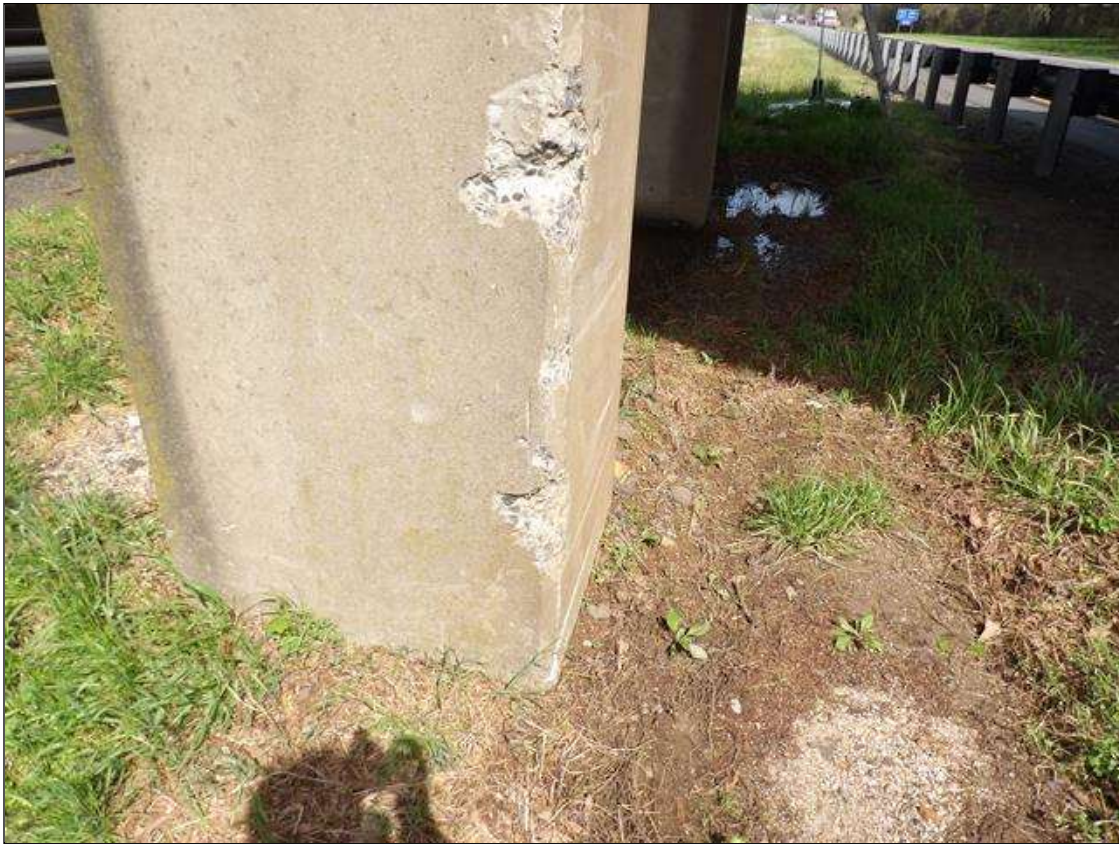
Bent 2 Pile 1: 3 SPALLS UP TO 12 INCHES X 4 INCHES X 4 INCHES AT NEAR LEFT CORNER NEAR BASE OF COLUMN 1

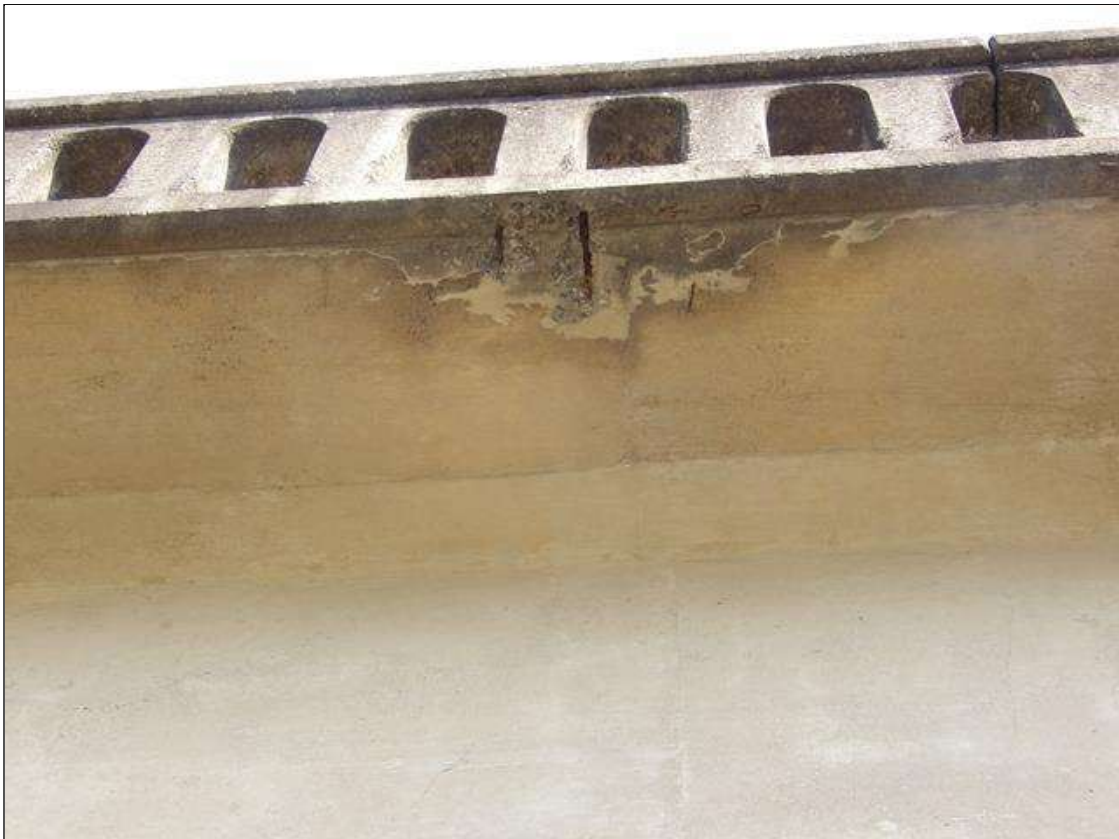
Span 2 Deck: 12 INCHES WIDE X 12 INCHES LONG X 1 INCHES DEEP SPALL WITH EXPOSED REBAR WITH ACTIVE CORROSION NO LOSS LOCATED AT UNDERSIDE OF LEFT OVERHANG 15 FEET FROM BENT 2

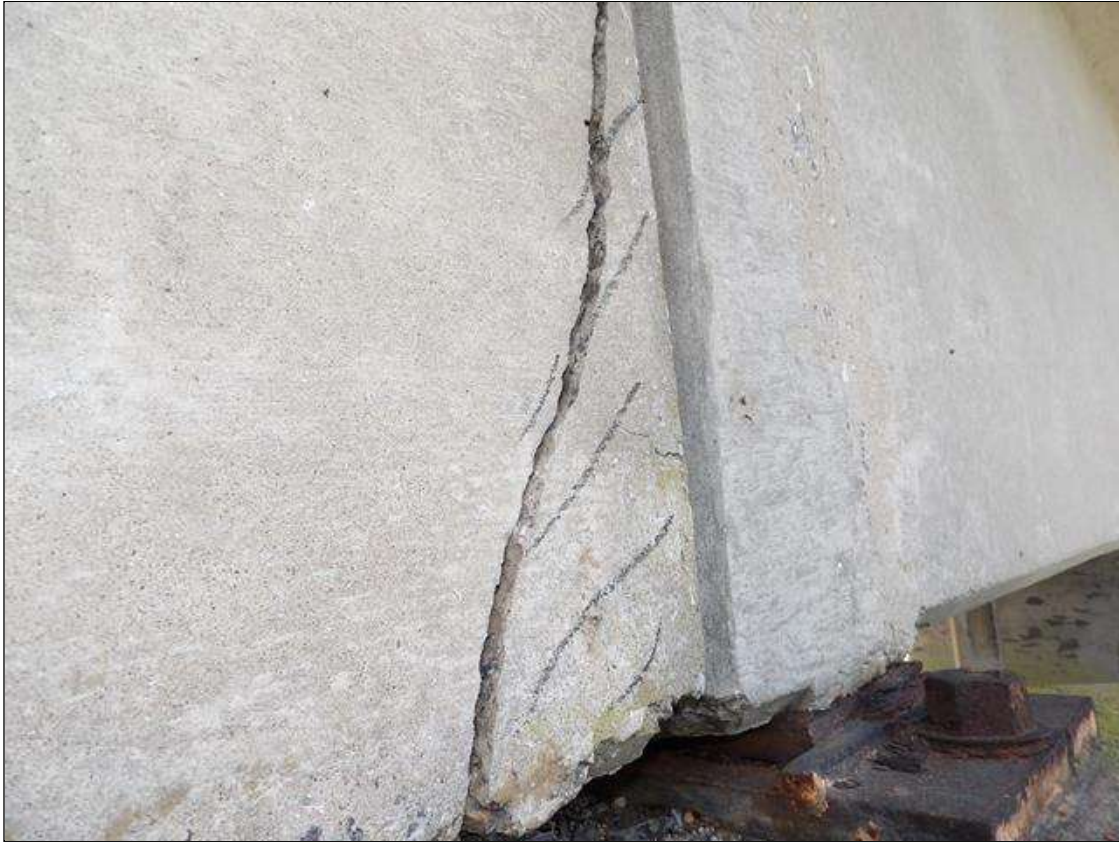
Span 2 Beam 5: AT BENT 2 BEARING, 24 INCHES HIGH X 6 INCHES WIDE DELAMINATION ON RIGHT SIDE, 1 FEET HIGH X 4 INCHES LONG ON LEFT SIDE, EXTENDING 3 INCHES ACROSS THE BEARING NO LOSS

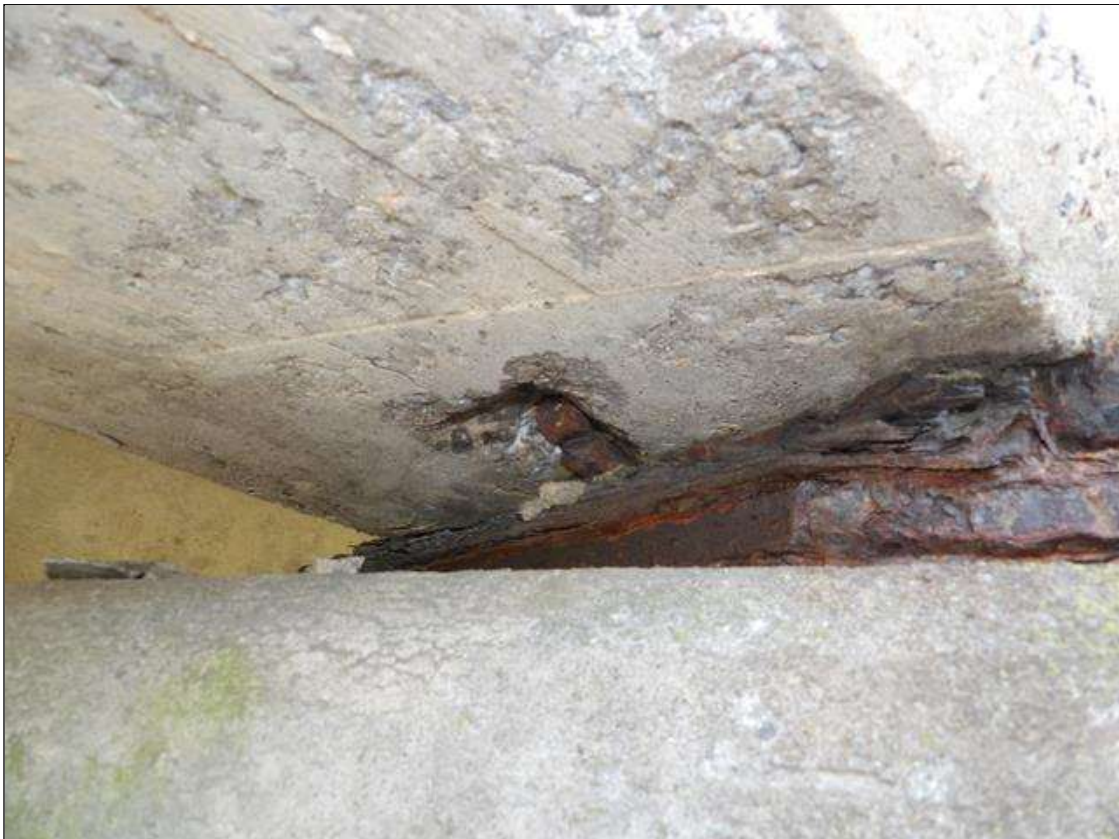
Span 2 Beam 5: 4 INCHES LONG X 4 INCHES WIDE X 1 INCHES DEEP SPALL ON BOTTOM FACE OF BEAM WITH EXPOSED STEEL NO LOSS AT FAR BEARING

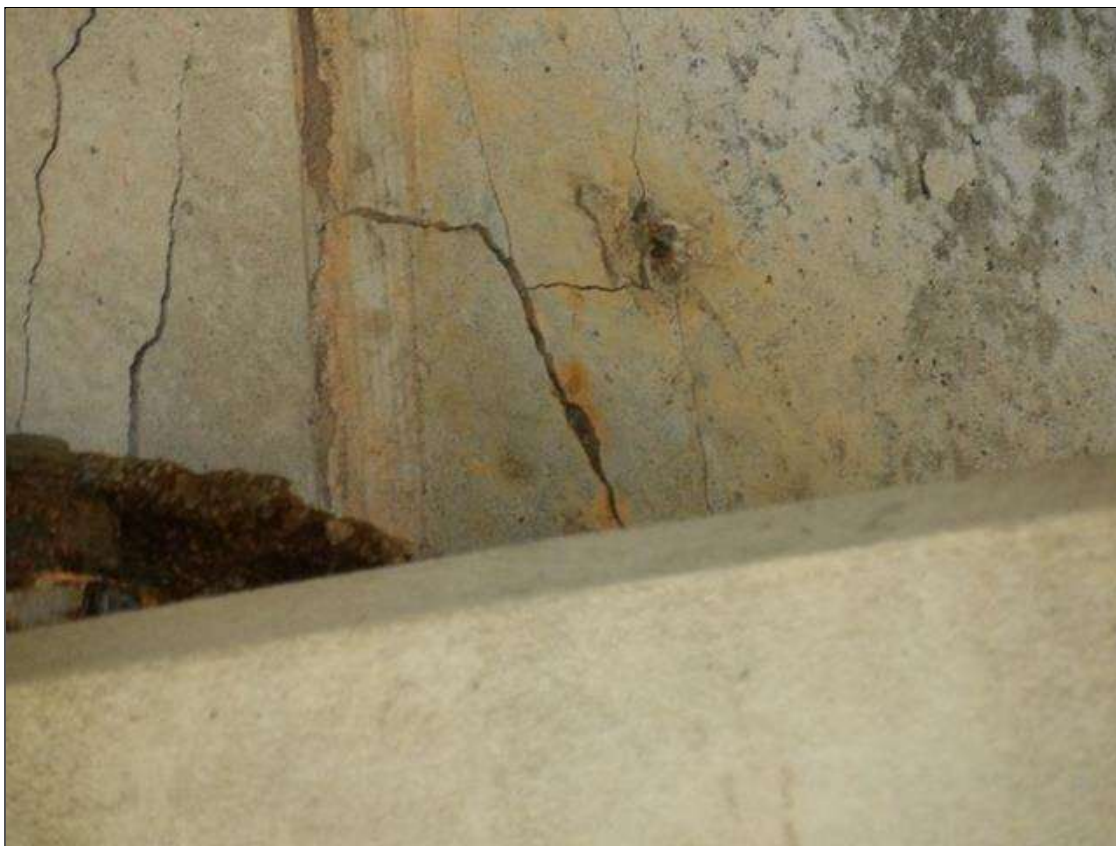
Span 3 Beam 4: AT BENT 3, 2 FEET HIGH X 6 INCHES WIDE DELAMINATED AREA ON LEFT SIDE

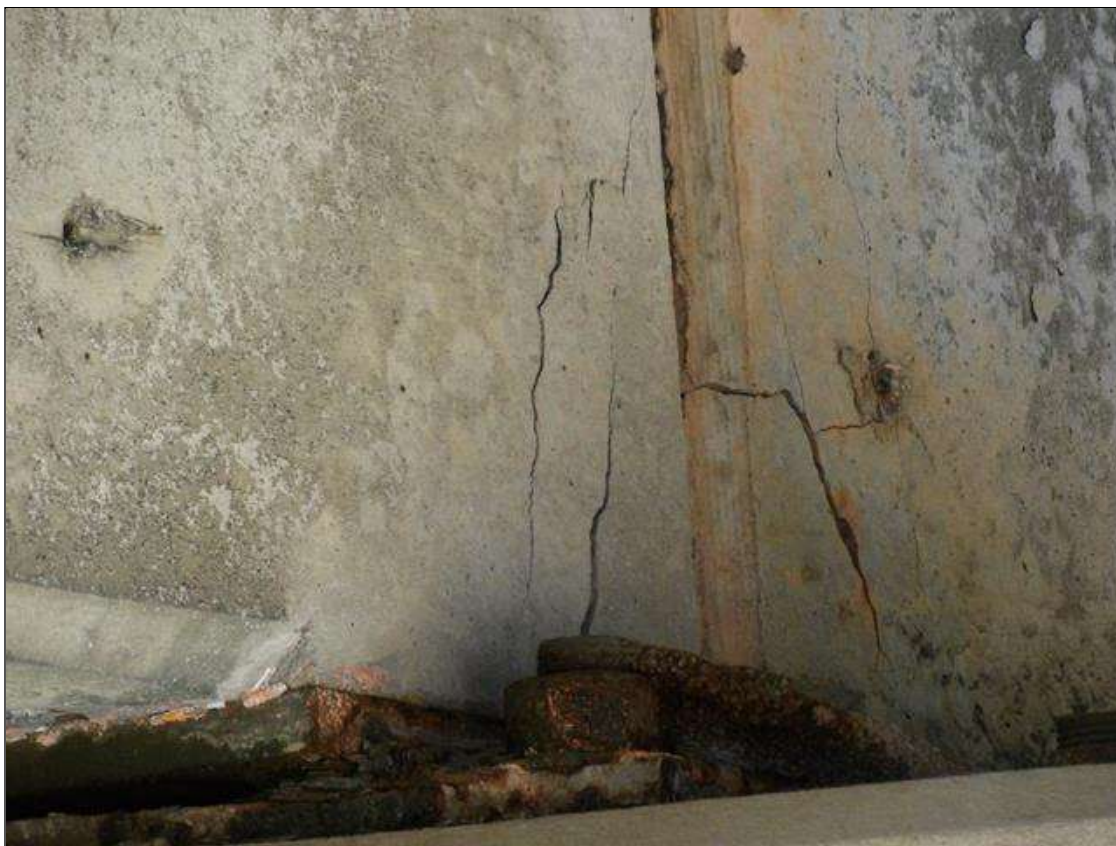
Span 4 Beam 4: AT BENT 3, 6 INCHES WIDE X 24 INCHES LONG DELAMINATION WITH CRACKING UP $\frac{3}{32}$ INCHES WIDE ON LEFT SIDE AT END OF BEAM 4

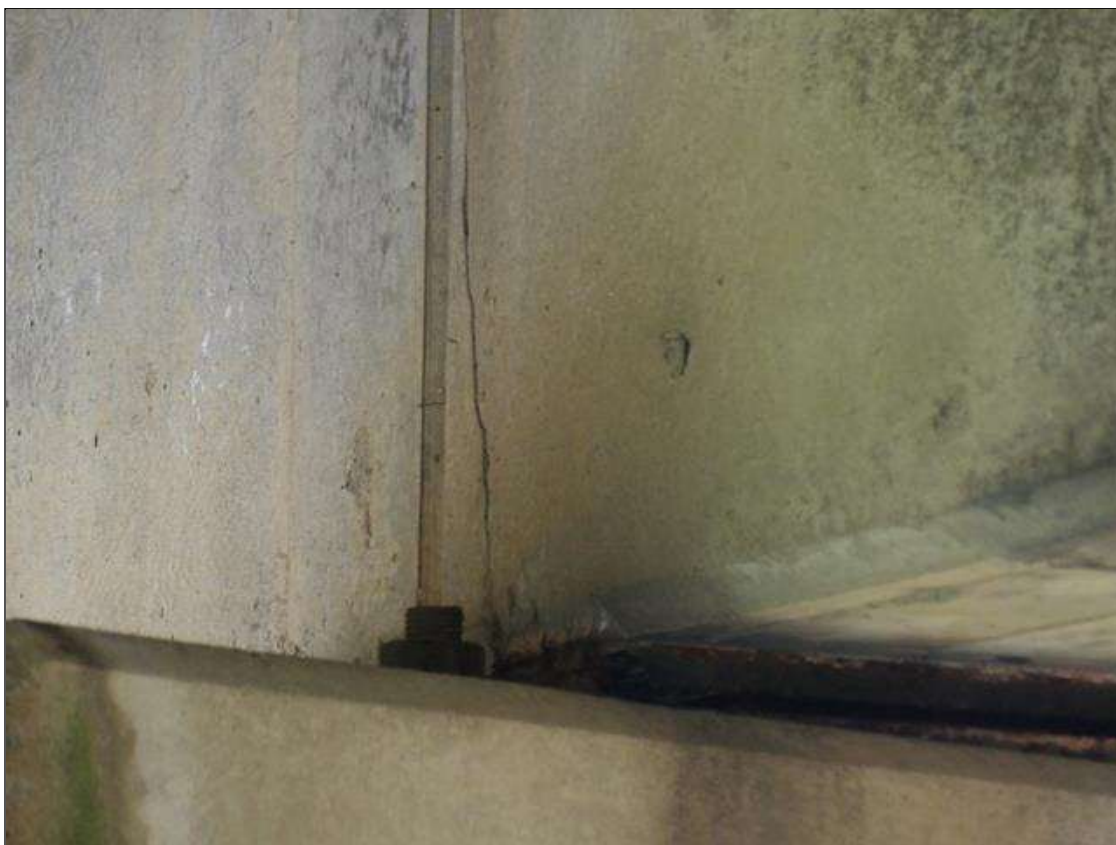
Span 4 Beam 4: 20 INCHES HIGH X 5 INCHES WIDE AREA OF DELAMINATION WITH UP TO $\frac{1}{8}$ INCHES WIDE CRACKING ON RIGHT SIDE OF BEAM AT NEAR END

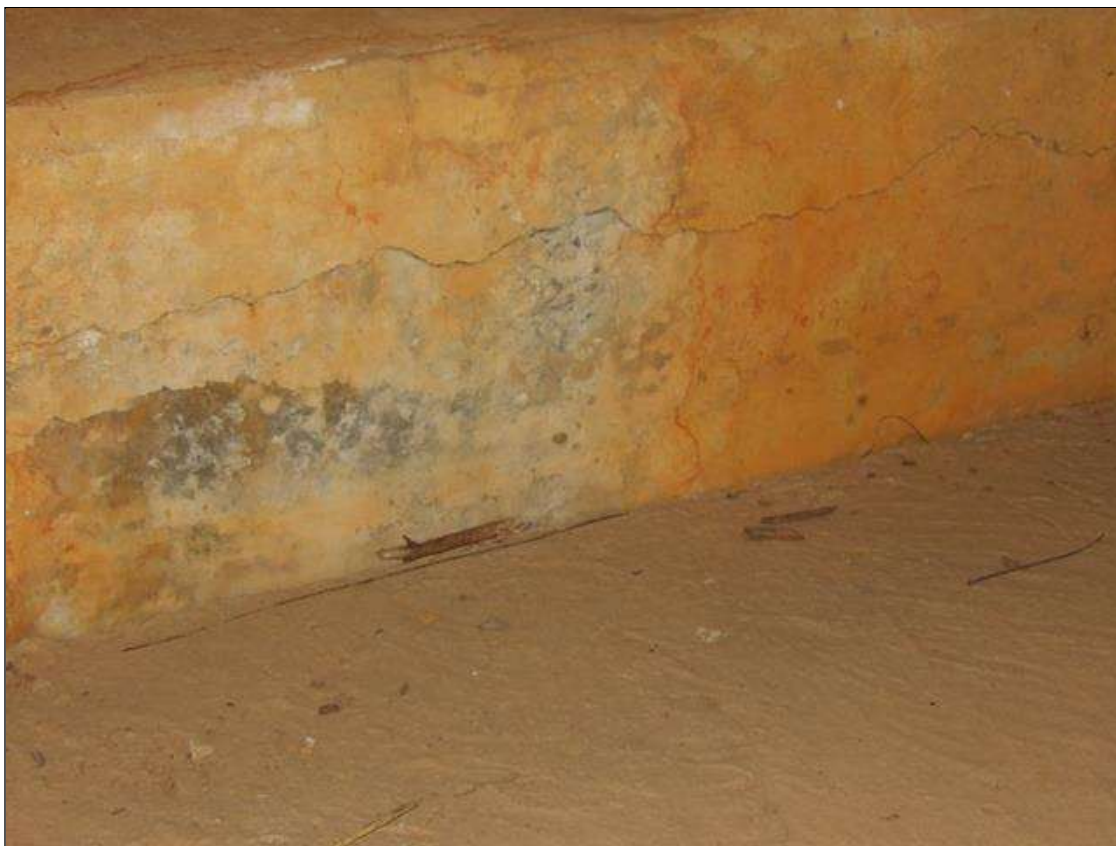
TYPICAL-- HORIZONTAL CRACK UP TO 1/16 INCHES WIDE ABUTMENT 2 CAP FACE, BAY 1 SHOWN

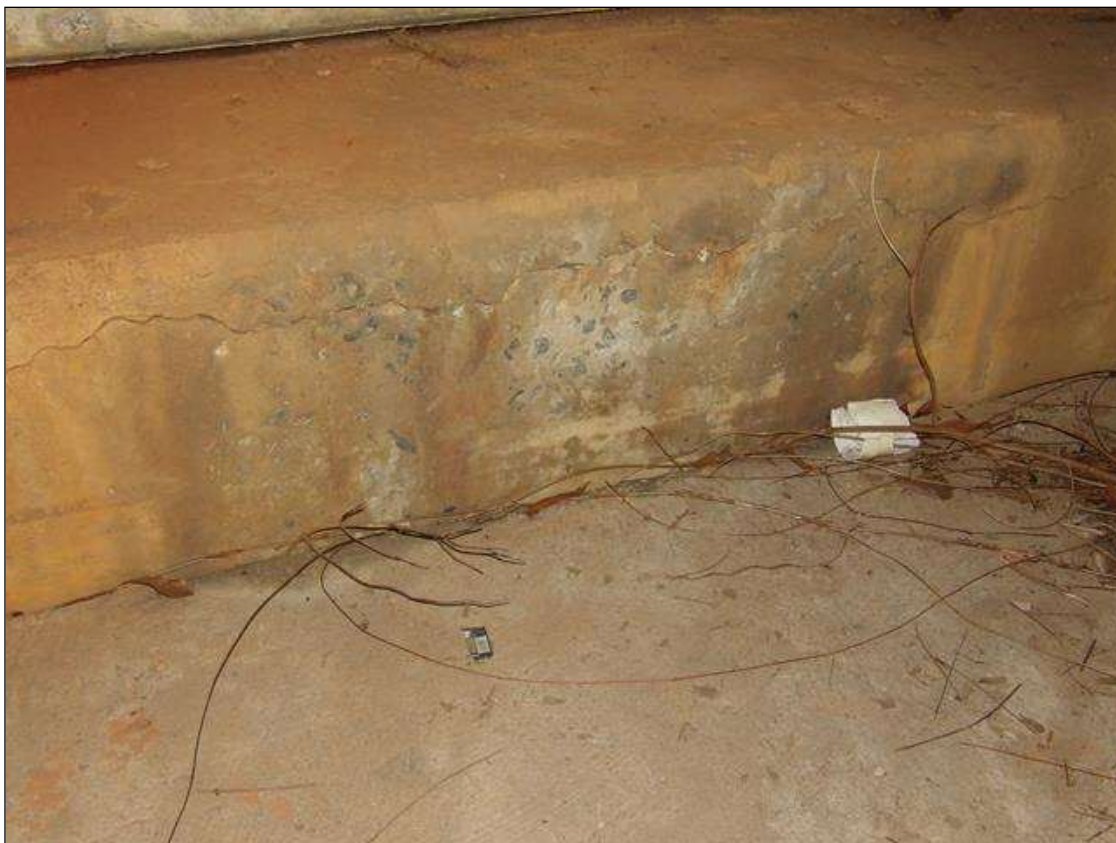
End Bent 2 Cap 1: 78 INCHES LONG HORIZONTAL CRACK UP TO 1/8 INCHES WIDE ON BAY 3 FACE OF CAP

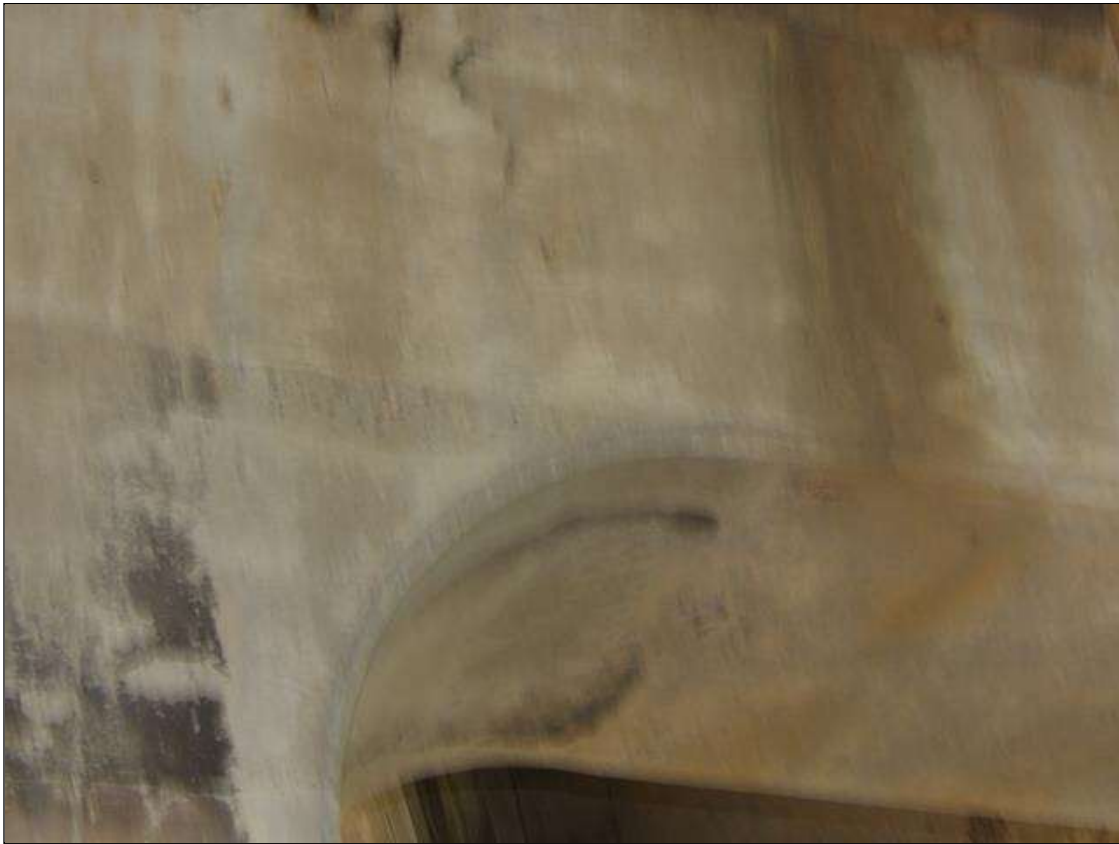
Bent 3 Cap 1: 3 FEET-6 INCHES LONG X 9 INCHES HIGH DELAMINATION, 6 INCHES DIAMETER X 1 INCHES DEEP SPALL WITH EXPOSED REBAR WITH ACTIVE CORROSION NO LOSS AND 5 INCHES HIGH X 1 INCHES WIDE X 3/4 INCHES DEEP SPALL WITH EXPOSED REBAR WITH ACTIVE CORROSION NO LOSS ON NEAR FACE UNDER BEAM 3

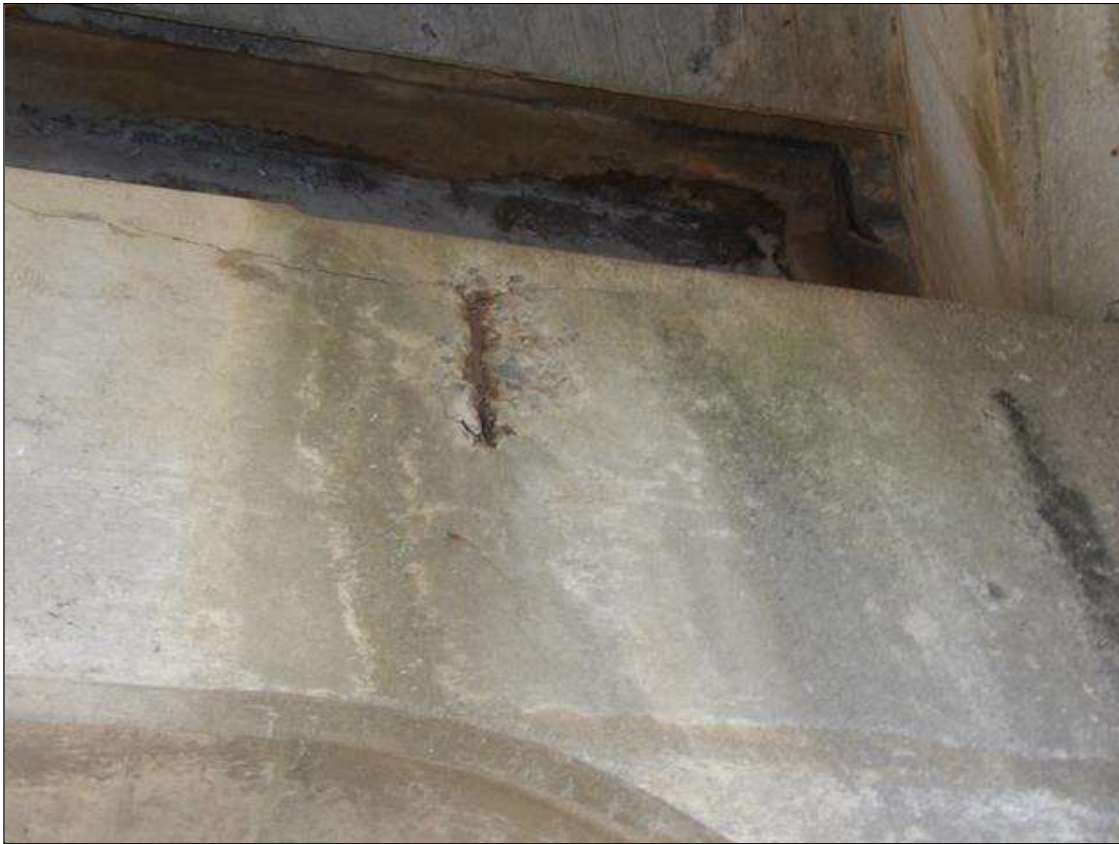
Bent 3 Cap 1: 18 INCHES HIGH X 8 INCHES WIDE X 1 INCHES DEEP SPALL WITH EXPOSED REBAR WITH ACTIVE CORROSION NO LOSS WITH A 3 FEET LONG HORIZONTAL CRACK UP TO 1/16 INCHES WIDE ON NEAR FACE OF CAP UNDER BAY 4

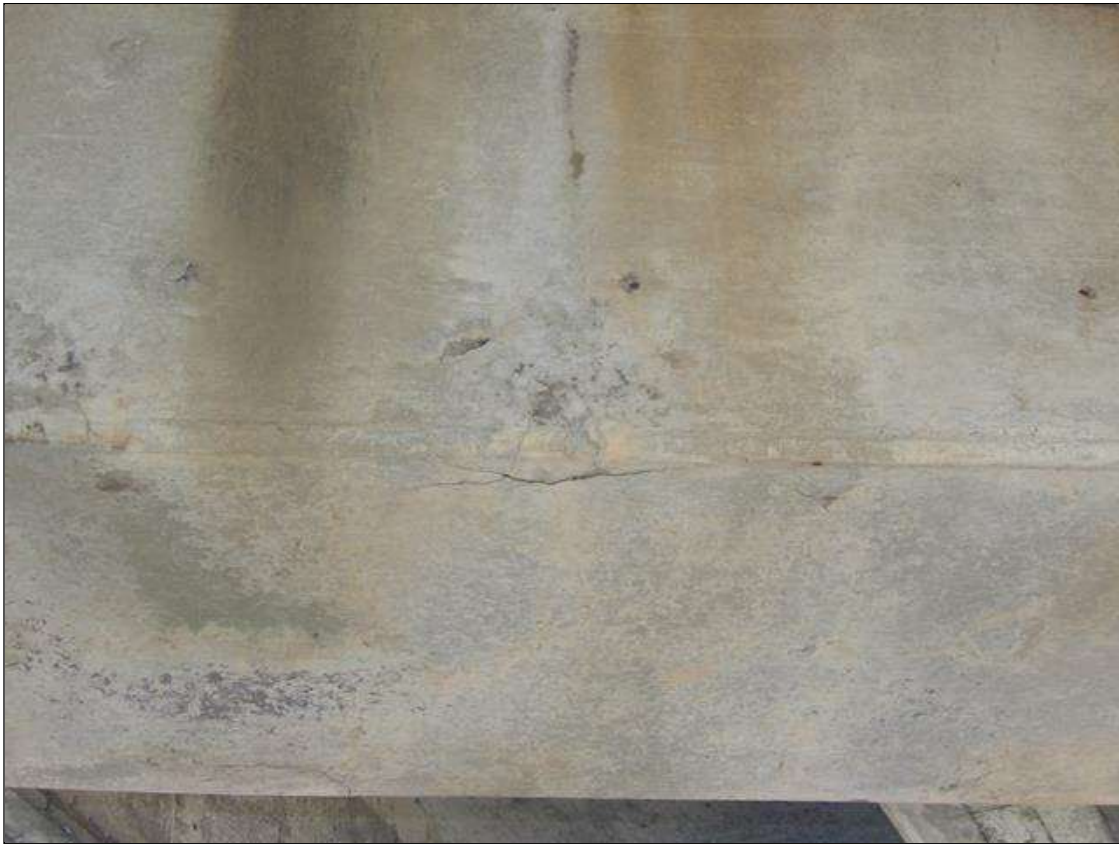
Bent 3 Cap 1: 16 INCHES LONG X 6 FEET HIGH AREA OF DELAMINATION WITH CRACKING UP TO 0.0625 INCHES WIDE ON BOTTOM OF CAP AND EXTENDING UP FAR FACE UNDER BEAM 4

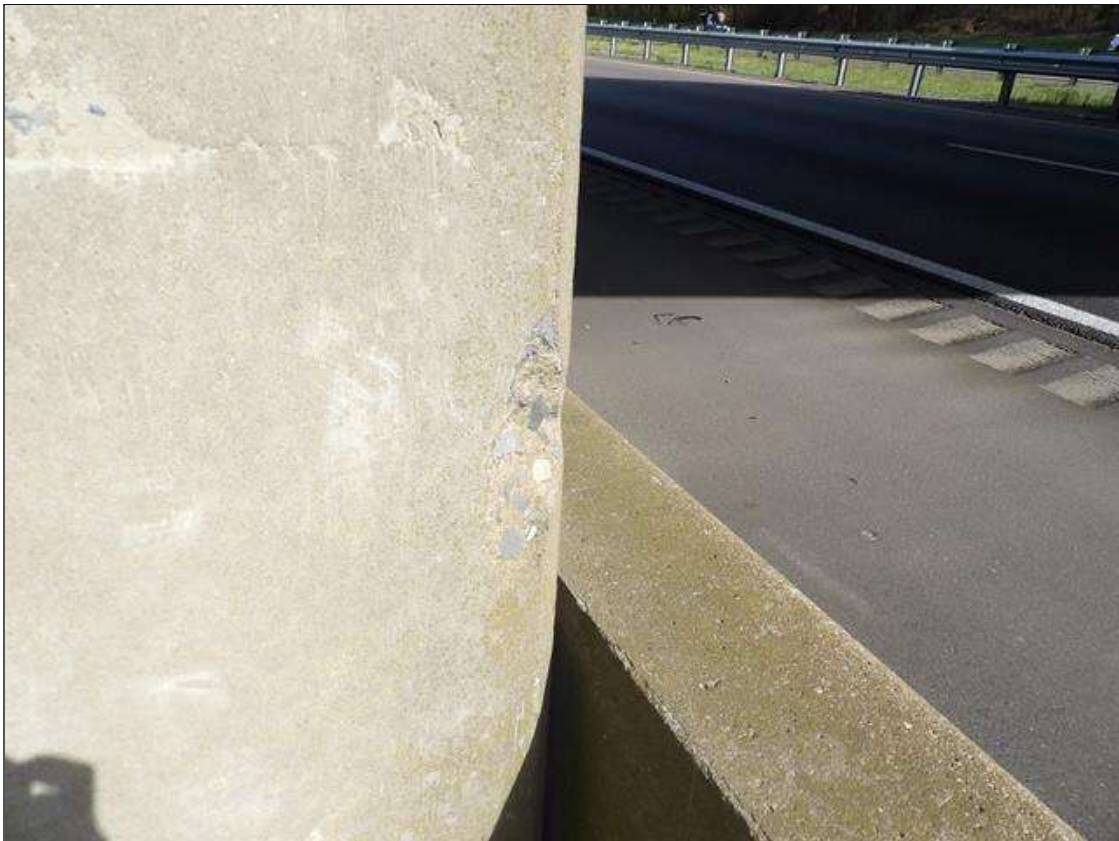
Bent 3 Pile 1: 6 INCHES X 3 INCHES X 1/2 INCHES DEEP SPALL WITH NO AT NEAR LEFT CORNER OF COLUMN 1 (BASE OF COLUMN)

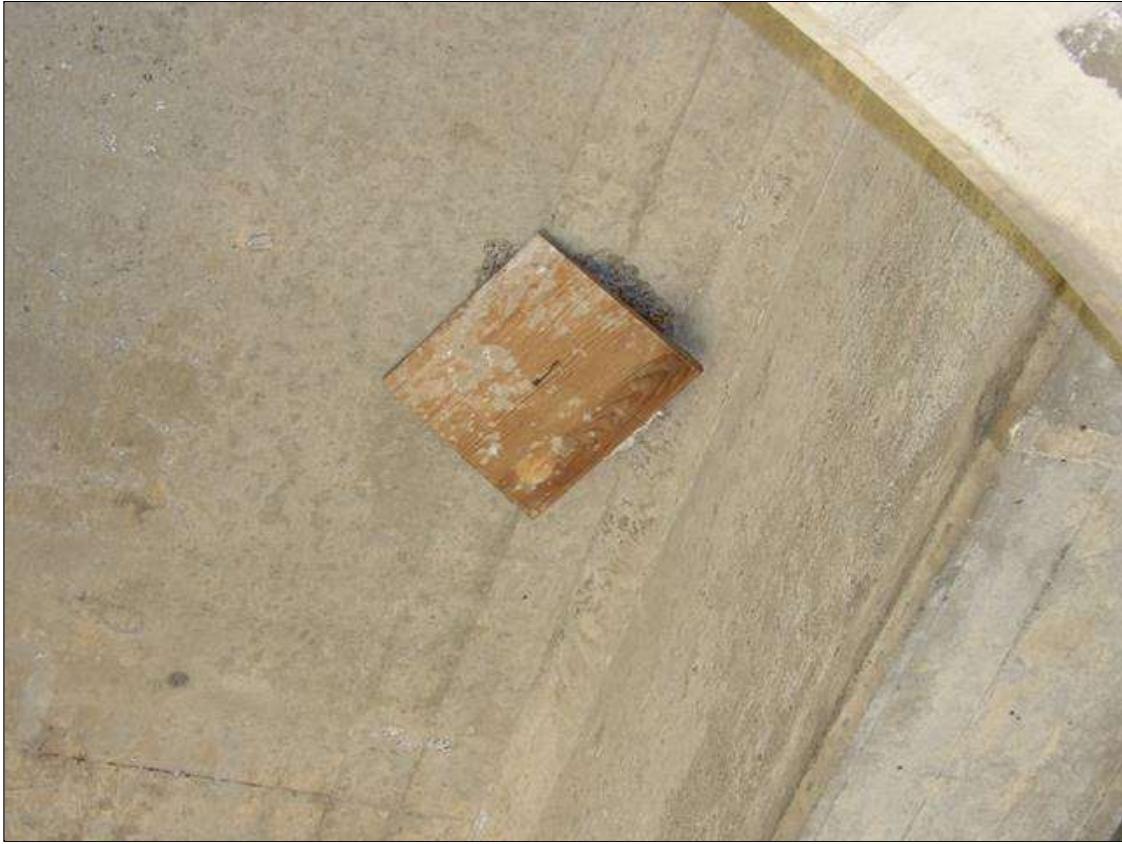
SPAN 4 DECK UNDERSIDE-- DECK REPAIR FORM LEFT IN PLACE (BAY 2, 6 FEET FROM BENT 3)

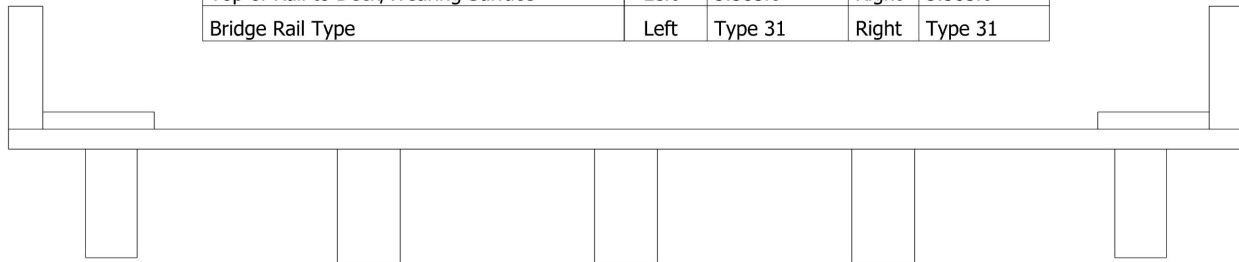
Measurements for Span #	1		
Deck Thickness	7in	Left Overhang	3ft
Top of Rail to Bottom of Beam (Avg)	7.333ft	Right Overhang	3ft
