NC DEPARTMENT OF TRANSPORTATION
 DIVISION OF HIGHWAYS
 STRUCTURE MANAGEMENT UNIT

ATTENTION: **prompt action request; sketches revised**

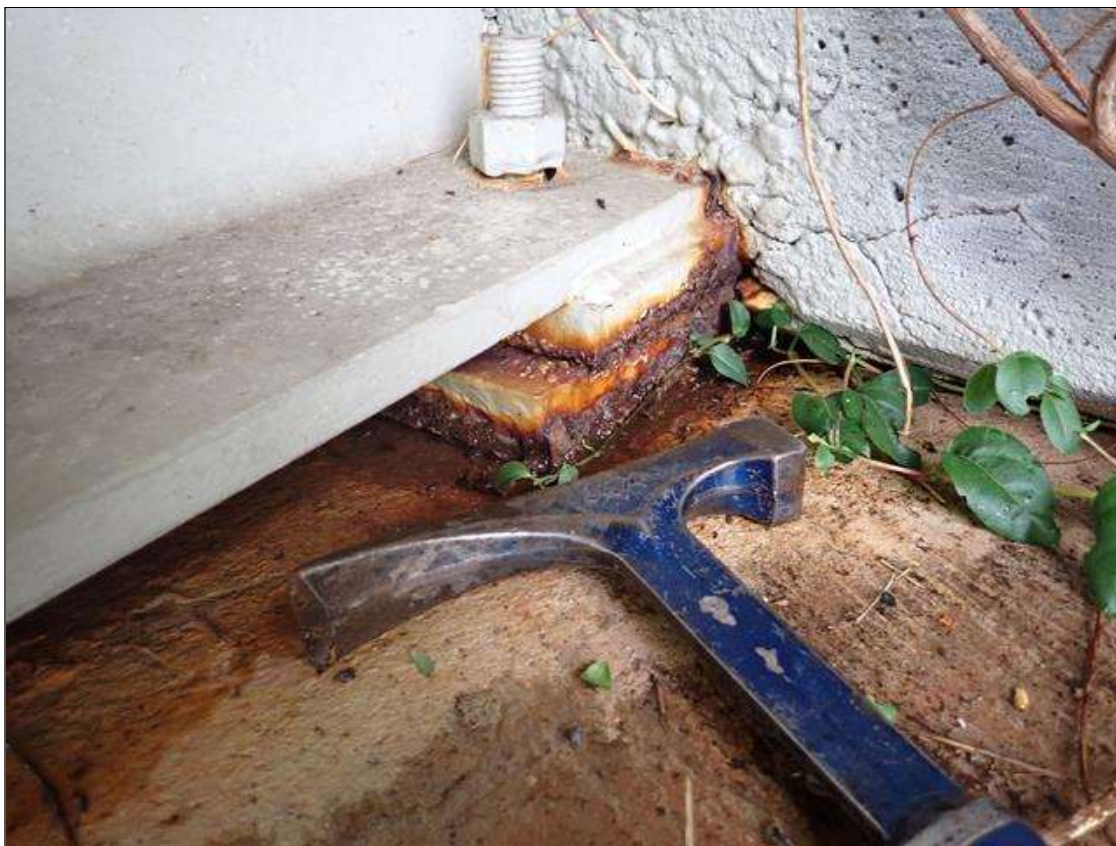
Span 4 Far Bearing 5: corrosion with section loss (up to 1/8 inch loss)

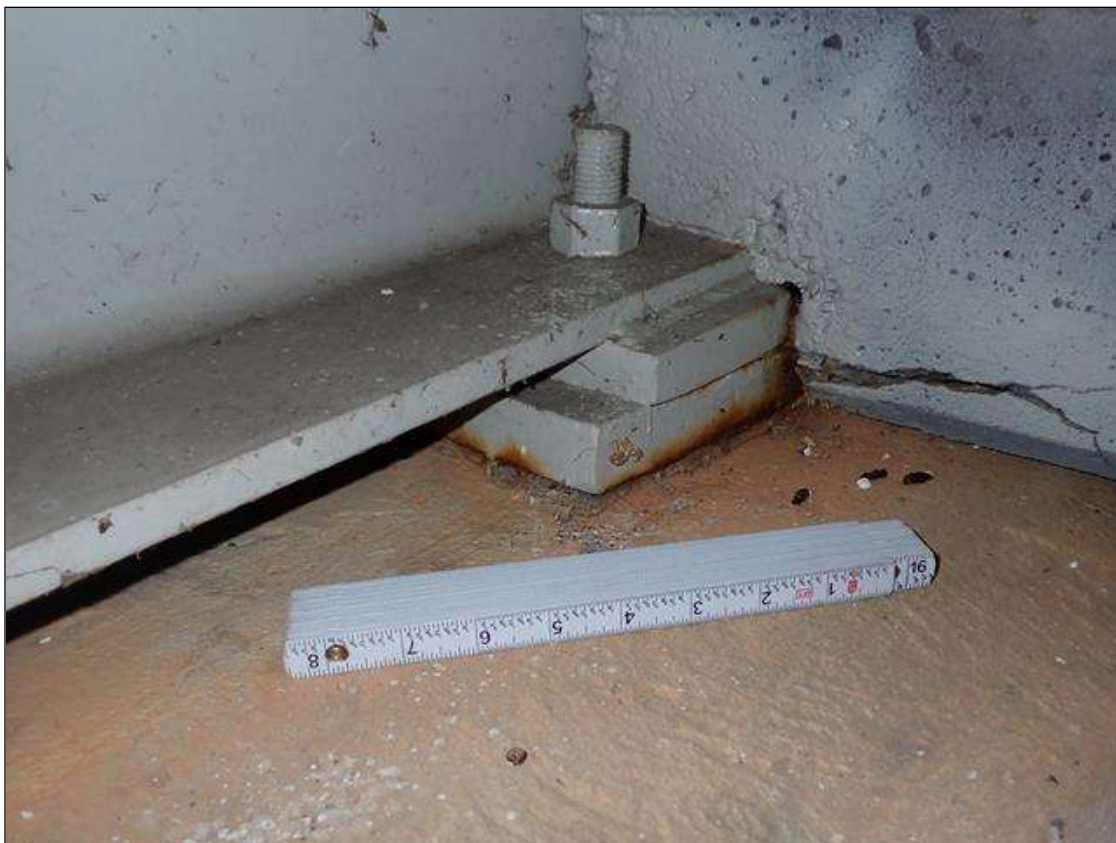
Span 4 Far Bearing 4: surface rust

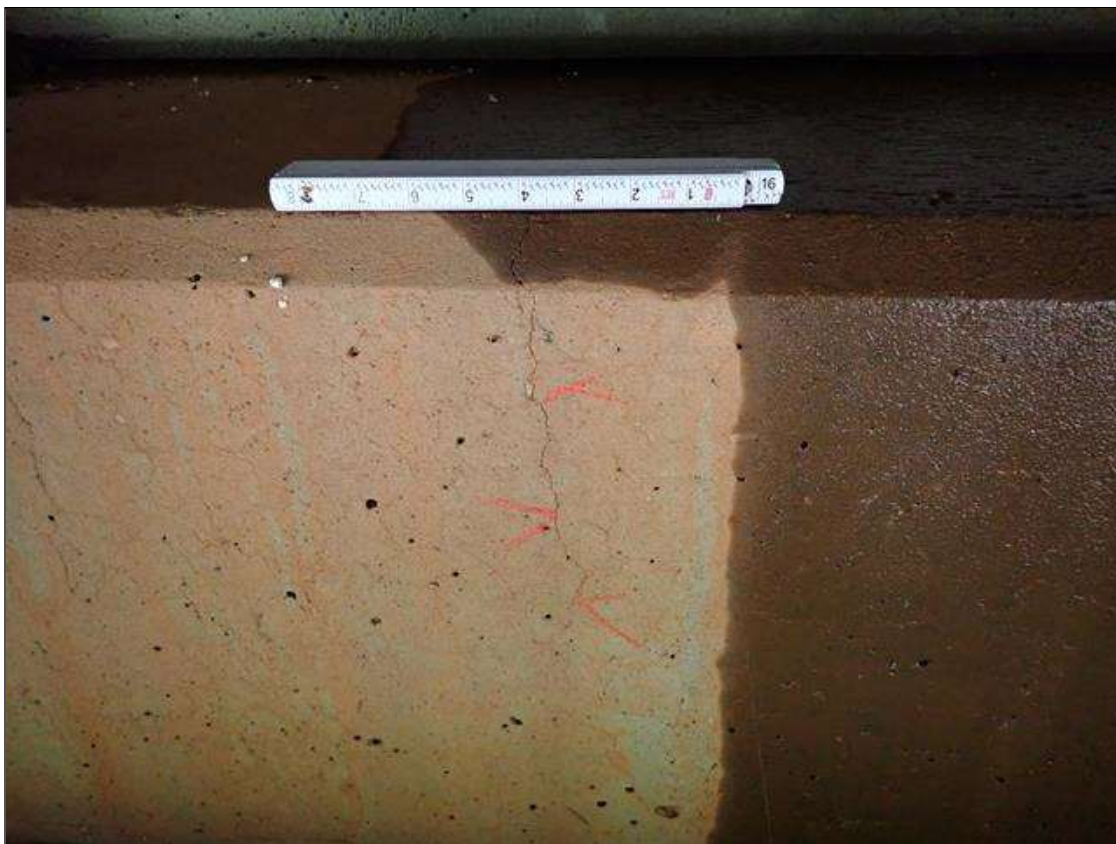
End Bent 2 Cap 1: END BENT 2 CAP HAS SCATTERED CRACKS THROUGHOUT ALL BAYS, UP TO TO FULL HEIGHT X 1/32 INCH

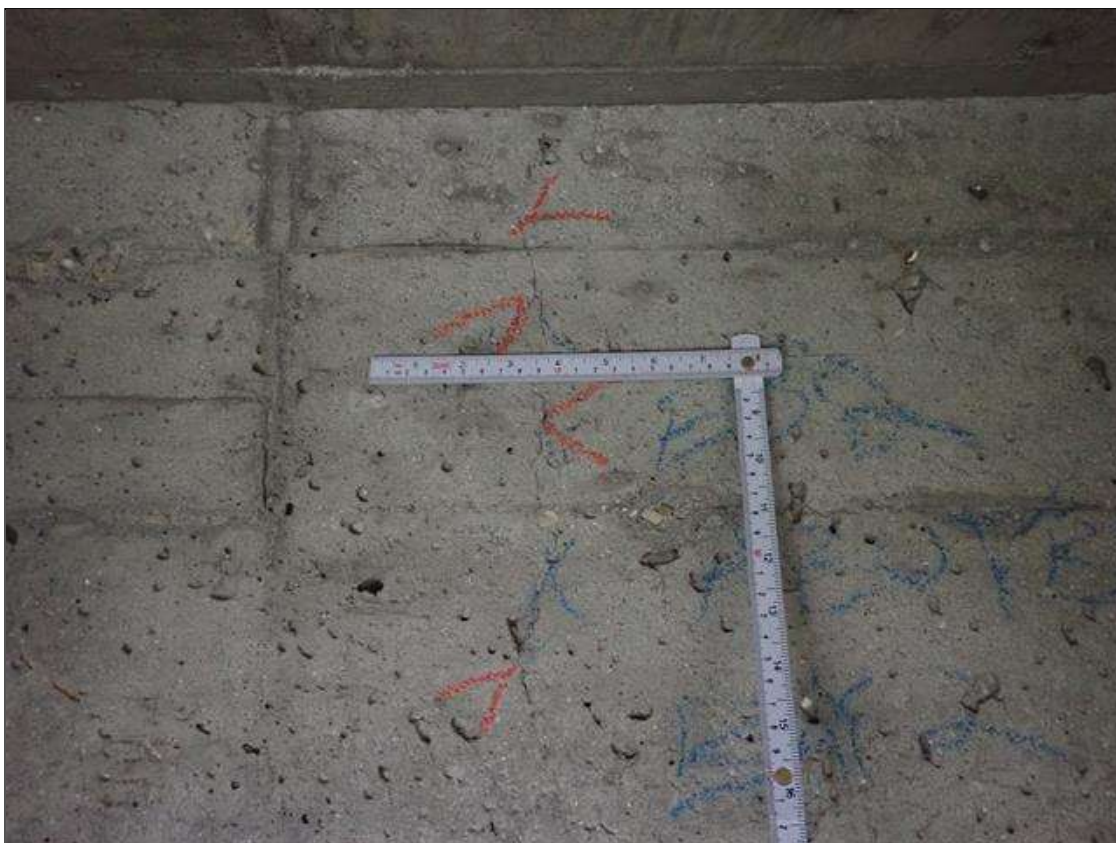
End Bent 2 Abutment: END BENT 2 ABUTMENT THROUGHOUT ALL BAYS, VERTICAL CRACKS, UP TO 2 FOOT X 1/64 INCH

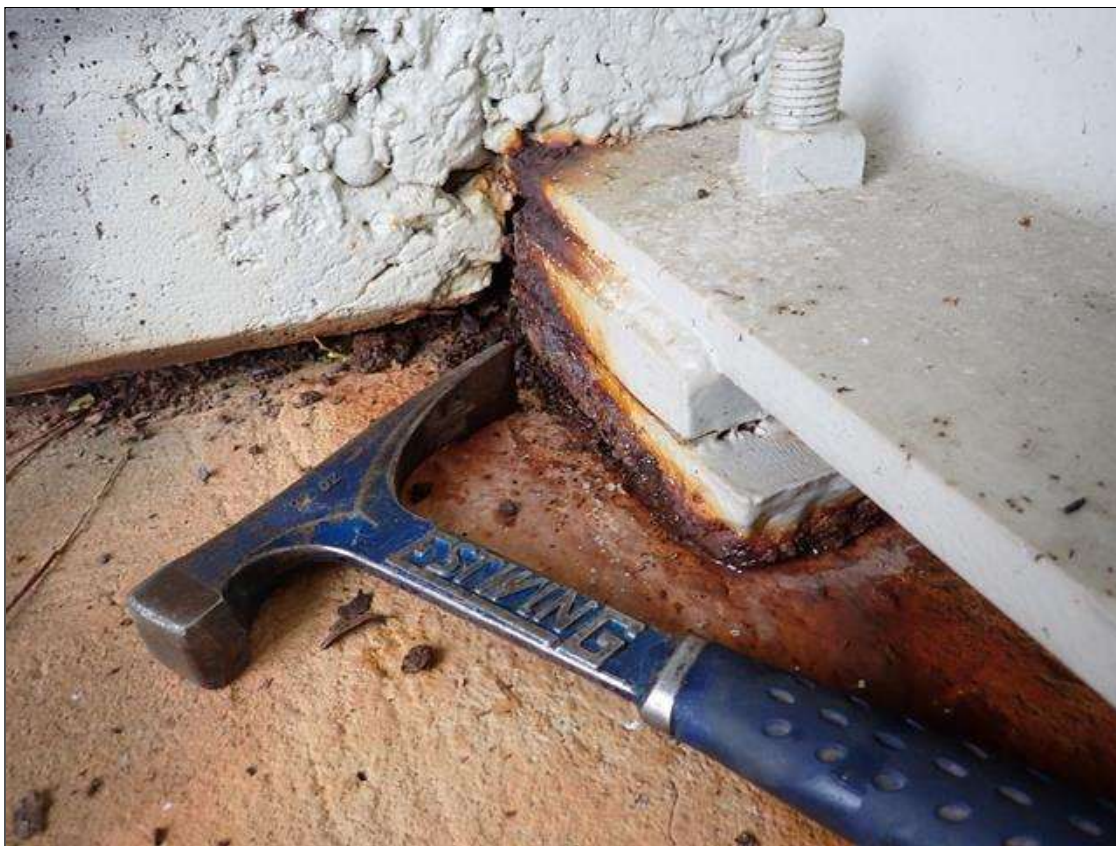
Span 4 Beam 1 - Far Bearing 1: corrosion with section loss (up to 1/8 inch loss)

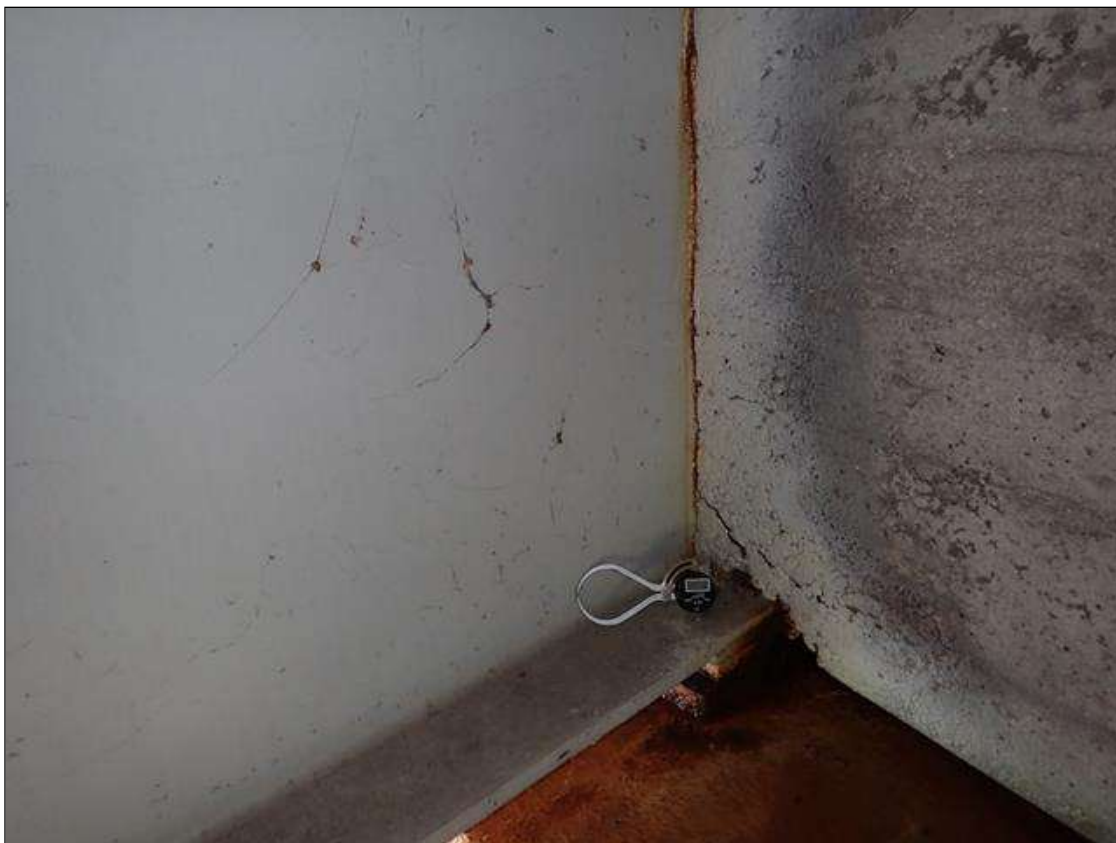
Span 4 Beam 1: (not found 2023) web at far end East face, arrested metal loss, up to 10 inch high x 12 inch long, average remaining 1/2 inch

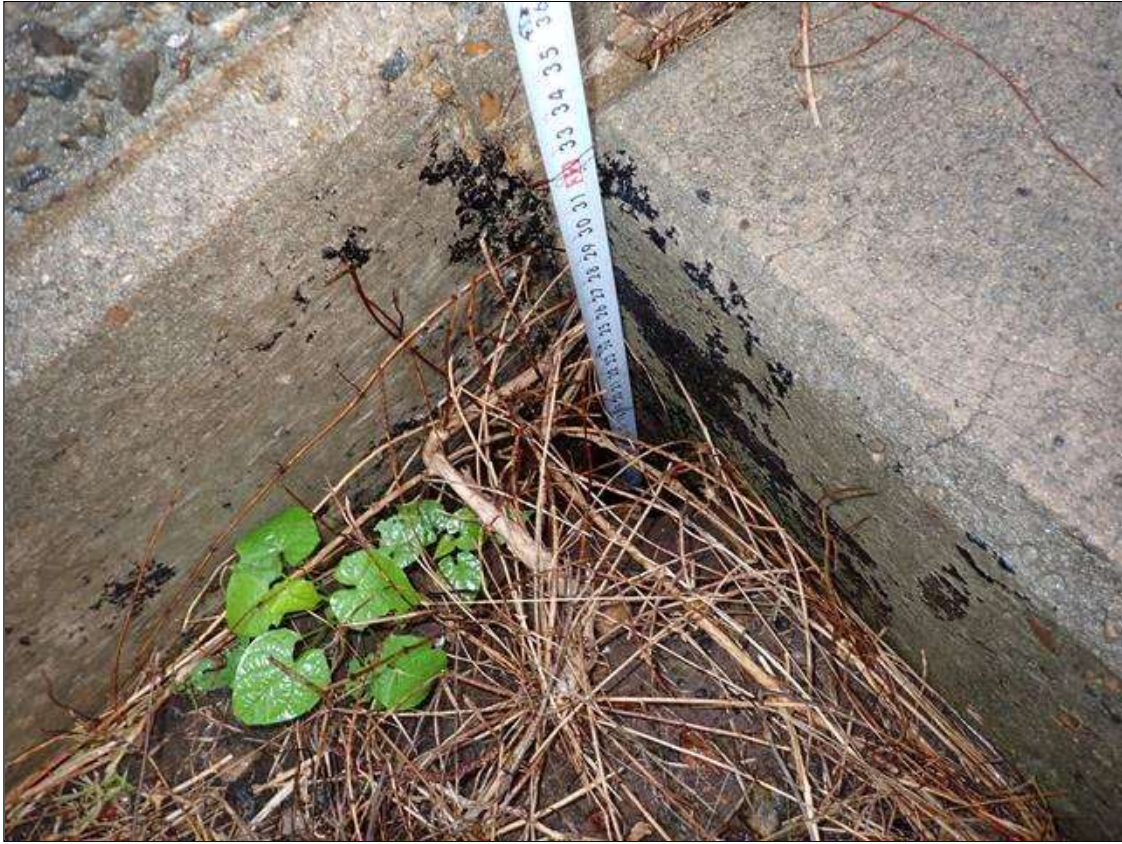
behind northwest wingwall, erosion hole (5 inch diameter x 2 foot deep)

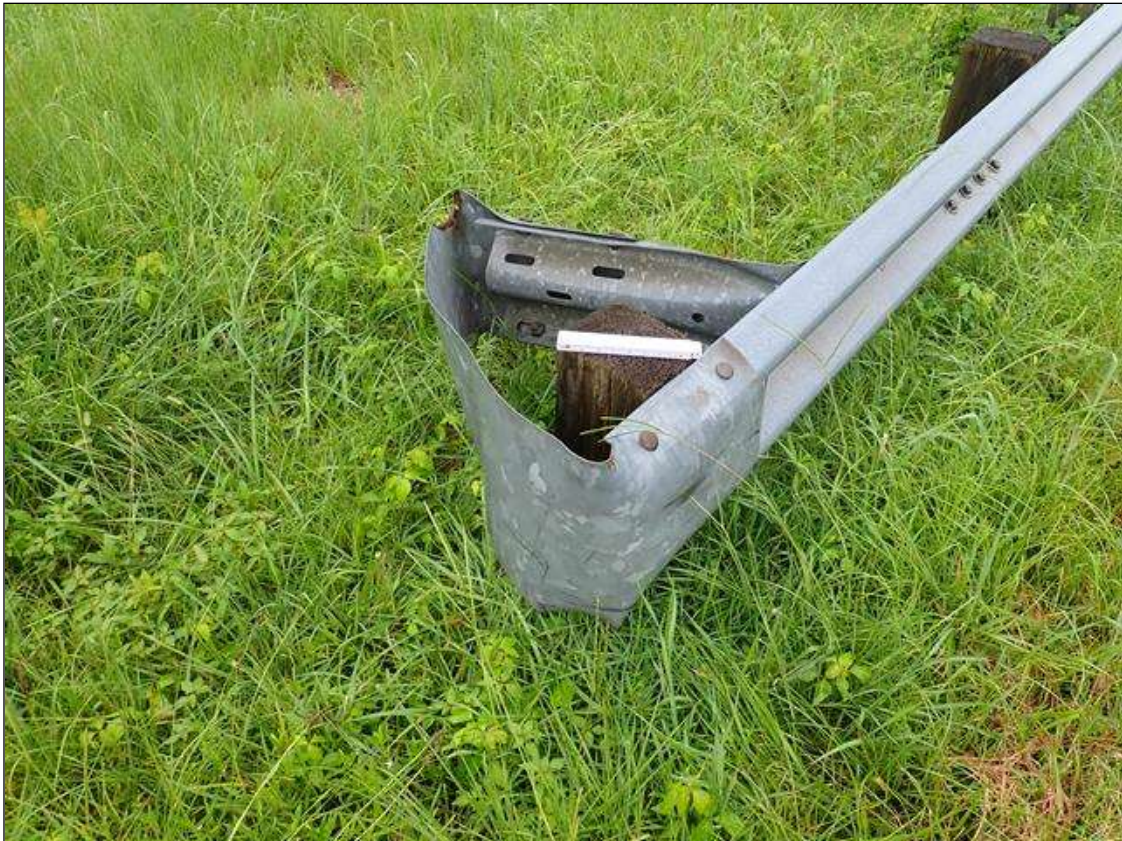
(PAR) northeast guardrail termination, impact damage

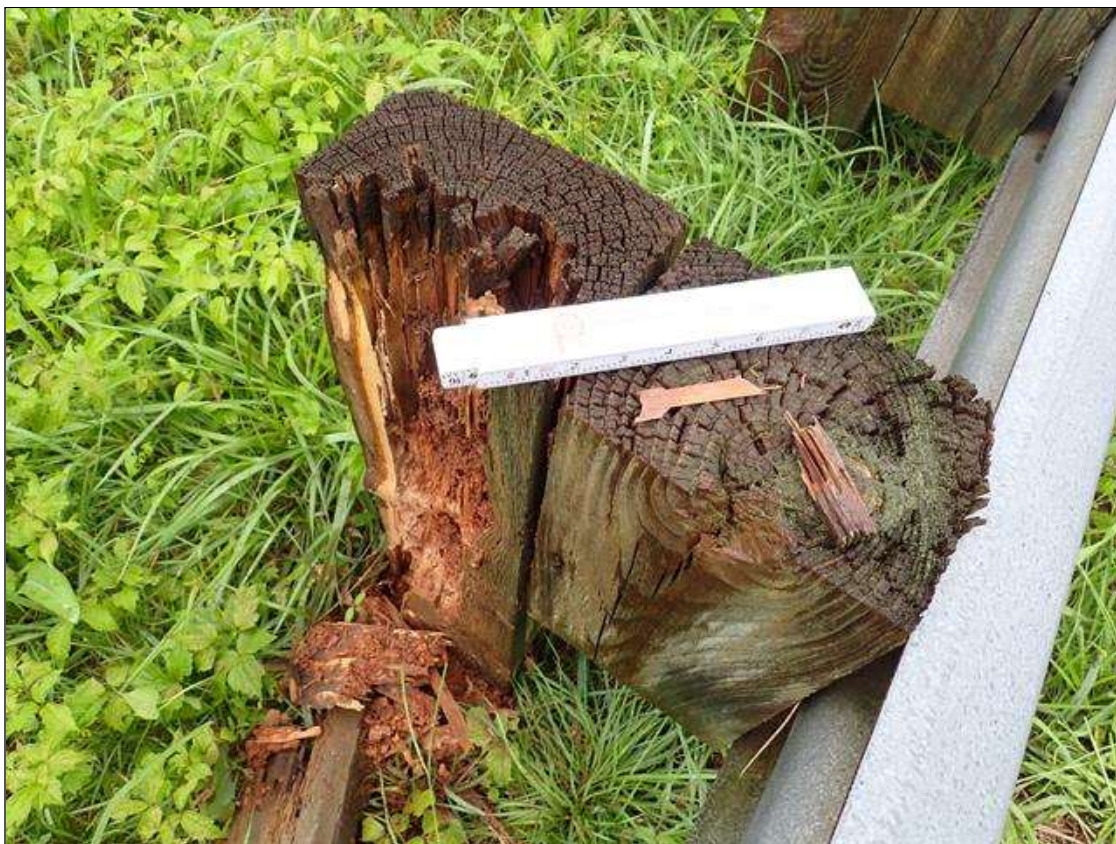
(PAR) northeast guardrail, 2nd, 4th and 6th timber posts, decay/section loss (up to full height x full width x full depth)

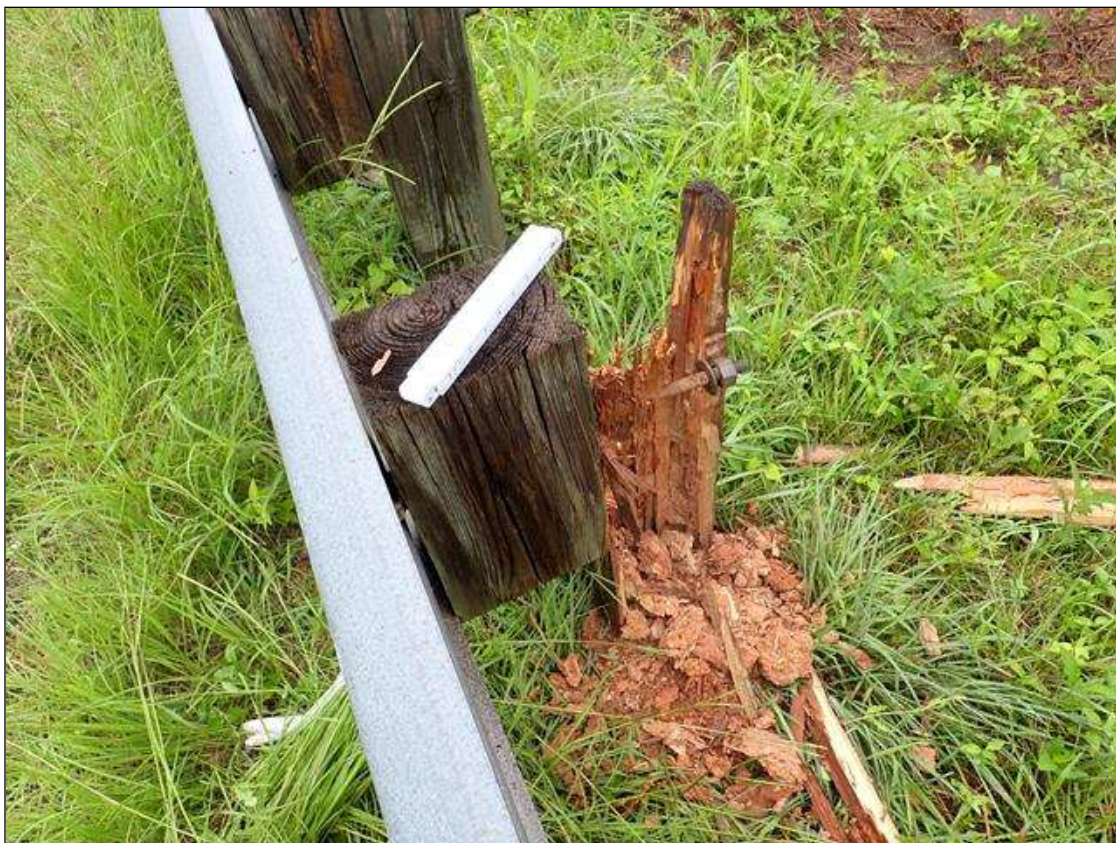
(PAR) northeast guardrail, 2nd, 4th and 6th timber posts, decay/section loss (up to full height x full width x full depth)

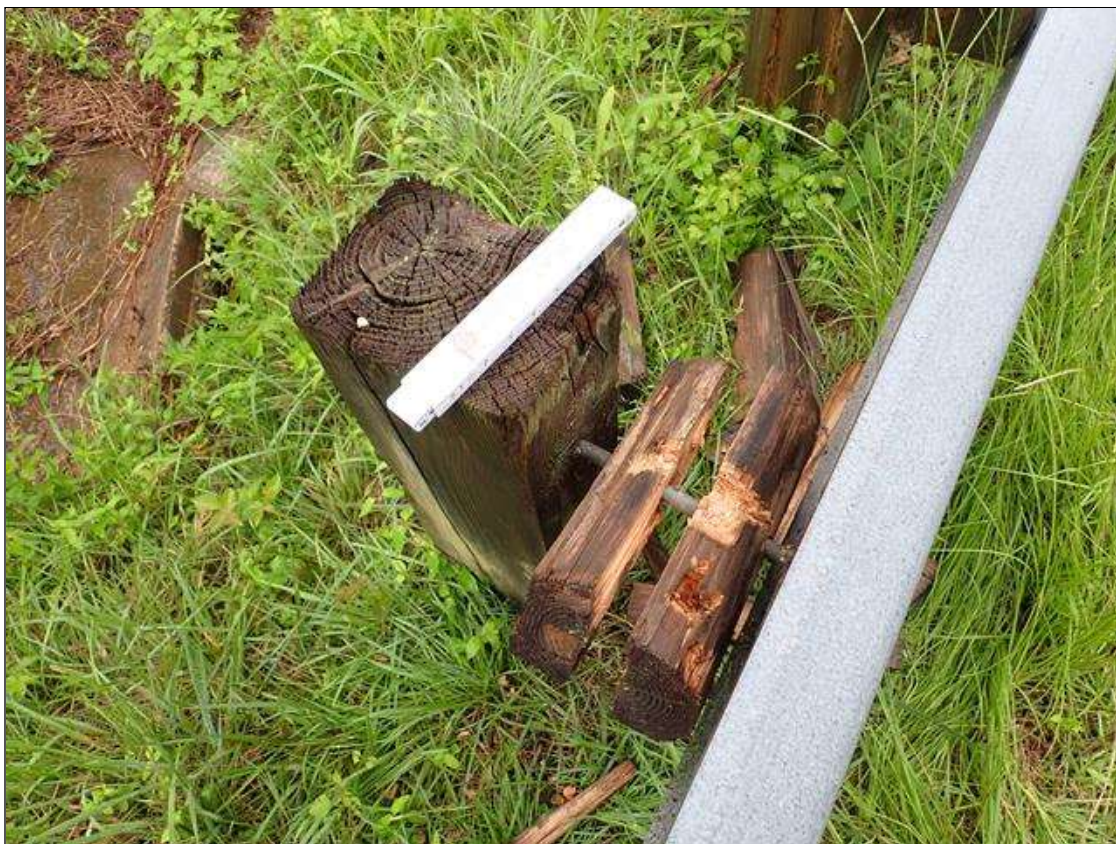
(PAR) northeast guardrail, 2nd, 4th and 6th timber posts, decay/section loss (up to full height x full width x full depth)

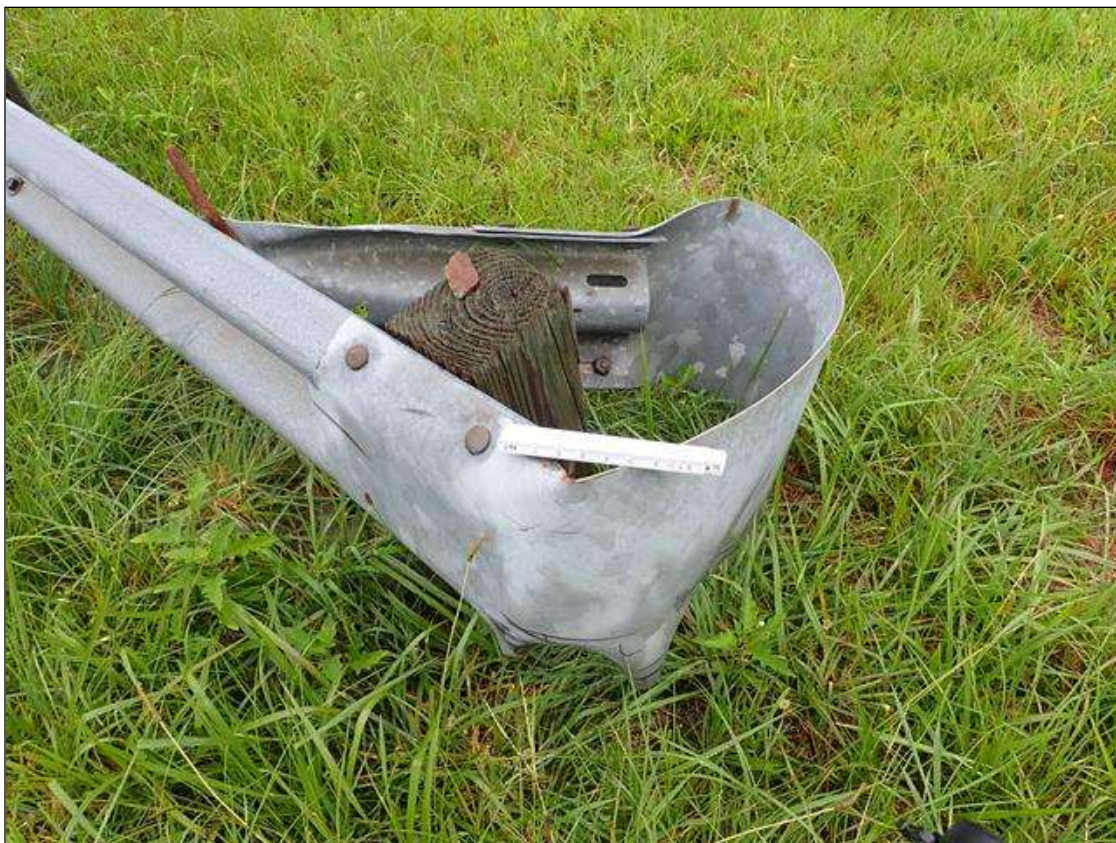
(PAR) southeast guardrail termination, impact damage

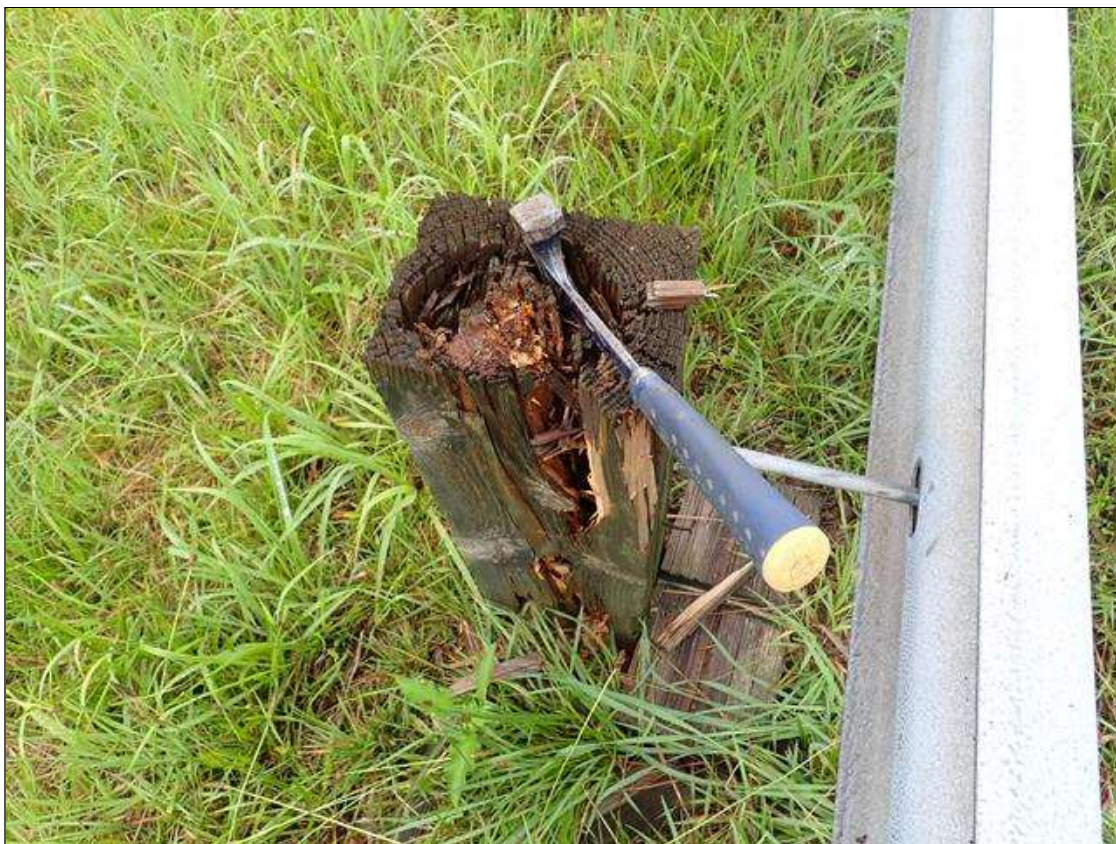
(PAR) southeast guardrail, timber posts 1-9, decay/section loss (up to full width x full height x full depth)

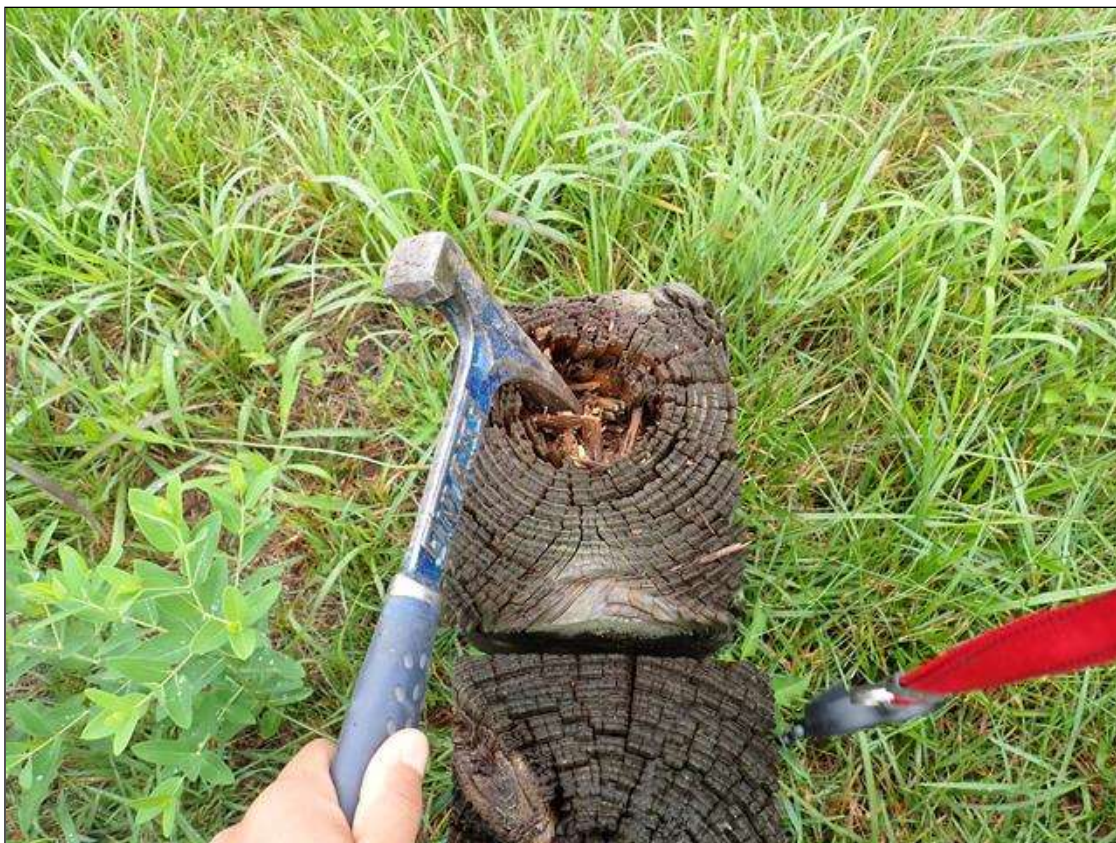
(PAR) southeast guardrail, timber posts 1-9, decay/section loss (up to full width x full height x full depth)

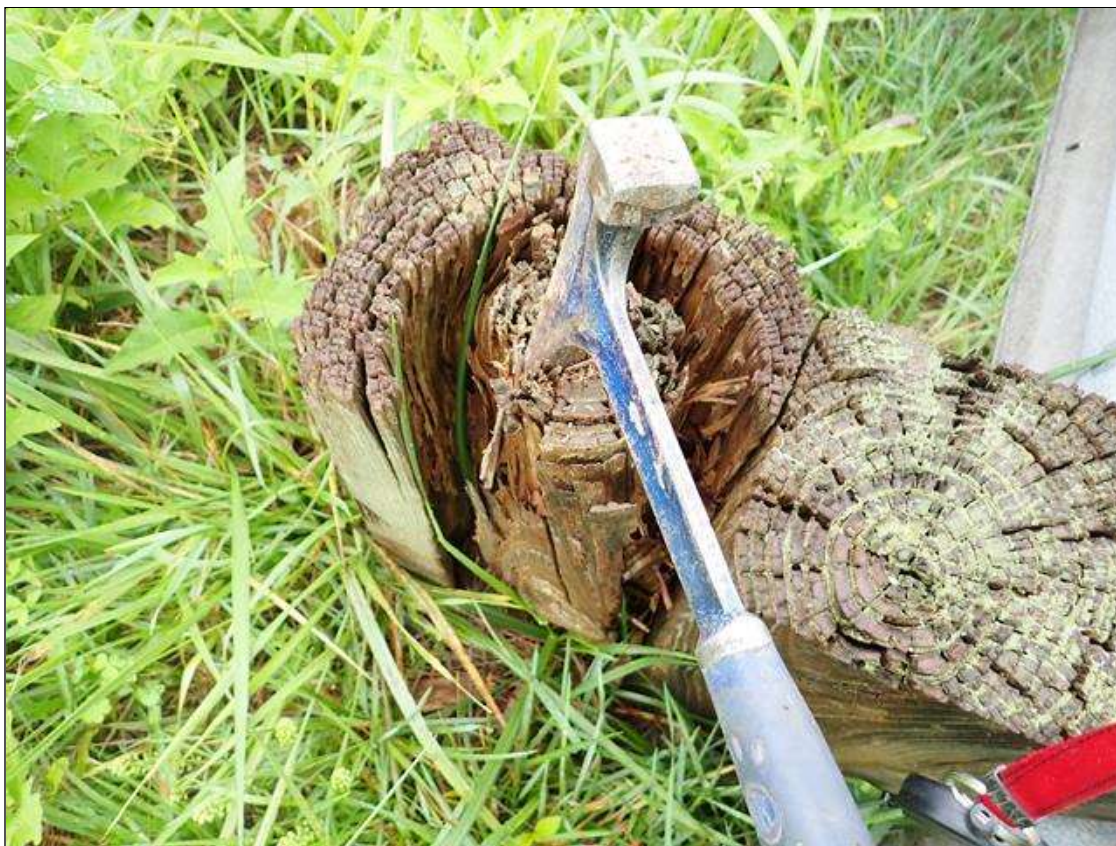
(PAR) southeast guardrail, timber posts 1-9, decay/section loss (up to full width x full height x full depth)

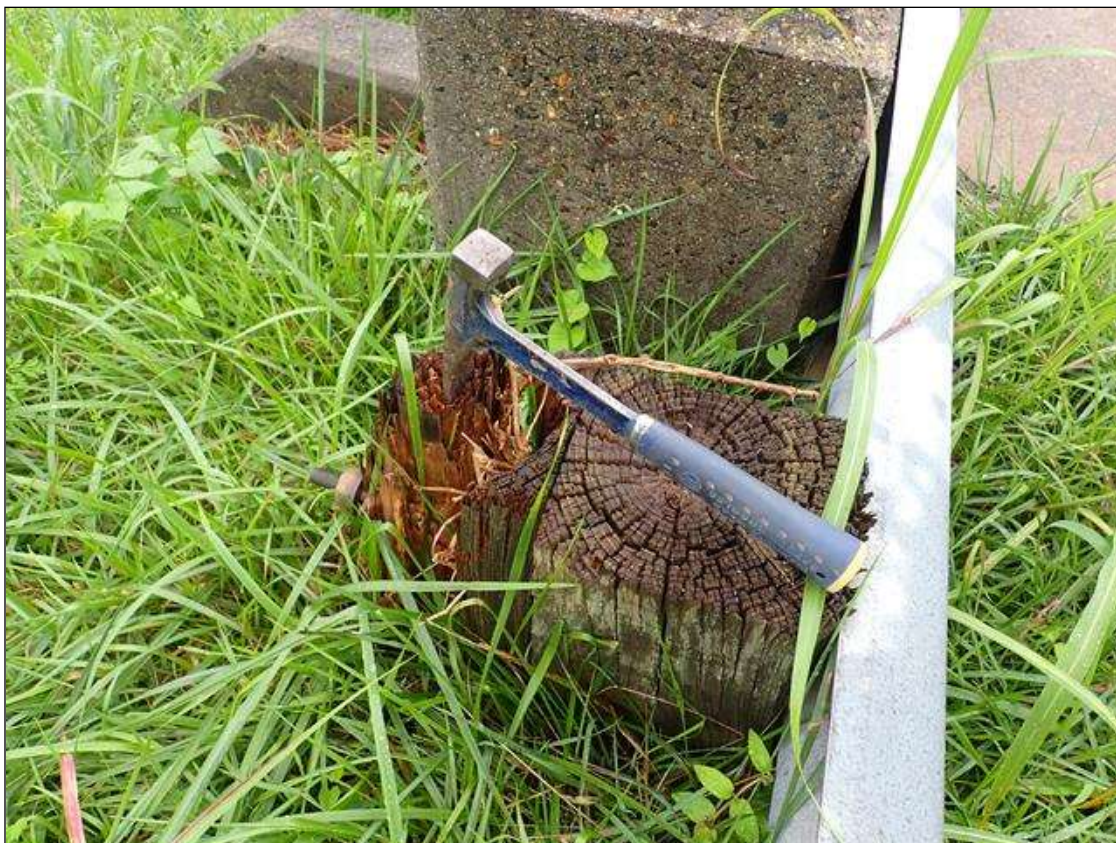
(PAR) southwest guardrail, timber posts 1-5, decay/section loss (up to full width x full height x full depth)

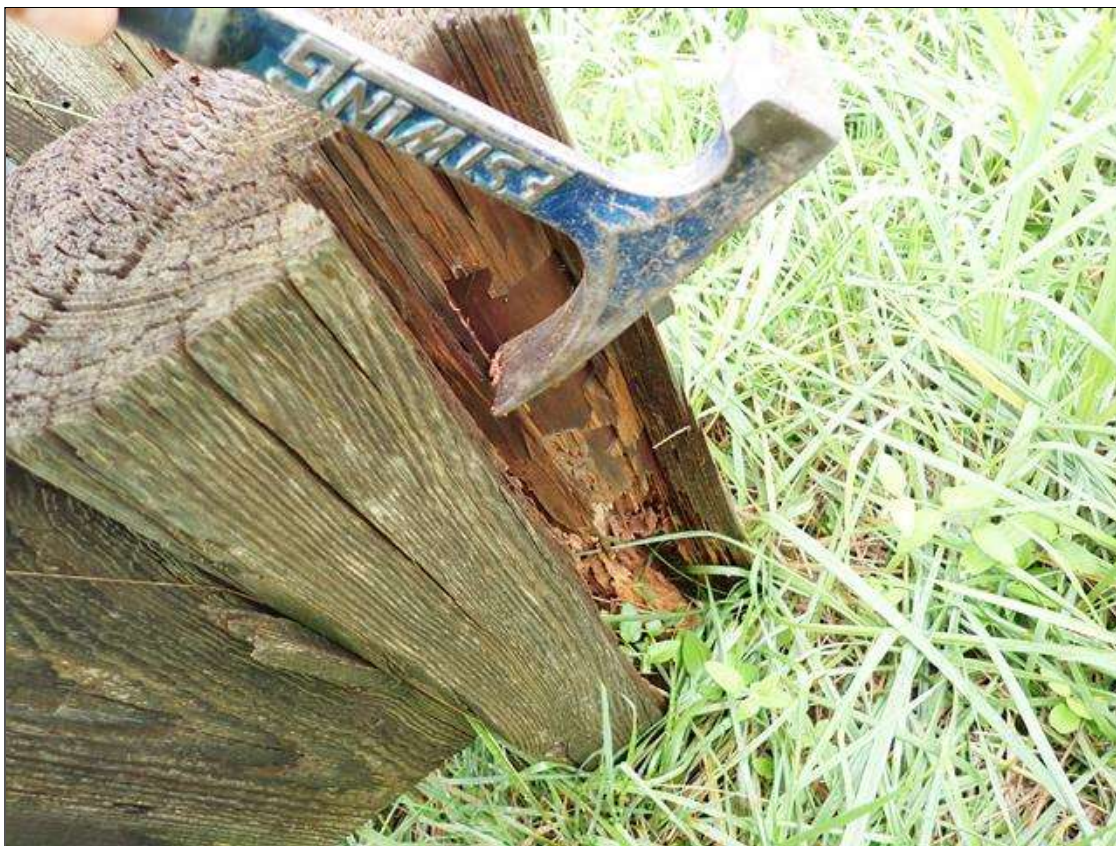
(PAR) southwest guardrail, timber posts 1-5, decay/section loss (up to full width x full height x full depth)

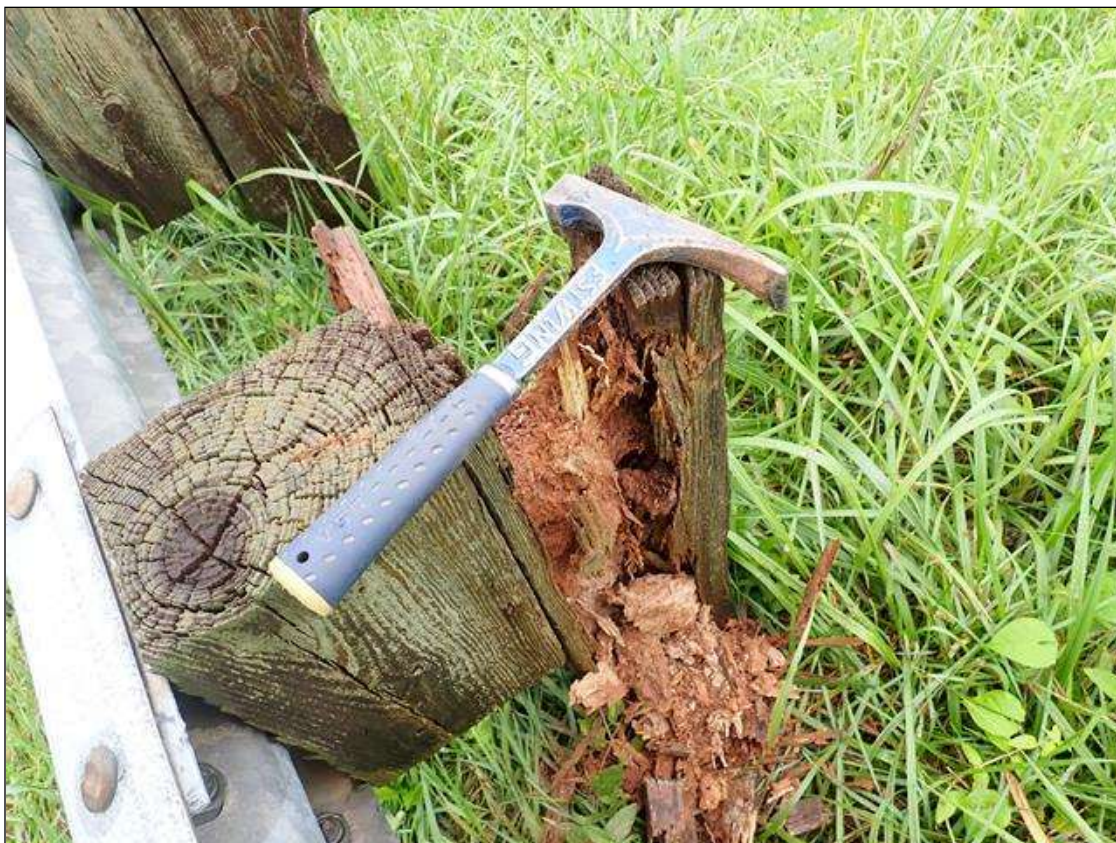
(PAR) southwest guardrail, timber posts 1-5, decay/section loss (up to full width x full height x full depth)

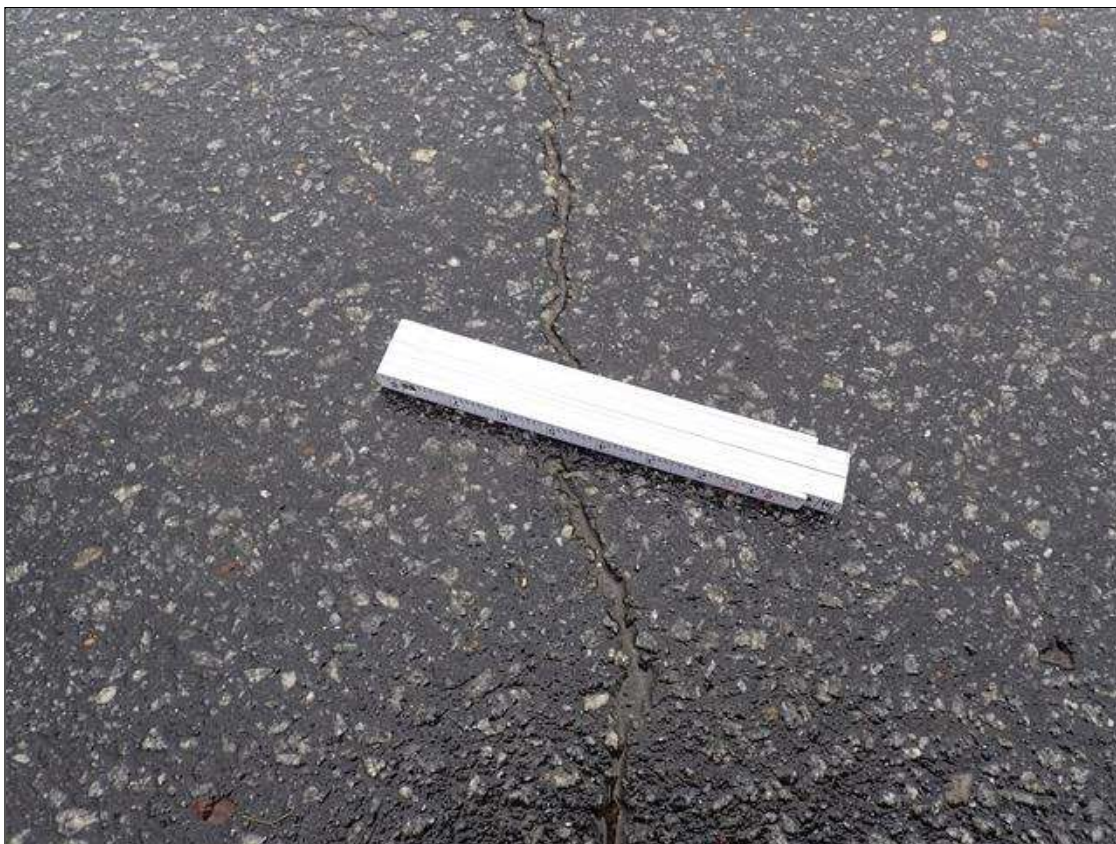
Span 1 Wearing Surface: throughout asphalt wearing surface, transverse and longitudinal cracks (up to 1/8 inch x 10 foot) at random

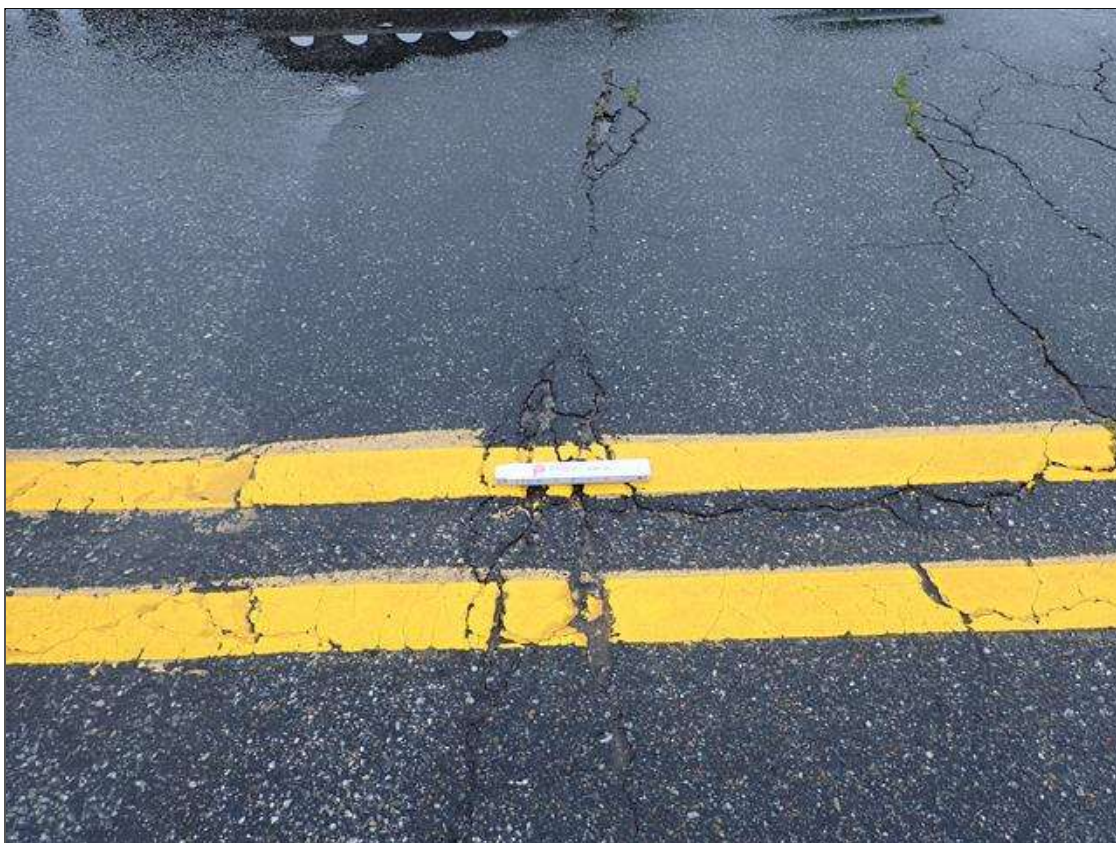
Span 1 Wearing Surface: over end bent 1, transverse cracks (up to 1/18 inch x full roadway width) with edge spalling (2 foot x 6 inch x 1.5 inch deep)

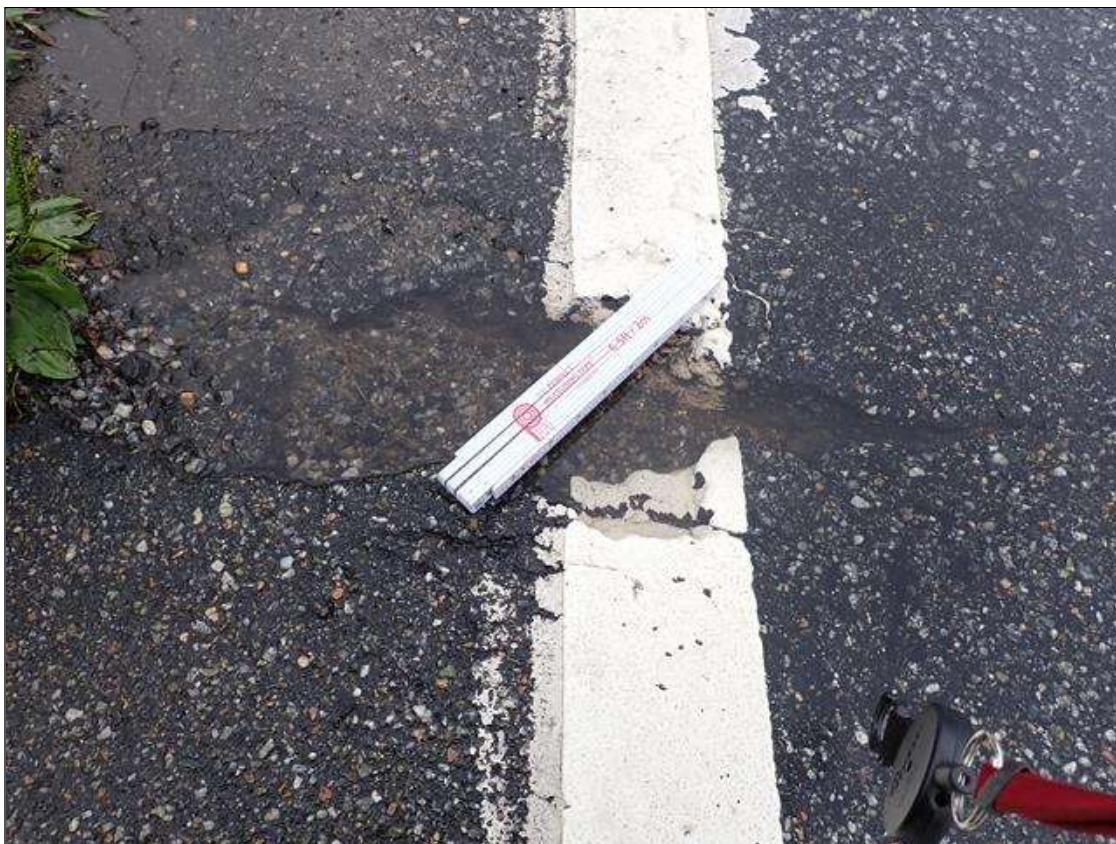
Span 1 Wearing Surface: over end bent 1, transverse cracks (up to 1/8 inch x full roadway width) with edge spalling (2 foot x 6 inch x 1.5 inch deep)

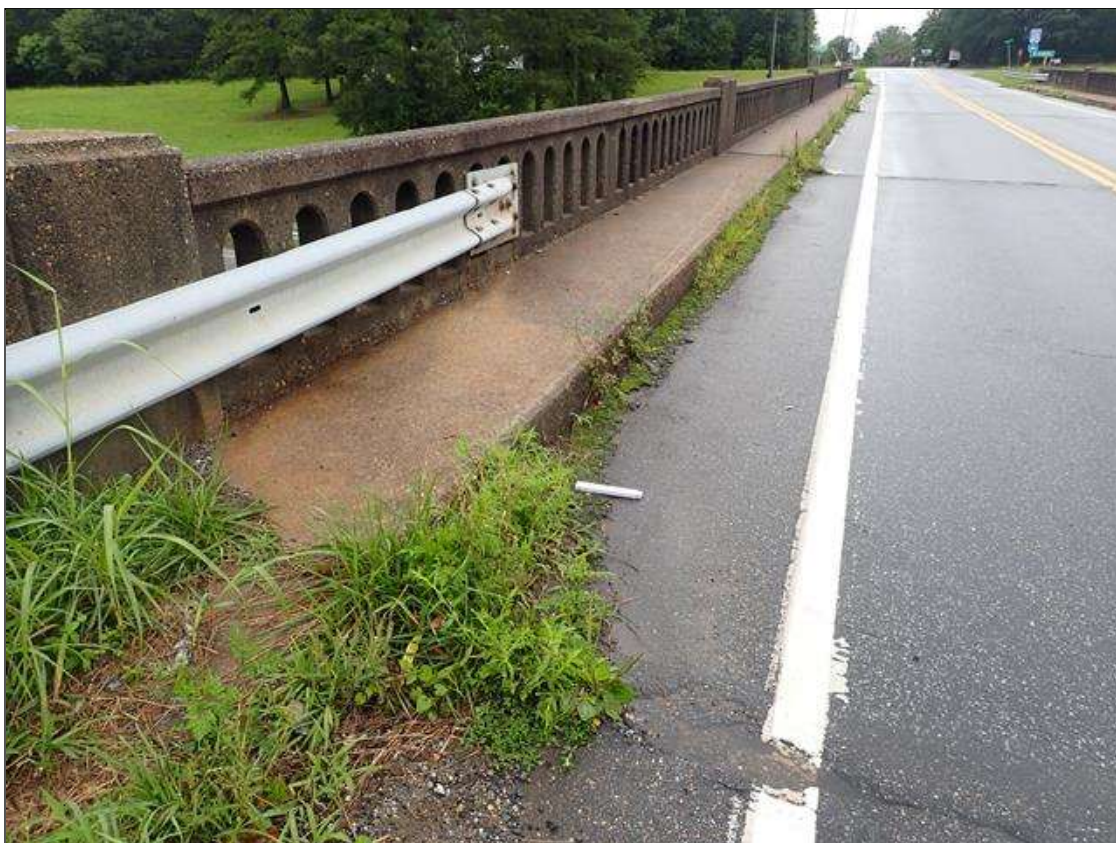
along both curbline, debris accumulation (up to 2 foot wide x full length) with vegetation growth; partially obstructing drainage

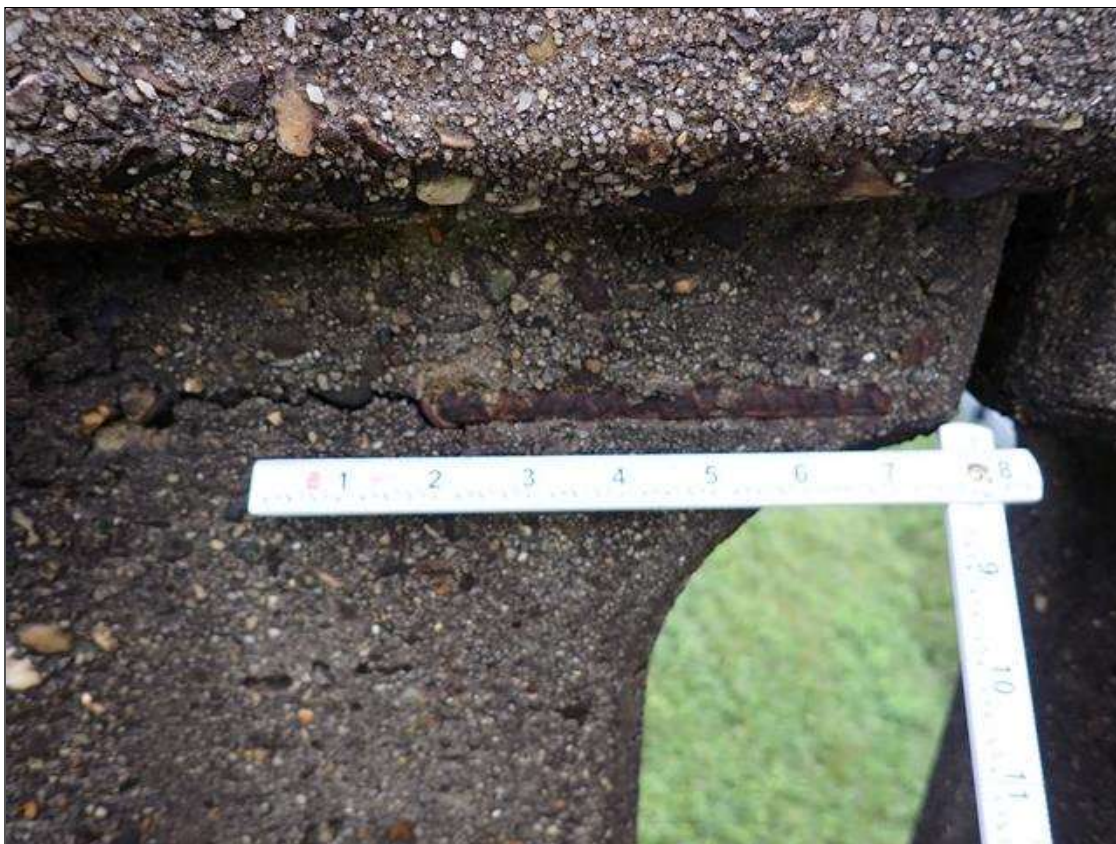
Span 1 Left Bridge Rail: UP TO 6 INCH X 3 INCH X 1/4 INCH DEEP SPALL WITH EXPOSED REBAR AT RANDOM THROUGHOUT

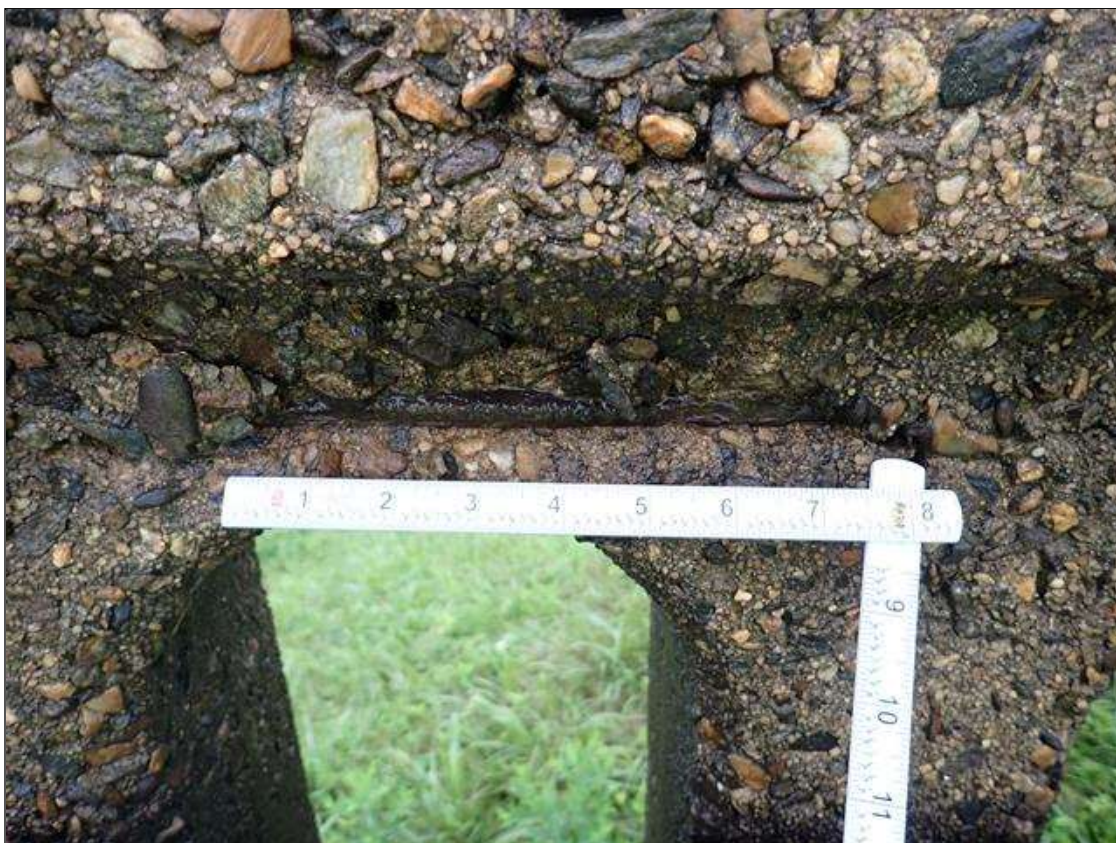
Span 1 Right Bridge Rail: UP TO 6 INCH X 3 INCH X 1/4 INCH DEEP SPALL WITH EXPOSED REBAR AT RANDOM THROUGHOUT
