NC DEPARTMENT OF TRANSPORTATION
 DIVISION OF HIGHWAYS
 STRUCTURE MANAGEMENT UNIT

ATTENTION: **prompt action request; sketches revised**

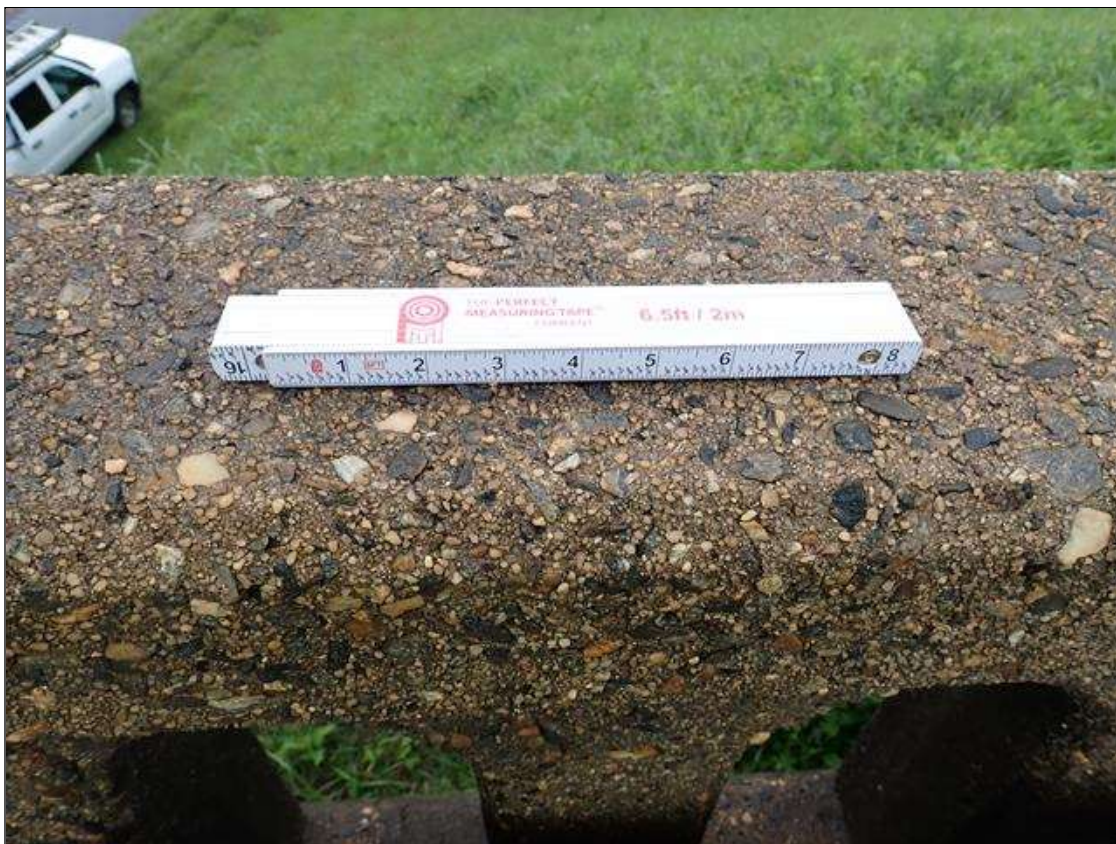
Span 1 Right Bridge Rail: along the length of the rail and sidewalk, scaling with secure aggregate at random

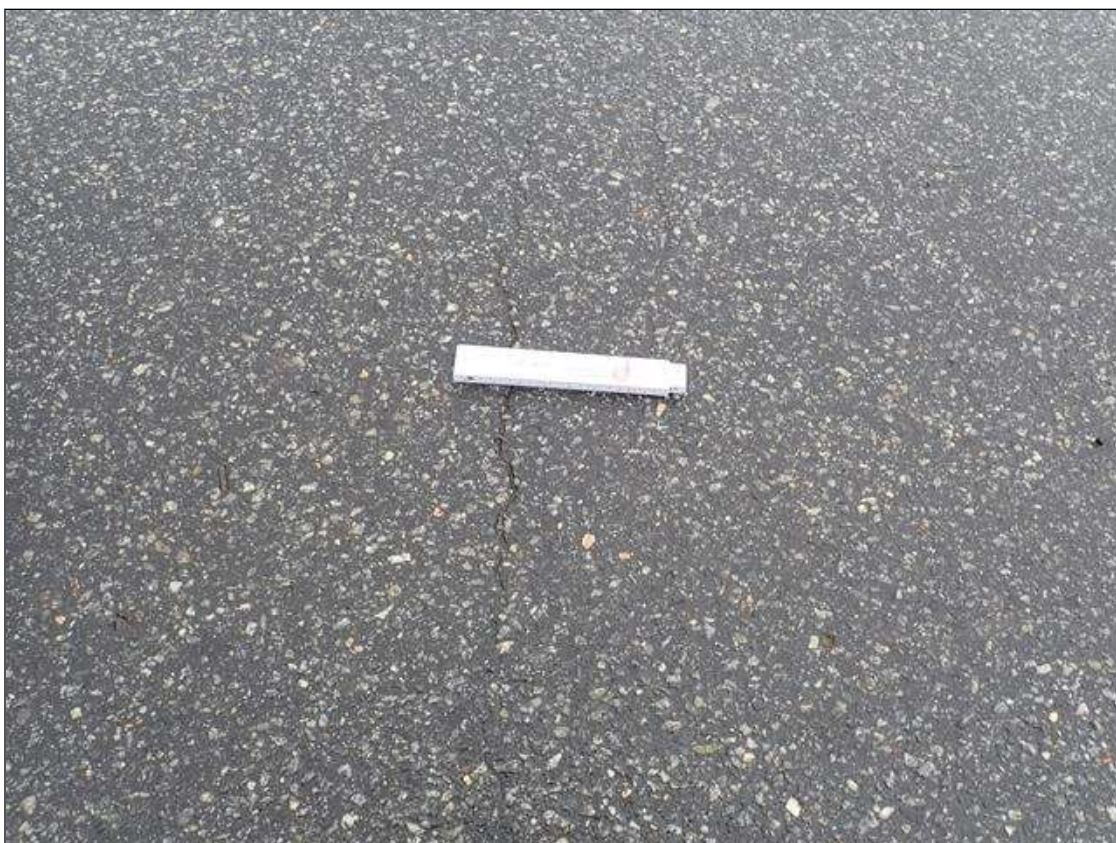
Span 2 Wearing Surface: throughout asphalt wearing surface, transverse and longitudinal cracks (up to 1/8 inch x 10 foot) at random

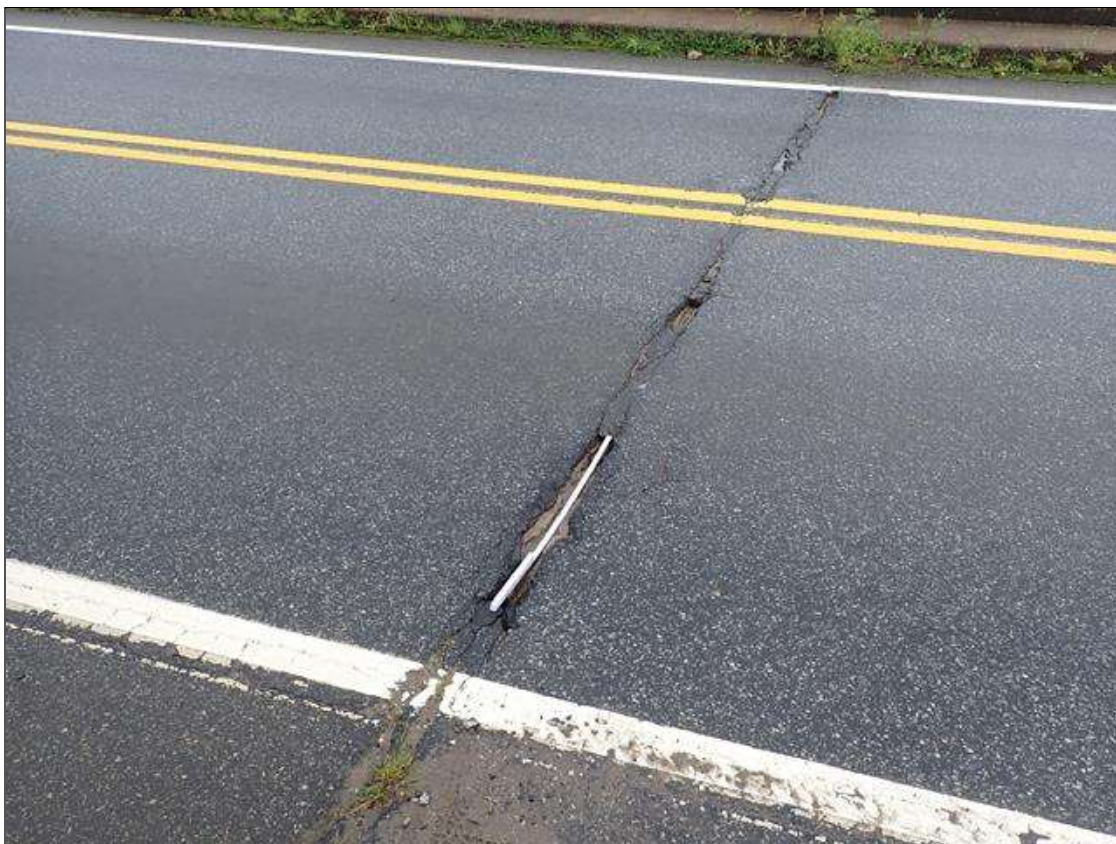
Span 2 Wearing Surface: (PAR) over bent 1, broken asphalt (full roadway width x 8 inch) with potholes (up to 32 inch x 5 inch x full depth)

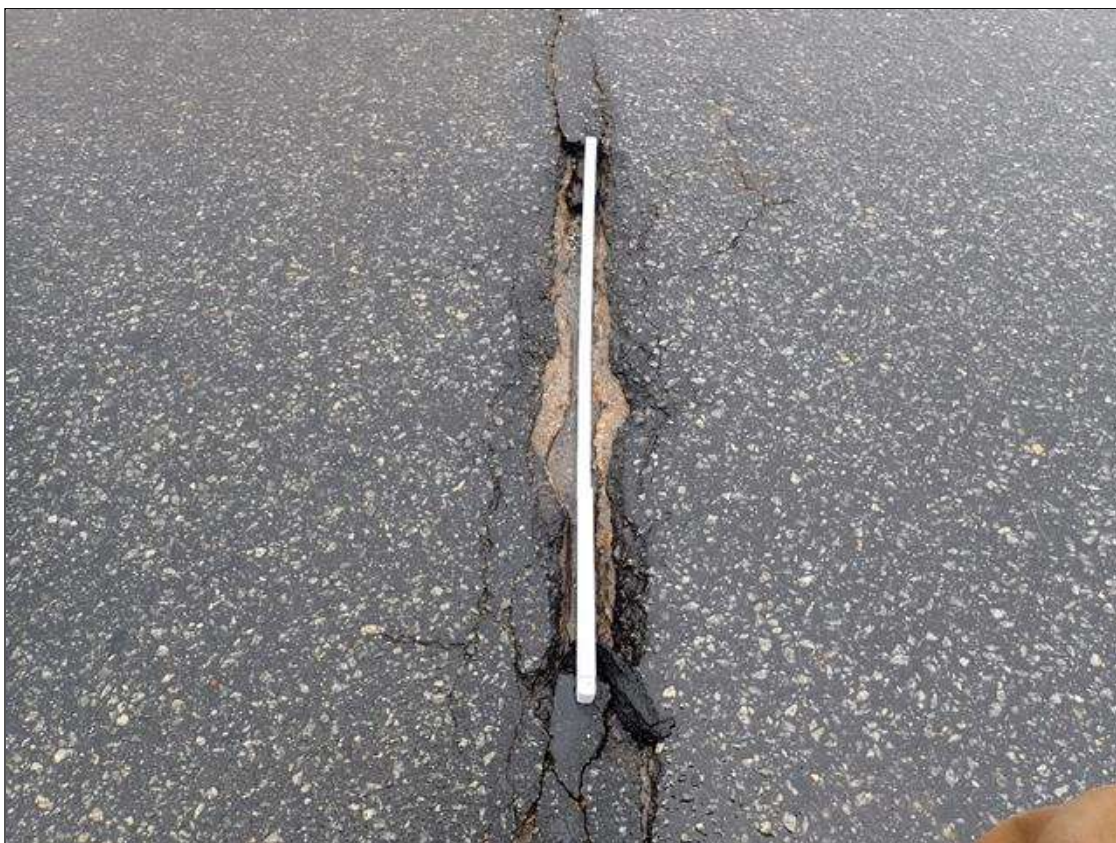
Span 2 Wearing Surface: (PAR) over bent 1, broken asphalt (full roadway width x 8 inch) with potholes (up to 32 inch x 5 inch x full depth)

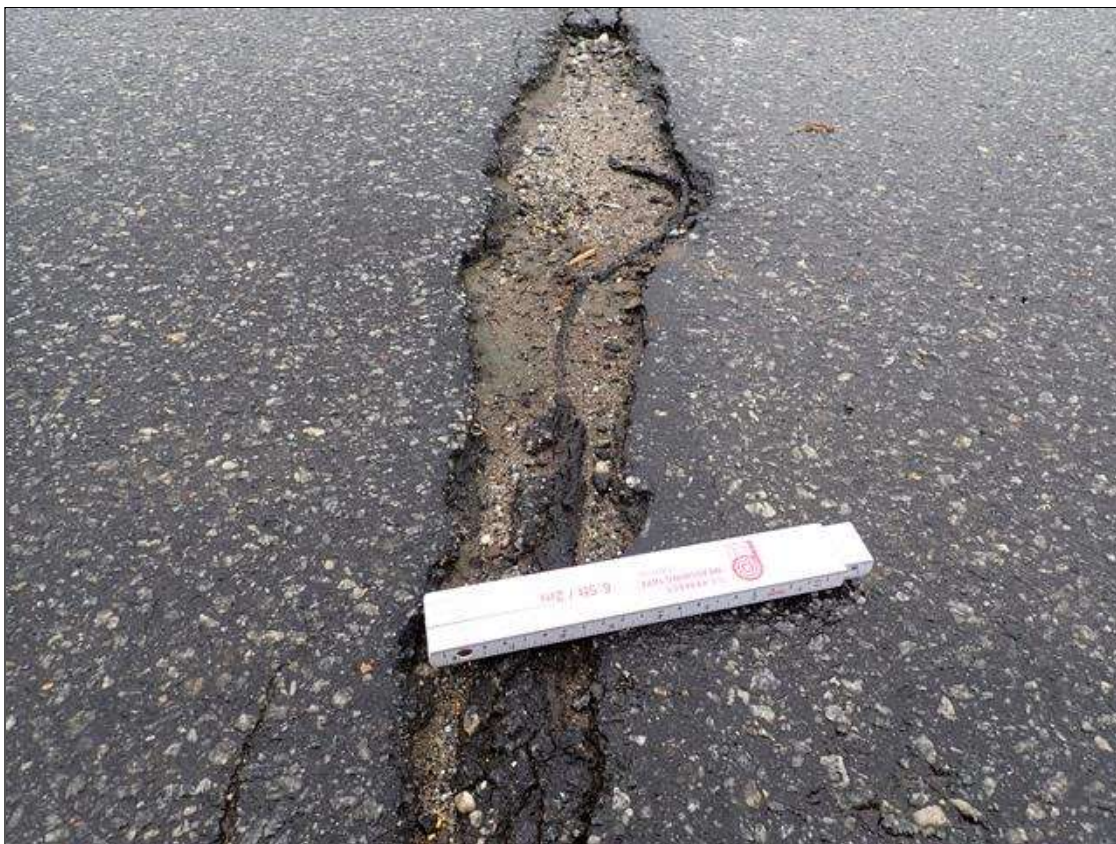
Span 2 Wearing Surface: (PAR) over bent 2, broken asphalt (full roadway width x 8 inch) with potholes (up to 10 foot x 9 inch x full depth)

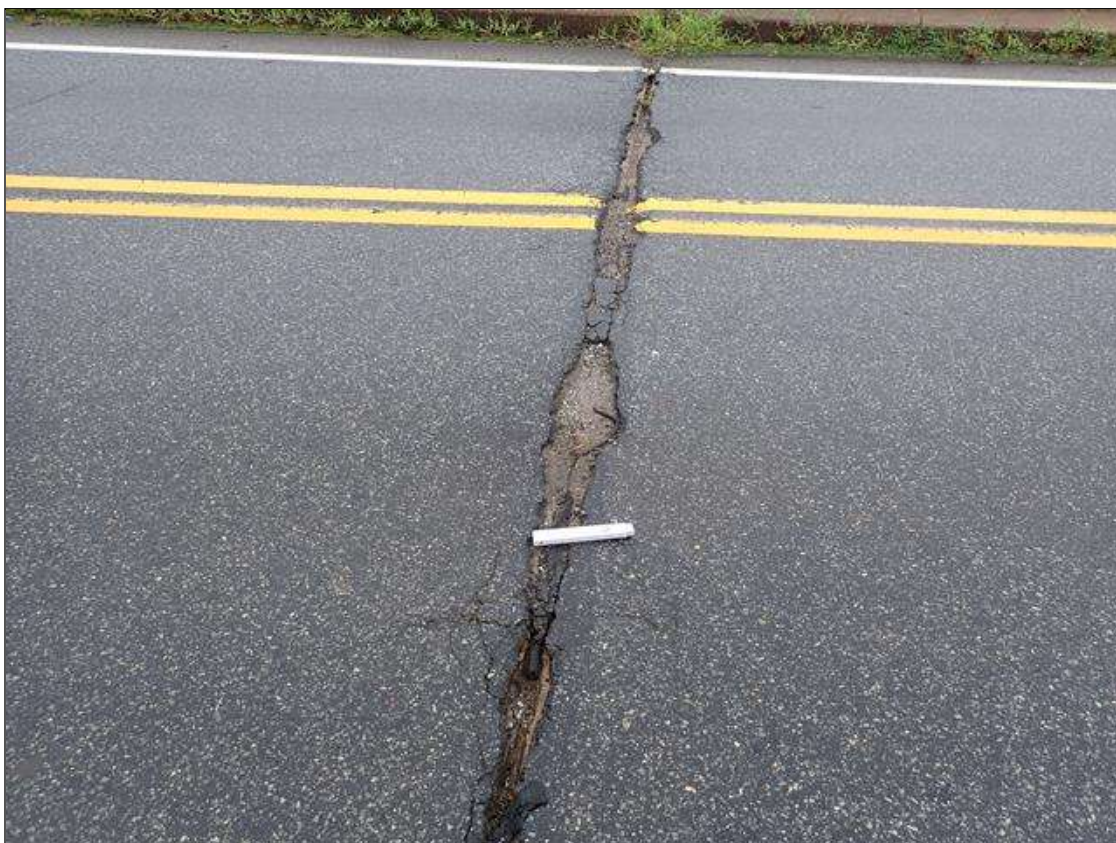
Span 2 Wearing Surface: (PAR) over bent 2, broken asphalt (full roadway width x 8 inch) with potholes (up to 10 foot x 9 inch x full depth)

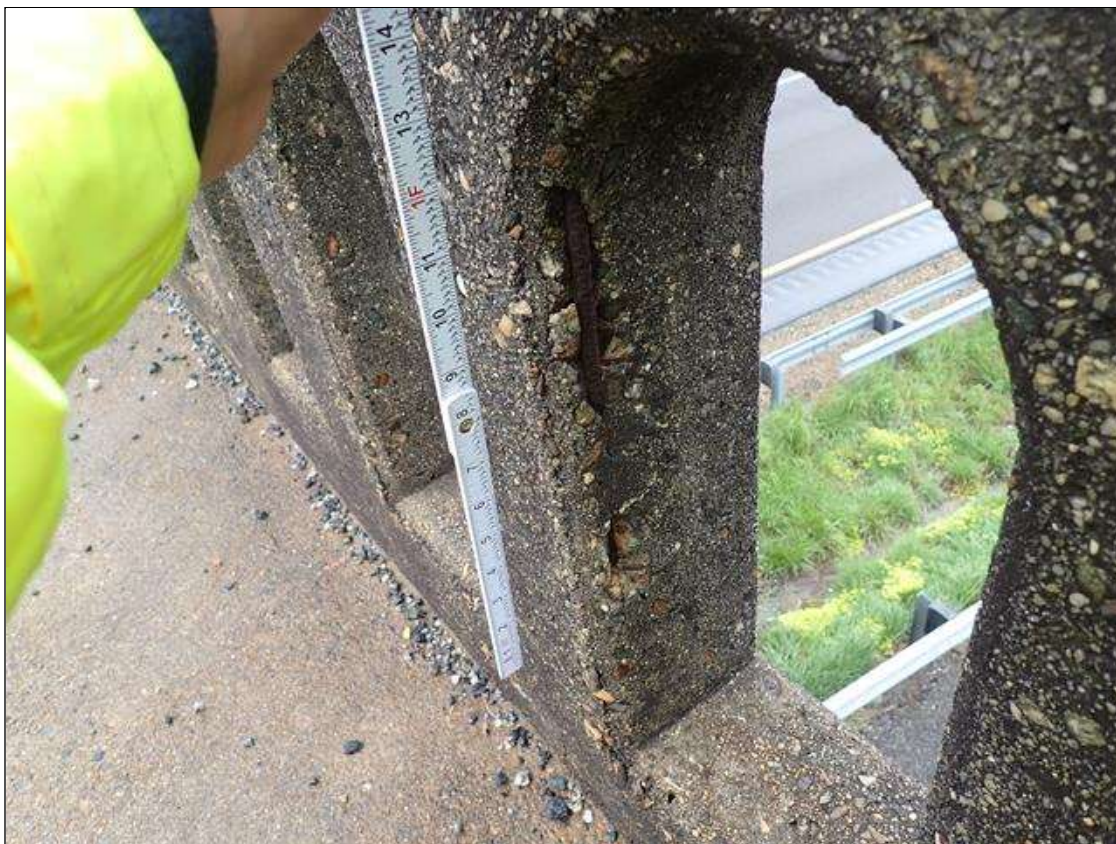
Span 2 Right Bridge Rail: UP TO 12 INCH X 3 INCH X 1/2 INCH DEEP SPALL WITH EXPOSED REBAR AT RANDOM THROUGHOUT

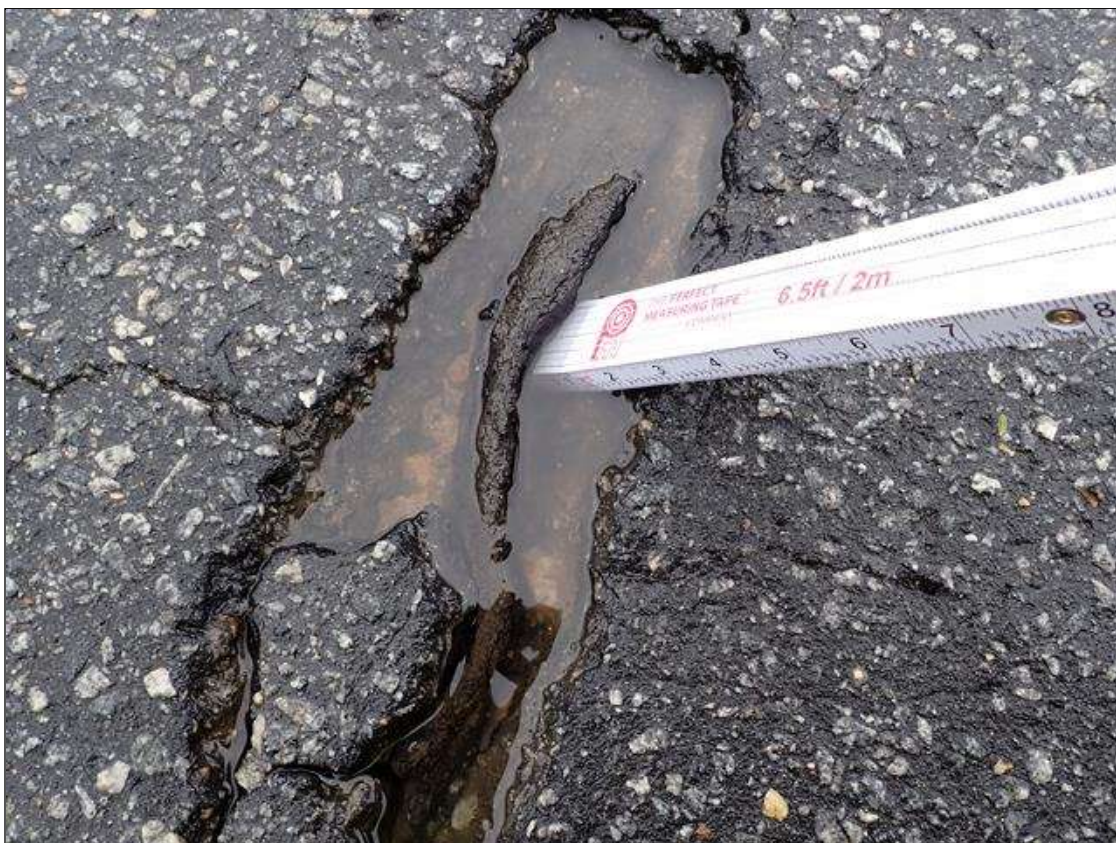
Span 2 Bent 1 Expansion Joint: at missing asphalt locations, seal deteriorated/torn/missing (up to full depth)

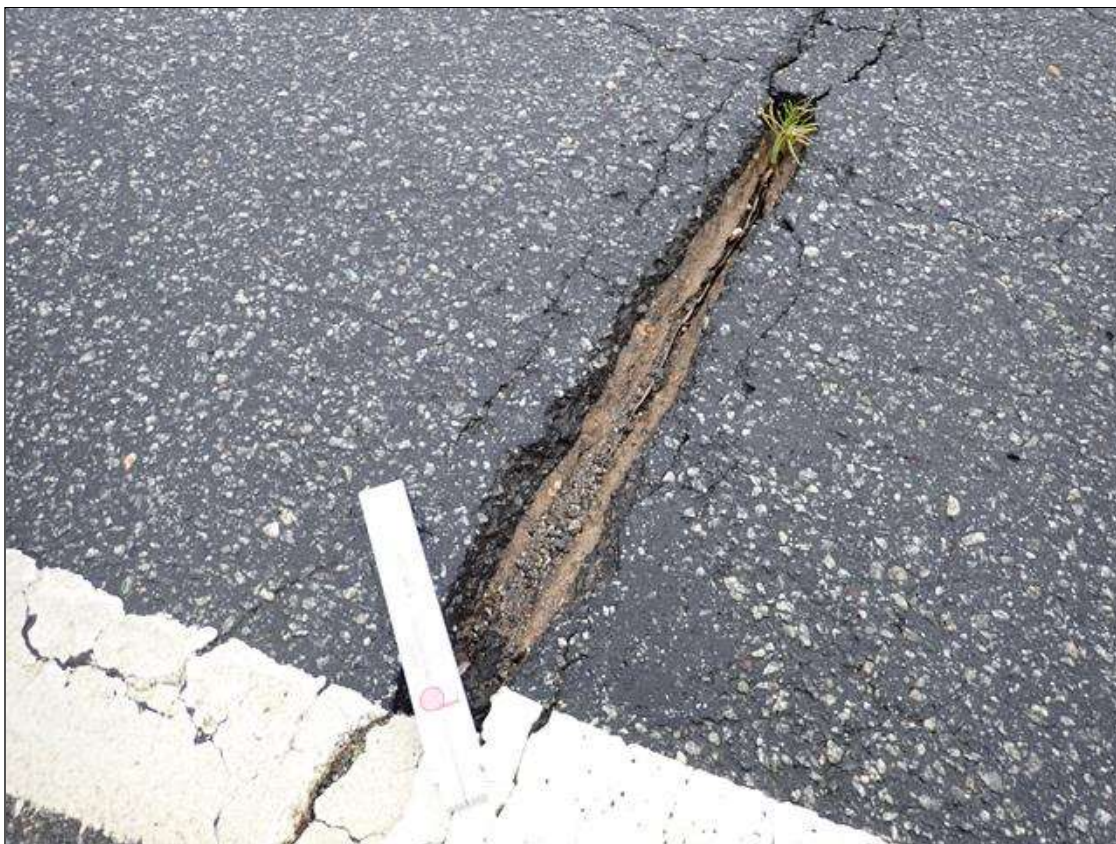
Span 2 Bent 1 Expansion Joint: at missing asphalt locations, seal deteriorated/torn/missing (up to full depth)

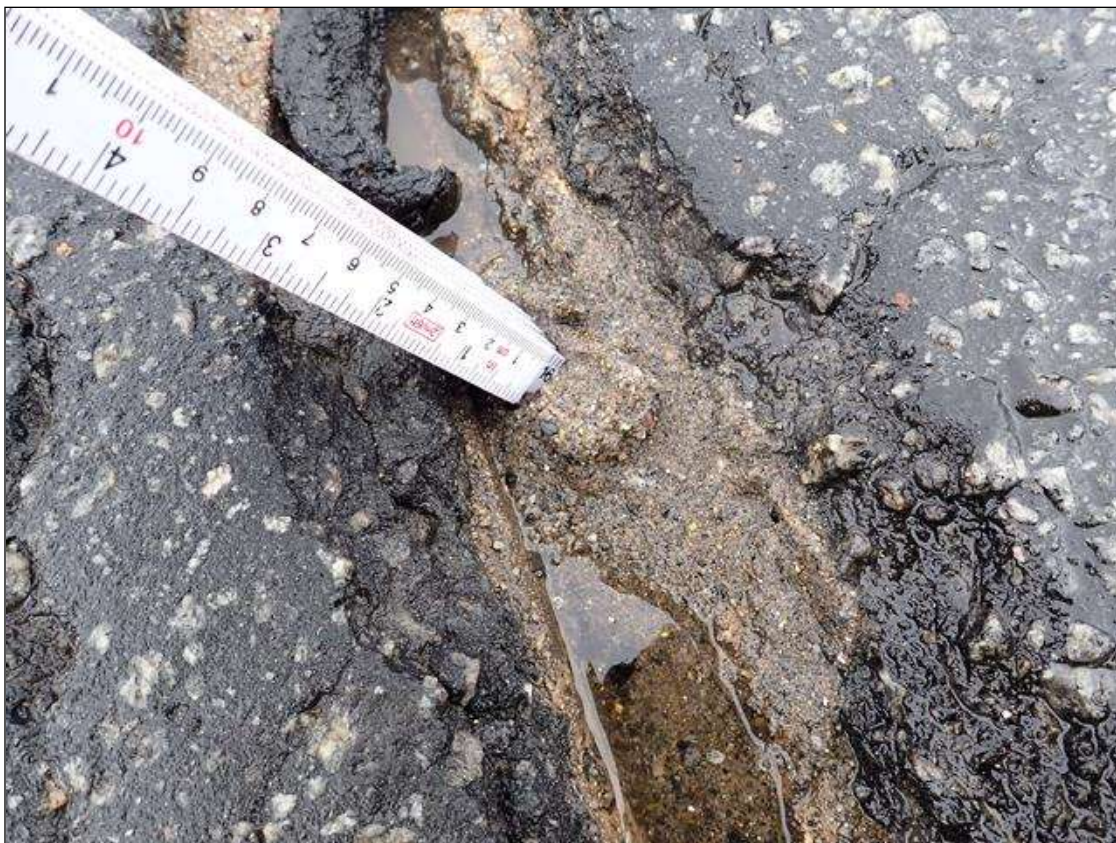
Span 2 Bent 1 Expansion Joint: at missing asphalt locations, debris accumulation (up to 32 inch) at random

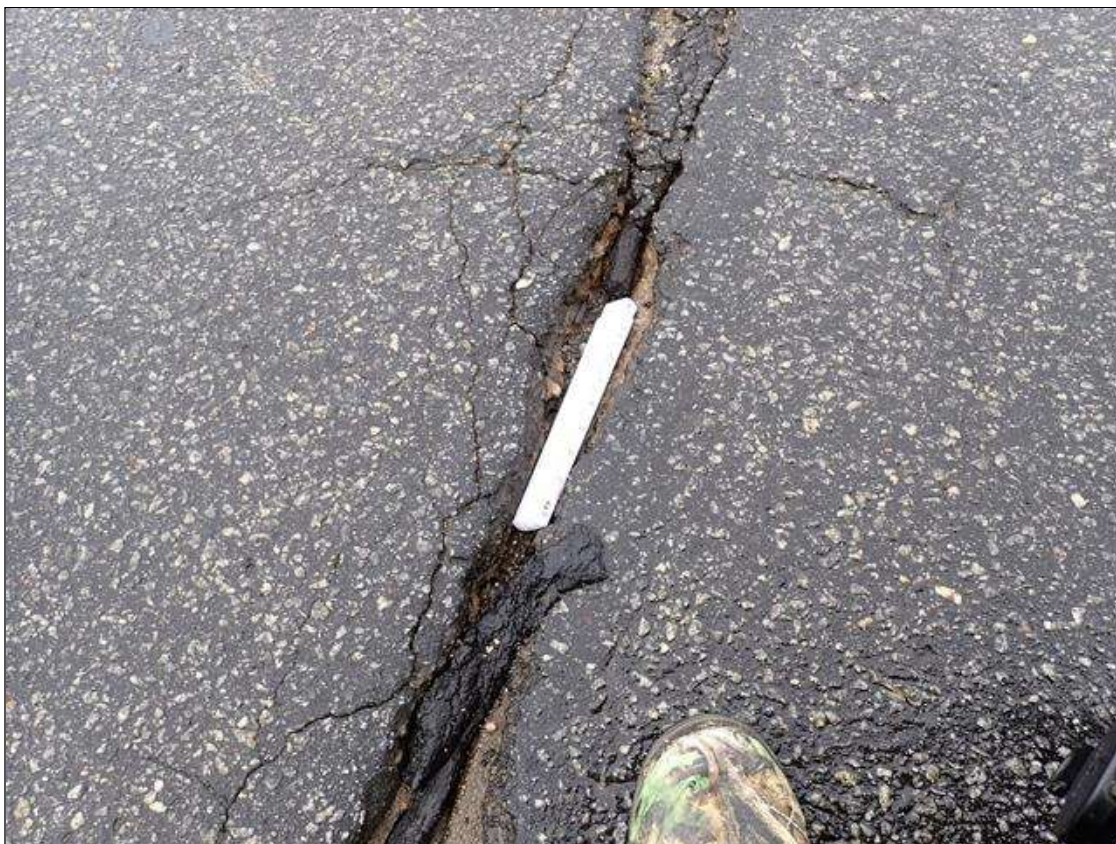
Span 3 Bent 2 Expansion Joint : at missing asphalt locations, seal deteriorated/torn/missing (up to full depth)

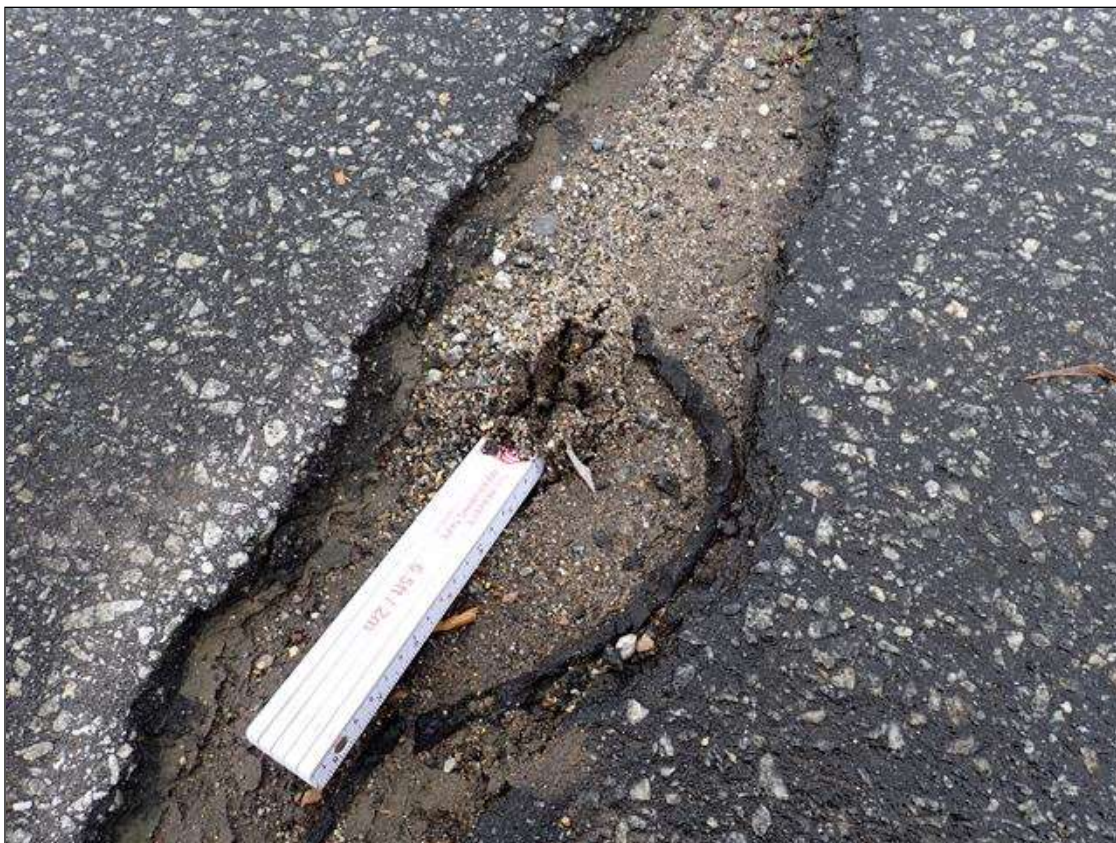
Span 3 Bent 2 Expansion Joint : at missing asphalt locations, debris accumulation (up to full length)

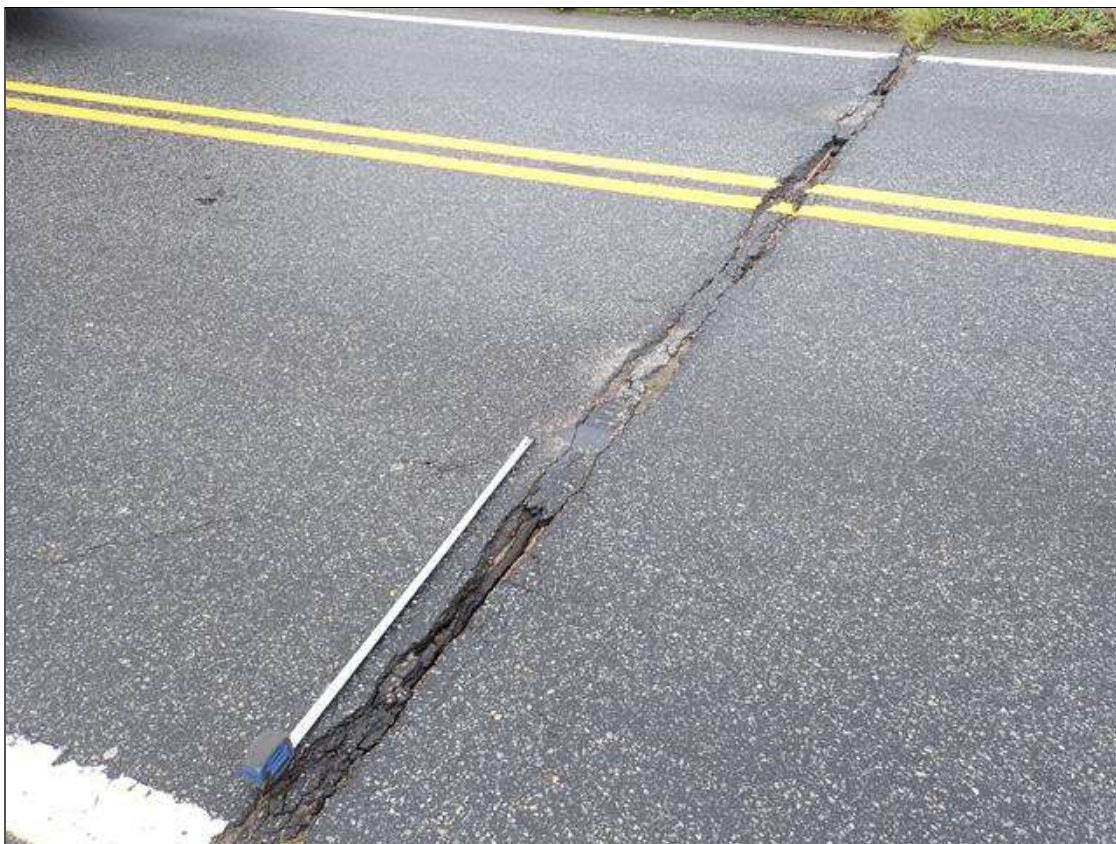
Span 3 Wearing Surface: (PAR) over bent 3, broken asphalt (full roadway width x 8 inch) with potholes (up to 5 foot x 5 inch x full depth)

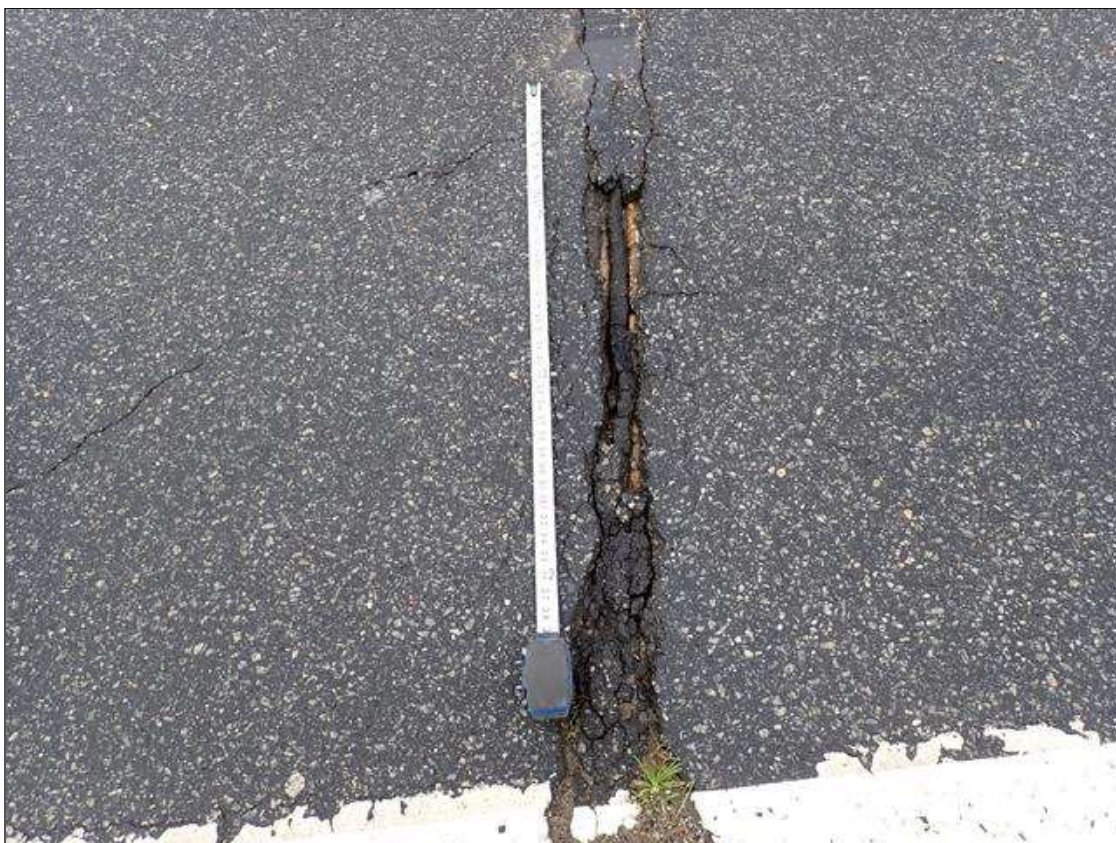
Span 3 Wearing Surface: (PAR) over bent 3, broken asphalt (full roadway width x 8 inch) with potholes (up to 5 foot x 5 inch x full depth)

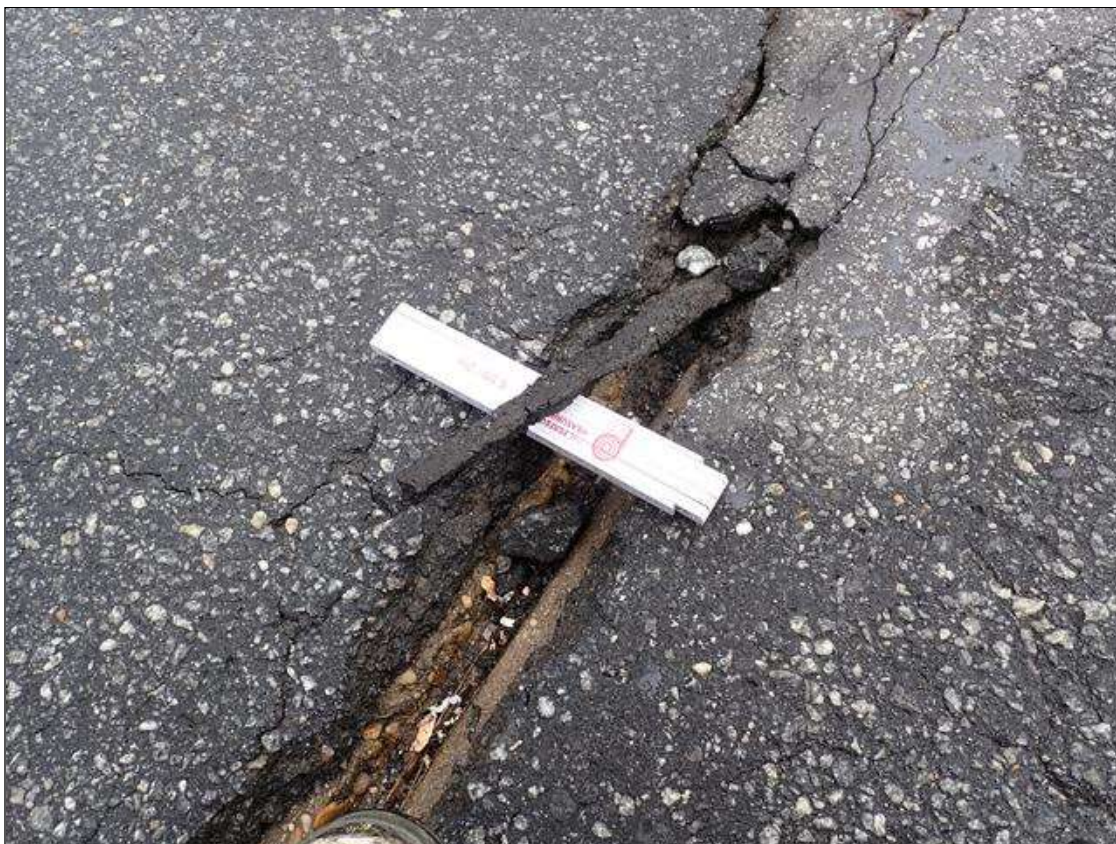
Span 4 Bent 3 Expansion Joint : at missing asphalt locations, seal deteriorated/torn/missing (up to 5 foot)

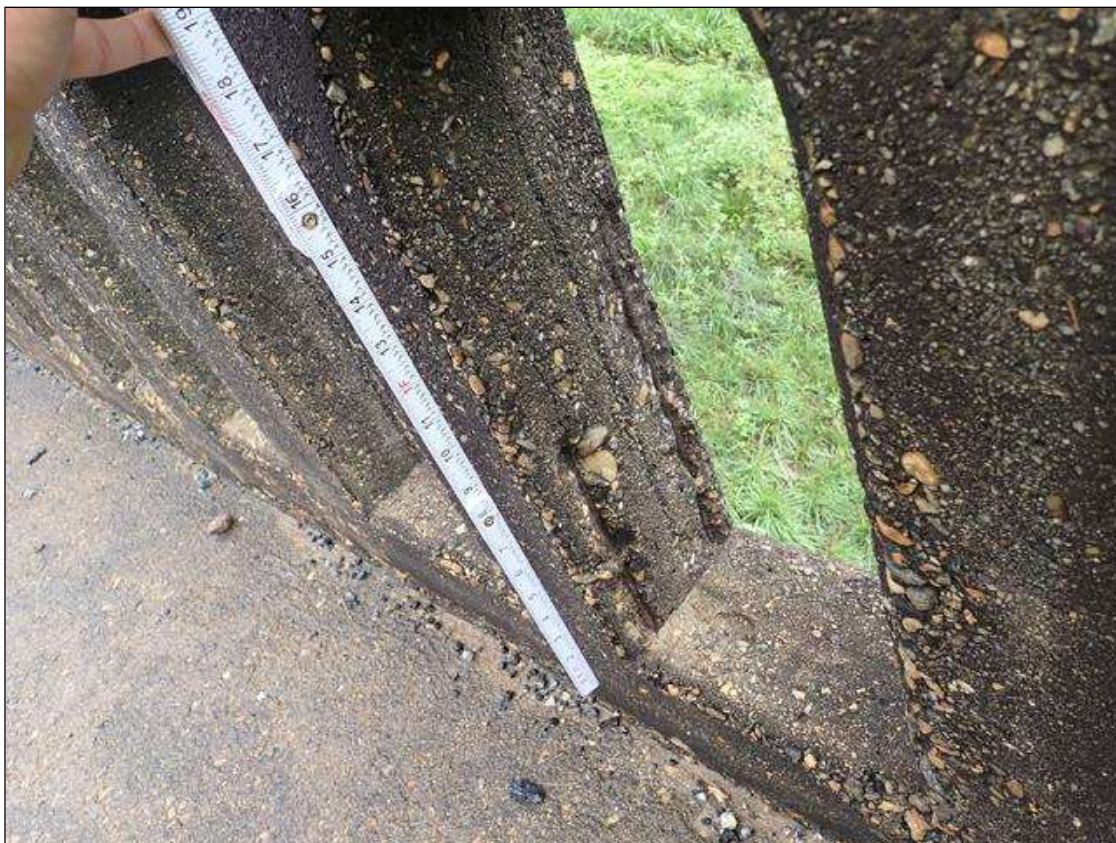
Span 4 Right Bridge Rail: UP TO 18 INCH X 3 INCH X 1/2 INCH DEEP SPALL WITH EXPOSED REBAR AT RANDOM THROUGHOUT

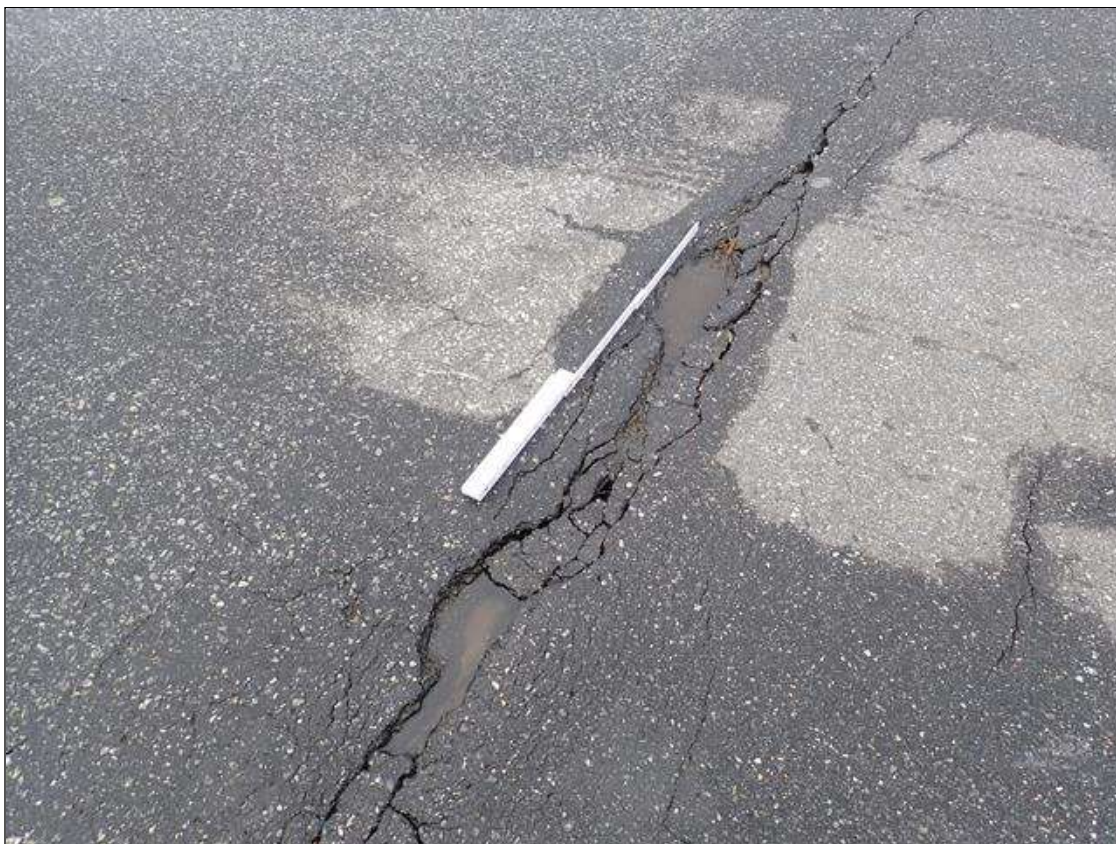
Span 4 Wearing Surface: over end bent 2, transverse cracks (up to 1/8 inch x full roadway width) with edge spalling (12 inch x 4 inch x 1 inch deep)

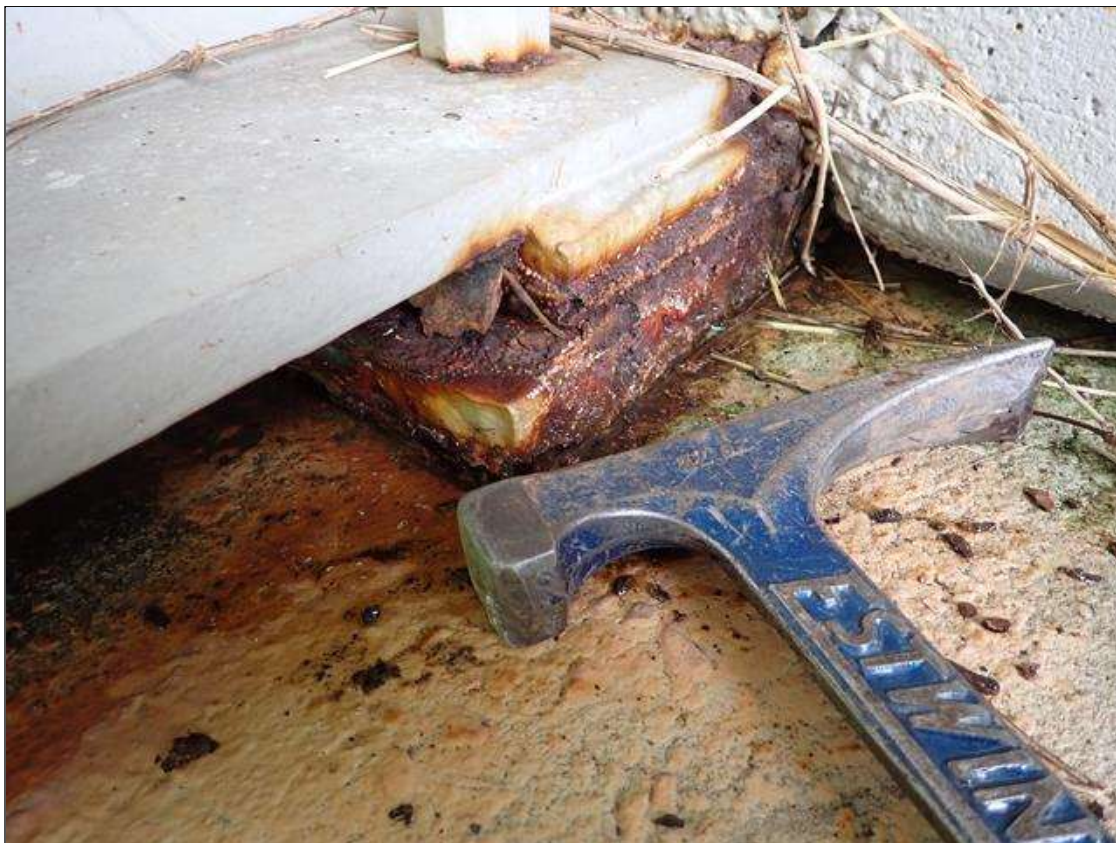
Span 1 Near Bearing 5: corrosion with section loss (up to 1/8 inch loss)

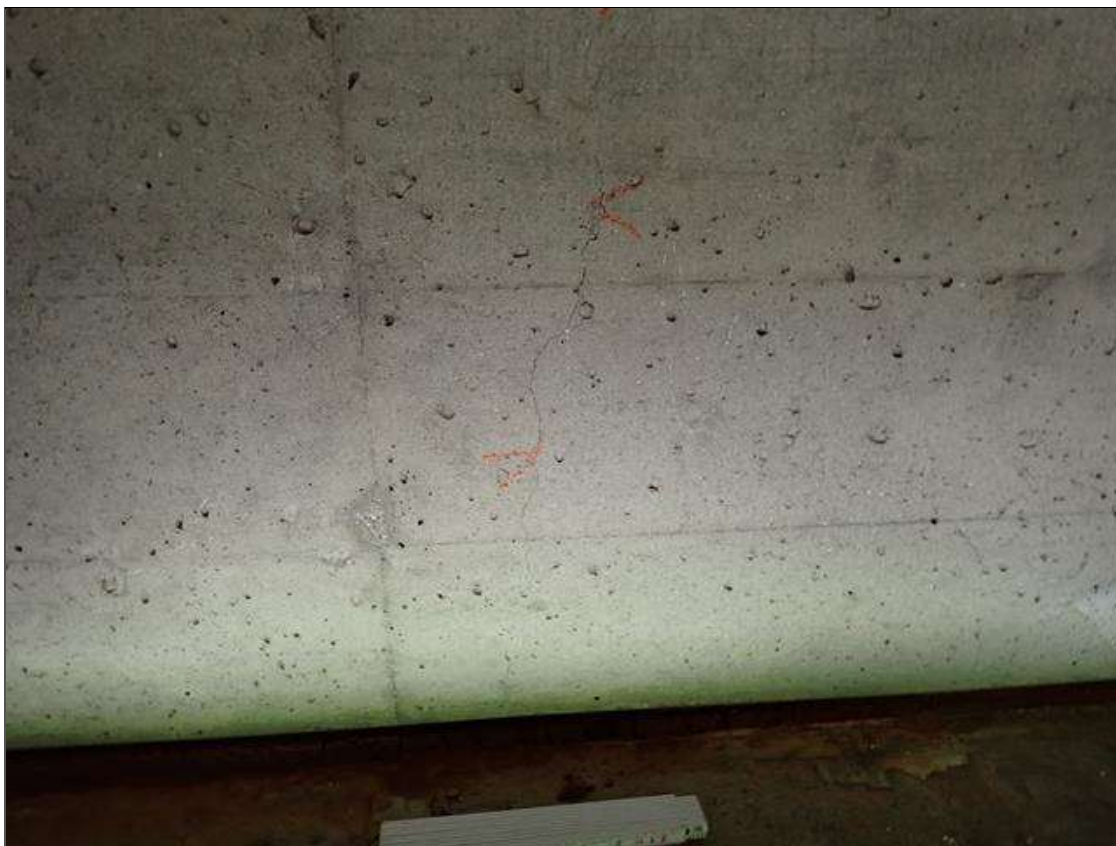
End Bent 1 Abutment: along the length of the abutment, vertical cracks (up to 1/64 inch x full height) at random

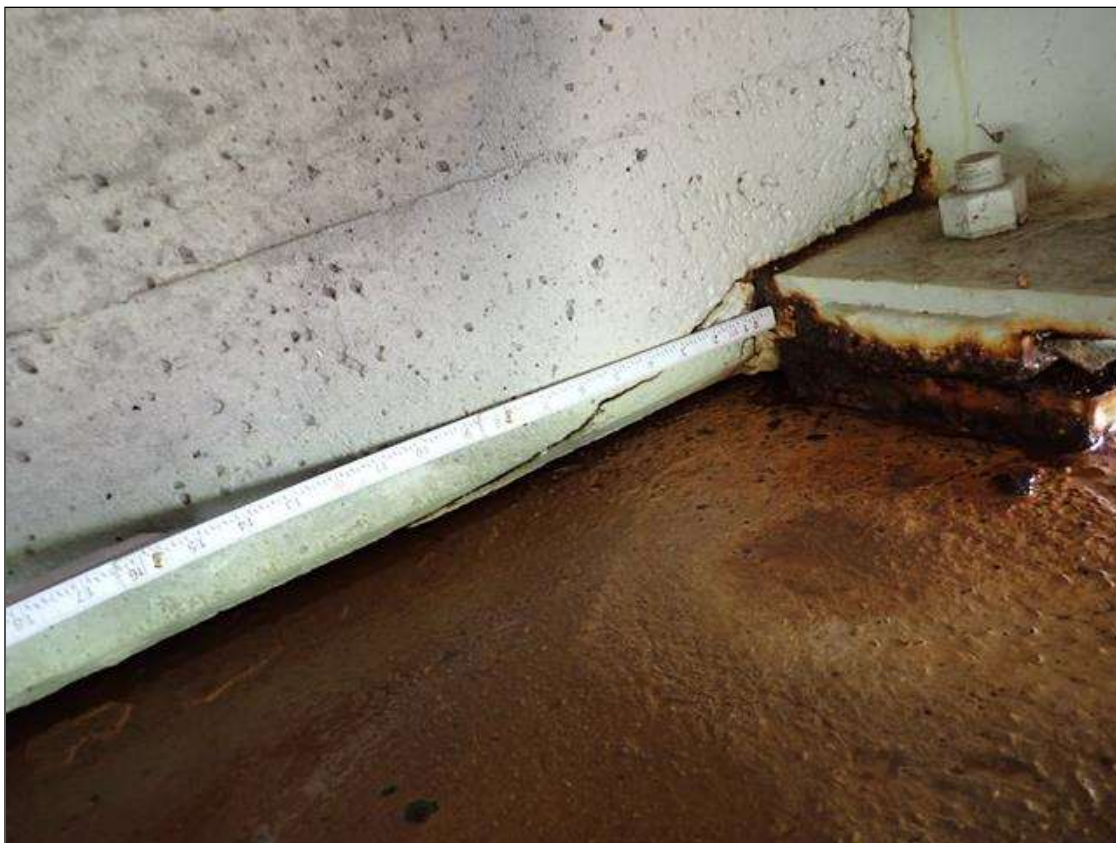
End Bent 1 Abutment: at beams 1 and 3 penetrations, diagonal cracks, up to 12 inch x 1/16 inch

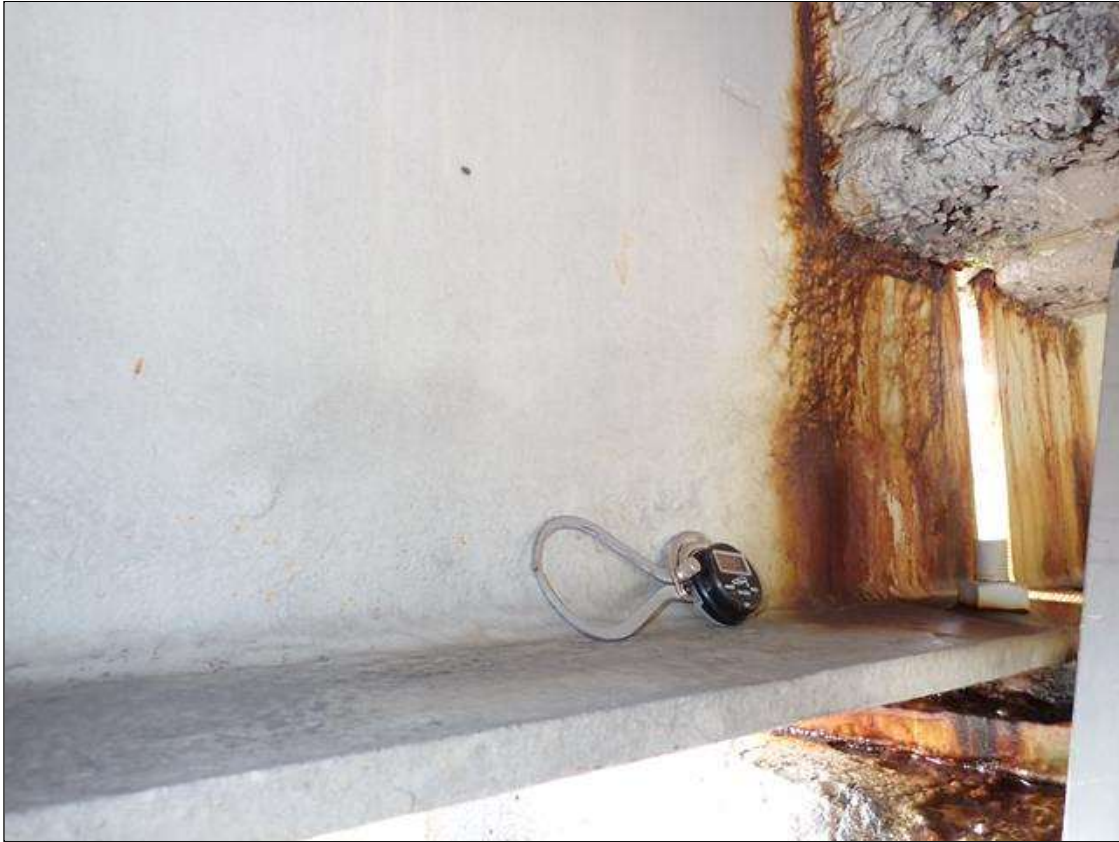
Span 2 Beam 5: (PAR) at bent 1, painted over section loss/pitting: bottom flange (0.72 inch average remaining x 2.5 foot); web (7/16 inch average remaining x 2.5 foot x 18 inch) with corrosion reactivating

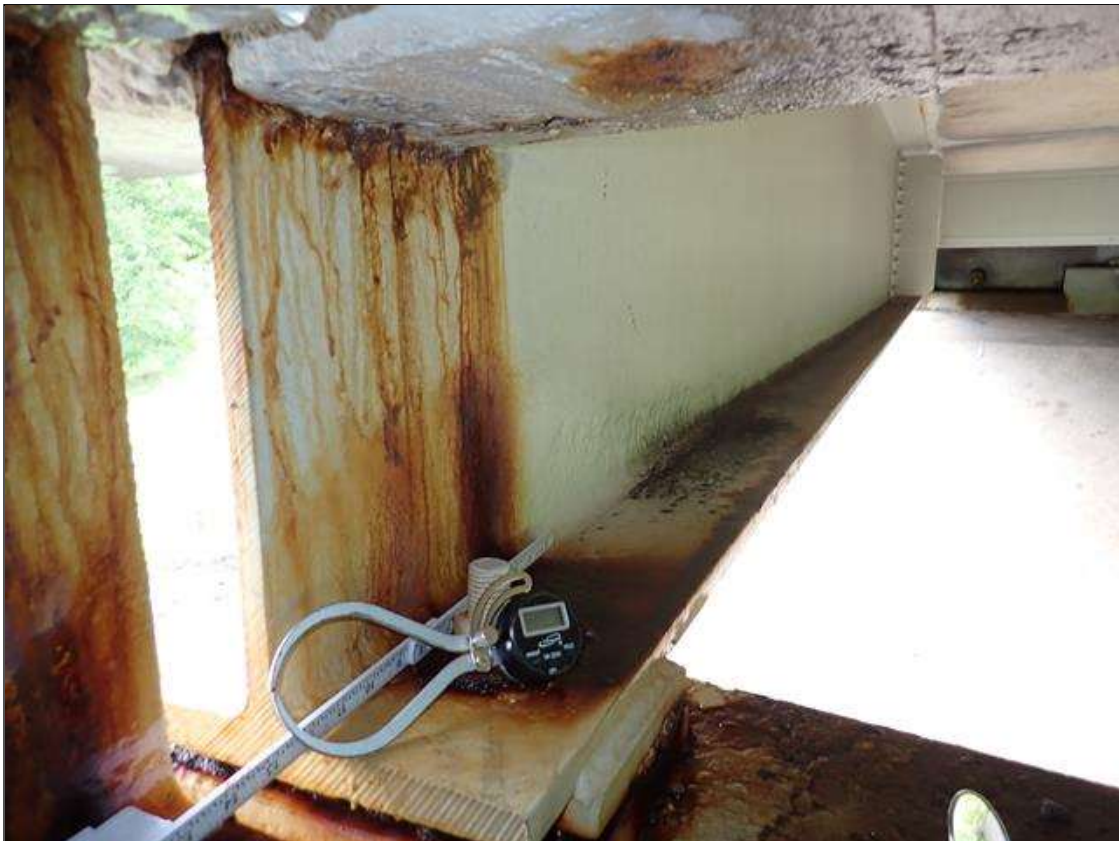
Span 1 Beam 5: (PAR) at bent 1, painted over section loss/pitting: upper web (7/16 inch average remaining x 11 inch x 8 inch); lower web (1/2 inch average remaining x 8 foot x 2 inch) with corrosion reactivating

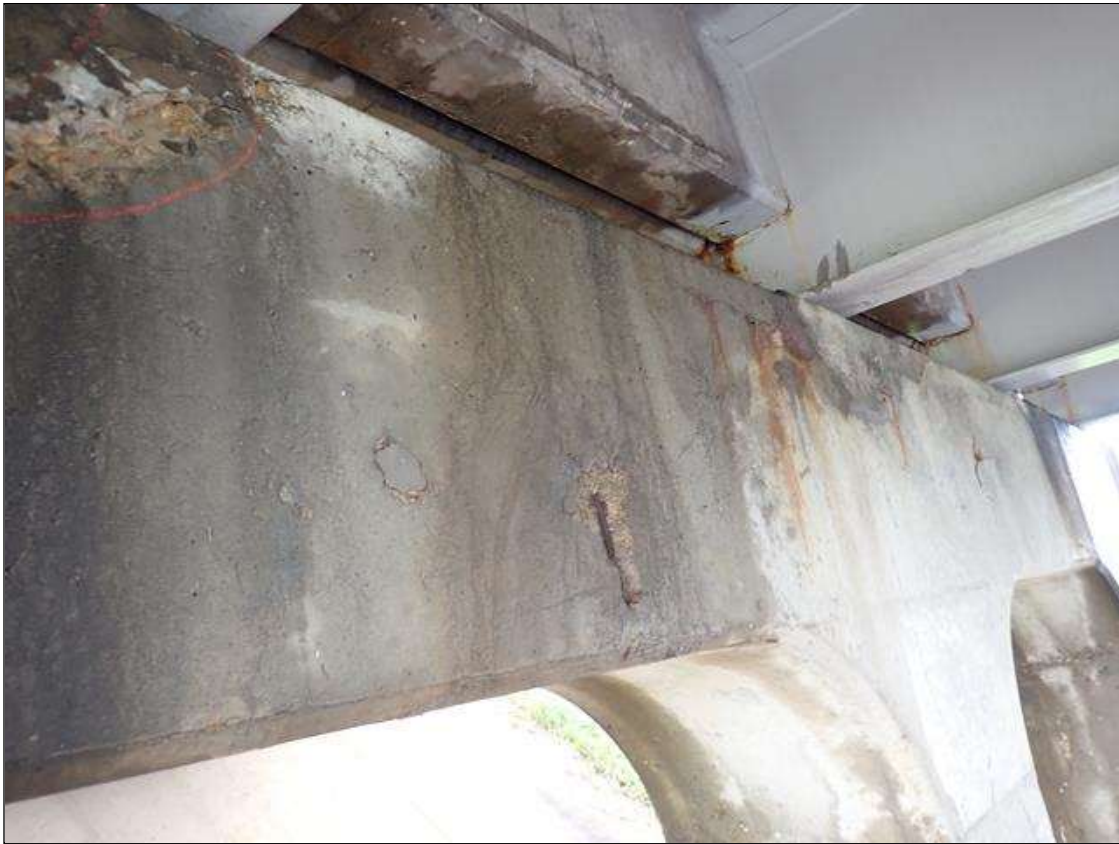
Bent 1 Cap 1: (PAR) south face between bays 2-4, multiple spalls/delaminations (5 foot x 16 inch x 1 inch deep) some with exposed rusted rebar (approximately 25 percent loss) and cracks (up to 1/16 inch) with rust stains
