NC DEPARTMENT OF TRANSPORTATION
 DIVISION OF HIGHWAYS
 STRUCTURE MANAGEMENT UNIT

ATTENTION: **prompt action request; sketches revised**

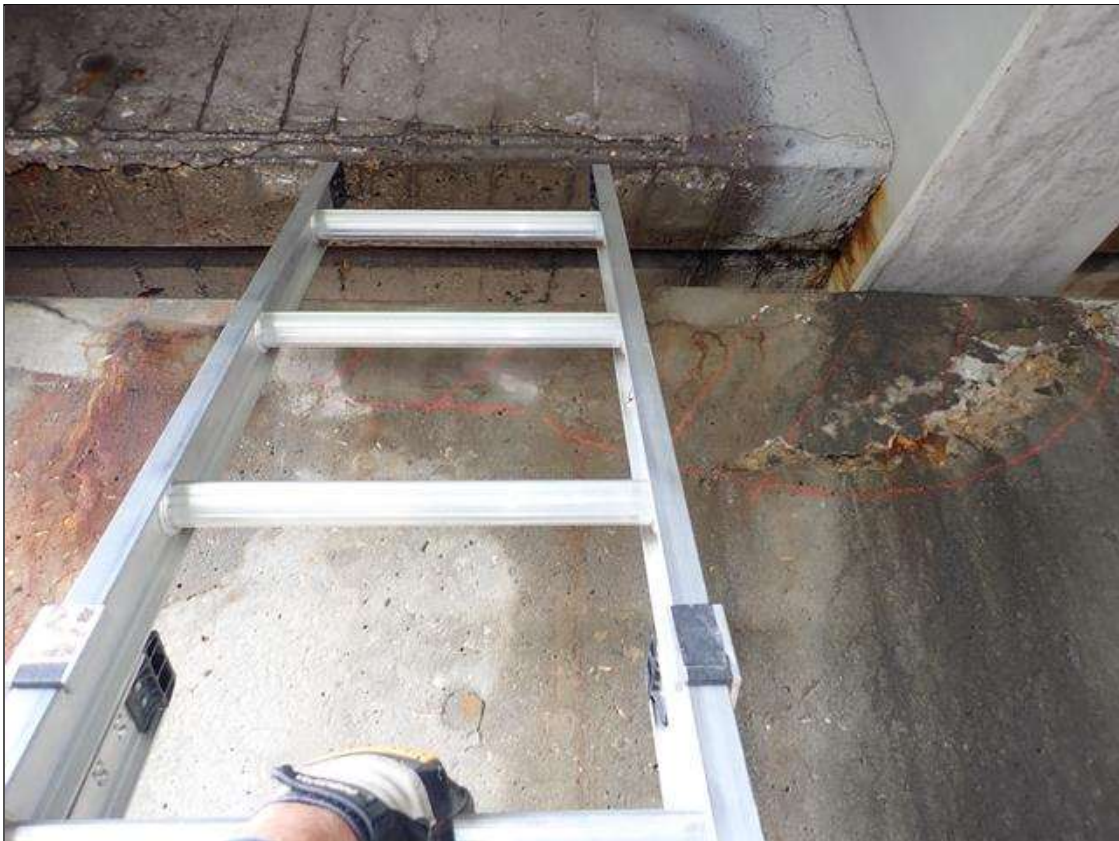
Bent 1 Cap 1: (PAR) south face between bays 2-4, multiple spalls/delaminations (5 foot x 16 inch x 1 inch deep) some with exposed rusted rebar (approximately 25 percent loss) and cracks (up to 1/16 inch) with rust stains

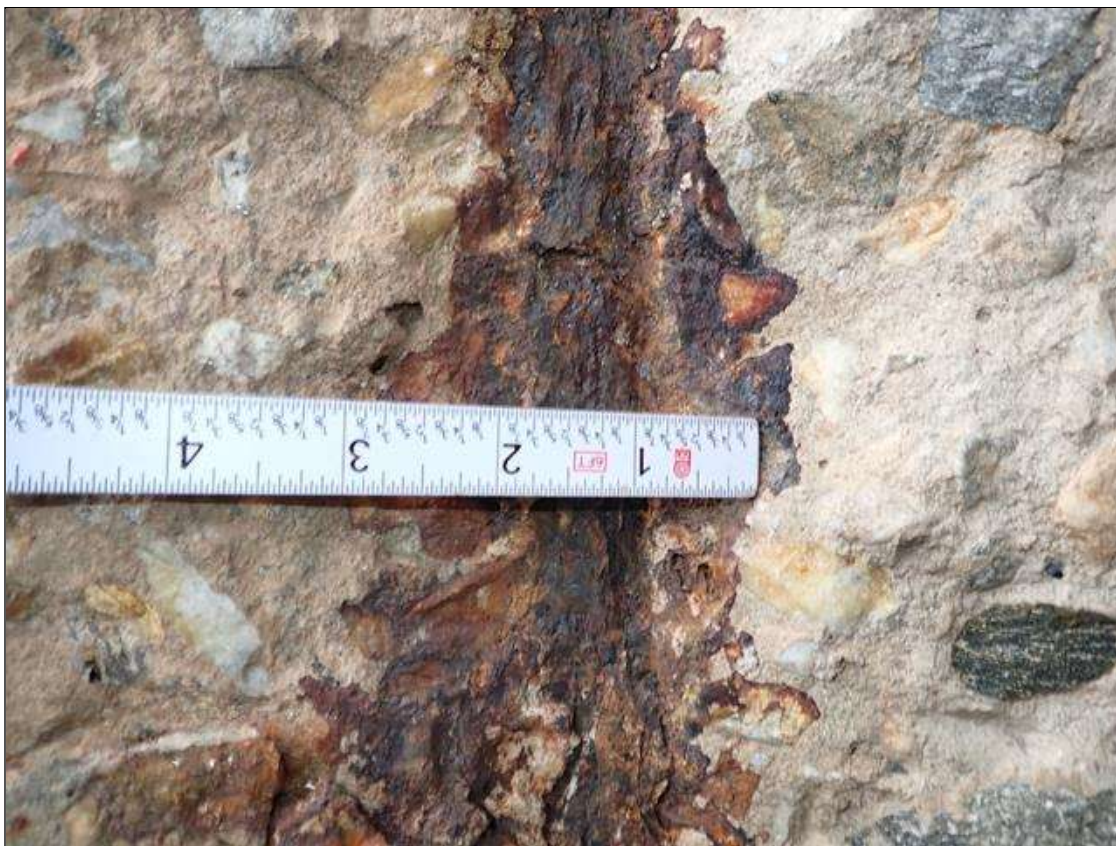
Bent 1 Pile 3: (PAR) north face, spall/delamination (2 foot x full height x 2 inch deep) with exposed rusted rebar (approximately 25 percent loss)

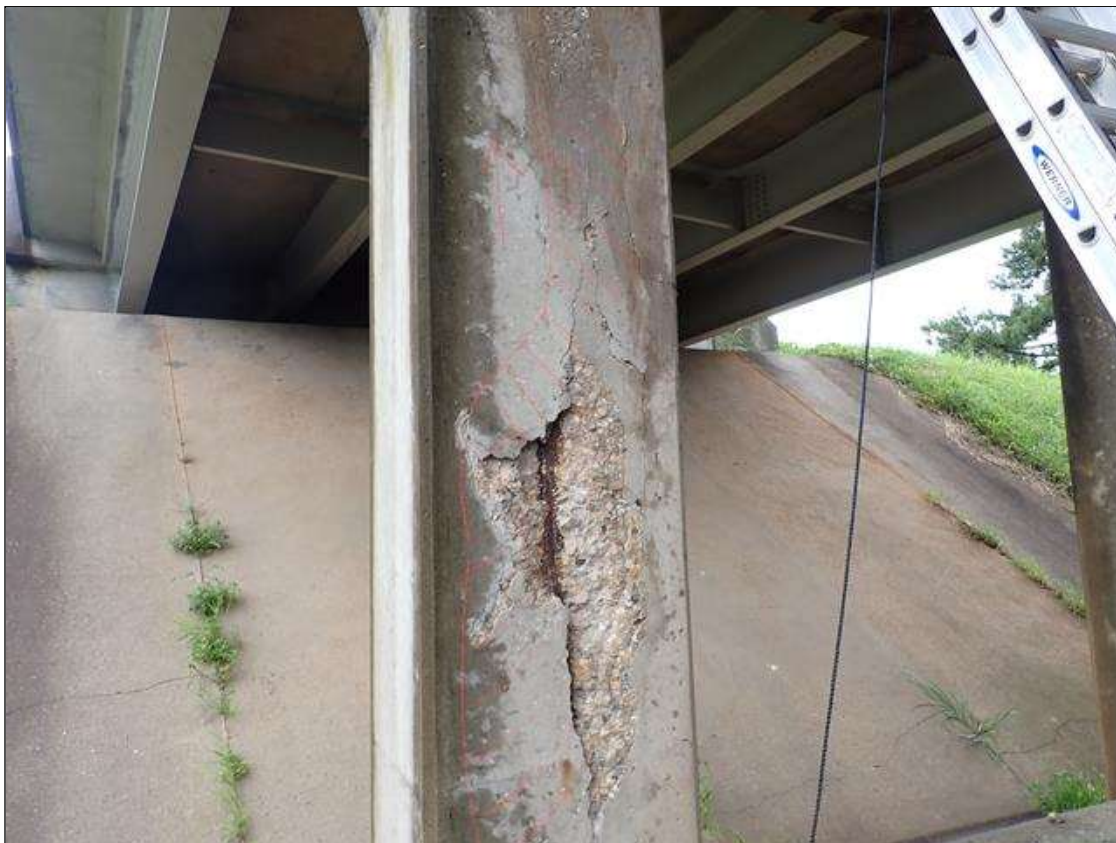
Bent 1 Pile 3: (PAR) north face, spall/delamination (2 foot x full height x 2 inch deep) with exposed rusted rebar (approximately 25 percent loss)

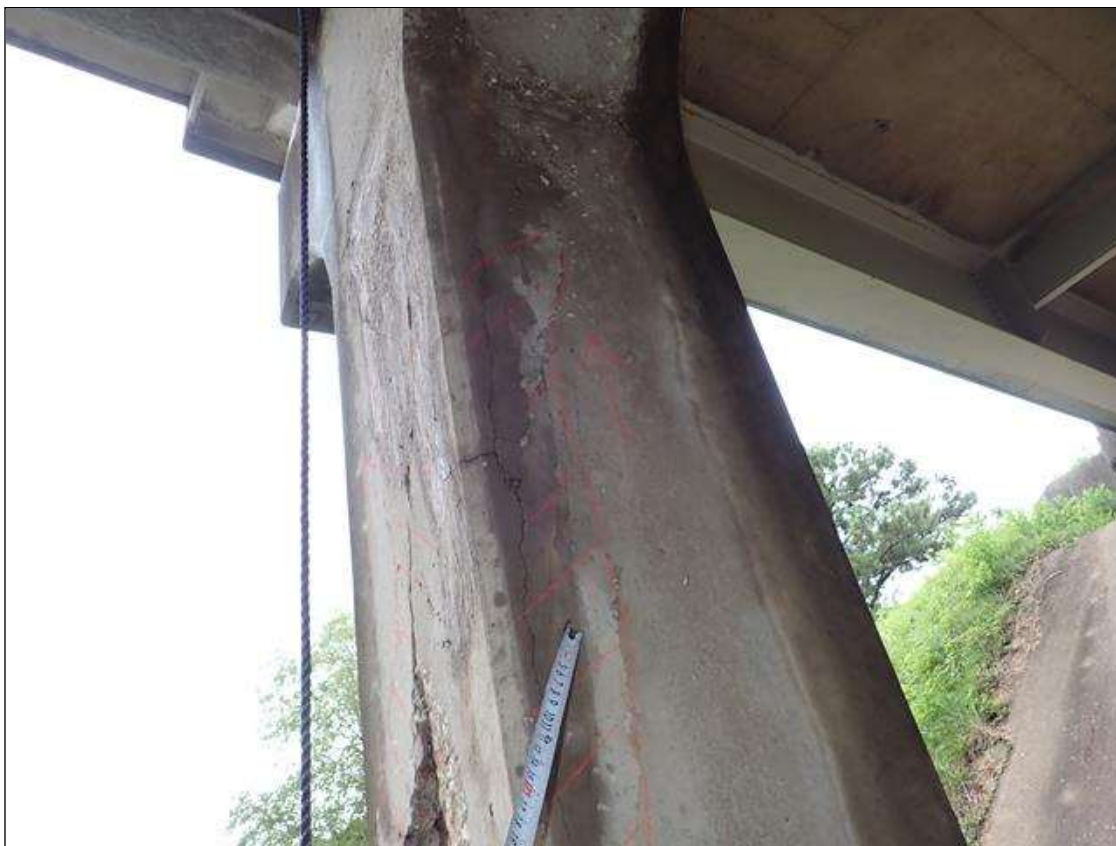
Bent 1 Pile 3: west face, delamination (1 foot x 6.5 foot) with cracks (up to 1/8 inch)

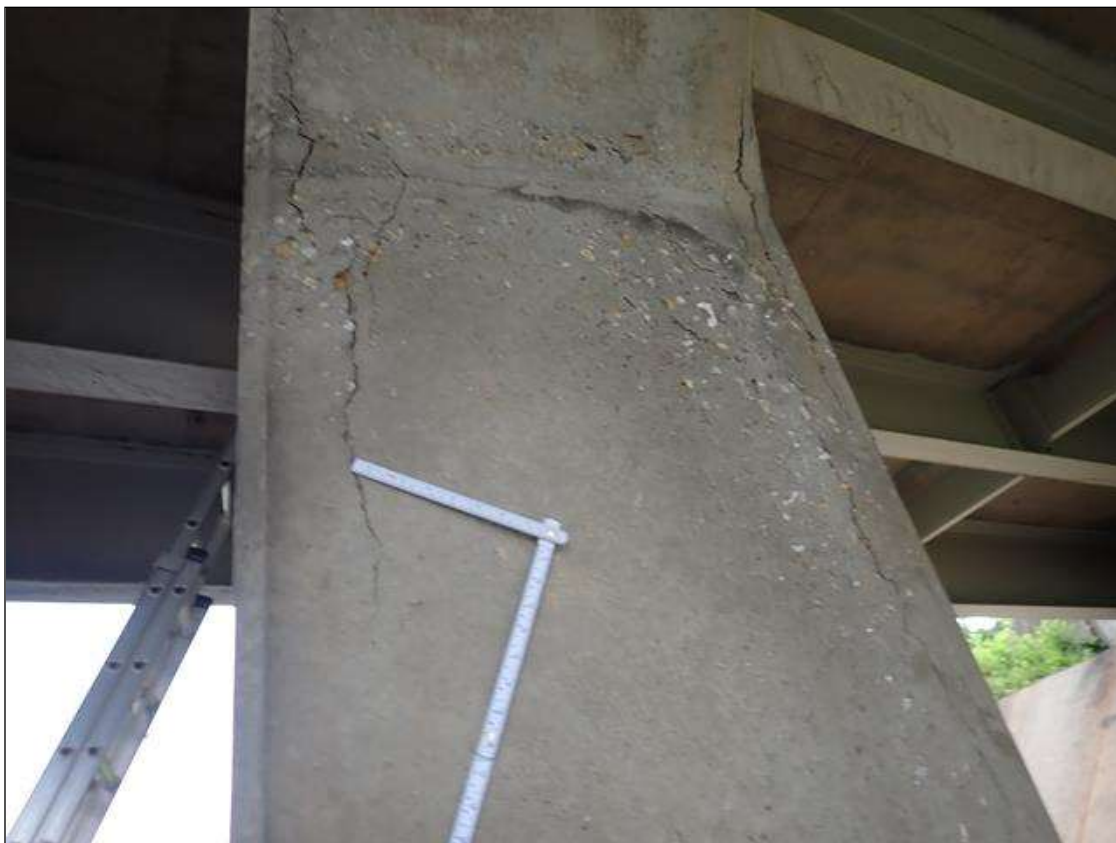
Bent 1 Pile 2: below cap, all corners, delaminations (1 foot x 3 foot) with cracks (up to 1/8 inch)

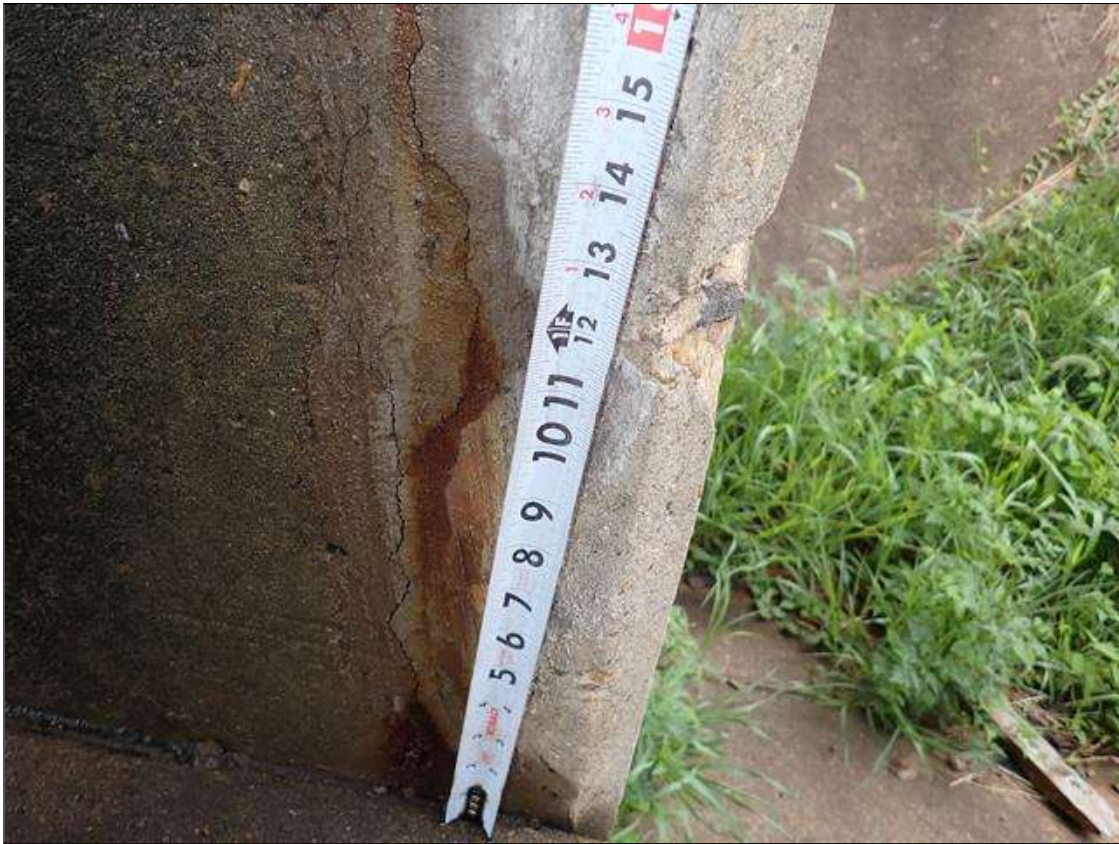
Bent 1 Pile 1: (PAR) NORTHWEST CORNER HAS A FAILED PATCHED AREA THAT IS CRACKED (UP TO 1/16 INCH) WITH RUST STAINS AND DELAMINATED. AREA ON NORTH FACE IS: 12 INCH WIDE, AREA ON WEST FACE IS: 10 INCH WIDE X 9 FOOT HIGH.

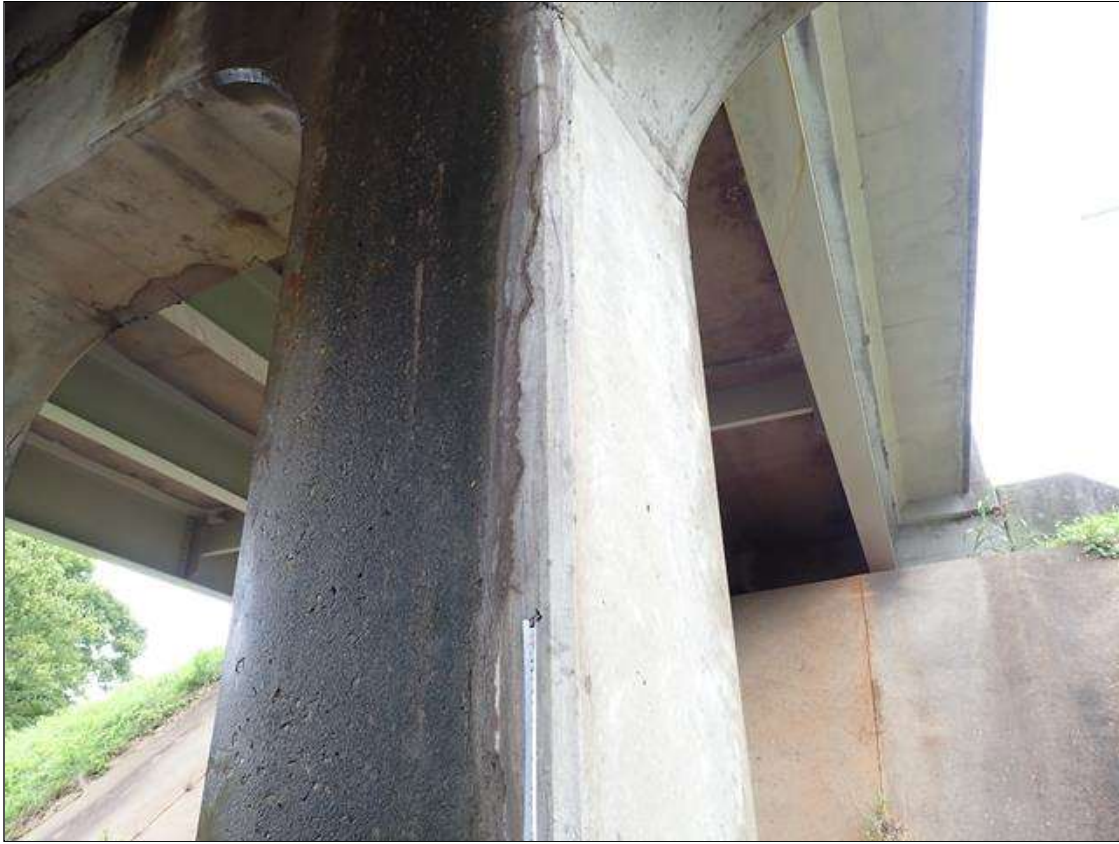
Bent 1 Pile 1: (PAR) NORTHWEST CORNER HAS A FAILED PATCHED AREA THAT IS CRACKED (UP TO 1/16 INCH) WITH RUST STAINS AND DELAMINATED. AREA ON NORTH FACE IS: 12 INCH WIDE, AREA ON WEST FACE IS: 10 INCH WIDE X 9 FOOT HIGH.

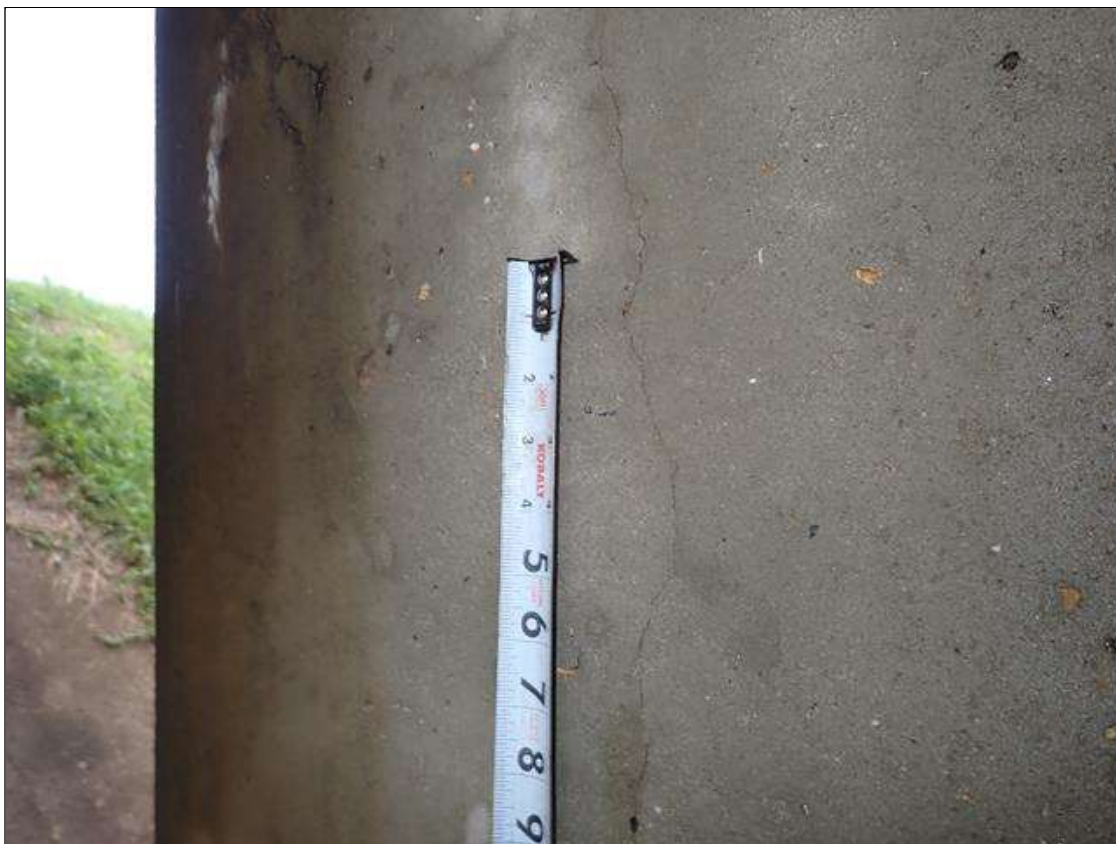
Bent 1 Pile 1: below cap, all corners, delaminations (9 inch x 4 foot) with cracks (up to 1/8 inch); along column, map cracks (hairline) and vertical cracks (up to 1/32 x full height) at random

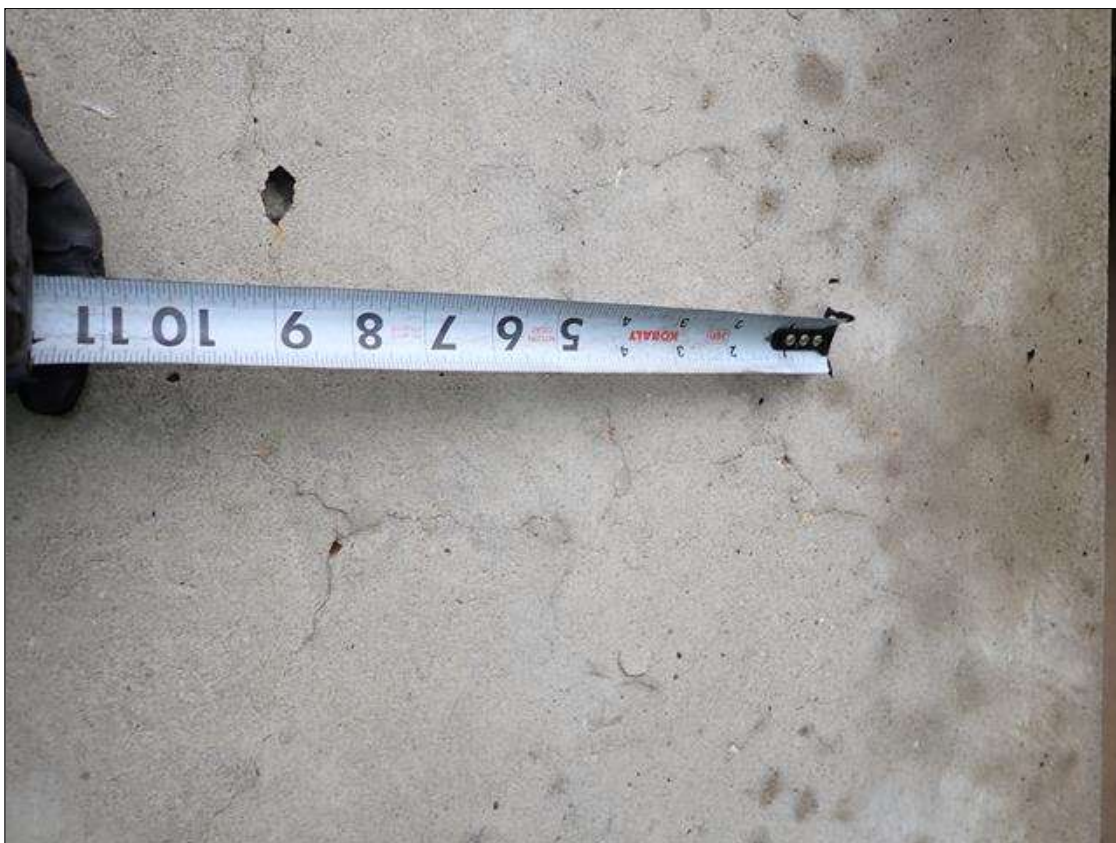
Bent 1 Pile 1: below cap, all corners, delaminations (9 inch x 4 foot) with cracks (up to 1/8 inch); along column, map cracks (hairline) and vertical cracks (up to 1/32 x full height) at random

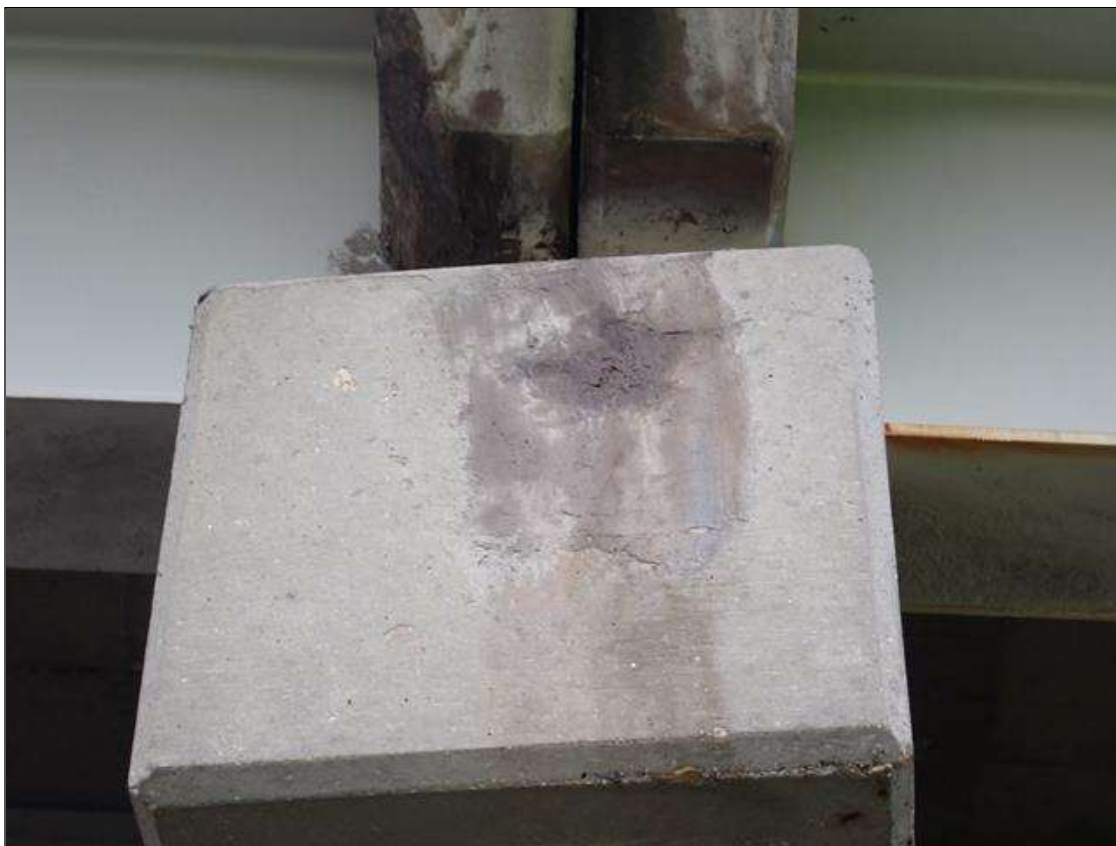
Bent 1 Cap 1: 8 INCH DIAMETER PATCH, IN WEST END OF CAP.

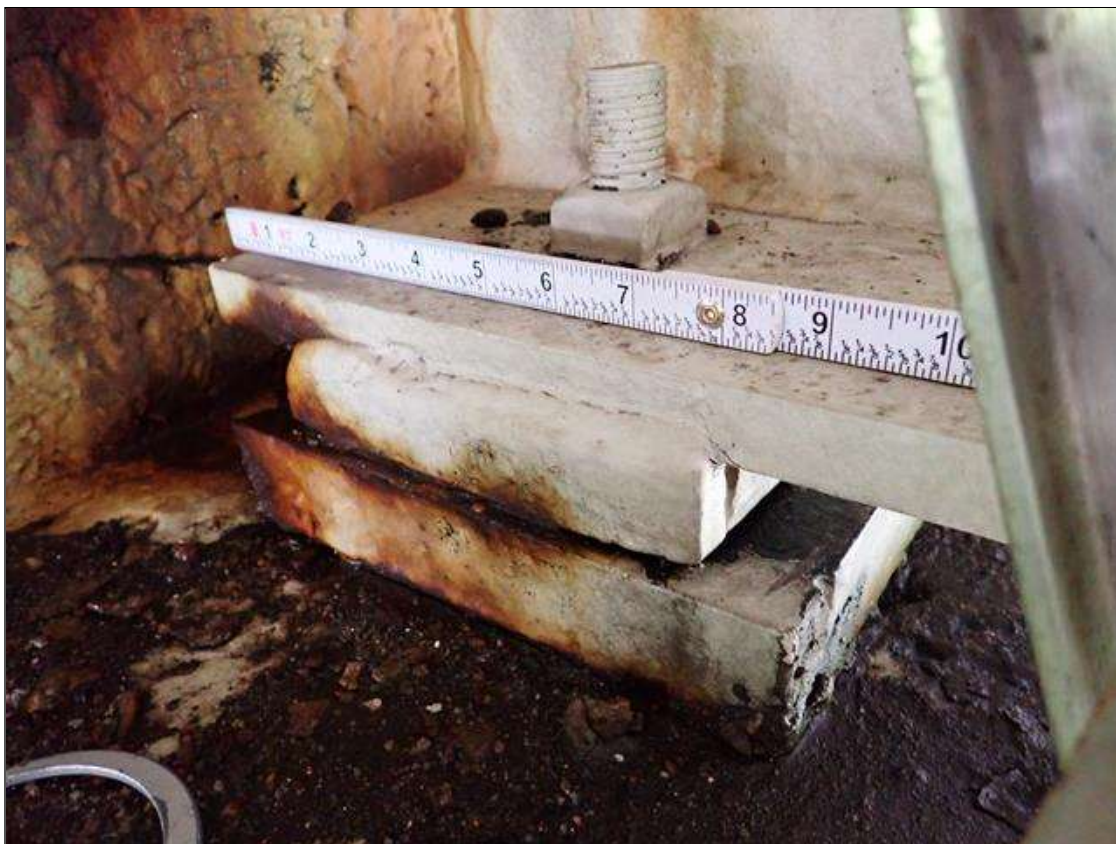
Span 2 Near Bearing 4: corrosion with section loss (up to 1/16 inch loss)

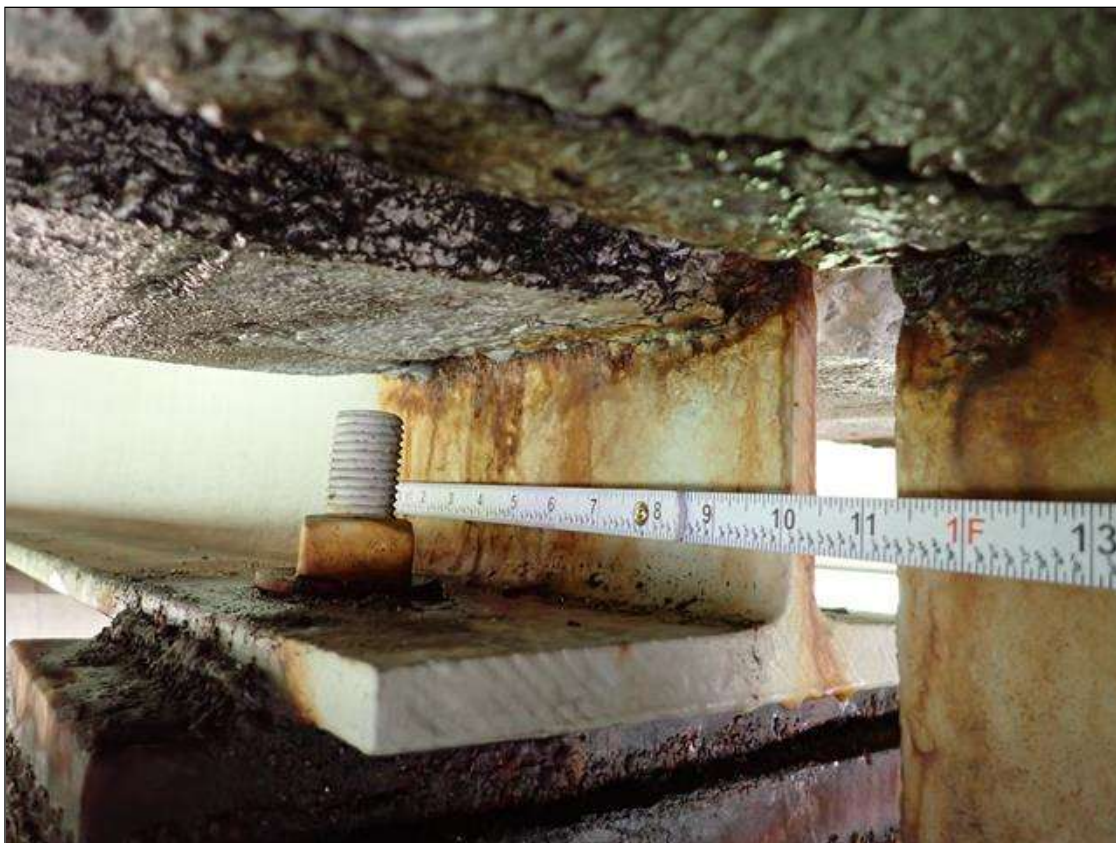
Span 1 Beam 4: at bent 1, corrosion with section loss/pitting: web adjacent to end diaphragm (7/16 inch average remaining x 10 inch x 2 inch)

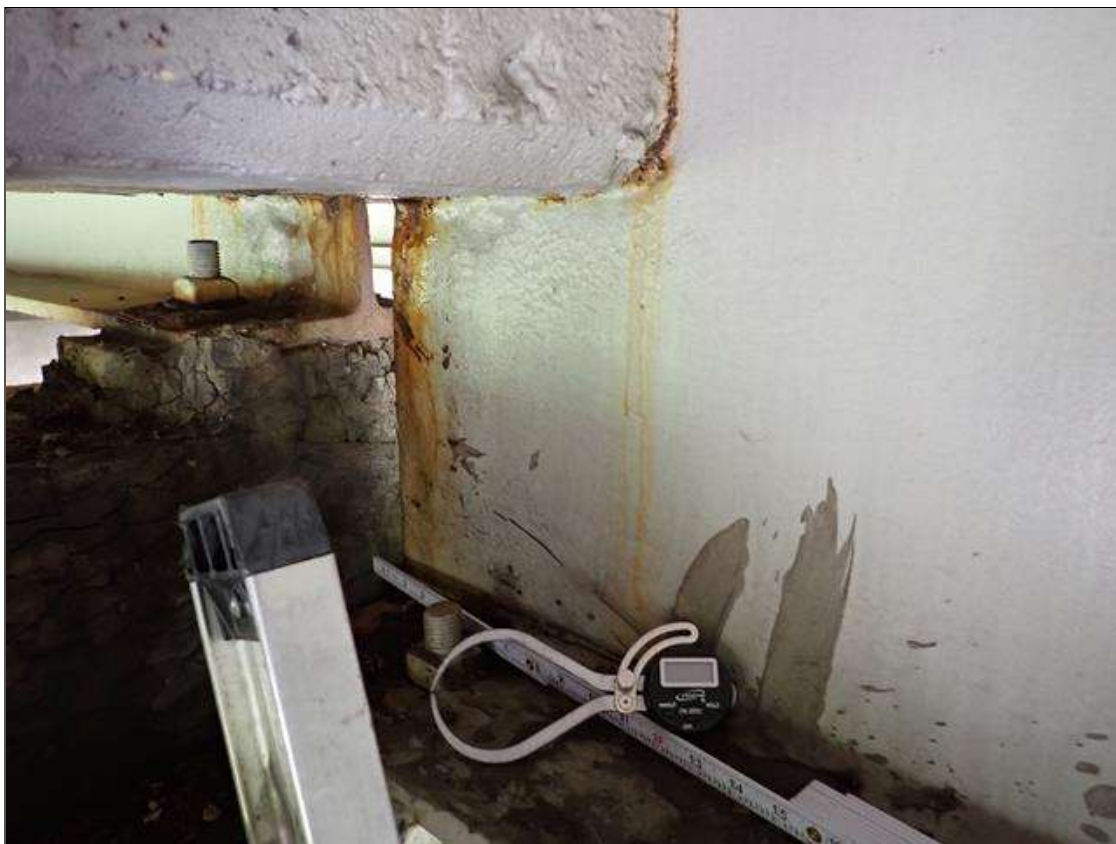
Span 2 Beam 3: (PAR) at bent 1, painted over section loss/pitting: web adjacent to end diaphragm ($3/8$ inch average remaining x 2 inch x 8 inch); bottom flange, pitting (up to $1/16$ inch deep x 2 foot); web, pitting (up to $1/16$ inch deep x 2 foot x up to full height)

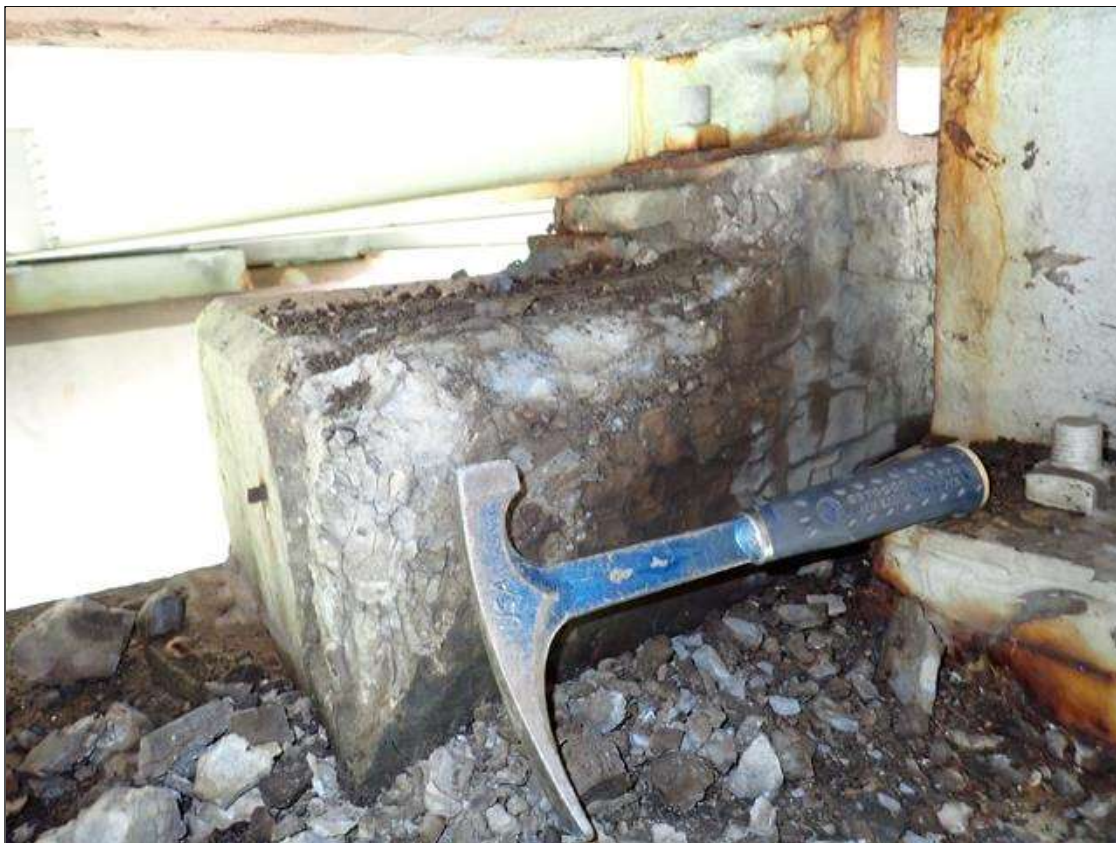
Bent 1 Cap 1: beam 3 cap step up, north face, failed patch (3 foot x 8 inch x 1 inch deep)

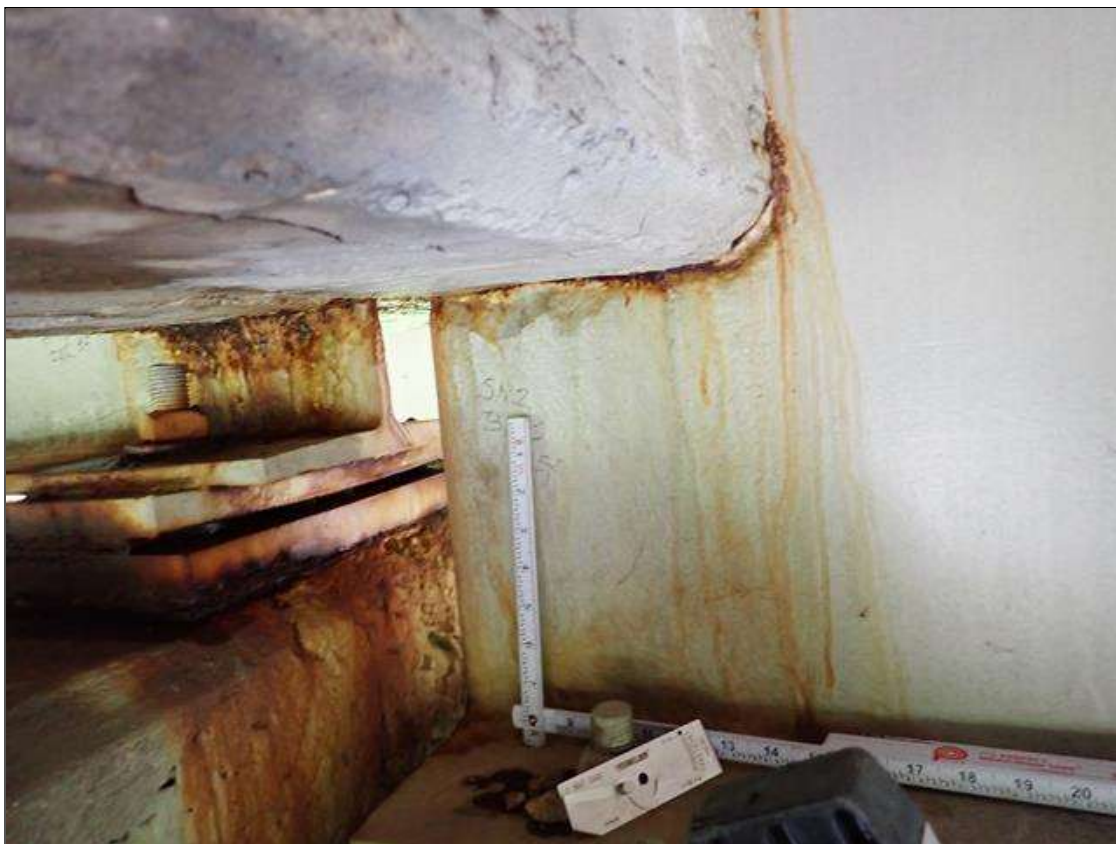
Span 2 Beam 2: (PAR) at bent 1, painted over section loss/pitting: web adjacent to end diaphragm (3/8 inch average remaining x 9 inch x 2 inch)

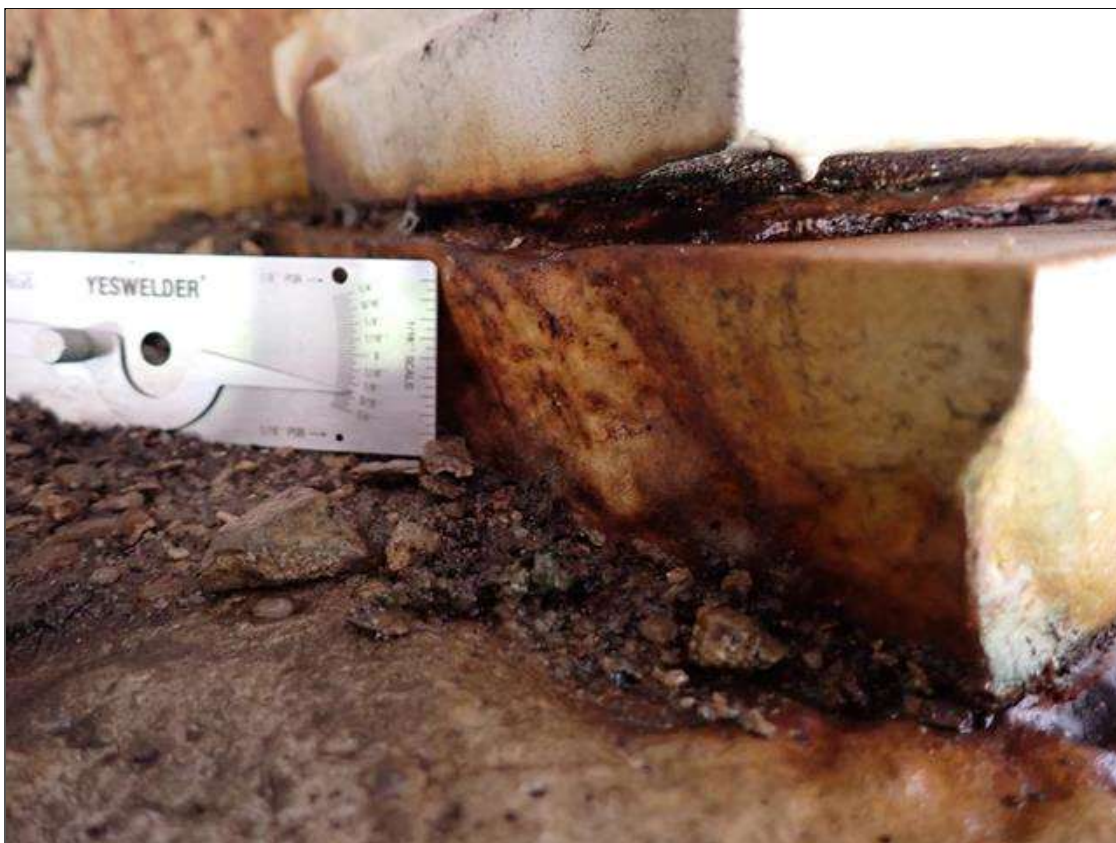
Span 2 Near Bearing 2: corrosion with section loss (up to 1/16 inch loss)

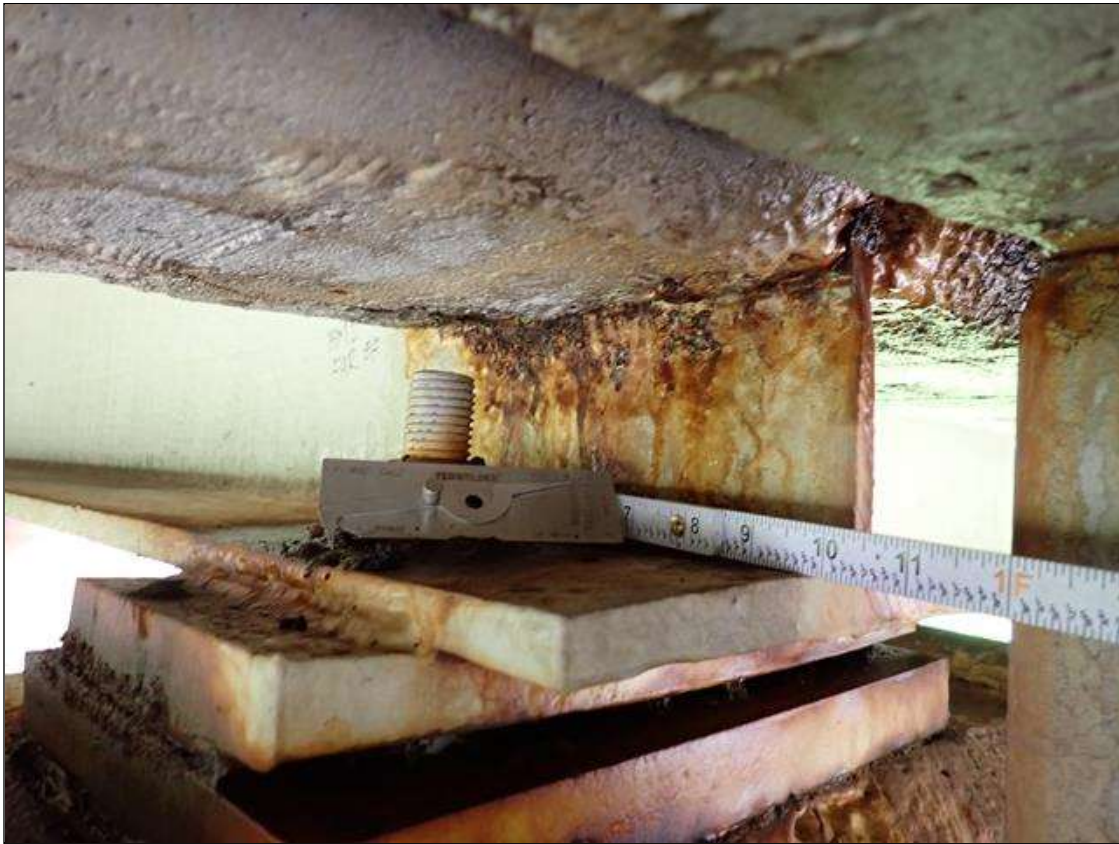
Span 1 Beam 2: (PAR) at bent 1, painted over section loss/pitting: web adjacent to end diaphragm (5/16 inch average remaining x 10 inch x 3.5 inch) with corrosion reactivating

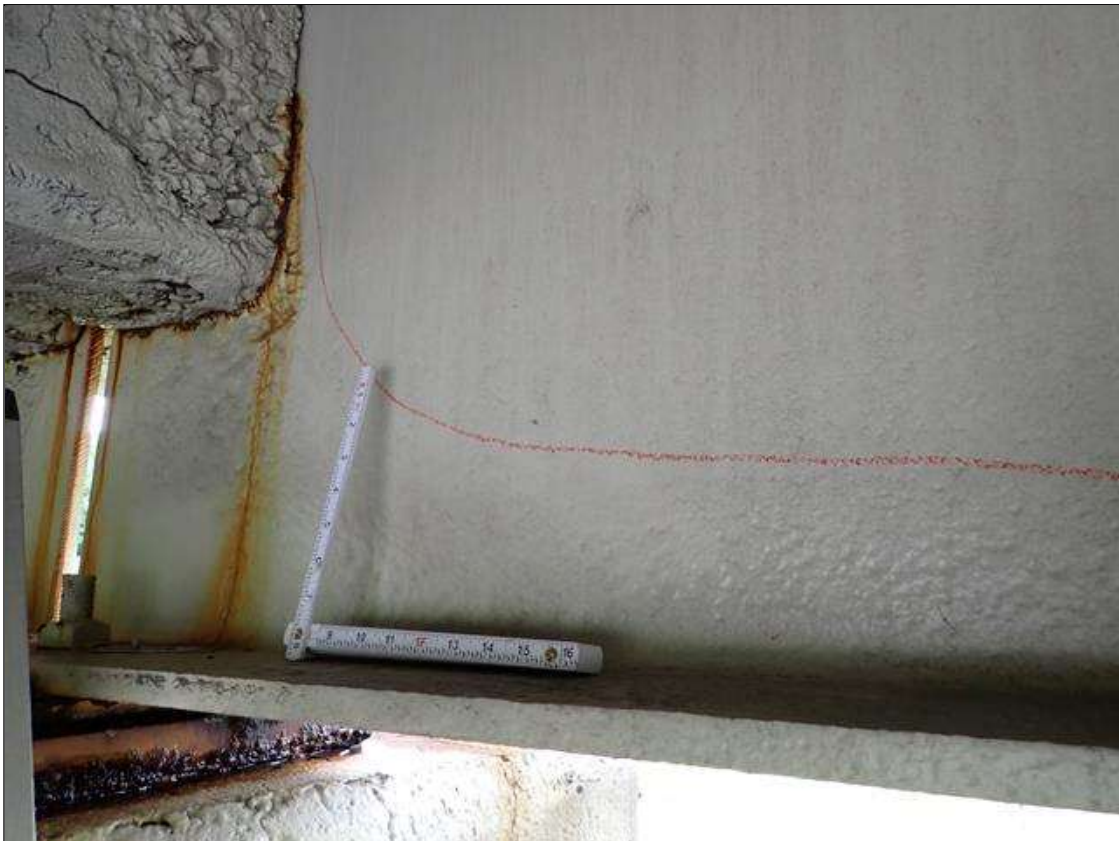
Span 2 Beam 1: at bent 1, painted over pitting: web (up to 1/8 inch deep x 3 foot x up to 17 inch); bottom flange (up to 1/16 inch deep x 3 foot) with corrosion reactivating

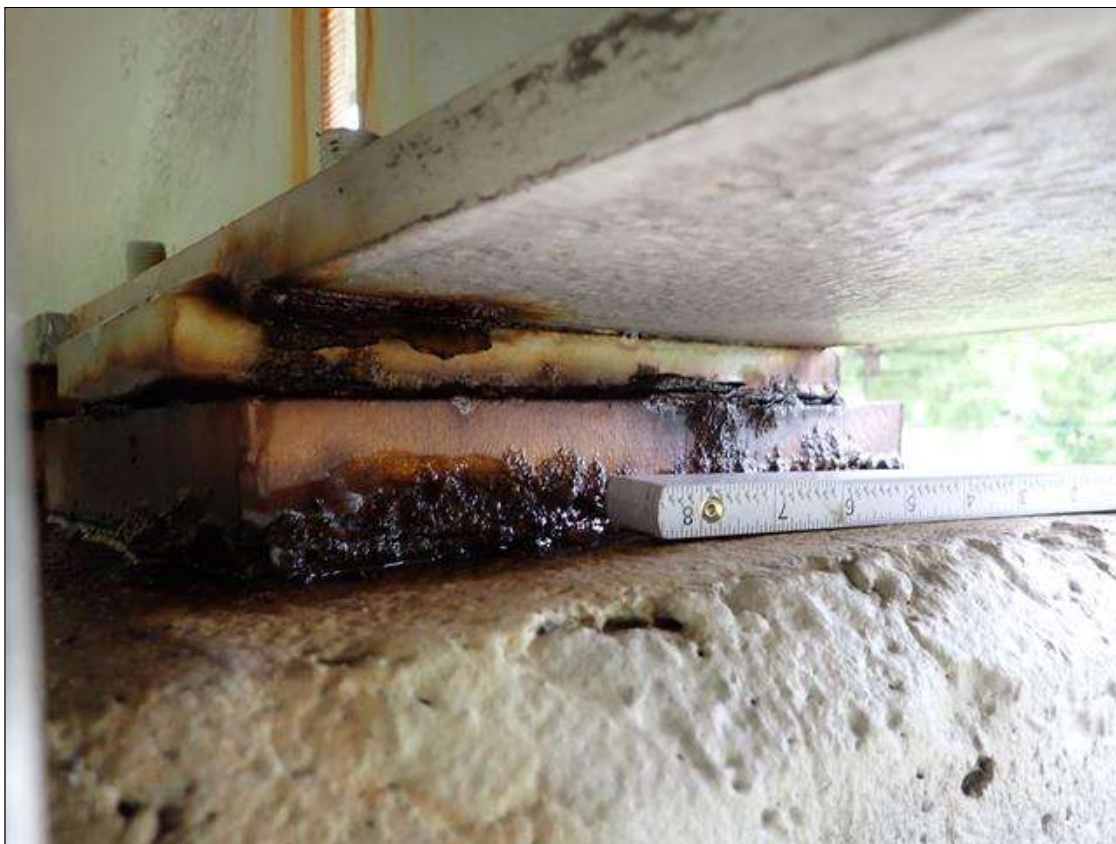
Span 2 Near Bearing 1: corrosion with section loss (up to 1/8 inch loss)

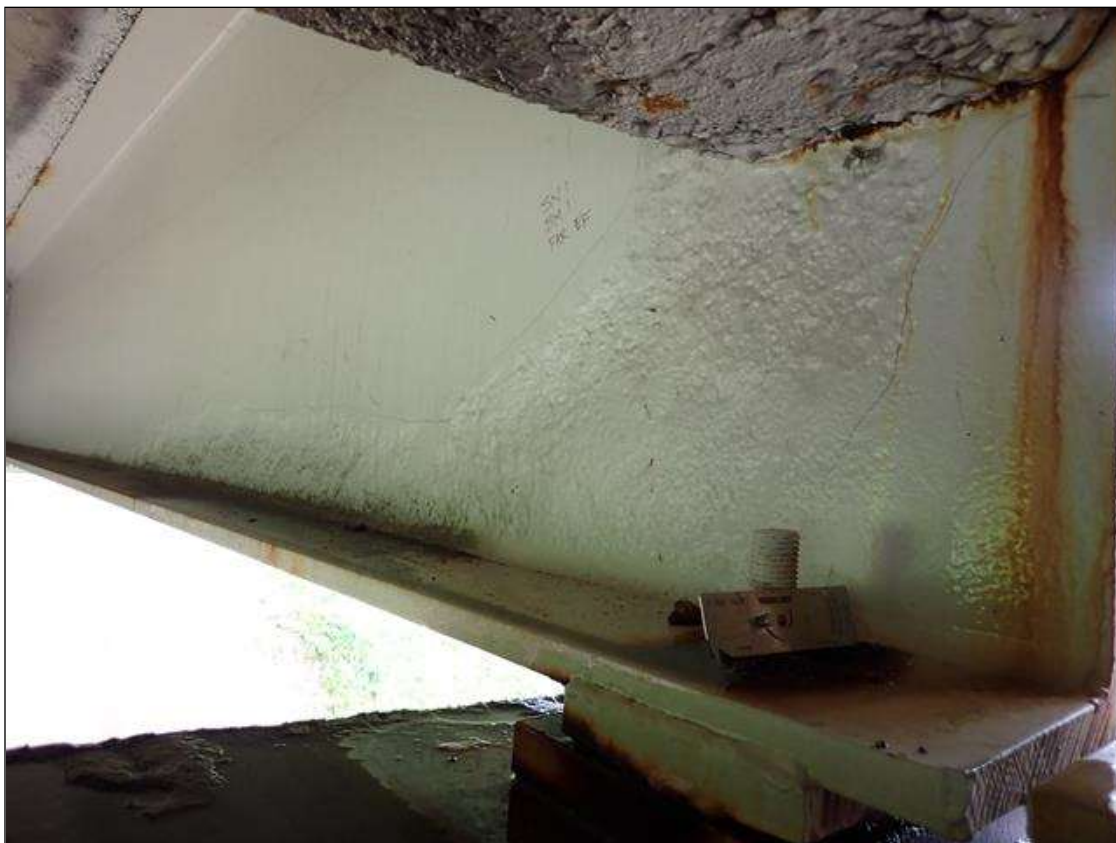
Span 1 Beam 1: at bent 1, painted over pitting: web (up to 1/8 inch deep x 11 foot x up to 16 inch) with corrosion reactivating

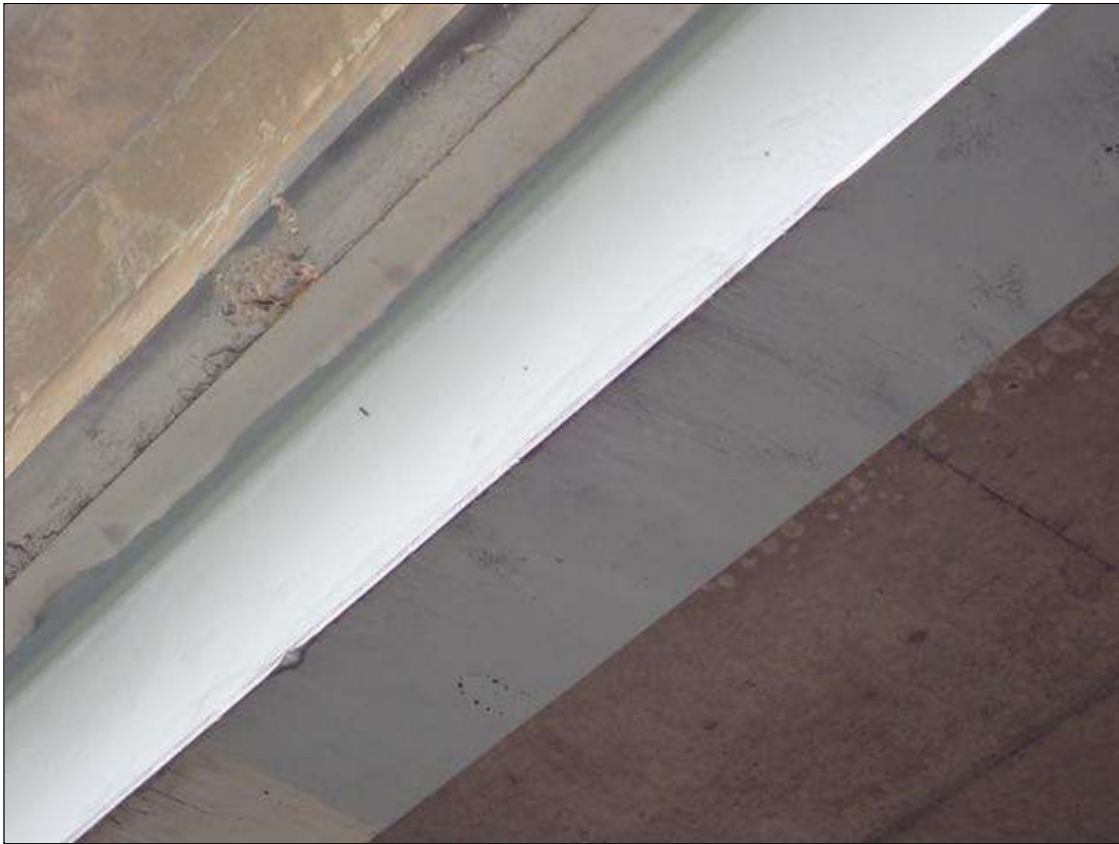
Span 2 Beam 1: POINT OF IMPACT TO BEAM 1 AT 24 FOOT 8 INCH FROM BENT 1 FOR A LENGTH OF 15 FOOT. BEAM 1 IS SWEEP EASTWARD FOR 1 INCH FOR A LENGTH OF 20 FOOT. SCATTERED SCRAPES TO LEFT SIDE OF BOTTOM WEB AND SCATTERED SCRAPES TO BOTTOM FLANGE. INDENTION IN LEFT SIDE OF BOTTOM FLANGE AT 14 FOOT 7 INCH FROM INTERIOR. BENT 1, 2 INCH LONG X 1 INCH WIDE X 1/8 INCH DEEP. INDENTION IN LEFT SIDE OF BOTTOM FLANGE AT 20 FOOT 9 INCH FROM BENT 1, 2 INCH LONG X 1 INCH WIDE X 1/8 INCH DEEP.

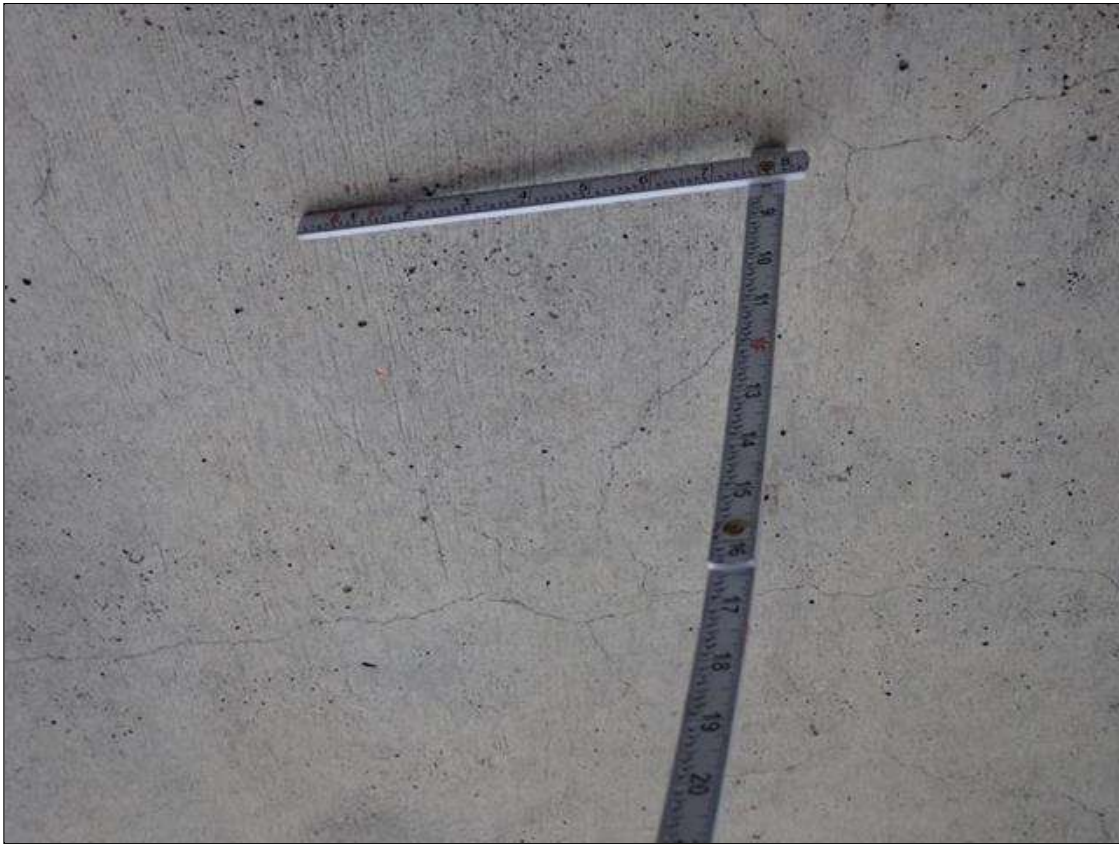
Span 1 Deck: throughout underside of deck, transverse cracks (up to 1/64 inch x full width) and map cracks (hairline) at random

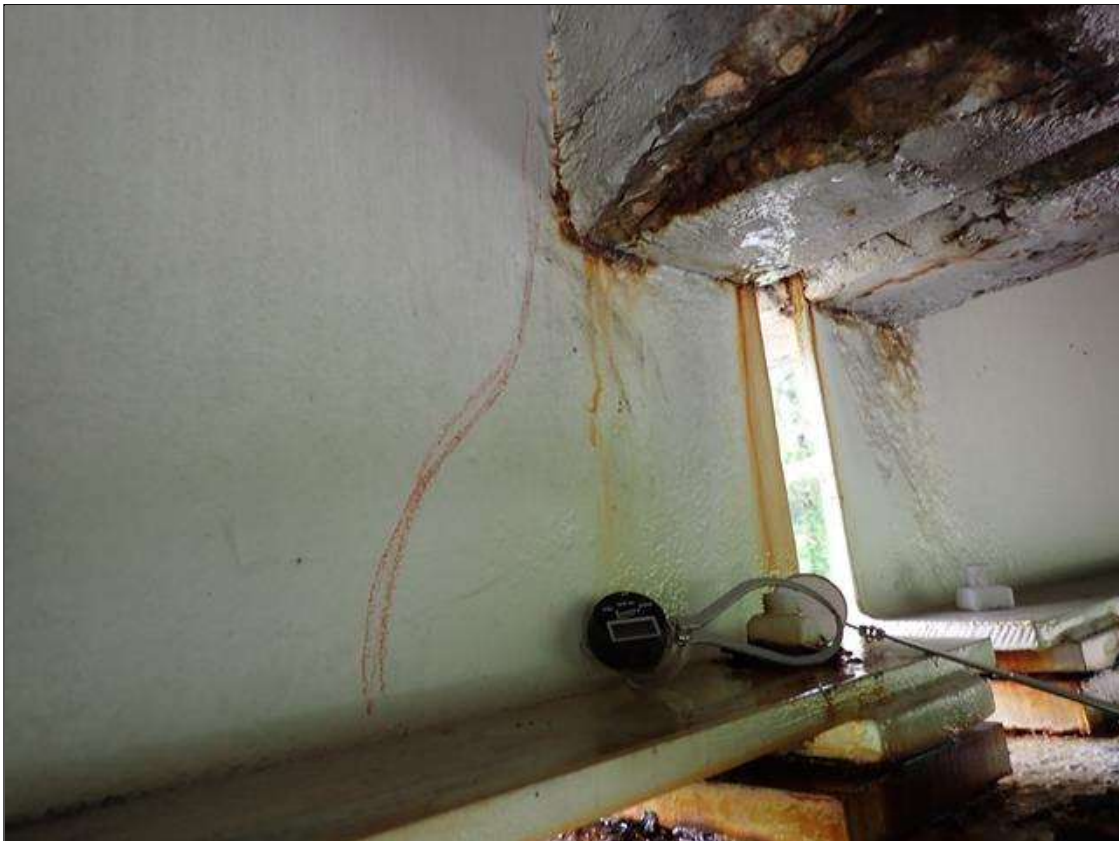
Span 2 Beam 1: at bent 2, painted over section loss/pitting: web adjacent to end diaphragm (1/2 inch average remaining x 16 inch x 13 inch); bottom flange, pitting (up to 1/16 inch deep x 16 inch) with corrosion reactivating
