NC DEPARTMENT OF TRANSPORTATION
 DIVISION OF HIGHWAYS
 STRUCTURE MANAGEMENT UNIT

ATTENTION: **prompt action request; sketches revised**

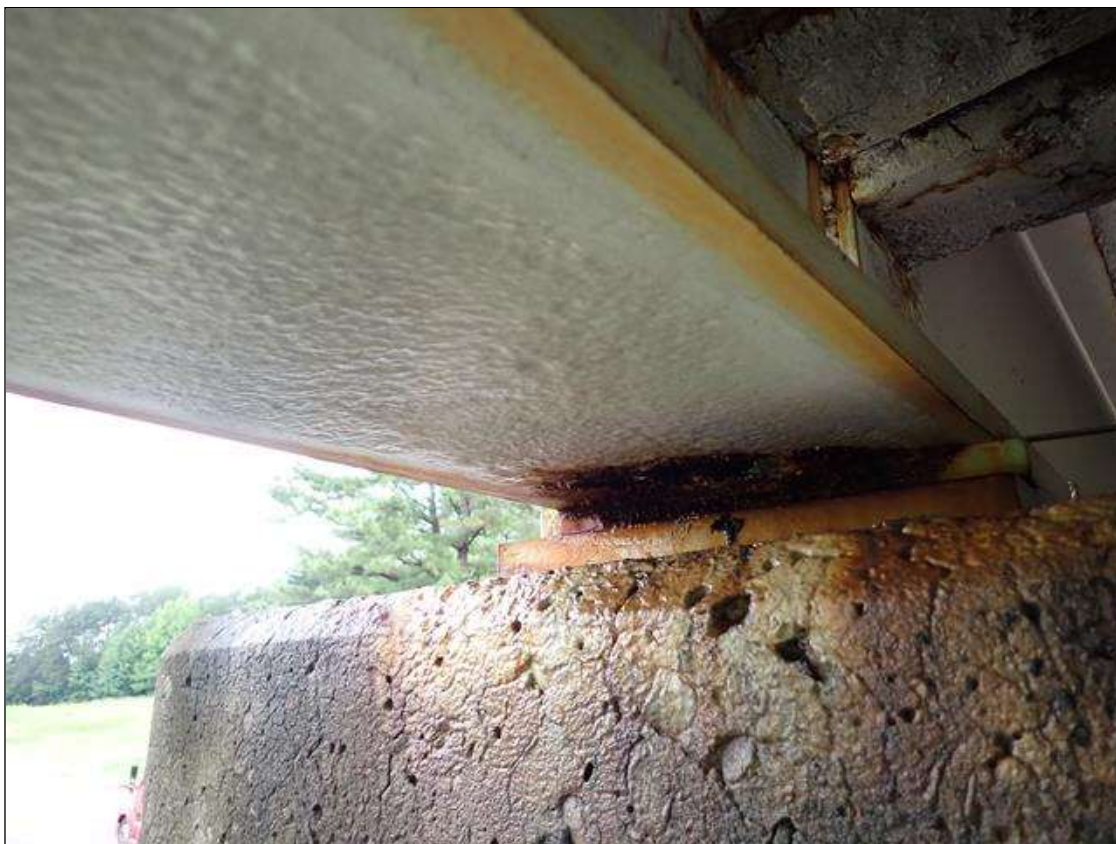
Span 2 Beam 1: at bent 2, painted over section loss/pitting: web adjacent to end diaphragm (1/2 inch average remaining x 16 inch x 13 inch); bottom flange, pitting (up to 1/16 inch deep x 16 inch) with corrosion reactivating

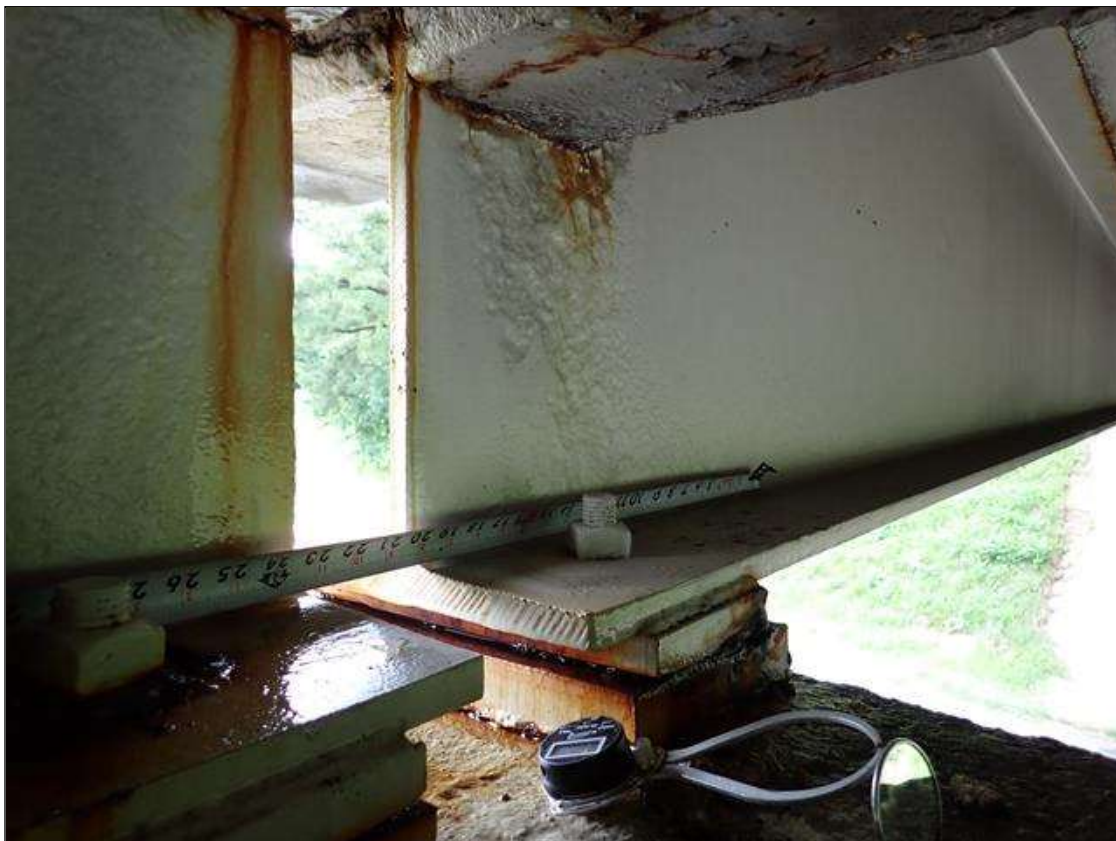
Span 3 Beam 1: at bent 2, painted over section loss/pitting: web adjacent to end diaphragm (1/2 inch average remaining x 16 inch x 13 inch); bottom flange, pitting (up to 1/16 inch deep x 16 inch) with corrosion reactivating

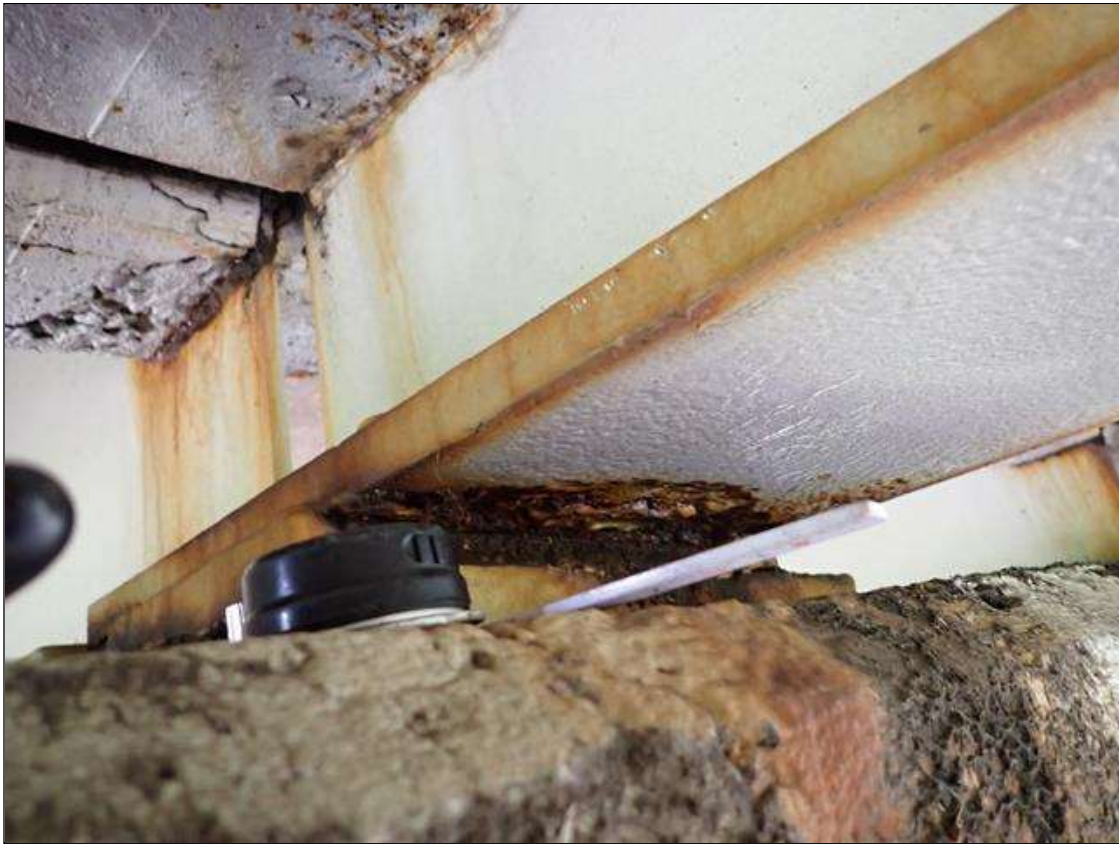
Span 2 Beam 2: (PAR) at bent 2, painted over section loss/pitting: bottom flange (0.73 inch average remaining x 3 inch); web adjacent to end diaphragm (3/8 inch average remaining x 10 inch x 6 inch)

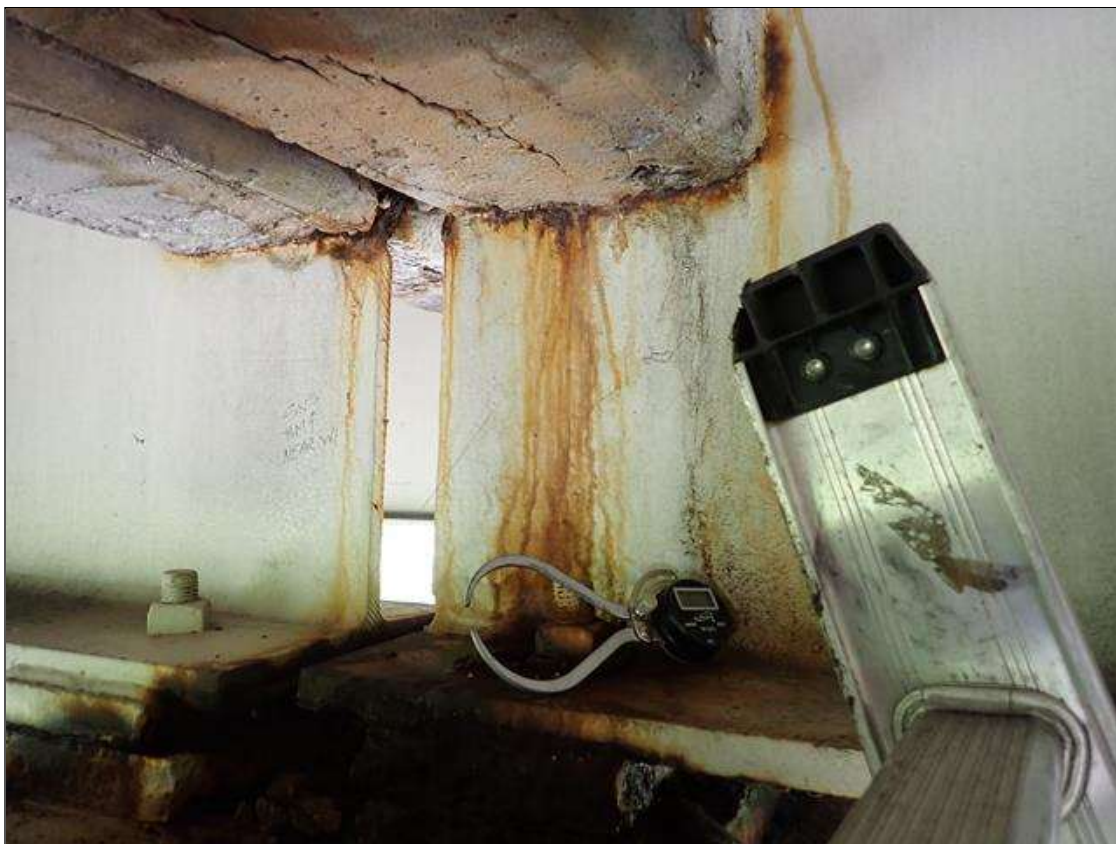
Span 2 Beam 4: at bent 2, painted over section loss/pitting: bottom flange (0.70 inch average remaining x 1.5 inch); web adjacent to end diaphragm (1/2 inch average remaining x 10 inch x 2 inch) with corrosion reactivating

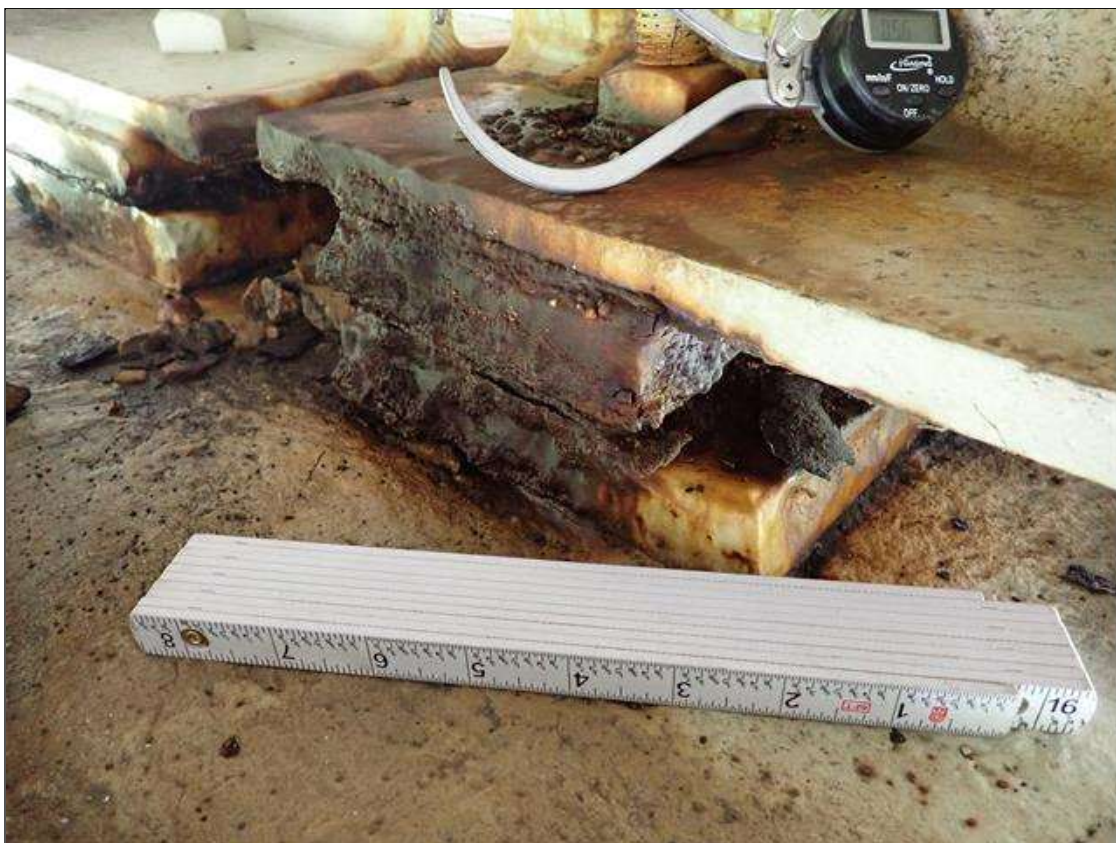
Span 2 Beam 4 - Far Bearing 4: corrosion with section loss (up to 3/16 inch deep)

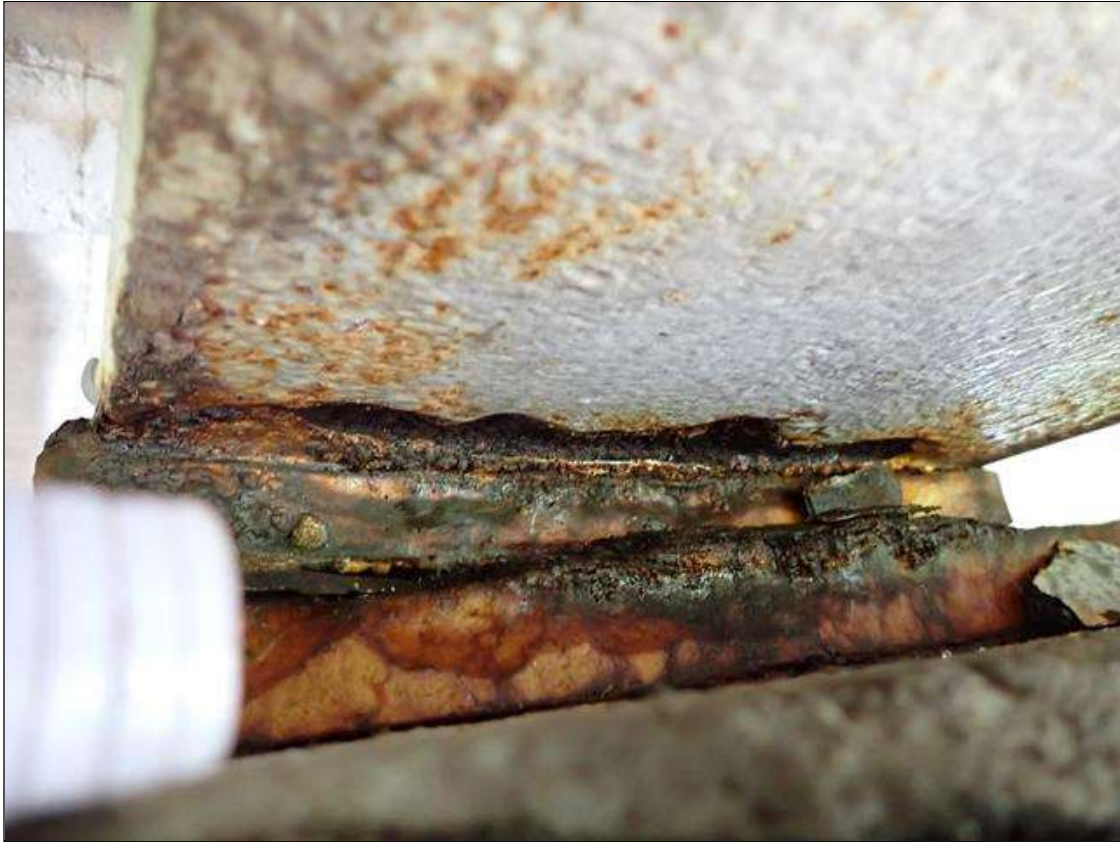
Span 2 Beam 4: at bent 2, painted over section loss/pitting: bottom flange (0.70 inch average remaining x 1.5 inch); web adjacent to end diaphragm (1/2 inch average remaining x 10 inch x 2 inch) with corrosion reactivating

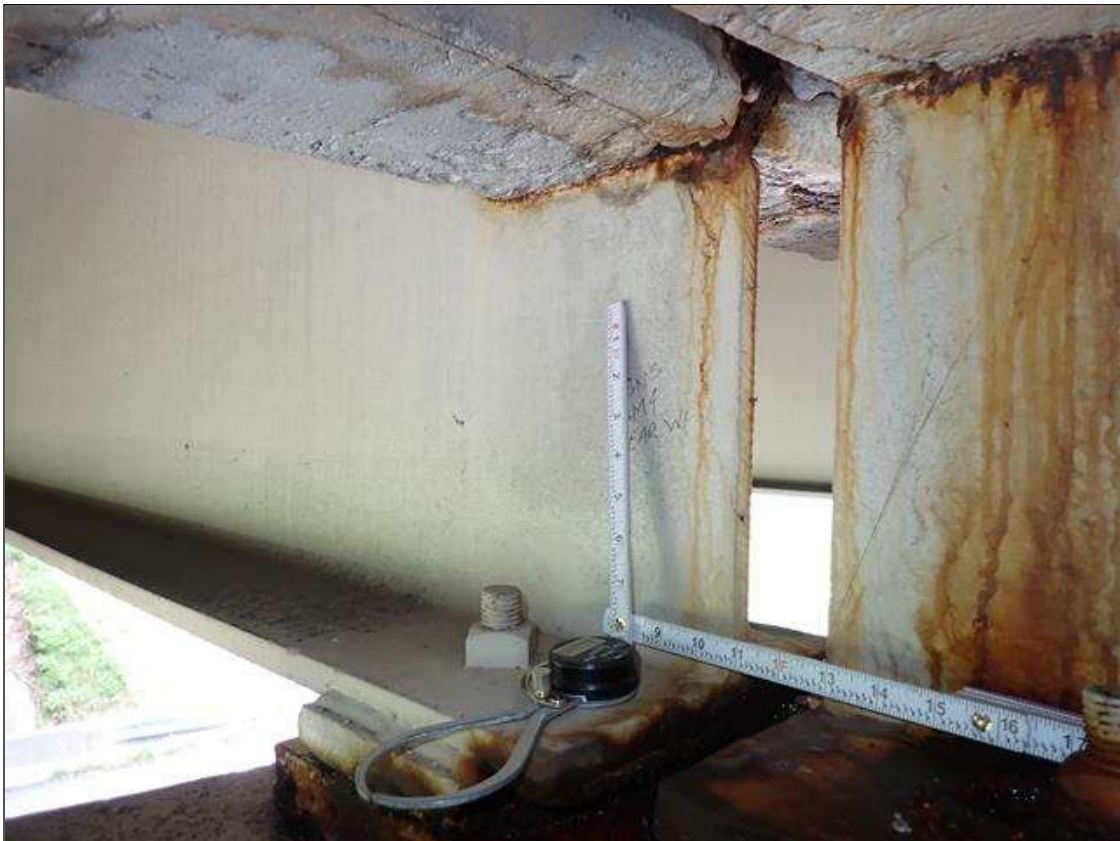
Span 3 Beam 4: (PAR) at bent 2, painted over section loss/pitting: web adjacent to end diaphragm (3/8 inch average remaining x 10 inch x 1 inch)

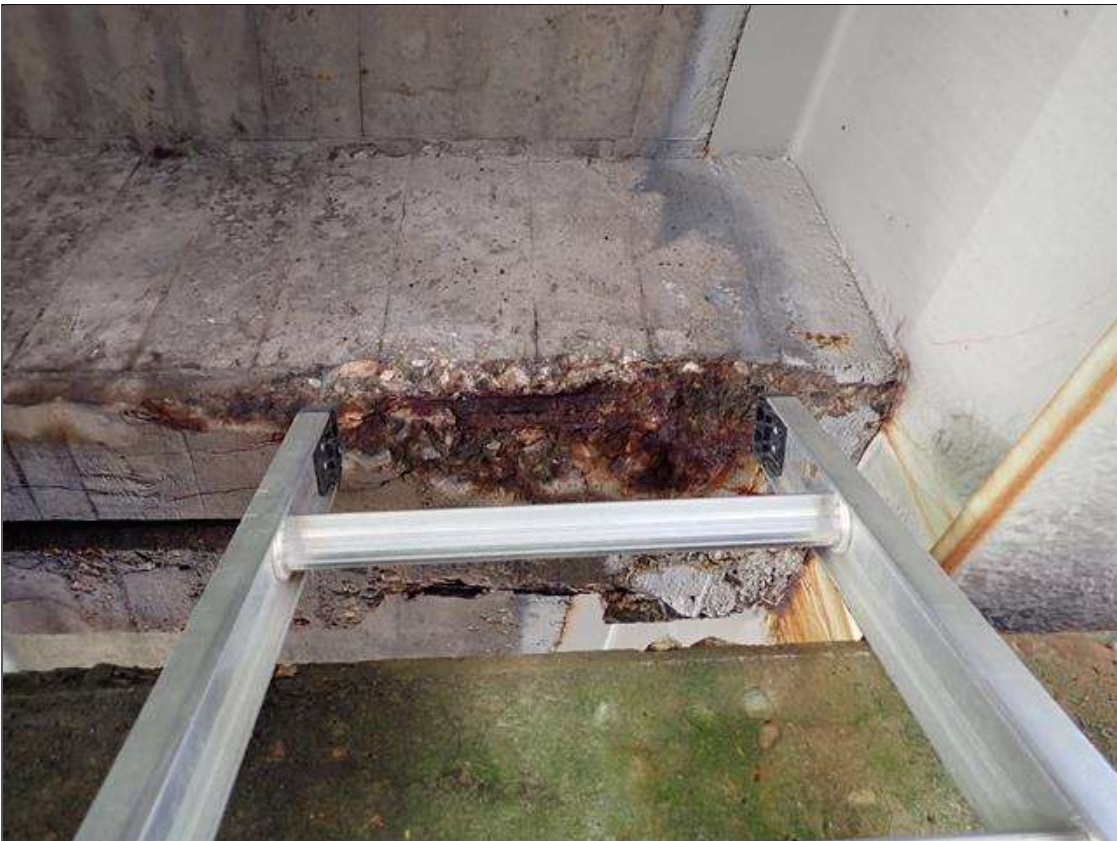
Span 2 Deck: (PAR) bays 1 and 4 end diaphragm over bent 2, spalls/delaminations (3 foot x 8 inch x 1 inch deep) with exposed rusted rebar (approximately 25 percent loss)

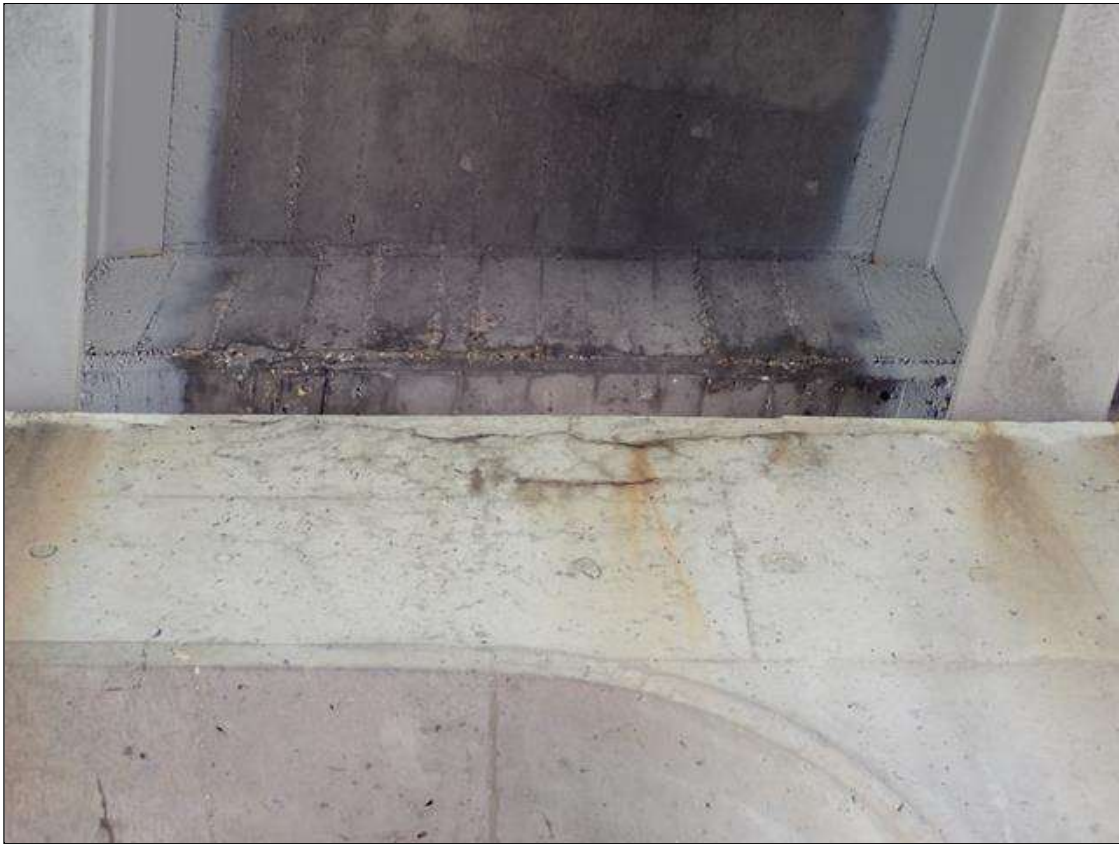
Bent 2 Cap 1: (PAR) UP TO 7 FOOT X 12 INCH DELAMINATIONS WITH HORIZONTAL CRACKS UP TO 1/16 INCH WITH RUST STAINING, SOUTH AND NORTH FACES, UNDER BAY 3.

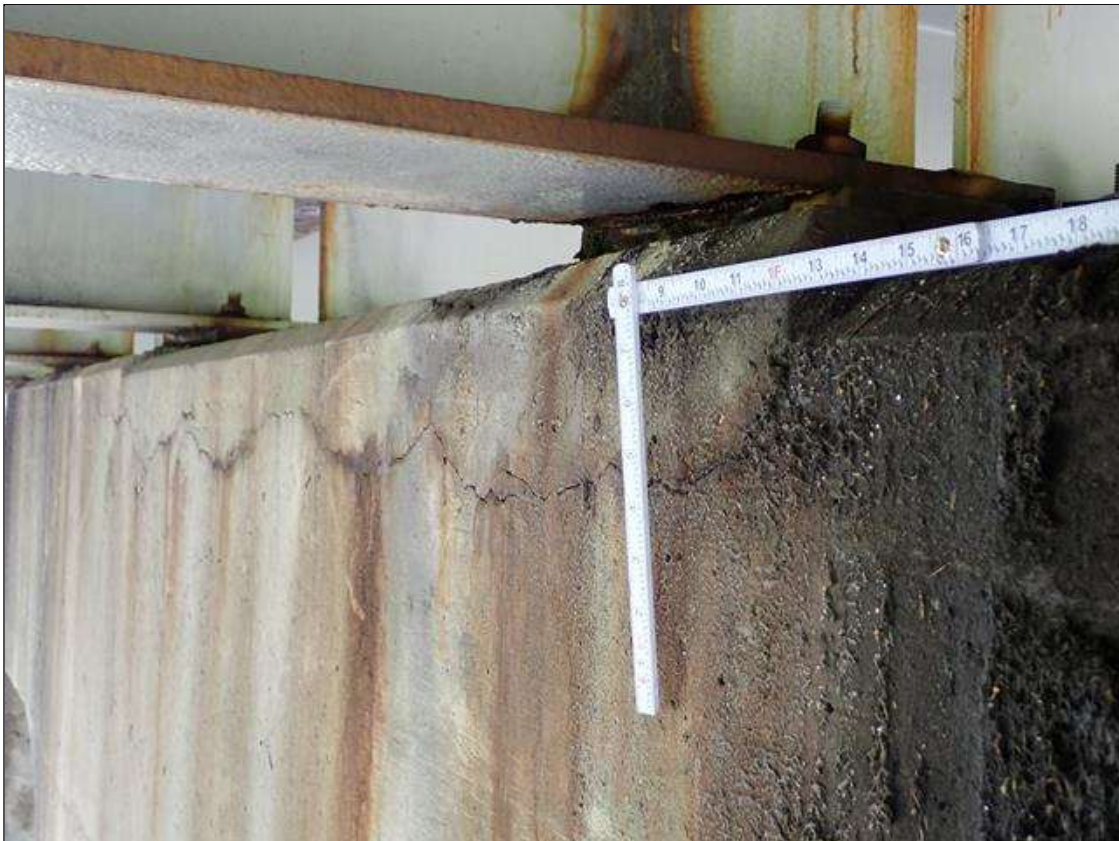
Bent 2 Cap 1: (PAR) UP TO 7 FOOT X 12 INCH DELAMINATIONS WITH HORIZONTAL CRACKS UP TO 1/16 INCH WITH RUST STAINING, SOUTH AND NORTH FACES, UNDER BAY 3.

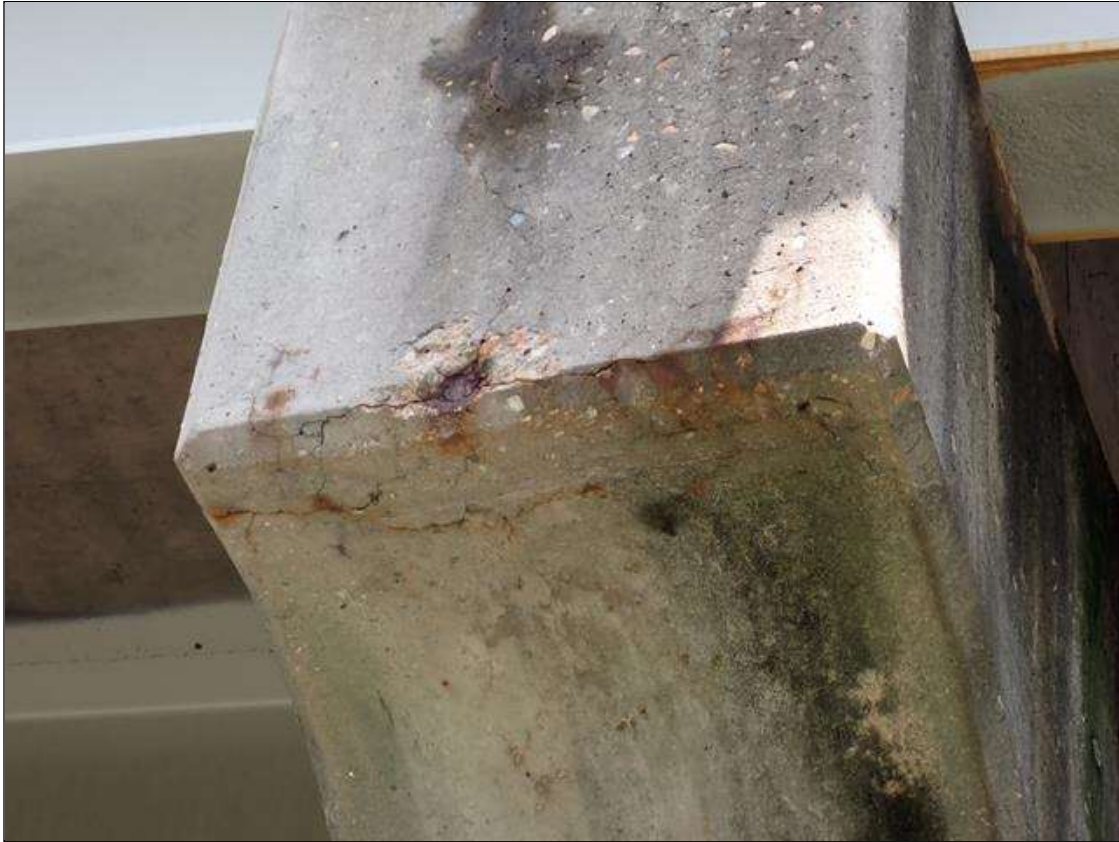
Bent 2 Cap 1: (PAR) BENT 2 CAP WEST FACE BOTTOM CORNER HAS A SPALL AND DELAMINATED AREA (2.5 FOOT X 1 FOOT X 1 INCH DEEP) WITH REBAR EXPOSED (APPROXIMATELY 25 PERCENT LOSS) AND MAP CRACKS (UP TO 1/16 INCH) WITH RUST STAINS

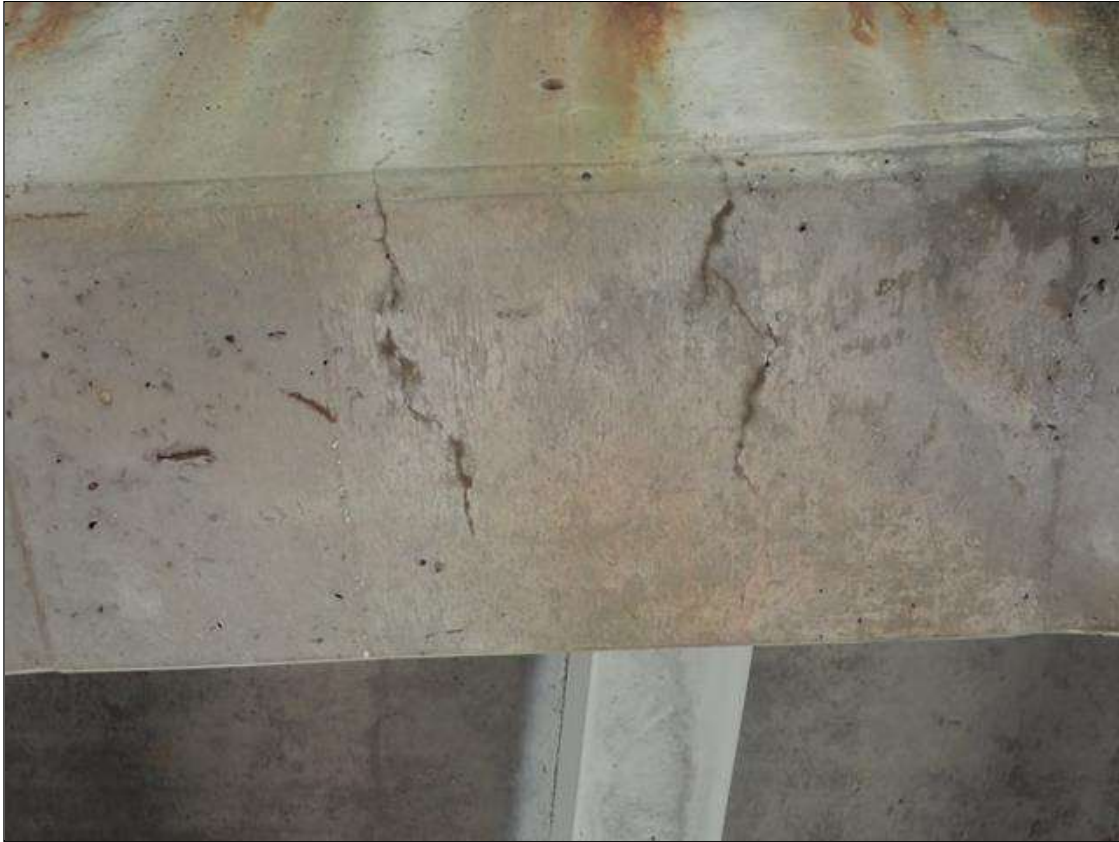
Bent 2 Cap 1: along the length of the cap, vertical cracks (up to 1/32 inch x full height) some extending into bottom face (full width) and map cracks (hairline) at random

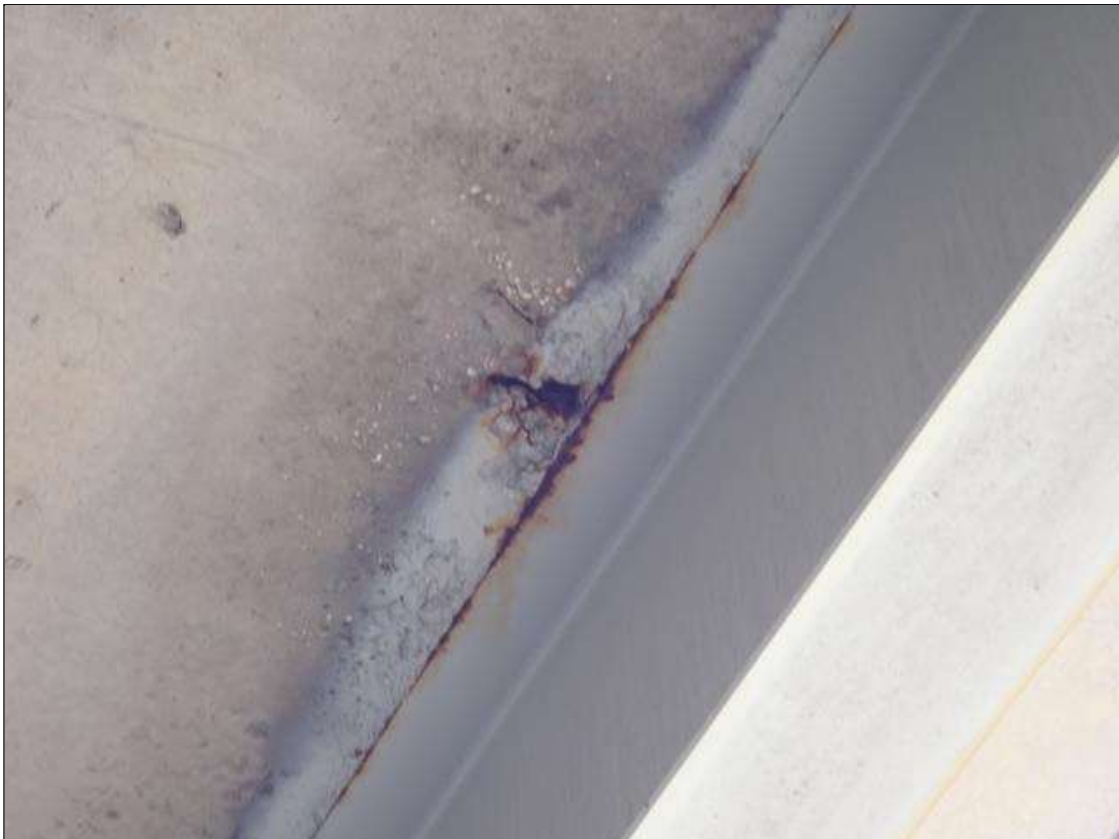
Span 2 Deck: (PAR) 2 FOOT X 1 FOOT X 3/4 INCH DEEP SPALL WITH EXPOSED REBAR BAY 1 ADJACENT TO BEAM 1 15 FOOT FROM BENT 2

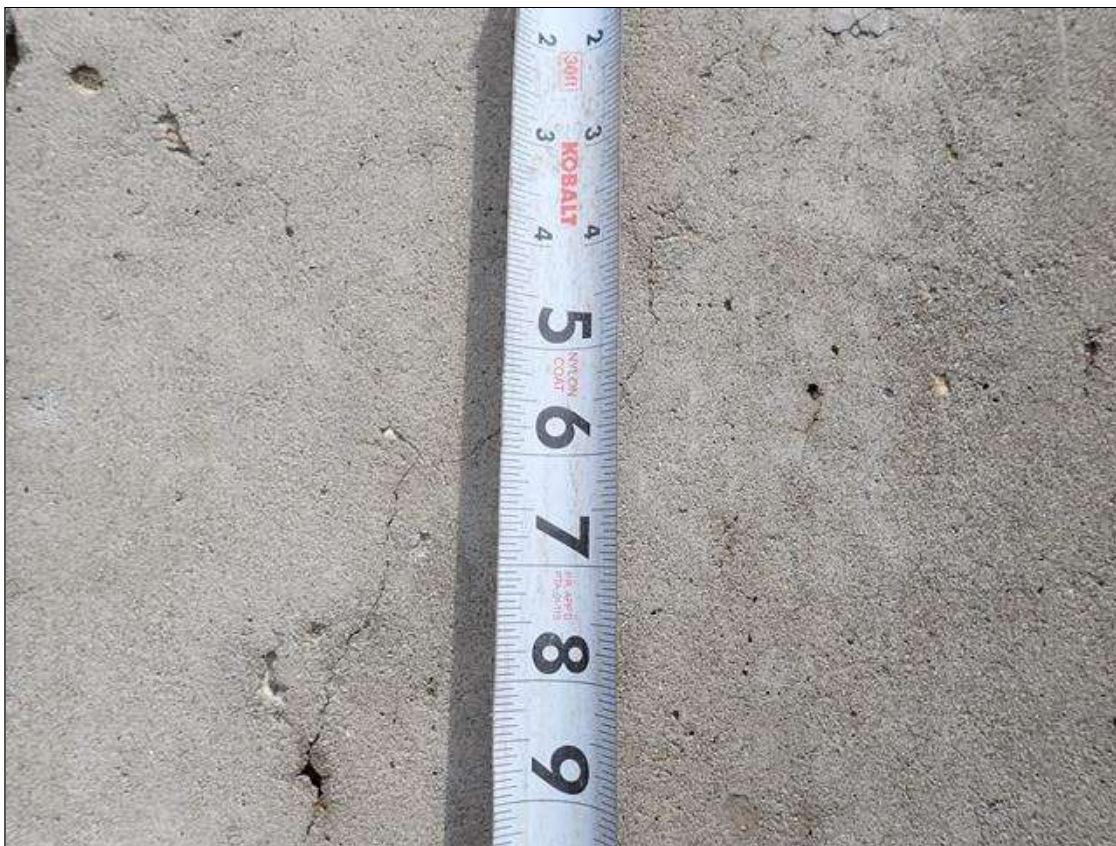
Bent 2 Pile 1: west face, map cracks (hairline) at random

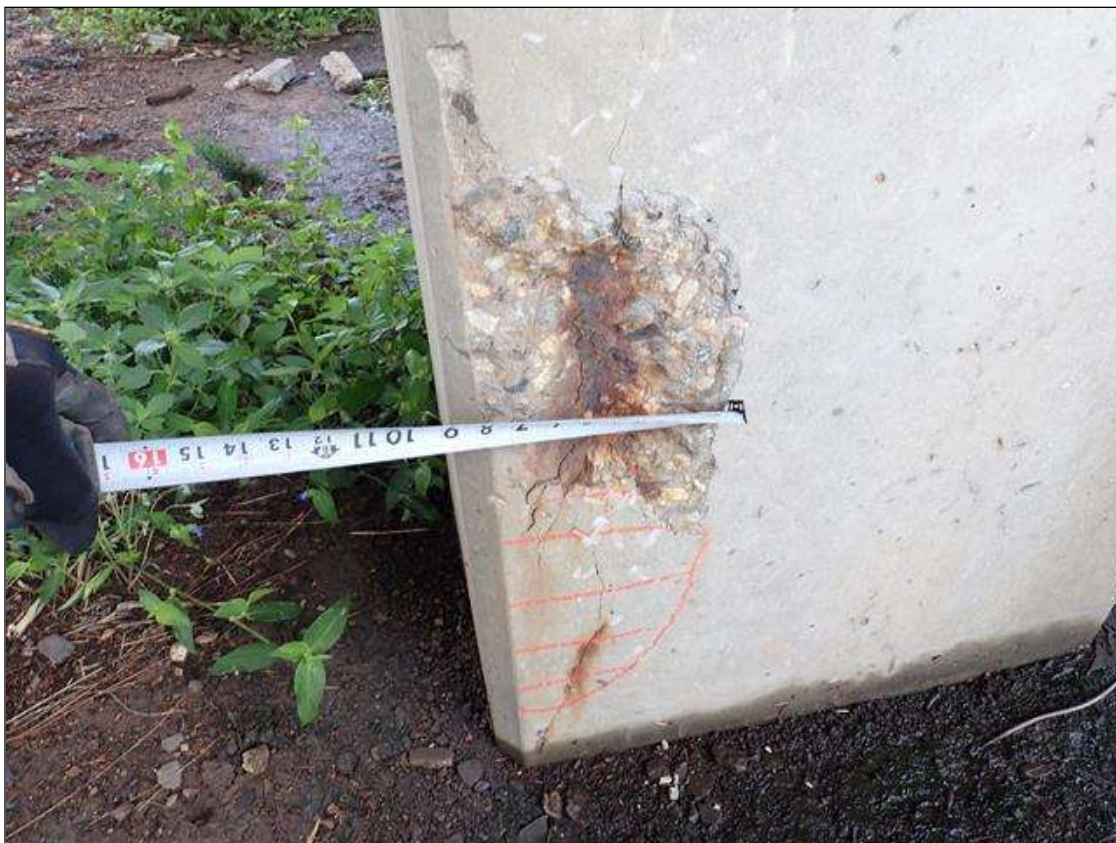
Bent 2 Pile 2: (PAR) west face at bottom, spall (2 foot x 8 inch x 1 inch deep) with exposed rusted rebar (approximately 25 percent loss)

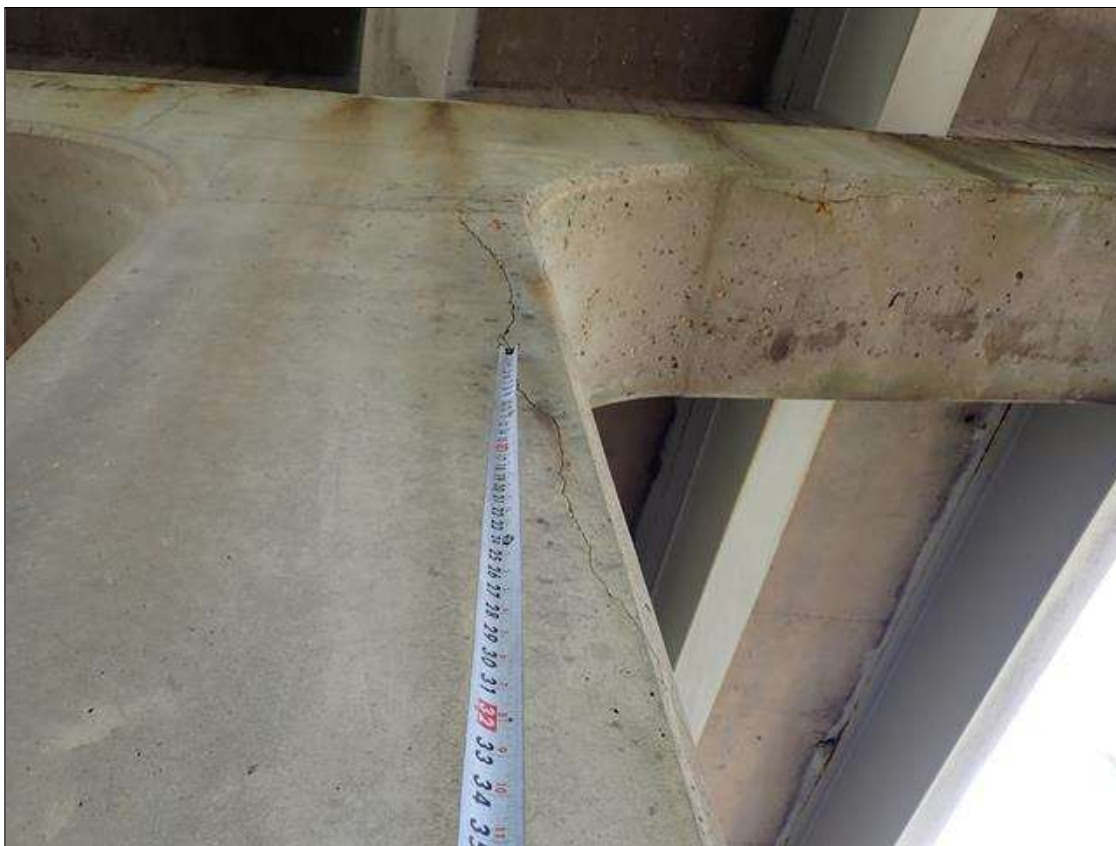
Bent 2 Pile 2: northwest and southwest corners below cap, (3) delamination (4.5 foot x 1 foot) with cracks (up to 1/16 inch)

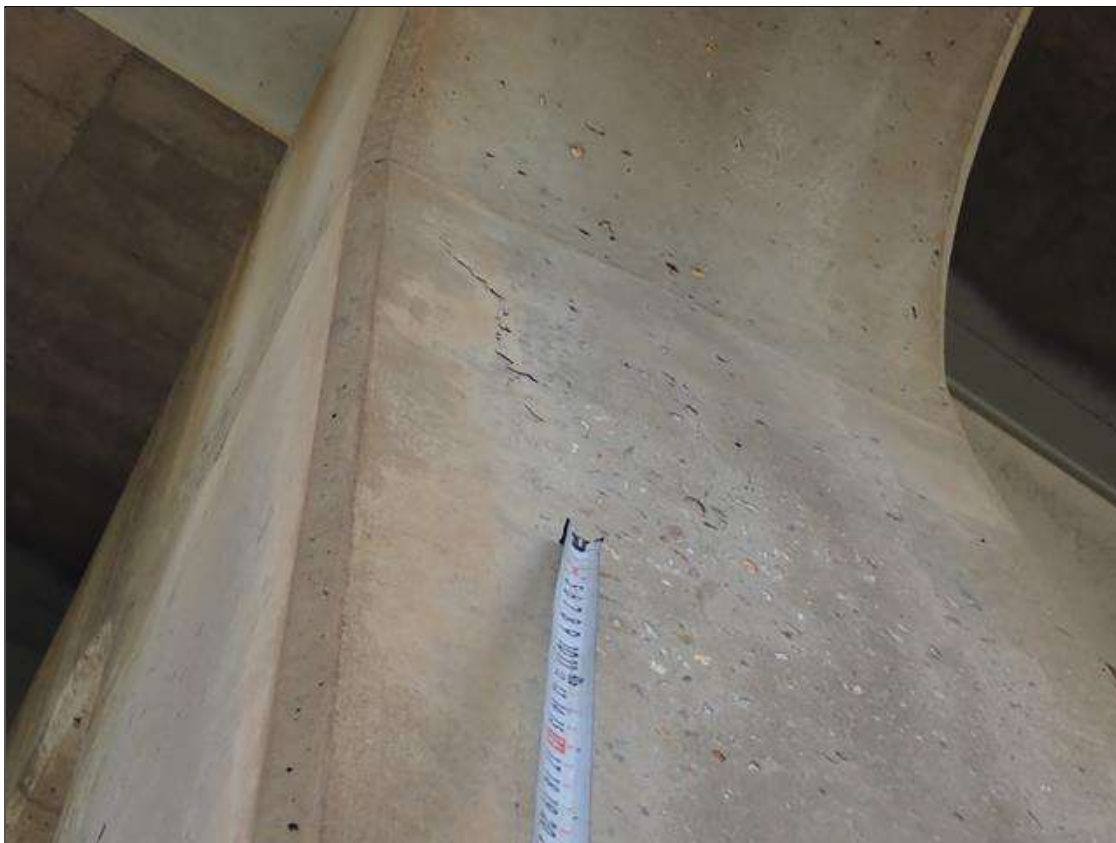
Bent 2 Pile 2: East face below cap, delamination, 32 inch x 11 inch

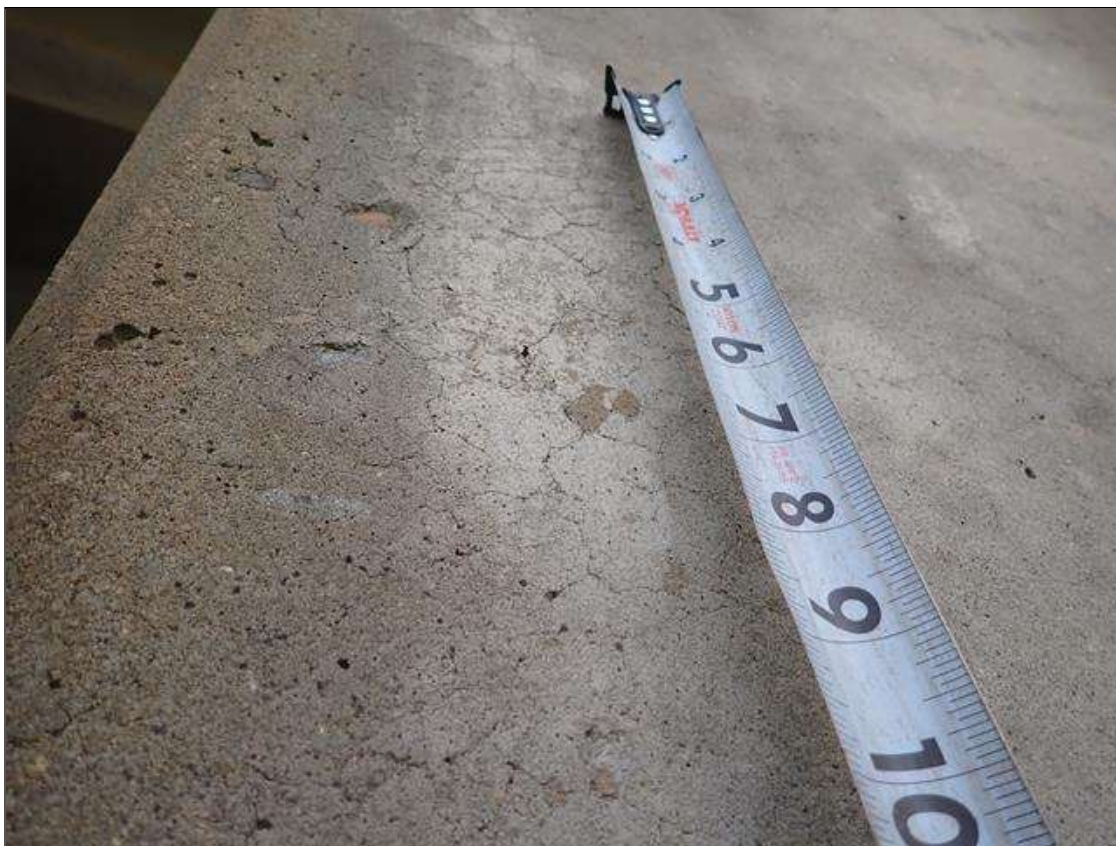
Bent 2 Pile 3: (PAR) along column, vertical cracks (up to 1/8 inch x 6.5 foot) some with efflorescence and rust stains and map cracks (hairline) at random

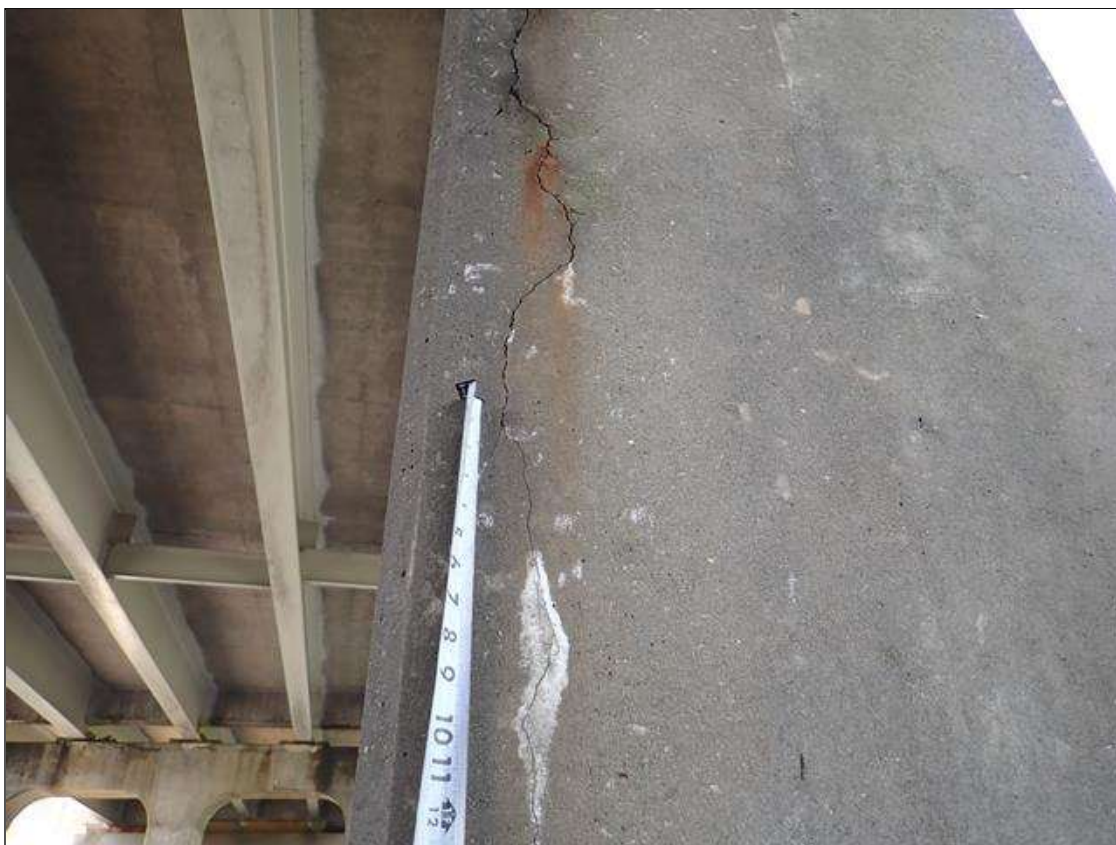
Bent 2 Pile 3: (PAR) along column, vertical cracks (up to 1/8 inch x 6.5 foot) some with efflorescence and rust stains and map cracks (hairline) at random

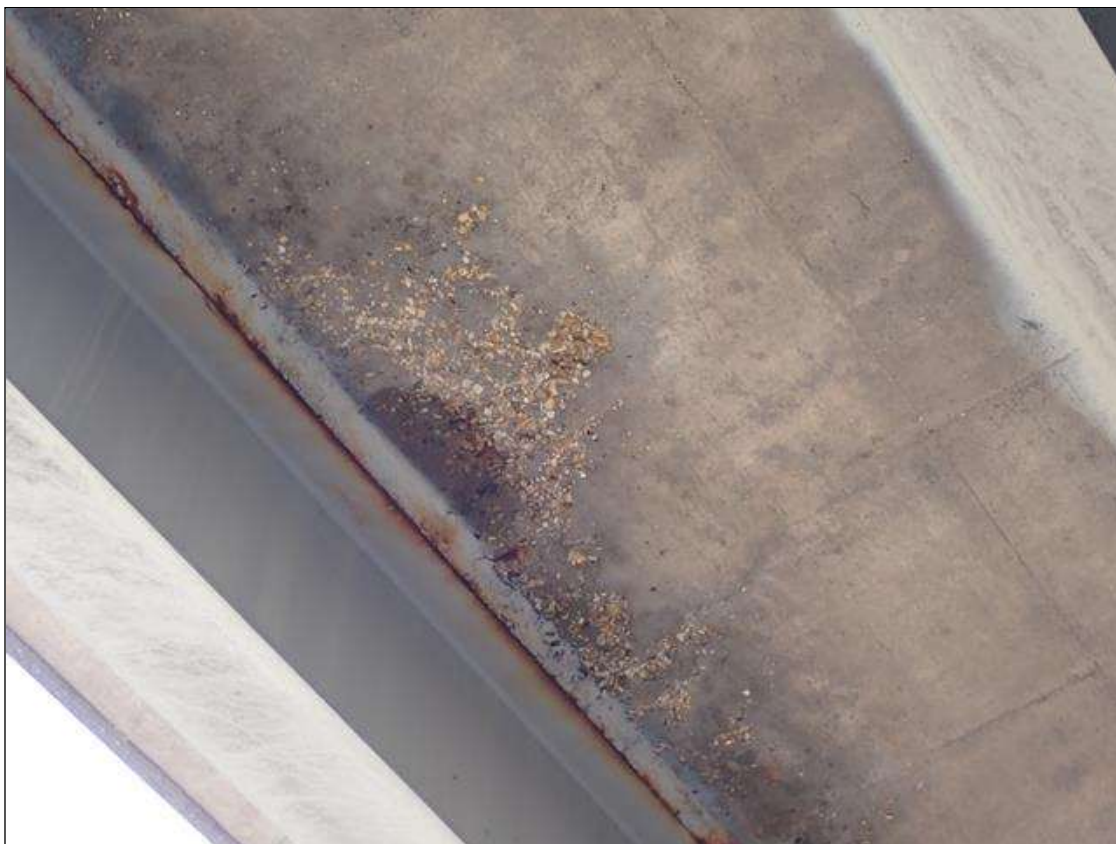
Span 3 Deck: MULTIPLE AREAS OF HONEYCOMBING IN BAYS 1 & 4 AT RANDOM THROUGHOUT.

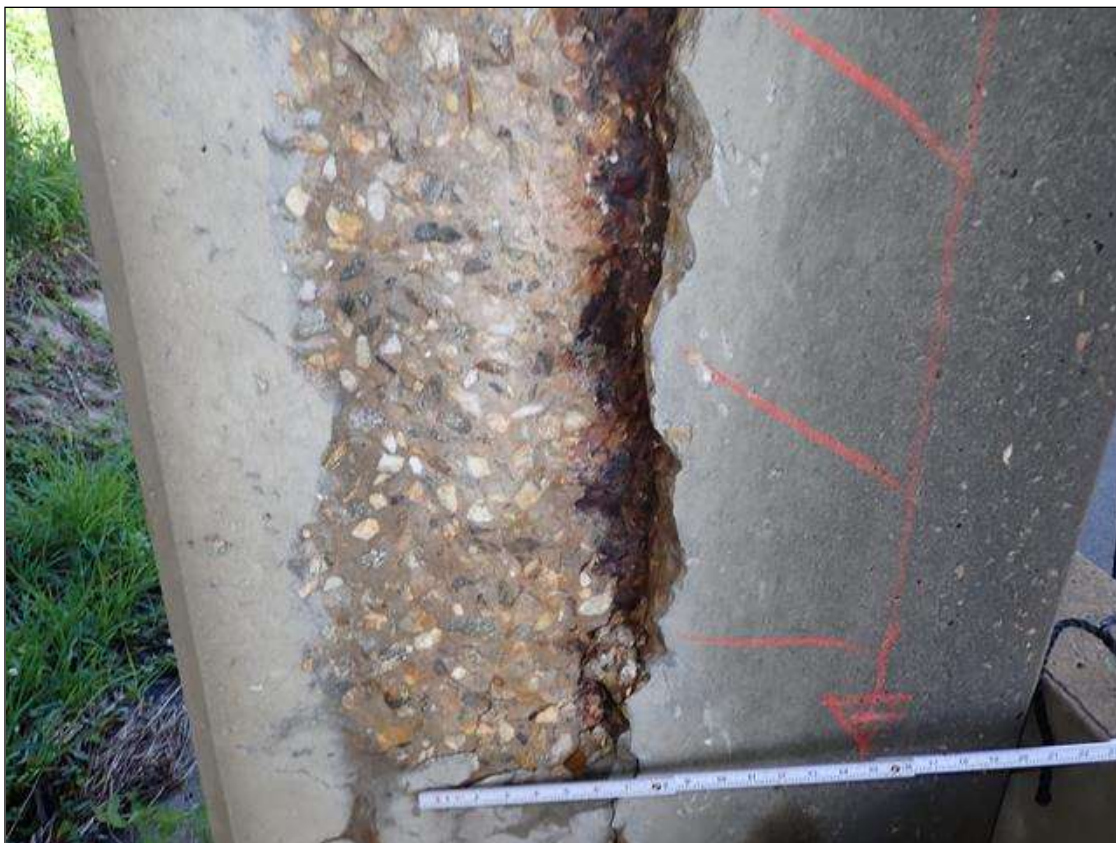
Bent 3 Pile 3: (PAR) west face, spall/delamination (20 inch x full height x 2 inch deep) with exposed rusted rebar (approximately 25 percent loss) and cracks (up to 1/8 inch) some with efflorescence

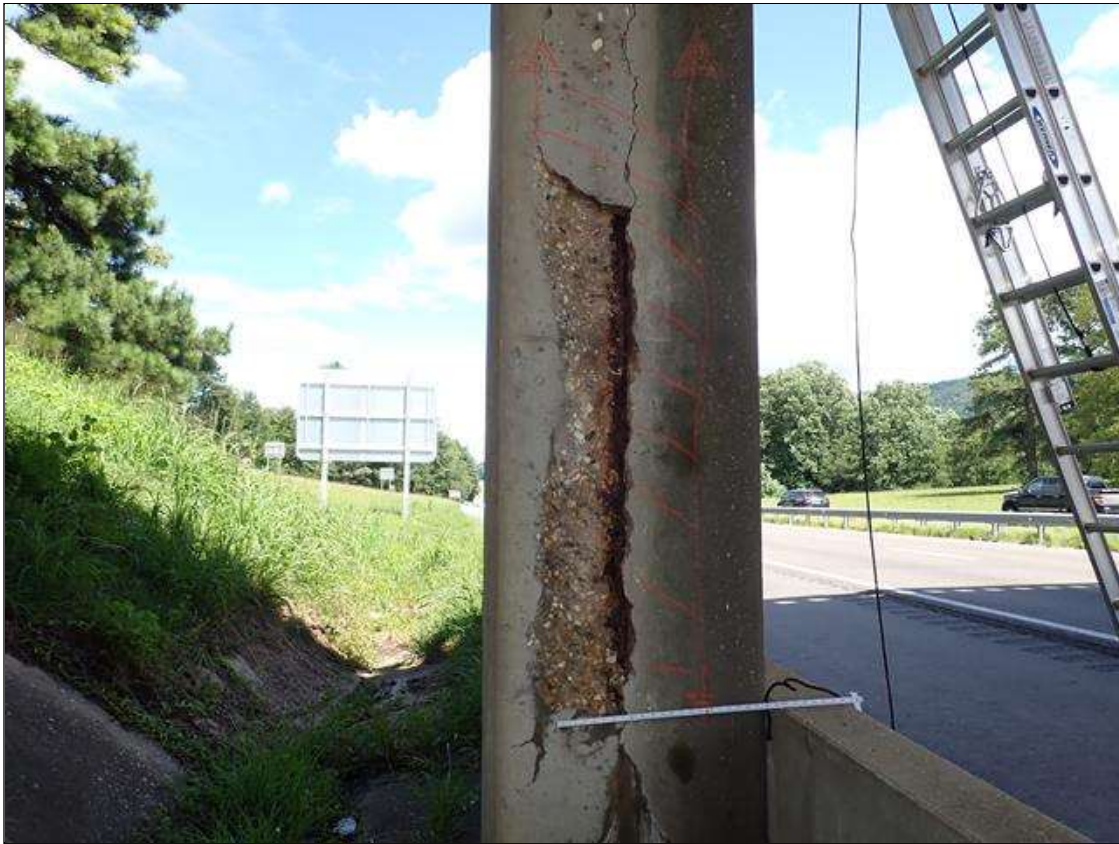
Bent 3 Pile 3: (PAR) west face, spall/delamination (20 inch x full height x 2 inch deep) with exposed rusted rebar (approximately 25 percent loss) and cracks (up to 1/8 inch) some with efflorescence

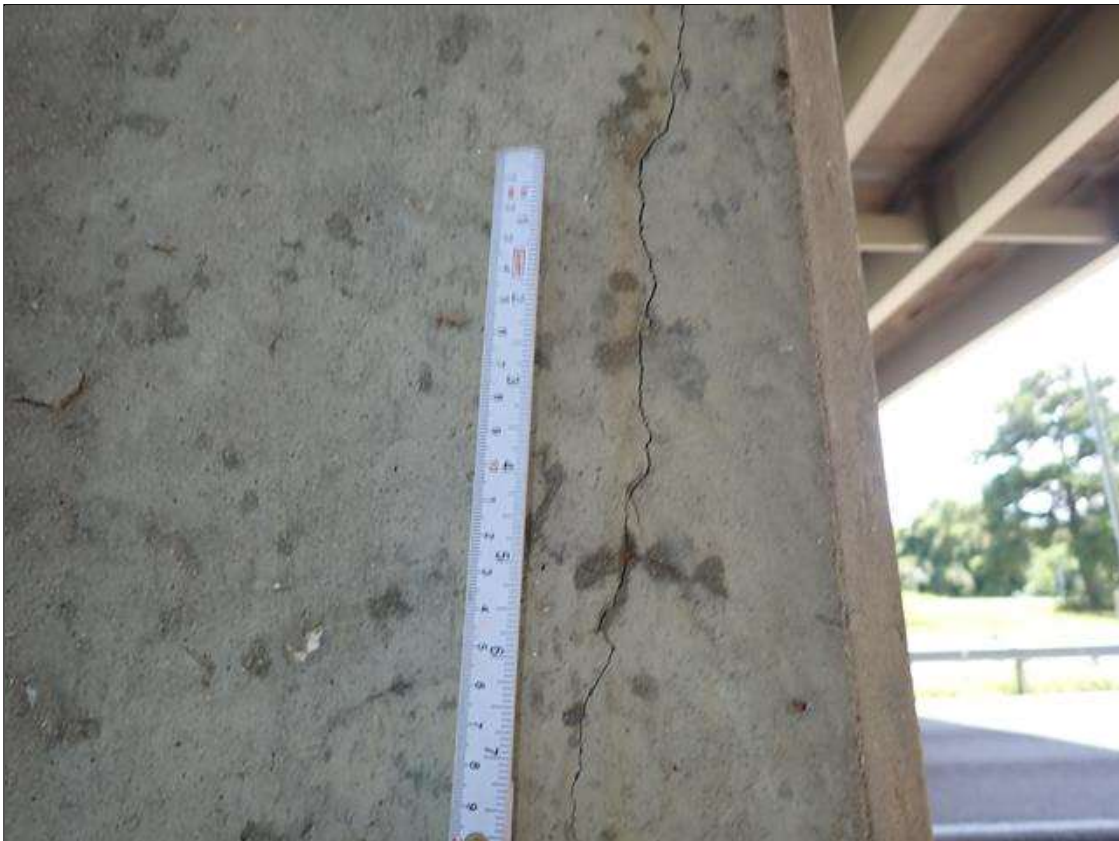
Bent 3 Pile 3: along column, vertical cracks (up to 1/32 inch x full height) and map cracks (hairline)
