NC DEPARTMENT OF TRANSPORTATION
 DIVISION OF HIGHWAYS
 STRUCTURE MANAGEMENT UNIT

ATTENTION: **prompt action request; sketches revised**

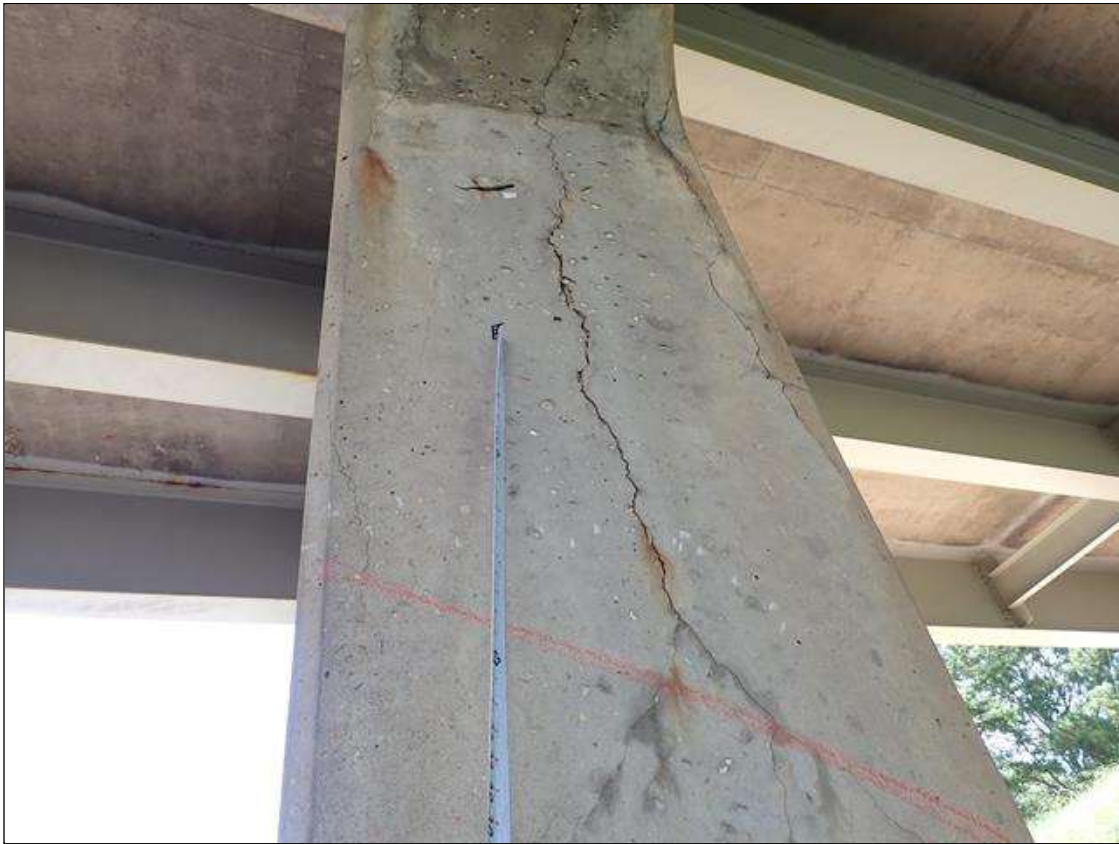
Bent 3 Pile 2: (PAR) east face below cap, delamination (full width x 5 foot) with cracks (up to 1/8 inch) with rust stains

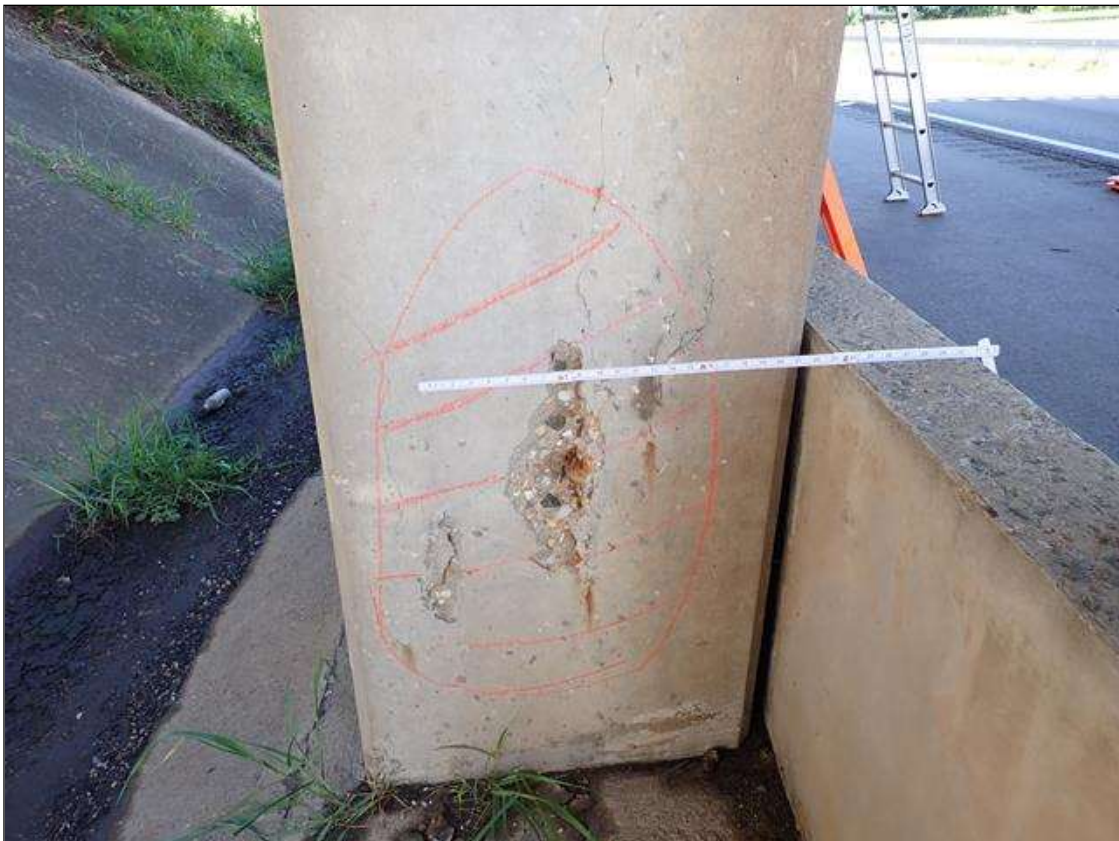
Bent 3 Pile 2: (PAR) west face at bottom, spall/delamination (3 foot x 21 inch x 1/2 inch) with exposed rusted rebar and cracks (up to 1/32 inch) with rust stains

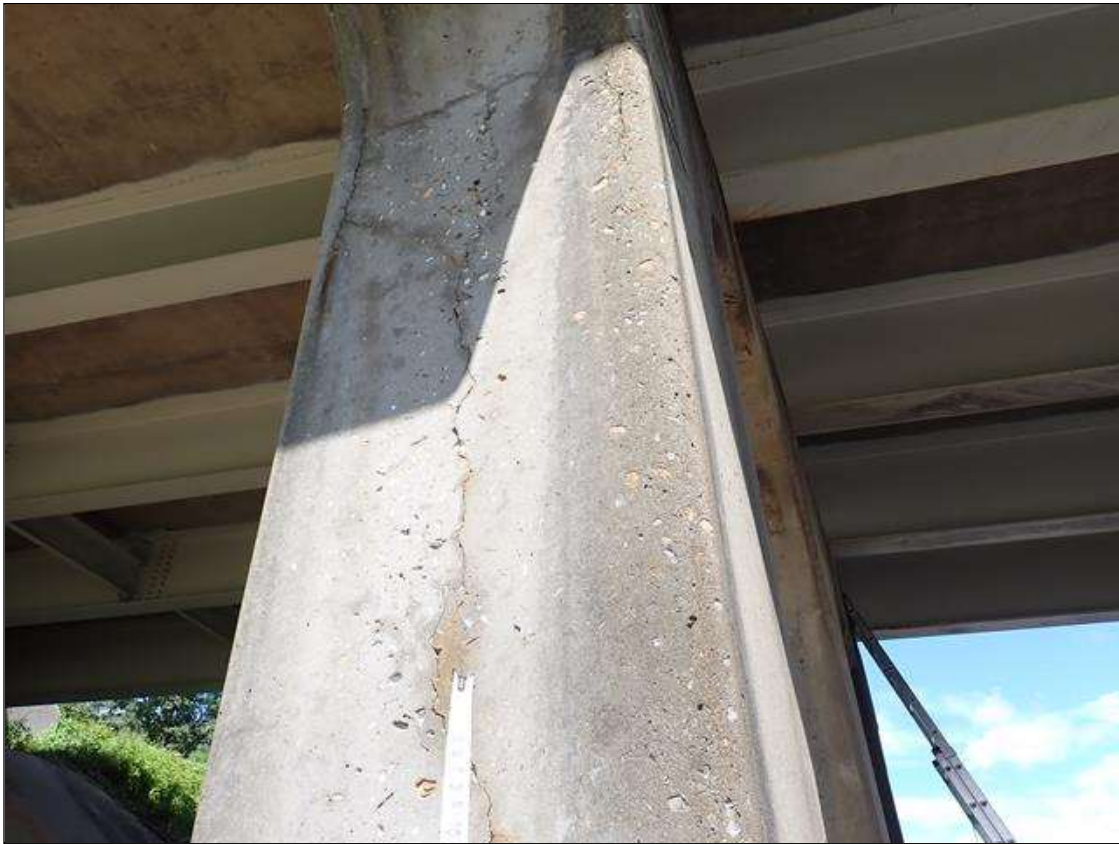
Bent 3 Pile 1: (PAR) WEST FACE HAS AN AREA THAT IS CRACKED (UP TO 1/16 INCH) AND DELAMINATED WITH SOME RUST STAINS VISIBLE AREA IS: 16 INCH X 10 FOOT.

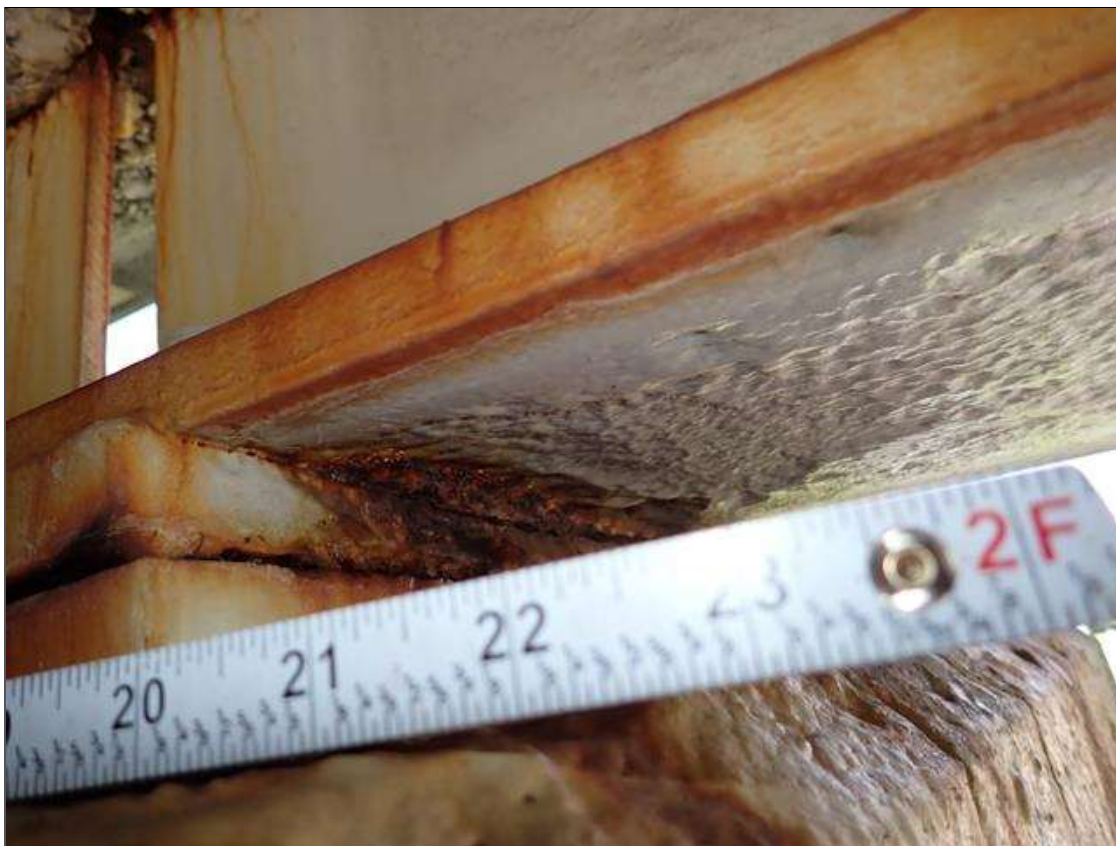
Span 3 Beam 5: at bent 3, painted over pitting/section loss: bottom flange (0.75 inch average remaining x 1 foot); bottom flange 1 foot from bearing, painted over pitting (up to 1/16 inch deep x 10 foot); web, painted over pitting (up to 1/8 inch deep x 10 foot x 12 inch)

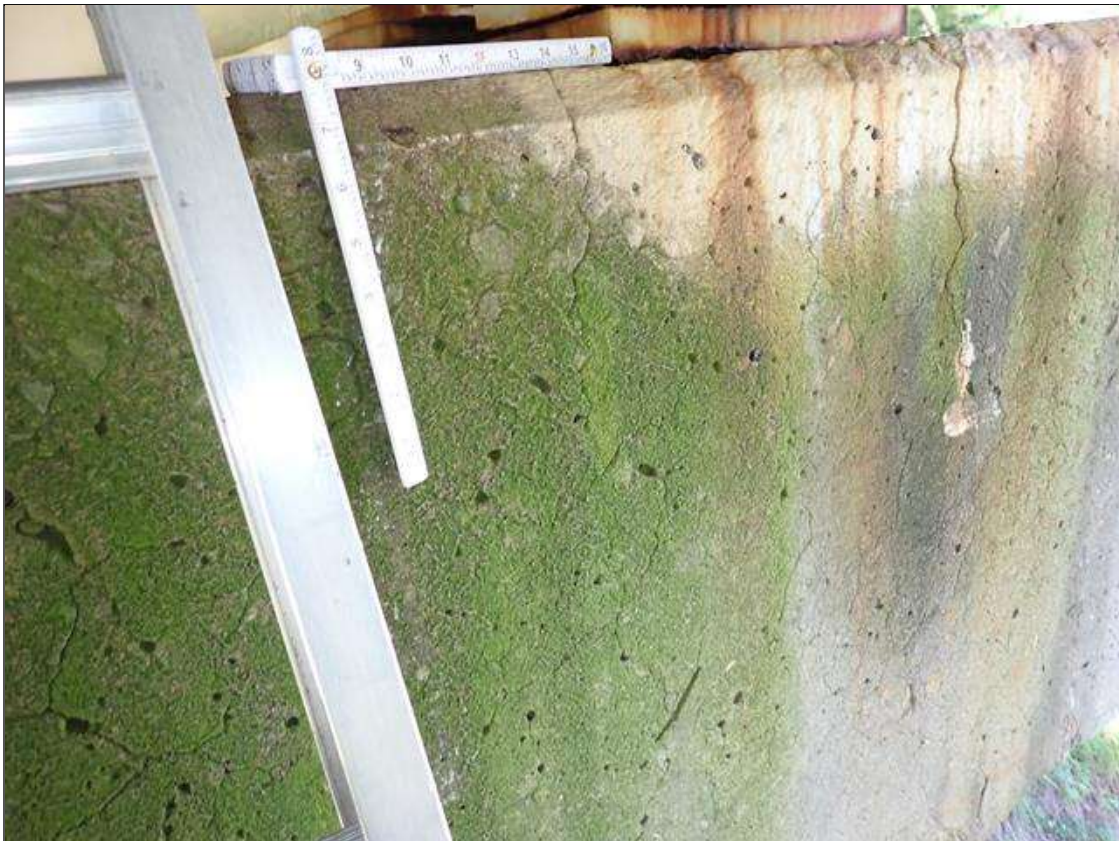
Bent 3 Cap 1: along the length of the cap, vertical cracks (up to 1/32 inch x full height) and map cracks (hairline) at random

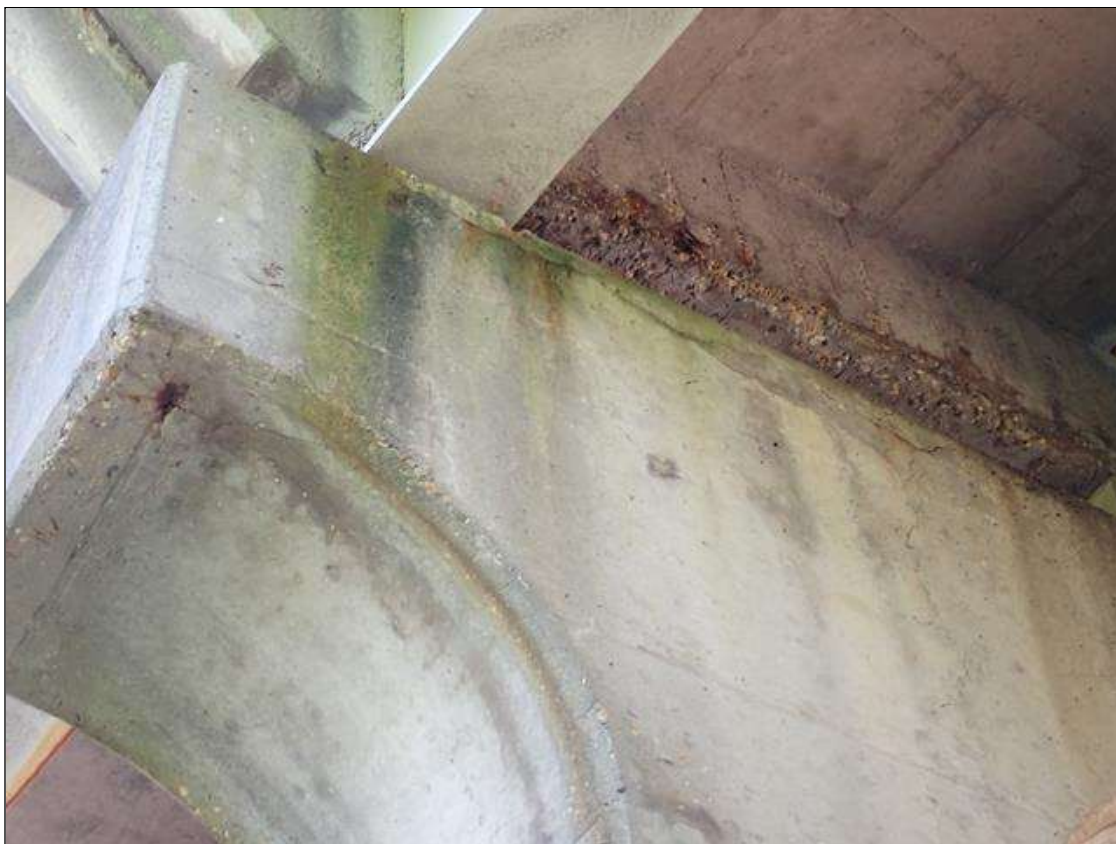
Bent 3 Cap 1: (PAR) both faces and underside, multiple delaminations (15 foot x 18 inch) with cracks (up to 1/8 inch) some with rust stains

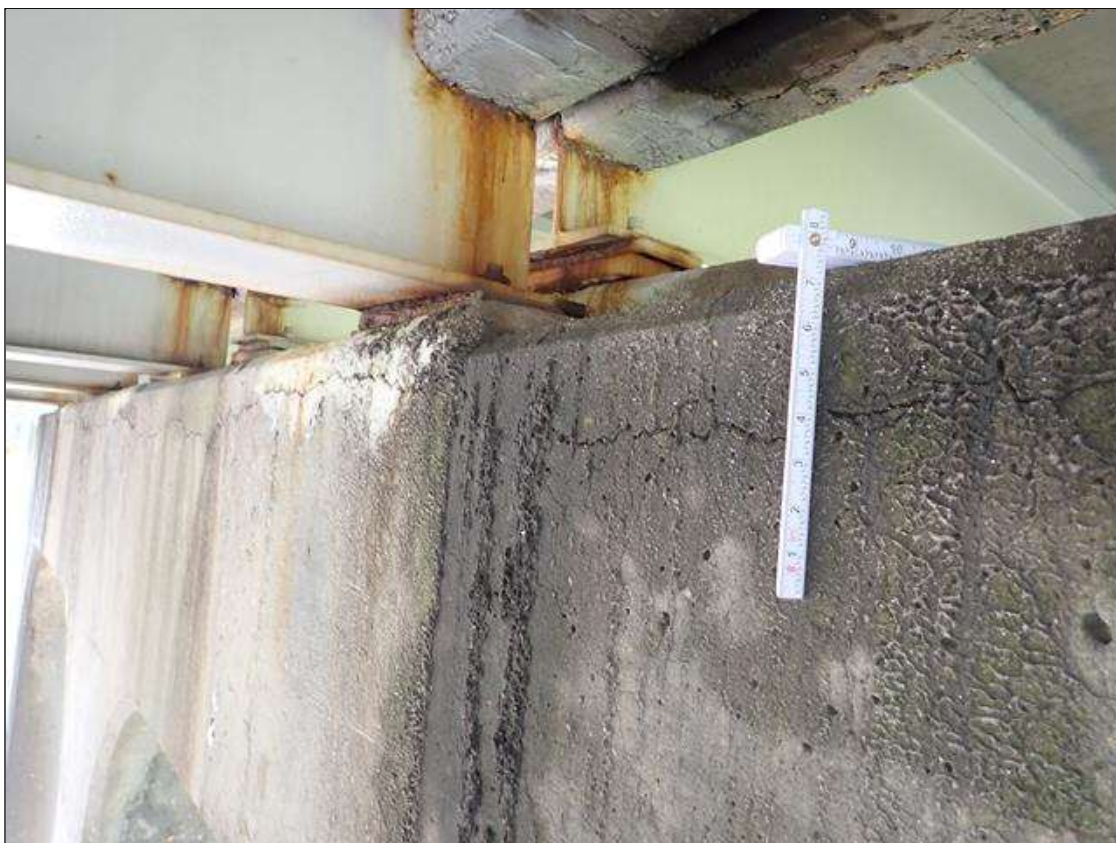
Bent 3 Cap 1: (PAR) both faces and underside, multiple delaminations (15 foot x 18 inch) with cracks (up to 1/8 inch) some with rust stains

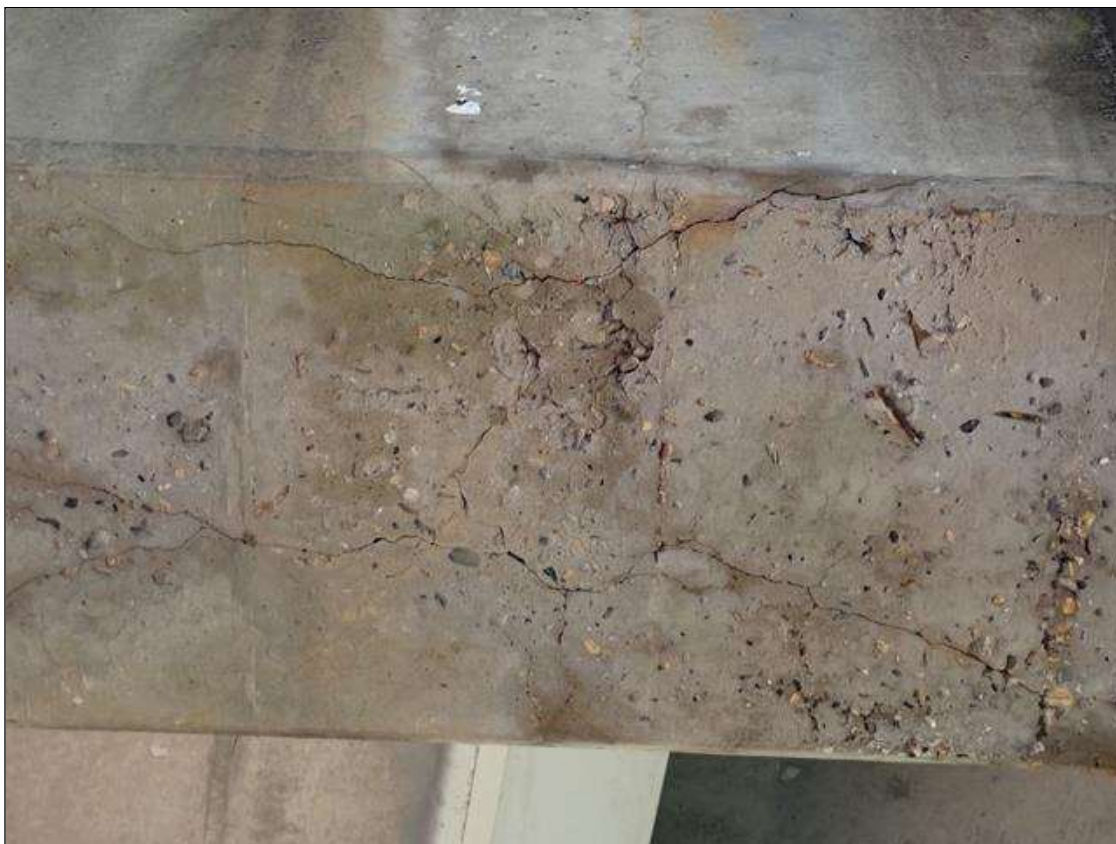
Bent 3 Cap 1: (PAR) both faces and underside, multiple delaminations (15 foot x 18 inch) with cracks (up to 1/8 inch) some with rust stains

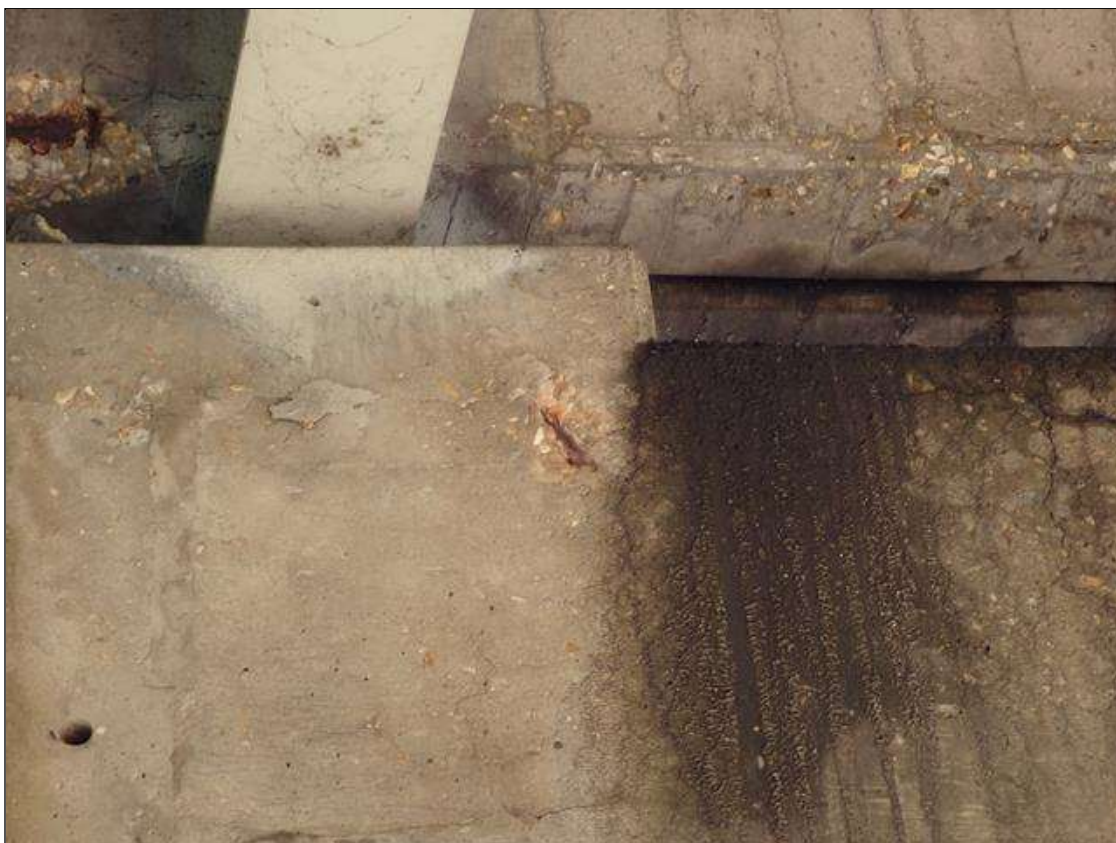
Bent 3 Cap 1: 5 INCH DIAMETER X 1/2 INCH SPALL WITH EXPOSED REBAR NORTH FACE UNDER BEAM 2

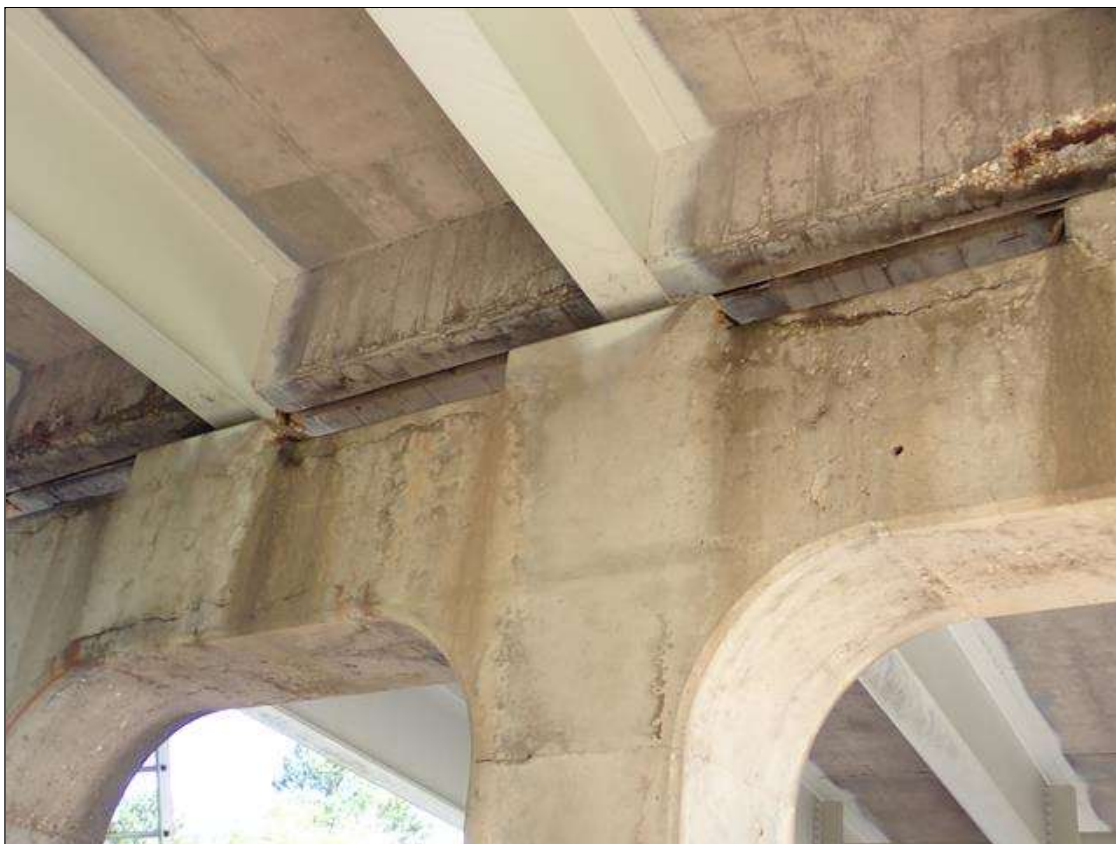
Bent 3 Cap 1: (PAR) both faces and underside, multiple delaminations (15 foot x 18 inch) with cracks (up to 1/8 inch) some with rust stains

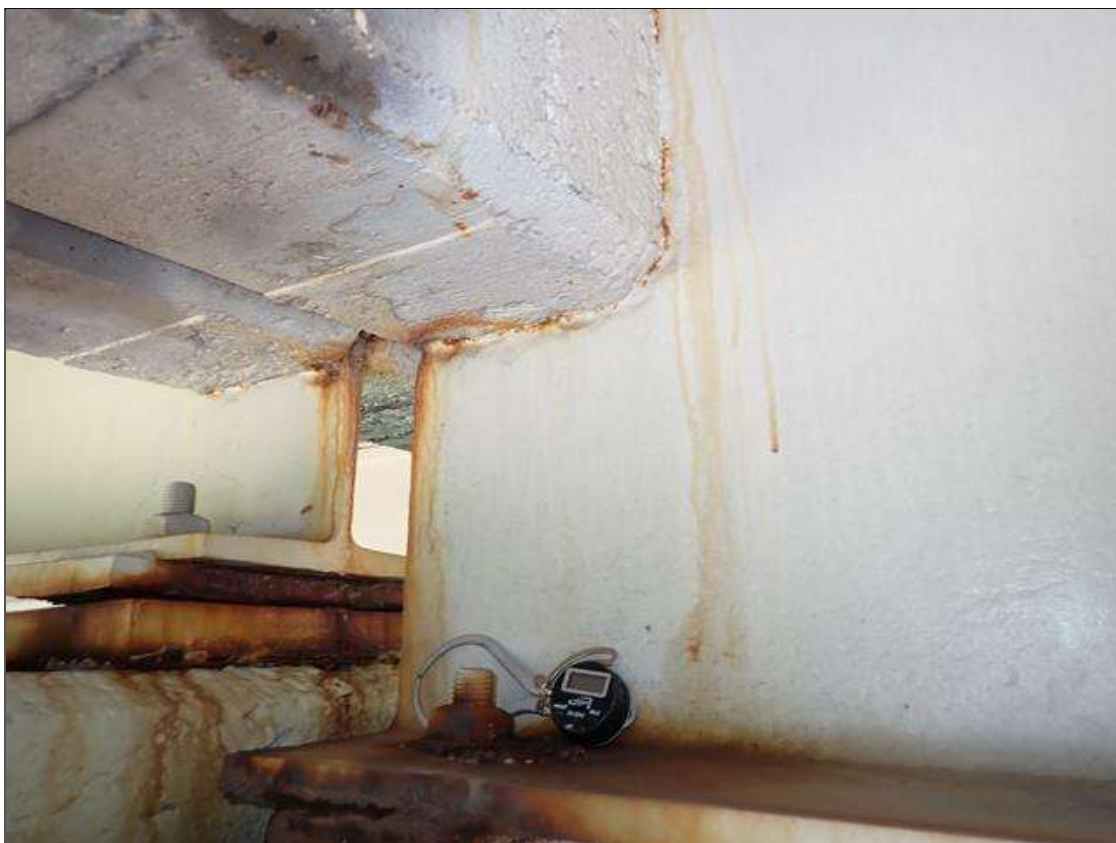
Span 3 Beam 4: at bent 3, painted over section loss/pitting: web adjacent to end diaphragm (1/2 inch average remaining x 10 inch x 2 inch)

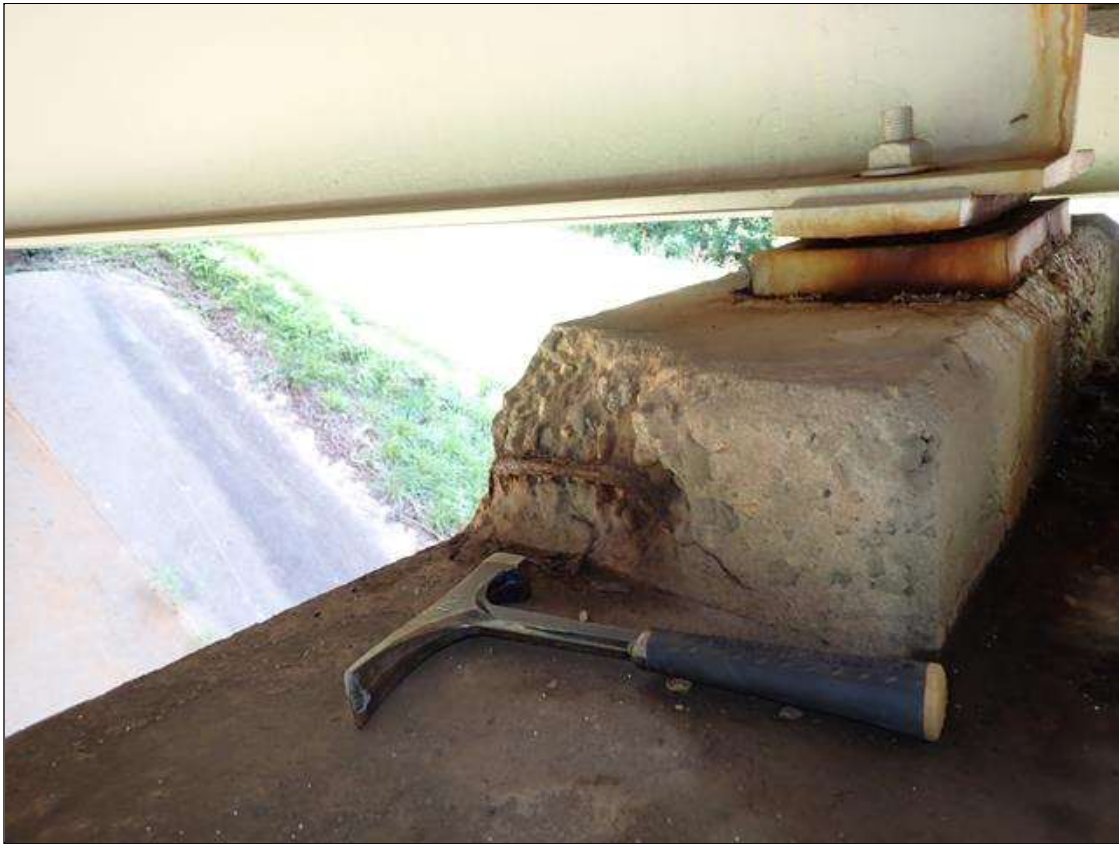
Bent 3 Cap 1: (PAR) 16 INCH X FULL HEIGHT X 2 INCH DEEP SPALL WITH EXPOSED REINFORCING WITH APPROXIMATELY 25 PERCENT LOSS, WEST FACE, IN BEAM 4 PEDESTAL.

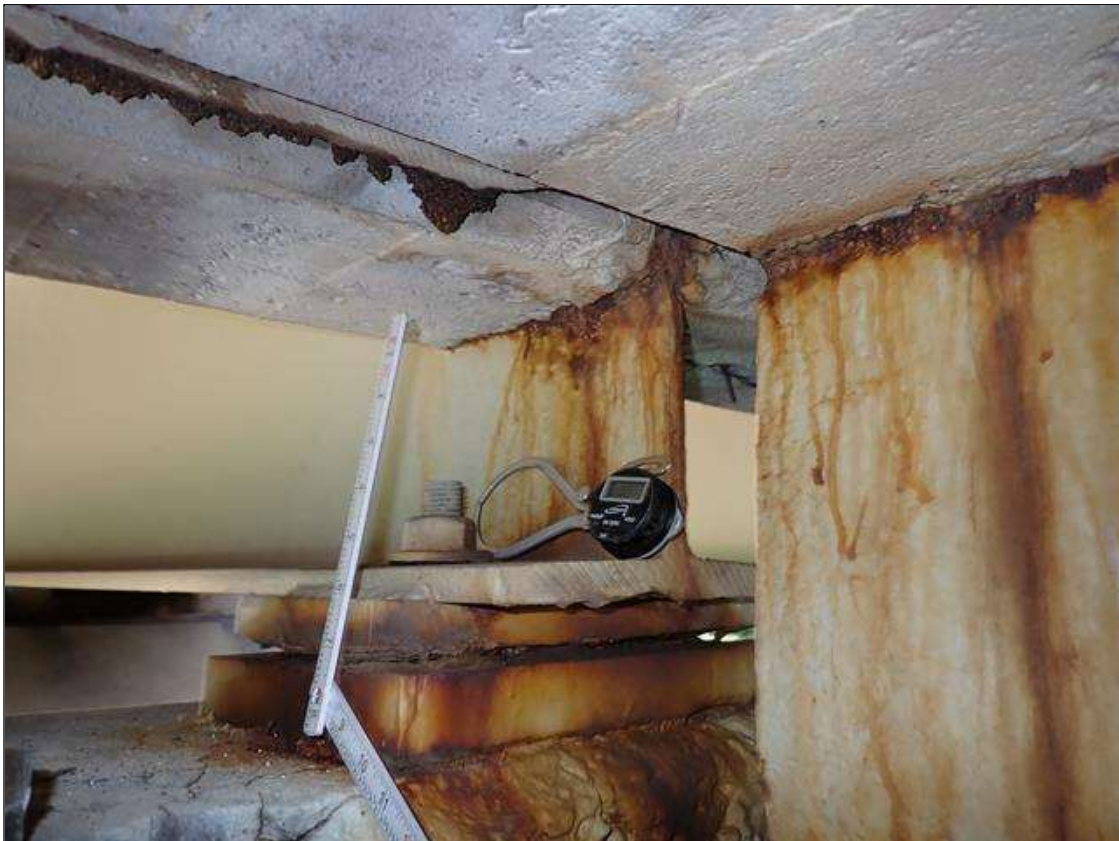
Span 4 Beam 3: (PAR) at bent 3, painted over section loss/pitting: web adjacent to end diaphragm (5/16 inch average remaining x 10 inch x 2 inch)

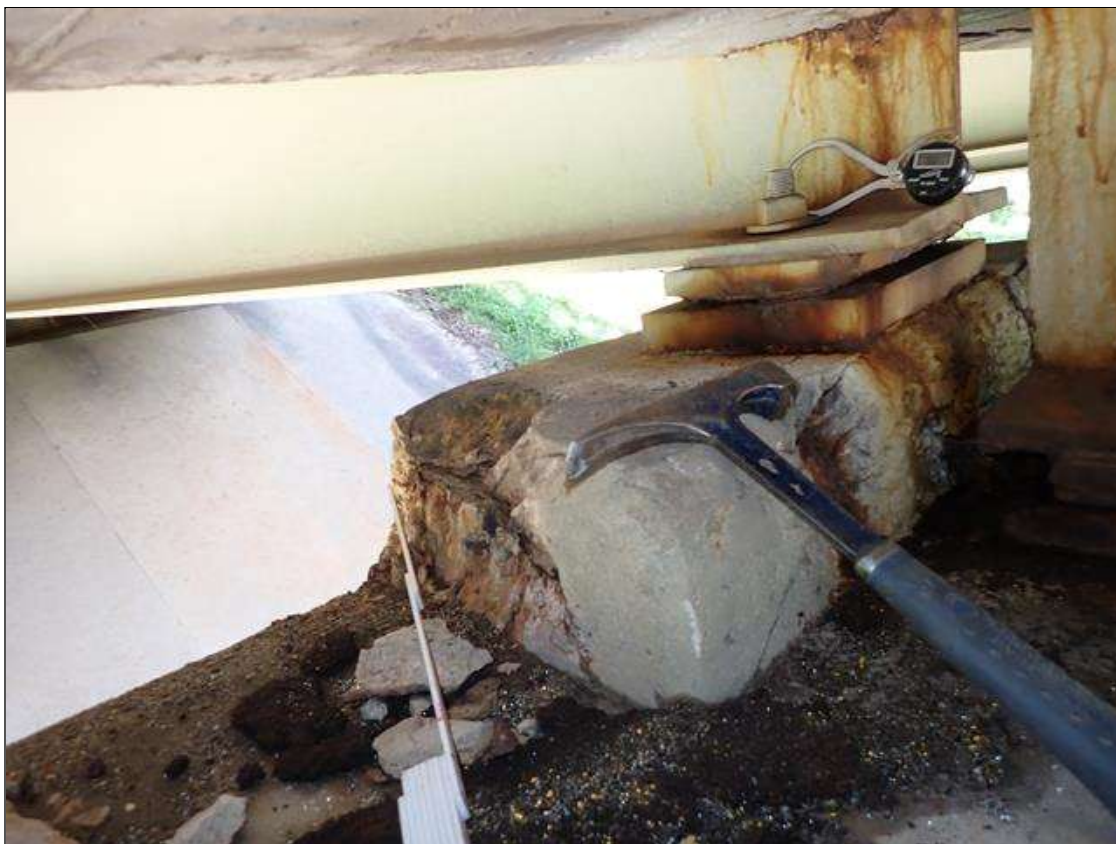
Bent 3 Cap 1: (PAR) 6 INCH X FULL WIDTH X 12 INCH X 2 INCH DEEP SPALL WITH EXPOSED REBAR WITH APPROXIMATELY 25 PERCENT LOSS, WEST FACE, IN BEAM 3 PEDESTAL.

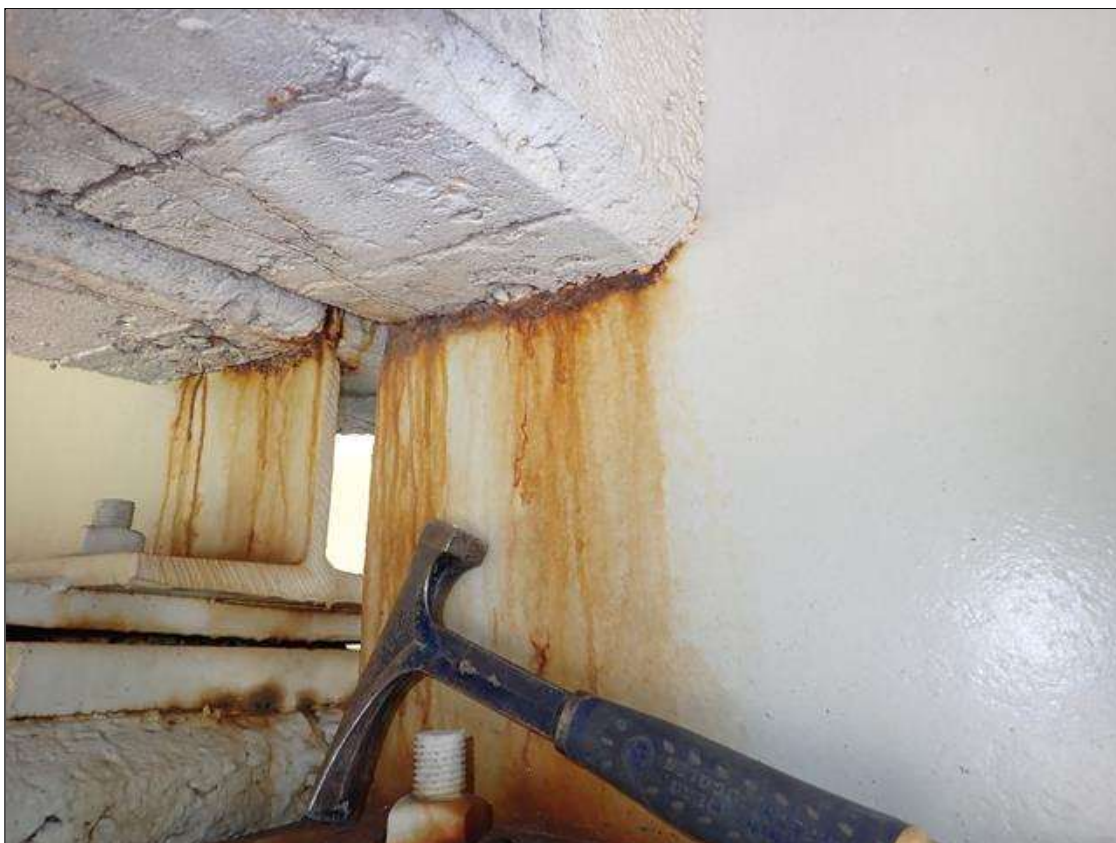
Span 3 Beam 2: at bent 3, web adjacent to end diaphragm, rust scale (10 inch)

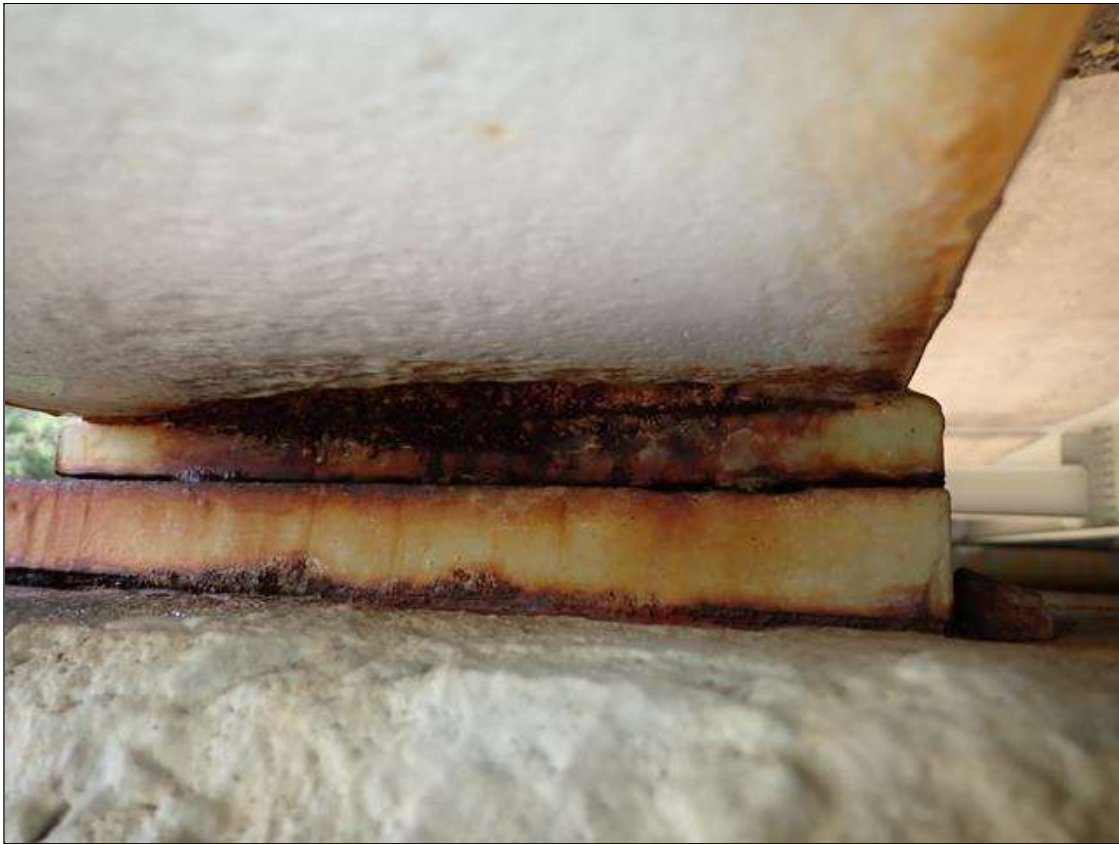
Span 3 Beam 1: at bent 3, painted over section loss/pitting: bottom flange (0.67 inch average remaining x 3 inch); web adjacent to end diaphragm, painted over pitting (up to 1/8 inch deep x 14 inch x 12 inch)

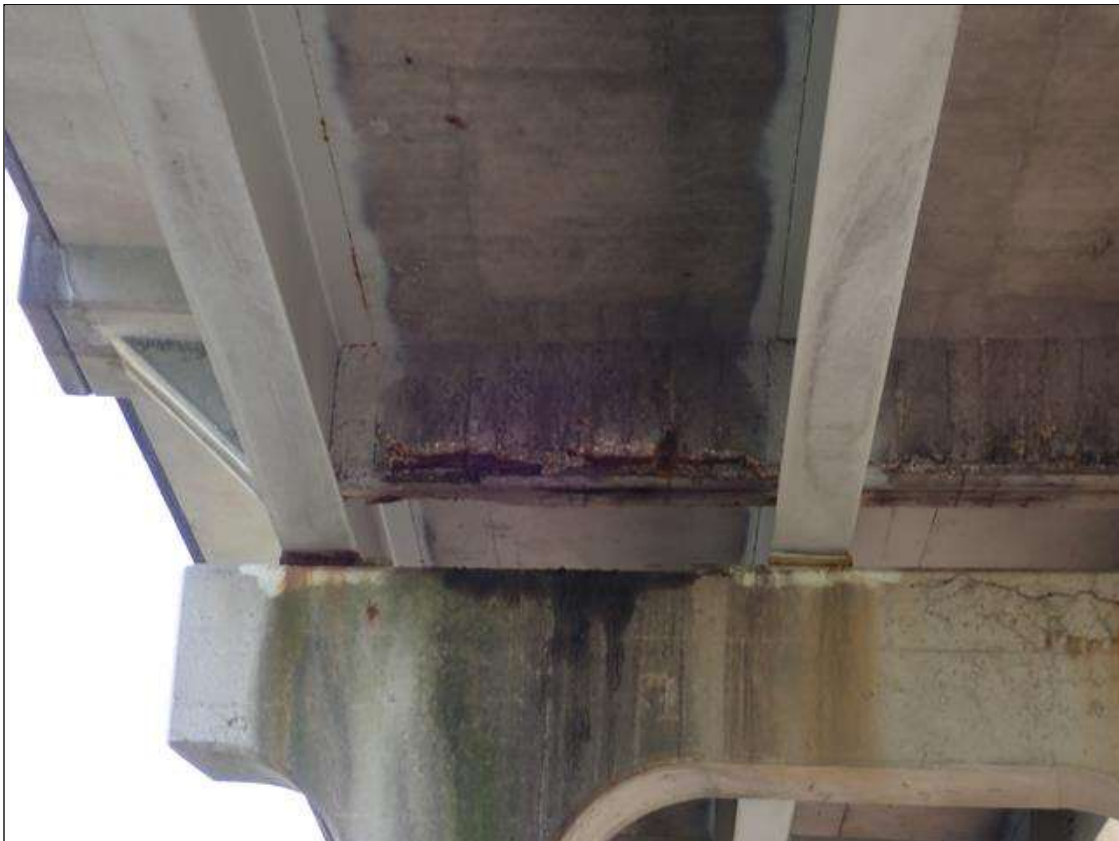
Span 3 Deck: (PAR) bay 4 end diaphragm over bent 2, spalls/delamination (full width x 1 foot x 1 inch deep) with exposed rusted rebar (approximately 25 percent loss)

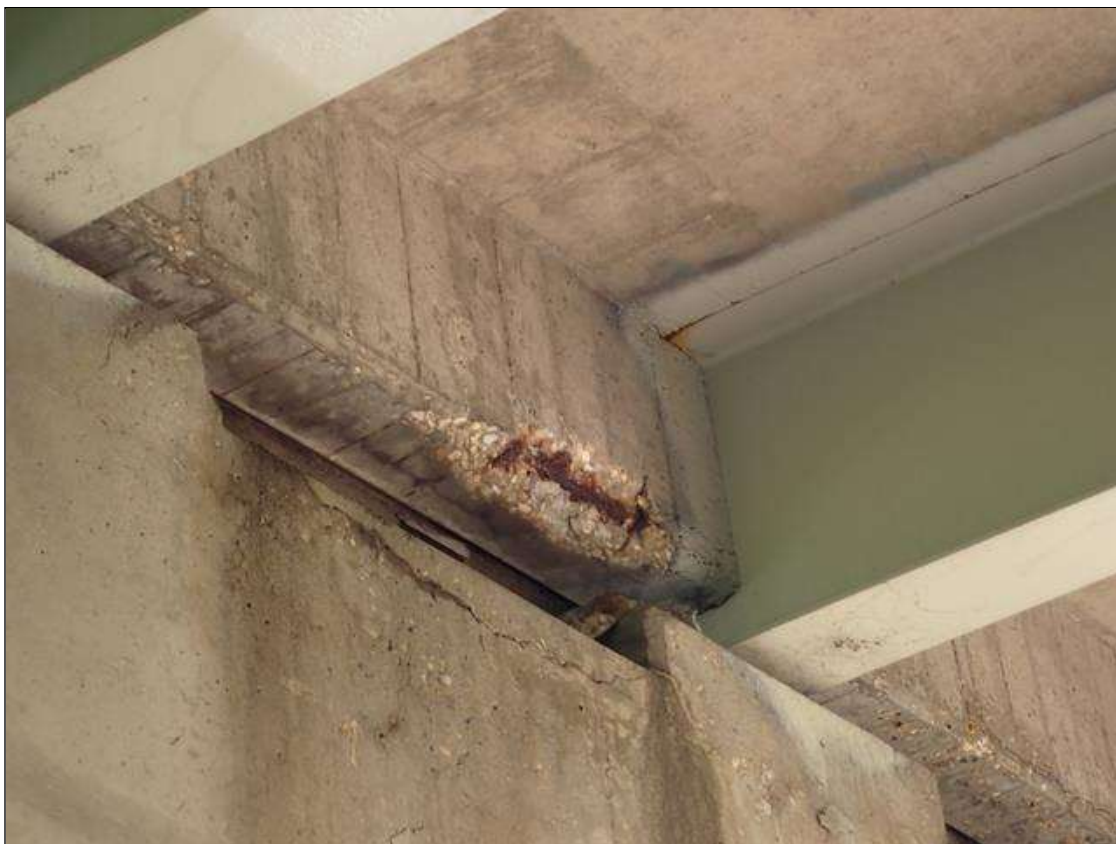
Span 4 Deck: (PAR) bay 2 end diaphragm over bent 2, spalls/delaminations (3 foot x 12 inch x 1 inch deep) with exposed rusted rebar (approximately 25 percent loss)

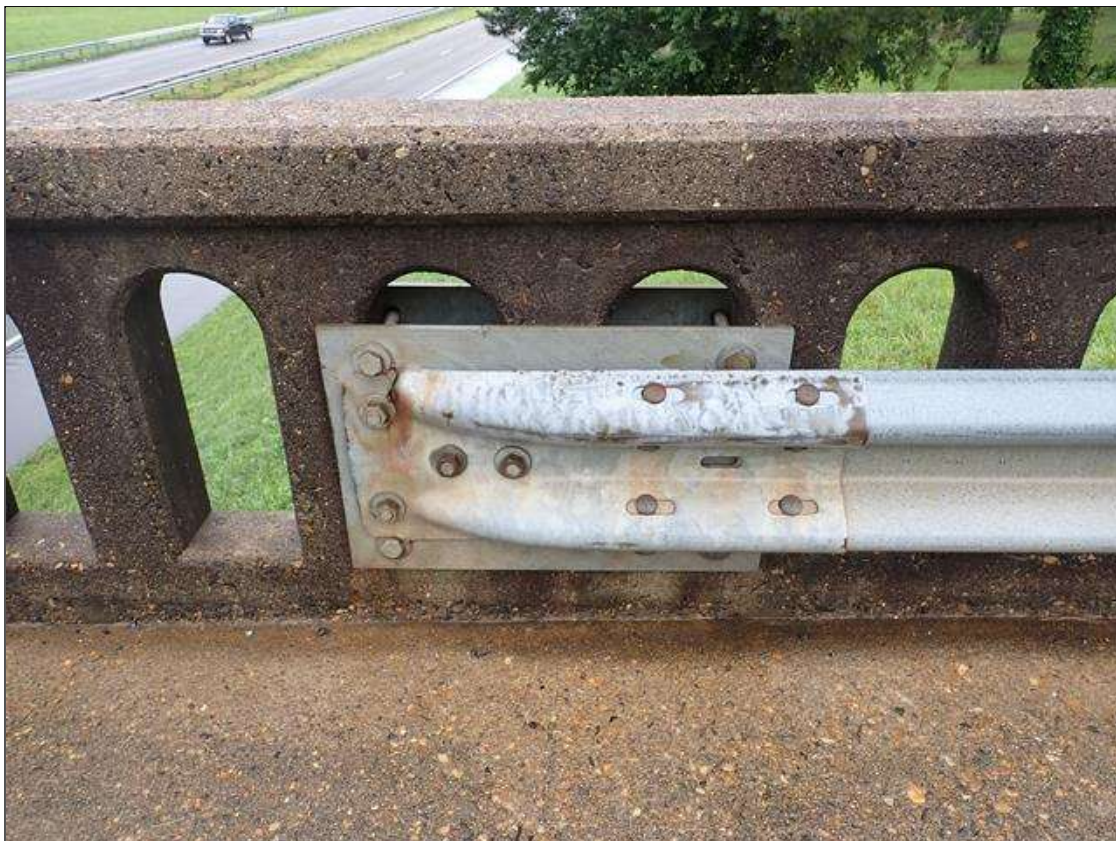
(PAR) northwest guardrail attachment, improper lap

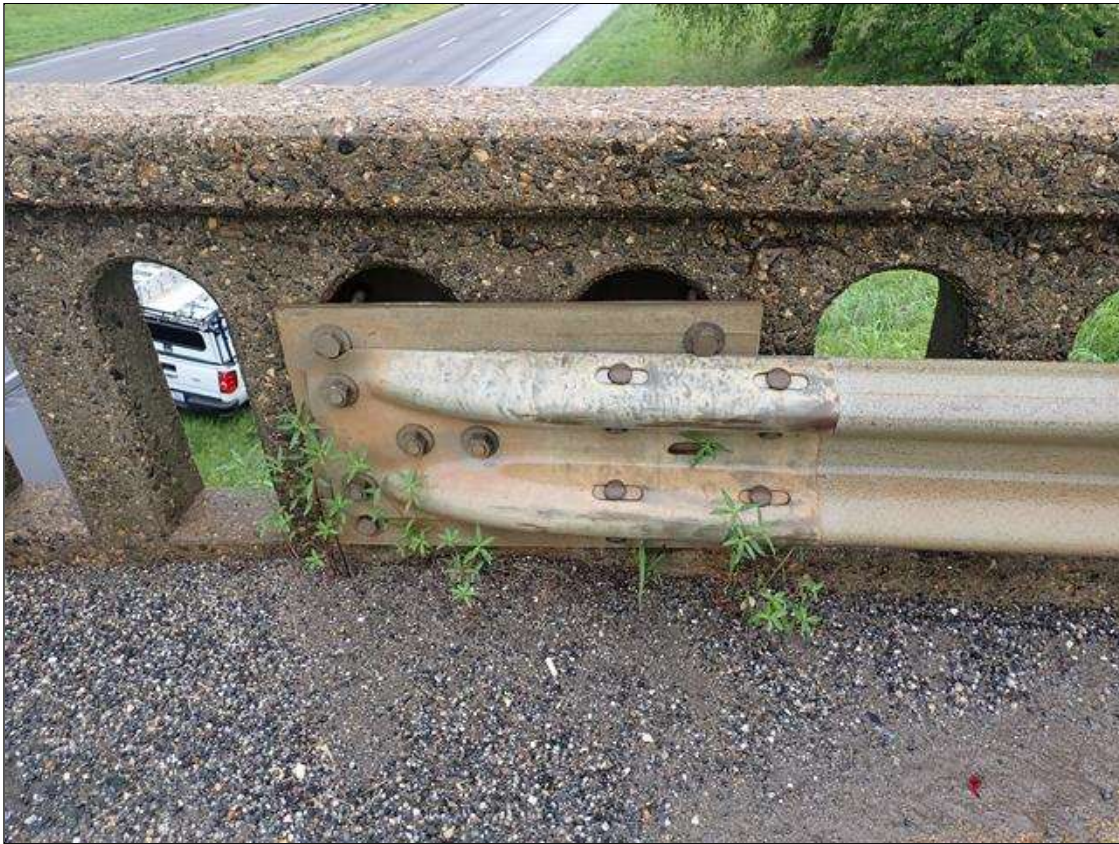
(PAR) southeast guardrail attachment, improper lap

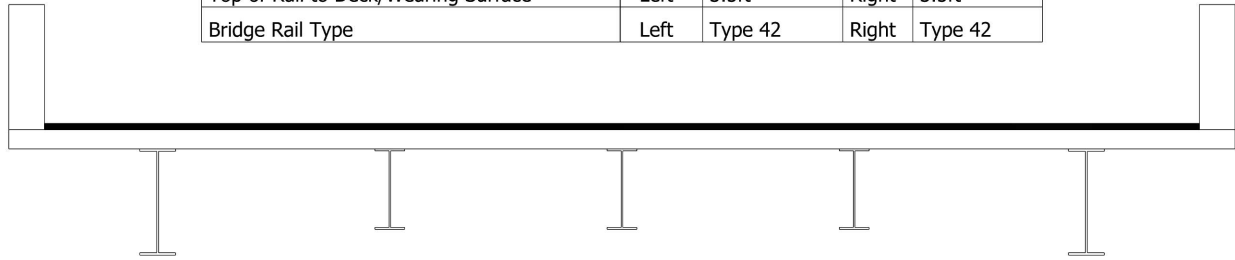
Measurements for Span #	1	All Spans Similar	
Deck Thickness	6.5in	Left Overhang	4.167ft
Top of Rail to Bottom of Beam (Avg)	7.167ft	Right Overhang	4.167ft

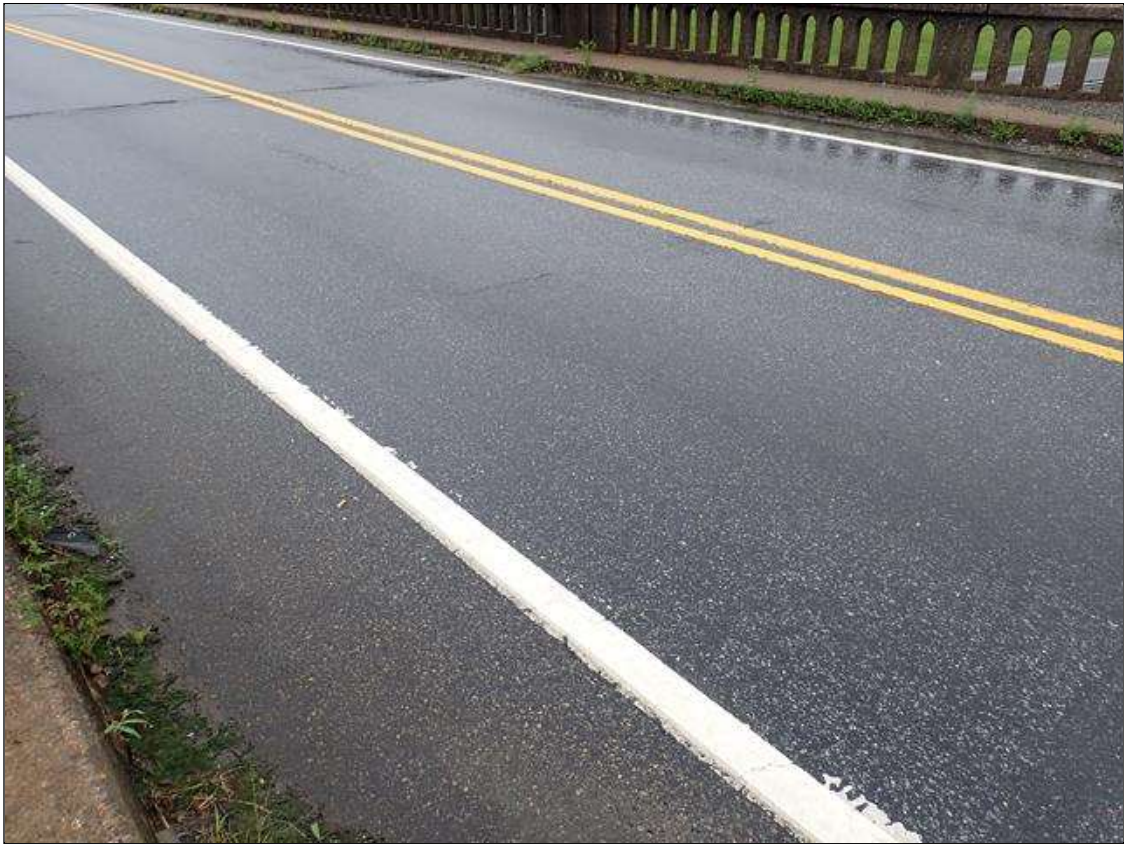
asphalt wearing surface
