**UT to Hominy Creek Stream Mitigation Site
TIP No. I -5402
Water Sampling and Benthic Macroinvertebrate Survey**

Haywood County, North Carolina

Monitoring Year 3 Report (MY-03)

**The North Carolina Department of Transportation
Project Development and Environmental Analysis Unit
Natural Environment Section**

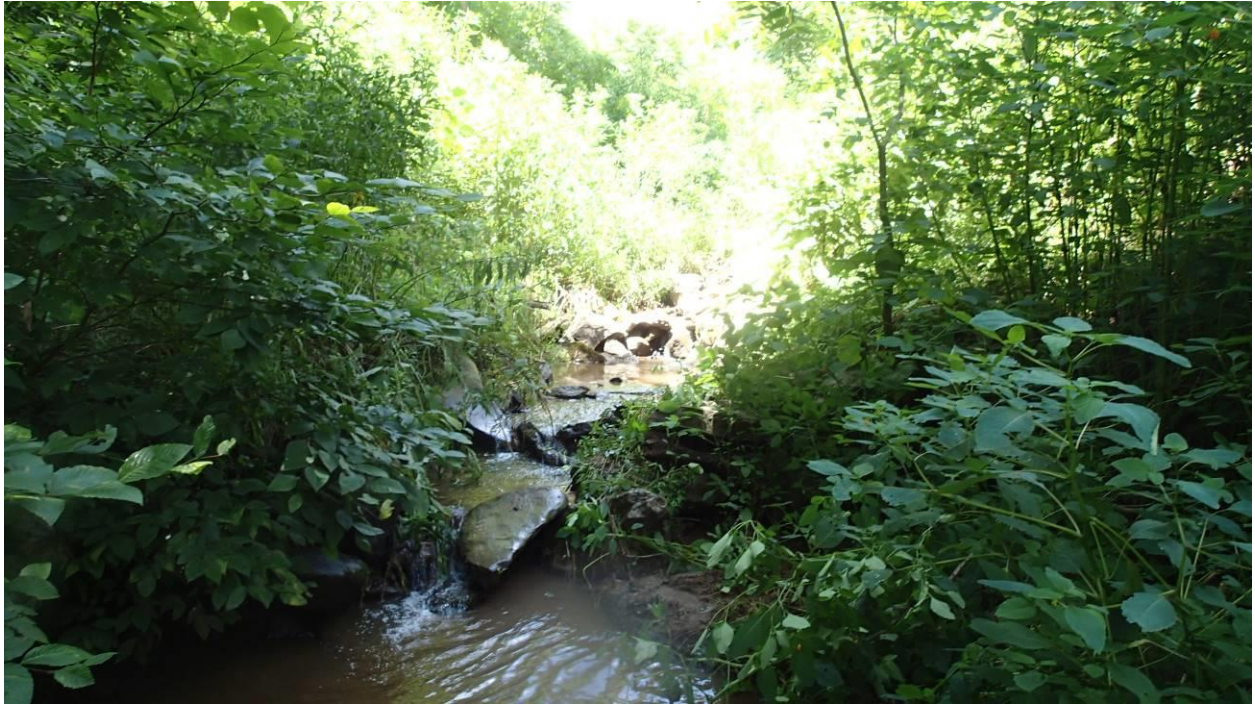
Site SA. Site SA is the most downstream site located on UT to Hominy Creek. The stream had a steep gradient with riffle pool sequence throughout. The top of bank width ranged from 1 to 3 meters (m) with a bank height of 1 m from the deepest part of the channel to the top of bank. At the time of the survey, the wetted width of the channel was approximately 1 m, with a water depth ranging from 0.2 to 0.5 m. Flow conditions were normal and the channel was wetted with little to no substrate exposed. Substrate was composed of boulder, cobble, gravel, sand, and silt. Very little aquatic vegetation was present in the channel. The riparian buffer was narrow with some mature trees in the lower portion of the reach and more shrubs and grasses in the upper portion of the reach.

Photo 1. Upstream facing view of Site SA.

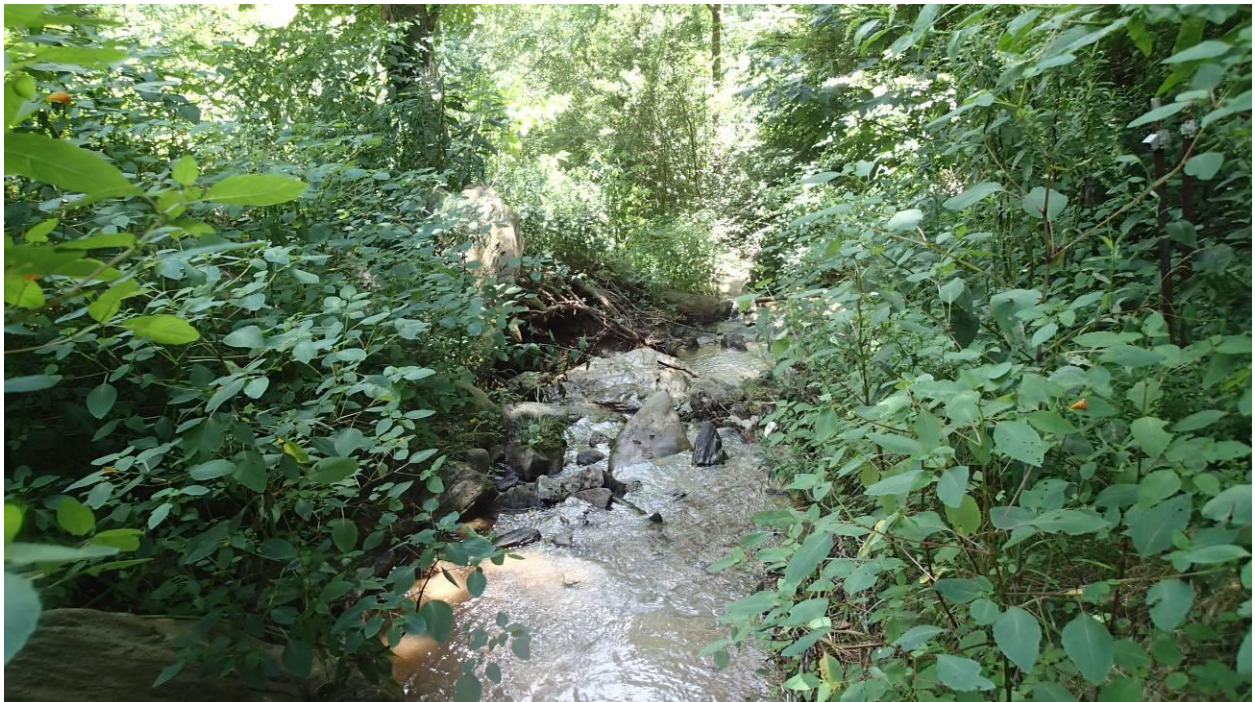
Photo 2. Downstream facing view of UT to Hominy Creek valley where Site SA is located.

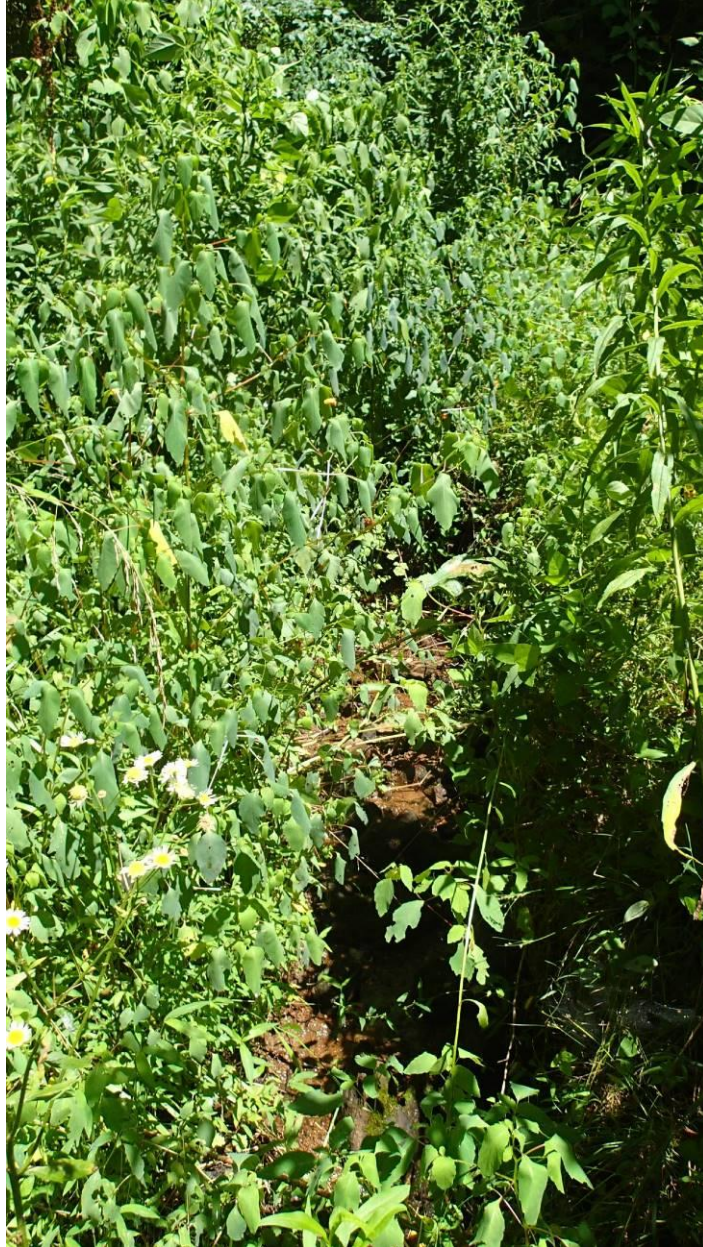
Site SE. Site SE is located approximately 200 m upstream of Site SA on a separate tributary flowing into UT to Hominy Creek. In contrast to Site SA, this site had a riparian buffer composed mainly of grasses and herbaceous vegetation (i.e. *Impatiens capensis*). Canopy tree species planted in 2014 within the stream buffer were observed. Stream wetted width ranged from 0.5 to 0.75 m. The water depth was very shallow throughout the site ranging from approximately 0 to 1 inches. Bank height from the deepest part of the channel to the top of bank was approximately 0.5 to 1 m. Flow conditions were normal and the channel was wetted with little to no substrate exposed. Stream habitat consisted of a shallow run throughout with no pools. The stream gradient was very steep just before a culvert near the confluence with UT to Hominy Creek. The substrate was mainly small gravel, sand, and silt underlain with bedrock.

Photo 3. Upstream facing view Site SE.

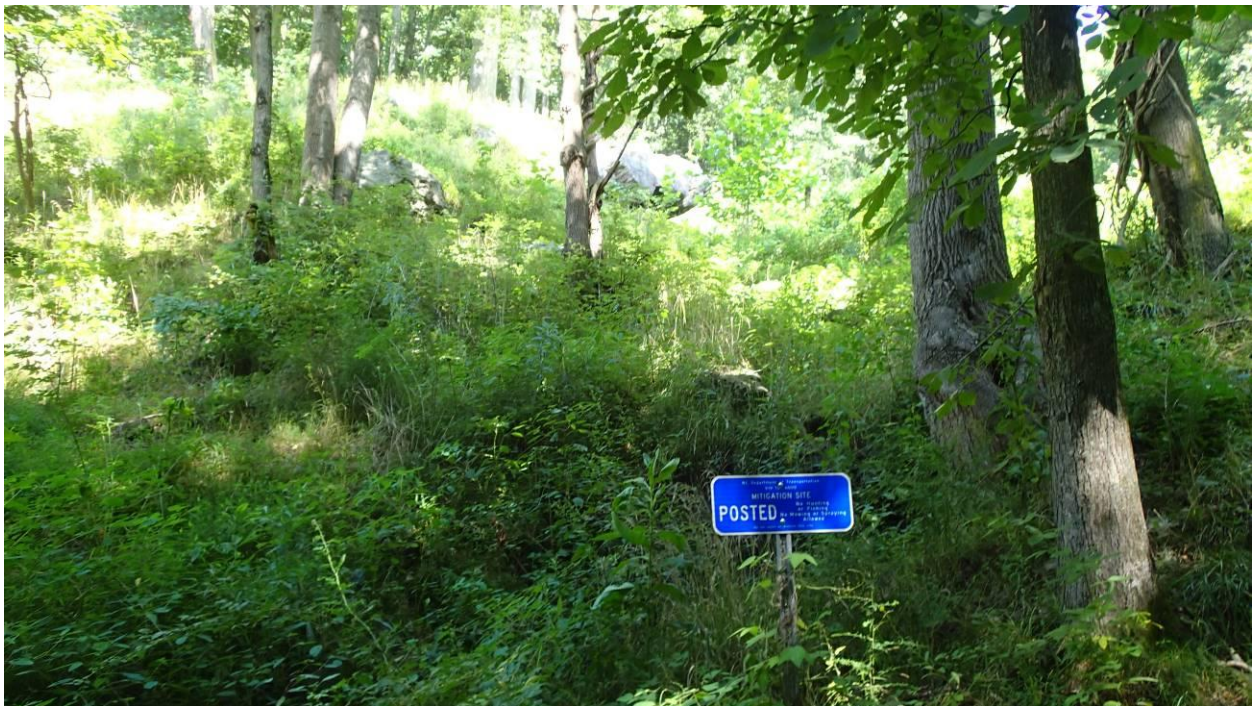
Photo 4. View of Site SE.
