ANNUAL REPORT FOR 2021

UT to Brushy Creek Site #33 Mitigation Site ONE ID #: 061-005 Mitchell County TIP No. R-2519B COE Action ID: SAW-2004-9987181 / 2004-30631 NCDWR Project #: 2013-0743v.2

Prepared By: Roadside Environmental Unit and Environmental Analysis Unit North Carolina Department of Transportation September 2021

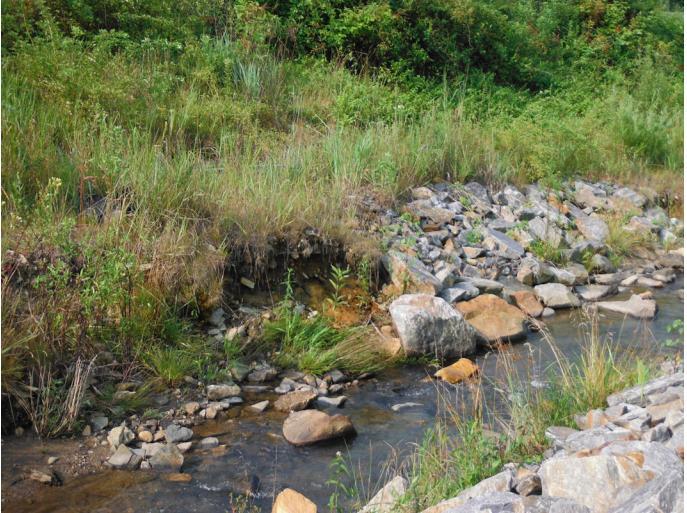
The visual assessment of the stream noted that the channel appears stable with little or no active bank erosion. Some minor bank scouring was noted along the left bank prior to the boulder toe wall. This area showed no change compared to the 2020 monitoring photos. NCDOT will continue to monitor the channel stability at Site #33 in 2022.

Minor bank scouring along left bank
