Privateer Farms Restoration Site

Annual Monitoring Report for 2007 (Year 3)

November 2007

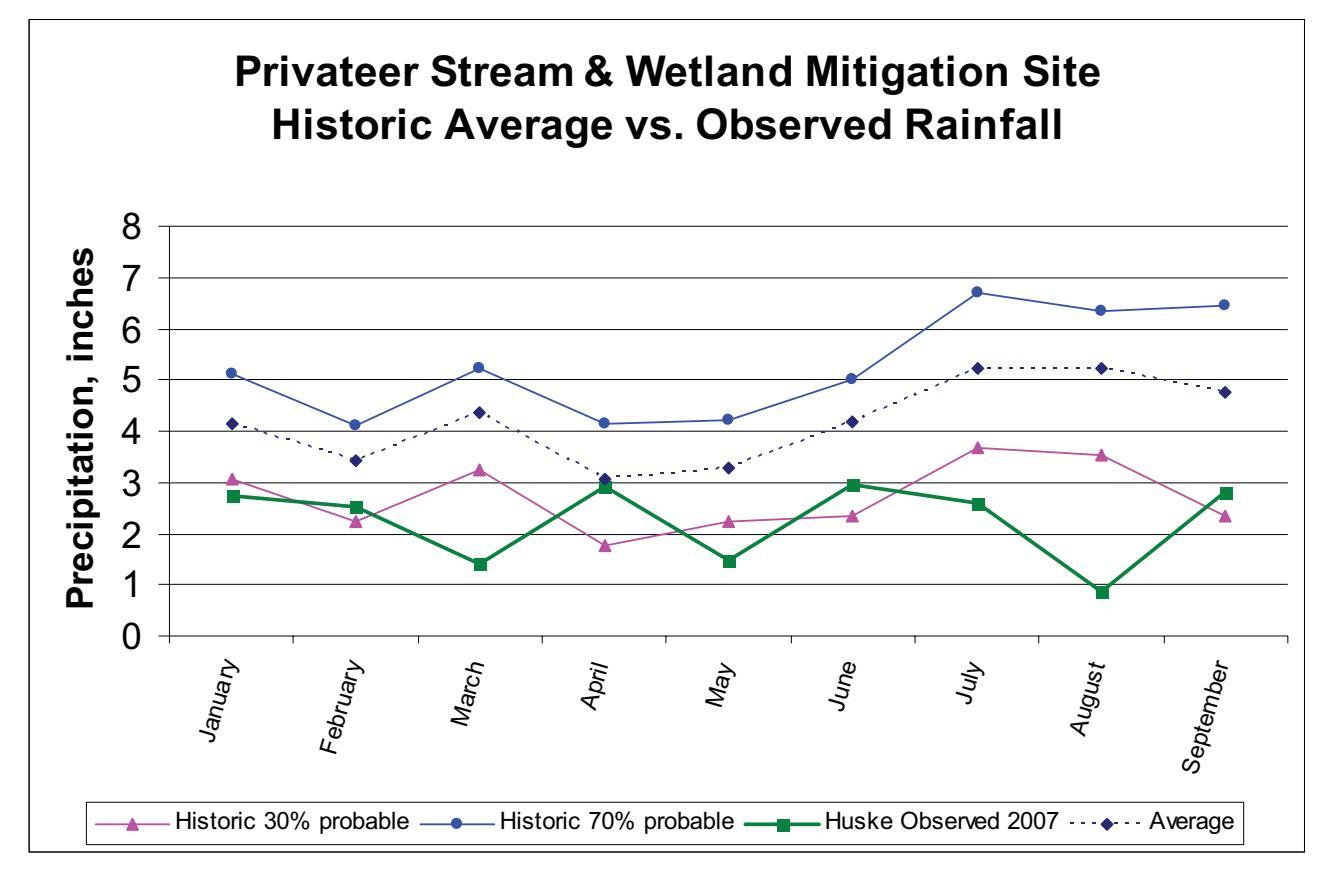
Figure 4. Comparison of Observed Rainfall and Historic Average Rainfall.

The total monthly rainfall for the 2007 growing season was below the approximated long-term average for the area. According to the automated weather station William O. Huske L&D, all months of the 2007 growing season experienced below average rainfall with the exception of April, which experienced normal conditions. For much of 2007, North Carolina was considered to be in severe drought conditions.

According to the automated weather station William O. Huske L&D, total rainfall for the 2007 growing season was more than 15 inches below the long-term average for total growing season rainfall. Year 3 may be considered an extremely dry year since the total monthly rainfall was half of the long-term average for the growing season. Table 4 and Figure 4 compare historic and average rainfall over the area with those observed during the 2007 growing season.

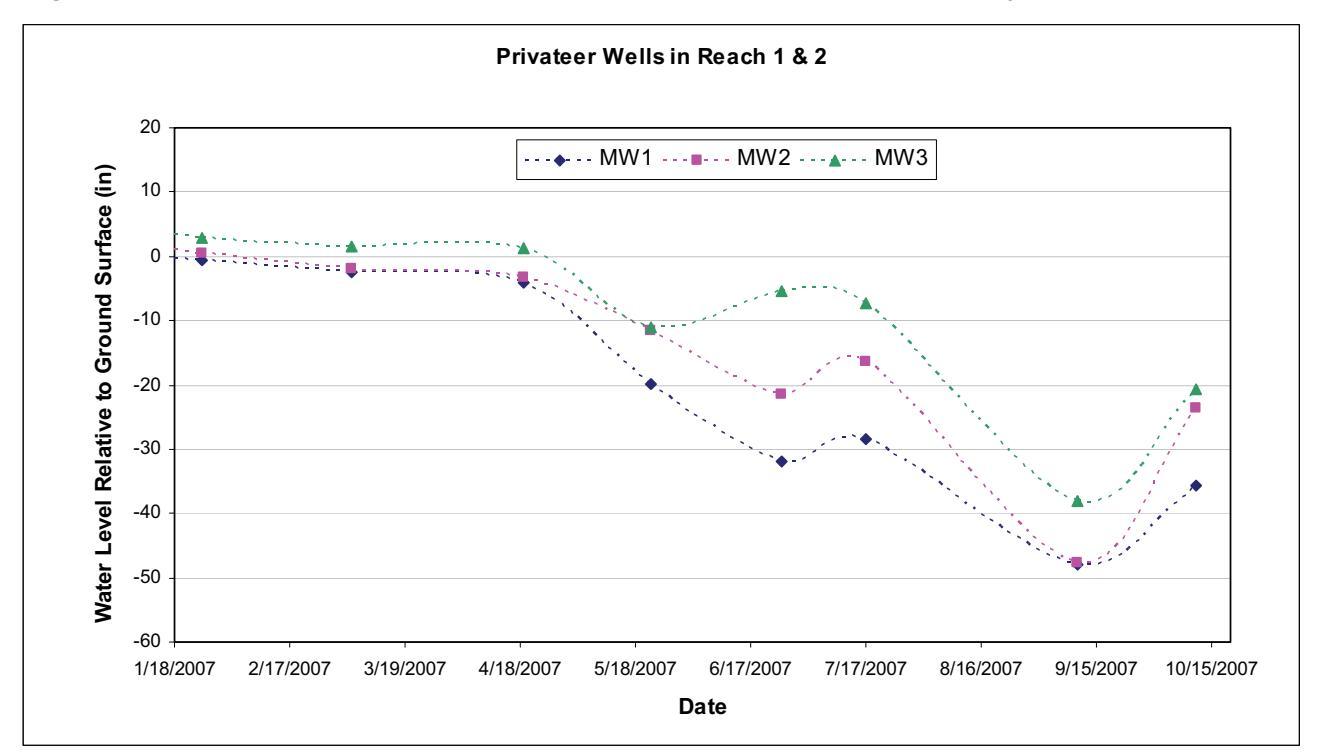
Figure 5. Well Data for Reach 1 and Reach 2 of the Privateer Restoration Project.

Data collected during Year 3 from the fifteen automatic monitoring well gauges at the Site showed that groundwater levels met hydrologic success criteria for only five of the gauges. The ten automatic gauges that did not meet the success criteria exhibited a continuous hydroperiod from 3.1 percent to 9.1 percent. However, the gauges did exhibit a cumulative hydroperiod from 10 to 58 days or 3.9 percent to 24.0 percent of the Year 3 growing season, indicating that the locations experience significant wetness, but the water table fluctuated rapidly, therefore, surface saturated conditions during the 2007 growing season were not present for long periods of time. Data collected from on-site gauges are presented in Appendix 4. The hydrologic monitoring results for the gauges are shown in Table 5.

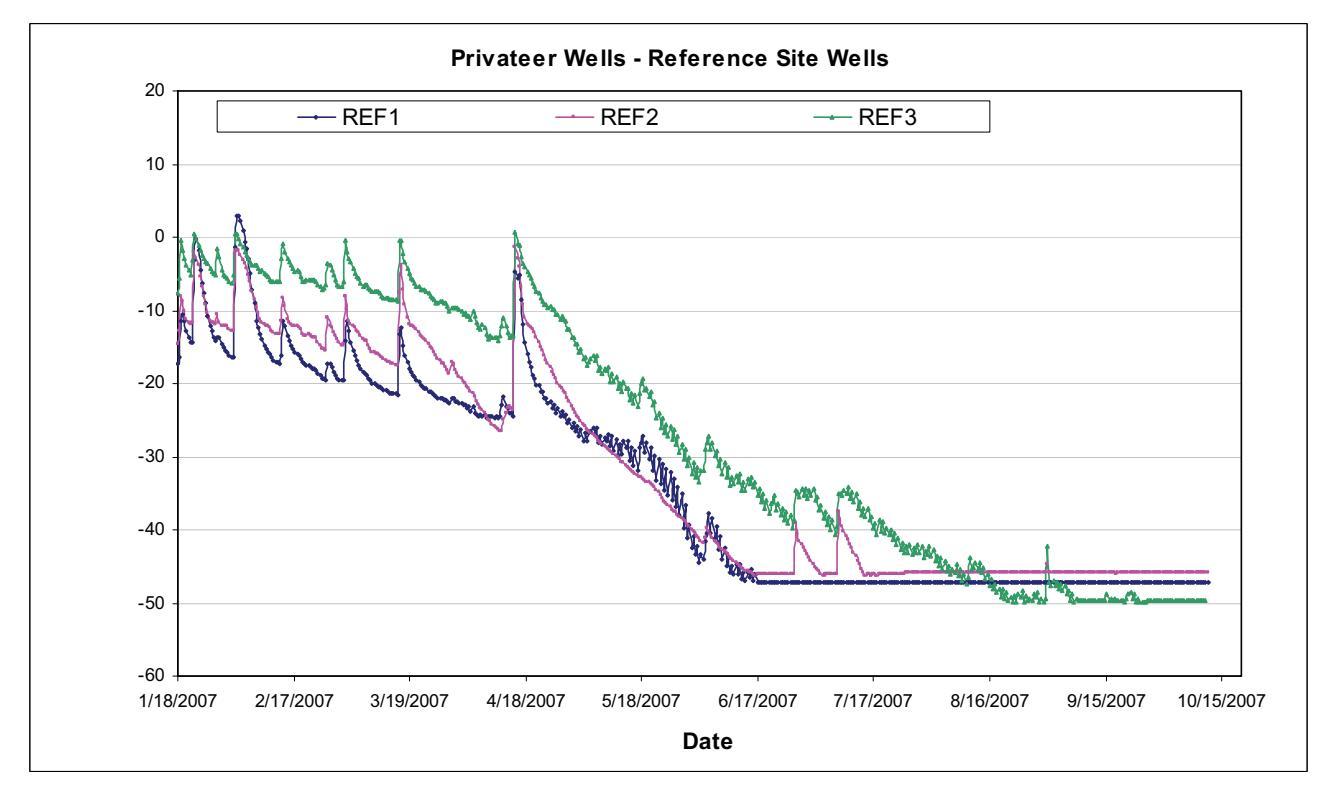
Figure 12. Well Data for Reference Site Wells - Privateer Restoration Project.

The three wells located in the reference site also indicated drier than normal conditions for 2007. The three automatic gauges exhibited a continuous hydroperiod from 2.5 to 16.5 days or 1 percent to 6.8 percent. The gauges exhibited a cumulative hydroperiod from 3 to 31 days or 1.0 percent to 12.8 percent of the Year 3 growing season. The REF3 gauge documented similar hydrologic conditions to areas of the Site, with a continuous hydroperiod of approximately 6.8 percent. The other two reference wells documented drier conditions, and it is suspected that these locations are experiencing a significant drainage effect from the nearby stream channel, especially during the drought conditions of 2007.
