Highway Geophysical Applications From the Rocky Mountains to the Volcano National Park Jacob Sheehan

Collier Geophysics

NPS Emergency Response Problem Statement: pavement distress and holes/voids along Chain of Craters Road

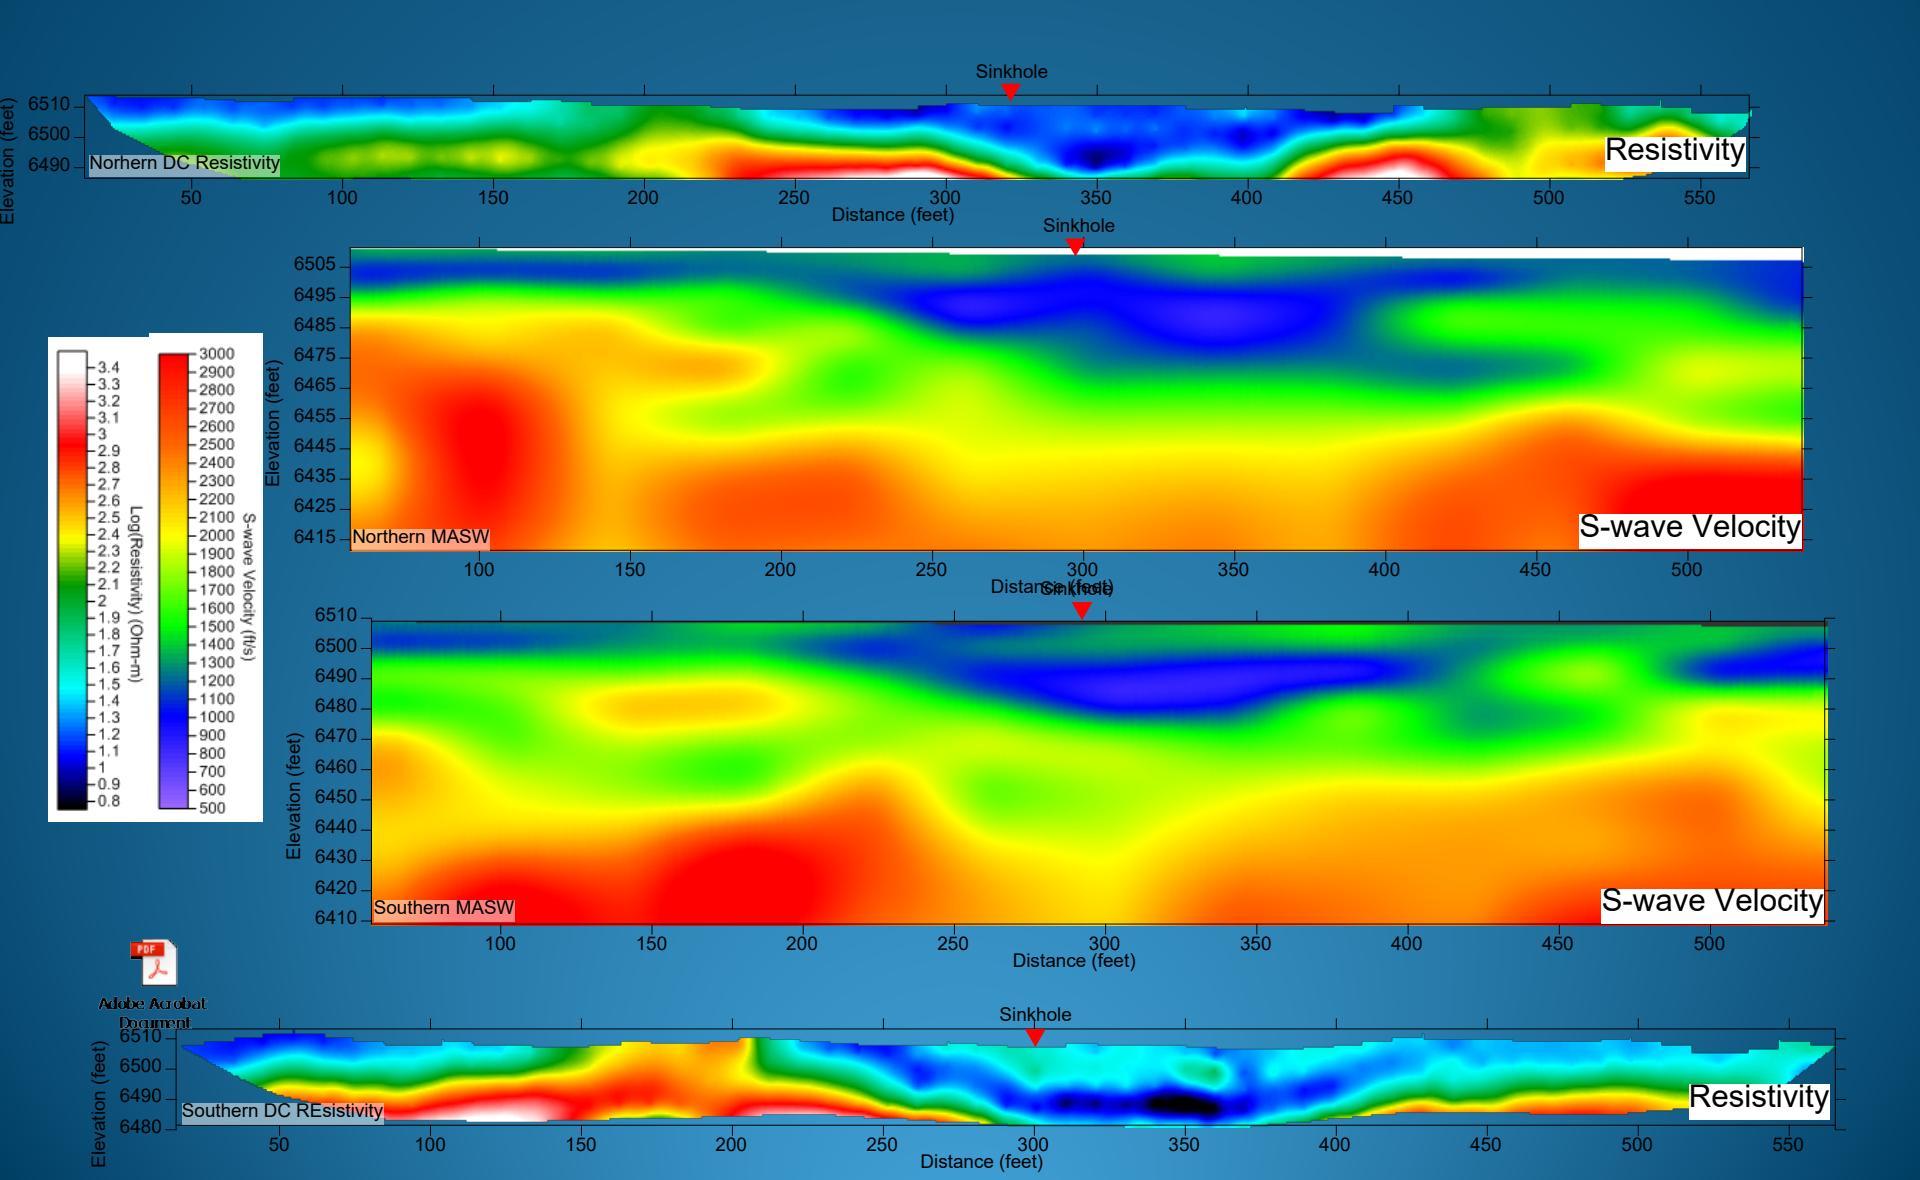
Results

- The resistivity results show a conductive zone that is centered to the east of the sinkhole feature that is 20 to 30 feet deep at the center
- The shear-wave velocity shows a low velocity zone in the same area as the conductive zone noted in the resistivity
- Combined, this suggests that there is a soft and possibly moist zone that is settling, causing the erosional/collapse feature observed.
 - We concluded that the hillside was slumping in the area of this soft moist zone, creating fissures at the edges of the slump.

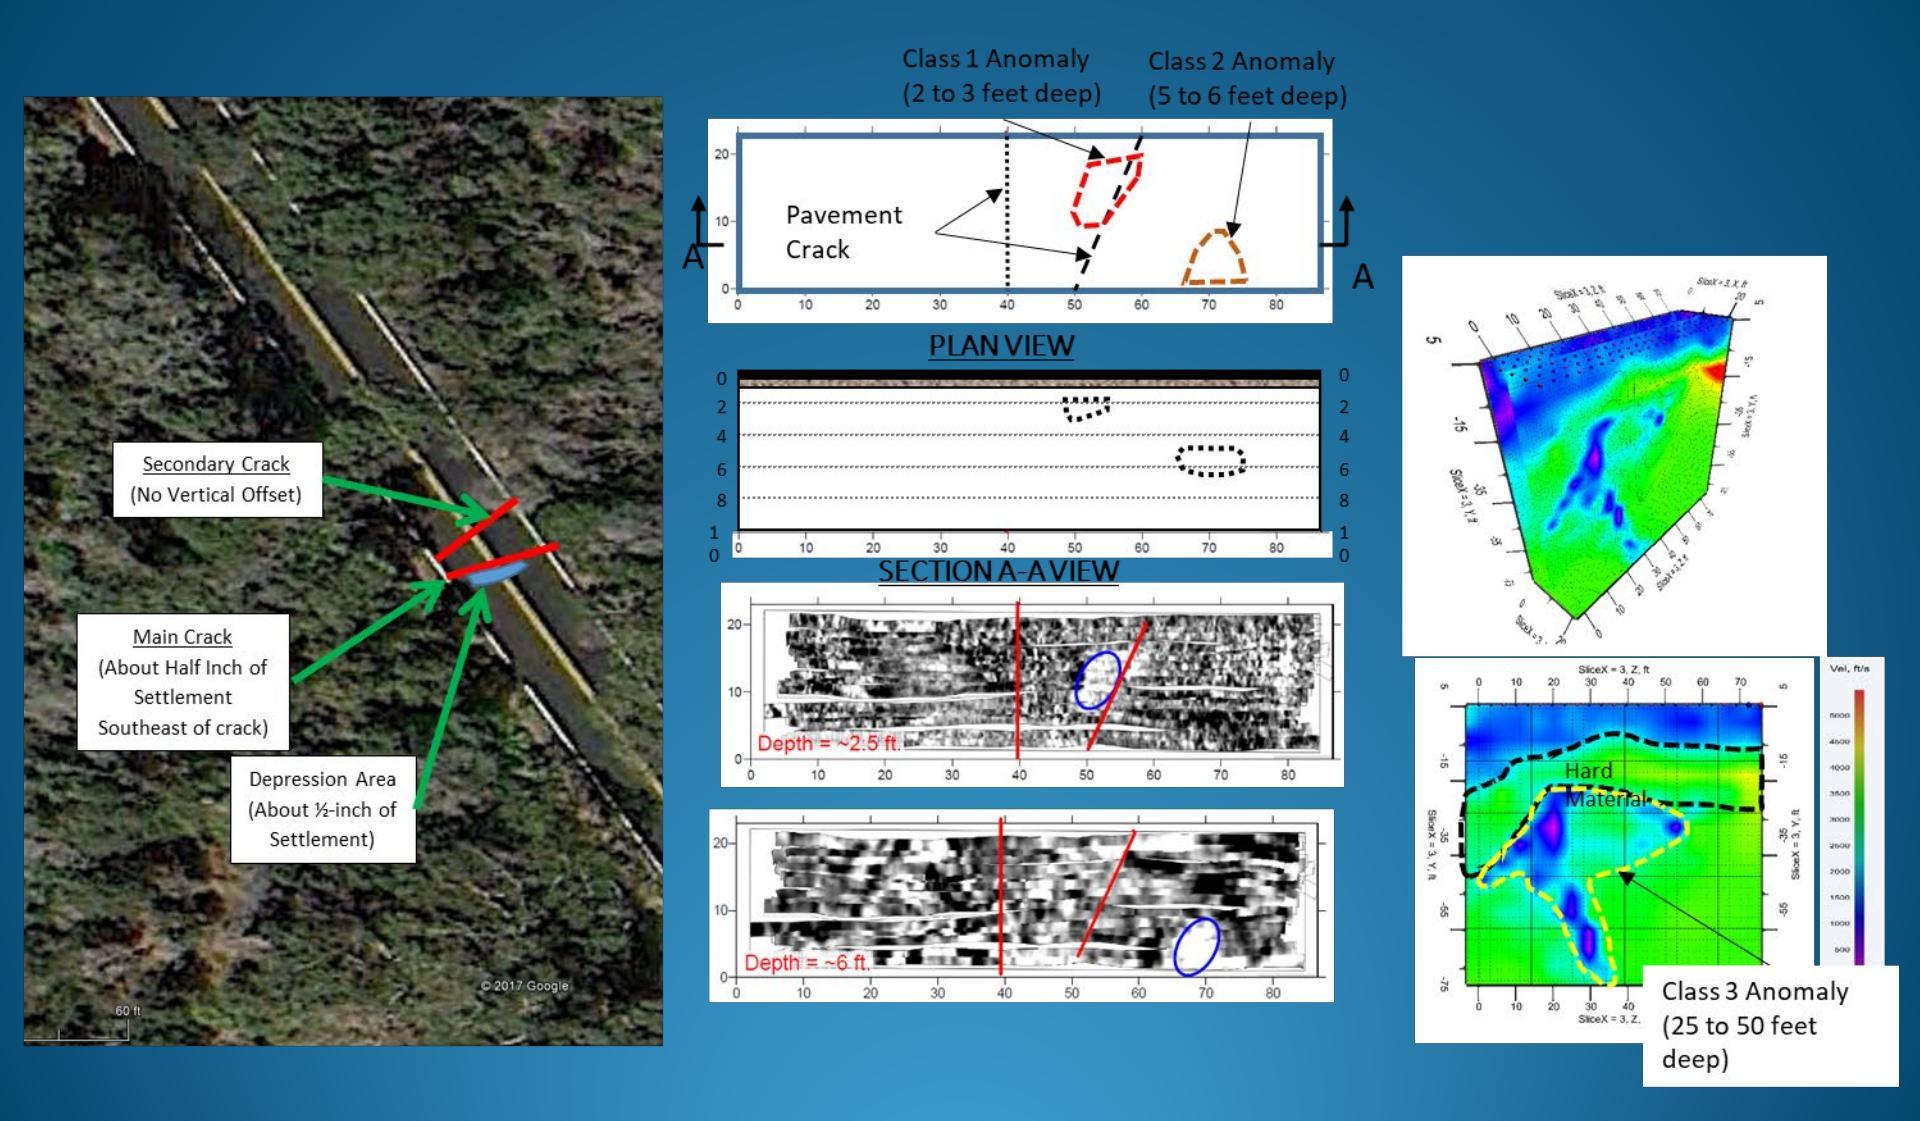
Study Area No. 1

3D GPR RESULTS

3D SRT RESULTS
