NC DEPARTMENT OF TRANSPORTATION
 DIVISION OF HIGHWAYS
 STRUCTURE MANAGEMENT UNIT

ATTENTION: **PAR SUBMITTED- NEW ASPHALT WEARING SURFACE**

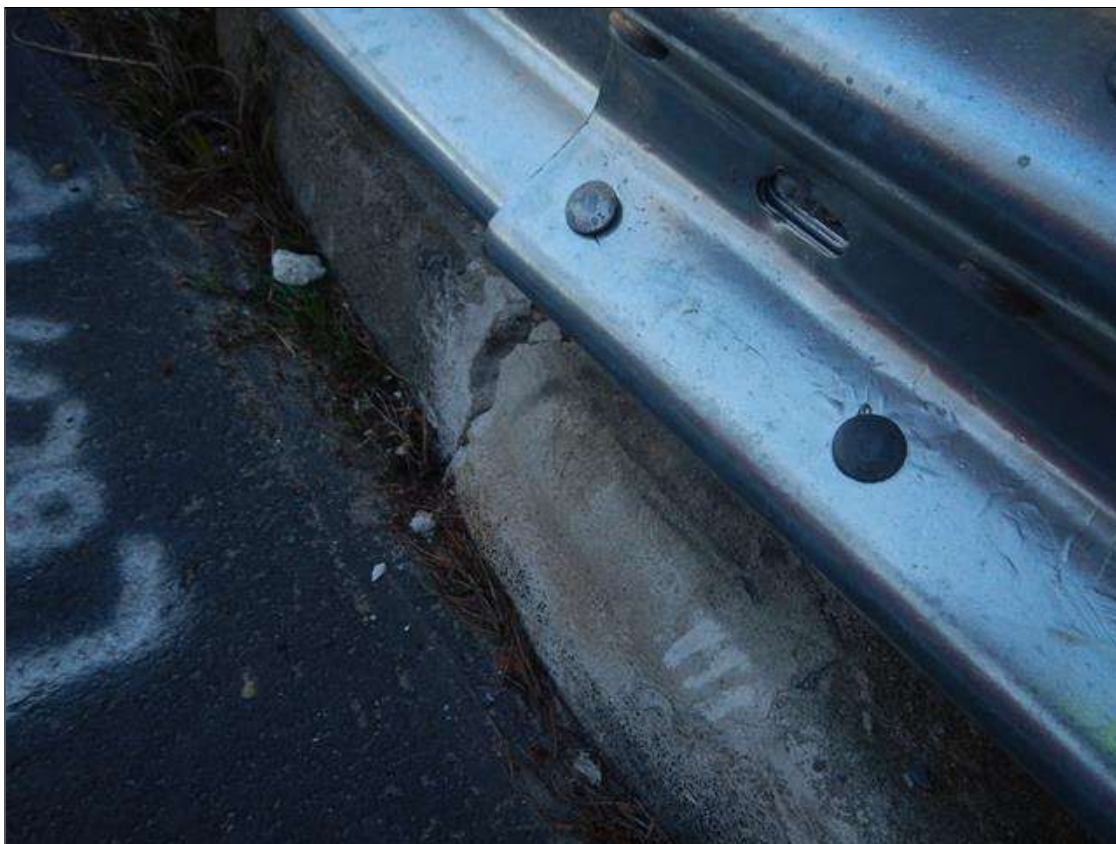
Span 1 Deck: 1 SQUARE FEET SOUND PATCH IN LEFT CURB OVER BENT 1

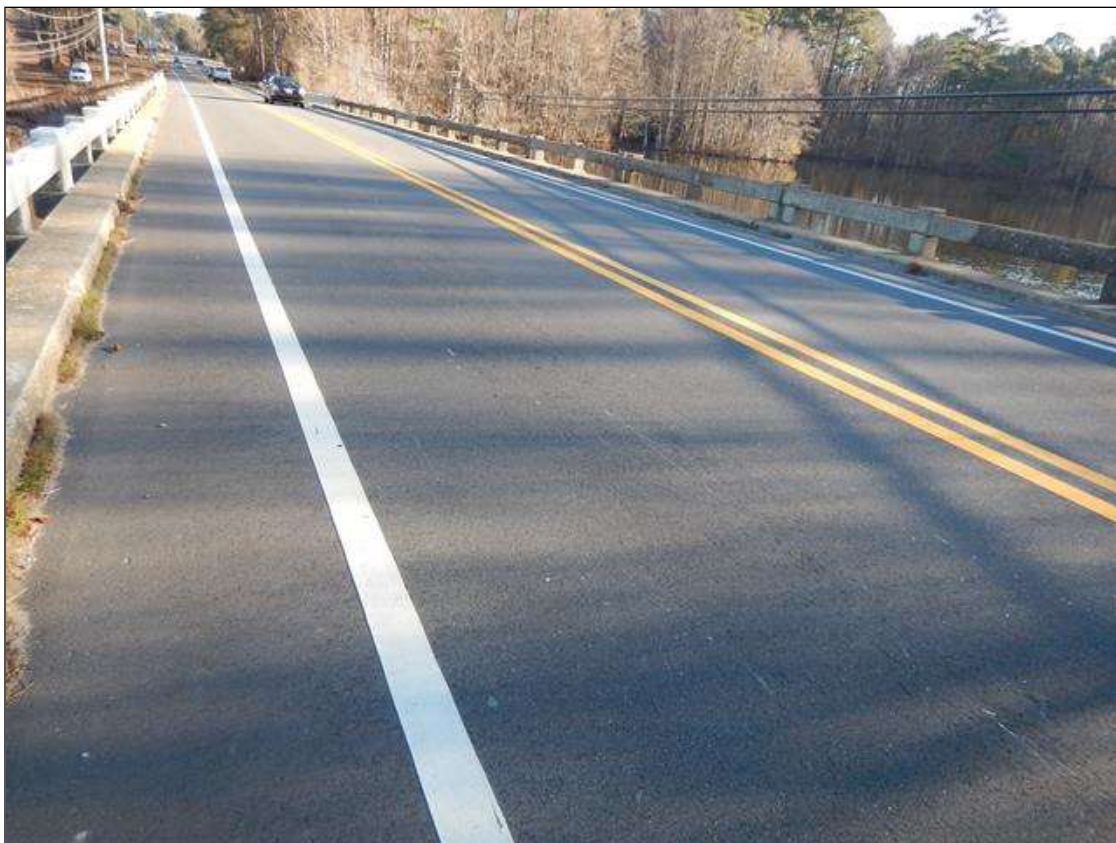
NEW 1/2 INCH ASPHALT WEARING ADDED TO THE DECK

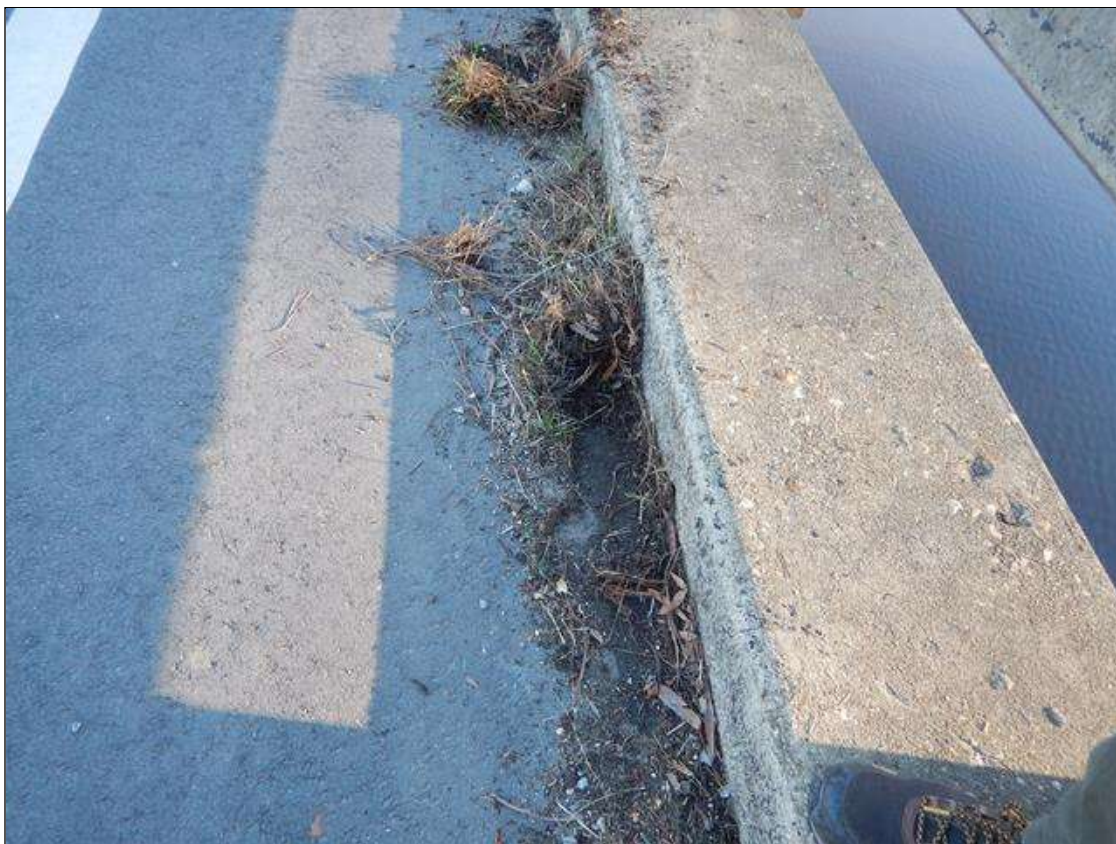
DECK DEBRIS 6 INCHES WIDE X FULL LENGTH ALONG RIGHT CURB

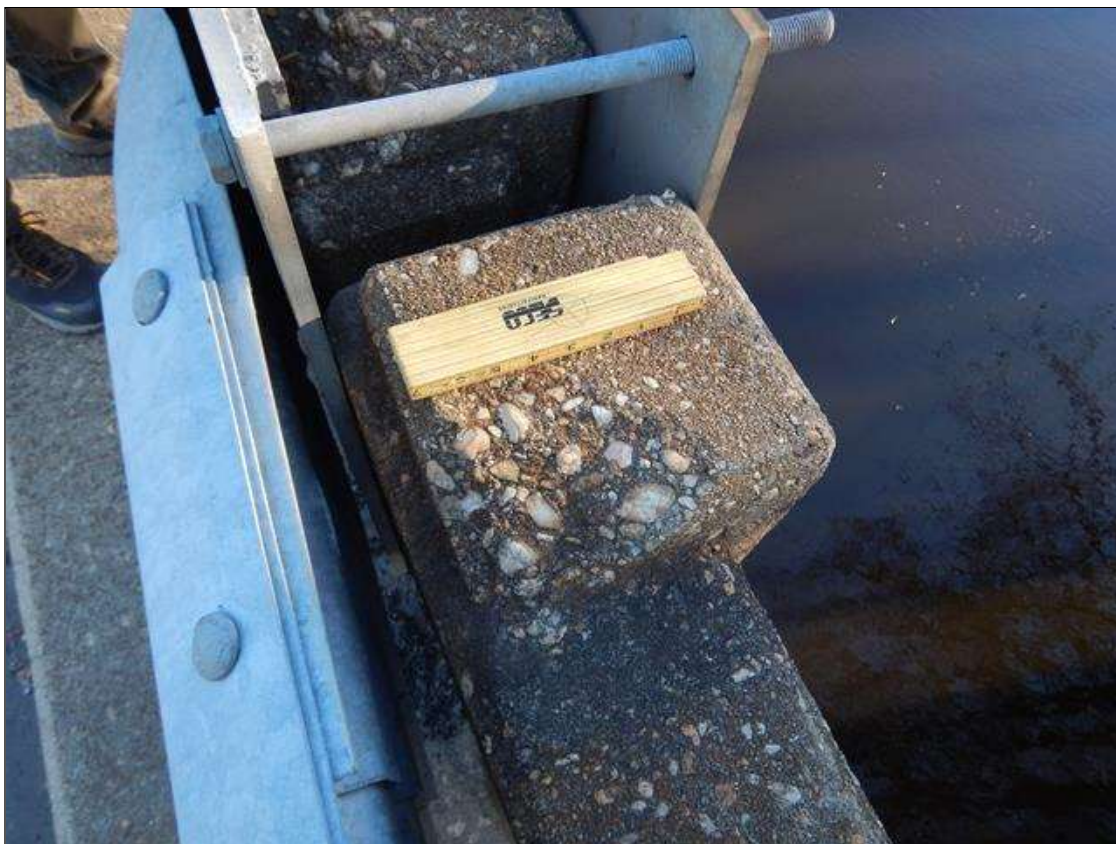
Span 1 Right Bridge Rail: 6 INCHES WIDE X 3 INCHES LONG X 1/2 INCH DEEP OF SPALLING/DELAMINATION POST 3 .

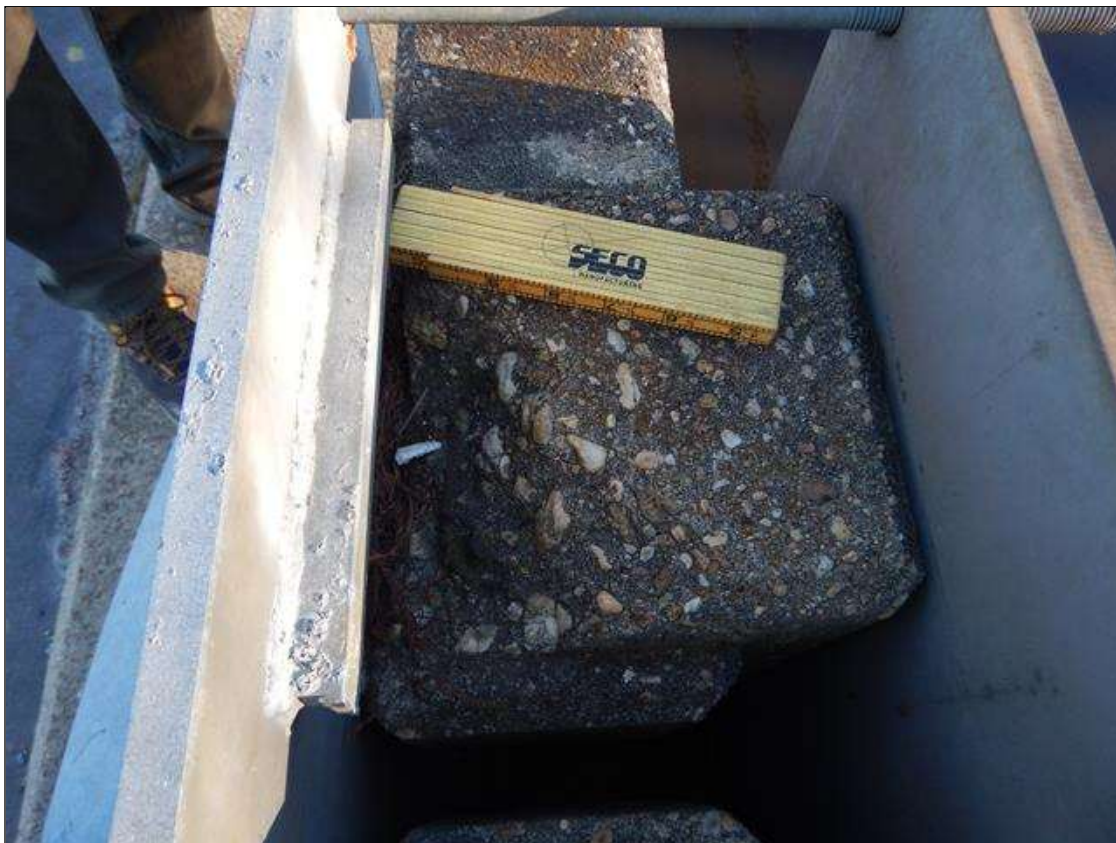
Span 1 Right Bridge Rail: 7 INCHES LONG X 3 INCHES WIDE X 2 INCHES DEEP WITH EXPOSED REBAR AT POST 4.

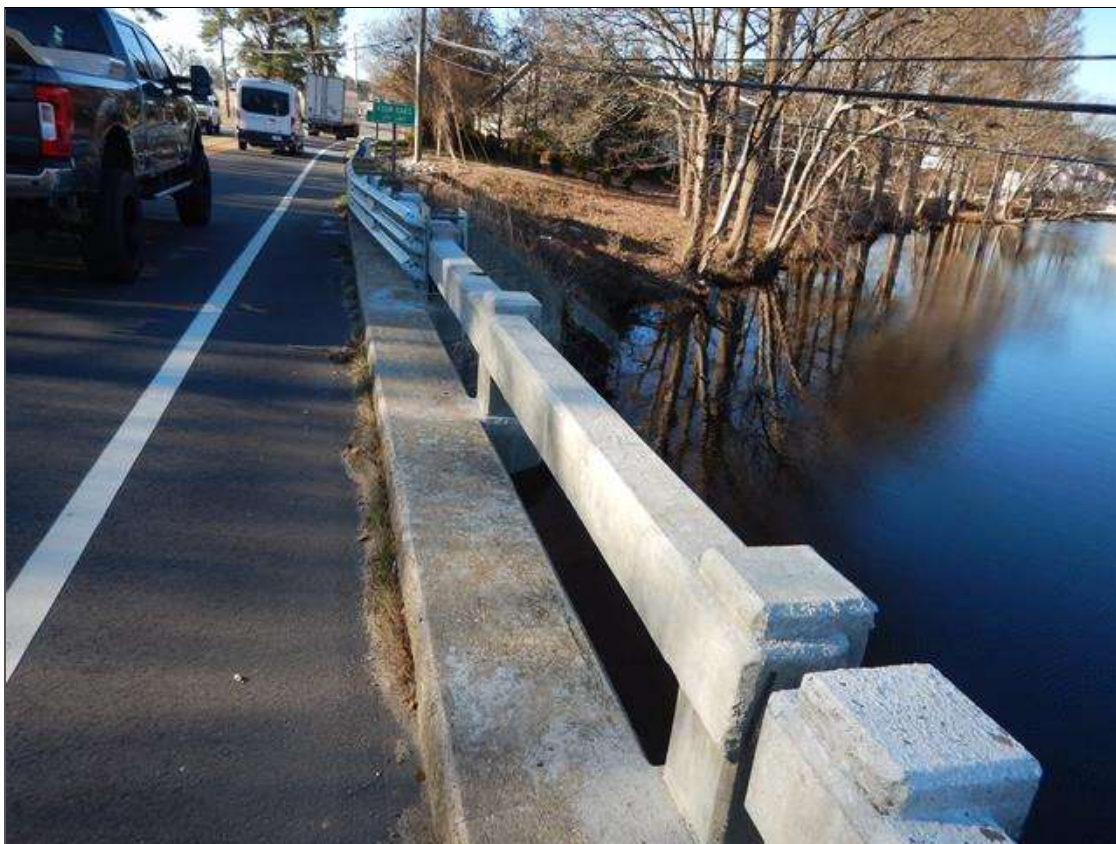
30 FEET LEFT RAIL IN SPAN 1 BEGINNING AT END BENT 1 HAS BEEN REPAIRED

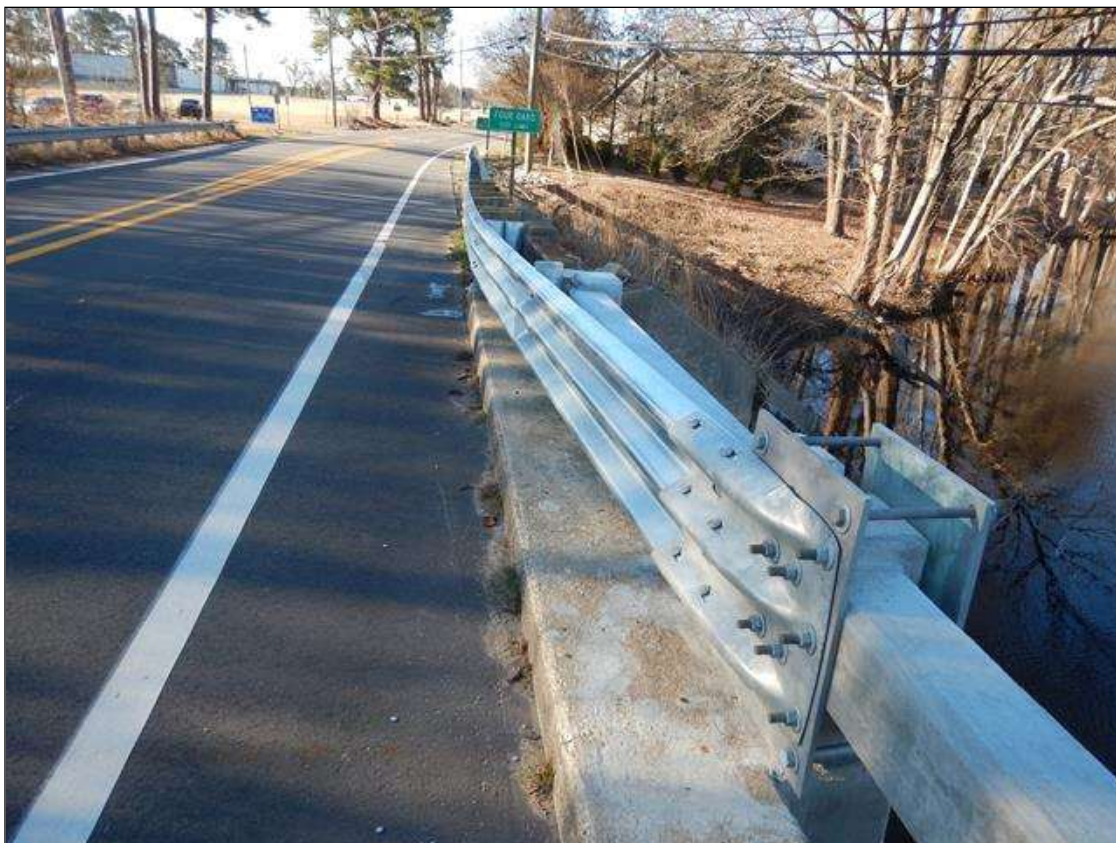
NEAR LEFT RAIL GUARDRAIL REPAIRED

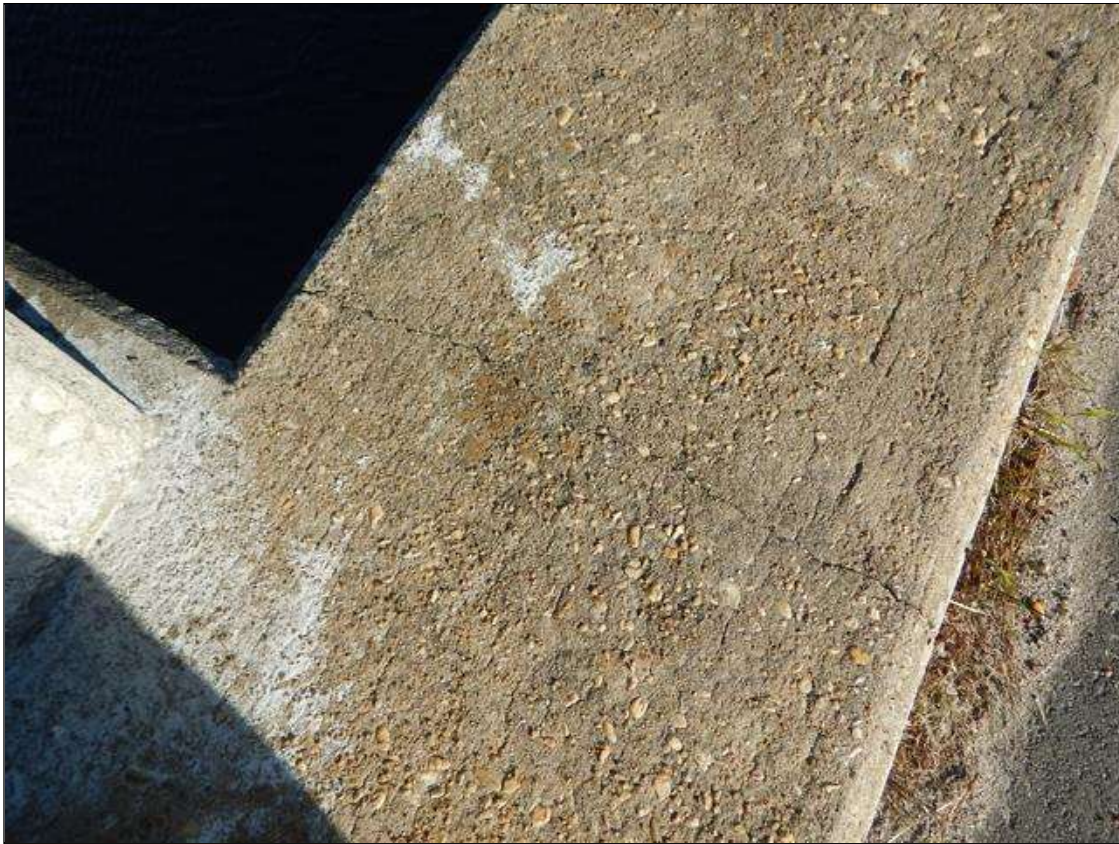
Span 2 Left Bridge Rail: TRANSVERSE CRACK 8 FEET FROM BENT 2

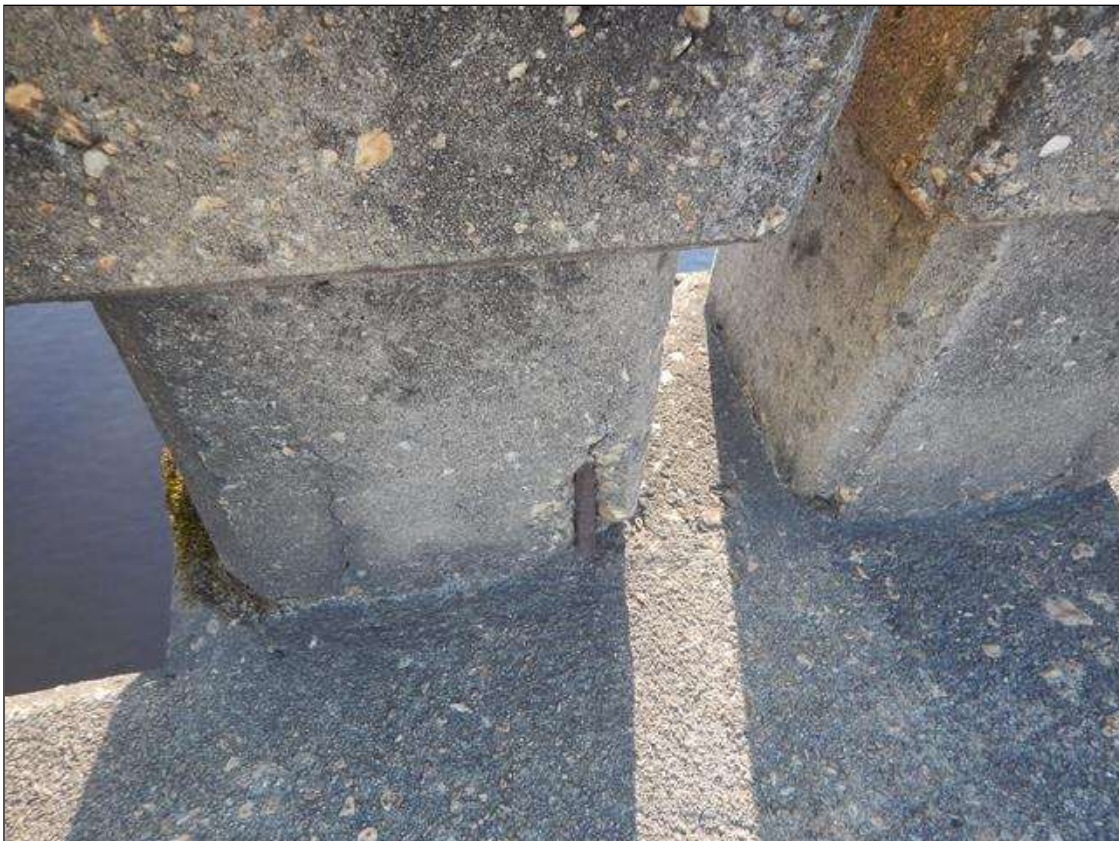
Span 2 Right Bridge Rail: 1 FEET OF EXPOSED REBAR WITH SPALL AT POST 4 FROM BENT 1

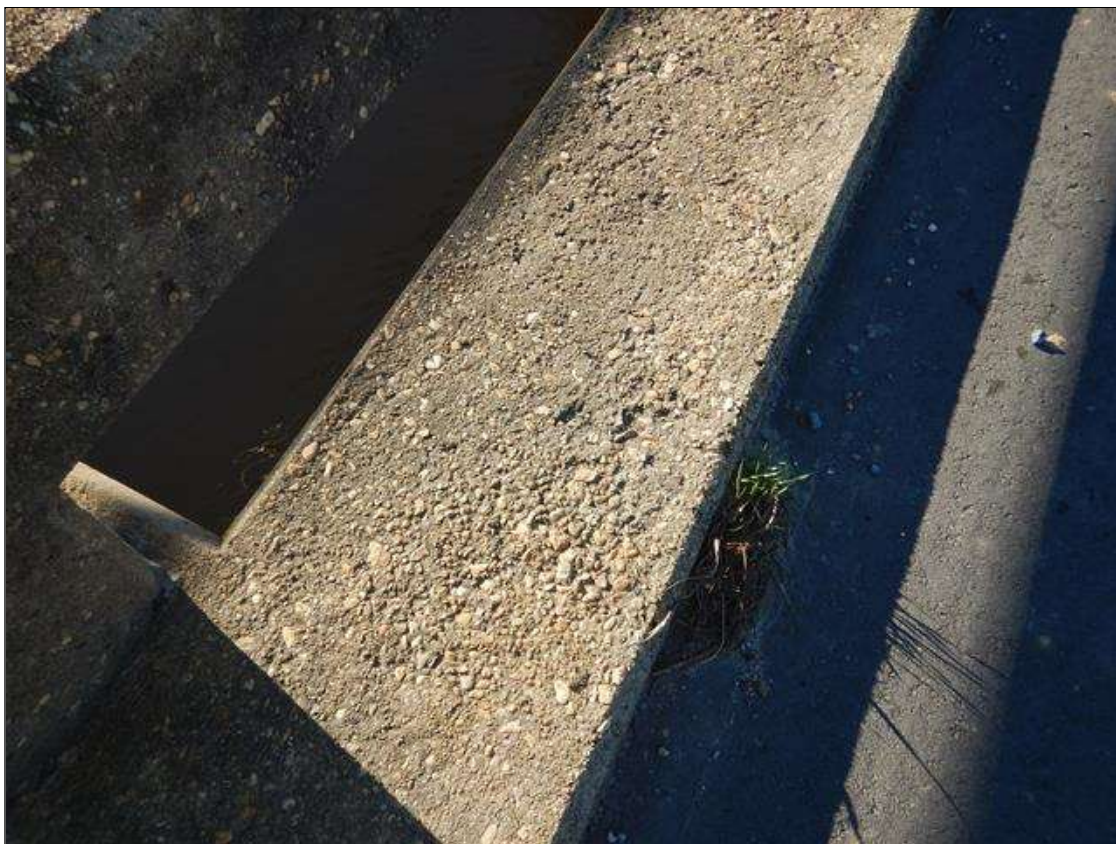
Span 3 Right Bridge Rail: ABRASION ALONG THE RIGHT CURB

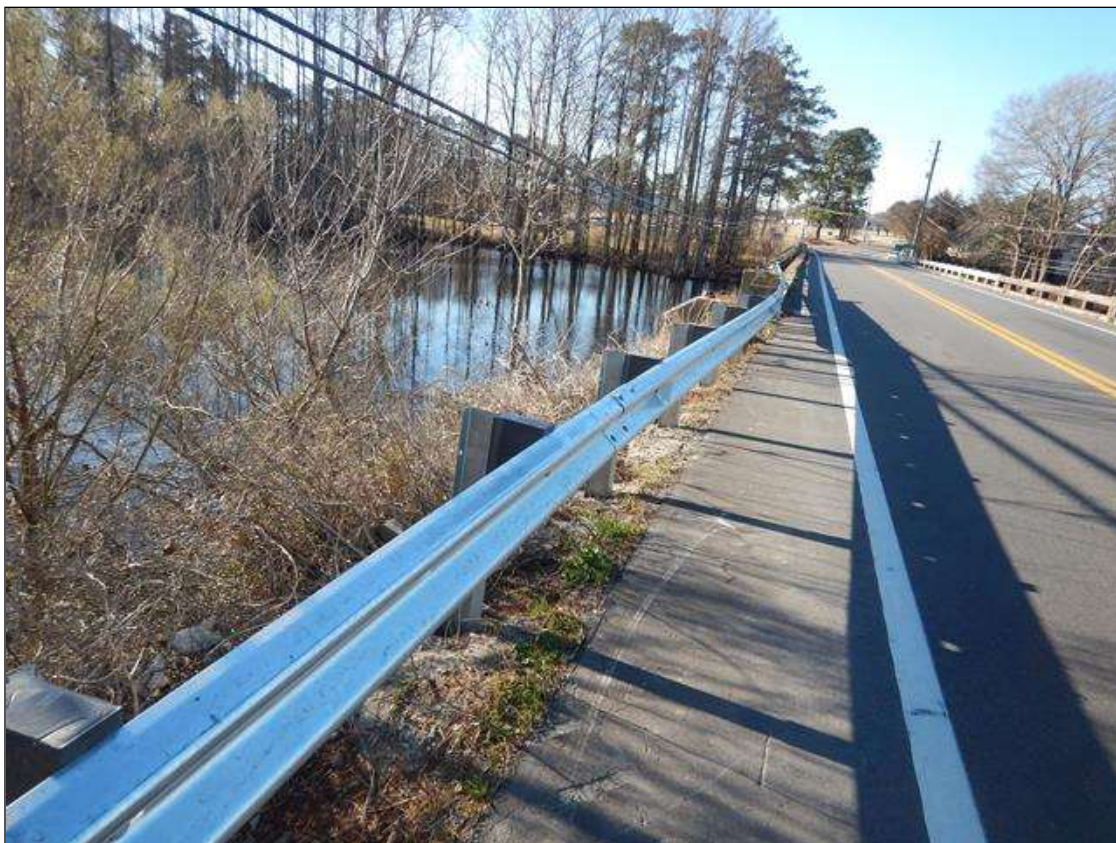
FAR RIGHT GUARDRAIL REPLACED

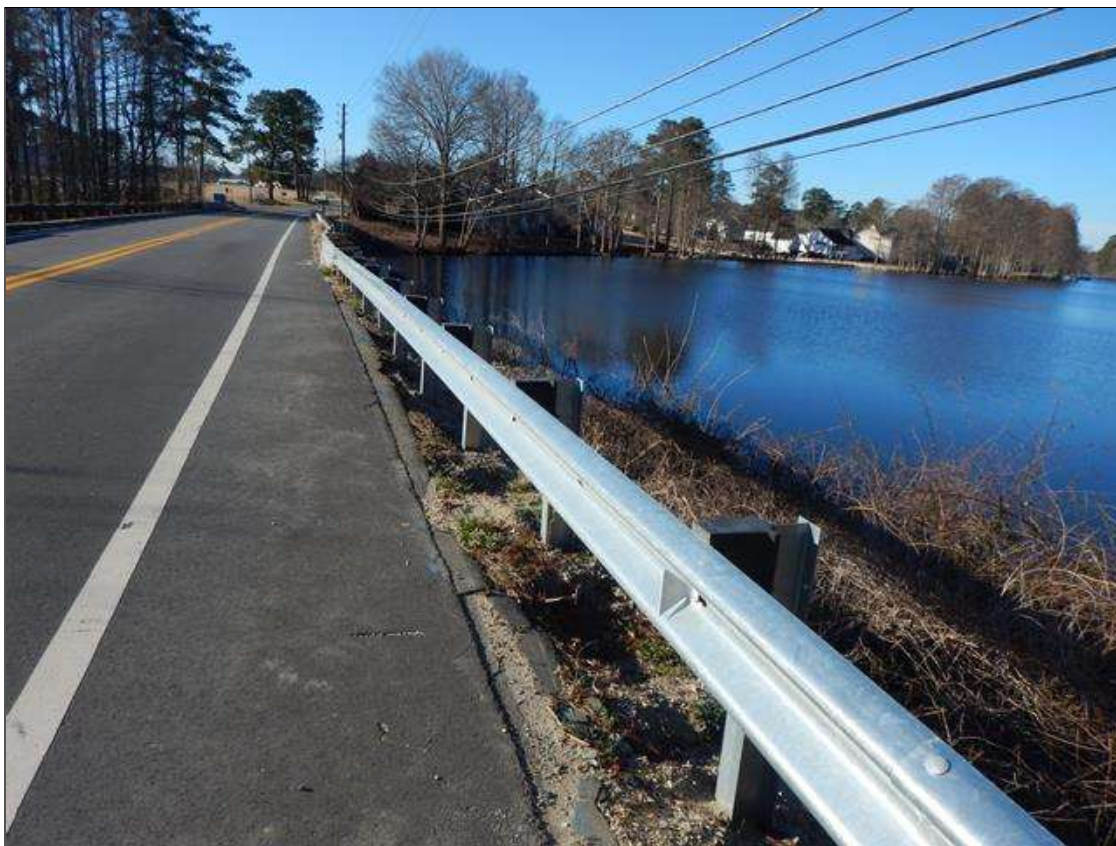
FAR LEFT GUARDRAIL REPLACED

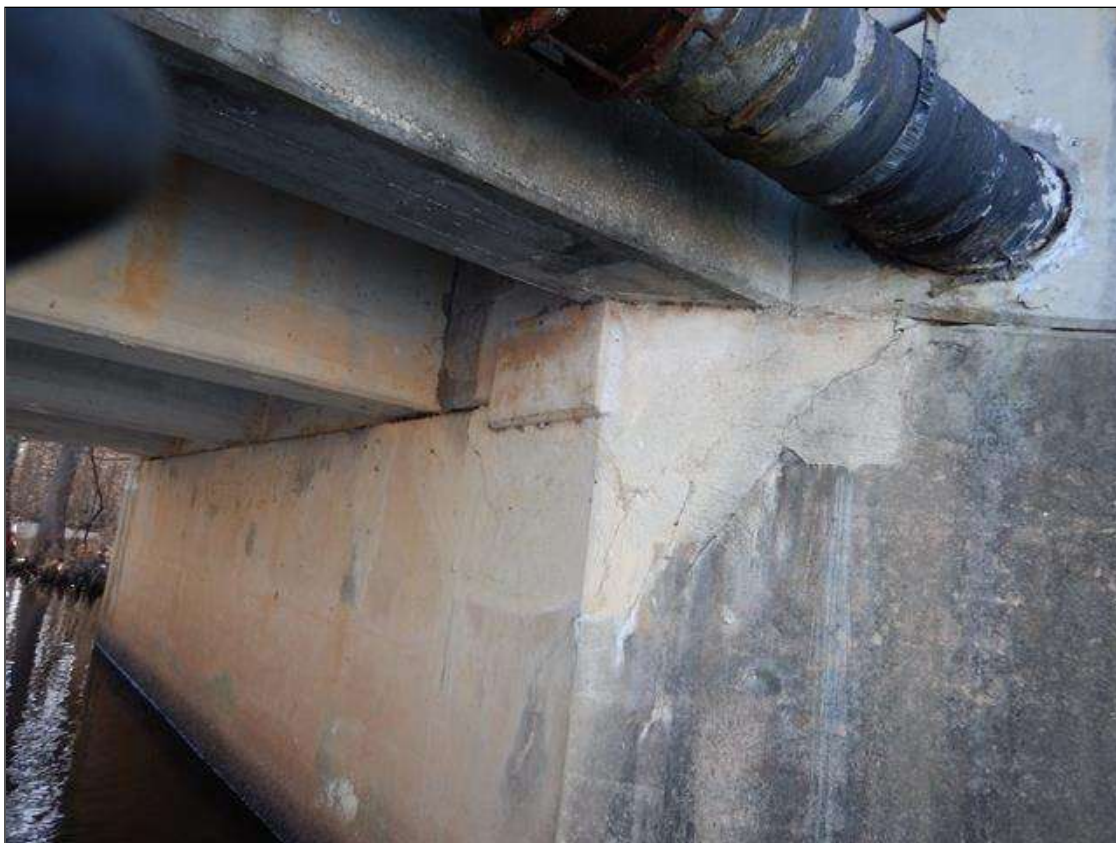
End Bent 1 Abutment: SOUND PATCHING IN CAP UNDER GIRDERS 1, 2 & 3.

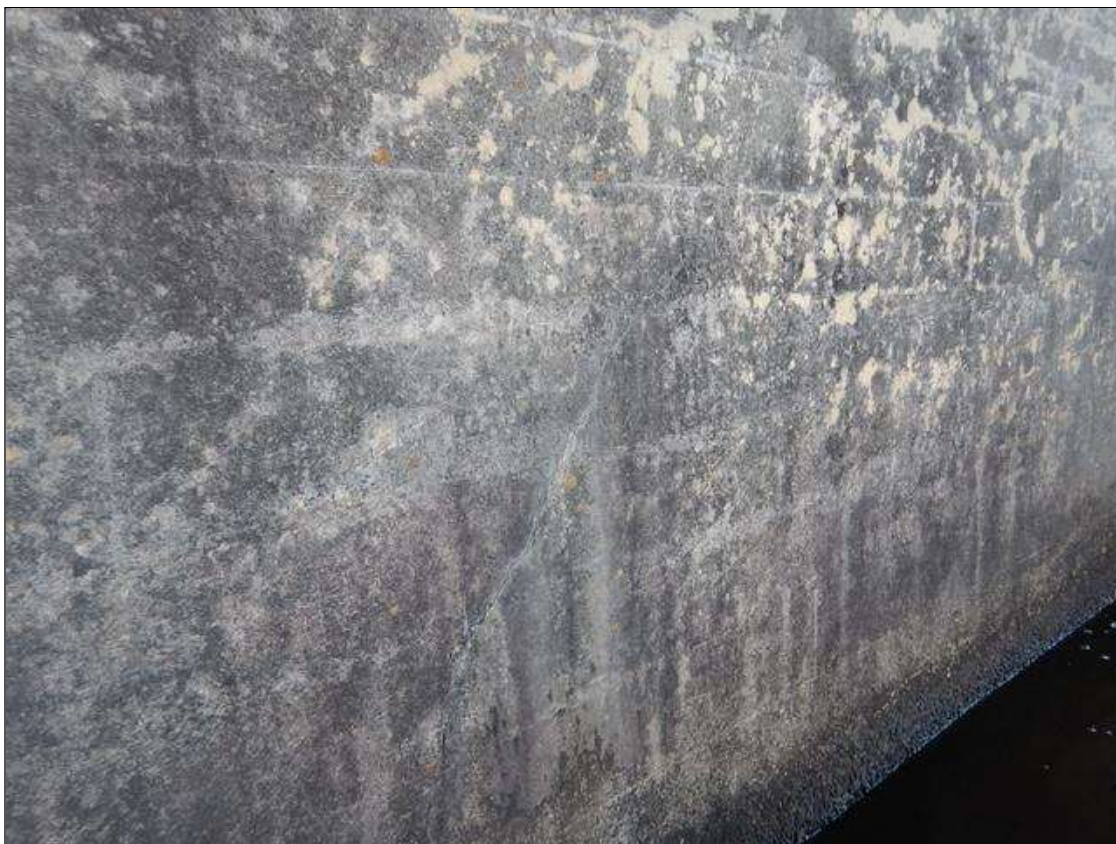
End Bent 1 Abutment: VERTICAL DIAGONAL CRACK 8 FEET LONG IN SOUTH WEST WINGWALL

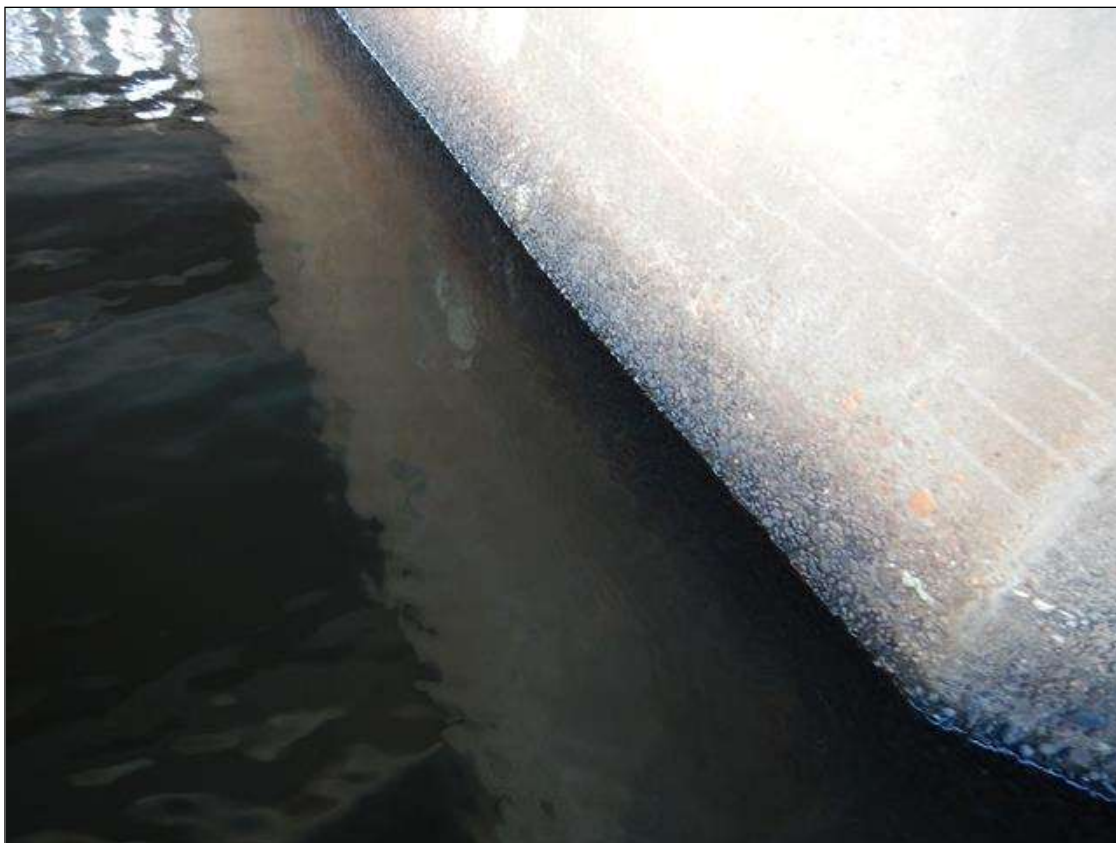
End Bent 1 Abutment: 57 FEET OF ABRASION WITH COARSE AGGREGATE EXPOSED FROM WATERLINE UP 3 FEET

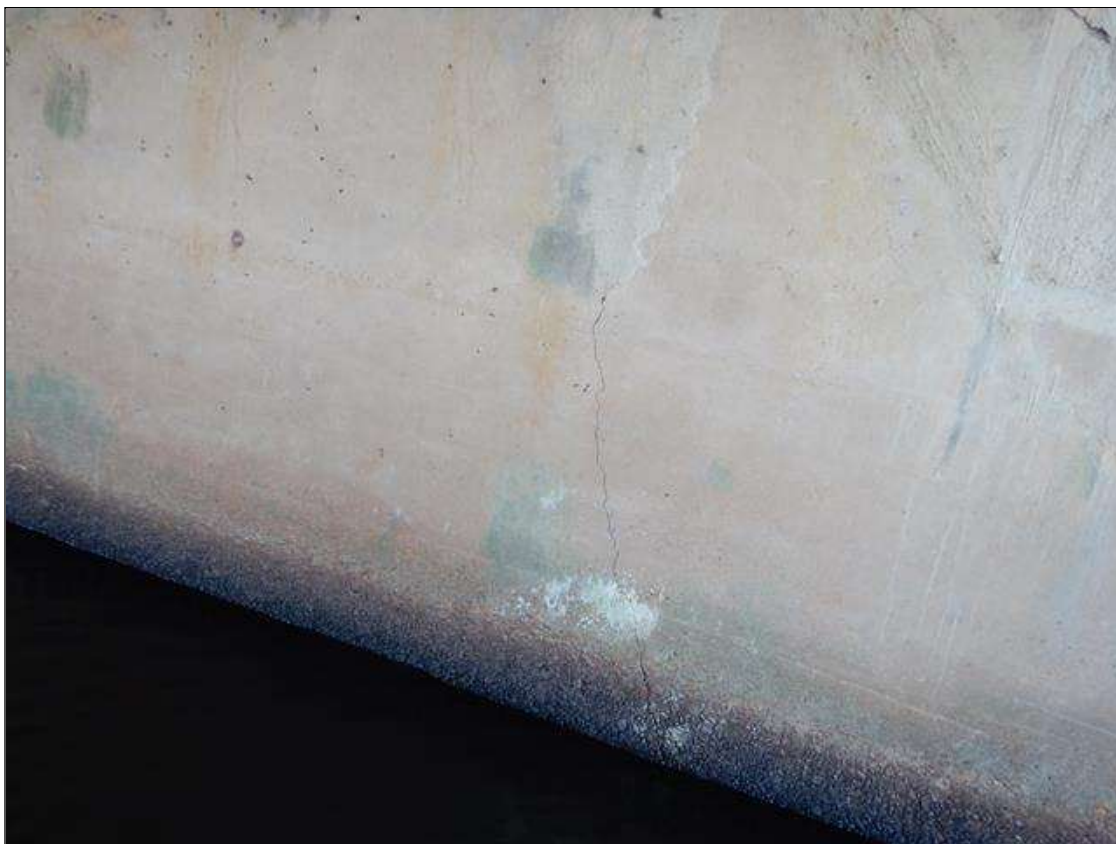
End Bent 1 Abutment: VERTICAL CRACKING 1/16 INCH WIDE IN FACE OF CAP AT GIRDERS 2 & 4 EXTENDING DOWN BREAST WALL.

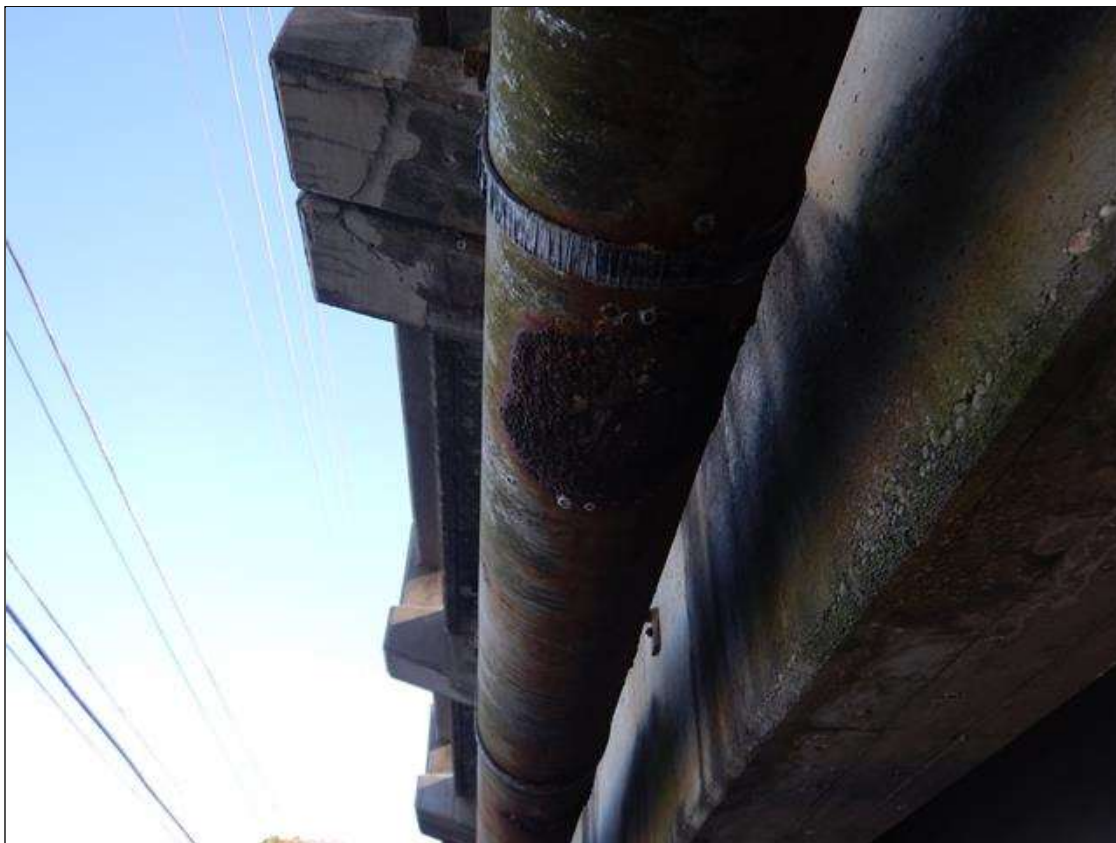
AREAS OF CORROSION ALONG BOTTOM OF 12 INCHES UTILITY PIPE ALONG THE LEFT OVERHANG

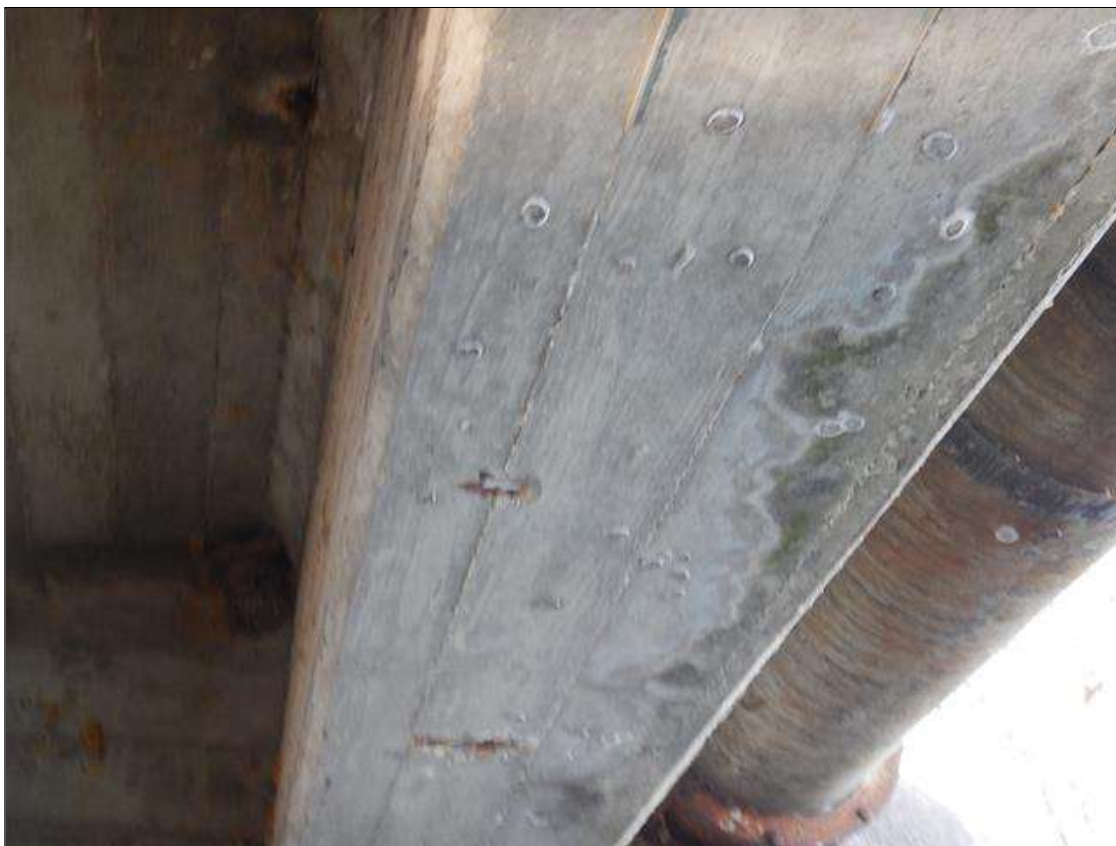
Span 1 Beam 1: SHALLOW SPALLS WITH EXPOSED REBAR IN BOTTOM OF GIRDER UP TO 6 FEET OUT FROM END BENT 1.

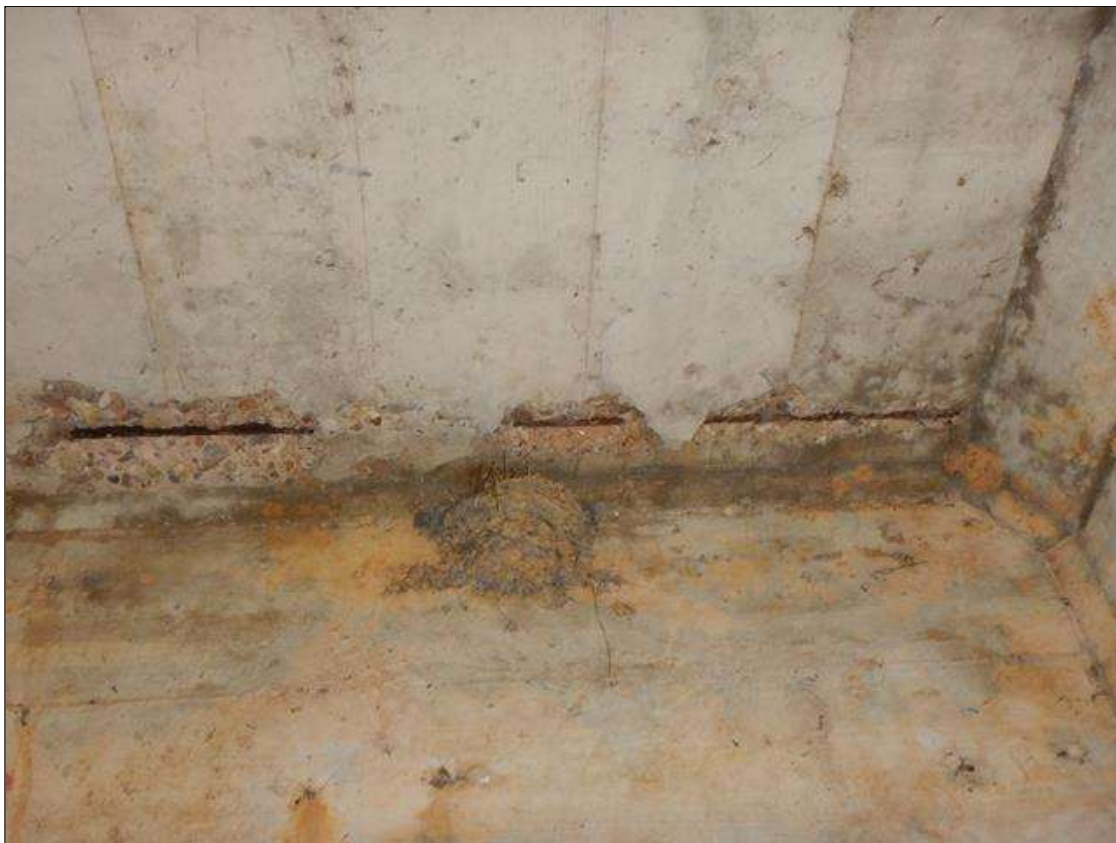
Span 1 Deck: 3 FEET WIDE X 5 INCHES LONG X 1/2 INCH DEEP SPALL WITH EXPOSED REBAR IN THE BOTTOM OF THE DECK BAY 3 AT END BENT 1

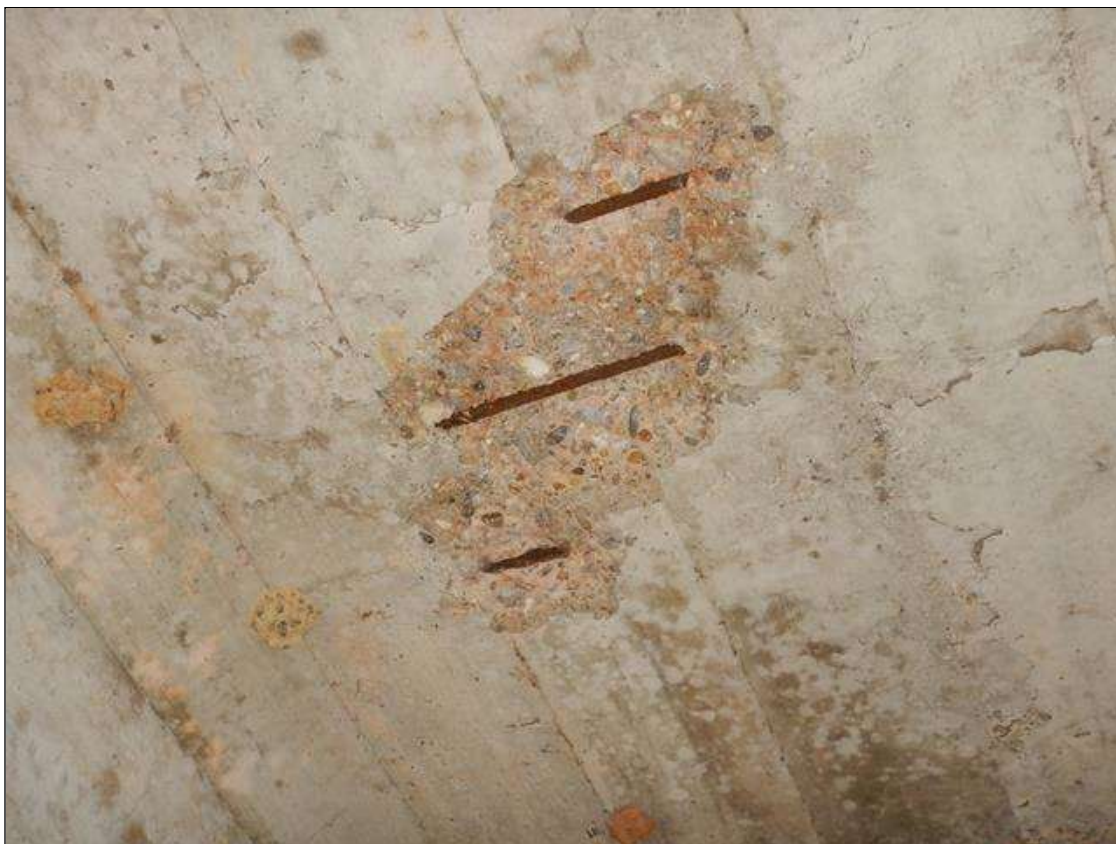
Span 1 Deck: 8 INCHES WIDE X 18 INCHES LONG X 1/2 INCHES DEEP SPALL WITH EXPOSED REBAR IN BOTTOM OF THE DECK AT BAY 3 NEAR END BENT 1 ADJACENT BEAM 4.

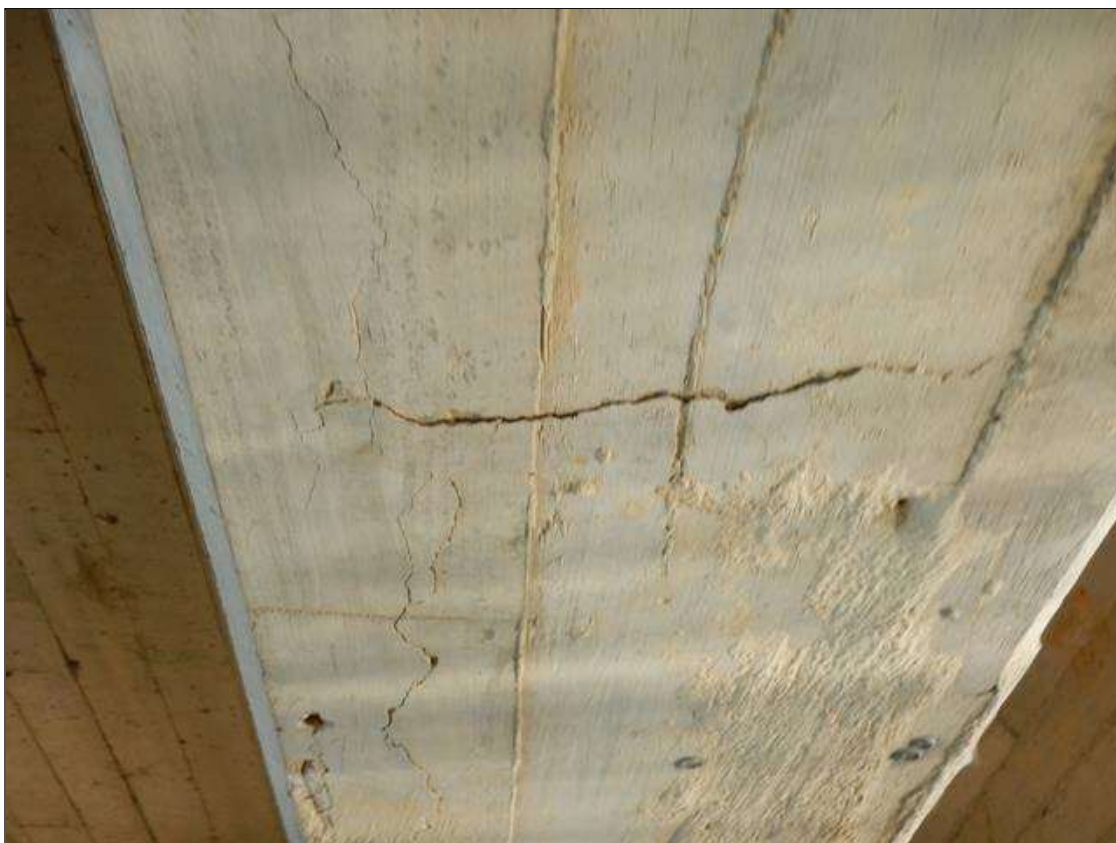
Span 1 Beam 4: 12 INCHES DIAMETER DELAMINATION IN BOTTOM OF BEAM AT MID-SPAN.

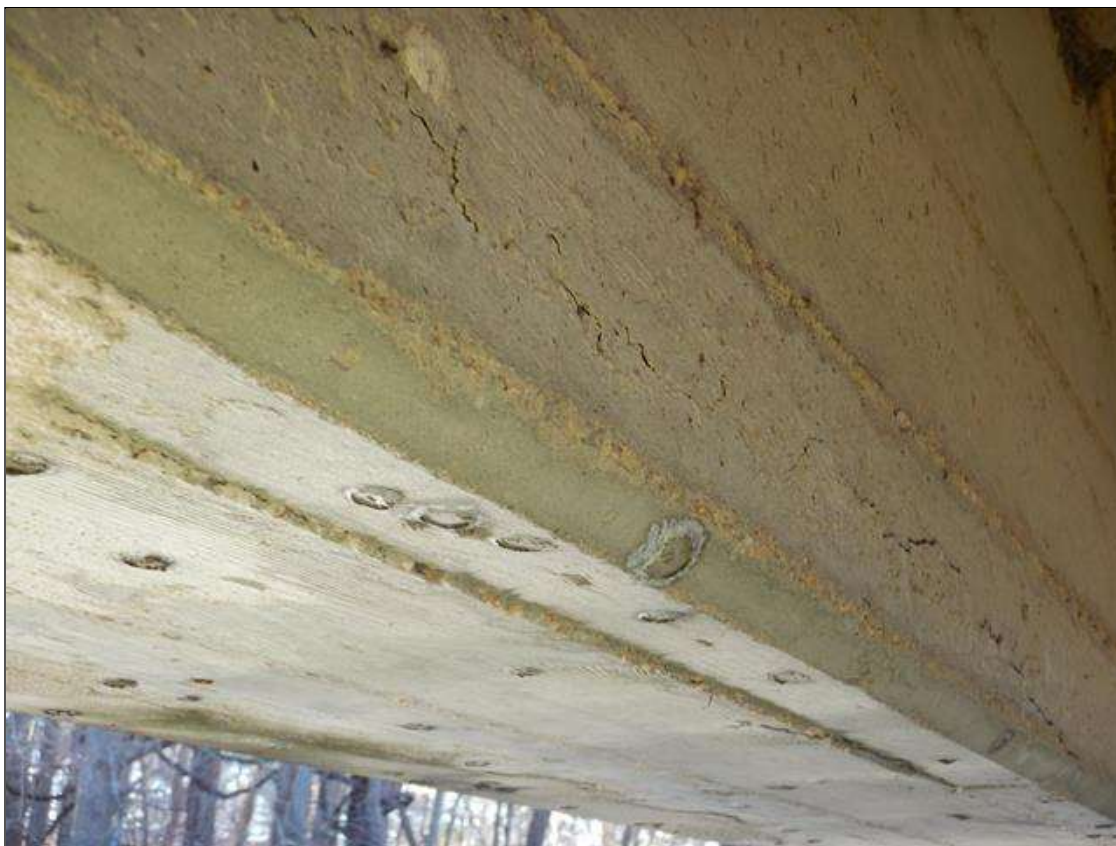
Span 1 Beam 5: 6 INCHES LONG LONGITUDINAL CRACKING IN BOTTOM AND LEFT SIDE AT MID-SPAN.

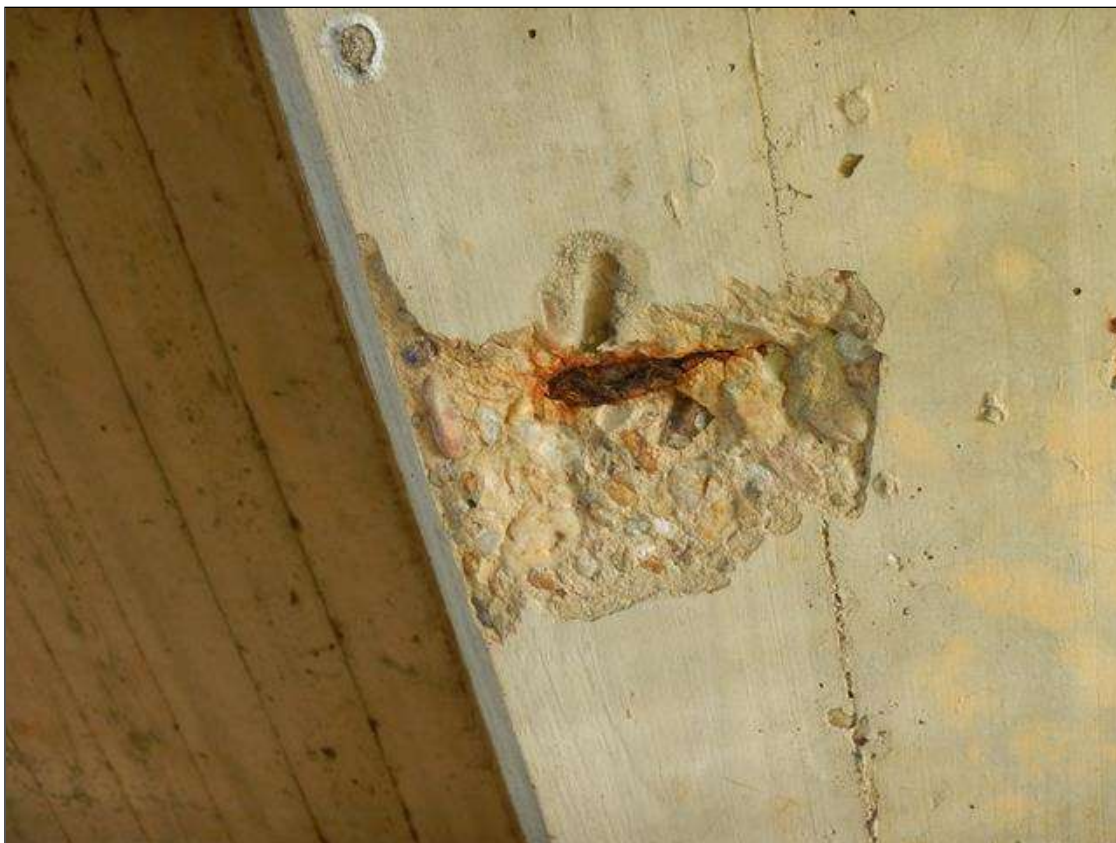
Span 1 Beam 4: 6 INCHES DIAMETER SPALL 3/4 INCHES DEEP WITH EXPOSED STEEL.

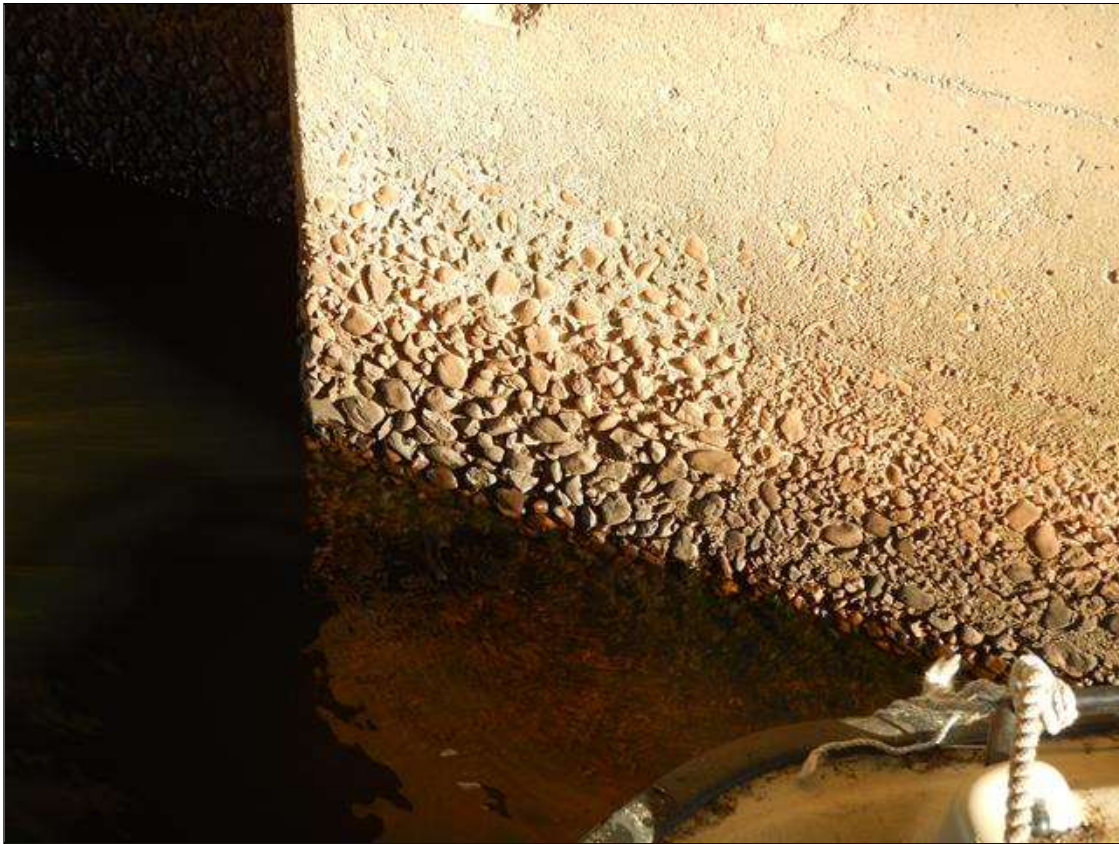
Bent 1 Pile 1: ABRASION WITH COARSE AGGREGATE EXPOSED FROM WATERLINE UP 3 FEET. ALSO NOTE FRONT OF BOAT.
