NC DEPARTMENT OF TRANSPORTATION
 DIVISION OF HIGHWAYS
 STRUCTURE MANAGEMENT UNIT

ATTENTION: **PAR SUBMITTED- NEW ASPHALT WEARING SURFACE**

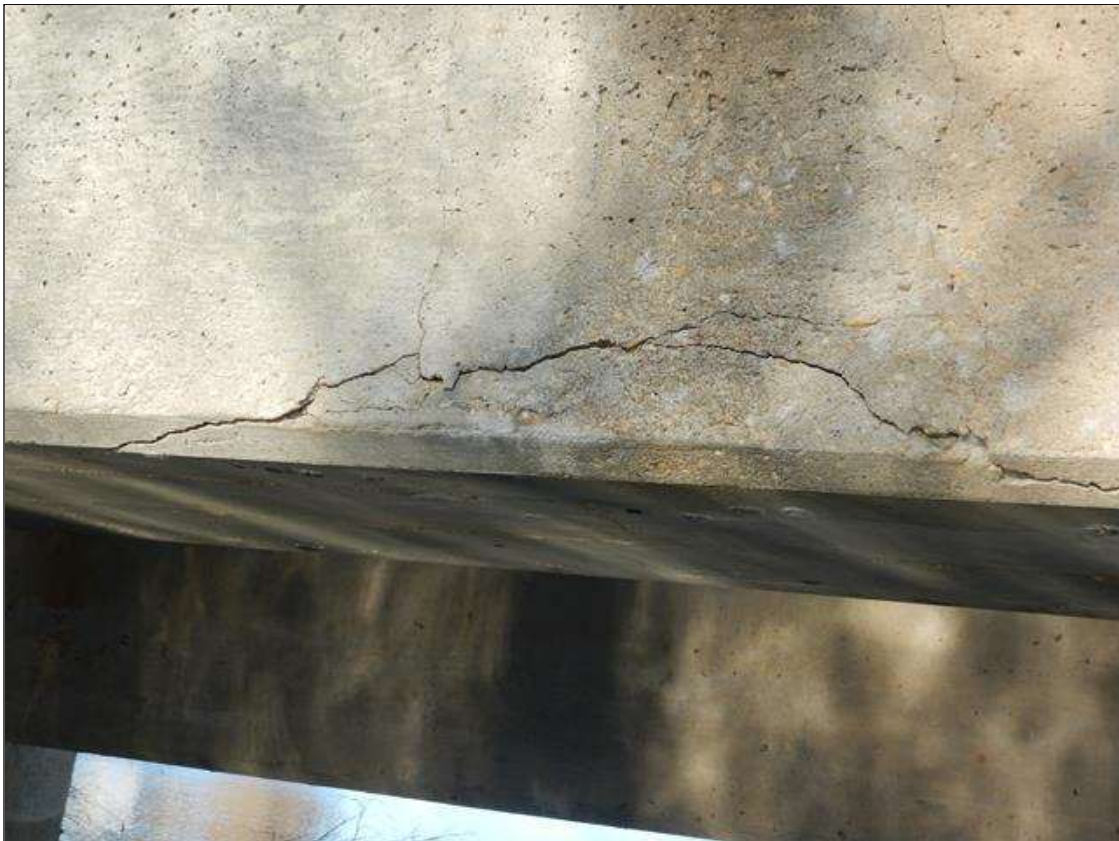
Span 1 Beam 5: 6 FEET CRACKING AND DELAMINATION IN RIGHT SIDE BOTTOM CORNER NEAR MID-SPAN.

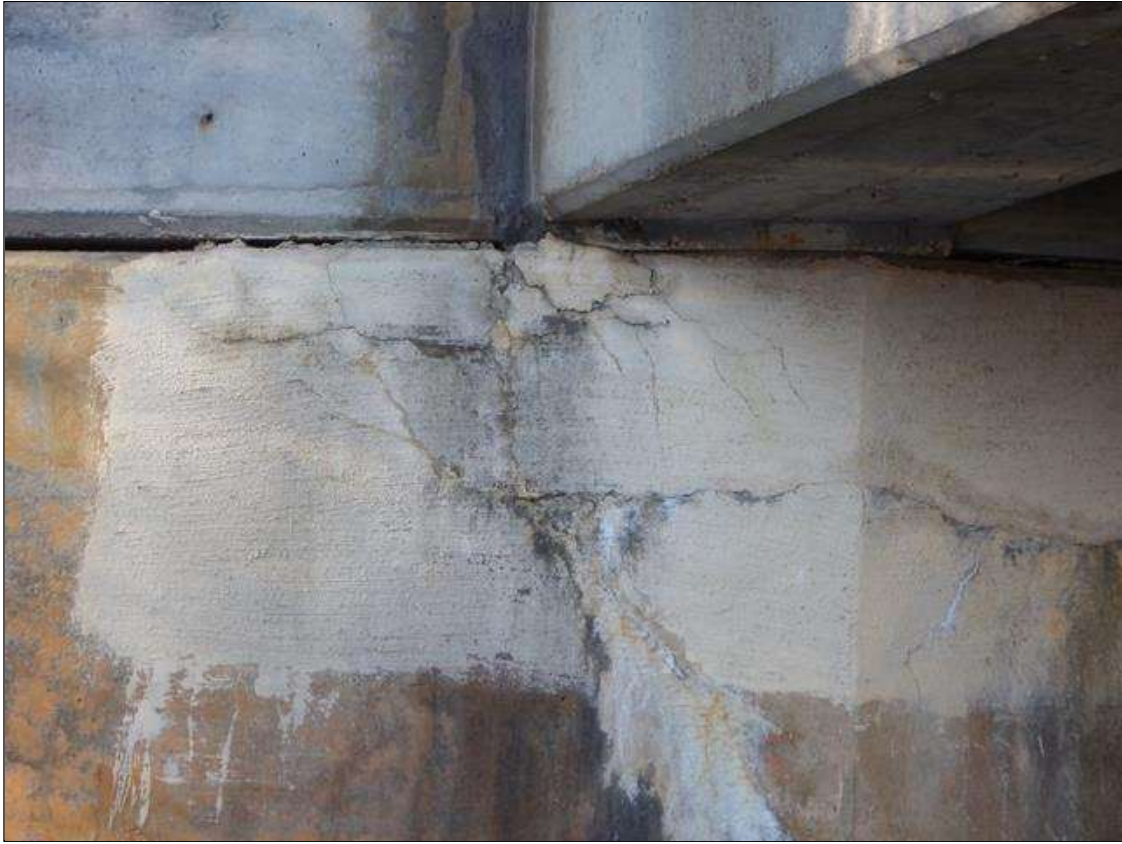
End Bent 1 Abutment: UNSOUND PATCHING IN CAP UNDER GIRDER 5 WITH 1/32 INCH WIDE VERTICAL CRACK IN PATCH.

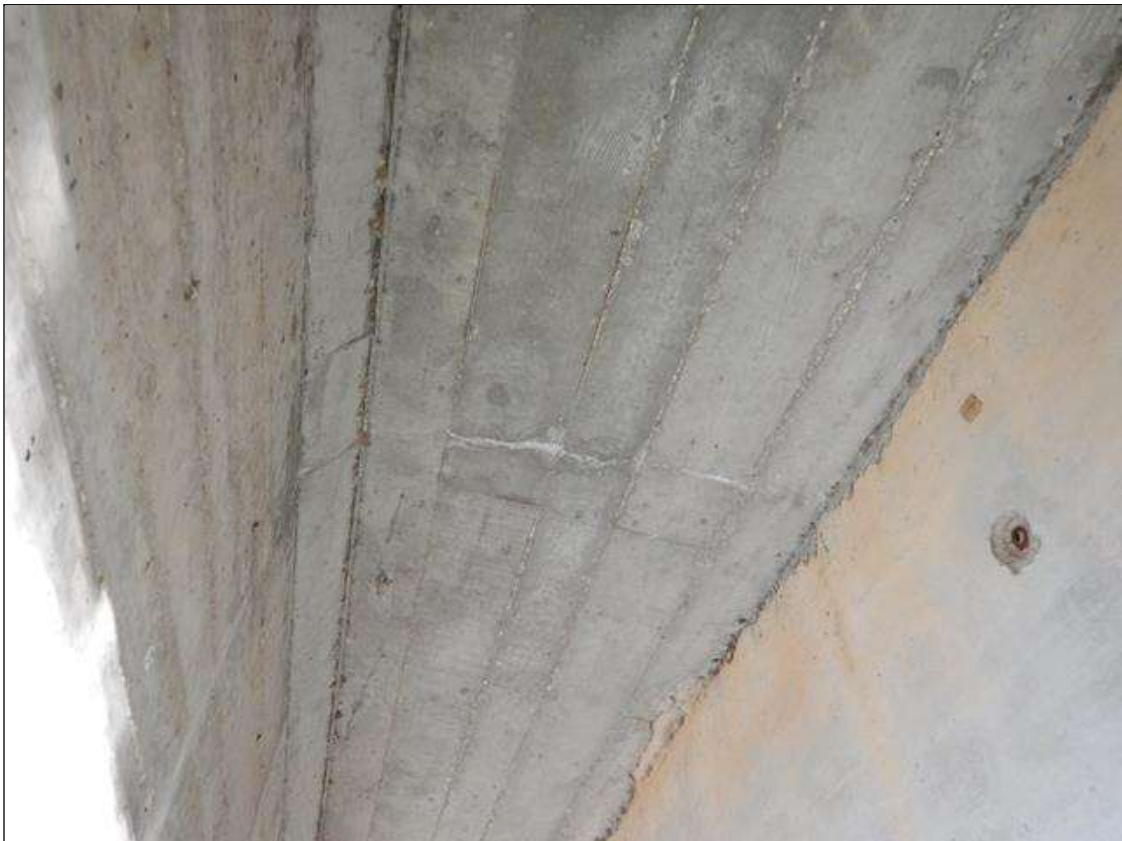
Span 2 Deck: SCATTERED TRANSVERSE CRACKING WITH EFFLORESCENCE IN BAY 1

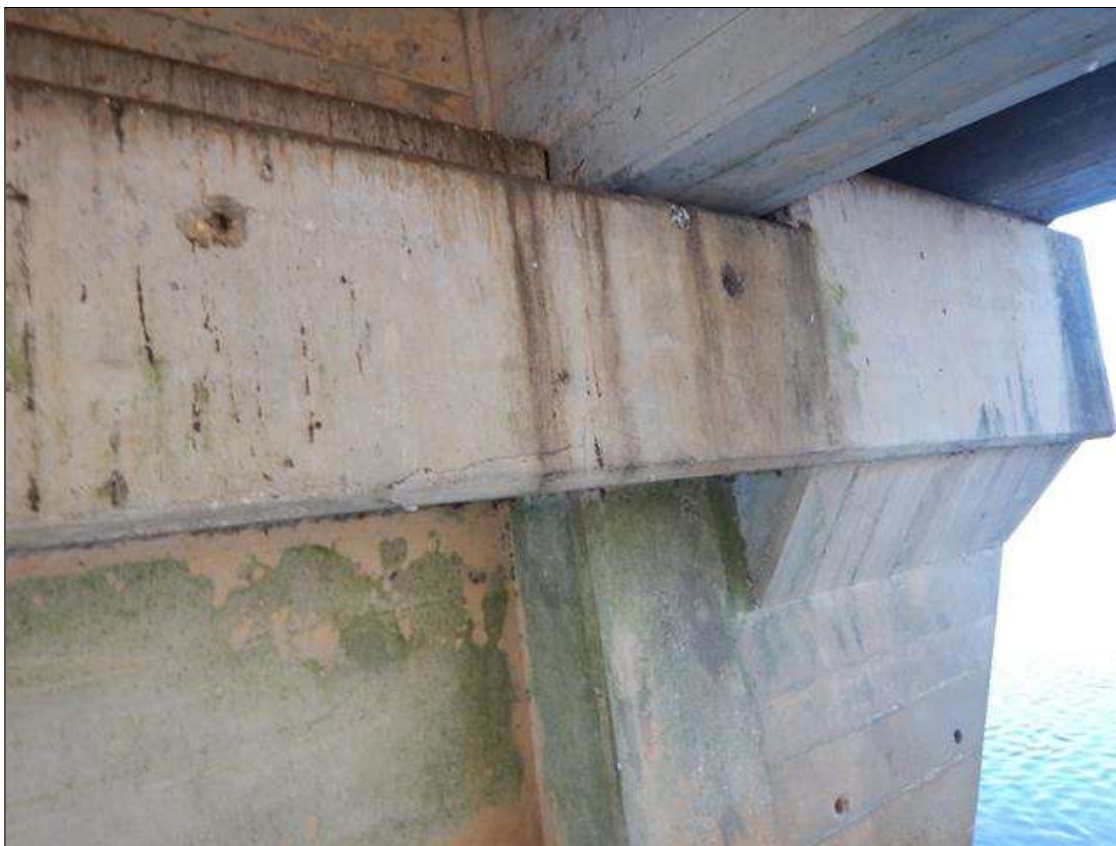
Bent 2 Cap 1: CRACKING ALONG THE BOTTOM CORNER OF CAP FOR 2 FEET LONG X 1- 1/2 INCHES HIGH UNDER BEAM 4

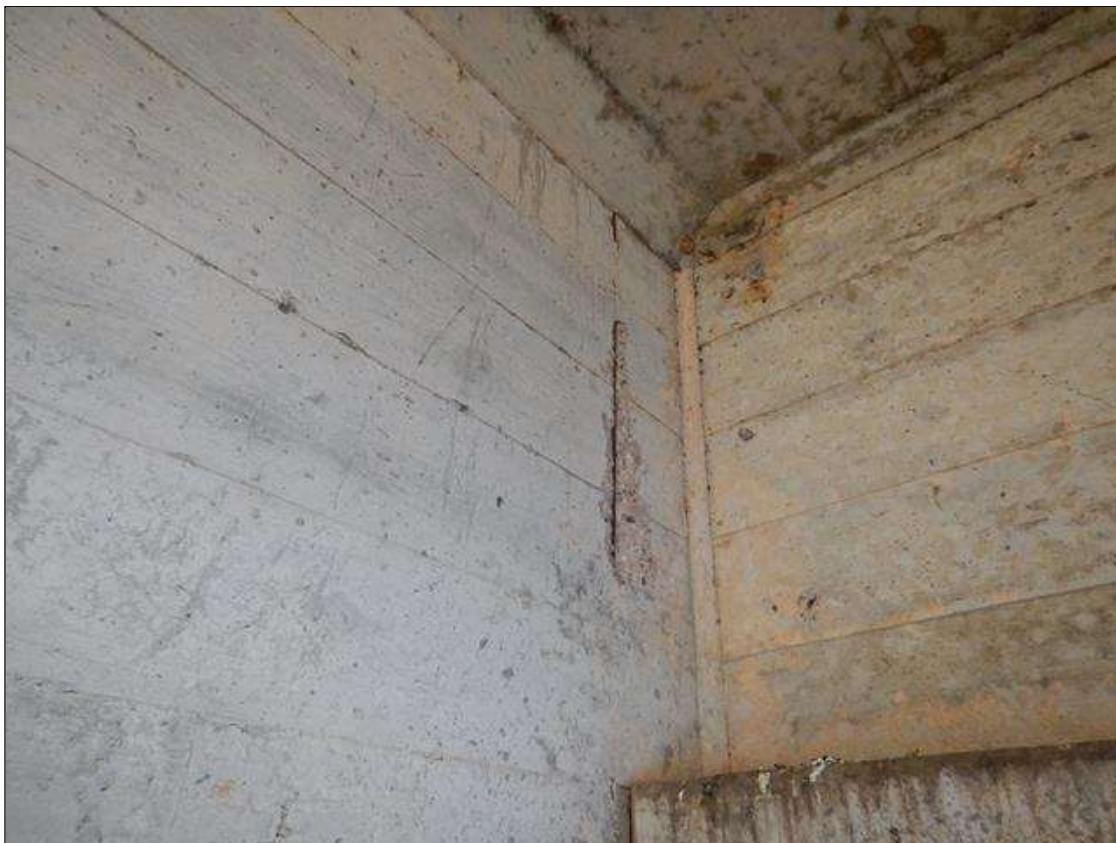
Span 3 Beam 3: 14 INCHES HIGH X 6 INCHES WIDE SPALL WITH EXPOSED STEEL IN THE LEFT SIDE AT BENT 2.

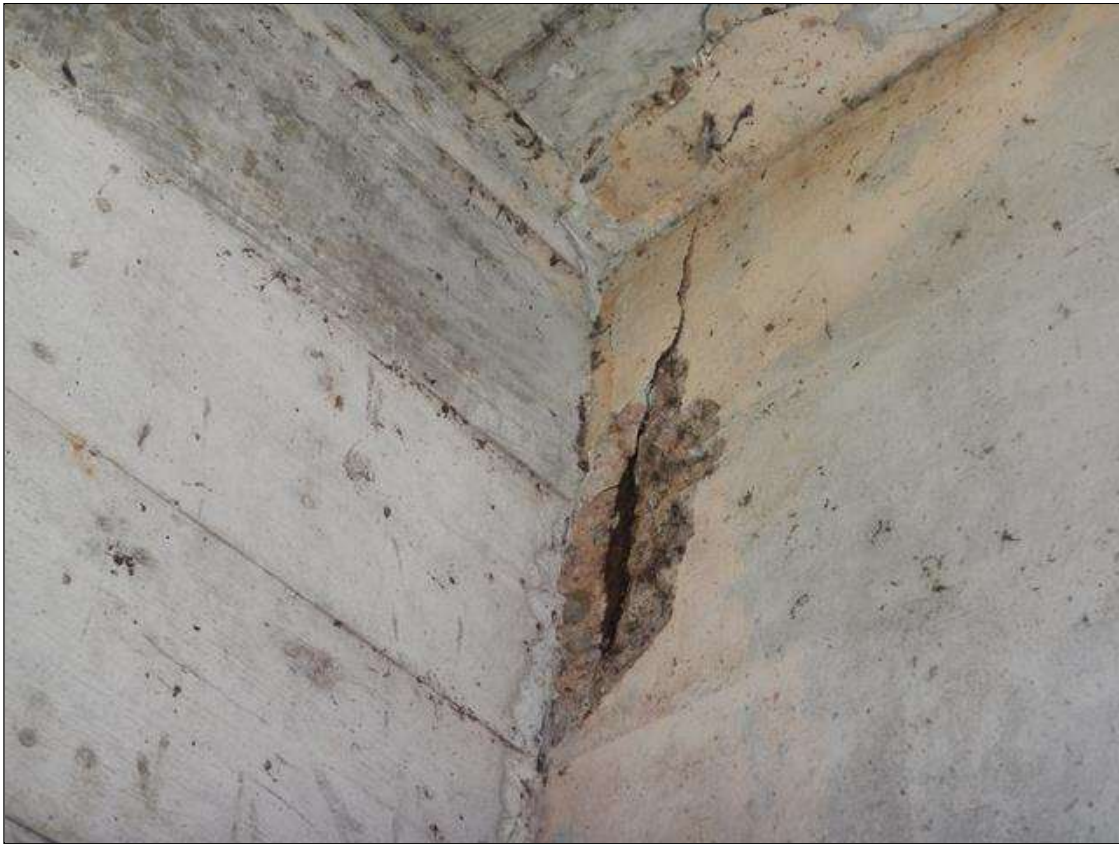
Span 3 Beam 4: 18 INCHES HIGH X 4 INCHES WIDE X 3/4 INCHES DEEP SPALL WITH EXPOSED REBAR IN RIGHT SIDE WEB AT BENT 3.

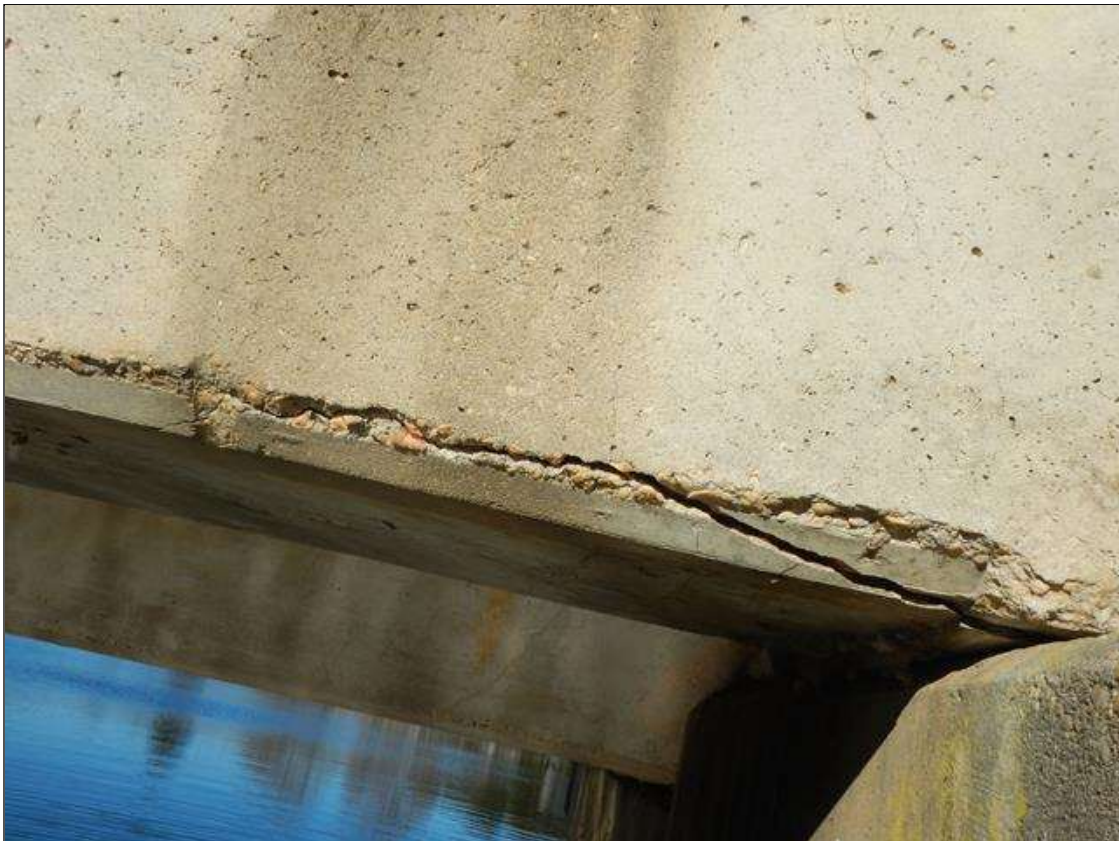
Span 3 Beam 5: 3/16 INCHES WIDE LONGITUDINAL CRACK 2 FEET LONG IN BOTTOM RIGHT AND LEFT CORNER AT BENT 3.

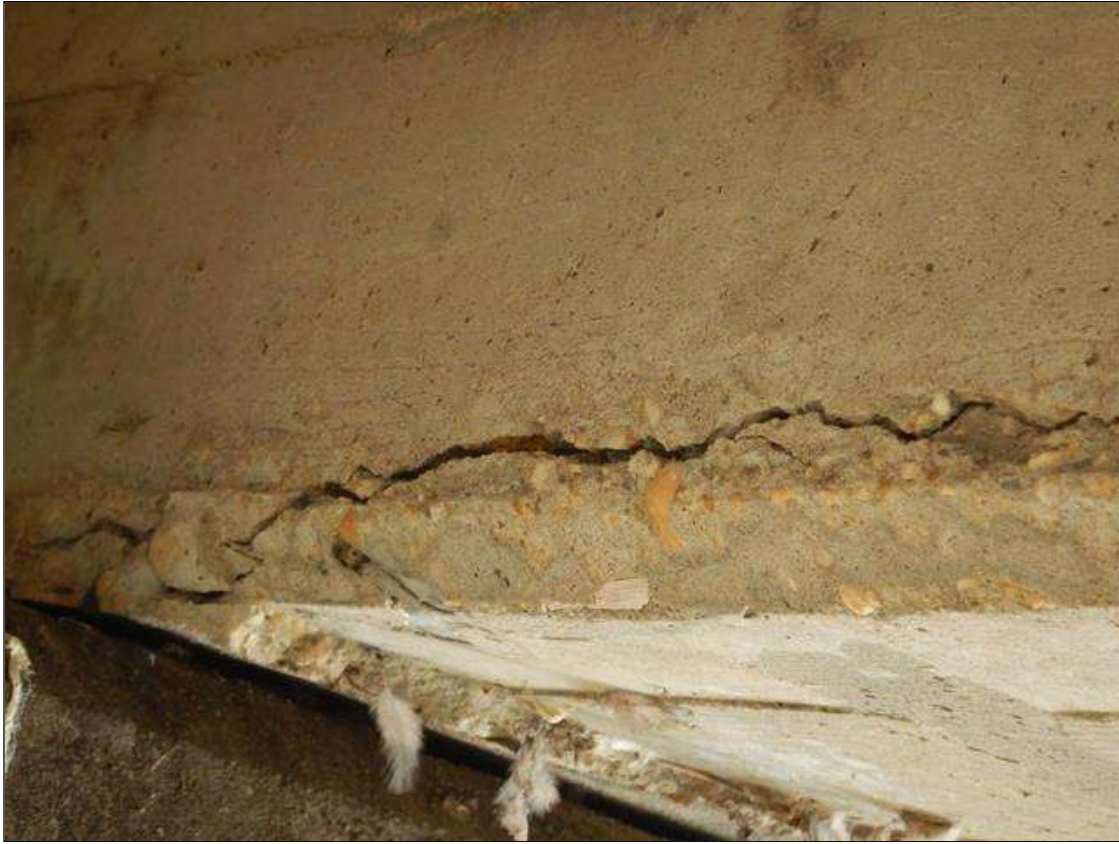
Span 3 Beam 5: 3/16 INCHES WIDE LONGITUDINAL CRACK 2 FEET ALONG IN BOTTOM RIGHT AND LEFT CORNER AT BENT 3.

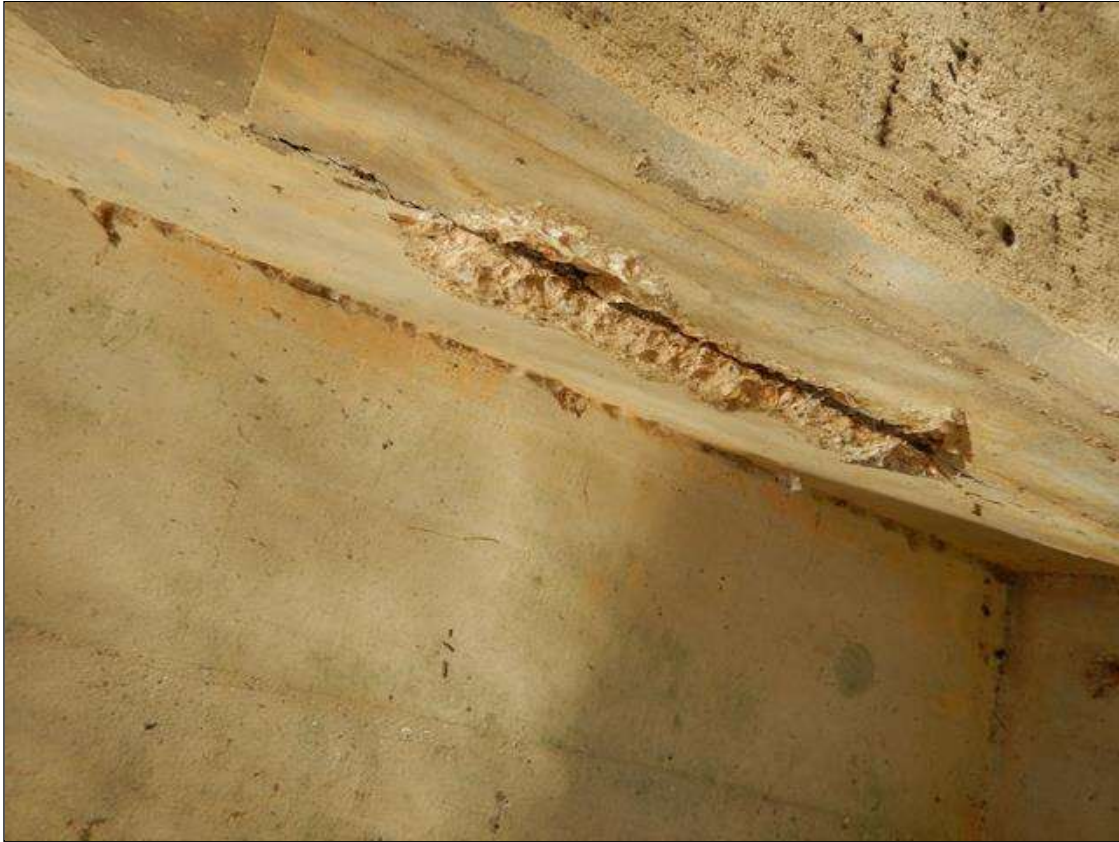
Bent 3 Cap 1: (PAR) 26 INCHES LONG X 7 INCHES WIDE X 2 INCHES DEEP SPALL WITH SECTION LOSS TO EXPOSED BAR IN BOTTOM OF CAP AT BENT 3 SPAN 3 SIDE UNDER BAY 4 (ESTIMATED 1 INCH DIAMETER BAR REMAINING).

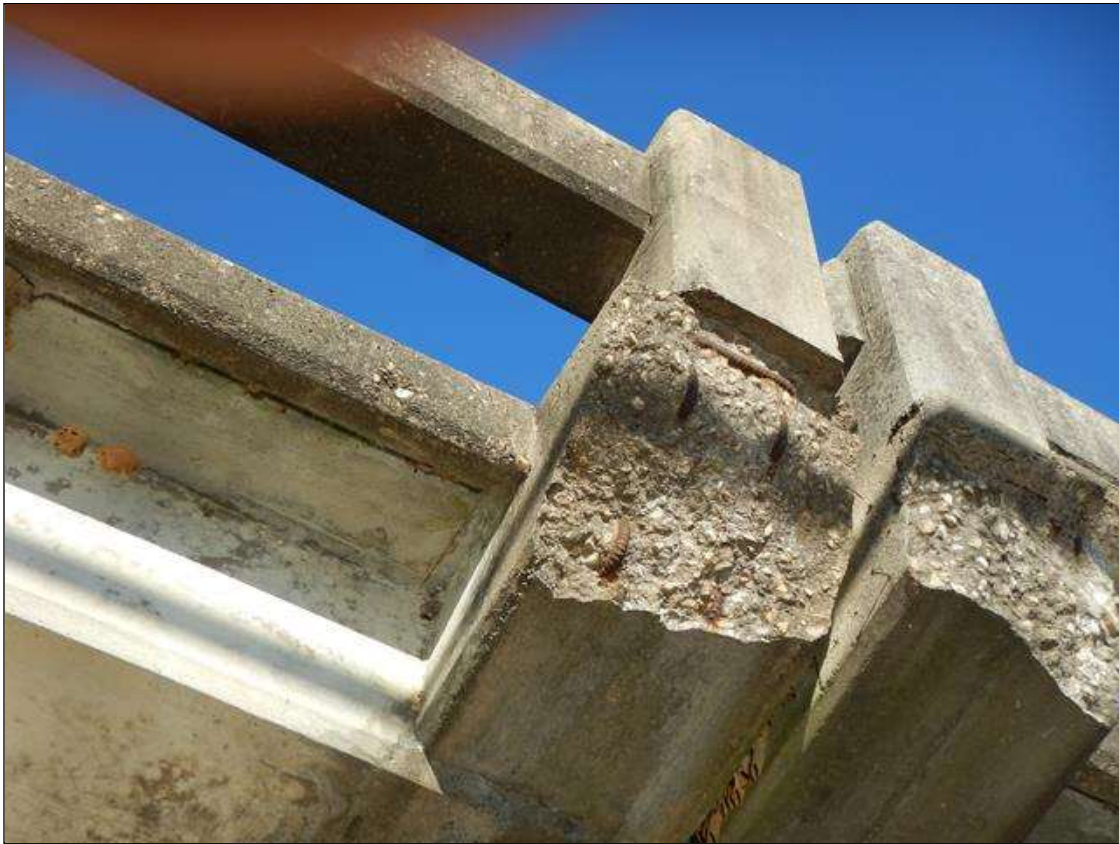
Span 3 Right Bridge Rail: (PAR) 1 FOOT OF SPALLING 3 INCHES DEEP WITH EXPOSED REBAR IN THE GUARDRAIL POST BASE AT BENT 3.

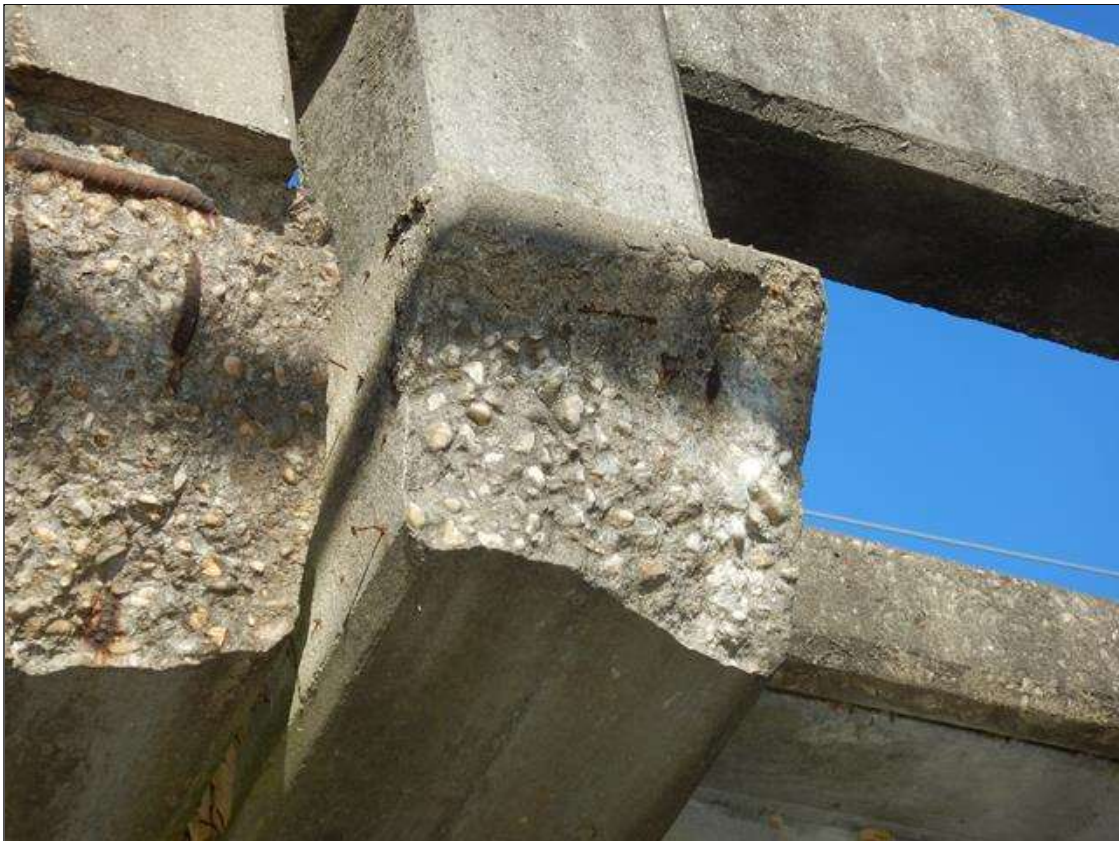
Span 4 Right Bridge Rail: (PAR) 1 FOOT OF SPALLING 3 INCHES DEEP WITH EXPOSED REBAR IN THE GUARDRAIL POST BASE AT BENT 3.

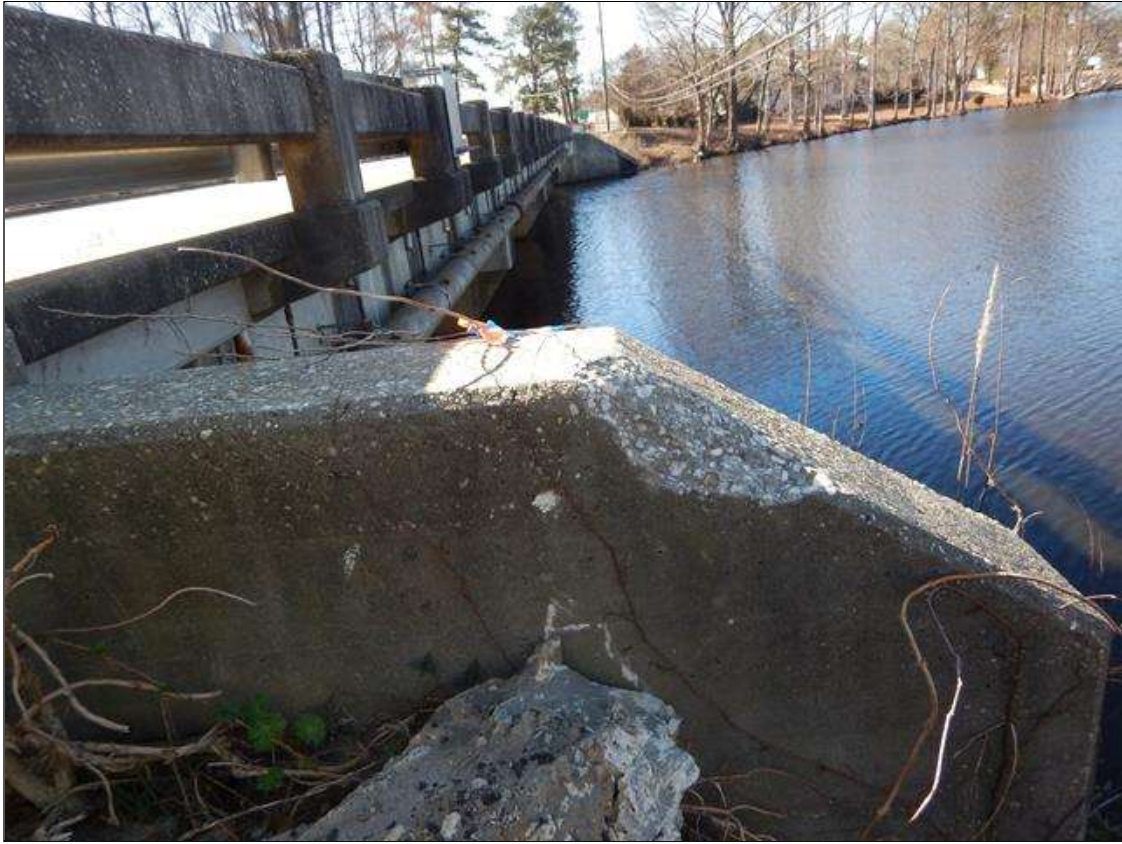
1 FOOT LONG X 6 INCHES WIDE X 1.5 INCHES DEEP SPALL TOP OF LEFT WINGWALL AT END BENT 2

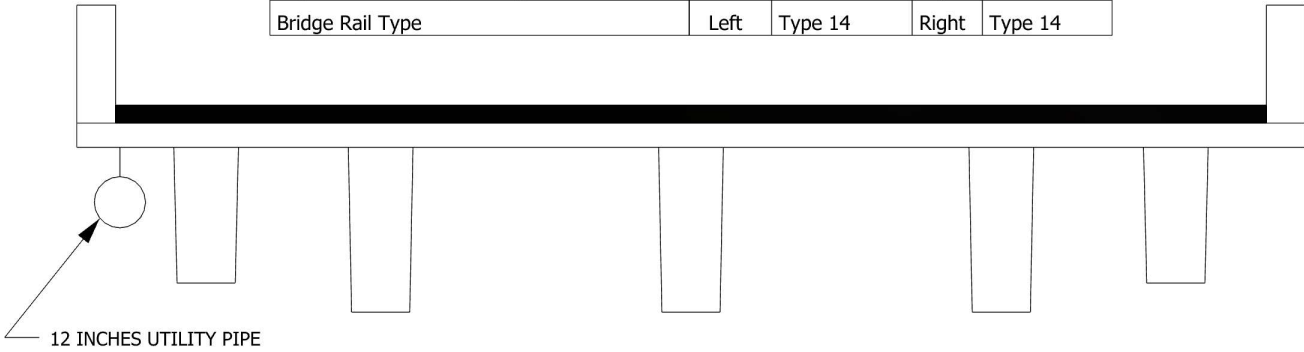
Measurements for Span #	1		
Deck Thickness	7.5in	Left Overhang	3.333ft
Top of Rail to Bottom of Beam (Avg)	6.8333ft	Right Overhang	3.333ft
