NC DEPARTMENT OF TRANSPORTATION
 DIVISION OF HIGHWAYS
 STRUCTURE MANAGEMENT UNIT

ATTENTION: **PAR ISSUED.**

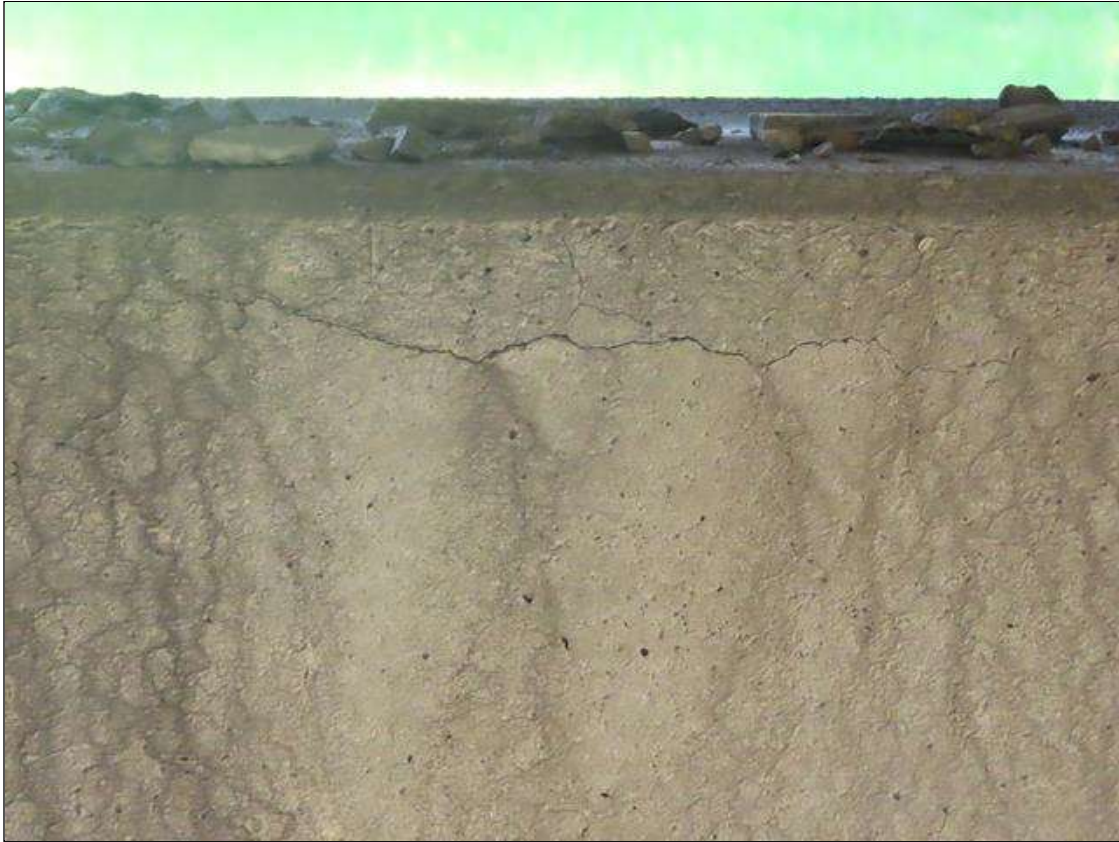
Bent 1 Cap 1: 3 FEET OF 1/16 INCH LONGITUDINAL CRACK BAY 1 SPAN 1 SIDE

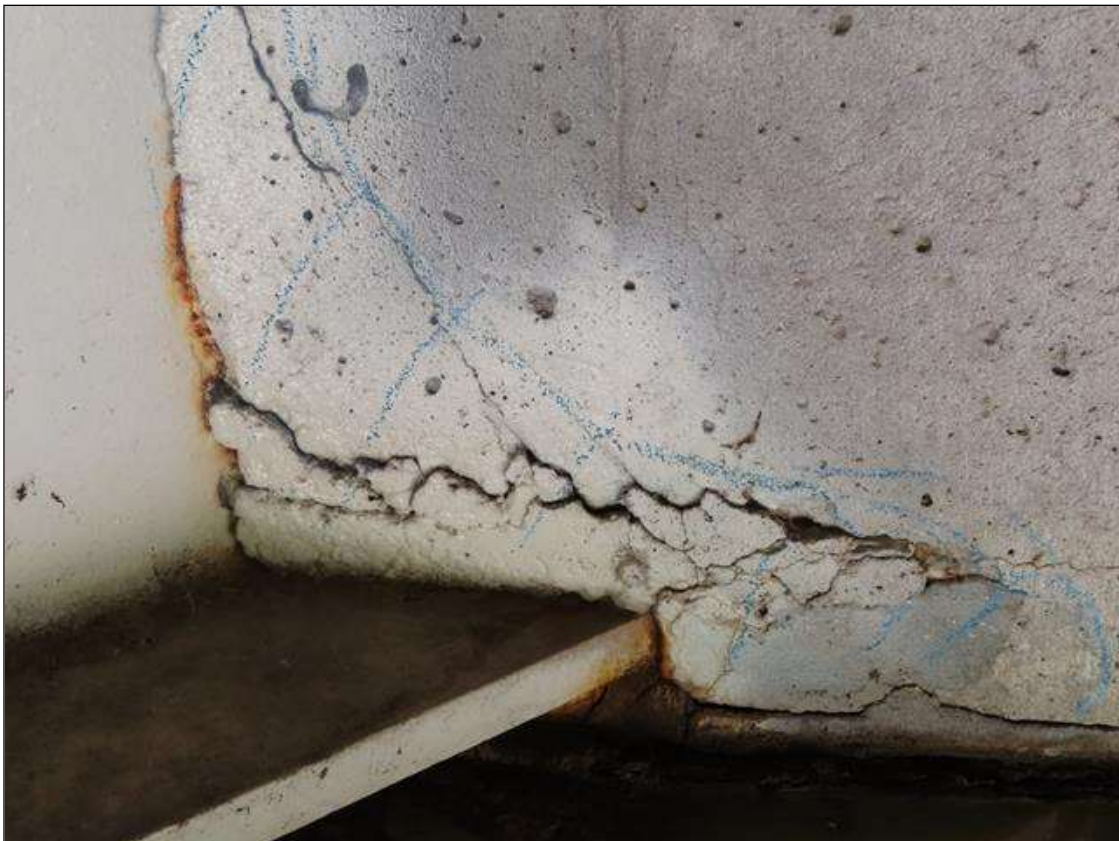
End Bent 1 Cap 1: DELAMINATION IN BE LEFT SIDE BEAM 2 BAY 1

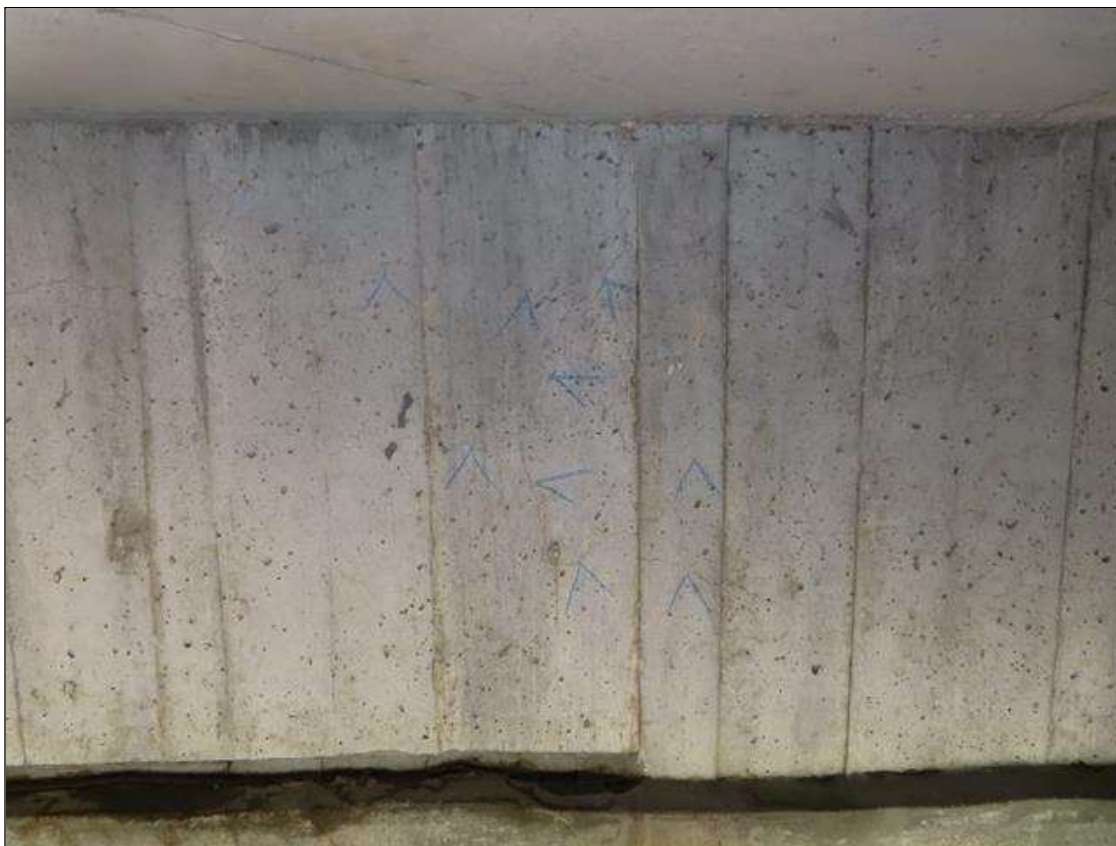
End Bent 1 Abutment/Backwall : ALL BAYS HAVE HAIRLINE MAP CRACKING

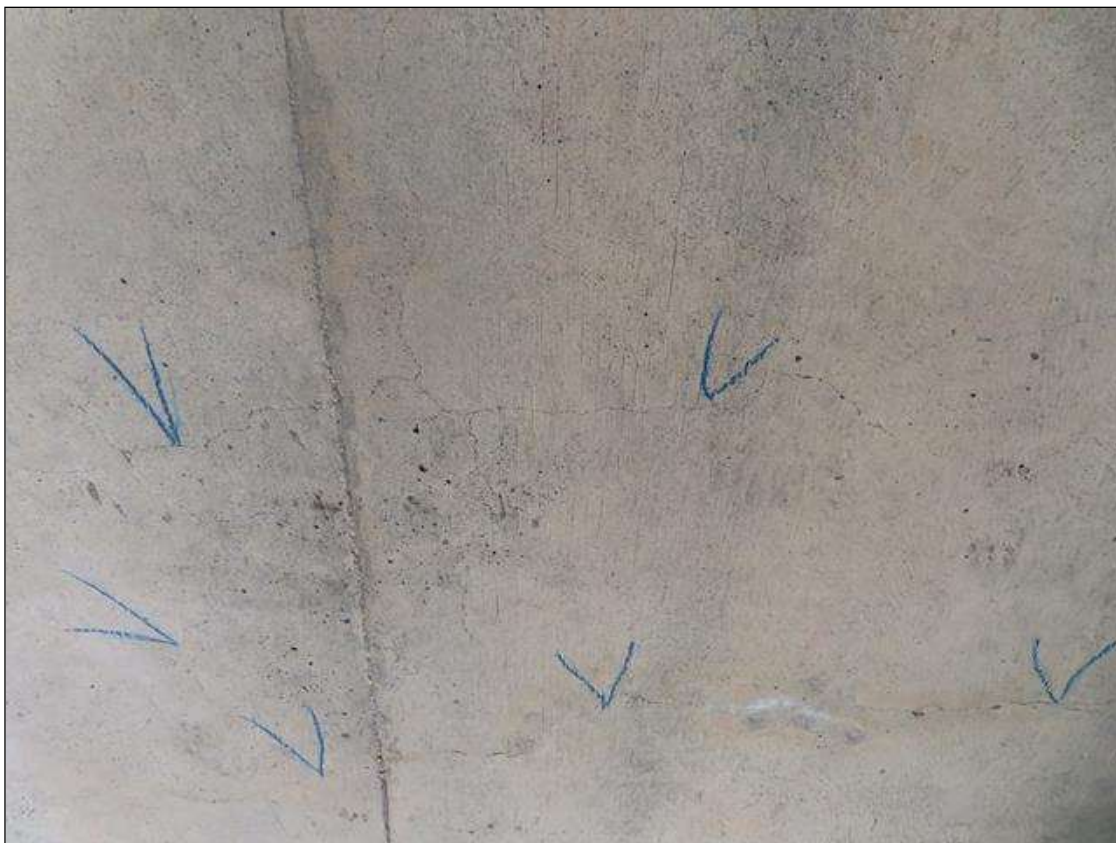
Span 1 Deck: BOTTOM OF DECK: HAIRLINE MAP TRANSVERSE AND DIAGONAL CRACKING IN ALL BAYS

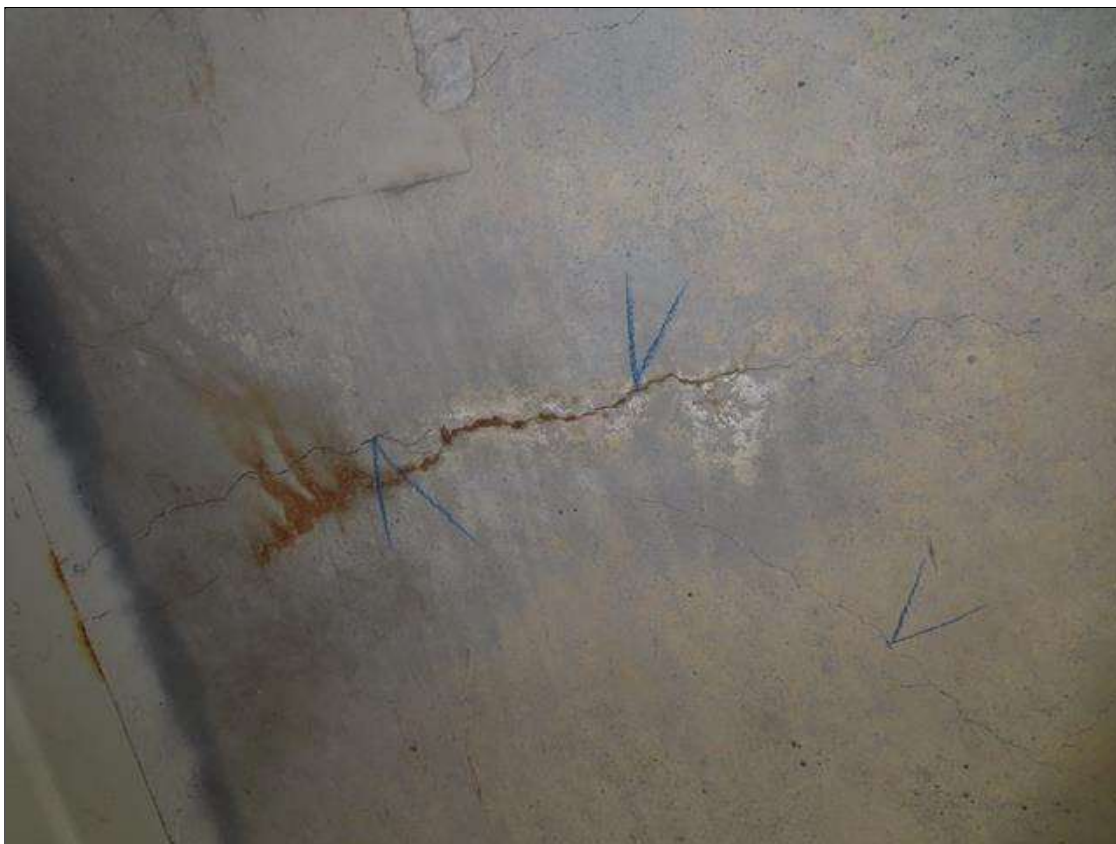
Span 1 Deck: BOTTOM OF DECK: HAIRLINE MAP TRANSVERSE AND DIAGONAL CRACKING IN ALL BAYS

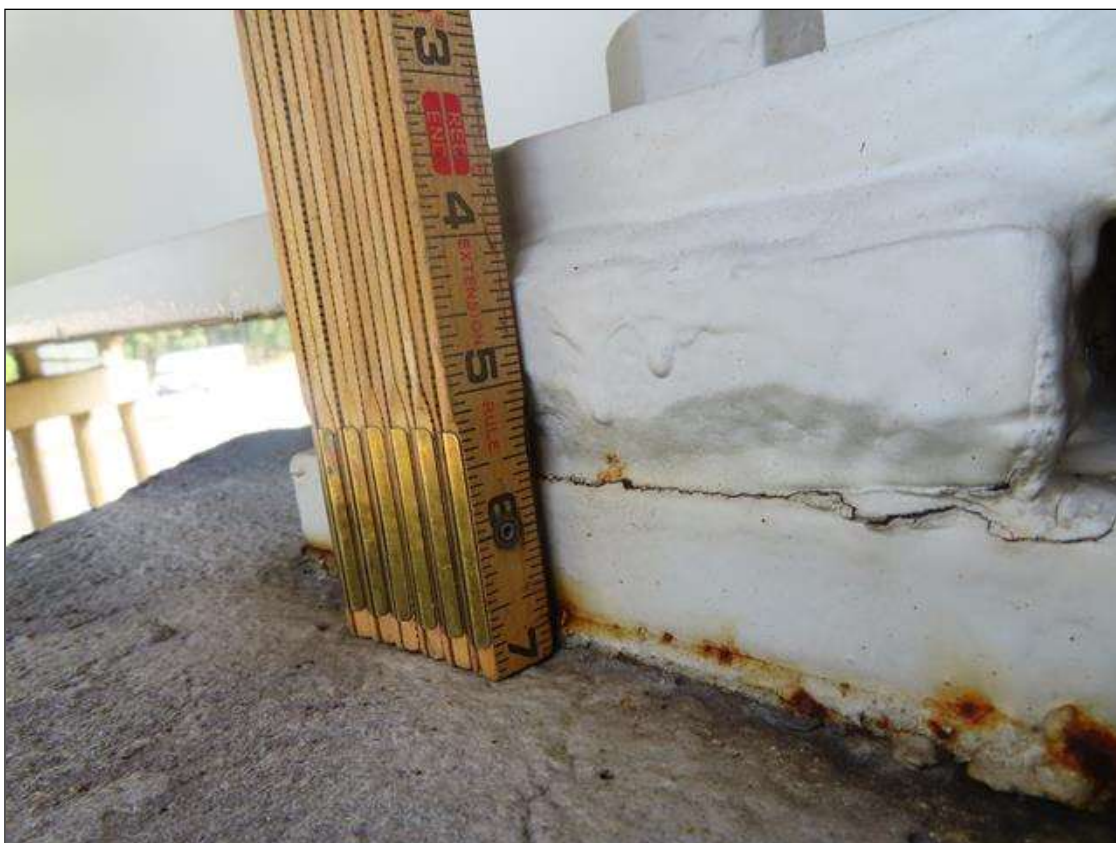
Span 1 Beam 1 Near Bearing: SECTION LOSS ARRESTED , PITTED 1/8 INCH DEEP IN VERTICAL FACES, COATING GOOD

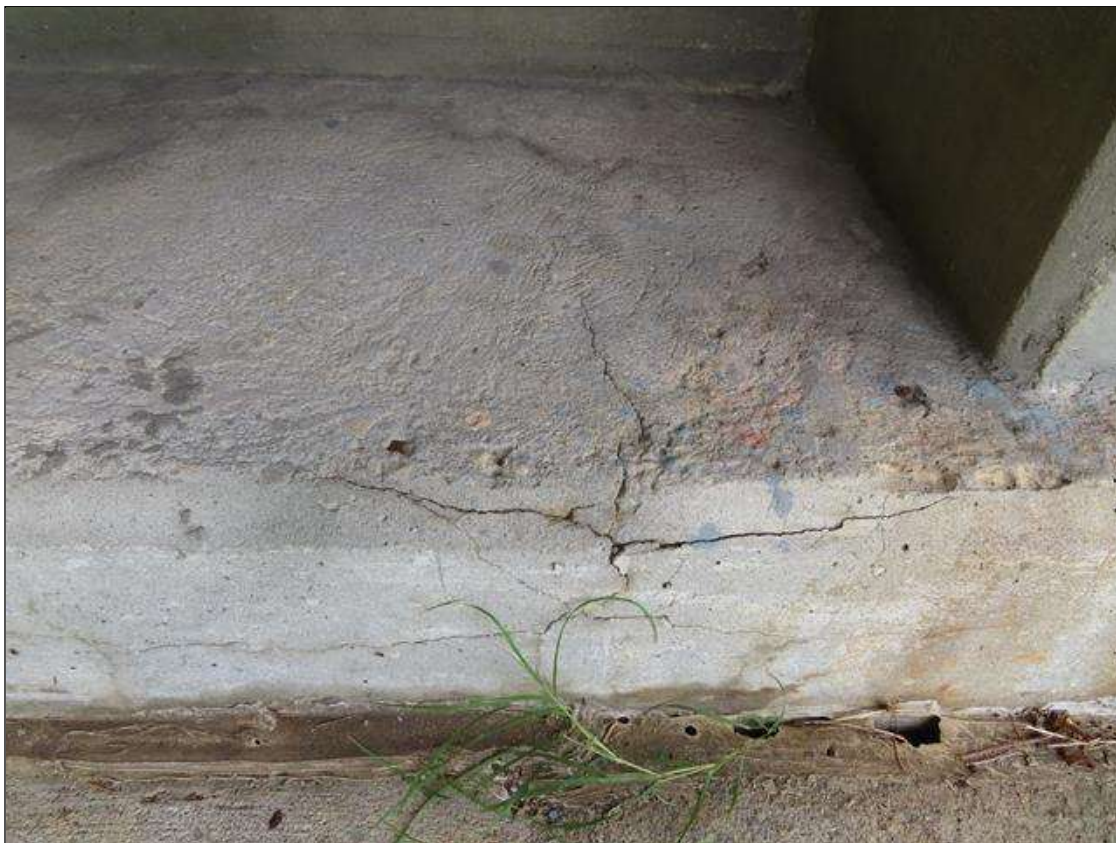
End Bent 1 Cap 1: 3 FEET CRACKING BAY 1 TOP , FACE 1/16 INCH WIDE

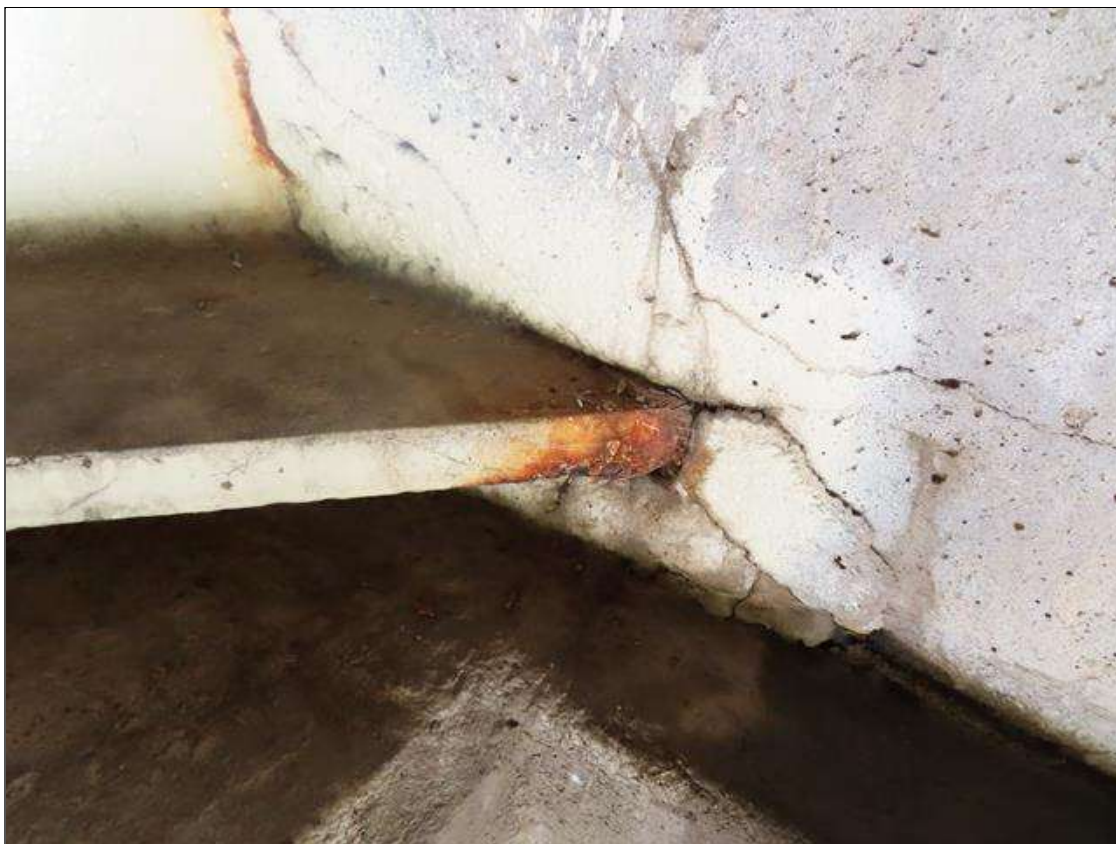
Span 1 Beam 3: FRECKLED RUST

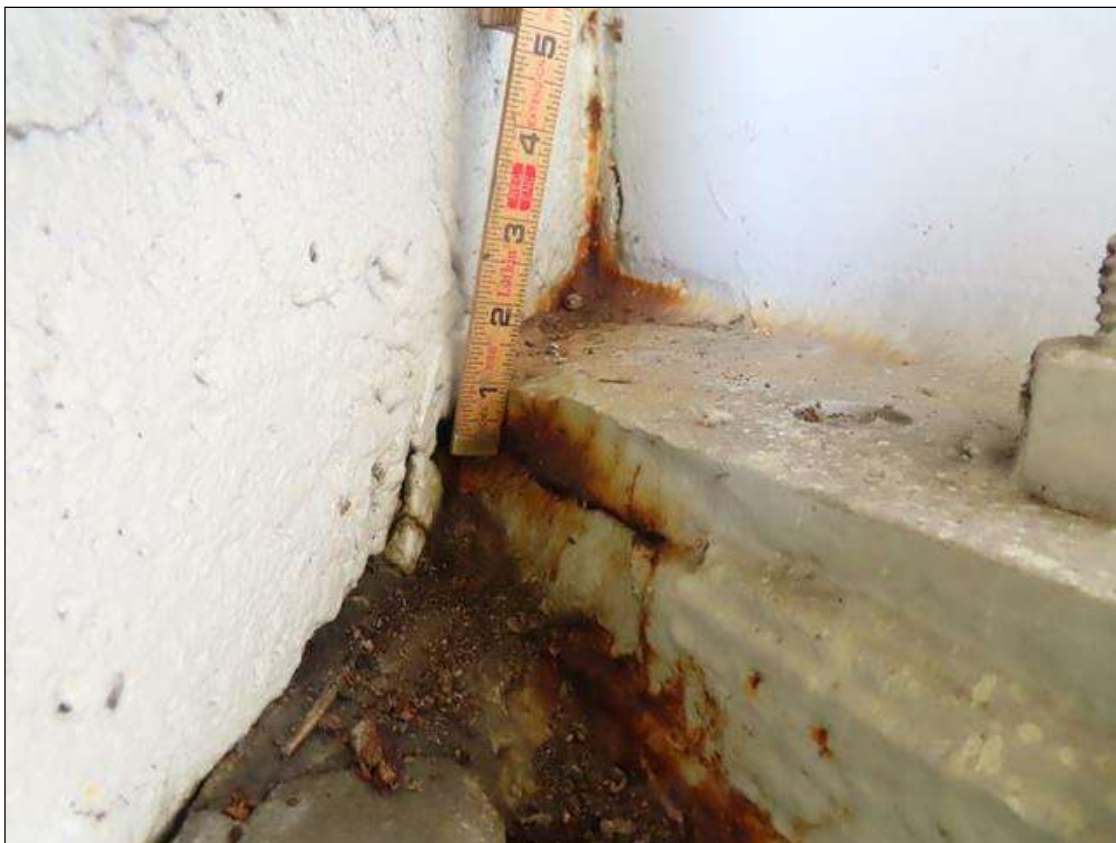
Span 1 Beam 4: SECTION LOSS BOTTOM FLANGE END BENT 1 - 7/8 INCH REMAINING FROM BEARING TO END

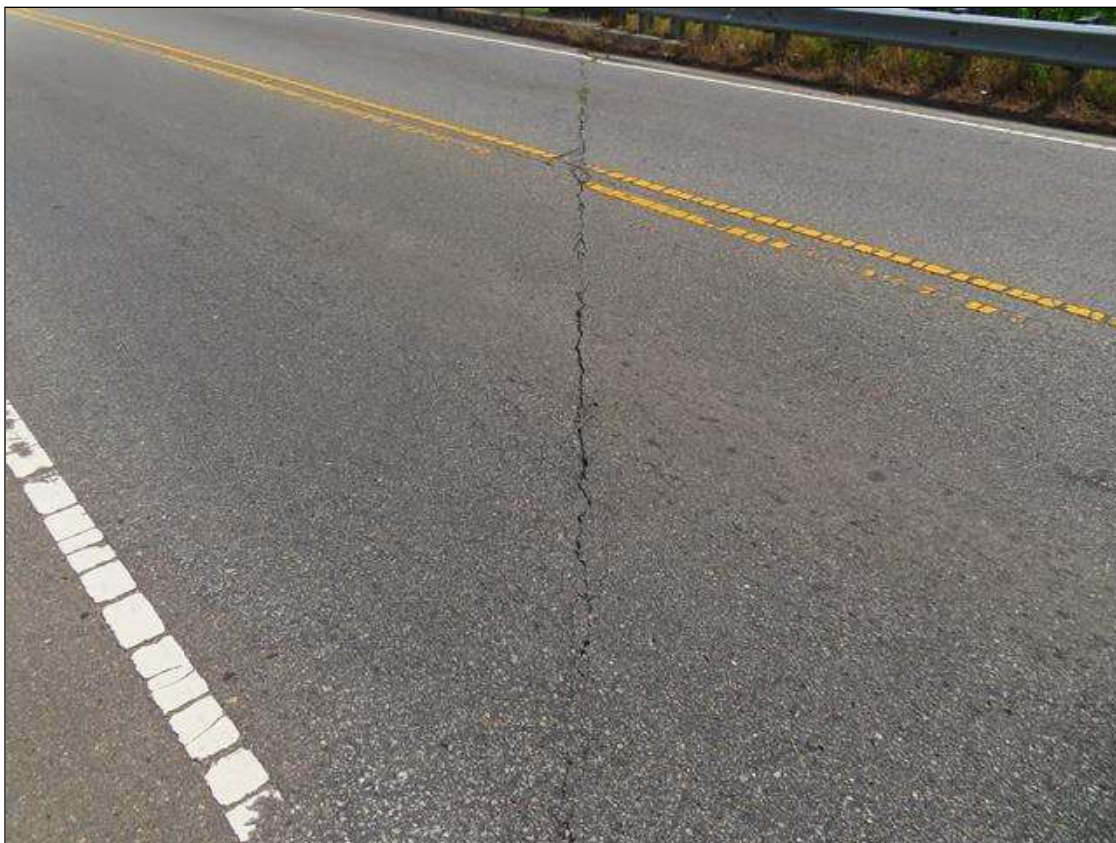
Span 1 Wearing Surface: 28 SQUARE FEET OF CRACKING OVER END BENT 1.

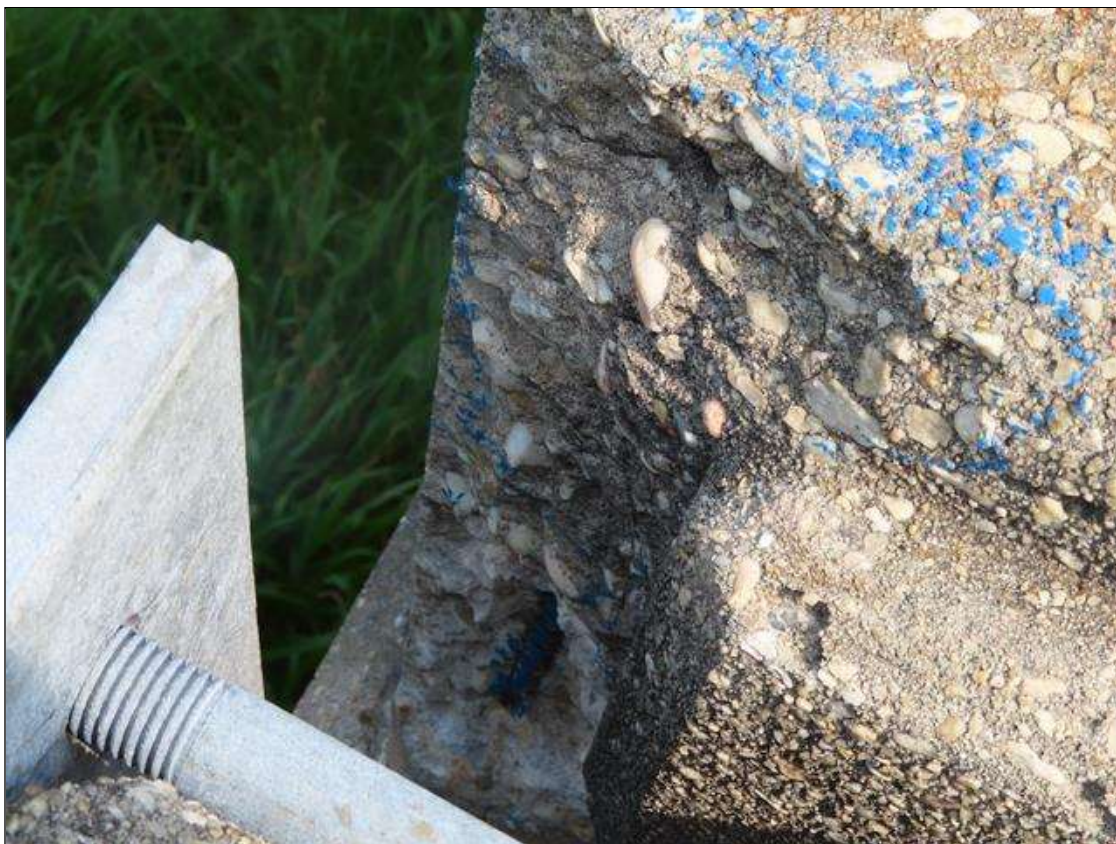
Span 1 Left Bridge Rail: 1 FOOT OF SPALLING IN POST #3. WITH EXPOSED REBAR

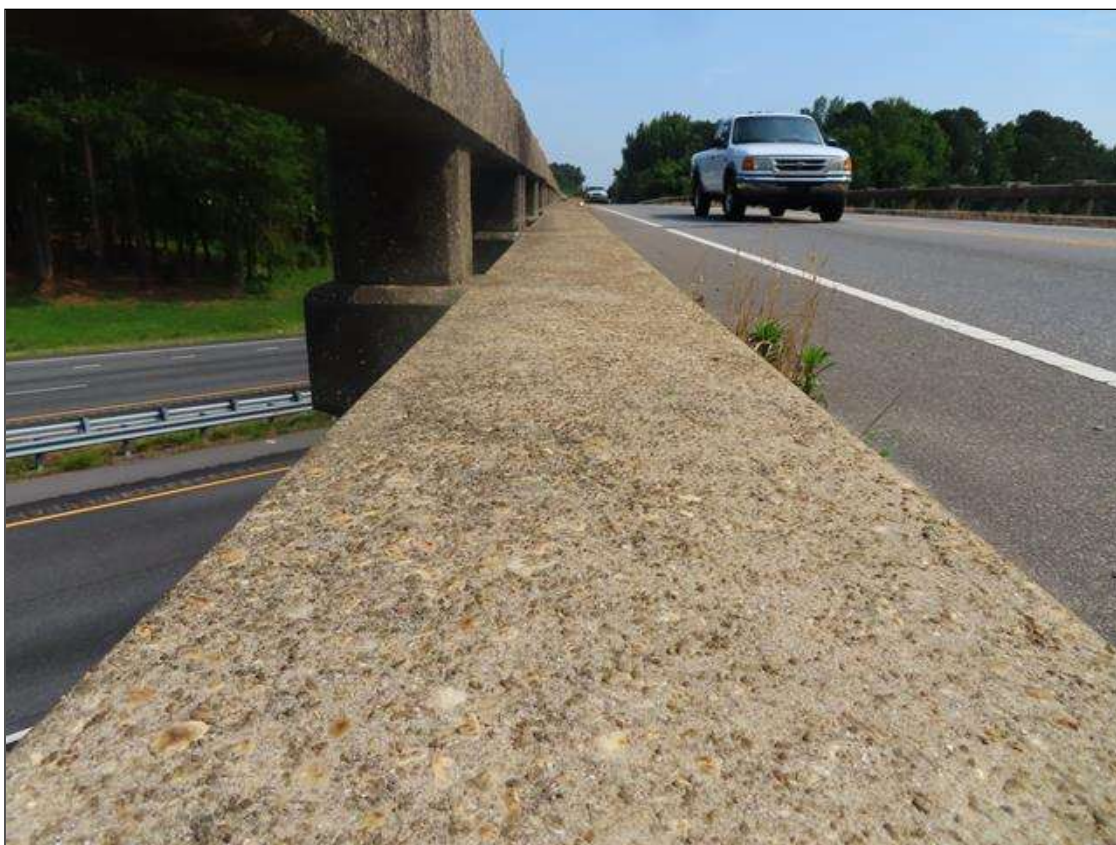
Span 1 Deck: 145 SQUARE FEET OF ABRASION ALONG CURBS.

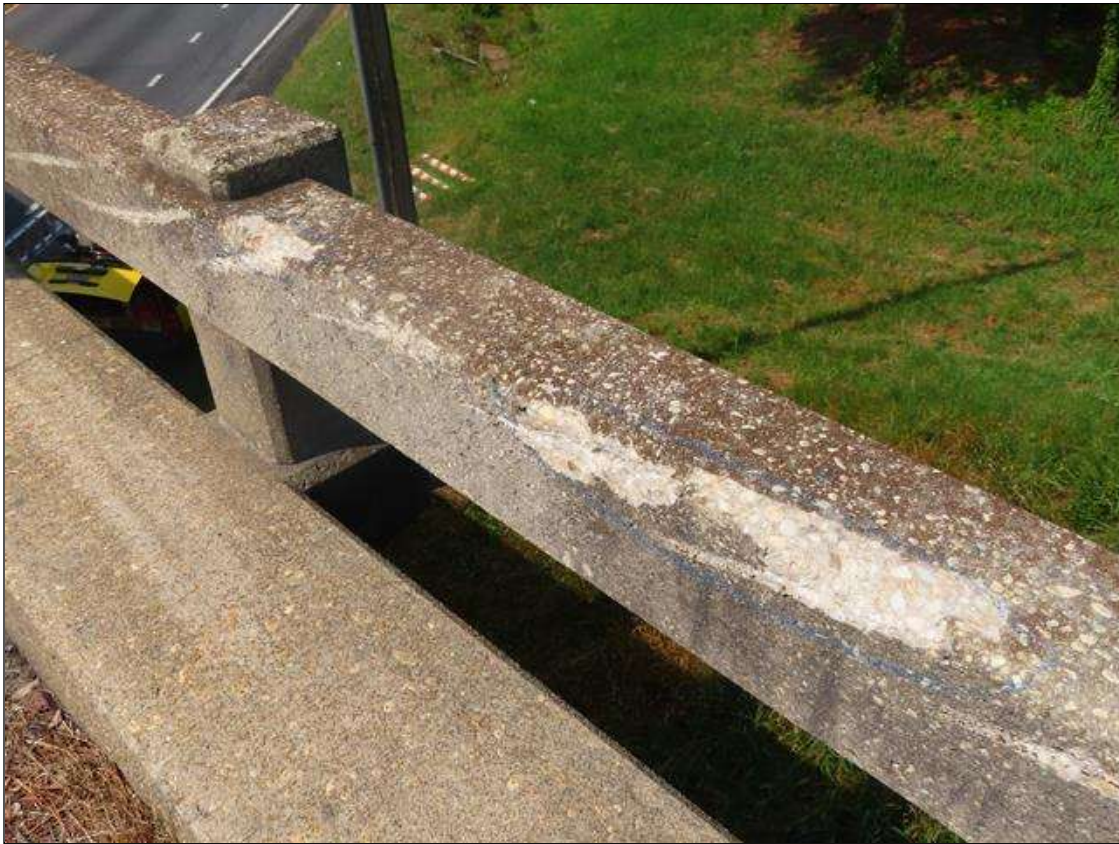
Span 4 Left Bridge Rail: 5 FEET OF IMPACT DAMAGE ALONG RAIL.

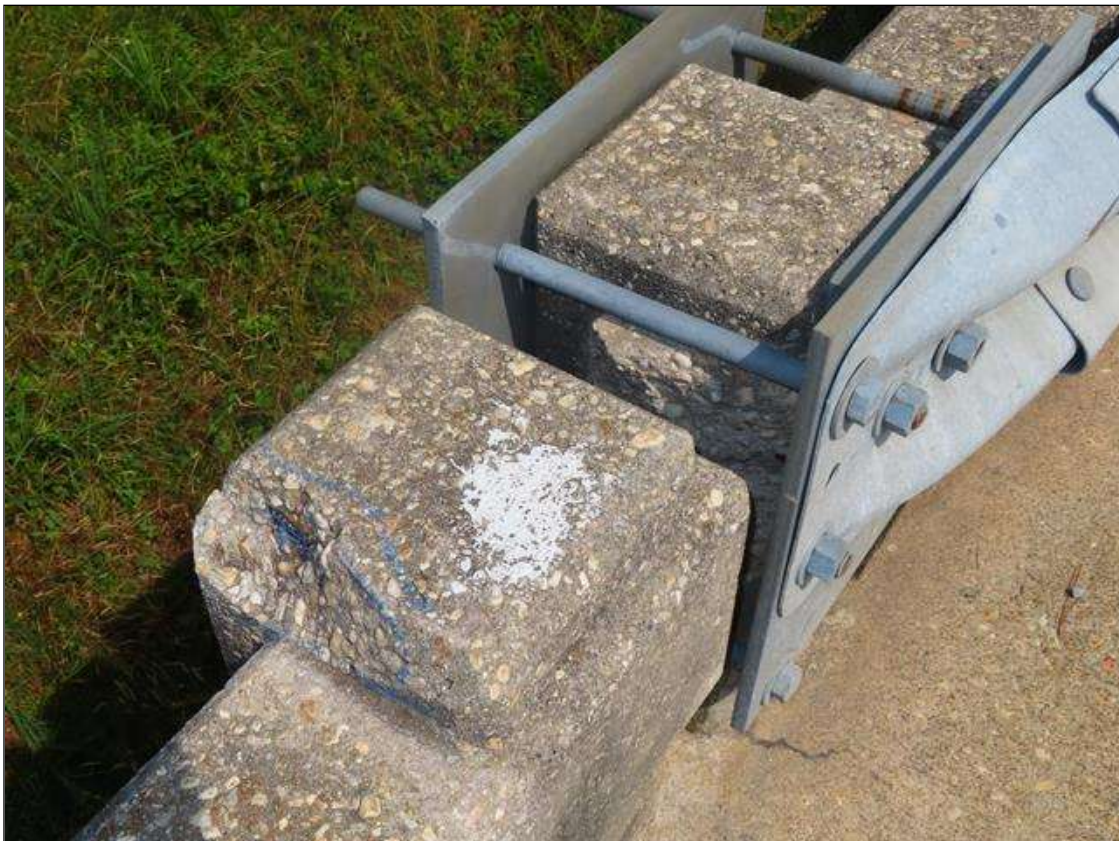
Span 4 Left Bridge Rail: 2 FEET OF SPALLING IN POSTS 5 & 6. WITH EXPOSED REBAR

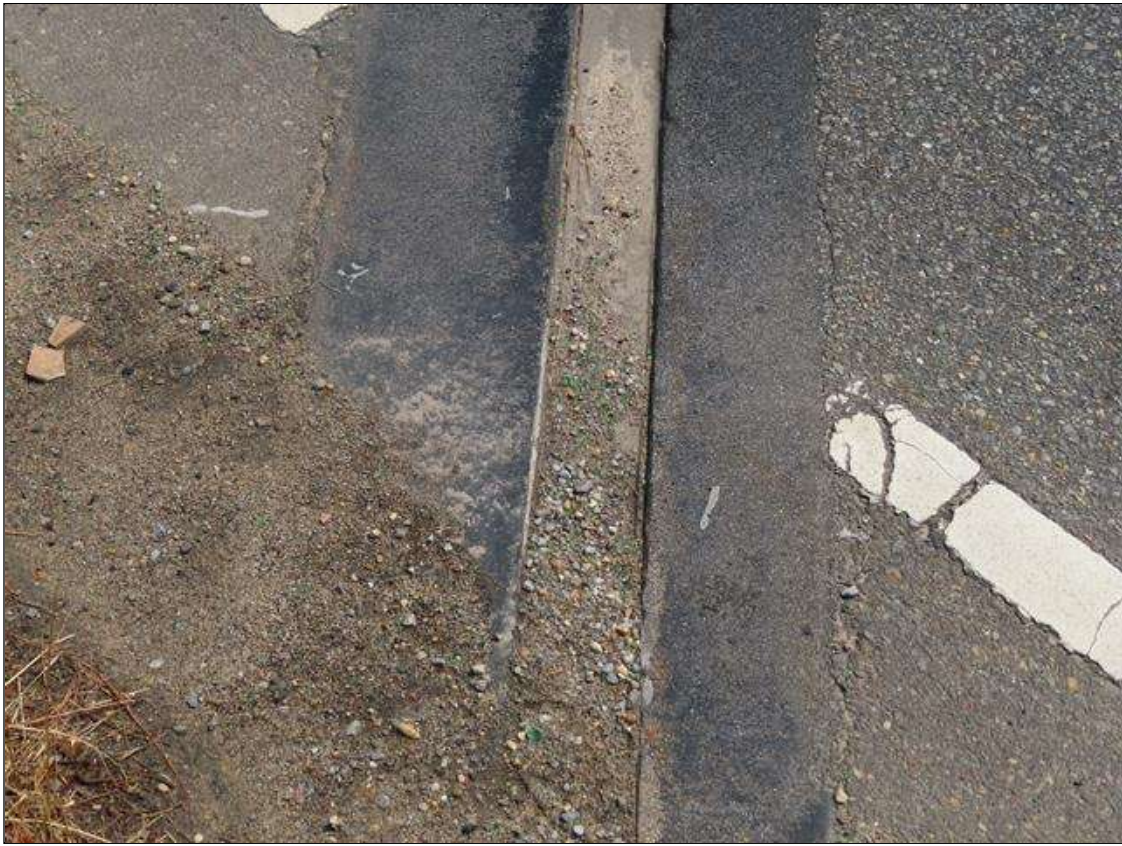
Expansion Joint : DIRT AND DEBRIS IMPACTION

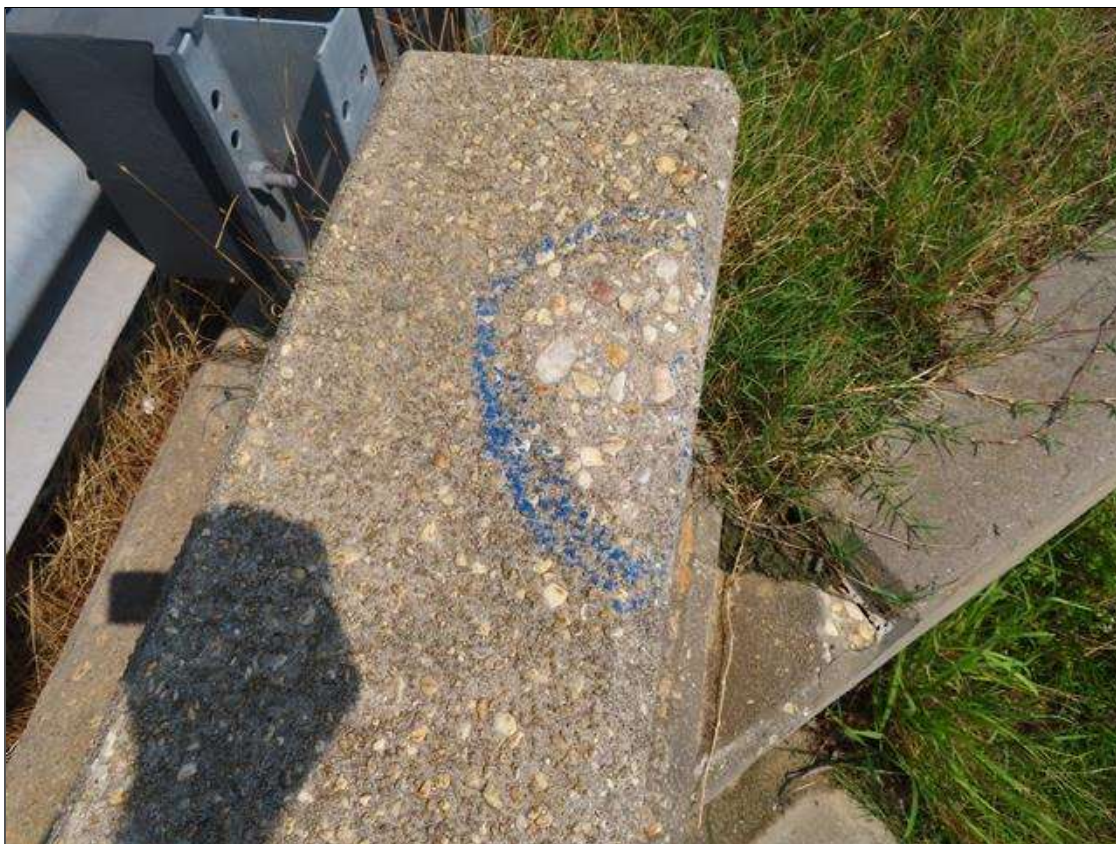
Span 4 Right Bridge Rail: 6 INCH DIAMETER X 1 INCH DEEP SPALL IN END POST

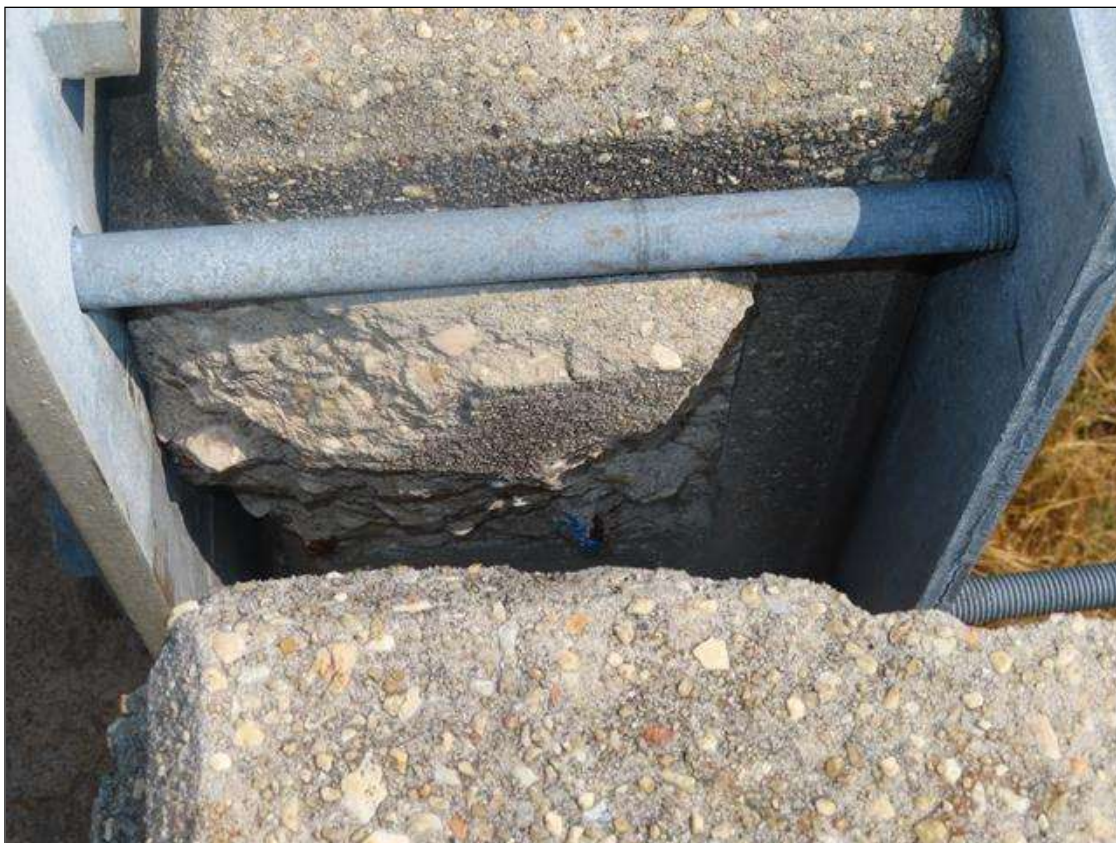
Span 4 Right Bridge Rail: 1 FOOT OF SPALLING WITH EXPOSED REBAR IN POST #6.

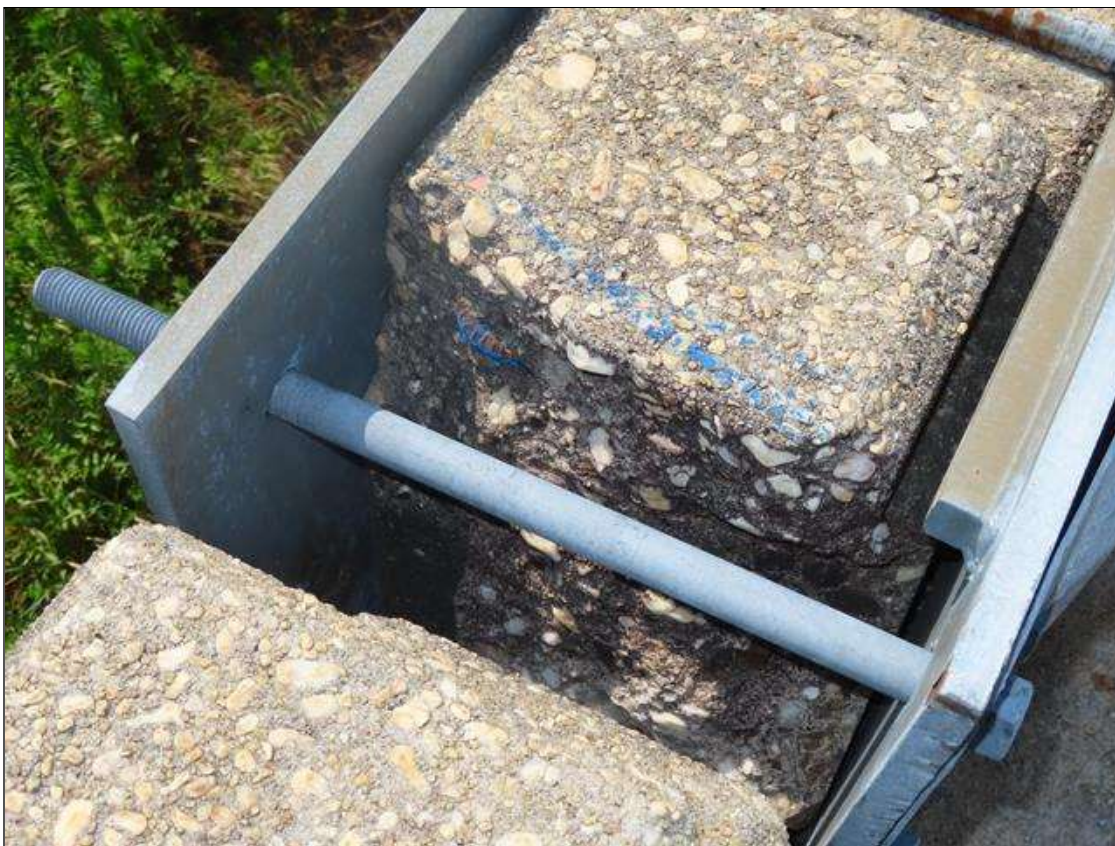
Span 1 Right Bridge Rail: 1 FOOT OF SPALL WITH EXPOSED REBAR IN POST #2.

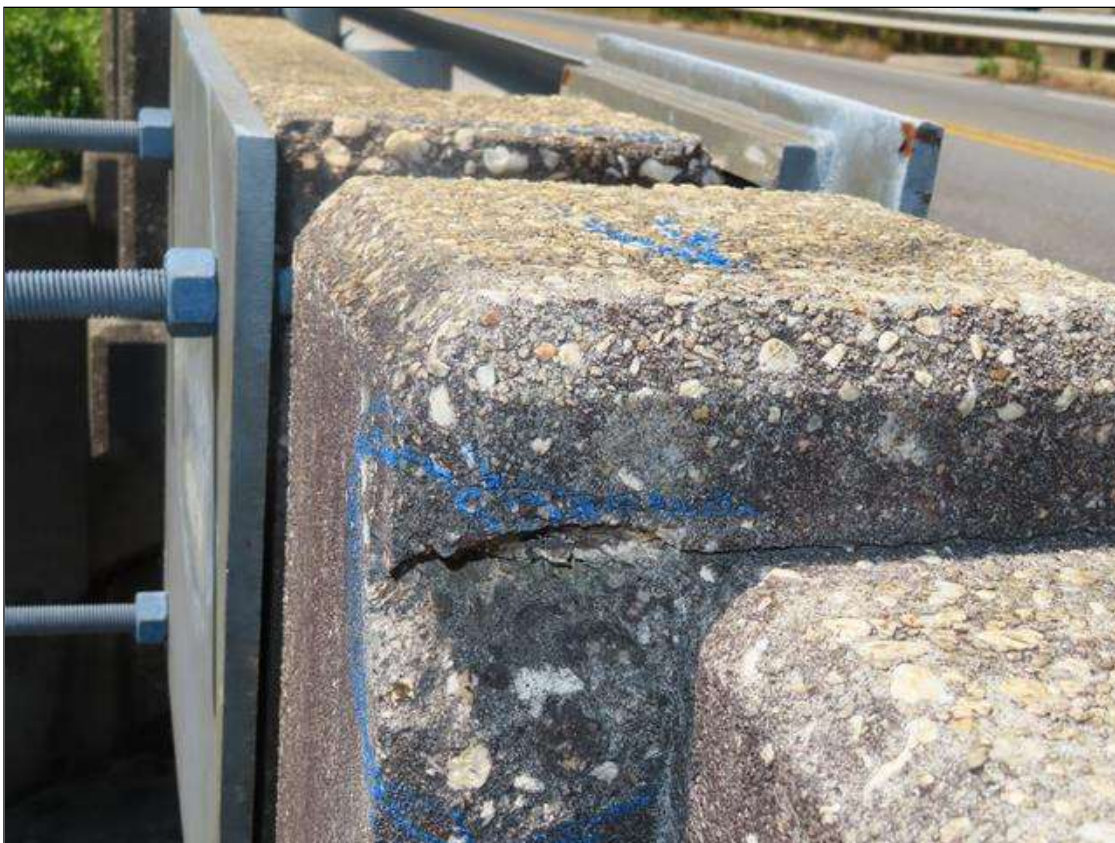
Span 1 Right Bridge Rail: 1 FOOT OF SPALLING WITH CRACKING IN POST #3.

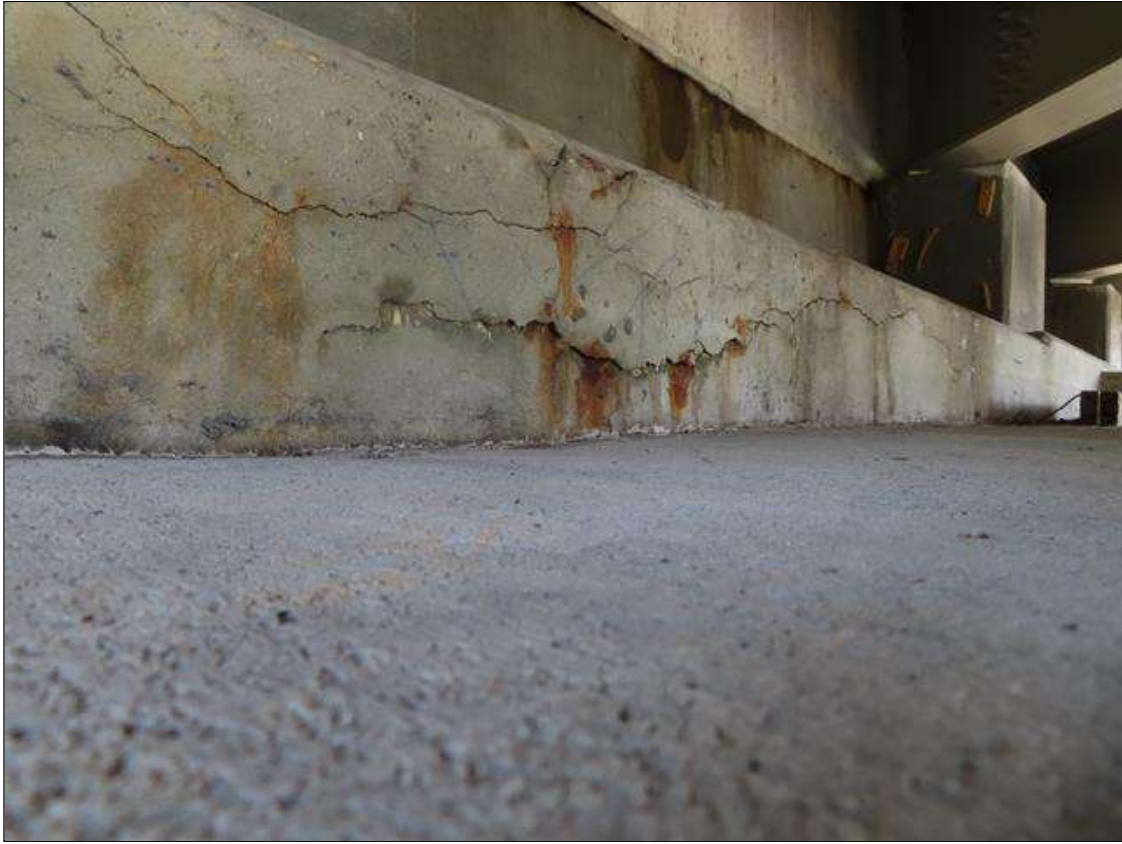
End Bent 2 Cap 1: 8 FEET LONGITUDINAL CRACKING FACE AND TOP OF CAP WITH DELAMINATION BETWEEN AND RUST STAINING UNDER BAY 1

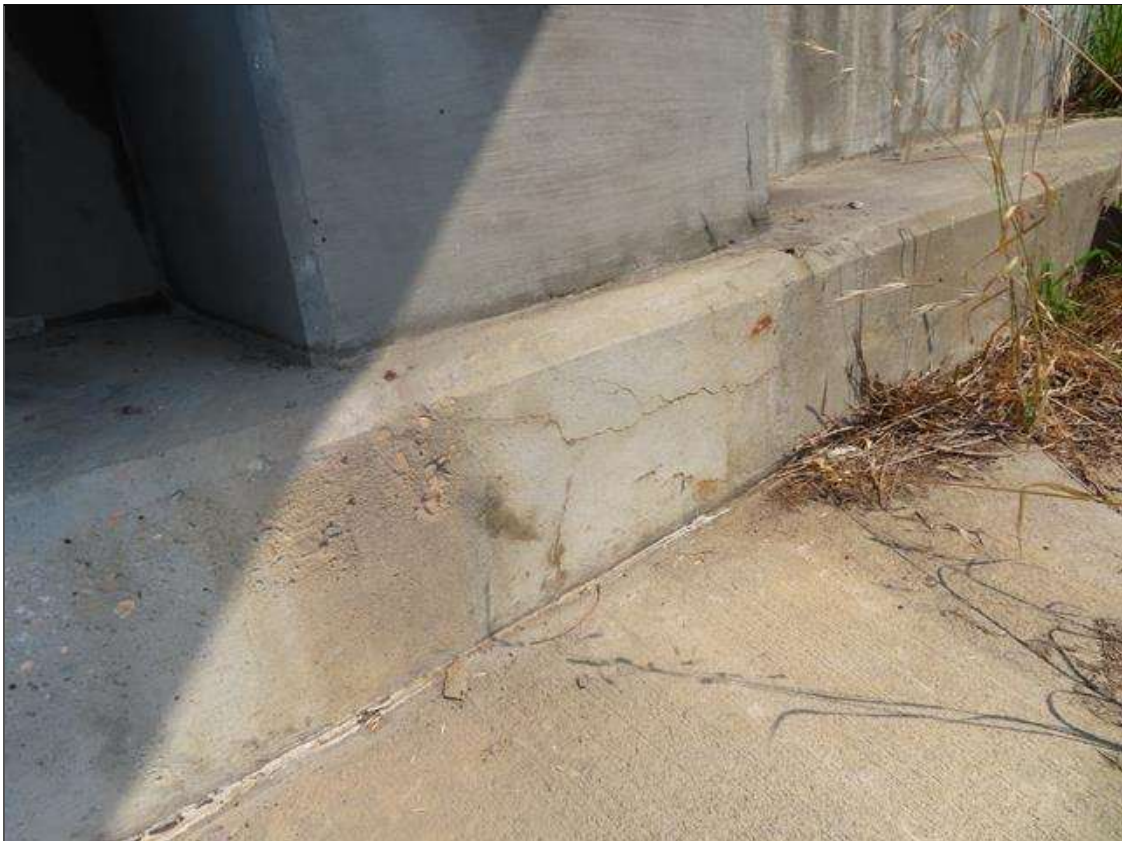
End Bent 2 Cap 1: 3 FEET X 1/8 INCH LONGITUDINAL FACE OF CAP BEAM 4

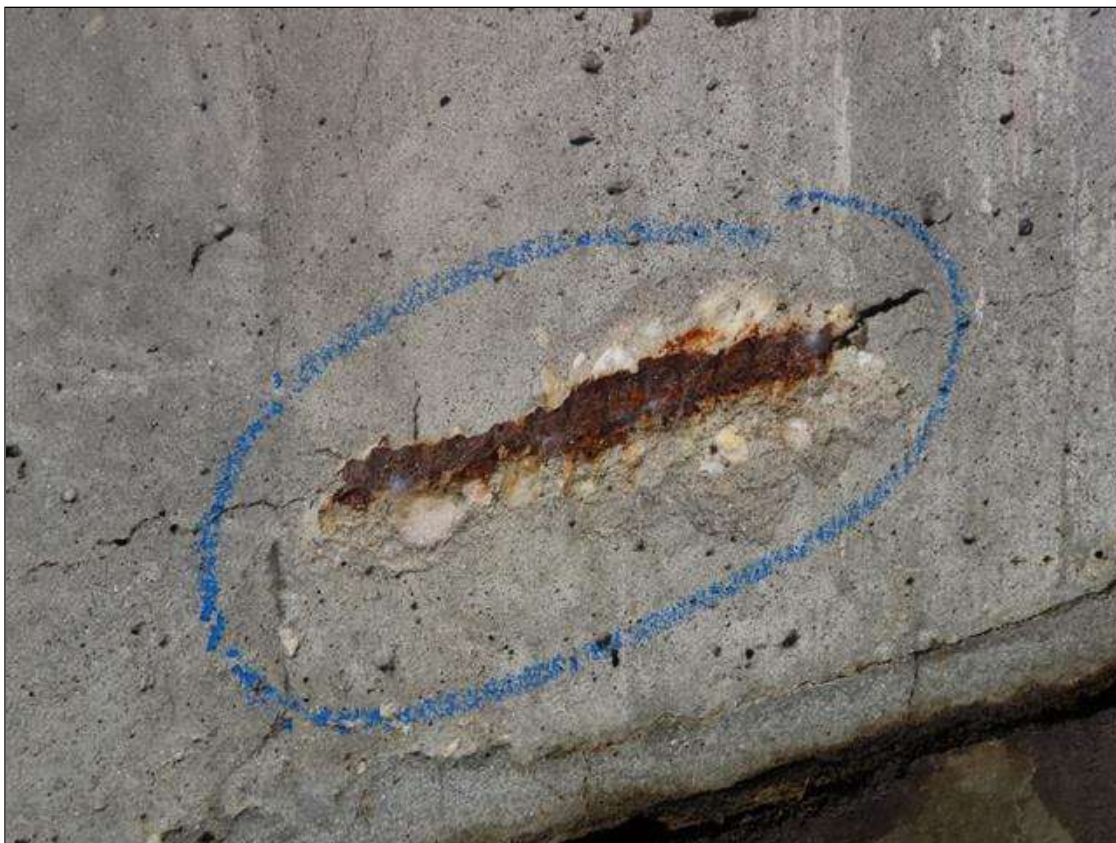
End Bent 2 Abutment/Backwall : 1 FOOT OF EXPOSED REBAR WITH SURFACE SPALLING BAY 2.

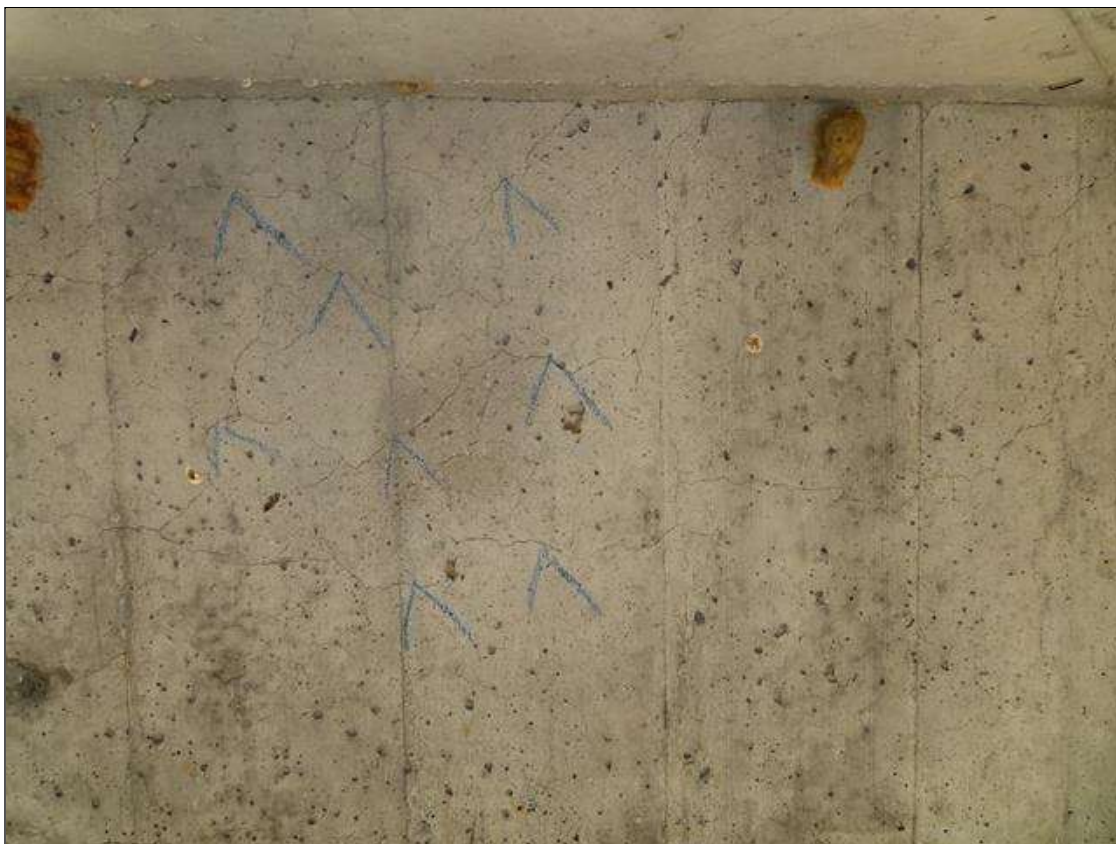
End Bent 2 Abutment/Backwall : 28 FEET HAIRLINE MAP CRACKING FULL LENGTH

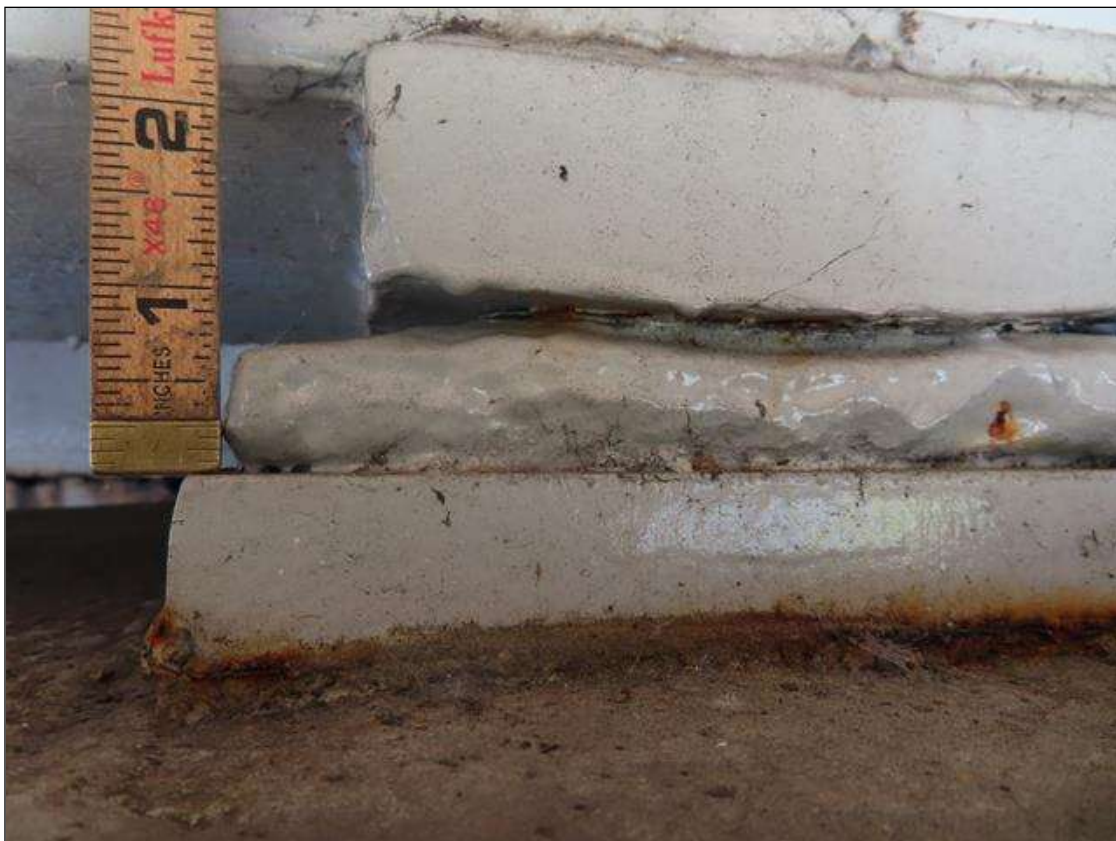
Span 4 Beam 3 Far Bearing: SECTION LOSS ARRESTED, PITTED 1/8 INCH DEEP IN VERTICAL FACES. COATING IS GOOD
