NC DEPARTMENT OF TRANSPORTATION
 DIVISION OF HIGHWAYS
 STRUCTURE MANAGEMENT UNIT

ATTENTION: **PAR ISSUED.**

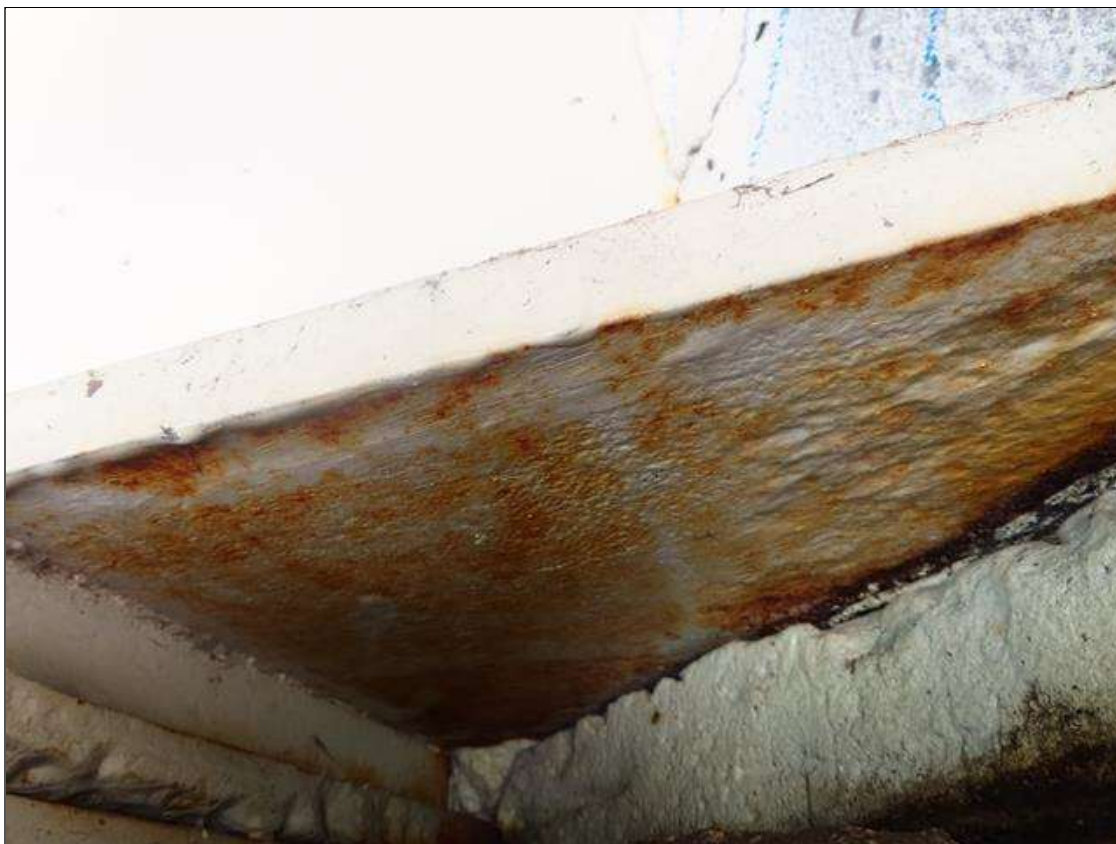
Span 4 Beam 3: SURFACE RUST BOTTOM FLANGE

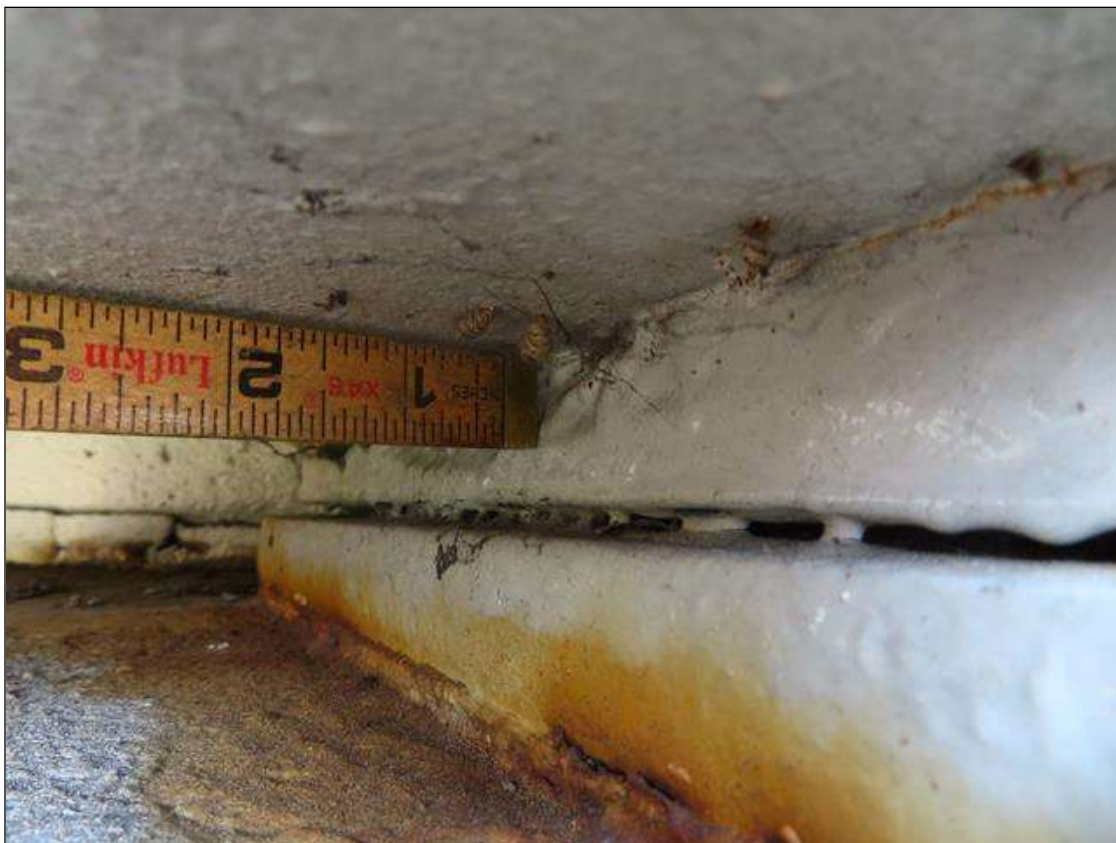
Span 4 Beam 4 Far Bearing: SECTION LOSS ARRESTED, PITTED 1/8 INCH DEEP IN VERTICAL FACES AND FRECKLED RUST

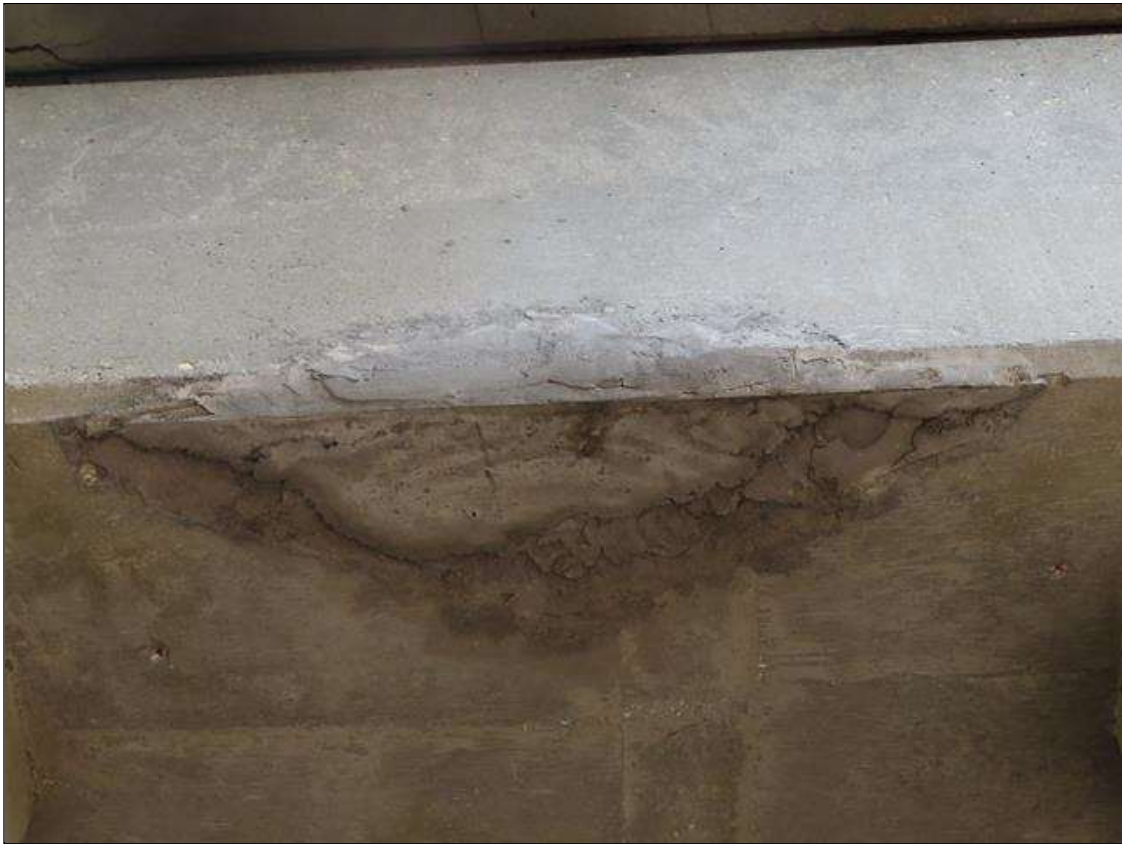
Bent 2 Cap 1: 3 FEET OF PATCHING BOTTOM OF CAP UNSOUND BAY 3

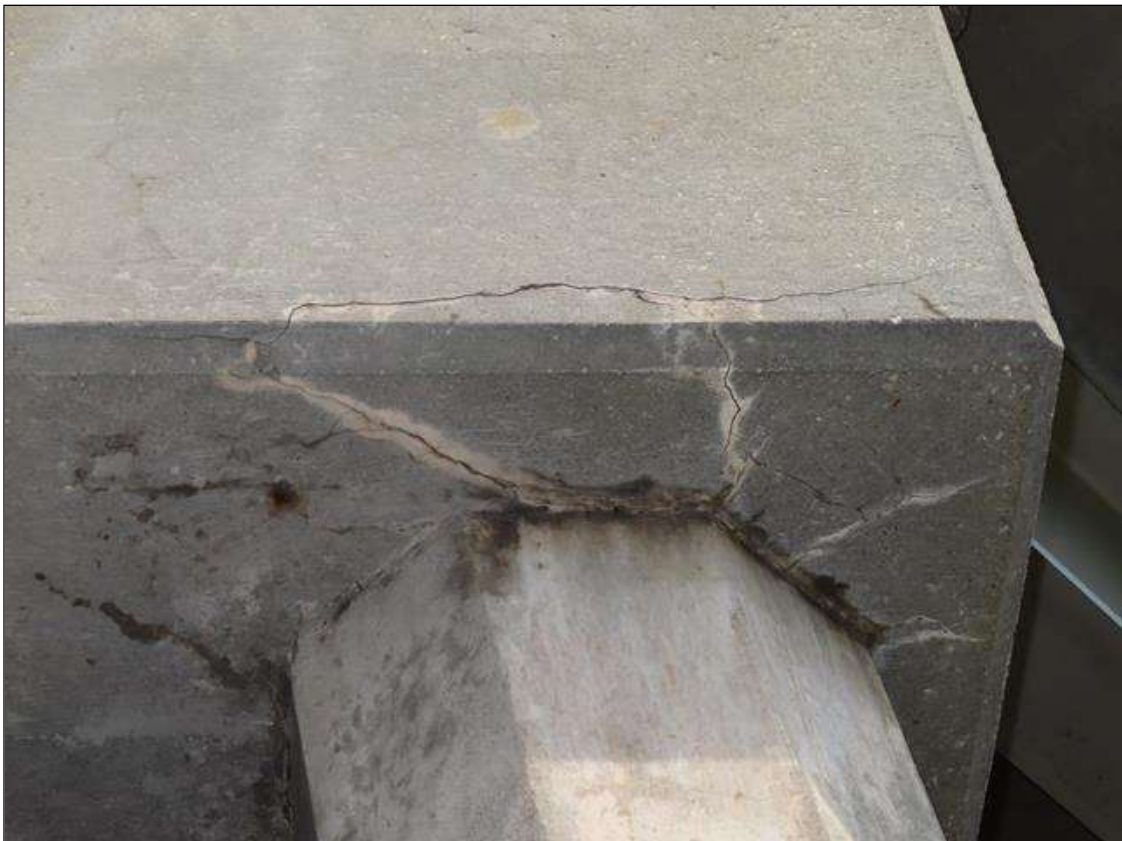
Bent 2 Cap 1: 1/32 INCH CRACKS RADIATING BOTTOM OF CAP AT PILE 7

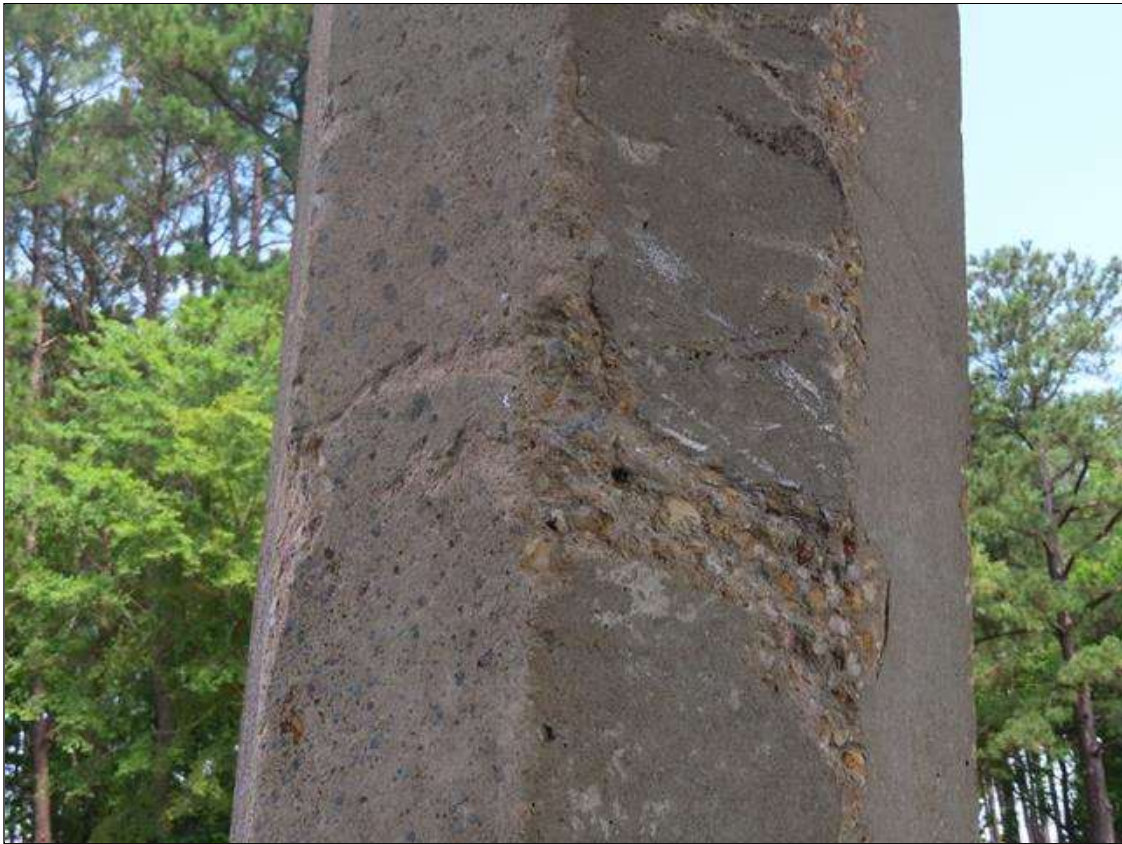
Bent 2 Pile 1: 1 FOOT SPALLING 1 INCH DEEP SPAN 2 SIDE

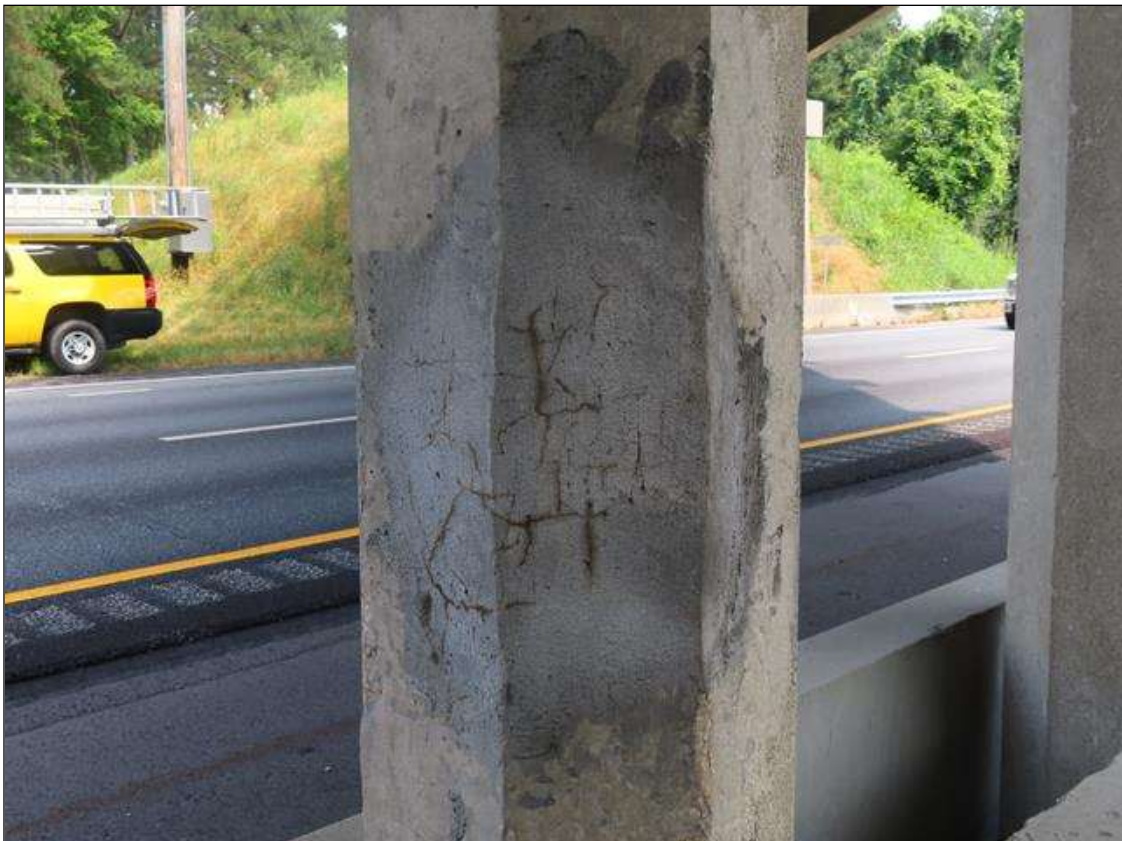
Bent 2 Pile 2: 2 FEET PATCHING

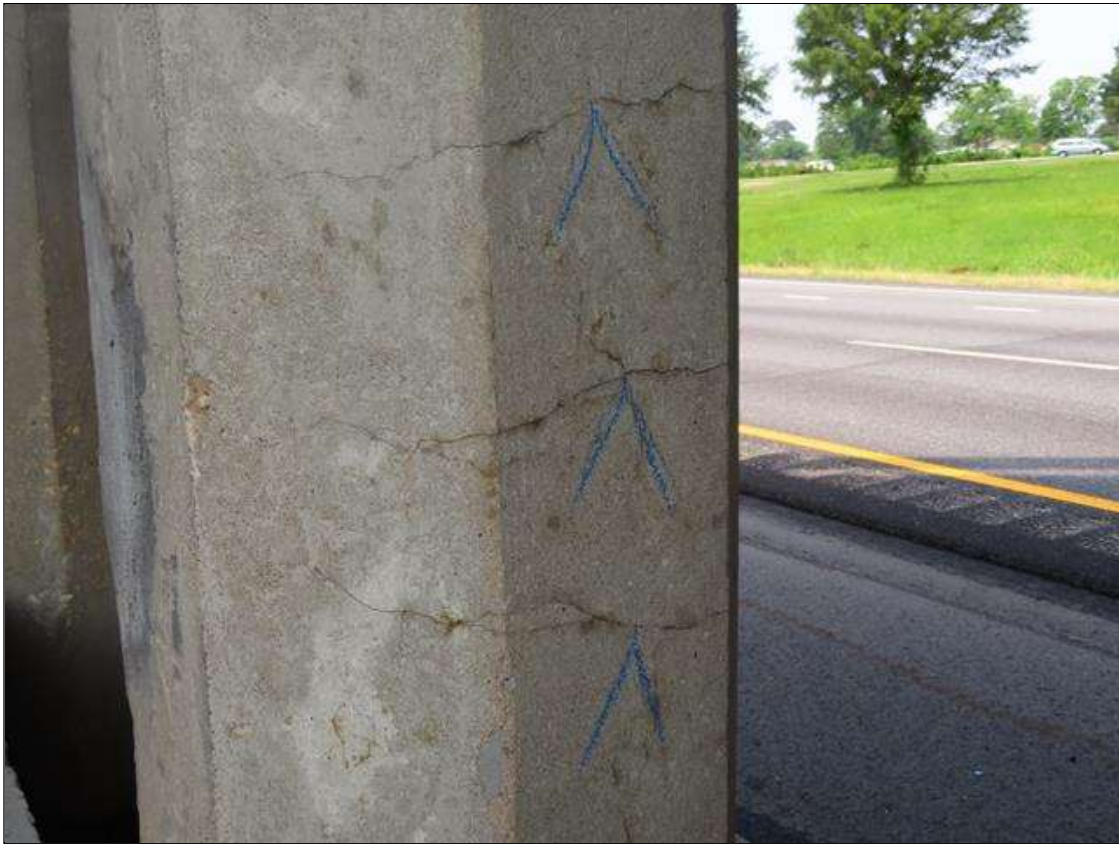
Bent 2 Pile 2: 3 TRANSVERSE 1/32 INCH CRACKS RIGHT SIDE 4 FEET FROM GROUNDLINE

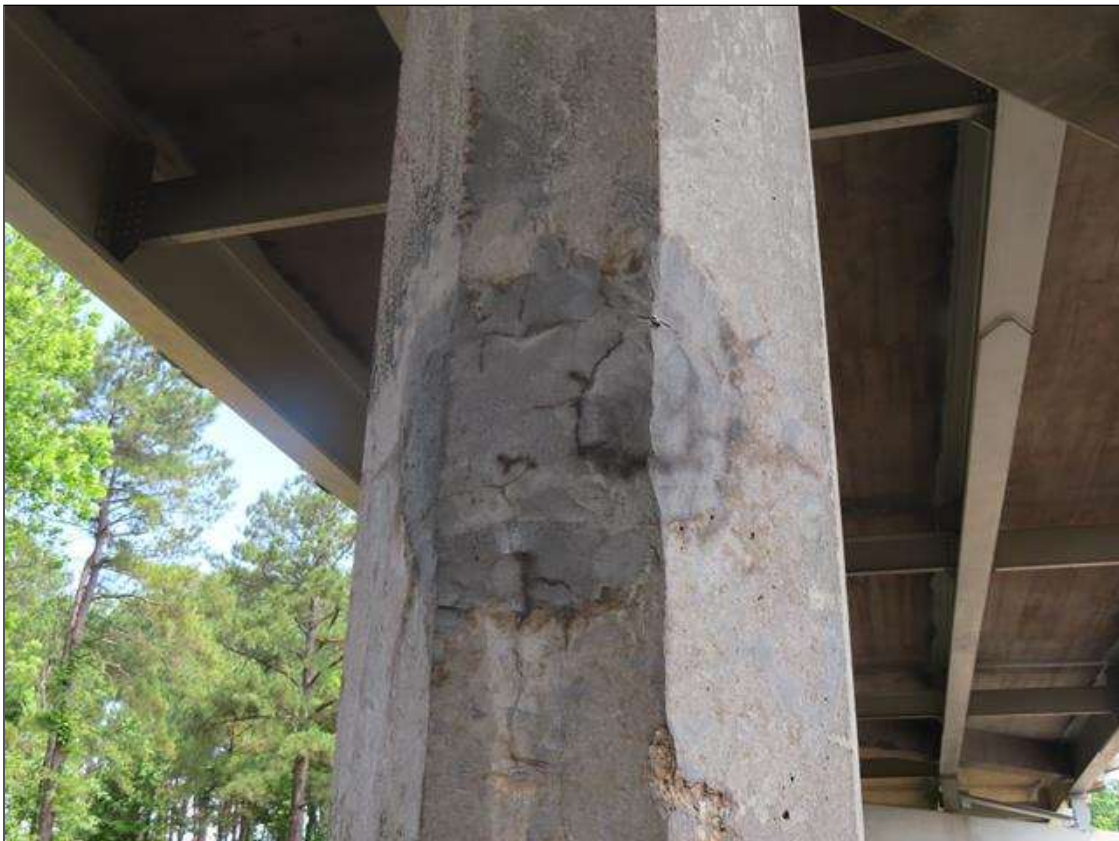
Bent 2 Pile 4: 2 FEET PATCHING

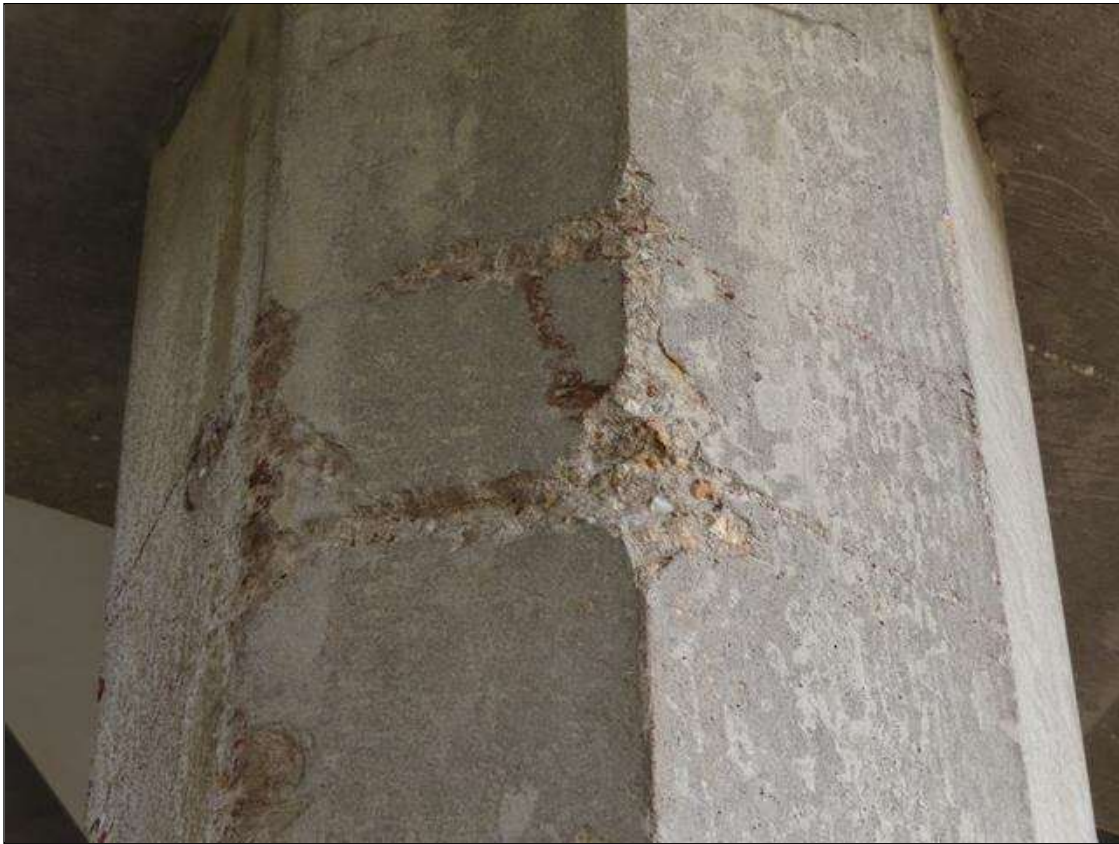
Bent 2 Pile 4: 3 FEET SURFACE SPALLING 1/2 INCH DEEP

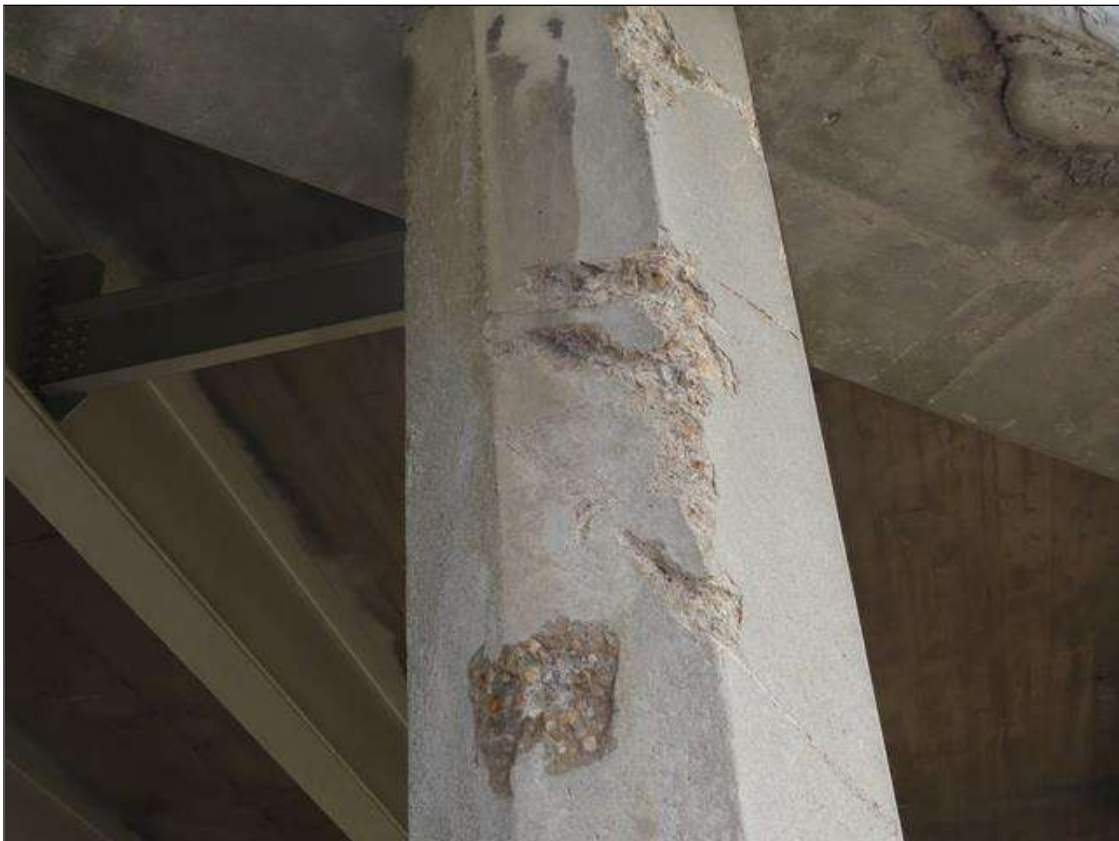
Bent 2 Pile 5: 5 SPALLS 1 IN DEEP TOTALLING 6 SQUARE FEET

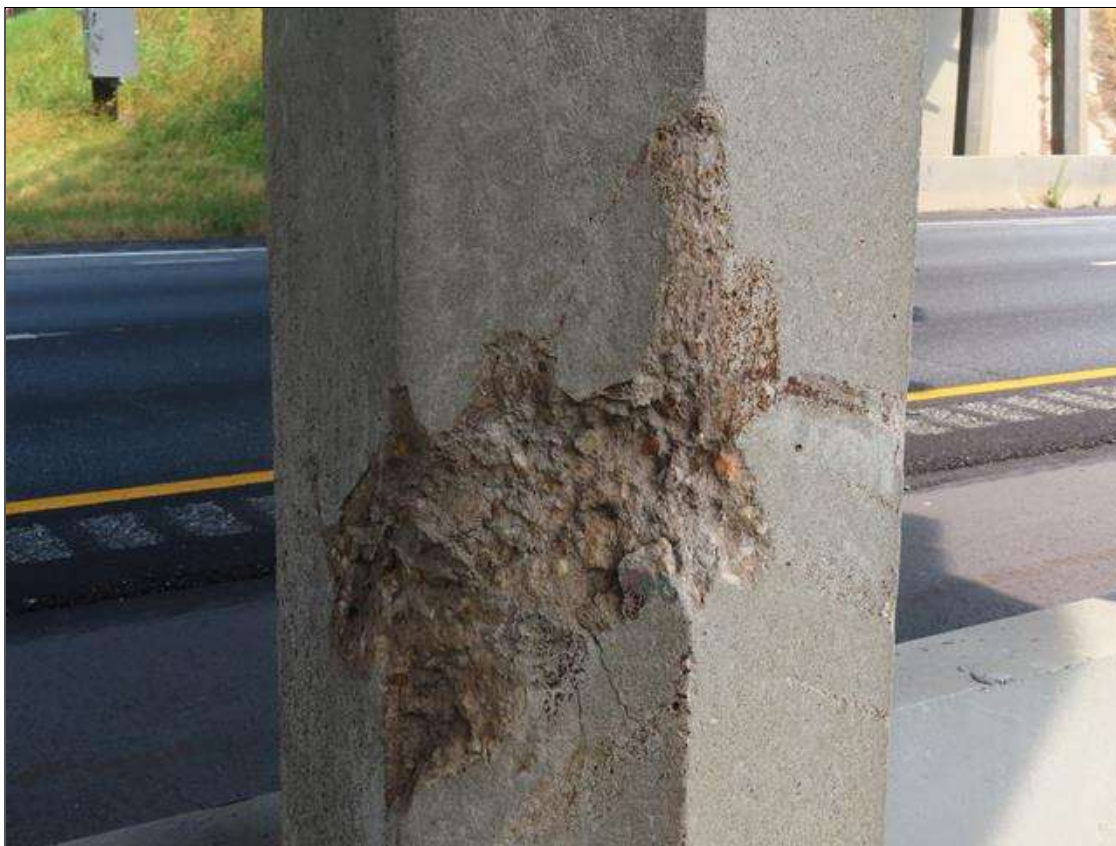
Bent 2 Pile 5: 5 SPALLS 1 IN DEEP TOTALLING 6 SQUARE FEET

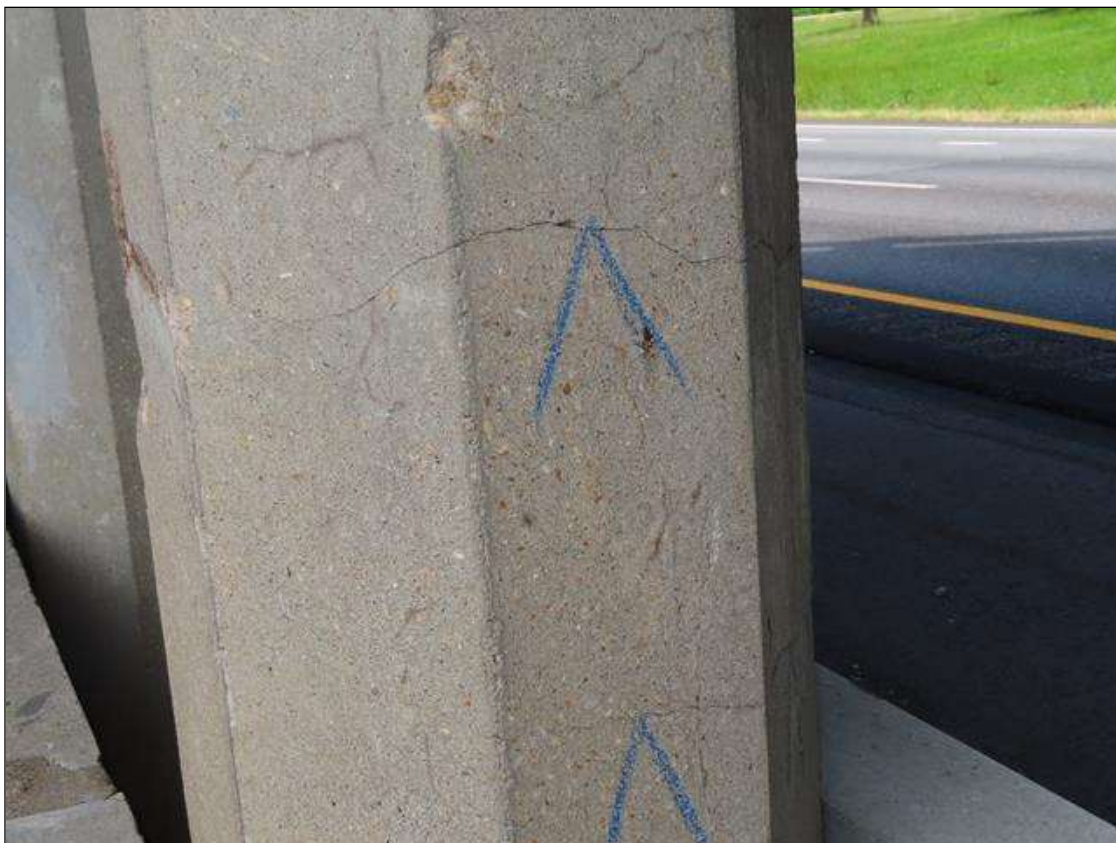
Bent 2 Pile 5: TRANSVERSE CRACKING SPAN 3 SIDE OPPOSITE SPALL IN SPAN 2 SIDE 4 FEET FROM GROUNDLINE

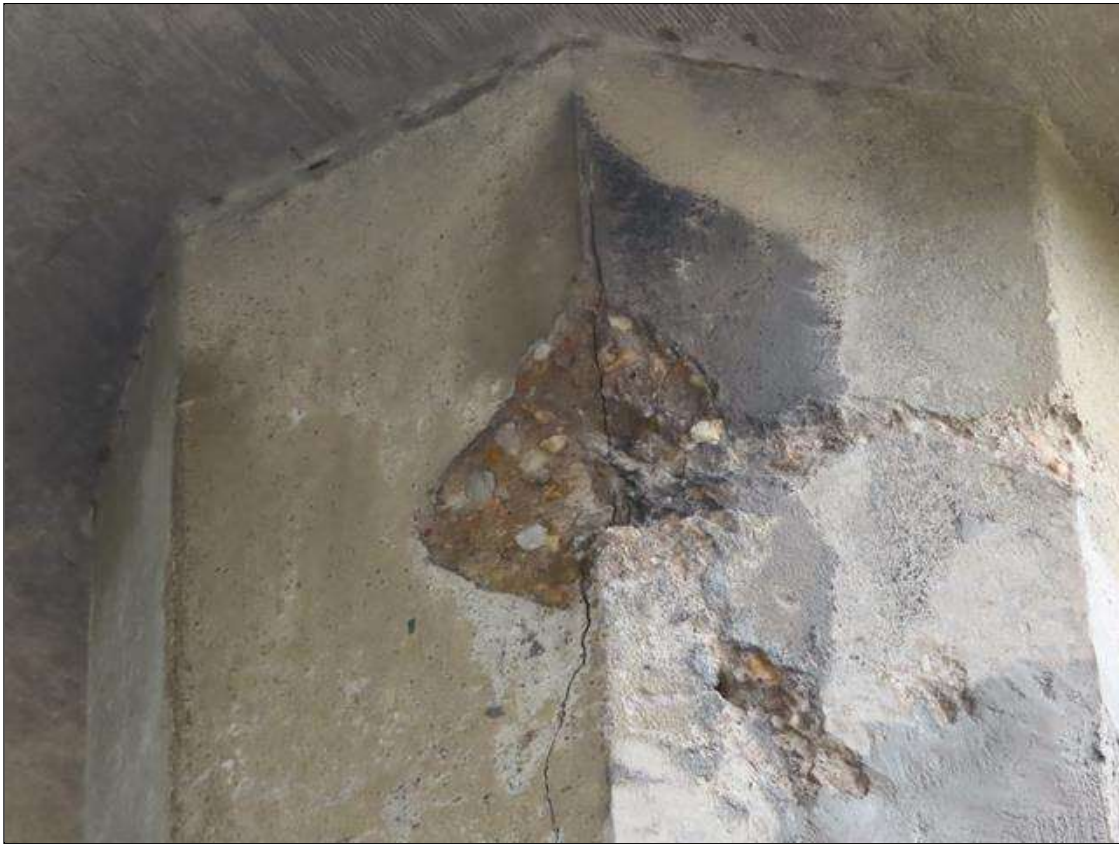
Bent 2 Pile 6: 6 INCH DIAMETER SPALL WITH 1/16 INCH X 1 FEET VERTICAL CRACK SPAN 2 SIDE

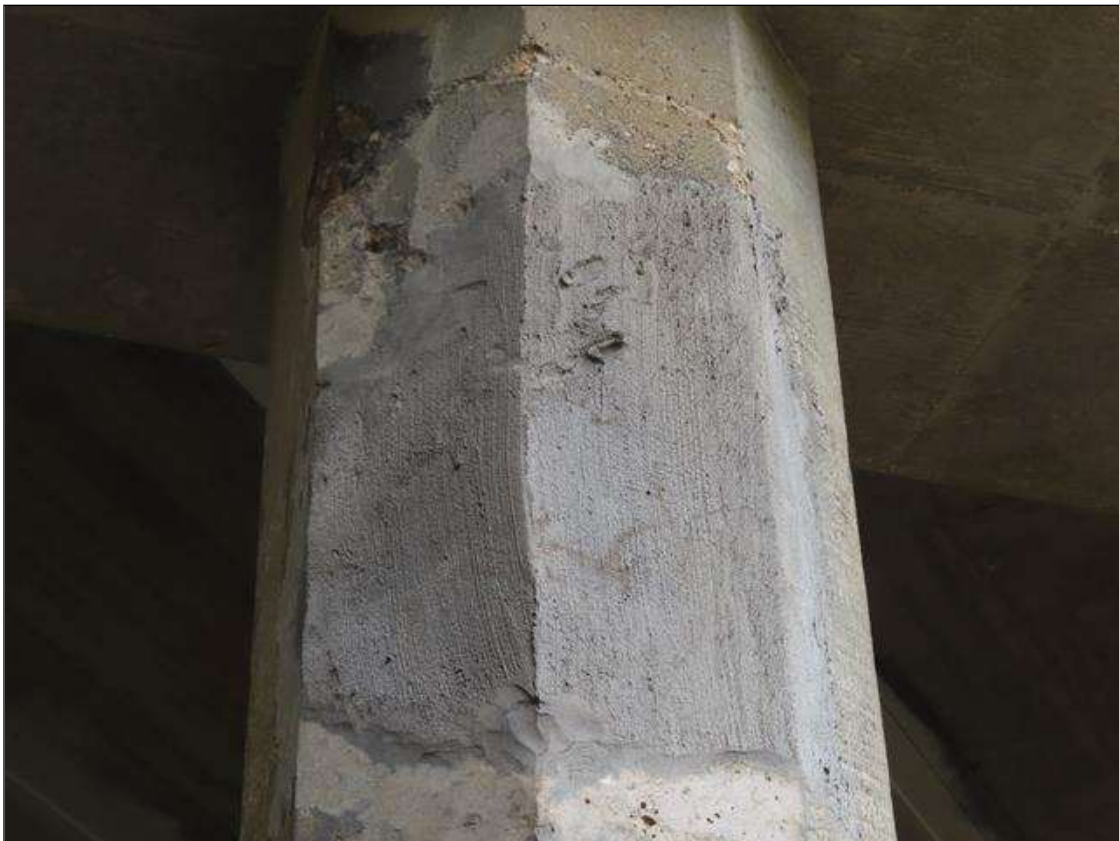
Bent 2 Pile 6: 2 FEET PATCHING

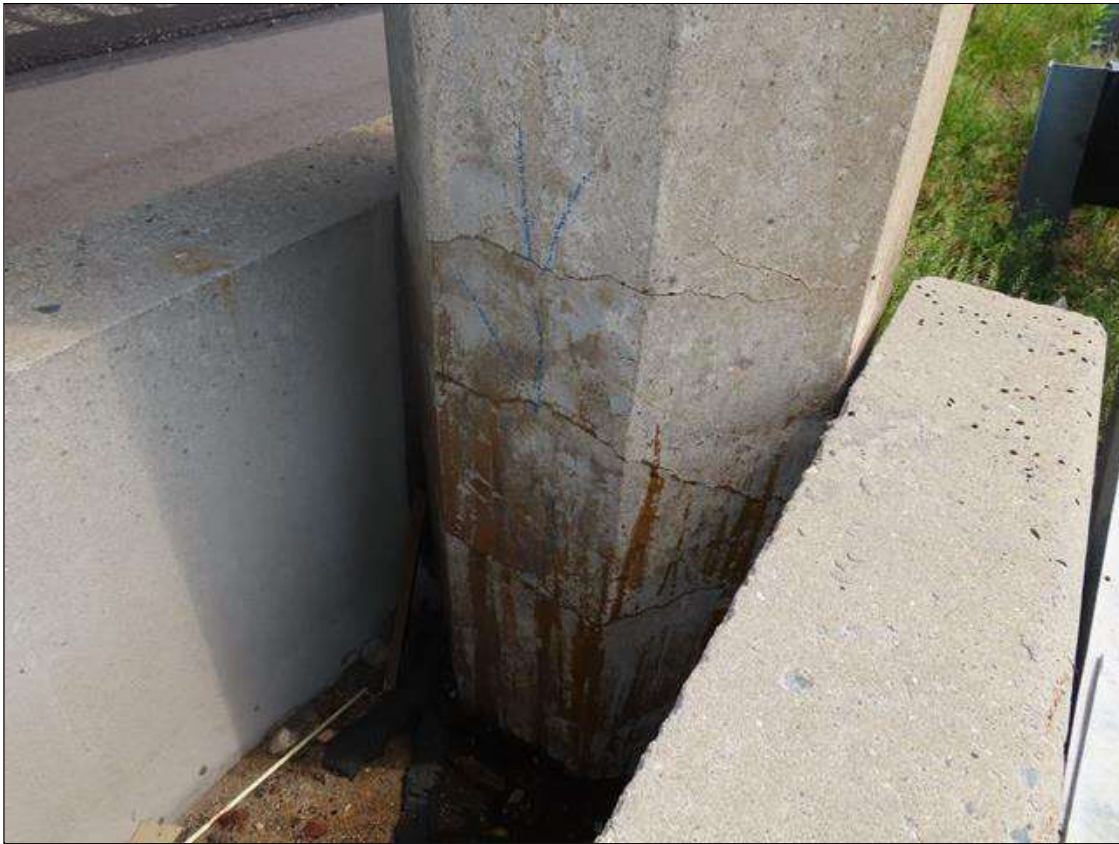
Bent 2 Pile 7: SPALL 1 FOOT FROM GROUNDLINE 4 INCH DEEP X 16 INCH DIAMETER RIGHT SIDE WITH 3 1/32 INCH HORIZONTAL CRACKS LEFT SIDE OPPOSITE SPALL

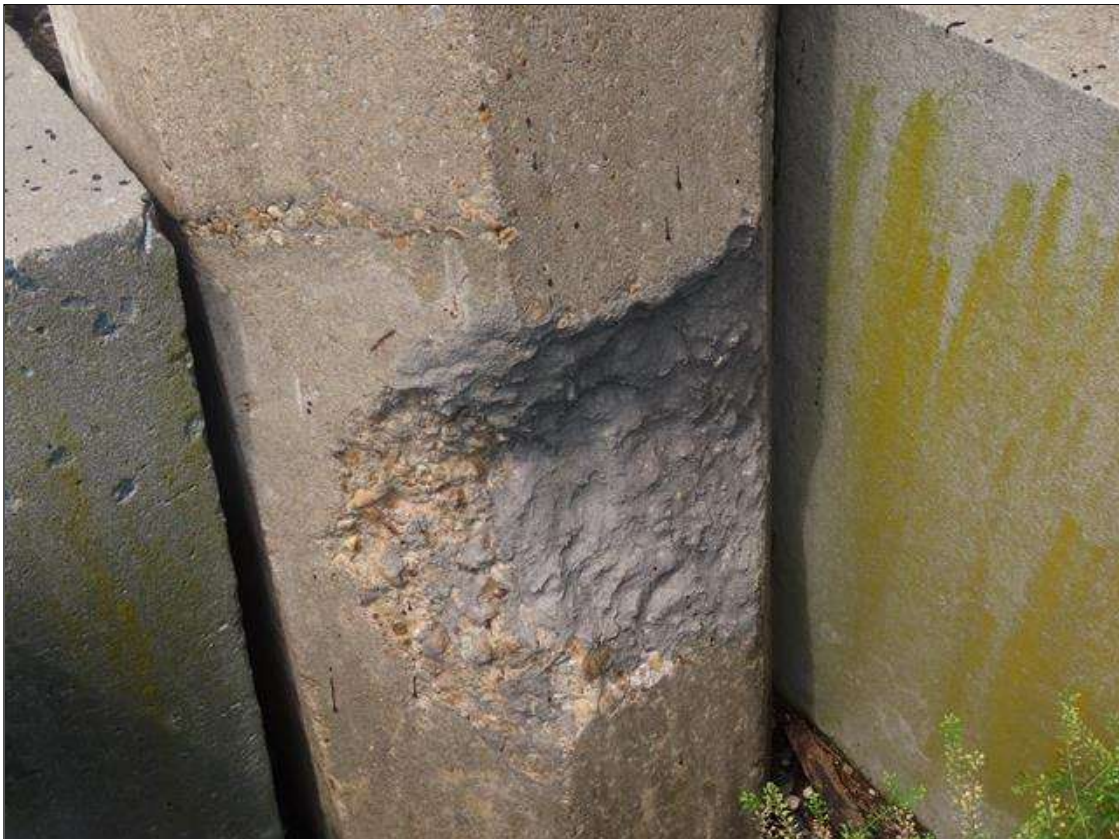
Bent 2 Pile 7: SPALL 1 FOOT FROM GROUNDLINE 4 INCH DEEP X 16 INCH DIAMETER RIGHT SIDE WITH 3 1/32 INCH HORIZONTAL CRACKS LEFT SIDE OPPOSITE SPALL

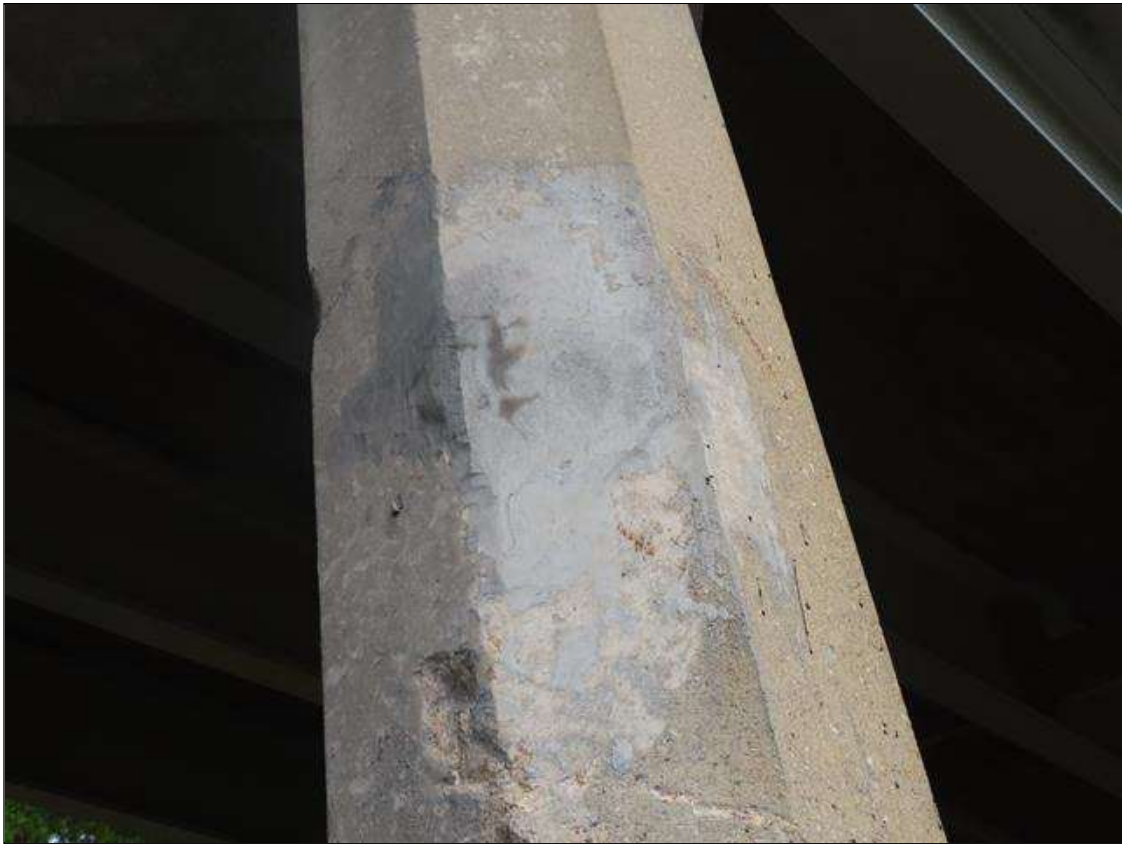
Bent 2 Pile 7: 2 FEET OF PATCHING SPAN 2 SIDE

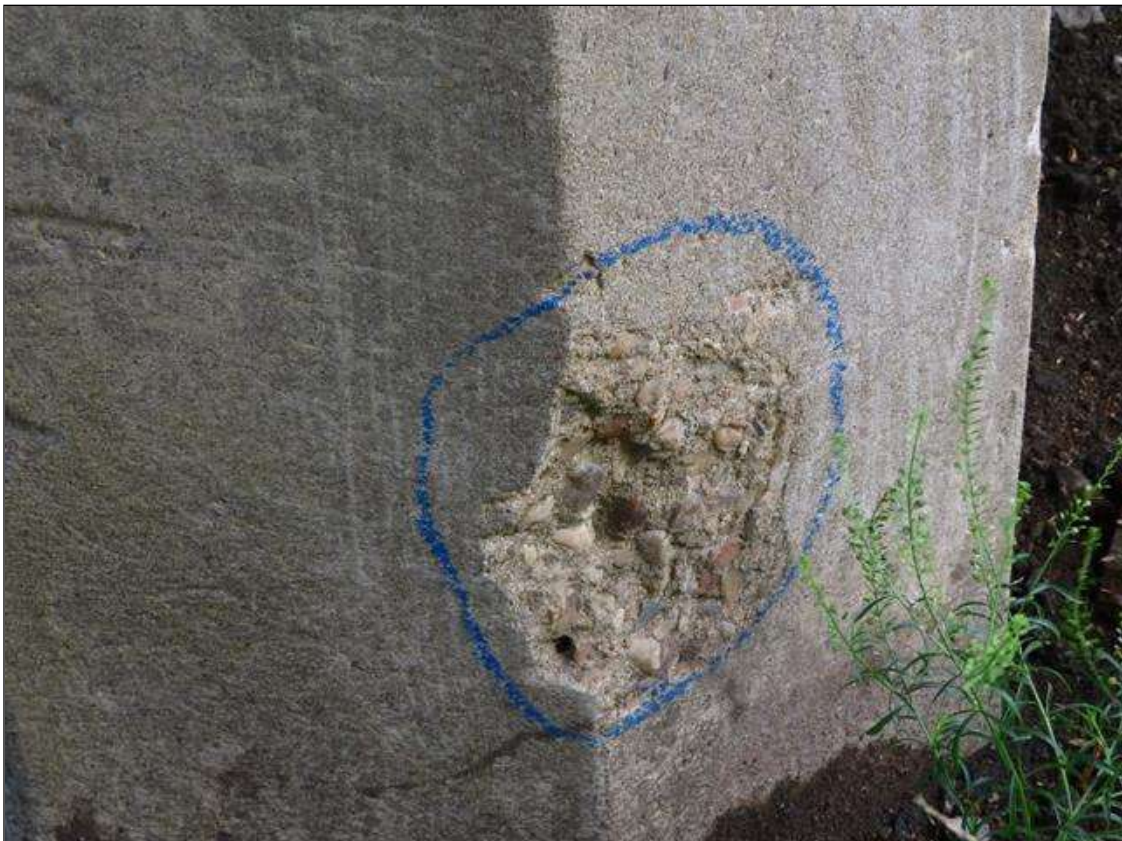
Bent 1 Pile 3: 5 INCH DIAMETER SPALL 1/2 INCH DEEP GROUNDLINE

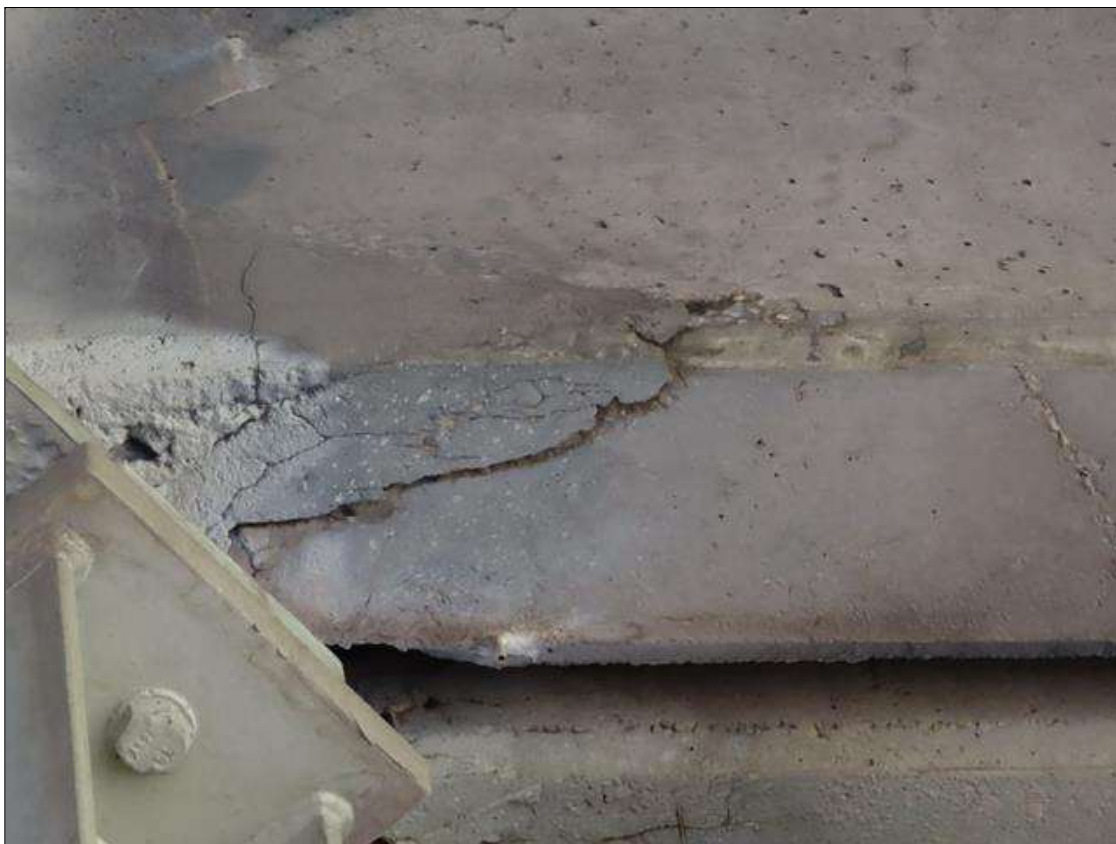
Span 1 Deck: 1/4 INCH WIDE CRACK LEFT OVERHANG DIAPHRAGM, 1 OF FOOT CRACKING IN BAY 1 DIAPHRAGM, 4 FEET OF CRACKING BAY 2 AND 3 DIAPHRAGM

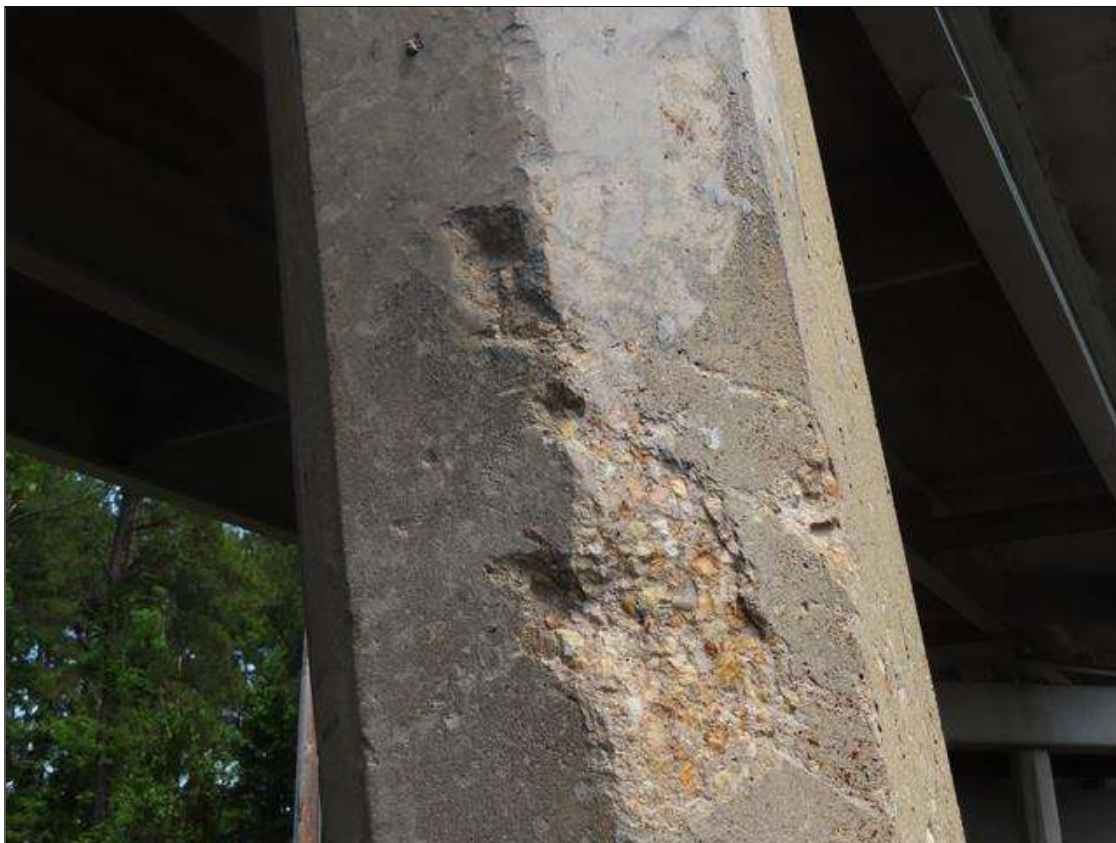
Bent 2 Pile 7: 2 FEET SPALLING SPAN 2 SIDE

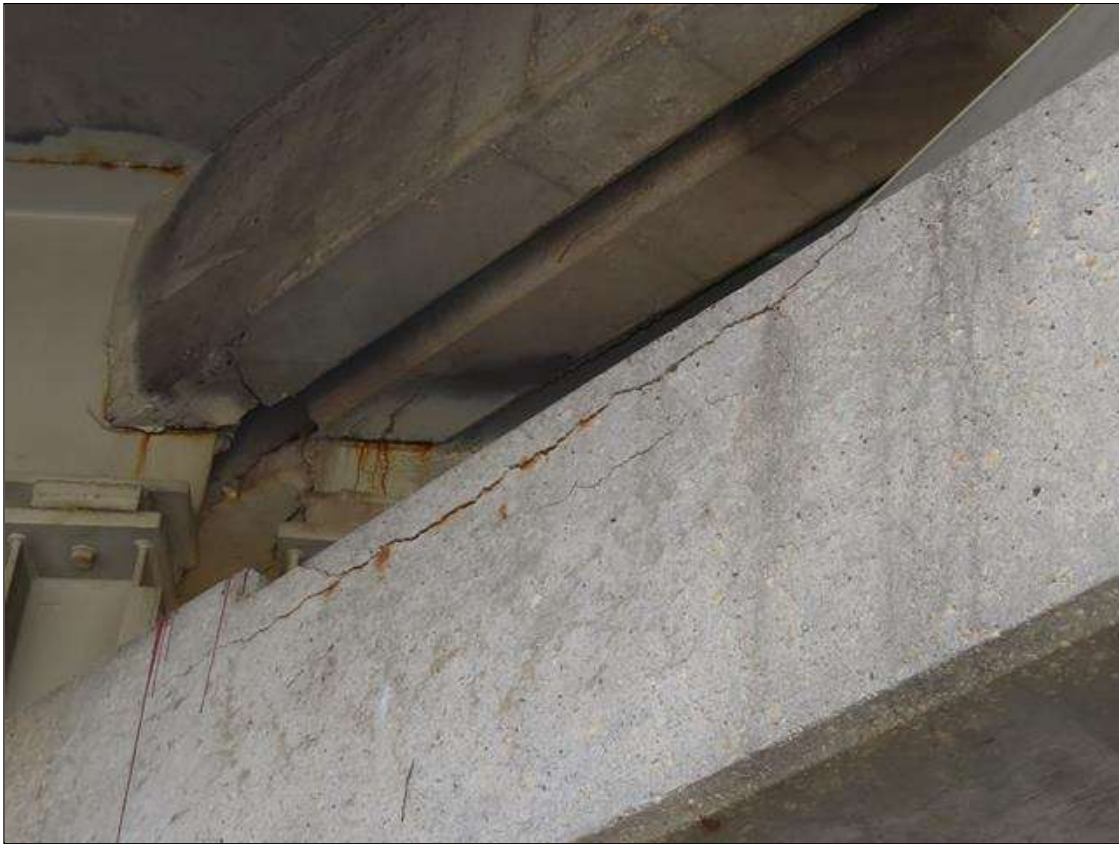
Bent 1 Cap 1: 8 FEET OF 1/4 INCH LONGITUDINAL CRACKING WITH RUST STAINING SPAN 2 SIDE UNDER BAY

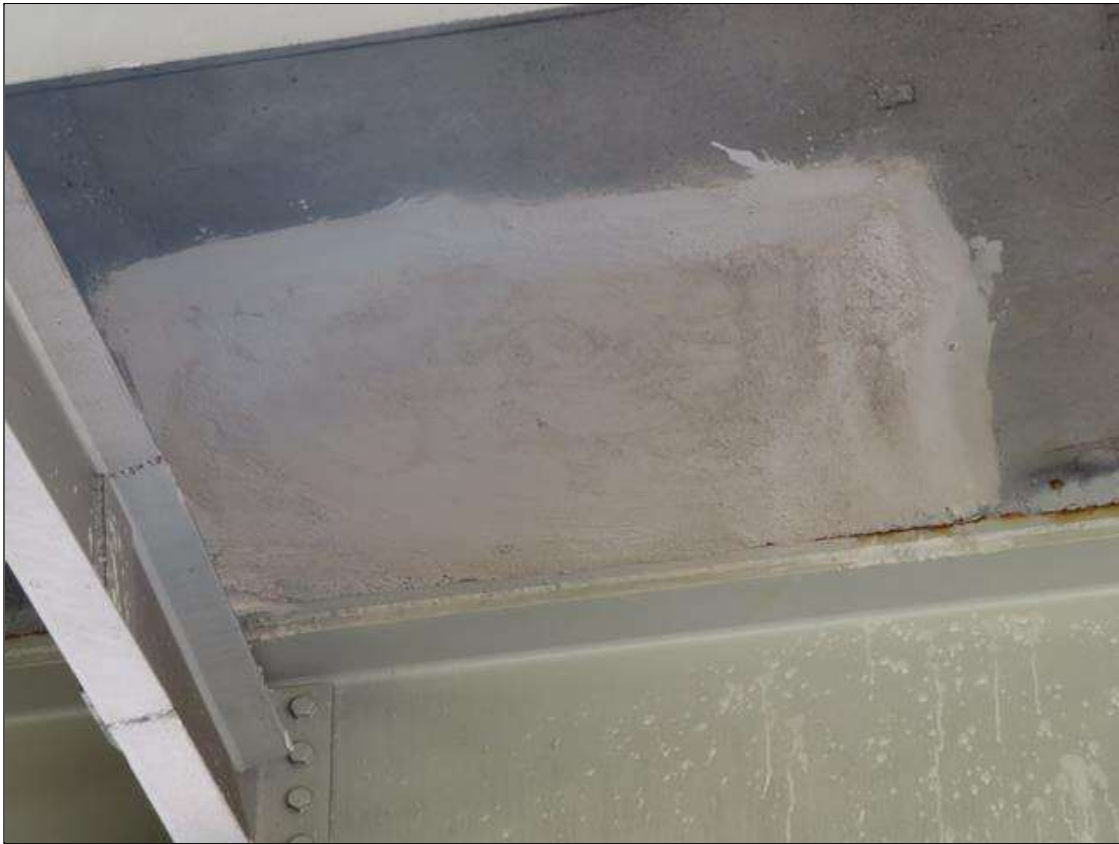
Span 2 Deck: 10 SQUARE FEET OF SOUND PATCHING IN BOTTOM OF DECK BAY 1 AT 1/3 POINT FROM BENT 1. THIS AREA WAS PREVIOUSLY DELAMINATING OVER LANES OF TRAFFIC AND WAS ISSUED A PRIORITY MAINTENANCE AND HAS BEEN REPAIRED SINCE LAST INSPECTION.

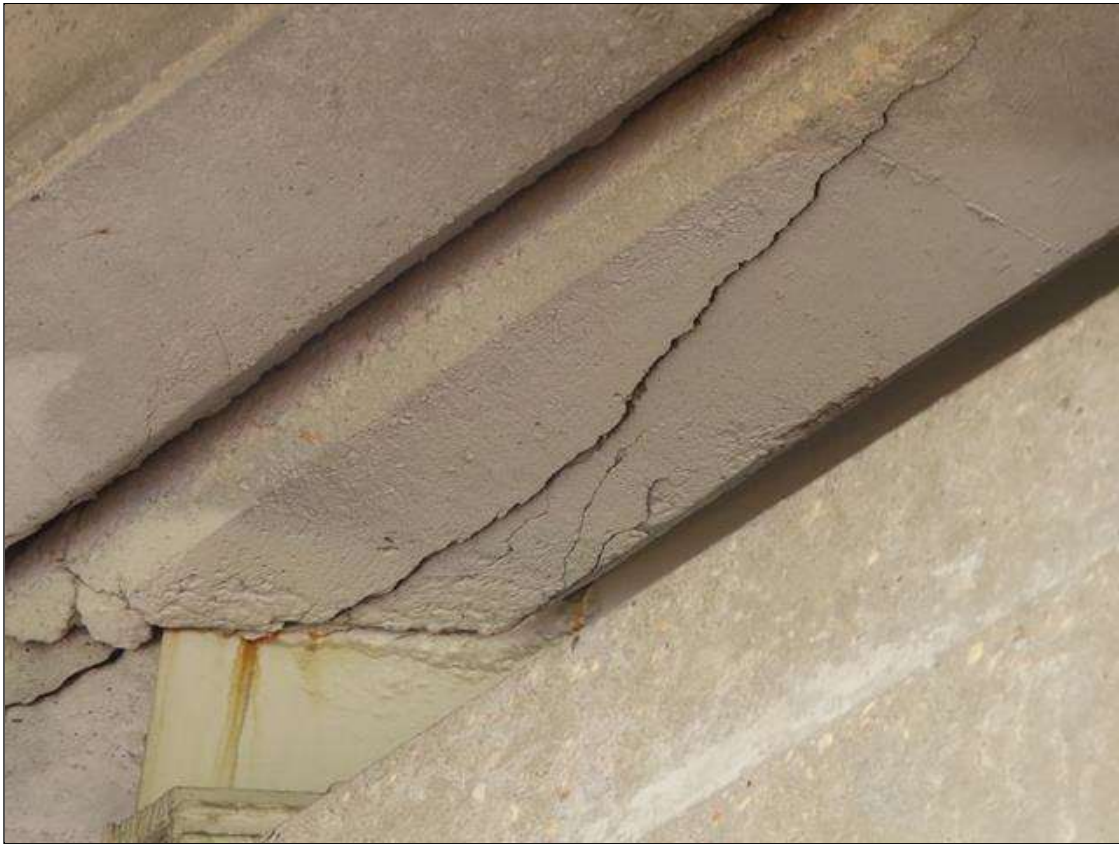
Span 3 Deck: 4 FEET TRANSVERSE CRACKING IN OVERHANGS AND TRANSVERSE CRACKING BENT 2 DIAPHRAGMS

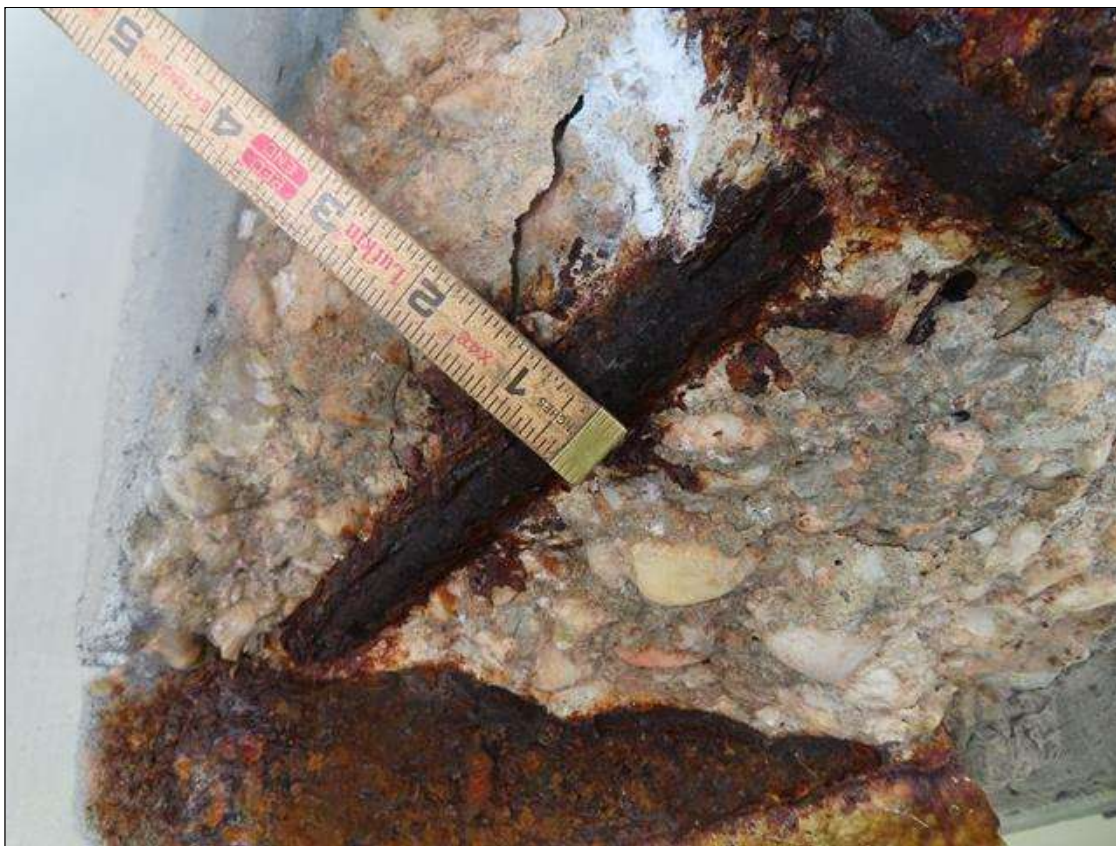
Span 3 Deck: SPALLING AND DELAMINATION WITH SECTION LOSS TO EXPOSED REBAR (ESTIMATED 1 INCH REMAINING) 4 INCHES DEEP X 6 FEET LONG X 10 INCHES WIDE IN SPAN 3 END DIAPHRAGM OVER BENT 3 BAY 2. PAR ISSUED. PHOTO 3 OF 3.
