NC DEPARTMENT OF TRANSPORTATION
 DIVISION OF HIGHWAYS
 STRUCTURE MANAGEMENT UNIT

ATTENTION: **PAR ISSUED.**

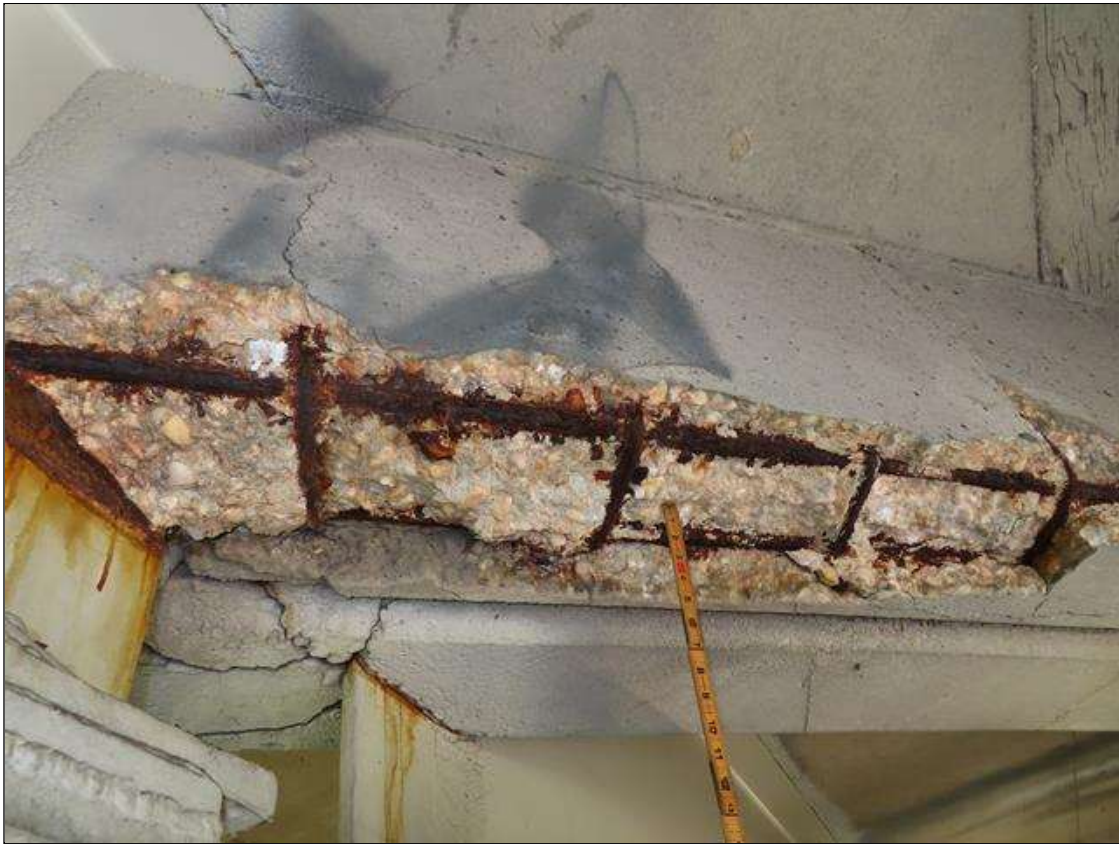
Span 3 Deck: SPALLING AND DELAMINATION WITH SECTION LOSS TO EXPOSED REBAR (ESTIMATED 1 INCH REMAINING) 4 INCHES DEEP X 6 FEET LONG X 10 INCHES WIDE IN SPAN 3 END DIAPHRAGM OVER BENT 3 BAY 2. PAR ISSUED. PHOTO 1 OF 3.

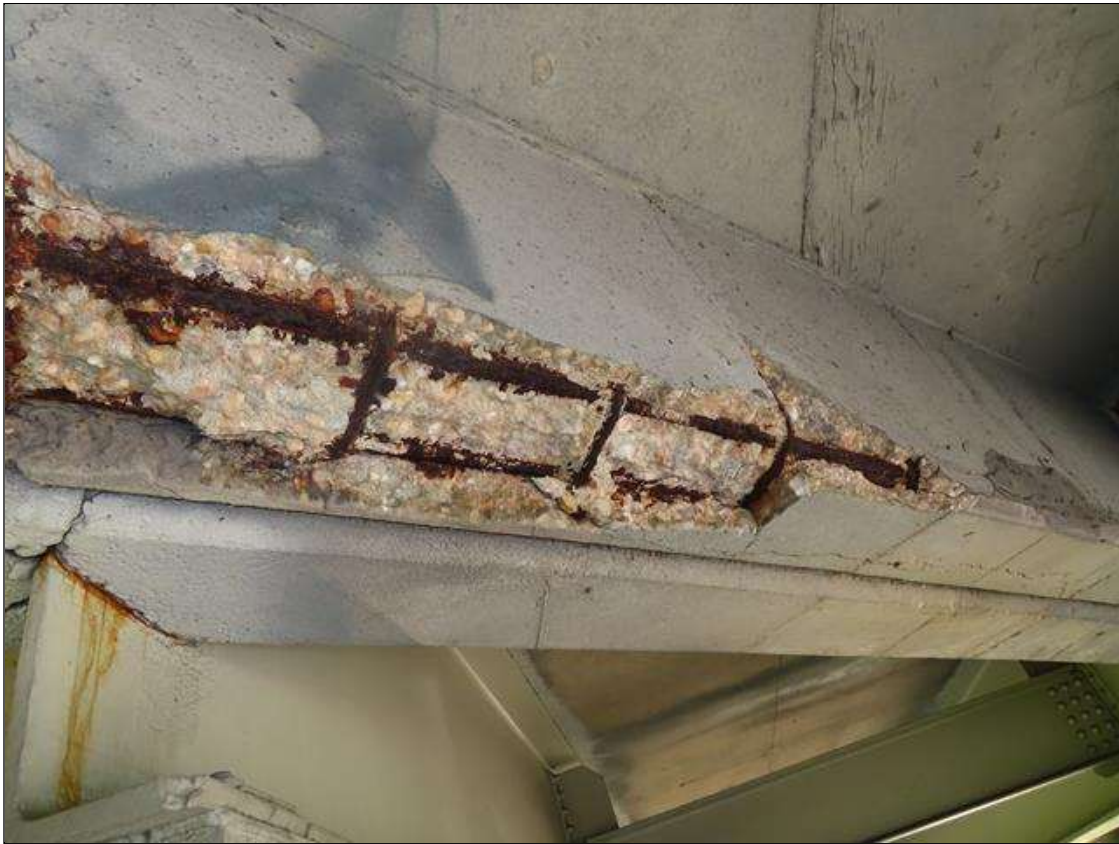
Span 3 Deck: SPALLING AND DELAMINATION WITH SECTION LOSS TO EXPOSED REBAR (ESTIMATED 1 INCH REMAINING) 4 INCHES DEEP X 6 FEET LONG X 10 INCHES WIDE IN SPAN 3 END DIAPHRAGM OVER BENT 3 BAY 2. PAR ISSUED. PHOTO 2 OF 3.

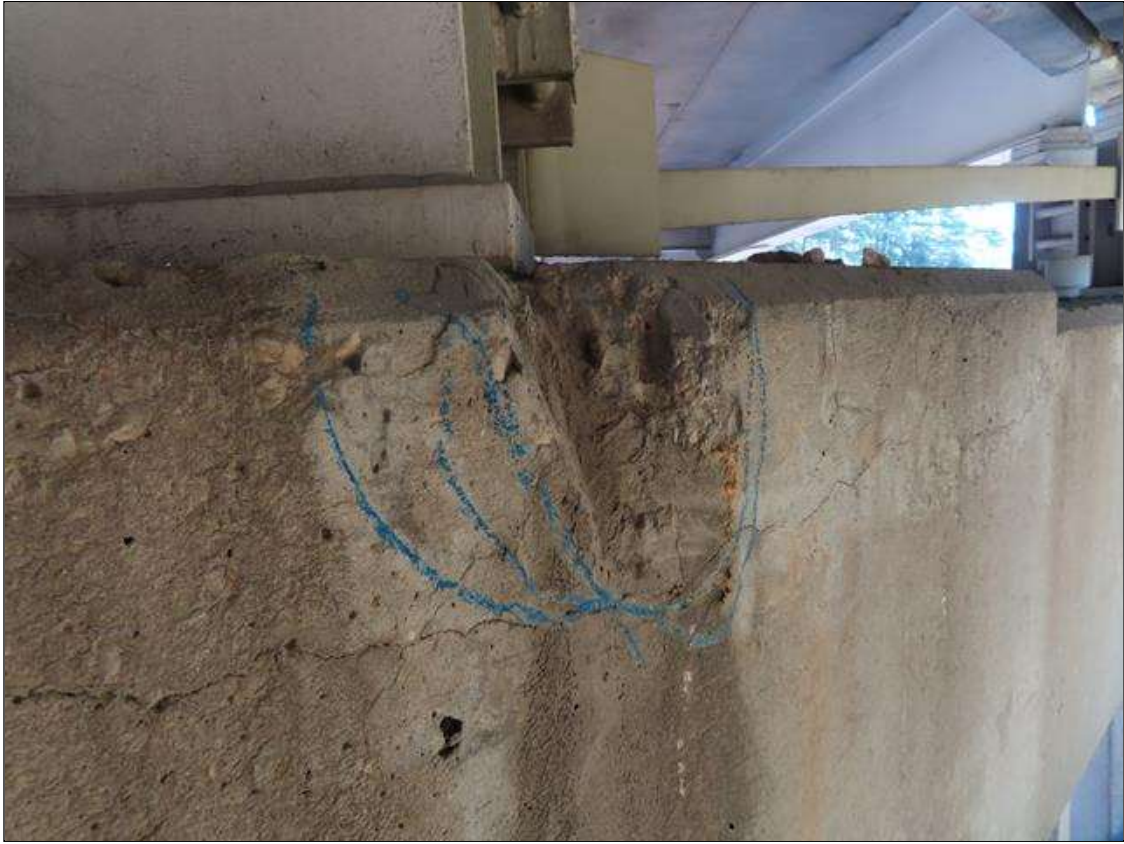
Bent 3 Cap 1: 6 INCH DIAMETER SPALL SPAN 4 SIDE 1 INCH DEEP TOP CORNER BEAM 2

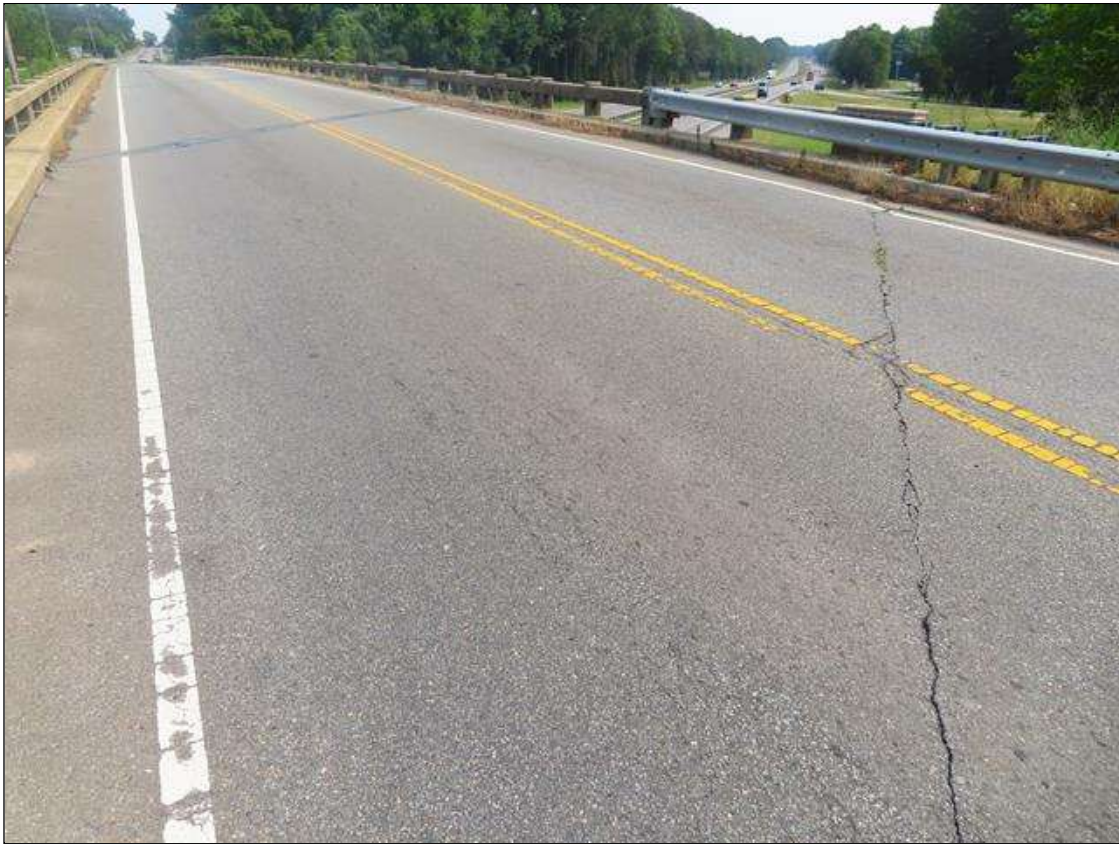
ASPHALT WEARING SURFACE OVERVIEW ALL OTHER SPANS SIMILAR

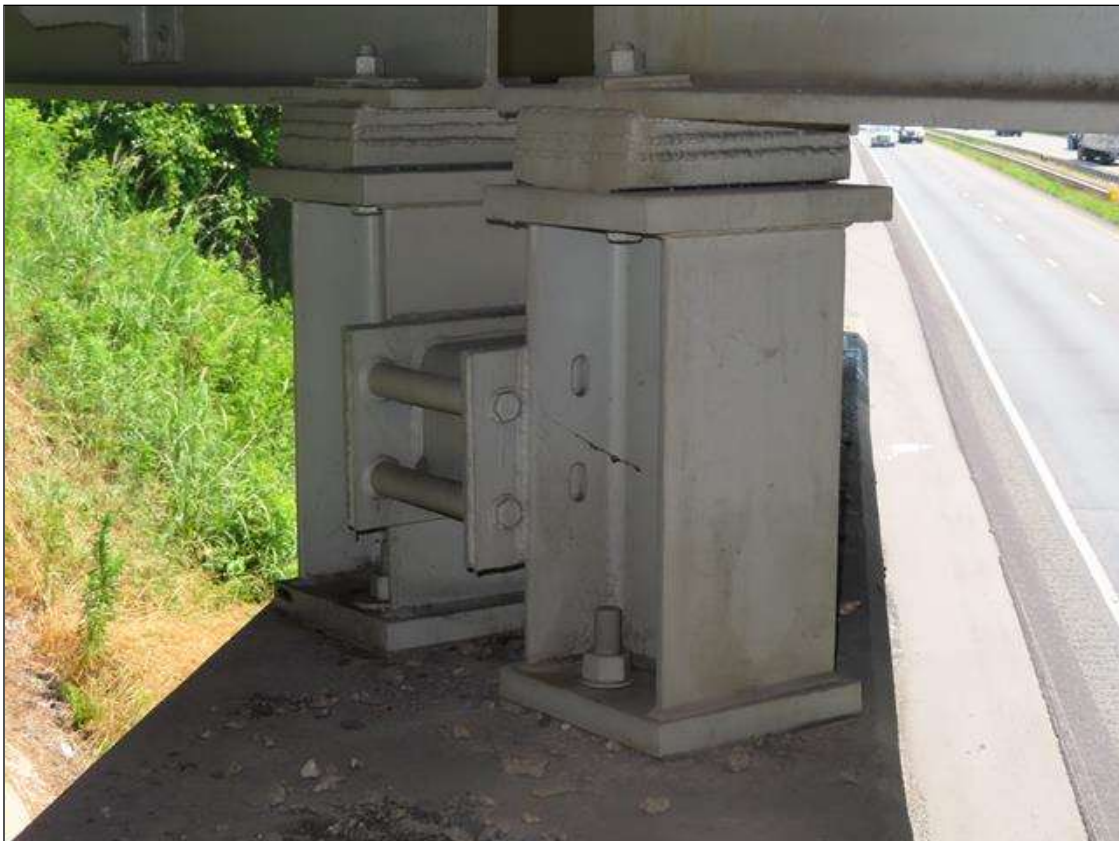
TYPICAL BEARING ASSEMBLY AND PEDESTAL AT INTERIOR BENTS

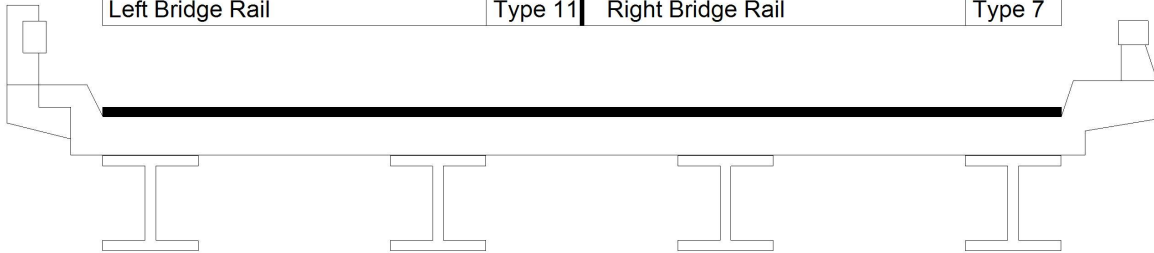
Measurements for Span #	1	ALL SPANS SIMILAR	
Deck Thickness	0.583	Left Overhang	4.708
Top of Rail to Bottom of Beam	6.083	Right Overhang	4.708

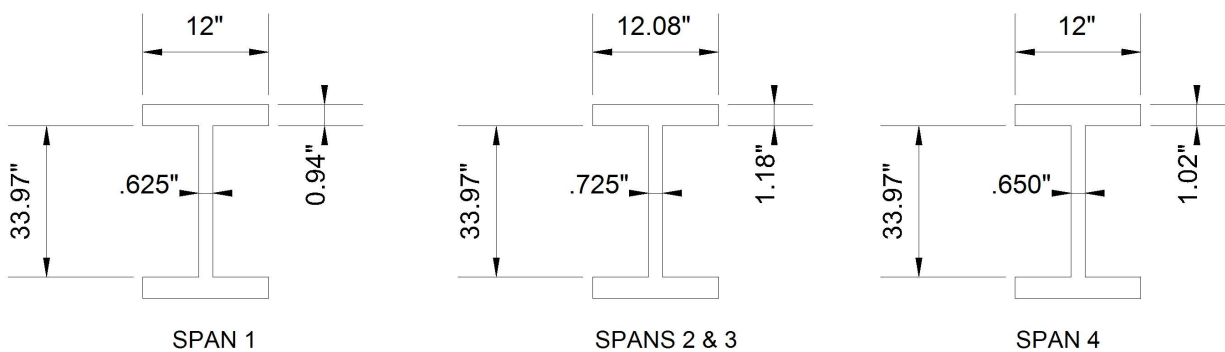
MODIFIED BY: WTW 6/6/2019

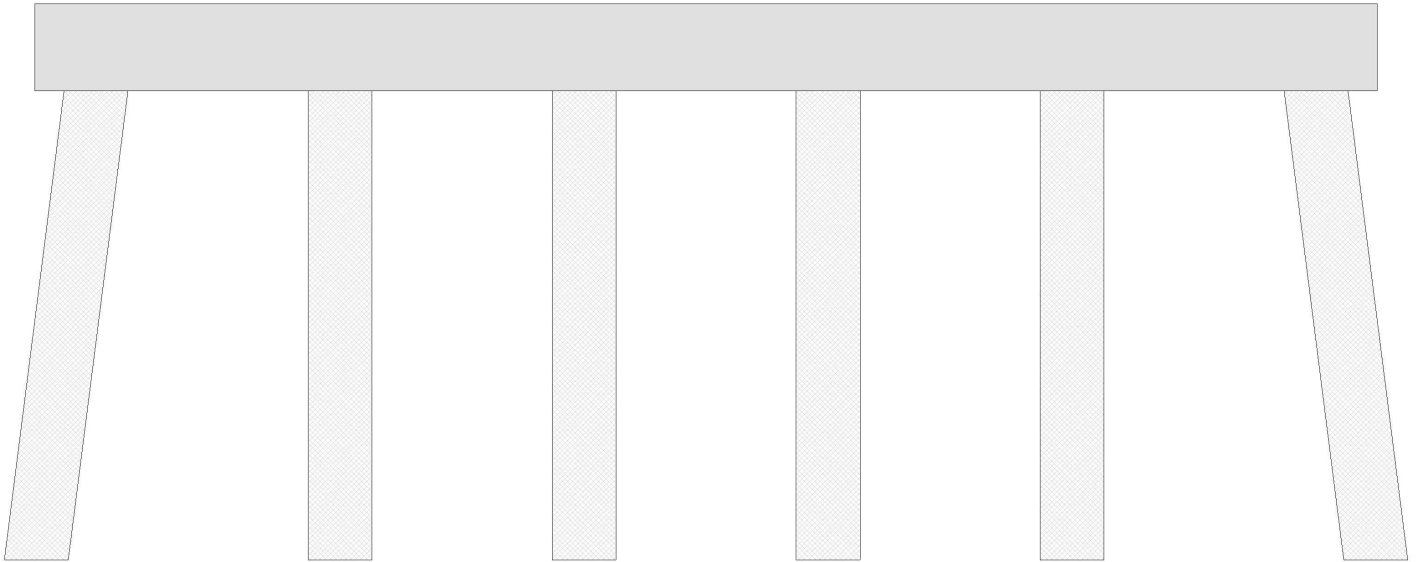
Cap Information			Material Cast-in-Place Concrete							
Length	Width	Height	Left Overhang	Right Overhang	Left Beam to End of Cap.	Right Beam to End of Cap.				
38.500 ft.	3.000 ft.	2.500 ft.	1.750 ft.	1.750 ft.	2.000 ft.	2.000 ft.				
Subcap Information			Material							
Length	Width	Height	Left Overhang	Right Overhang	Left Pile to Splice.					
Sill Information			Material							
Length	Width	Height	VERIFIED BY: WTW 6/6/2019							
Pile #	Material	Spacing	Width/Dia.	Height	Length	Orientation	Driven?	Replacement?	Removed?	Collar?
1	Concrete	7 ft.	1.833 ft.			Battered	No	No	No	No
2	Concrete	7 ft.	1.833 ft.			Vertical	No	No	No	No
3	Concrete	7 ft.	1.833 ft.			Vertical	No	No	No	No
4	Concrete	7 ft.	1.833 ft.			Vertical	No	No	No	No
5	Concrete	7 ft.	1.833 ft.			Vertical	No	No	No	No
6	Concrete		1.833 ft.			Battered	No	No	No	No
Bent/Abutment #: 1			Similar Bents:

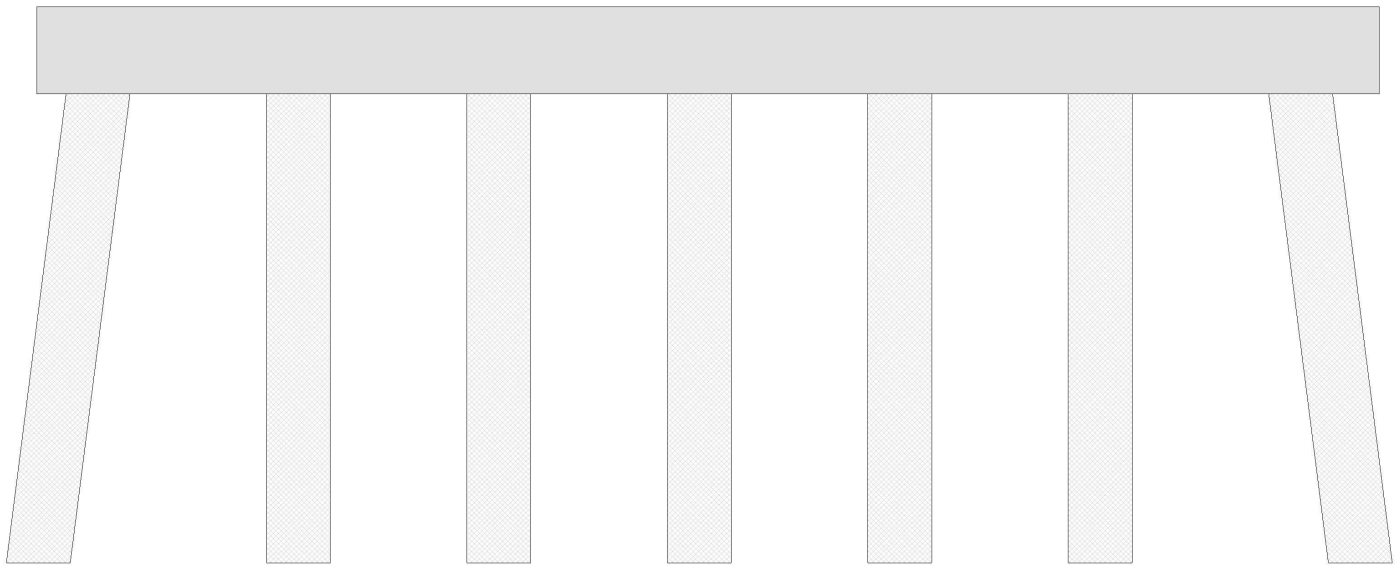
Cap Information			Material Cast-in-Place Concrete							
Length	Width	Height	Left Overhang	Right Overhang	Left Beam to End of Cap.	Right Beam to End of Cap.
