NC DEPARTMENT OF TRANSPORTATION
 DIVISION OF HIGHWAYS
 STRUCTURE MANAGEMENT UNIT

ATTENTION: PAR SUBMITTED, REQUEST LIDAR, CHANGE TO STRUCTURE DATA

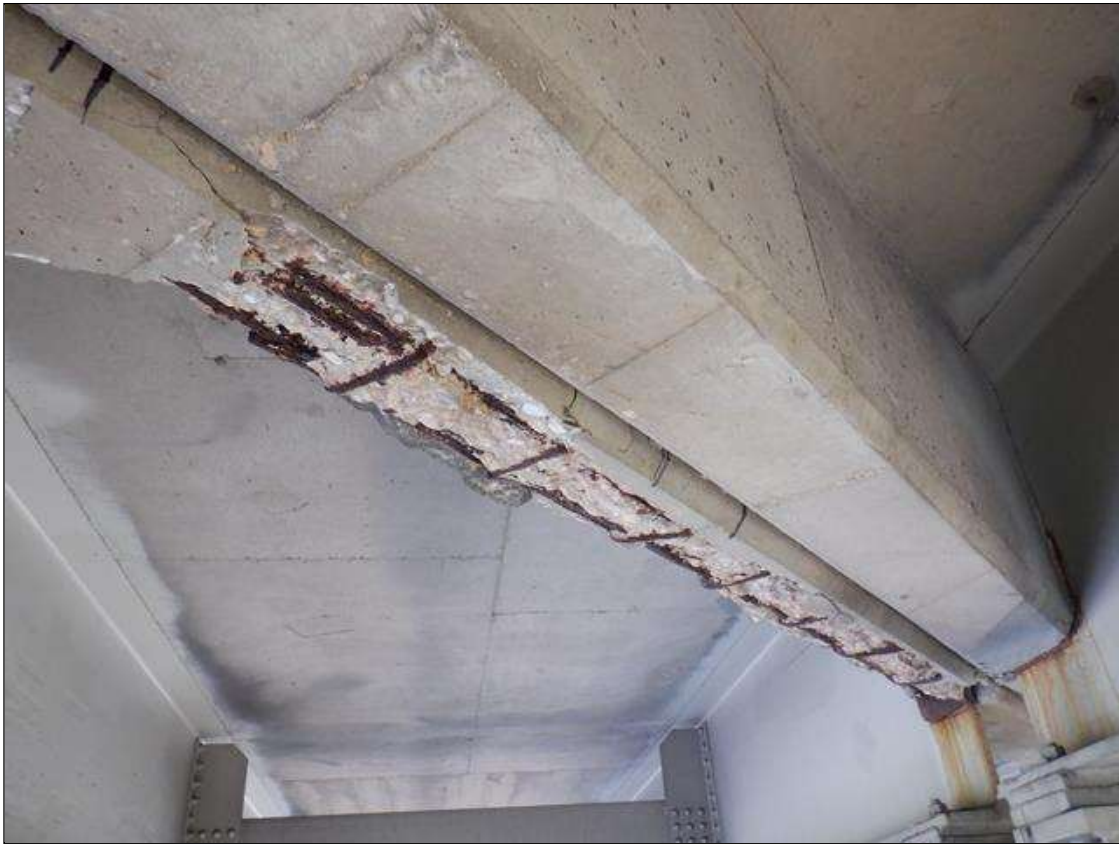
Span 3 Deck: PAR. 6 FEET OF SPALLING AND DELAMINATION WITH SECTION LOSS TO EXPOSED REBAR (ESTIMATED 1 INCH REMAINING) 4 INCHES DEEP X 6 FEET LONG X 10 INCHES WIDE IN SPAN 3 END DIAPHRAGM OVER BENT 3, BAY 2.

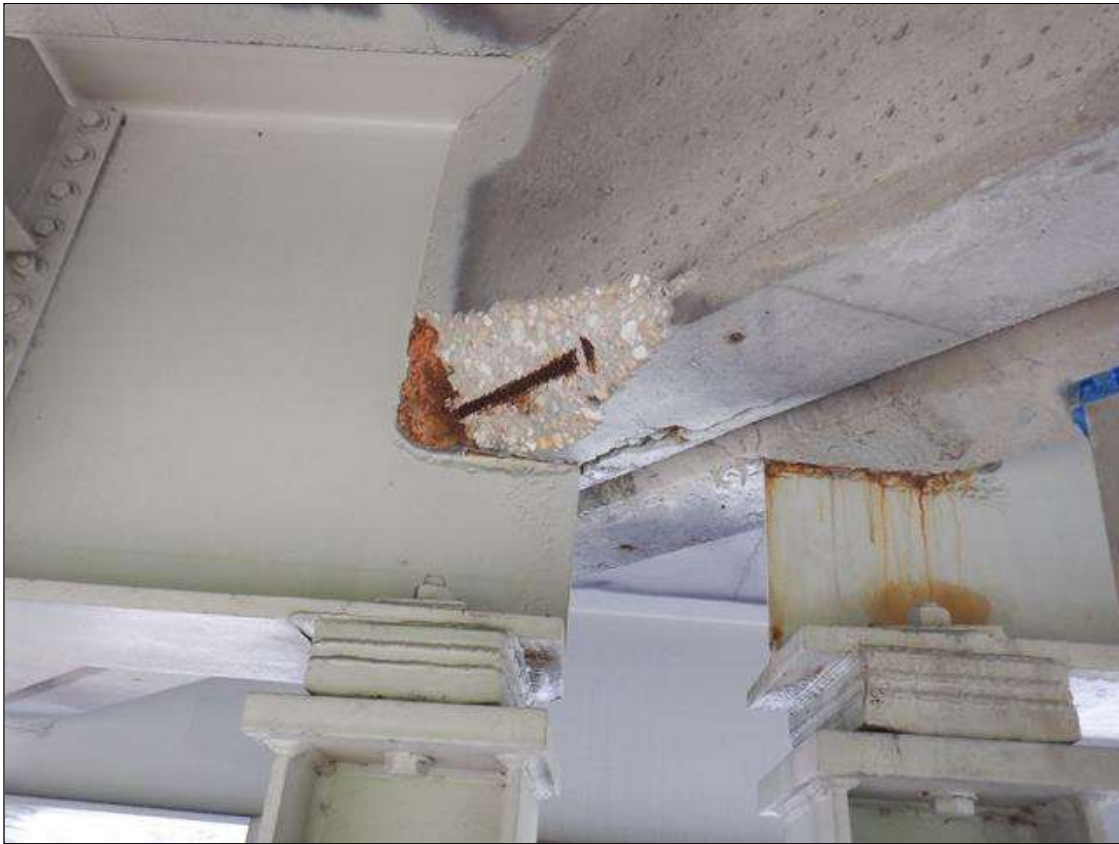
Span 4 Deck: PAR. BAY 2 DIAPHRAGM ADJACENT TO BEAM 3 SPALL WITH EXPOSED REBAR 1 FOOT X 4 INCHES X 4 INCHES. 5 PERCENT SECTION LOSS.

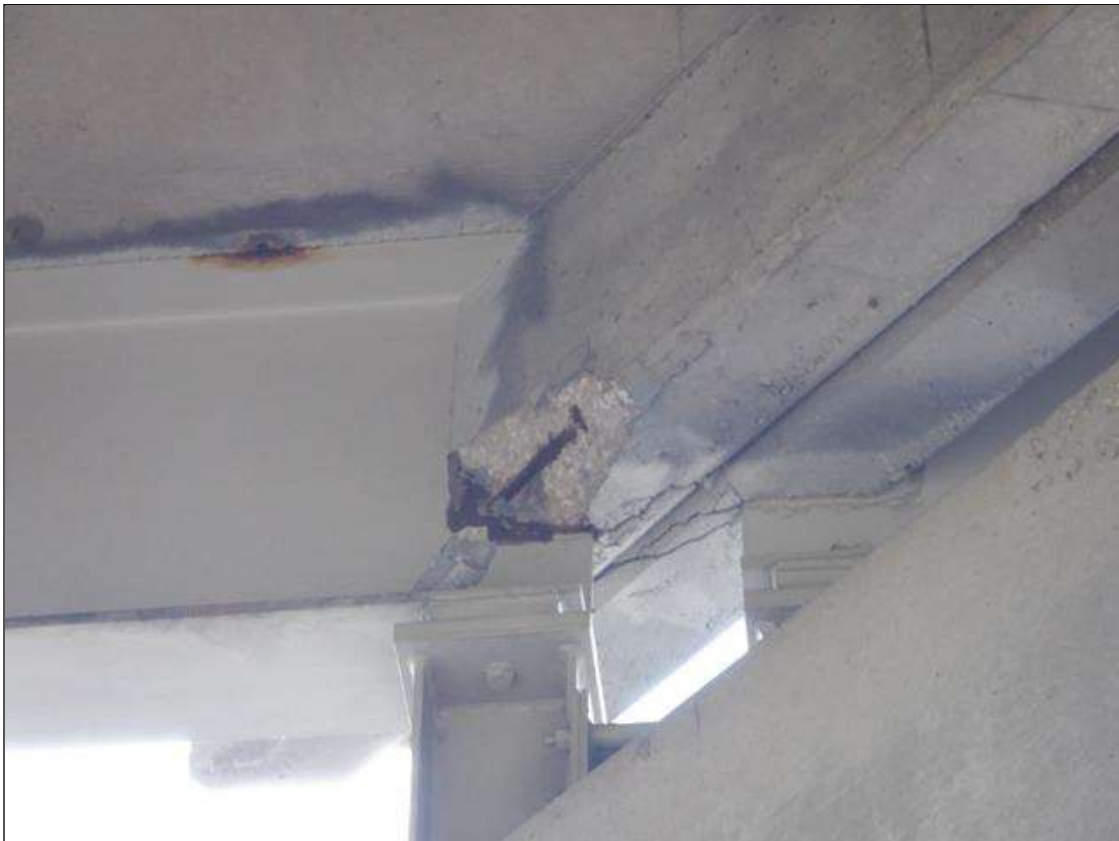
Span 4 Deck: PAR. BAY 3 DIAPHRAGM ADJACENT TO BEAM 4 SPALL WITH EXPOSED REBAR 1 FOOT X 4 INCHES X 4 INCHES. 5 PERCENT SECTION LOSS.

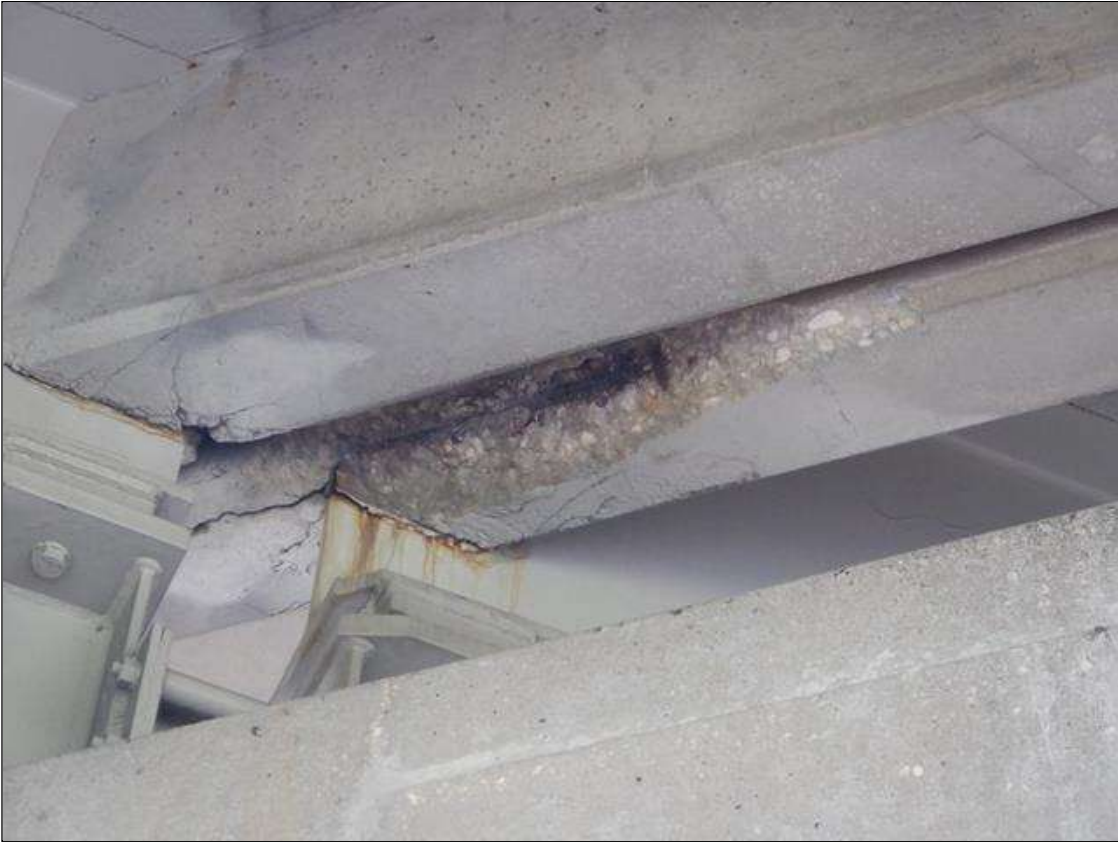
Span 3 Deck: PAR. 36 INCHES LONG SPALL 6 INCHES WIDE X 3 INCHES DEEP WITH SECTION LOSS TO EXPOSED REBAR (ESTIMATED 3/4 INCH REMAINING) IN END DIAPHRAGM AT BENT 2 BAY 2.

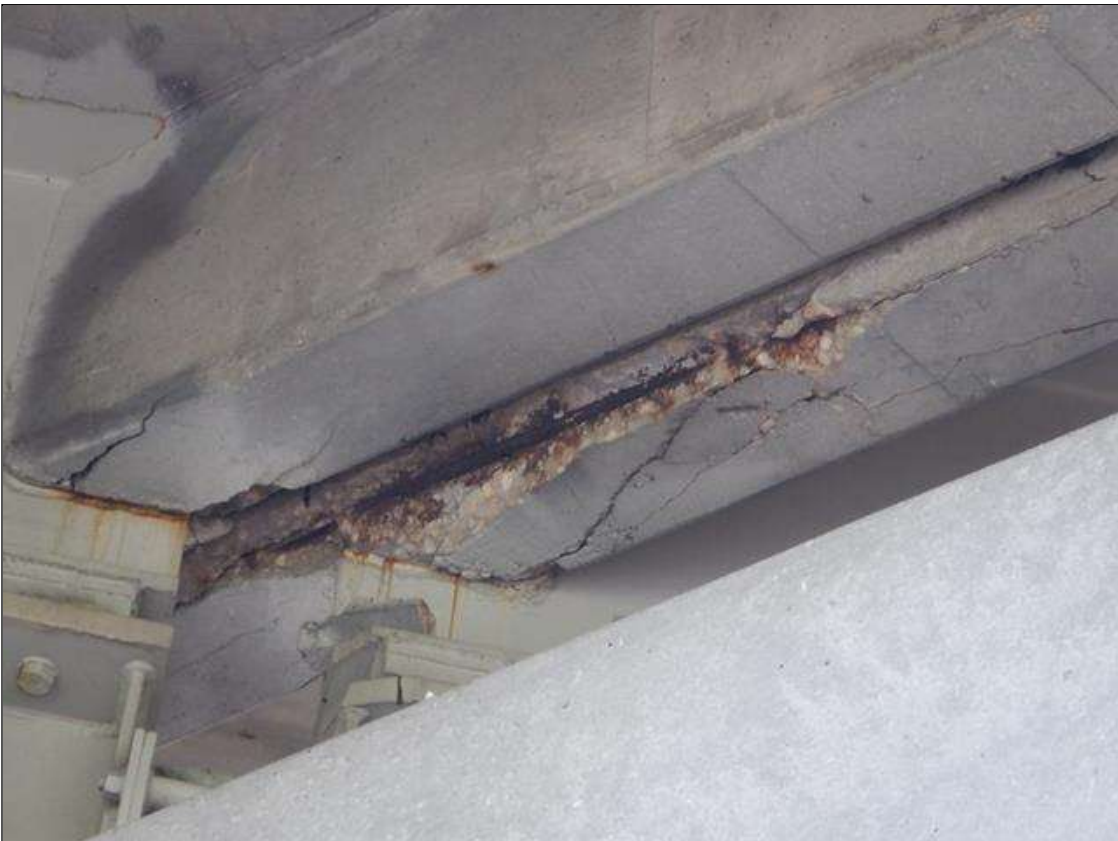
Span 3 Deck: PAR. BAY 3 DIAPHRAGM ADJACENT TO BEAM 3 SPALL WITH EXPOSED REBAR 4 FEET X 6 INCHES X 6 INCHES, 10 PERCENT SECTION LOSS.

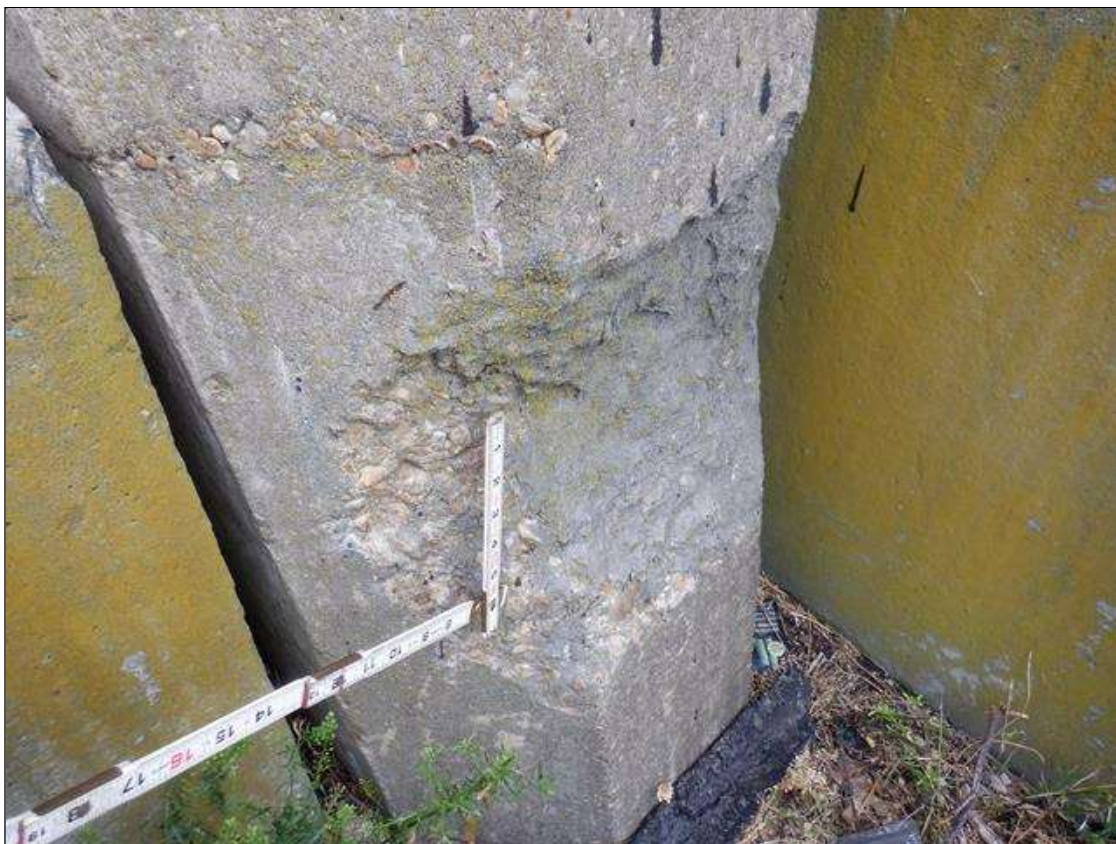
Bent 2 Pile 7: SPALL 1 FOOT FROM GROUNDLINE 4 INCHES DEEP X 16 INCHES DIAMETER RIGHT SIDE WITH THREE (3) 1/32 INCH HORIZONTAL CRACKS LEFT SIDE OPPOSITE SPALL.

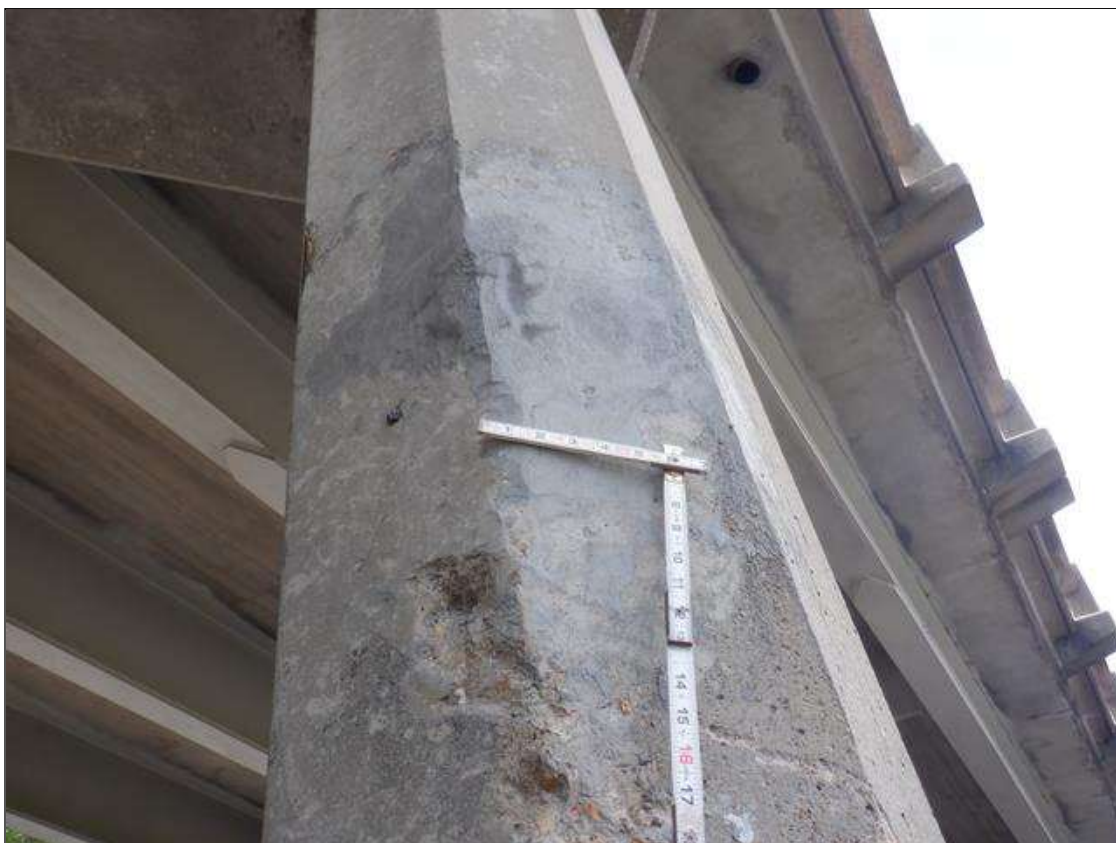
Bent 2 Pile 7: 2 FEET OF SOUND PATCHING SPAN 2 SIDE

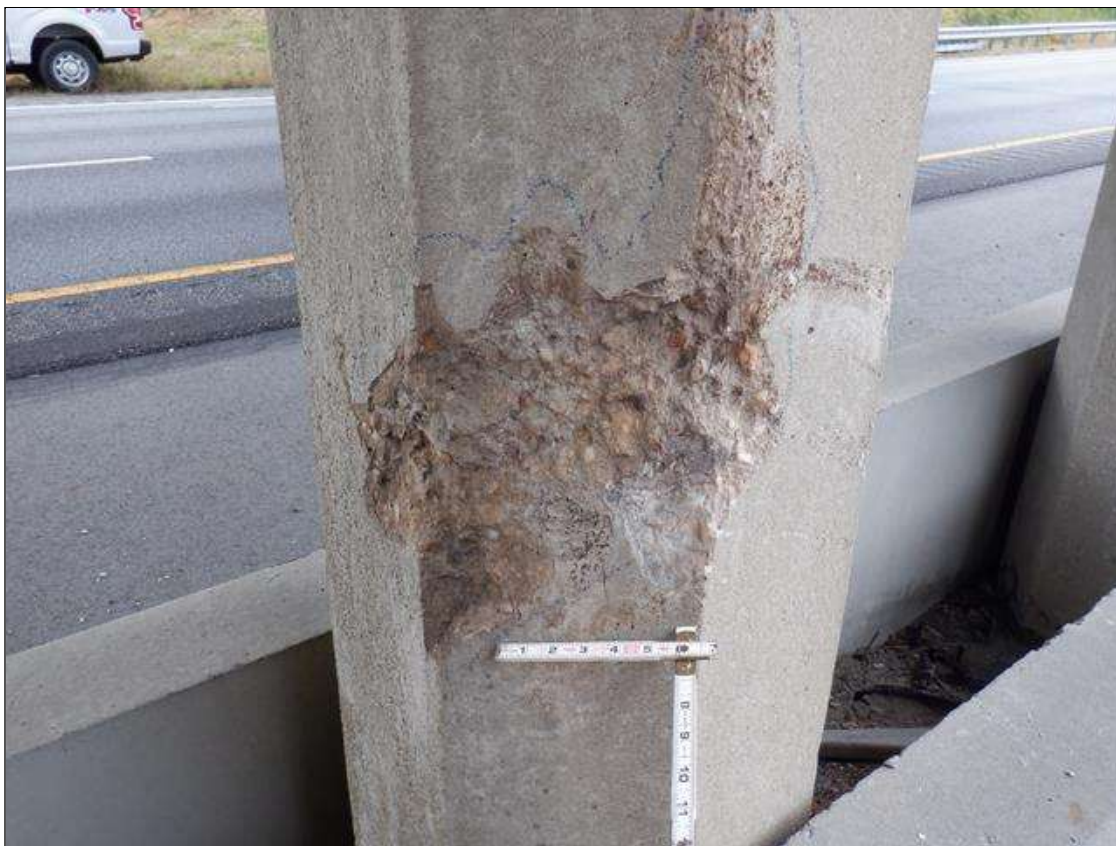
Bent 2 Pile 5: 5 SPALLS 1 INCH DEEP TOTALLING 6 SQUARE FEET

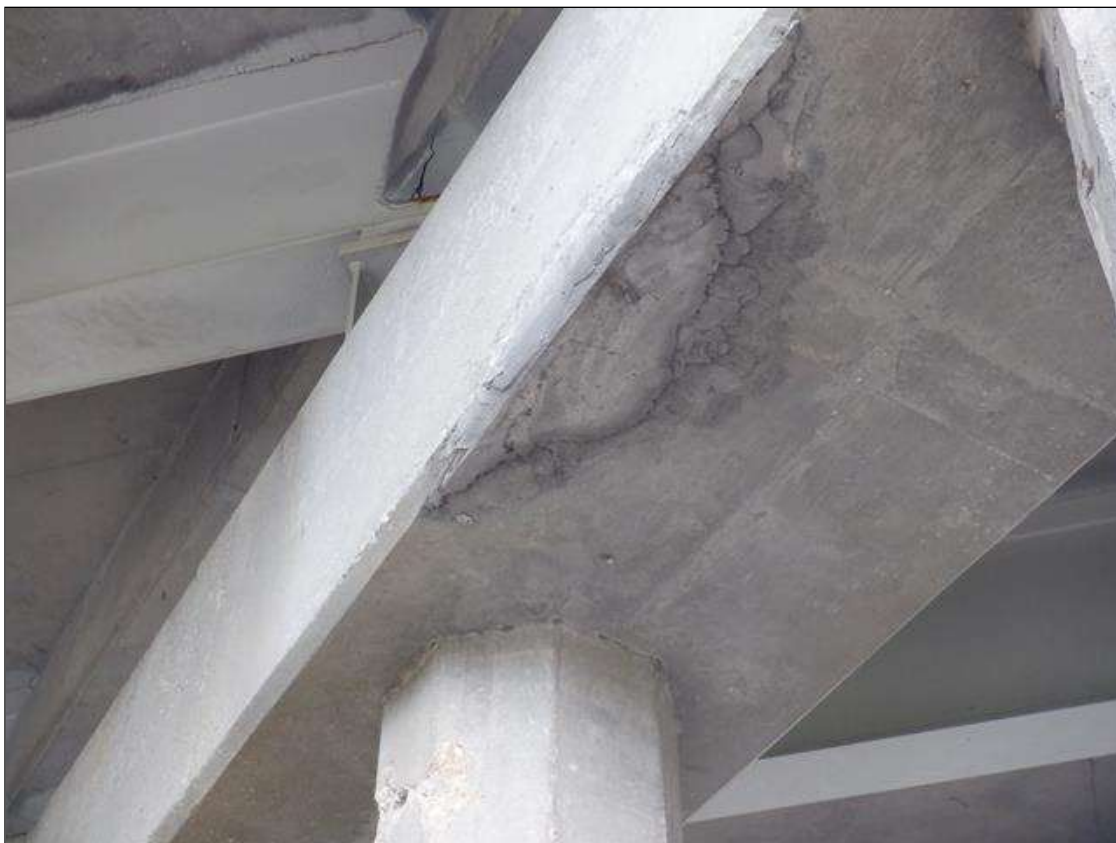
Bent 2 Cap 1: 3 FEET OF UNSOUND PATCHING BOTTOM OF CAP BAY 3

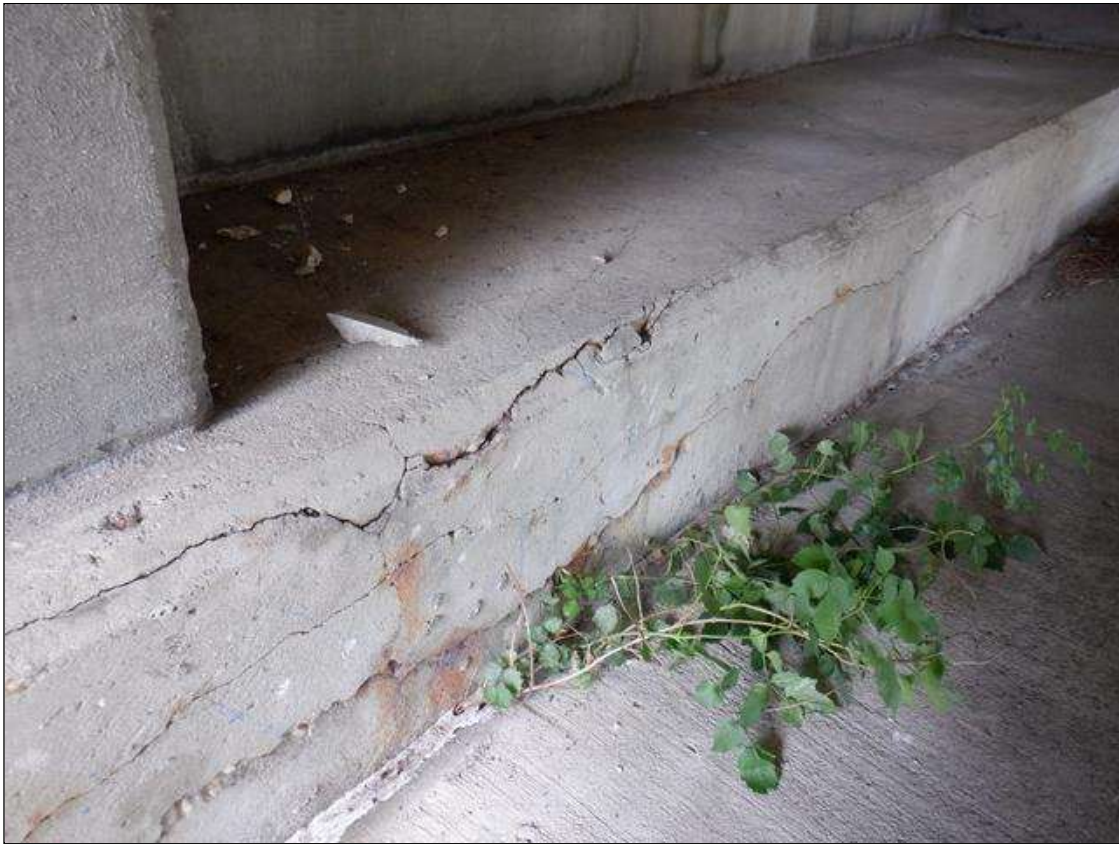
End Bent 2 Cap 1: 8 FEET LONGITUDINAL UP TO 1/8 INCH CRACKING FACE AND TOP WITH 6 FEET X 6 INCHES DELAMINATION AND RUST STAINING IN BAY 1.

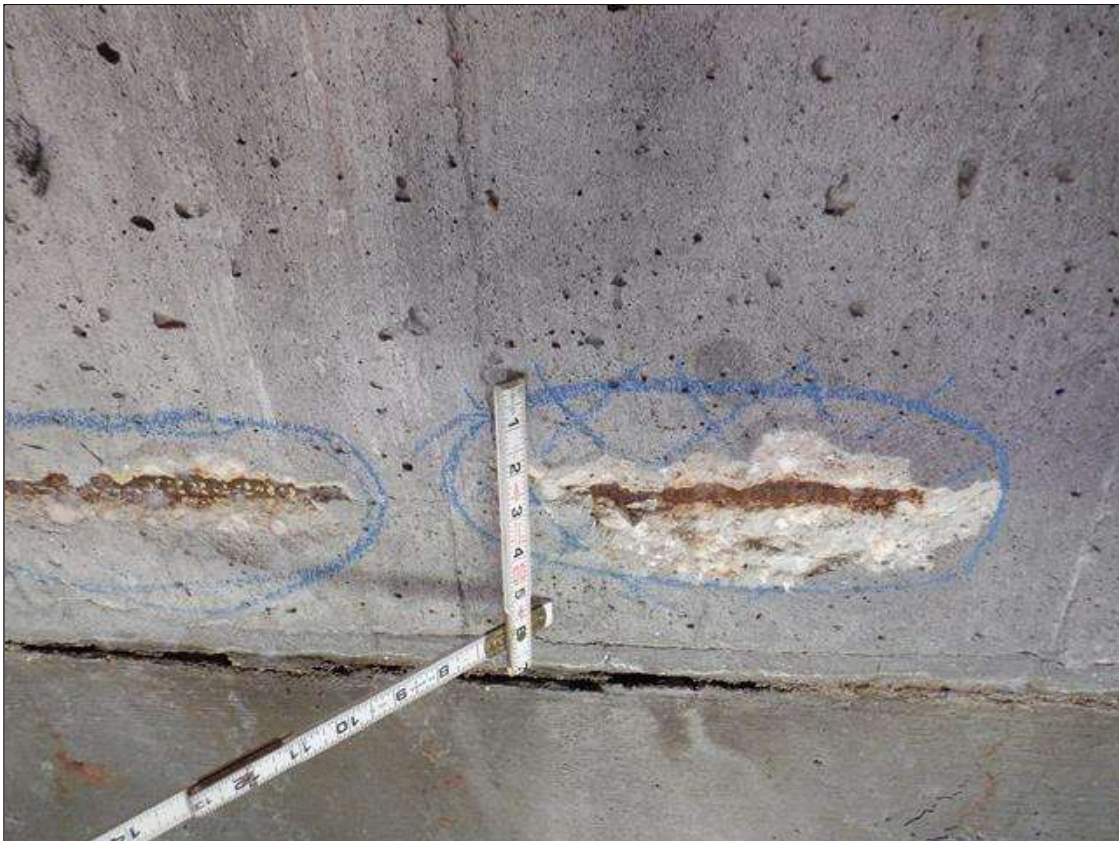
End Bent 2 Abutment: SPALL WITH EXPOSED REBAR IN BAY 2 ADJACENT TO EXPOSED REBAR. 1 FOOT X 5 INCHES, NO SECTION LOSS.

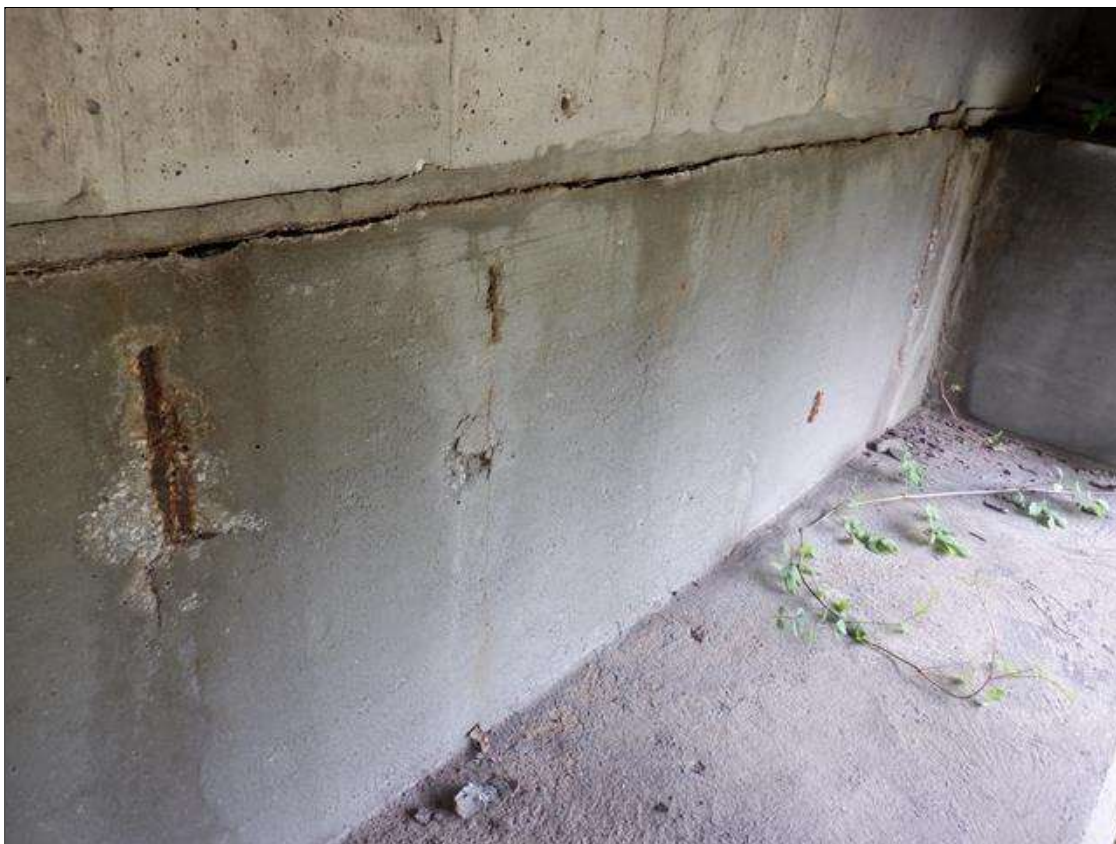
End Bent 2 Abutment: IN BAYS 2 AND 3, SPALLS WITH EXPOSED REBAR 6 INCHES X UP TO 18 INCHES X UP TO 1/4 INCH DEEP. NO SECTION LOSS.

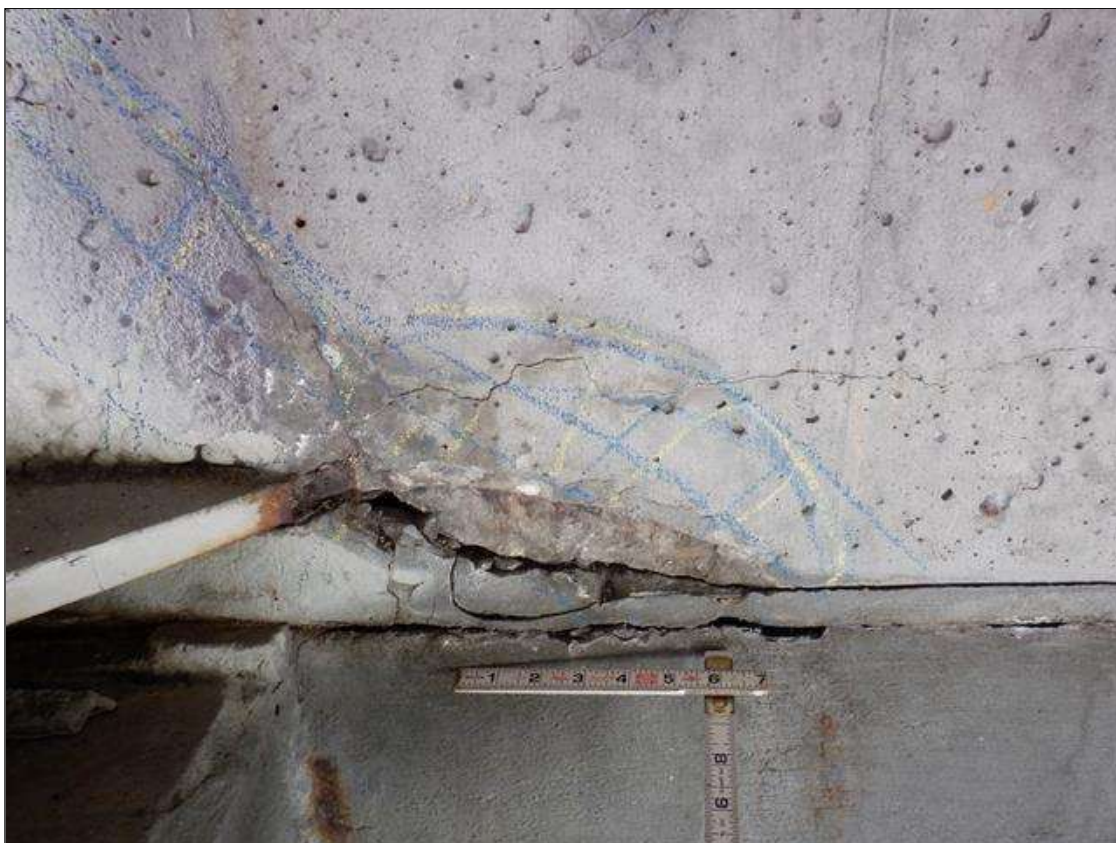
End Bent 2 Abutment: ADJACENT TO BEAM 3 IN BAY 3 SPALL 1 FOOT X 2 INCHES X UP TO 1 INCH DEEP.

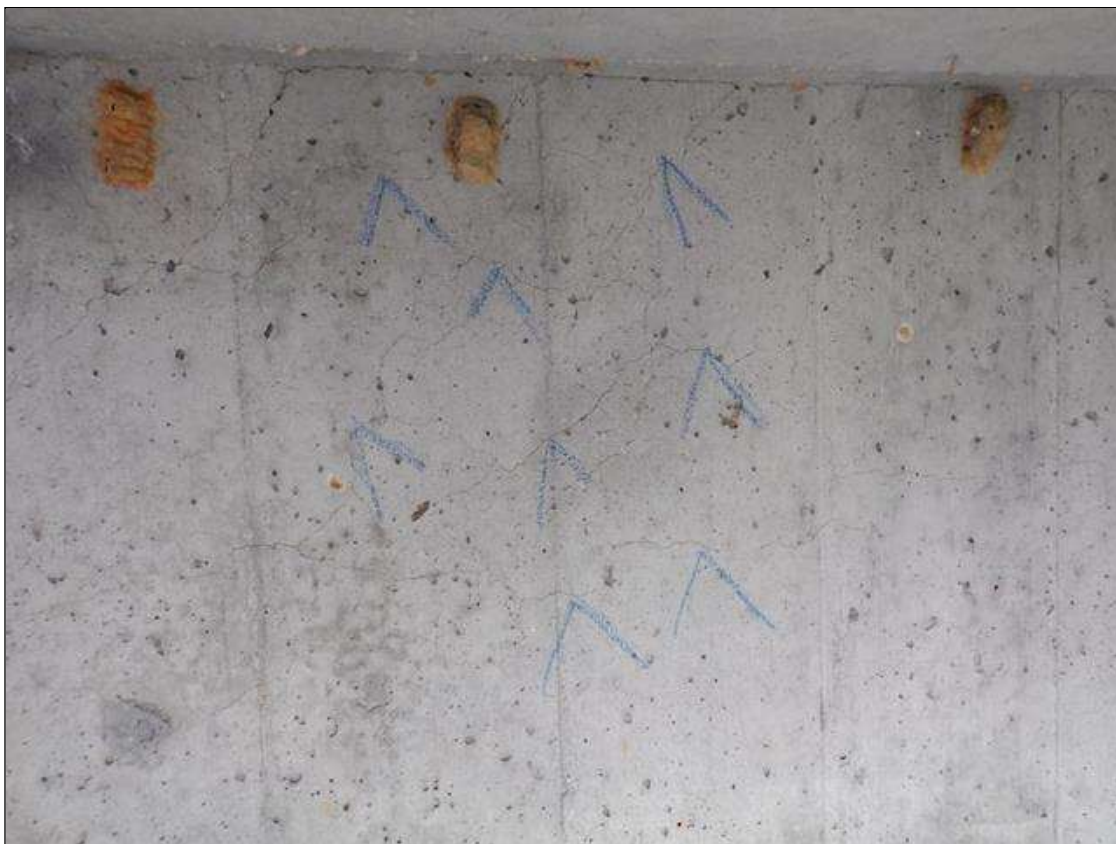
End Bent 2 Abutment: 28 FEET HAIRLINE MAP CRACKING FULL LENGTH

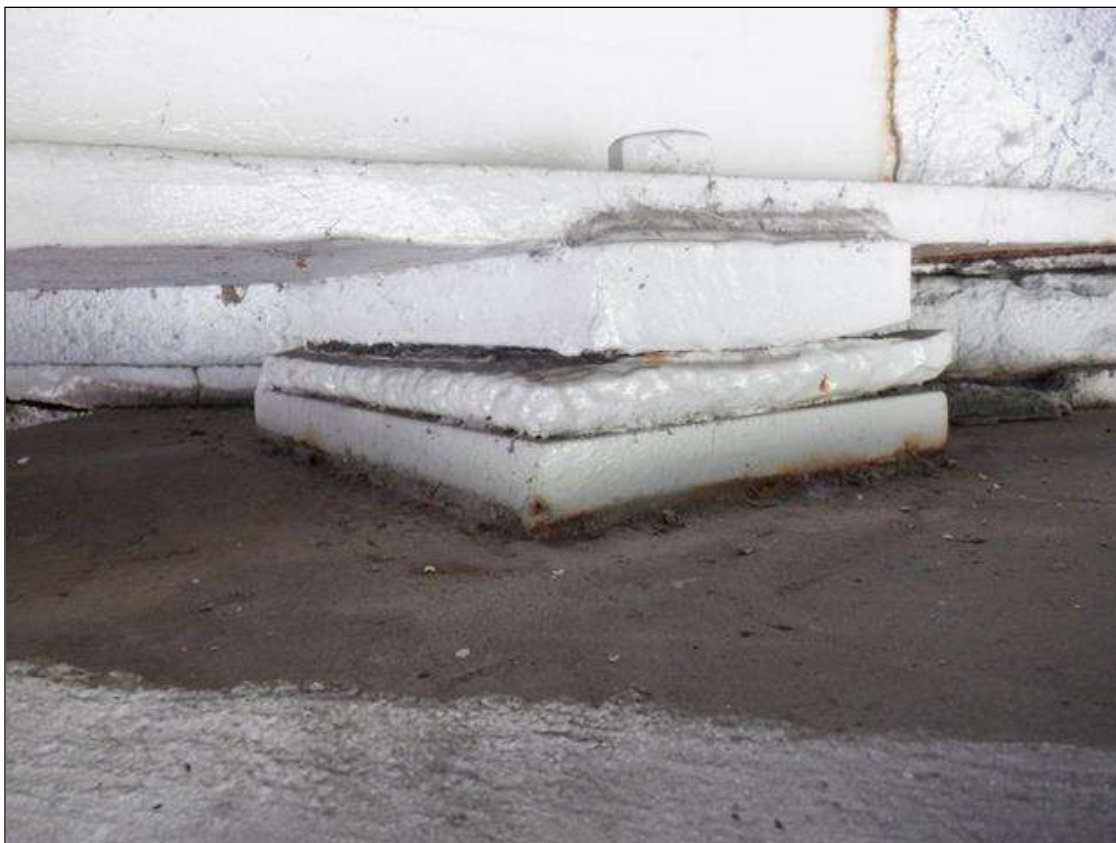
Span 4 Beam 3 - Far Bearing: SECTION LOSS ARRESTED. PITTED 1/8 INCH DEEP IN VERTICAL FACES. COATING GOOD.

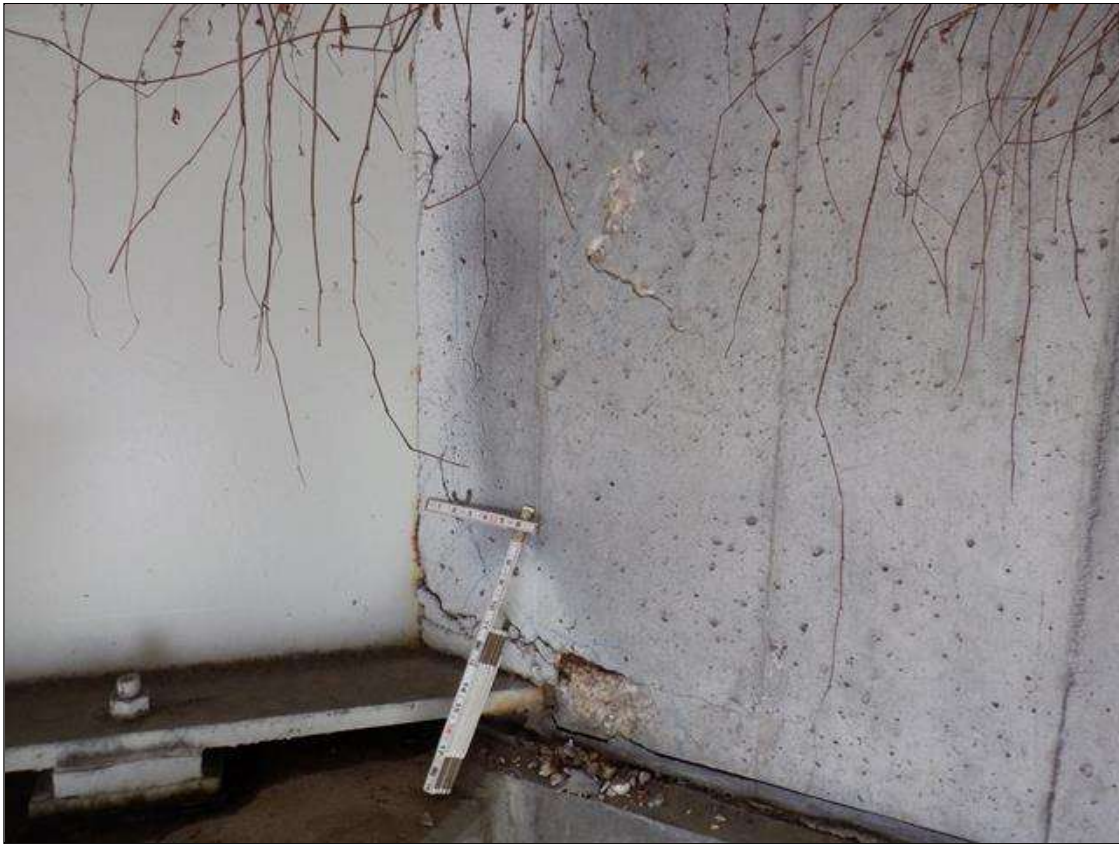
End Bent 1 Abutment: LEFT SIDE BEAM 2 BAY 1 DELAMINATION WITH SPALL AND EXPOSED REBAR. 2 FEET X 3 FEET X UP TO 1 INCH DEEP. NO SECTION LOSS.

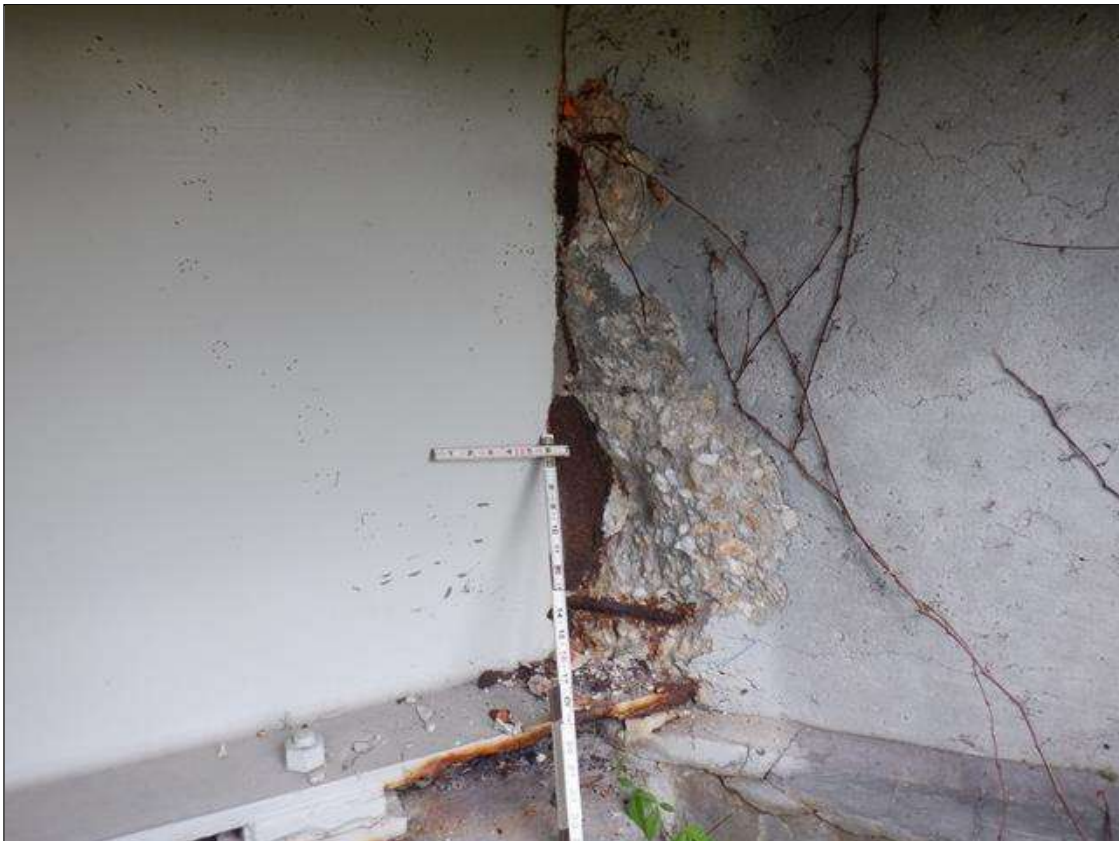
End Bent 1 Abutment: 20 INCHES HIGH X 12 INCHES WIDE X 3 INCHES DEEP SPALL WITH EXPOSED REBAR IN BACKWALL ADJACENT TO THE LEFT SIDE WEB OF BEAM 1, NO SECTION LOSS.

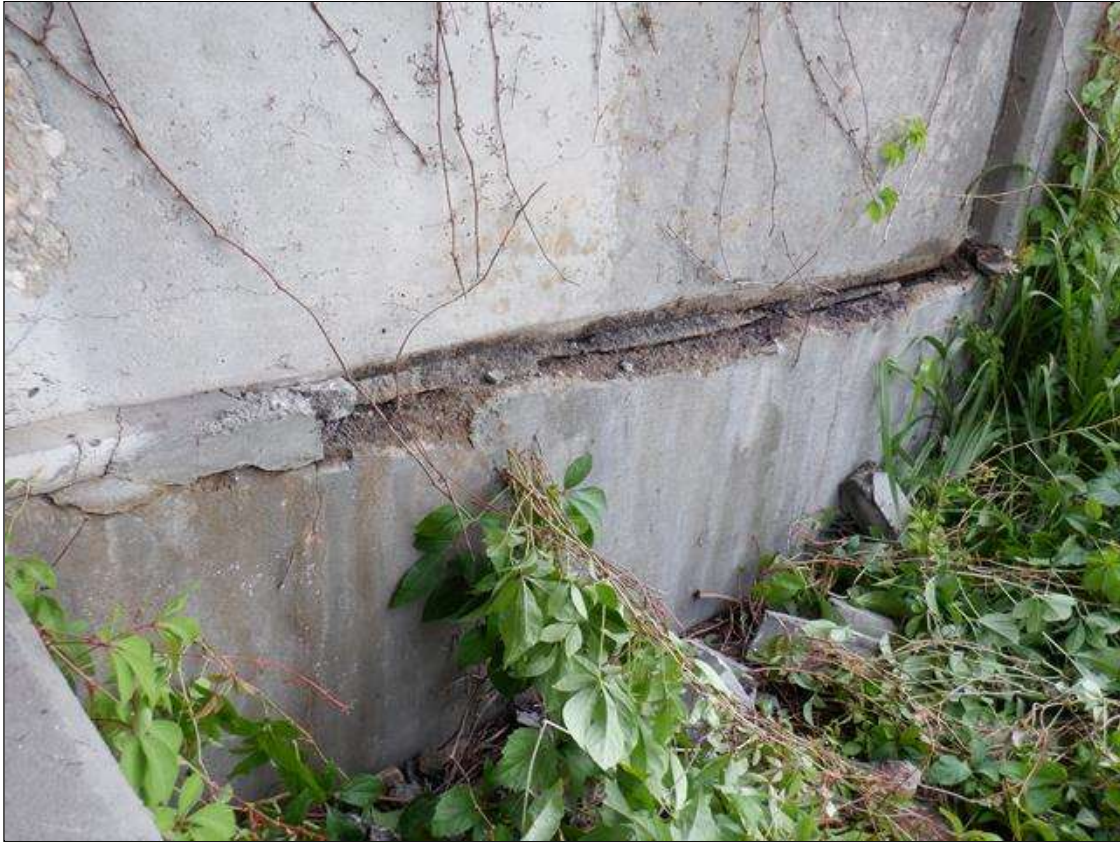
End Bent 1 Abutment: FROM LEFT END TO BEAM 1 CONCRETE IN JOINT SPALLED OFF 7 FEET X 4 INCHES X 4 INCHES.

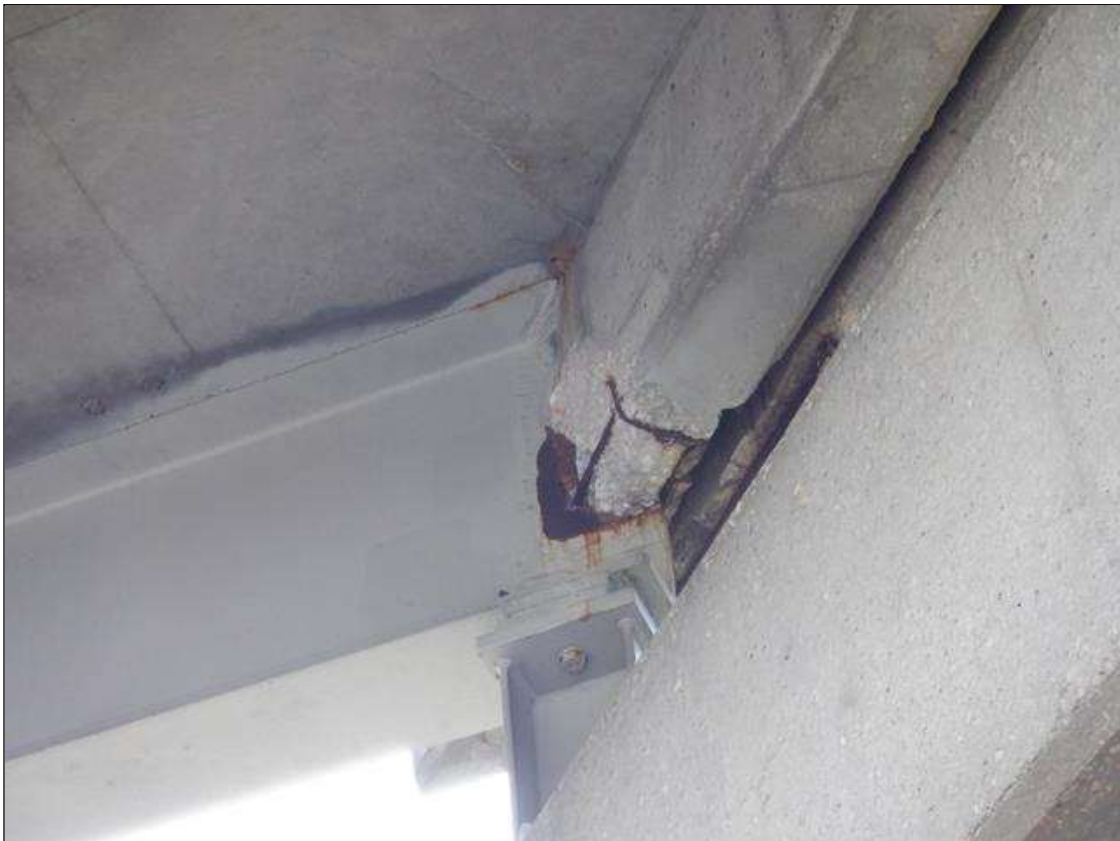
Span 2 Deck: PAR. BAY 3 DIAPHRAGM OVER BENT 1 ADJACENT TO BEAM 4 SPALL WITH EXPOSED REBAR 1 FOOT X 8 INCHES X 3 INCHES DEEP. 5 PERCENT SECTION LOSS.

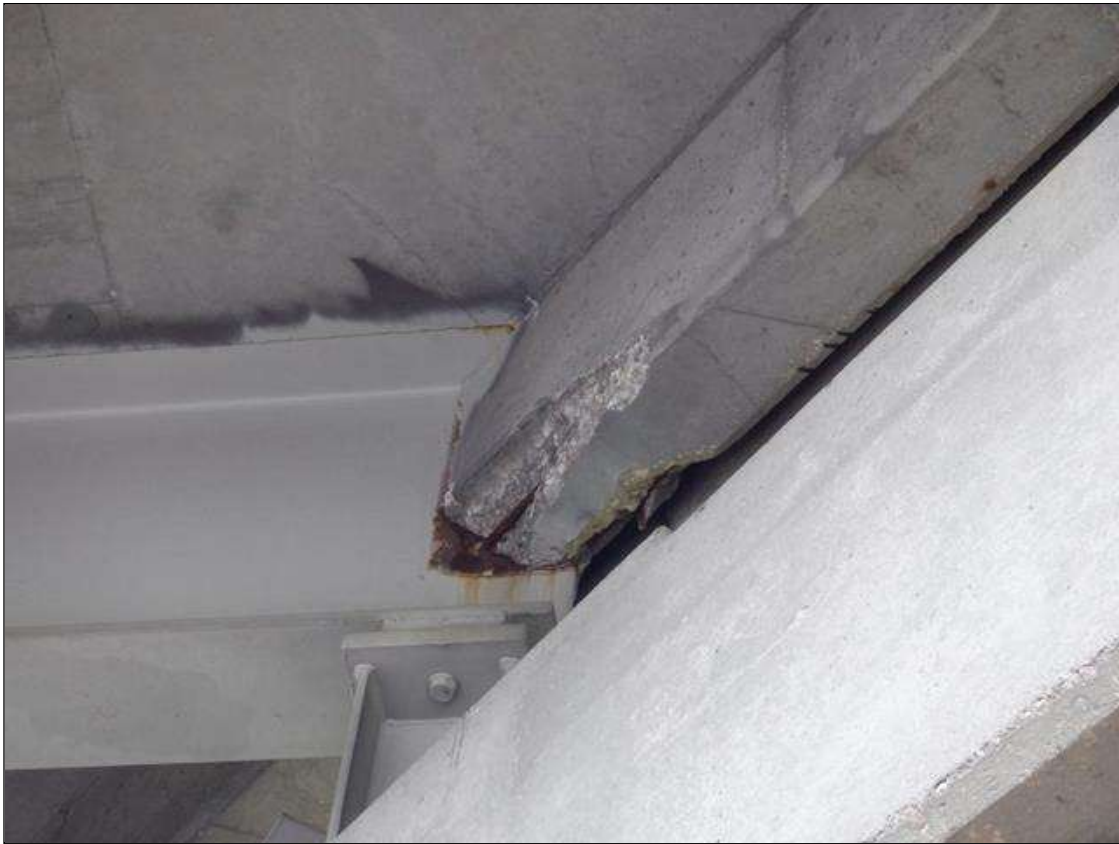
Span 2 Deck: 12 INCHES X 8 INCHES X 3 INCHES DEEP SPALL WITH EXPOSED REBAR (WITHOUT SECTION LOSS) IN END DIAPHRAGM AT BENT 1 BAY 2.

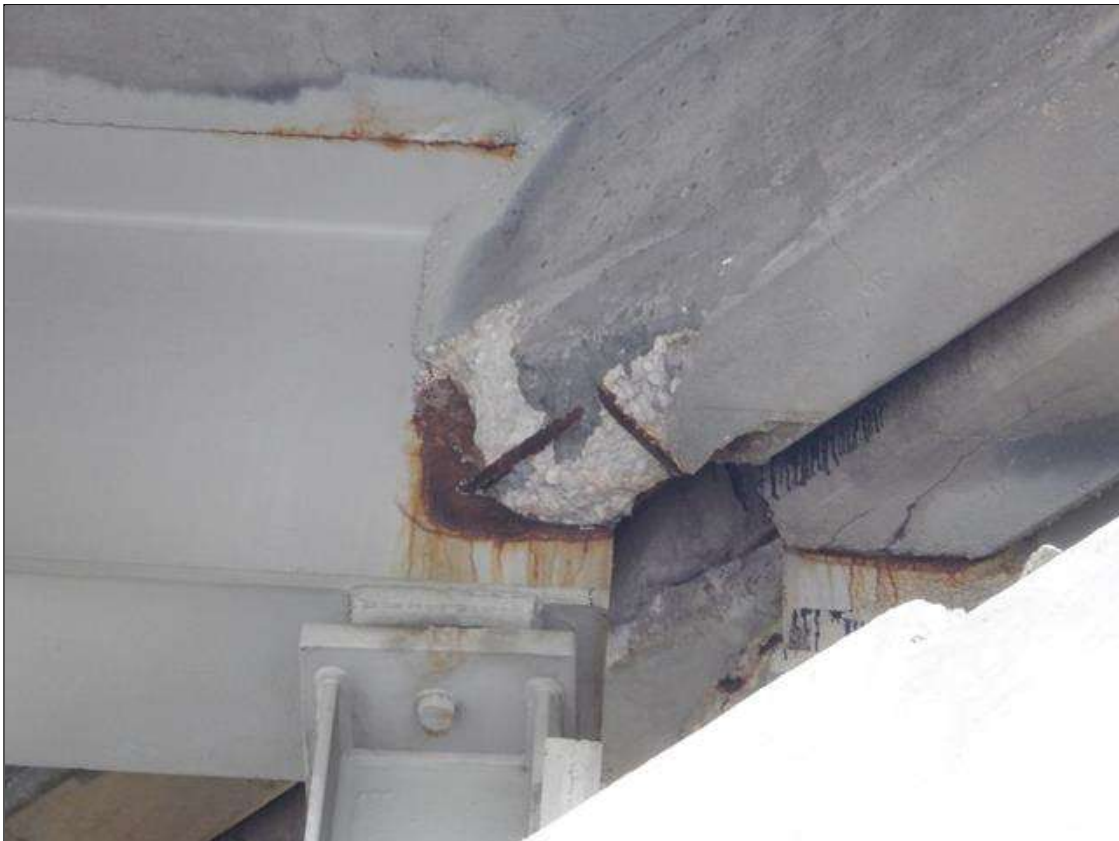
Span 2 Deck: PAR. BAY 1 NEAR DIAPHRAGM ADJACENT TO BEAM 2 SPALL WITH EXPOSED REBAR 1 FOOT X 4 INCHES X 4 INCHES, 5 PERCENT SECTION LOSS.

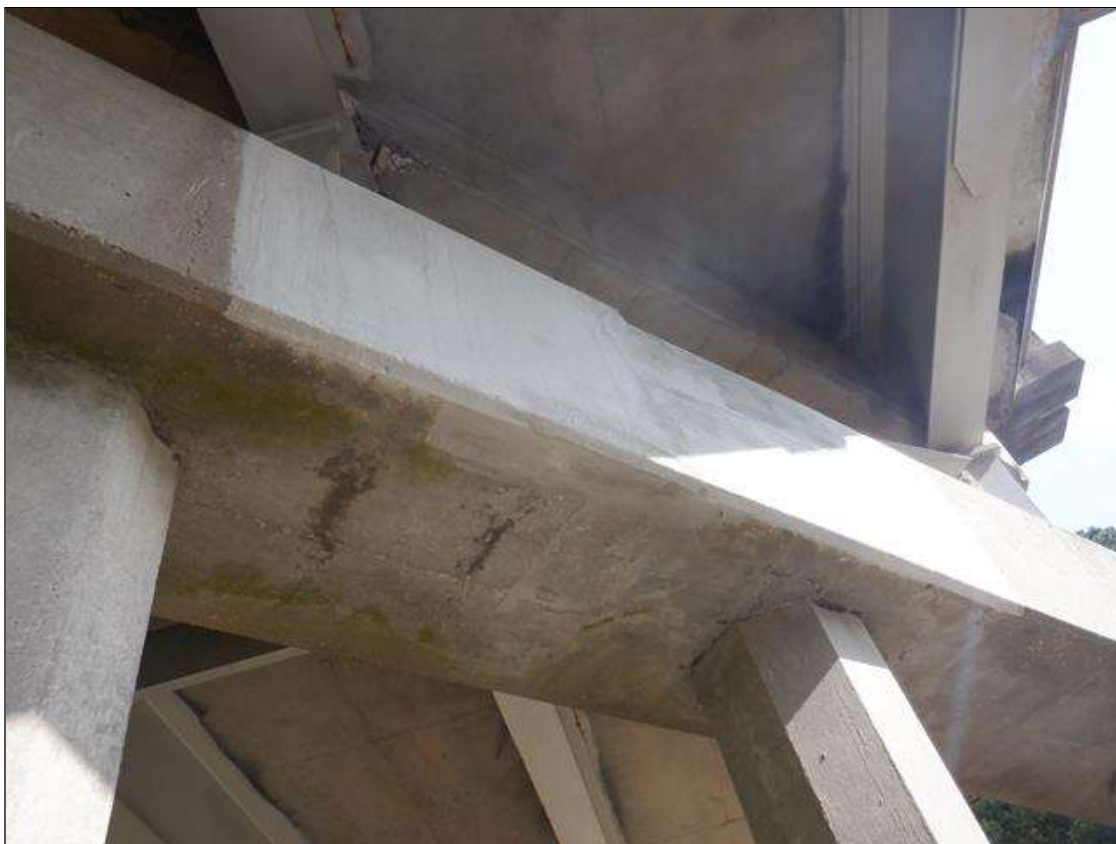
Bent 1 Cap 1: SPAN 2 SIDE UNDER BAY 1, 8 FEET X FULL HEIGHT SOUND PATCH.

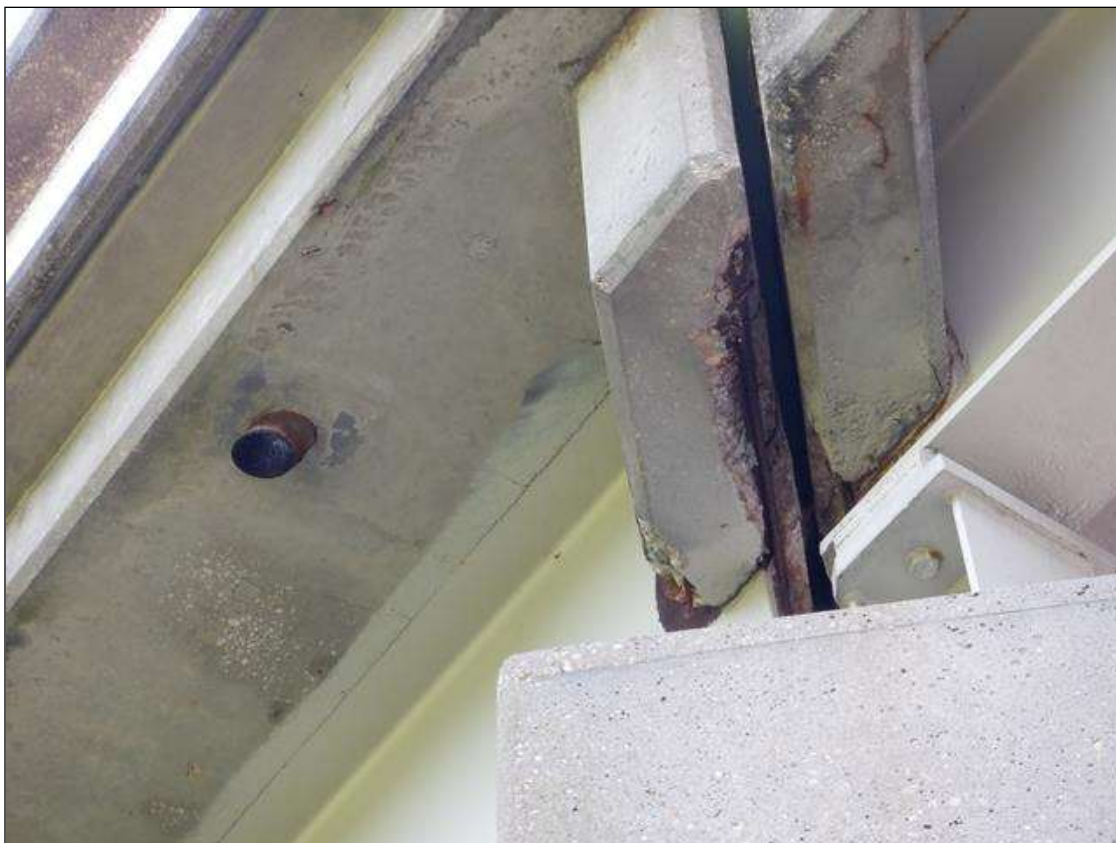
Span 1 Deck: PAR. RIGHT OVERHANG DIAPHRAGM SPALL WITH EXPOSED REBAR 2 FEET X 5 INCHES X UP TO 1 FOOT, 5 PERCENT SECTION LOSS.
