NC DEPARTMENT OF TRANSPORTATION
 DIVISION OF HIGHWAYS
 STRUCTURE MANAGEMENT UNIT

ATTENTION: PAR SUBMITTED, REQUEST LIDAR, CHANGE TO STRUCTURE DATA

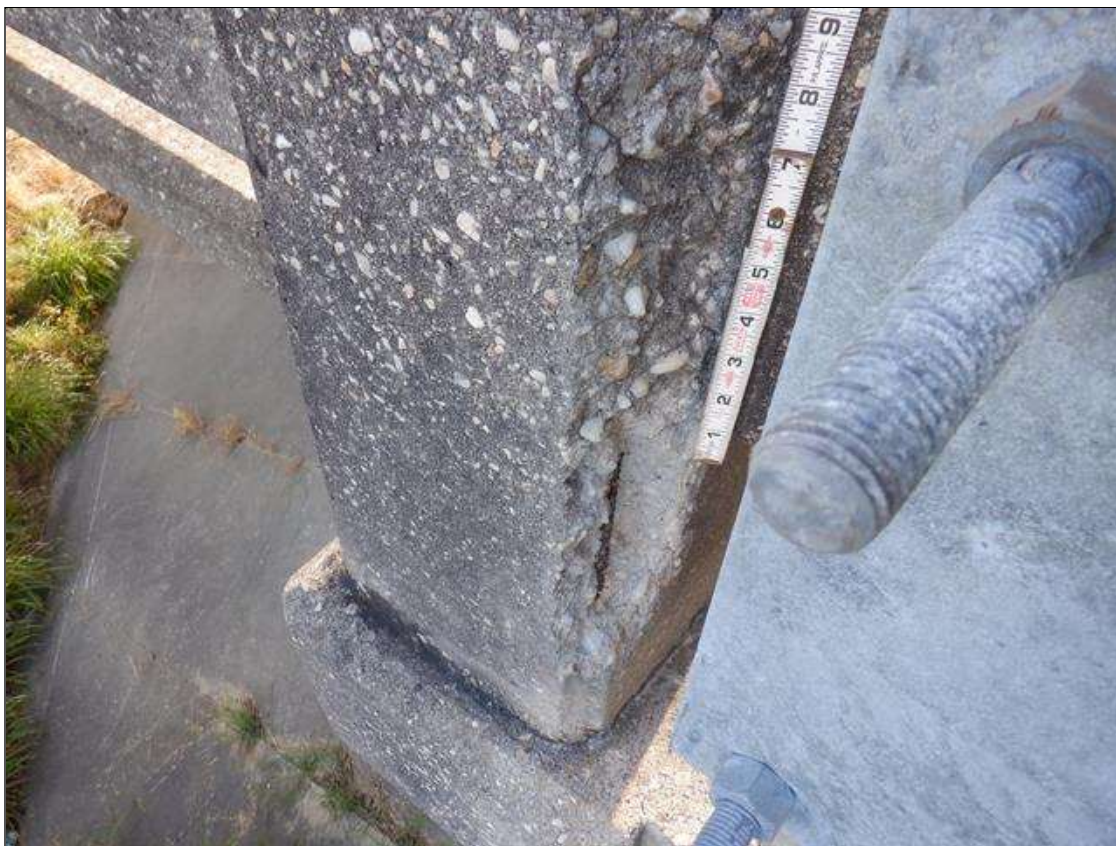
Span 1 Left Bridge Rail: 1 FOOT OF SPALLING IN POST 3 WITH EXPOSED REBAR, NO SECTION LOSS.

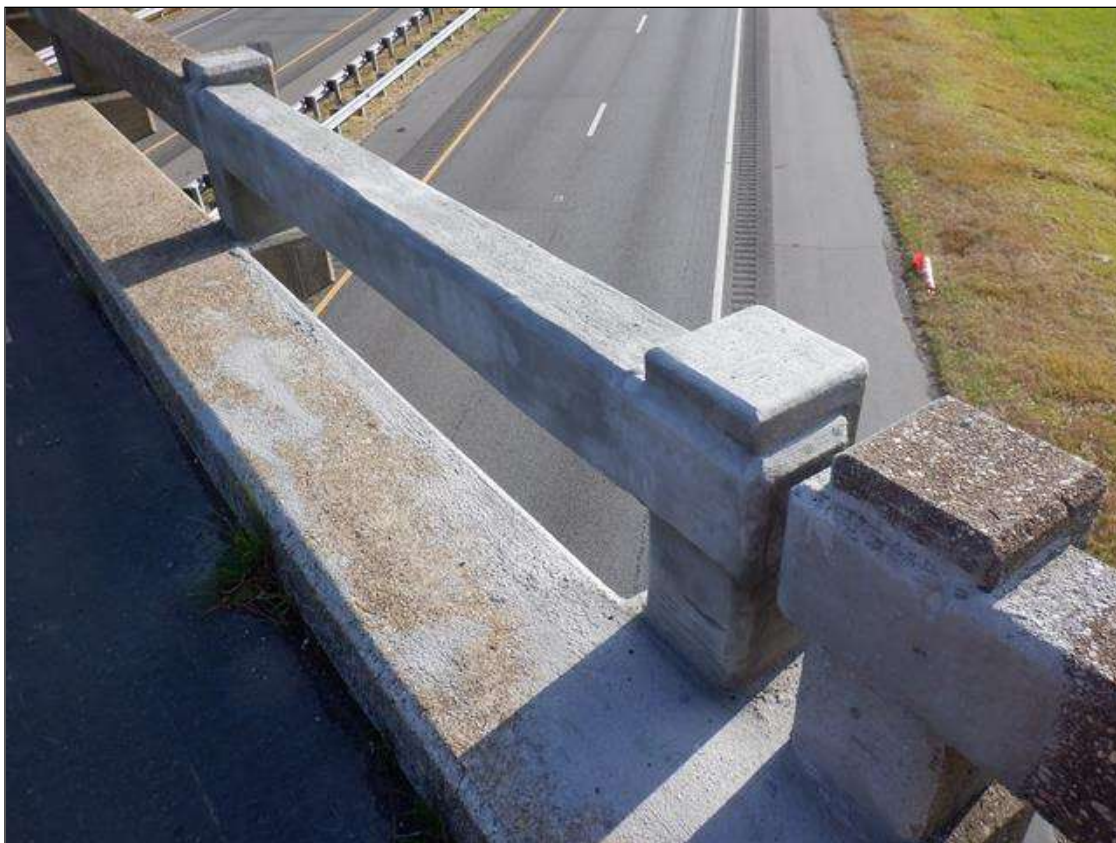
Span 2 Right Bridge Rail: PREVIOUS IMPACT DAMAGE FROM POST 3 TO 5 HAS BEEN REPAIRED.

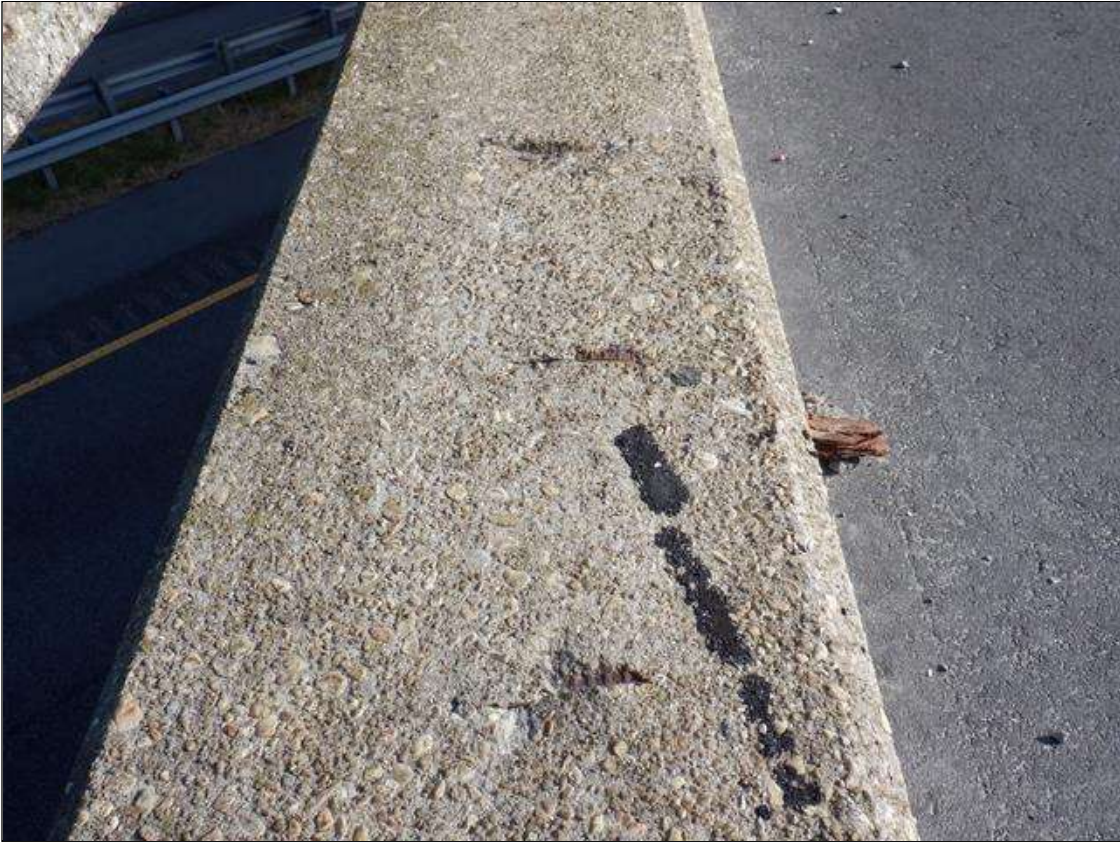
Span 2 Left Bridge Rail: ON TOP OF CURB SCATTERED THROUGHOUT 11 SPALLS WITH EXPOSED REBAR 2 INCHES X 3 INCHES X 1/4 INCH DEEP, NO SECTION LOSS

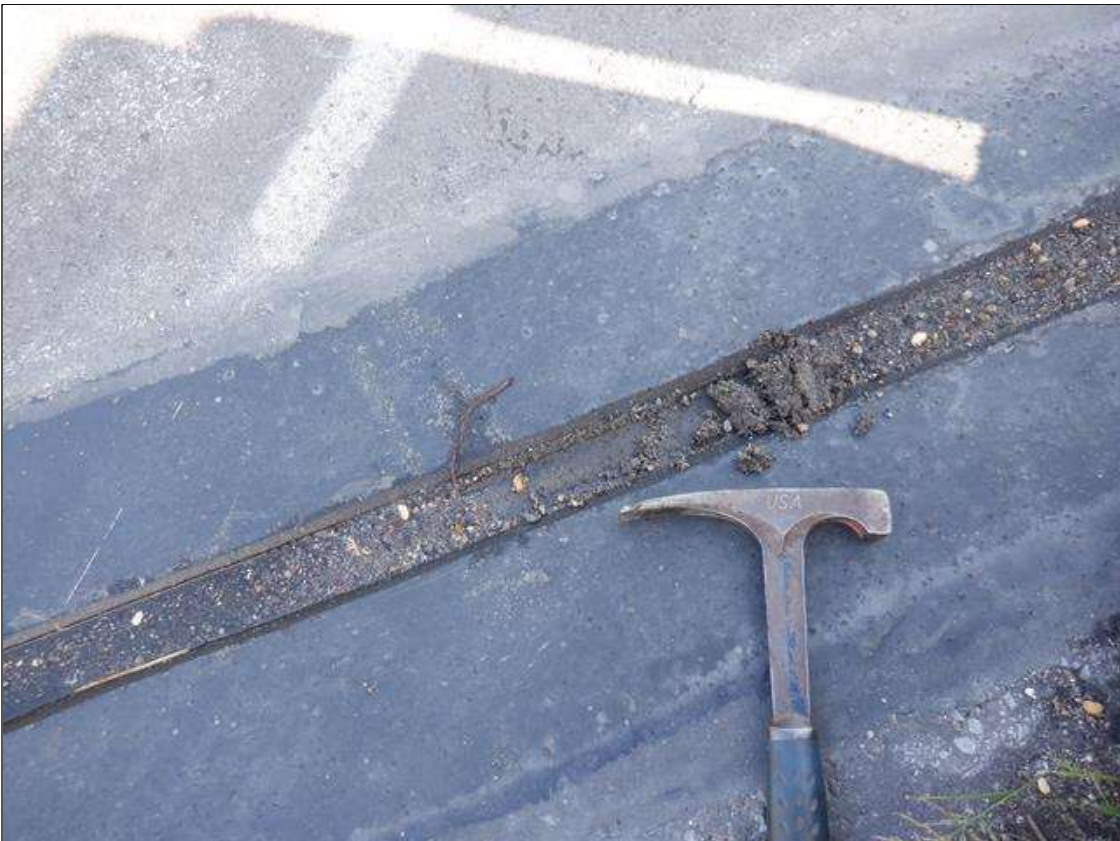
Span 3 Expansion Joint 3: IN BOTH SHOULDERS 2 FEET DIRT AND DEBRIS IMPACTION. STILL ALLOWS FREE JOINT MOVEMENT.

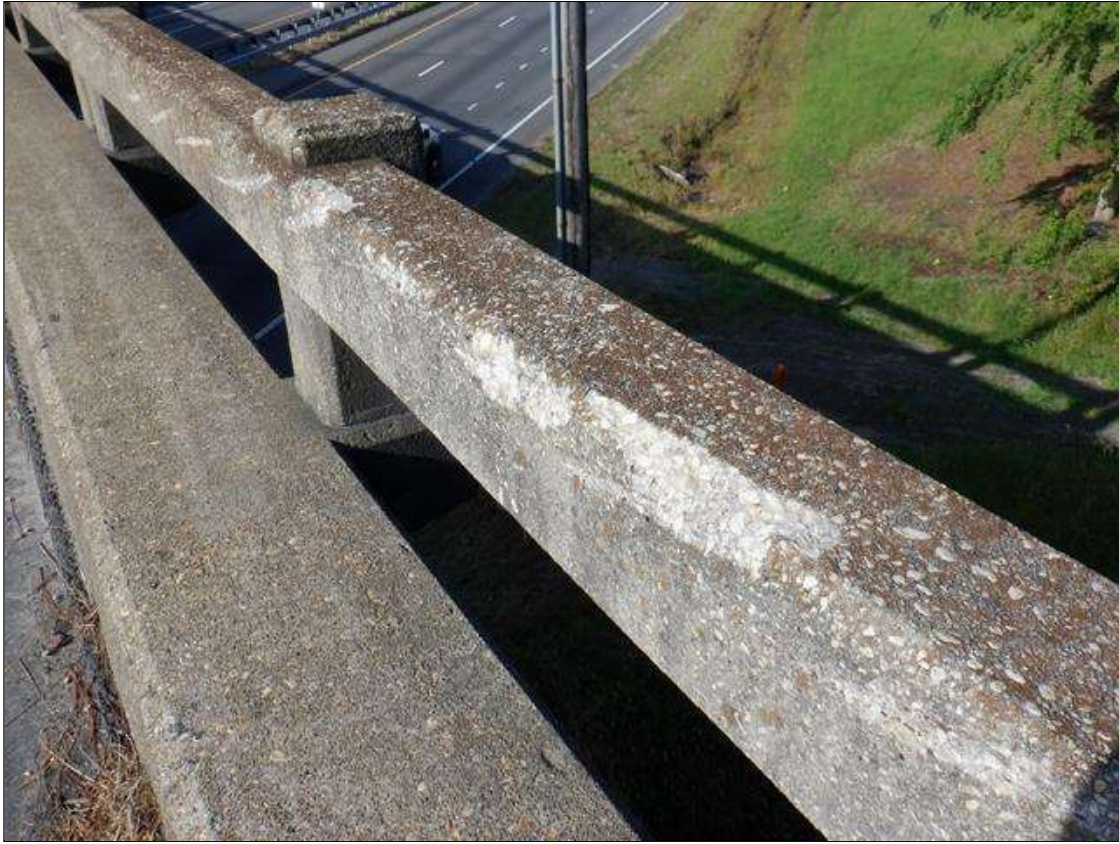
Span 4 Left Bridge Rail: 10 FEET OF IMPACT DAMAGE ALONG RAIL WITH SPALLS UP TO 1 FOOT X 2 INCHES X 2 INCHES.

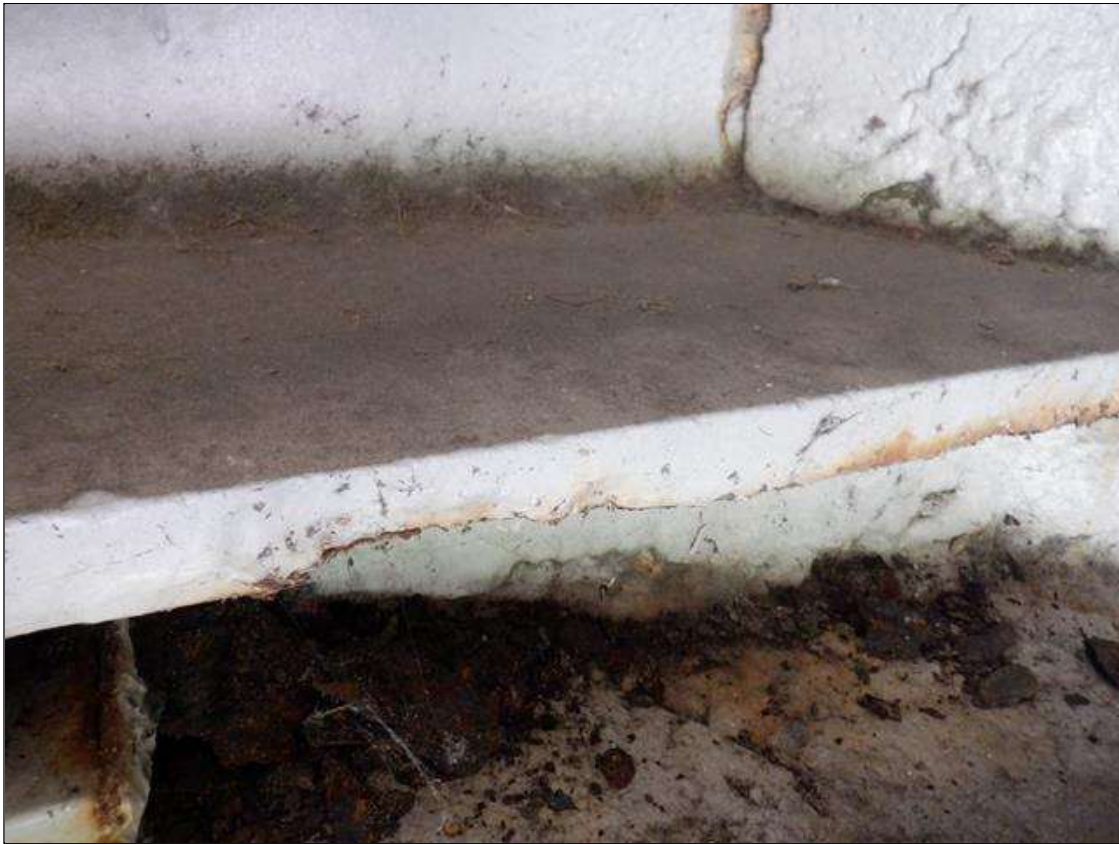
Span 1 Beam 1: 1/4 INCH SECTION LOSS IN BOTTOM FLANGE BETWEEN BACKWALL AND NEAR BEARING ASSEMBLY (NOT IN BEARING AREA) WITH 3/4 INCH REMAINING AT END BENT 1. SURFACE RUST IN WEB ADJACENT TO BACKWALL.

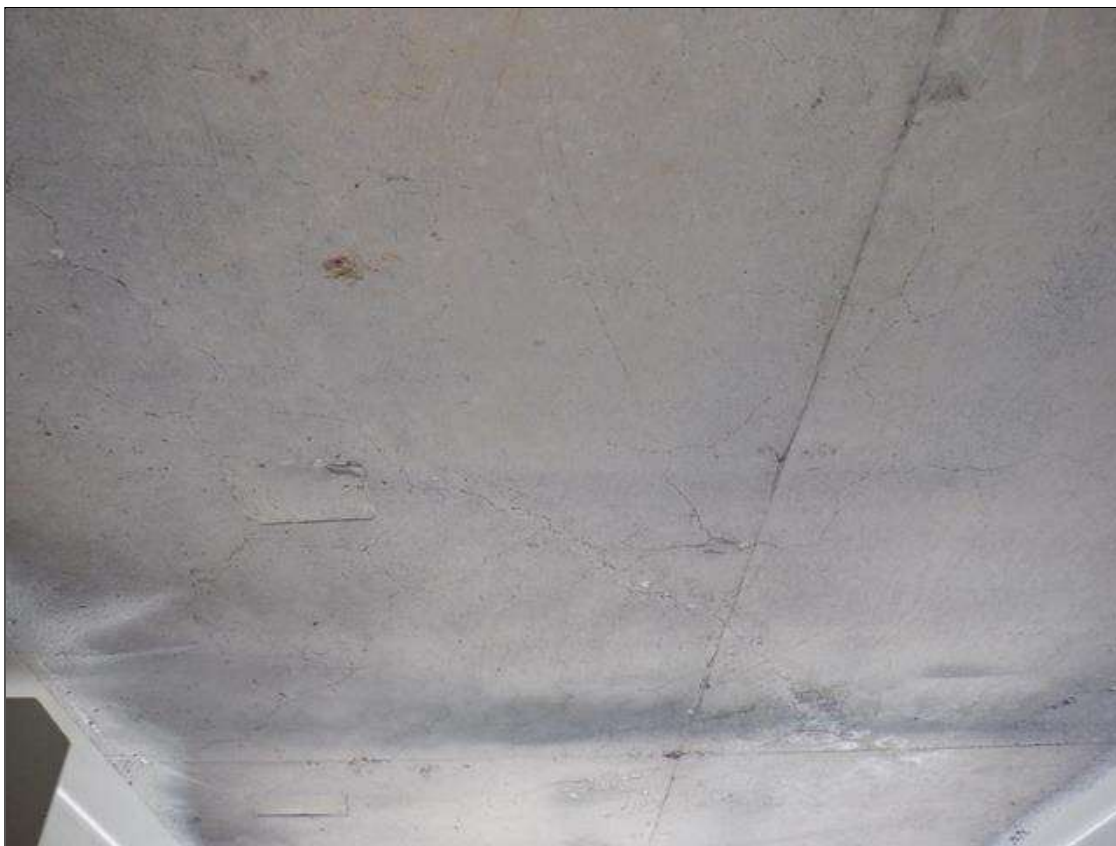
Span 1 Deck: BOTTOM OF DECK: HAIRLINE MAP TRANSVERSE AND DIAGONAL CRACKING IN ALL BAYS

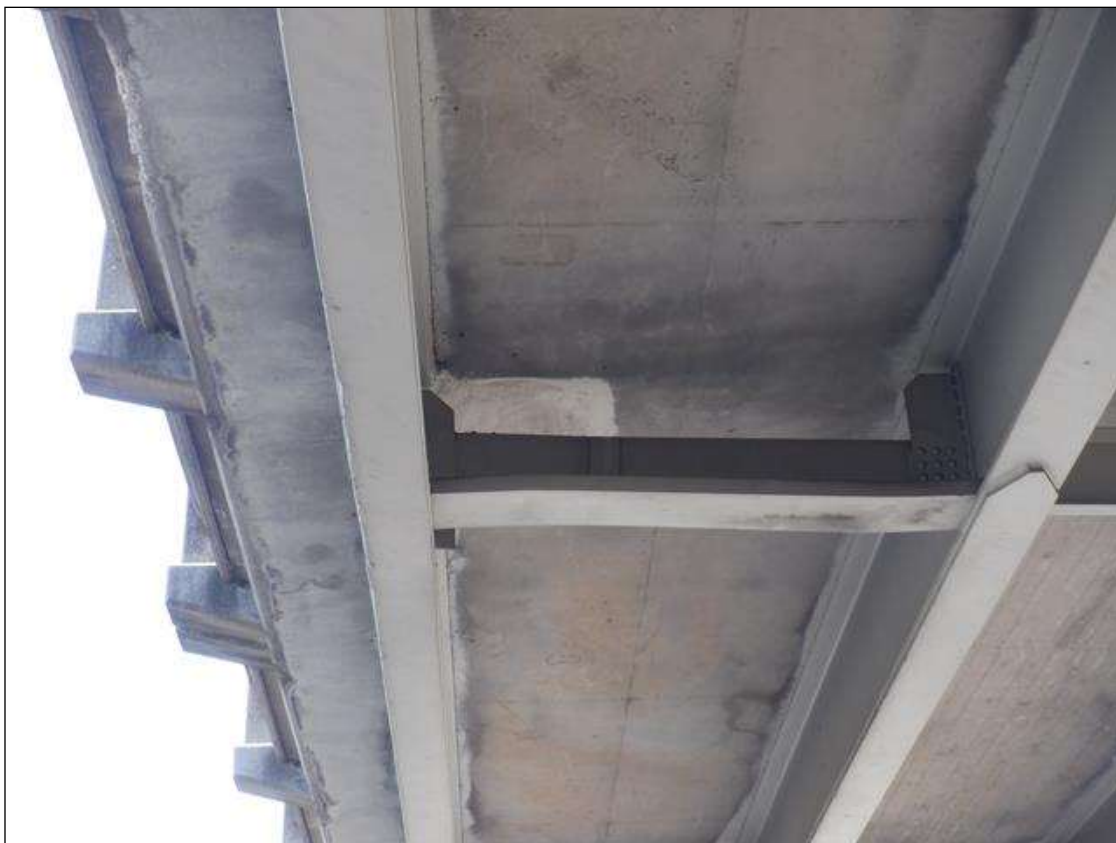
Span 2 Beam 1: PREVIOUS IMPACT DAMAGE AT FIRST INTERMEDIATE DIAPHRAGM WITH SCRAPES IN COVER PLATE, 12 INCHES COLUMN CHANNEL ADDED AT DIAPHRAGM.

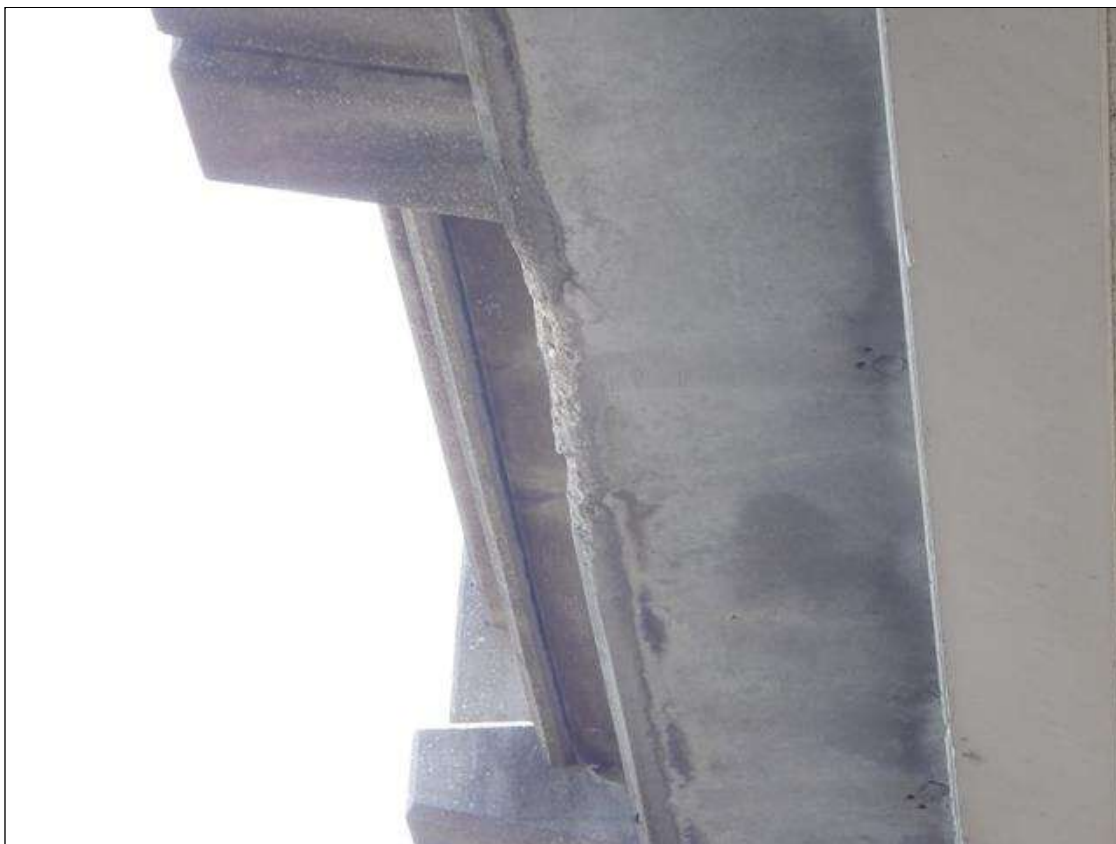
Span 2 Deck: BETWEEN RAIL POSTS 4 AND 5 AT LEFT OVERHANG CORNER 3 FEET X 2 INCHES X 2 INCHES SPALLING.

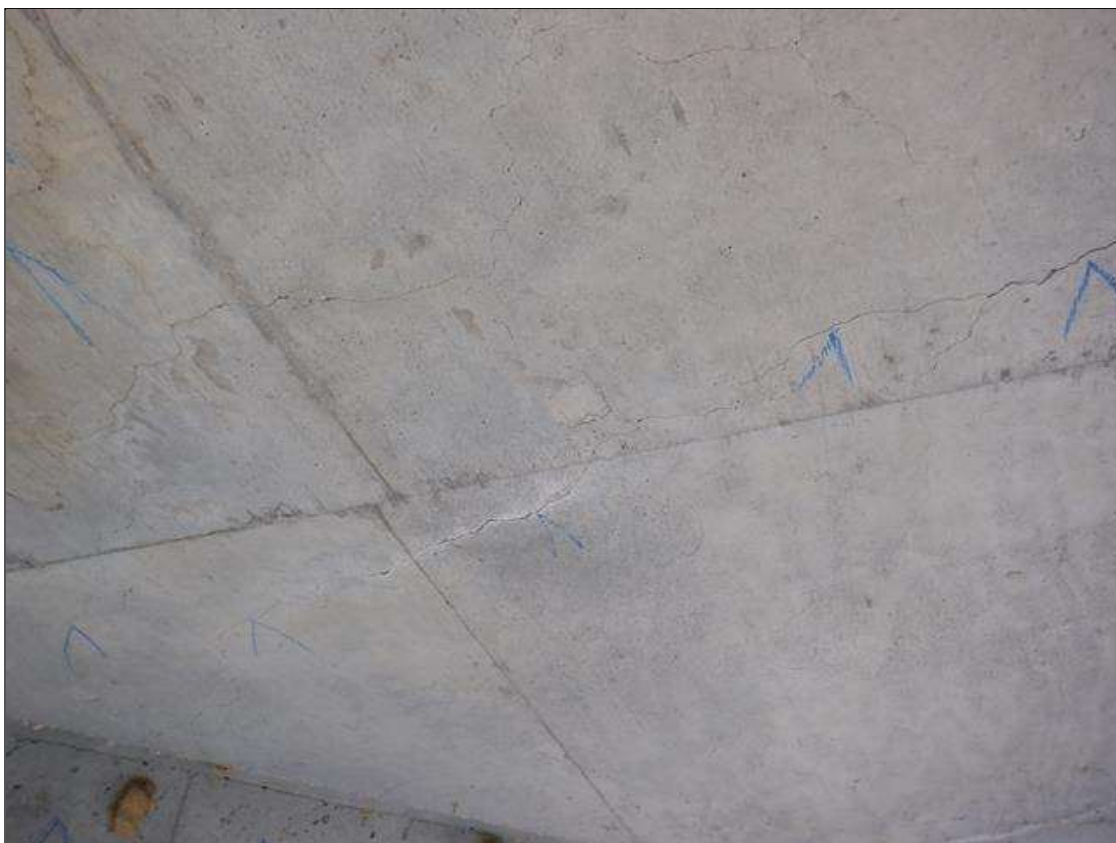
Span 4 Deck: 5 FEET OF 1/16 INCH TRANSVERSE AND MAP-CRACKING IN BOTTOM OF DECK BAY 3

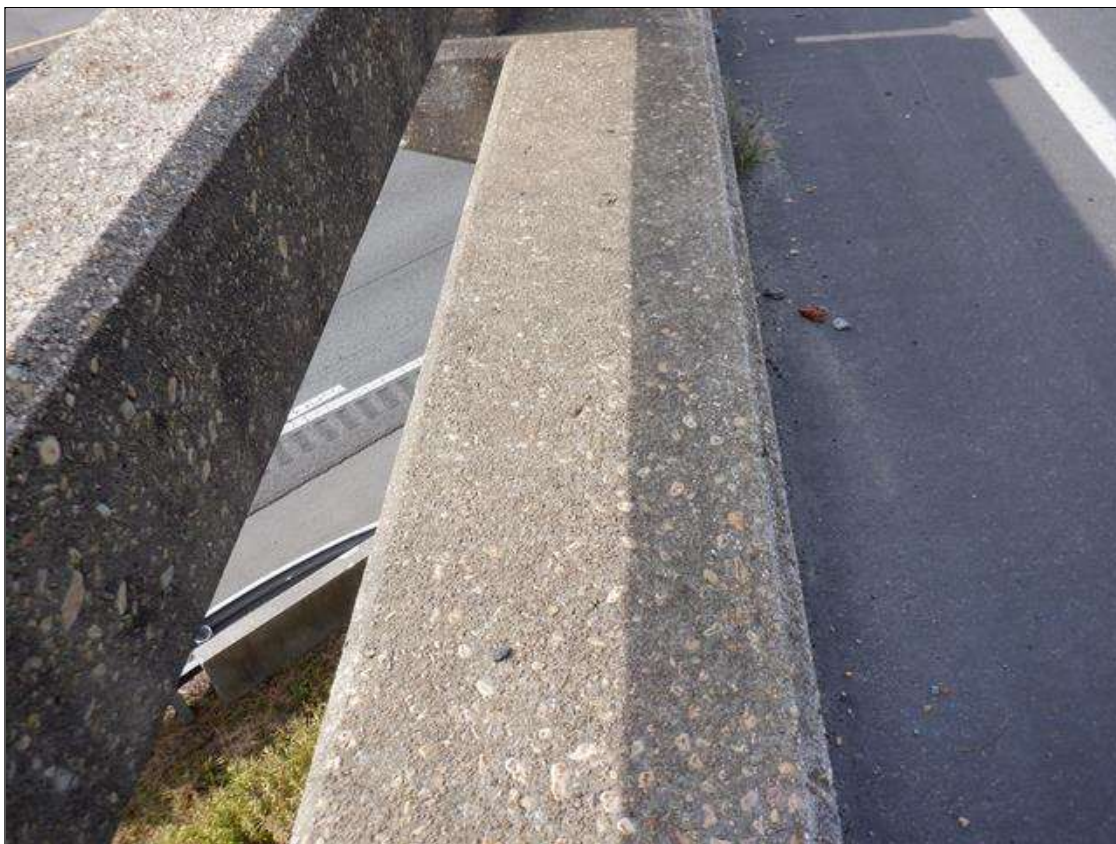
Span 4 Deck: 172 SQUARE FEET OF ABRASION ALONG DECK CURBS.

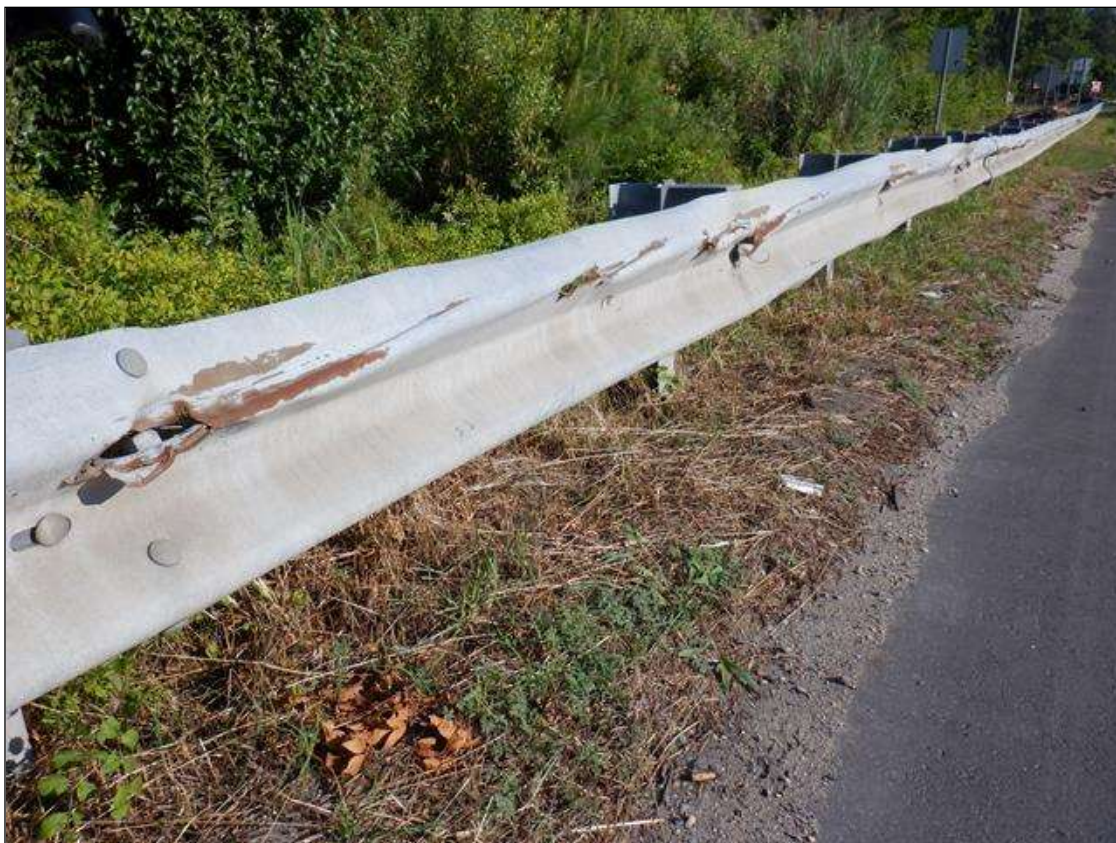
PAR. AT NORTHWEST APPROACH GUARDRAIL 2 AREAS OF UP TO 45 FEET OF IMPACT DAMAGE WITH LOSS OF CONNECTION AT 4 POSTS AND DISTORTION UP TO 3 INCHES.

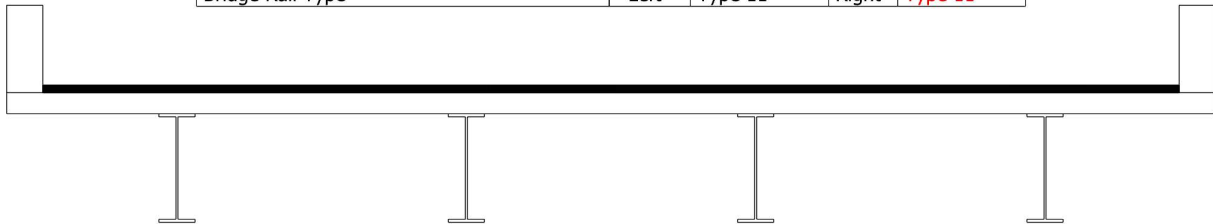
Measurements for Span #	1	ALL SPANS SIMILAR	
Deck Thickness	7in	Left Overhang	4.708ft
Top of Rail to Bottom of Beam (Avg)	6.001ft	Right Overhang	4.708ft

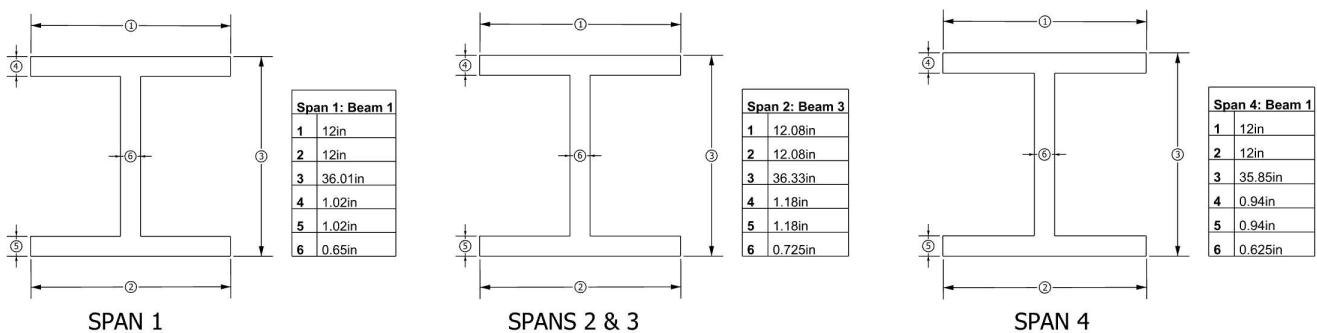
UPDATED BY ARV & LL ON 6/14/23

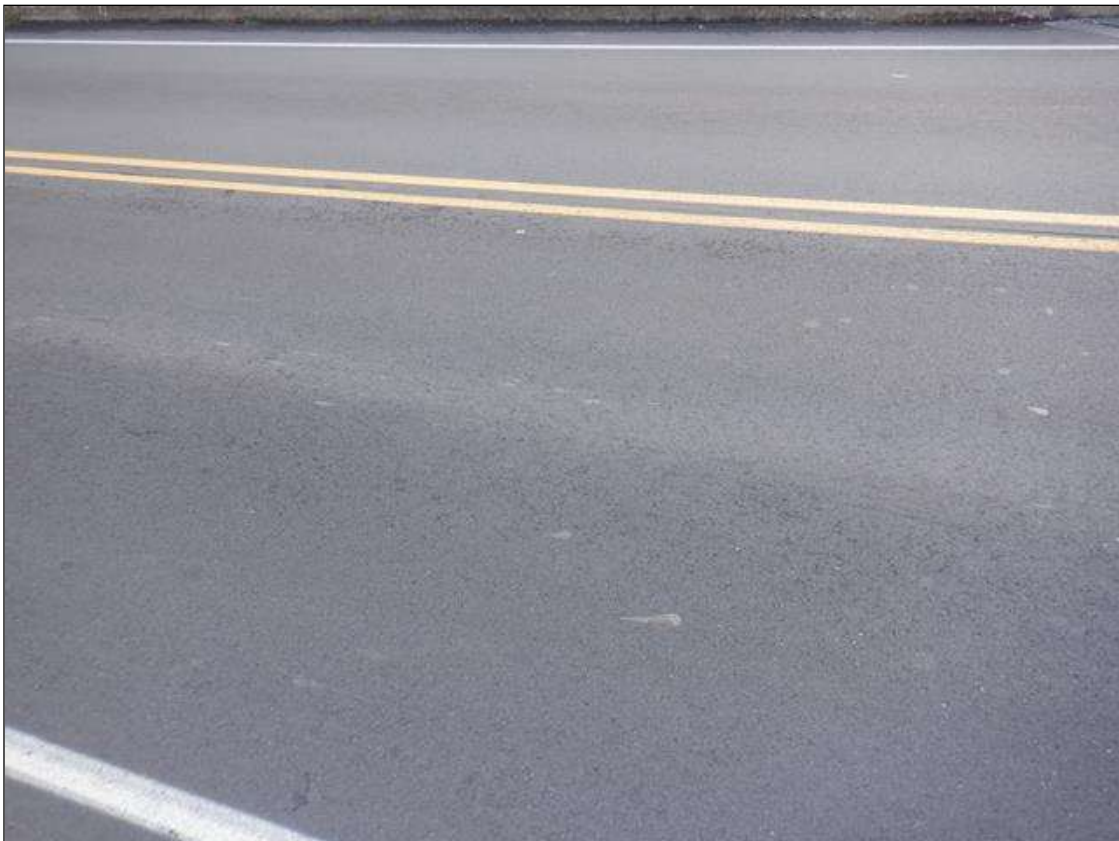
SPAN 1 WEARING SURFACE (REPLACED, BUT NO CHANGE IN THICKNESS)
