NC DEPARTMENT OF TRANSPORTATION
 DIVISION OF HIGHWAYS
 STRUCTURE MANAGEMENT UNIT

ATTENTION: **PAR'S SUBMITTED**

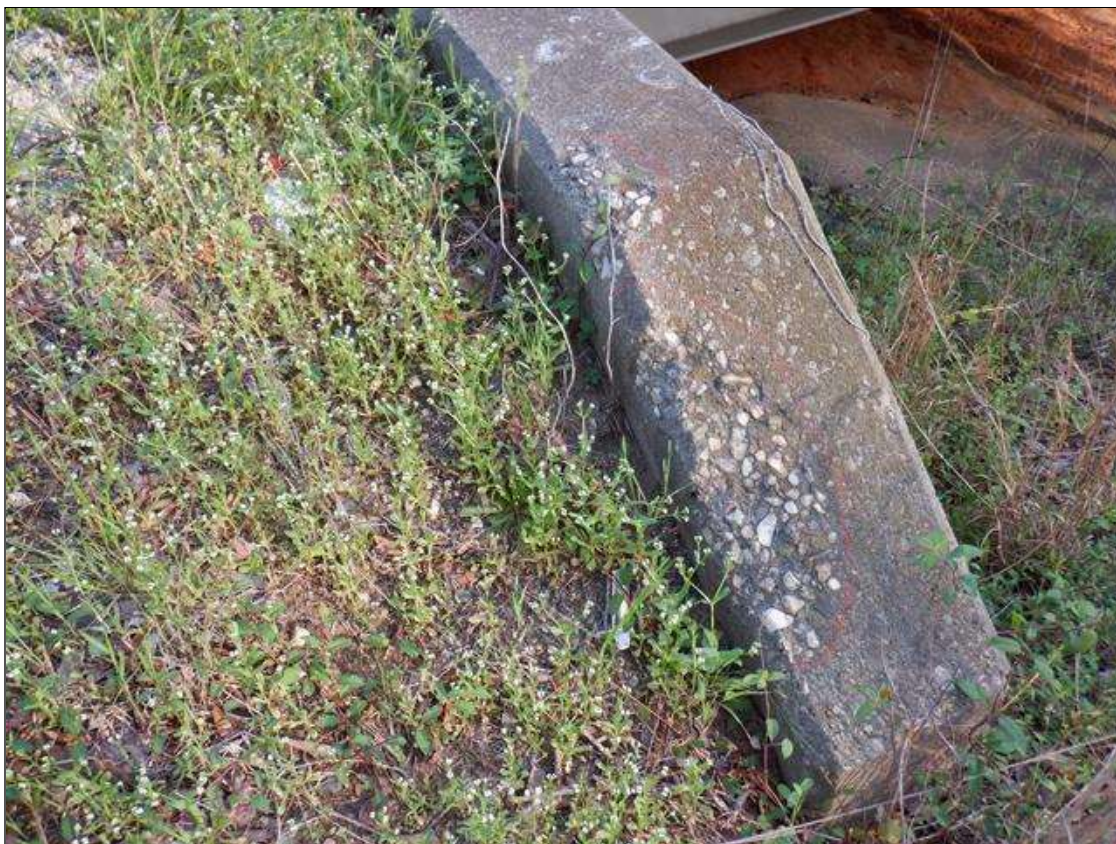
WINGWALL: 2- UP TO 18 INCHES X 5 INCHES X 3 INCHES SPALLS IN TOP OF SOUTHEAST WINGWALL.

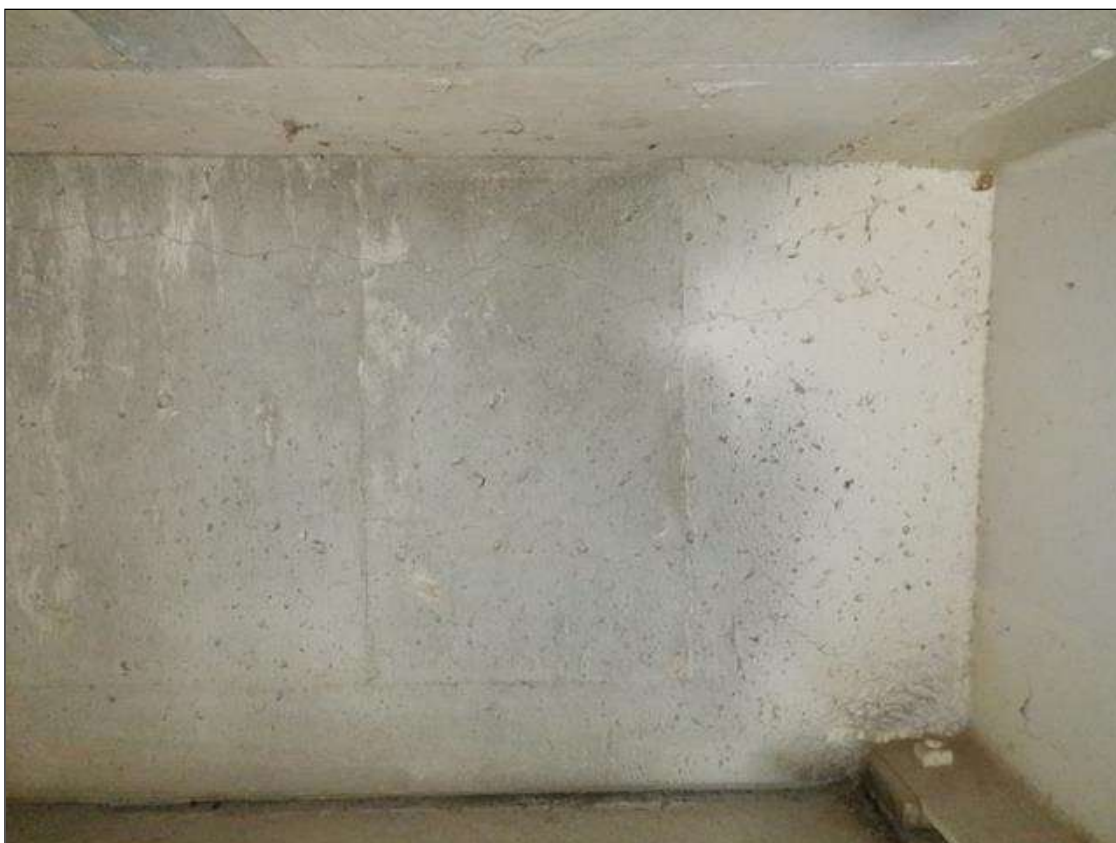
End Bent 1 Abutment: 32 FEET OF UP TO 1/32 INCHES HORIZONTAL AND VERTICAL CRACKS, SOME WITH EFFLORESCENCE. (PHOTO TAKEN IN BAY 2)

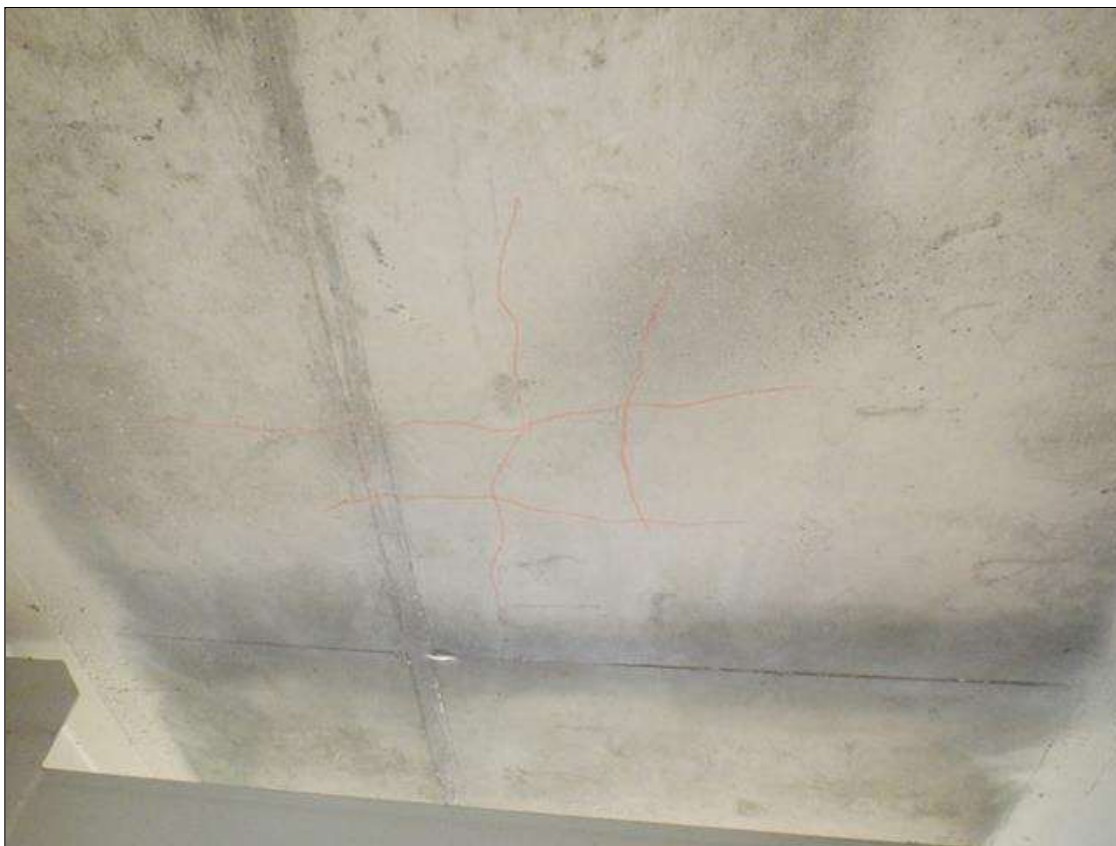
Span 1 Deck: 750 SQUARE FEET OF UP TO 1/32 INCHES MAP CRACKING AT RANDOM THROUGHOUT UNDERSIDE. (PHOTO TAKEN IN BAY 1)

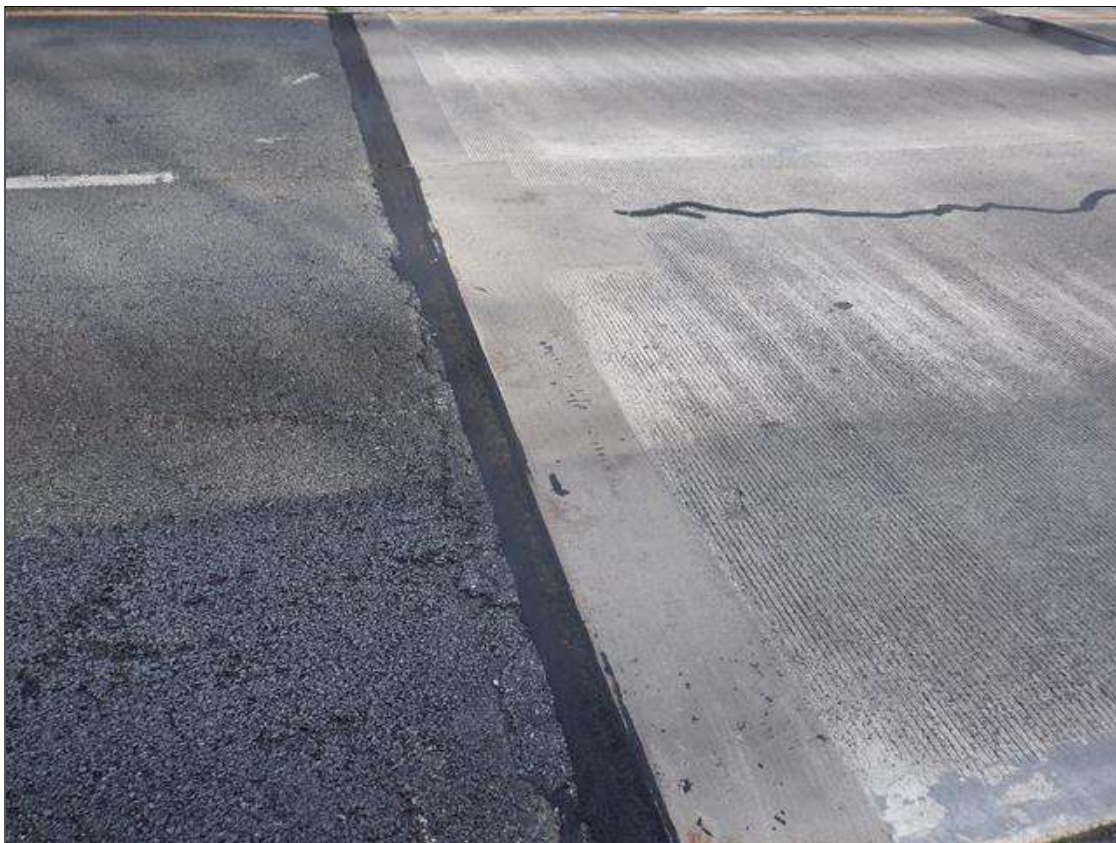
Approach 1 : FULL WIDTH X UP TO 3 FEET PATCHED AREA IN SOUTH END.

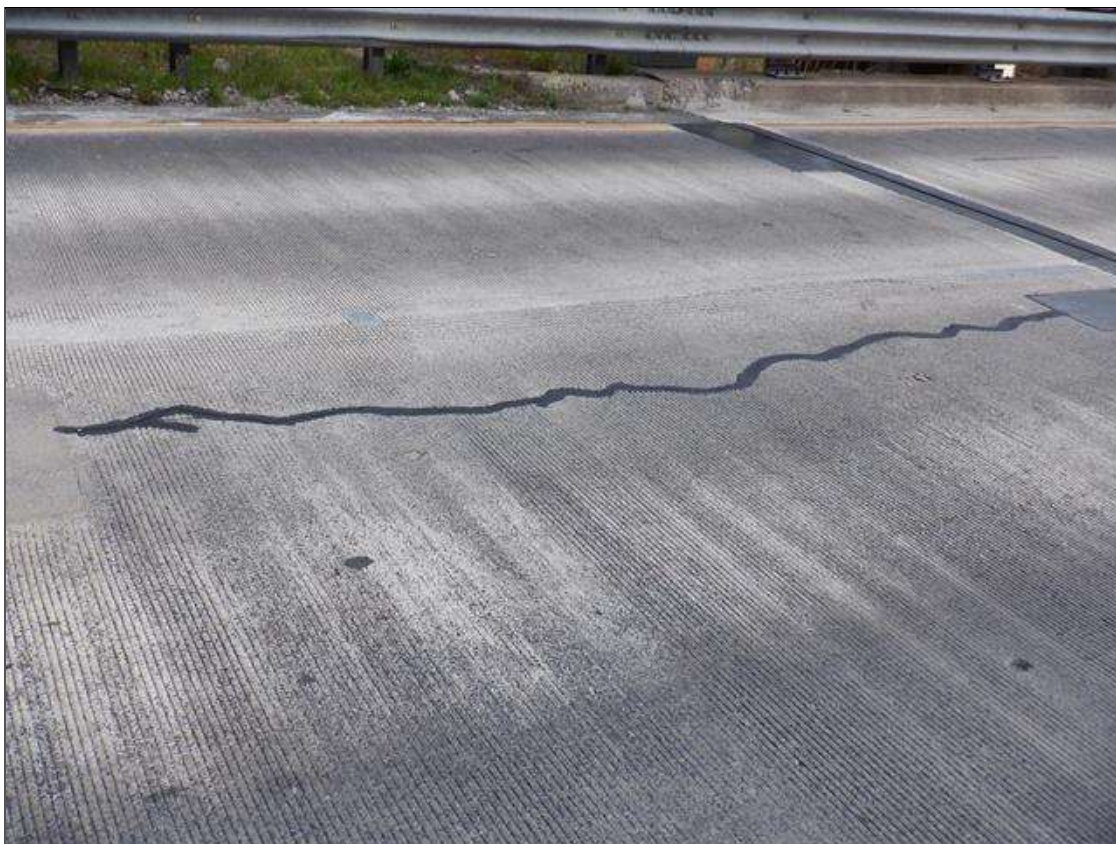
Approach 1 : 15 FEET SEALED LONGITUDINAL CRACK NEAR CENTERLINE

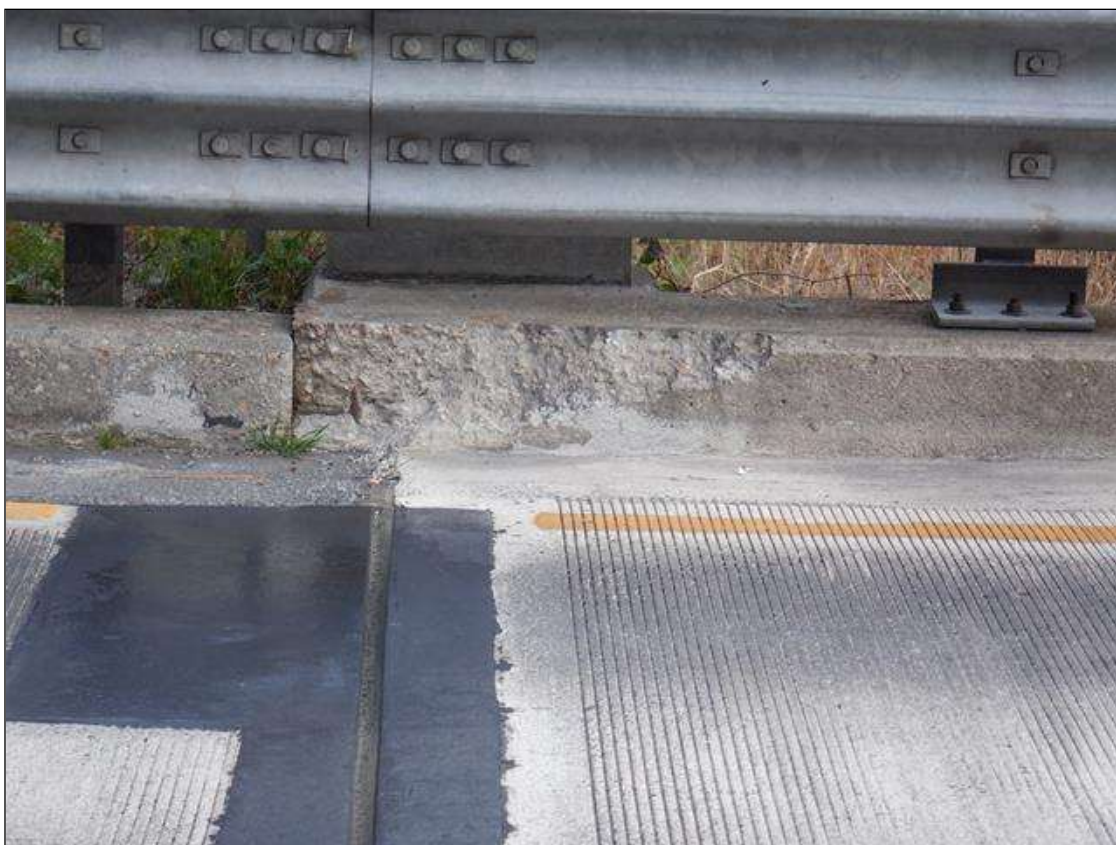
Span 1 Left Concrete Rail: 35 INCHES X UP TO 9 INCHES X 2 INCHES SPALL WITH EXPOSED REBAR IN CURB AT END BENT 1.

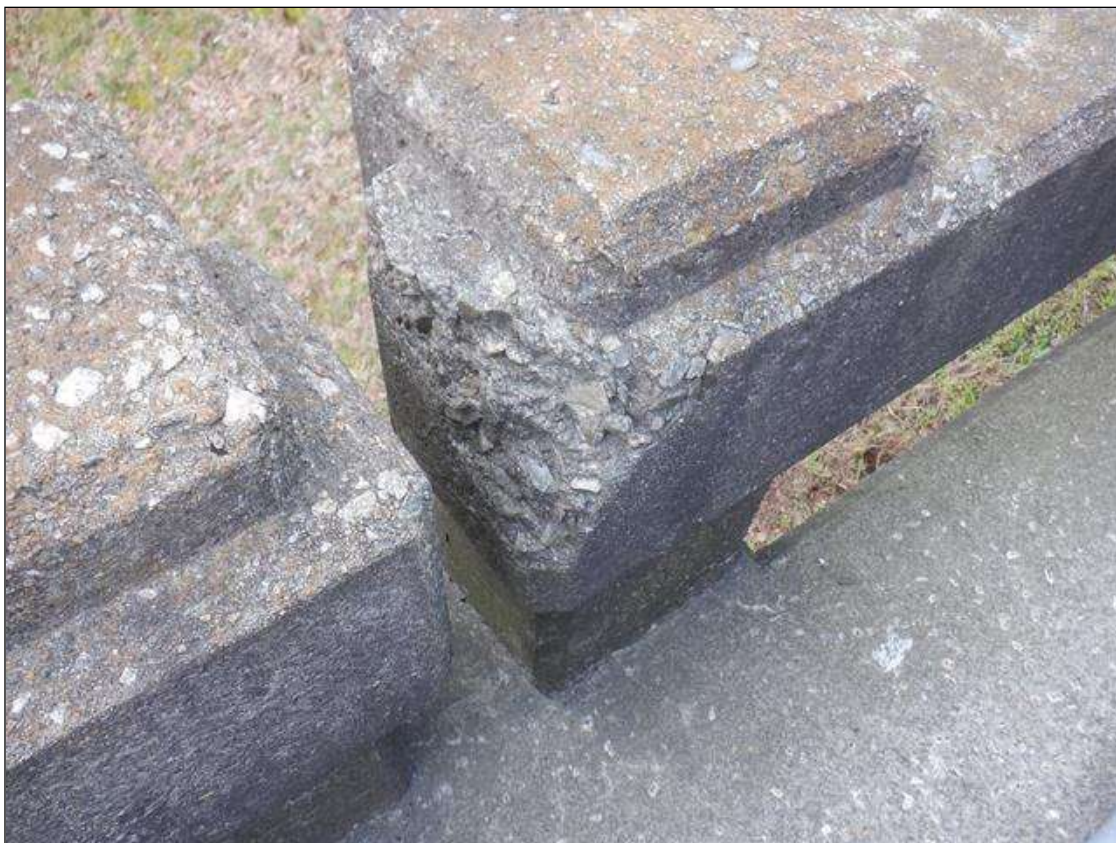
Span 1 Right Concrete Rail: 4 INCHES X 7 INCHES X UP TO 6 INCHES SPALL AT POST 2.

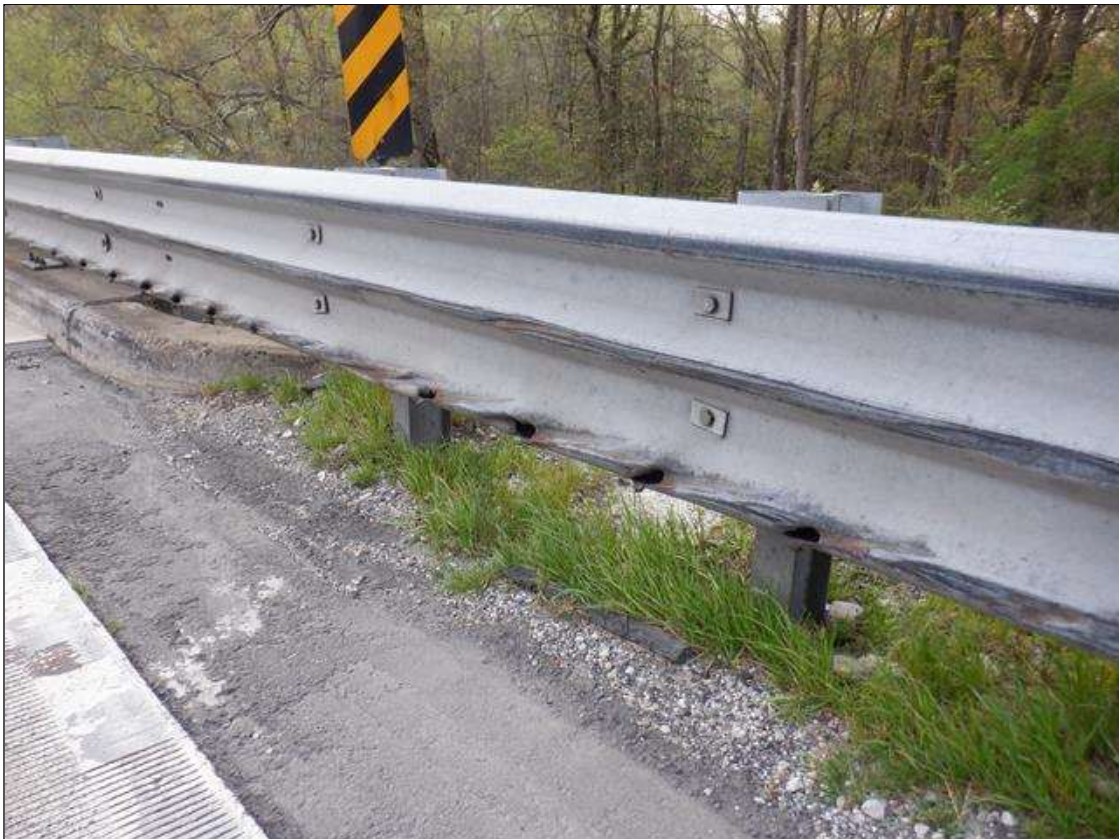
General Comments and Misc. Items: (PAR) 15 FEET OF IMPACT DAMAGE WITH 11- UP TO 4 INCHES X 2 INCHES GOUGES IN SOUTHEAST GUARDRAIL AT END BENT 1.

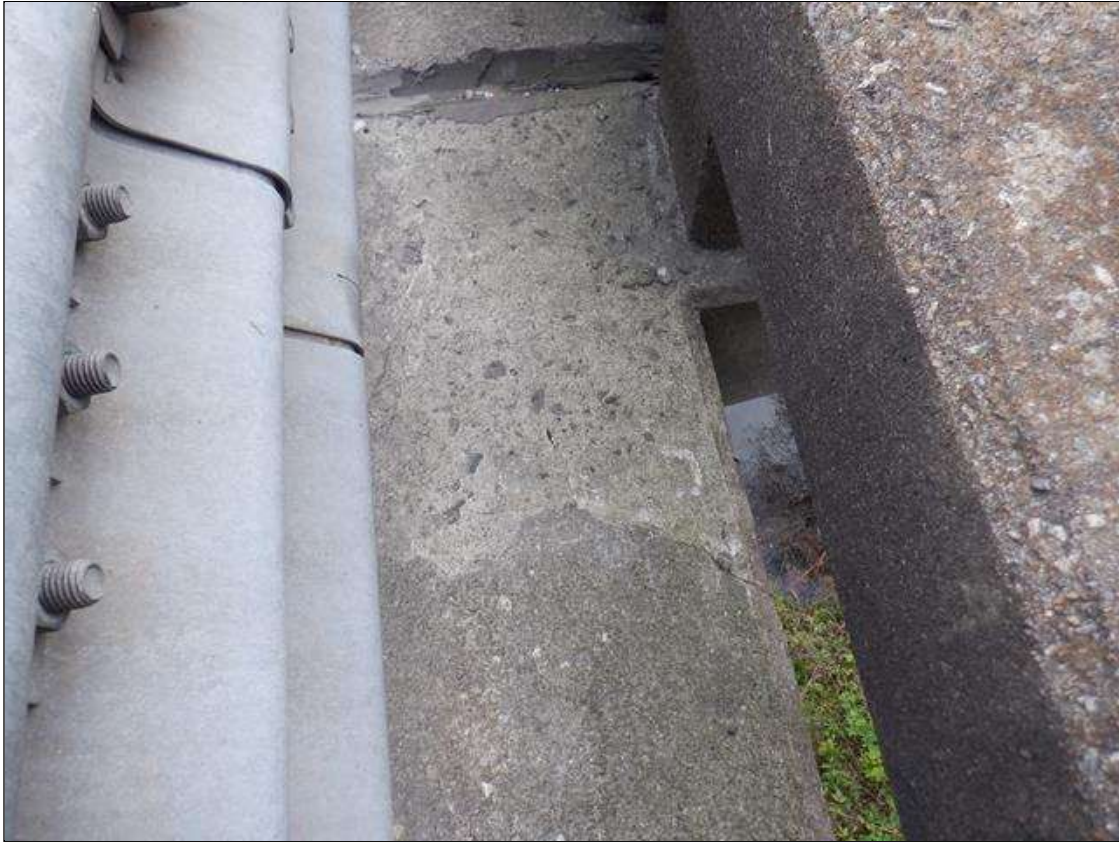
Span 1 Right Concrete Rail: 2 FEET X UP TO 2 FEET CRACKED PATCHED AREA WITH UP TO 1/32 INCHES CRACKING IN CURB AT BENT 1.

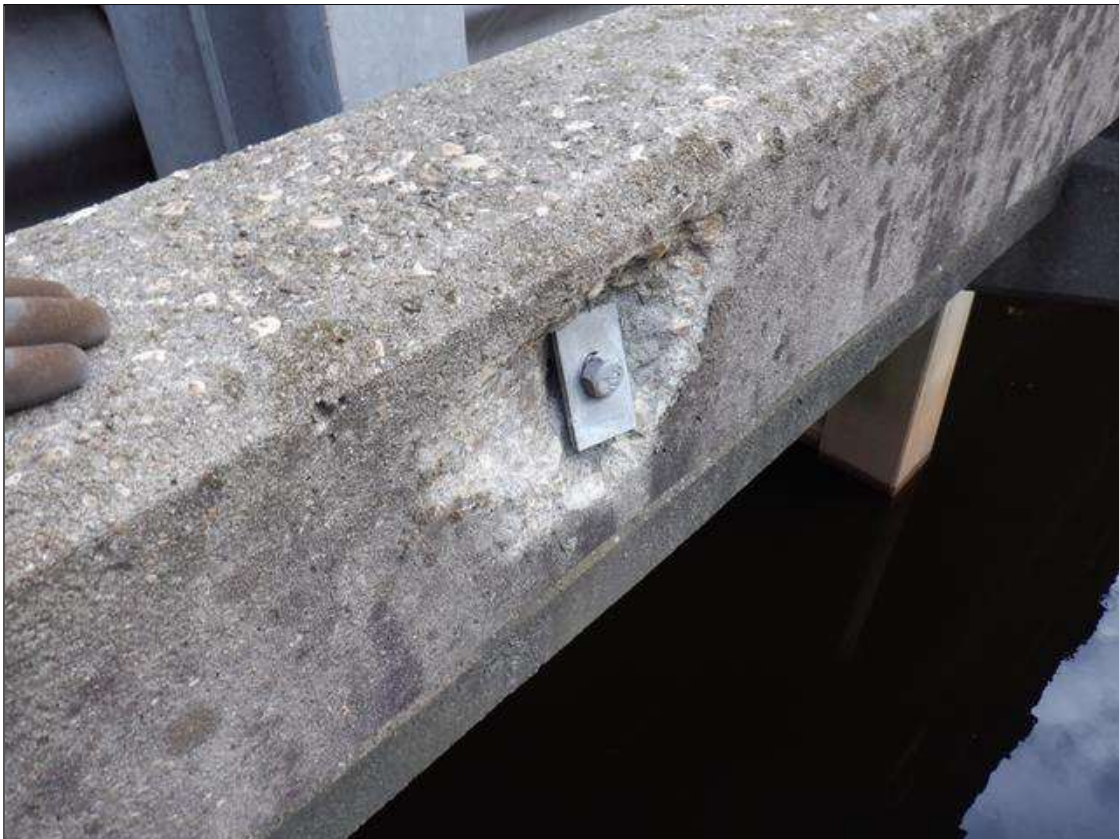
Span 2 Right Concrete Rail: 9 INCHES X UP TO 9 INCHES X 1 INCHES SPALL IN OUTSIDE FACE AT MIDSPAN.

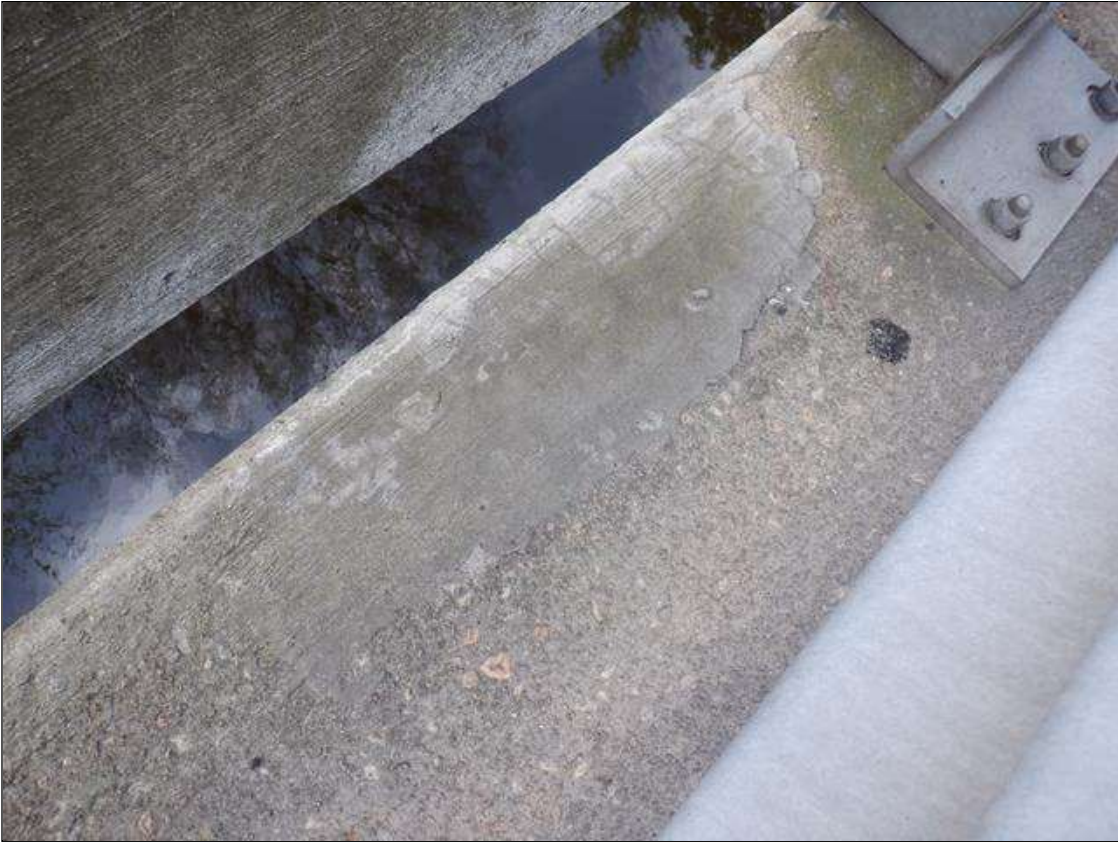
Span 2 Right Concrete Rail: 36 INCHES X UP TO 9 INCHES CRACKED PATCHED AREA WITH UP TO 1/64 INCHES CRACKING IN CURB NEAR BENT 2.

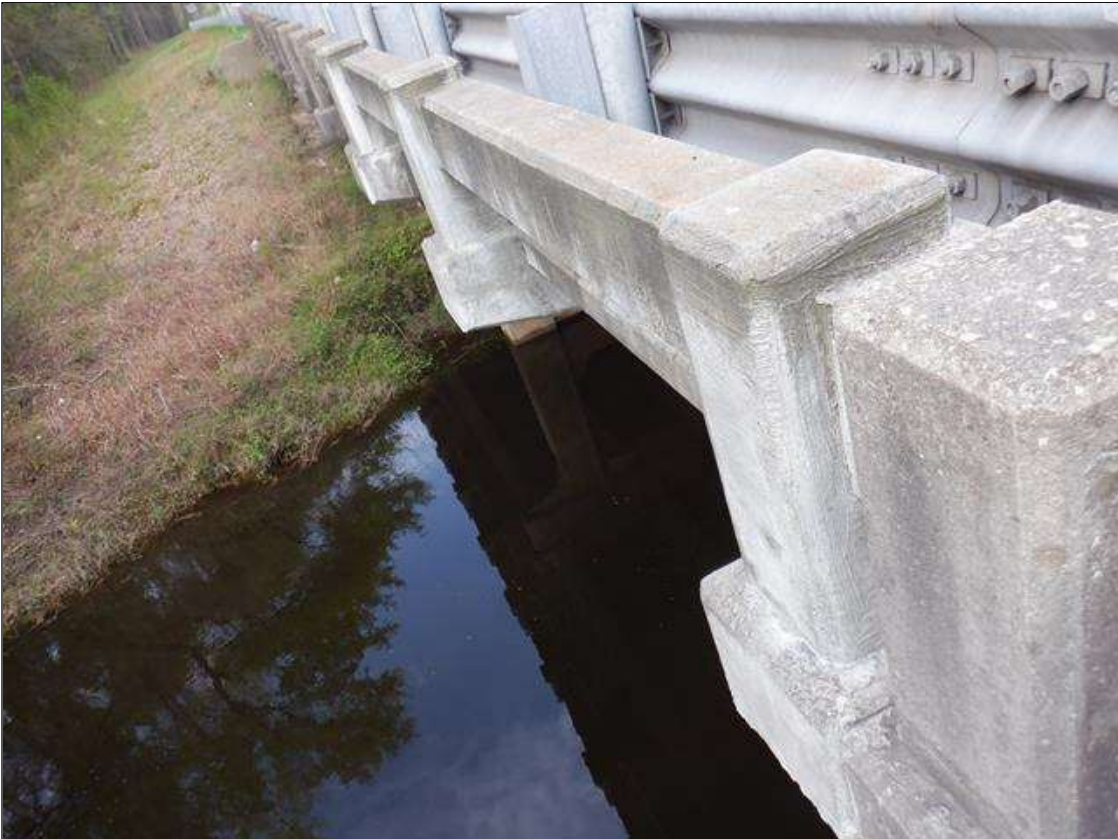
Span 2 Right Concrete Rail: 16 FEET OF REPAIRED SECTION OF CONCRETE RAIL AT BENT 2.

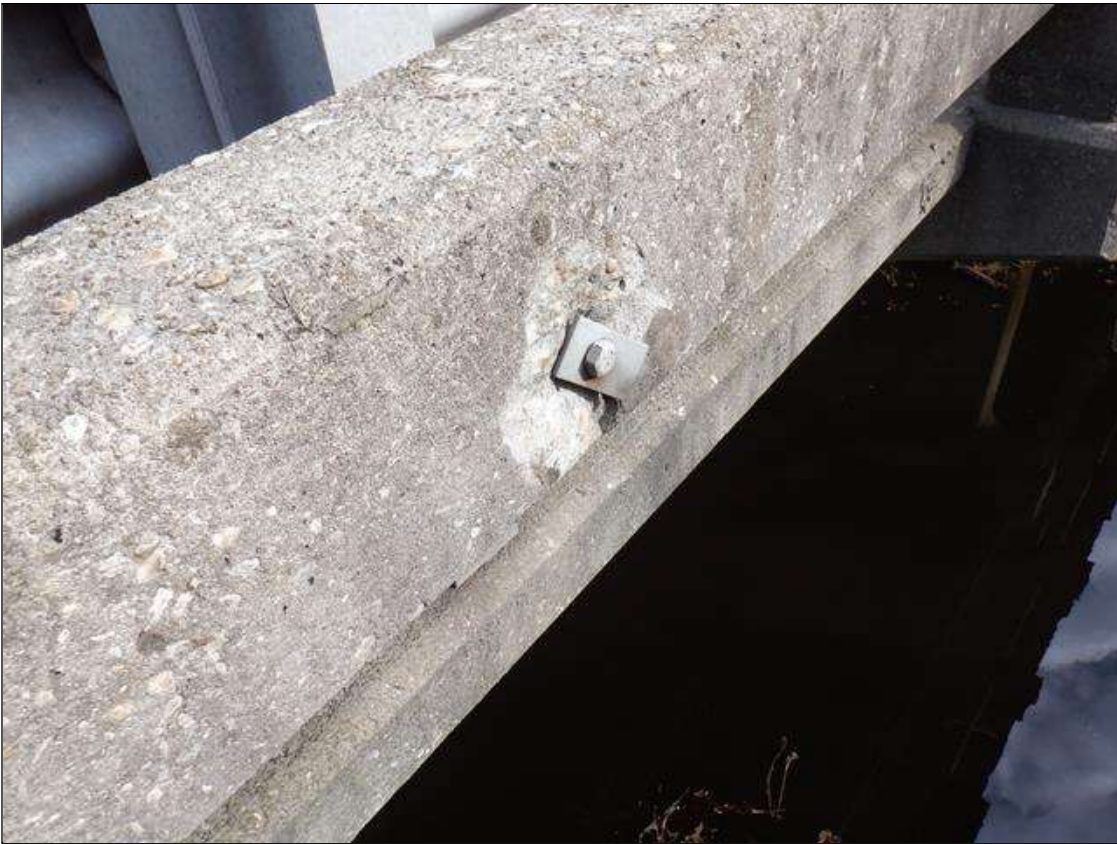
Span 3 Right Concrete Rail: (3) UP TO 9 INCHES X 9 INCHES X 1 INCHES SPALLS IN OUTSIDE FACE. (PHOTO TAKEN NEAR BENT 2)

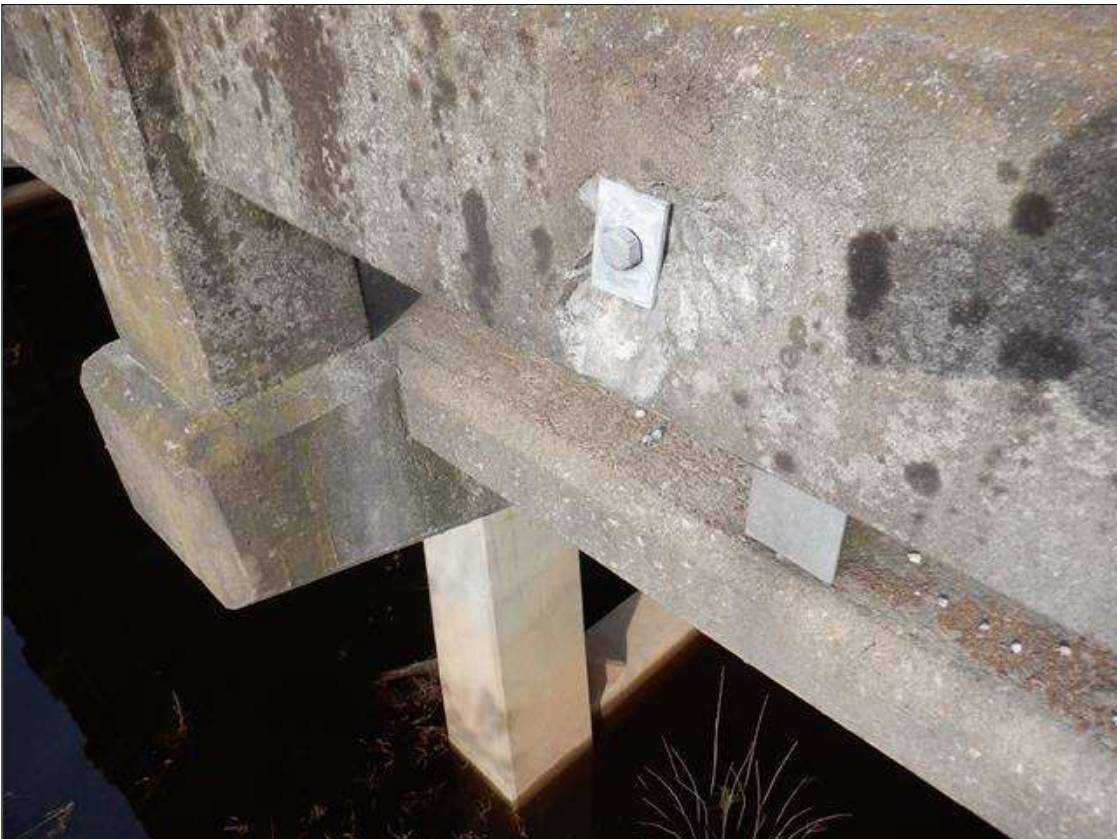
Span 4 Right Concrete Rail: 5- UP TO 7 INCHES X 6 INCHES X 1 INCHES SPALLS IN OUTSIDE FACE OF RAIL. (PHOTO TAKEN NEAR MIDSPAN)

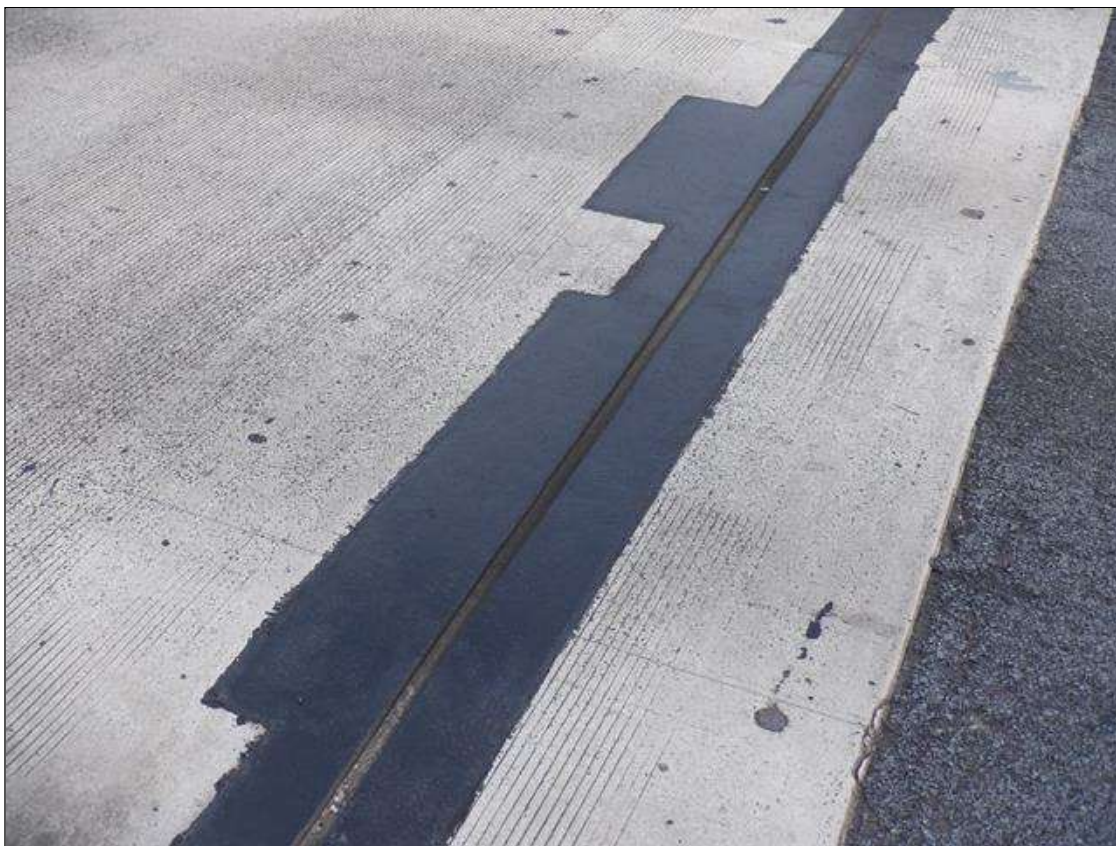
Span 4 Expansion Joint at End Bent 2: 2- UP TO 7 FEET X 18 INCHES PATCHED AREAS ALONG SOUTH EDGE IN EAST LANE.

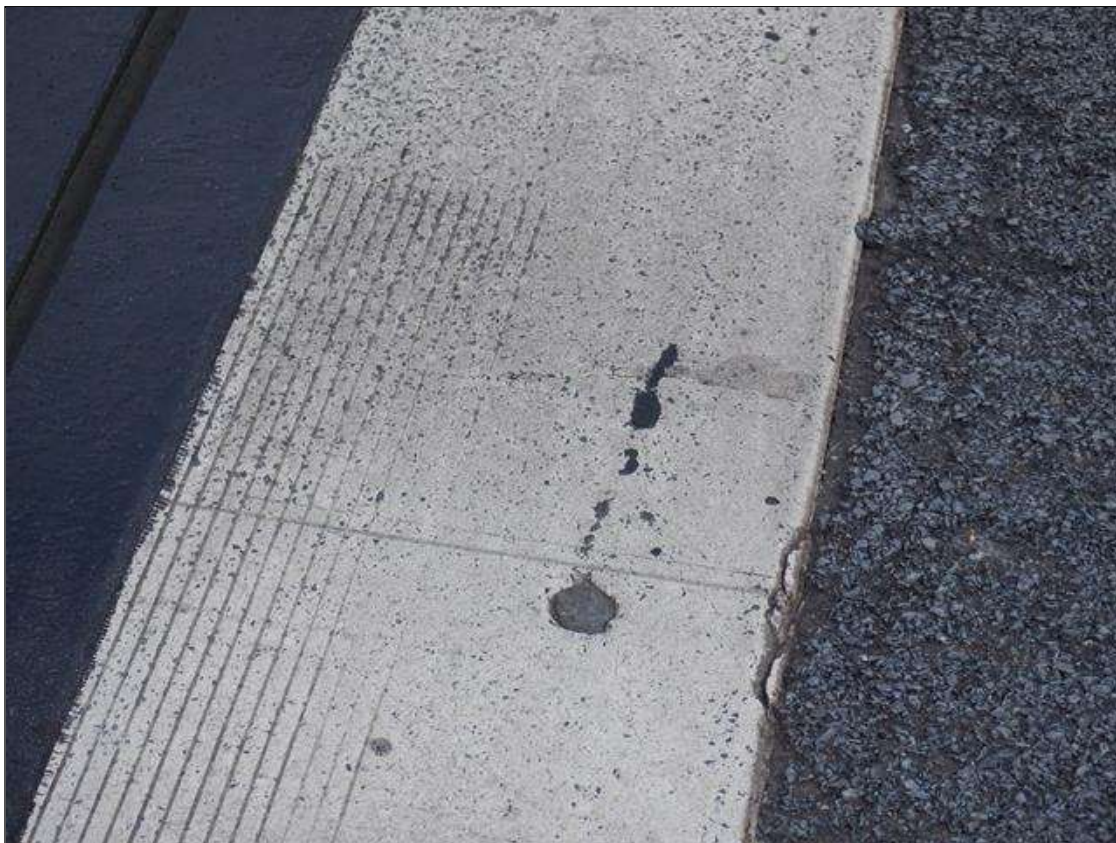
Approach 2 : 18 INCHES X UP TO 1/64 INCHES LONGITUDINAL CRACK IN EAST LANE

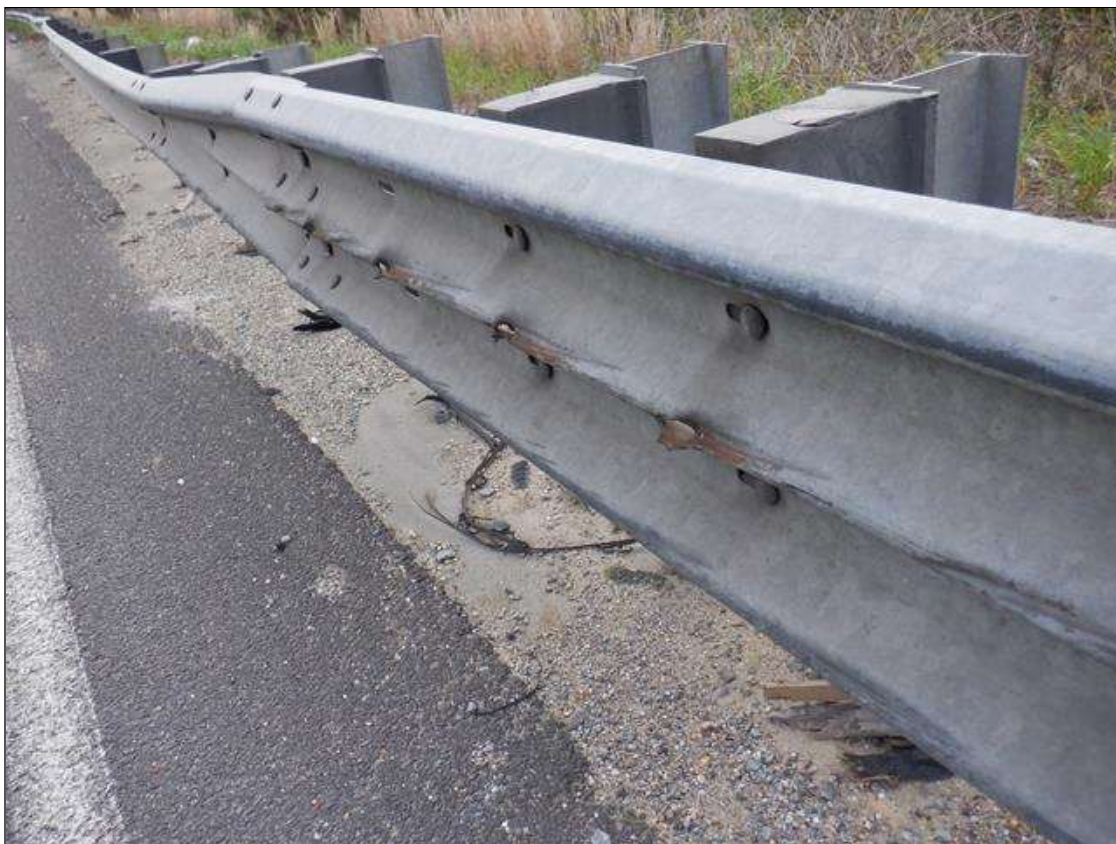
General Comments and Misc. Items: (PAR) 15 FEET OF IMPACT DAMAGE WITH 4- UP TO 3 INCHES X 1 INCHES GOUGES IN NORTHEAST GUARDRAIL, 50 FEET FROM END BENT 2.

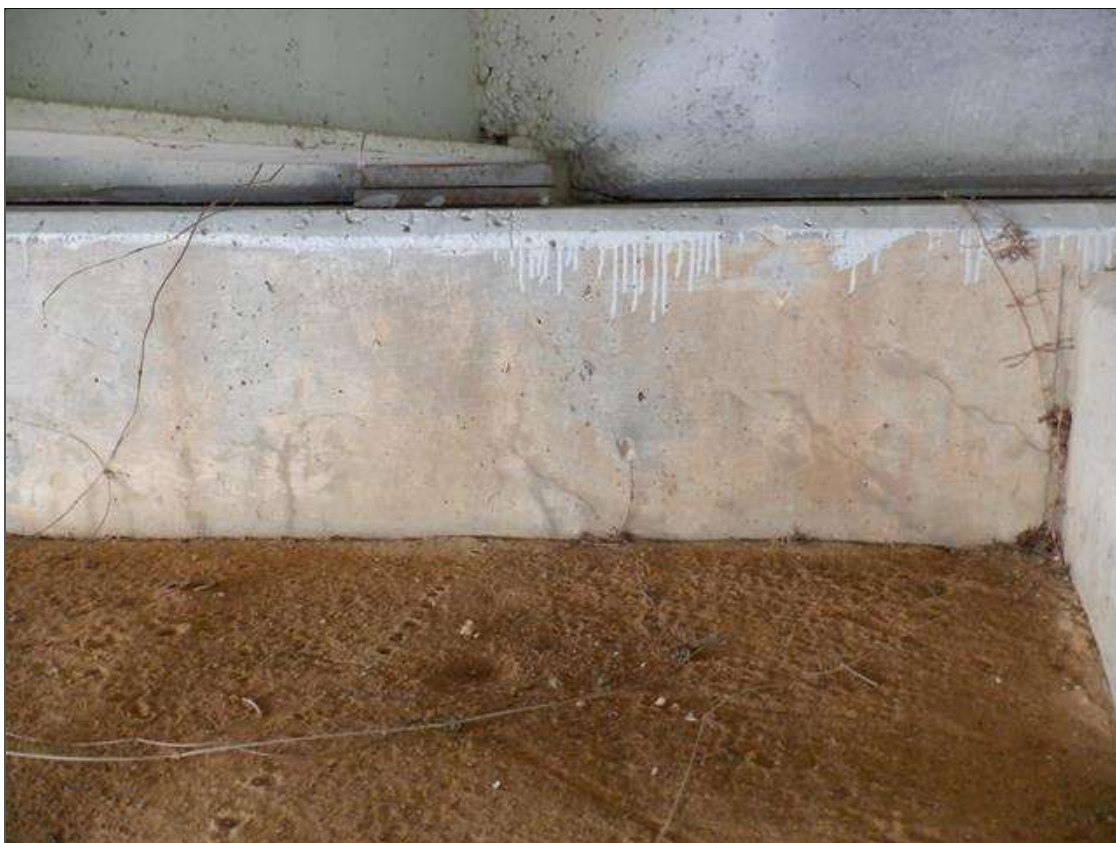
End Bent 2 Cap 1: 12 FEET X UP TO 2 FEET AREA OF UP TO 1/32 INCHES MAP CRACKING, BEGINNING AT WEST END.

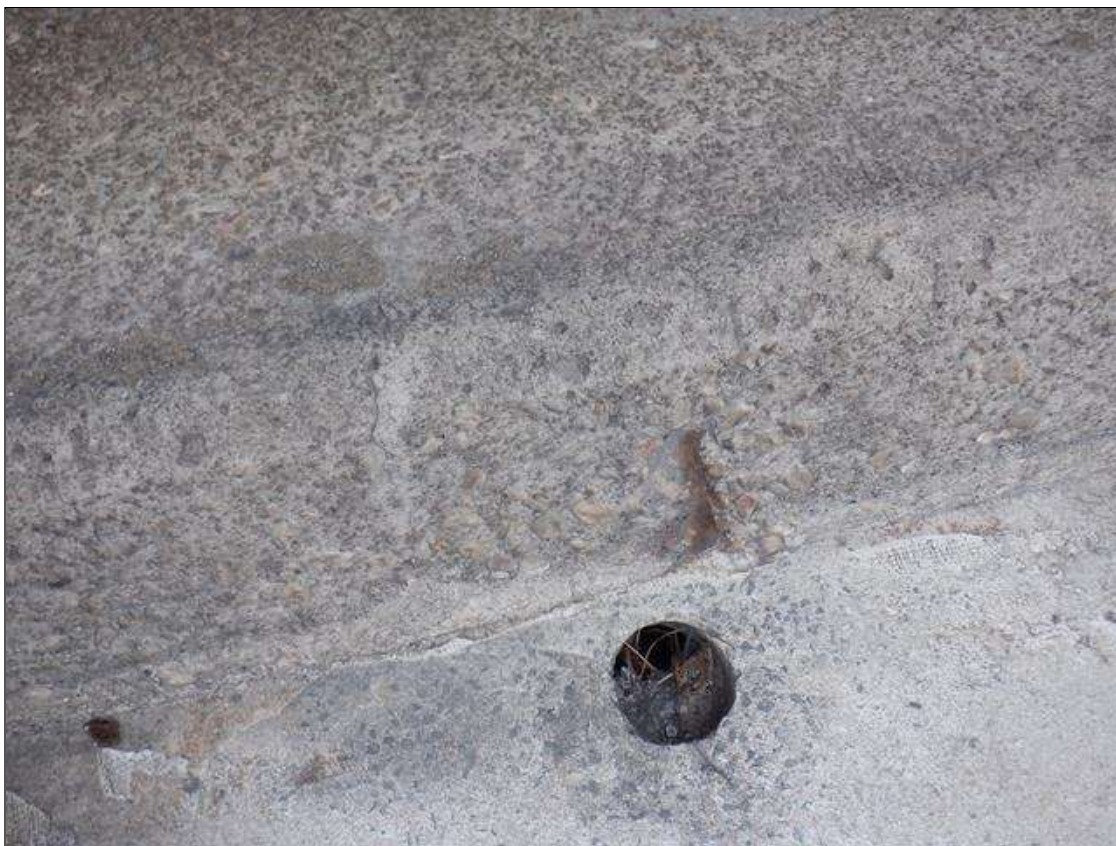
Span 4 Left Concrete Rail: 2 INCHES X 6 INCHES X UP TO 1/2 INCHES SPALL WITH EXPOSED REINFORCING IN EAST FACE OF CURB, NEAR MIDSPAN.

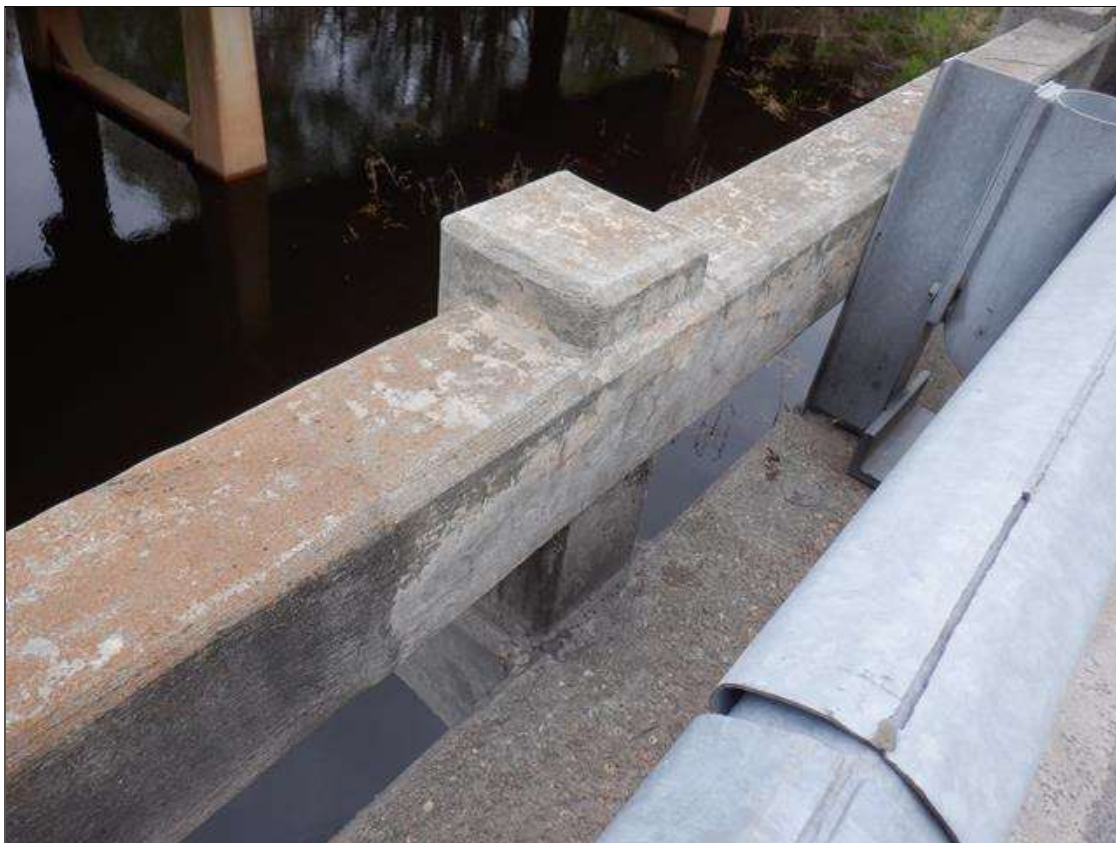
Span 2 Left Concrete Rail: 10 FEET X 1 FEET X 1 FEET CRACKED PATCHED AREA WITH UP TO 1/64 INCHES CRACKING AT MIDSPAN.

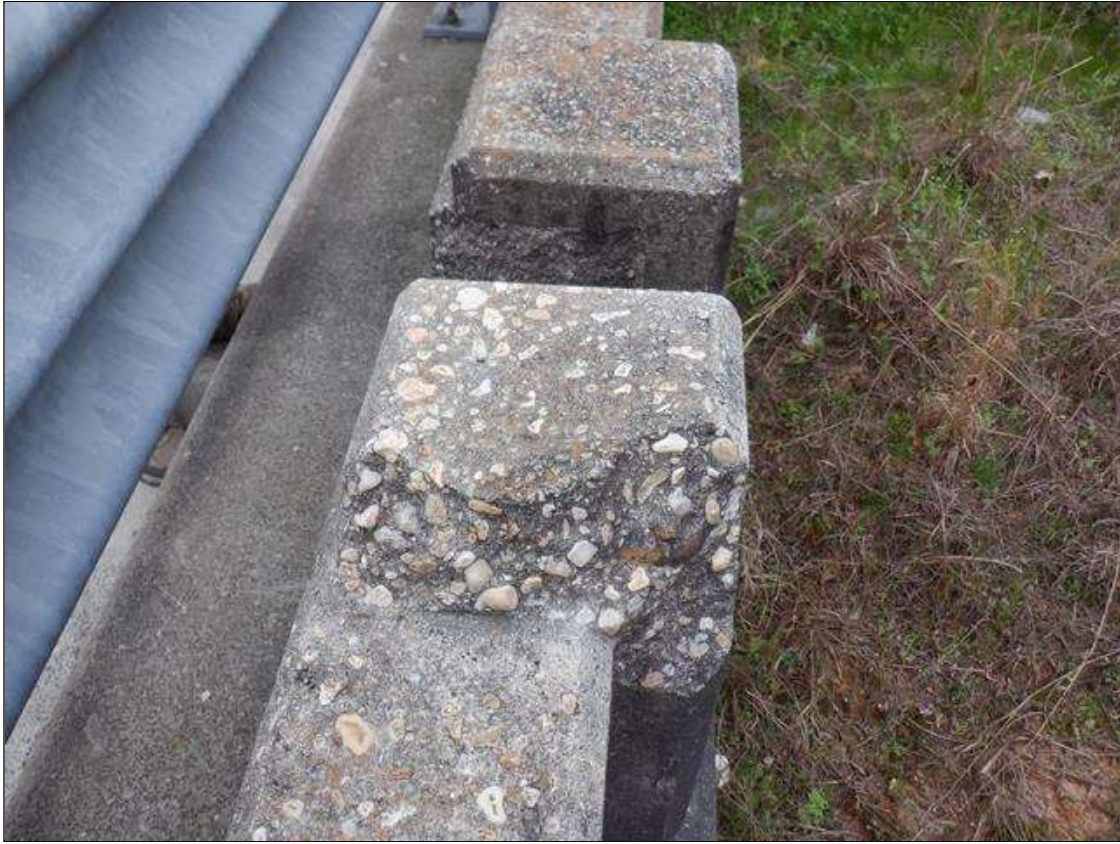
Span 1 Left Concrete Rail: 2- UP TO 4 INCHES X 10 INCHES X 7 INCHES SPALLS WITH EXPOSED REINFORCING IN TOP OF POSTS, 17 FEET FROM END BENT 1.

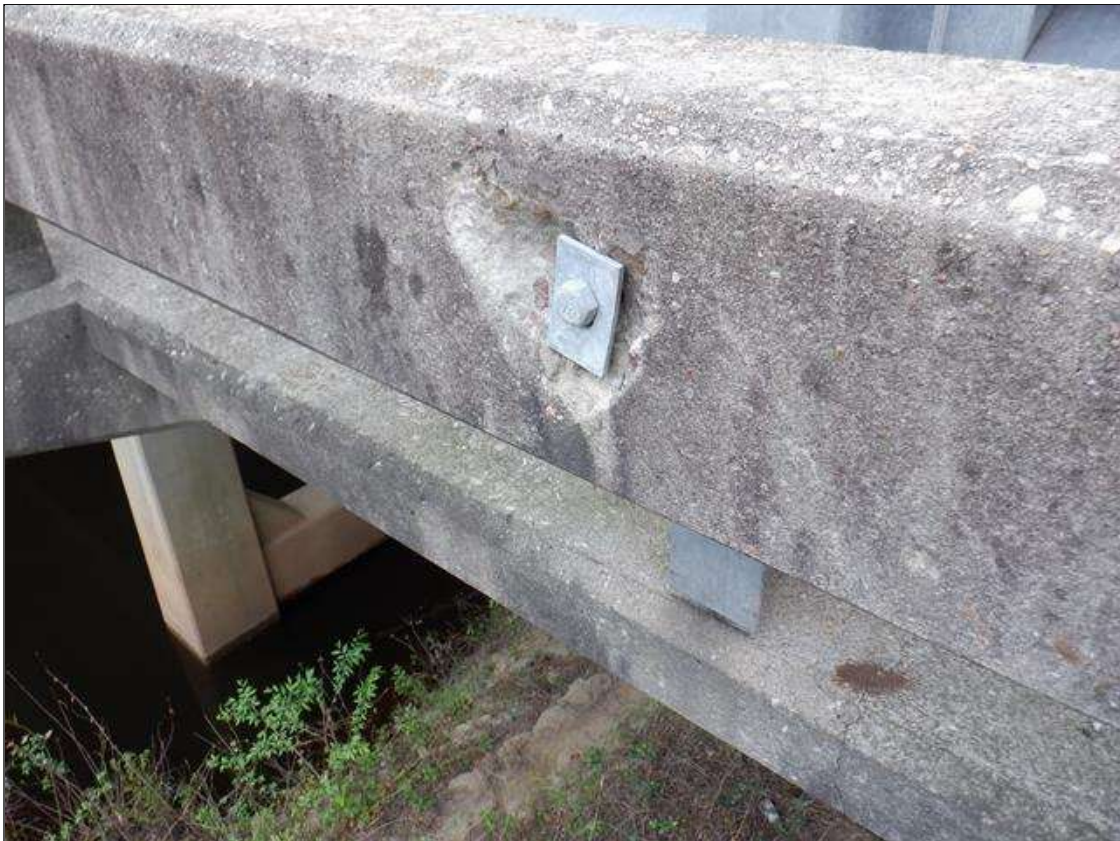
Span 1 Left Concrete Rail: (5) UP TO 7 INCHES X 9 INCHES X 1 INCHES SPALLS ON OUTSIDE FACE AT BOLT LOCATIONS.

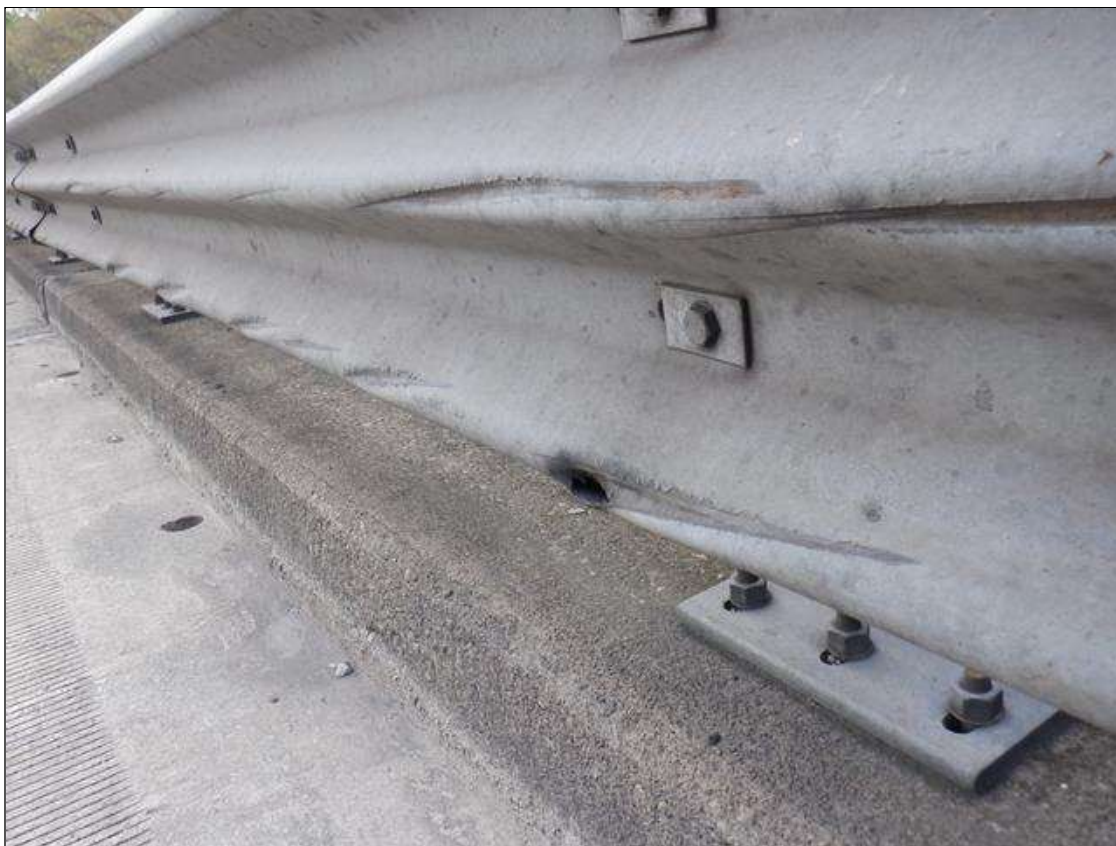
Span 1 Right Metal Rail: (PAR) 52 FEET OF IMPACT DAMAGE WITH SCRAPES AND 4- UP TO 3 INCHES X 1.5 INCHES GOUGES.

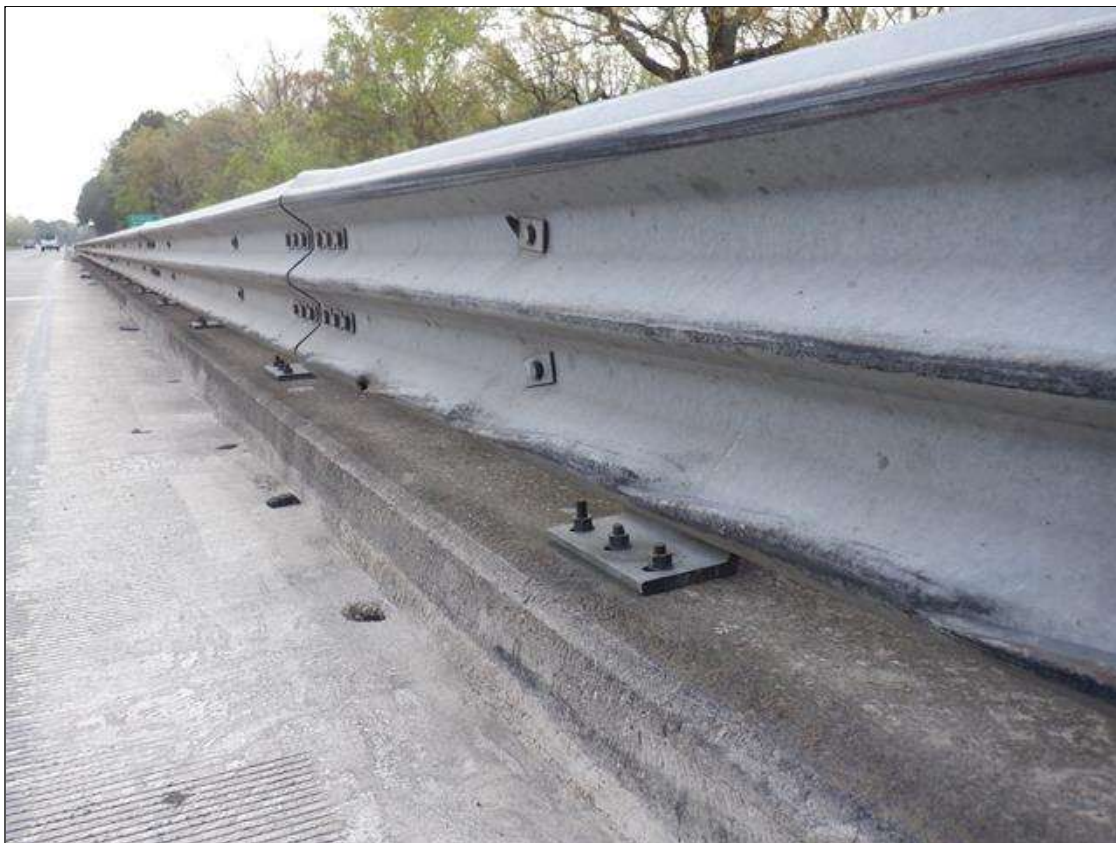
Span 1 Right Metal Rail: (PAR) 52 FEET OF IMPACT DAMAGE WITH SCRAPES AND 4- UP TO 3 INCHES X 1.5 INCHES GOUGES.
