NC DEPARTMENT OF TRANSPORTATION
 DIVISION OF HIGHWAYS
 STRUCTURE MANAGEMENT UNIT

ATTENTION: **PAR'S SUBMITTED**

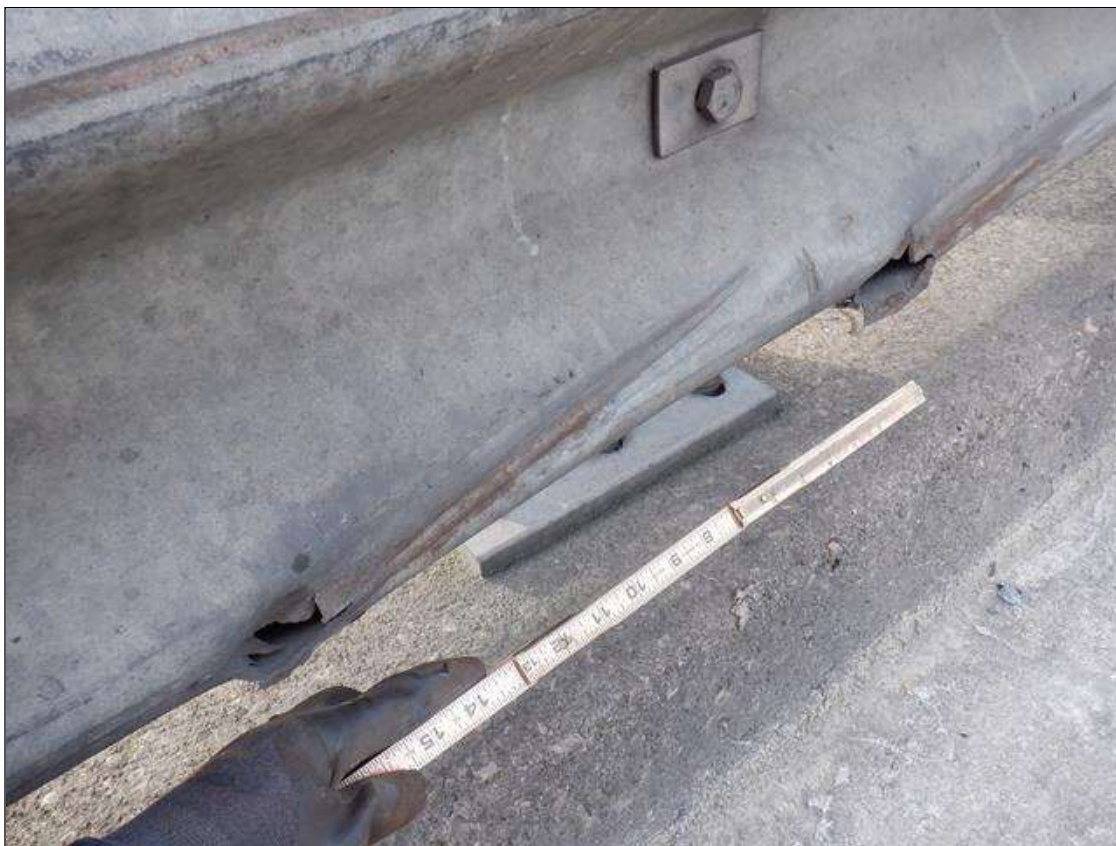
Span 3 Right Metal Rail: (PAR) 50 FEET OF IMPACT DAMAGE WITH 8- UP TO 4 INCHES X 1.5 INCHES GOUGES.

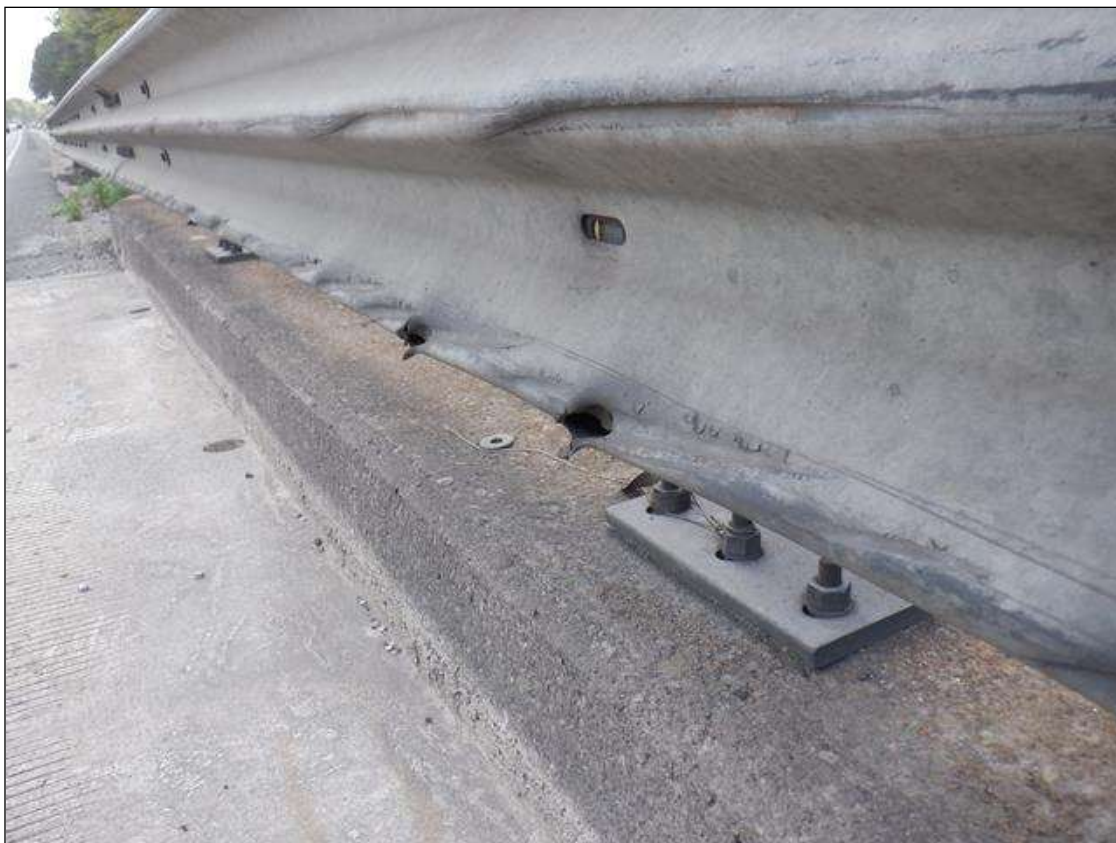
Span 4 Right Metal Rail: (PAR) 51 FEET OF IMPACT DAMAGE WITH 5- UP TO 3 INCHES X 1 INCHES GOUGES.

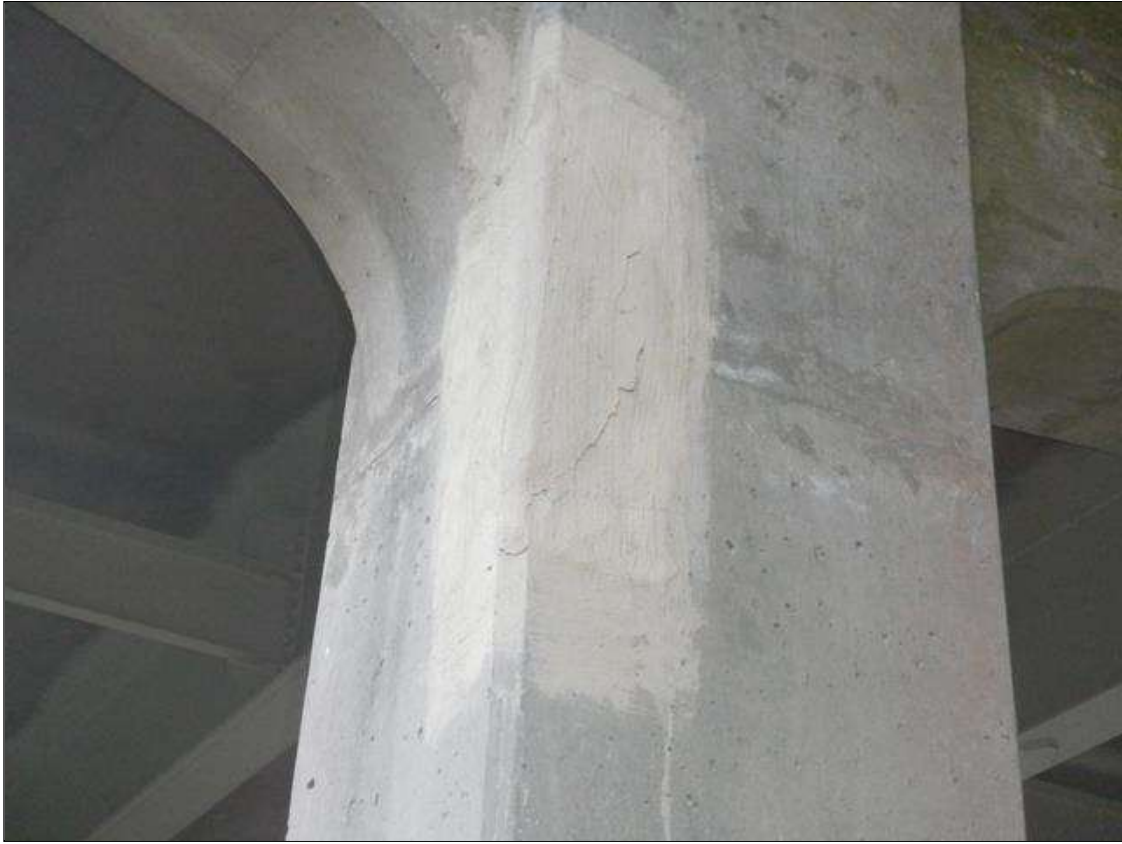
Bent 3 Pile 1: 24 INCHES X UP TO 7 INCHES X 4 INCHES CRACKED AND DELAMINATED PATCHED AREA WITH UP TO 1/16 INCHES CRACKING IN SOUTH FACE, 2 FEET FROM BOTTOM OF CAP.

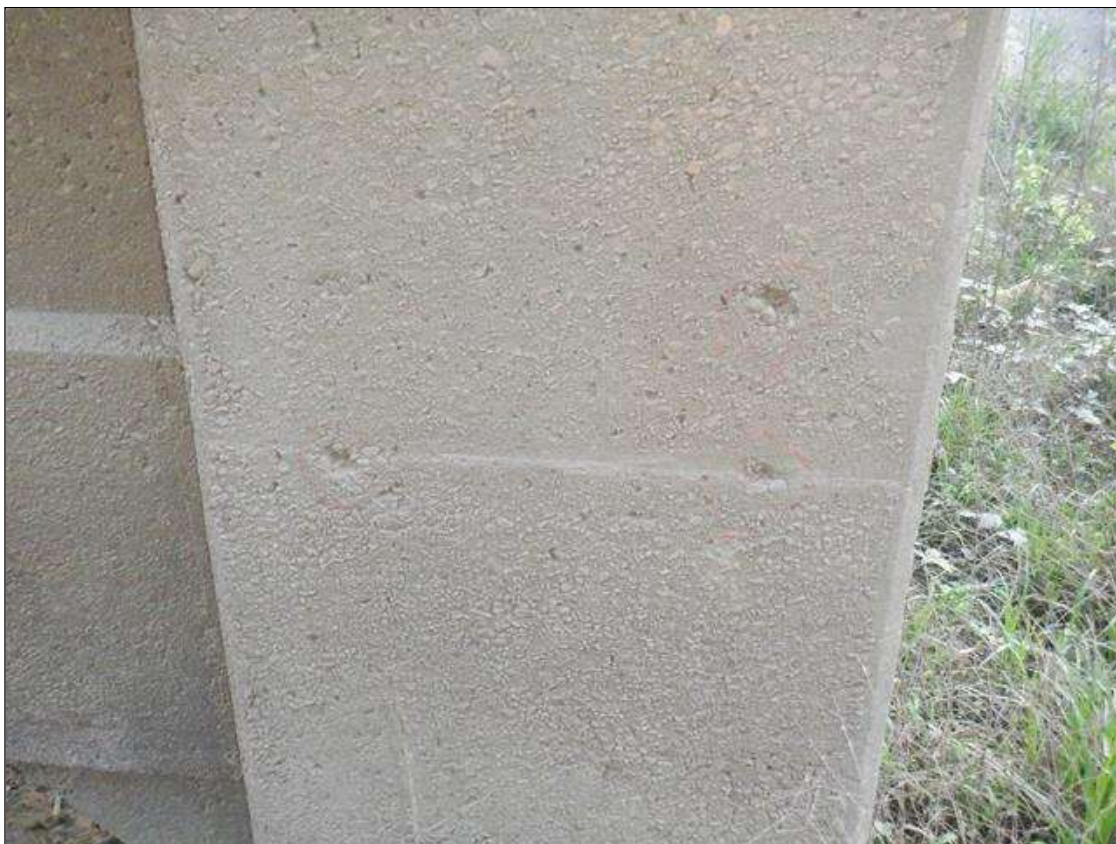
Bent 3 Pile 2: (3) UP TO 2 INCHES X 2 INCHES X 1/2 INCHES SPALLS IN SOUTH FACE, 11 FEET FROM BOTTOM OF CAP.

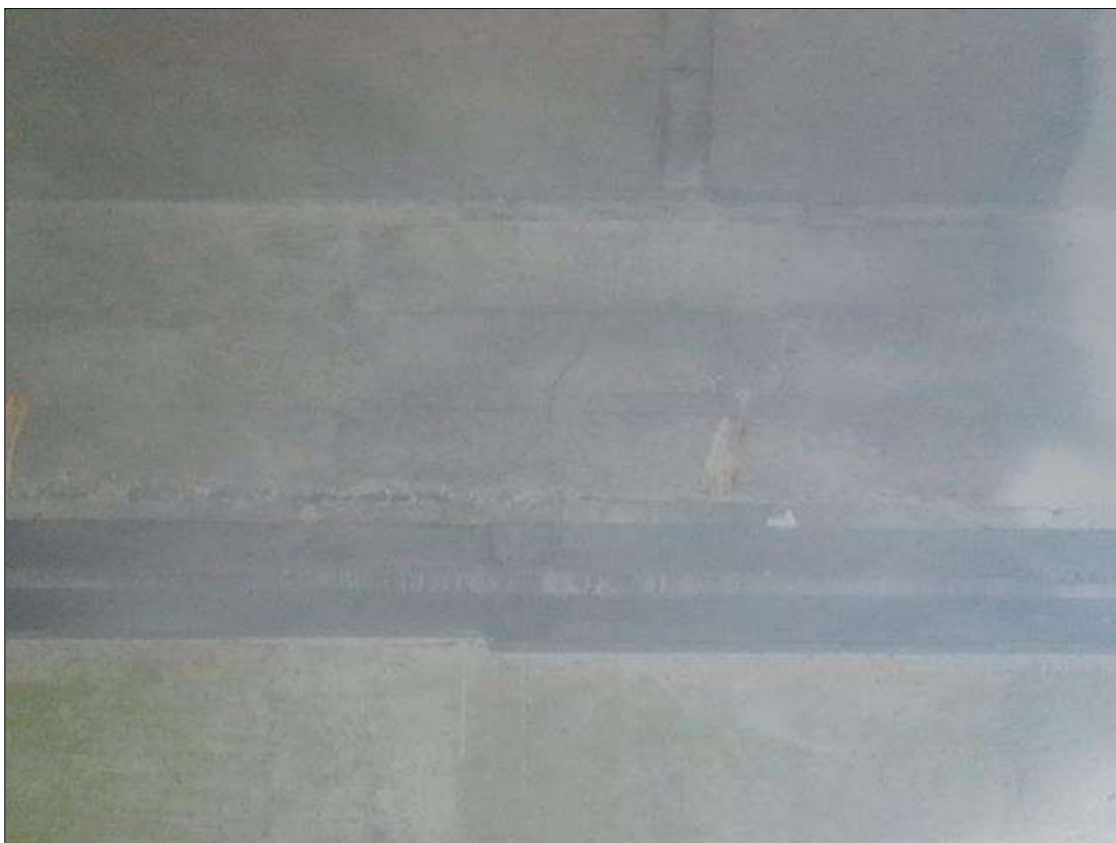
Span 4 Deck: 5- FULL HEIGHT X UP TO 1/32 INCHES VERTICAL CRACKS IN BENT 3 BAY 1 DIAPHRAGM. (BAYS 2 AND 3 SIMILAR)

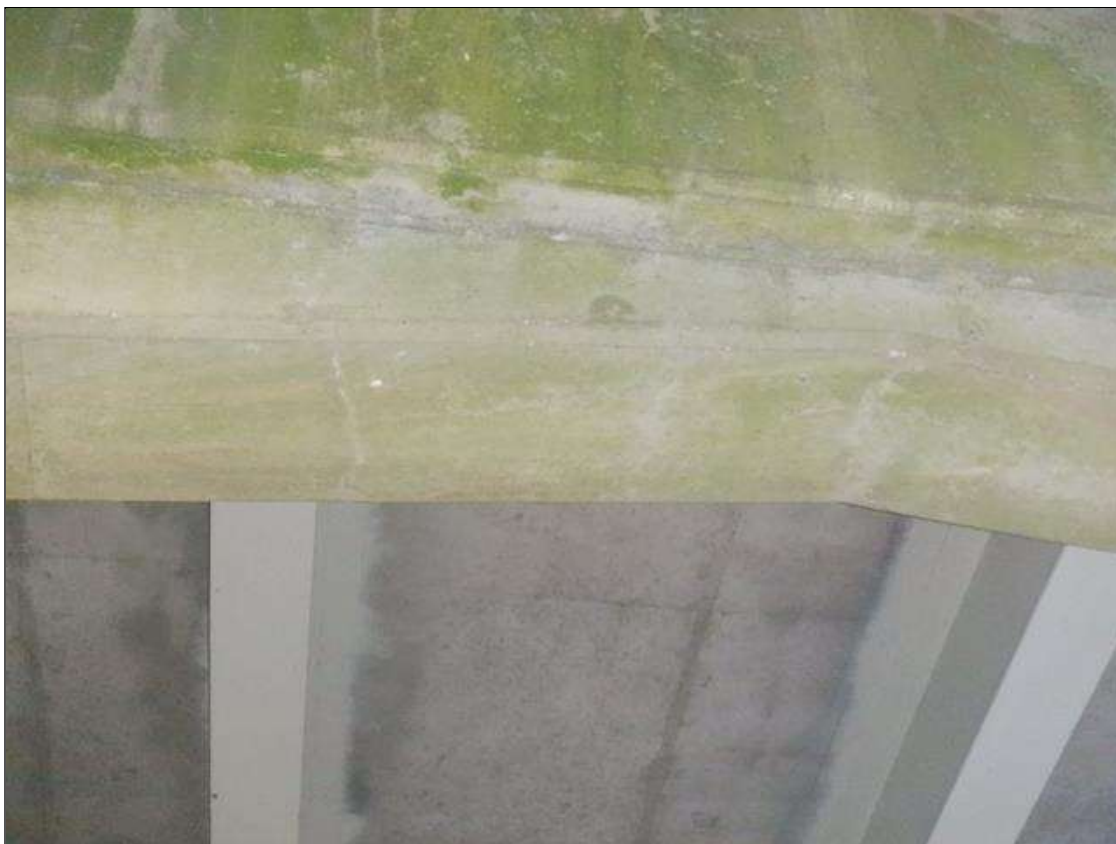
Bent 2 Cap 1: (3) UP TO 20 INCHES X 1/64 INCHES TRANSVERSE CRACKS, SOME WITH EFFLORESCENCE, ON BOTTOM OF CORBEL BETWEEN COLUMNS 1 AND 2.

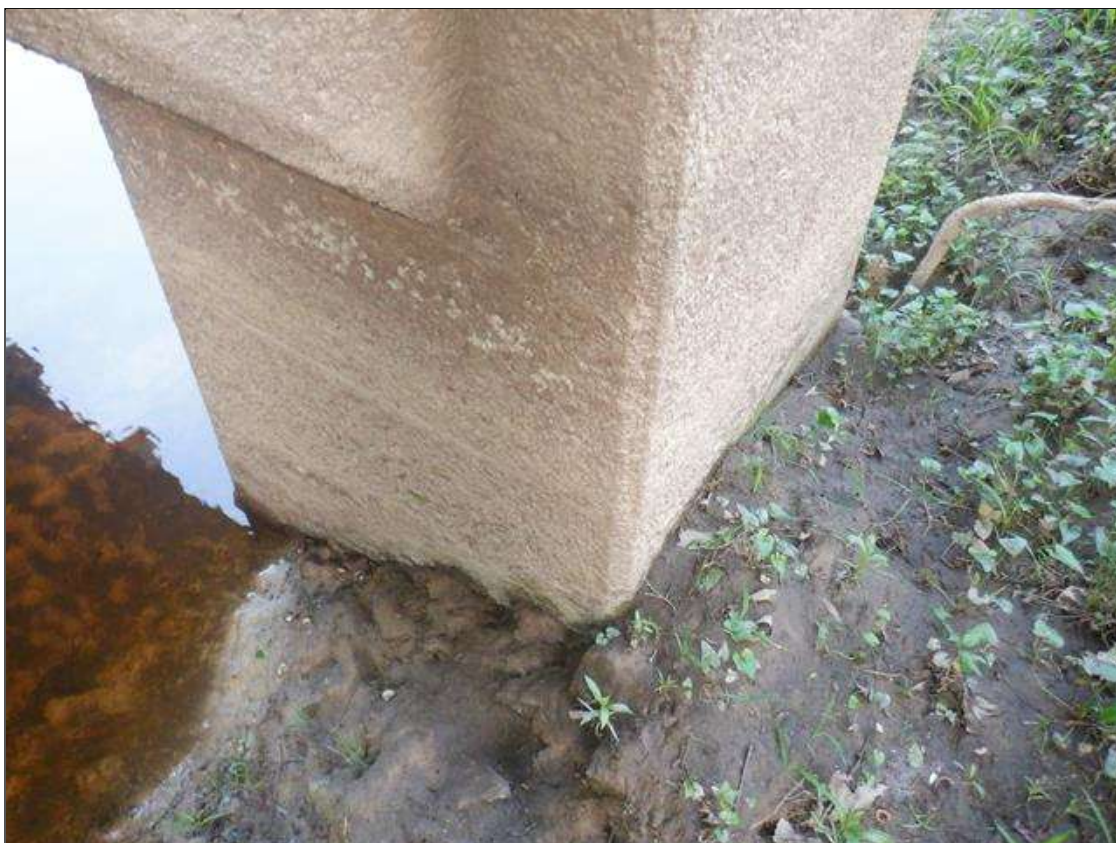
Bent 2 Pile 1: 4 FEET ABRASION/WEAR WITH EXPOSED COARSE AGGREGATE, 12 FEET FROM BOTTOM OF CAP.

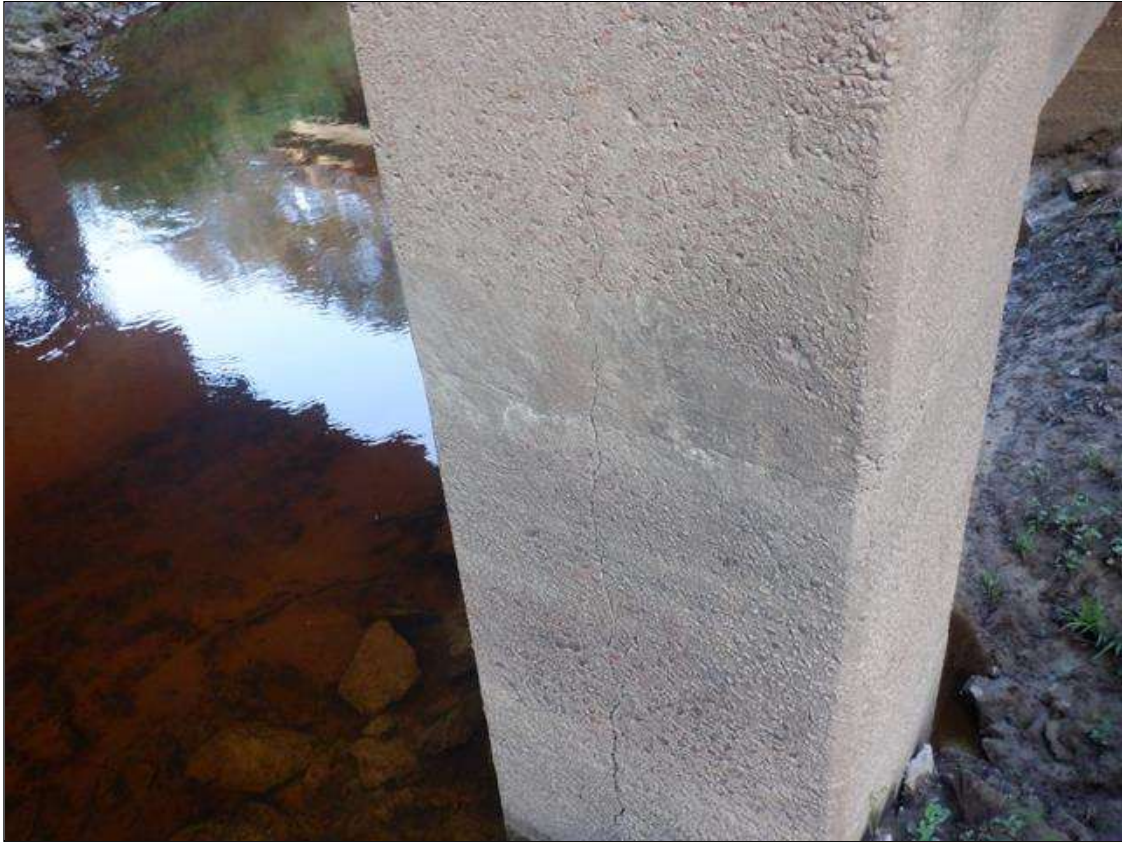
Bent 2 Pile 2: 2- UP TO 6 FEET X 1/8 INCHES VERTICAL CRACKS ON NORTH AND EAST FACE, 13 FEET FROM BOTTOM OF CAP.

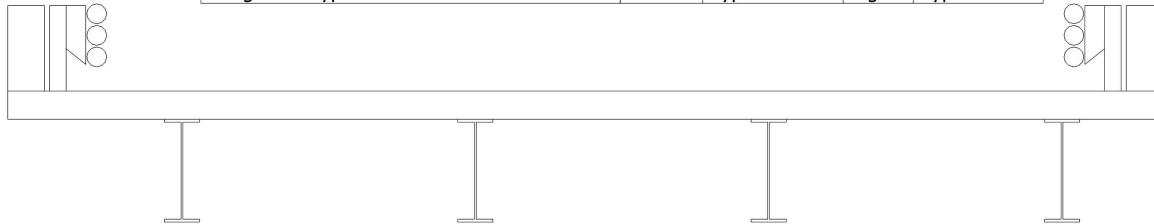
Measurements for Span #	1	Spans 2-4 Similar	
Deck Thickness	8.75in	Left Overhang	4.75ft
Top of Rail to Bottom of Beam (Avg)	6.49ft	Right Overhang	4.75ft

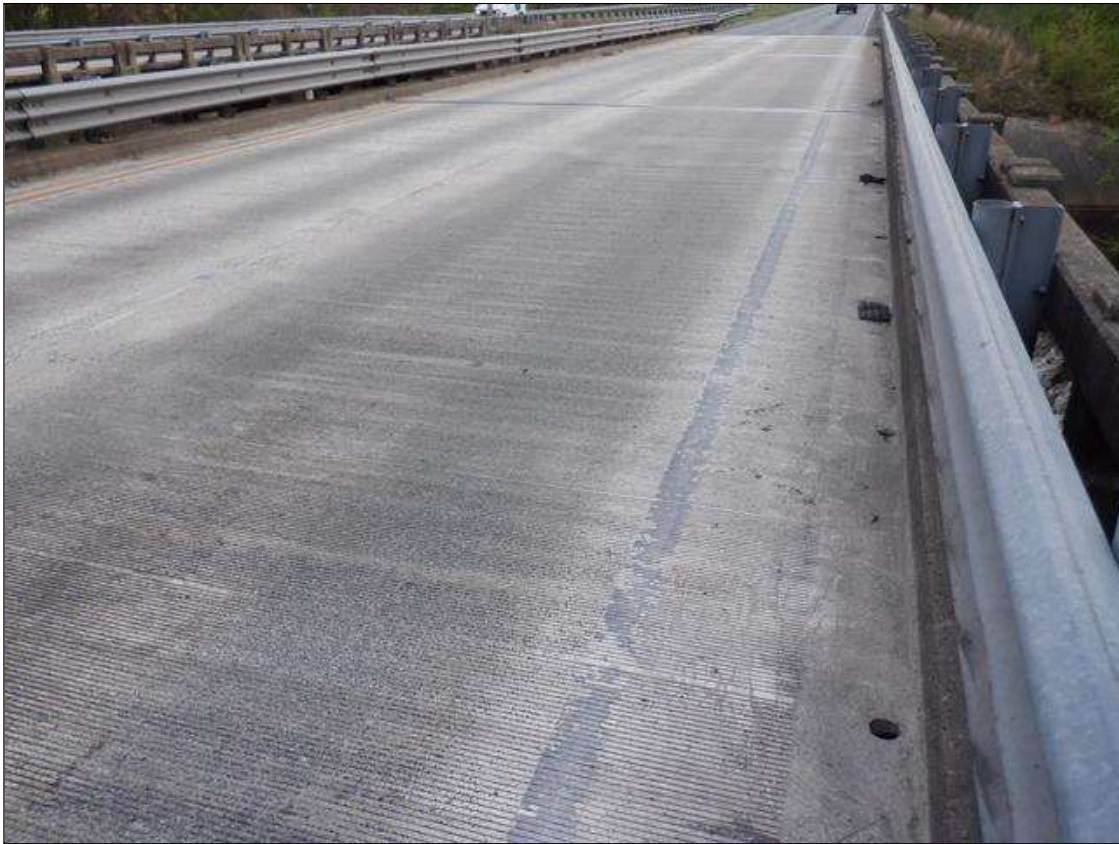
SPAN 2 CONCRETE WEARING SURFACE LOOKING NORTH

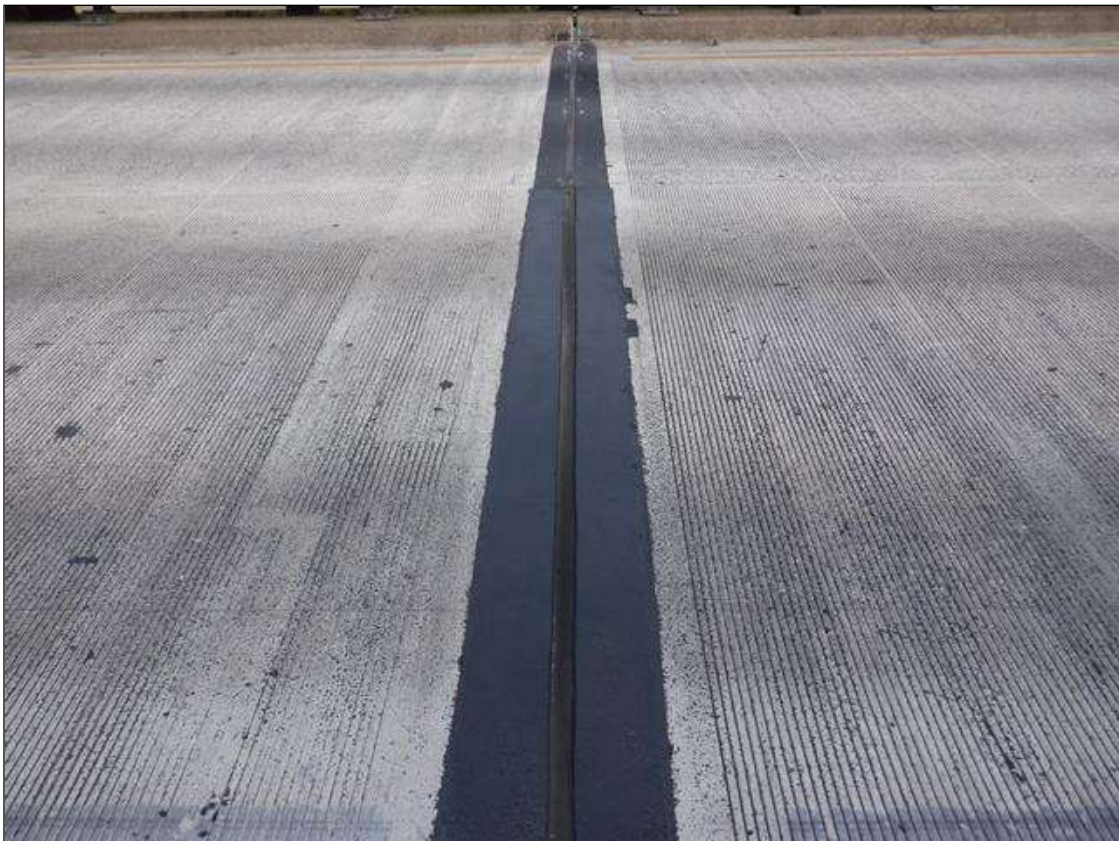
JOINT OVER BENT 2 LOOKING WEST
