NC DEPARTMENT OF TRANSPORTATION
 DIVISION OF HIGHWAYS
 STRUCTURE MANAGEMENT UNIT

ATTENTION: **PAR'S SUBMITTED(DAMAGED GUARDRAIL AND BRIDGE RAIL); CHANGE IN STRUCTURE DATA; STRUCTURE HAS BEEN RESURFACED AND BEAMS AND BEARINGS HAVE BEEN REPAINTED**

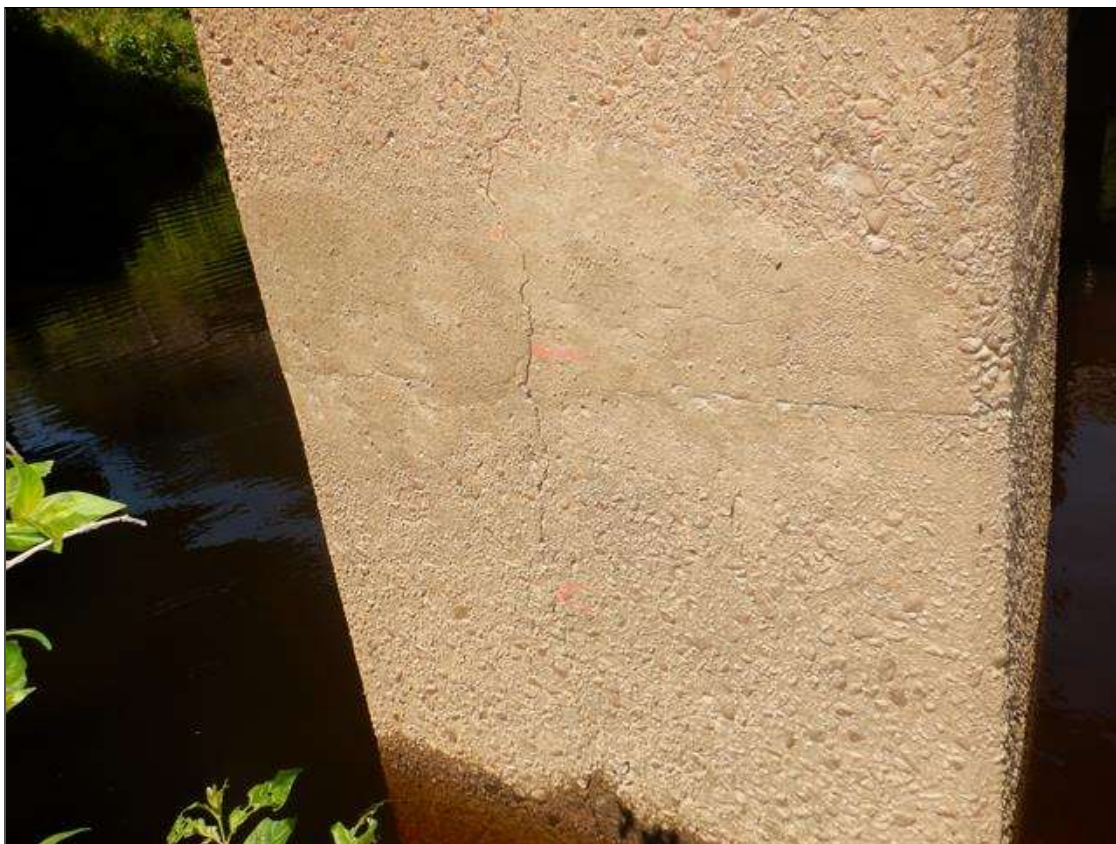
Bent 2 Pile 2: 46" x up to 1/16" vertical crack on East face, 13' from bottom of cap (Span 3 face similar)

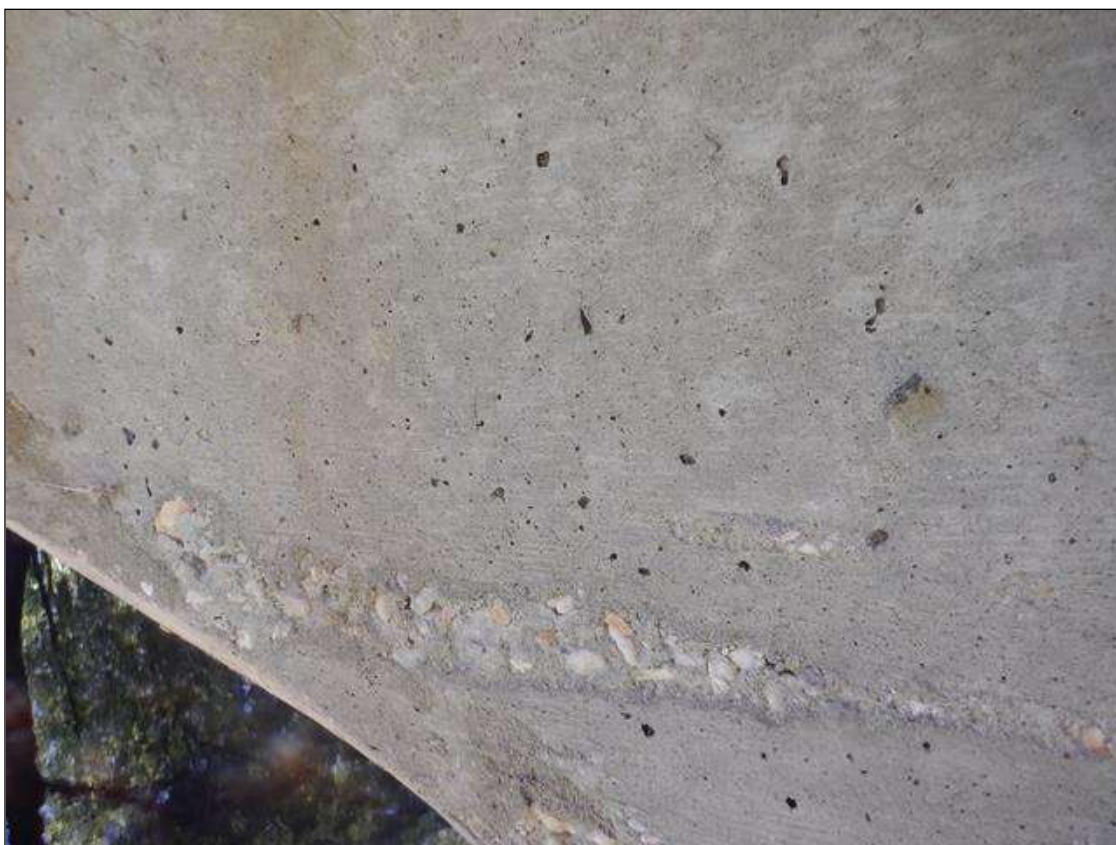
Bent 2 Pile 2: 2" x 10" area of honeycombing on East corbel on Span 3 face

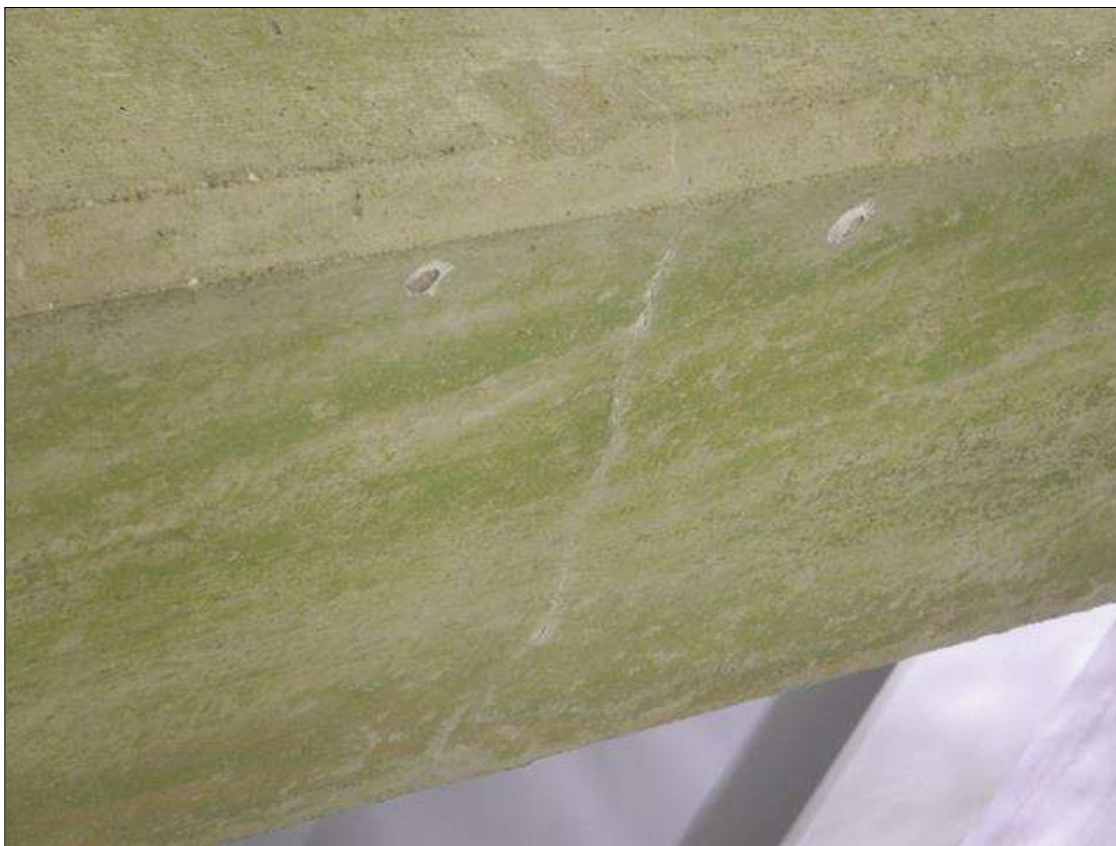
Bent 2 Cap 1: (3) up to 20" x 1/64" transverse cracks, some with efflorescence, on bottom of corbel between Columns 1 and 2

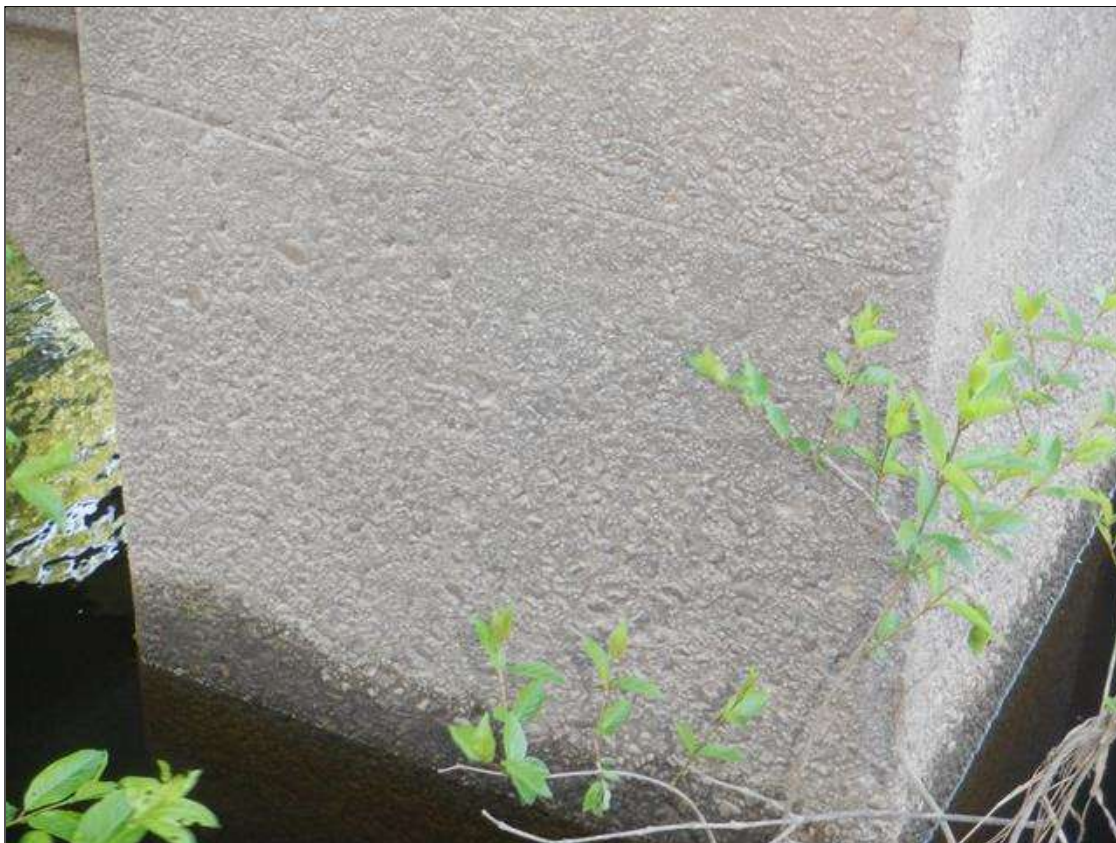
Bent 2 Pile 1: 4' ABRASION/WEAR 12' FROM BOTTOM OF CAP.

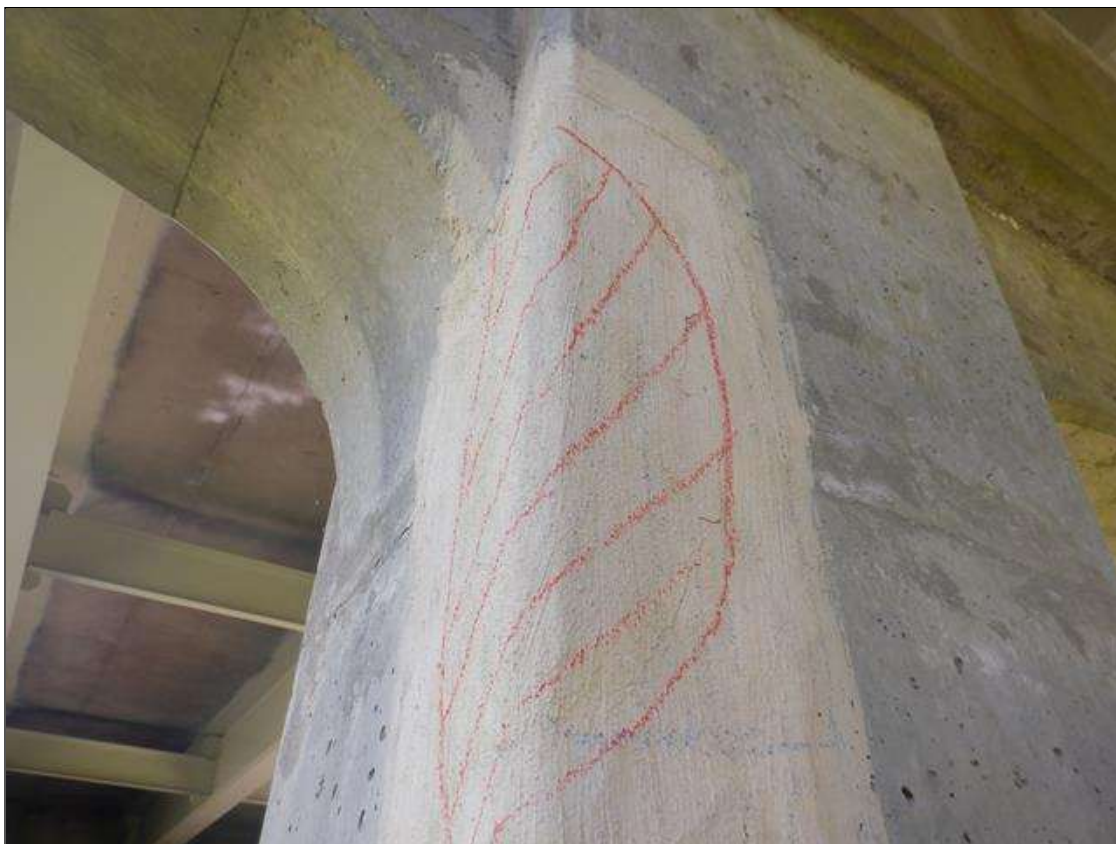
Bent 3 Pile 1: 24" x up to 7" x 4" cracked patched area and delamination, 2' from bottom of cap, on Span 3 face

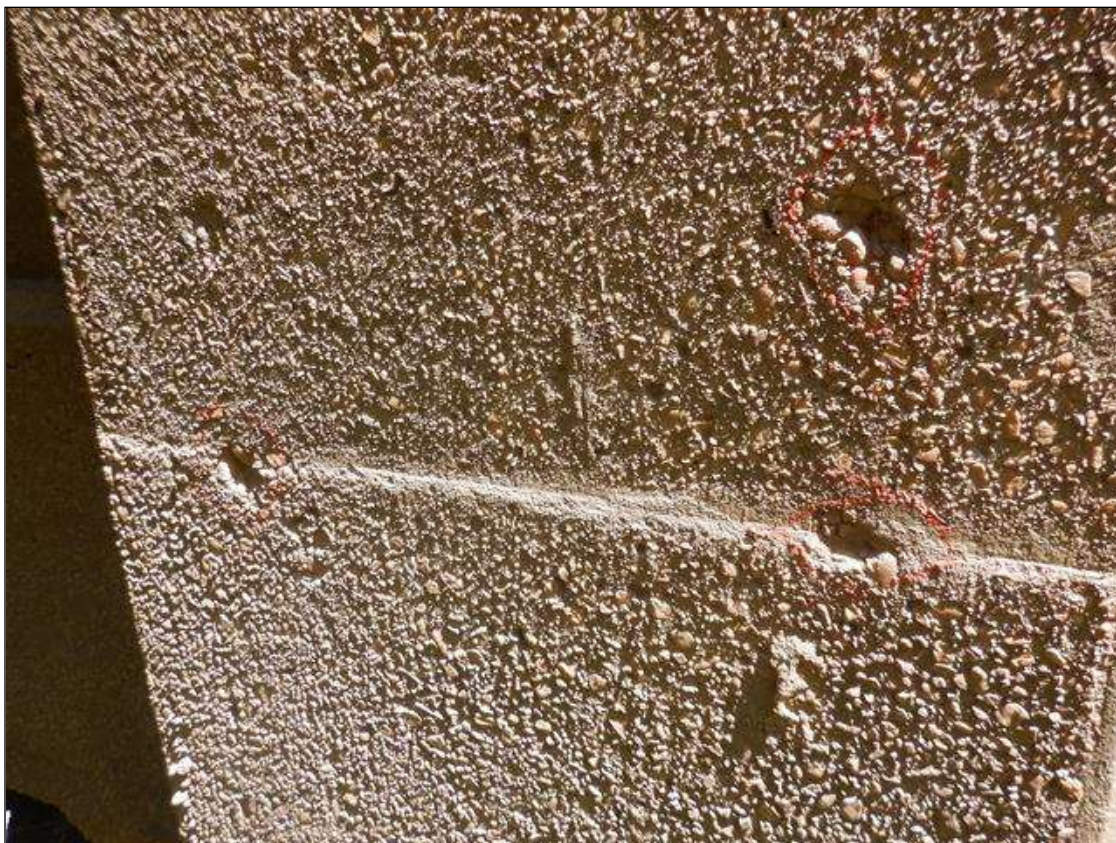
Bent 3 Pile 2: (3) up to 2" x 2" x 1/2" deep spalls on Span 3 face, 11' from bottom of cap

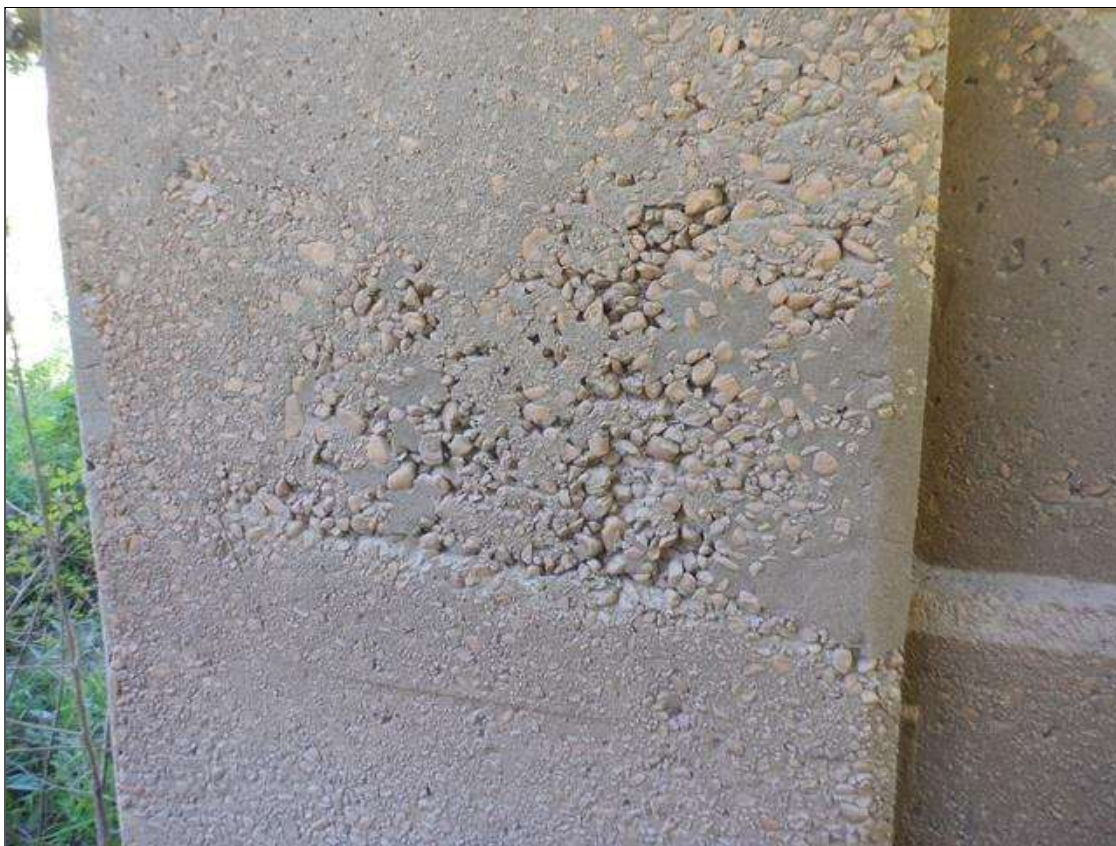
Bent 3 Pile 1: 15" x 19" area of honeycombing with loose aggregate on Span 3 face, at strut height (Span 4 face similar)

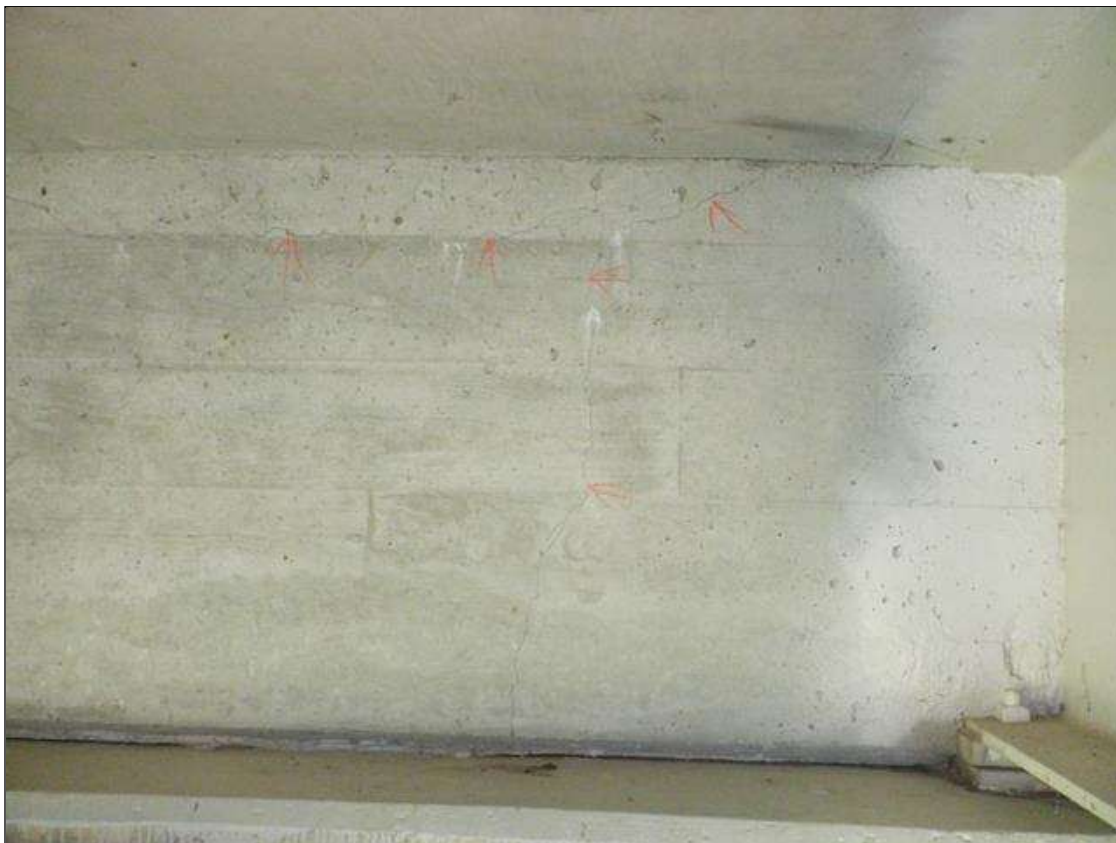
End Bent 2 Abutment/Backwall : HORIZONTAL AND VERTICAL CRACKS UP TO 1/32", SOME WITH EFFLORESCENCE, IN ALL BAYS (PHOTO TAKEN IN BAY 2).

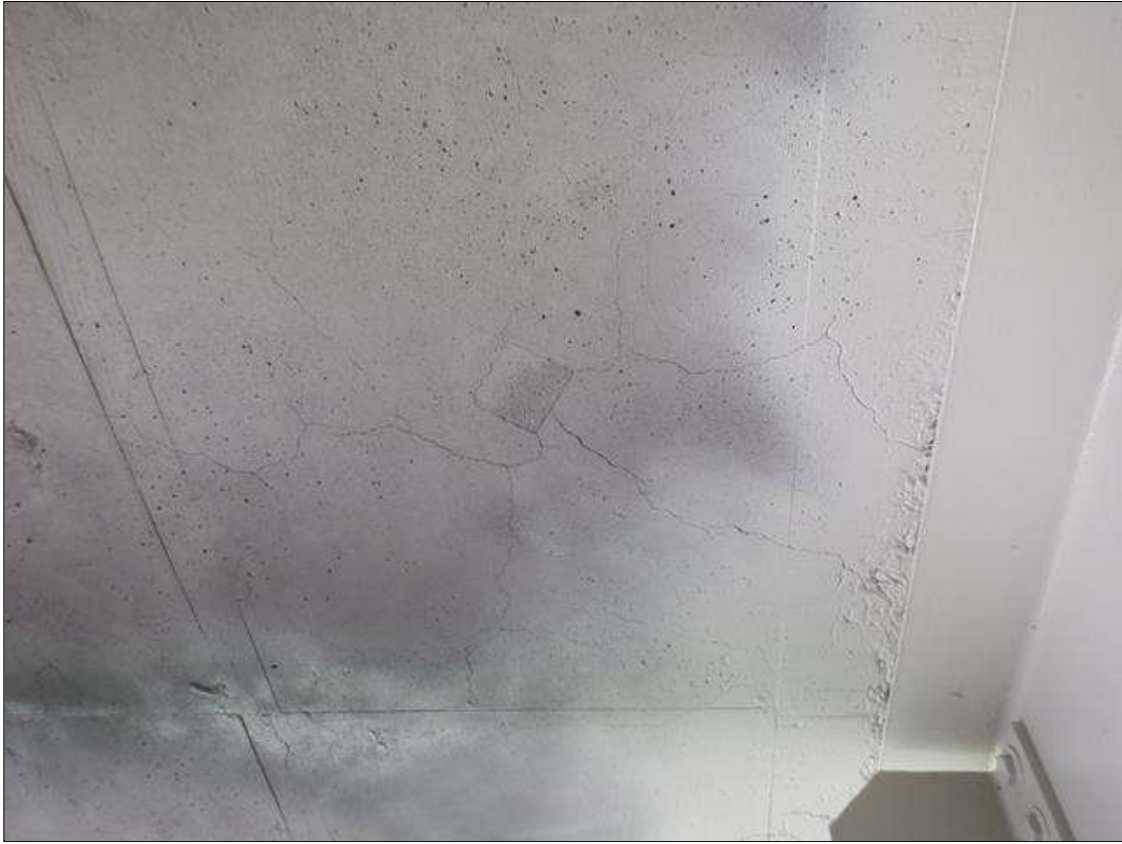
Span 4 Deck: 750 SF OF MAP CRACKING UP TO 1/32", IN UNDERSIDE OF DECK, AT RANDOM THROUGHOUT (PHOTO TAKEN BAY 2 NEAR MIDSPAN).

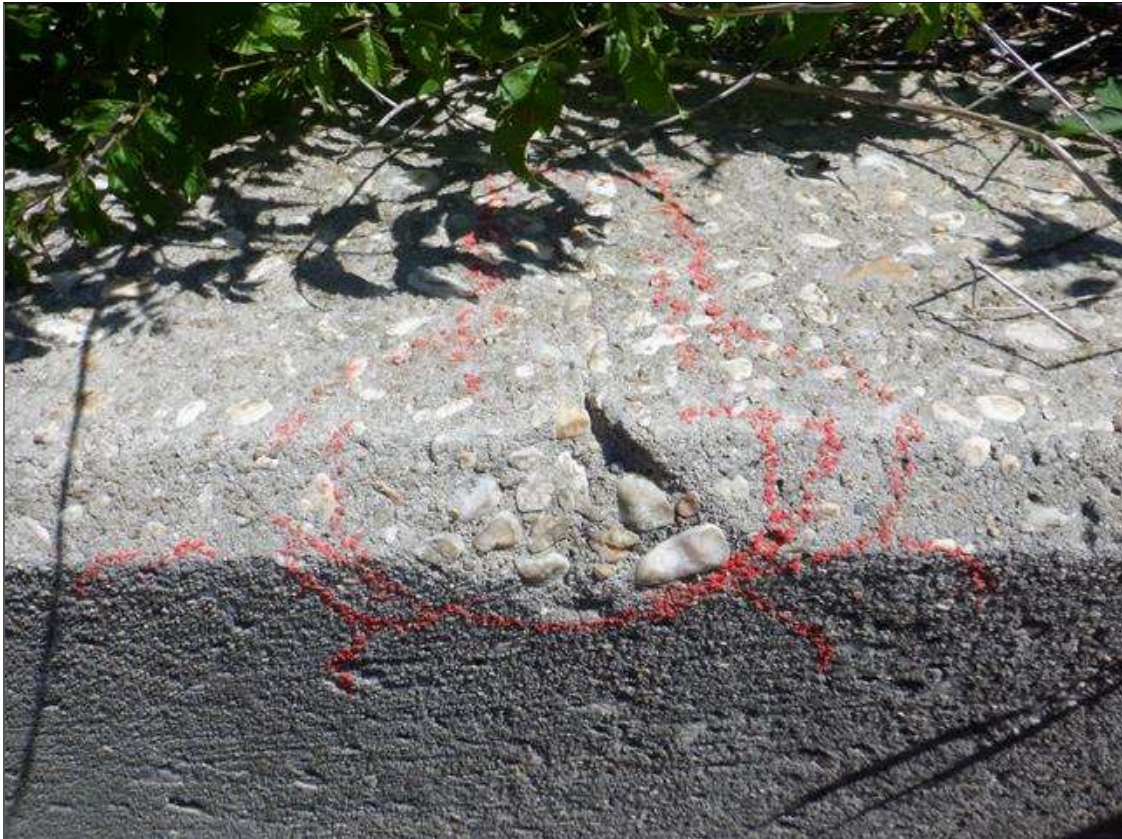
Wingwalls: 5" x 3" x 1" deep spall on Northwest wingwall.

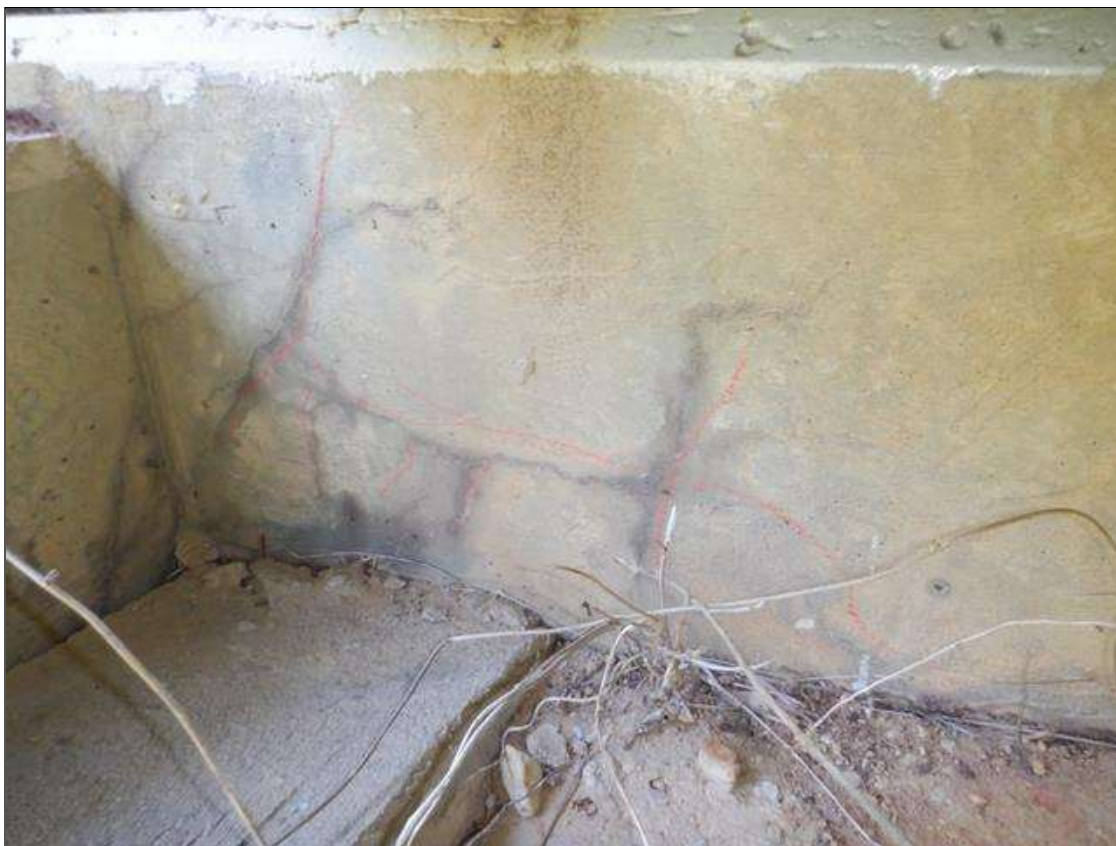
End Bent 2 Cap 1: 12' X 2' AREA OF MAP CRACKING UP TO 1/32", BEGINNING AT WEST END (PHOTO TAKEN UNDER BEAM 1).

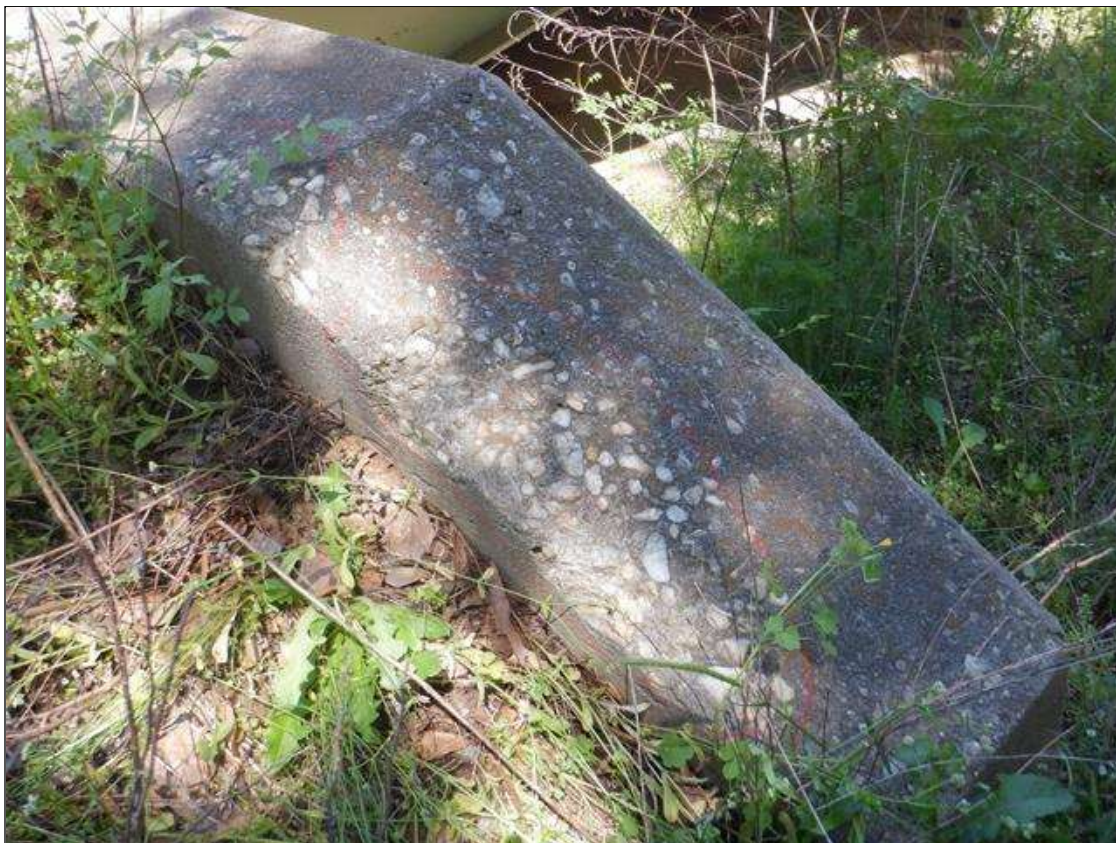
Wingwalls: (2)- up to 18" x 5" x 3" deep spall on top of Southeast wingwall.

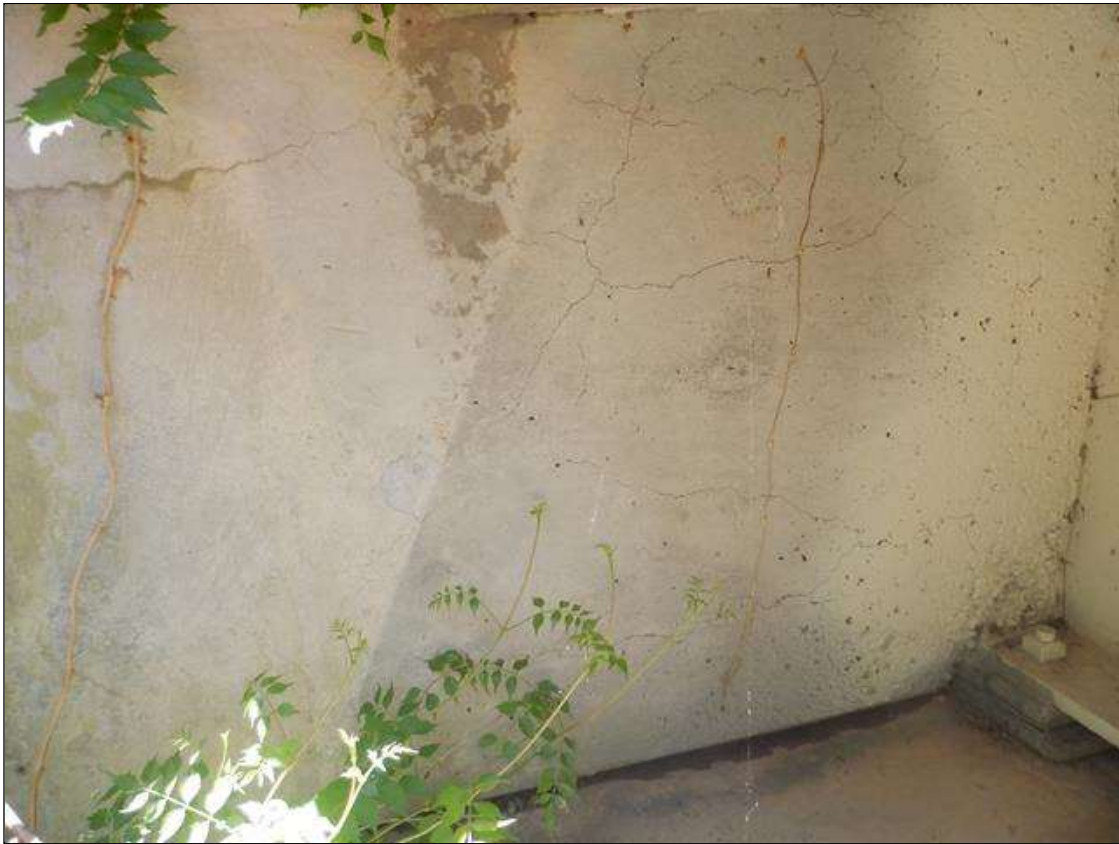
End Bent 1 Abutment/Backwall : 32' OF HORIZONTAL AND VERTICAL CRACKS UP TO 1/32", SOME WITH EFFLORESCENCE (PHOTO TAKEN AT EAST END).

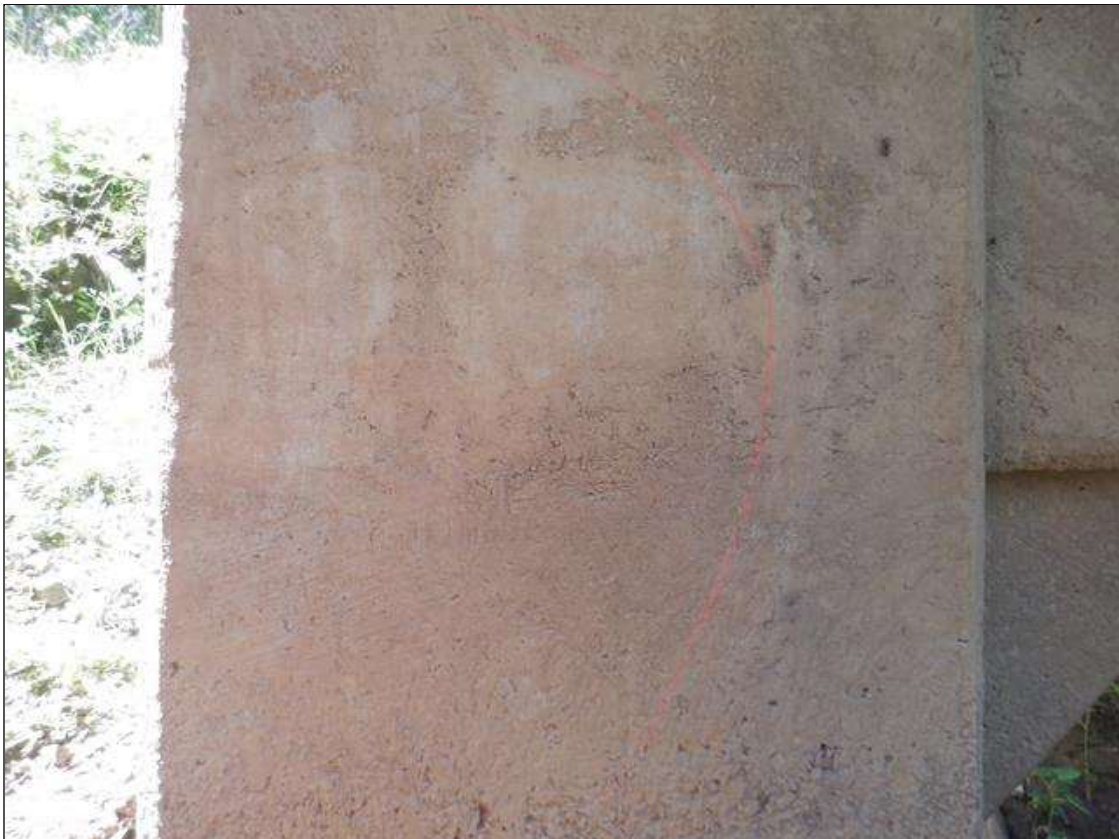
Bent 1 Pile 2: 2' diameter area of sound patch on Span 2 face, 12' from bottom of cap.

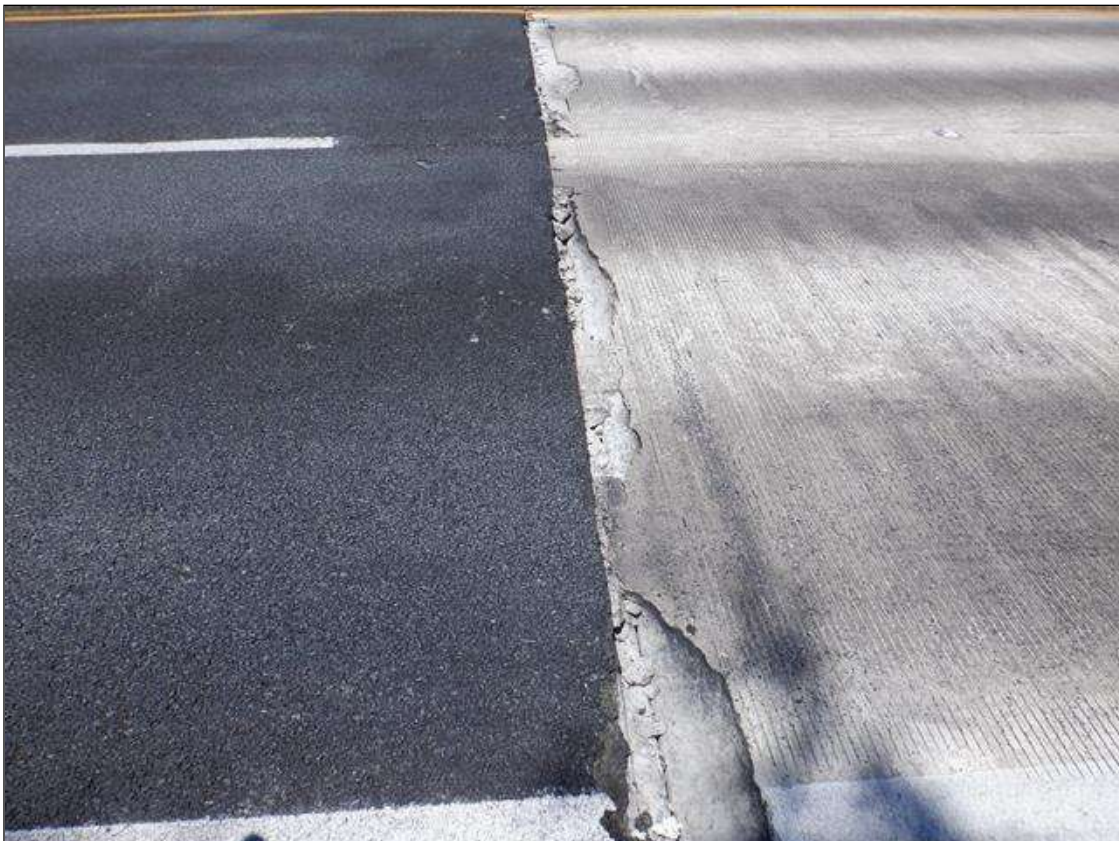
Approach 1: (3)- UP TO 11' X UP TO 1' X 3" SPALLS, AT SOUTH END.

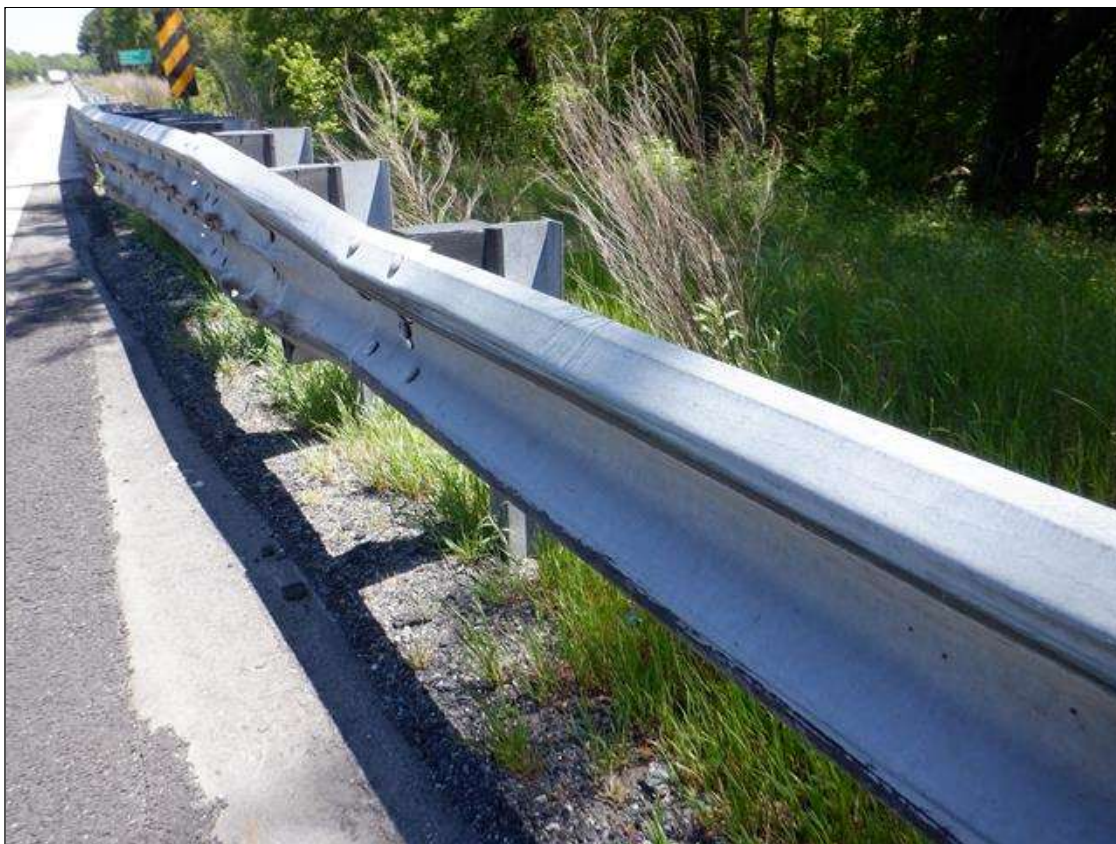
General Comments and Misc. Items: (PAR) 36' OF DAMAGED GUARDRAIL AT SOUTHEAST CORNER, AT END BENT 1.

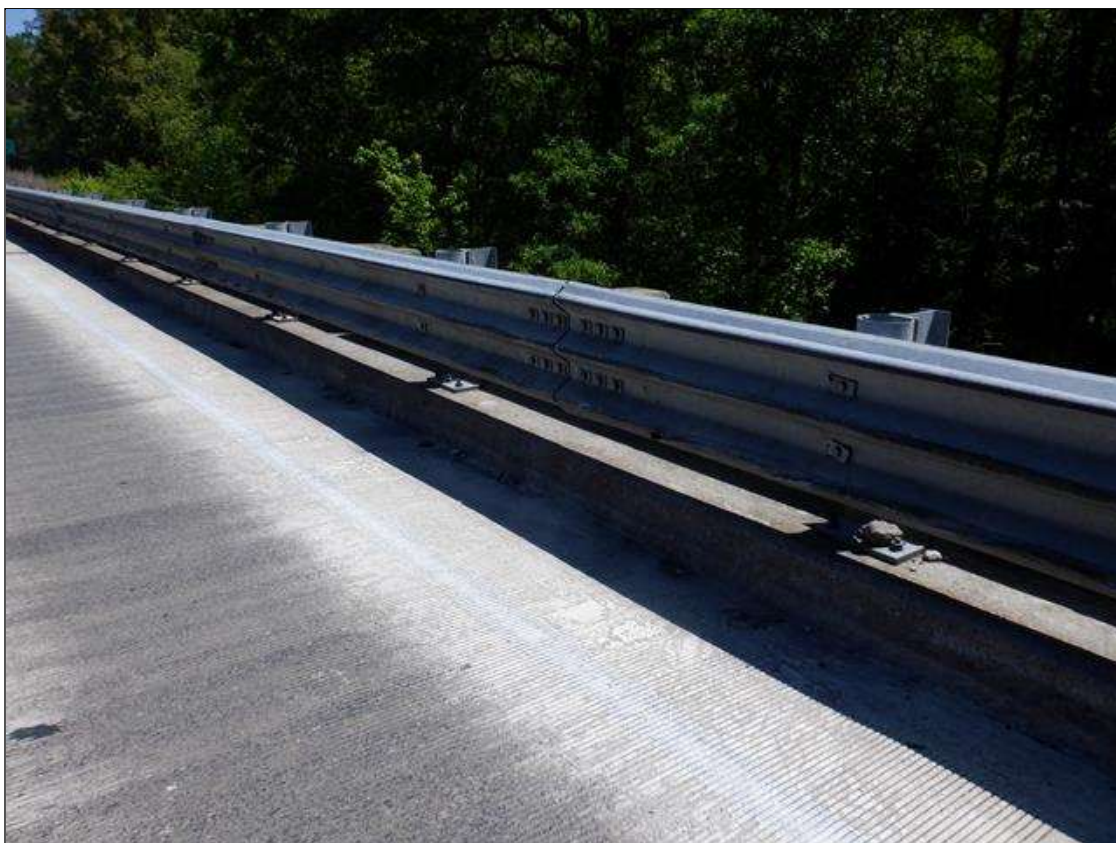
Span 1 Right Bridge Rail: (PAR) 52' OF DAMAGE TO METAL BRIDGE RAIL.

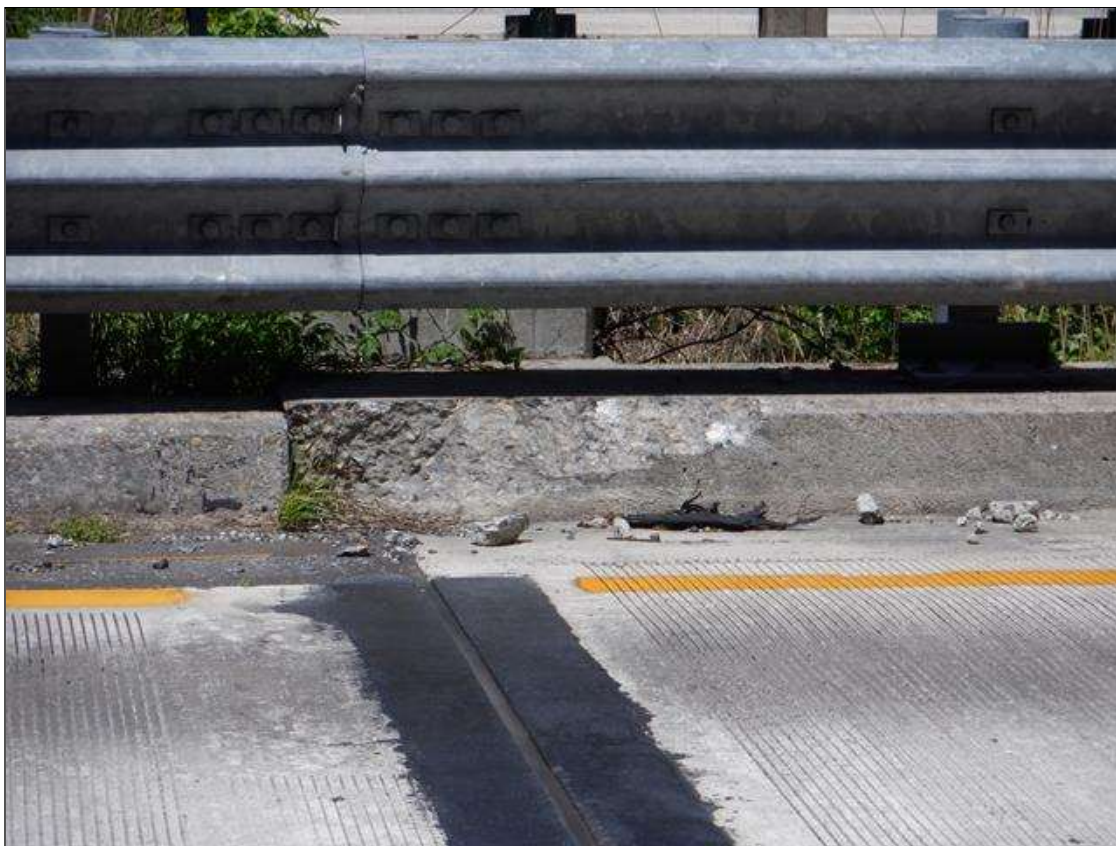
Span 1 Left Bridge Rail: 35" x 9" x 2" deep spall with exposed rebar on concrete curb at End Bent 1

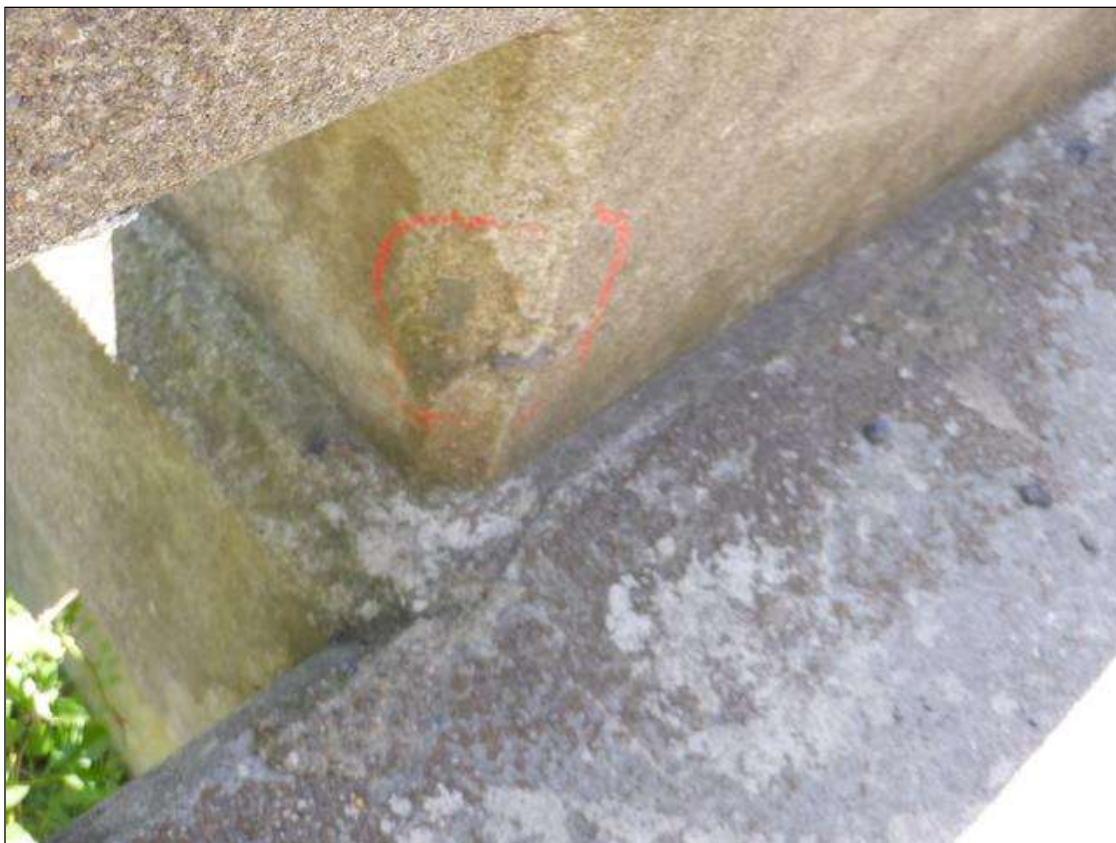
Span 1 Right Bridge Rail: 2" x 3" x 1/2" deep spall on end post at End Bent 1

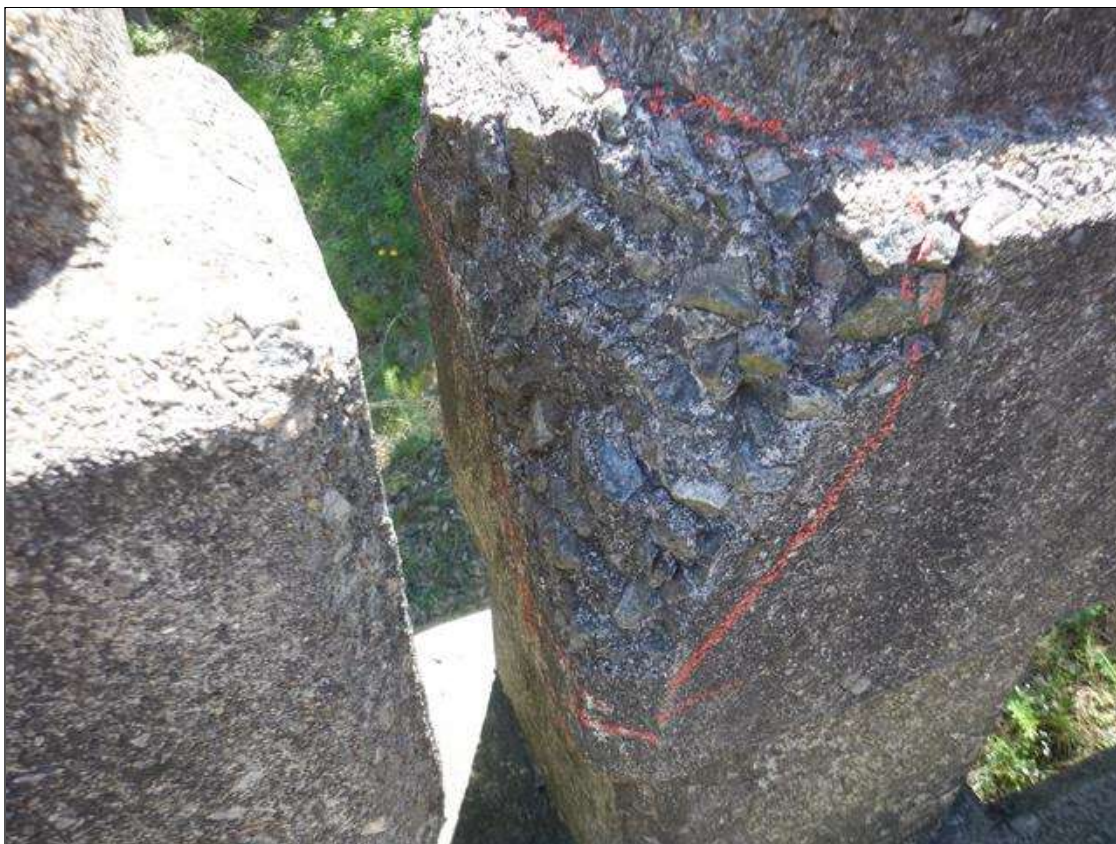
Span 1 Right Bridge Rail: 4" x 7" x 6" deep spall on concrete rail at Post 2

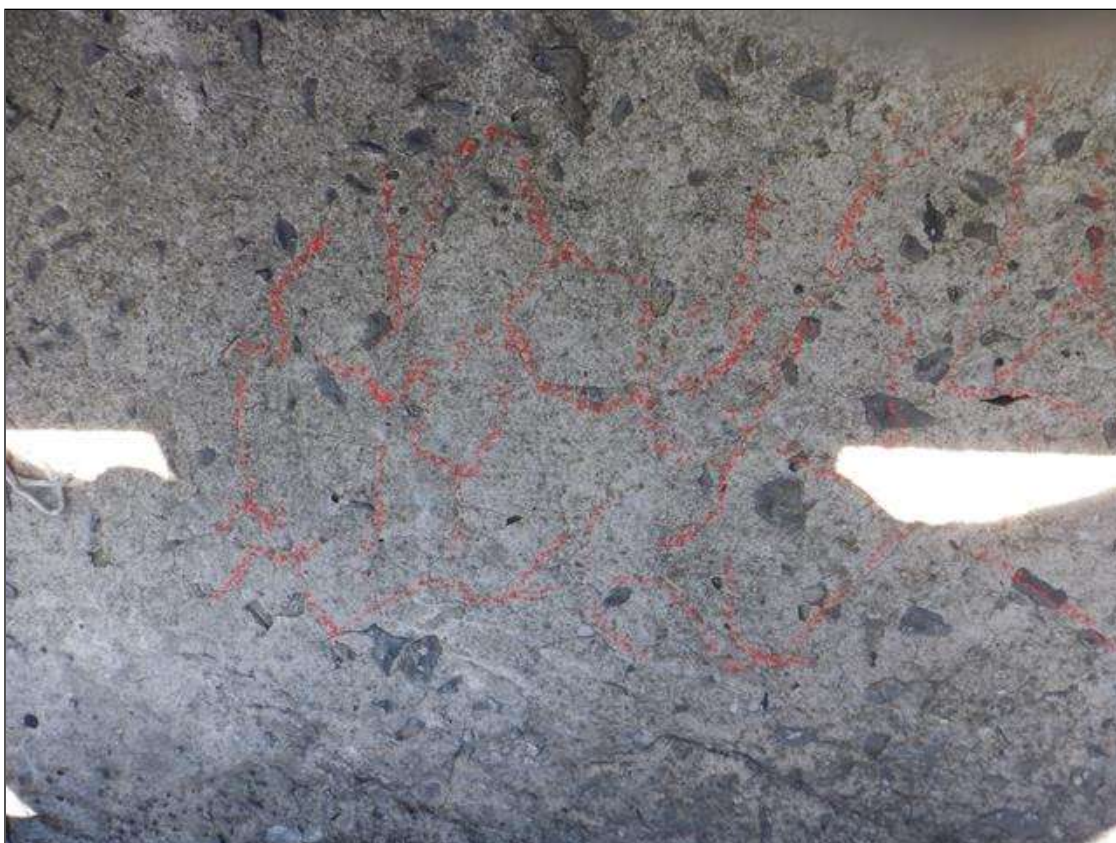
Span 1 Right Bridge Rail: 2' x 2' cracked patched area on concrete curb at Bent 1

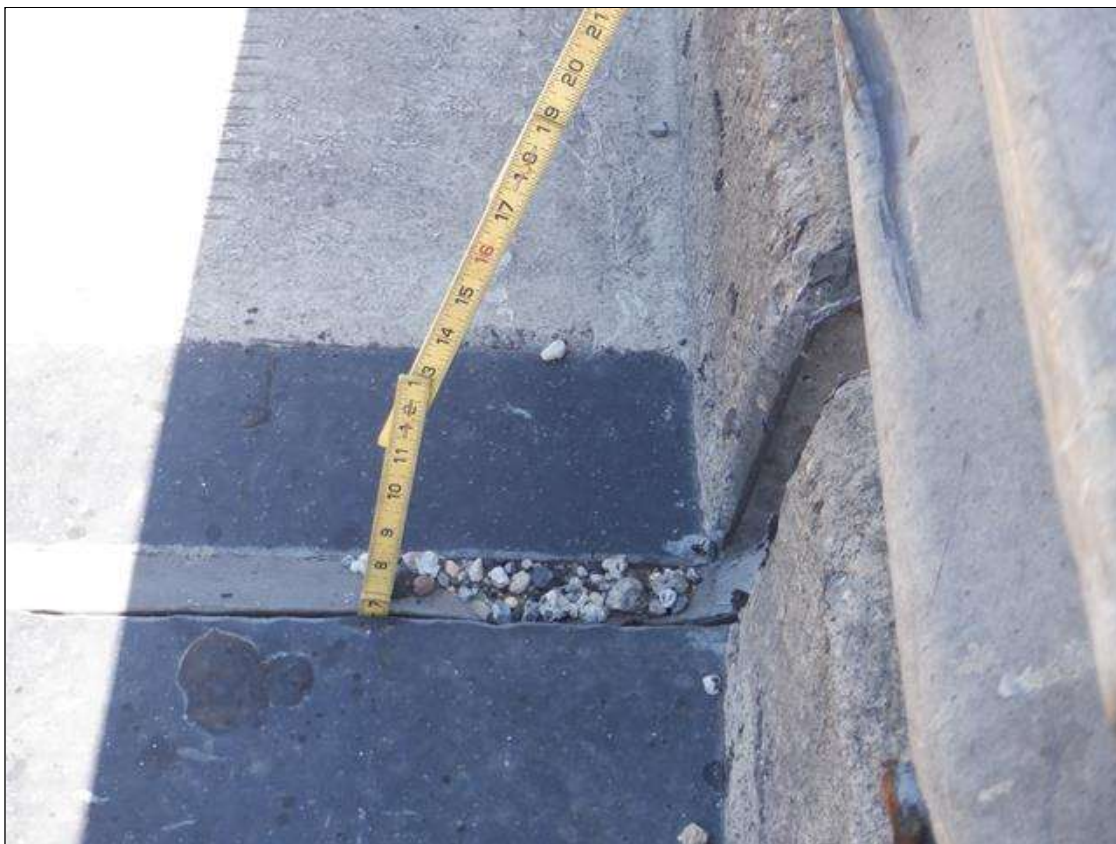
Expansion Joint at Bent 1 : Full length x full depth detached joint material

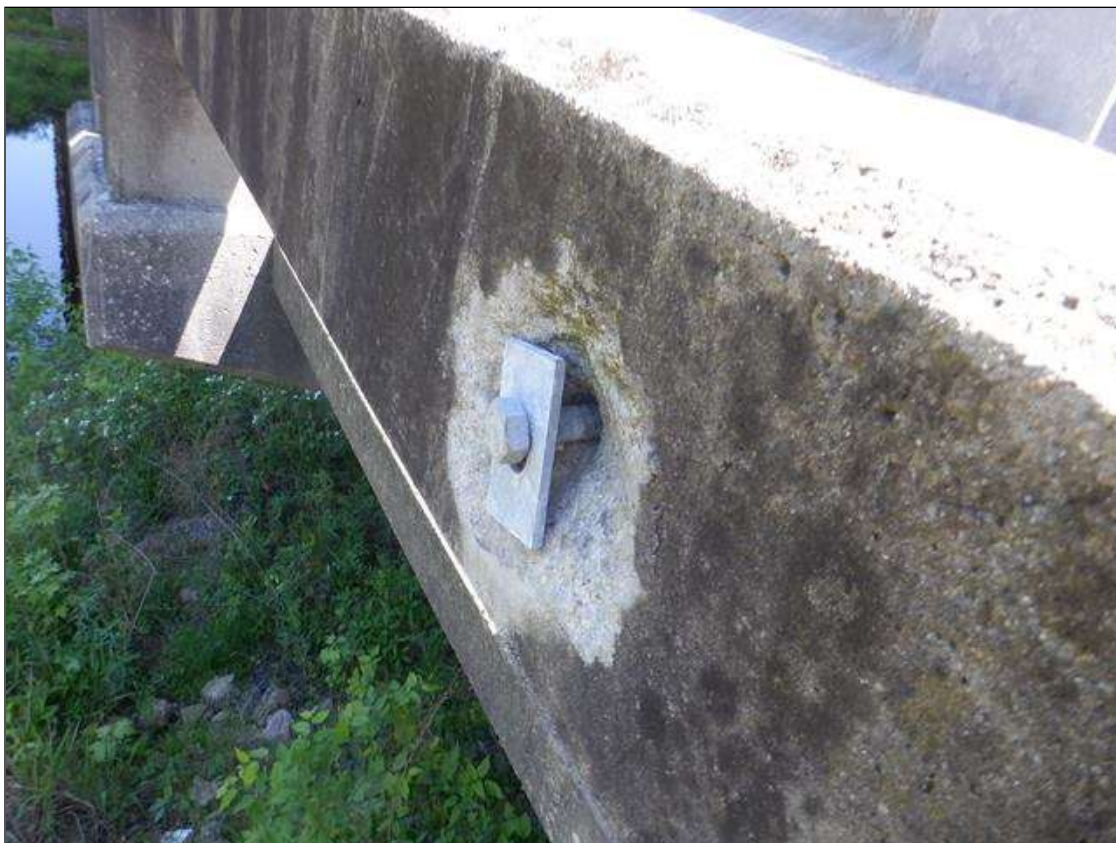
Span 1 Left Bridge Rail: (5) up to 7" x 9" x 1" deep spalls on outside face of concrete rail at bolt locations.

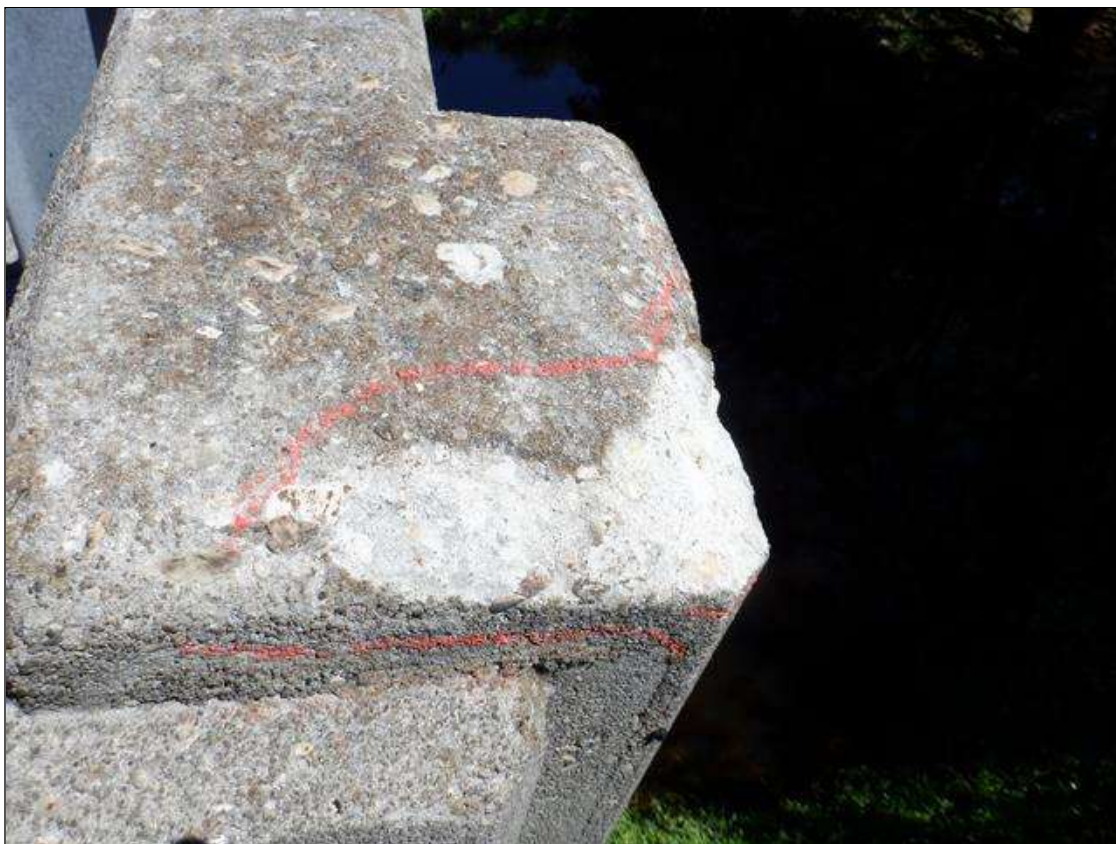
Span 2 Right Bridge Rail: 5" x 6" x 1" deep spall on concrete Post 1
