NC DEPARTMENT OF TRANSPORTATION
 DIVISION OF HIGHWAYS
 STRUCTURE MANAGEMENT UNIT

ATTENTION: **PAR'S SUBMITTED(DAMAGED GUARDRAIL AND BRIDGE RAIL); CHANGE IN STRUCTURE DATA; STRUCTURE HAS BEEN RESURFACED AND BEAMS AND BEARINGS HAVE BEEN REPAINTED**

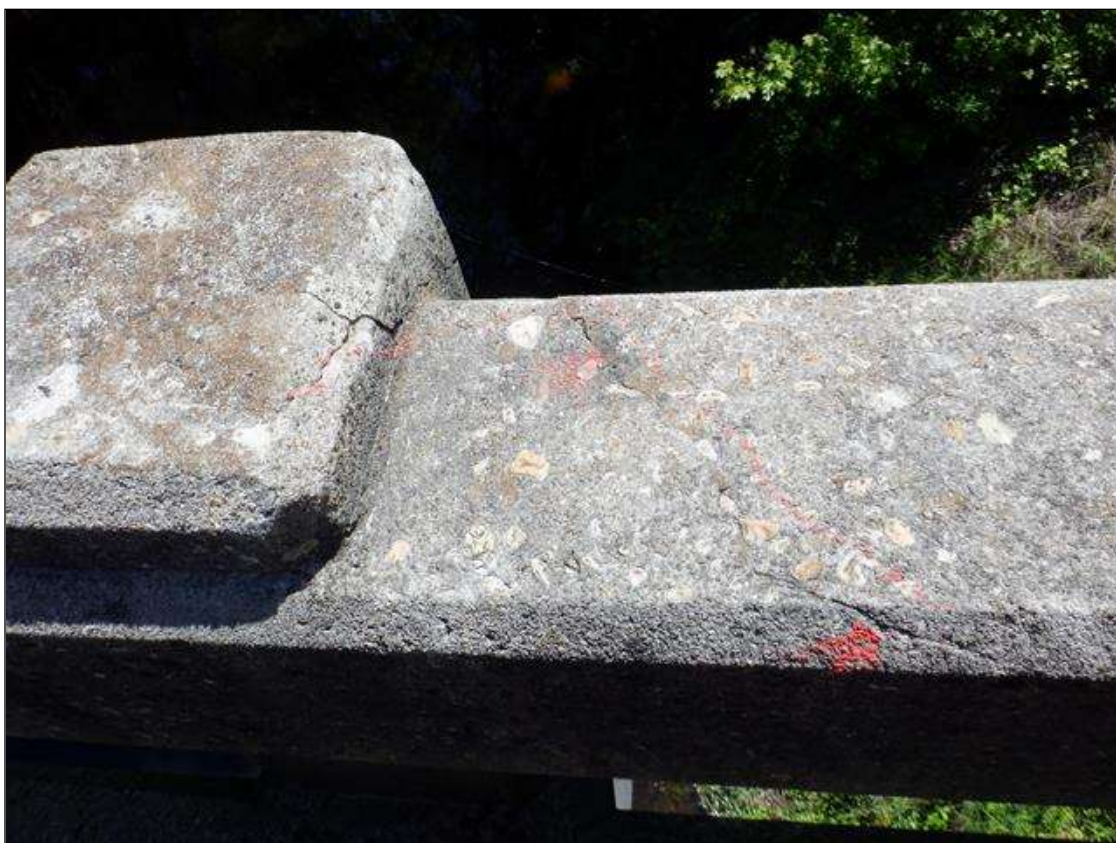
Span 2 Right Bridge Rail: 3" x 1/64" longitudinal crack on top of concrete Post 2

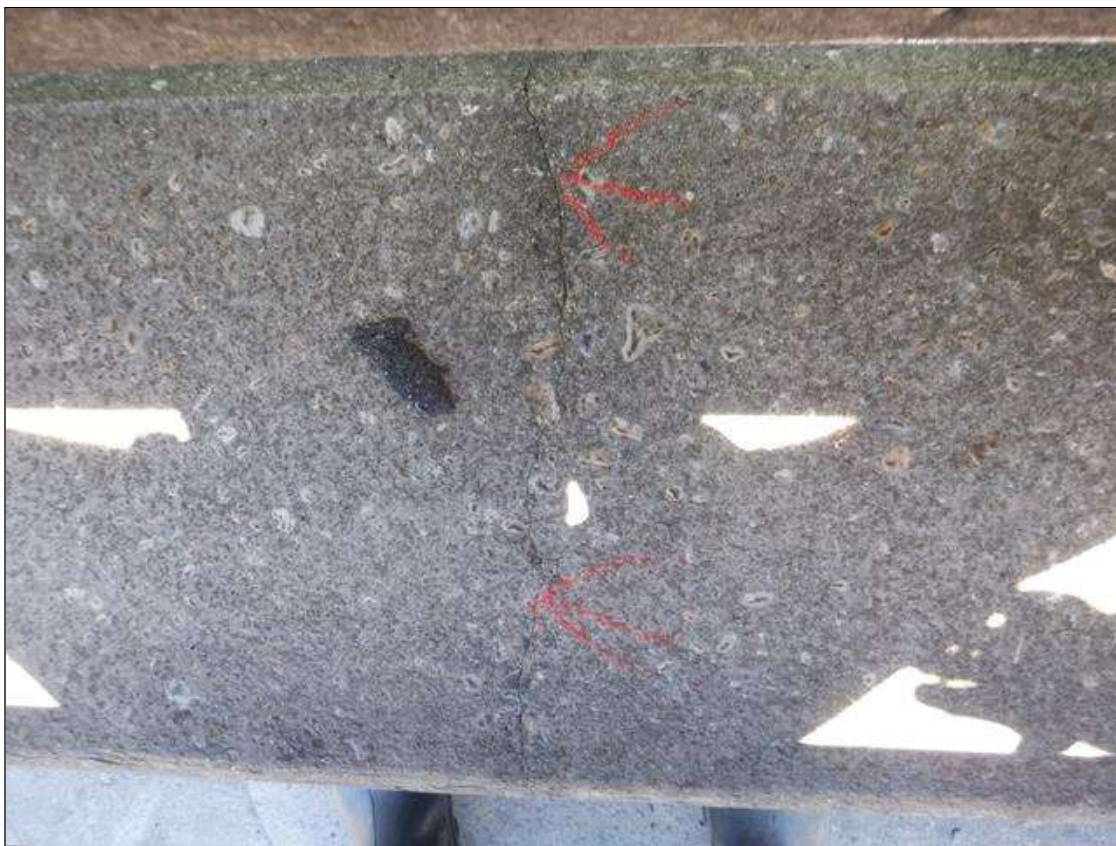
Span 2 Right Bridge Rail: (4) up to 1/64" vertical and transverse cracks on concrete curb and rail

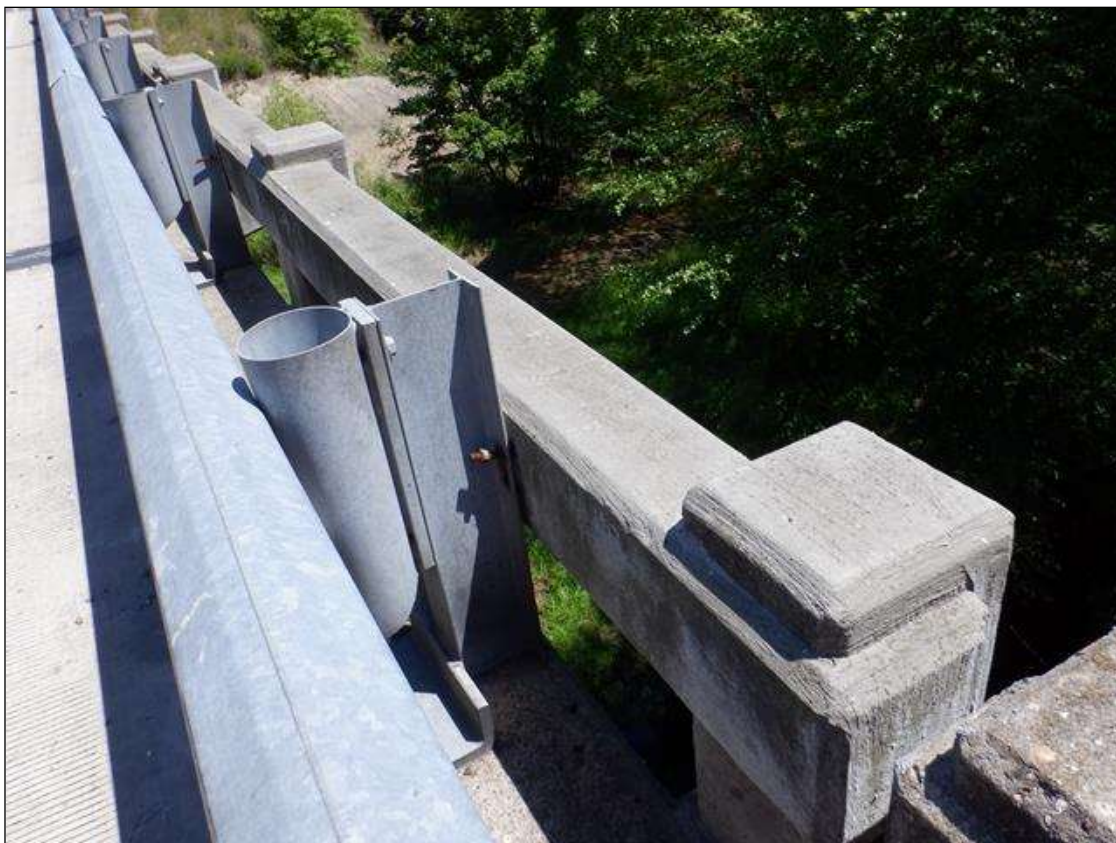
Span 2 Right Bridge Rail: 16' repaired section of concrete rail at Bent 2

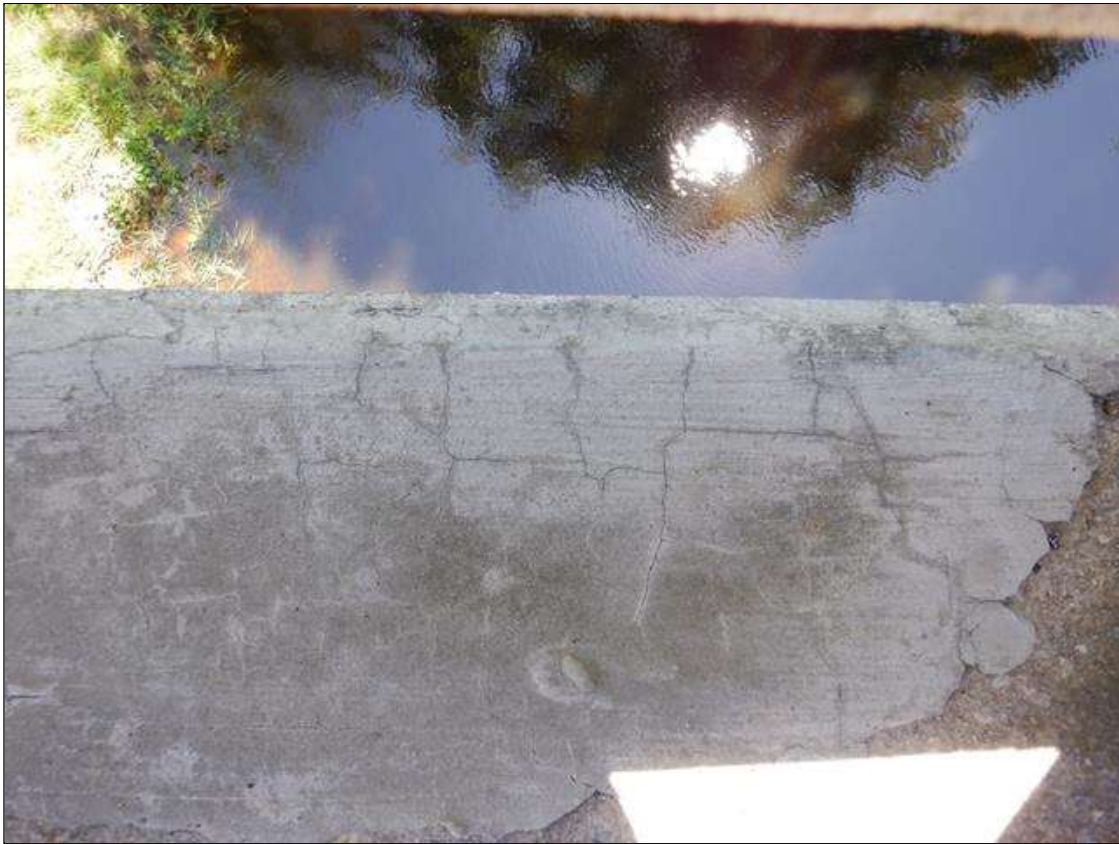
Span 2 Right Bridge Rail: 36" x 9" cracked patched area on concrete curb near Bent 2

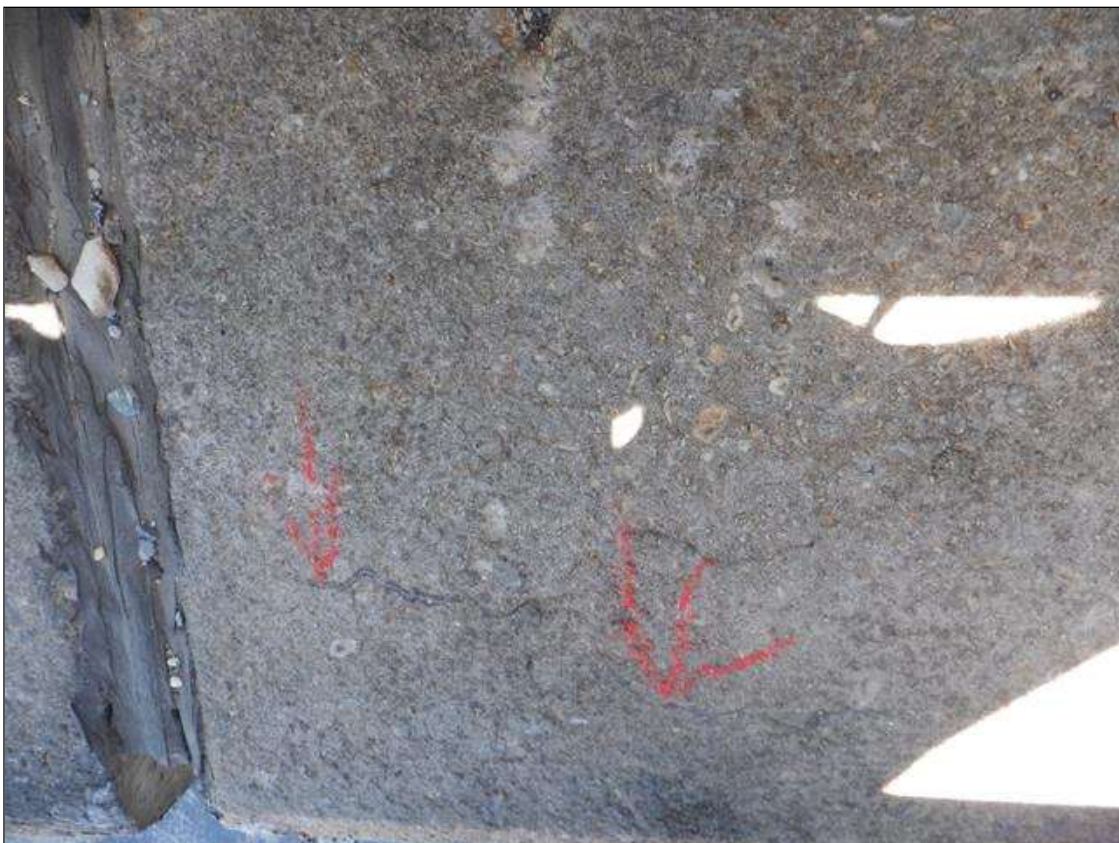
Span 2 Right Bridge Rail: 30" x 1/64" longitudinal cracks on concrete curb at Bent 2

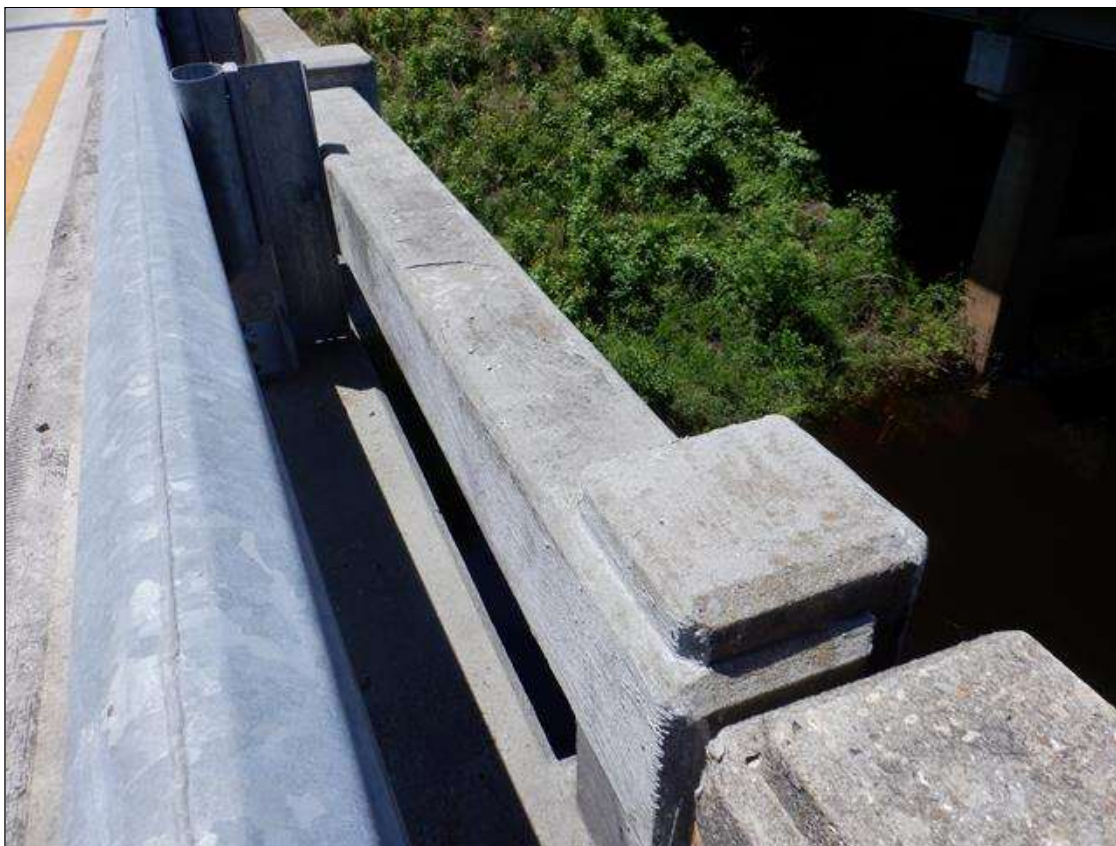
Span 2 Left Bridge Rail: 10' repaired section of concrete rail at midspan

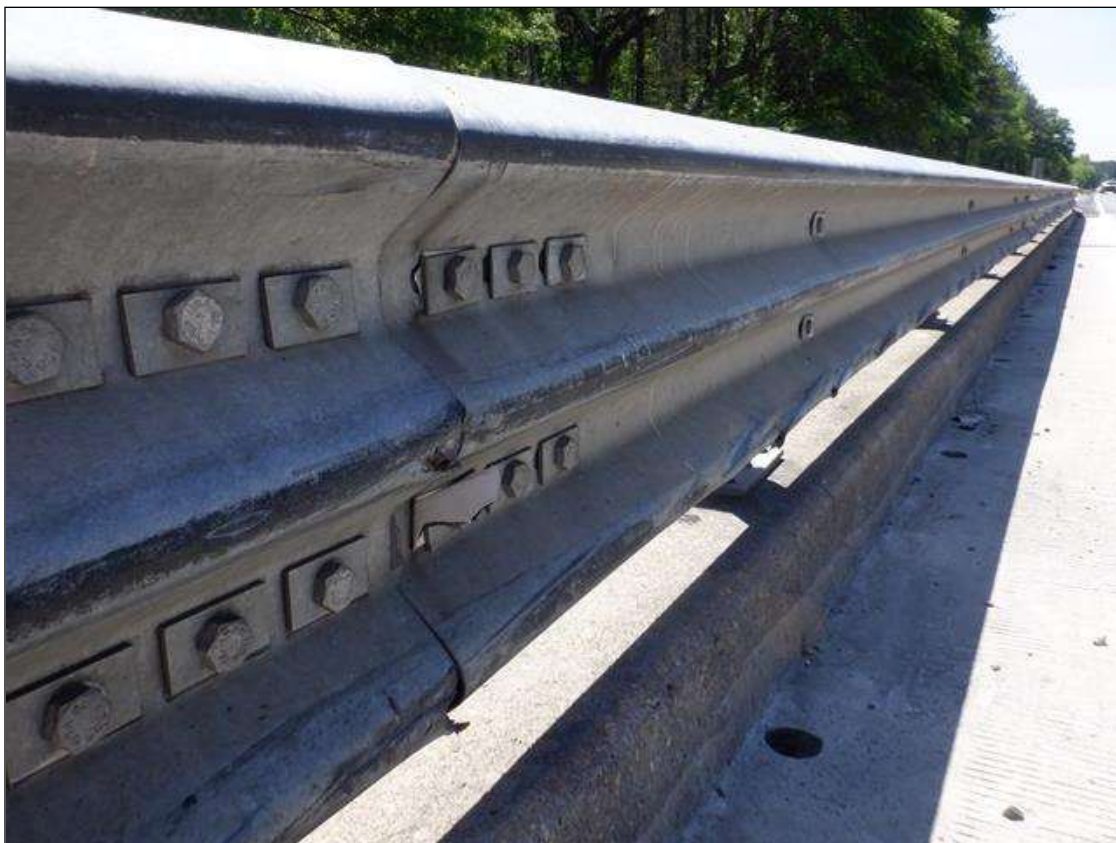
Span 2 Right Bridge Rail: (PAR) 50' OF DAMAGE TO METAL BRIDGE RAIL.

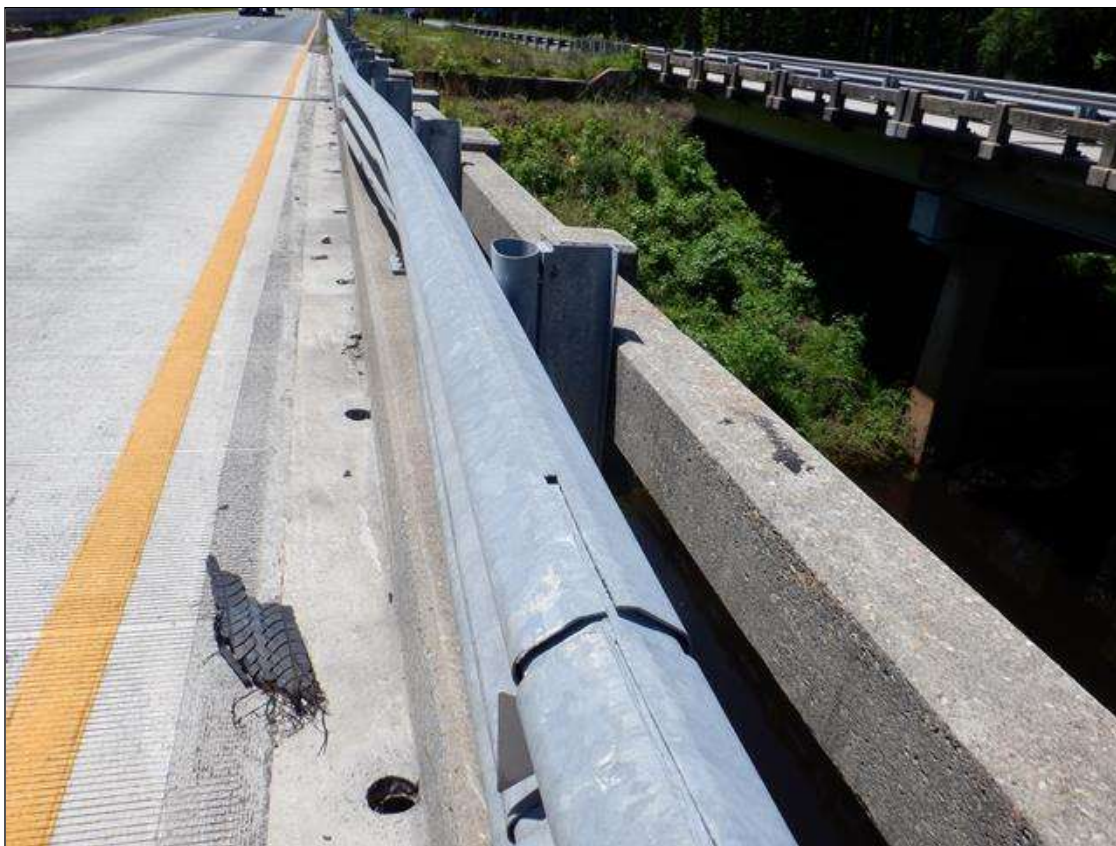
Span 2 Left Bridge Rail: (PAR) 20' impact damage with 2" deflection to the West on metal rail, extending from bent 2.

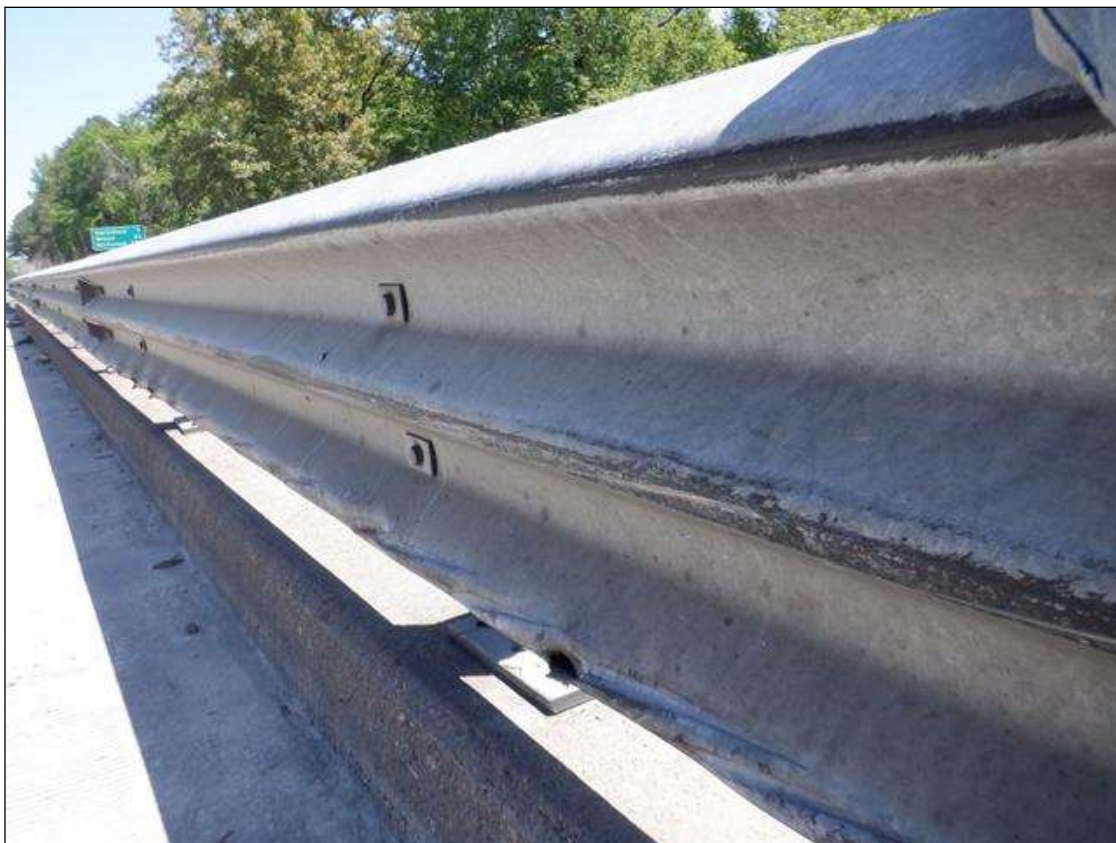
Span 3 Right Bridge Rail: (PAR) 50' OF DAMAGE TO METAL BRIDGE RAIL.

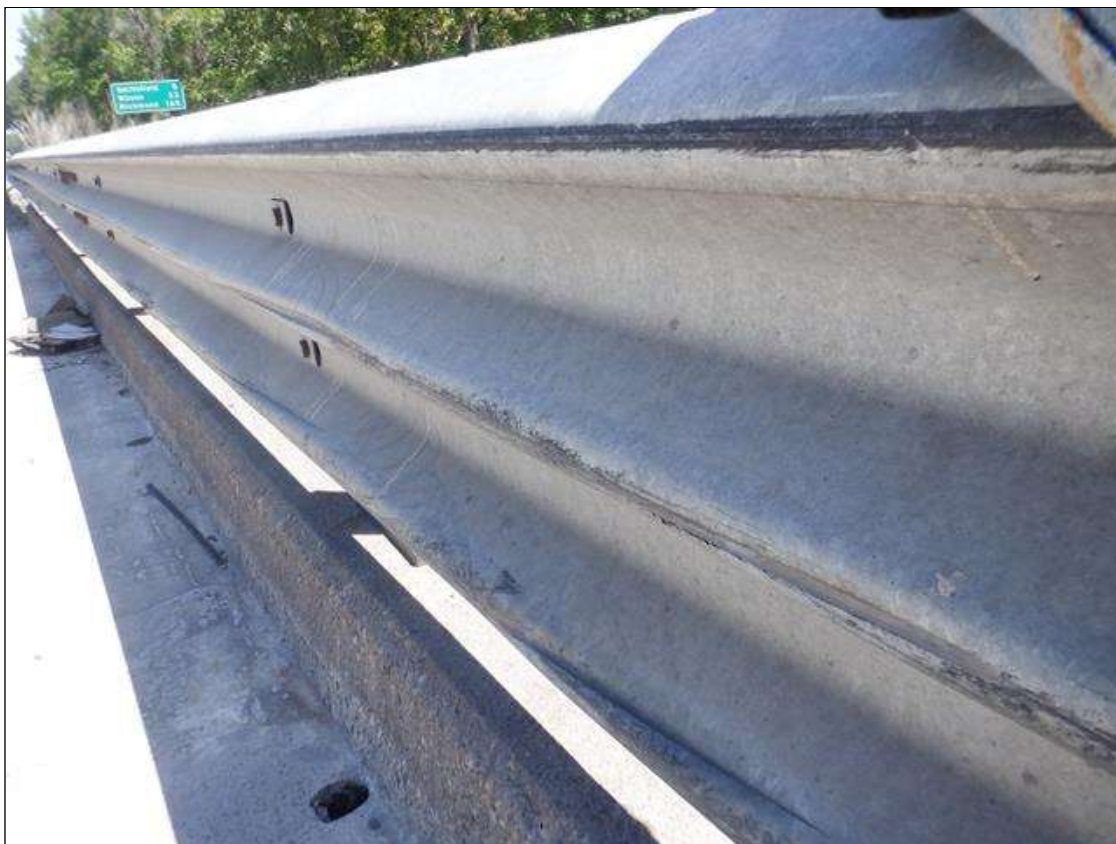
Span 4 Right Bridge Rail: 51' OF DAMAGE/SCRAPES TO METAL BRIDGE RAIL.

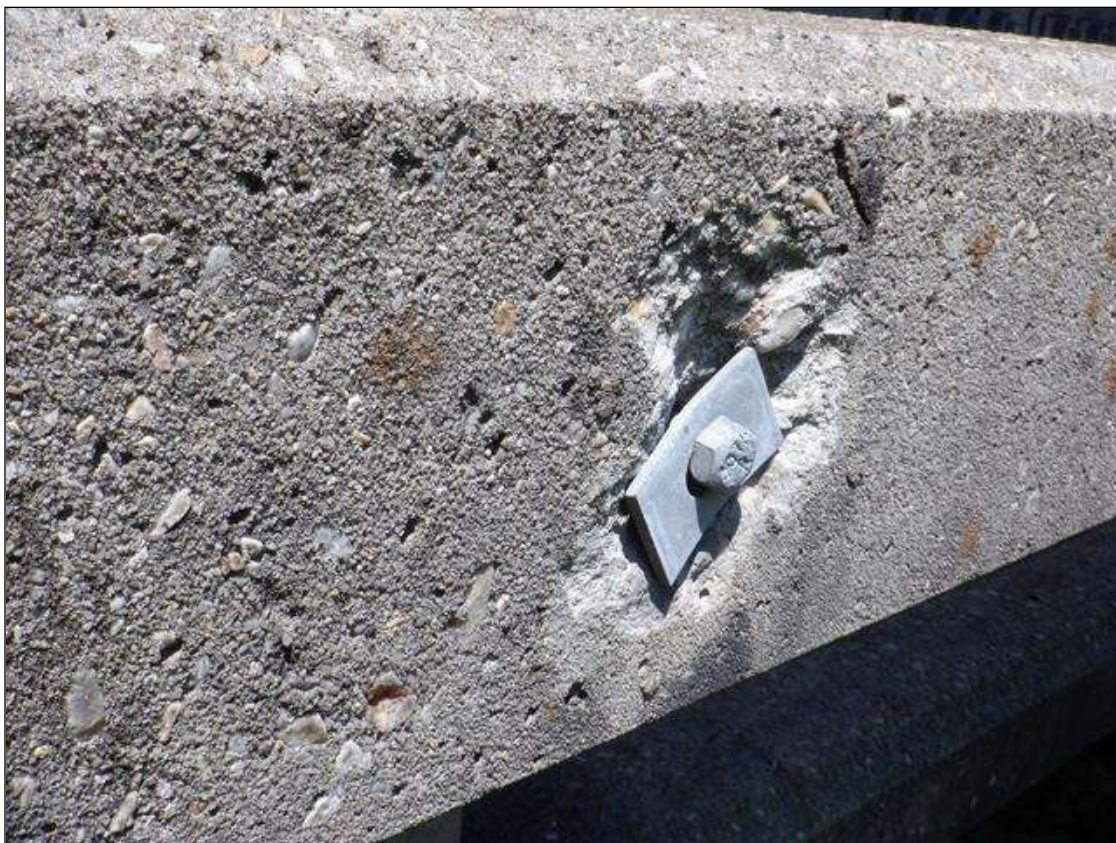
Span 4 Right Bridge Rail: (5) up to 7" x 6" x 1" deep spalls on outside face of concrete rail (PHOTO TAKEN NEAR MIDSPAN)

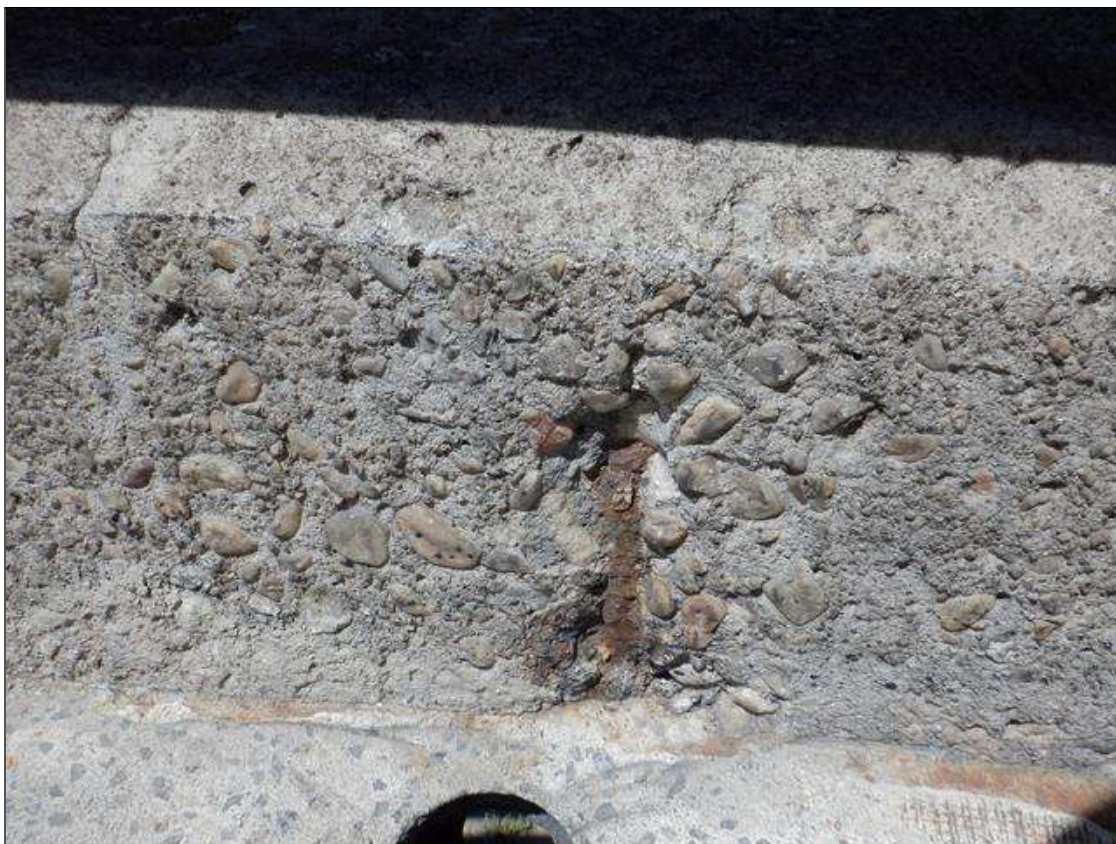
Span 4 Left Bridge Rail: 2" X 6" X 1/2" SPALL WITH EXPOSED REINFORCING, EAST FACE OF CURB, NEAR MIDSPAN.

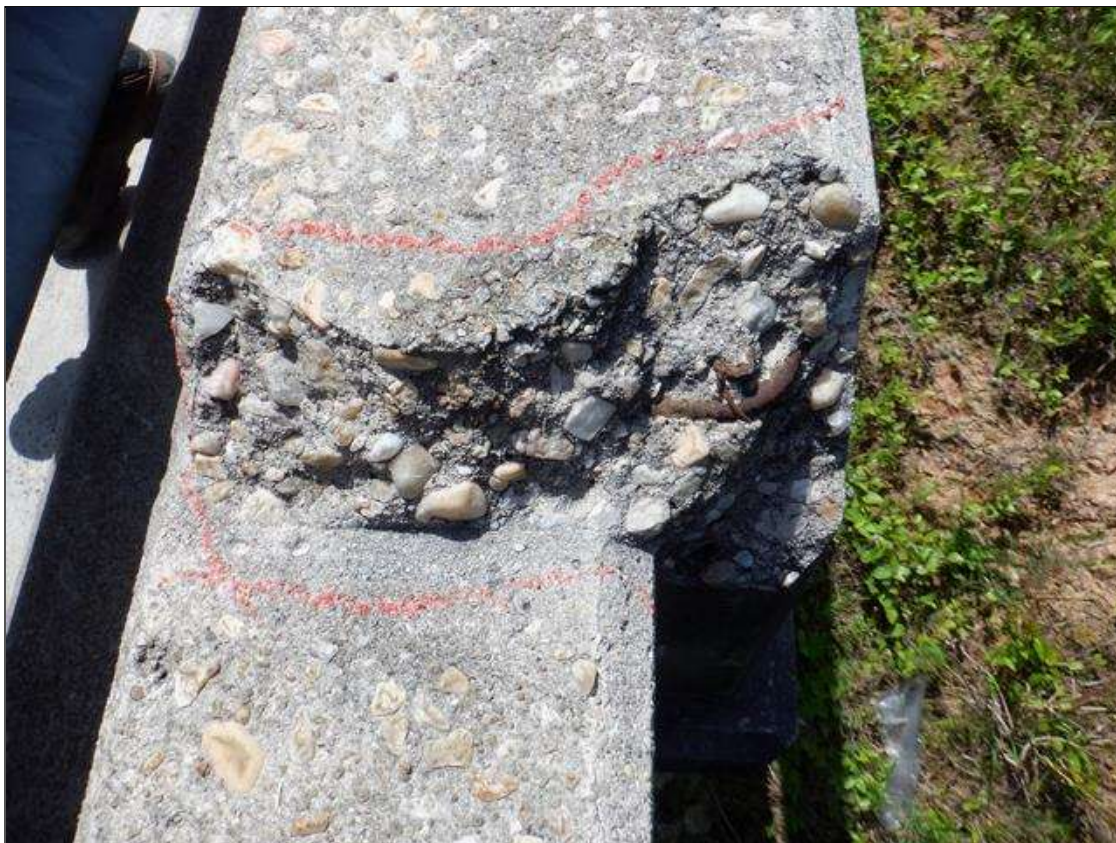
Span 1 Left Bridge Rail: 5" X UP TO 10" X 7" SPALL WITH EXPOSED REINFORCING, 18' FROM END BENT 1.

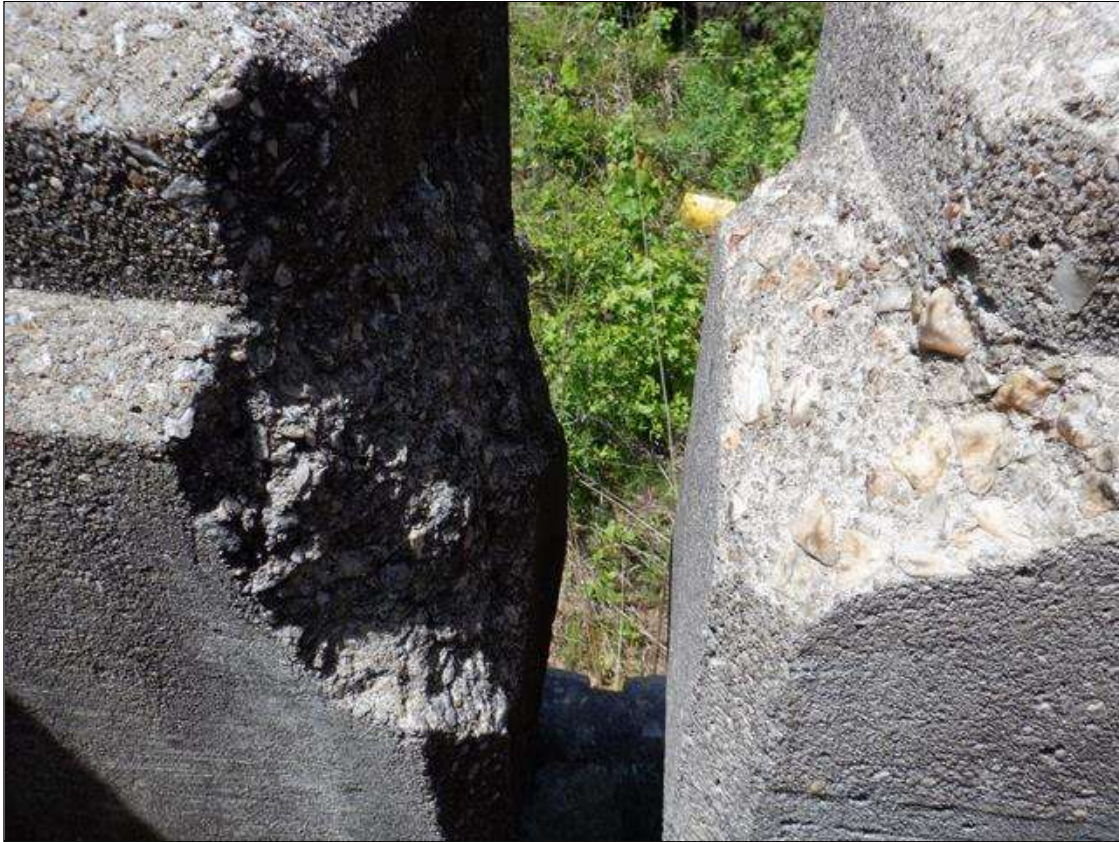
Span 1 Left Bridge Rail: (2)- UP TO 4" X 10" X 7" SPALLS IN TOP OF POSTS, 17' FROM END BENT 1.

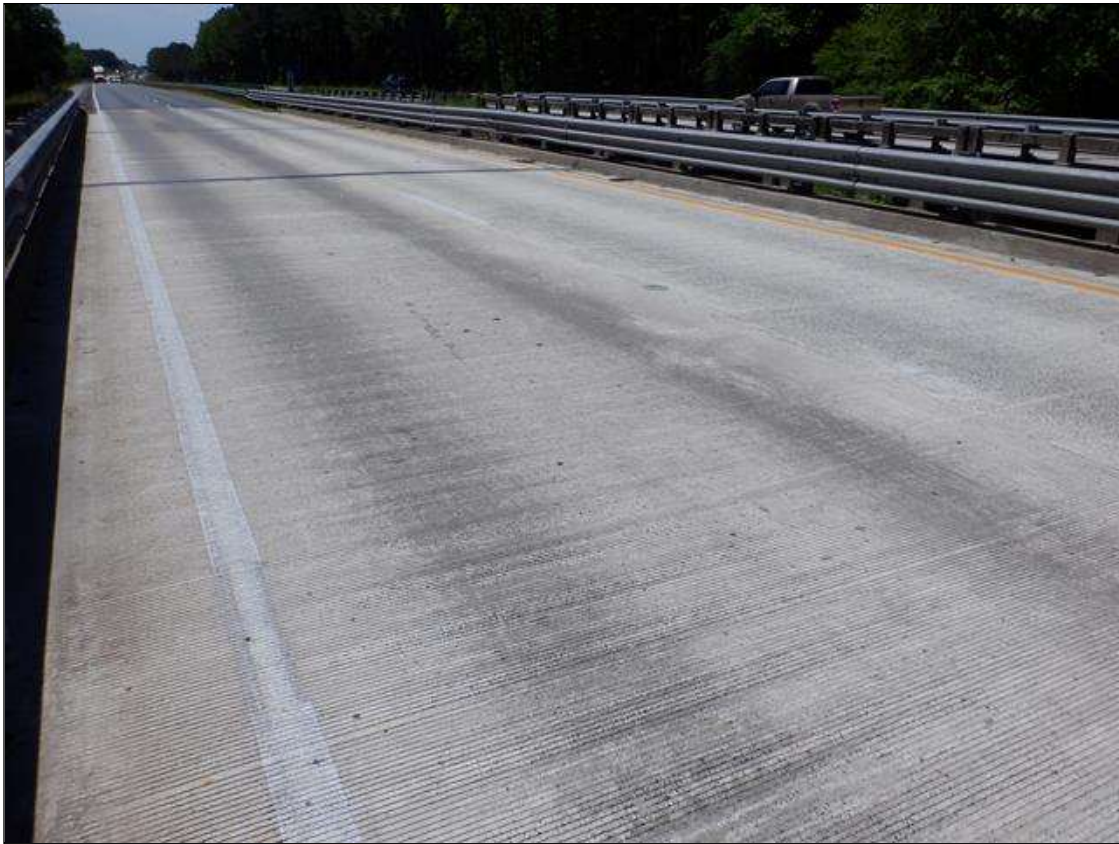
SPAN 3 CONCRETE WEARING SURFACE LOOKING SOUTH

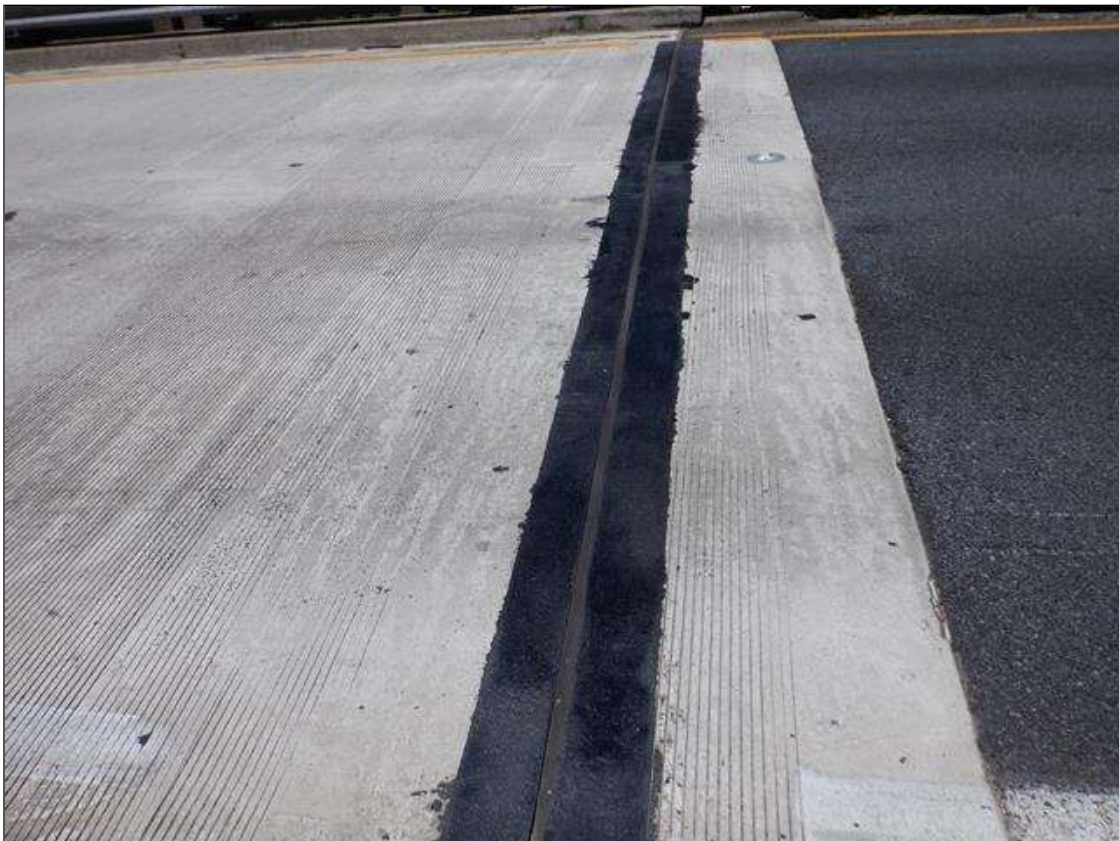
JOINT OVER END BENT 2, LOOKING WEST

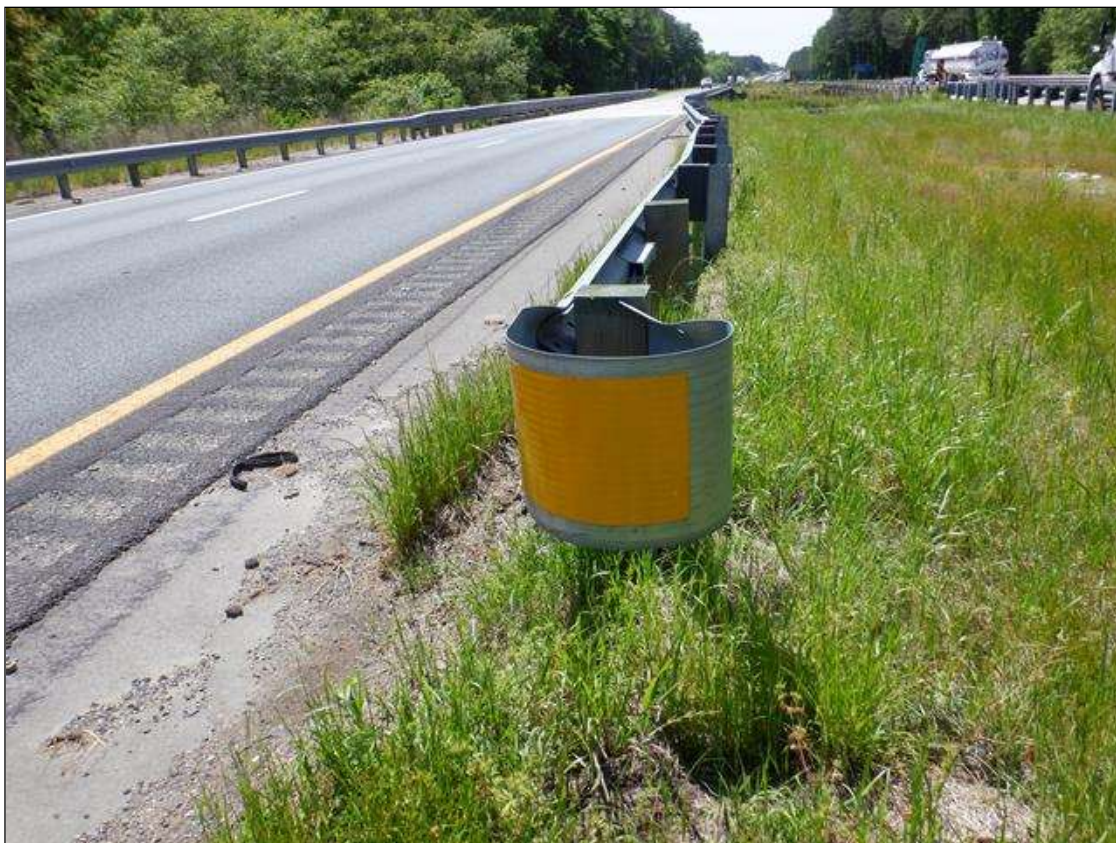
NORTHWEST GUARDRAIL TERMINAL (NORTHEAST SIMILAR)

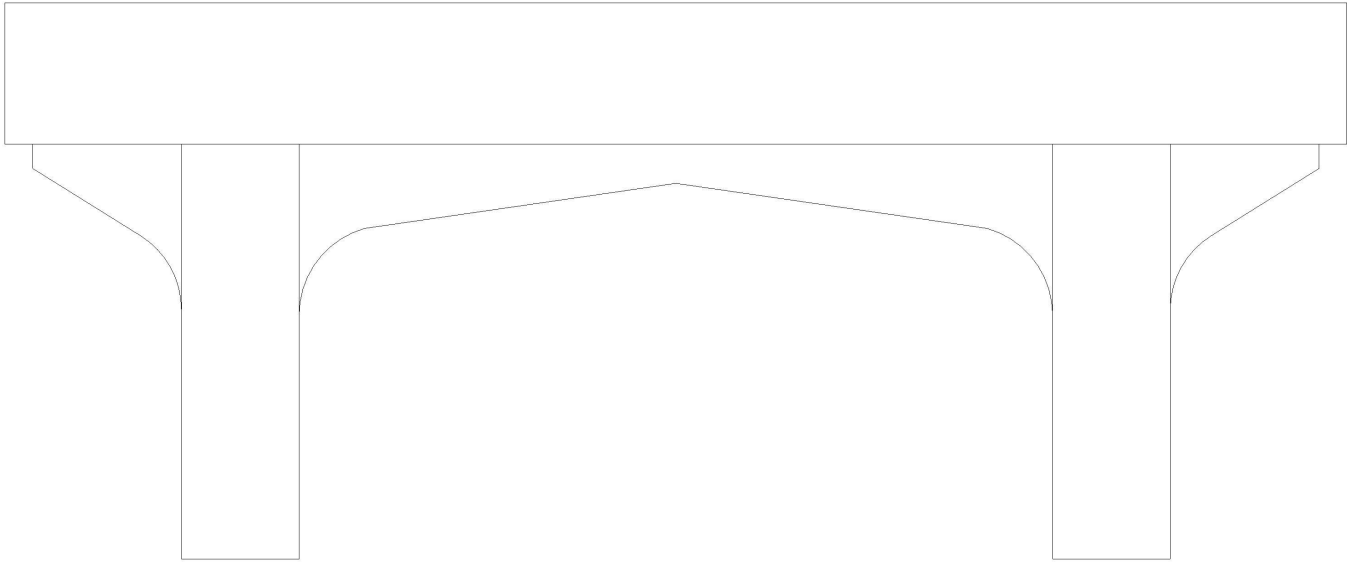
Cap Information			Material Cast-in-Place Concrete							
Length	Width	Height	Left Overhang	Right Overhang	Left Beam to End of Cap.	Right Beam to End of Cap.				
27.000 ft.	2.500 ft.	2.500 ft.	5.000 ft.	5.000 ft.	1.500 ft.	1.500 ft.				
Subcap Information			Material							
Length	Width	Height	Left Overhang	Right Overhang	Left Pile to Splice.					
Sill Information			Material							
Length	Width	Height								
Pile #	Material	Spacing	Width/Dia.	Height	Length	Orientation	Driven?	Replacement?	Removed?	Collar?
1	Concrete	17.000 ft.	2.333 ft.			Vertical	No	No	No	No
2	Concrete		2.333 ft.			Vertical	No	No	No	No
VERIFIED BY R. ASENCIO ON 4-22-2020.										
Bent/Abutment #: 1			Similar Bents: BENTS 2 & 3
