NC DEPARTMENT OF TRANSPORTATION ATTENTION:
 DIVISION OF HIGHWAYS
 STRUCTURE MANAGEMENT UNIT

Structure Safety Report

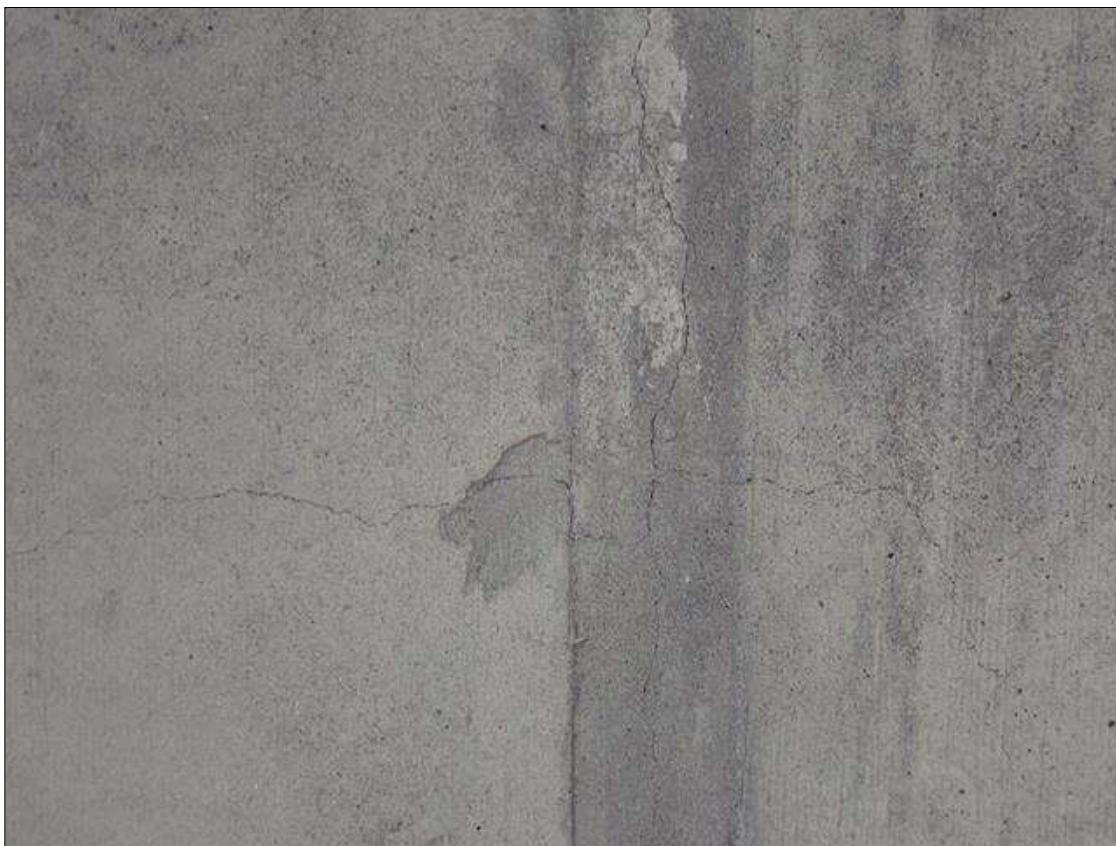
Span 1 Deck: 750 SF OF MAP CRACKING UP TO 1/32", IN UNDERSIDE OF DECK, AT RANDOM THROUGHOUT.

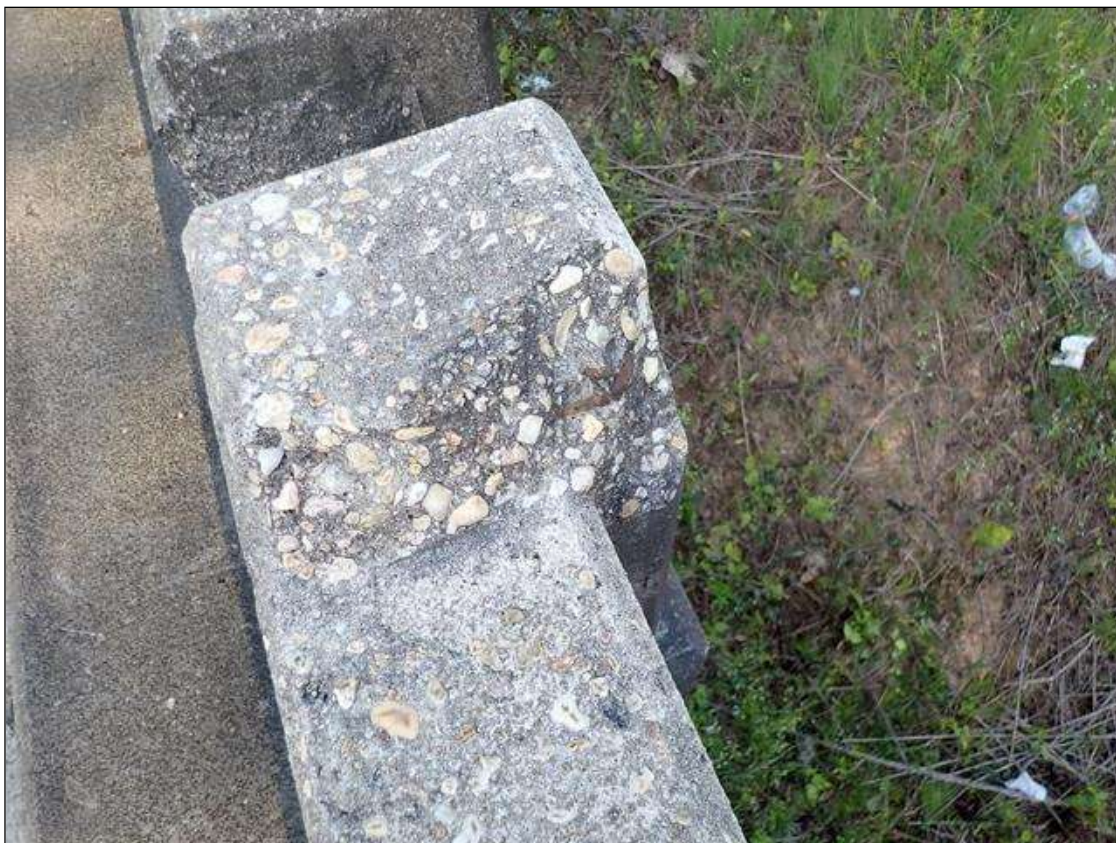
Span 1 Left Bridge Rail: (2)- UP TO 4" X 10" X 7" SPALLS WITH EXPOSED REBAR, NO MEASURABLE SECTION LOSS, IN TOP OF POSTS, 17' FROM END BENT 1.

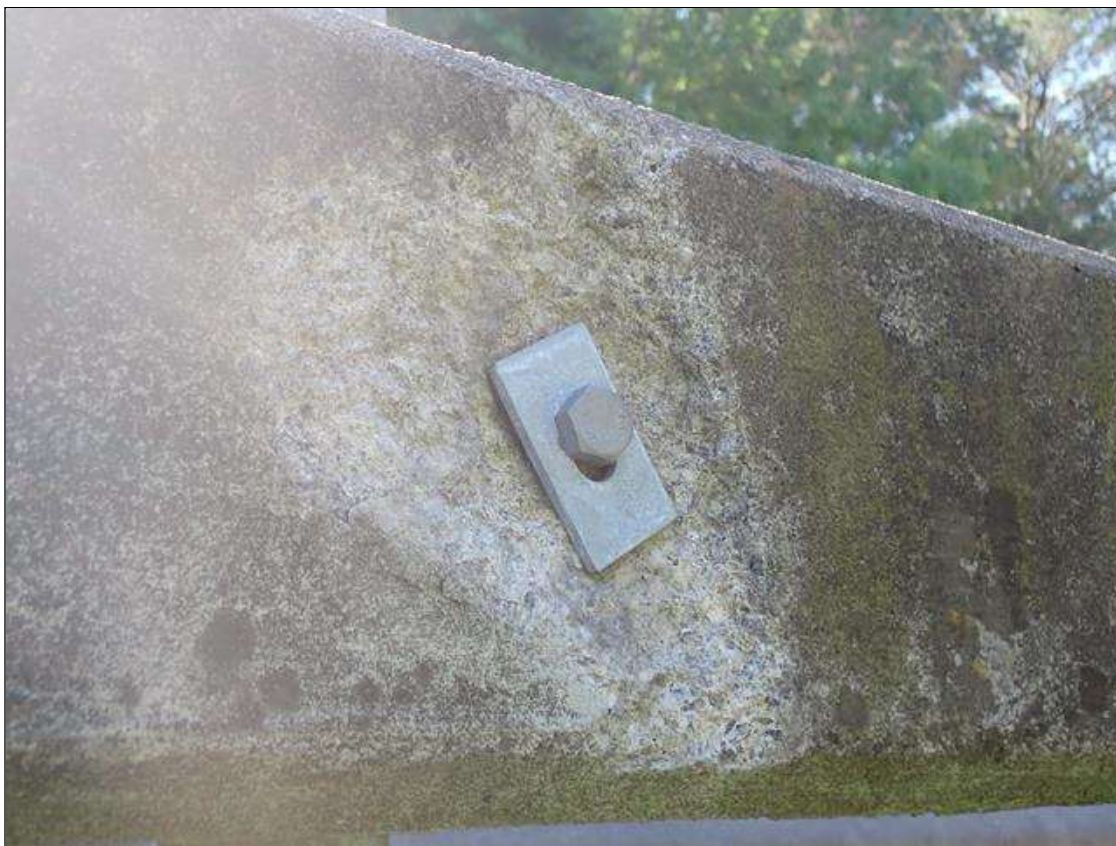
Span 1 Left Bridge Rail: (5) up to 7" x 9" x 1" deep spalls on outside face of concrete rail at bolt locations, no exposed rebar.

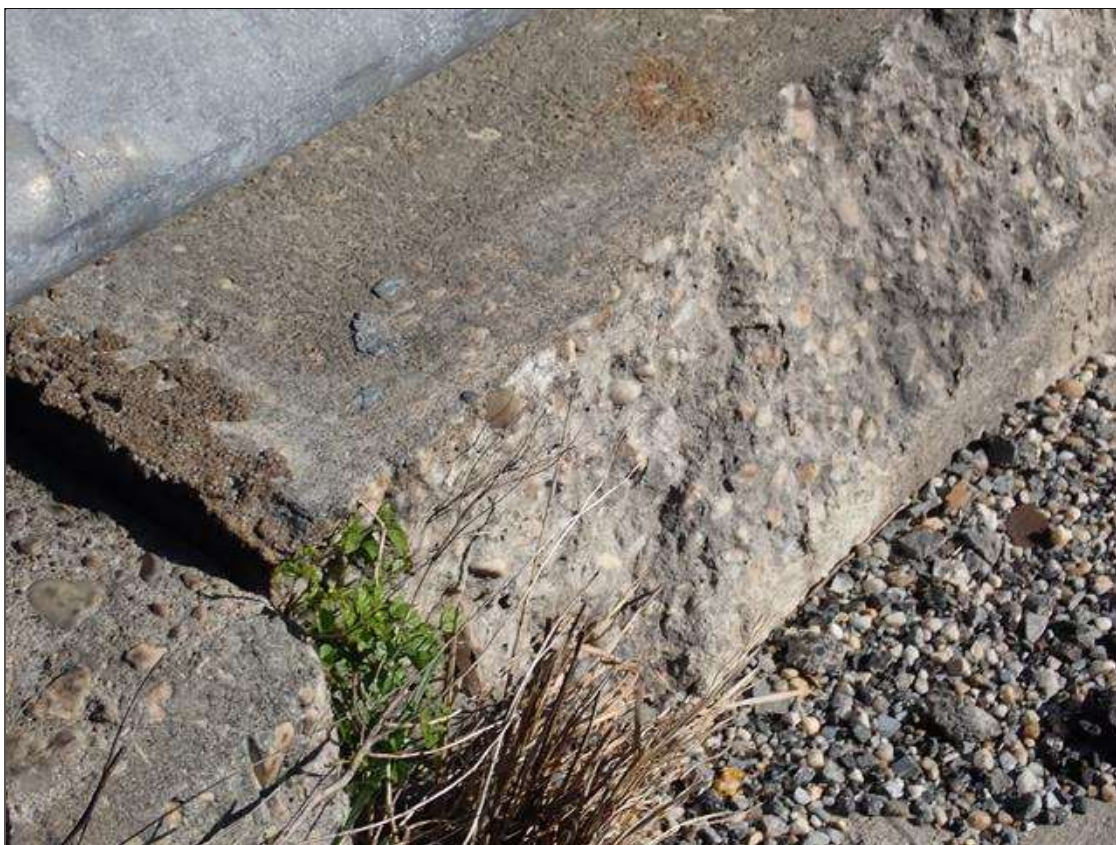
Span 1 Left Bridge Rail: 35" x 9" x 2" deep spall with exposed rebar and no measurable section loss on concrete curb at End Bent 1

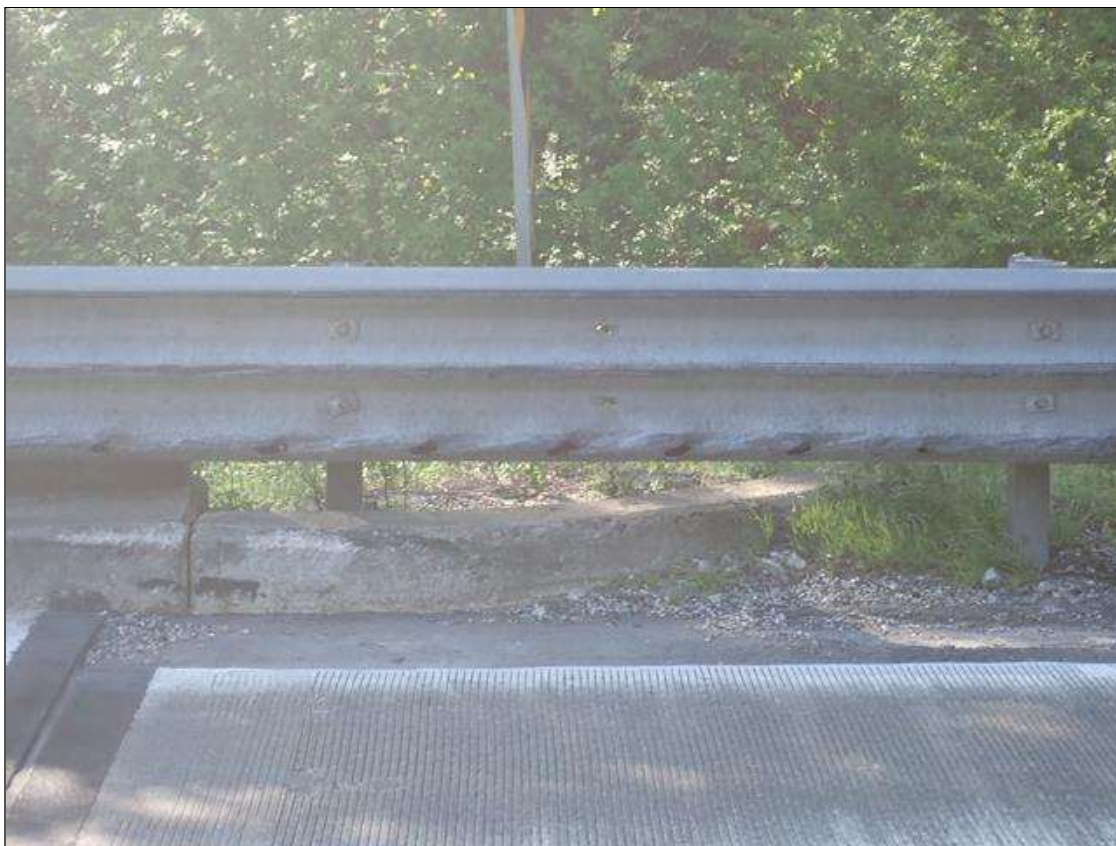
Span 1 Right Bridge Rail: 52' OF DAMAGE TO METAL BRIDGE RAIL, RAIL STILL FUNCTIONAL.

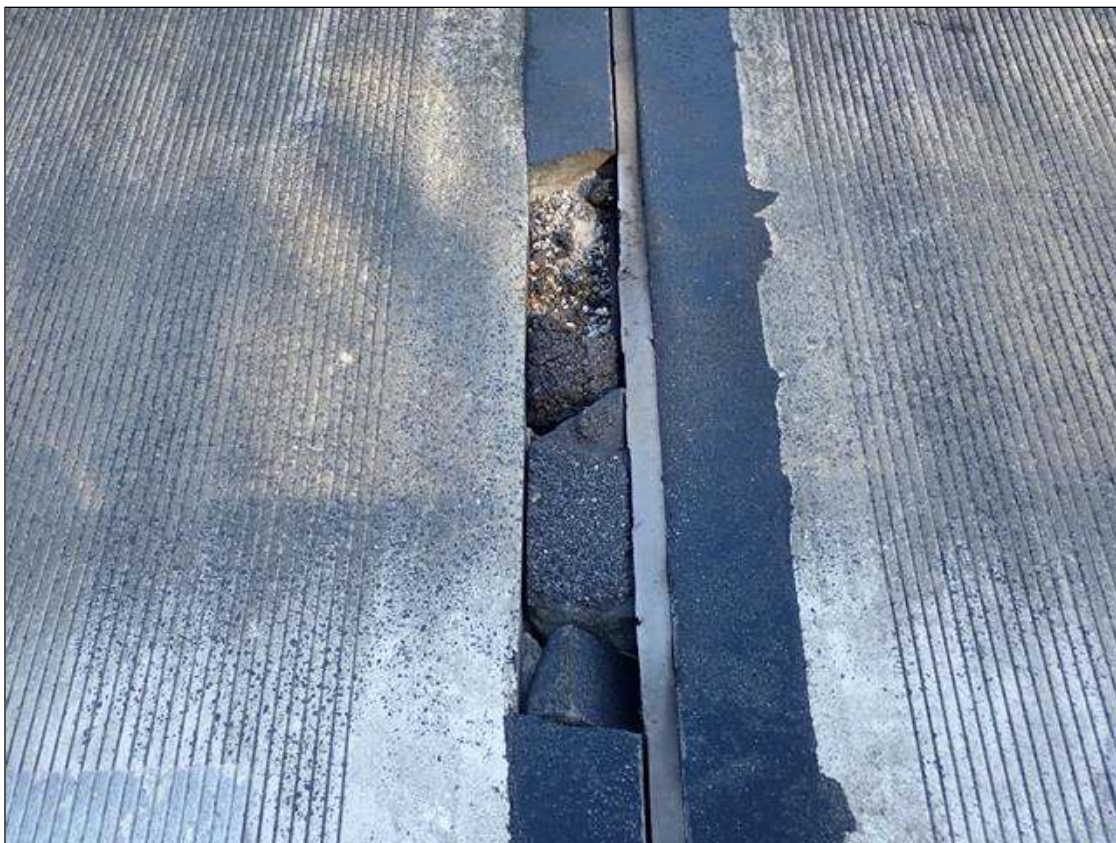
Span 2 Expansion Joint at Bent 1: 32" x 6" x 3" deep spall in the right Northbound lane joint header, no exposed rebar.

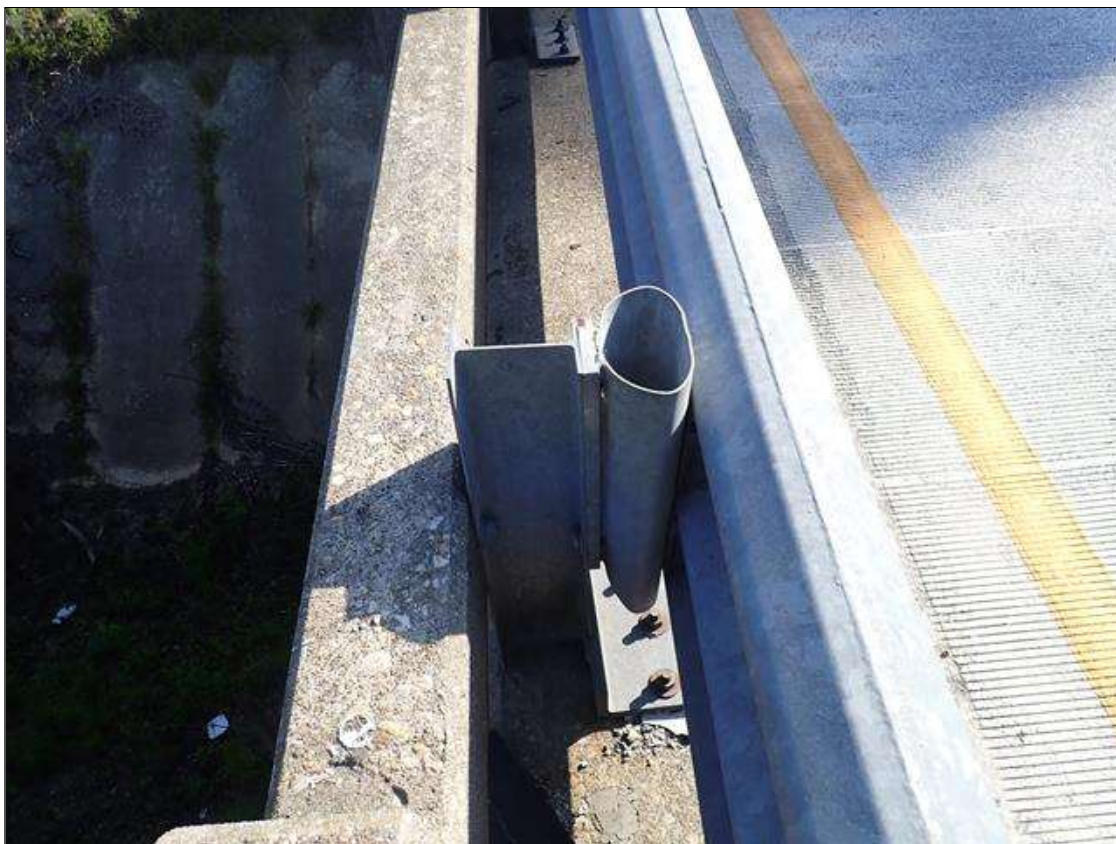
Span 2 Left Bridge Rail: 20' impact damage with 2" deflection to the West on metal rail, extending from Bent 2, rail still functional.

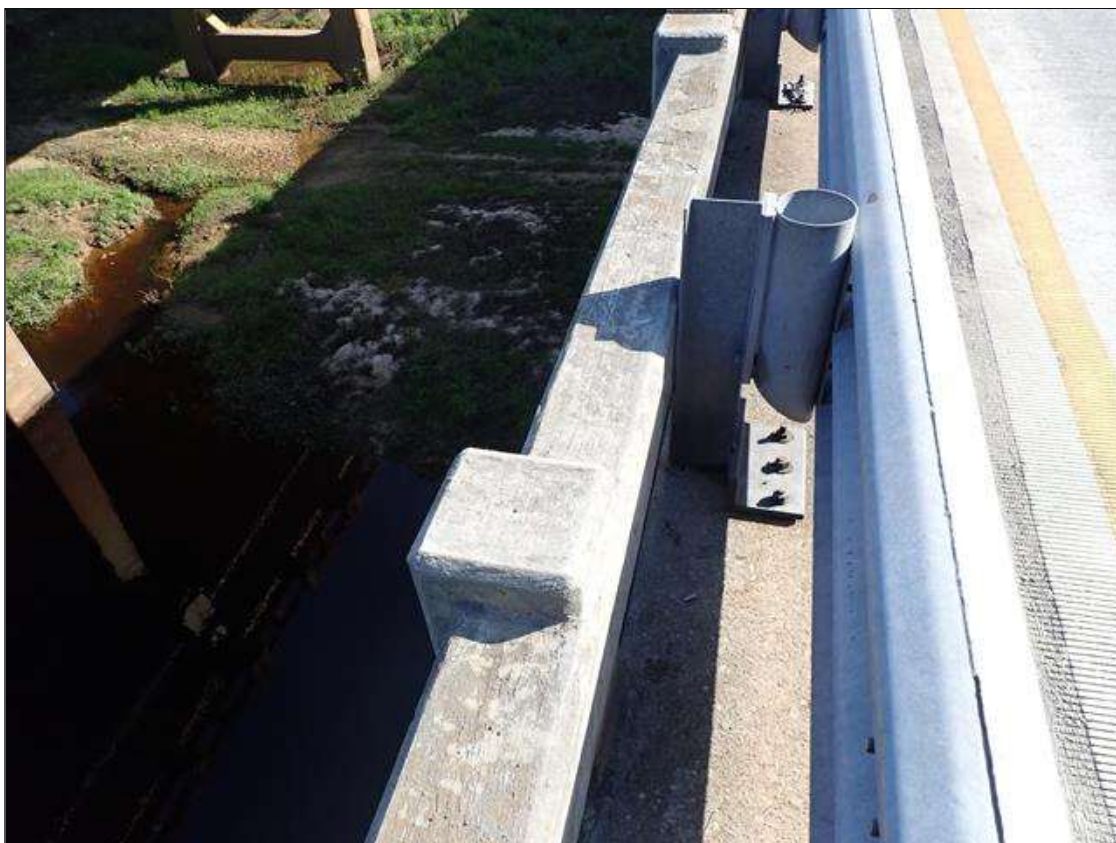
Span 2 Left Bridge Rail: 10' repaired section of concrete rail at midspan

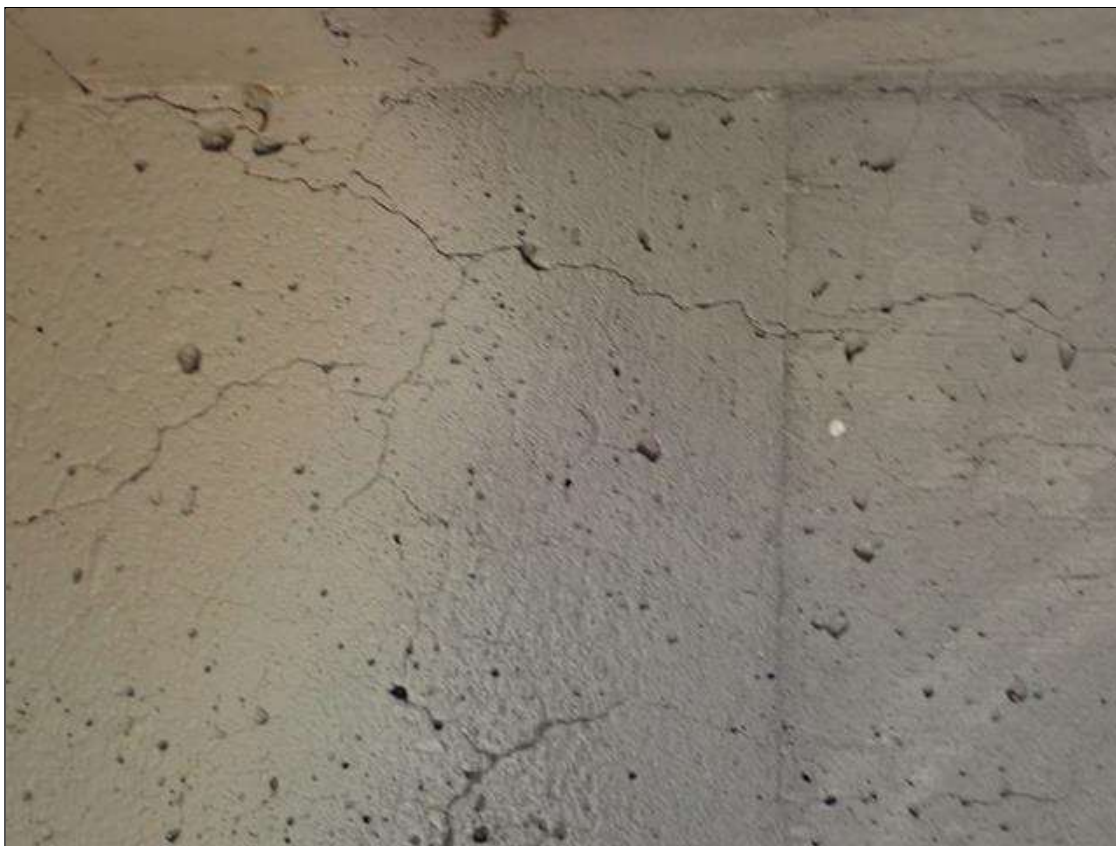
End Bent 1 Abutment: 32' OF HORIZONTAL AND VERTICAL CRACKS UP TO 1/32", SOME WITH EFFLORESCENCE.

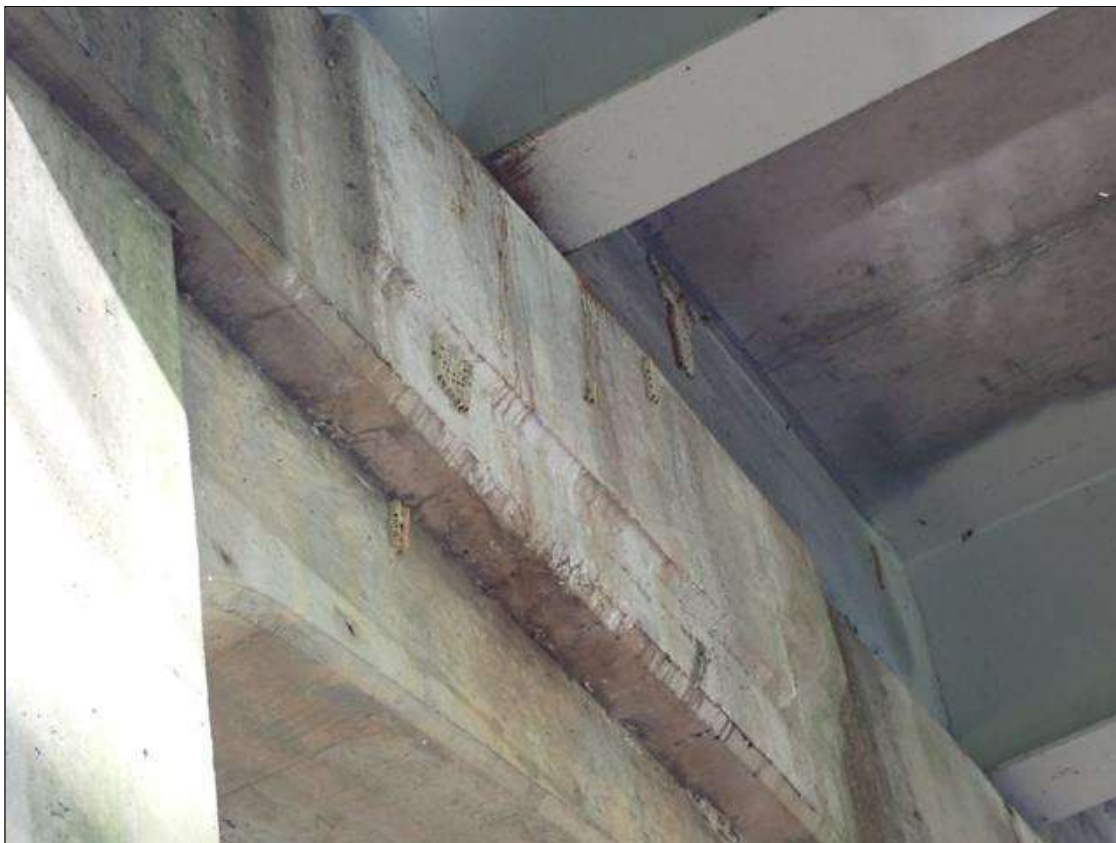
Bent 1 Cap 1: 6' X UP TO 16" SOUND PATCHED AREA, NORTH FACE, UNDER BEAM 3.

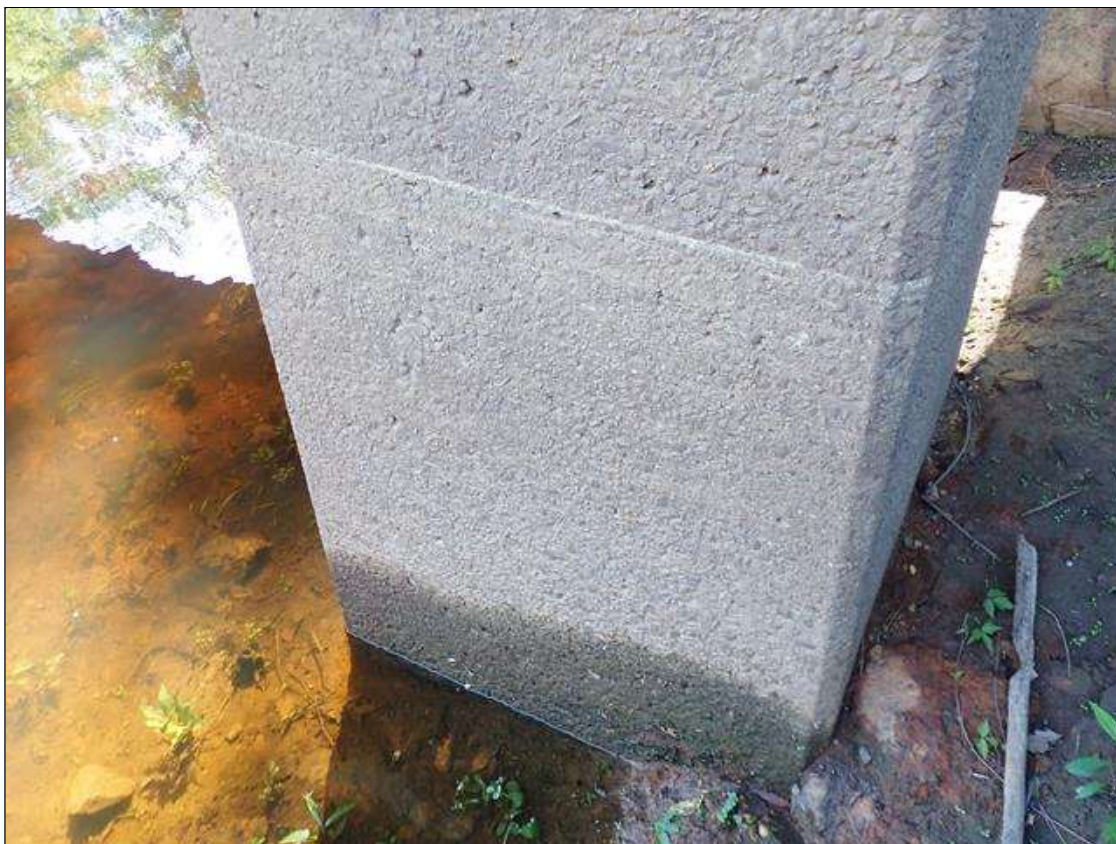
Bent 1 Pile 1: 2' ABRASION/WEAR 12' FROM BOTTOM OF CAP WITH AGGREGATE INTACT

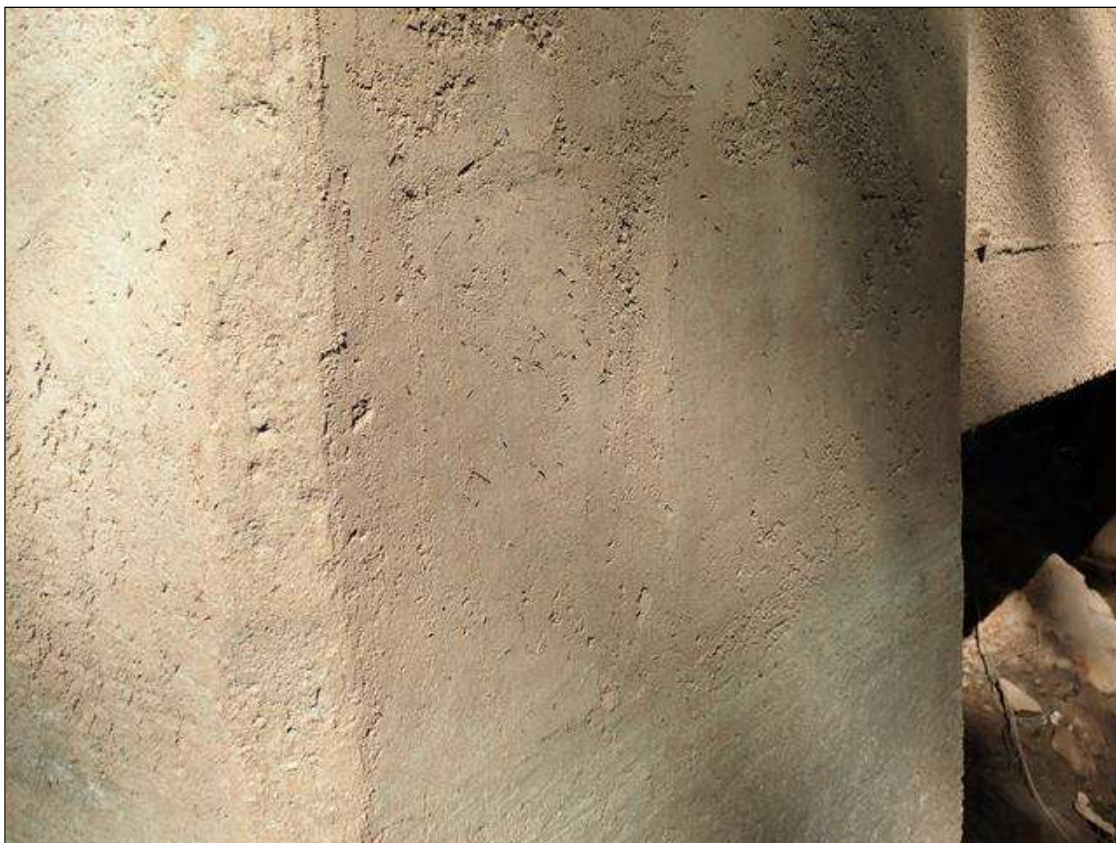
Bent 1 Pile 2: 2' diameter area of sound patch on Span 2 face, 12' from bottom of cap.

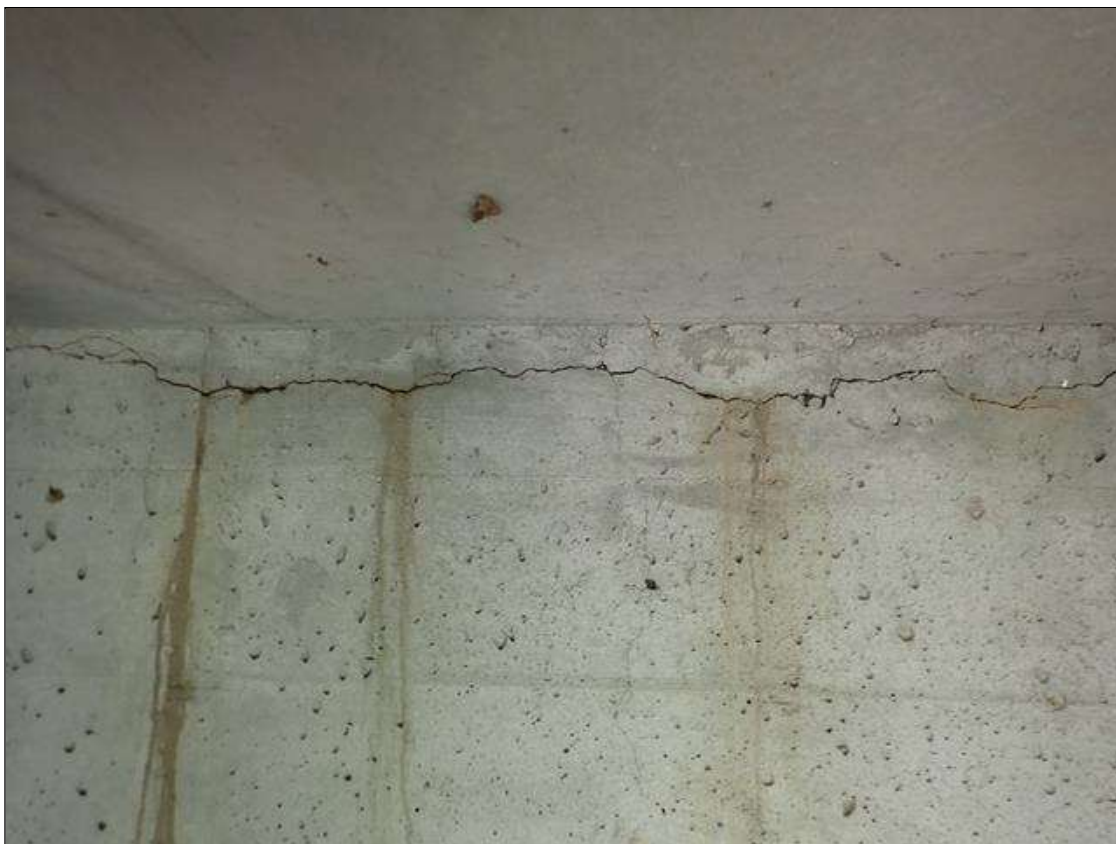
End Bent 2 Abutment: HORIZONTAL AND VERTICAL CRACKS UP TO 1/8", SOME WITH EFFLORESCENCE, IN ALL BAYS.

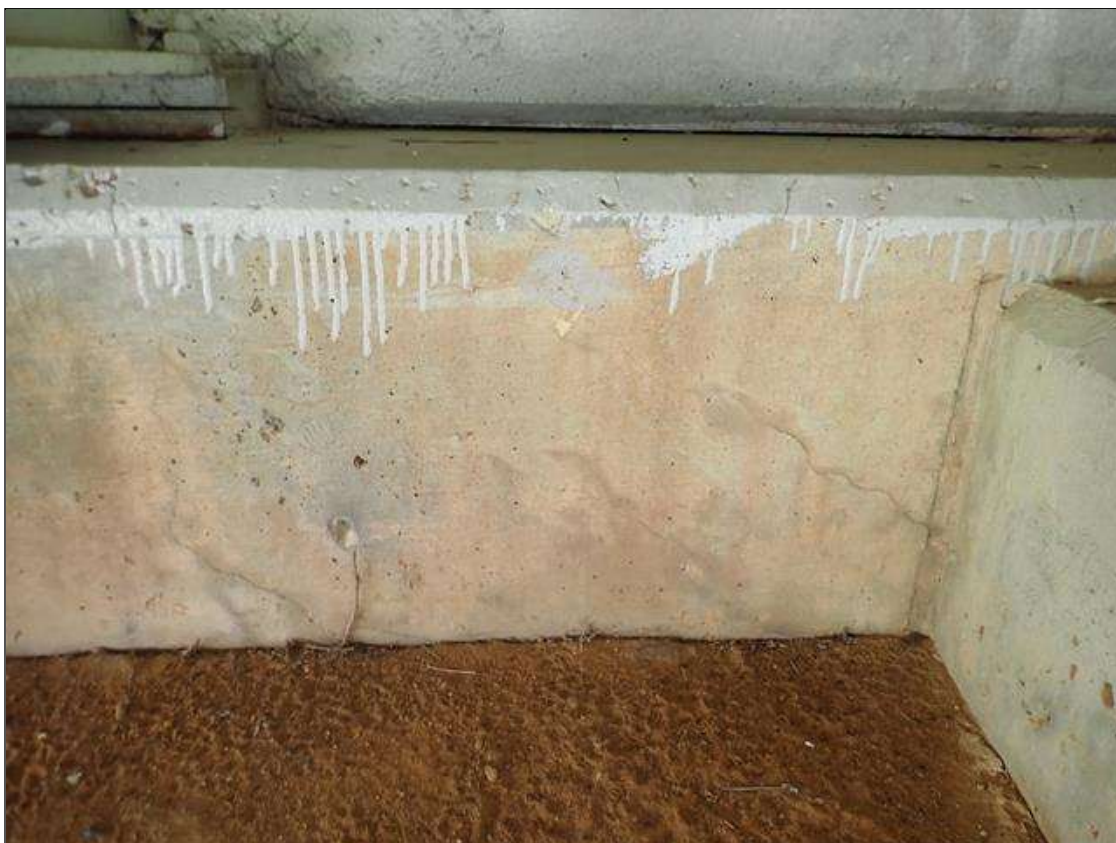
End Bent 2 Cap 1: 12' X 2' AREA OF MAP CRACKING UP TO 1/32", BEGINNING AT WEST END.

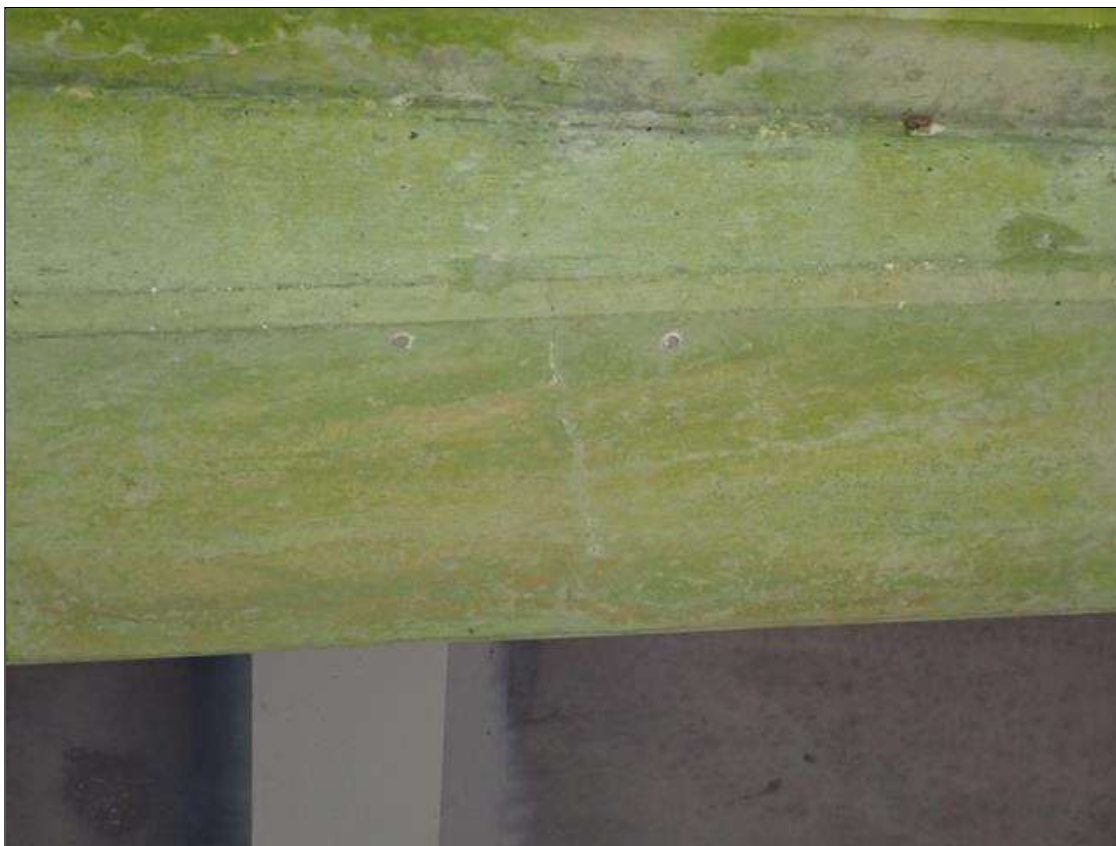
Bent 2 Cap 1: (3) up to 20" x 1/64" transverse cracks, some with efflorescence, on bottom of corbel between Columns 1 and 2

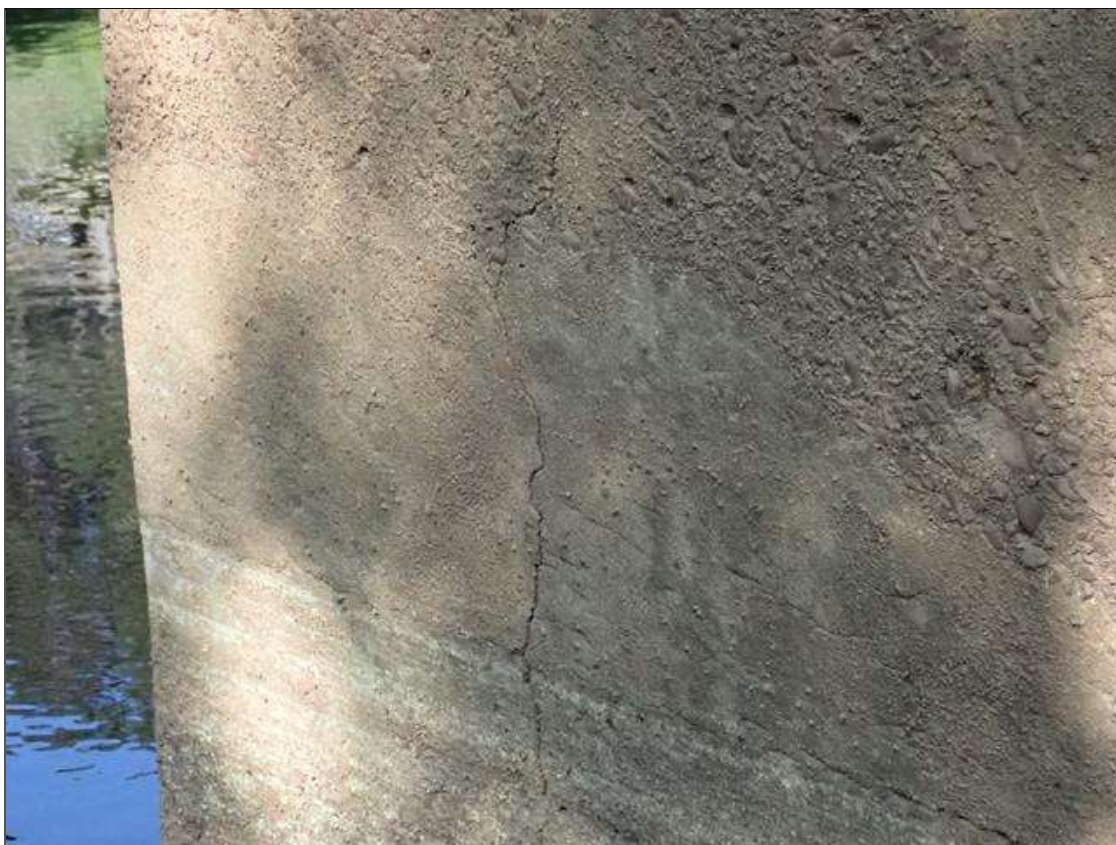
Bent 2 Pile 2: 72" x up to 1/16" vertical crack on East face, 13' from bottom of cap (Span 3 face similar)

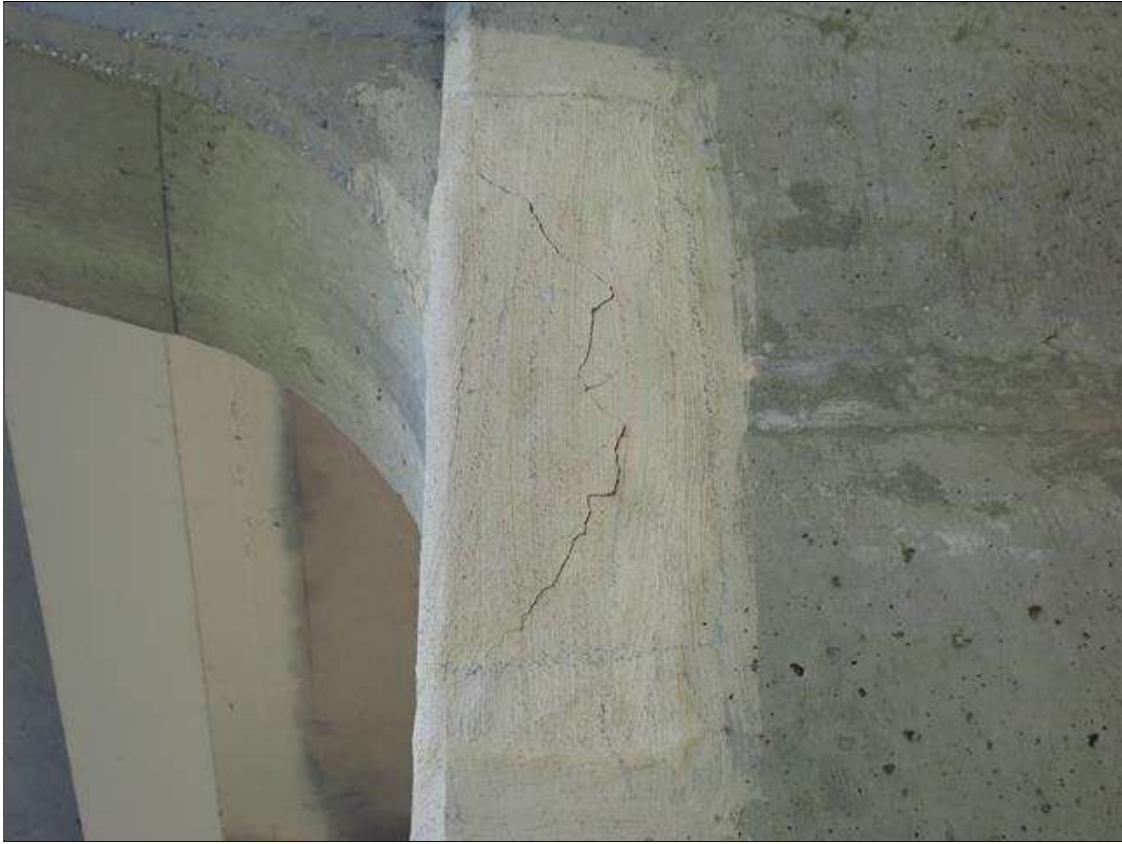
Bent 3 Pile 1: 24" x up to 7" x 4" cracked patched area and delamination, 2' from bottom of cap, on Span 3 face

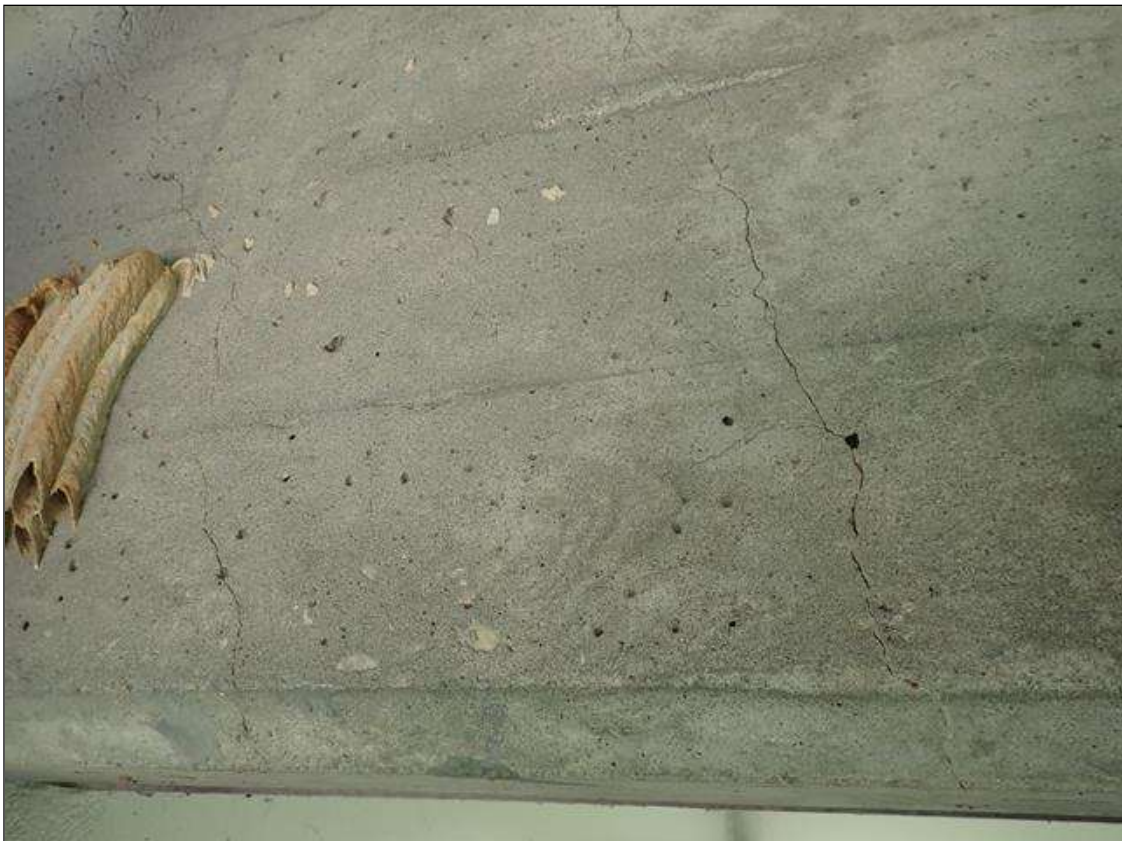
Span 4 Beam 1: 5 FULL HEIGHT HAIRLINE VERTICAL CRACKS IN BAY 1 END BENT DIAPHRAGM.

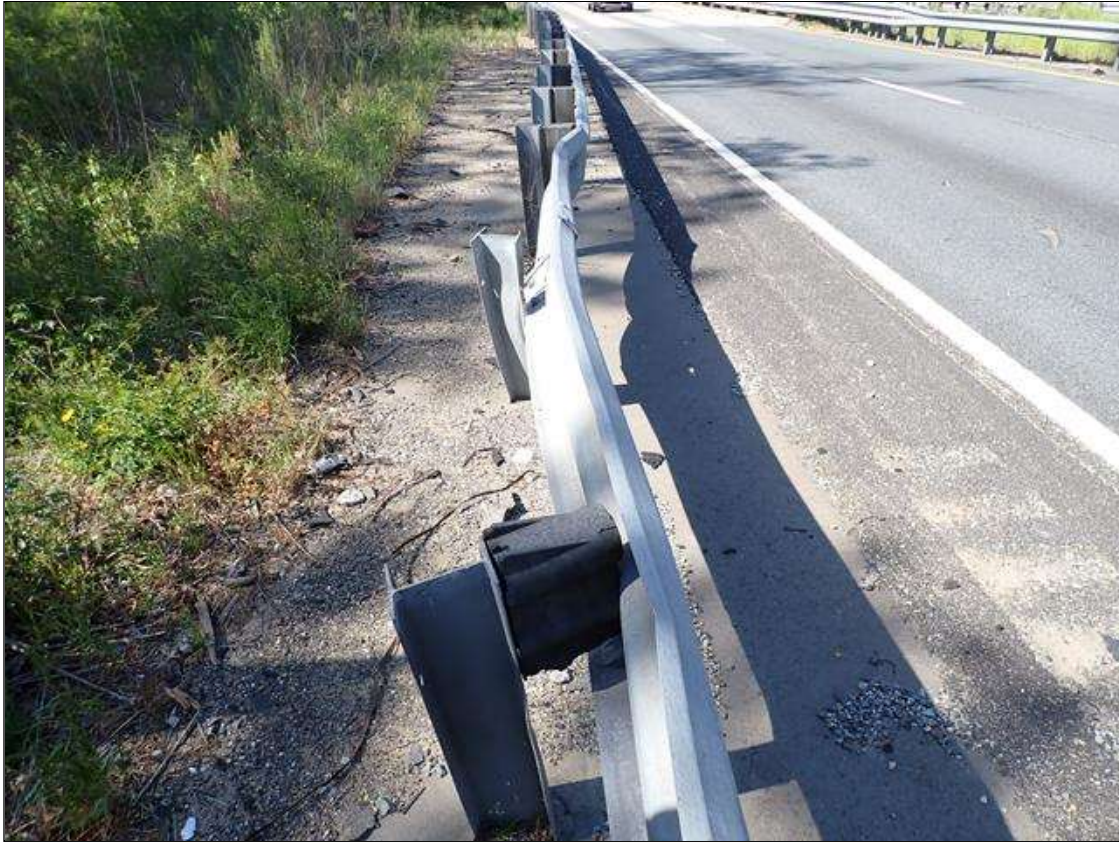
15' LONG SECTION OF IMPACT DAMAGE TO APPROACH GUARDRAIL ON NORTHEAST CORNER 50' FROM BRIDGE, RAIL STILL FUNCTIONAL.

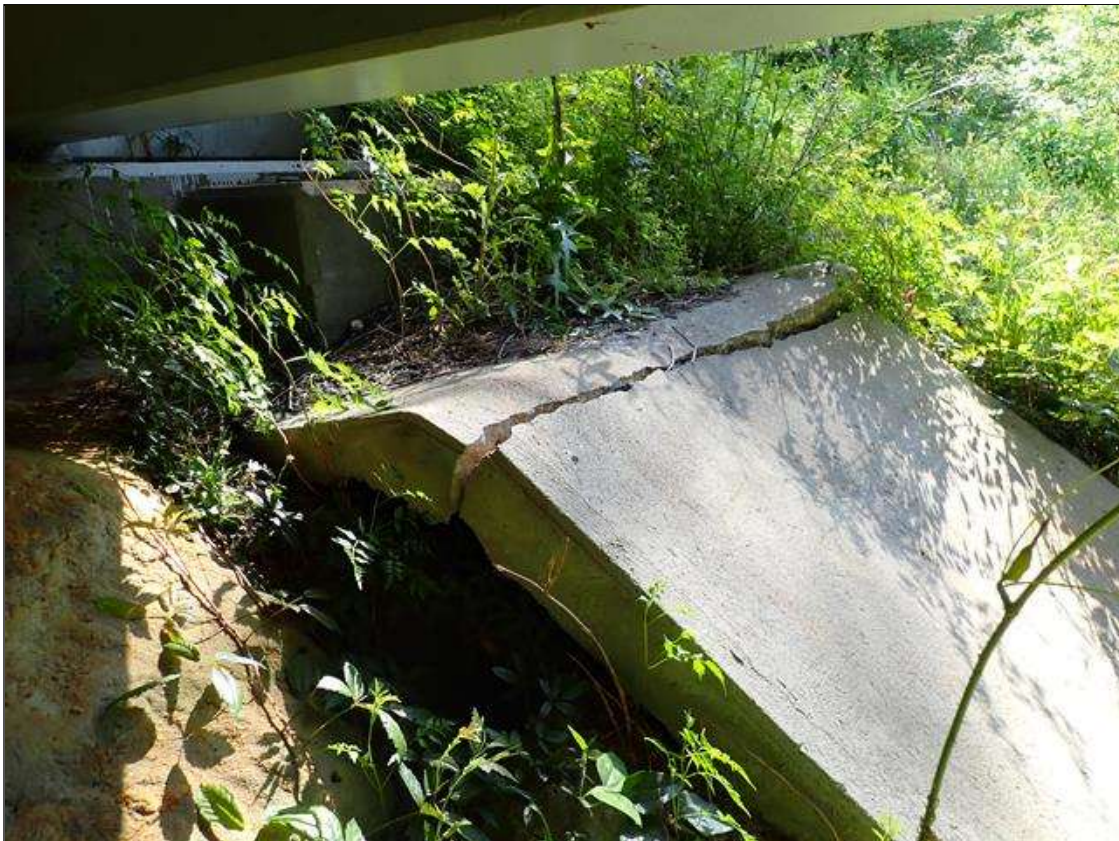
DECK DRAIN DITCH IS CRACKED AND SETTLED UP TO 6" ON EAST AND WEST SIDES OF END BENT 2.

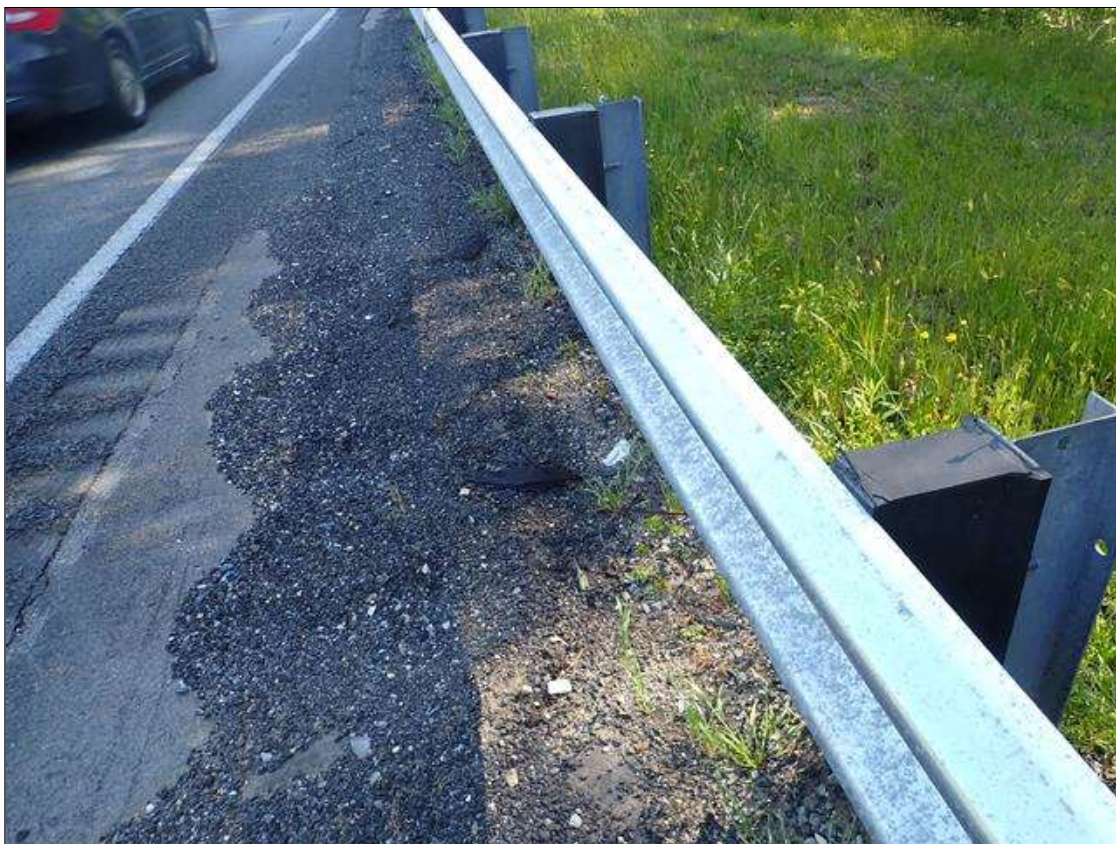
36' OF REPAIRED GUARDRAIL AT SOUTHEAST CORNER, AT END BENT 1.

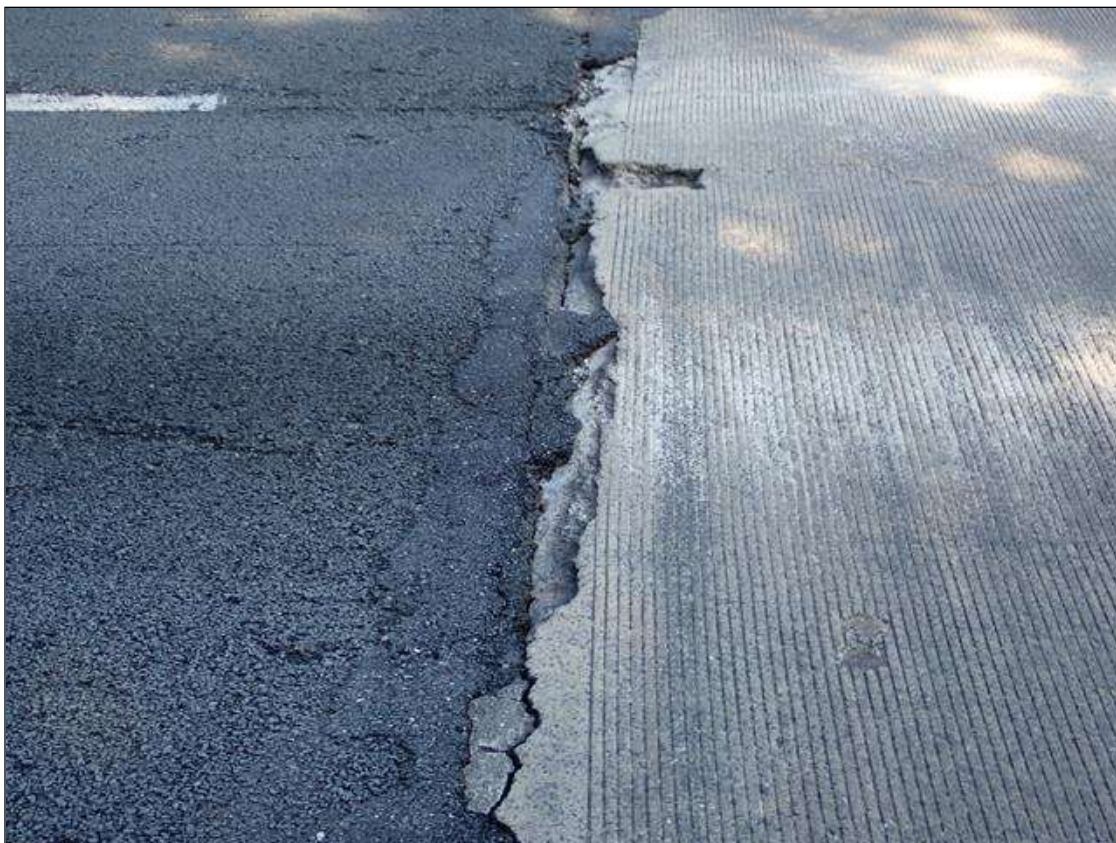
Approach 1 : (3)- UP TO 11' X UP TO 1' X 3" SPALLS, AT SOUTH END.

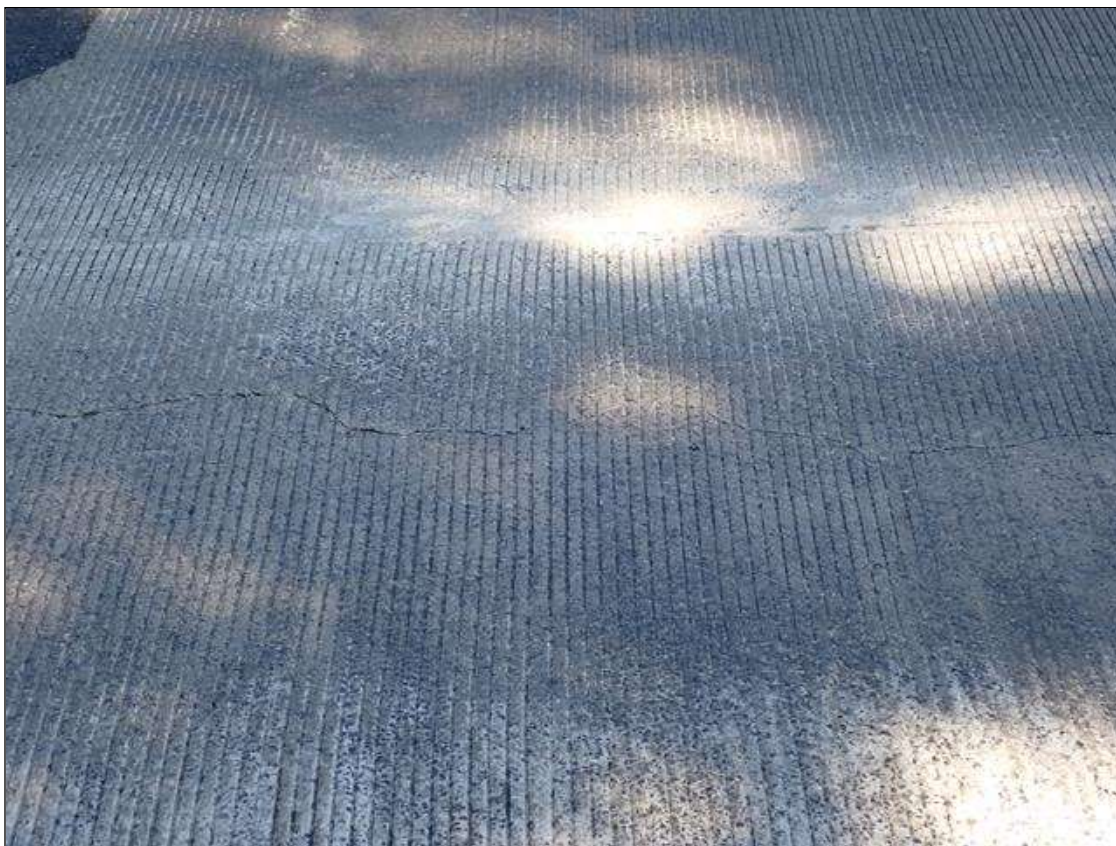
Approach 1 : 3' x up to 1/16" transverse crack in East lane at South end

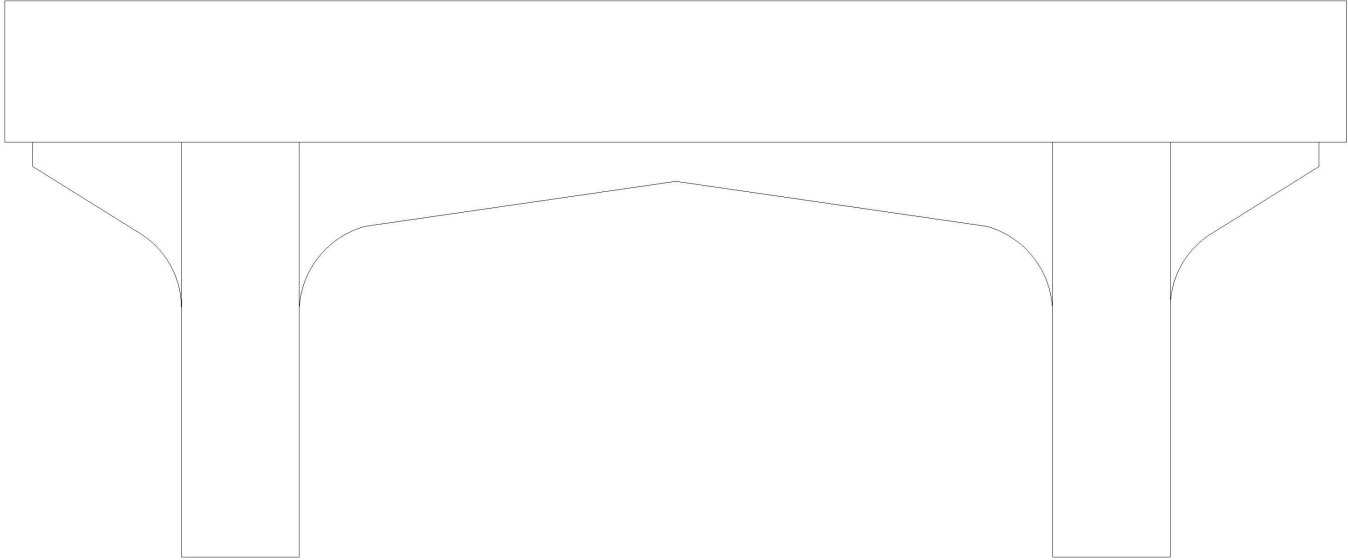
Cap Information			Material Cast-in-Place Concrete							
Length	Width	Height	Left Overhang	Right Overhang	Left Beam to End of Cap.	Right Beam to End of Cap.				
27.000 ft.	2.500 ft.	2.500 ft.	5.000 ft.	5.000 ft.	1.500 ft.	1.500 ft.				
Subcap Information			Material							
Length	Width	Height	Left Overhang	Right Overhang	Left Pile to Splice.					
Sill Information			Material							
Length	Width	Height								
Pile #	Material	Spacing	Width/Dia.	Height	Length	Orientation	Driven?	Replacement?	Removed?	Collar?
1	Concrete	17.000 ft.	2.333 ft.			Vertical	No	No	No	No
2	Concrete		2.333 ft.			Vertical	No	No	No	No
VERIFIED ON 4/22/2022 BY JEK.										
Bent/Abutment #: 1			Similar Bents: BENTS 2 & 3
