NC DEPARTMENT OF TRANSPORTATION ATTENTION:
 DIVISION OF HIGHWAYS
 STRUCTURE MANAGEMENT UNIT

Structure Safety Report

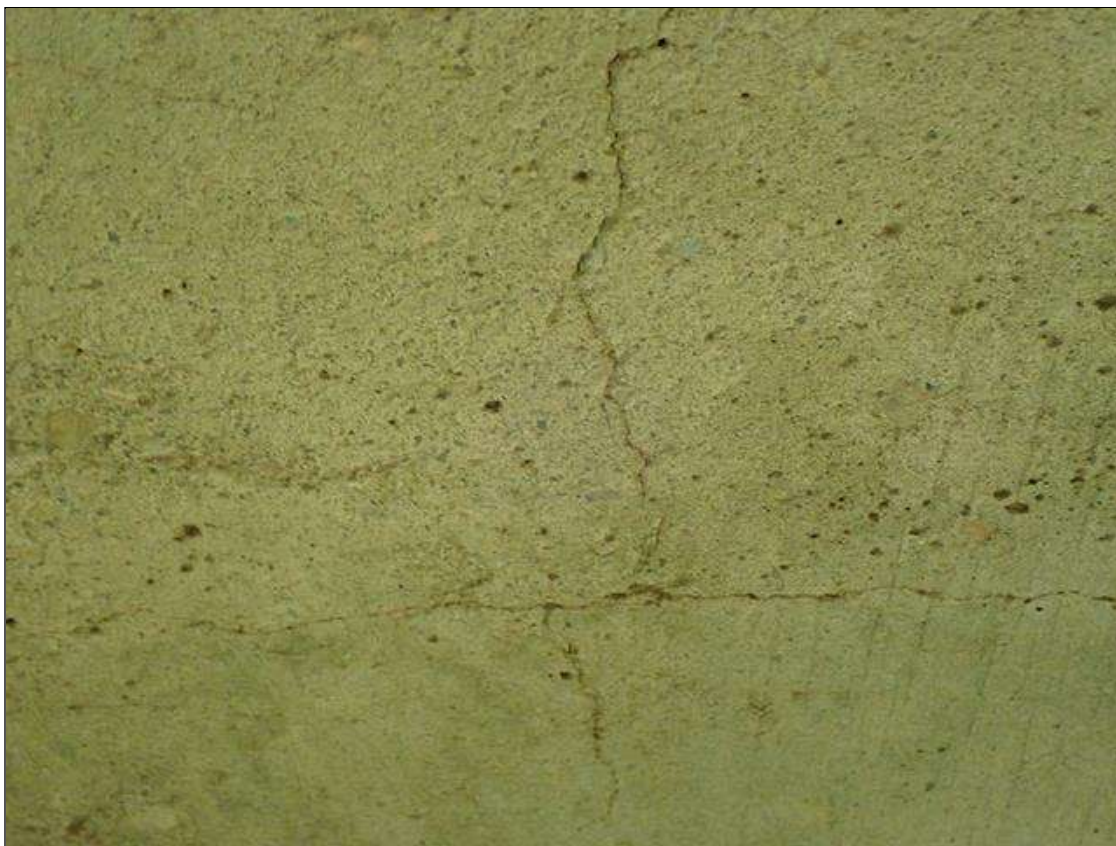
Span 1 Deck: 400 SF MAP CRACKING UP TO 1/32" AT RANDOM THROUGHOUT UNDERSIDE OF DECK

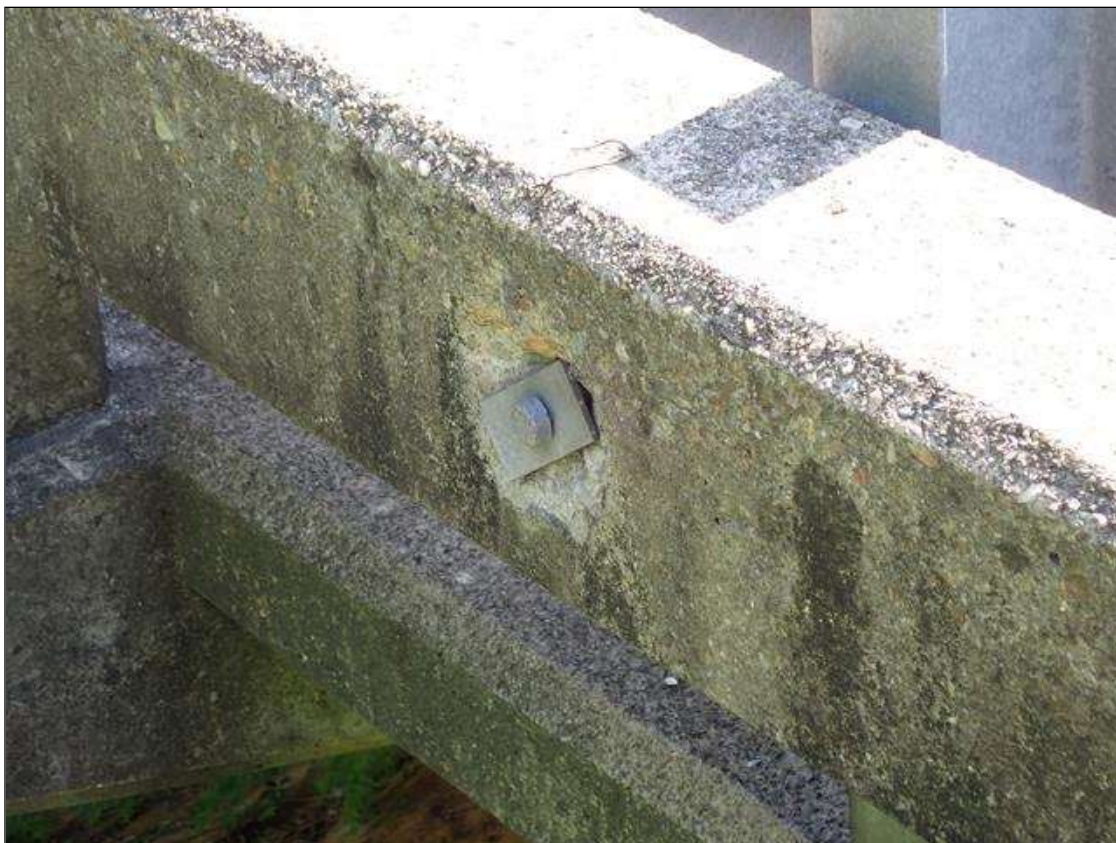
Span 1 Left Bridge Rail: (3) up to 10" x 6" x 1" deep spall on outside face of concrete rail PHOTO TAKEN NEAR END BENT 1. NO EXPOSED REBAR.

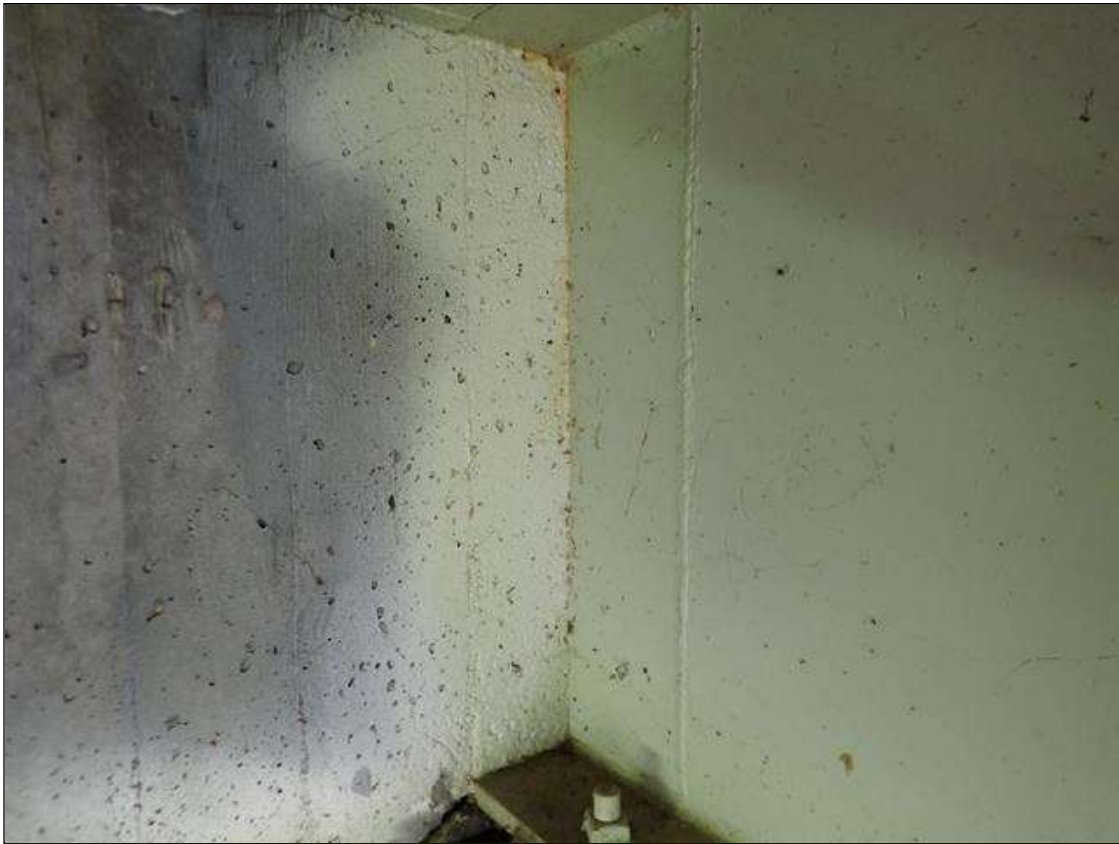
Span 1 Beam 1: 7" x 31" area of replaced beam at End Bent 1

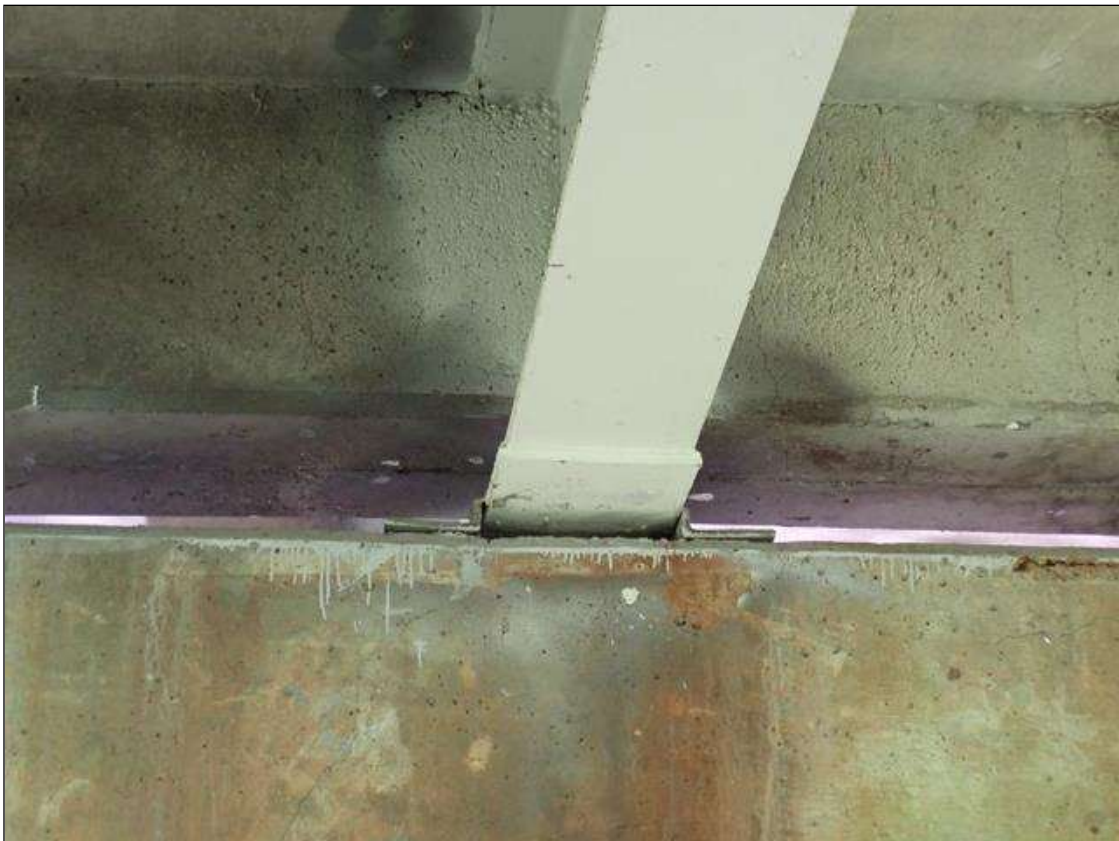
Span 1 Beam 2: 20" x 12" X 3/8" plate welded to bottom flange at Bent 1

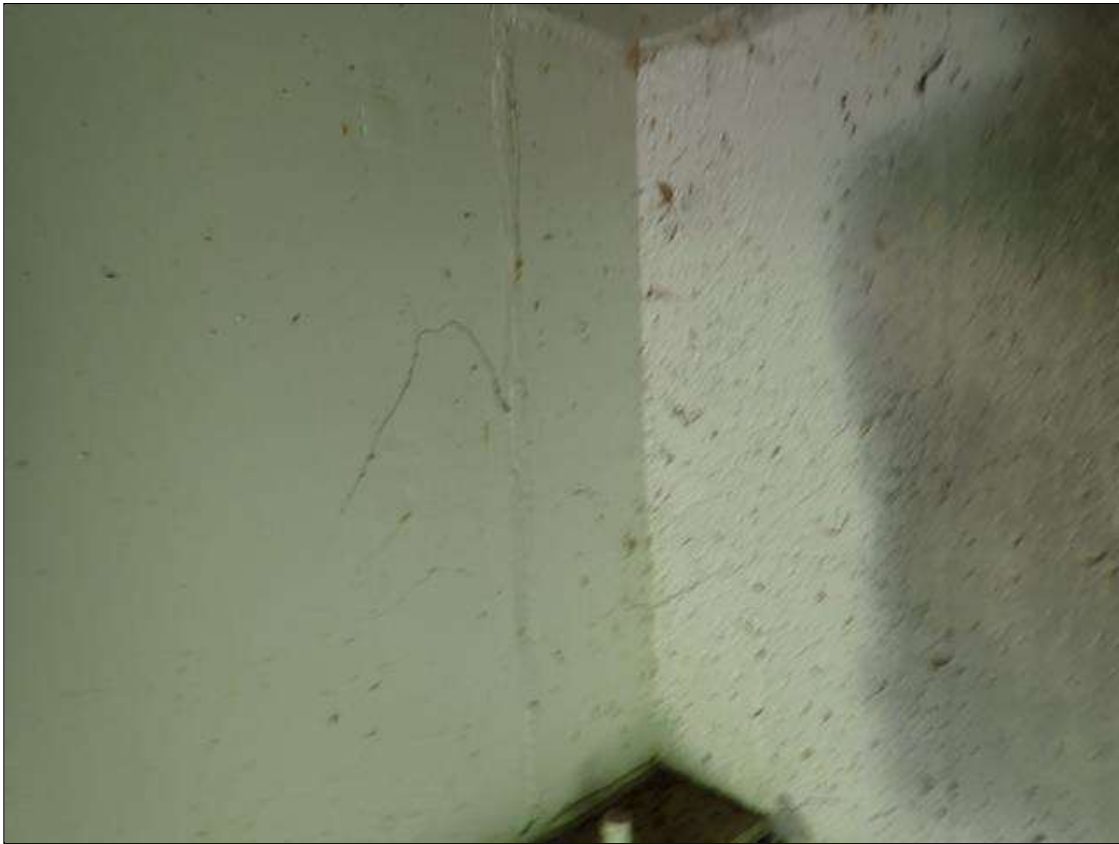
Span 1 Beam 2: 7" x 31" area of replaced beam at End Bent 1

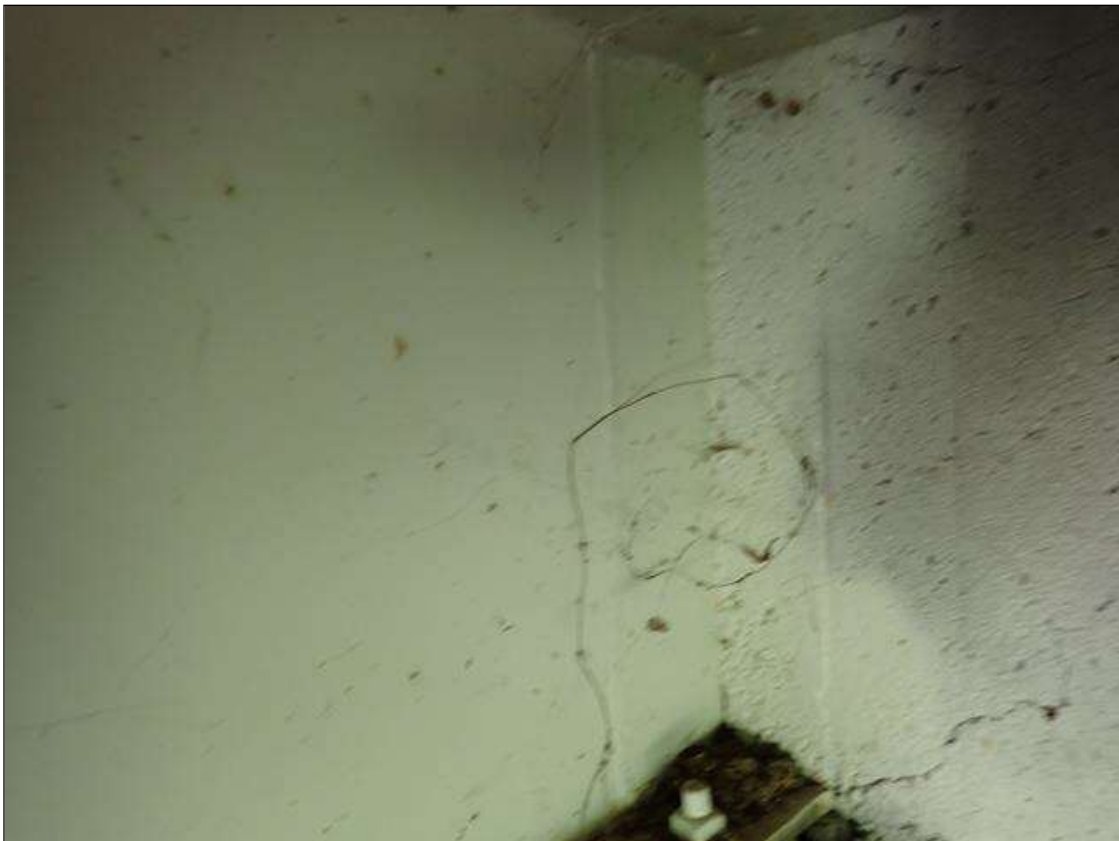
Span 1 Beam 3: 7" x 31" area of replaced beam at End Bent 1

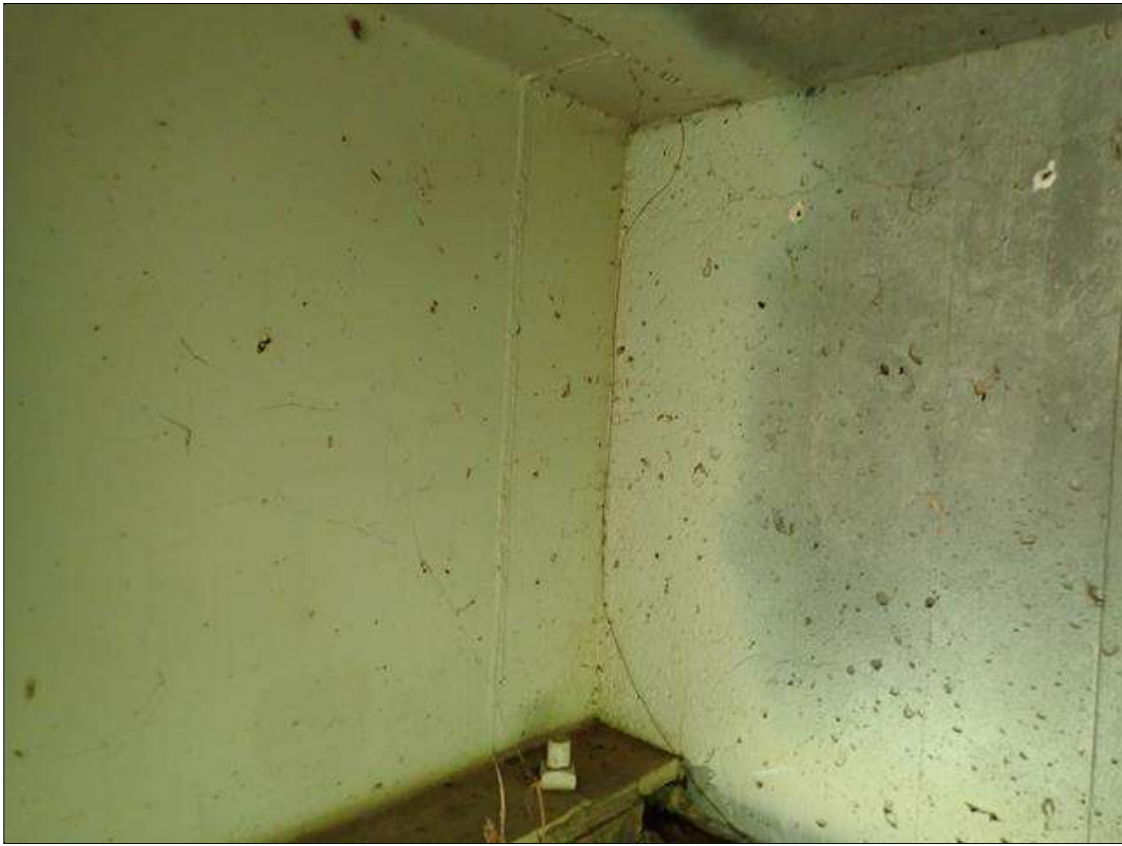
Span 1 Beam 4: 7" x 31" area of replaced beam at End Bent 1

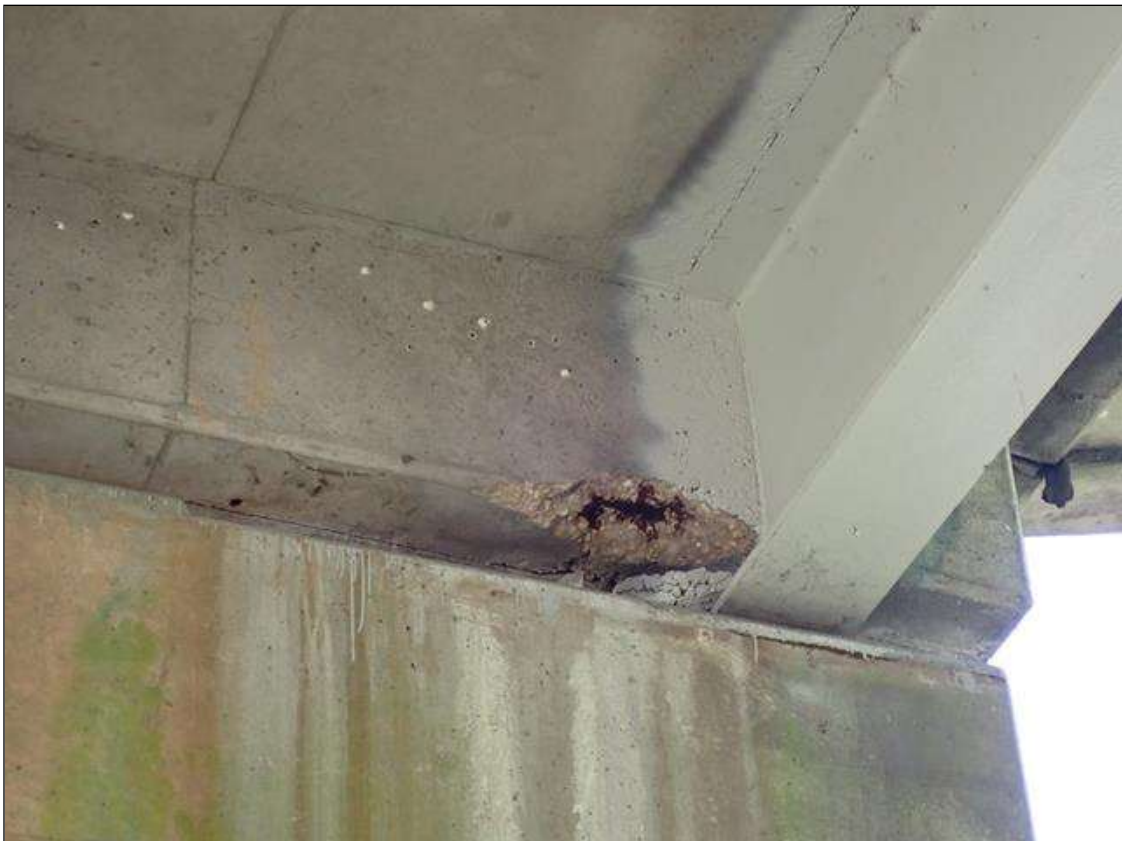
Span 4 Beam 1 end diaphragm at bent 3, bay 1 with a spall, 2 ft x 6" x 6" with exposed rebar, no measurable section loss adjacent to beam 1

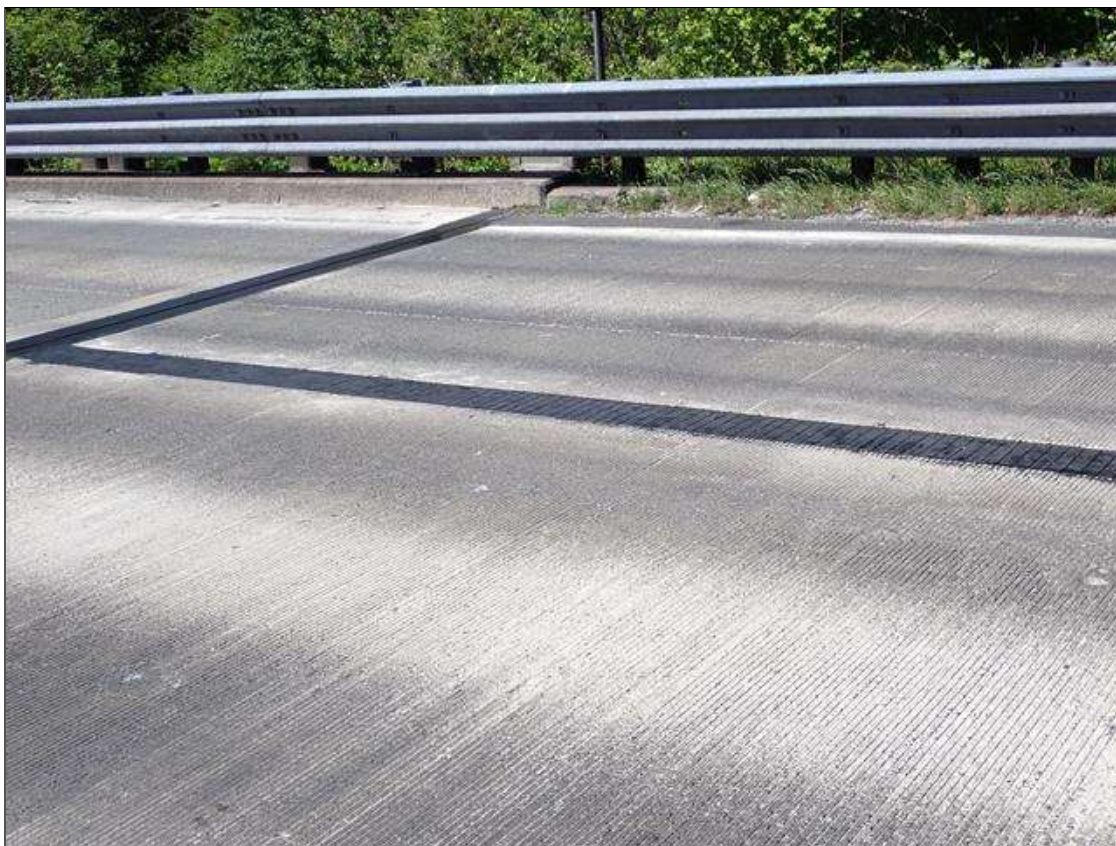
Approach 2 : REPAIR MADE TO CRACK IN CENTERLINE OF APPROACH SLAB

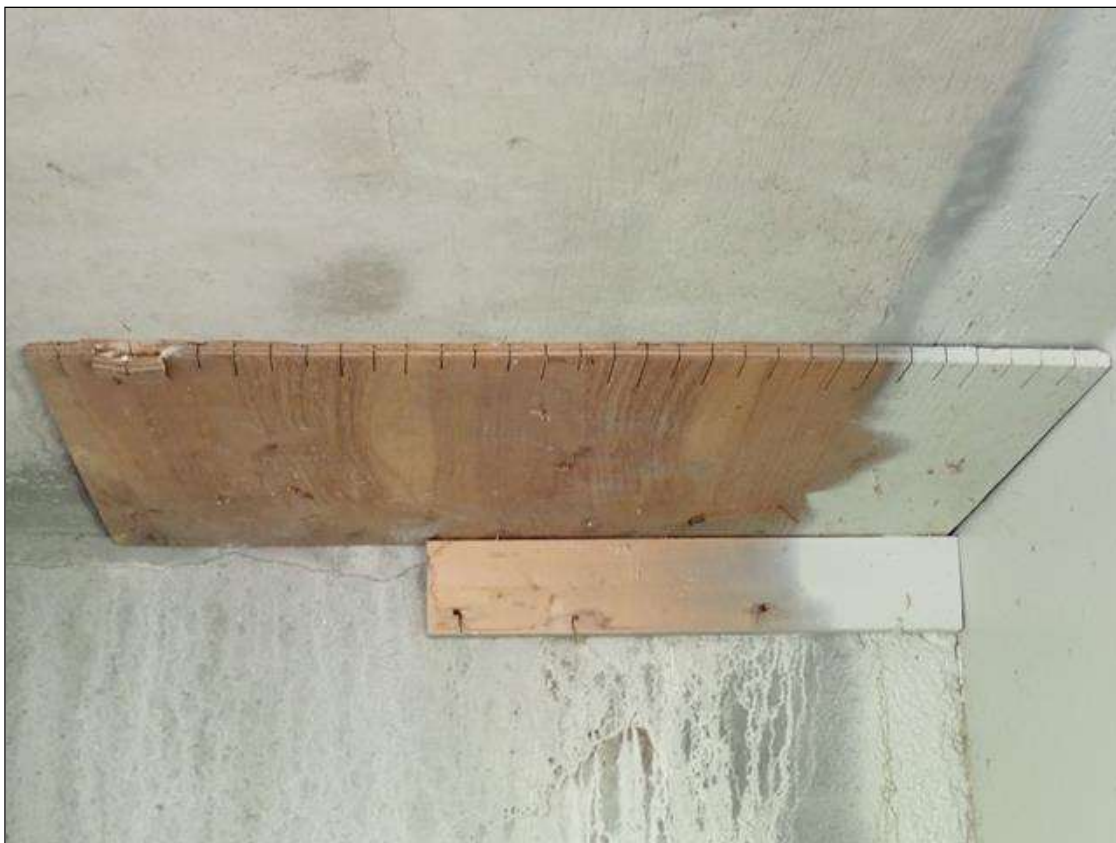
Span 4 Deck: 4' x 2.5' TIMBER STAY IN PLACE FORM WORK IN BAY 1 AT END BENT 2.(1' X 1' SIMILAR IN BAY 3)

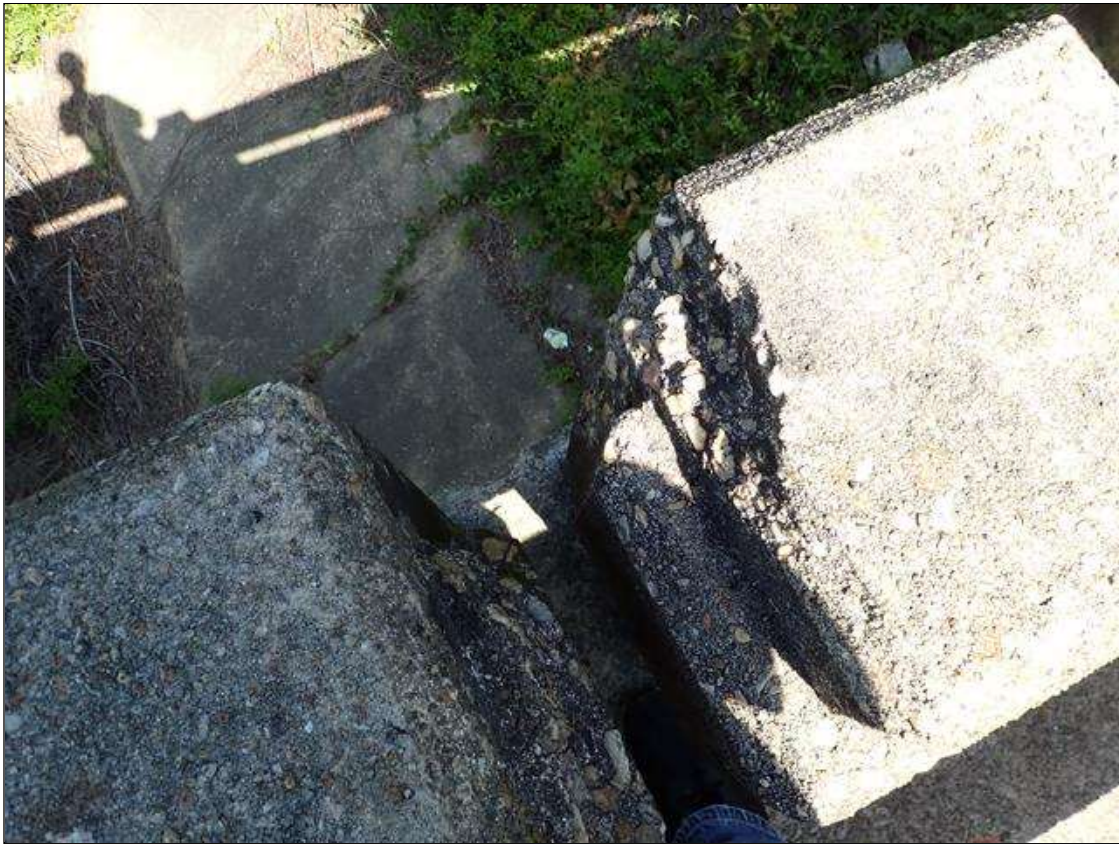
Span 4 Left Bridge Rail: 6" x 1" x 1/2" deep spall with exposed rebar on top of curb, 7' from Bent 3. No measurable section loss.

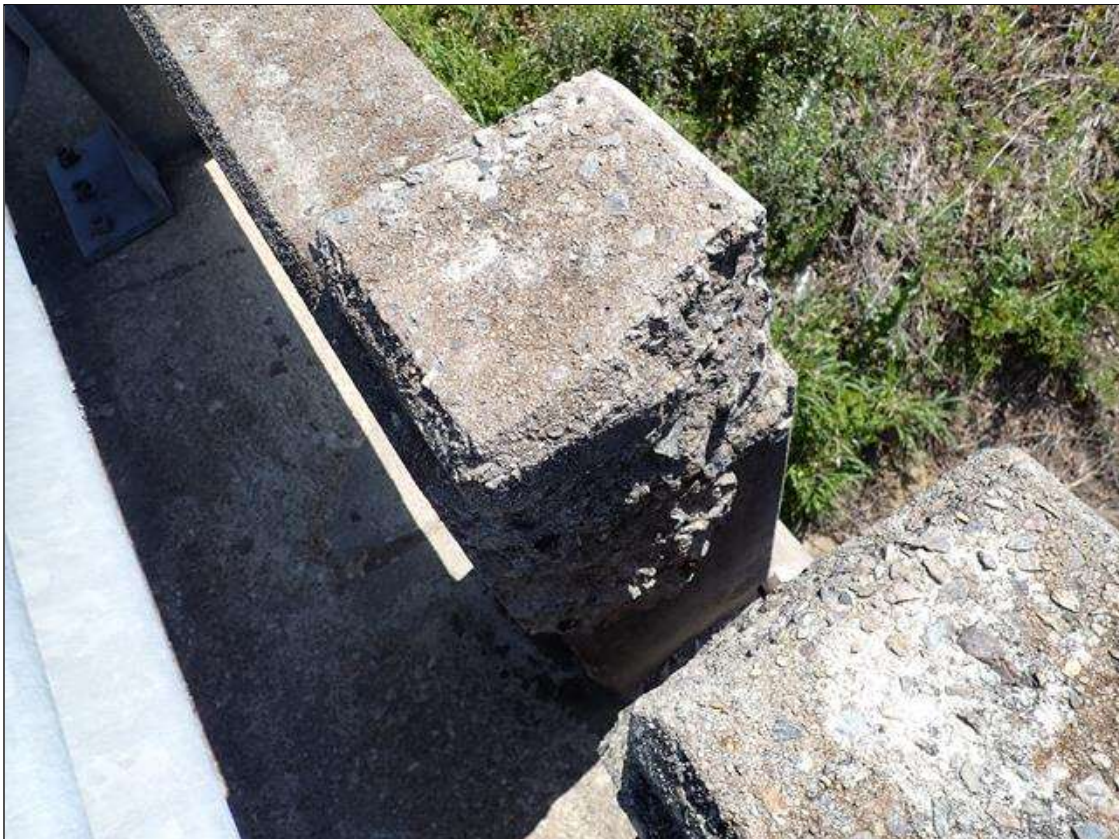
Span 4 Right Bridge Rail: 2" x 8" x 10" deep spall with exposed rebar on concrete Post 7 (Post 6 similar) no measurable section loss

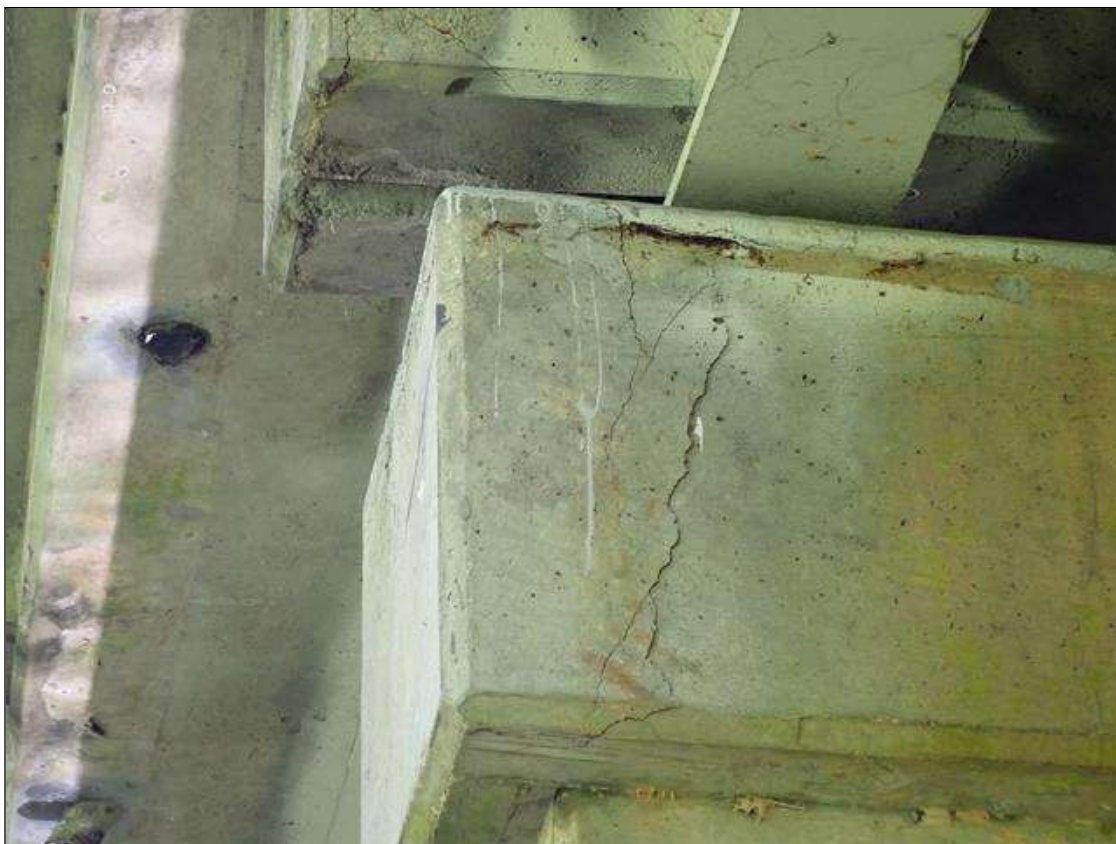
Bent 1 Cap 1: 12" x 24" area of delamination with hairline vertical, diagonal cracks on Span 1 face at West end

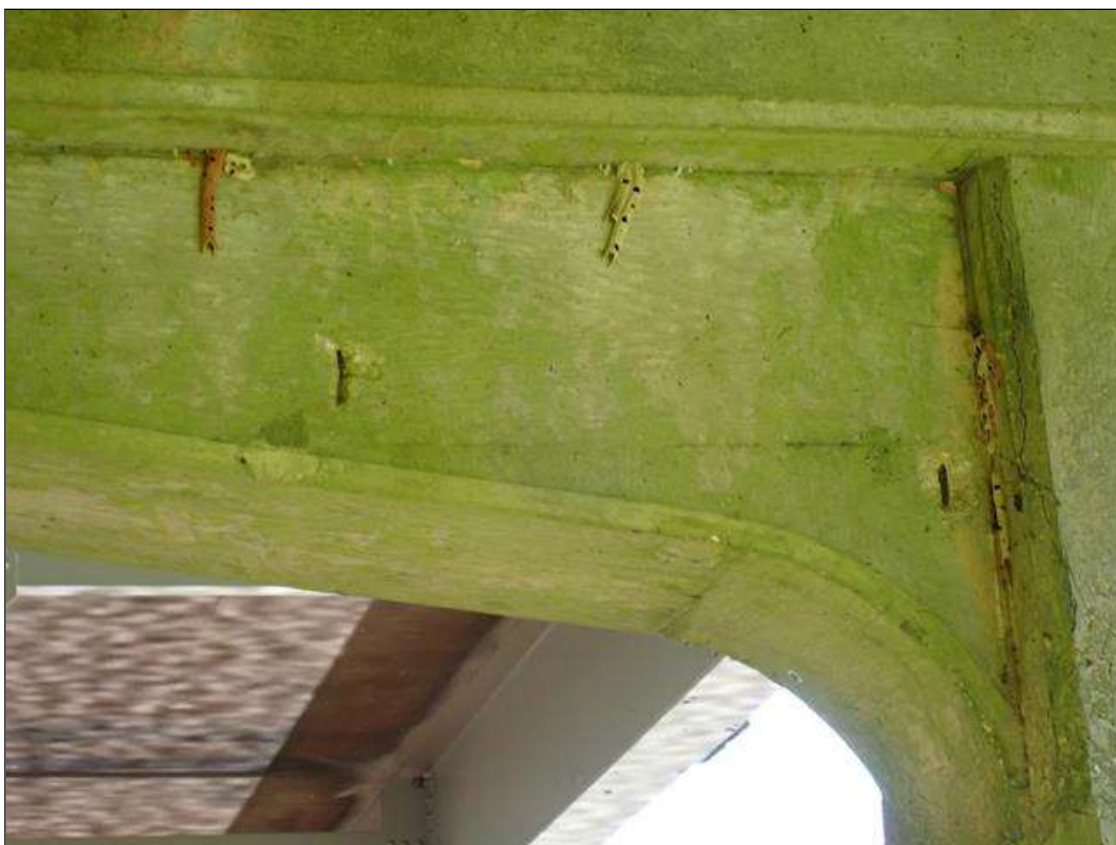
Bent 1 Cap 1: (2) up to 3" x 3" x 1" deep spall with exposed rebar on corbel on Span 1 face no measurable section loss

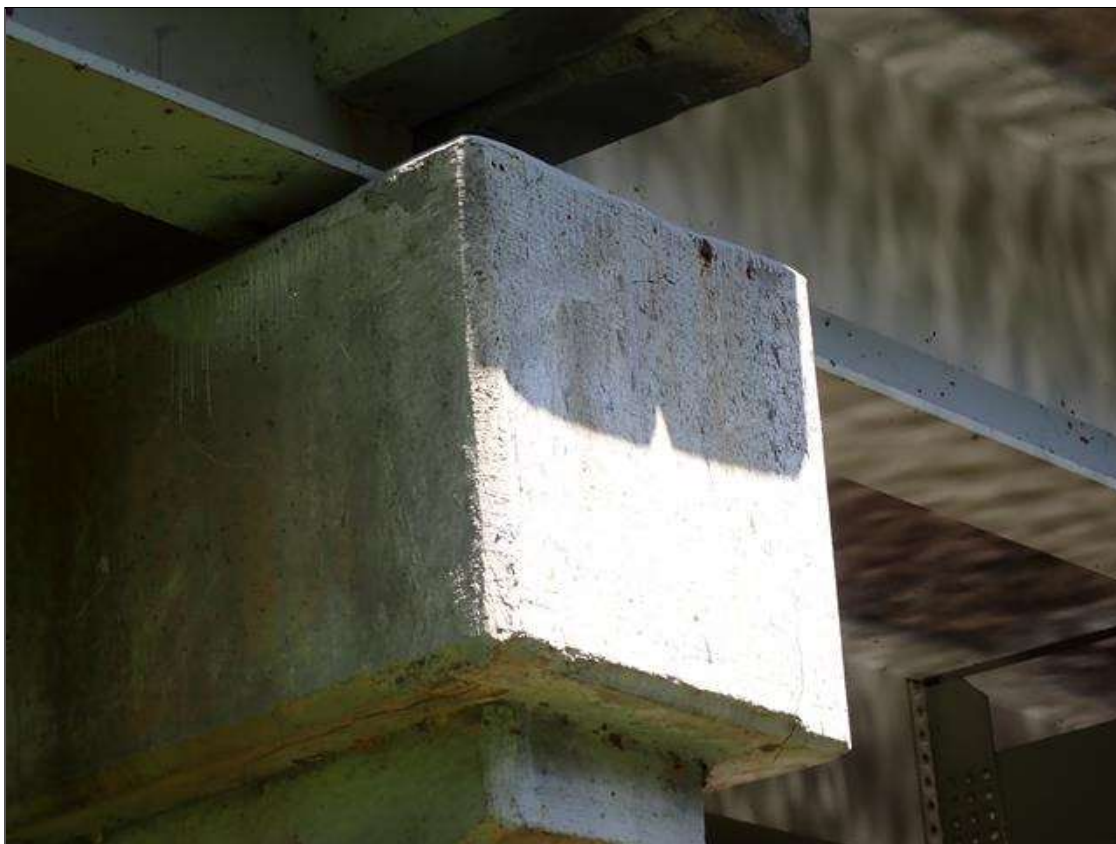
Bent 1 Cap 1: Unsound patch east end of cap. Full height x Full width x 1' long cracking.

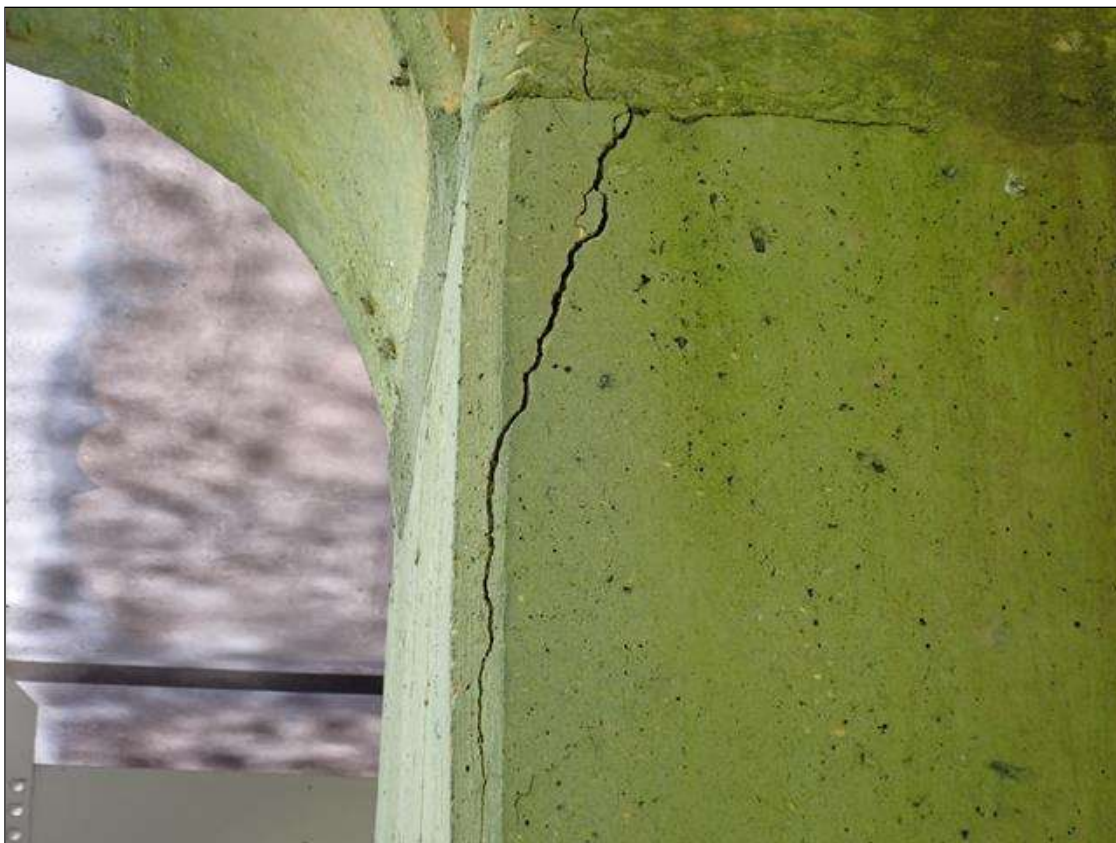
Bent 1 Pile 1: 42" up to 1/4" vertical crack on Span 1 face

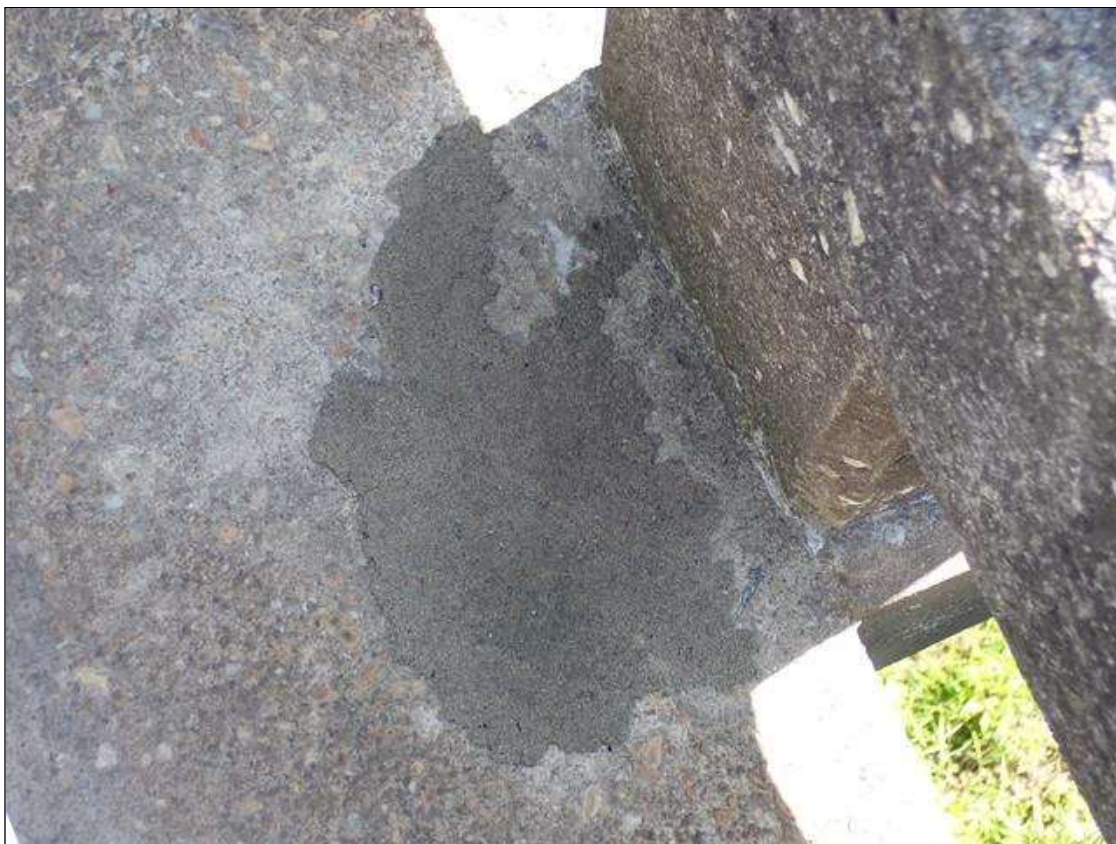
Span 2 Right Bridge Rail: 4" x 3" area of sound patch on top of Post 9

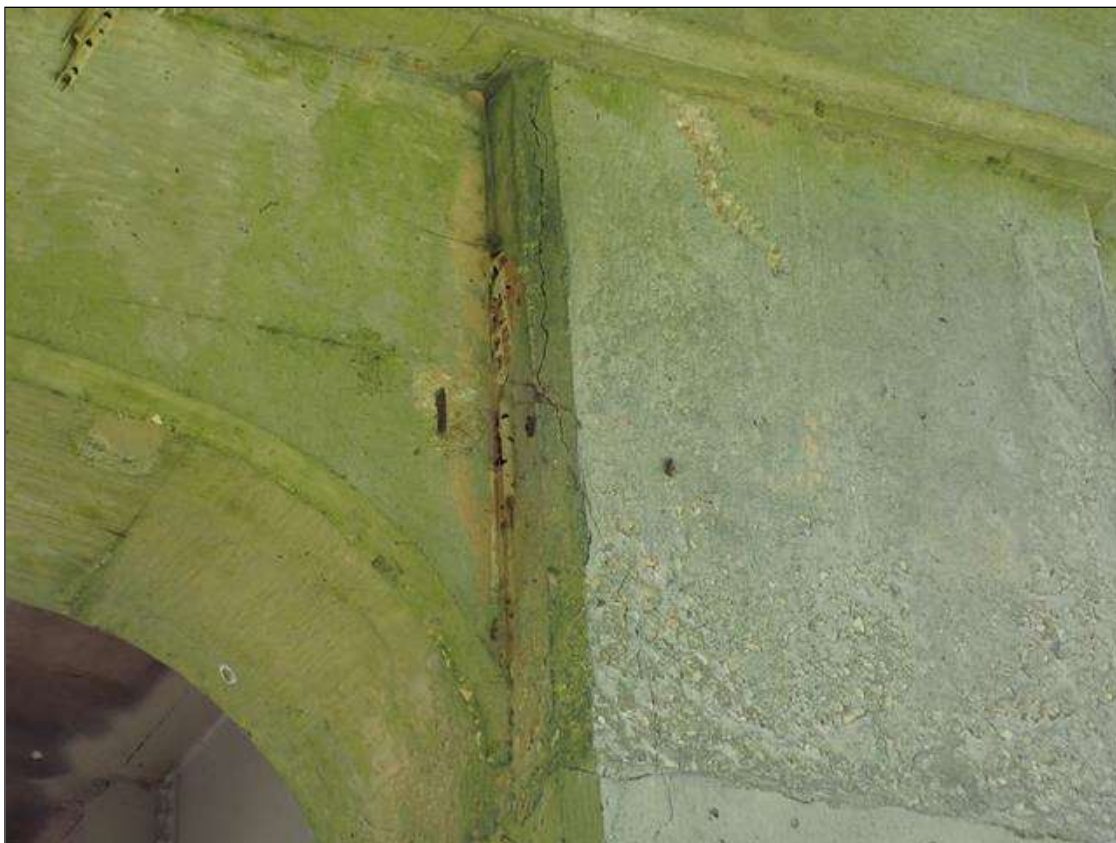
Bent 1 Pile 2: 8" X 2" X 1/4" SPALL AT BOTTOM OF CAP WITH ADJACENT 18" up to 1/16" vertical crack on Span 1 face. No exposed rebar

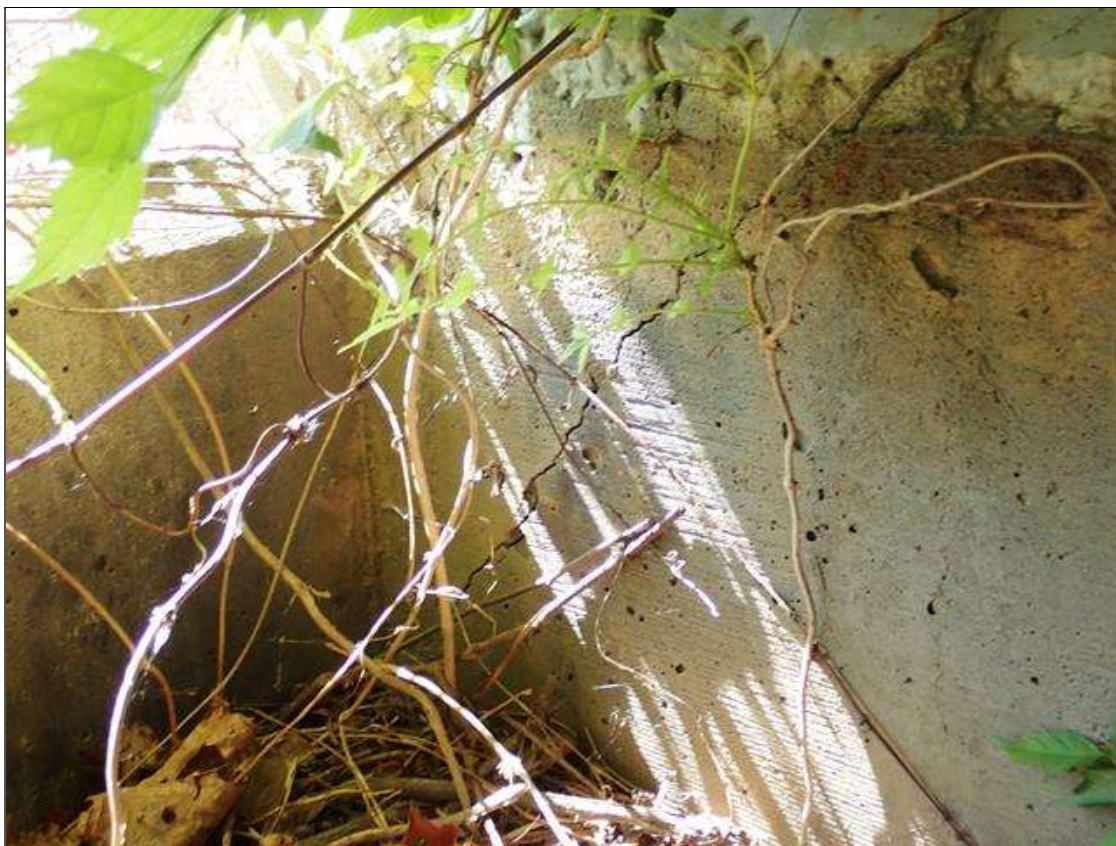
End Bent 1 Cap 1: 16" up to 1/16" diagonal crack under Beam 4 (Beam 1 similar)

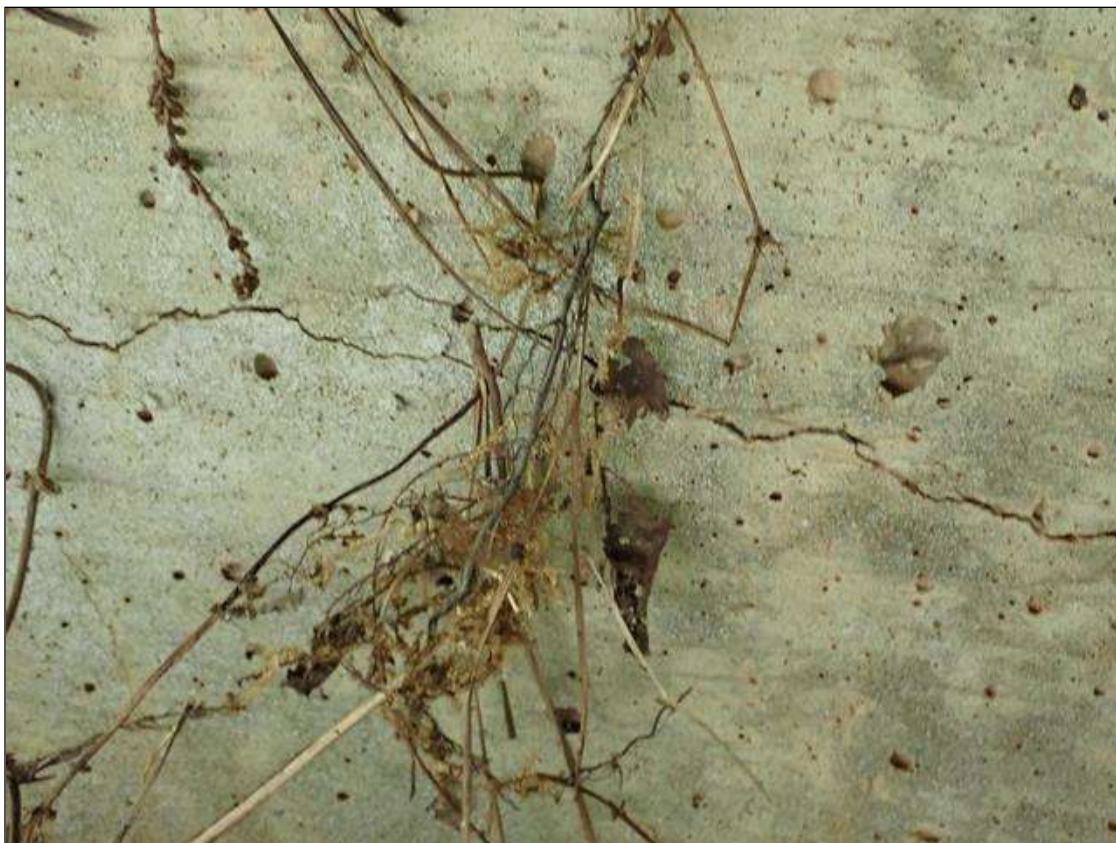
End Bent 1 Cap 1: 6' x 1/16" horizontal crack under Bay 2

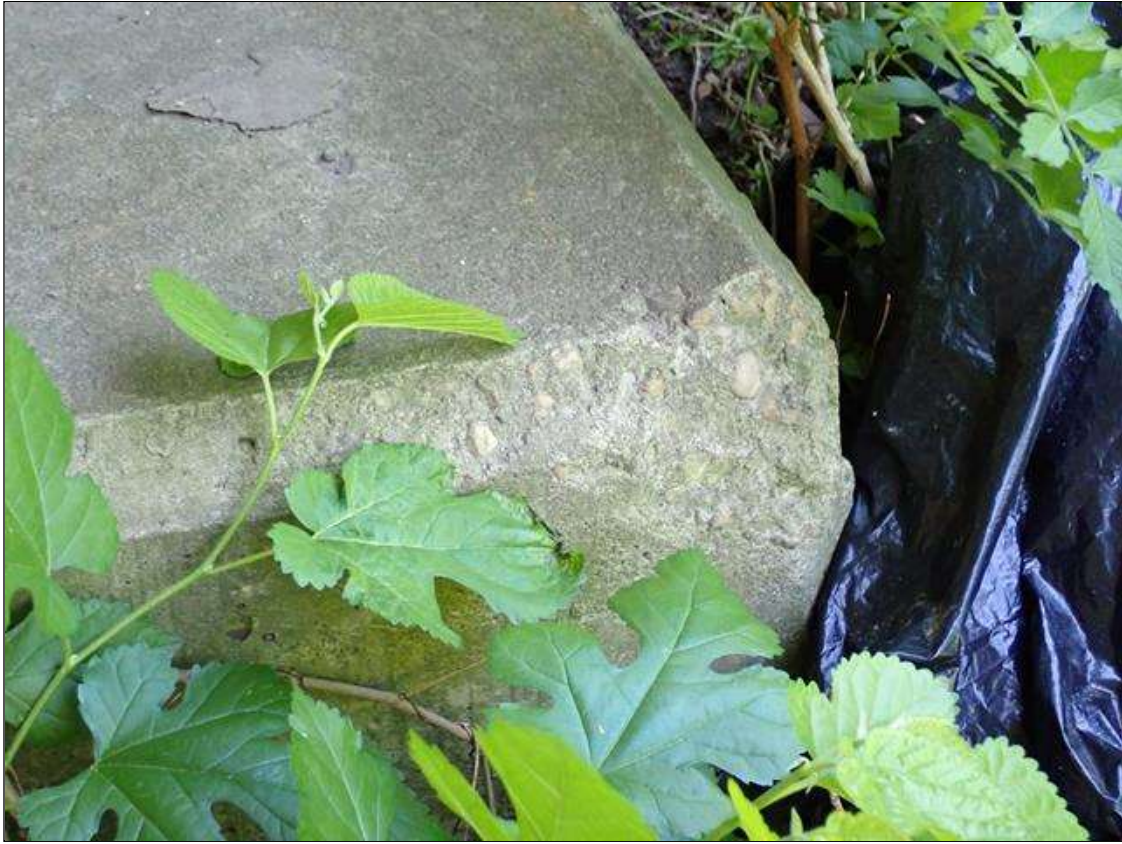
End Bent 1 Cap 1: 4" x 4" x 2" deep spall on Pile Cap 1. No Exposed Rebar.

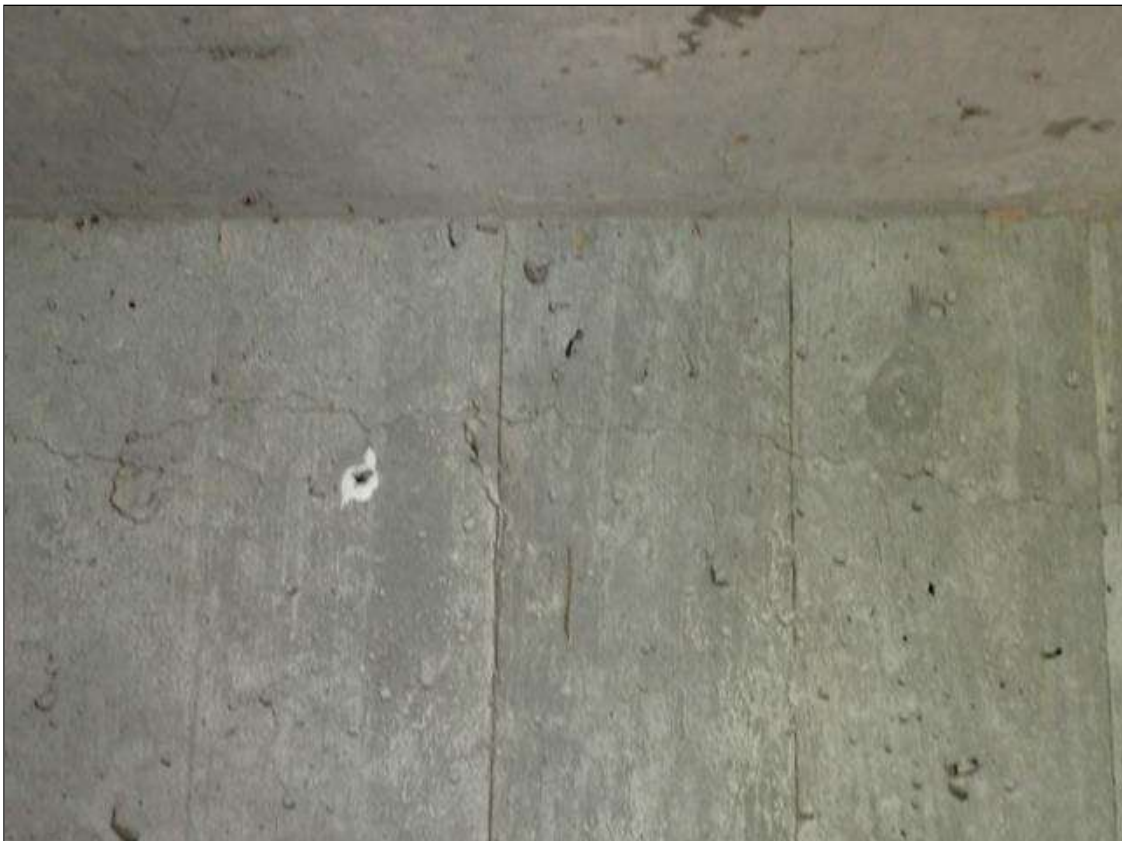
End Bent 1 Abutment: 6' x up to 1/64" horizontal crack WITH EFFLORESCENCE in Bay 3 (Bays 2 and 1 similar)

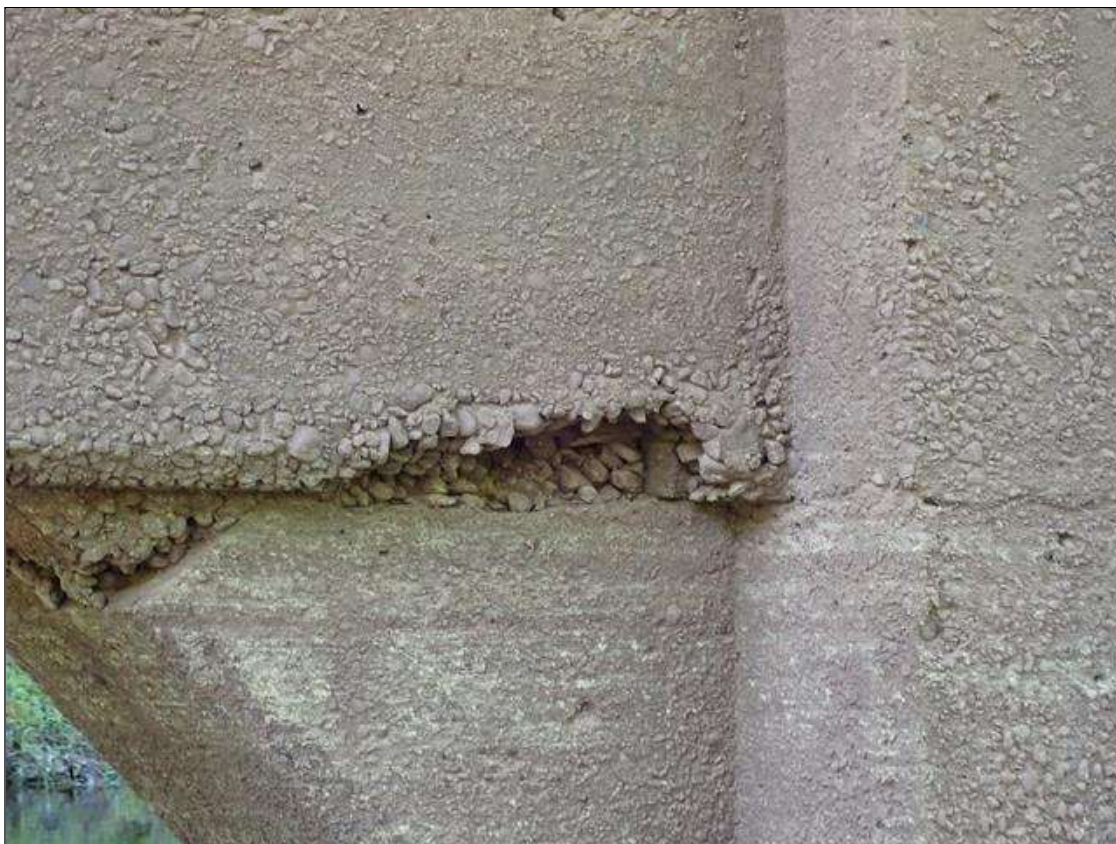
Bent 2 Pile 1: 10" x 2" x 2" deep spall on Span 3 face of strut. No exposed rebar.

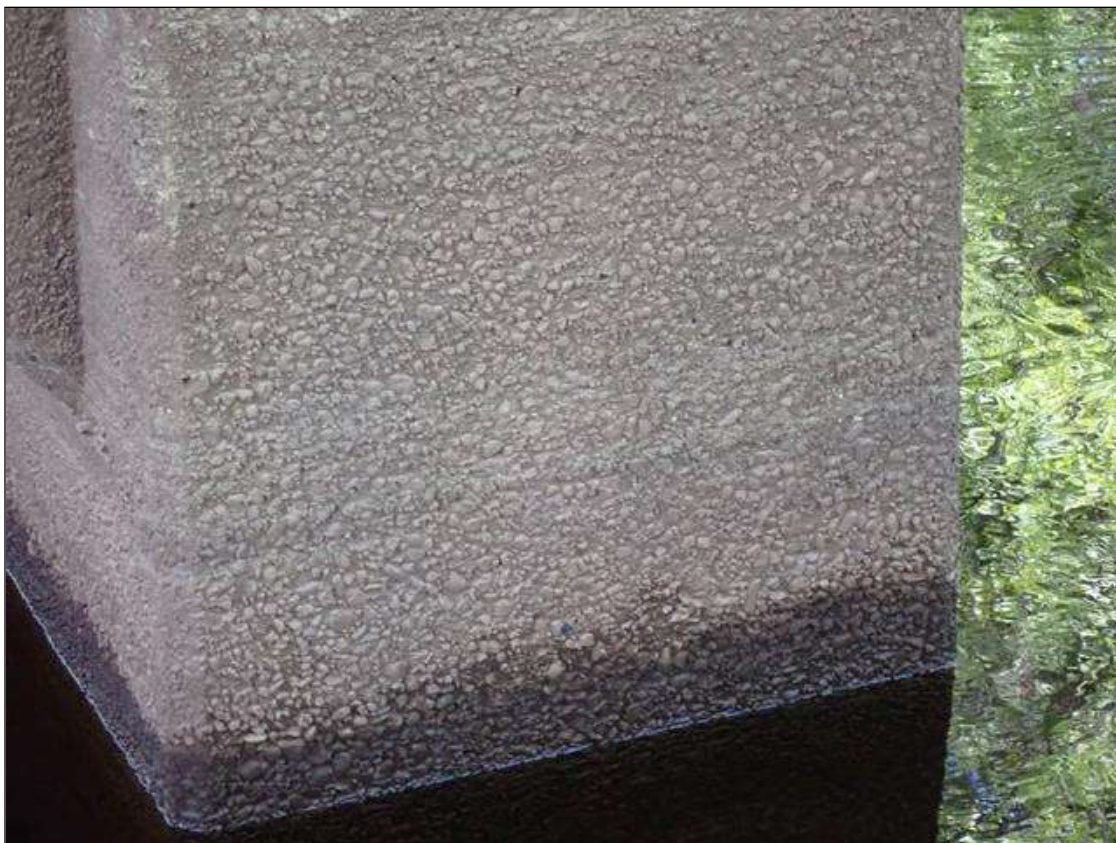
Bent 2 Pile 1: 4' ABRASION/WEAR 15' FROM BOTTOM OF CAP. AGGREGATE INTACT
