NC DEPARTMENT OF TRANSPORTATION ATTENTION:
 DIVISION OF HIGHWAYS
 STRUCTURE MANAGEMENT UNIT

Structure Safety Report

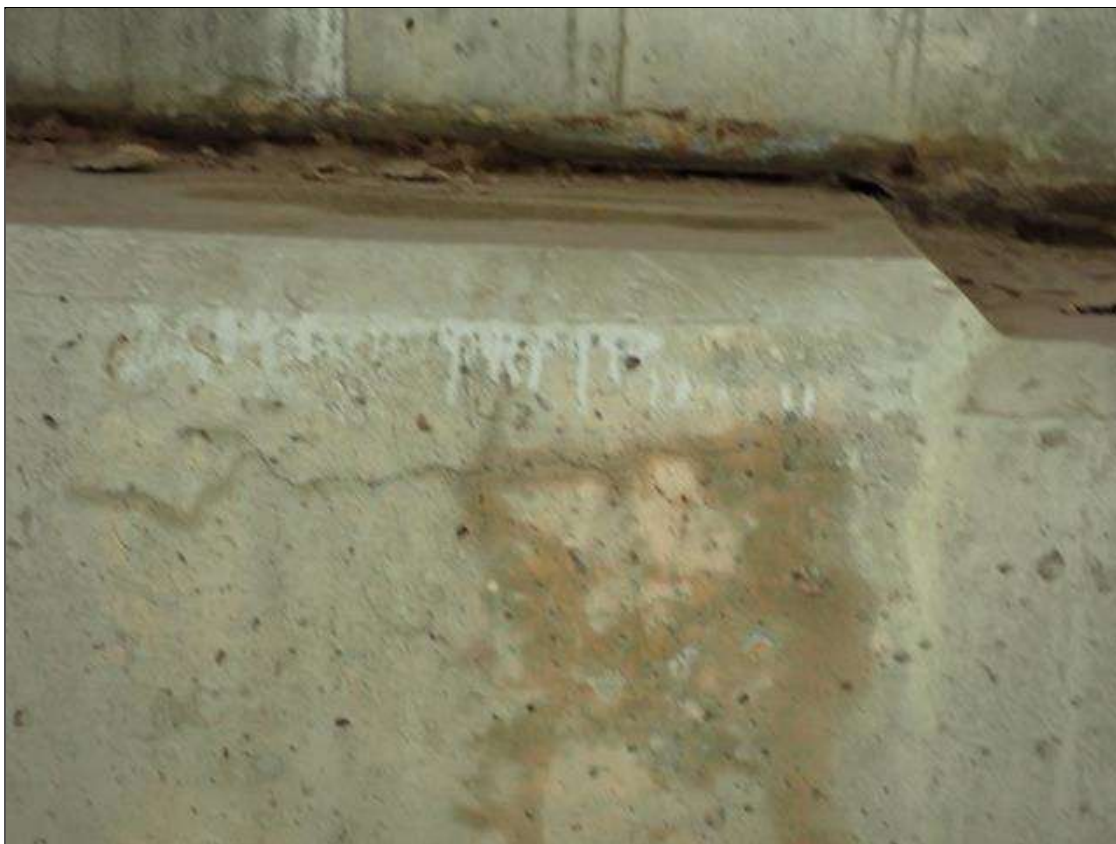
End Bent 2 Cap 1: 15" x up to 1/64" horizontal crack under Bay 3

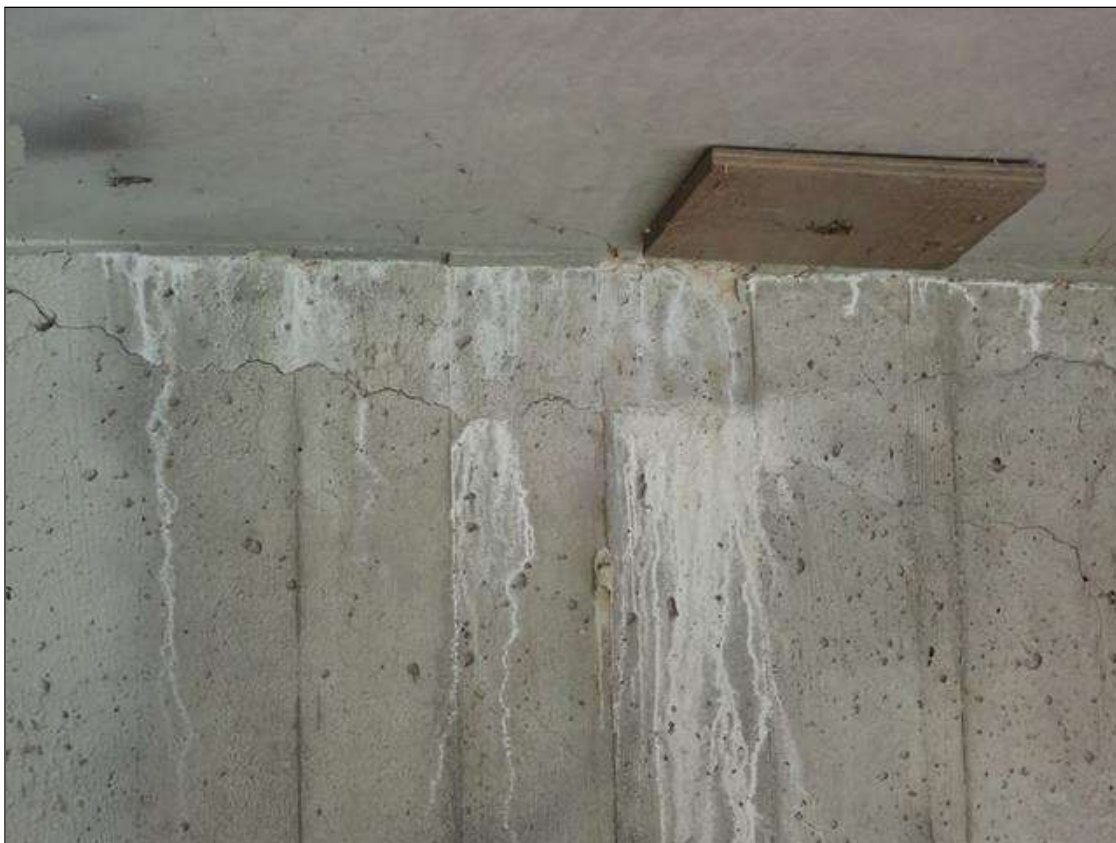
End Bent 2 Abutment: 7' x up to 1/16" horizontal crack with efflorescence in Bay 3

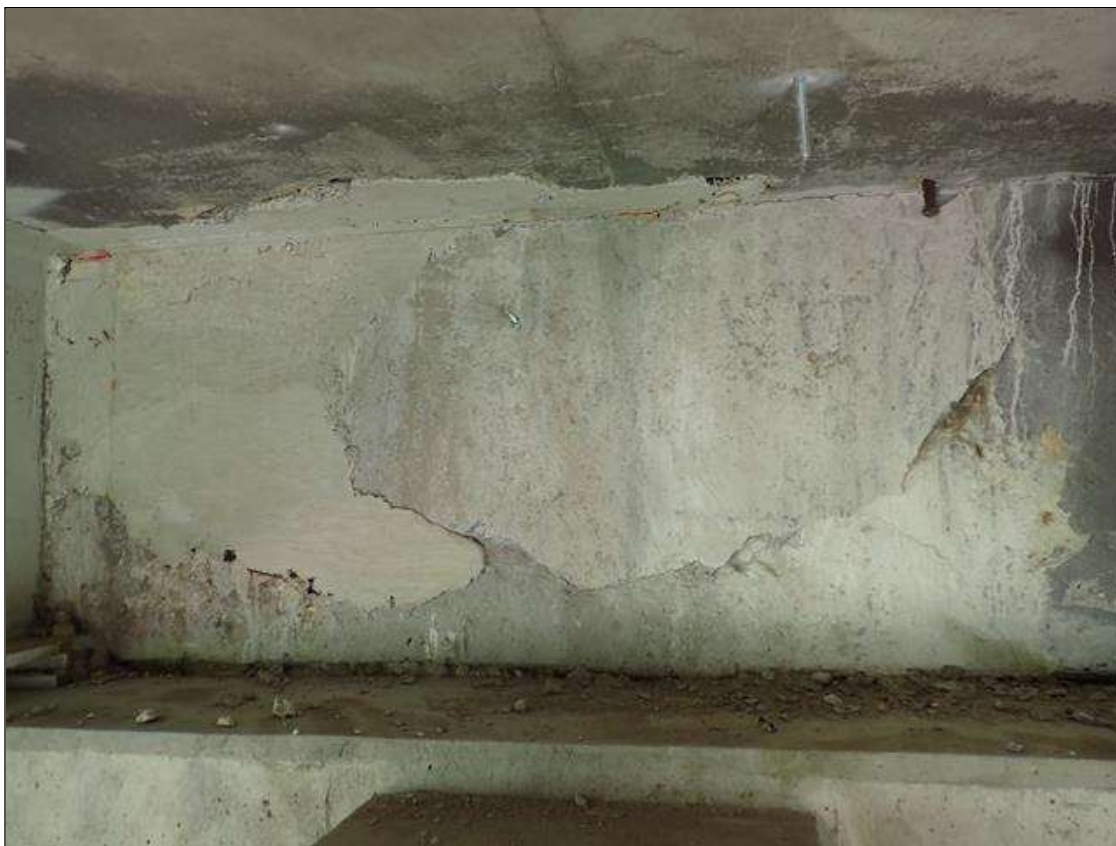
End Bent 2 Abutment: 8' x 2' area of delaminated patch in Bay 2

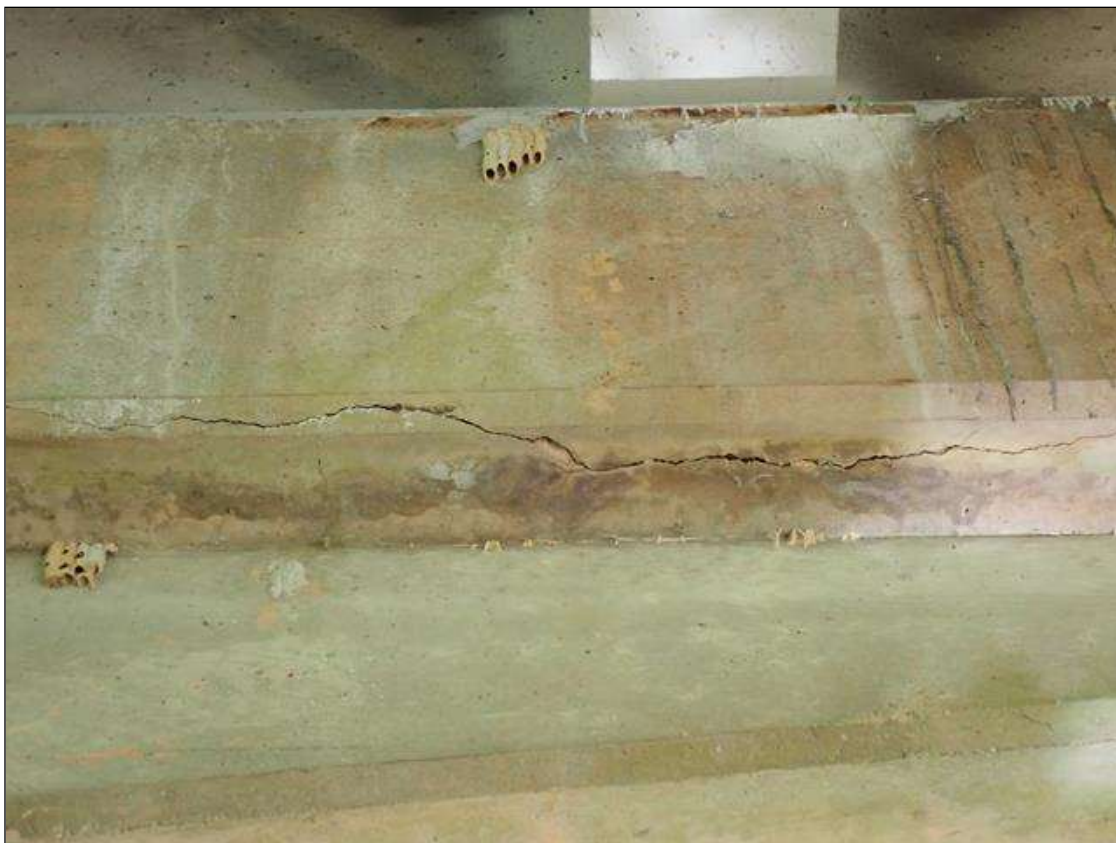
Bent 3 Cap 1: 4' up to 1/8" horizontal crack on Span 3 BOTTOM face UNDER BEAM 2

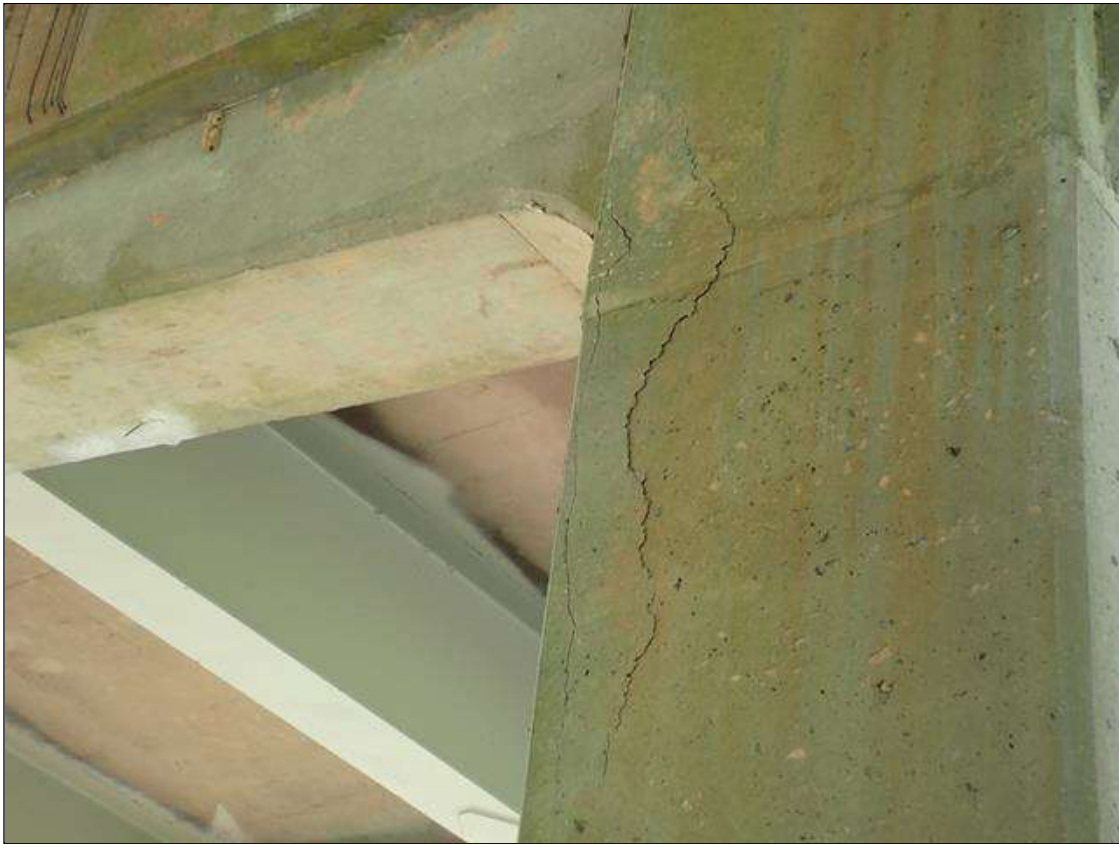
Bent 3 Pile 1: 4' x 1' x 8" delamination at north east corner of pile 1, 2' below cap.

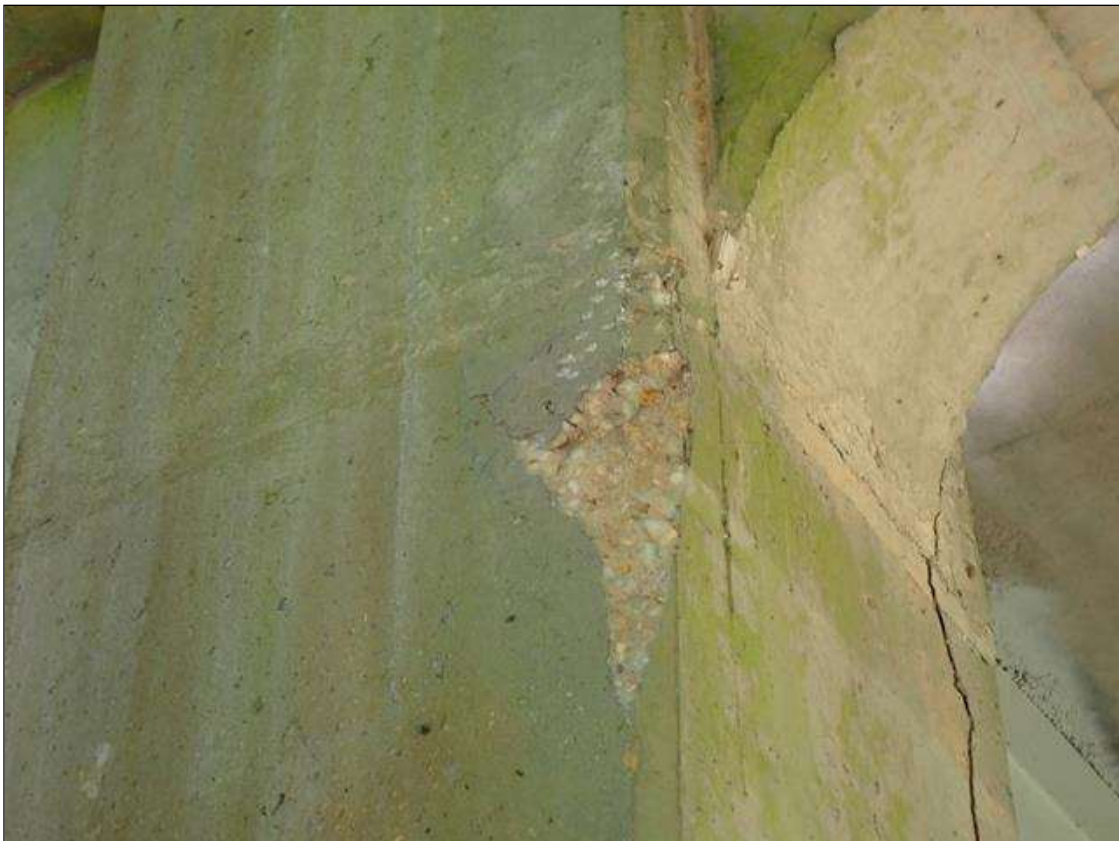
Bent 3 Pile 1: 14" X UP TO 6" X 2" SPALL WITH ADJACENT 1' DIAMETER DELAMINATION ON SOUTHEAST CORNER 2' FROM BOTTOM OF CAP. NO EXPOSED REINFORCEMENT.

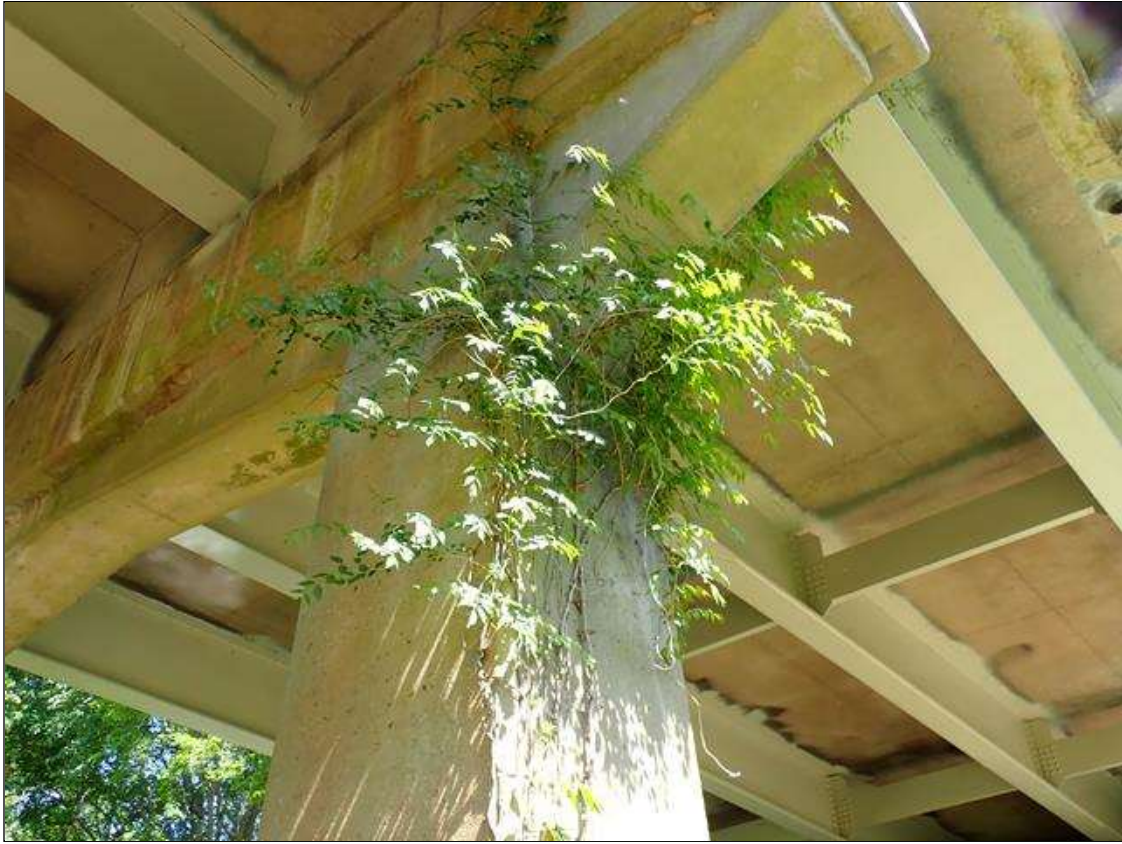
Bent 3 Pile 2: Vegetation around Bent 3 Pile 2.

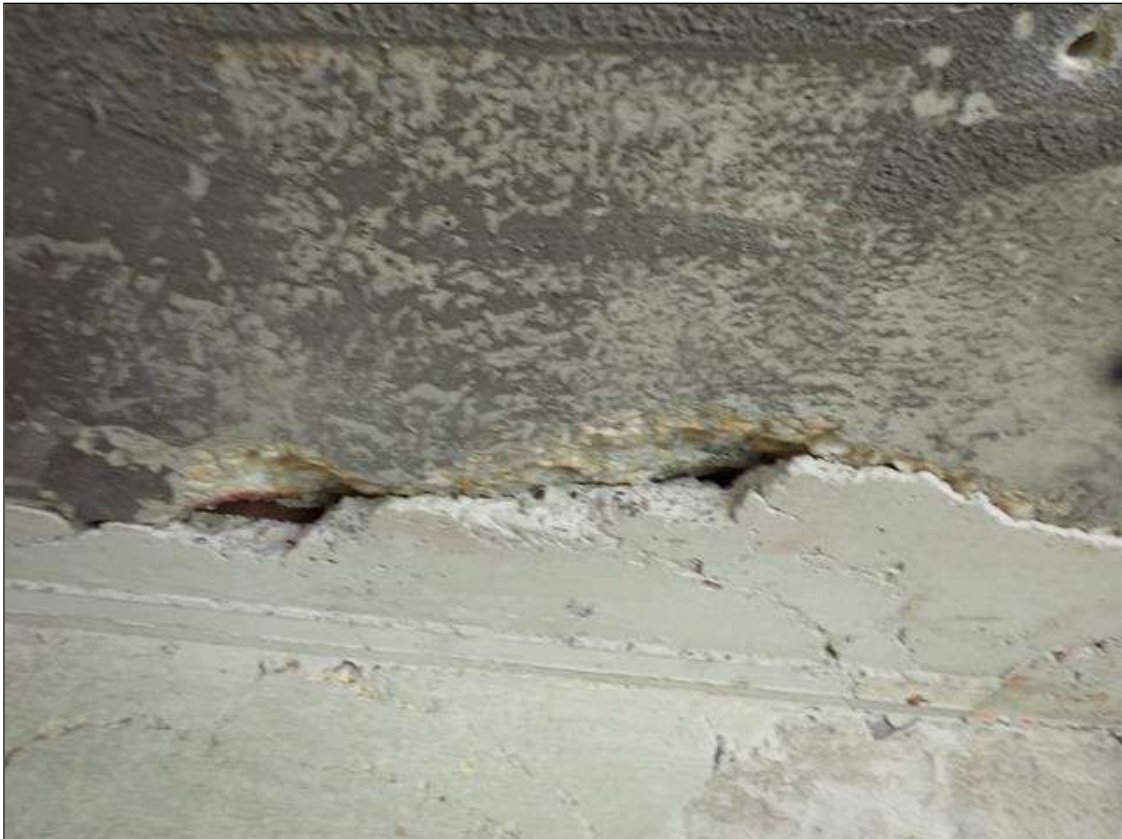
Span 4 Deck: Spall 17" x 4" x 2" deep in underside of deck in bay 2 at end bent 2 with no measurable section loss.

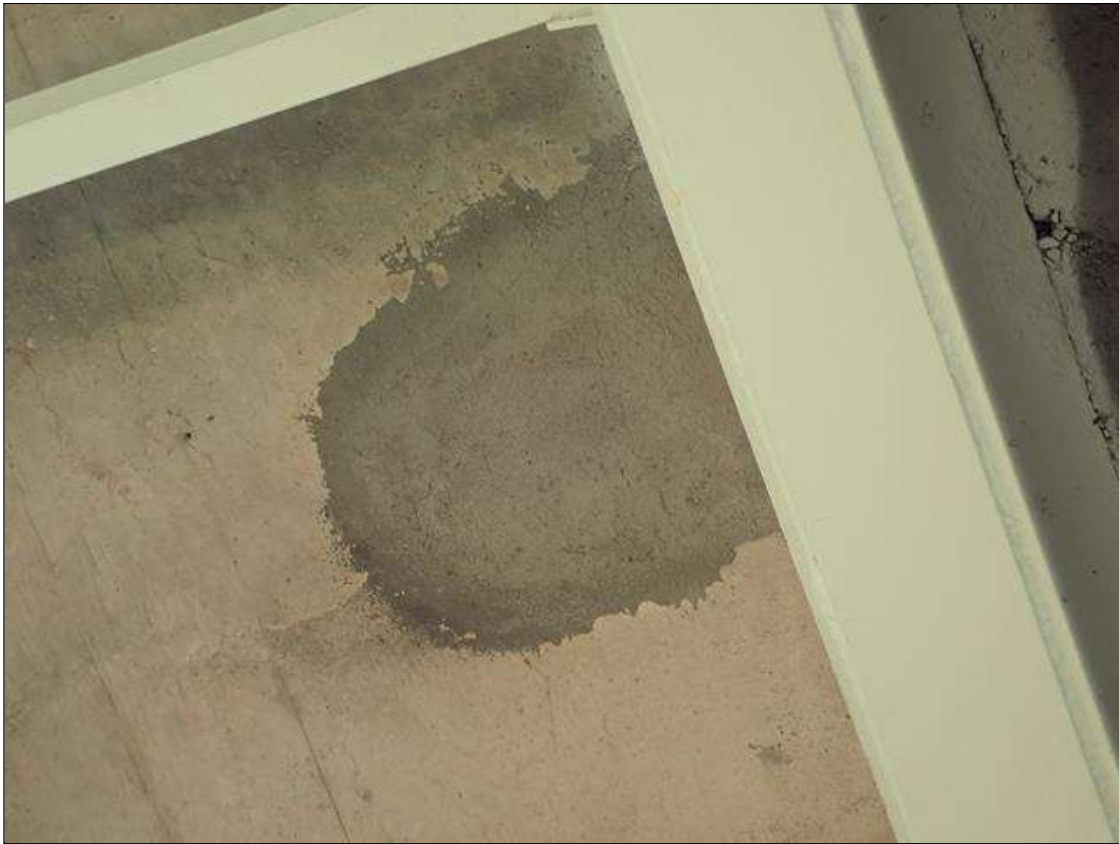
Span 3 Deck: Sound patch 2.5' x 2.5' Bay 3, 16' from Bent 2.

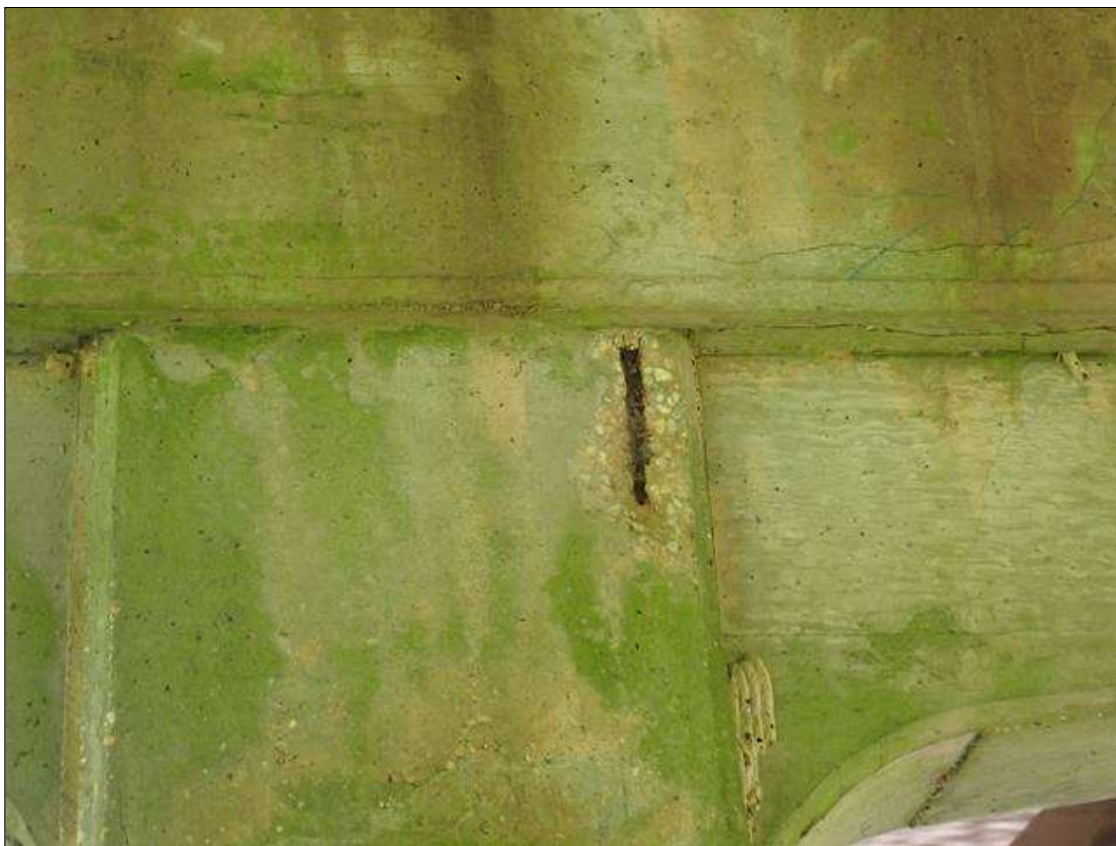
Bent 1 Pile 1: 12" x 5" x 1" SPALL WITH EXPOSED REBAR ON SOUTH FACE AT BOTTOM OF CAP. NO MEASURABLE SECTION LOSS.

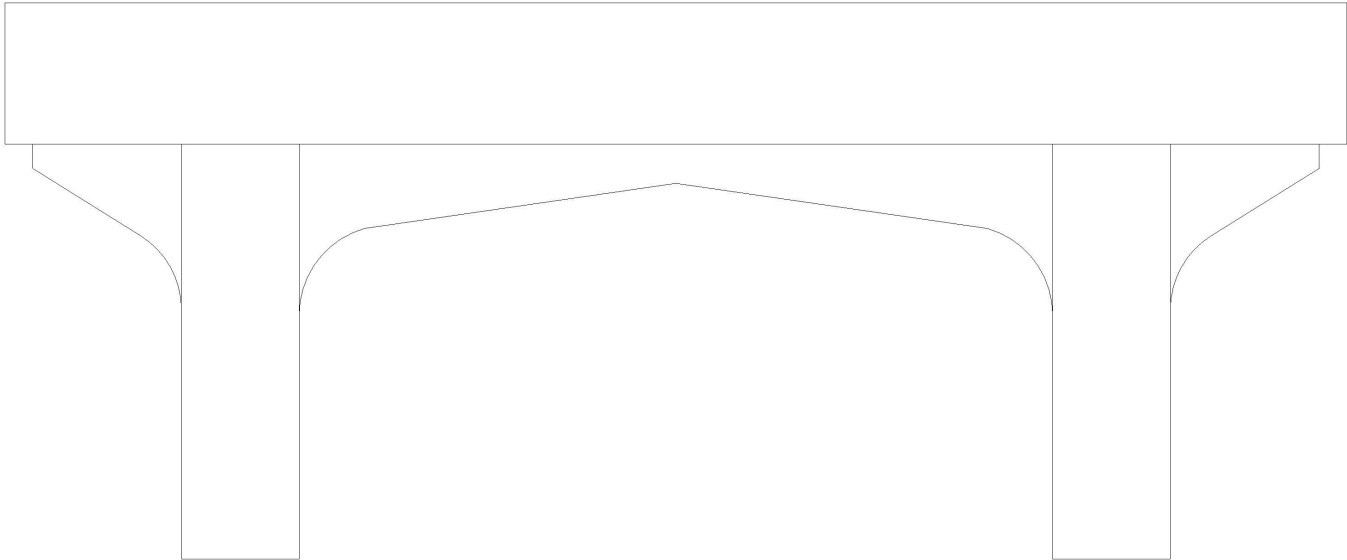
Cap Information			Material Cast-in-Place Concrete							
Length	Width	Height	Left Overhang	Right Overhang	Left Beam to End of Cap.	Right Beam to End of Cap.				
27.000 ft.	2.500 ft.	2.500 ft.	5.000 ft.	5.000 ft.	1.500 ft.	1.500 ft.				
Subcap Information			Material							
Length	Width	Height	Left Overhang	Right Overhang	Left Pile to Splice.					
Sill Information			Material							
Length	Width	Height								
Pile #	Material	Spacing	Width/Dia.	Height	Length	Orientation	Driven?	Replacement?	Removed?	Collar?
1	Concrete	17.000 ft.	2.333 ft.			Vertical	No	No	No	No
2	Concrete		2.333 ft.			Vertical	No	No	No	No
							SKETCH VERIFIED BY JEK 4-22-2022			
Bent/Abutment #: 1			Similar Bents: BENTS 2 & 3
