NC DEPARTMENT OF TRANSPORTATION
 DIVISION OF HIGHWAYS
 STRUCTURE MANAGEMENT UNIT

ATTENTION: **PAR'S SUBMITTED**

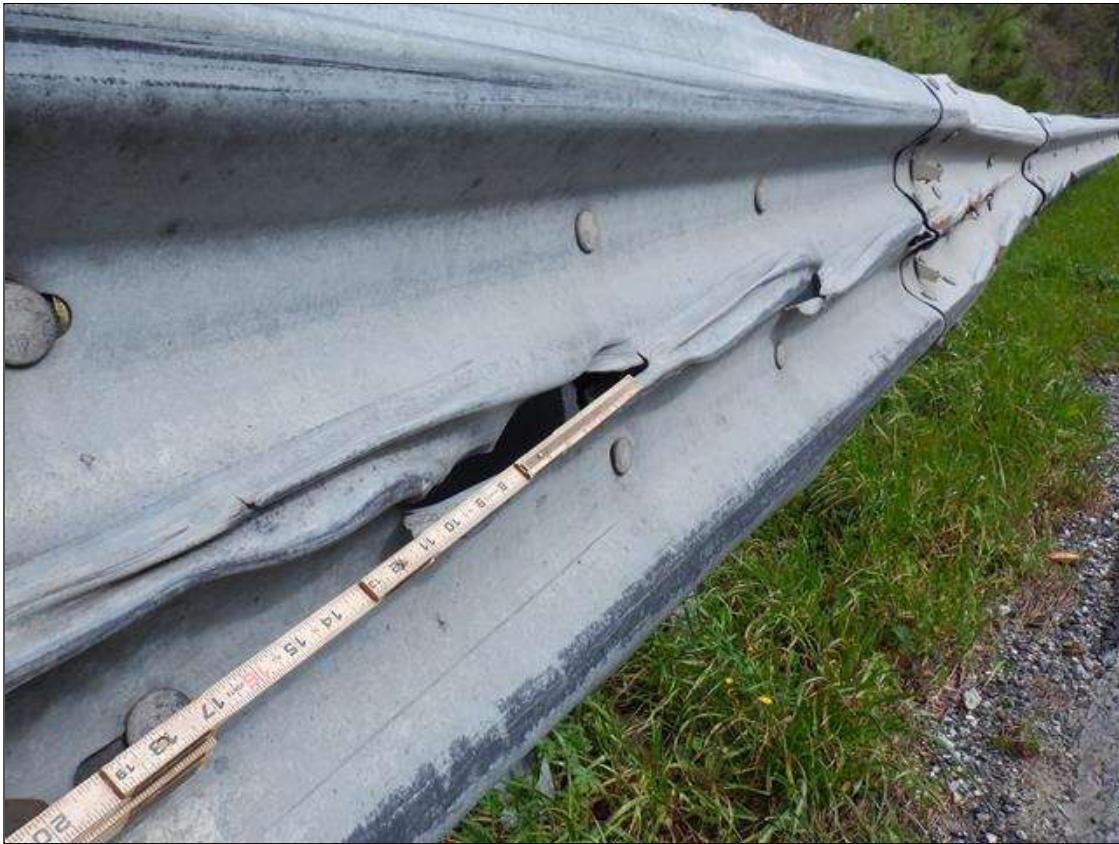
General Comments and Misc. Items: (PAR) 20 FEET OF IMPACT DAMAGE WITH 12- UP TO 10 INCHES X 1.5 INCHES GOUGES IN NORTHWEST GUARDRAIL, 15 FEET FROM END BENT 2.

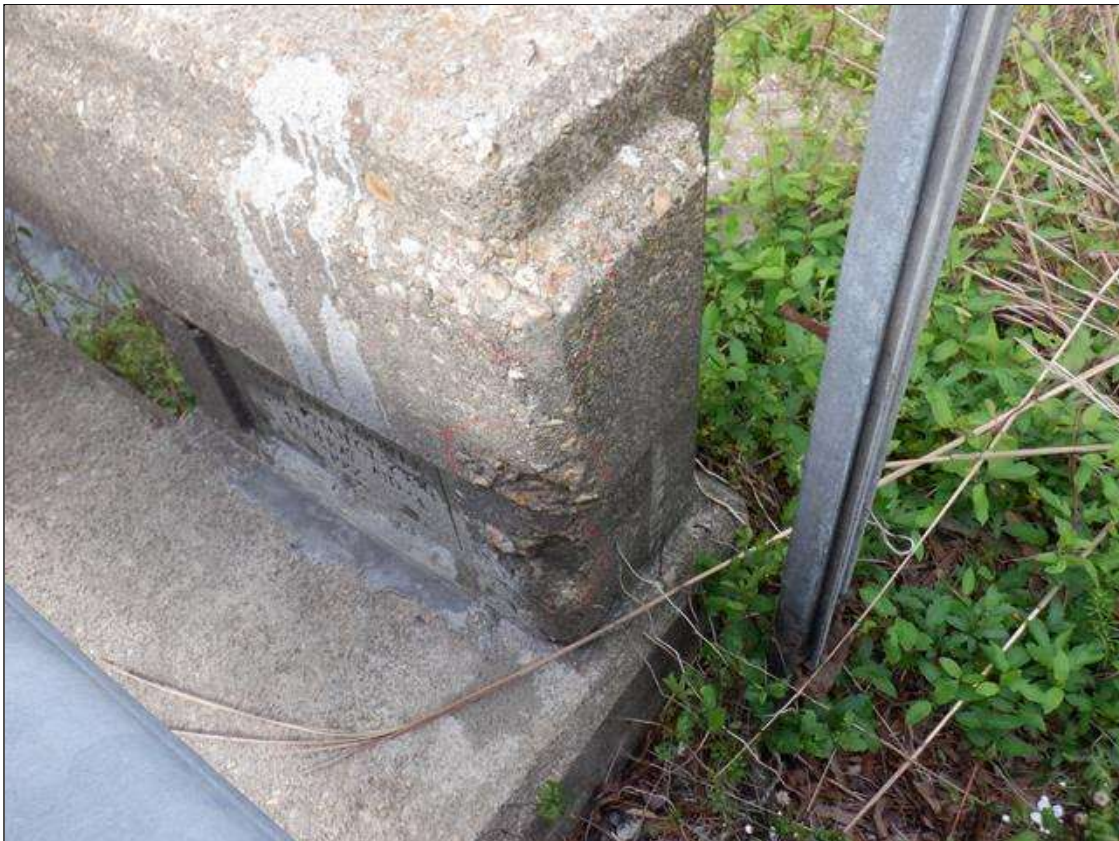
Span 4 Left Concrete Rail: (3) UP TO 3 INCHES X 5 INCHES X 1 INCHES DEEP SPALLS ON END POST

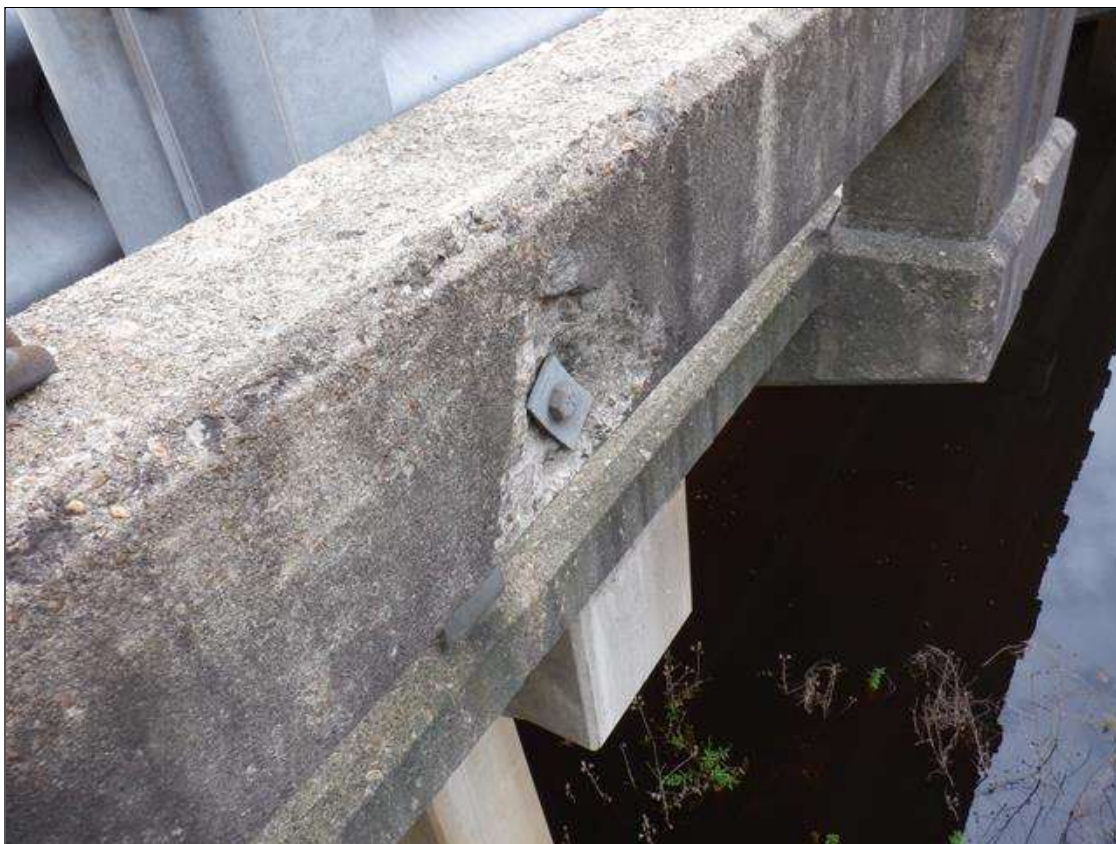
Span 4 Left Concrete Rail: (4) UP TO 10 INCHES X 9 INCHES X 1 INCHES DEEP SPALLS IN OUTSIDE FACE OF CONCRETE RAIL, AT RANDOM

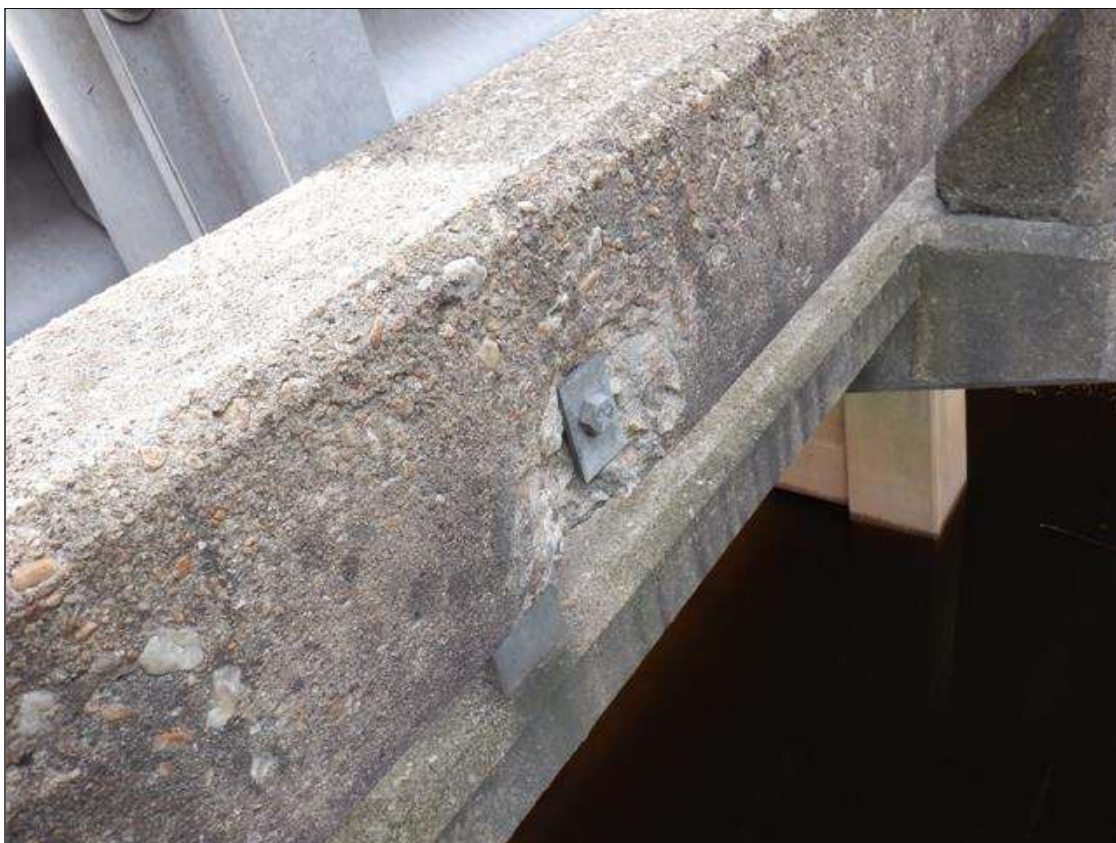
Span 2 Left Concrete Rail: (4) UP TO 9 INCHES X 6 INCHES X 1 INCHES DEEP SPALLS IN OUTSIDE FACE OF CONCRETE RAIL, AT RANDOM

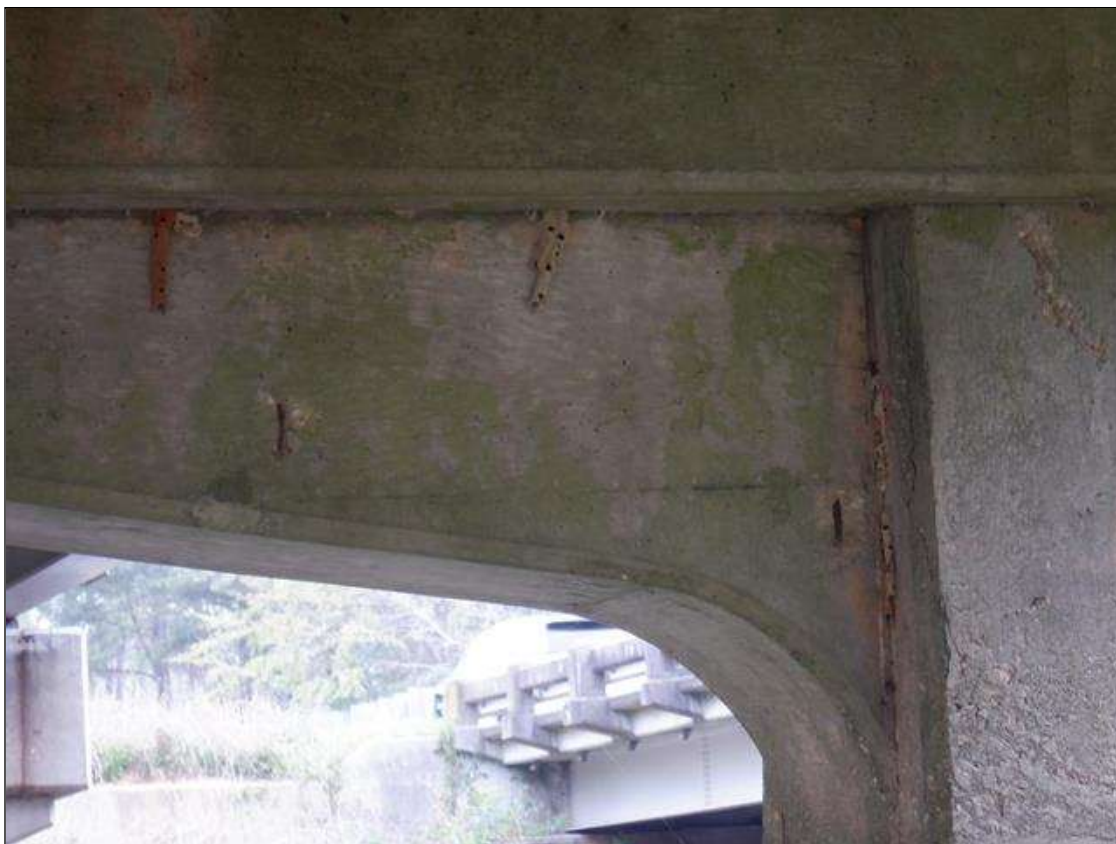
Bent 1 Cap 1: (2) UP TO 3 INCHES X 3 INCHES X 1 INCHES DEEP SPALLS WITH EXPOSED REBAR ON CORBEL OF SPAN 1 FACE

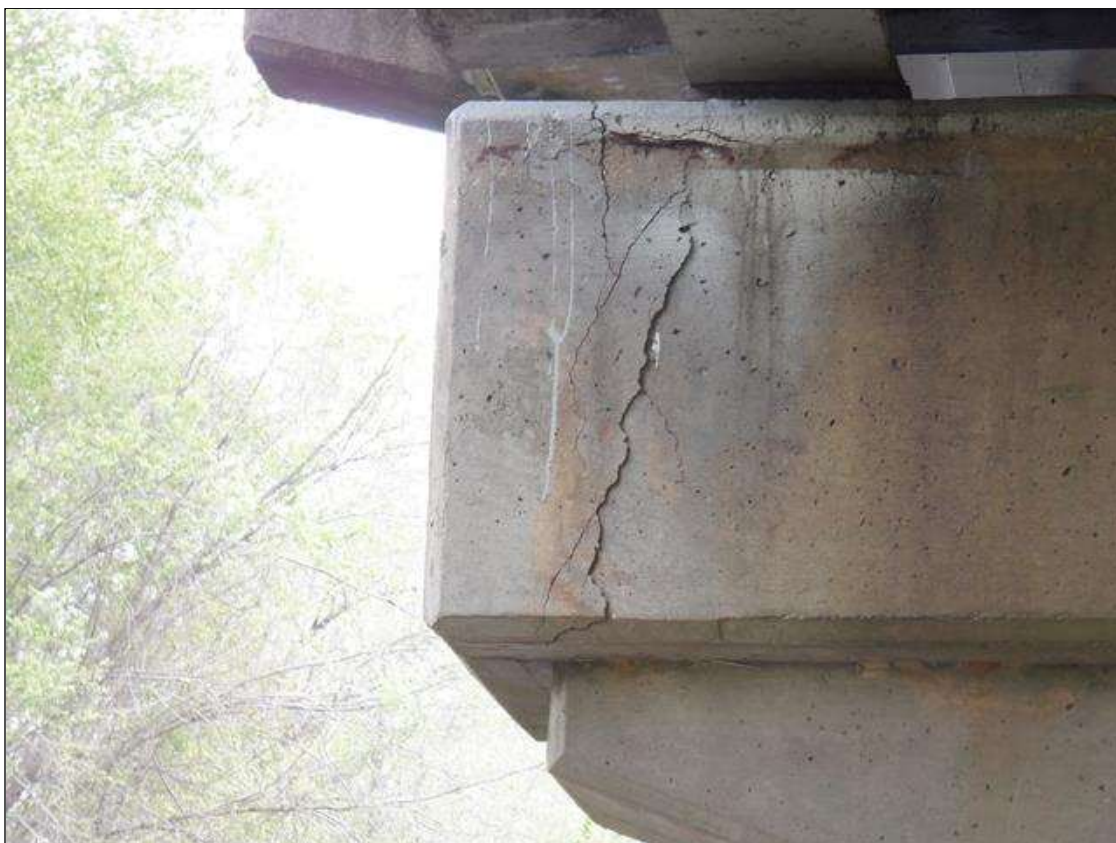
Bent 1 Cap 1: 12 INCHES X 24 INCHES AREA OF DELAMINATION WITH UP TO 1/8 INCHES VERTICAL AND DIAGONAL CRACKS ON SPAN 1 FACE AT WEST END

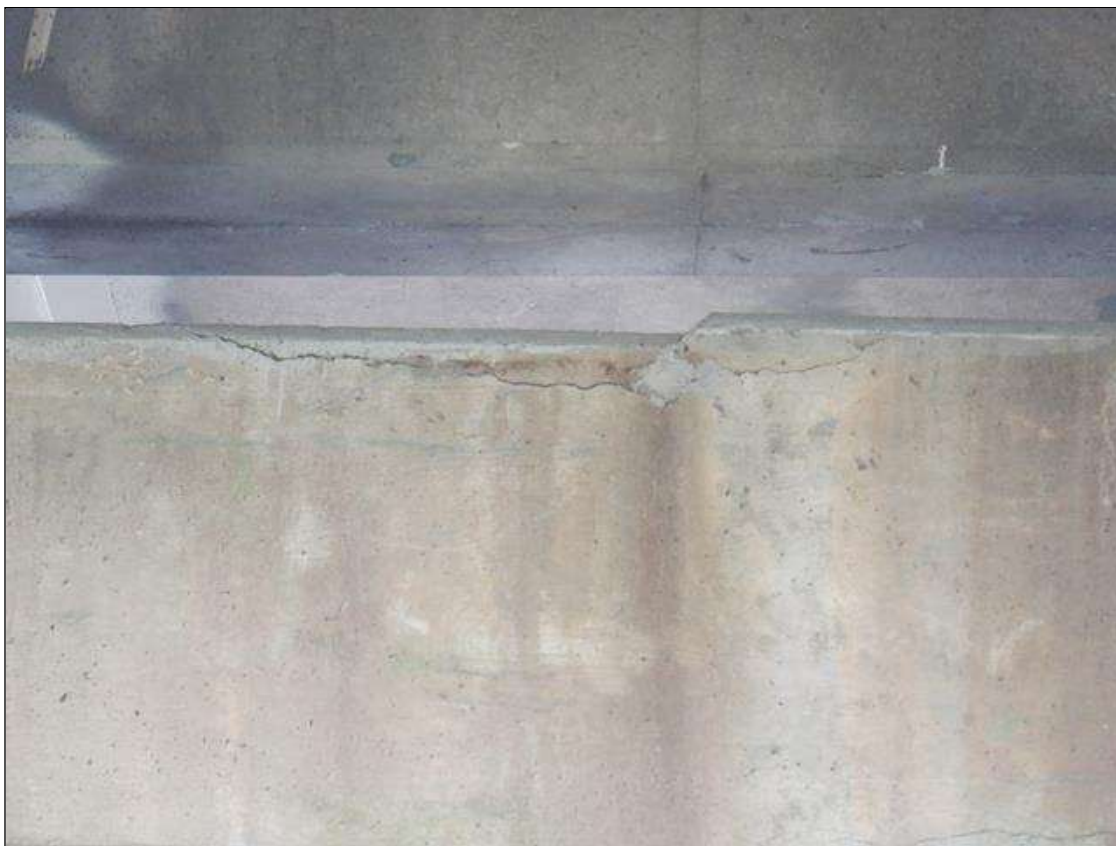
Bent 1 Cap 1: 3 FEET X UP TO 1/8 INCHES HORIZONTAL CRACK ON SPAN 1 FACE UNDER BAY 1

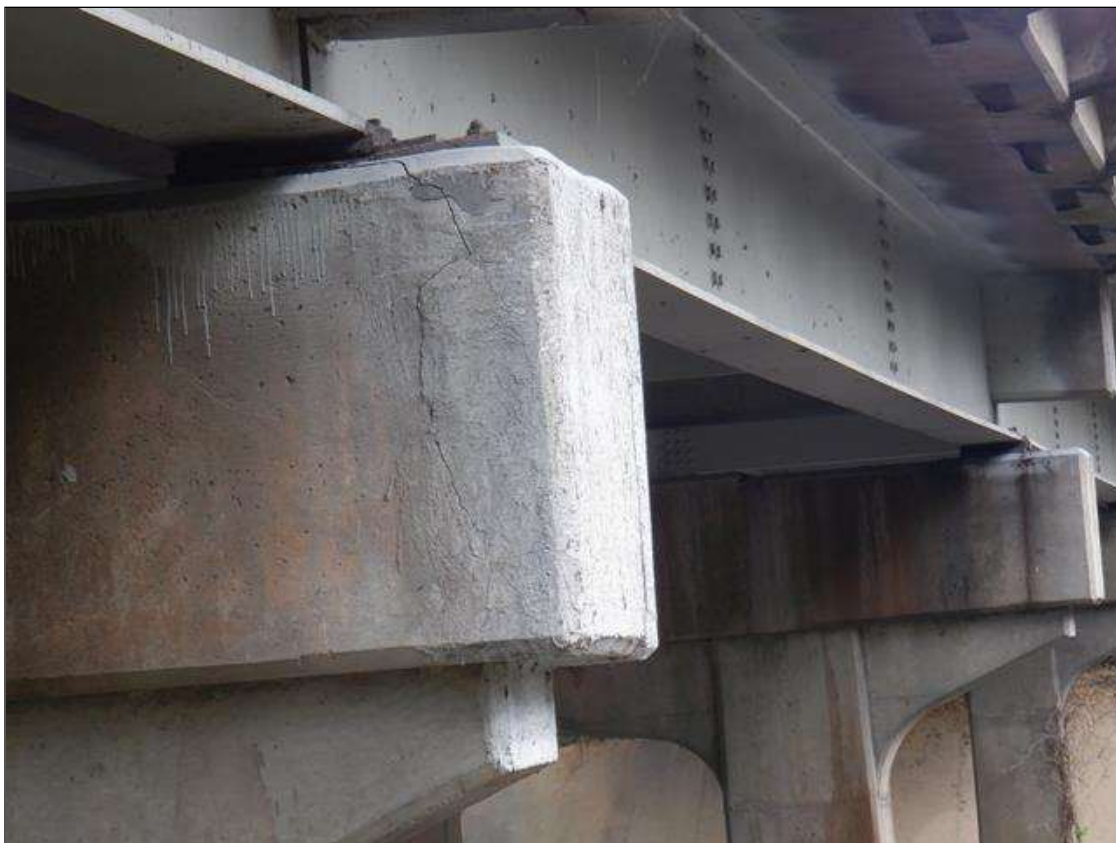
Bent 1 Cap 1: FULL HEIGHT X FULL WIDTH CRACKED PATCHED AREA UP TO 1/16 INCHES ON EAST END OF CAP, EXTENDING 9 INCHES ONTO SOUTH FACE.

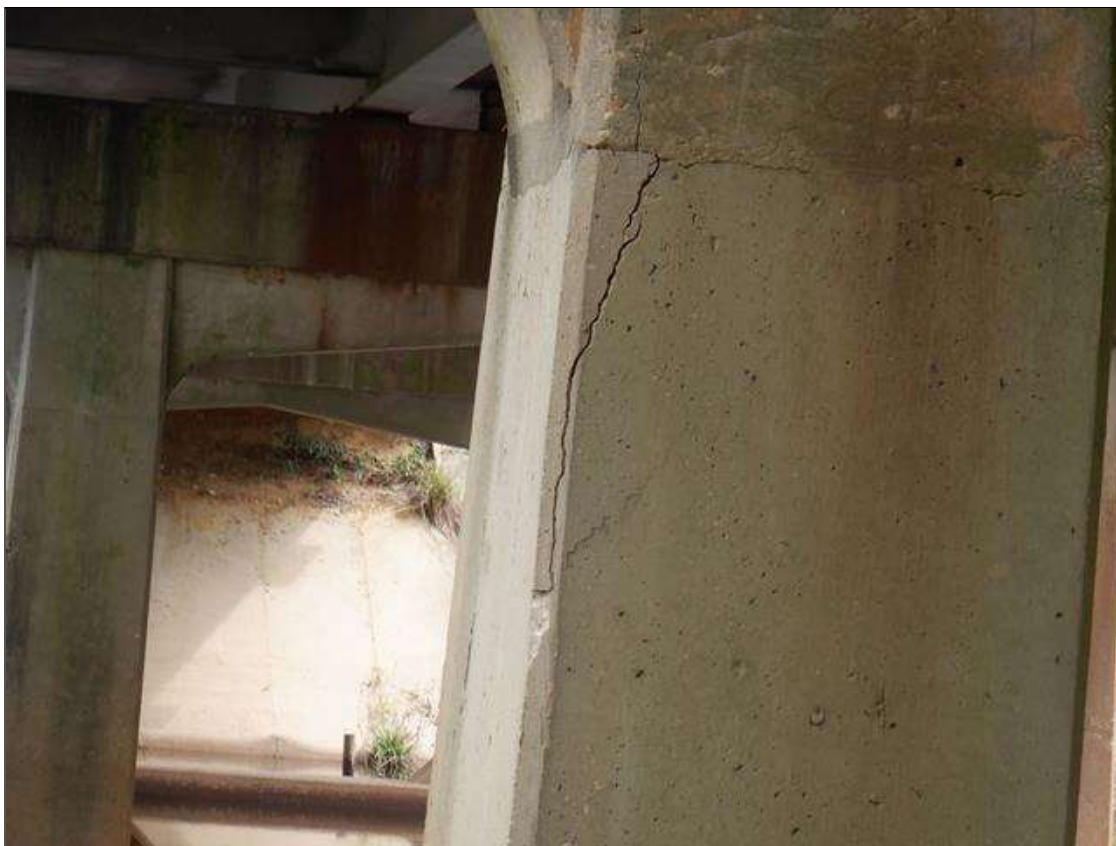
Bent 1 Pile 1: 42 INCHES X UP TO 1/4 INCHES VERTICAL CRACK WITH ADJACENT 4 FEET X UP TO 5 INCHES X 3 INCHES DELAMINATION ON SPAN 1 FACE

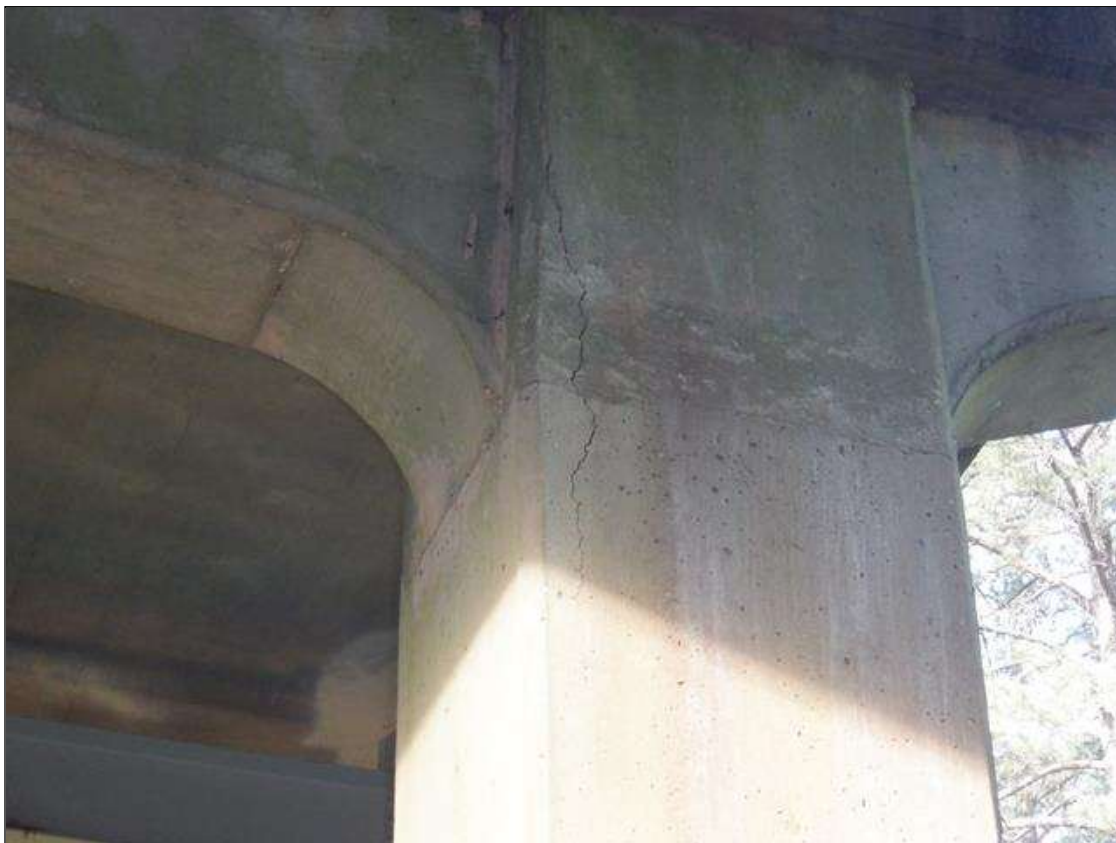
Bent 1 Pile 1: 6 FEET X UP TO 1/8 INCHES VERTICAL CRACK IN NORTHEAST CORNER, 1 FOOT FROM BOTTOM OF CAP.

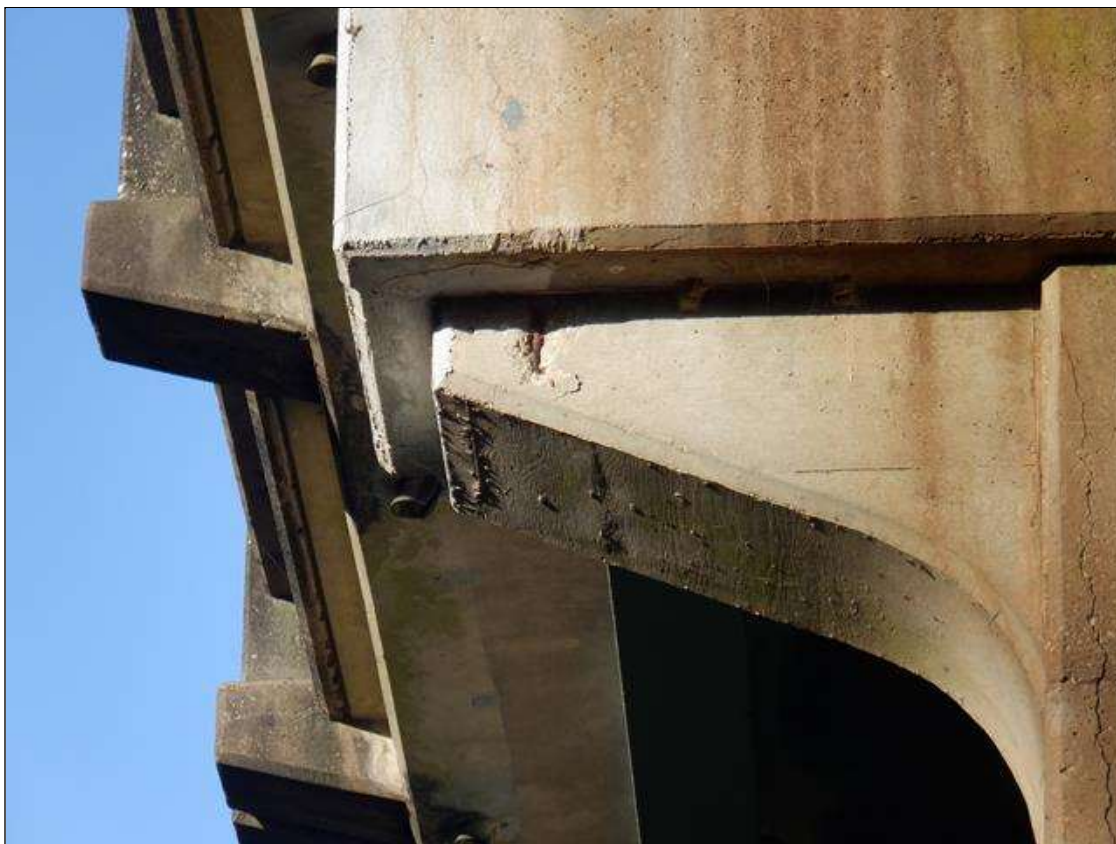
Bent 1 Pile 2: 6 INCHES X 8 INCHES X UP TO 1/2 INCHES SPALL WITH EXPOSED REINFORCING IN NORTH FACE OF CORBEL, UNDER BEAM 4.

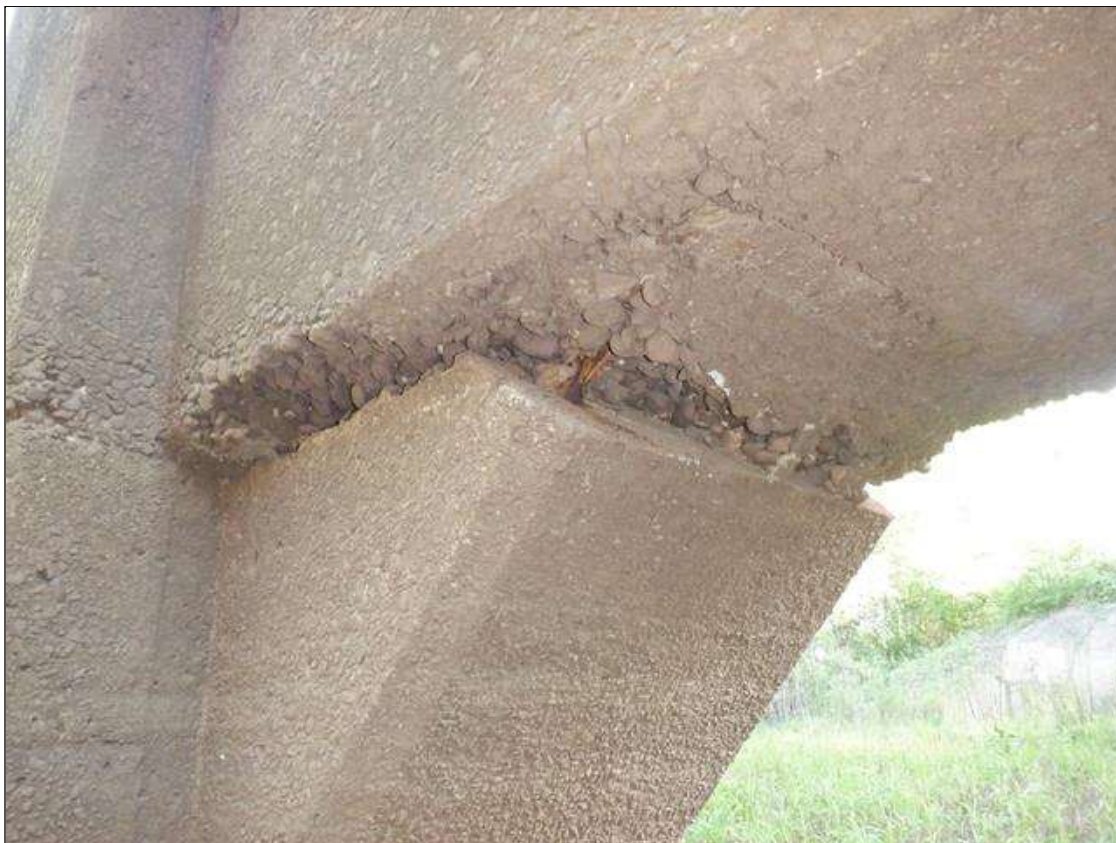
Bent 2 Pile 1: 20 INCHES X UP TO 4 INCHES X 18 INCHES SPALL WITH EXPOSED REINFORCING ON WEST CORBEL UNDER STRUT.

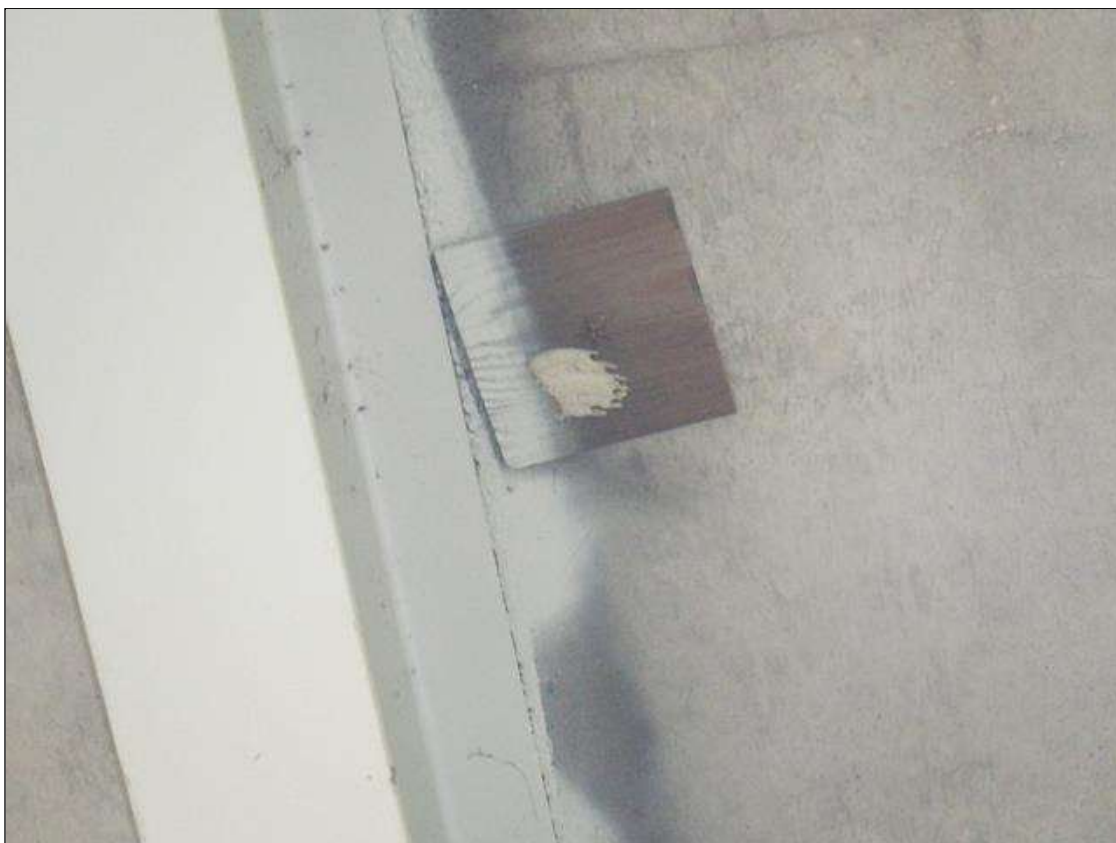
Span 3 Deck: 1 FEET X 1 FEET TIMBER PATCH IN BAY 2, 8 FEET FROM BENT 2, ADJACCENT TO BEAM 3.

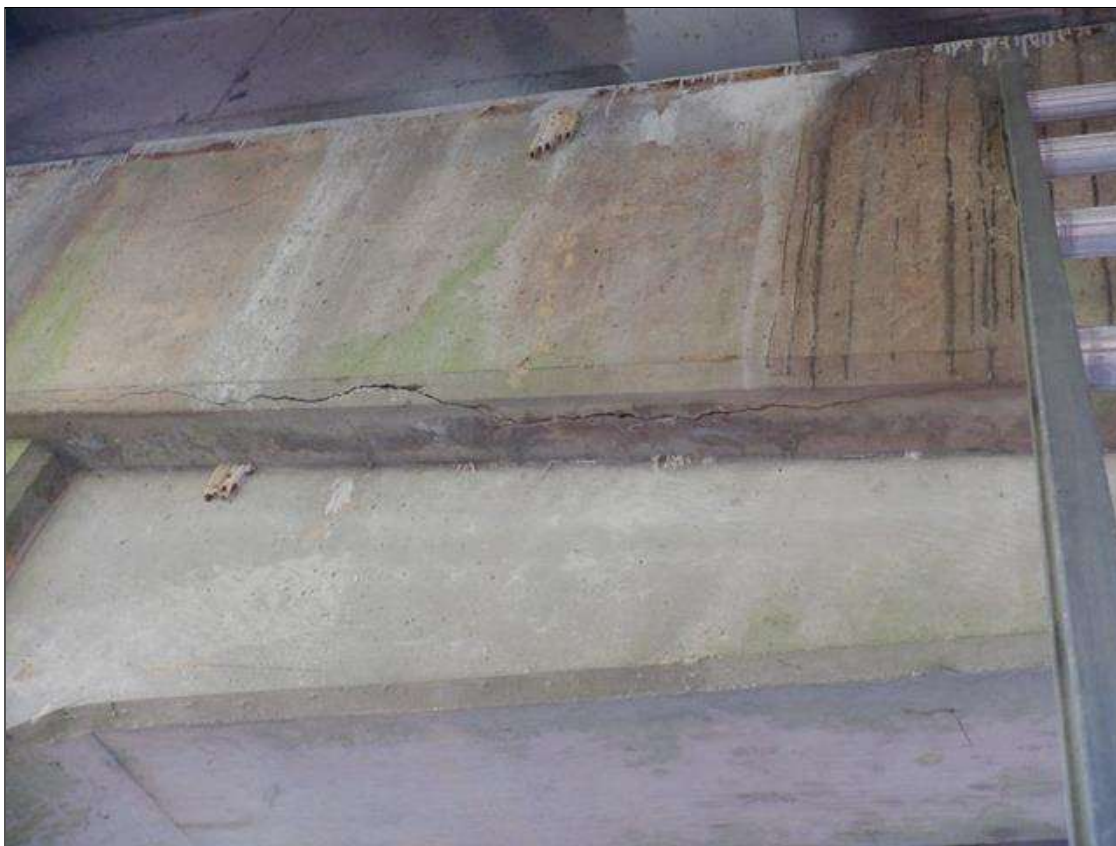
Bent 3 Cap 1: 6 FEET X UP TO 1/8 INCHES HORIZONTAL CRACK ON SOUTH BOTTOM FACE UNDER BEAM 2

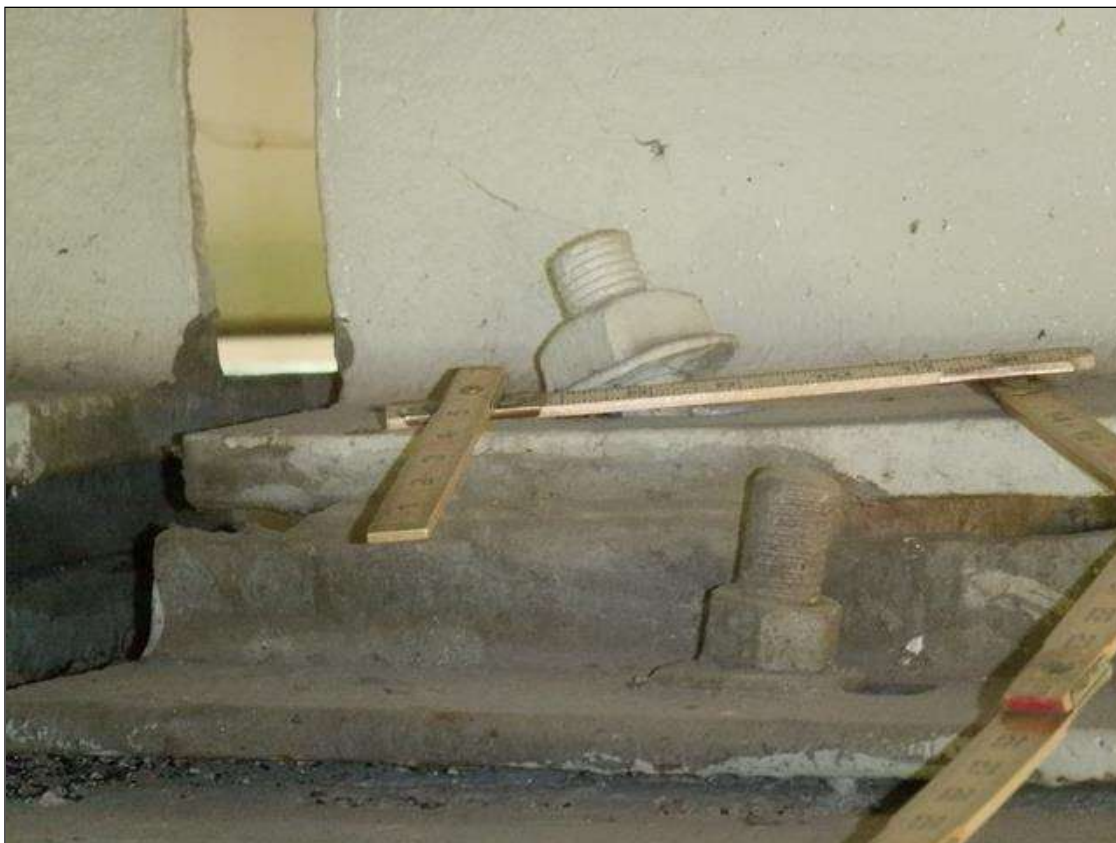
Span 3 Beam 3-Far Bearing 3: WEST ANCHOR BOLT IS BENT UP TO 1 INCHES NORTH.

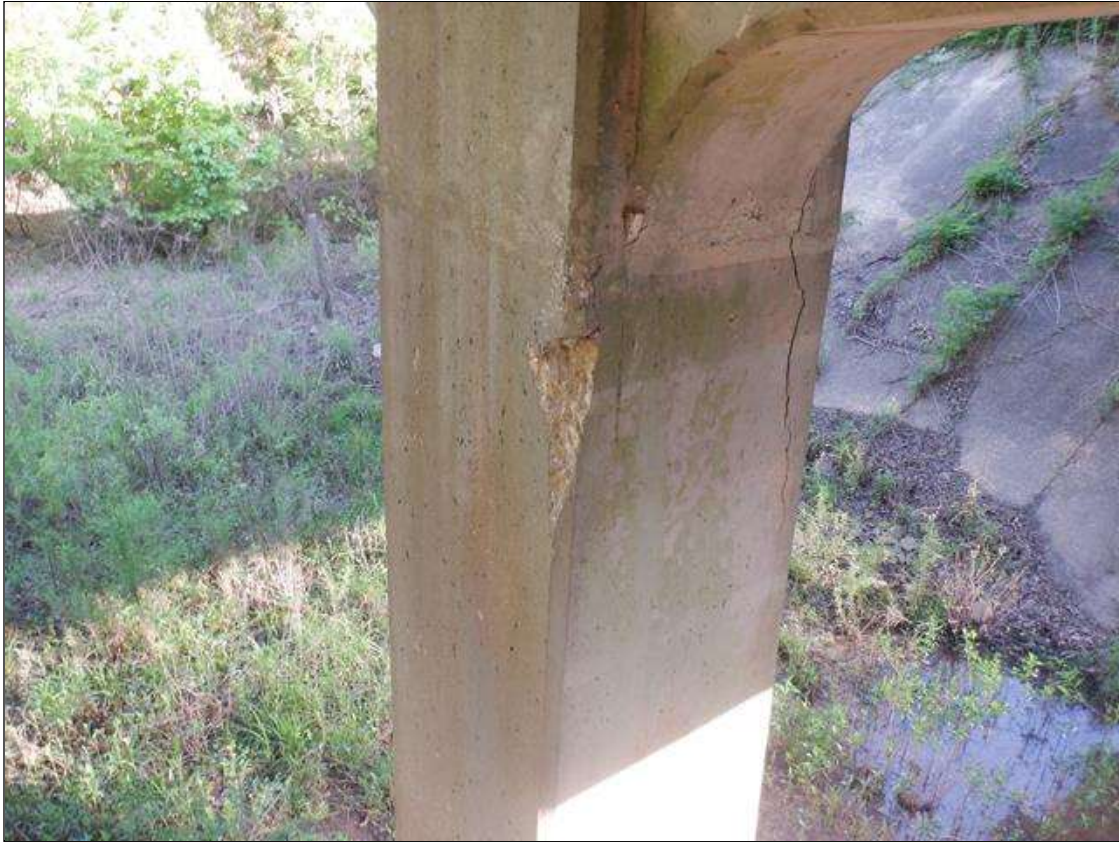
Bent 3 Pile 1: 14 INCHES X UP TO 6 INCHES X 2 INCHES SPALL WITH ADJACENT 1 FEET DIAMETER DELAMINATION ON SOUTHEAST CORNER, 2 FEET FROM BOTTOM OF CAP

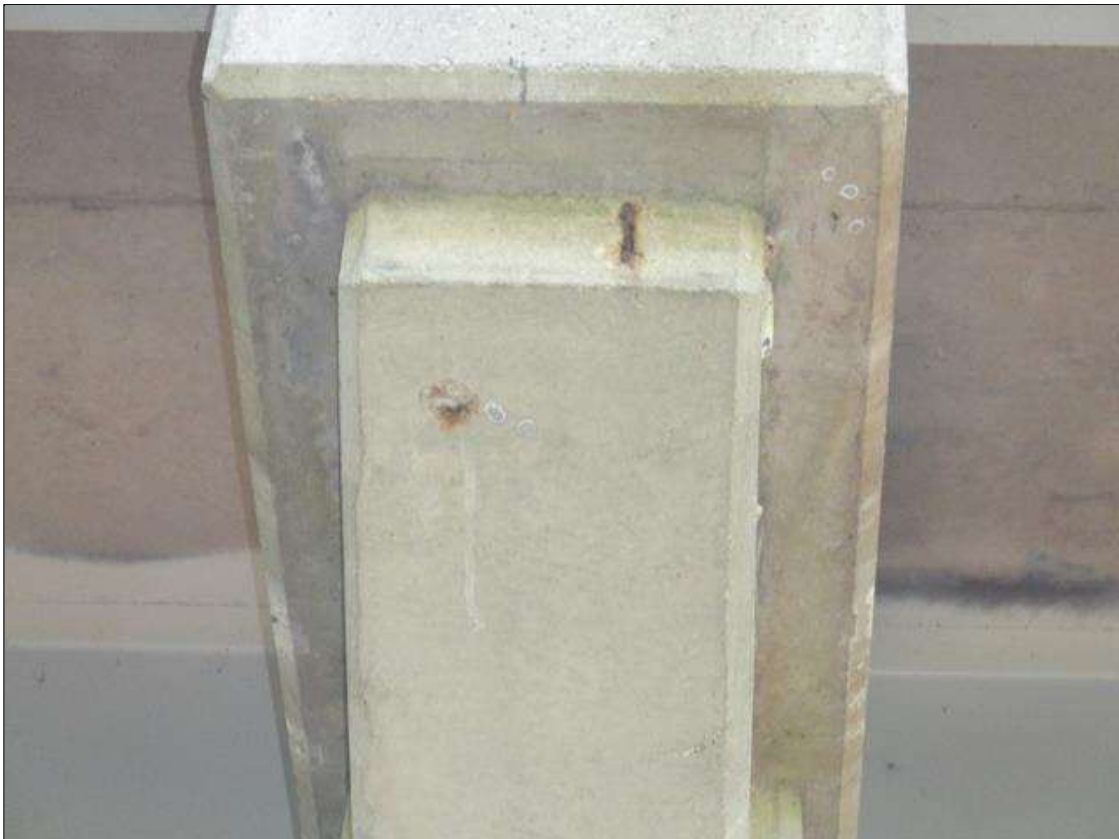
Bent 3 Pile 1: (2) UP TO 3 INCHES X 6 INCHES X 1 INCHES DEEP SPALLS WITH EXPOSED REBAR ON WEST AND BOTTOM FACE OF CORBEL.

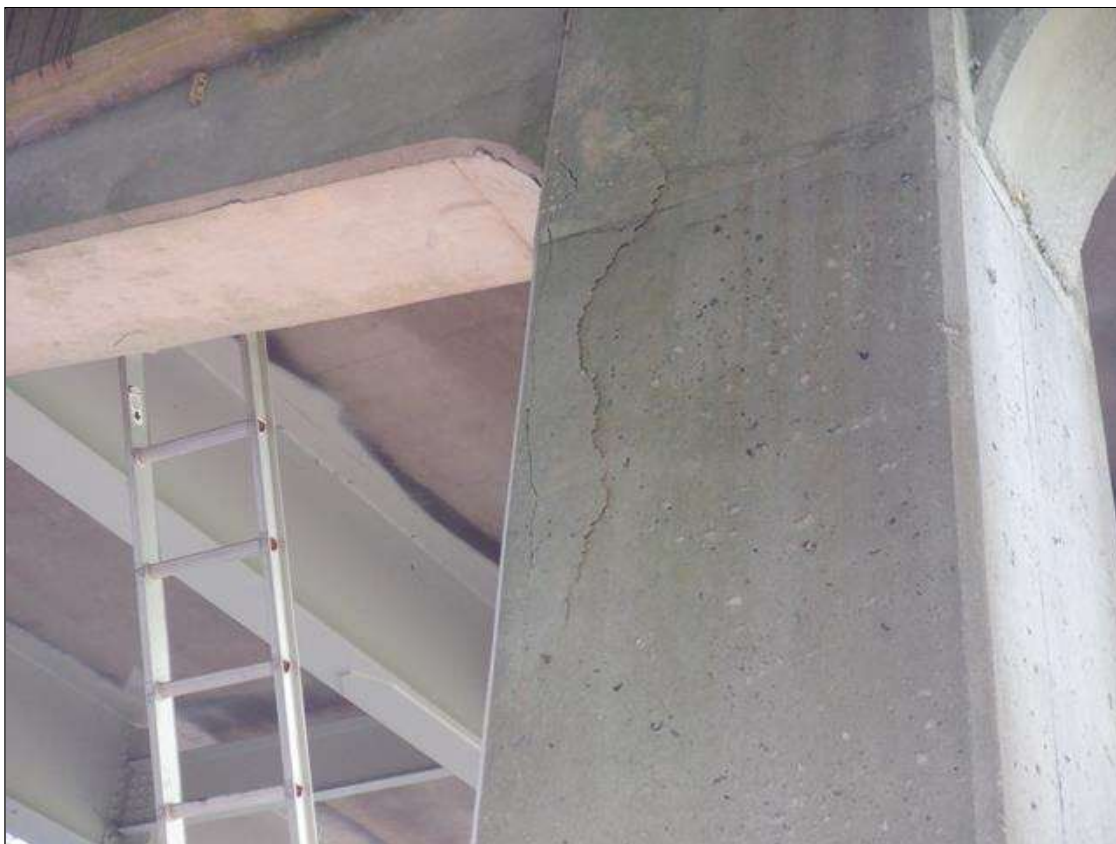
Bent 3 Pile 1: 6 FEET X UP TO 1 FEET X 8 INCHES DELAMINATION WITH UP TO 1/16 INCHES CRACKING AT NORTHEAST CORNER, 2 FEET BELOW CAP.

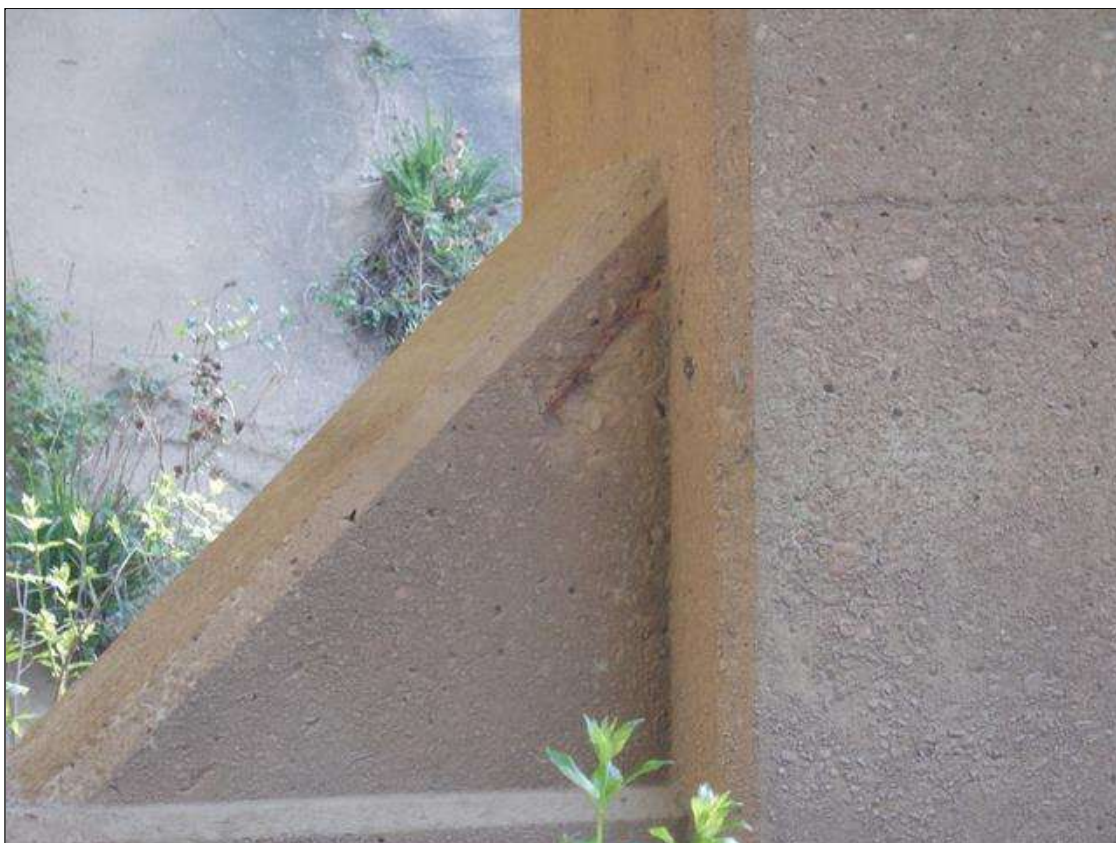
Bent 3 Pile 2: 8 INCHES X 4 INCHES X UP TO 1/2 INCHES SPALL WITH EXPOSED REINFORCING ON SPAN 3 FACE OF CORBEL UNDER STRUT.

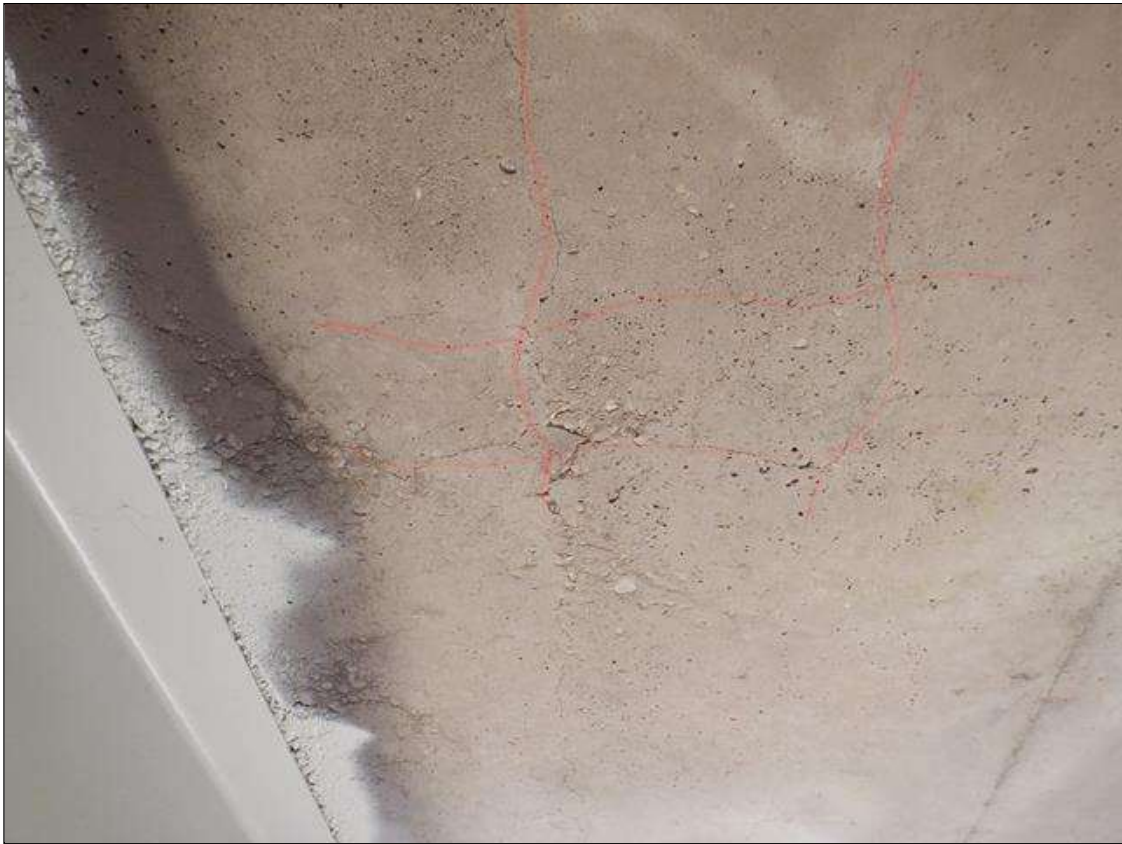
Span 4 Deck: 400 SQUARE FEET OF MAP CRACKING UP TO 1/32 INCHES AT RANDOM THROUGHOUT UNDERSIDE OF DECK

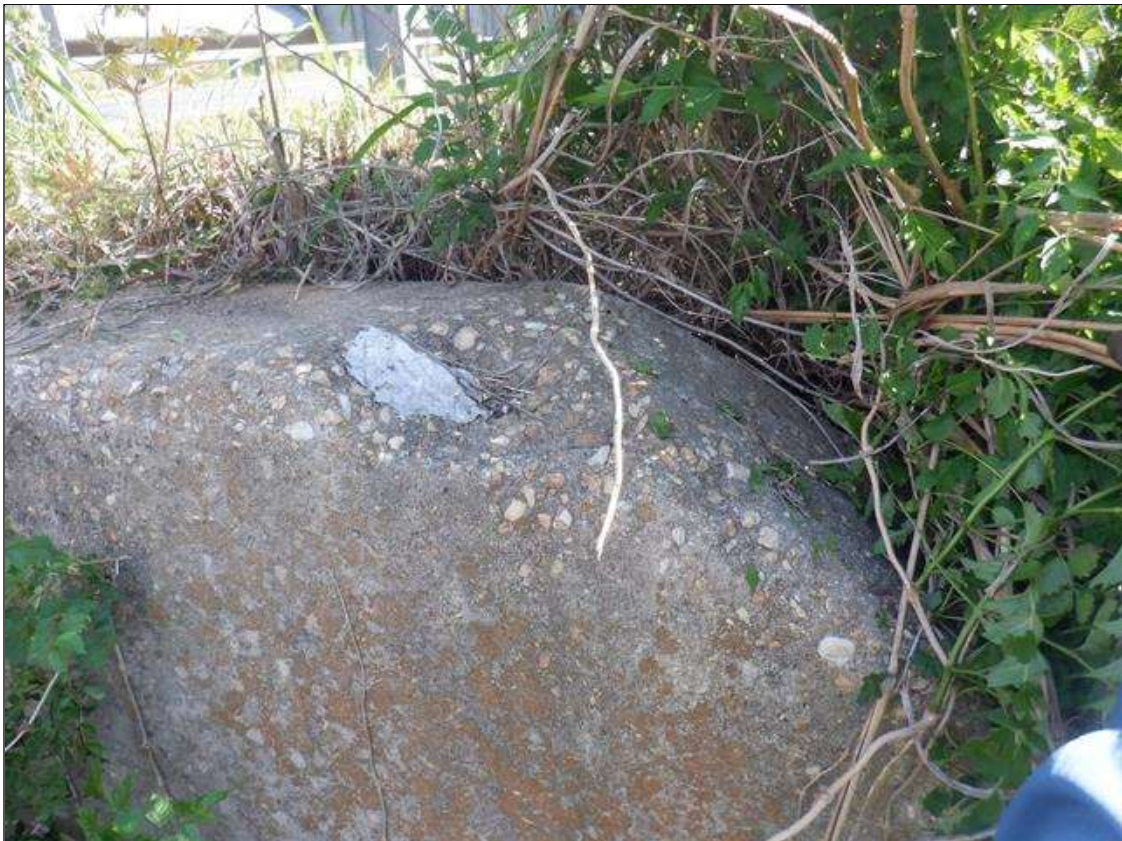
Wingwalls: 2 FEET X UP TO 1 FOOT X 2 INCHES SPALL IN TOP OF NORTHEAST WINGWALL.

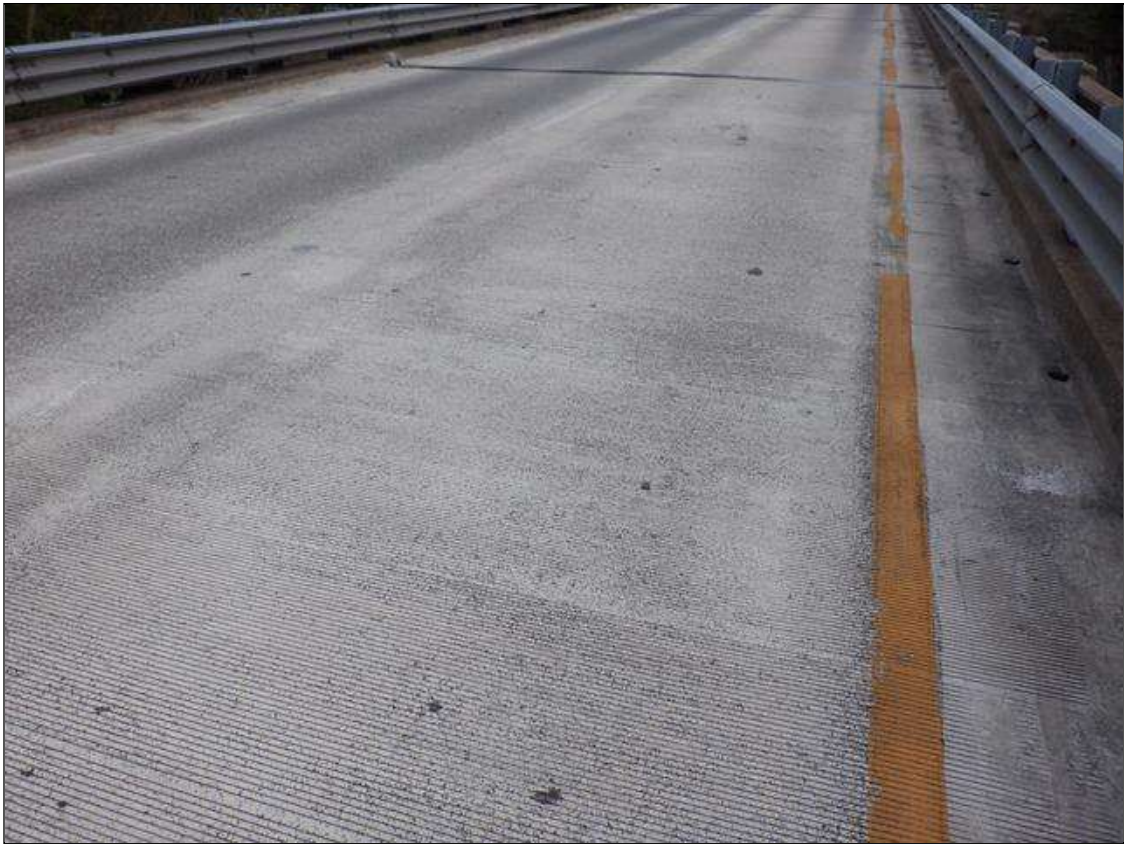
SPAN 1 CONCRETE WEARING SURFACE LOOKING NORTH

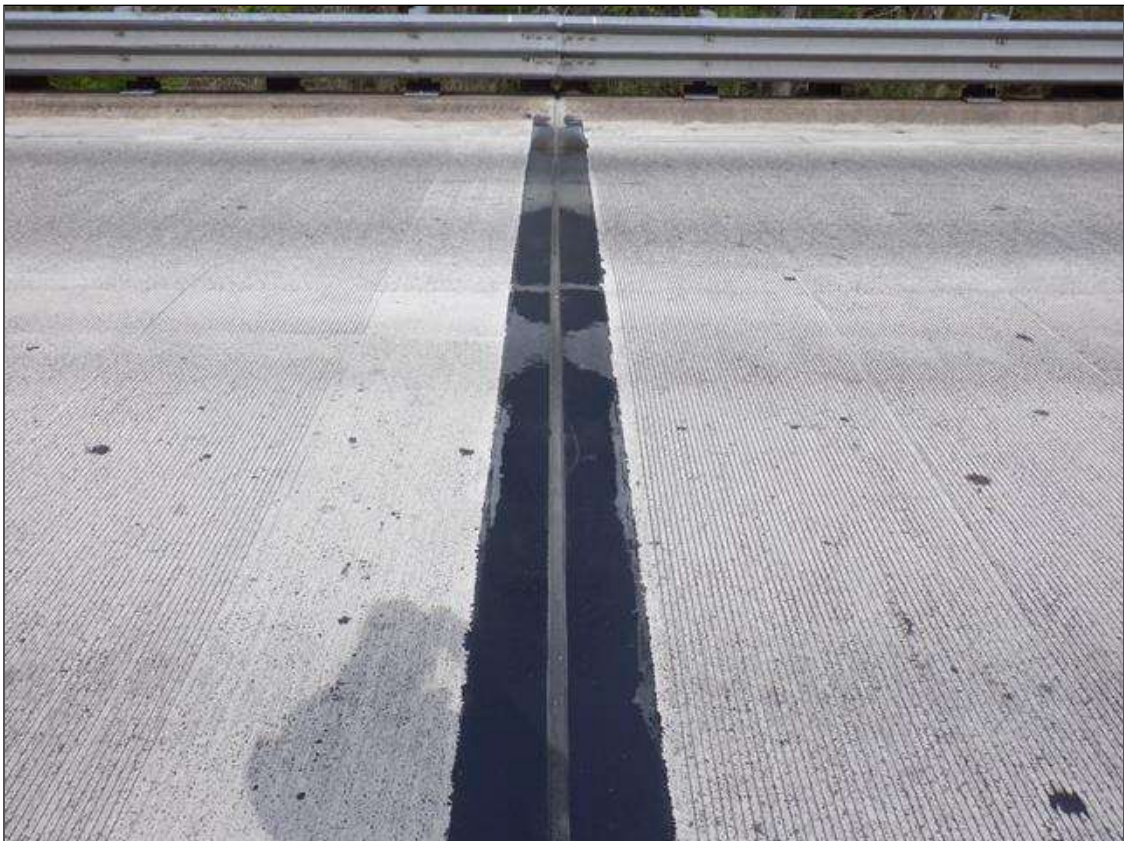
JOINT OVER BENT 1 LOOKING WEST
