NC DEPARTMENT OF TRANSPORTATION  
 DIVISION OF HIGHWAYS  
 STRUCTURE MANAGEMENT UNIT

ATTENTION: PAR SUBMITTED FOR BENT 1 PILE 1; STRUCTURE HAS BEEN RESURFACED; BEAMS AND BEARINGS HAVE BEEN REPAINTED; CHANGE TO STRUCTURE DATA

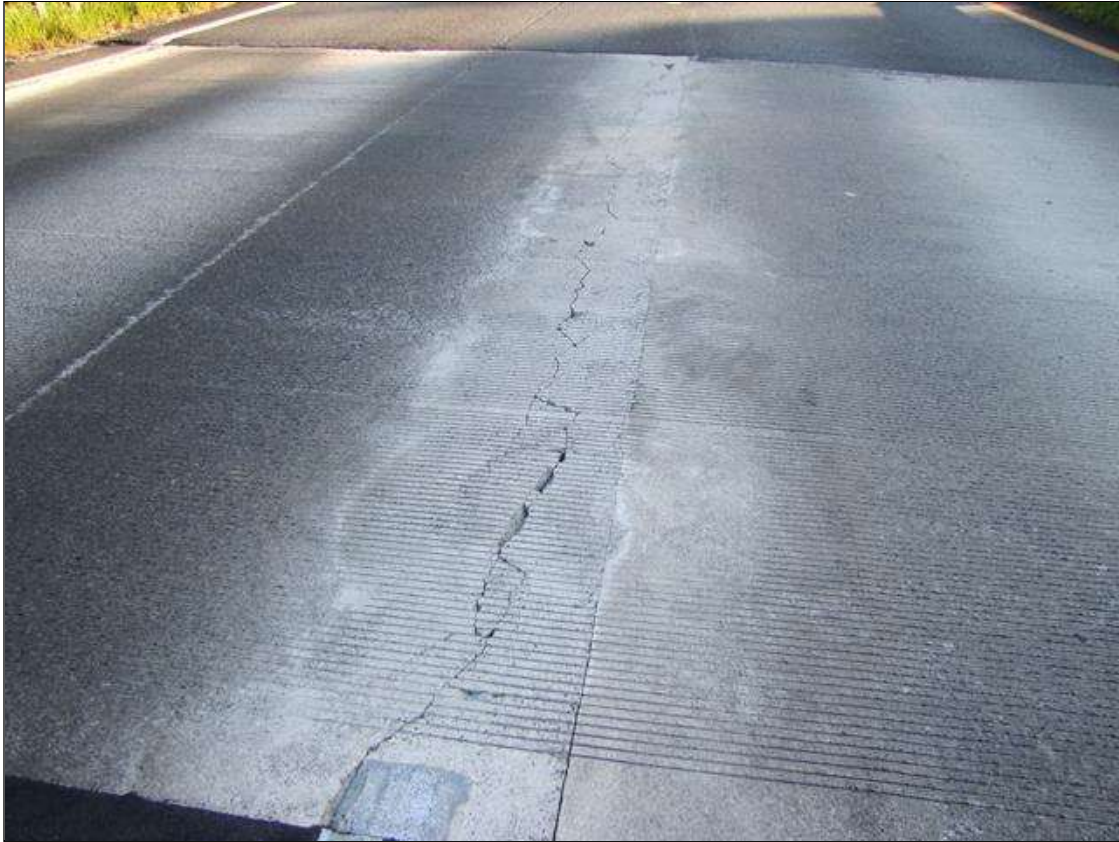
Approach 2: 25' X UP TO 1/8" LONGITUDINAL CRACK AT CENTERLINE OF ROADWAY

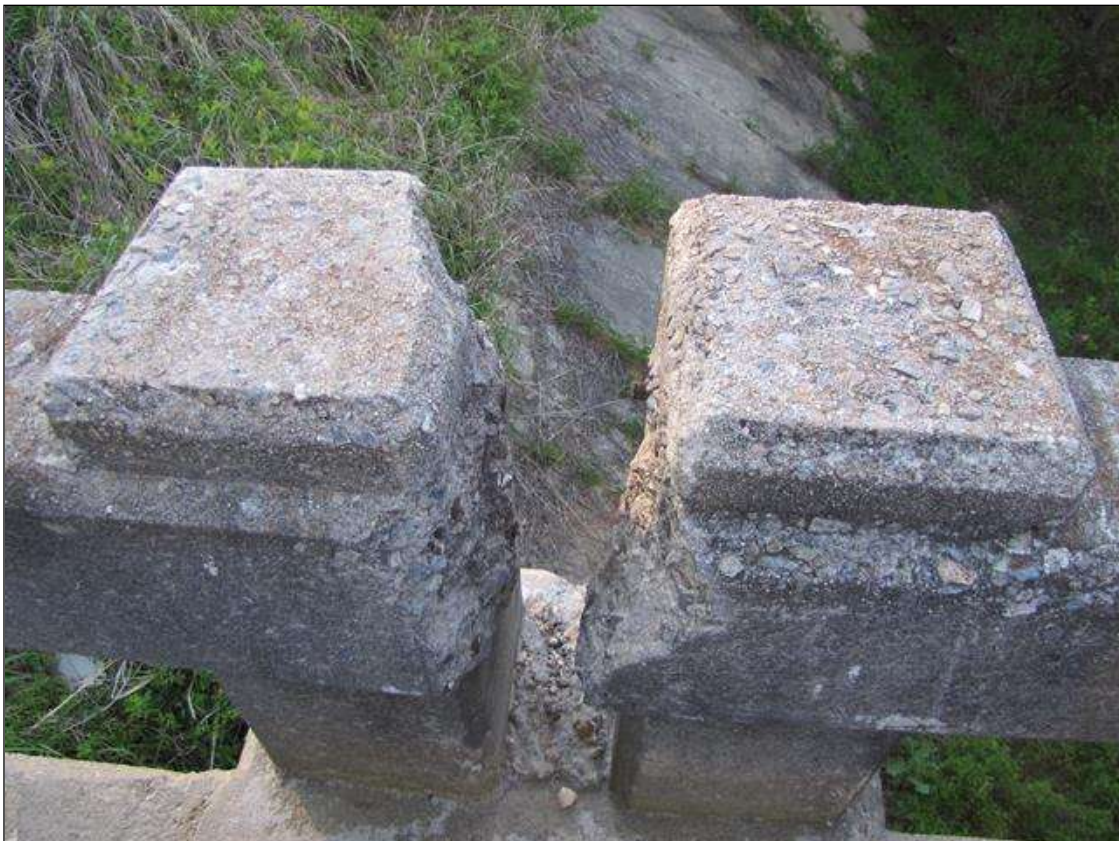
Span 4 Right Bridge Rail: 2" x 8" x 10" deep spall with exposed rebar on concrete Post 7 (Post 6 similar)

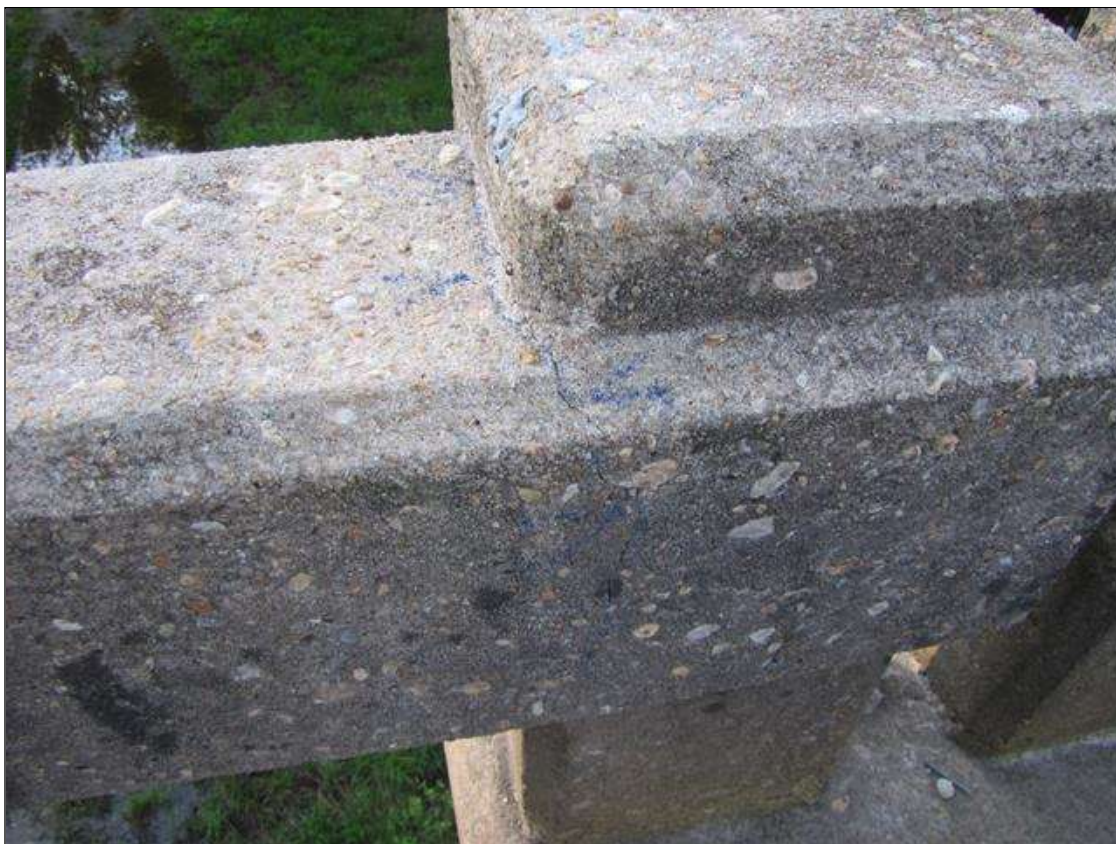
Span 3 Right Bridge Rail: (5) x up to 1/64" vertical and transverse cracks on concrete rail and curb (PHOTO TAKEN NEAR MIDSPAN)

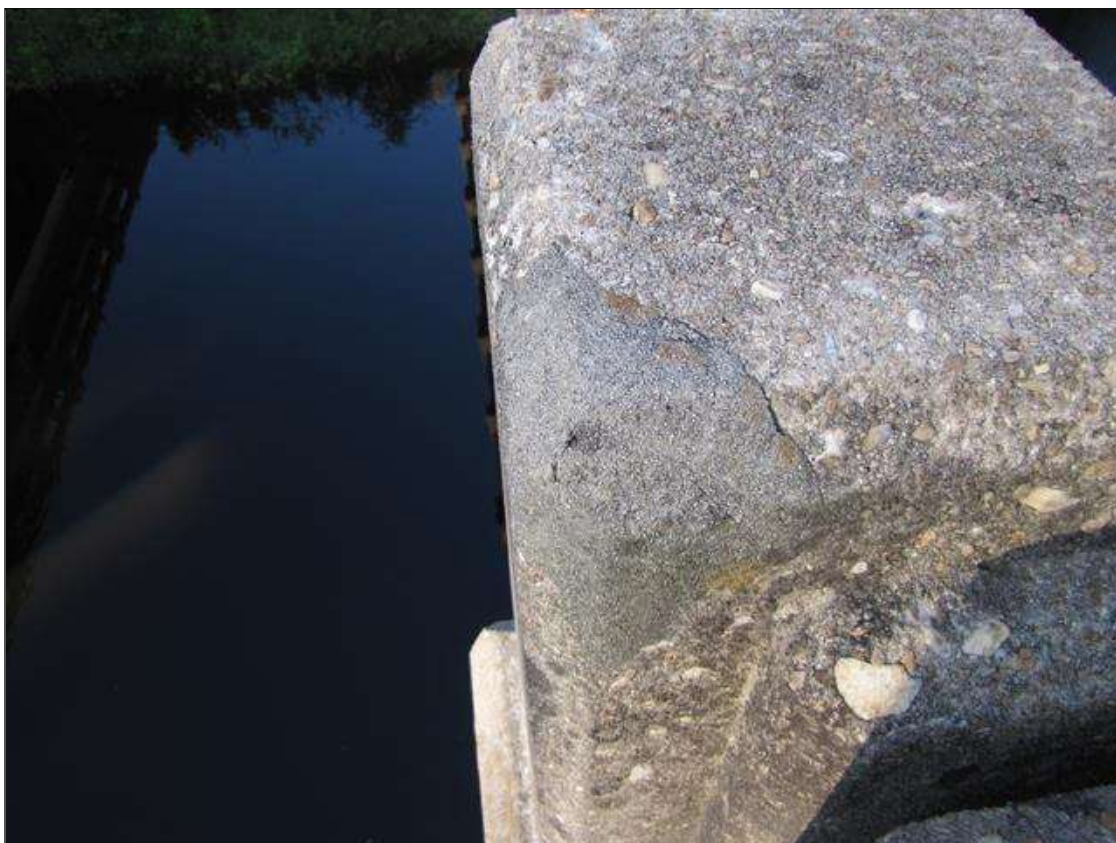
Span 2 Right Bridge Rail: 4" x 3" area of sound patch on top of Post 9

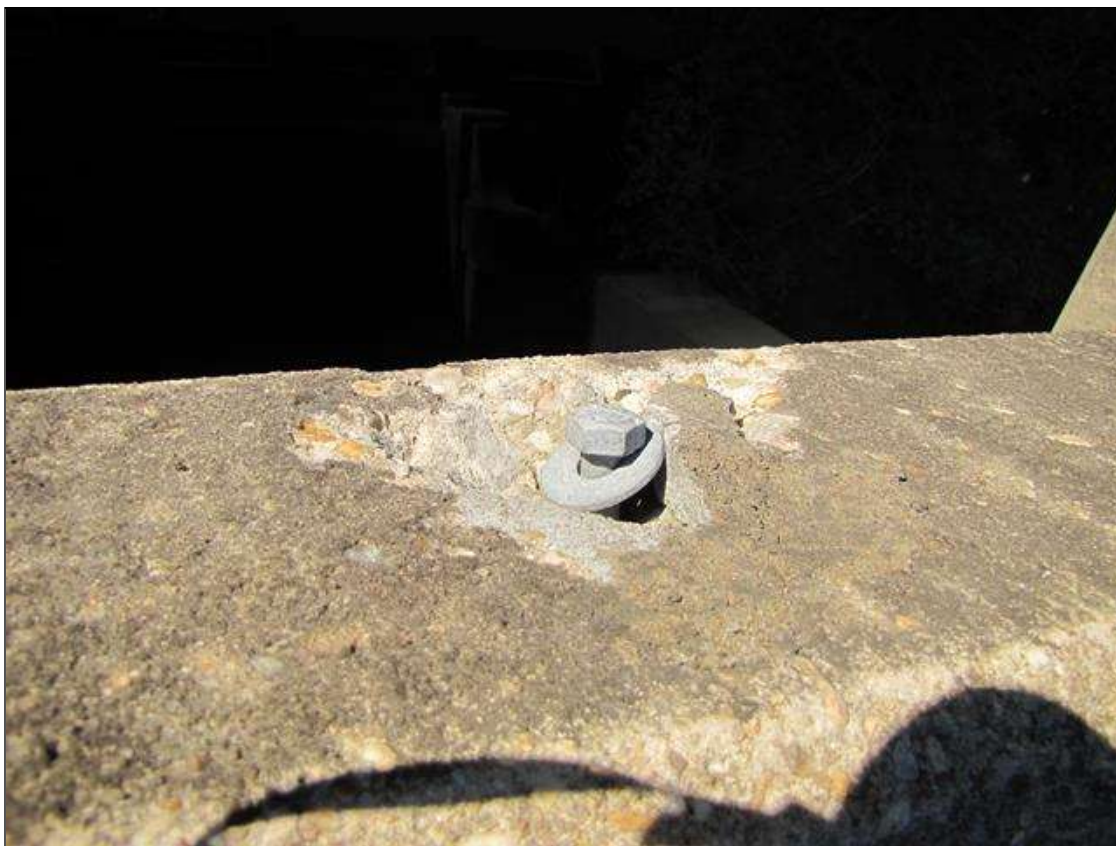
Span 2 Right Bridge Rail: 7" x 5" x 1" deep spall on outside face of concrete rail 10' FROM BENT 1

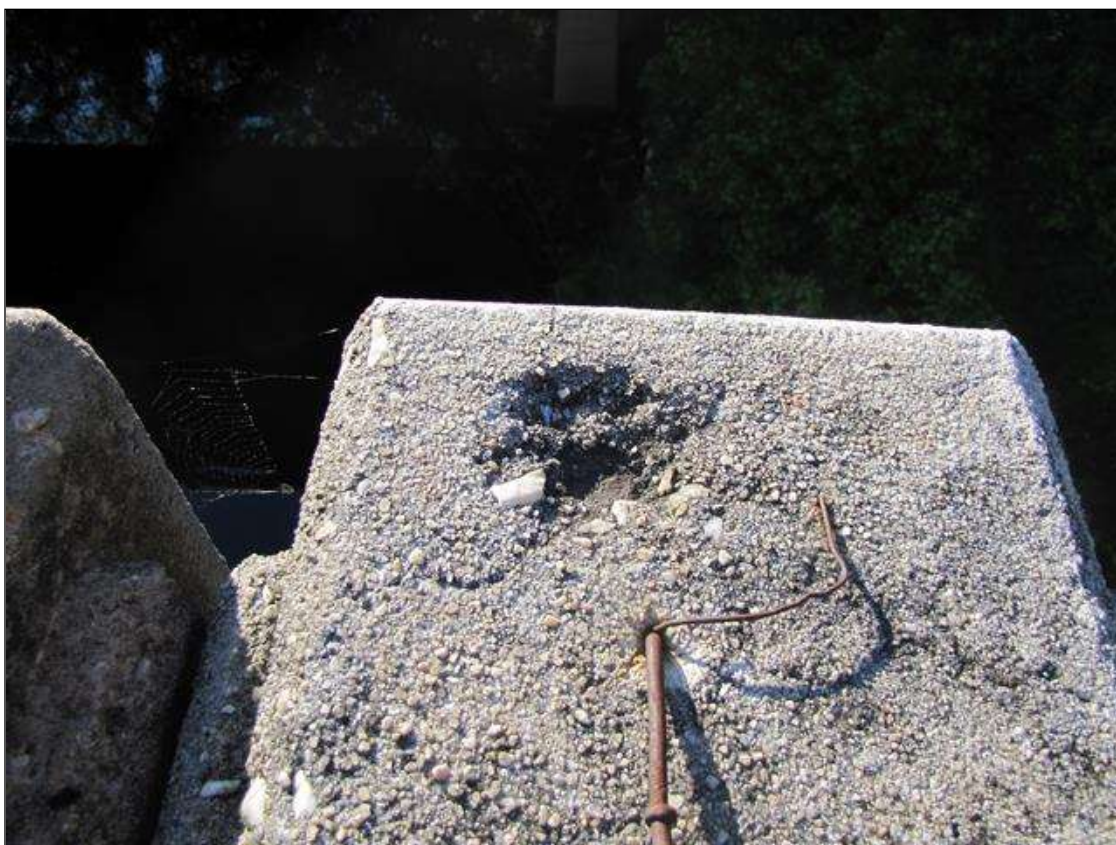
Span 1 Right Bridge Rail: 3" x 2" x 1/2" SPALL TOP OF POST 8

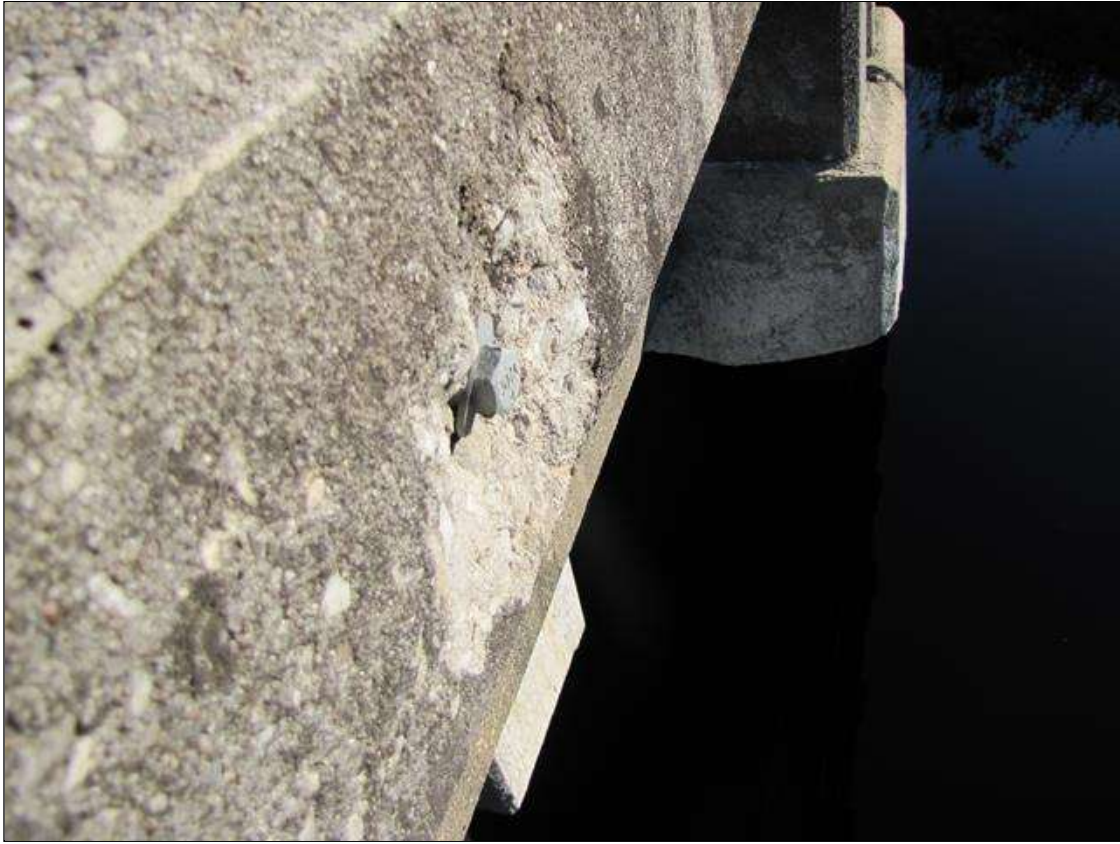
Span 1 Right Bridge Rail: 2- UP TO 7" x 6" x 1" spall on outside face of rail NEAR BENT 1

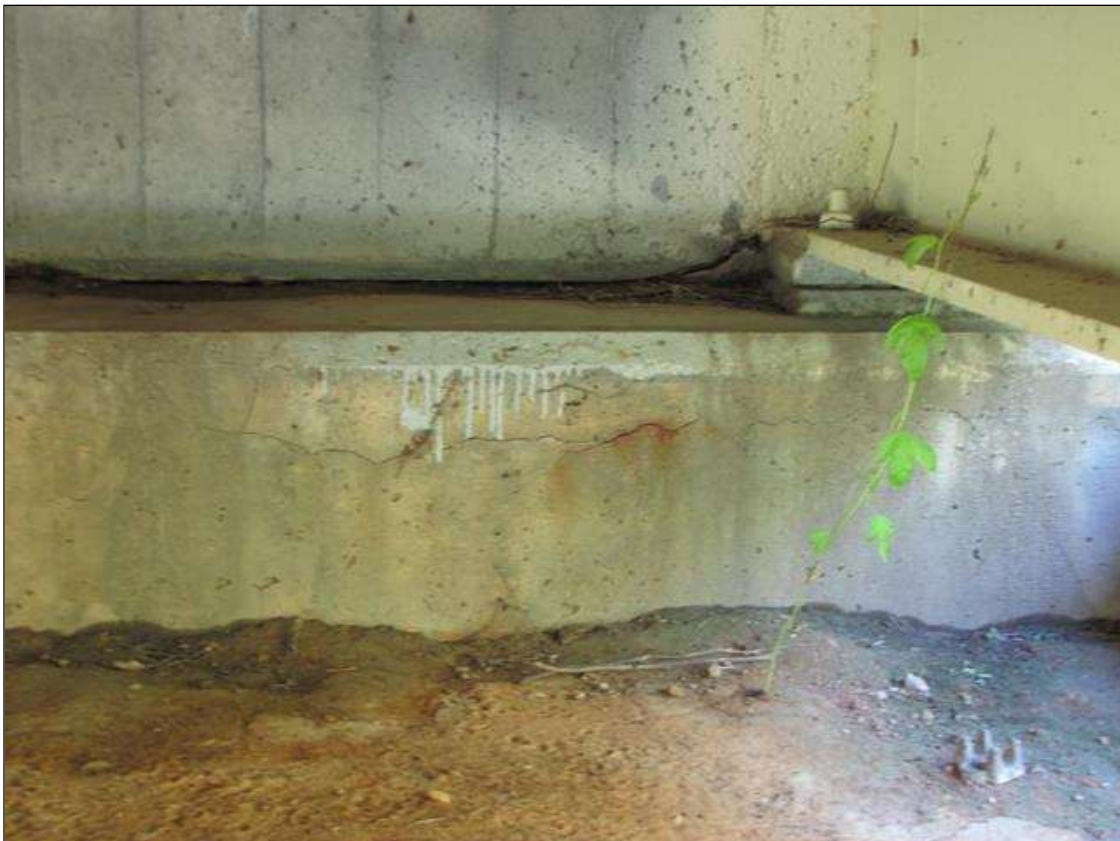
End Bent 1 Cap 1: 5' up to 1/32" horizontal crack WITH RUST STAINING under Bay 1

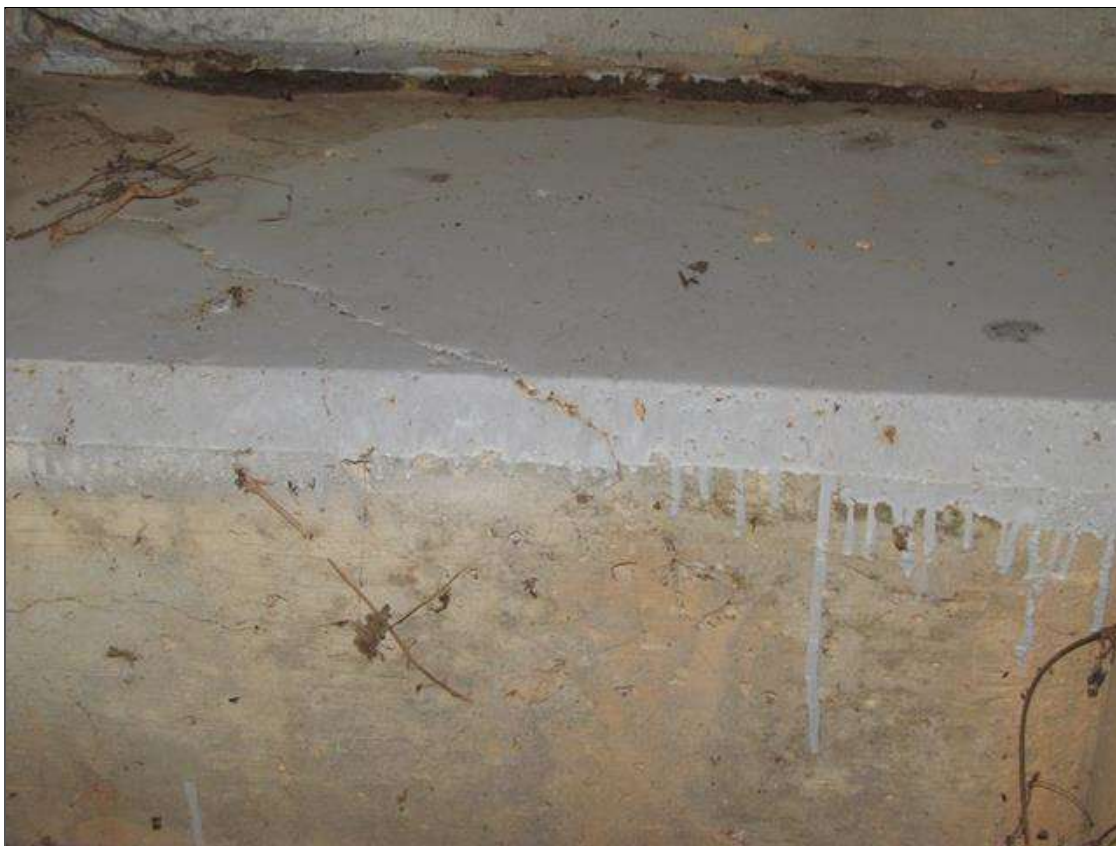
End Bent 1 Cap 1: 6' x 1/16" horizontal crack under Bay 2

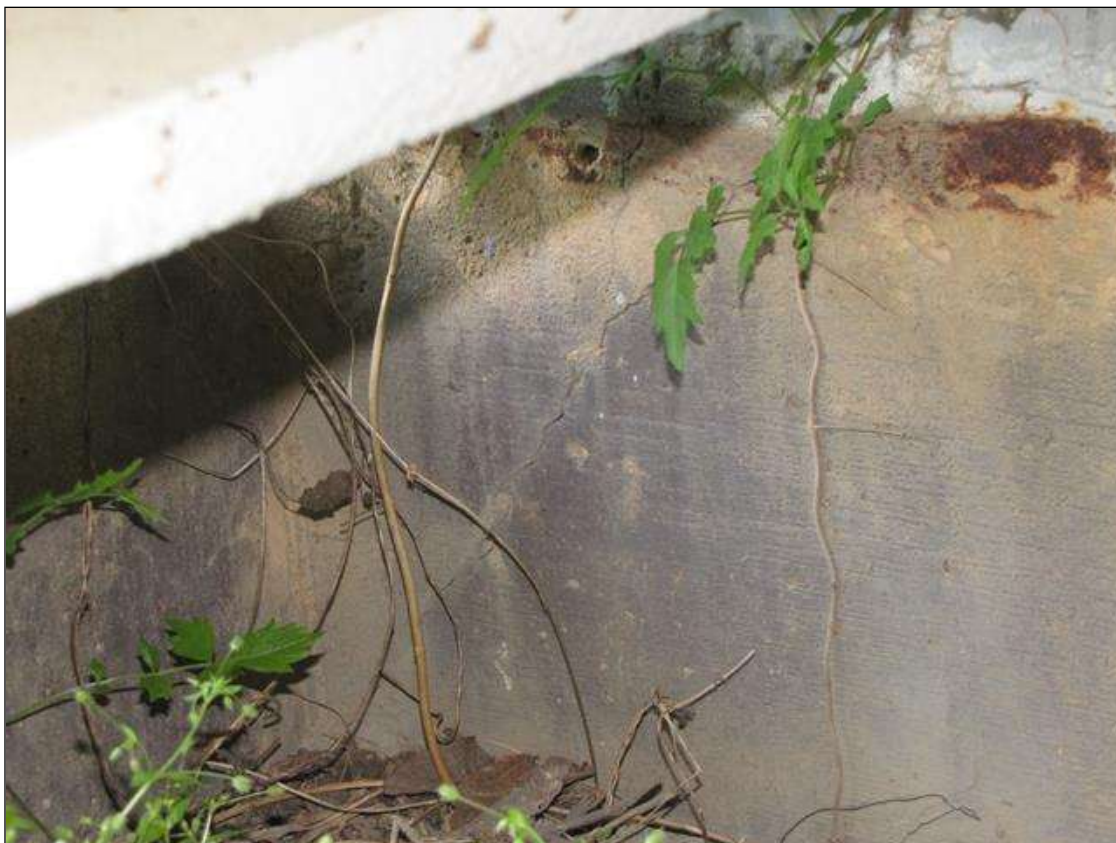
End Bent 1 Cap 1: 16" up to 1/16" diagonal crack under Beam 4 (Beam 1 similar)

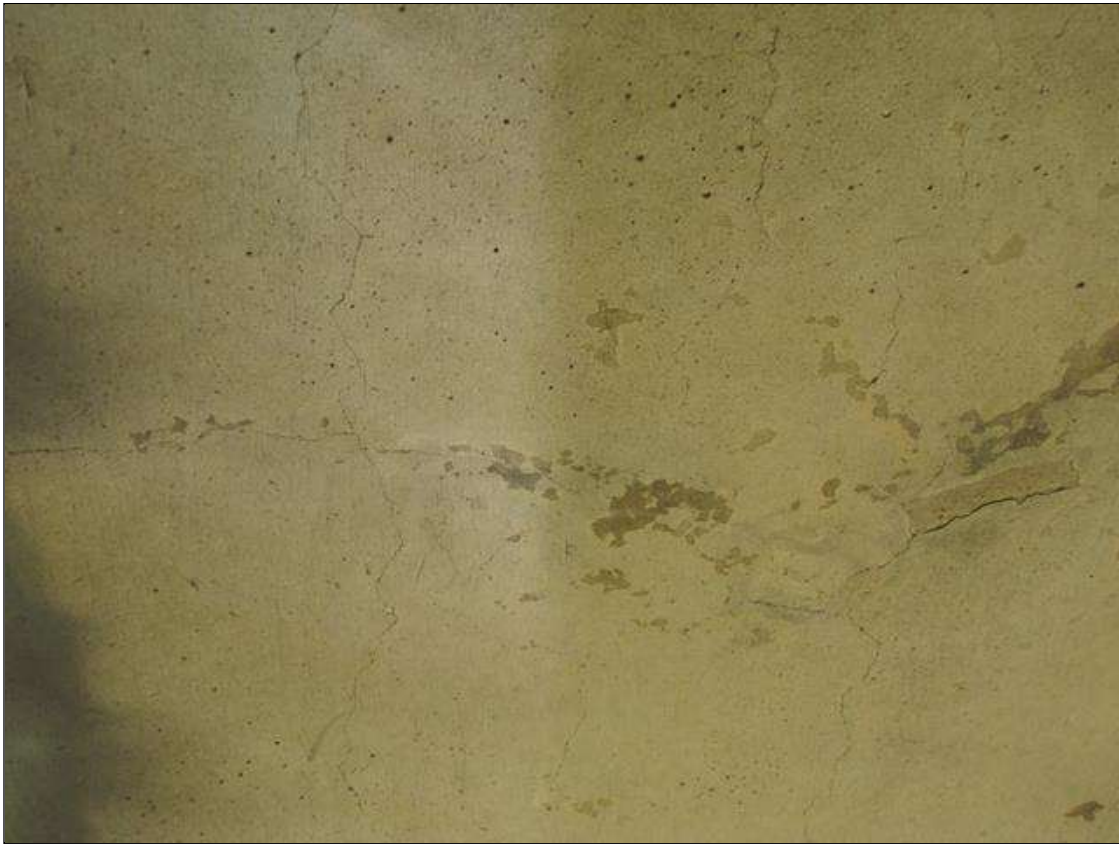
Span 1 Deck: 400 SF MAP CRACKING UP TO 1/32" AT RANDOM THROUGHOUT UNDERSIDE OF DECK (PHOTO TAKEN BAY2 MIDSPAN).

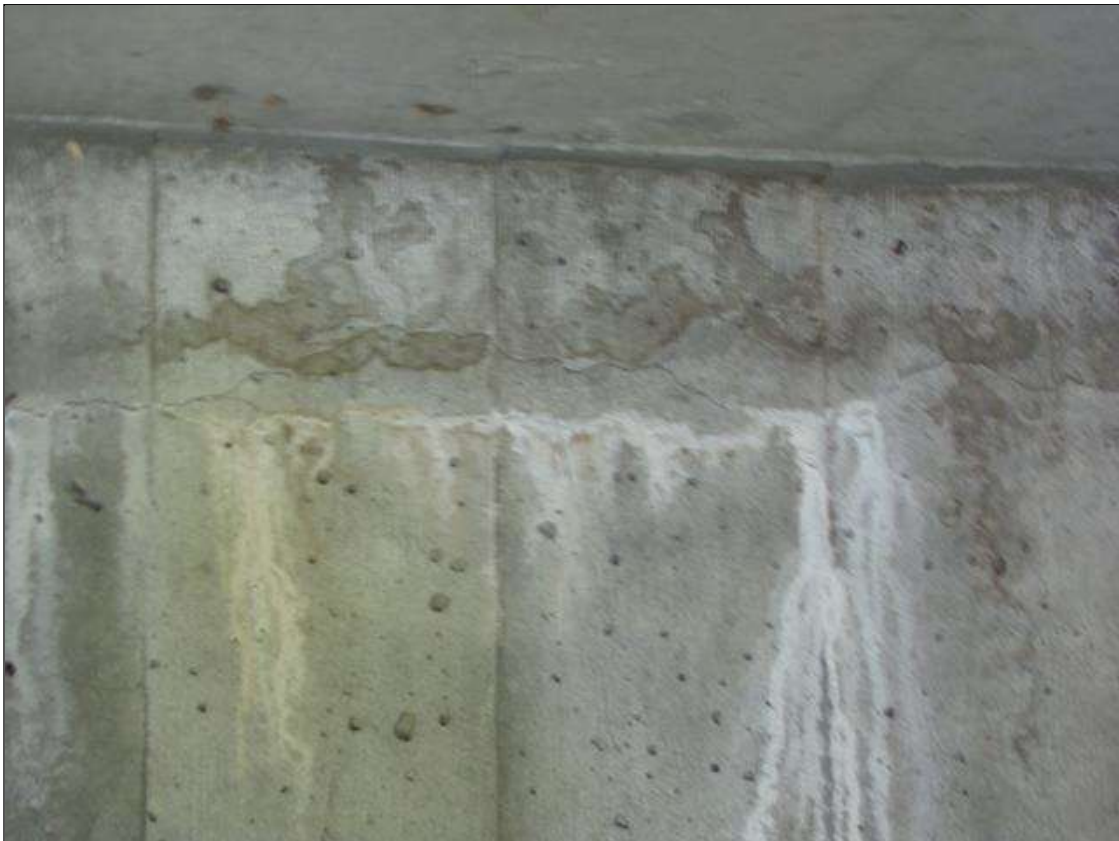
End Bent 1 Abutment/Backwall : 6' x up to 1/64" horizontal crack WITH EFFLORESCENCE in Bay 1 (Bays 2 and 3 similar)

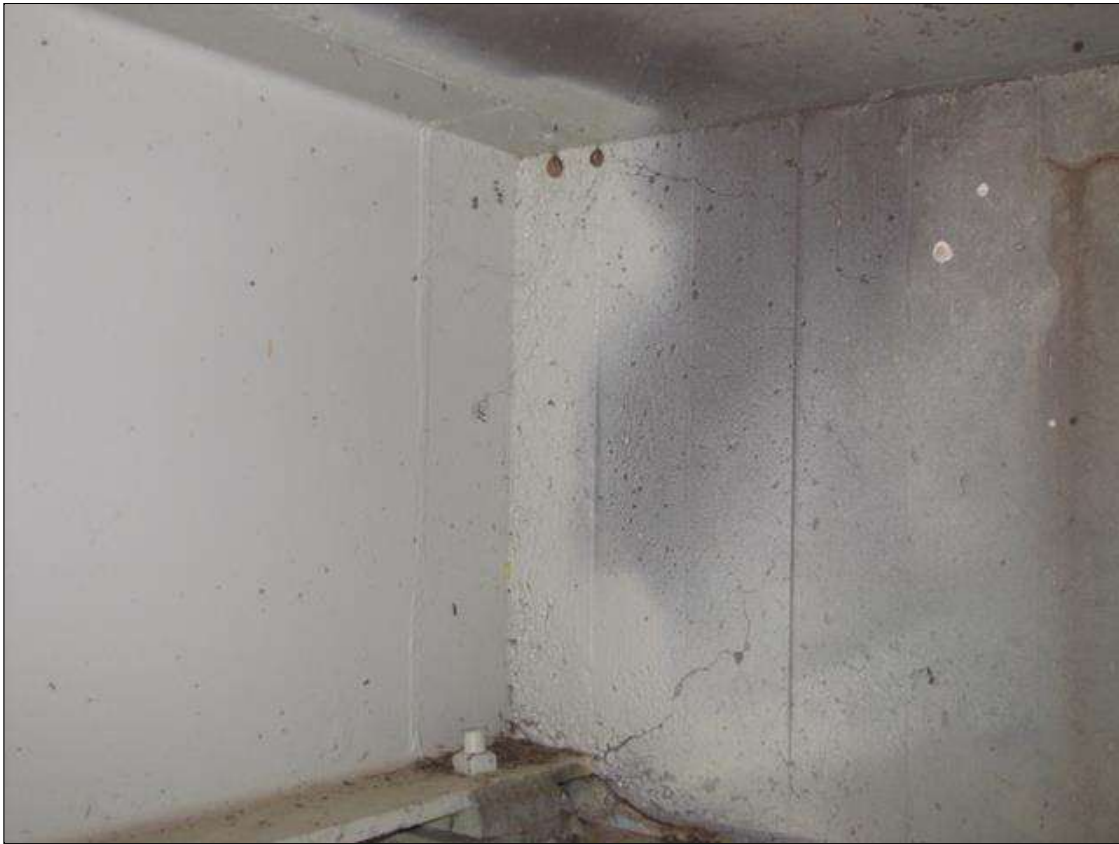
Span 1 Beam 3: 7" x 31" REPAIR AT END BENT 1

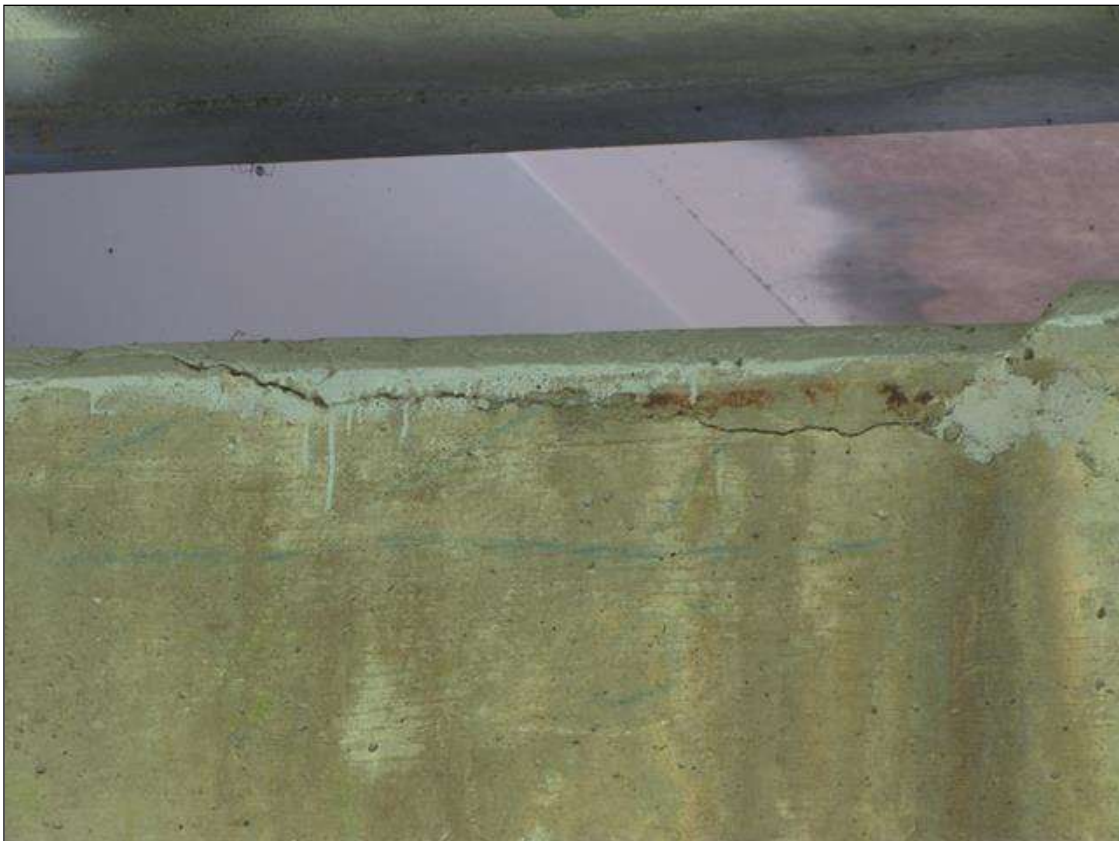
Bent 1 Cap 1: 18" up to 1/8" horizontal crack on Span 1 face under Bay 1

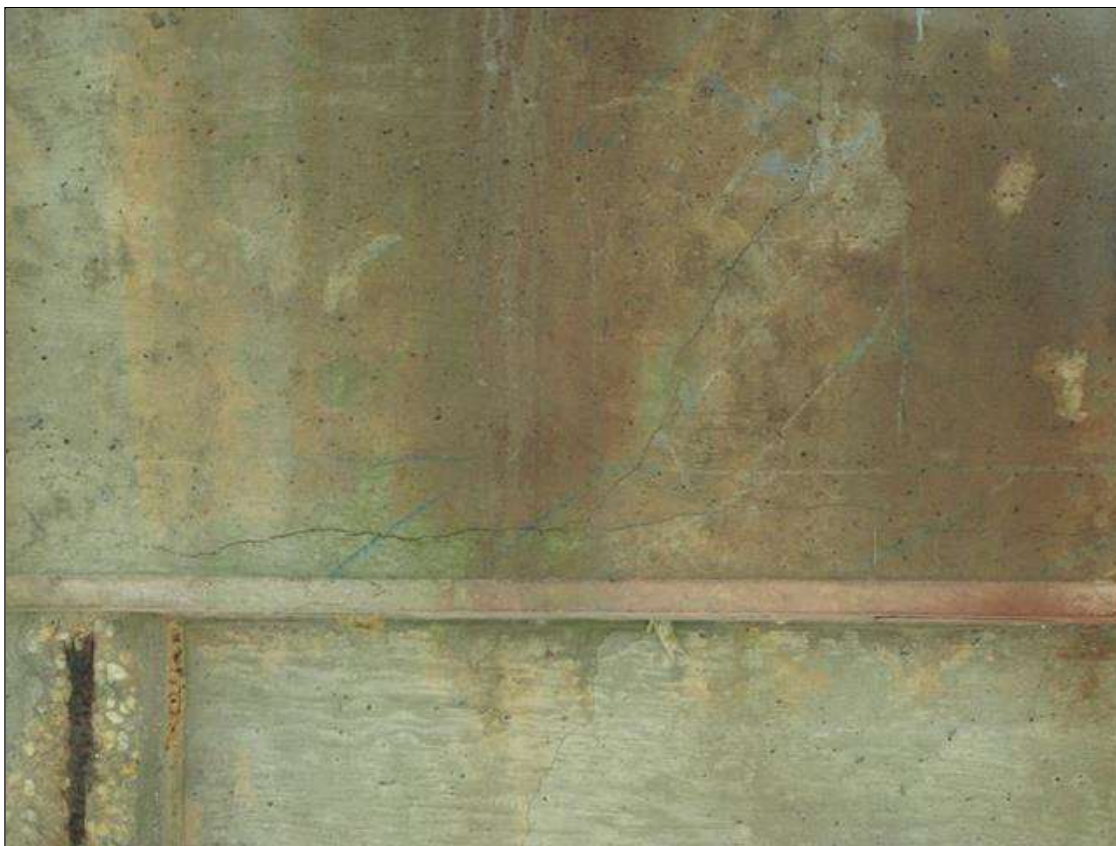
Bent 1 Cap 1: 42" x 24" area of hairline vertical and horizontal cracks on Span 1 face under Bay 1

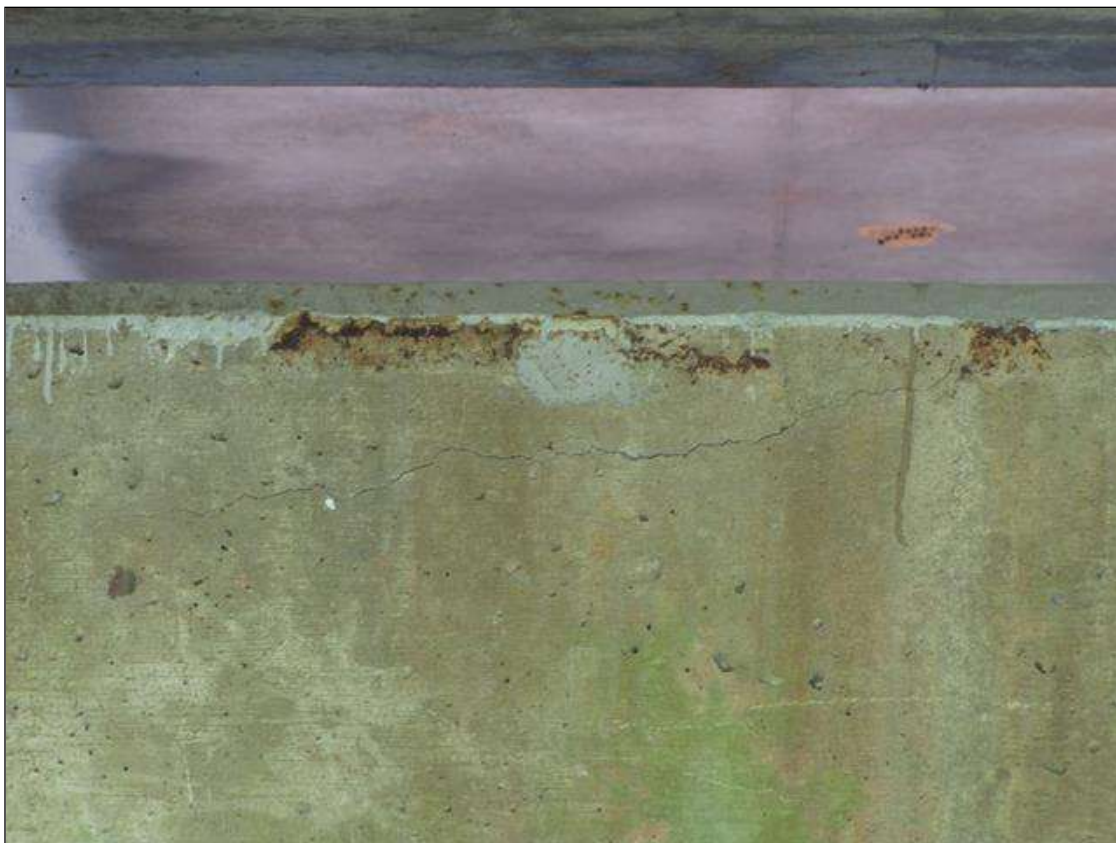
Bent 1 Cap 1: 2' X UP TO 1/32" HORIZONTAL CRACK UNDER BAY 2 NEAR TOP SOUTH FACE

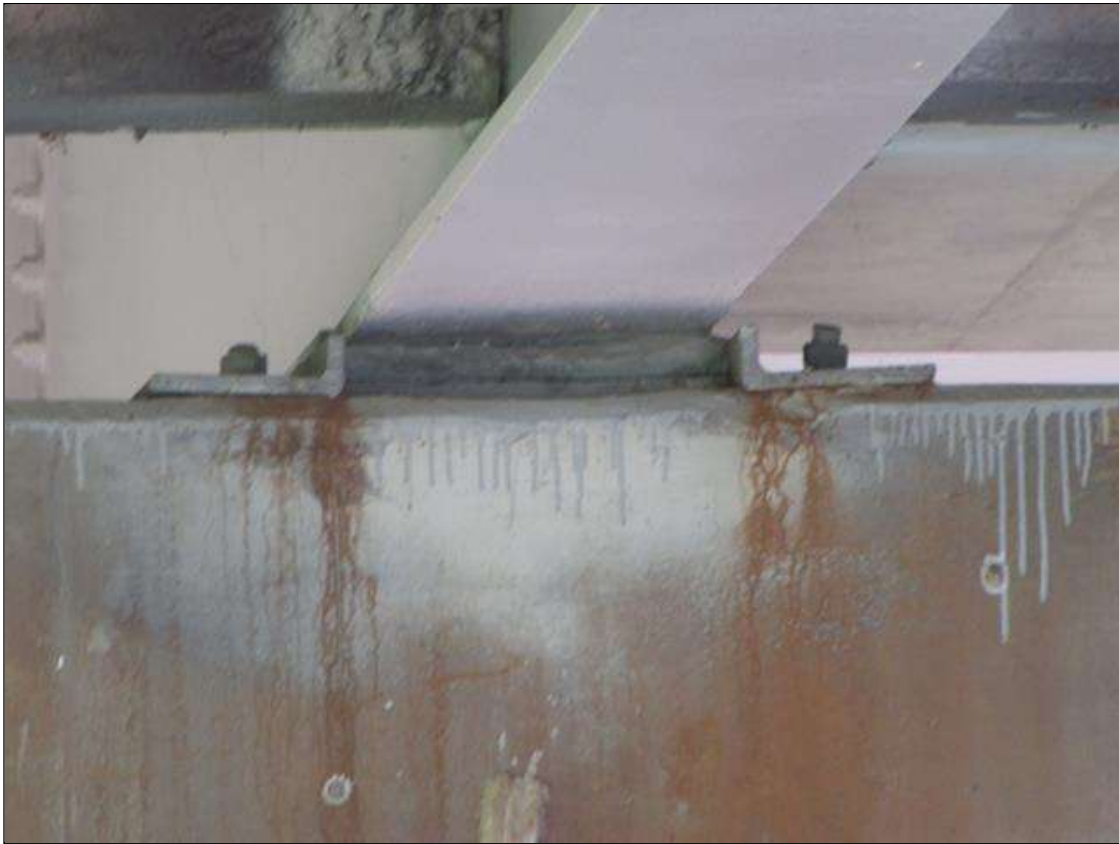
Bent 2 Cap 1: 4' x 15" area of sound patch on Span 2 face under Beam 3 (Beam 2 similar)

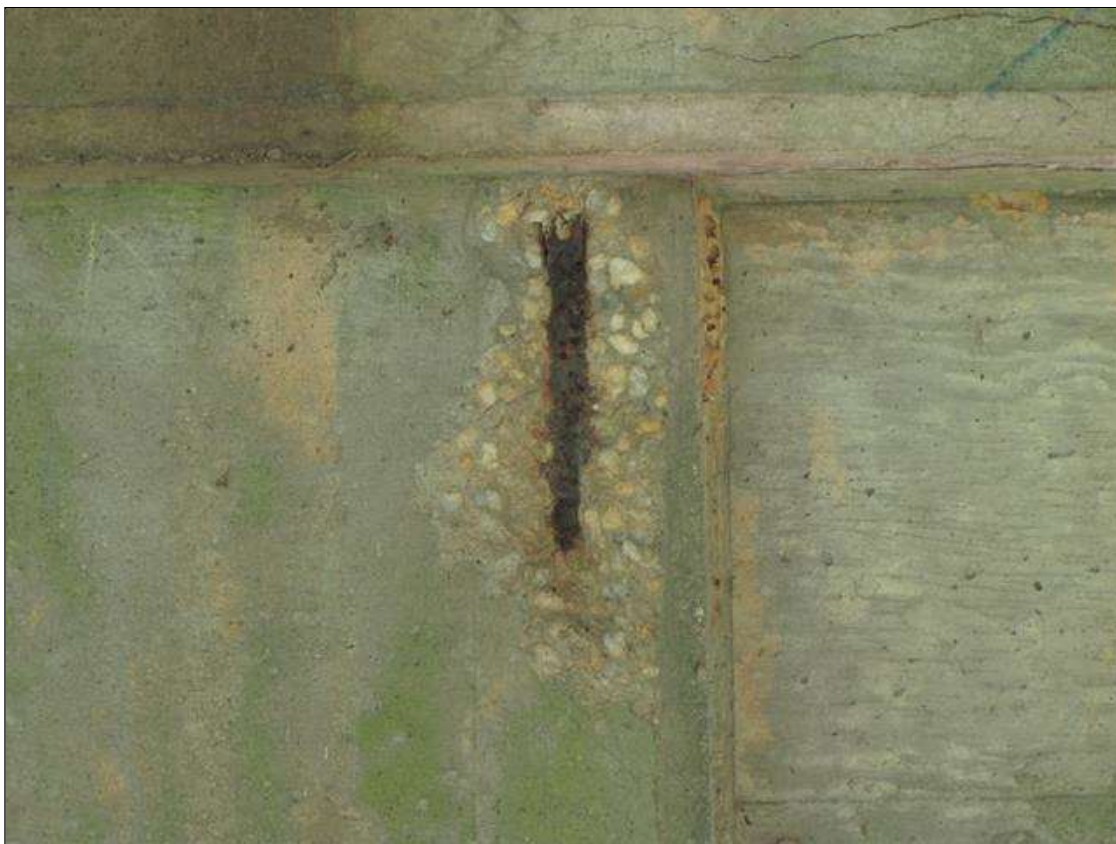
Bent 1 Pile 1: (PAR) 12" x 5" x 1" SPALL WITH EXPOSED REBAR ON SOUTH FACE AT BOTTOM OF CAP.

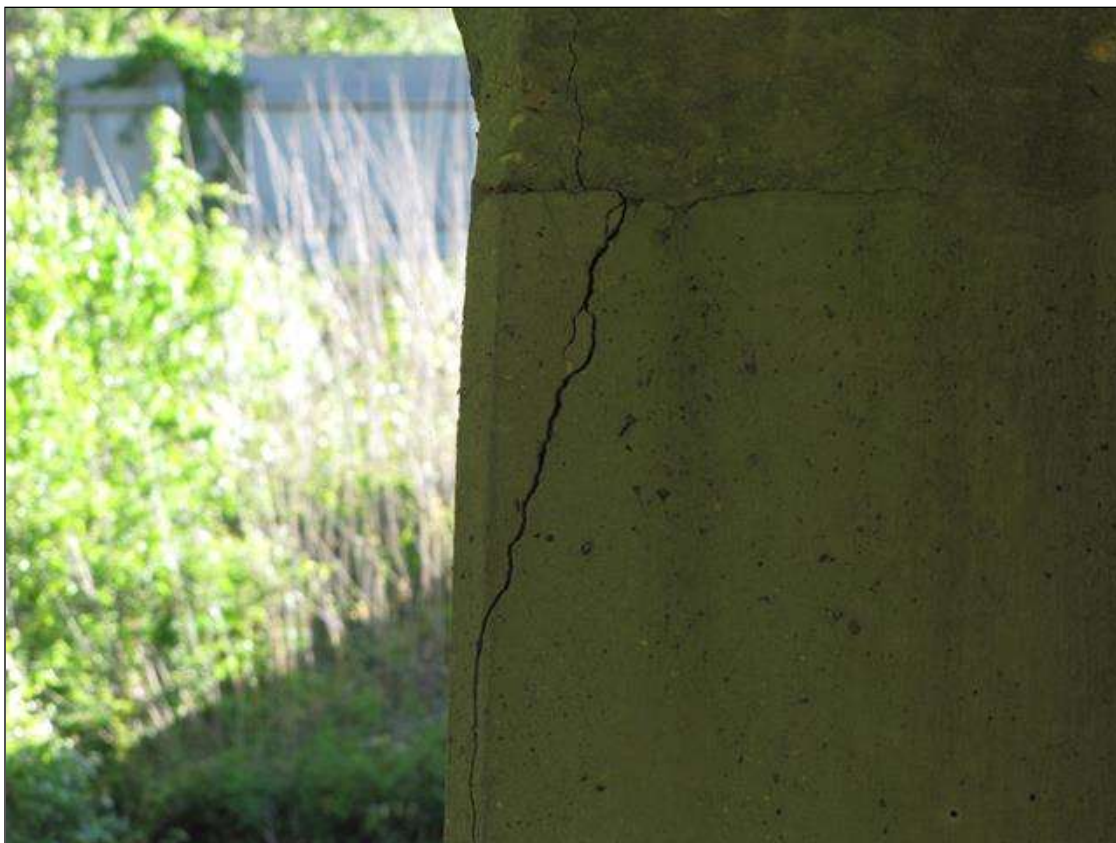
Bent 1 Pile 1: 30" up to 1/8" vertical crack on Span 1 face

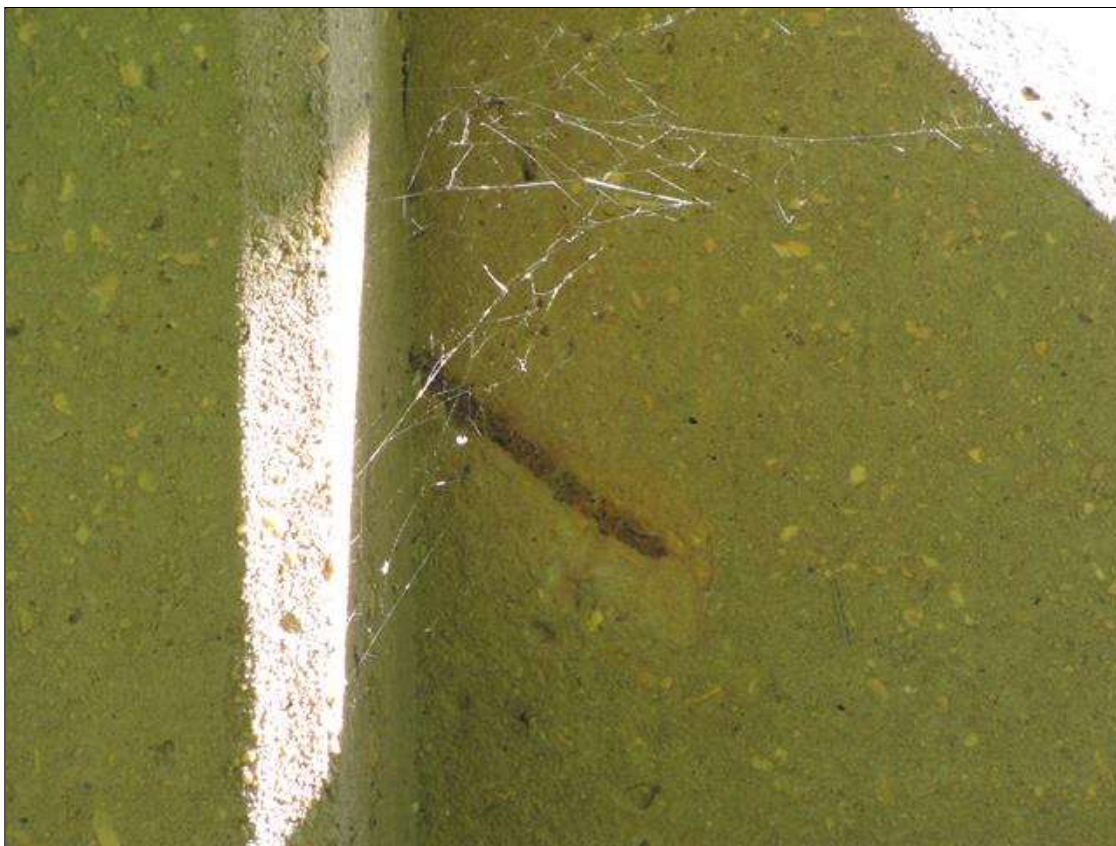
Bent 1 Pile 1: 2" x 6" x 1/2" deep spall with exposed rebar on Span 1 face of strut

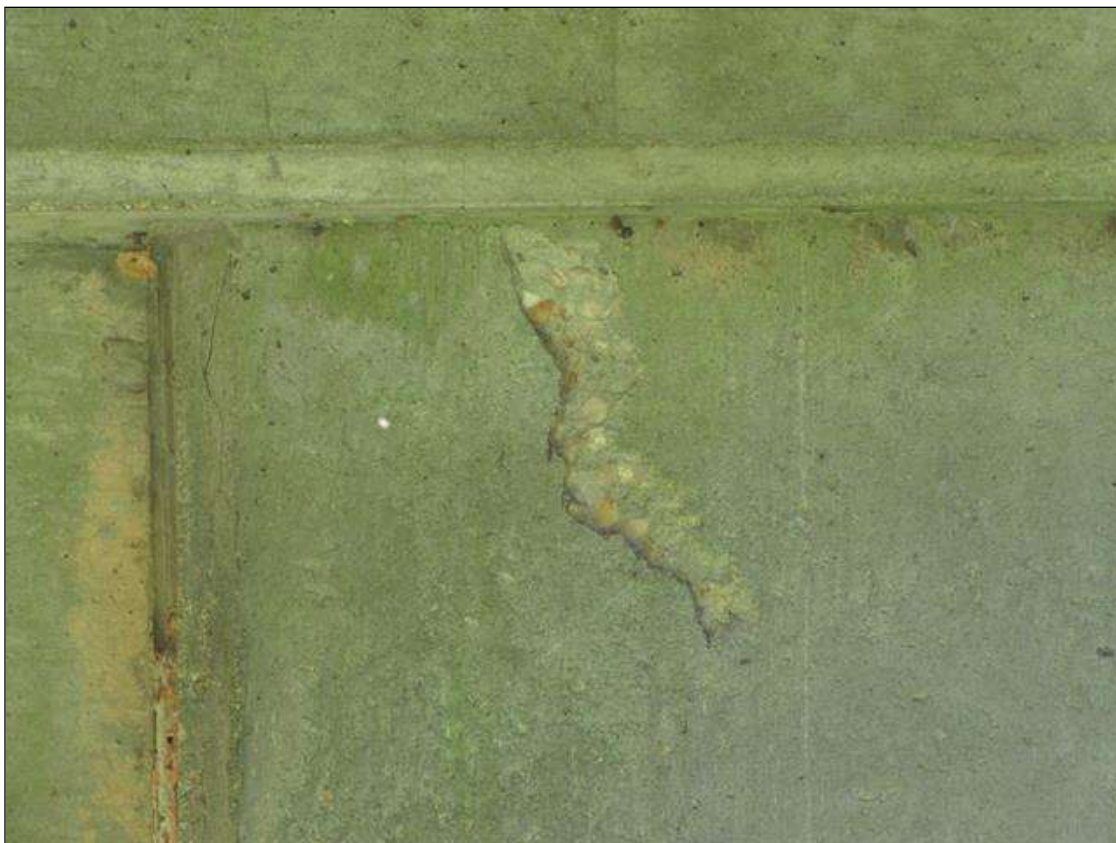
Bent 1 Pile 2: 8" X 2" X 1/4" SPALL AT BOTTOM OF CAP WITH ADJACENT 18" up to 1/16" vertical crack on Span 1 face

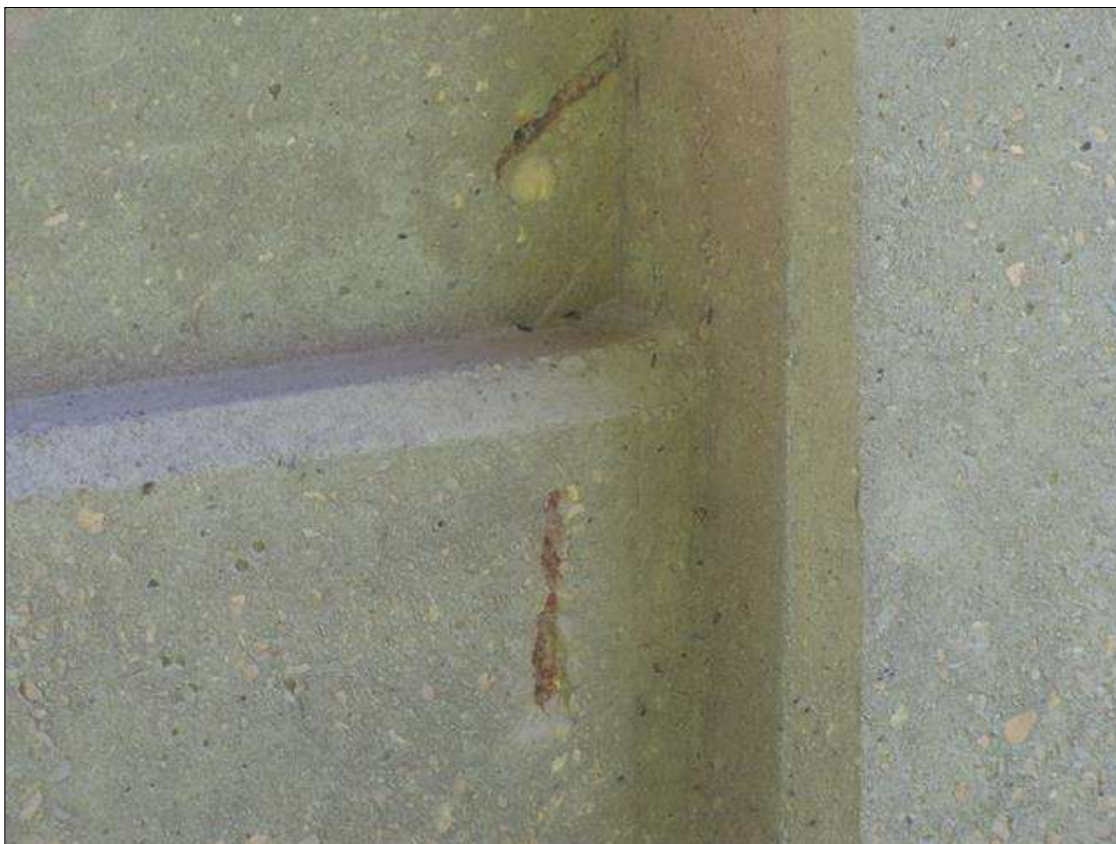
Bent 1 Pile 2: (2) up to 3" x 2" x 1/2" deep spall with exposed rebar on corbel and strut on Span 1 face

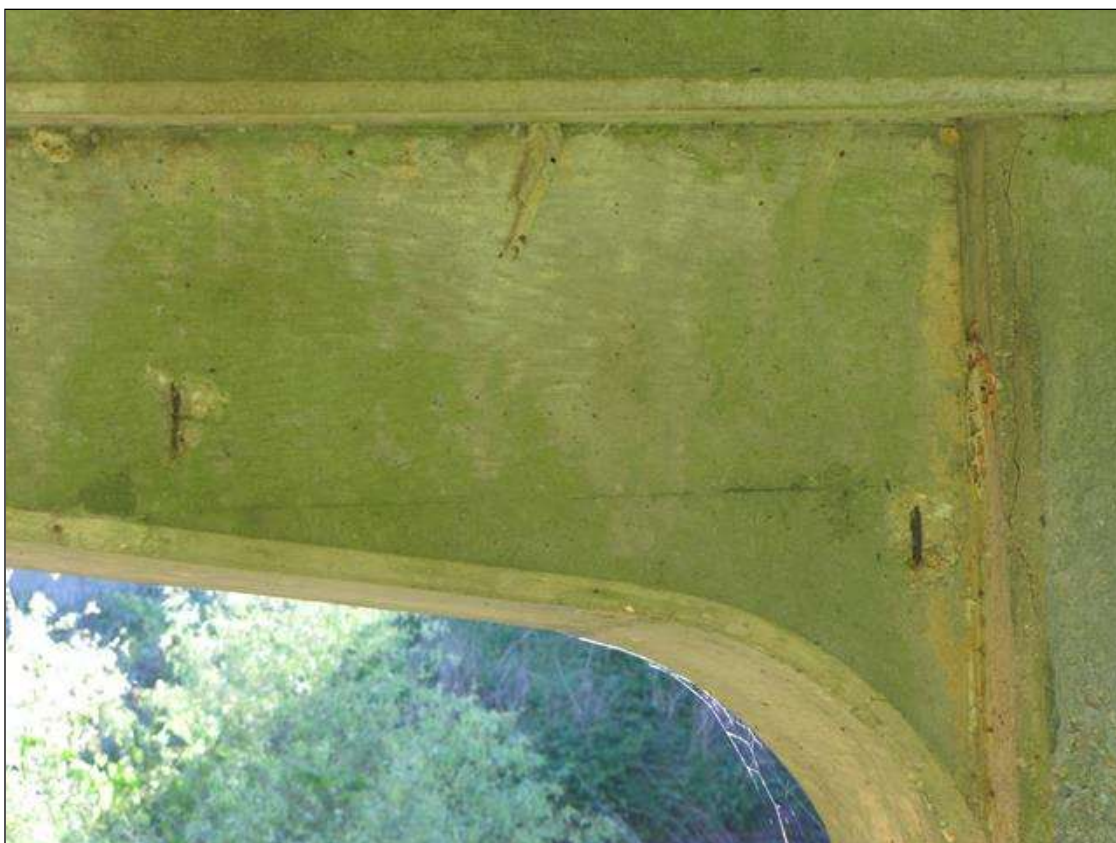
Bent 1 Pile 2: 2- UP TO 3" DIAMETER x 1/2" deep spall with exposed rebar on Span 1 face of corbel

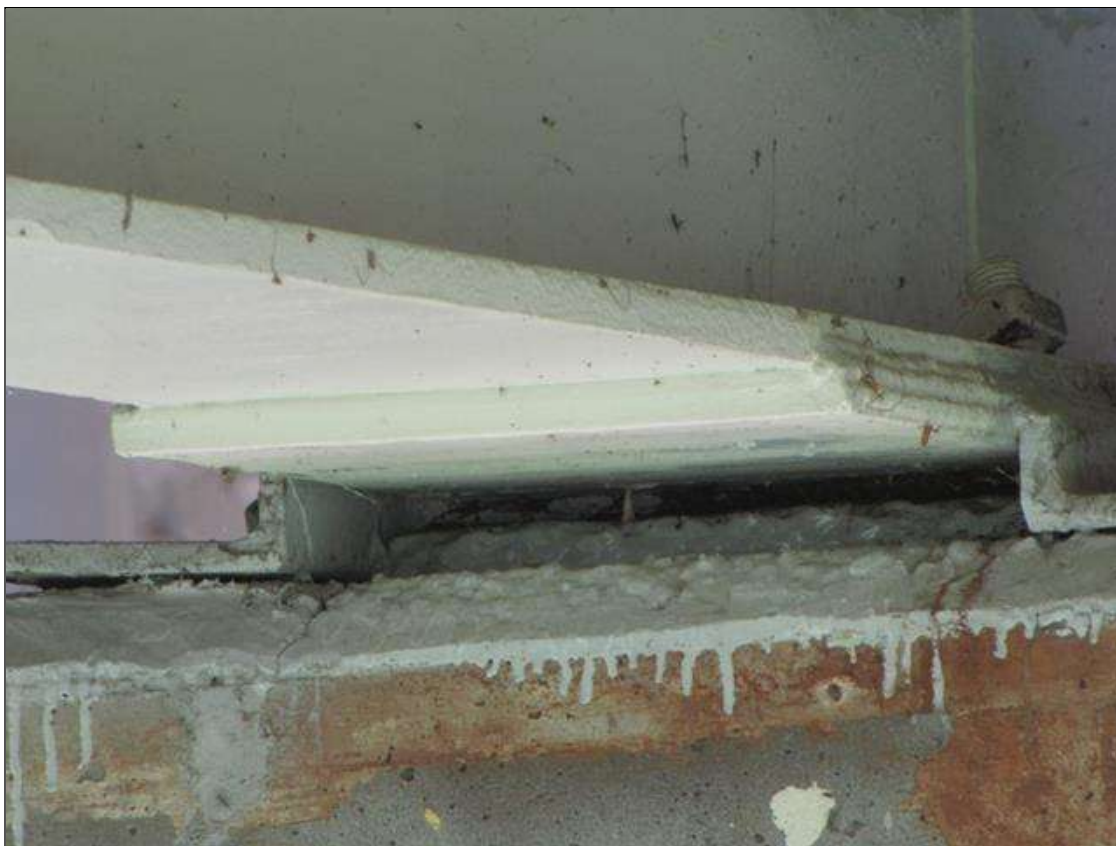
Span 1 Beam 2: 20" x 12" X 3/8" plate welded to bottom flange at Bent 1 (similar span 2 beam 2 at bent 1)
