NC DEPARTMENT OF TRANSPORTATION  
 DIVISION OF HIGHWAYS  
 STRUCTURE MANAGEMENT UNIT

ATTENTION: PAR SUBMITTED FOR BENT 1 PILE 1; STRUCTURE HAS BEEN RESURFACED; BEAMS AND BEARINGS HAVE BEEN REPAINTED; CHANGE TO STRUCTURE DATA

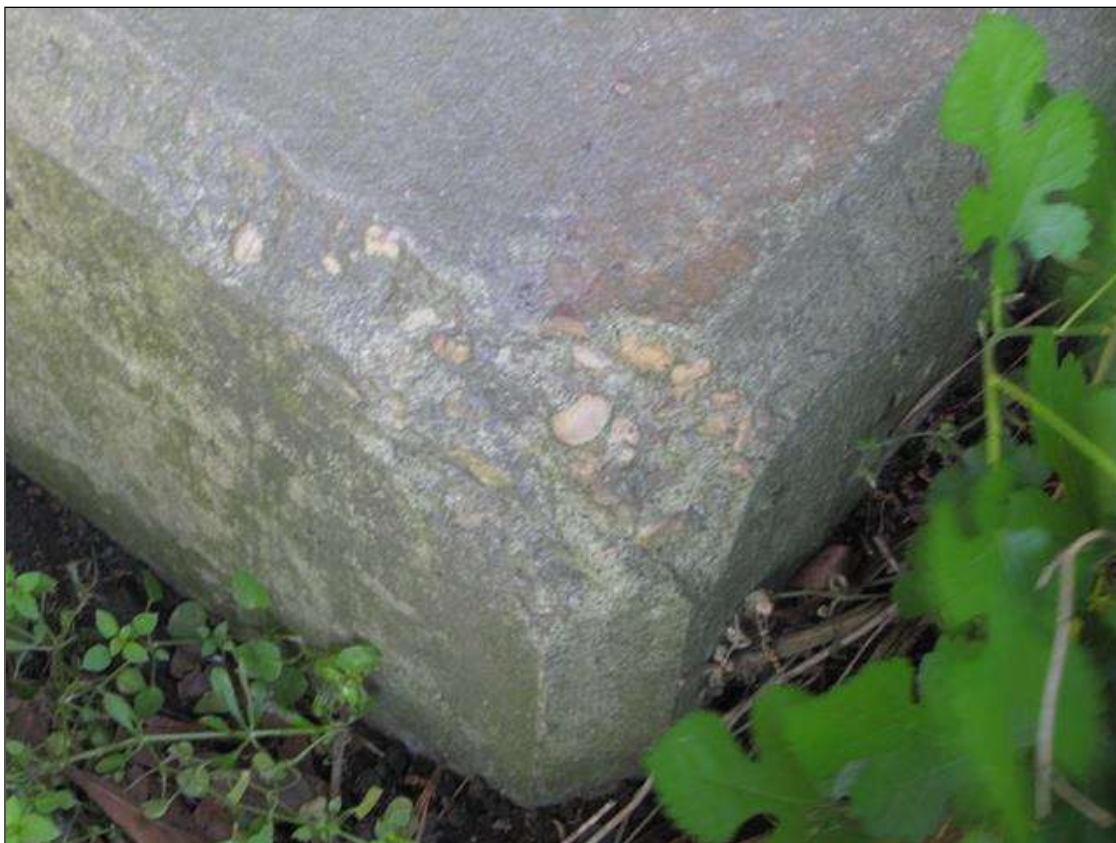
End Bent 1 Cap 1: 4" x 4" x 2" deep spall on Pile Cap 1

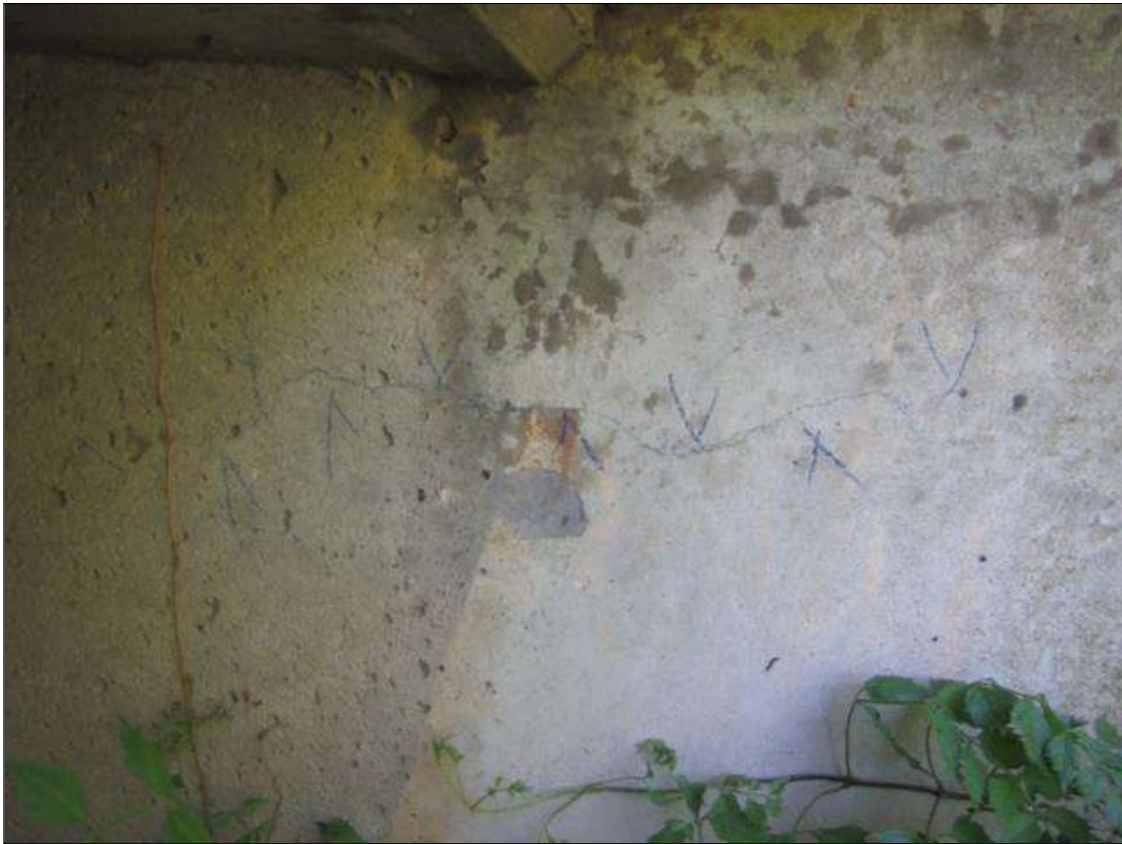
End Bent 1 Abutment/Backwall : 28" x up to 1/64" horizontal crack at West end

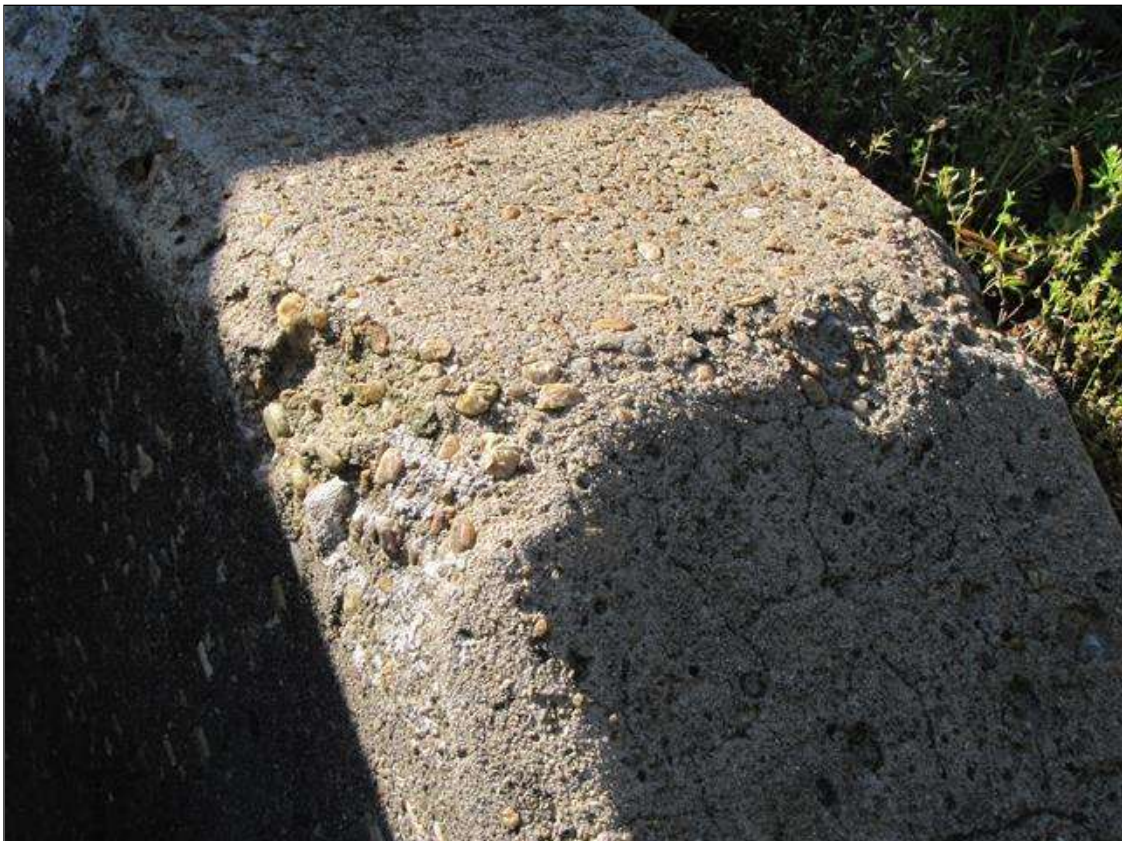
Wingwalls: 2 - UP TO 6" x 3" x 1" SPALLS ON TOP OF SOUTHWEST WINGWALL

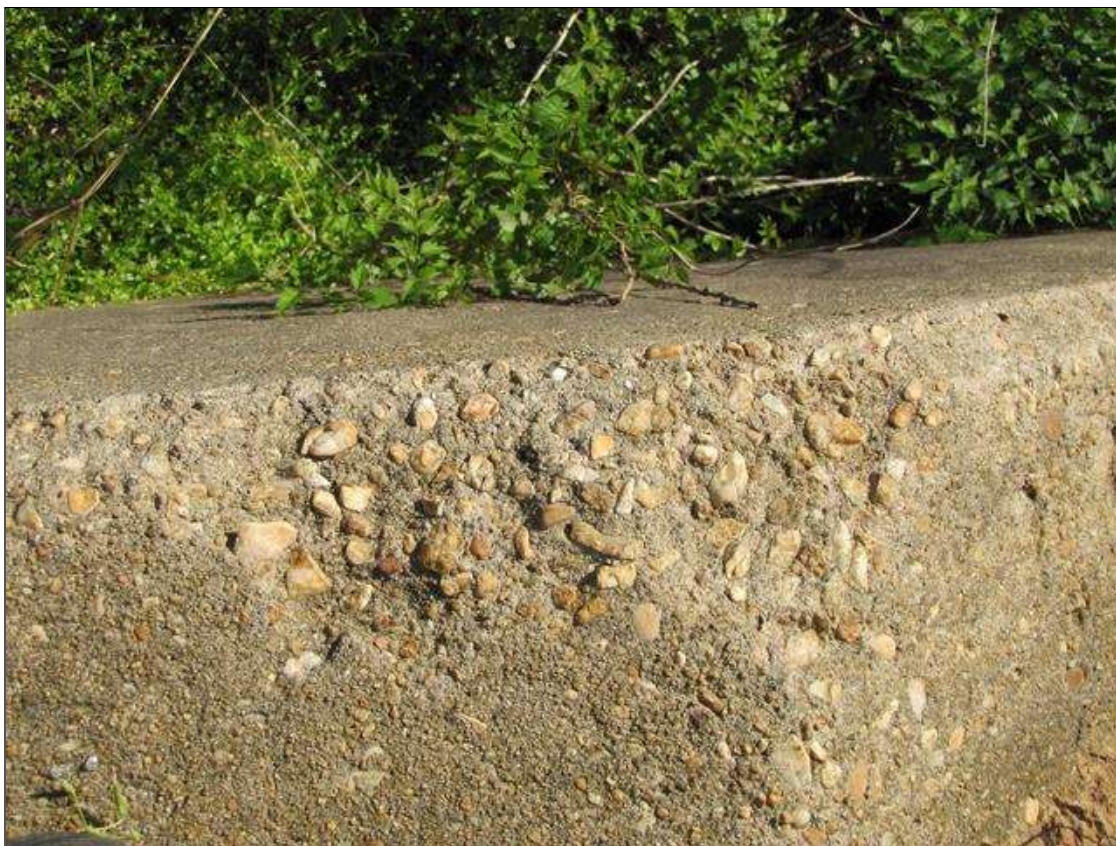
Wingwalls: 2 - 14" x 5" x 1" SPALLS ON TOP OF SOUTHEAST WINGWALL

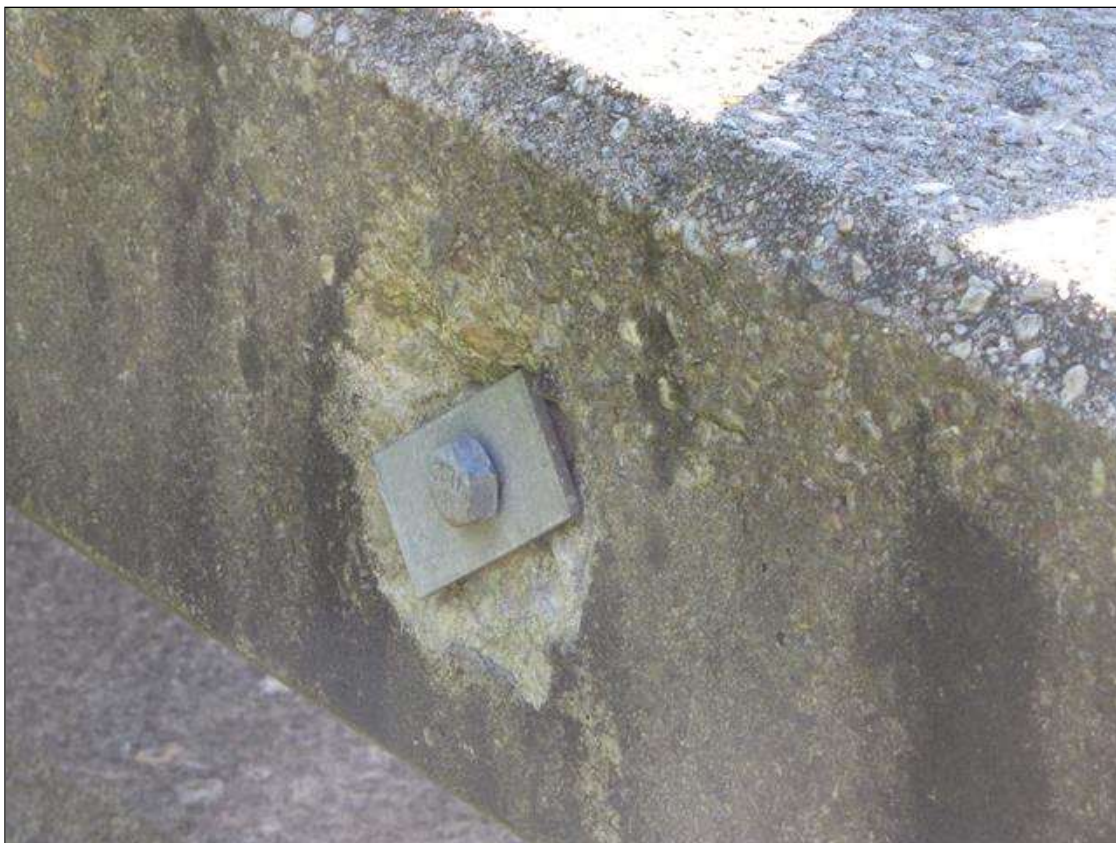
Span 1 Left Bridge Rail: (3) up to 10" x 6" x 1" deep spall on outside face of concrete rail (PHOTO TAKEN NEAR END BENT 1)

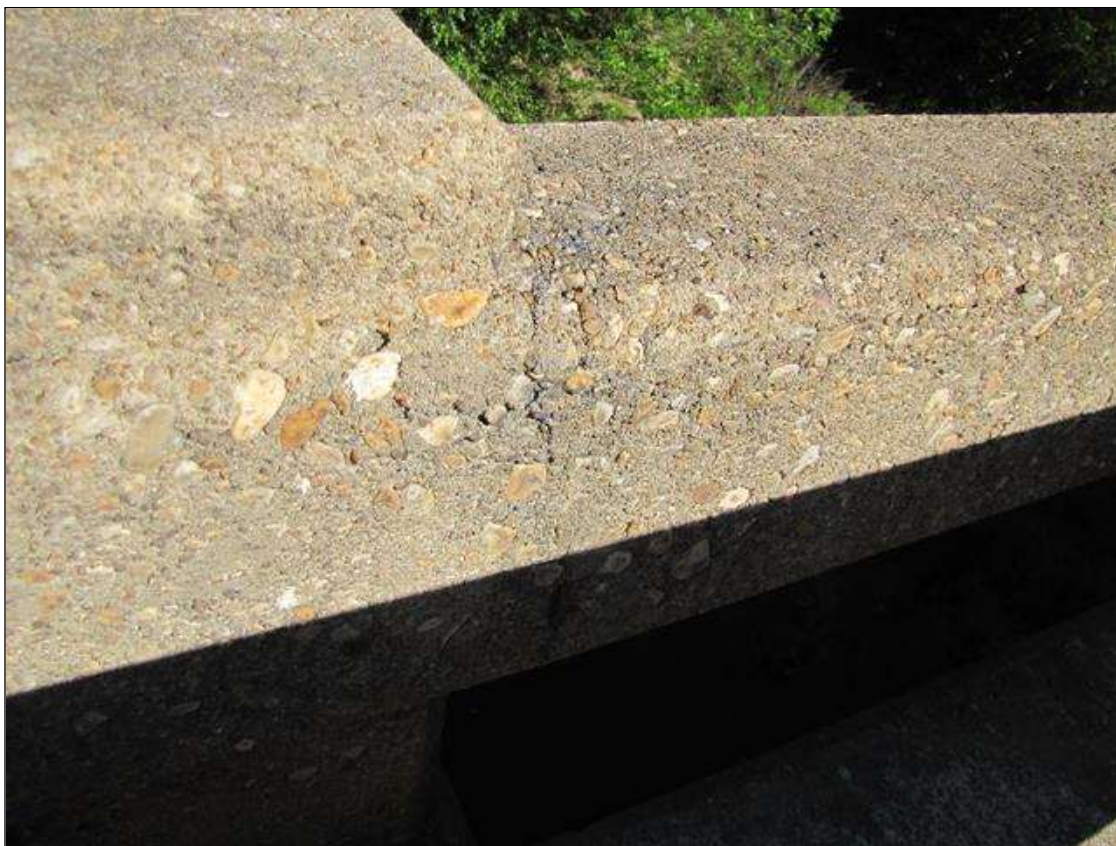
Span 2 Left Bridge Rail: (4) x up to 1/64" vertical and transverse cracks on concrete rail and curb

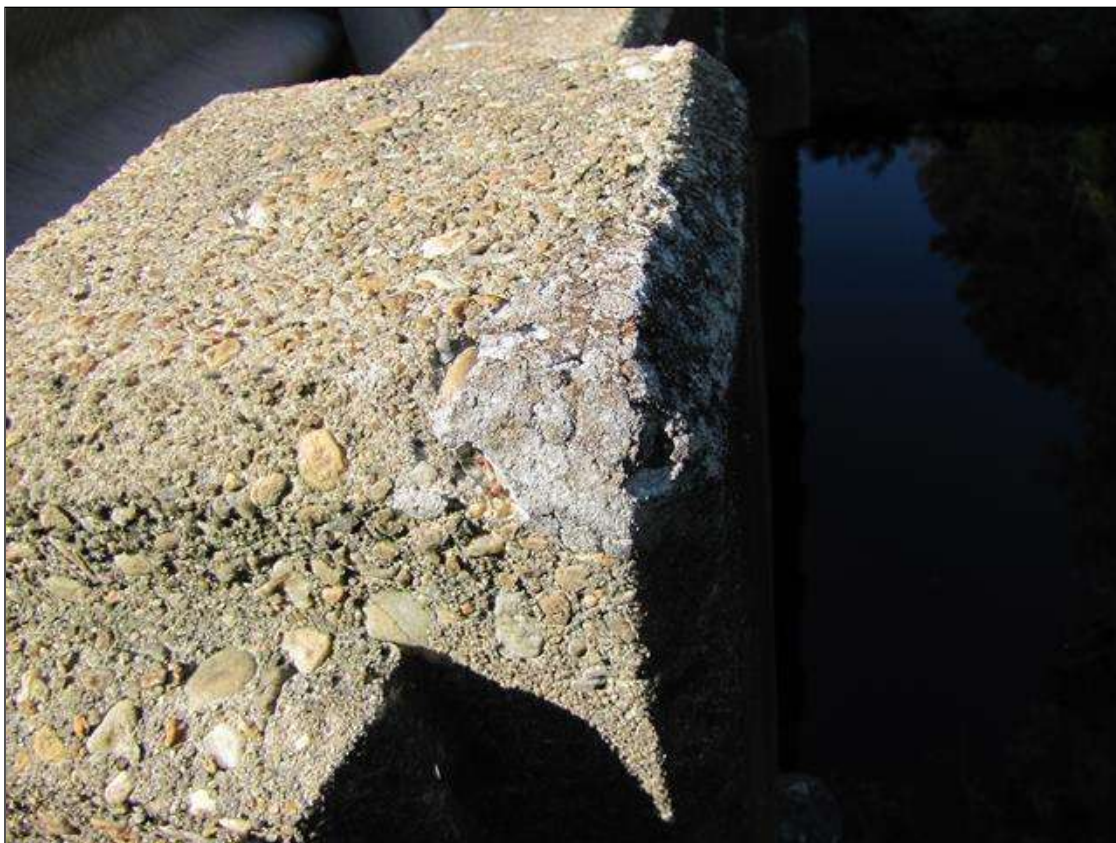
Span 3 Left Bridge Rail: 5" x 2" area of sound patch on top of concrete Post 3

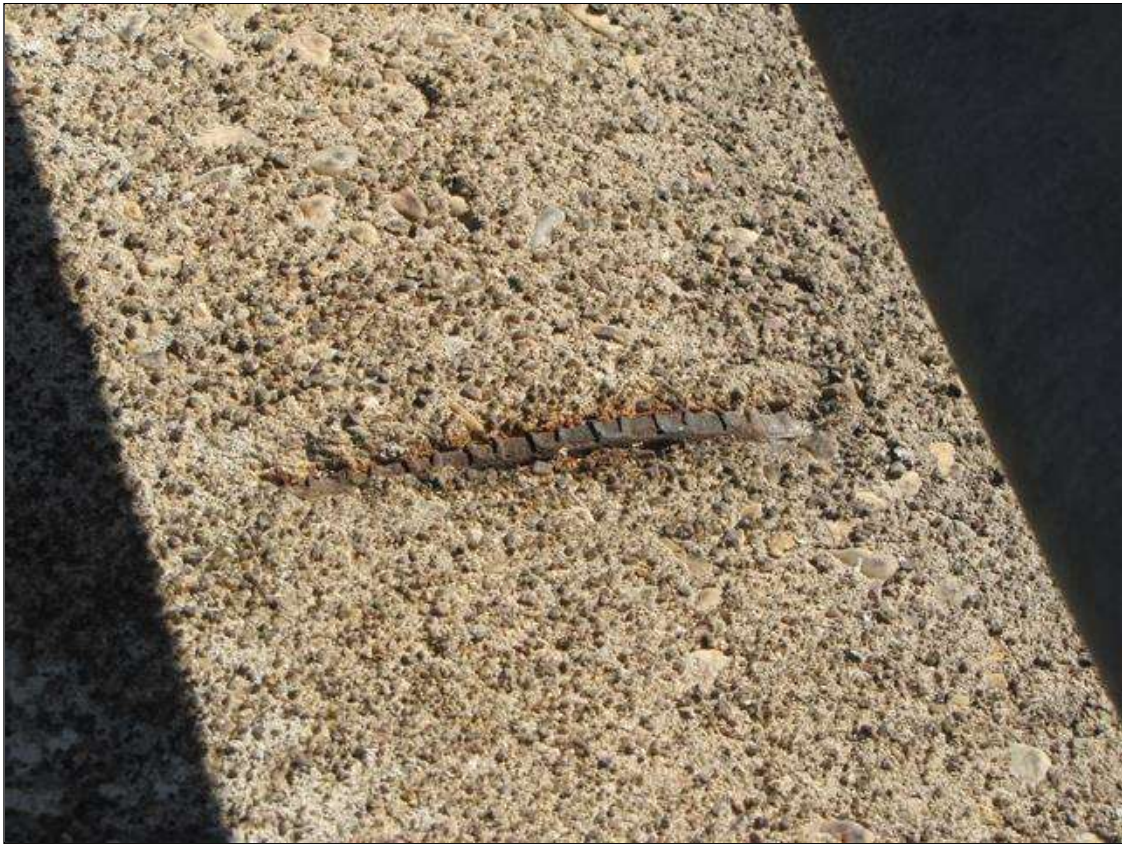
Span 4 Left Bridge Rail: 6" x 1" x 1/2" deep spall with exposed rebar on top of curb, 7' from Bent 3

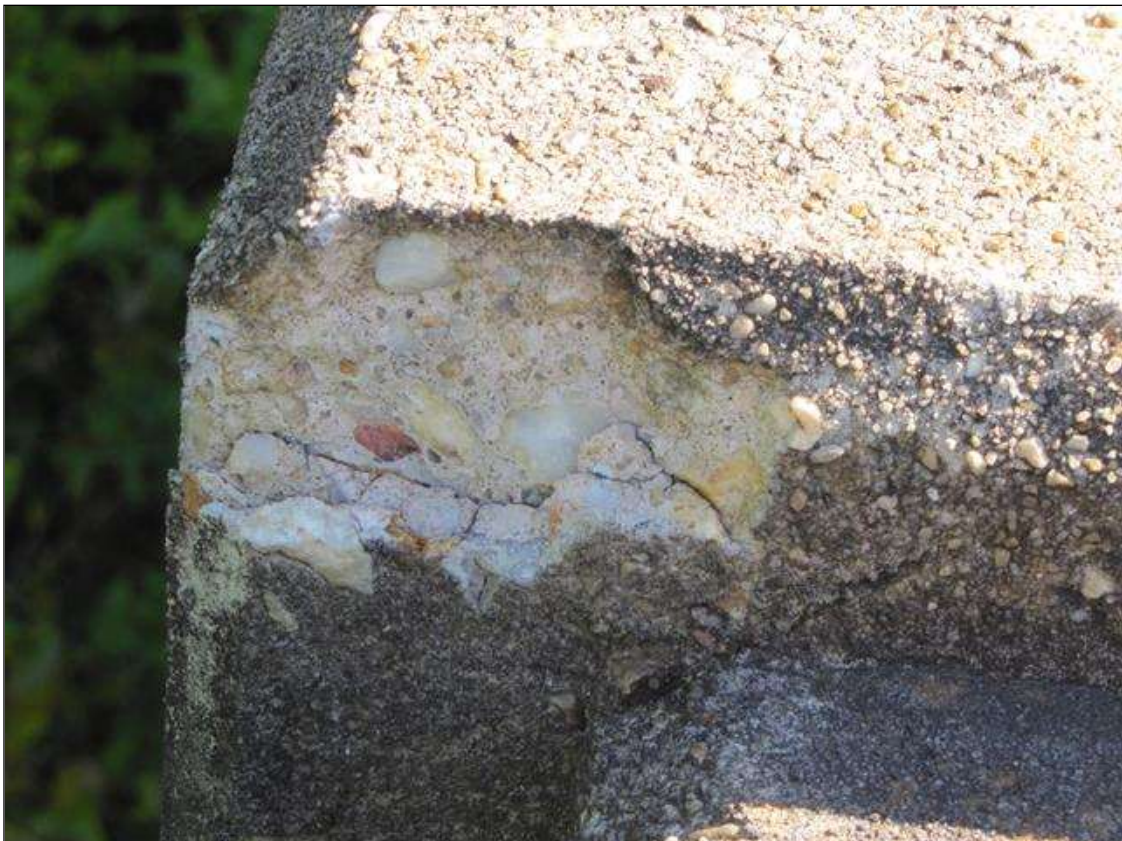
Span 4 Left Bridge Rail: 1" x 4" x 2" deep spall on concrete Post 6

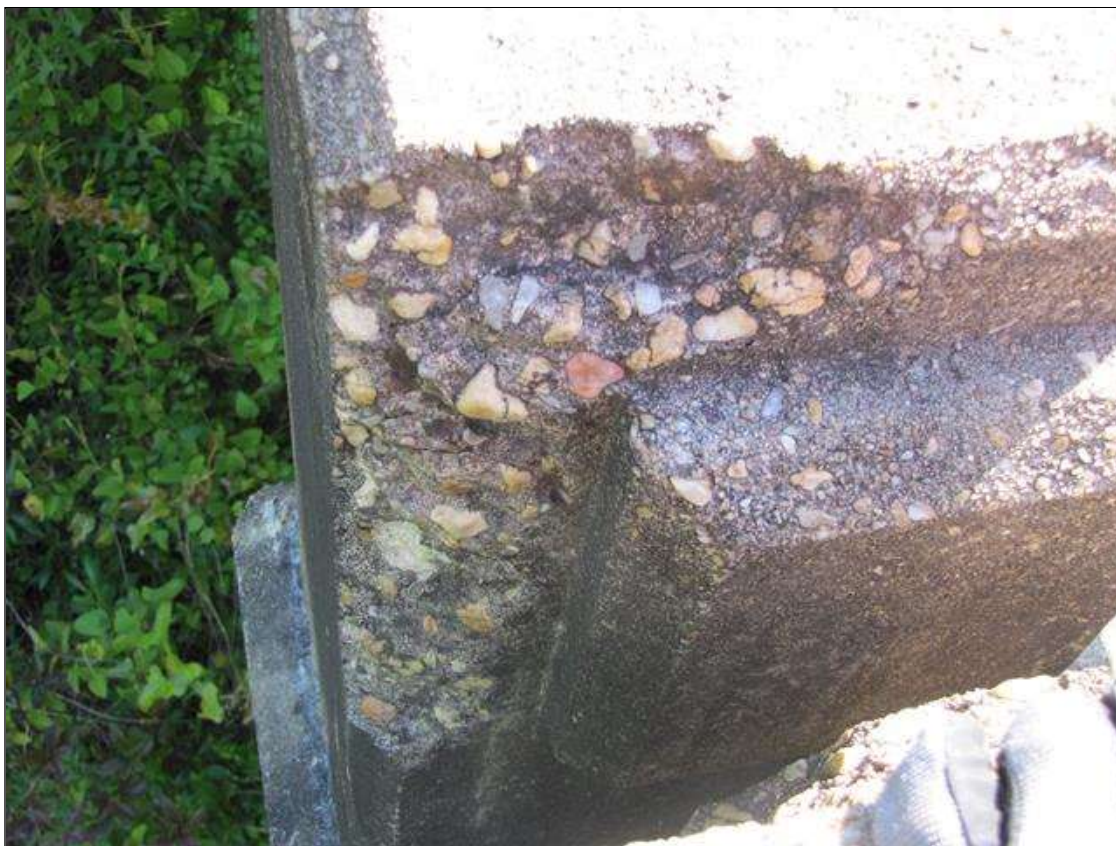
Span 4 Left Bridge Rail: 2" x 10" x 6" deep spall on concrete Post 7

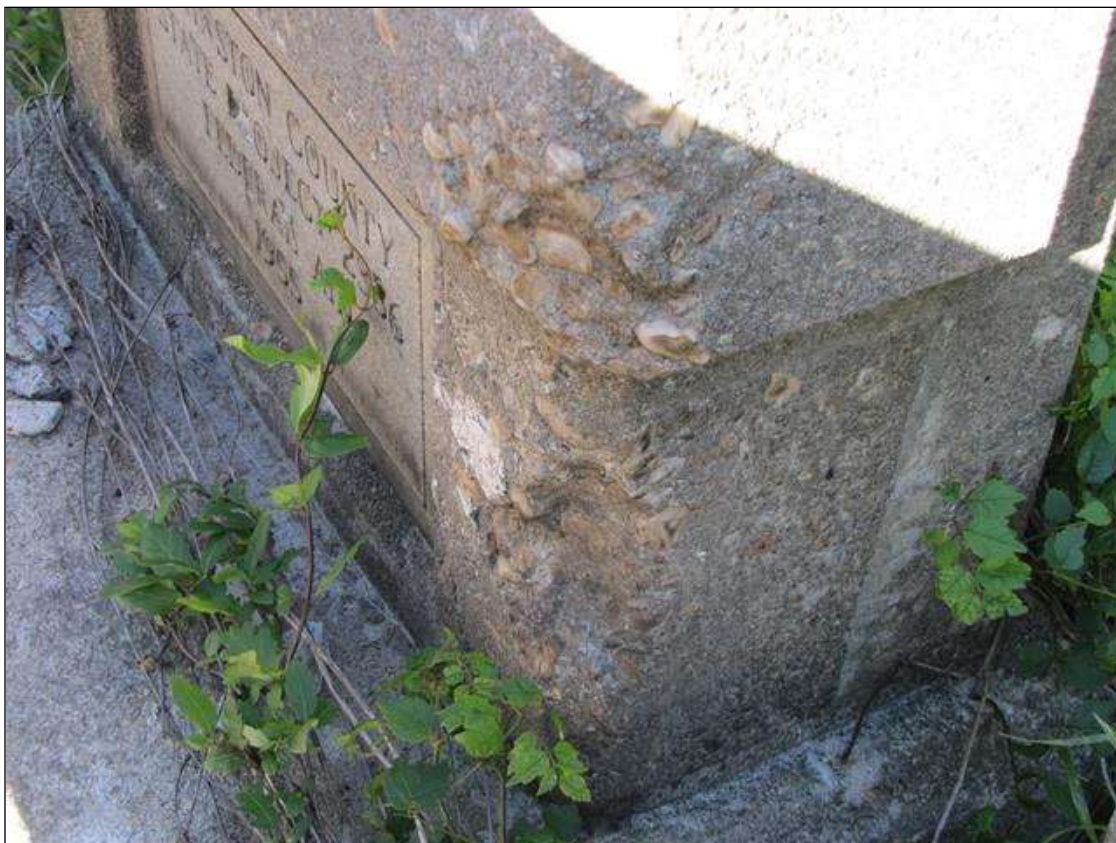
Span 4 Left Bridge Rail: (2) up to 3" x 5" x 1" deep spalls on end post

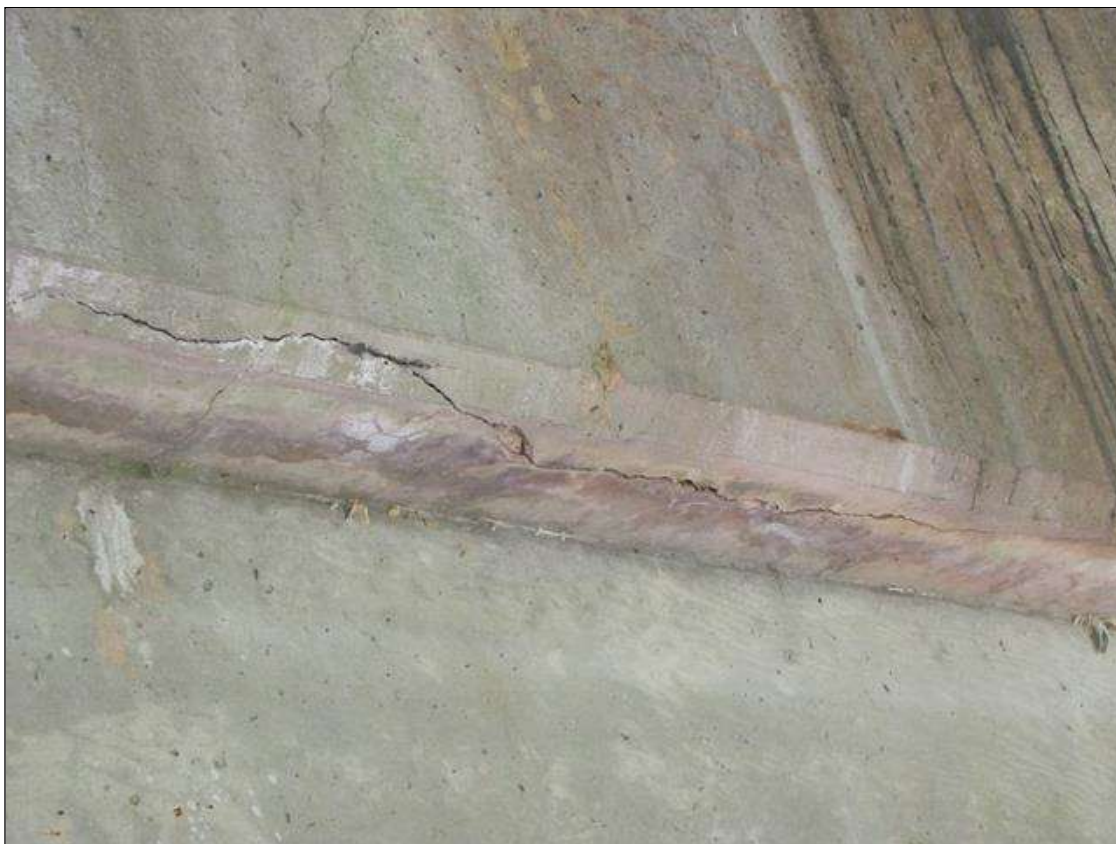
Bent 3 Cap 1: 4' up to 1/16" horizontal crack on Span 3 BOTTOM face UNDER BEAM 2

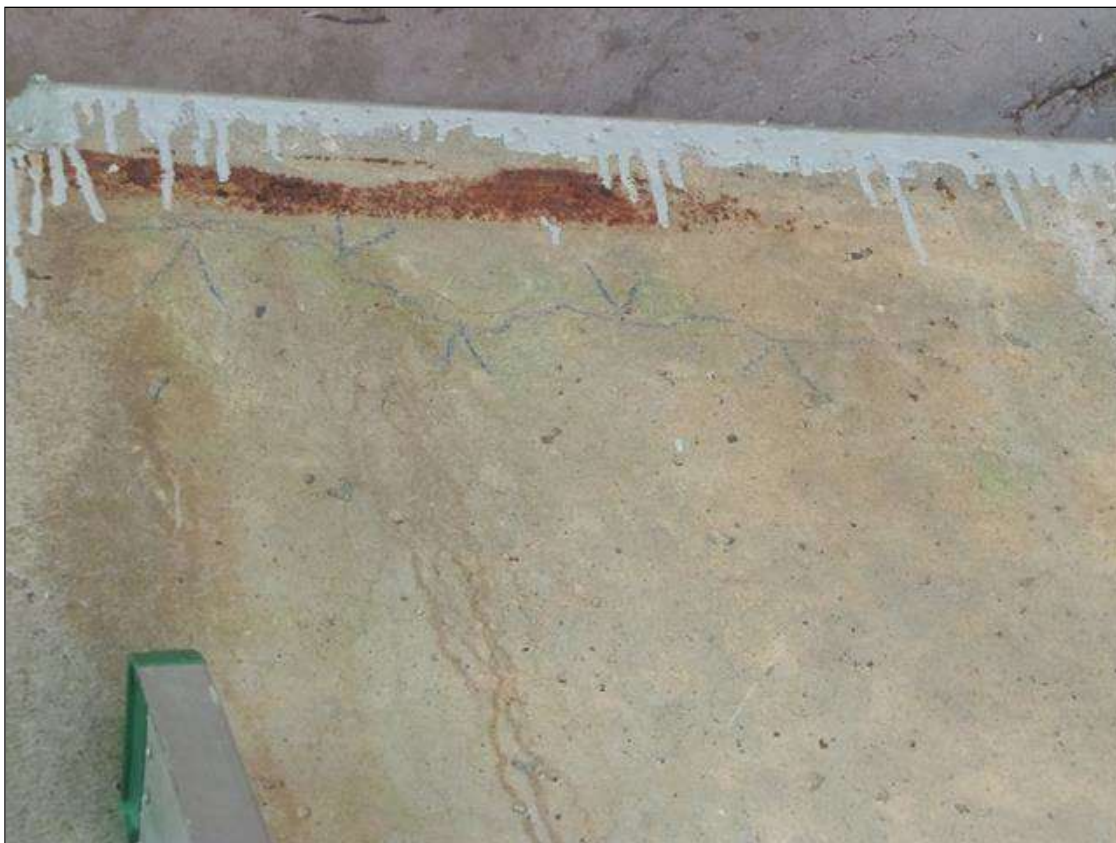
Bent 3 Cap 1: VERTICAL AND HORIZONTAL CRACKS UP TO 1/32" AT RANDOM THROUGHOUT (PHOTO TAKEN SOUTH FACE UNDER BEAM 2)

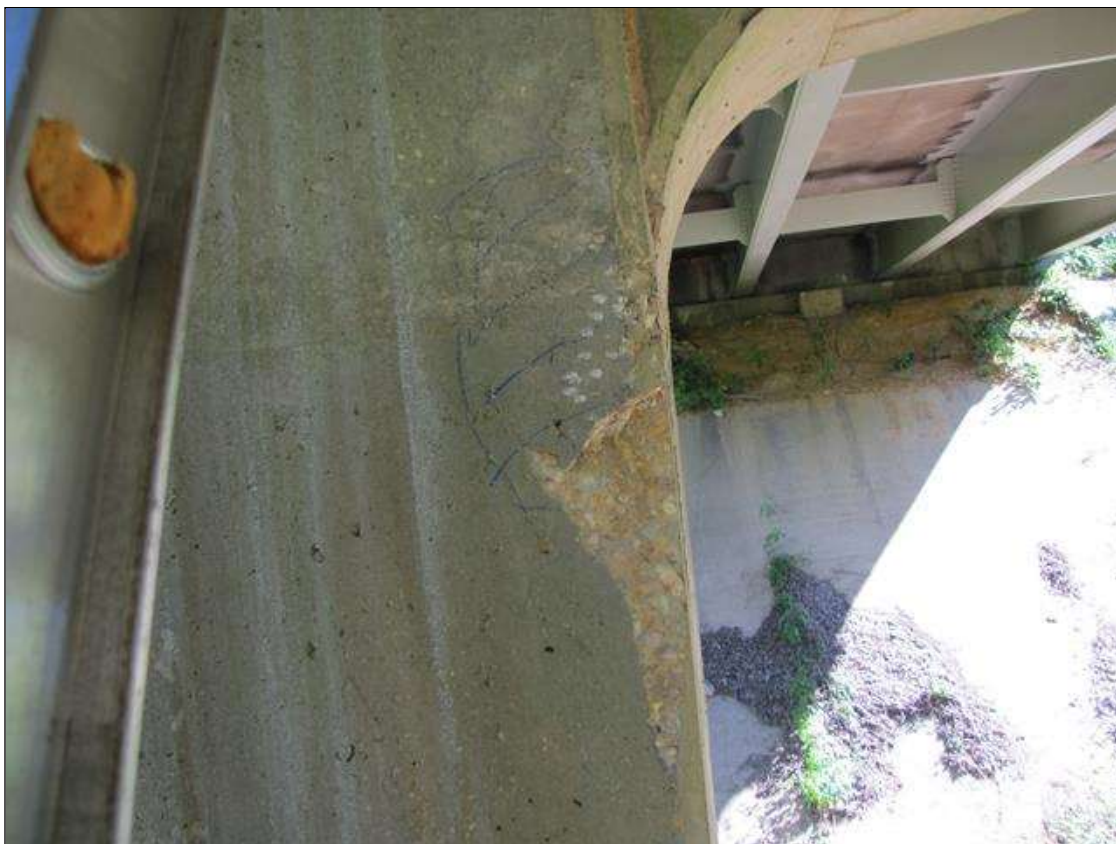
Bent 3 Pile 1: 14" X UP TO 6" X 2" SPALL WITH ADJACENT 1' DIAMETER DELAMINATION ON SOUTHEAST CORNER 2' FROM BOTTOM OF CAP.

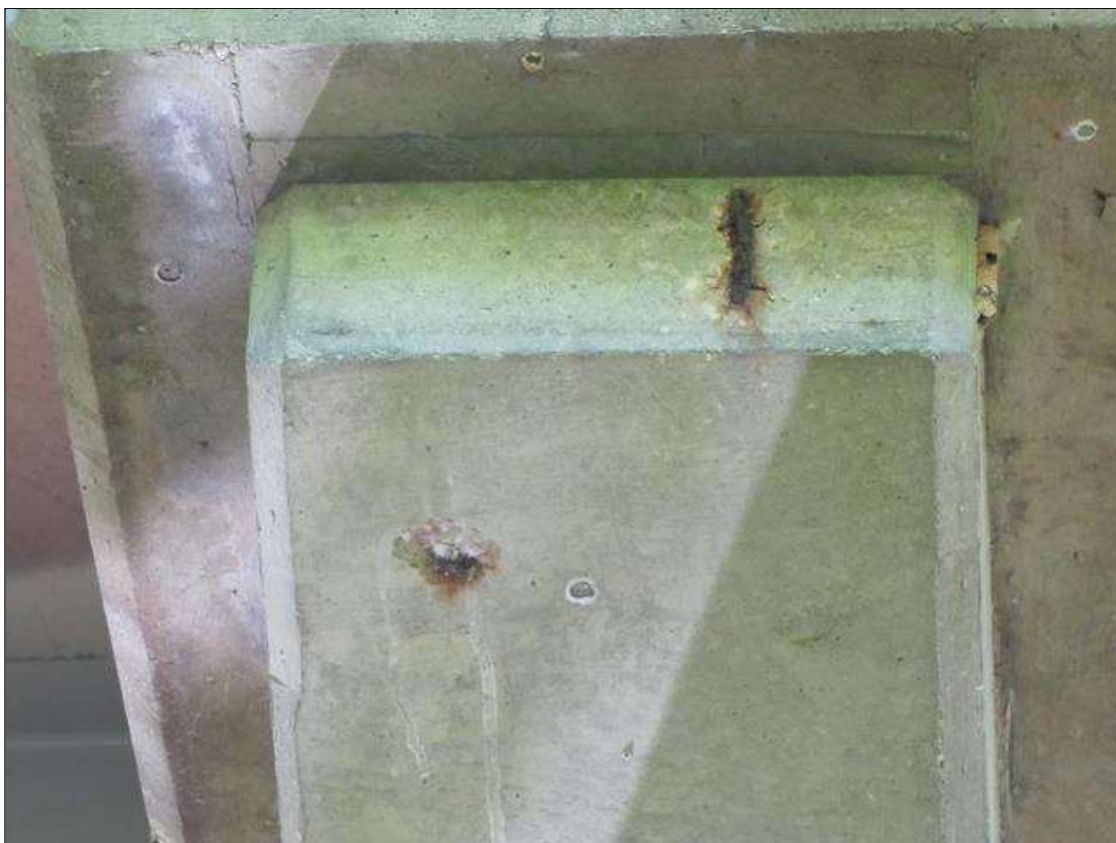
Bent 3 Pile 1: (2) up to 3" x 6" x 1" deep spall with exposed rebar on West face of corbel

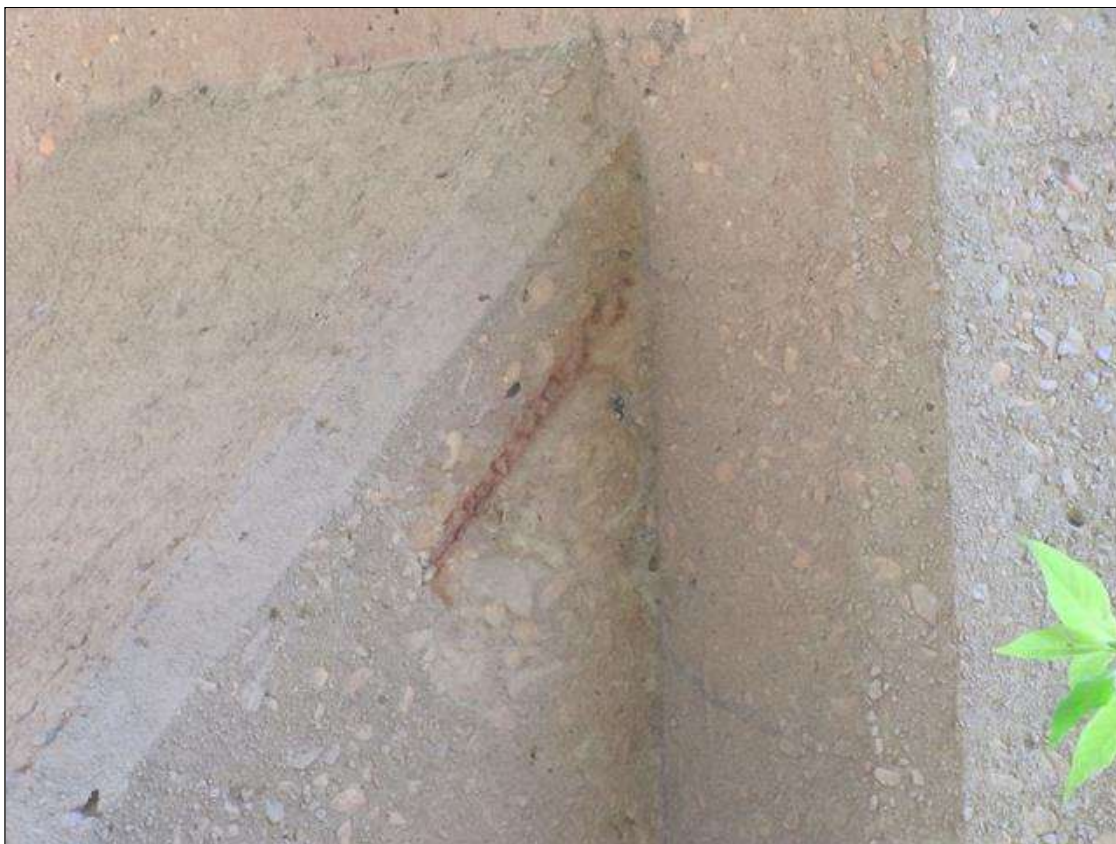
Bent 3 Pile 2: 6" x 8" x 1" deep spall with exposed rebar on Span 3 face of corbel above strut

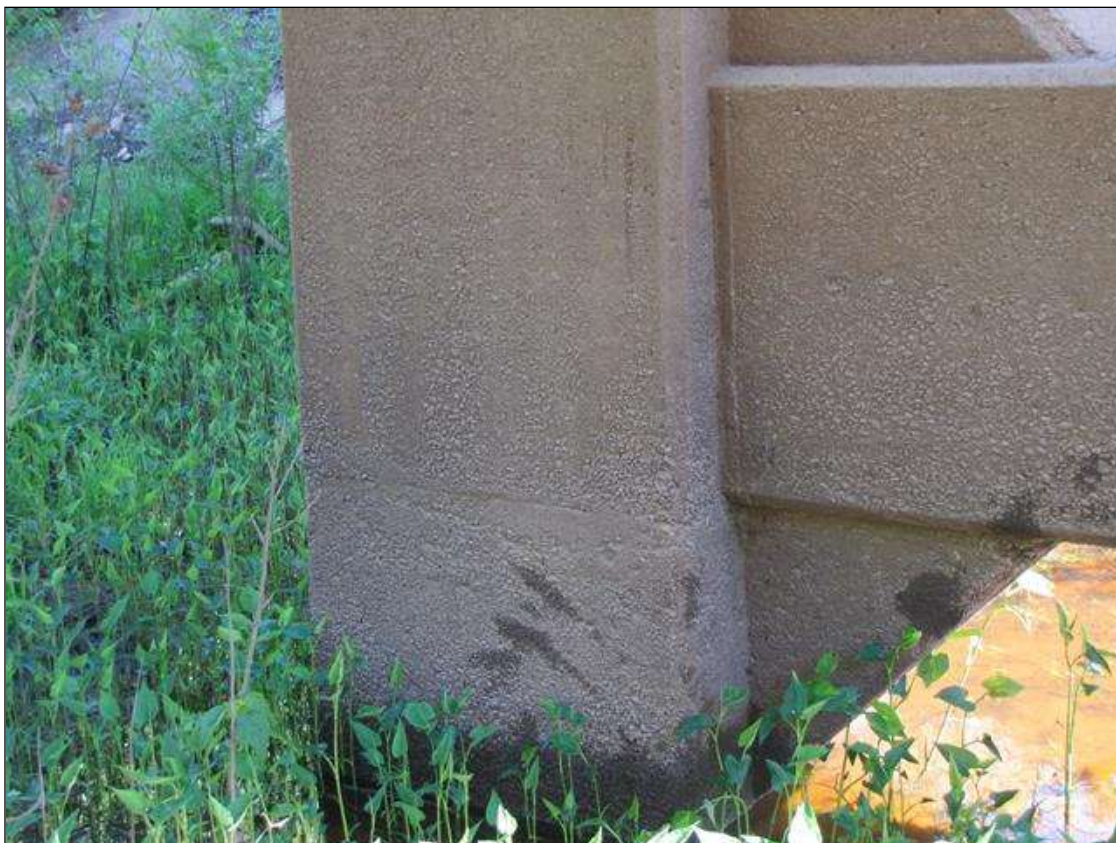
Bent 3 Pile 1: 3' ABRASION/WEAR 15' FROM BOTTOM OF CAP

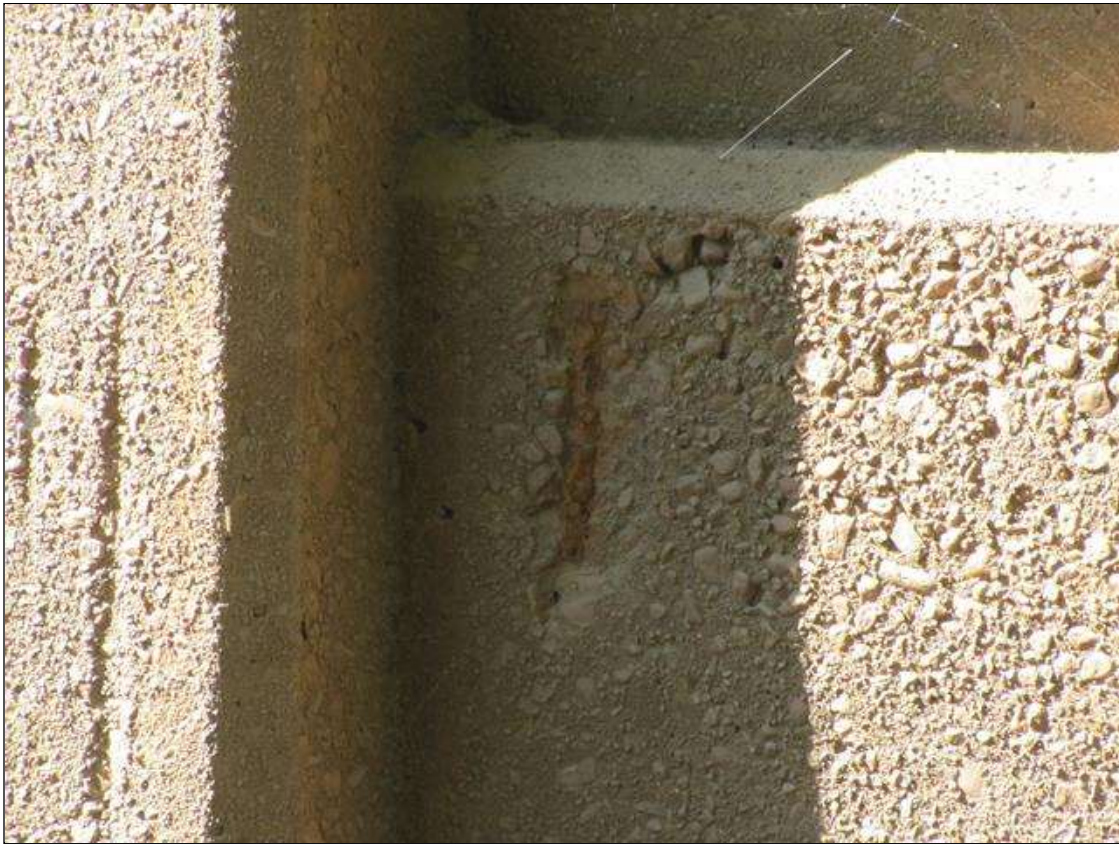
Bent 2 Pile 2: 2" x 6" x 1/2" deep spall with exposed rebar on Span 3 face of strut

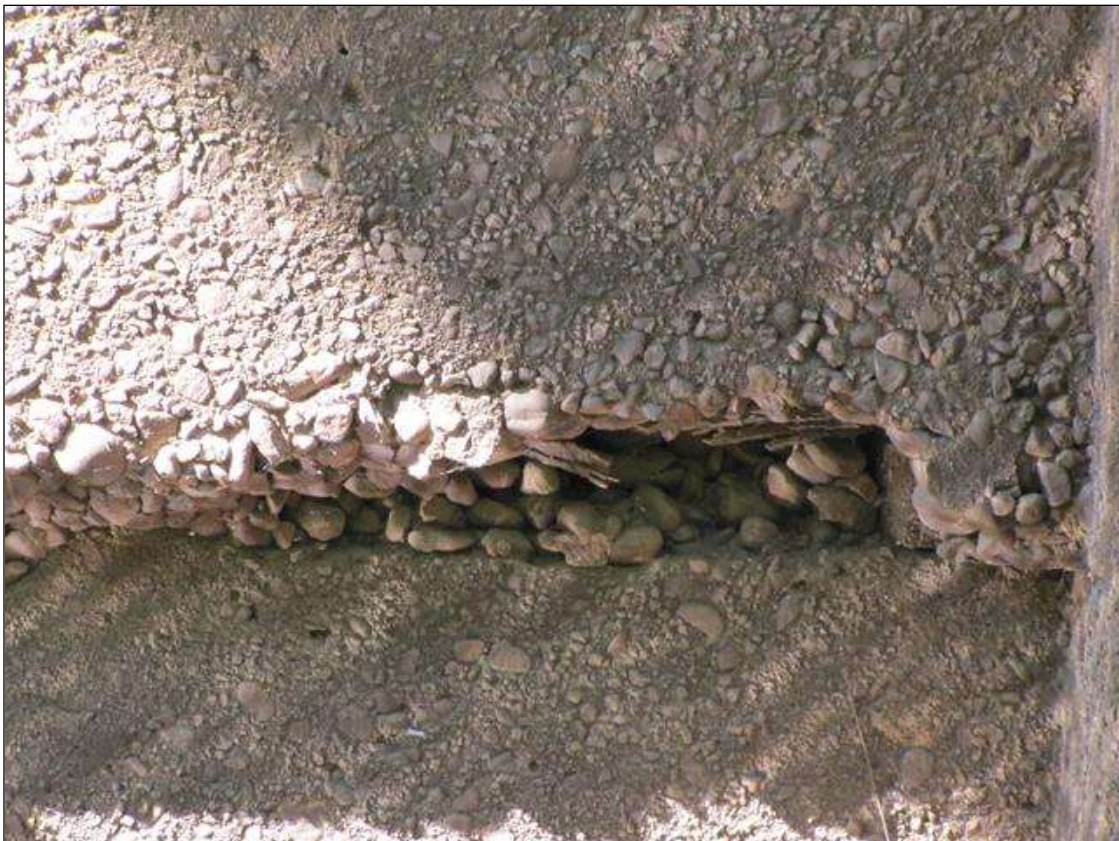
Bent 2 Pile 1: 10" x 2" x 2" deep spall on Span 3 face of strut

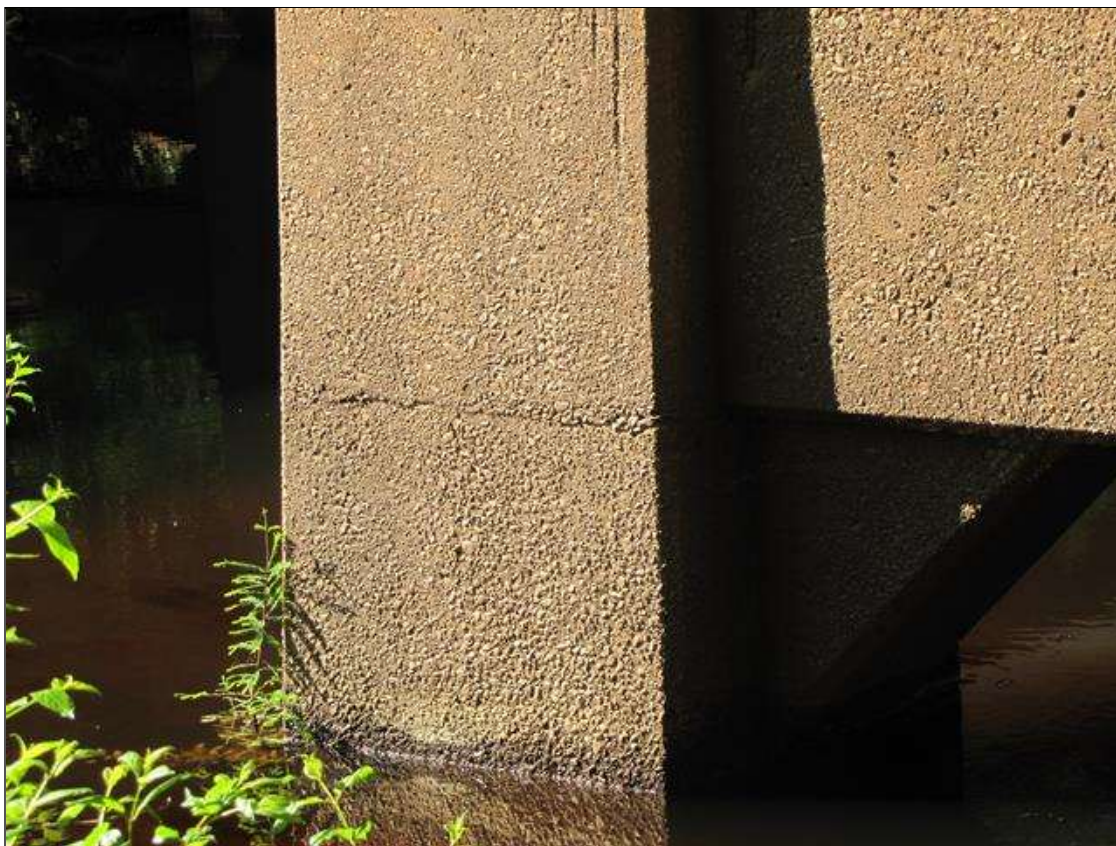
Bent 2 Pile 2: 4' ABRASION/WEAR 15' FROM BOTTOM OF CAP

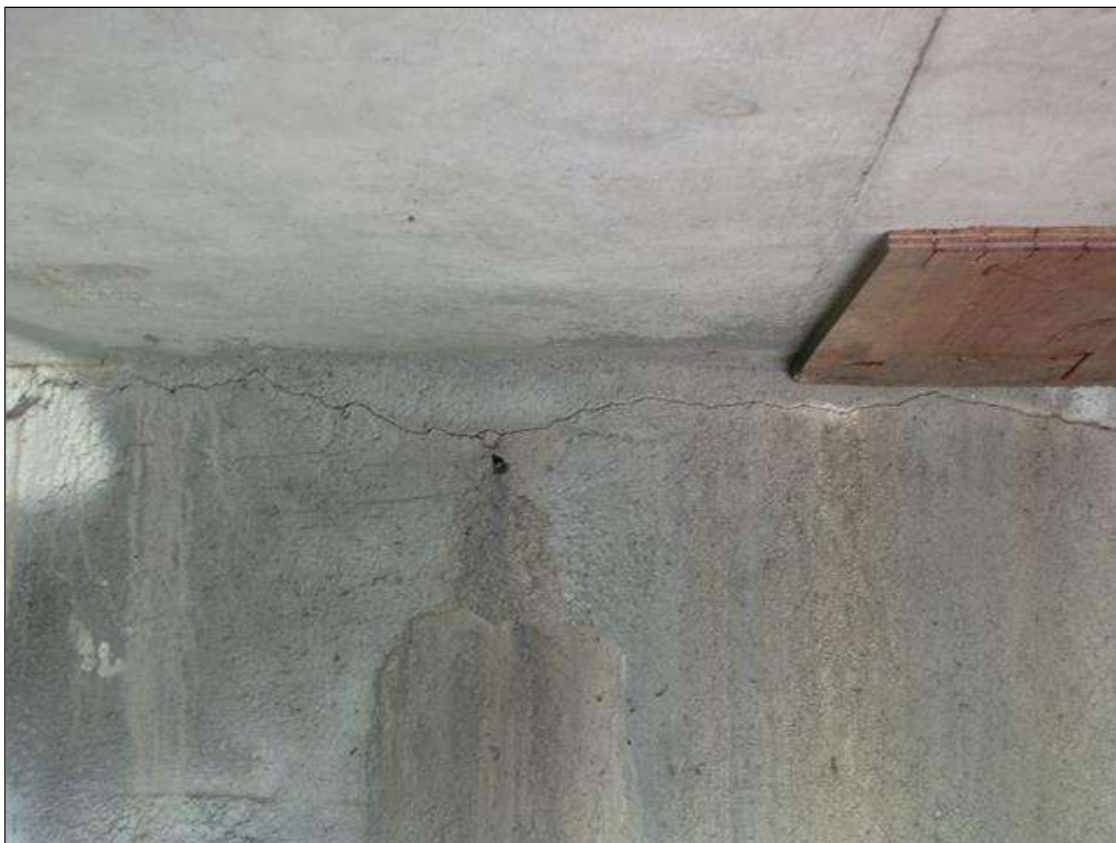
End Bent 2 Abutment/Backwall : 6' x up to 1/64" horizontal crack with efflorescence in Bay 1

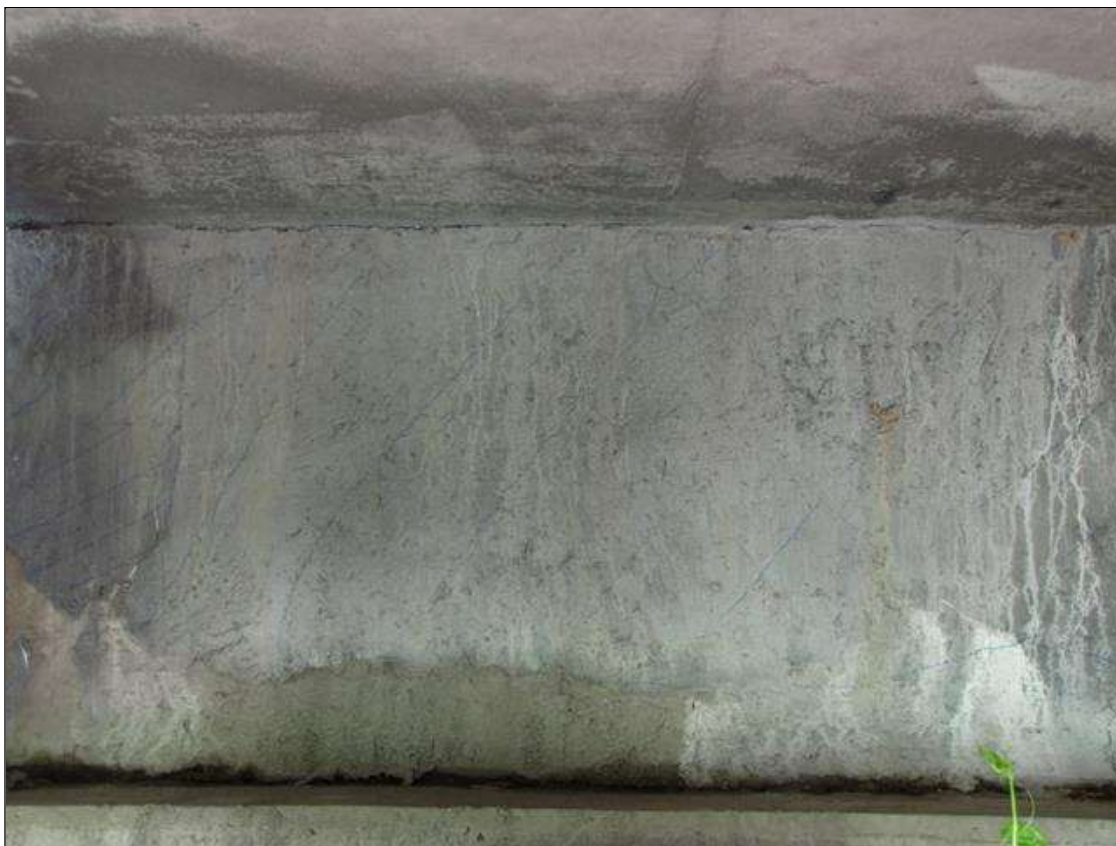
End Bent 2 Abutment/Backwall : 8' x 2' area of delaminated patch in Bay 2

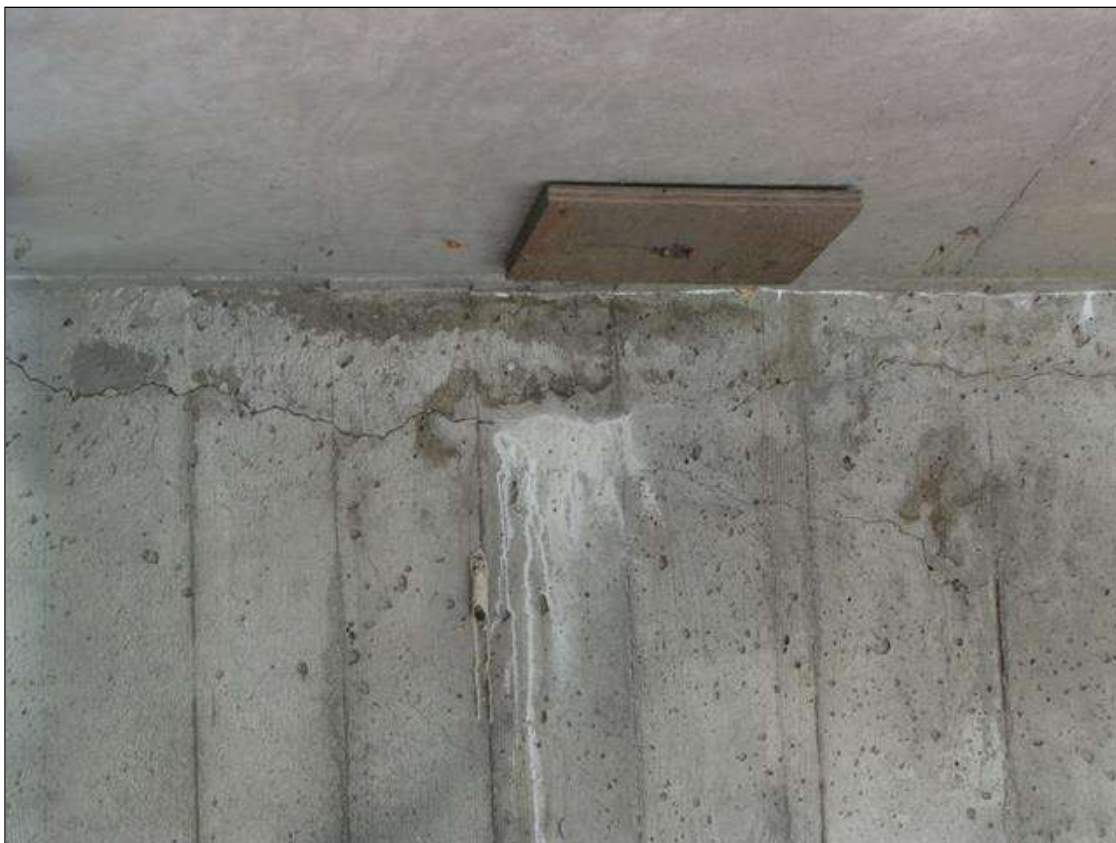
End Bent 2 Abutment/Backwall : 7' x up to 1/16" horizontal crack with efflorescence in Bay 3

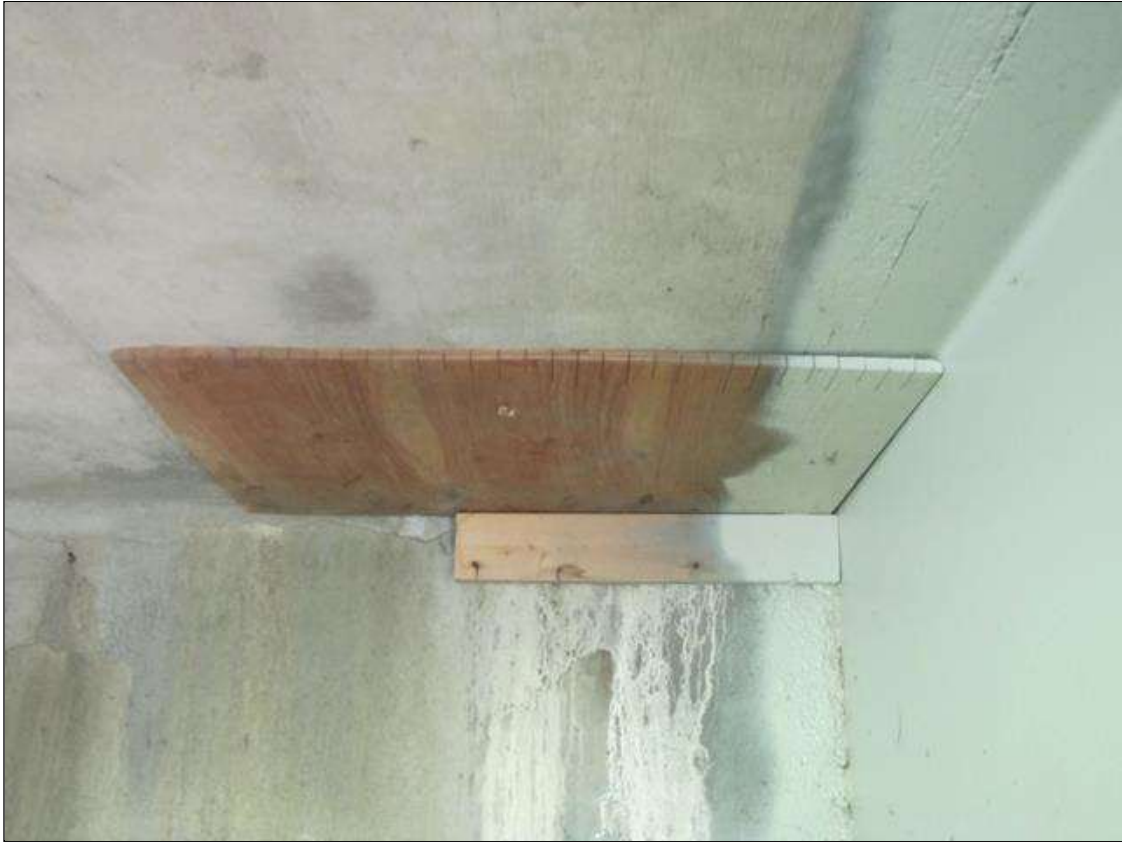
Span 4 Deck: 4' x 2.5' TIMBER STAY IN PLACE FORM WORK IN BAY 1 AT END BENT 2.( 1' X 1' SIMILAR IN BAY 3)
