NC DEPARTMENT OF TRANSPORTATION  
 DIVISION OF HIGHWAYS  
 STRUCTURE MANAGEMENT UNIT

ATTENTION: PAR SUBMITTED FOR BENT 1 PILE 1; STRUCTURE HAS BEEN RESURFACED; BEAMS AND BEARINGS HAVE BEEN REPAINTED; CHANGE TO STRUCTURE DATA

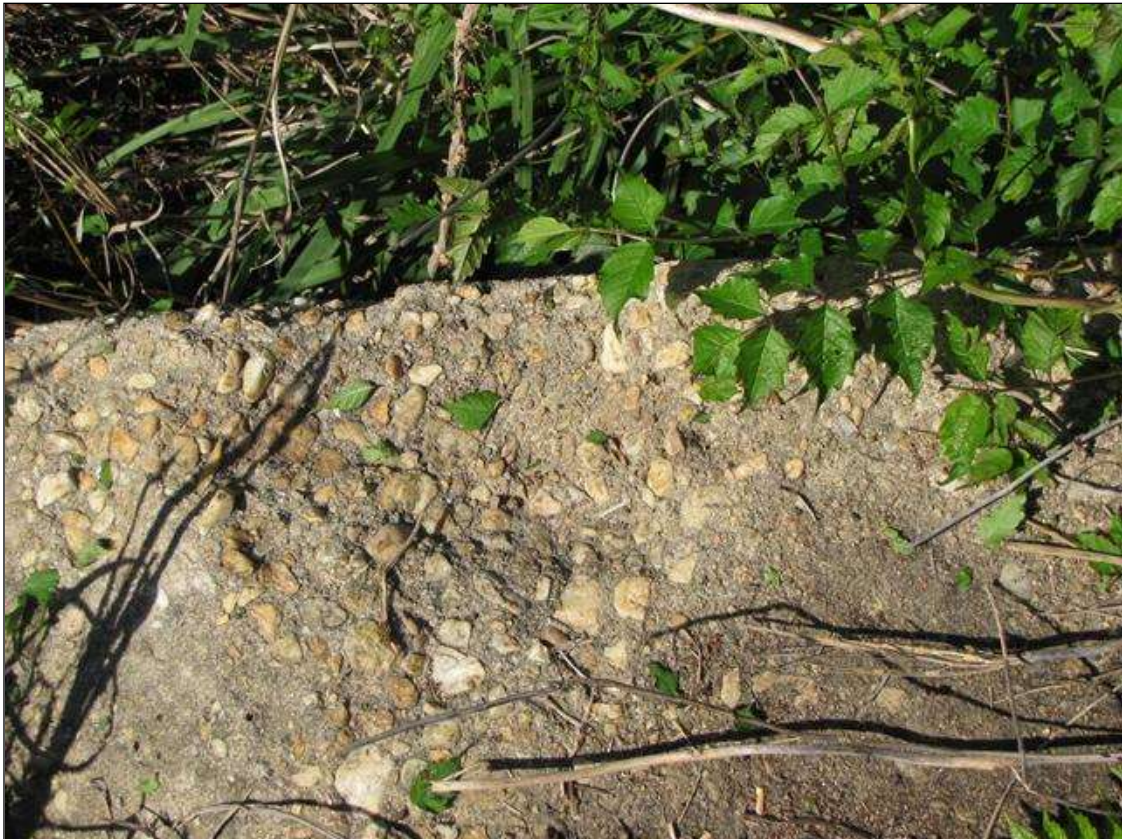
Wingwalls: UP TO 24" x 12" x 2" SPALL ON TOP OF NORTHEAST WINGWALL

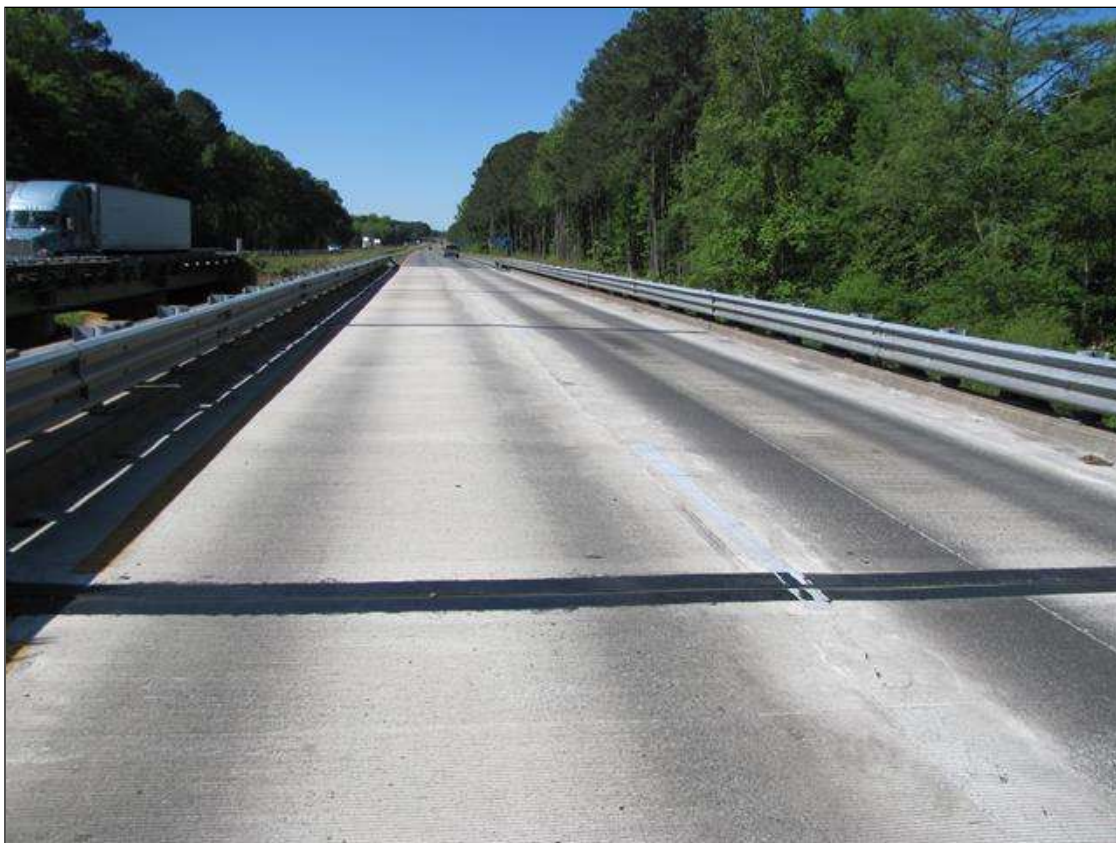
CONCRETE WEARING SURFACE SPAN 4 LOOKING SOUTH

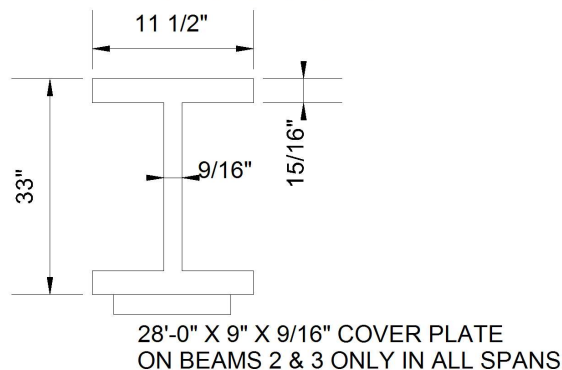
MODIFIED BY WOK/RA 4-23-2020  
 MODIFIED BETWEEN RAILS, CLEAR, RAIL TO WEARING SURFACE & BOTTOM OF BEAM, AND DECK THICKNESS  
 REMOVED AWS & ADDED BEAM AND COVER PLATE DATA

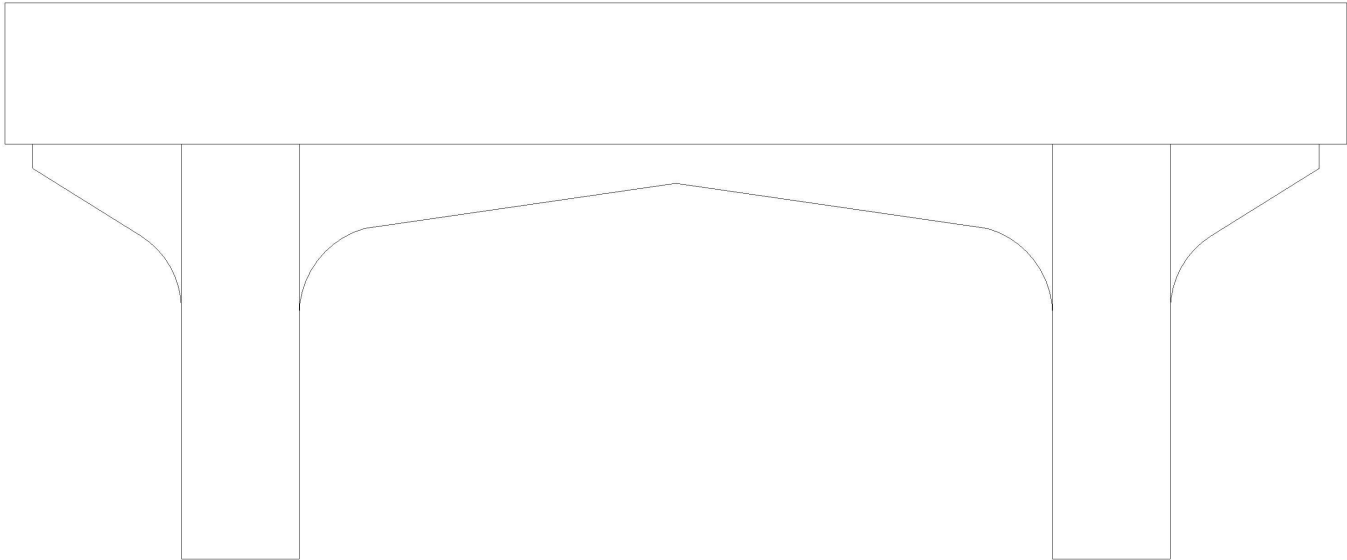
<b>Cap Information</b>			Material Cast-in-Place Concrete							
Length	Width	Height	Left Overhang	Right Overhang	Left Beam to End of Cap.	Right Beam to End of Cap.				
27.000 ft.	2.500 ft.	2.500 ft.	5.000 ft.	5.000 ft.	1.500 ft.	1.500 ft.				
<b>Subcap Information</b>			Material							
Length	Width	Height	Left Overhang	Right Overhang	Left Pile to Splice.					
<b>Sill Information</b>			Material							
Length	Width	Height								
Pile #	Material	Spacing	Width/Dia.	Height	Length	Orientation	Driven?	Replacement?	Removed?	Collar?
1	Concrete	17 ft.	2.333 ft.			Vertical	No	No	No	No
2	Concrete		2.333 ft.			Vertical	No	No	No	No
							SKETCH VERIFIED BY WOK/RA 4-23-2020			
<b>Bent/Abutment #:</b> 1			<b>Similar Bents:</b> BENTS 2 & 3
