NC DEPARTMENT OF TRANSPORTATION      ATTENTION  
 DIVISION OF HIGHWAYS  
 BRIDGE MANAGEMENT UNIT

# BRIDGE INSPECTION REPORT

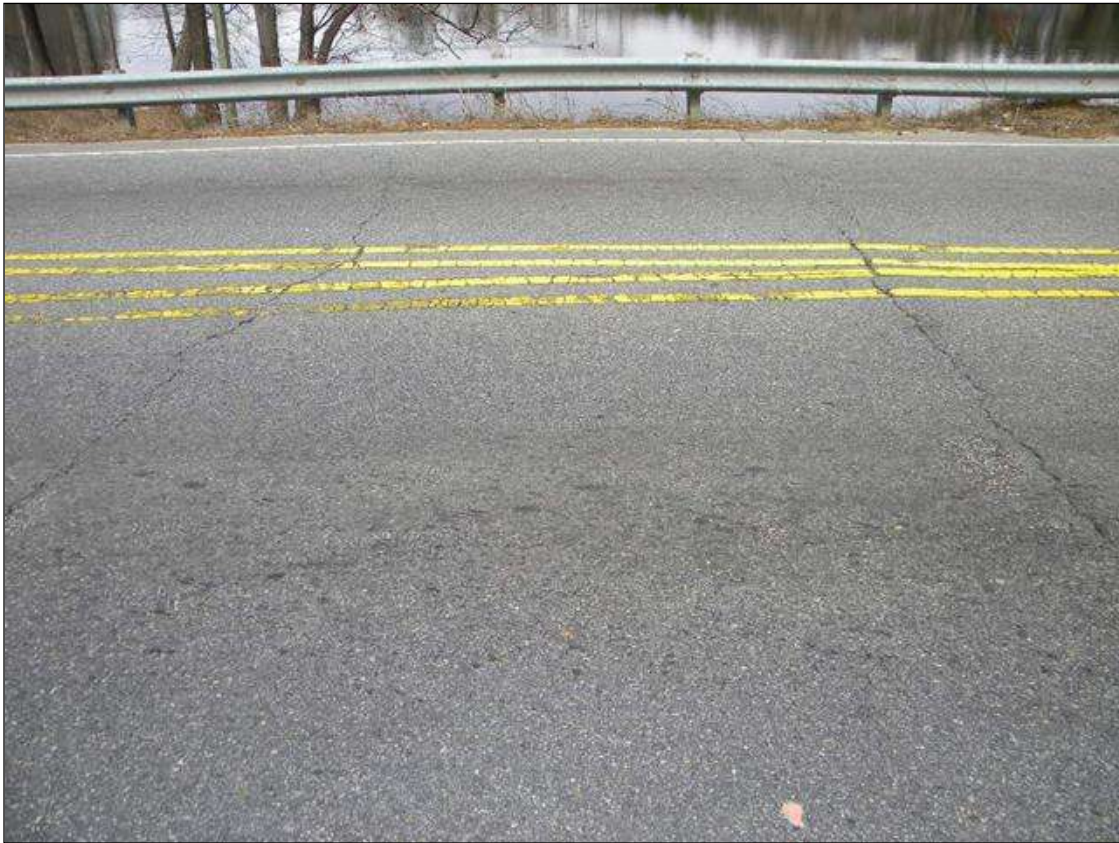
TRANSVERSE CRACKS IN APPROACH 1 WEARING SURFACE

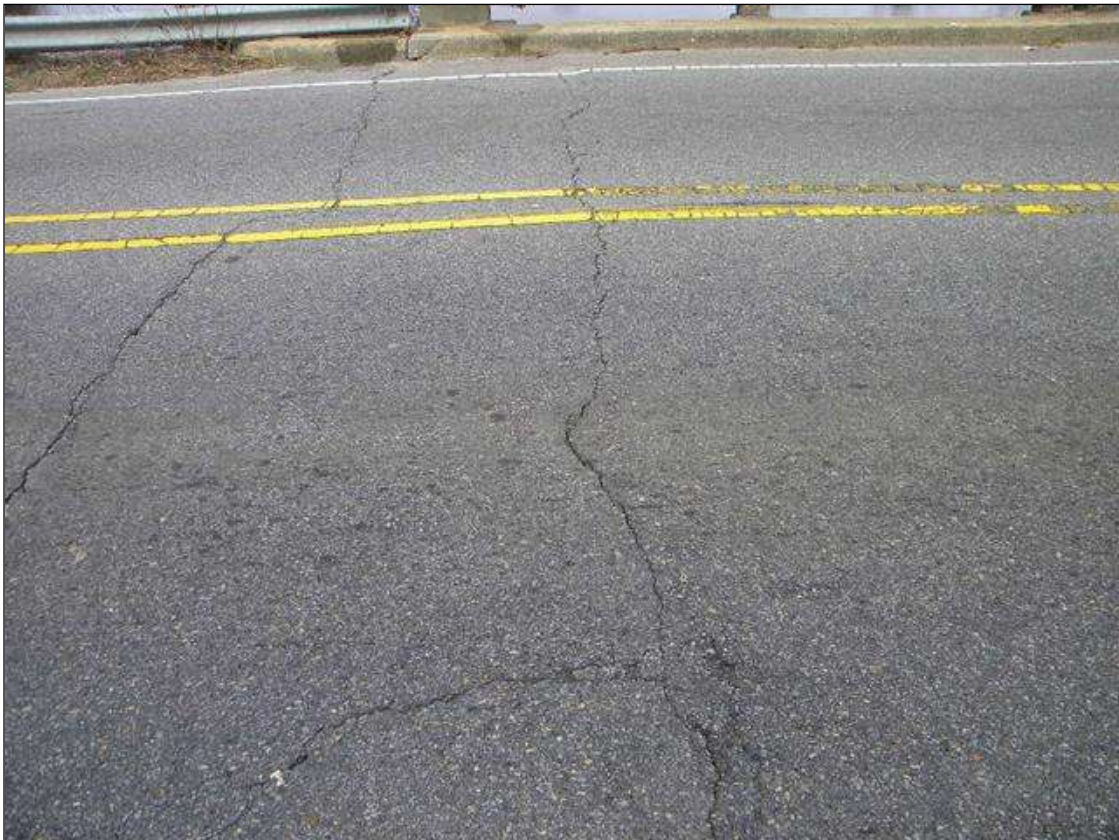
TRANSVERSE CRACK AND UNEVENNESS OVER END BENT 1 WEARING SURFACE

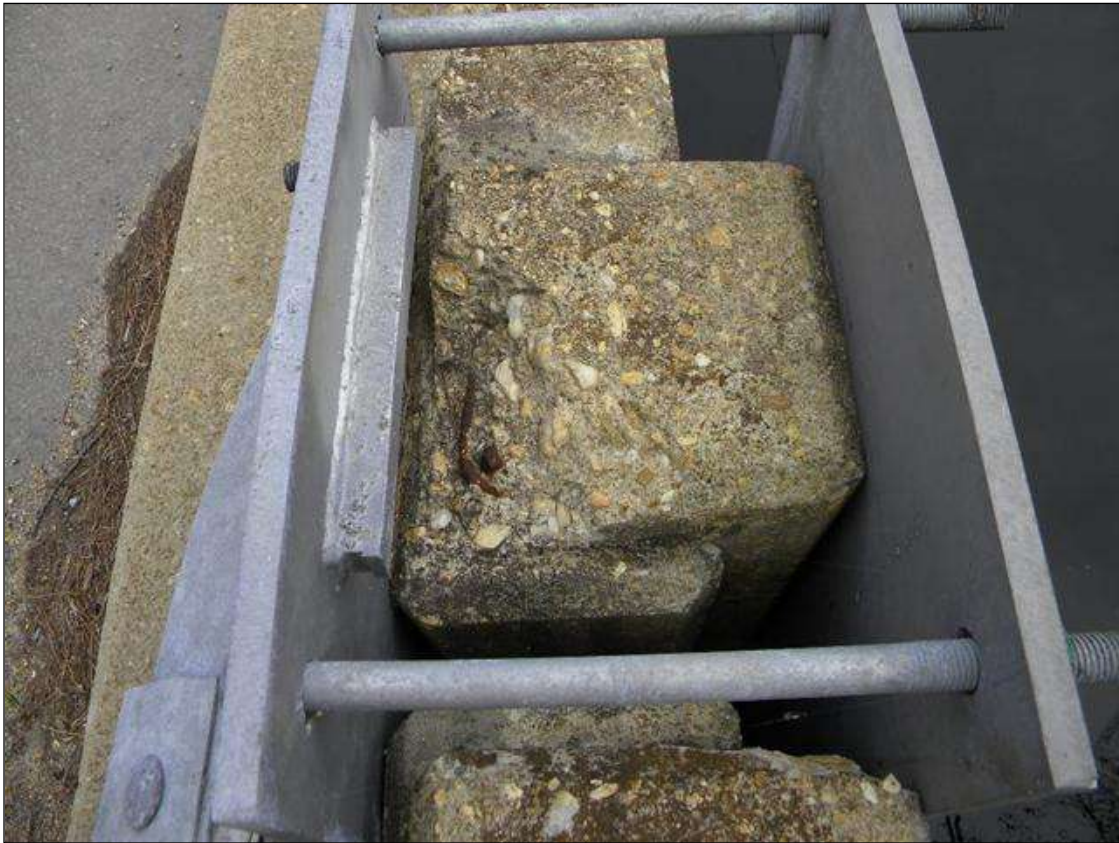
RIGHT SIDE GUARDRAIL POST AT GUARDRAIL CONNECTION IN SPAN 1 SPALLED

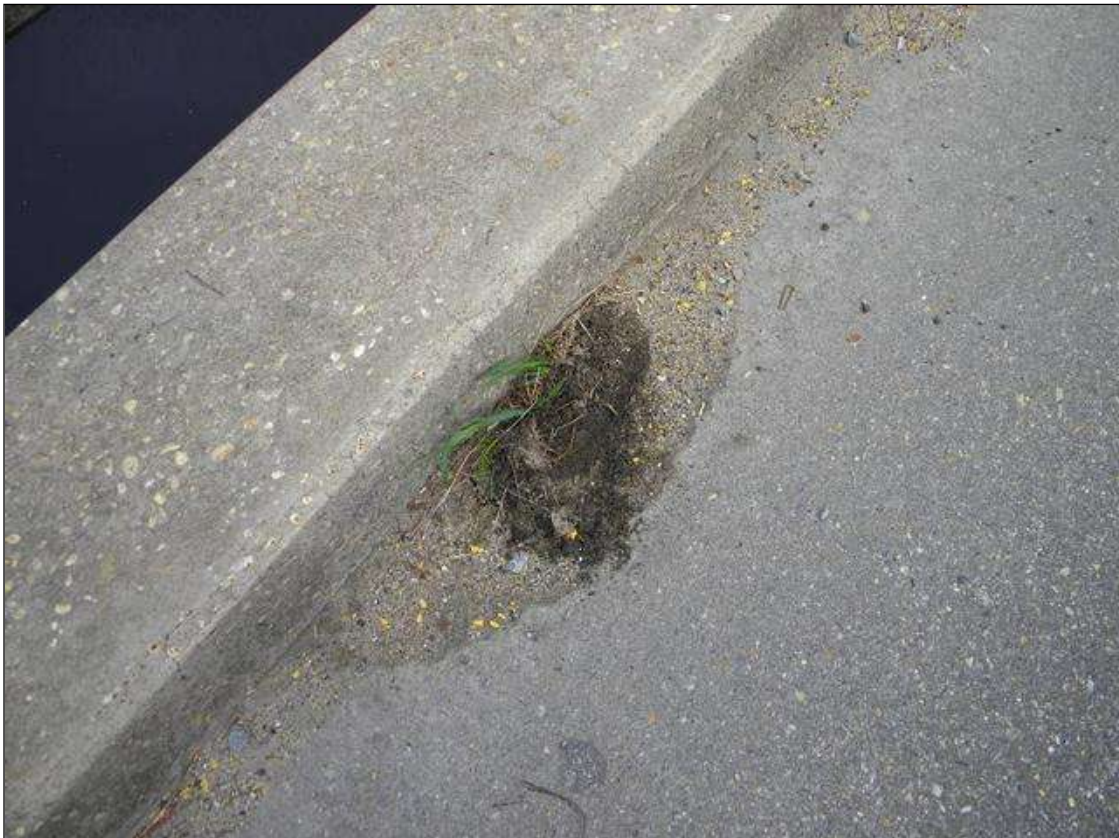
DECK DRAINS CLOGGED WITH VEGETATION

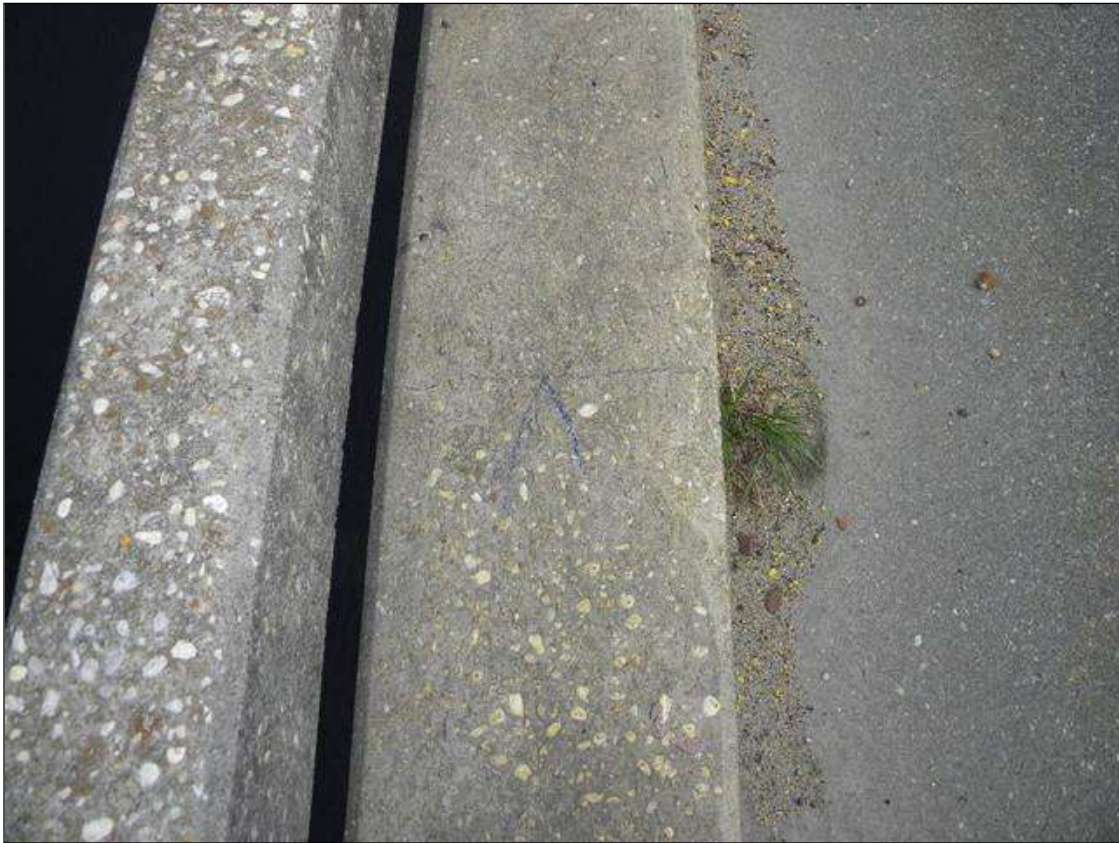
RANDOM TRANSVERSE CRACK IN TOP OF CURBLINES

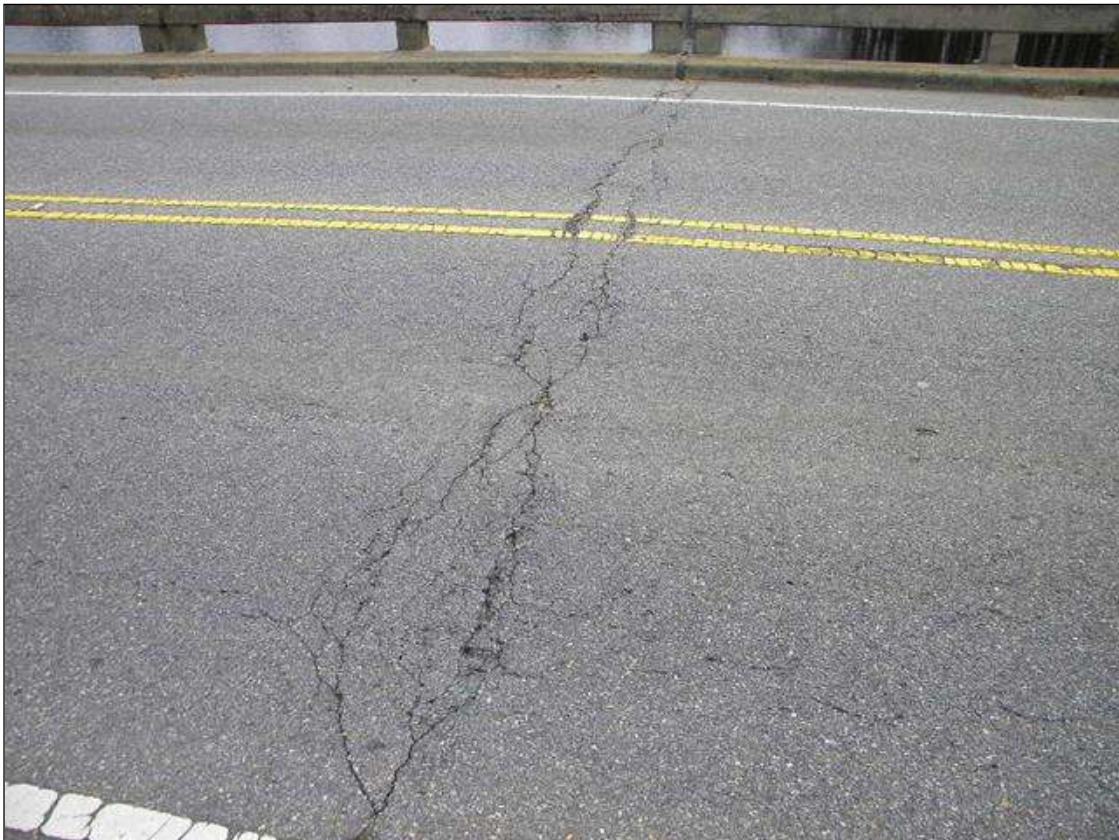
TRANSVERSE CRACKING IN WEARING SURFACE OVER BENT 1

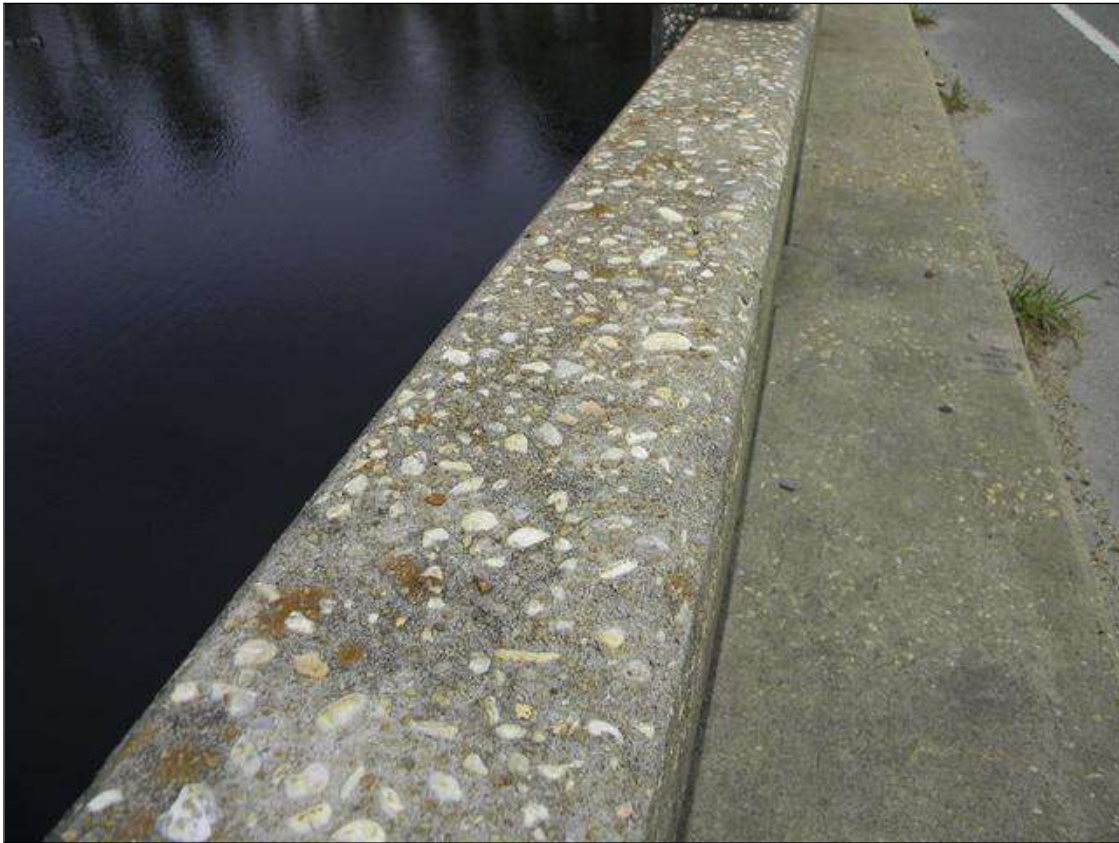
GUARDRAILS SCALED WITH COARSE AGGREGATE EXPOSED

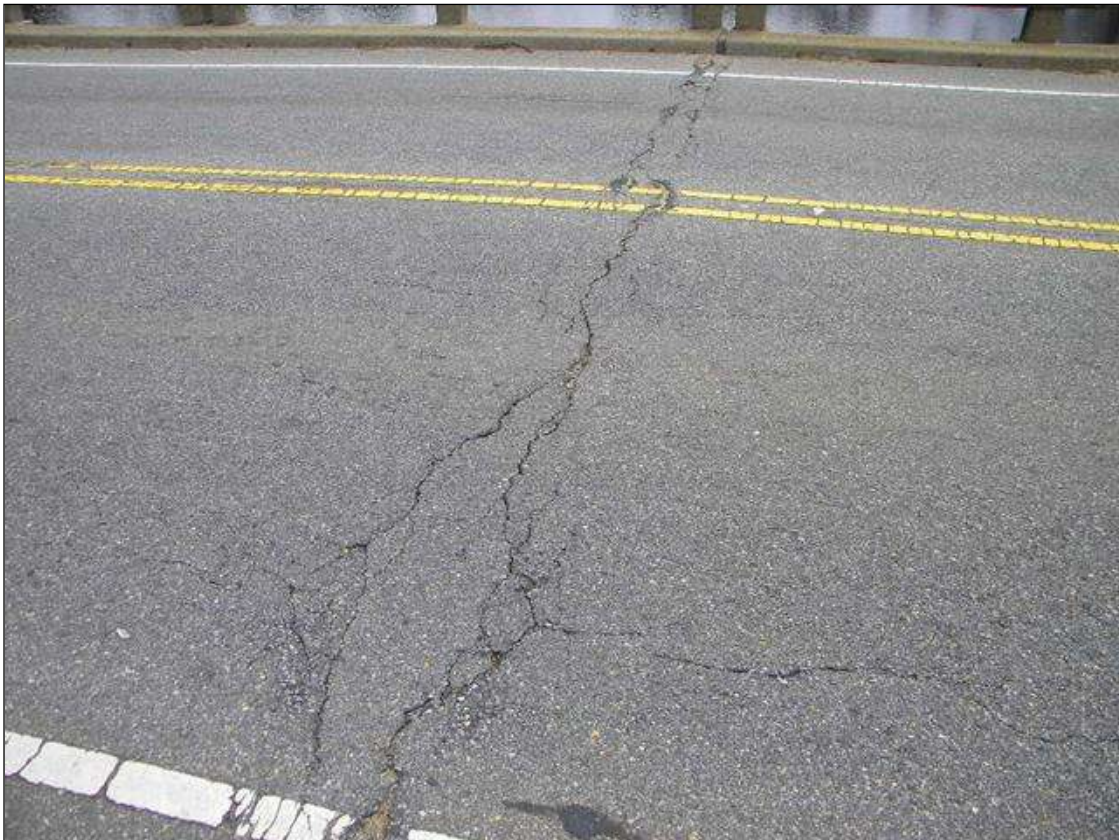
TRANSVERSE CRACKING AND SMALL VOIDS IN WEARING SURFACE OVER BENT 2

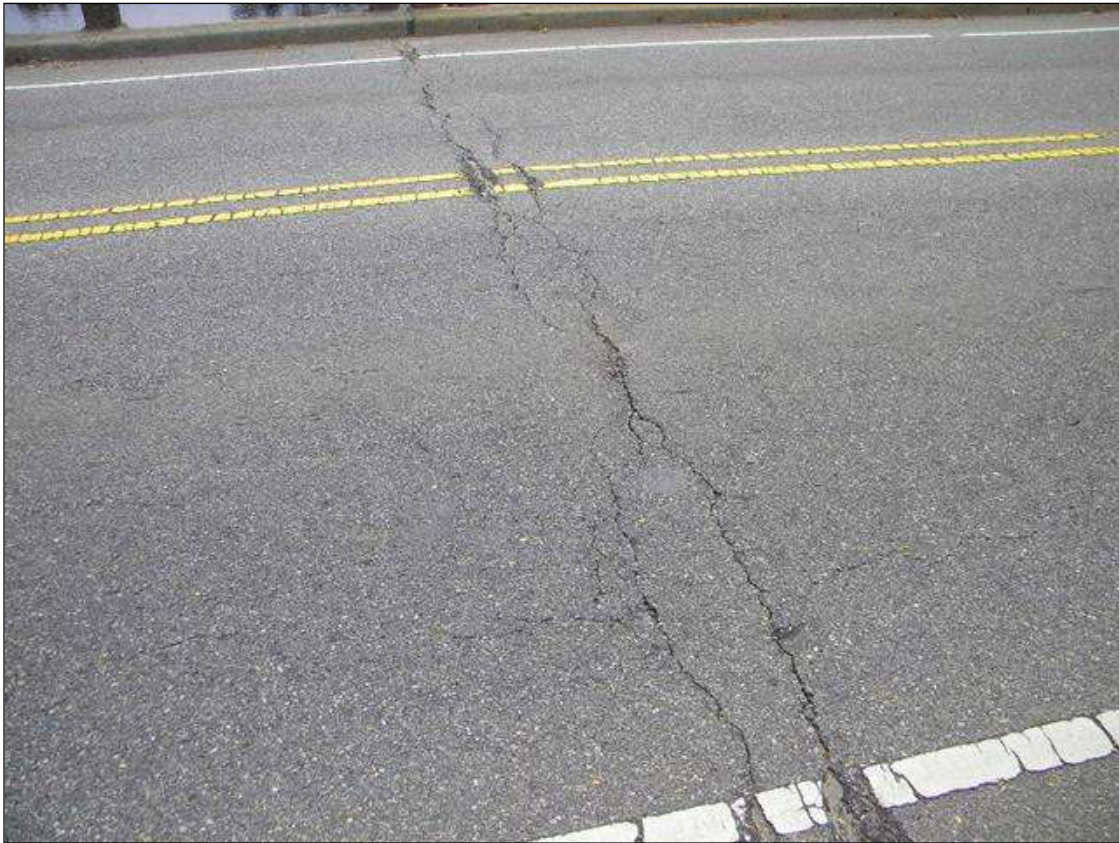
TRANSVERSE CRACKING IN WEARING SURFACE OVER BENT 3

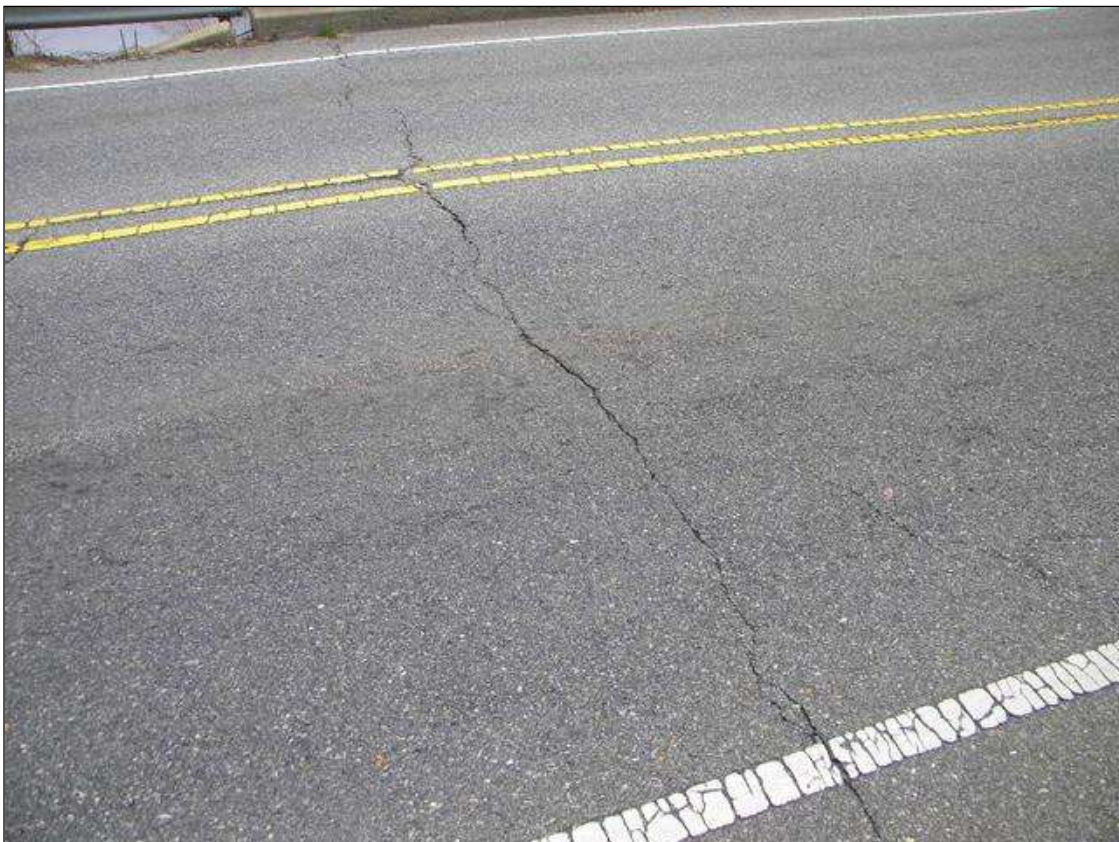
TRANSVERSE CRACK IN WEARING SURFACE OVER END BENT 2

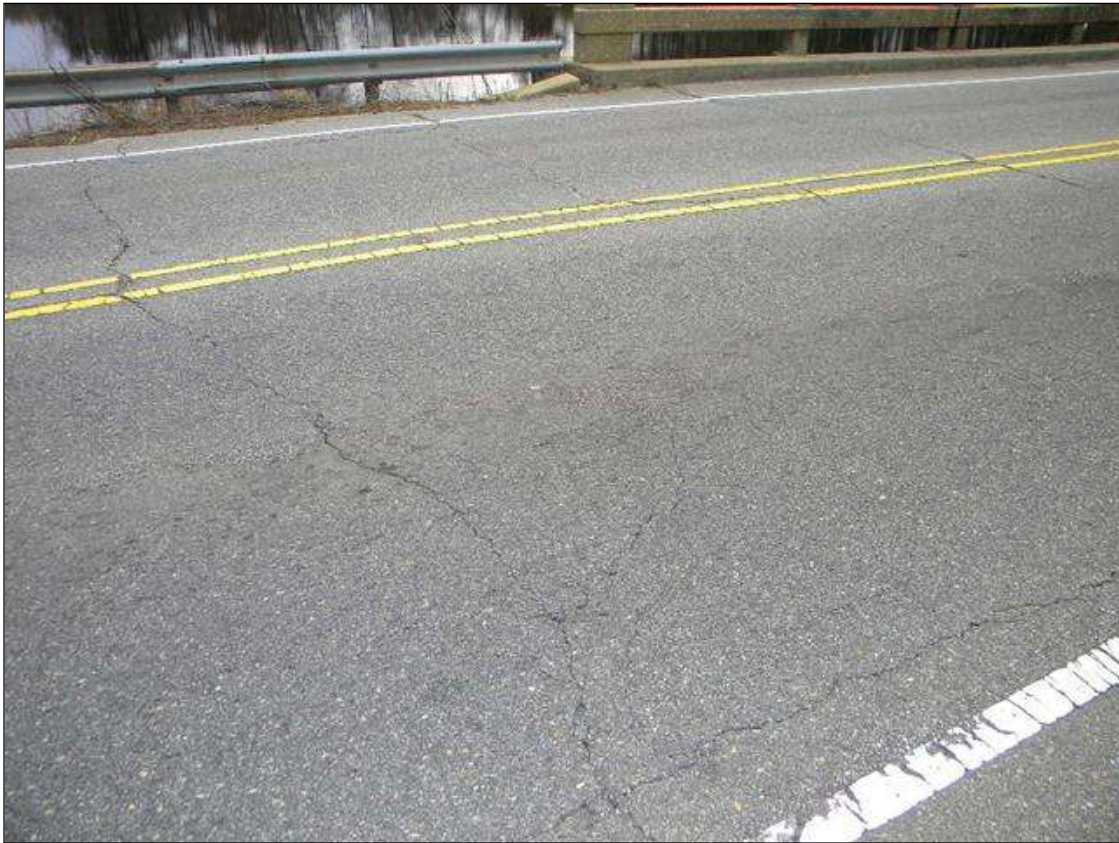
TRANSVERSE AND LONGITUDINAL CRACKS IN APPROACH 2 WEARING SURFACE

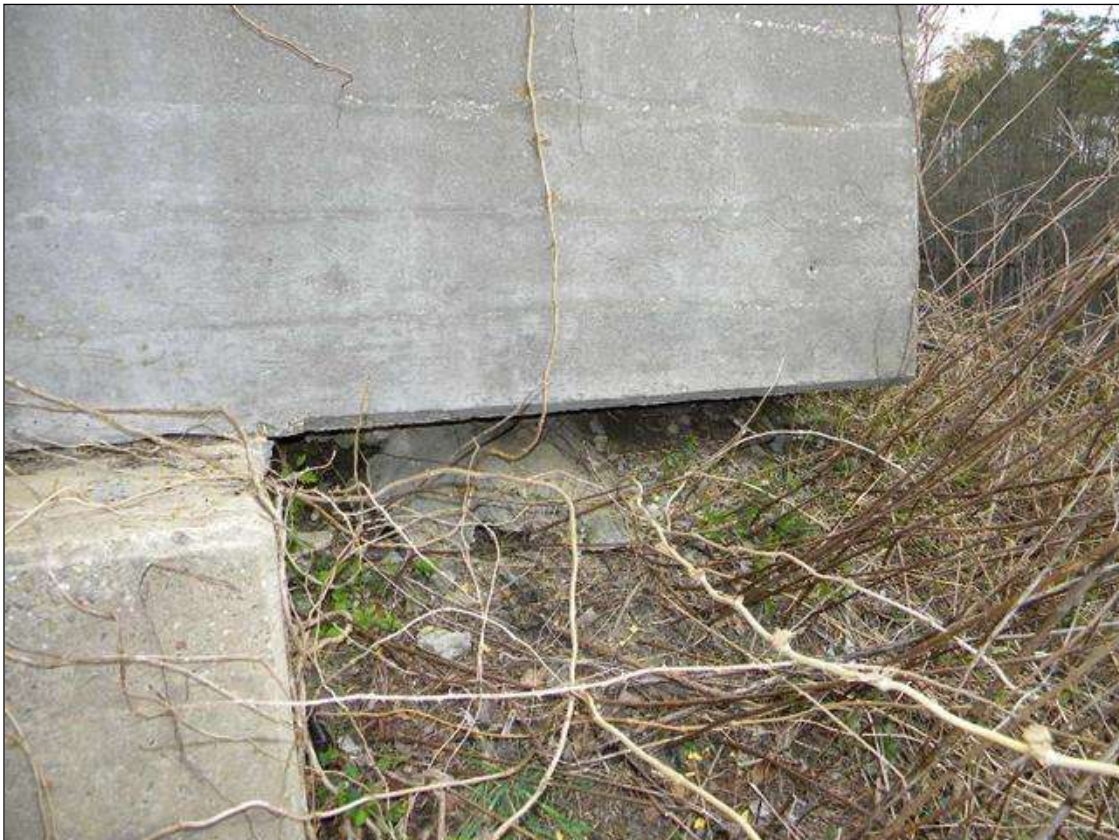
UNDERMINING AT END BENT 2 RIGHT SIDE WINGWALL - LEFT SIDE SIMILAR

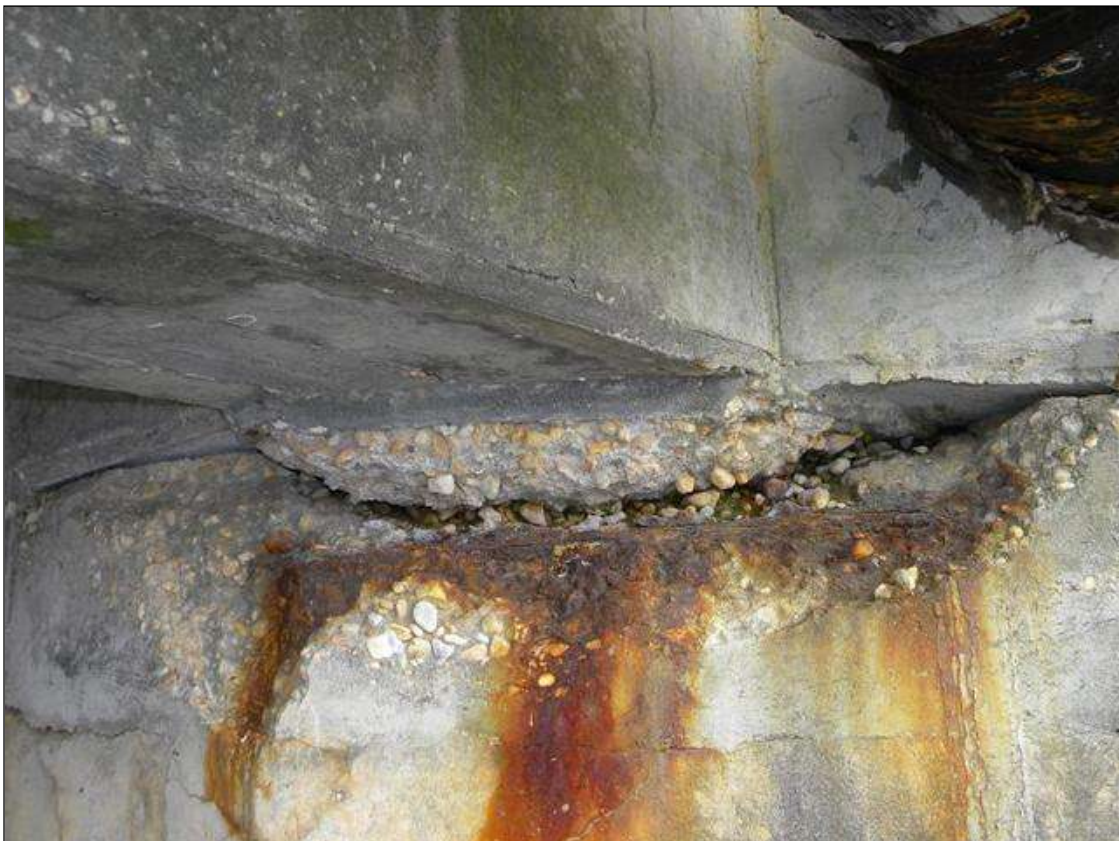
SPALLING UNDER GIRDER 1 BEARING AT ABUTMENT 1

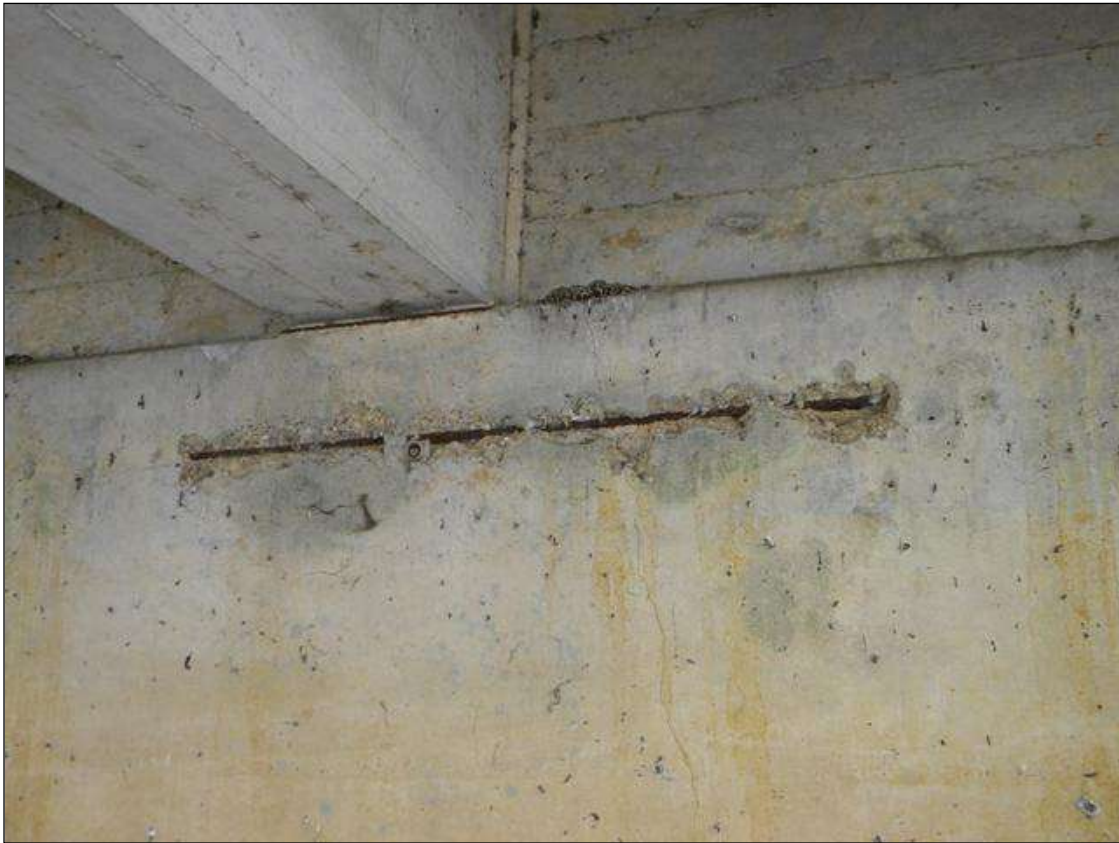
SPALL WITH EXPOSED REBAR IN ABUTMENT 1 UNDER GIRDER 3

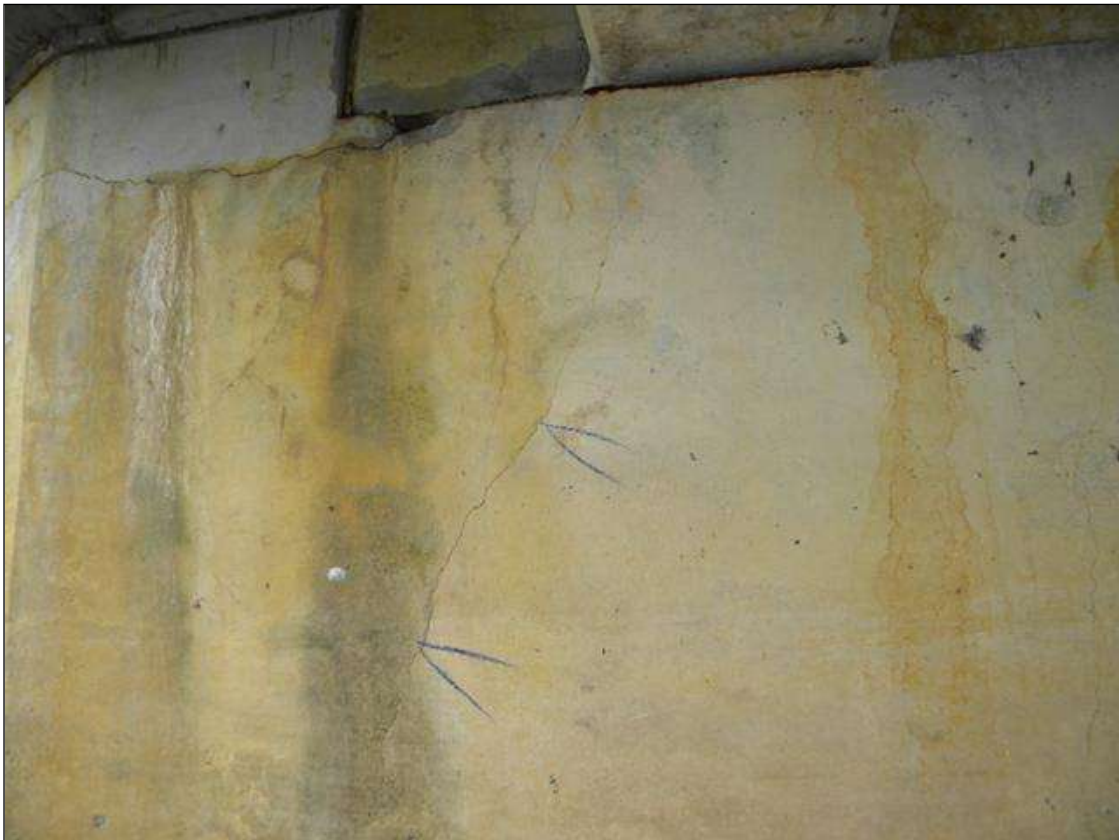
RANDOM VERTICAL CRACKS IN FACE OF ABUTMENT 1

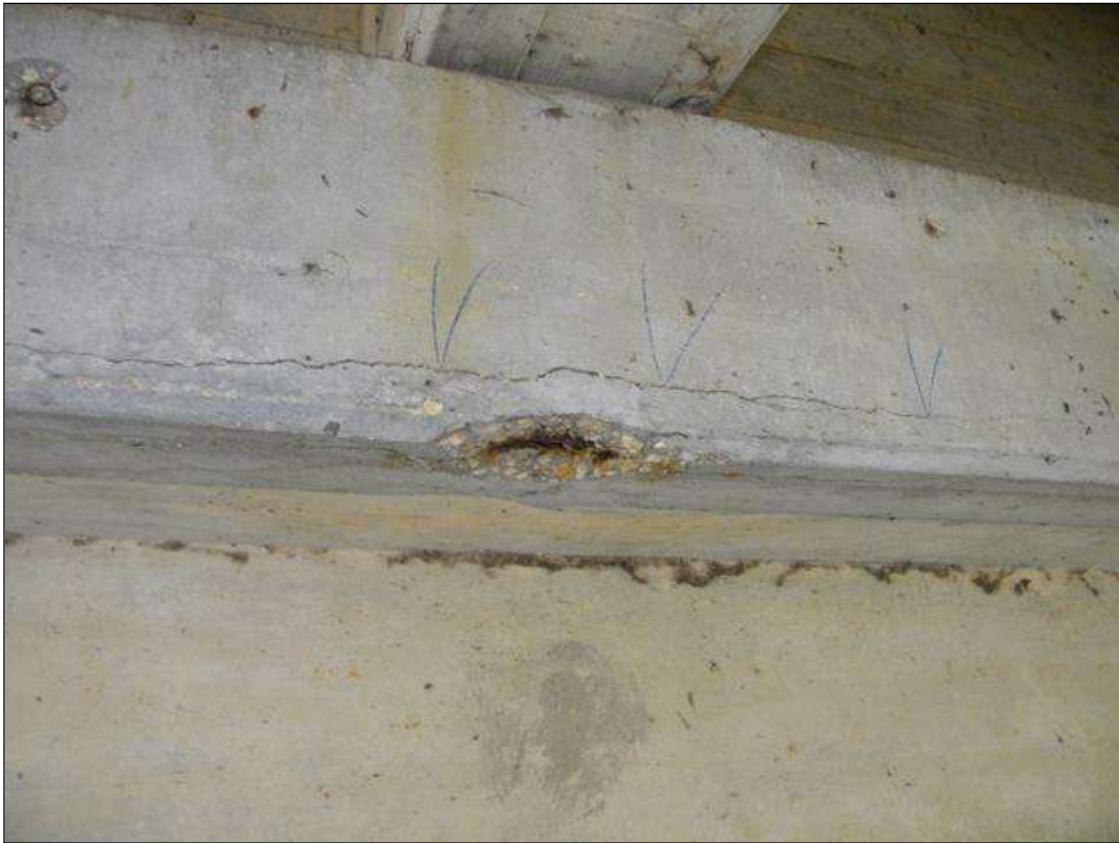
SPALLING AND DELAMINATION IN BOTTOM EDGE OF BENT 1 CAP SPAN 1 SIDE

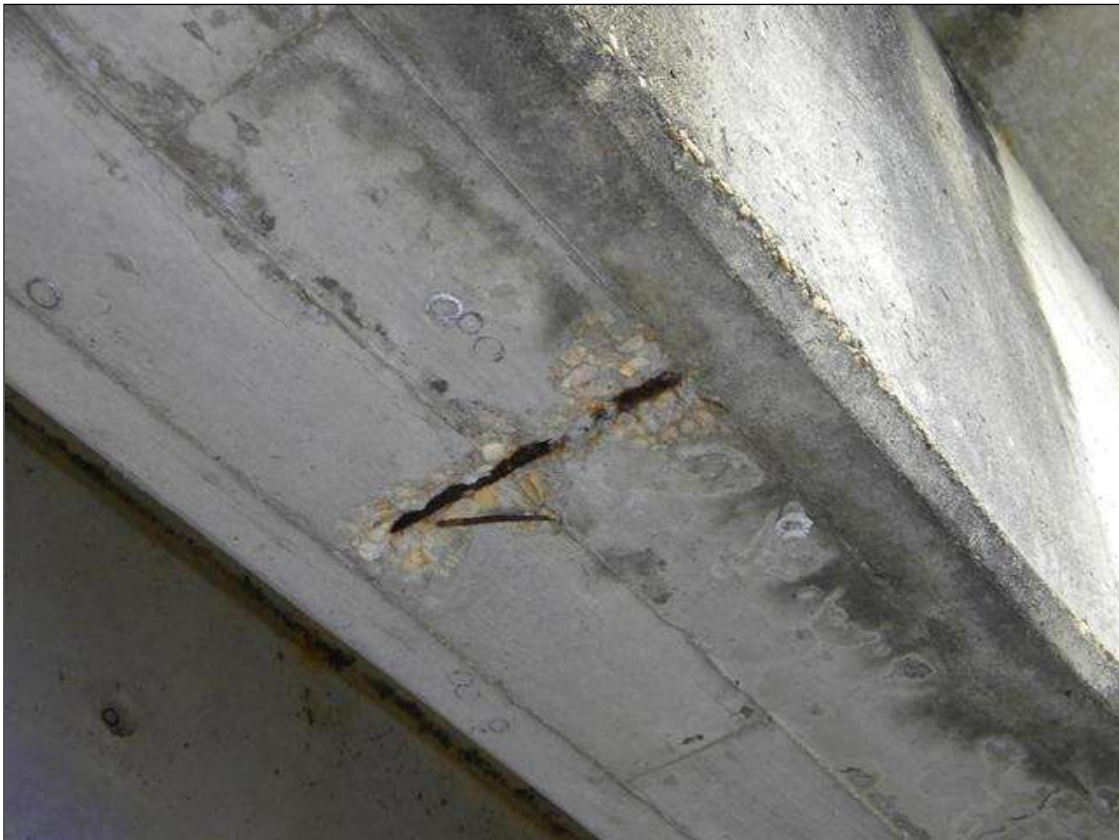
SHALLOW SPALLING WITH EXPOSED REBAR IN BOTTOM OF GIRDER 5 IN SPAN 2 AT 1/3 POINT FROM BENT 1

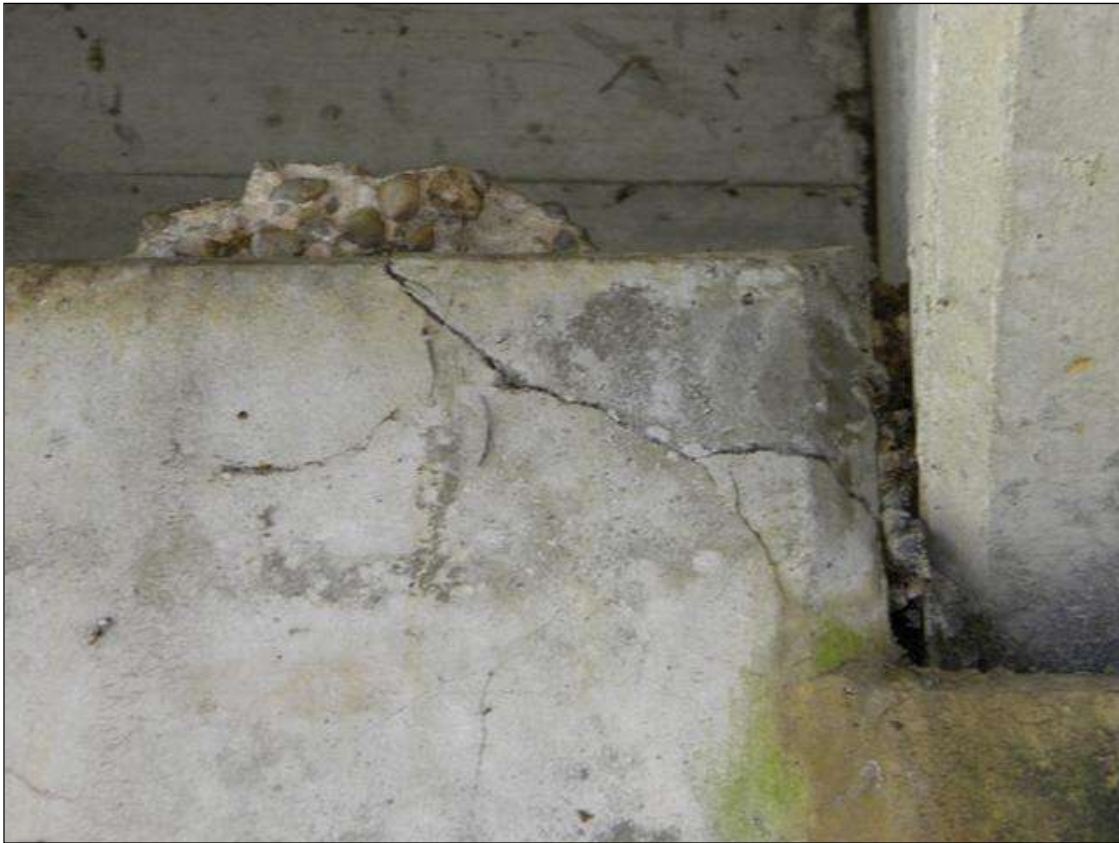
CRACK IN GIRDER 4 RETAINING BLOCK AT BENT 2 SPAN 3 SIDE

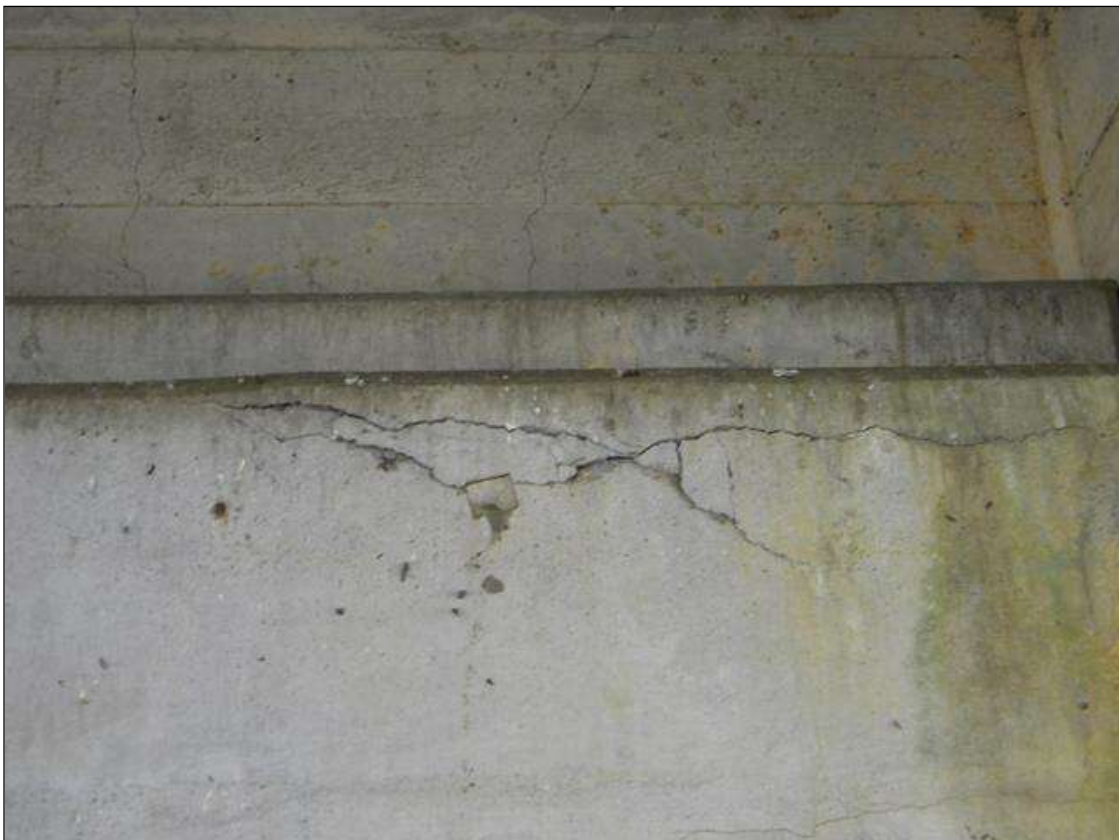
CRACKING IN FACE OF CAP AT BENT 3 BAY 3 SPAN 3 SIDE

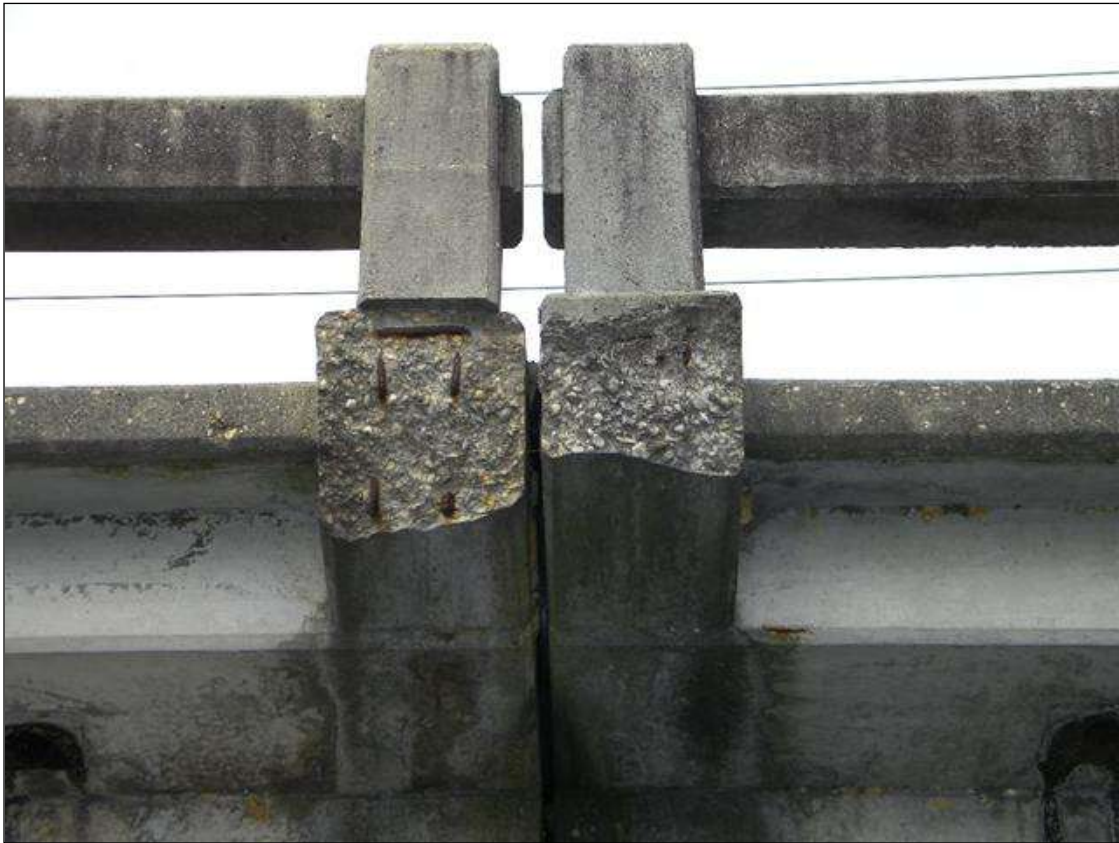
GUARDRAIL POST BASES AT THE RIGHT SIDE OF BENT 3 SPALLED WITH EXPOSED REBAR

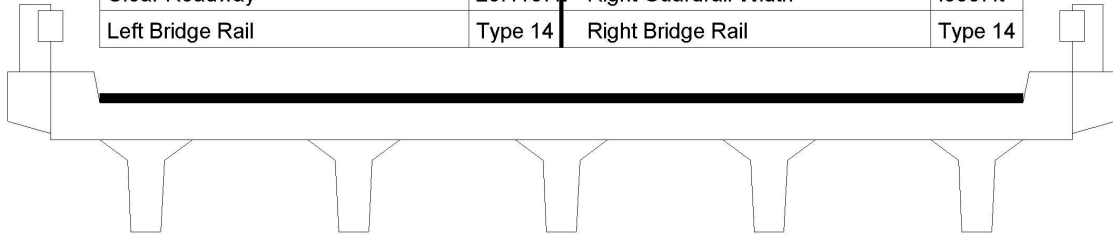
Measurements for Span #	1		
Deck Thickness	.625	Left Overhang	3.3333
Top of Rail to Bottom of Beam	*6.8333	Right Overhang	3.3333
