NC DEPARTMENT OF TRANSPORTATION
 DIVISION OF HIGHWAYS
 STRUCTURE MANAGEMENT UNIT

ATTENTION: **PRIORITY MAINTENANCE ISSUED.**

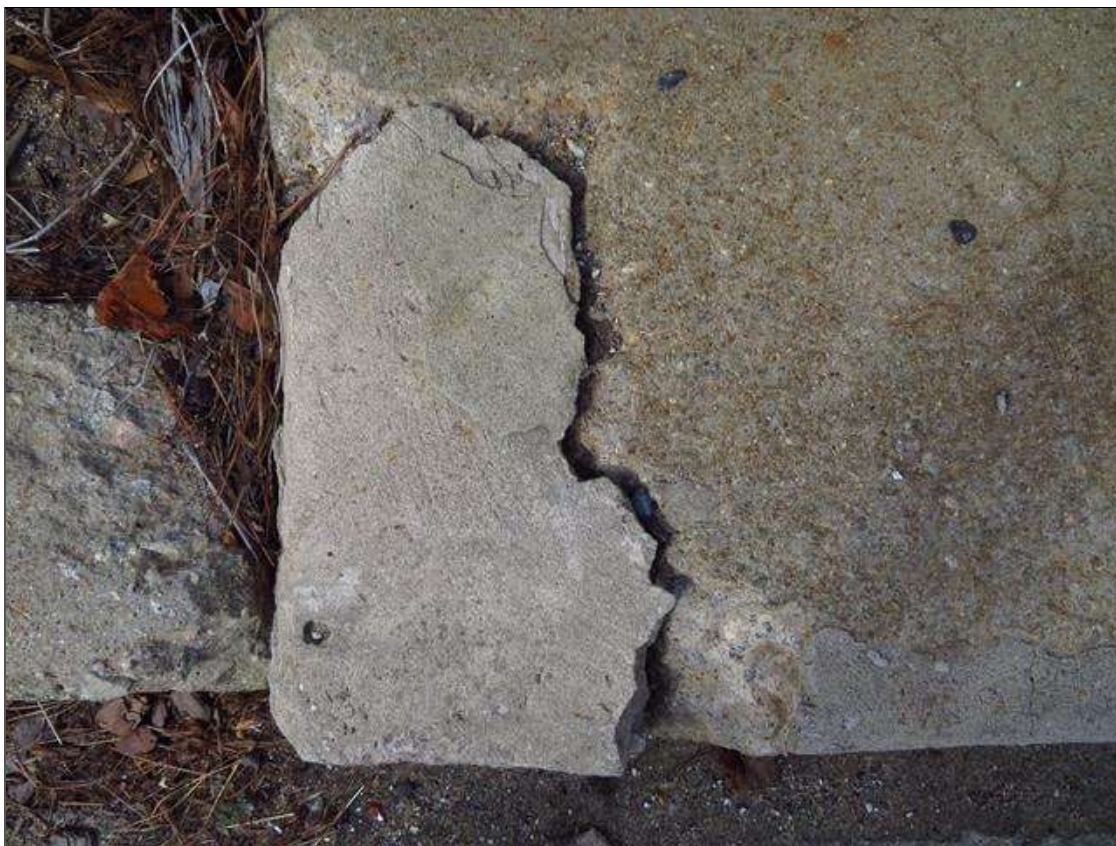
LEFT CURB AT END BENT 1 CRACKED AND SPALLED

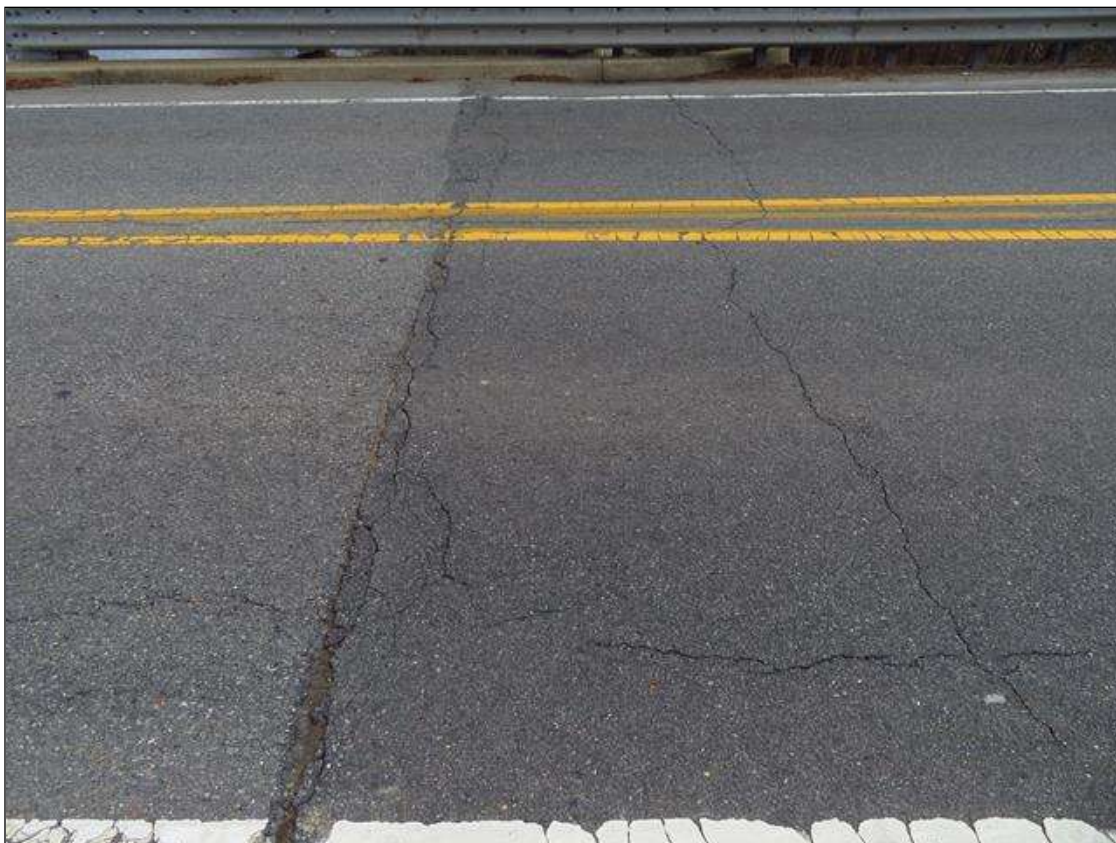
CRACKING IN WEARING SURFACE OVER END BENT 1

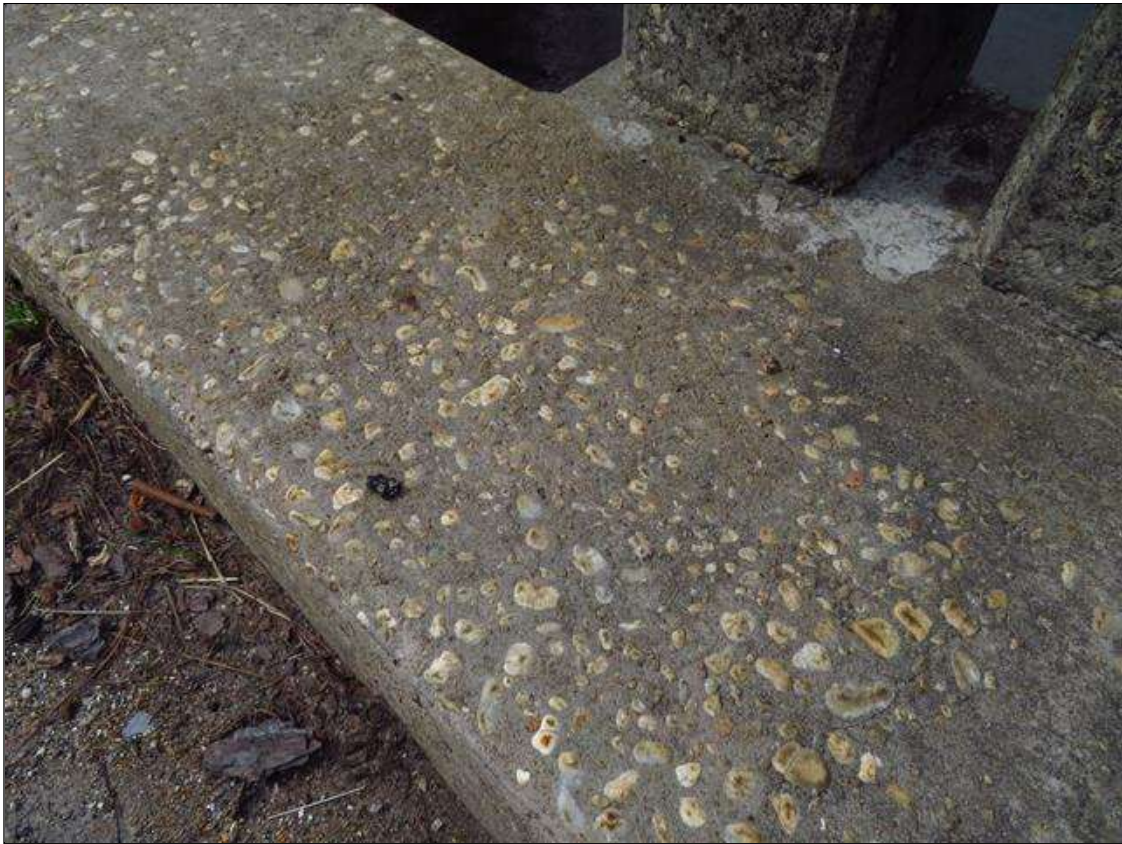
ABRASION WITH COARSE AGGREGATE EXPOSED ALONG DECK CURBS IN SPAN 1

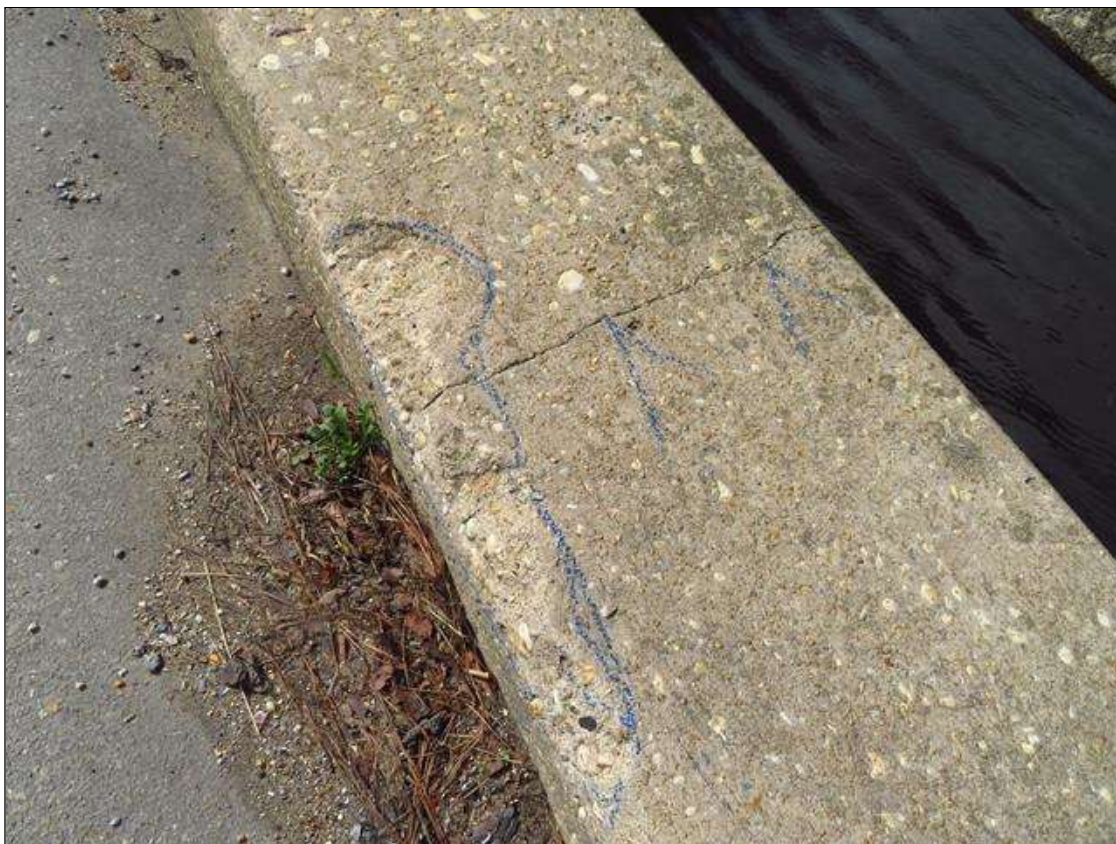
TRANSVERSE CRACK WITH SPALLING IN THE LEFT CURB OF SPAN 1

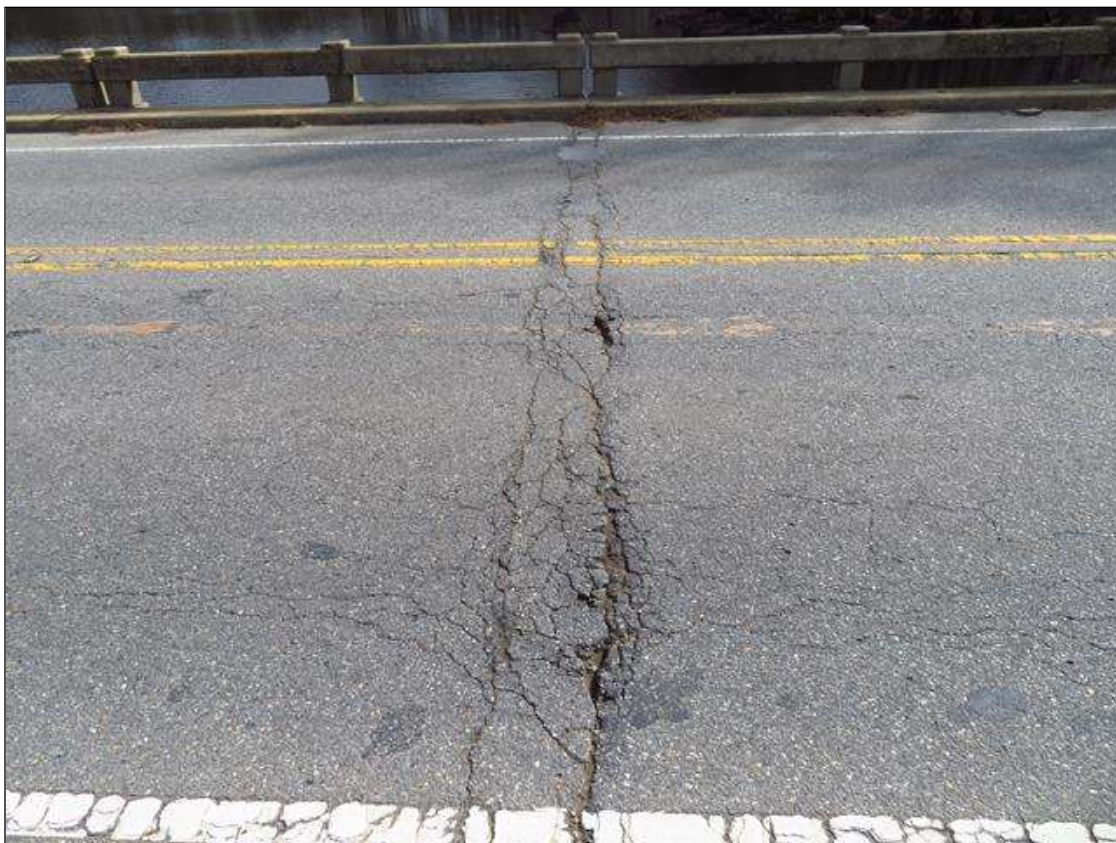
CRACKING IN WEARING SURFACE OVER BENT 1

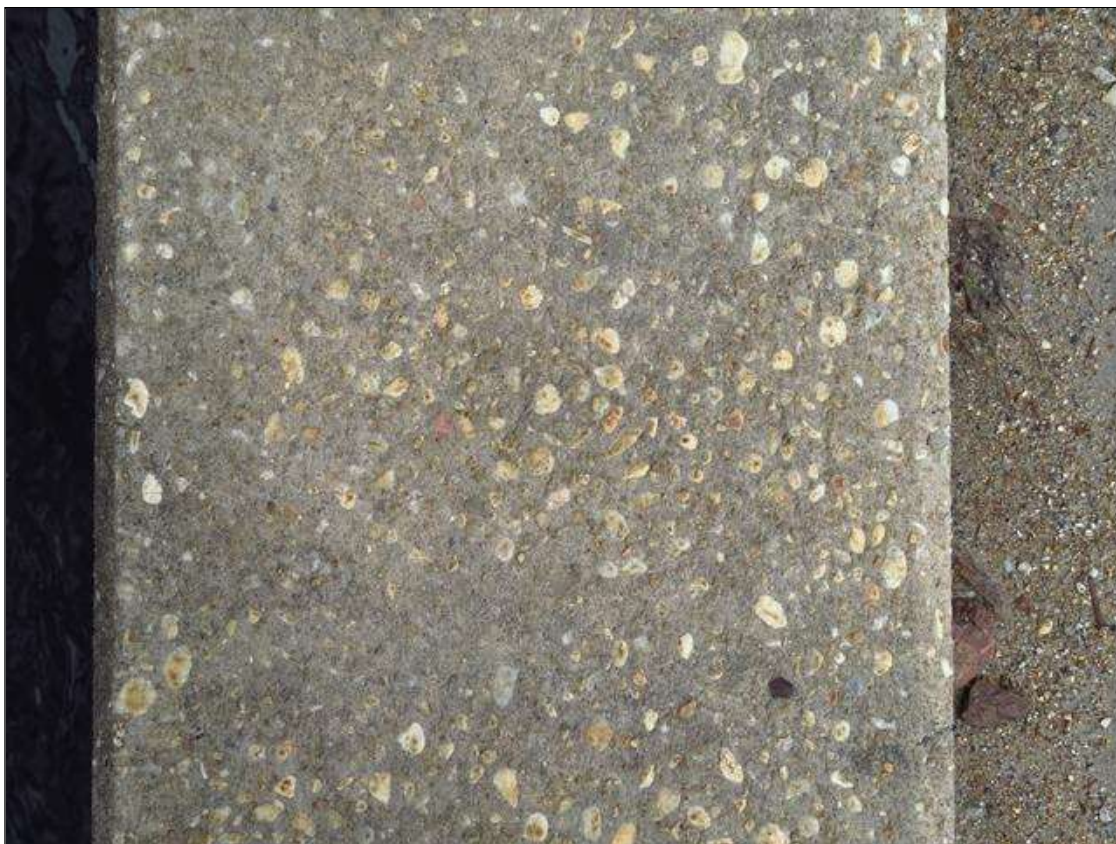
ABRASION WITH COARSE AGGREGATE EXPOSED ALONG DECK CURBS IN SPAN 2

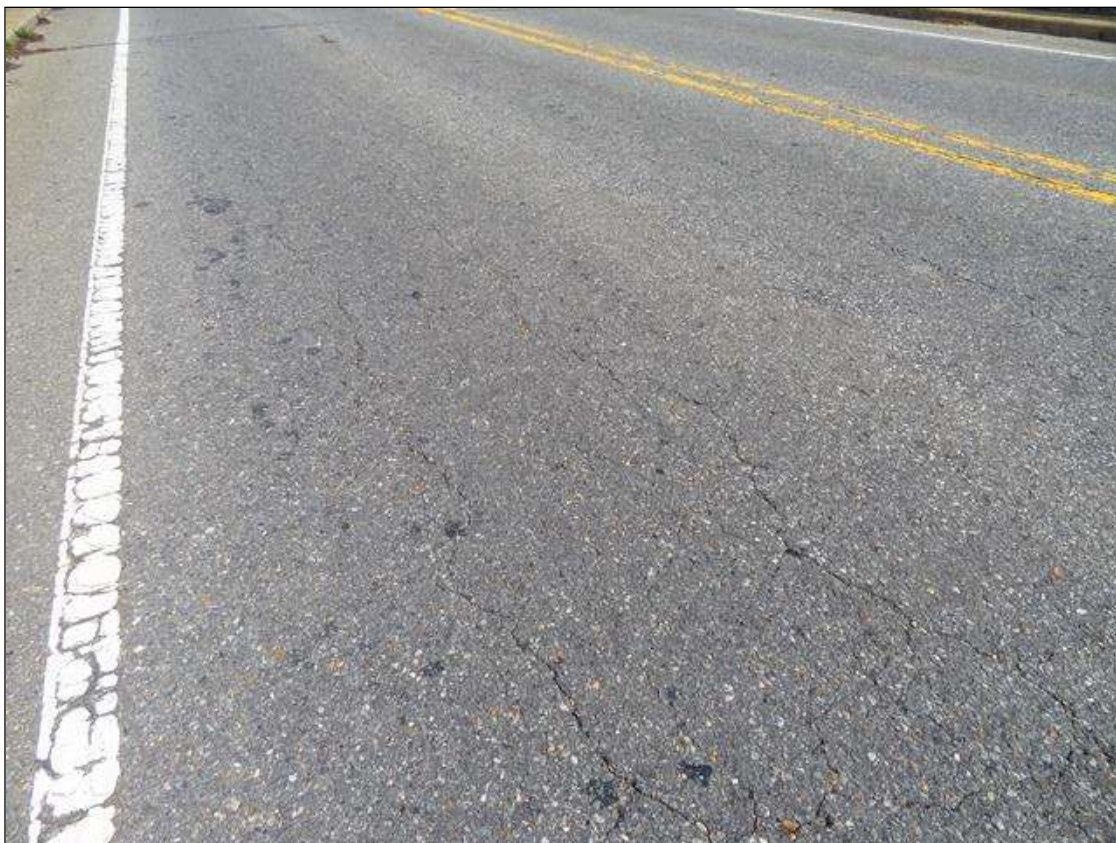
LONGITUDINAL CRACKING IN SPAN 2 WEARING SURFACE - OTHER SPANS SIMILAR

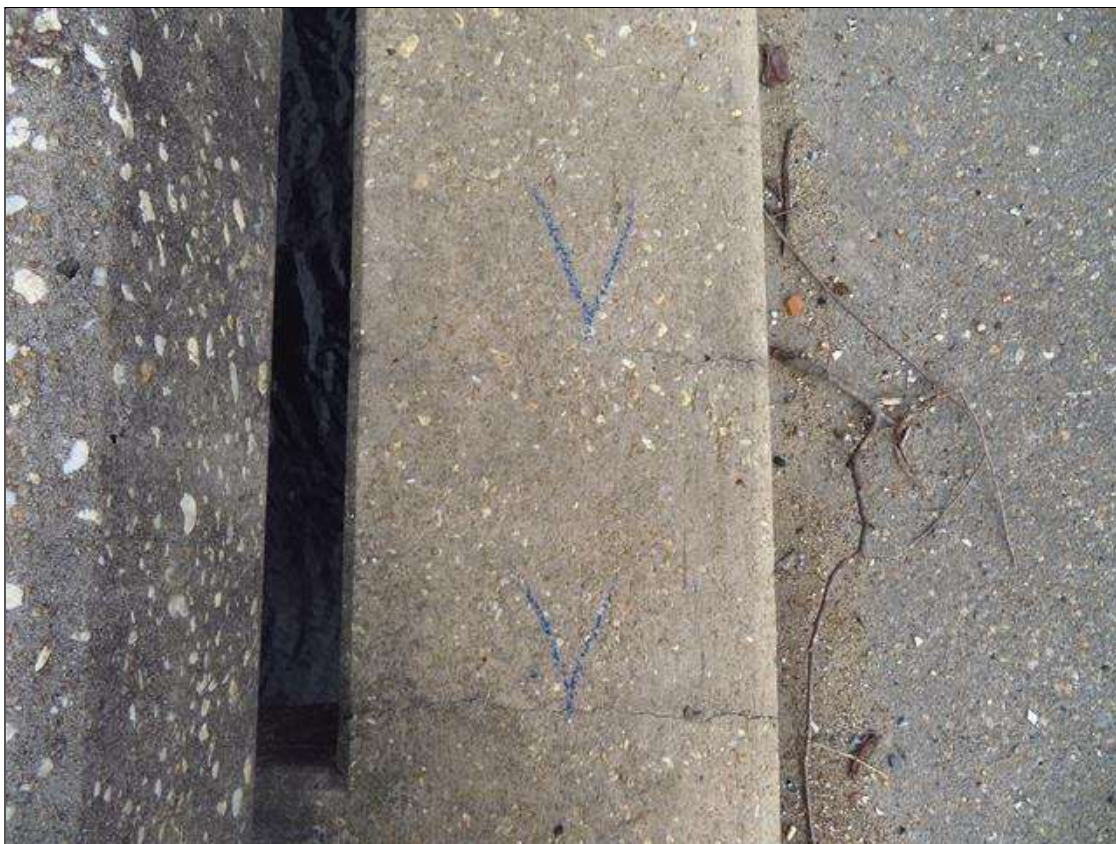
RANDOM TRANSVERSE CRACKS IN THE LEFT CURB OF SPAN 2

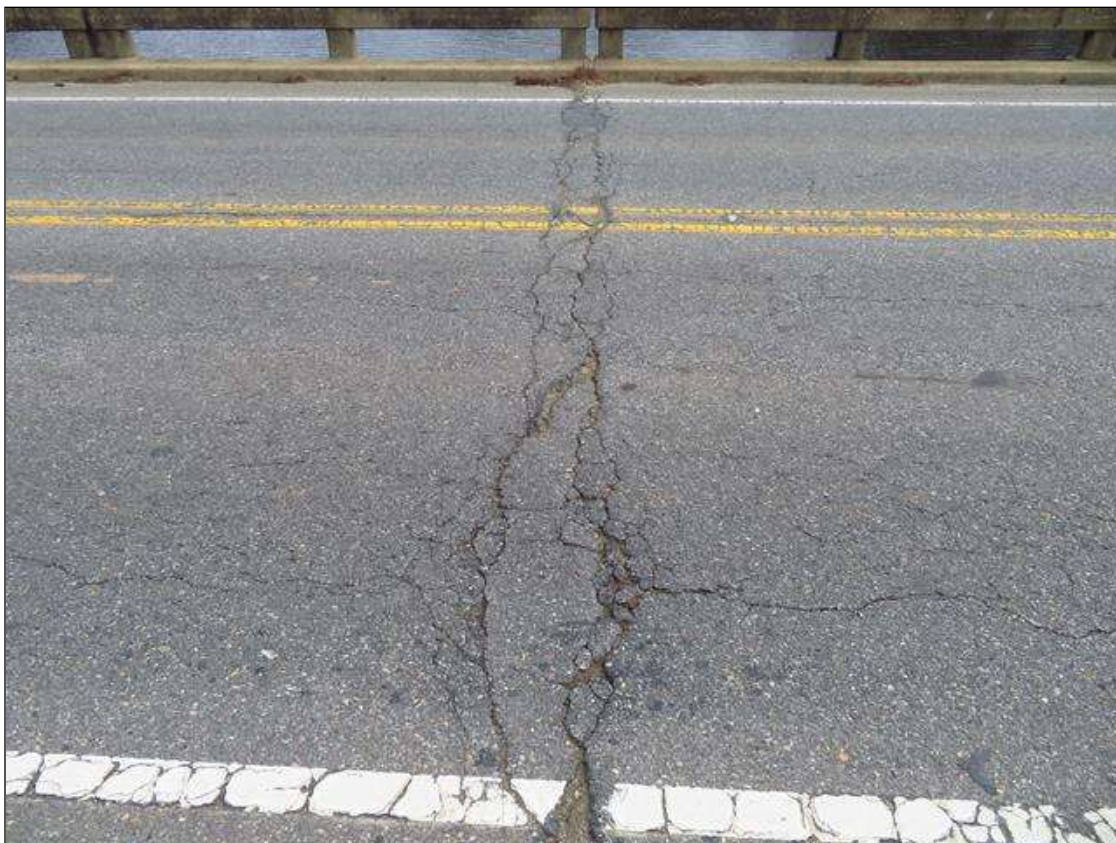
CRACKING IN WEARING SURFACE OVER BENT 2

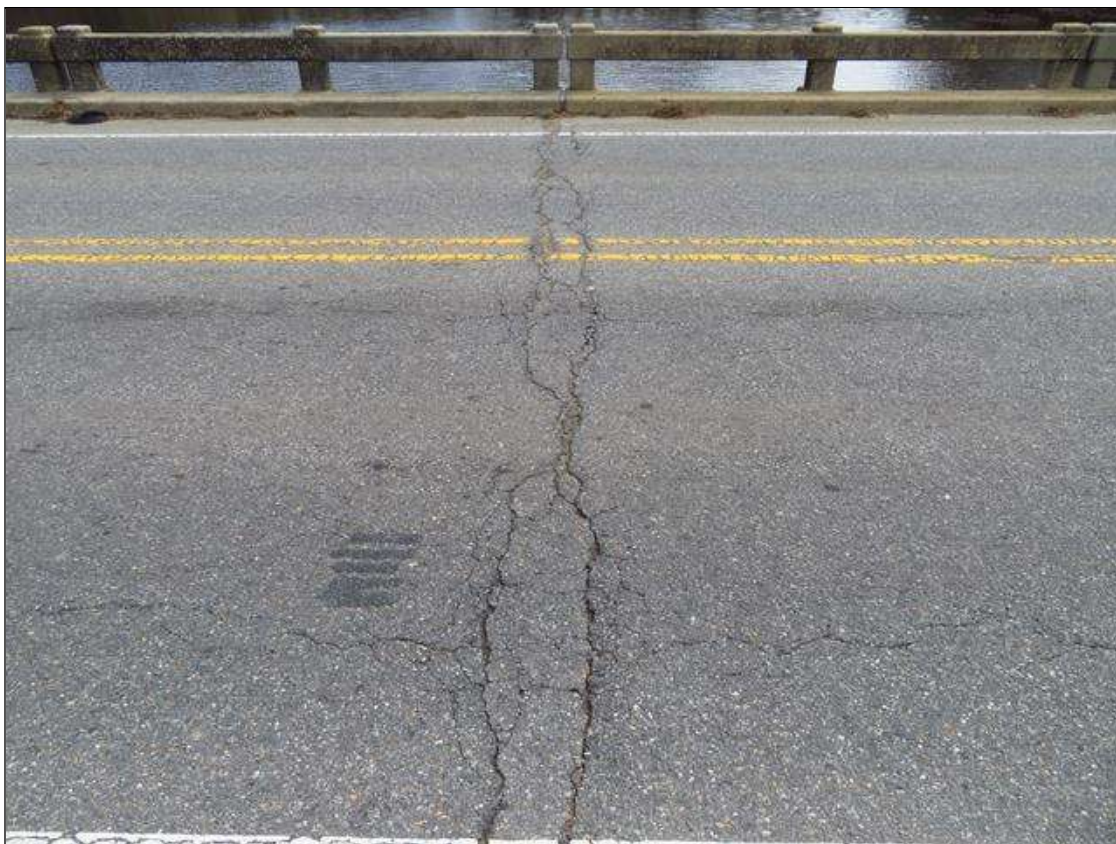
CRACKING IN WEARING SURFACE OVER BENT 3

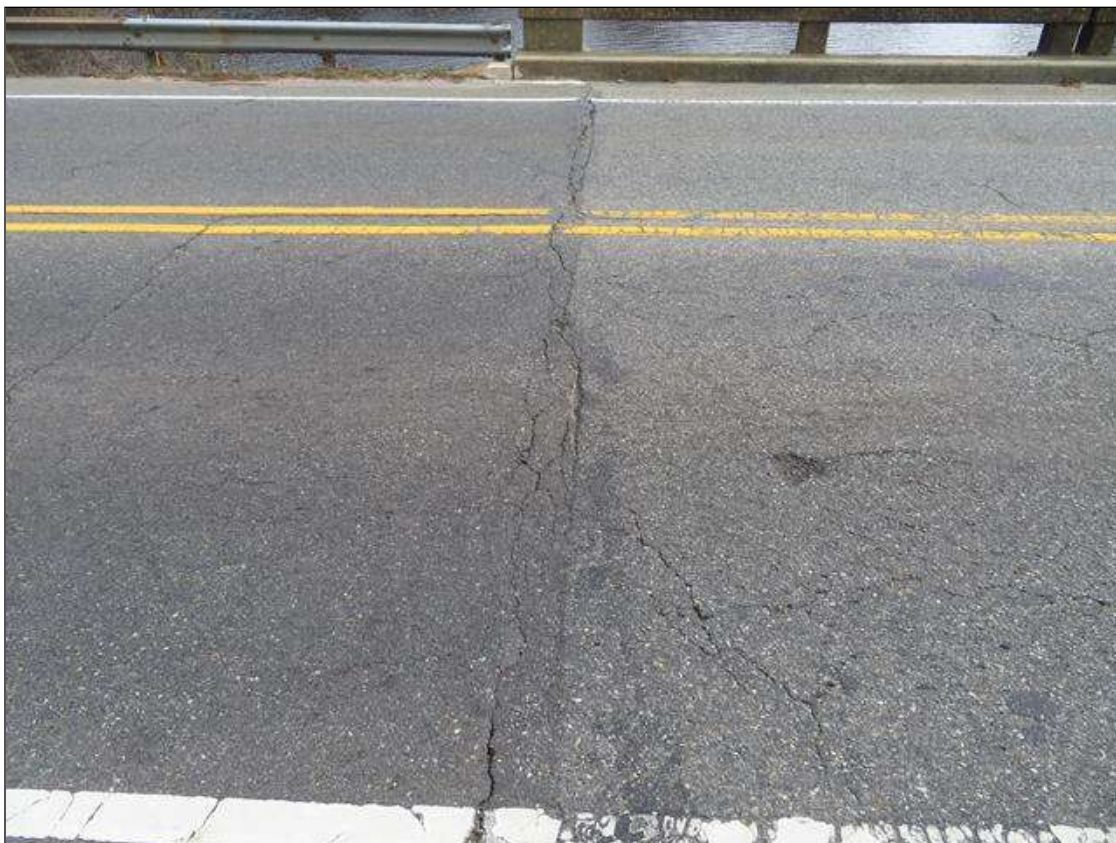
CRACKING IN WEARING SURFACE OVER END BENT 2

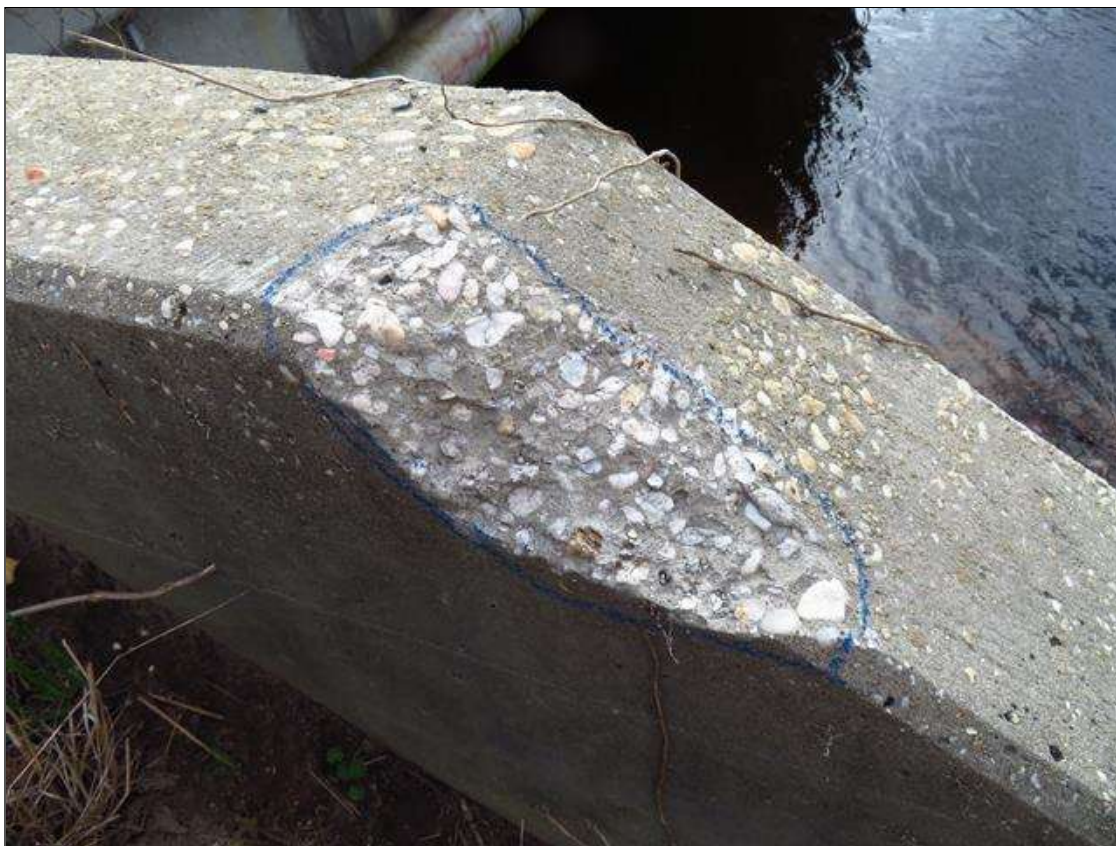
SPALL IN THE LEFT END OF ABUTMENT AT END BENT 2

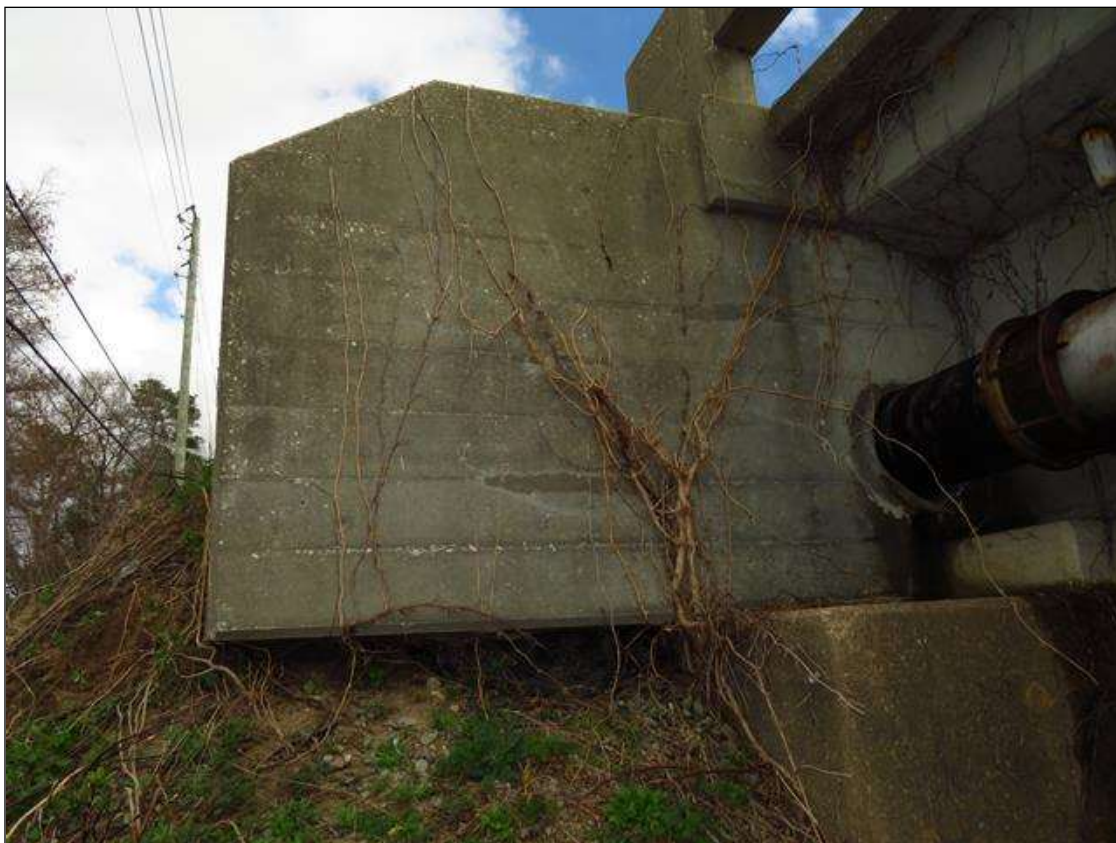
LEFT END OF ABUTMENT 2 UNDERMINED 4'L X 10" HIGH X 10" DEEP

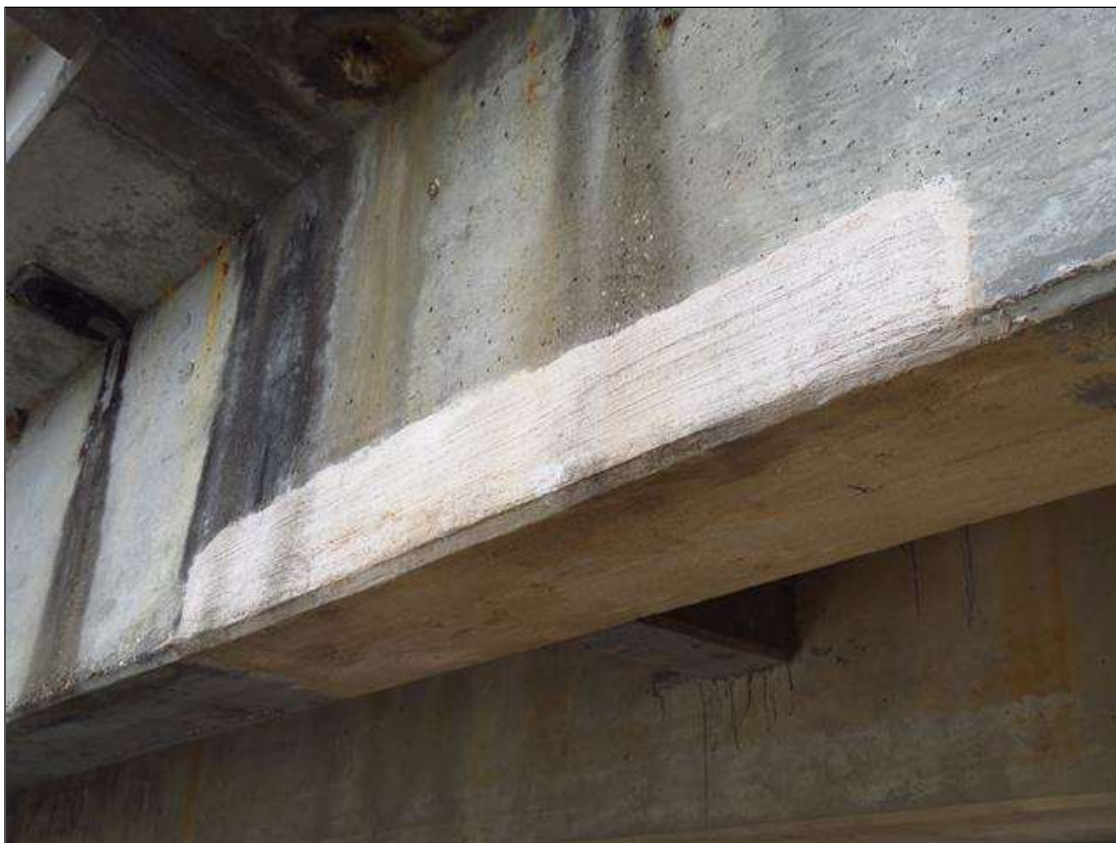
REPAIR PATCH IN THE RIGHT SIDE BOTTOM OF GIRDER 5 IN SPAN 4

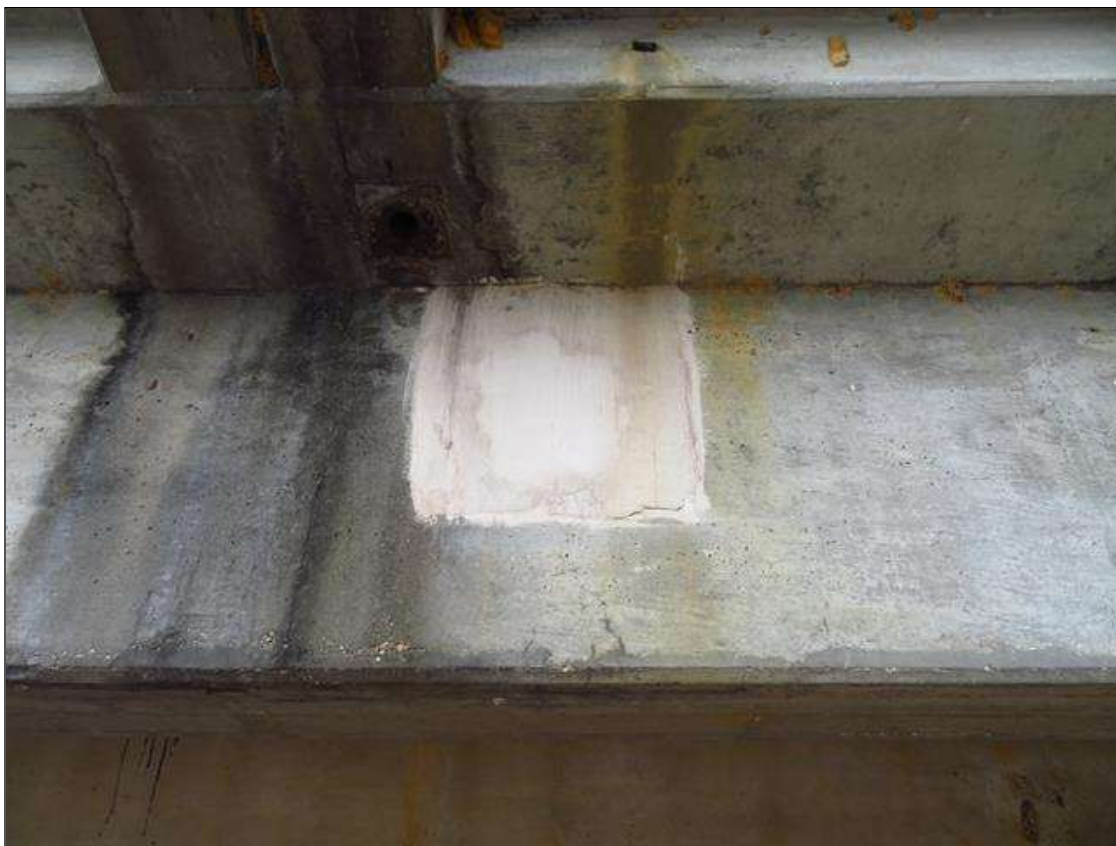
REPAIR PATCH IN THE RIGHT SIDE WEB OF GIRDER 5 IN SPAN 4 AT 2/3 POINT FROM BENT 3

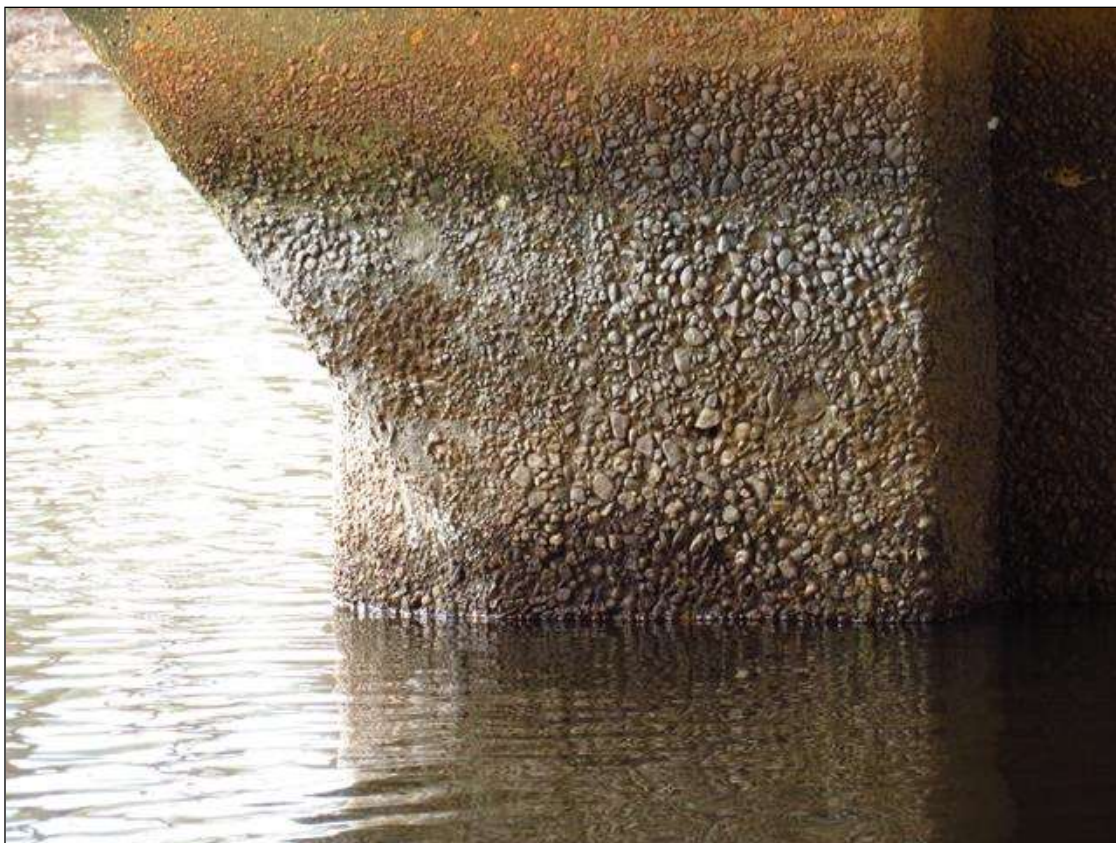
ABRASION WITH COARSE AGGREGATE EXPOSED FROM WATERLINE UP 2 FT. AROUND BENT 3 - OTHER BENTS SIMILAR

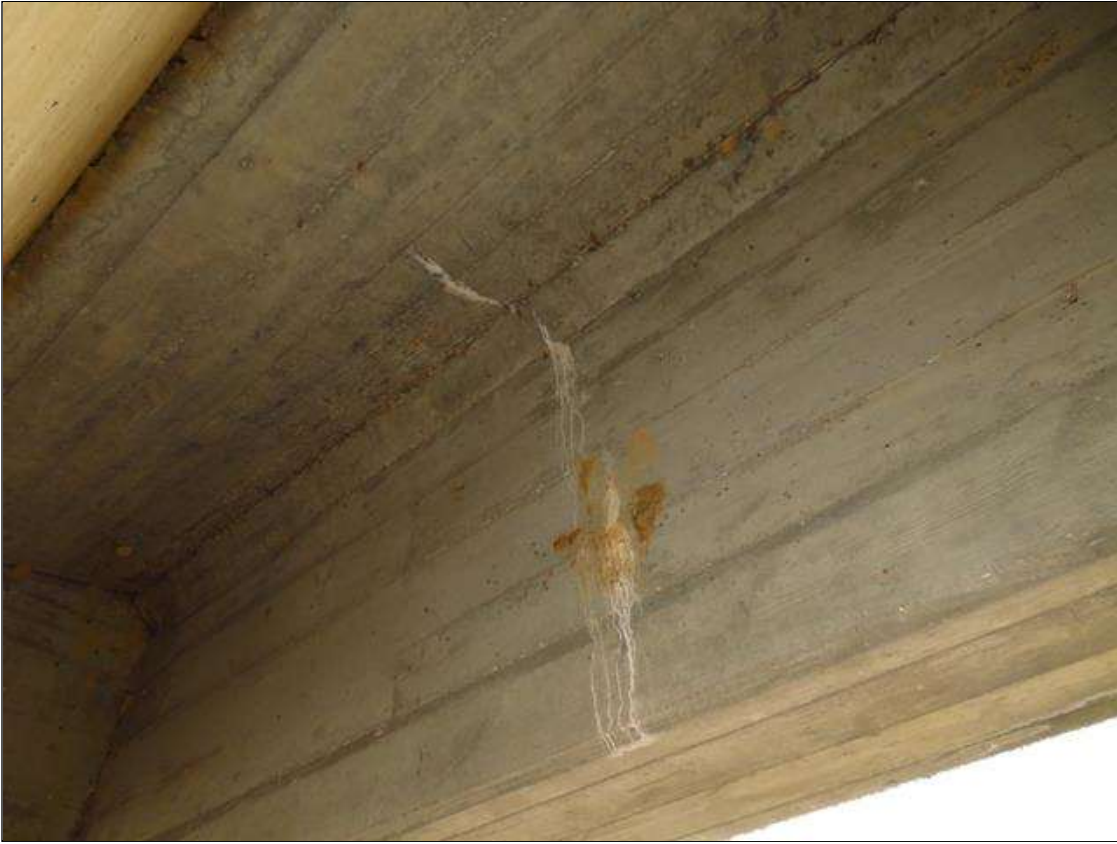
HAIRLINE CRACK WITH SURFACE WHITE EFFLORESCENCE IN BOTTOM OF DECK IN SPAN 4, BAY 1
EXTENDING DOWN THE RIGHT SIDE WEB OF GIRDER 1 NEAR MID-SPAN

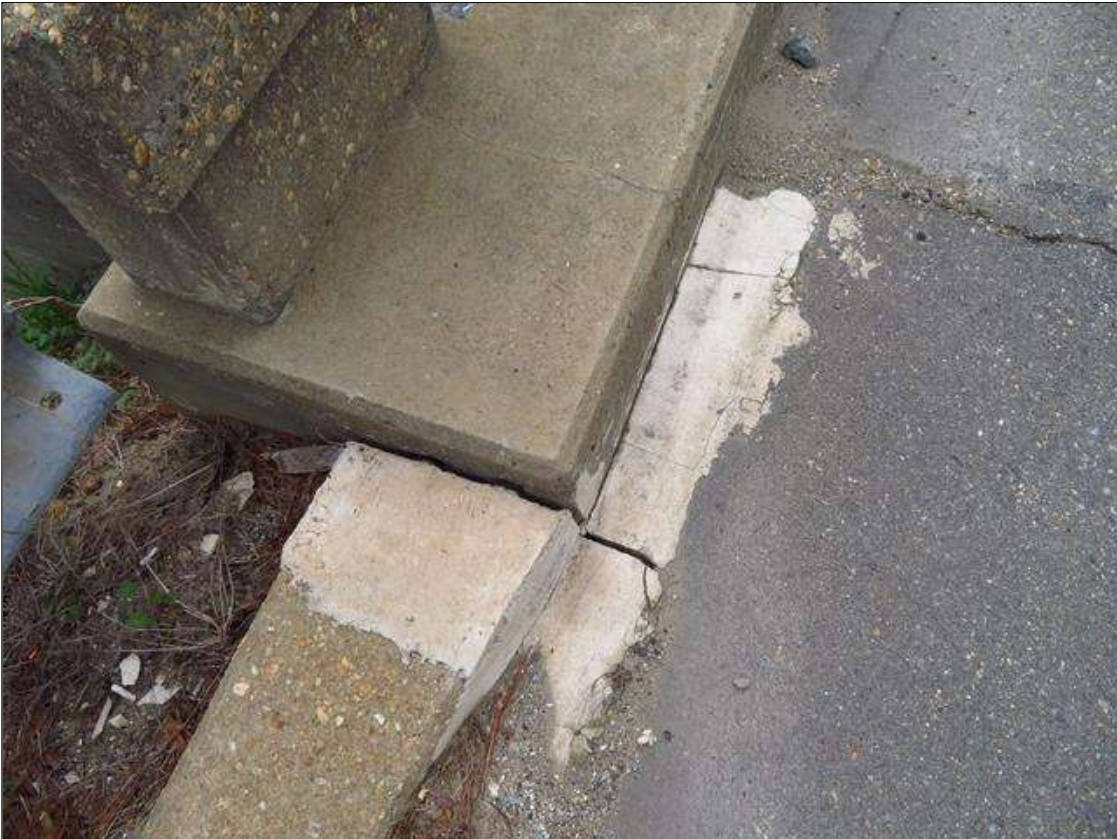
REPAIR PATCH IN THE RIGHT SHOULDER AND CURB AT END BENT 2

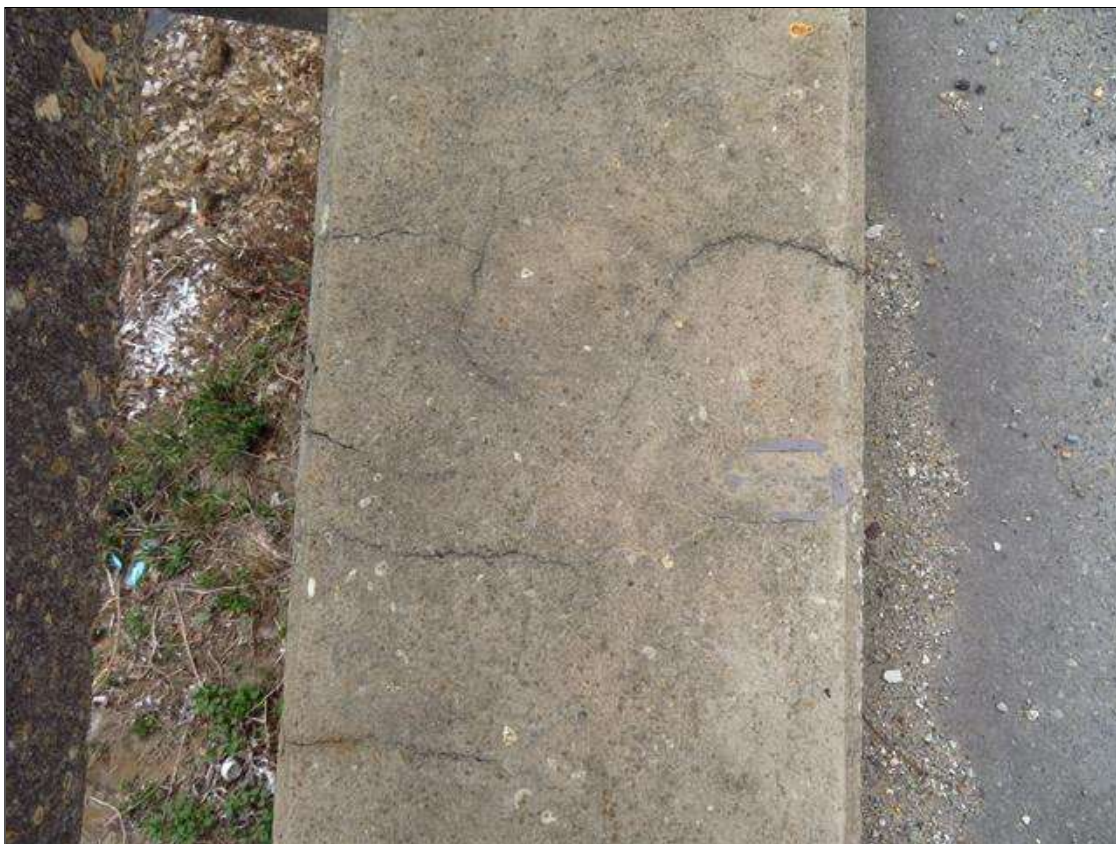
HAIRLINE CRACKING IN THE RIGHT CURB OF SPAN 4

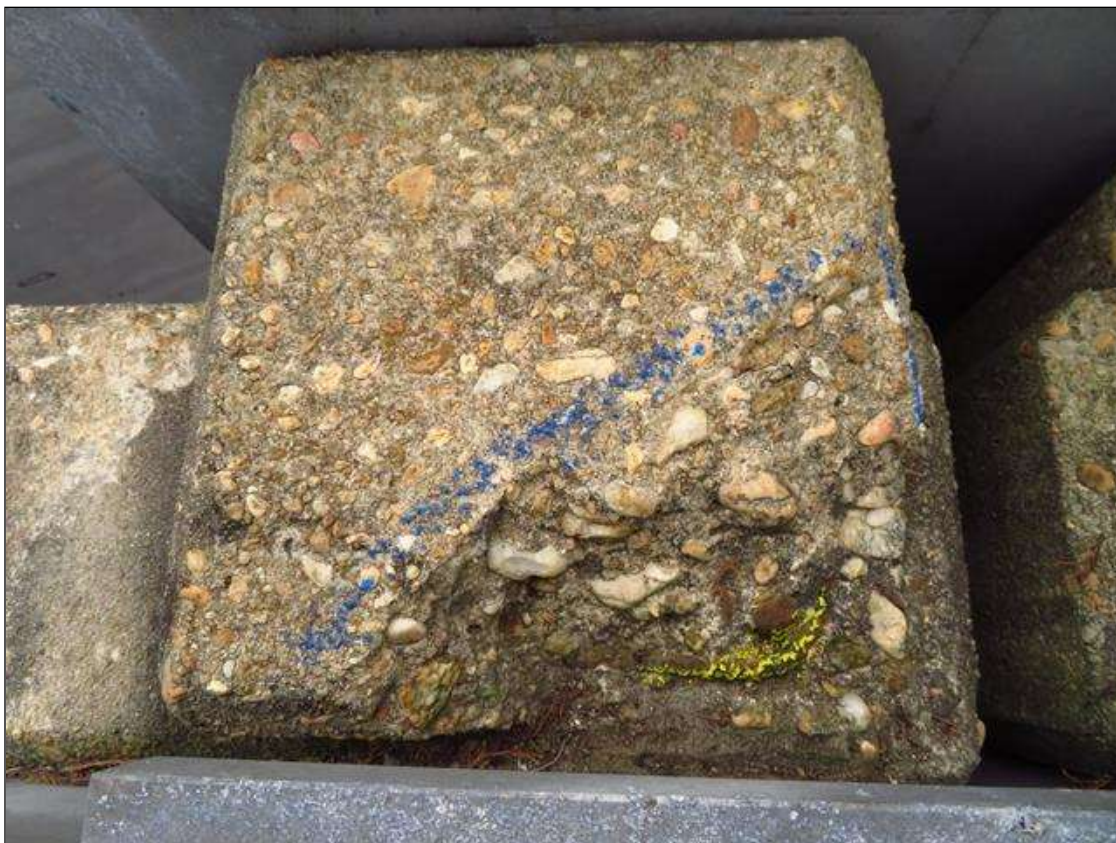
SPALL WITH EXPOSED REBAR IN THE RIGHT SIDE GUARDRAIL POST AT APPROACH GUARDRAIL CONNECTION IN SPAN 1

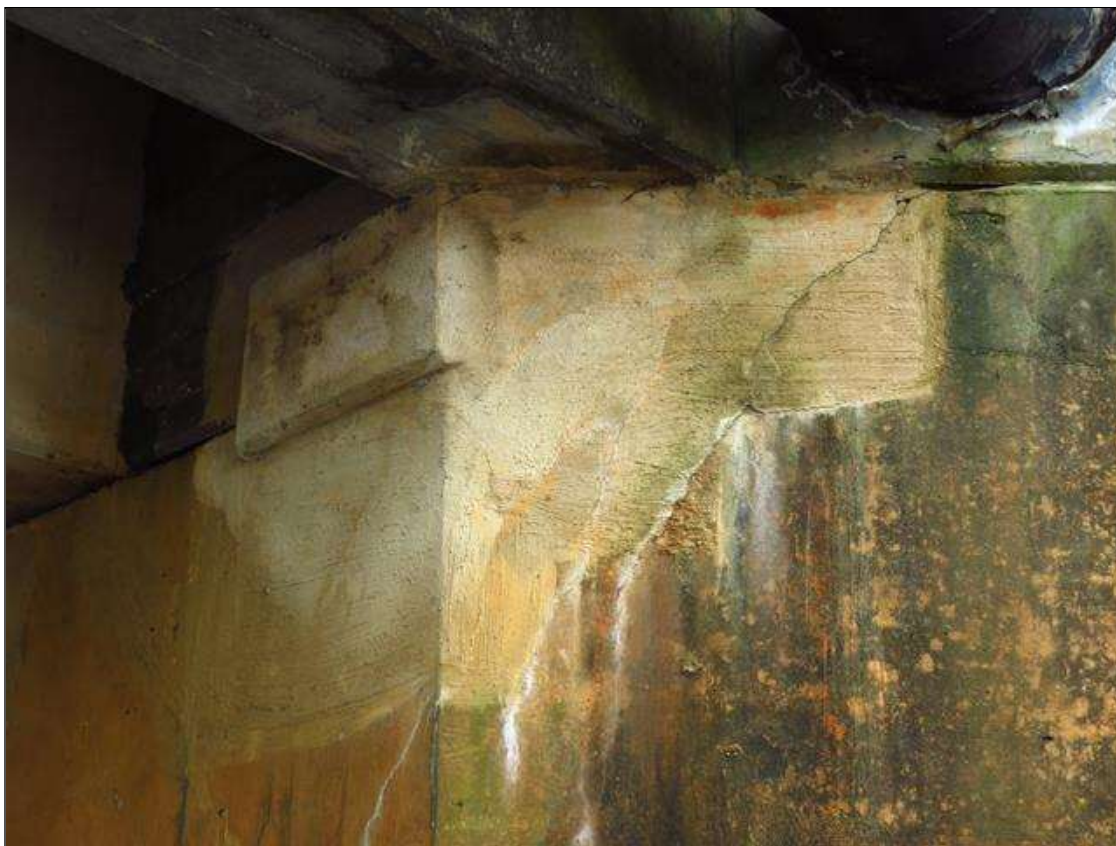
HAIRLINE TO 1/32" CRACK WITH SURFACE WHITE EFFLORESCENCE IN REPAIR PATCH IN ABUTMENT 1 AND IN CAP UNDER GIRDER 1

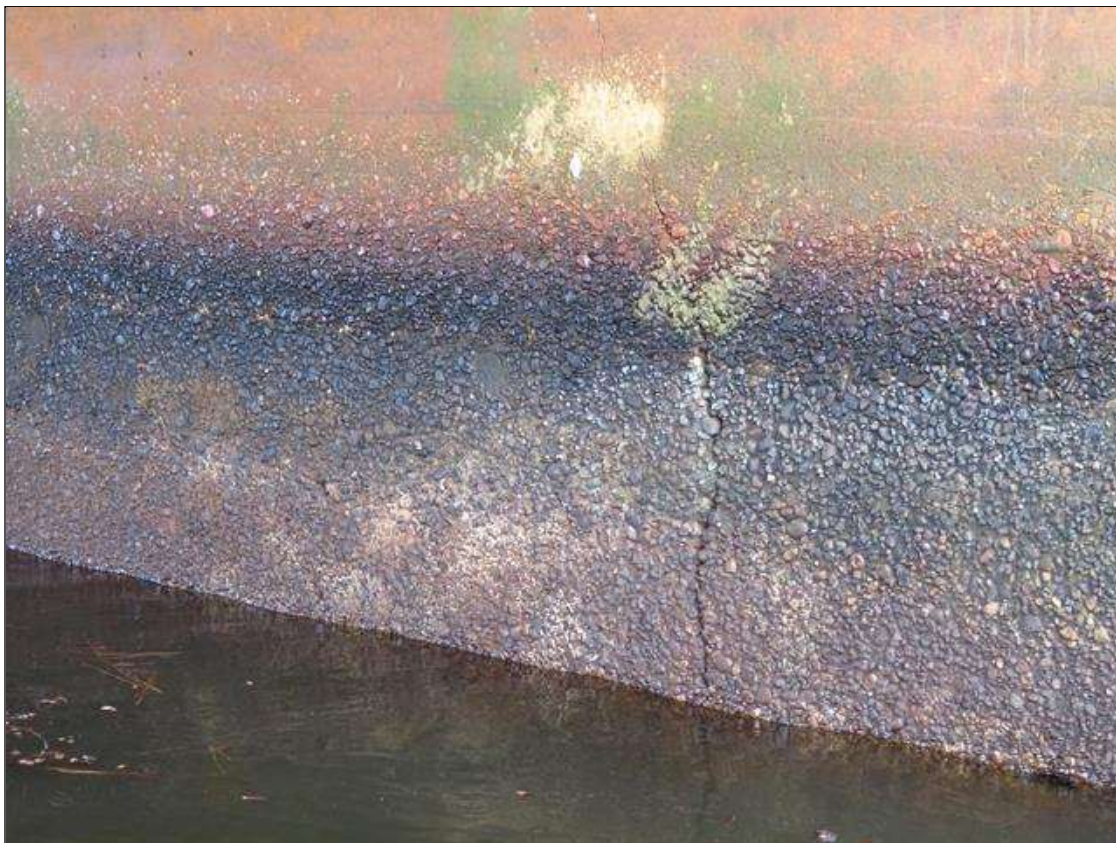
ABRASION WITH COARSE AGGREGATE EXPOSED FROM WATERLINE UP 3' AT ABUTMENT 1

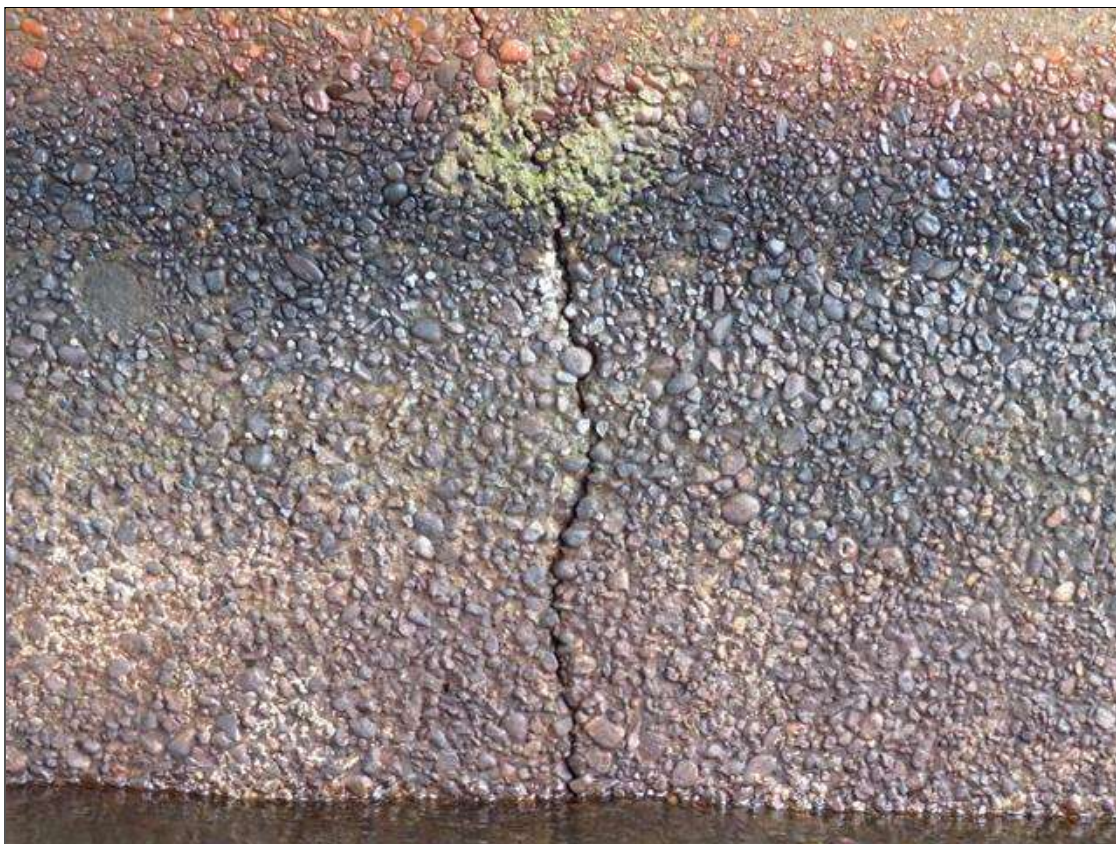
1/4" WIDE VERTICAL CRACK IN FACE OF ABUTMENT 1

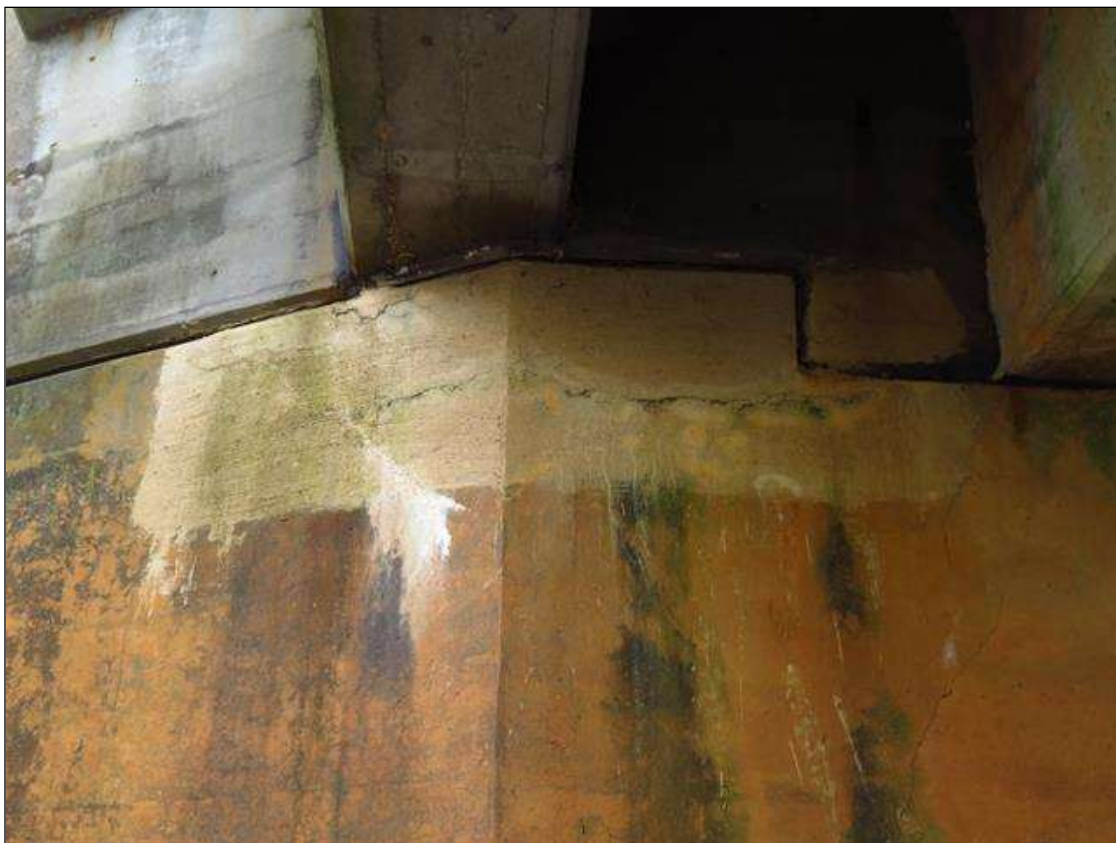
HAIRLINE CRACK WITH SURFACE WHITE EFFLORESCENCE IN REPAIR PATCH IN ABUTMENT 1 AND IN CAP UNDER GIRDER 5
