NC DEPARTMENT OF TRANSPORTATION
 DIVISION OF HIGHWAYS
 STRUCTURE MANAGEMENT UNIT

ATTENTION: **PRIORITY MAINTENANCE ISSUED.**

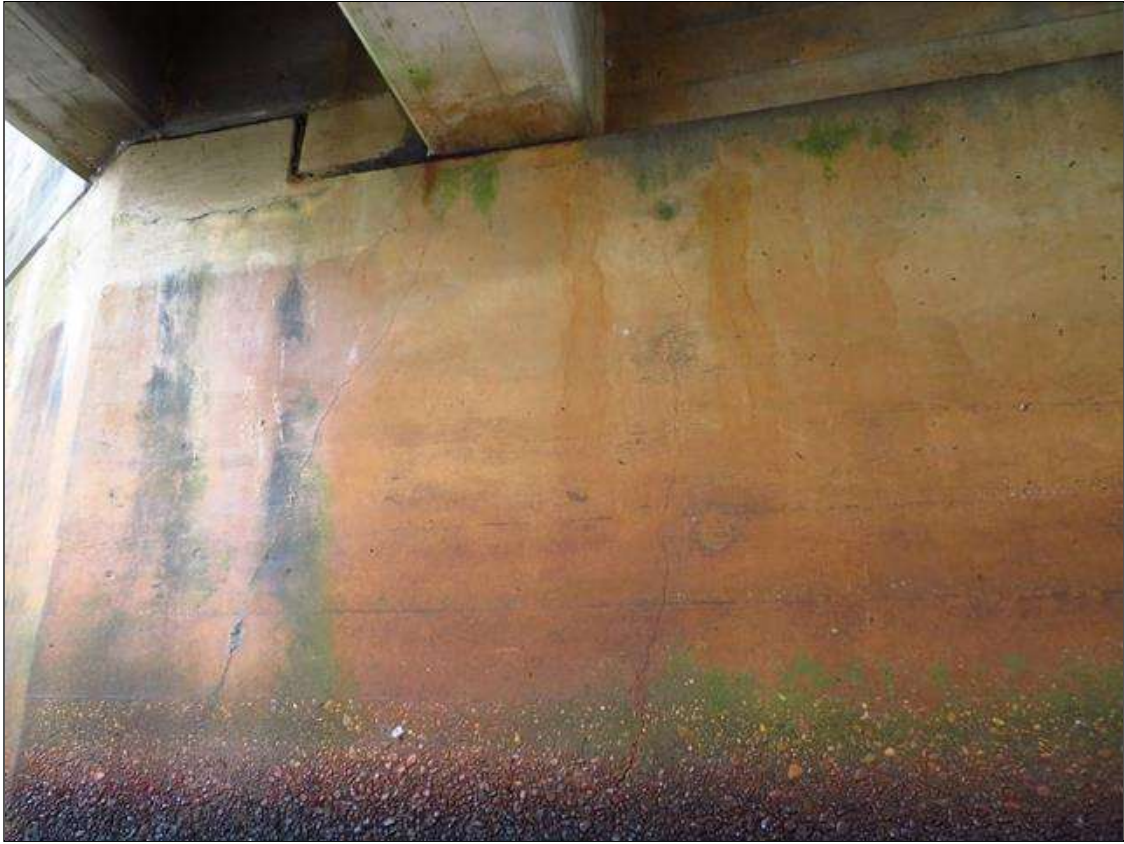
VERTICAL CRACKS IN FACE OF ABUTMENT 1 UNDER GIRDER 4

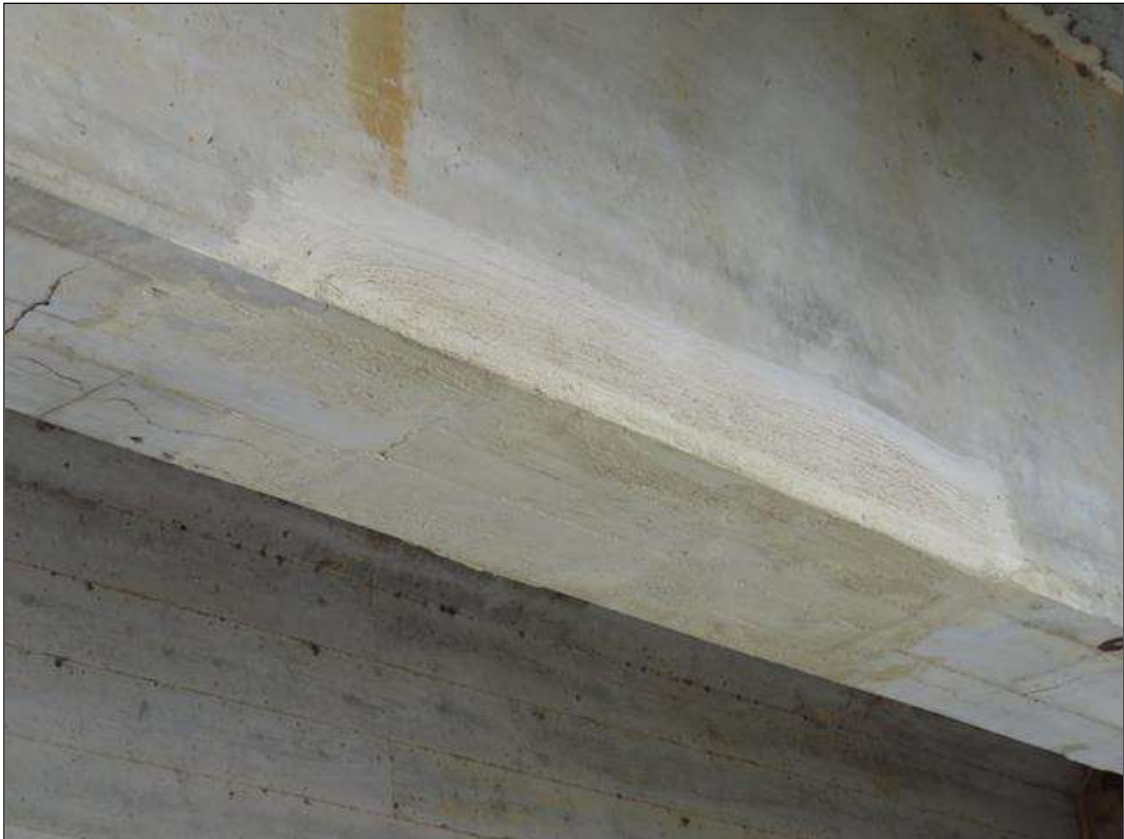
REPAIR PATCH IN THE BOTTOM OF GIRDER 4 IN SPAN 1 AT 2/3 POINT FROM ABUTMENT 1

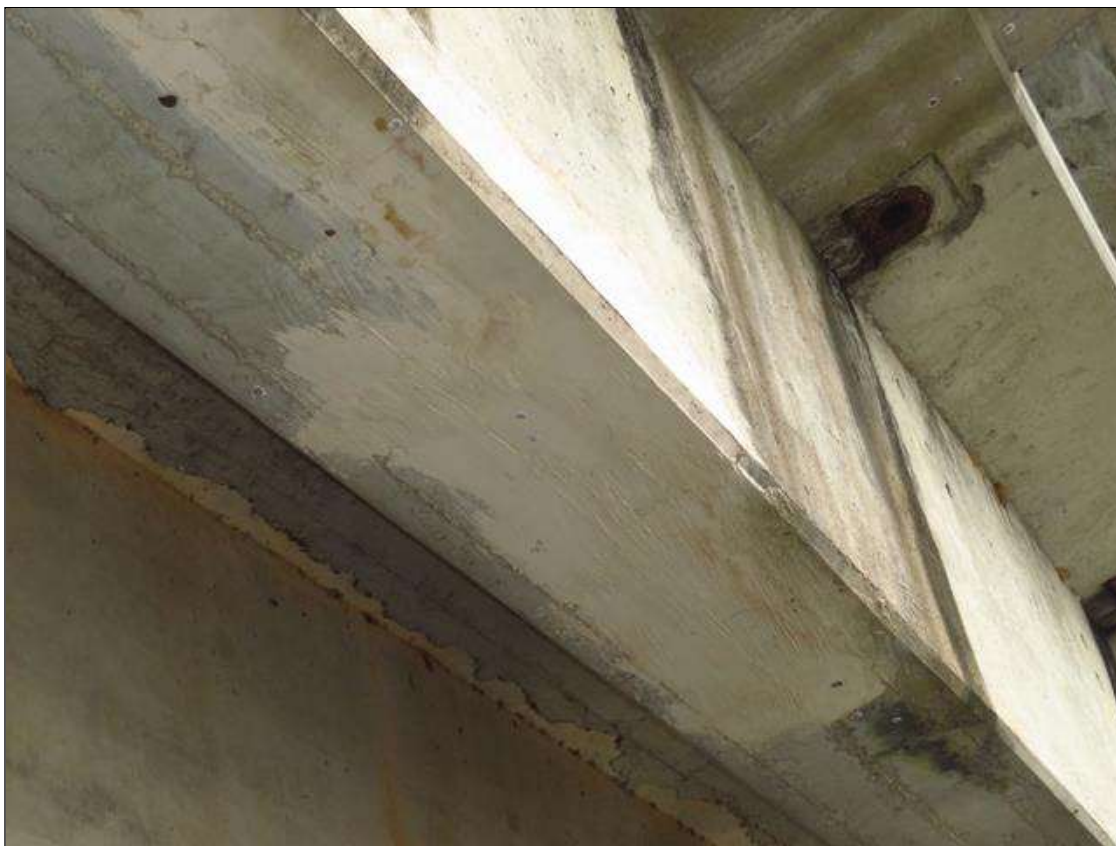
REPAIR PATCH IN THE BOTTOM OF GIRDER 5 IN SPAN 1 AT 2/3 POINT FROM ABUTMENT 1

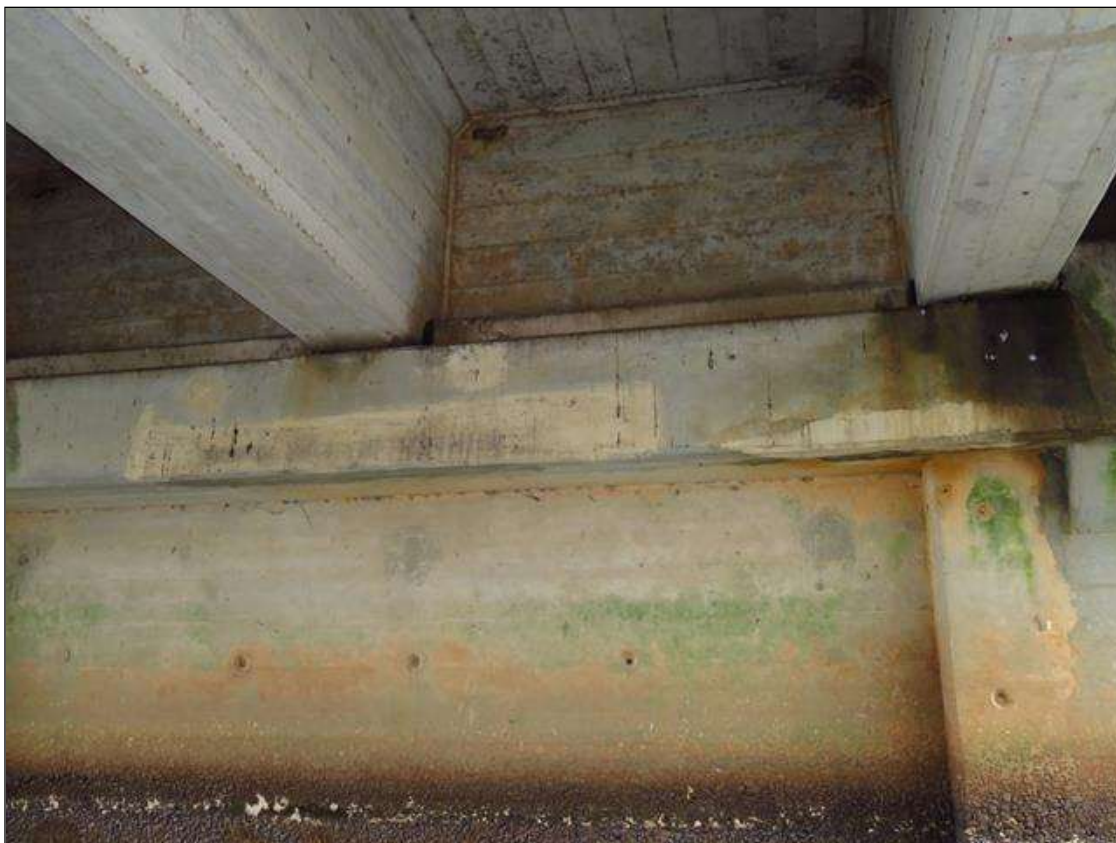
REPAIR PATCHING IN FACE OF CAP AT BENT 1 SPAN 1 SIDE UNDER GIRDERS 3 AND 4

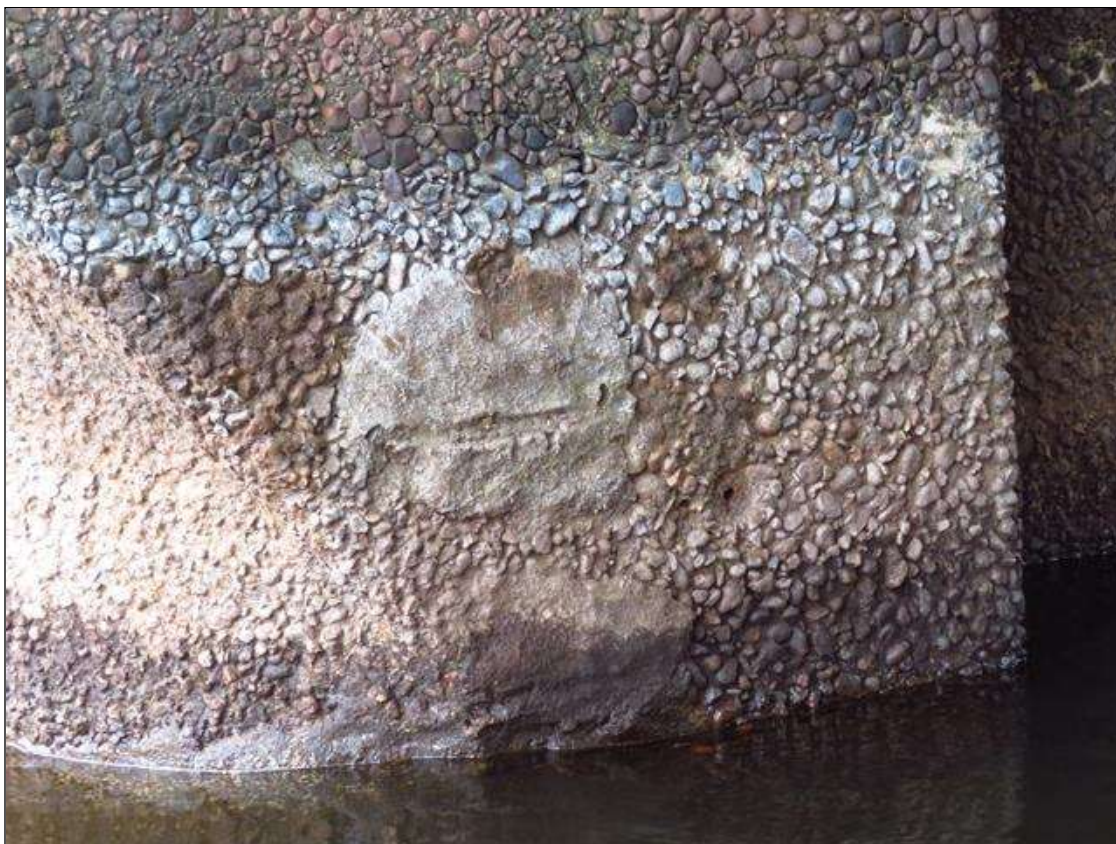
REPAIR PATCH IN SPAN 1 SIDE OF COLUMN 1 AT BENT 1 - COLUMN 2 SIMILAR

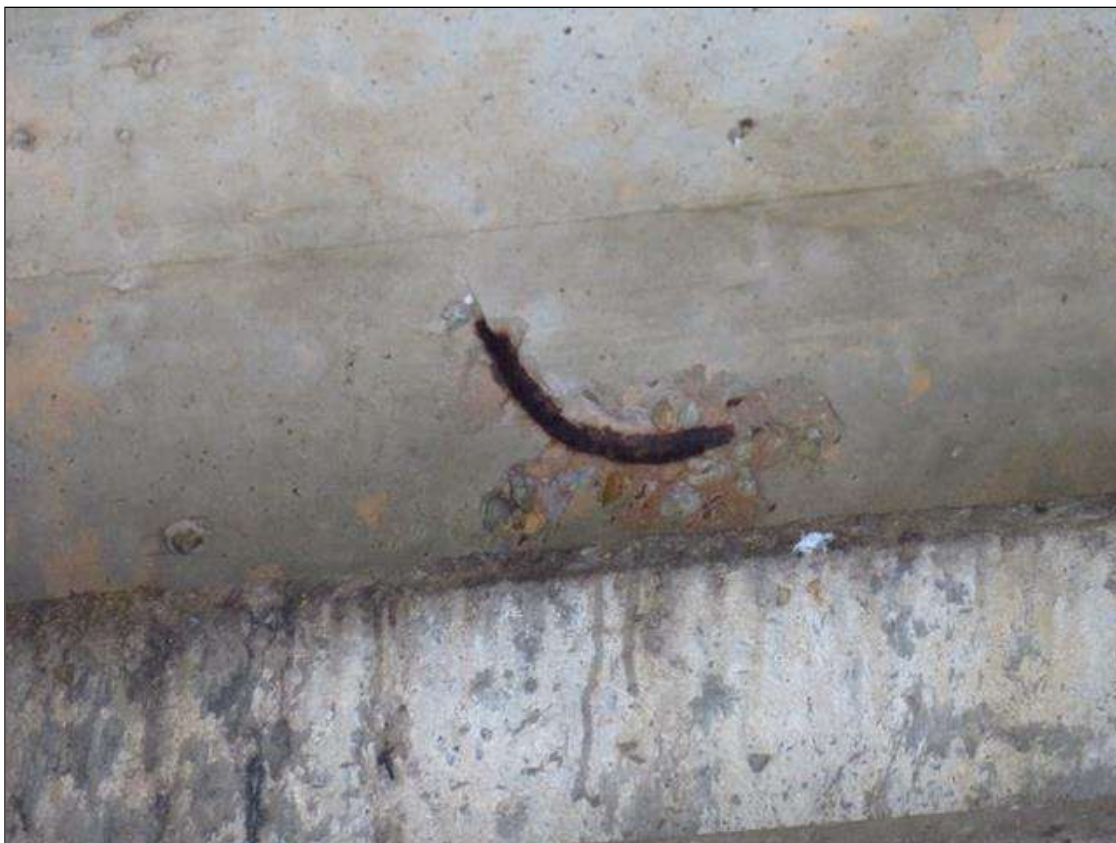
6" DIAMETER X 1" DEEP SPALL WITH EXPOSED REBAR IN SPAN 2 END DIAPHRAGM AT BENT 2 BAY 3

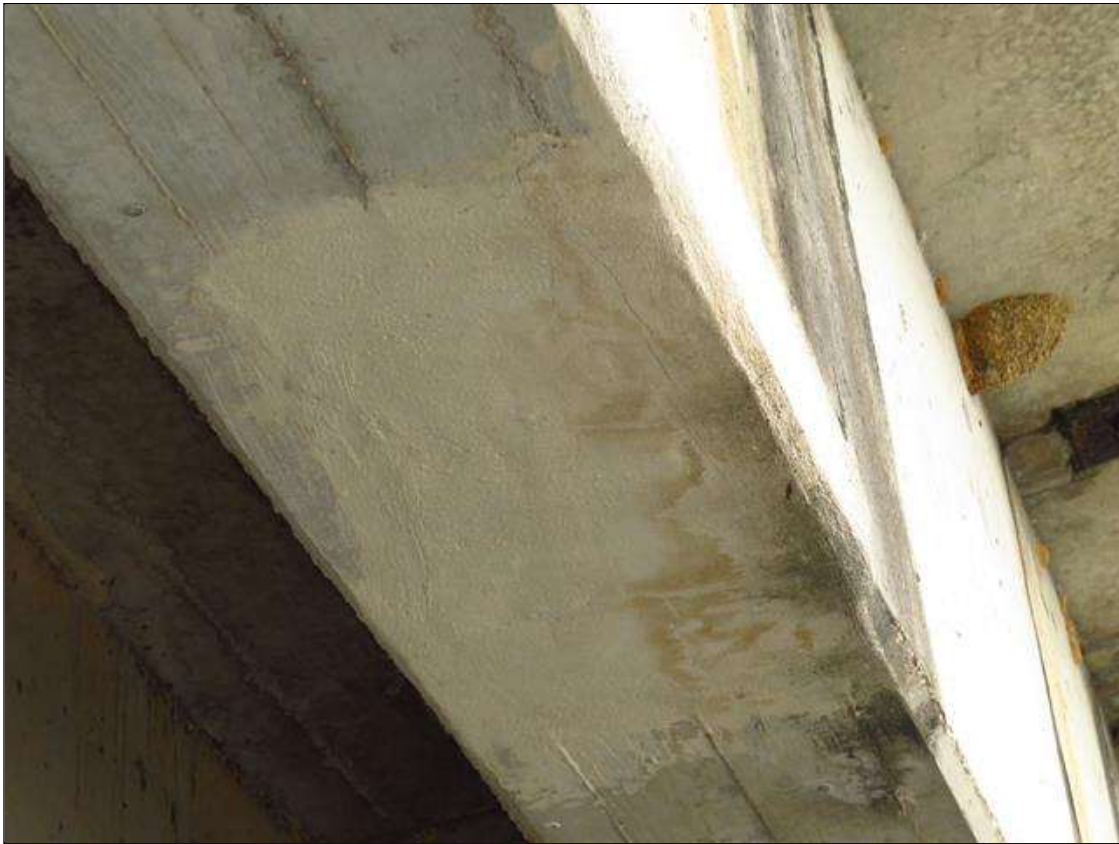
REPAIR PATCH IN THE BOTTOM OF GIRDER 5 IN SPAN 2 NEAR BENT 2

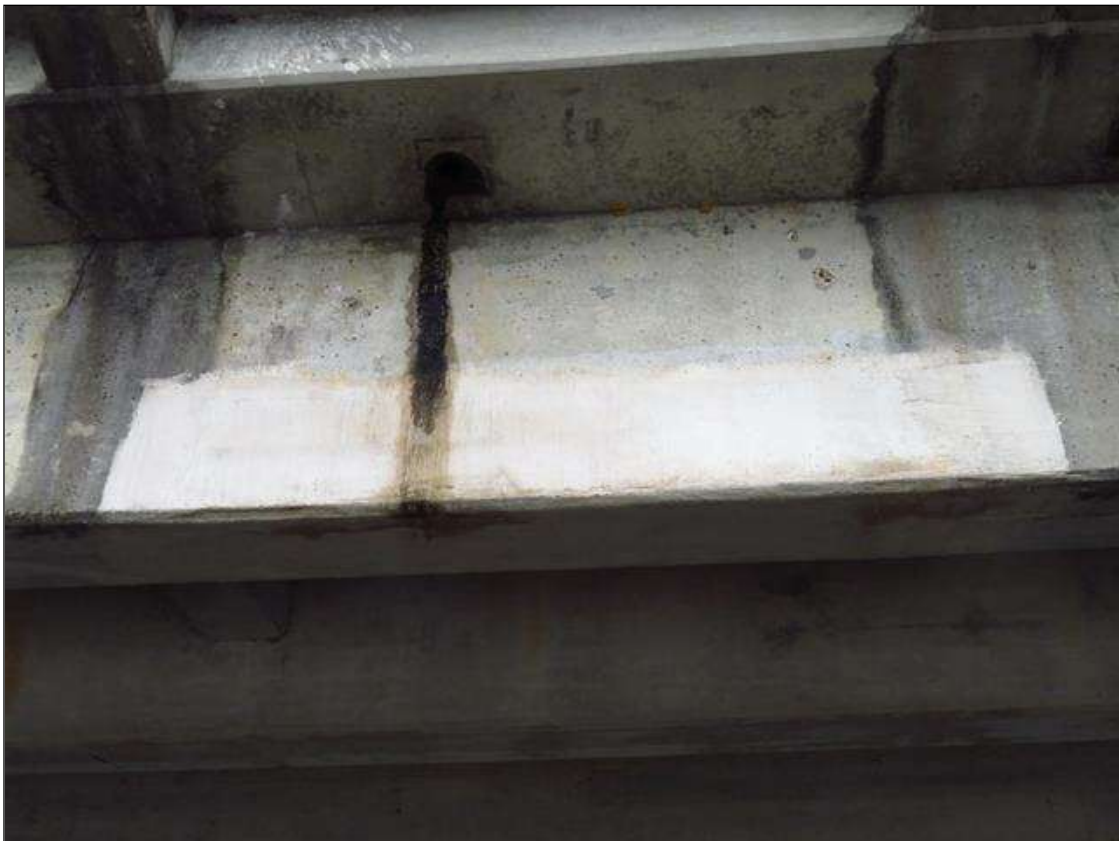
REPAIR PATCH IN THE RIGHT SIDE OF GIRDER 5 IN SPAN 2 AT MID-SPAN

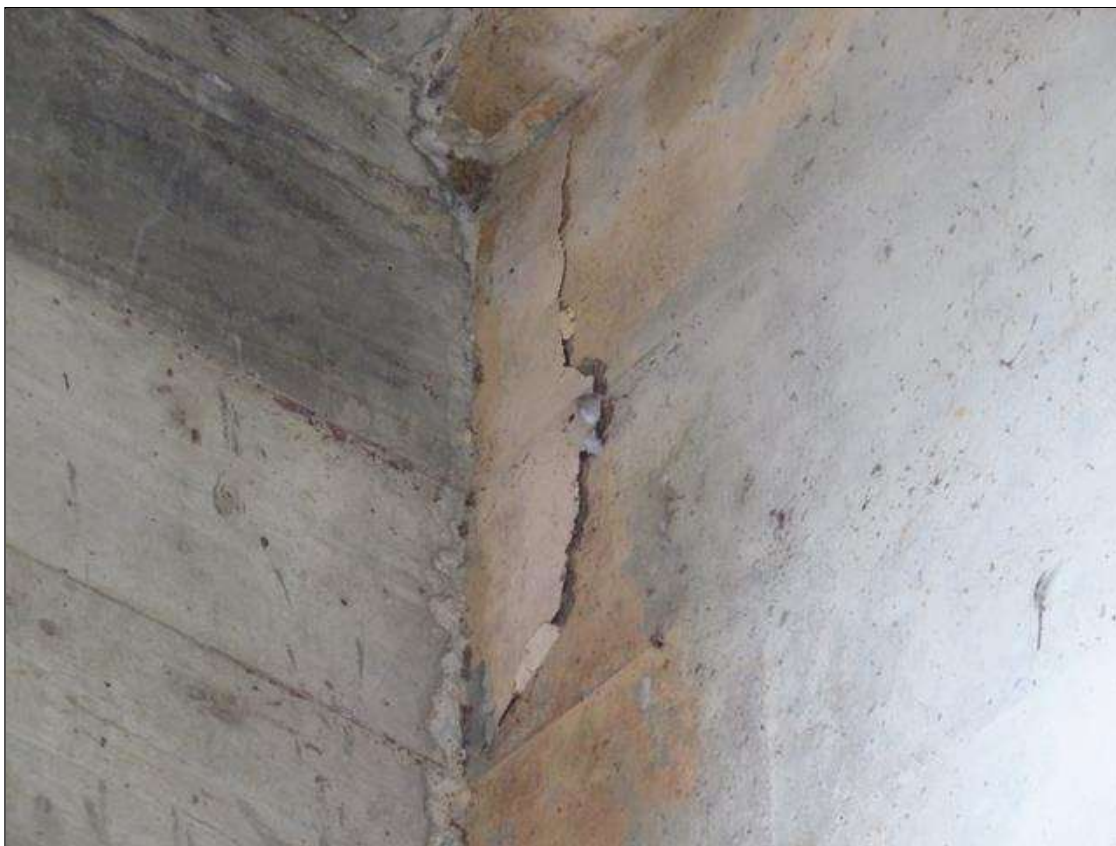
DELAMINATION IN THE RIGHT SIDE OF GIRDER 4 IN SPAN 3 OVER BENT 2

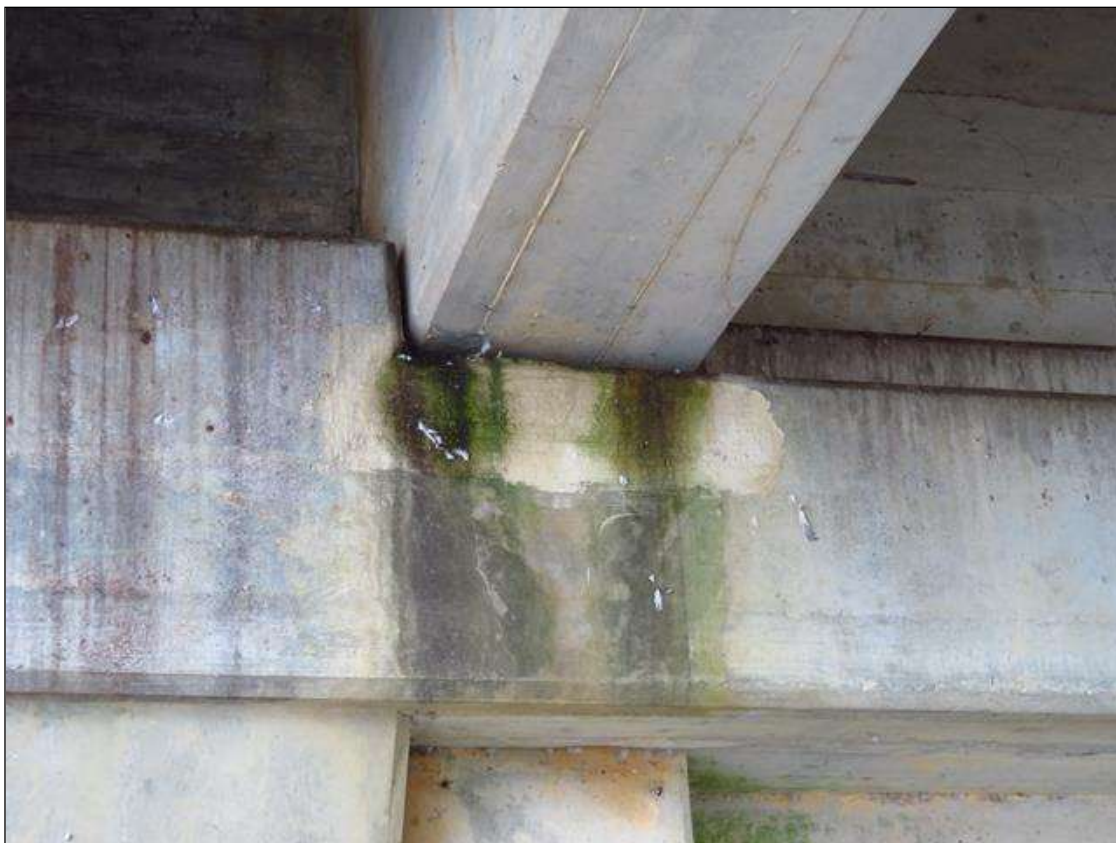
REPAIR PATCH IN FACE OF CAP AT BENT 3 SPAN 3 SIDE UNDER GIRDER 2

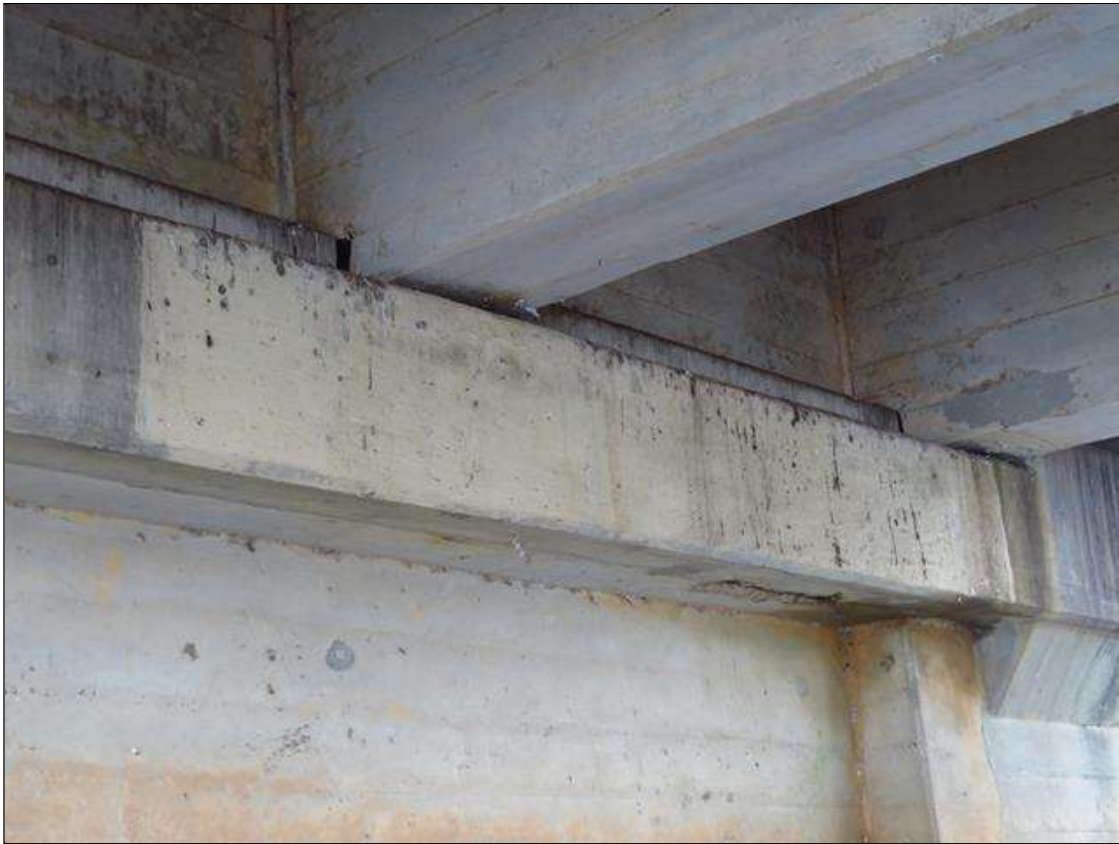
REPAIR PATCH IN FACE OF CAP AT BENT 3 SPAN 3 SIDE FROM GIRDER 3 TO GIRDER 4

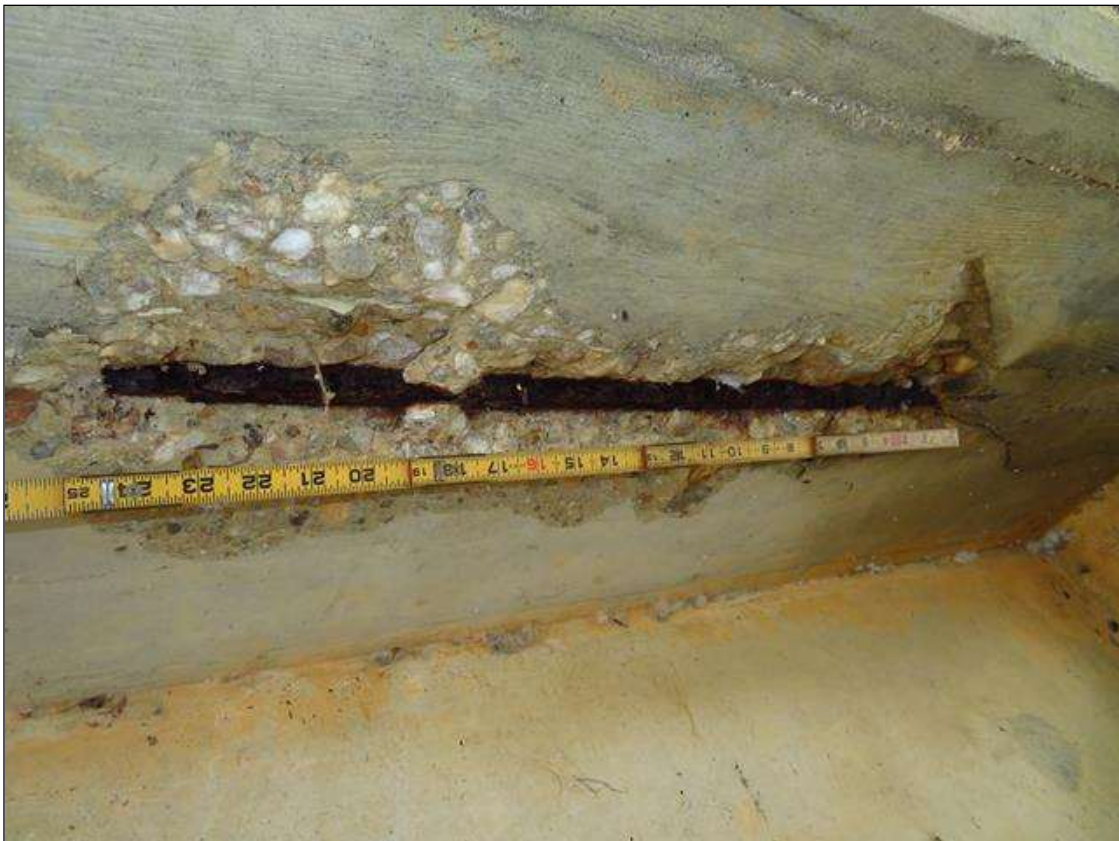
26" LONG X 7" WIDE X 2" DEEP SPALL WITH SECTION LOSS TO EXPOSED BAR IN BOTTOM OF CAP AT BENT 3 SPAN 3 SIDE UNDER BAY 4 (ESTIMATED 1" DIAMETER BAR REMAINING) PHOTO 1 OF 2

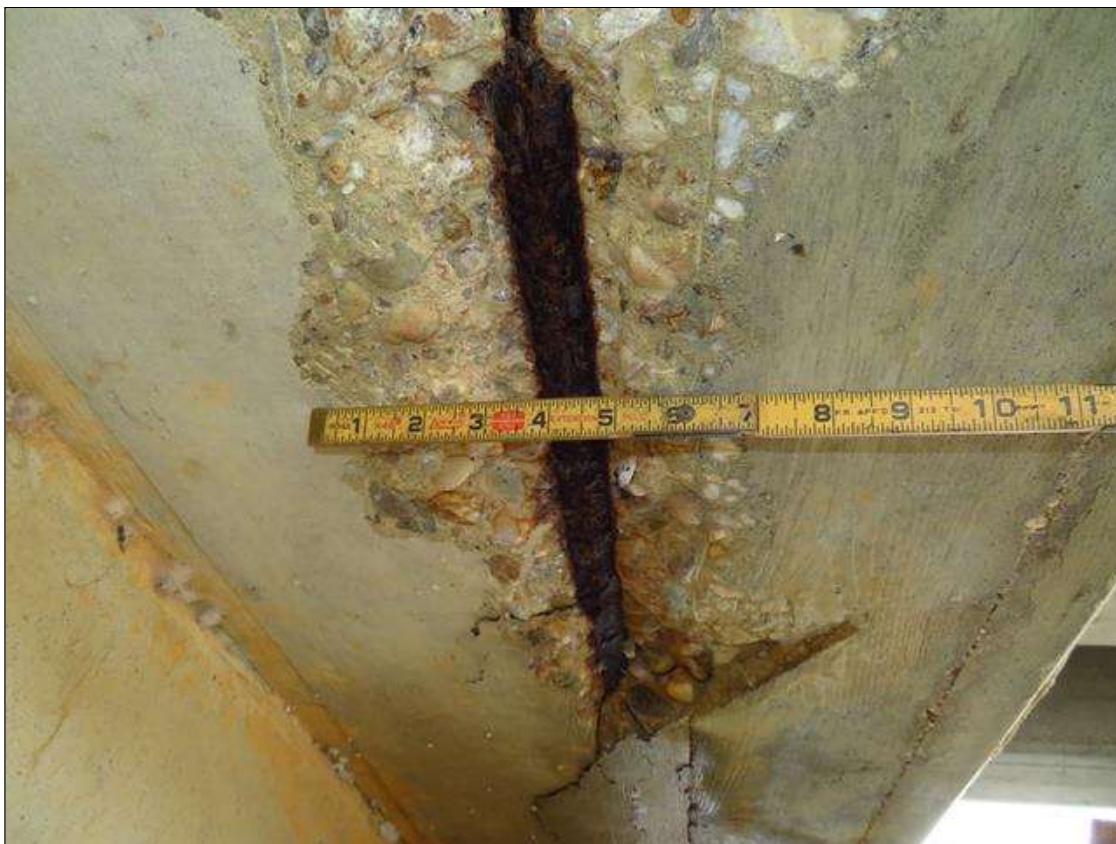
26" LONG X 7" WIDE X 2" DEEP SPALL WITH SECTION LOSS TO EXPOSED BAR IN BOTTOM OF CAP AT BENT 3 SPAN 3 SIDE UNDER BAY 4 (ESTIMATED 1" DIAMETER BAR REMAINING) PHOTO 2 OF 2

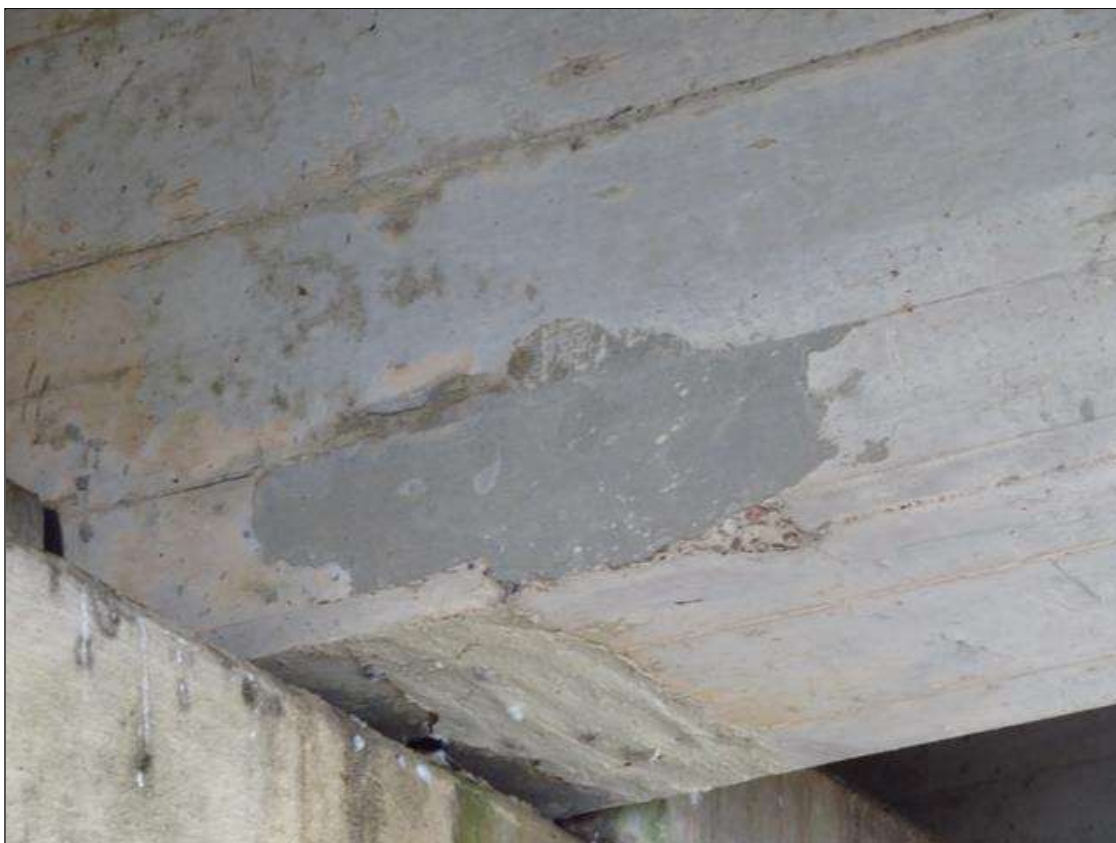
REPAIR PATCH IN THE LEFT SIDE OF GIRDER 4 IN SPAN 3 NEAR BENT 3

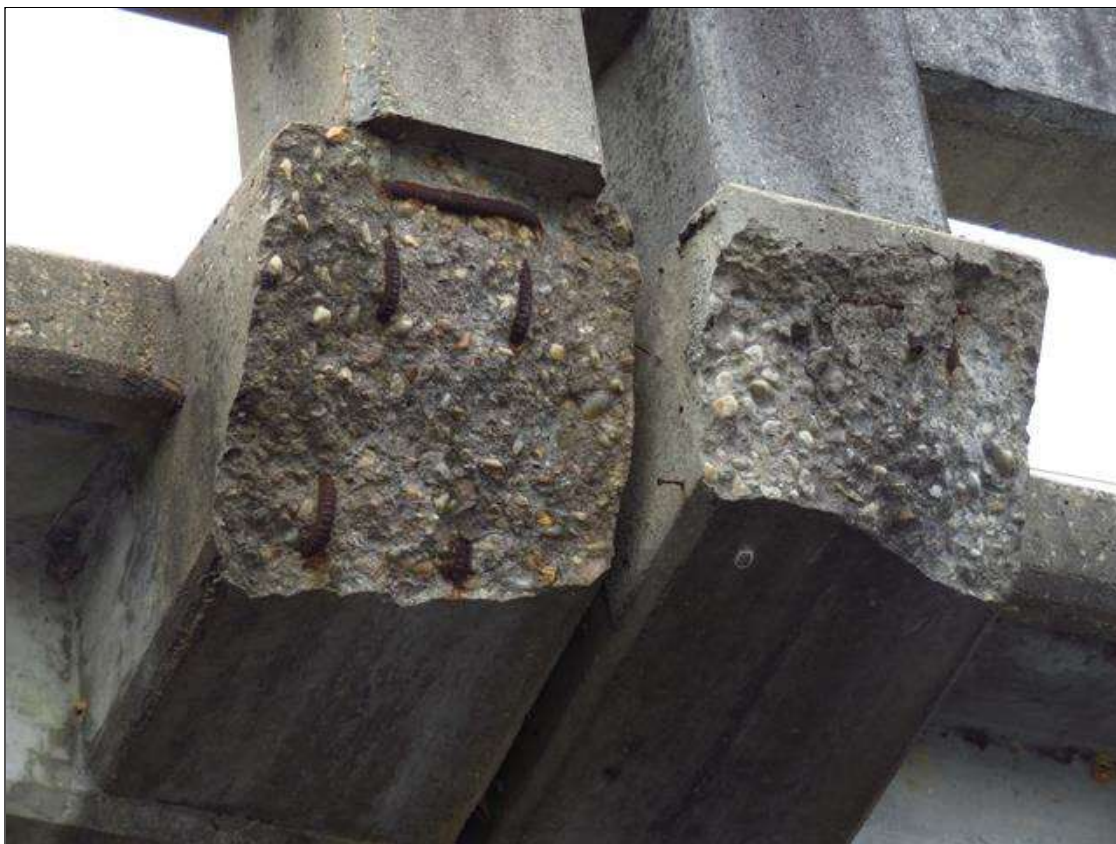
SPALLING WITH EXPOSED REBAR IN THE RIGHT SIDE DOG-EARS AT BENT 3

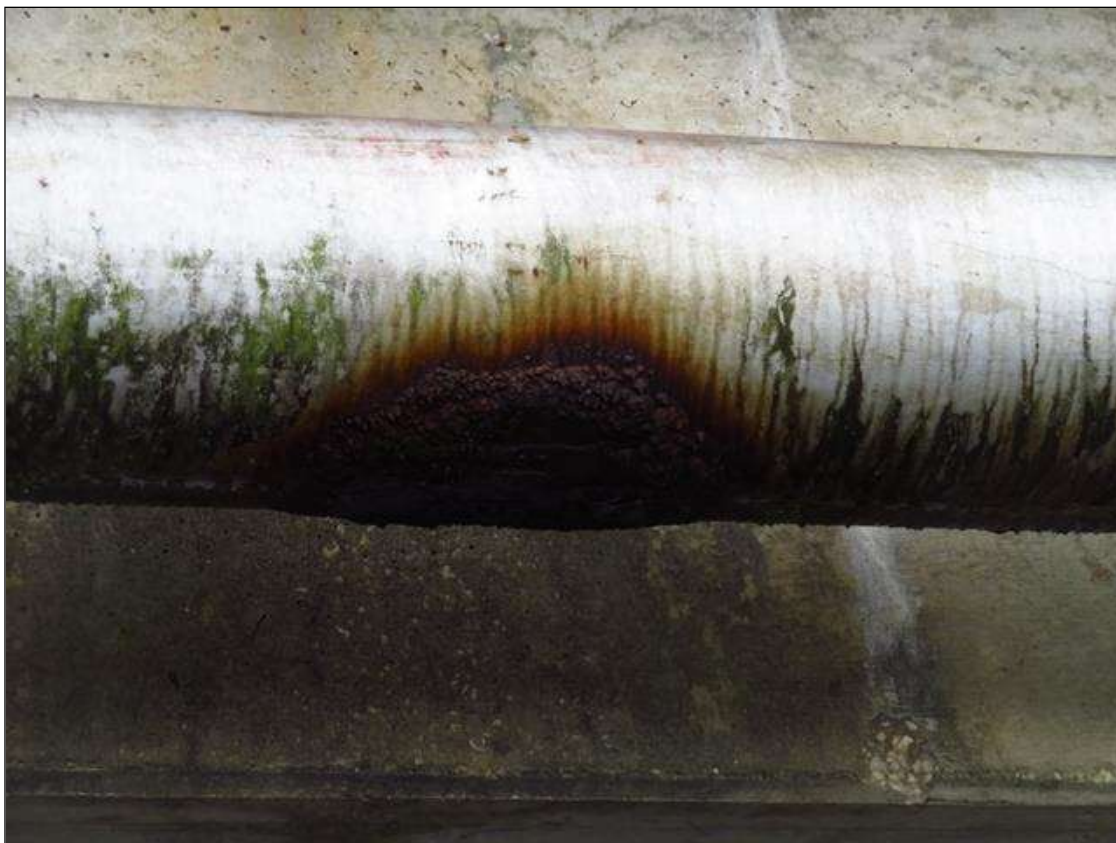
SPOTS OF CORROSION ALONG BOTTOM OF UTILITIES PIPE ALONG THE LEFT OVERHANG

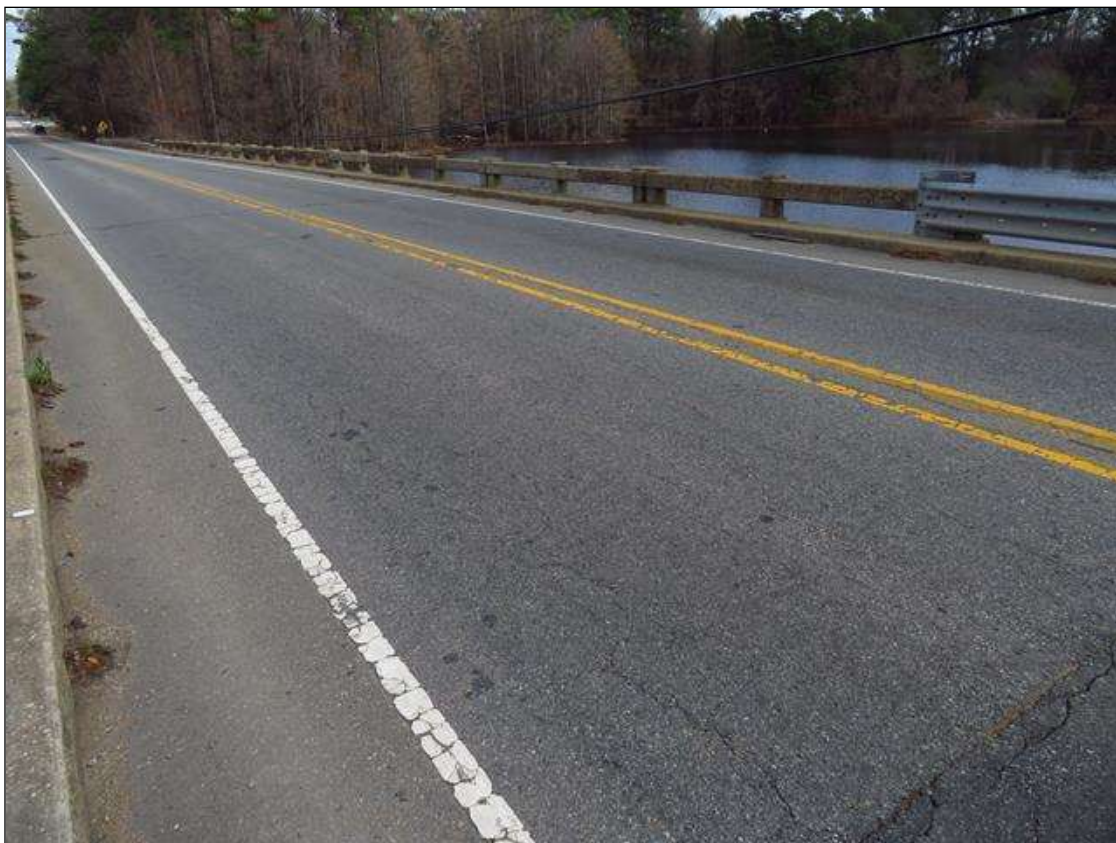
SPAN 1 WEARING SURFACE OVERVIEW

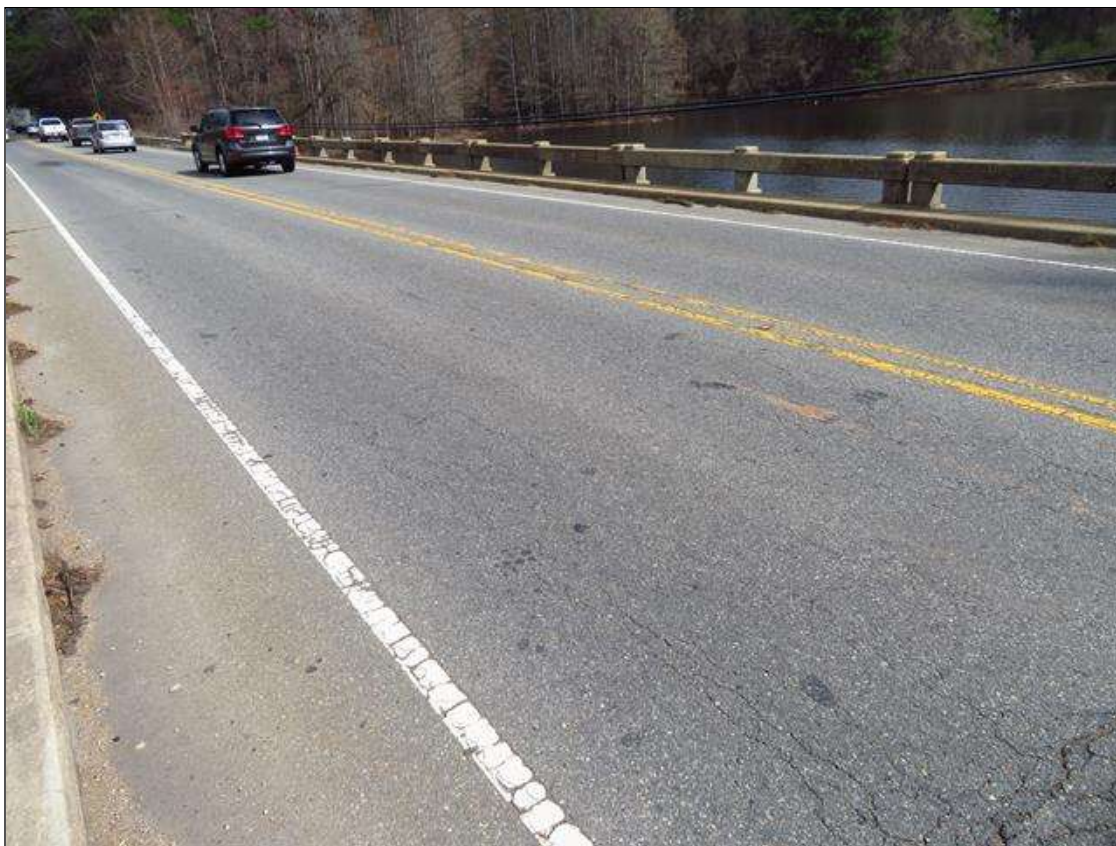
SPAN 2 WEARING SURFACE OVERVIEW

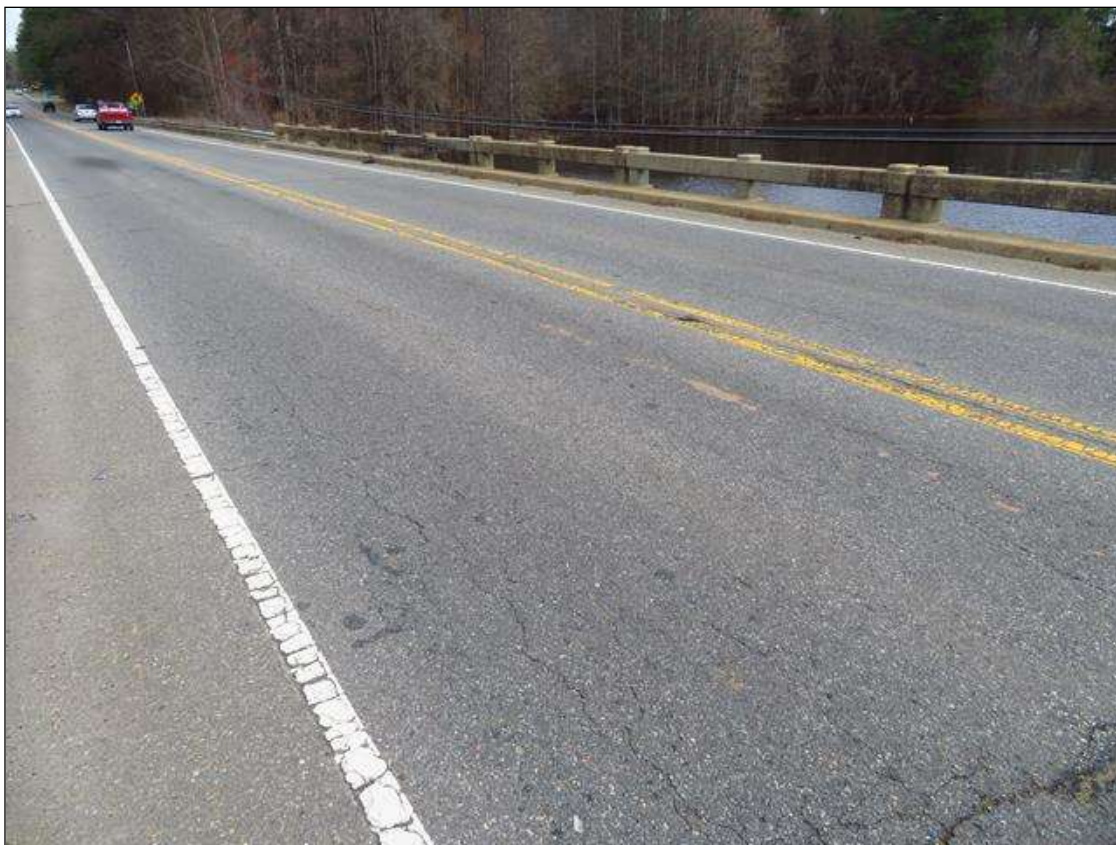
SPAN 3 WEARING SURFACE OVERVIEW

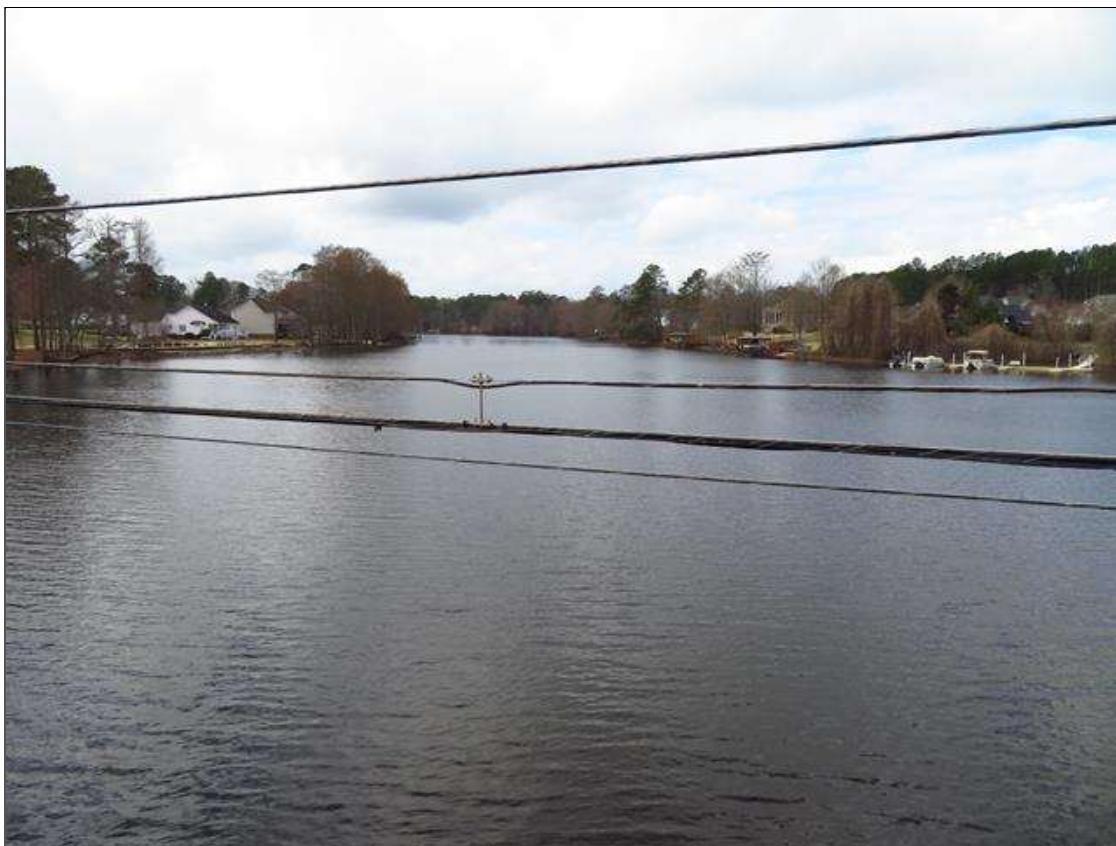
LOOKING WEST UPSTREAM

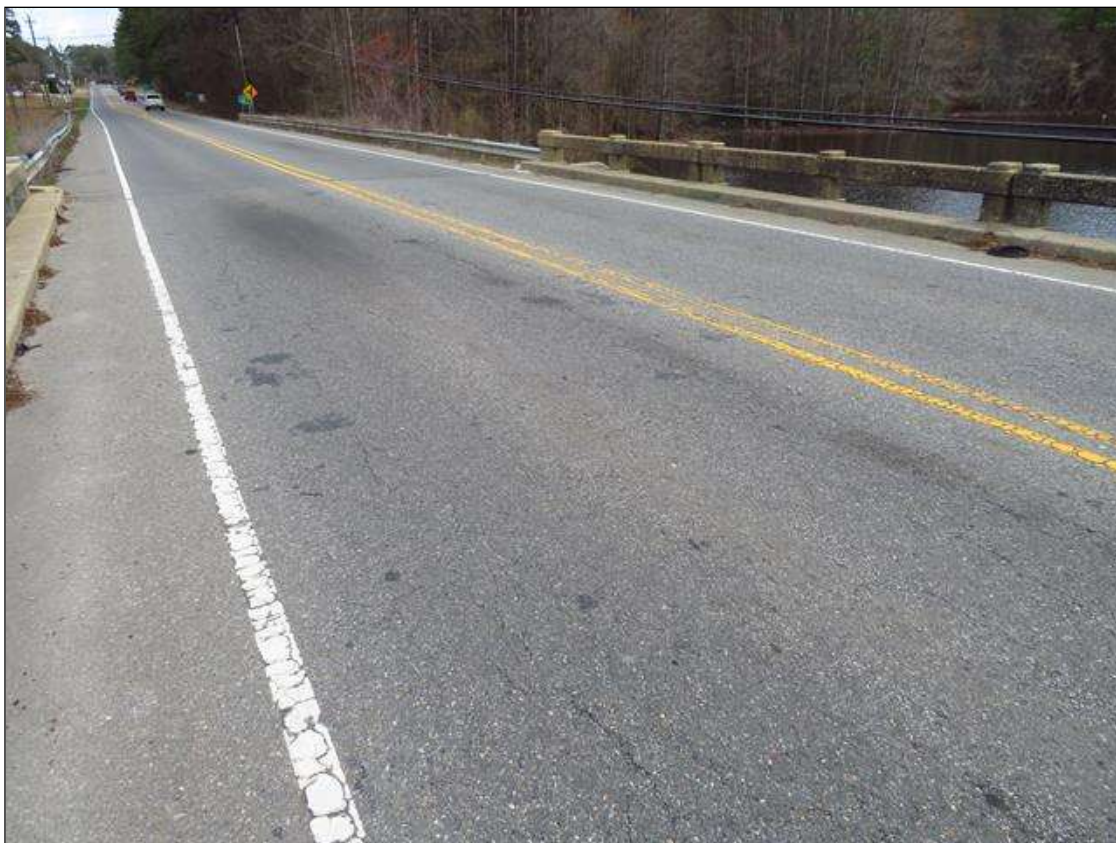
SPAN 4 WEARING SURFACE OVERVIEW

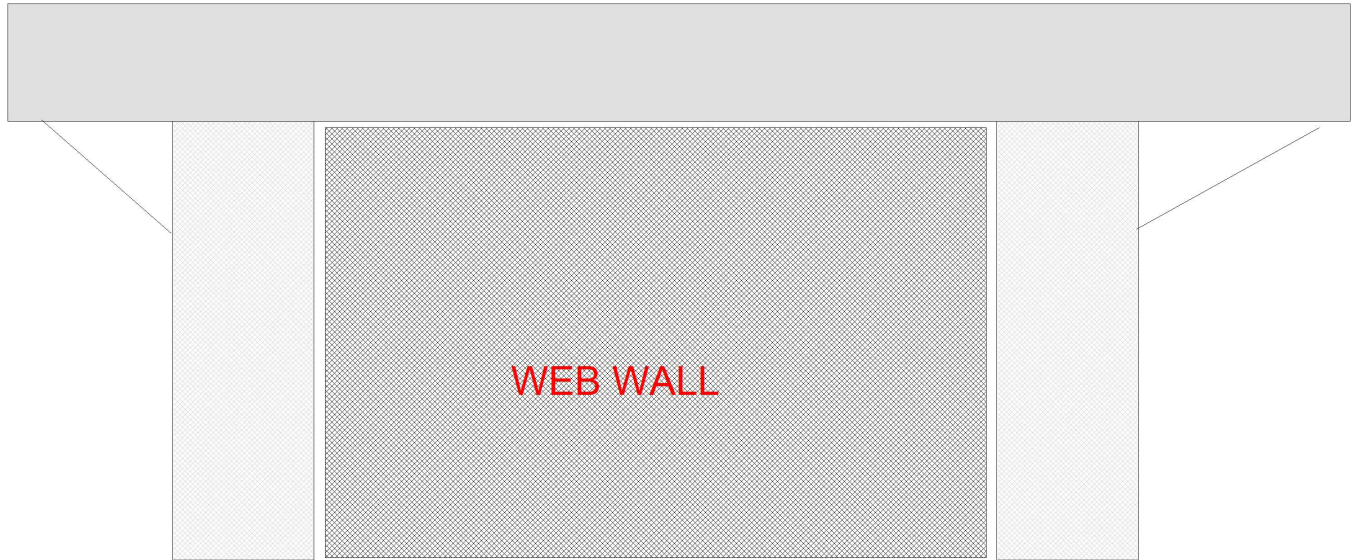
Cap Information			Material Cast-in-Place Concrete							
Length	Width	Height	Left Overhang	Right Overhang	Left Beam to End of Cap.		Right Beam to End of Cap.			
28.0 ft.	4.5 ft.	2.333 ft.	5.333 ft.	5.333 ft.						
Subcap Information			Material							
Length	Width	Height	Left Overhang	Right Overhang	Left Pile to Splice.					
Sill Information			Material							
Length	Width	Height								
Pile #	Material	Spacing	Width/Dia.	Height	Length	Orientation	Driven?	Replacement?	Removed?	Collar?
1	Concrete		3 ft.			Vertical	No	No	No	No
2	Concrete	17.333 ft.	3 ft.			Vertical	No	No	No	No
Bent/Abutment #: 1			Similar Bents: 2, 3

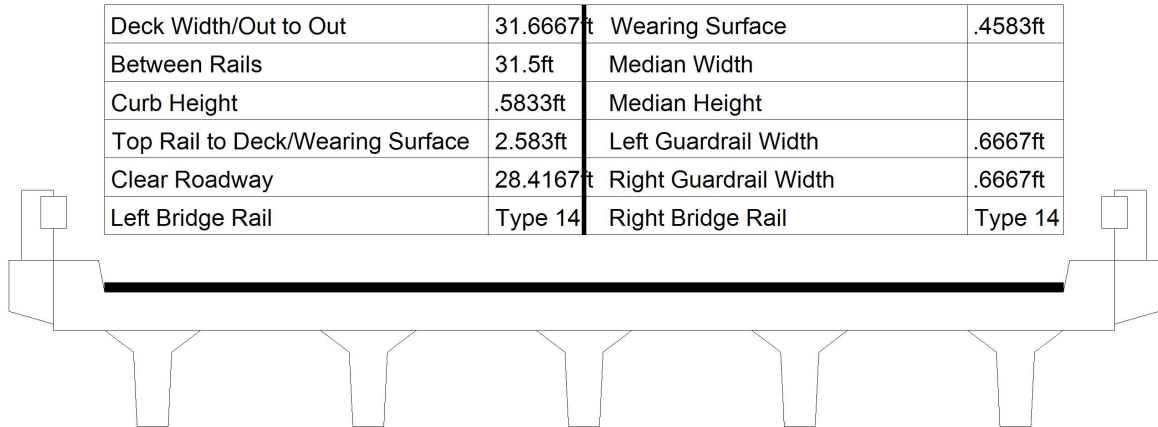
Deck Width/Out to Out	31.6667ft	Wearing Surface	.4583ft
Between Rails	31.5ft	Median Width	
Curb Height	.5833ft	Median Height	
Top Rail to Deck/Wearing Surface	2.583ft	Left Guardrail Width	.6667ft
Clear Roadway	28.4167ft	Right Guardrail Width	.6667ft
Left Bridge Rail	Type 14	Right Bridge Rail	Type 14
