NC DEPARTMENT OF TRANSPORTATION ATTENTION
 DIVISION OF HIGHWAYS
 BRIDGE MANAGEMENT UNIT

BRIDGE INSPECTION REPORT

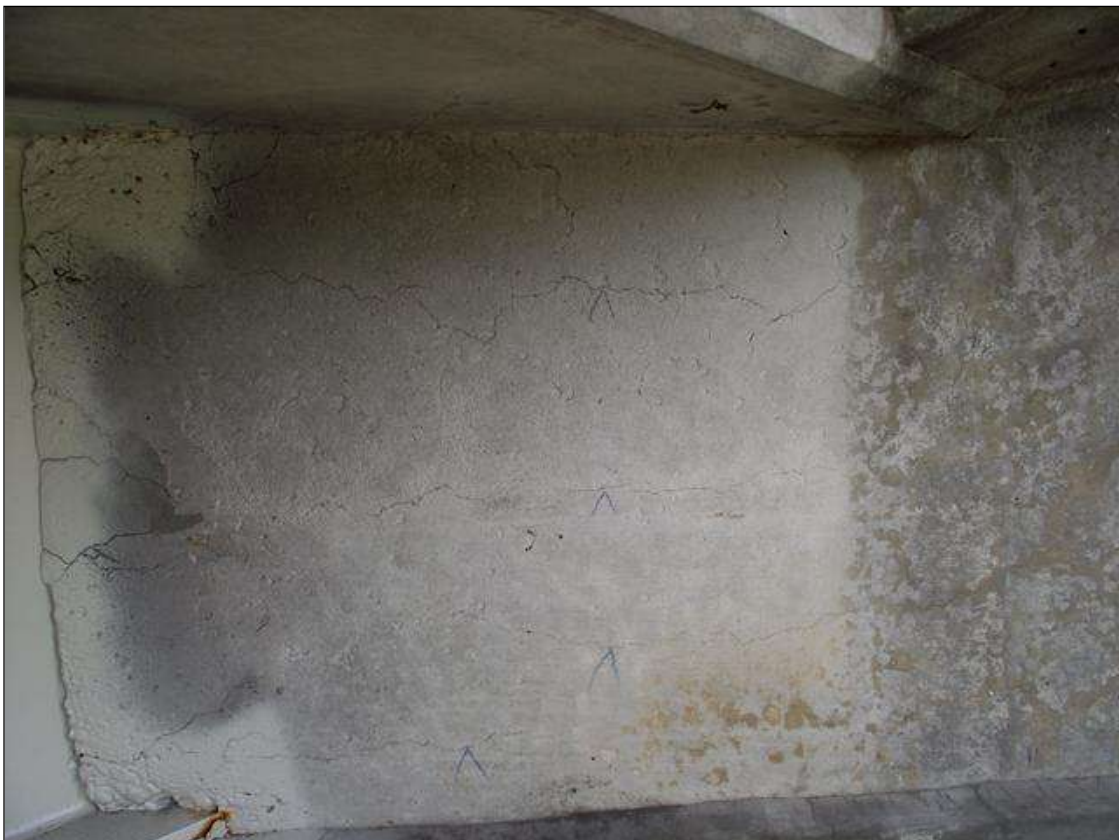
HORIZONTAL CRACKS IN LEFT BACKWALL EXTENSION AT END BENT 1

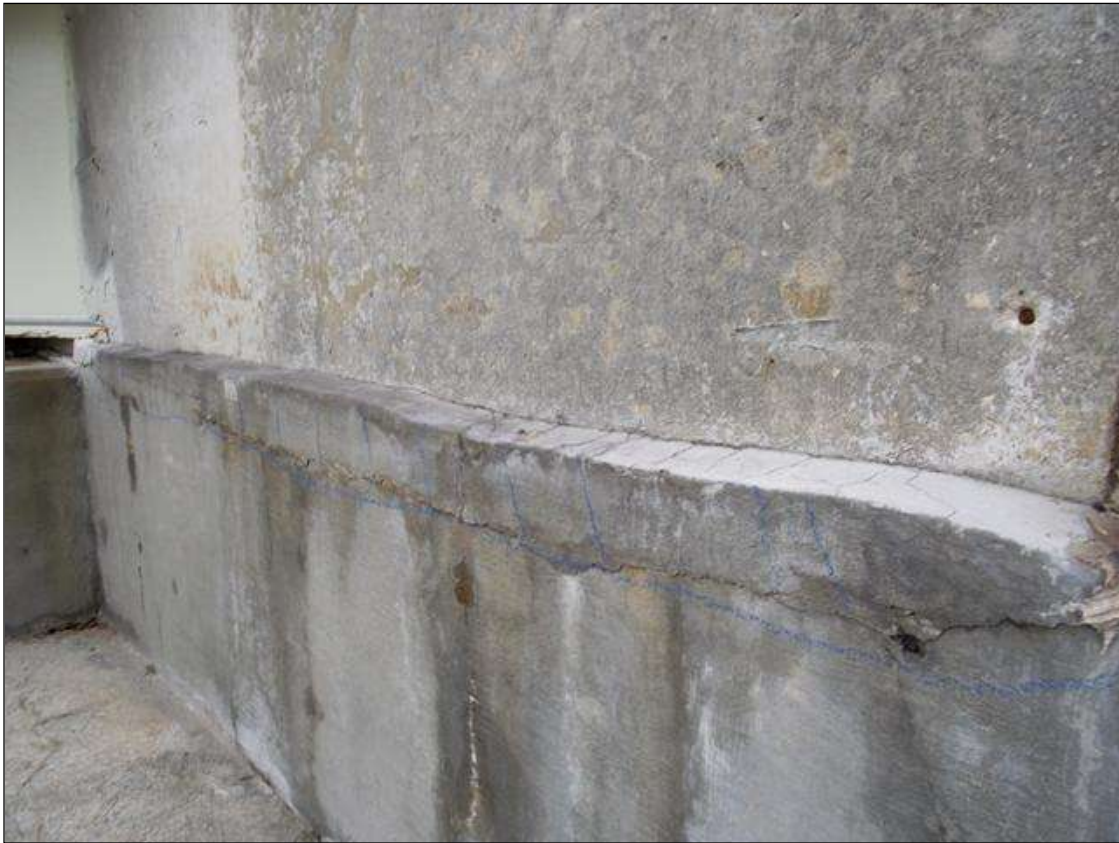
DELAMINATION ALONG TOP EDGE OF BACKWALL ADDITION FROM LEFT END TO BEAM 1 AT END BENT 1

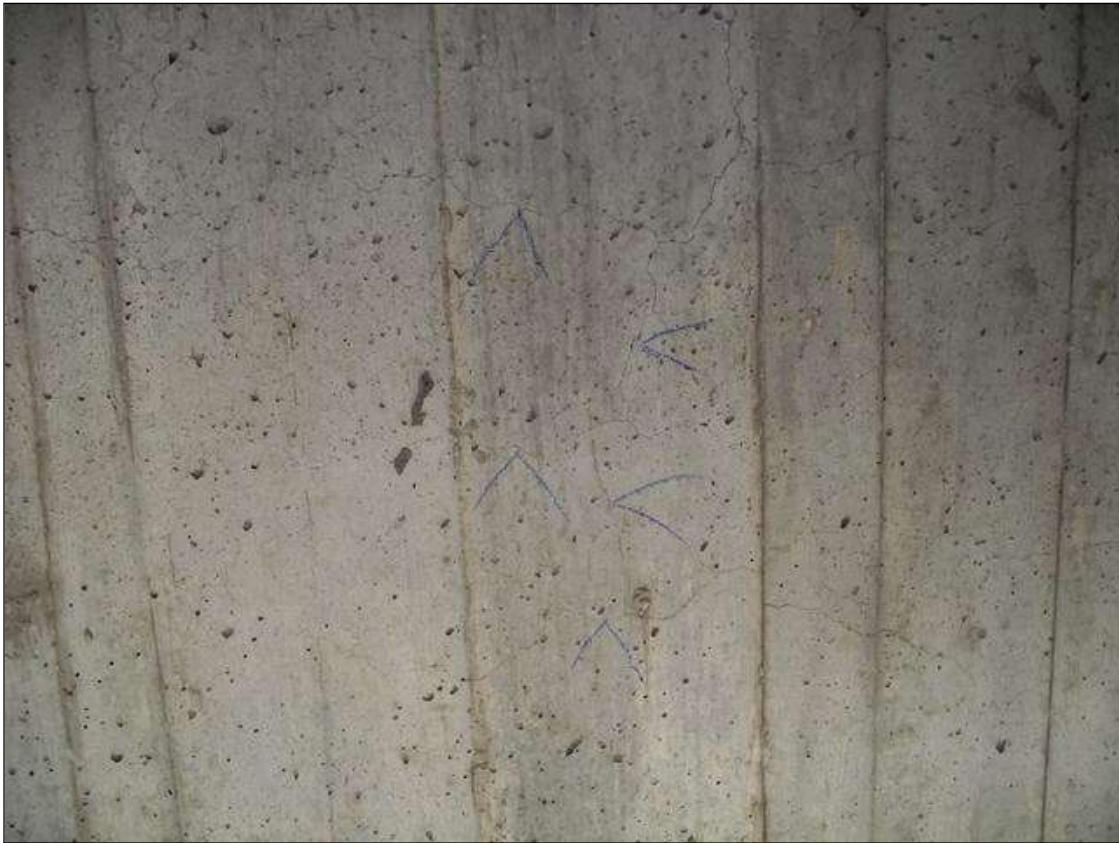
MAP CRACKING ACROSS ORIGINAL BACKWALL AT END BENT 1 BAY 1

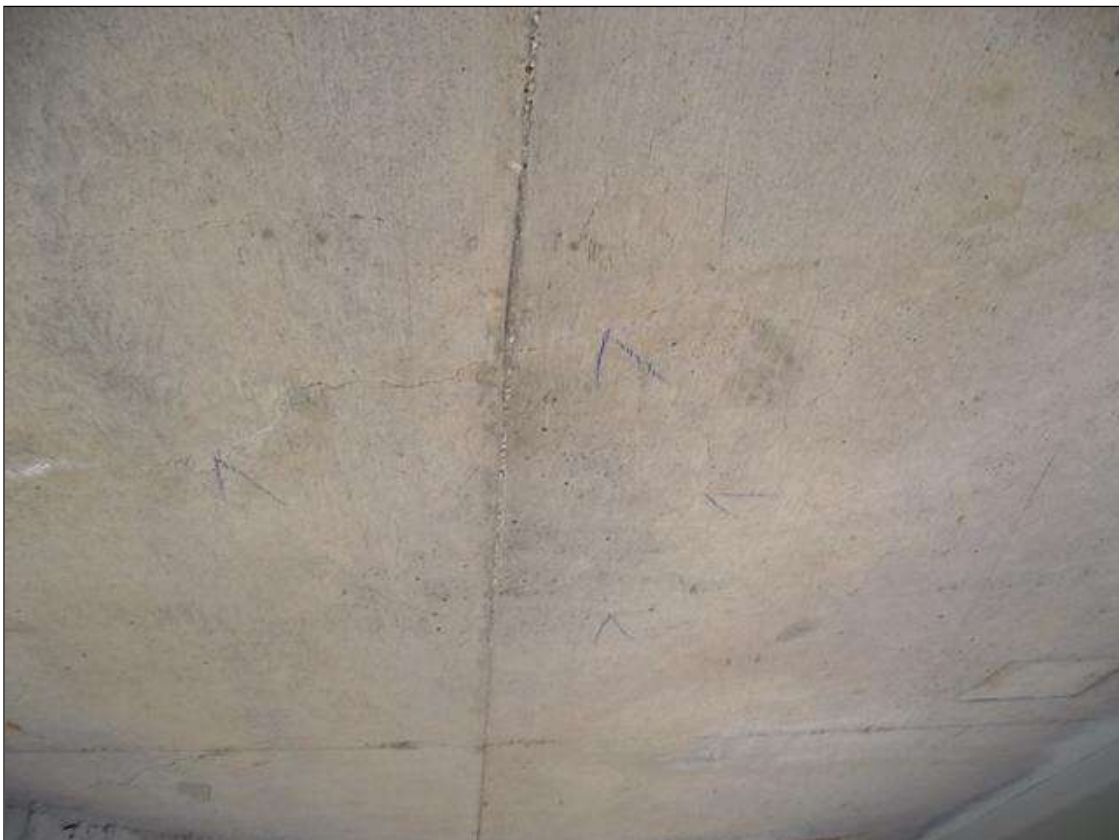
HAIRLINE TO 1/32 IN. MAP CRACKING IN BOTTOM OF DECK OF SPAN 1 BAY 1 - OTHER BAYS SIMILAR

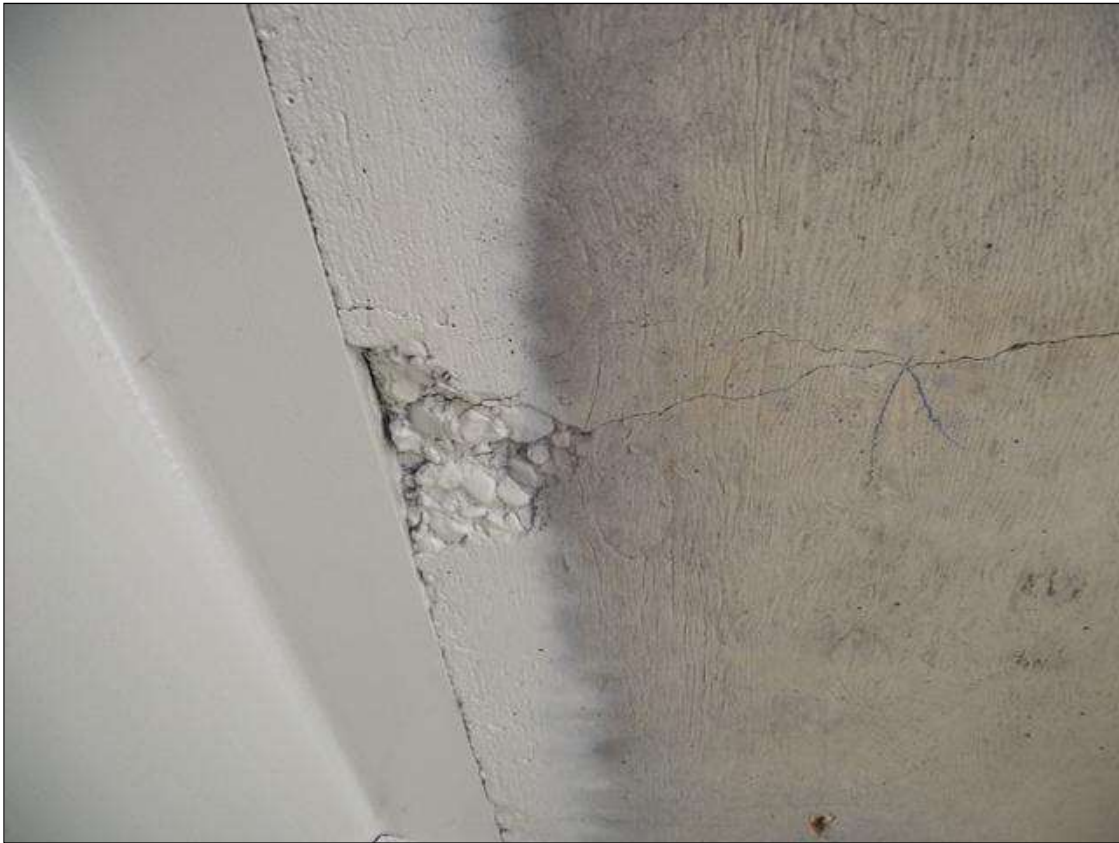
AREA OF HONEYCOMING TO THE LEFT SIDE OF BEAM 2 IN SPAN 1 BAY 1

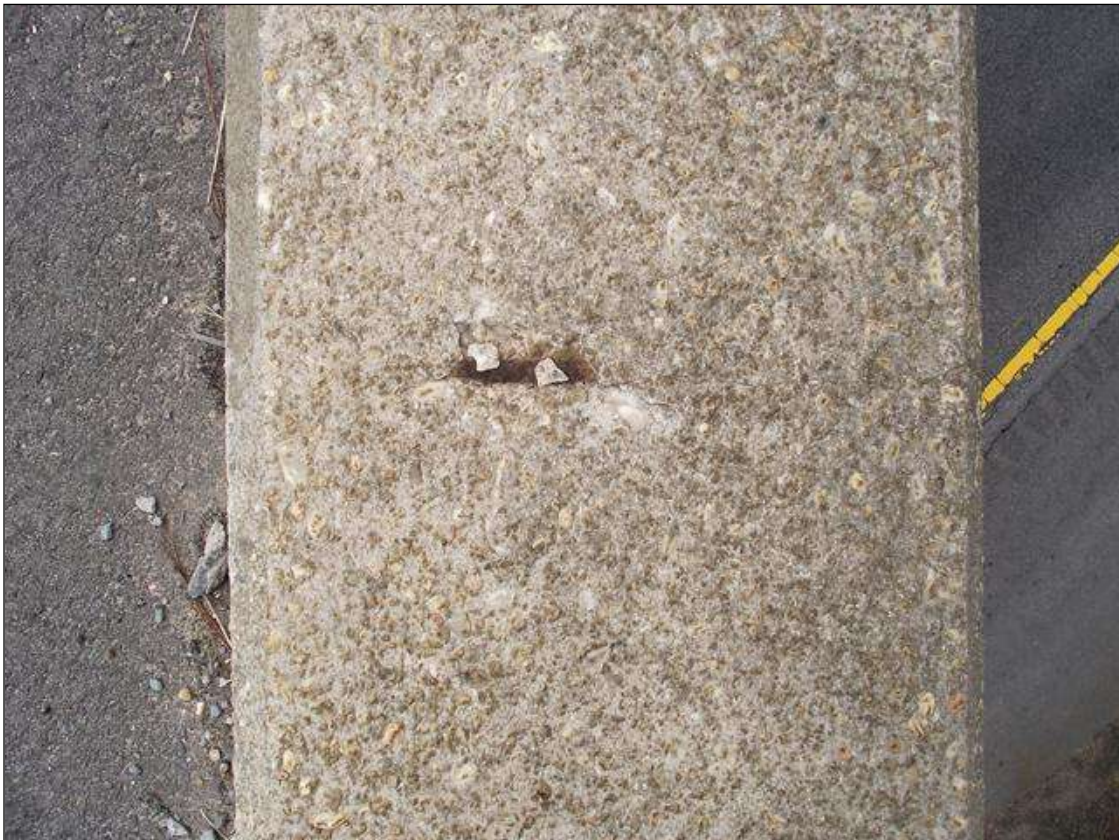
RANDOM SHALLOW SPALLS WITH EXPOSED REBAR ALONG TOP OF CURBLINES

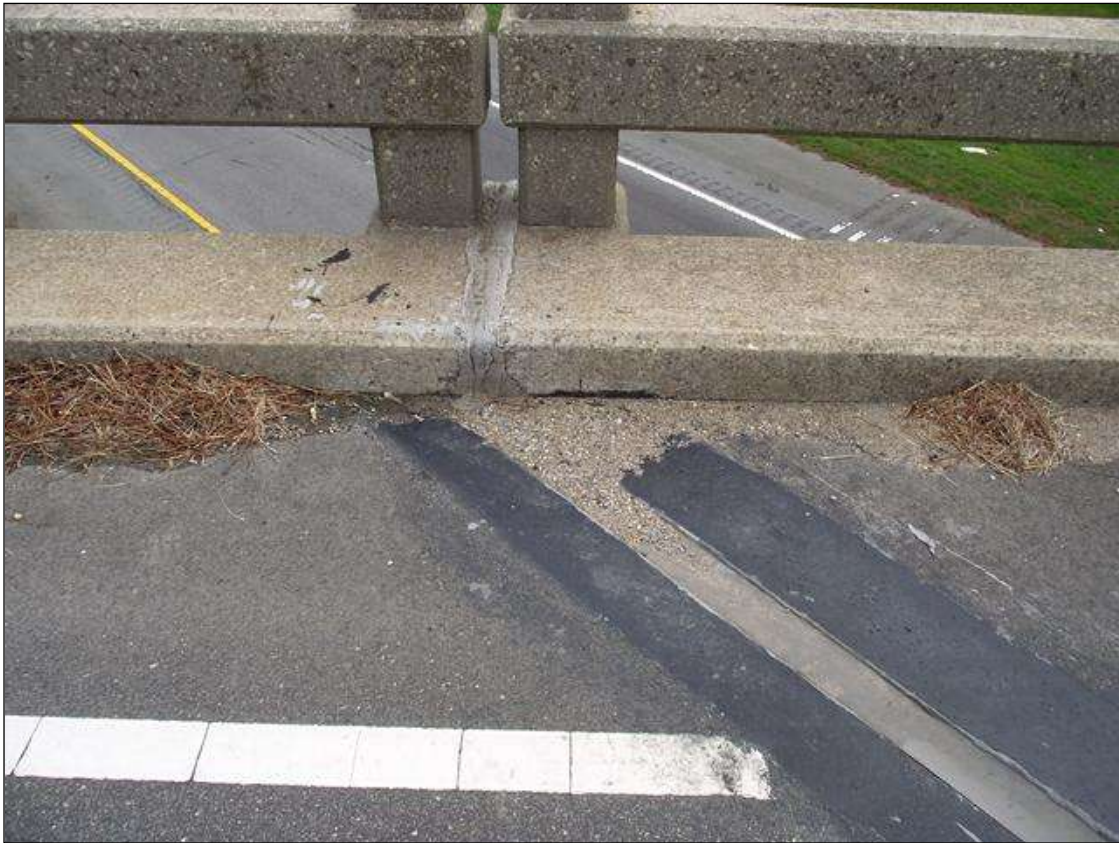
DIRT AND DEBRIS IN SHOULDERS AT EXPANSION JOINTS

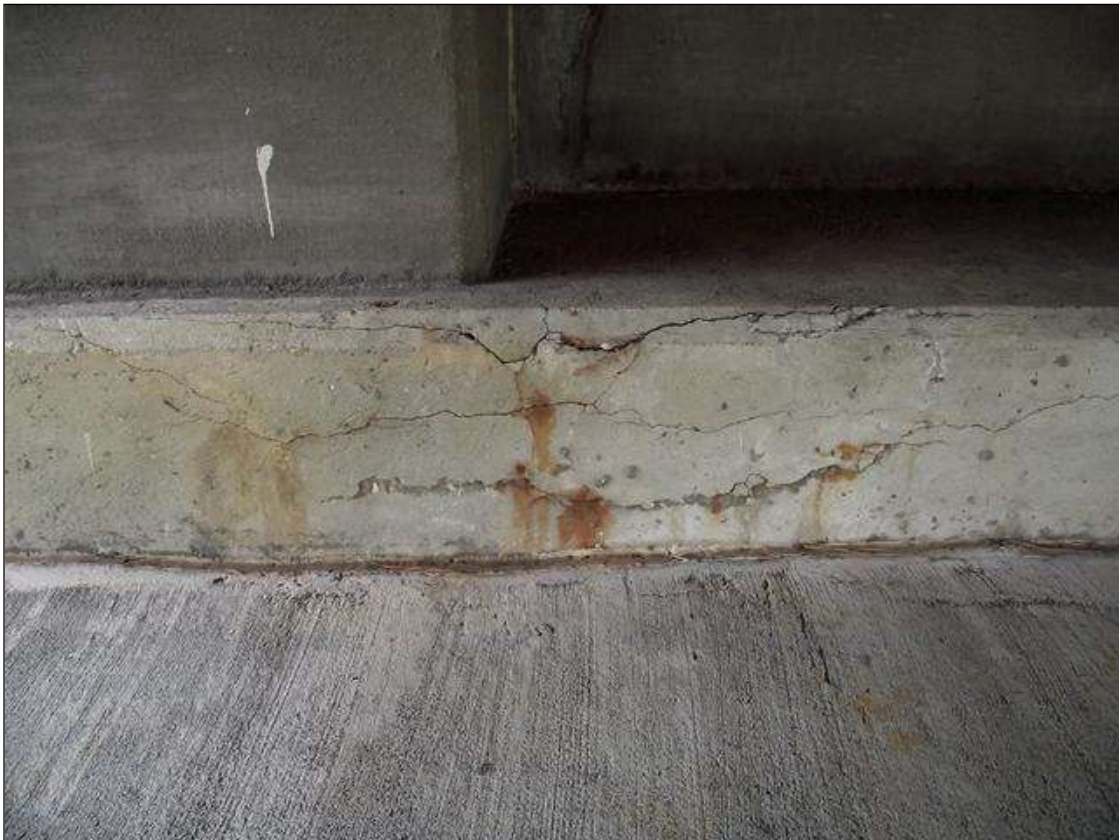
CRACKING AND DELAMINATION WITH RUST STAINS IN FACE OF CAP AT END BENT 2 BAY 1

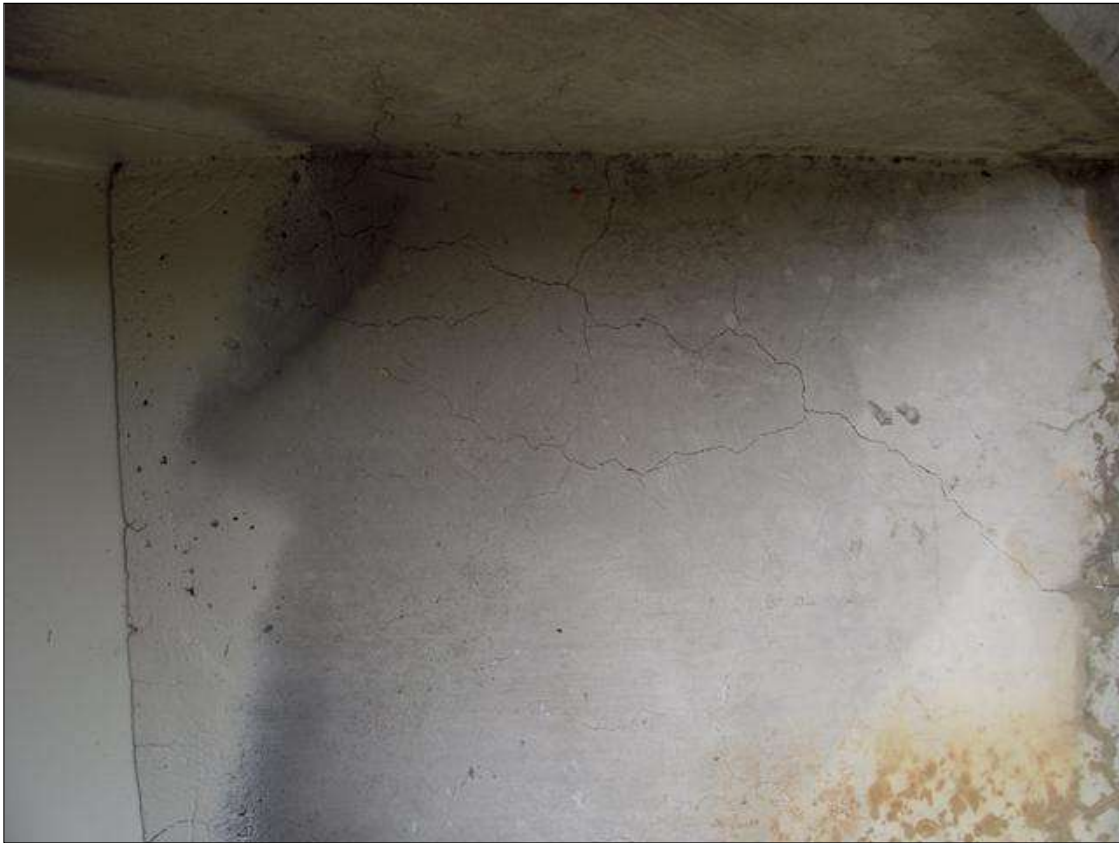
MAP CRACKING IN BACKWALL AT END BENT 2 RIGHT SIDE EXTENSION

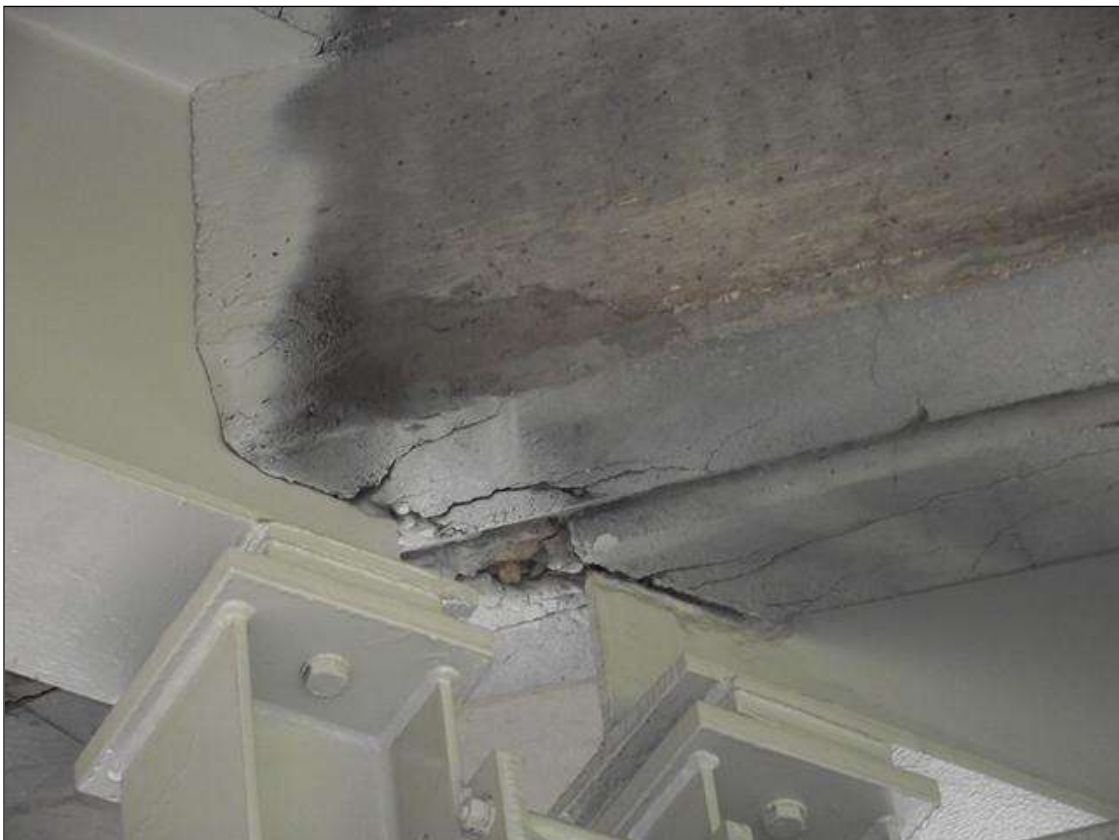
SPAN 3 AND 4 END DIAPHRAGMS AT BENT 3 BAY 2 ARE CRACKED AROUND ENDS OF BEAM 2

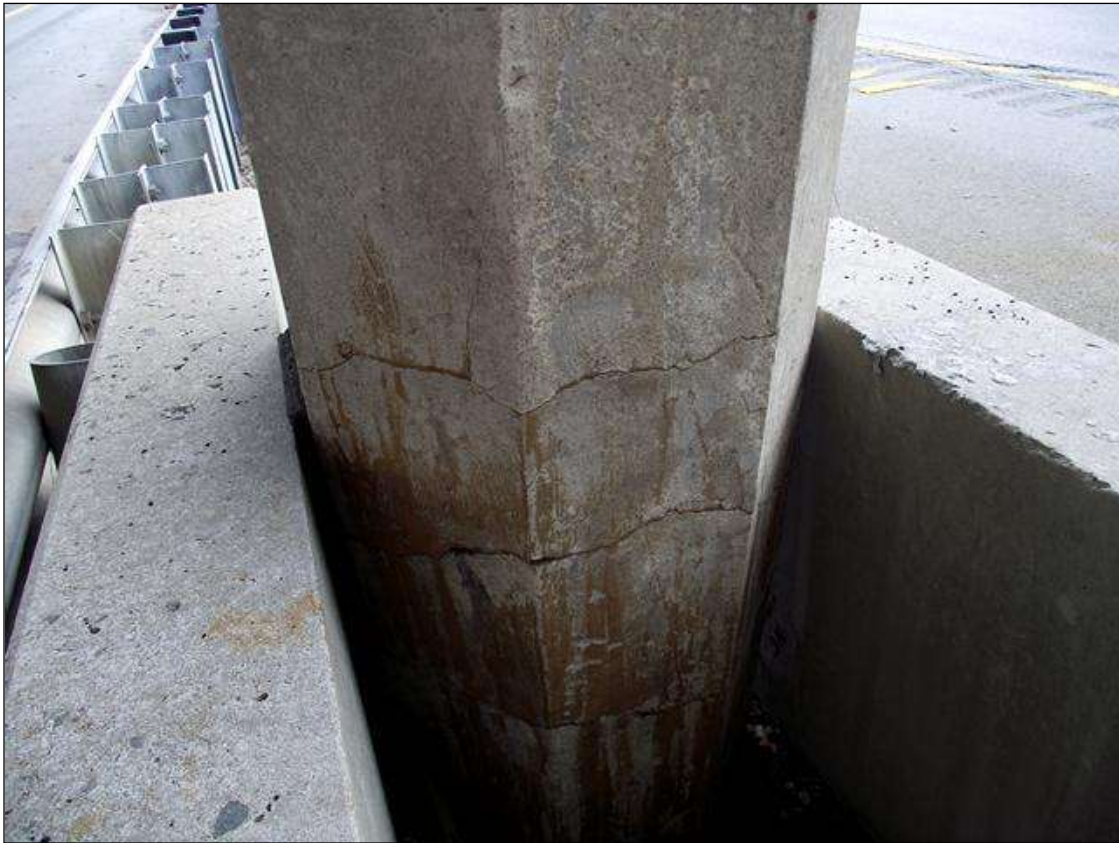
HORIZONTAL CRACKS IN FACES 1, 2, 3, 4 & 5 OF PILE NO.6 AT BENT 2

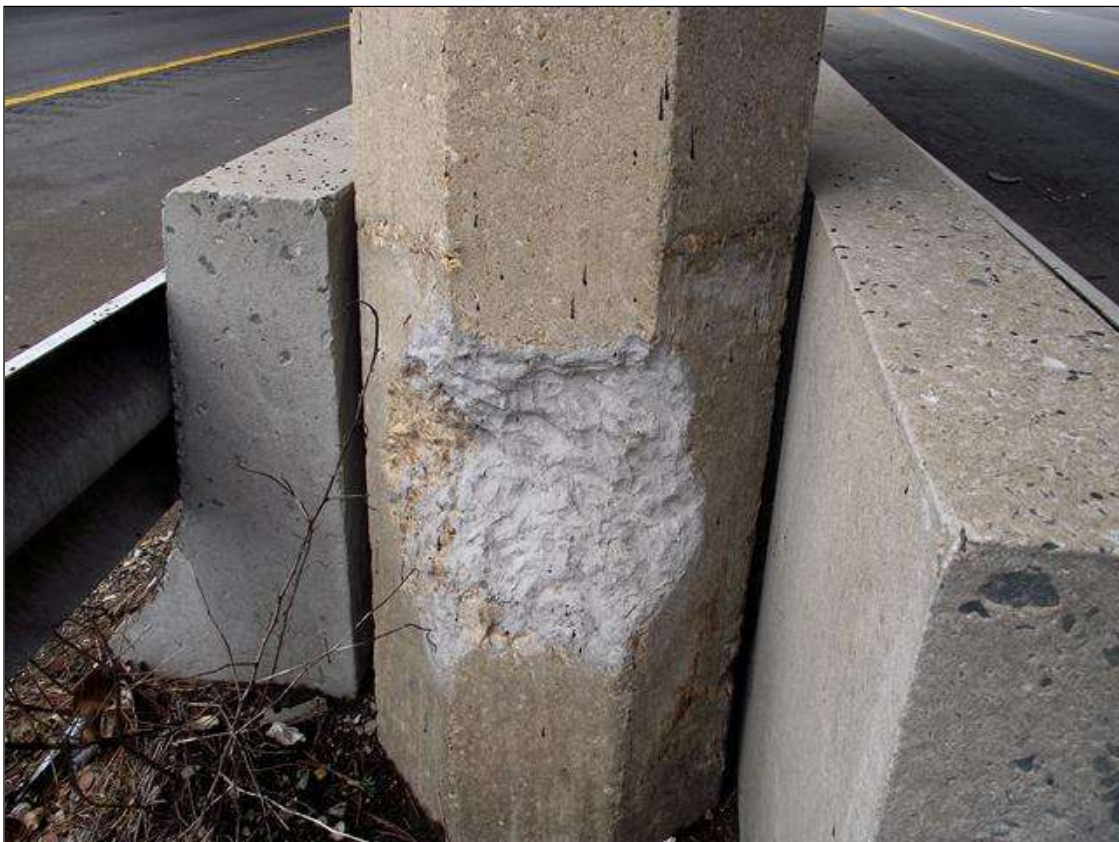
SPALL IN THE RIGHT SIDE OF PILE NO.7 AT BENT 2

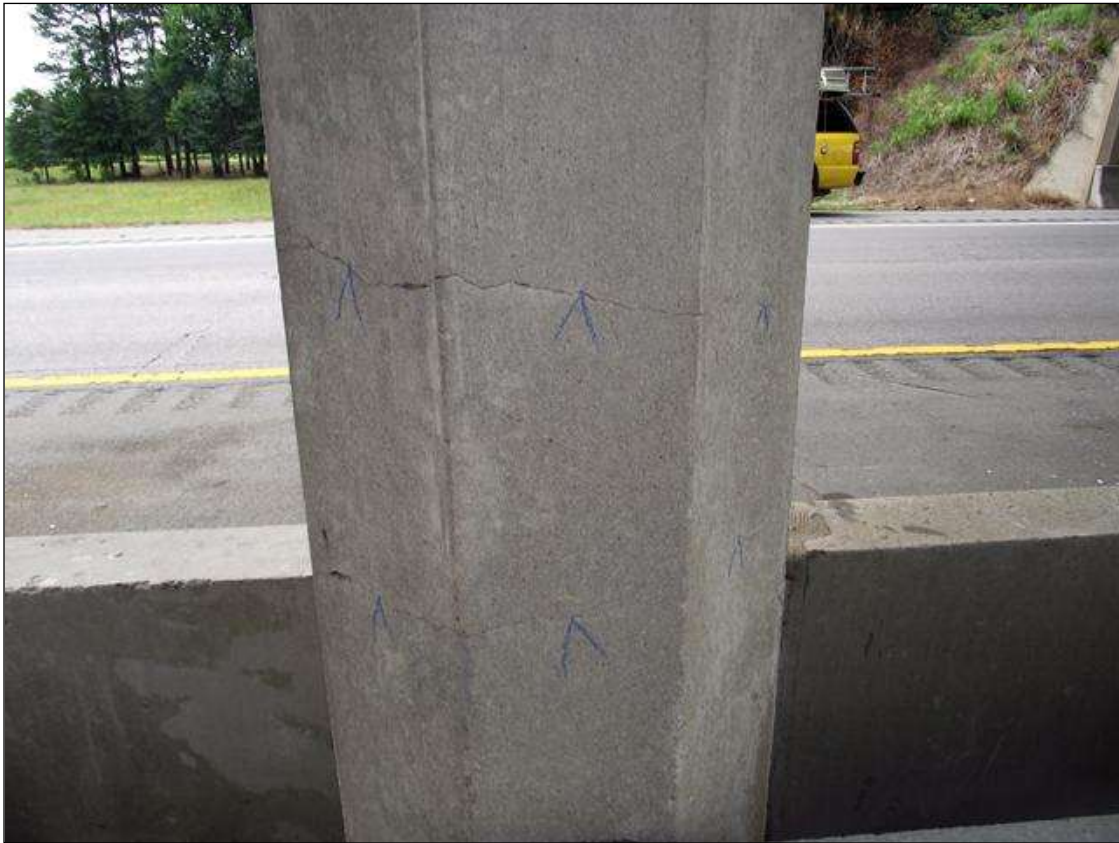
HORIZONTAL CRACKS IN FACES 4, 5, 6, 7 & 8 OF PILE NO.5 AT BENT 2 - PILES 2 & 4 ARE SIMILAR

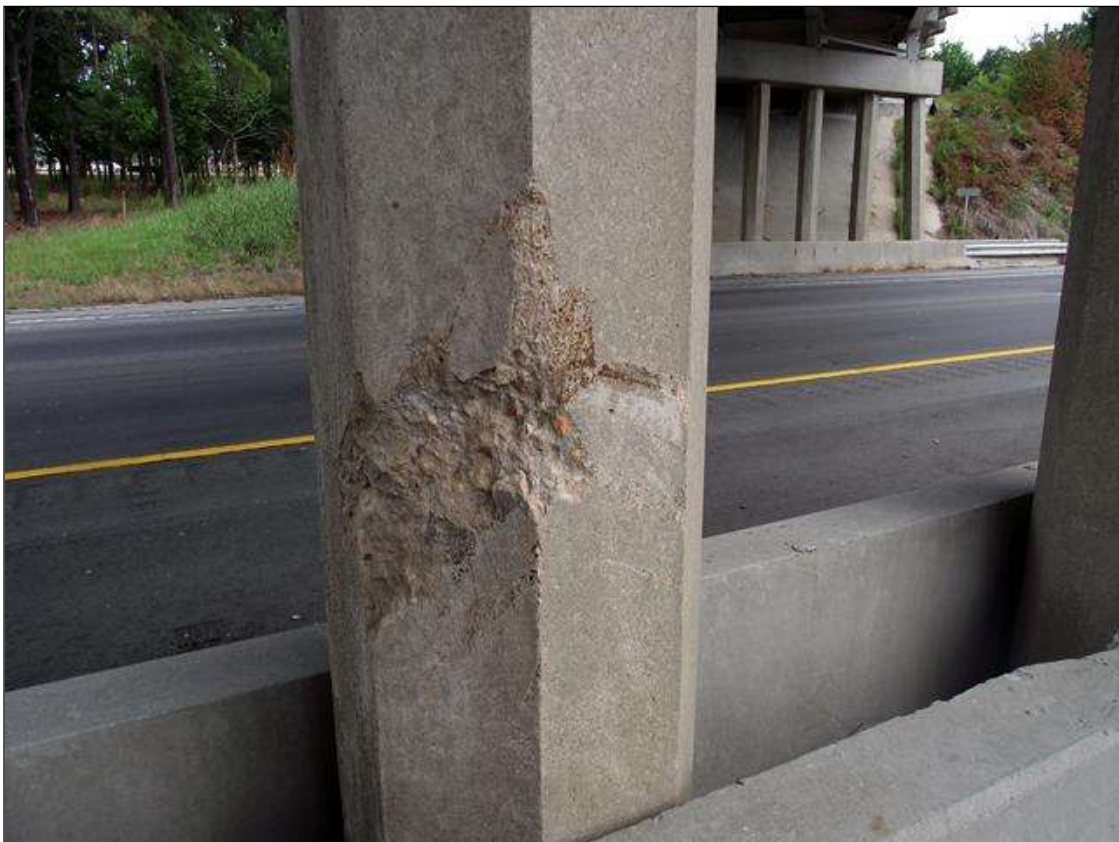
SPALLS IN FACES 1, 2 & 3 OF PILE NO.5 AT BENT 2

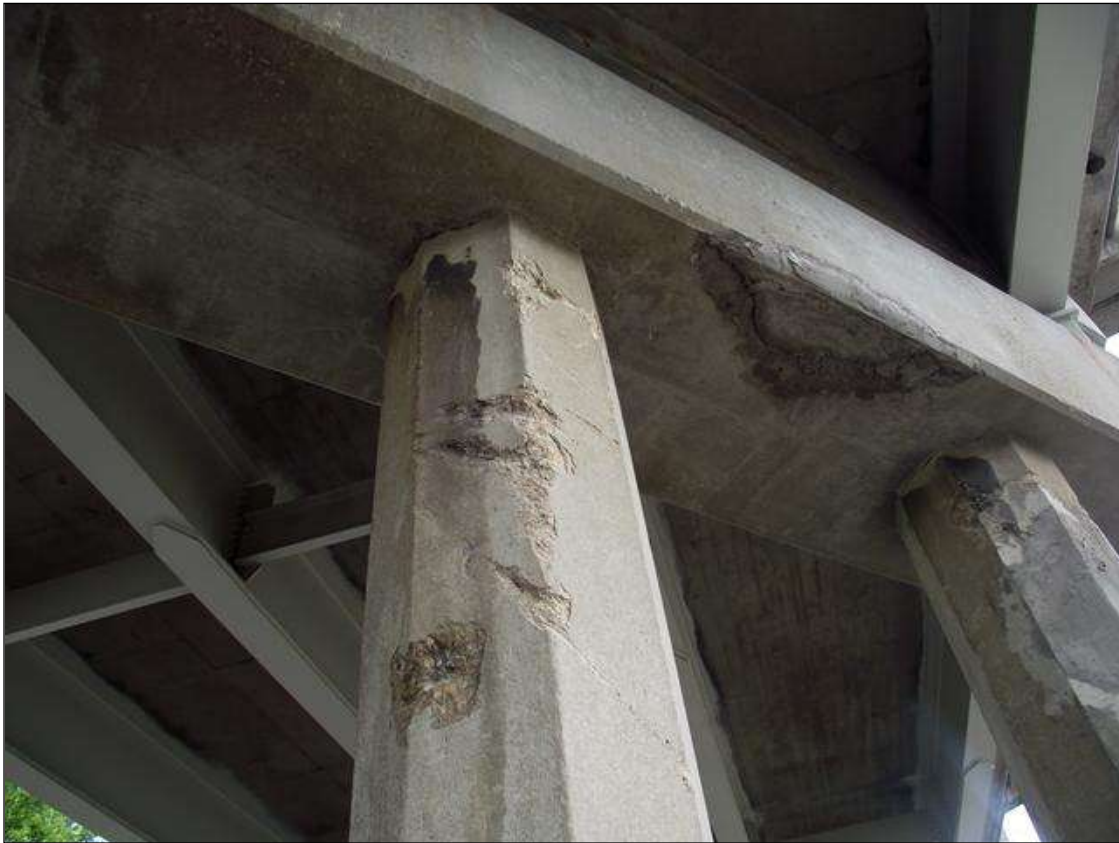
SPALLS IN FACES 1, 2 & 3 OF PILE NO.5 AT BENT 2

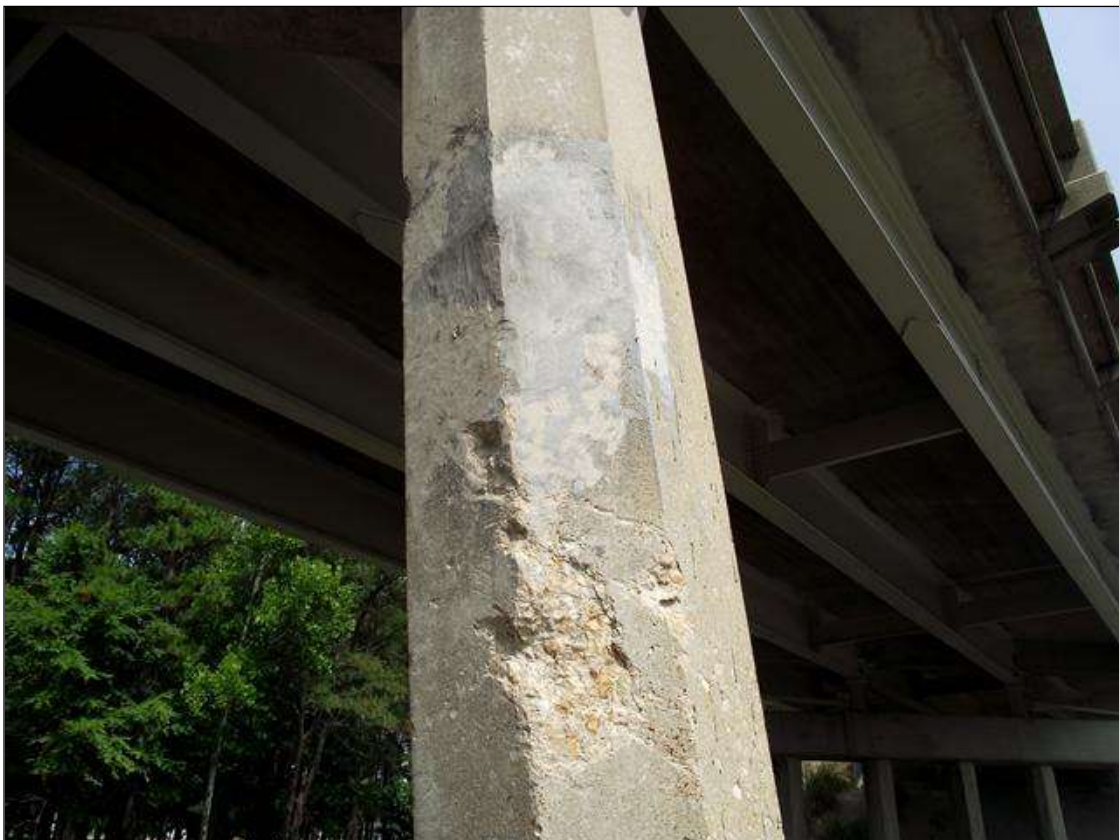
SPALL AND SPALL REPAIR IN FACES 1 & 2 OF PILE NO.7 AT BENT 2

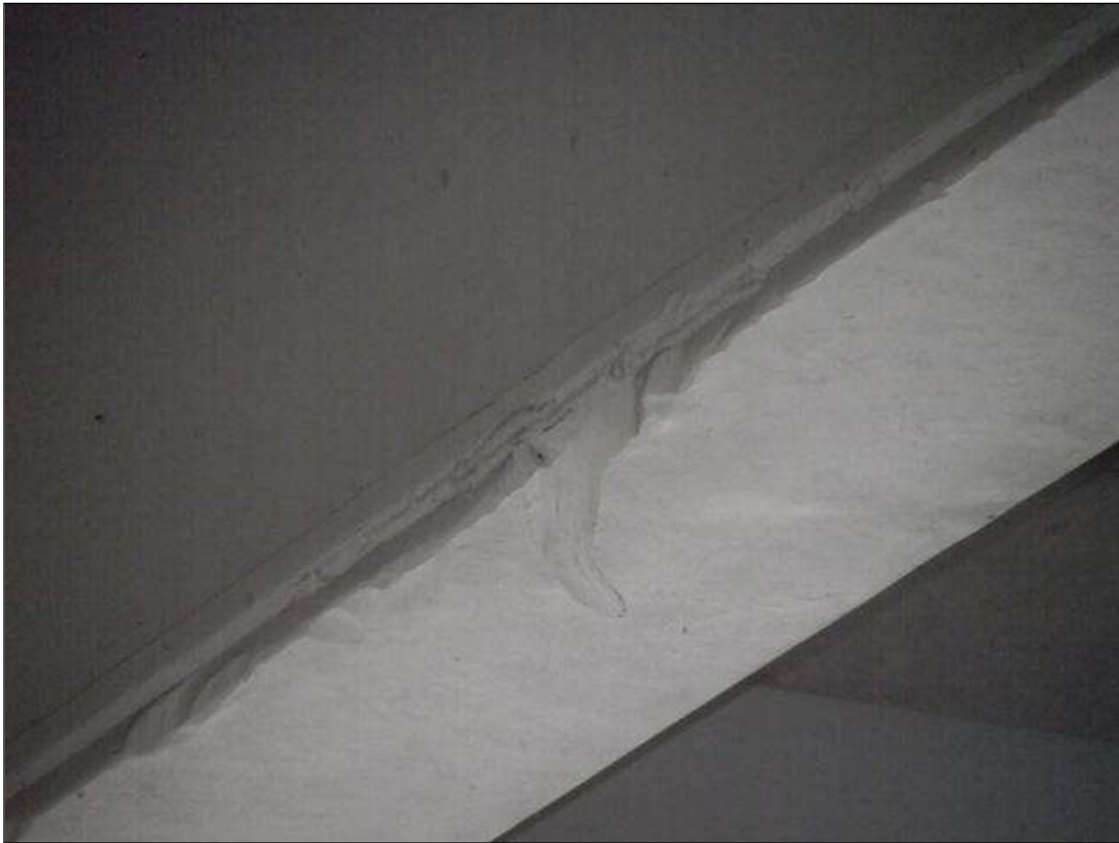
GOUGE IN THE BOTTOM FLANGE OF BEAM 3 IN SPAN 2 AT MIDSPAN

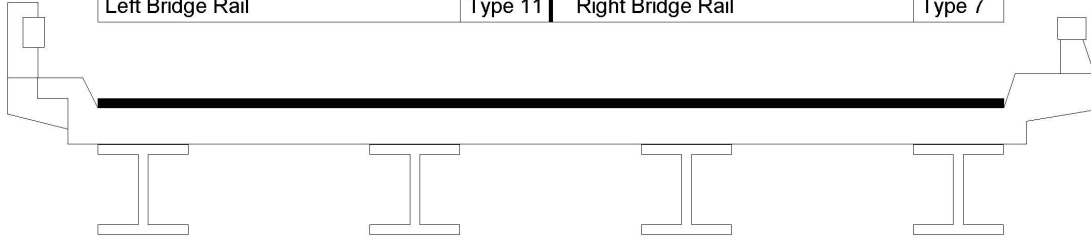
Measurements for Span #	1	ALL SPANS SIMILAR	
Deck Thickness	0.583	Left Overhang	3.708
Top of Rail to Bottom of Beam	5.823	Right Overhang	3.708

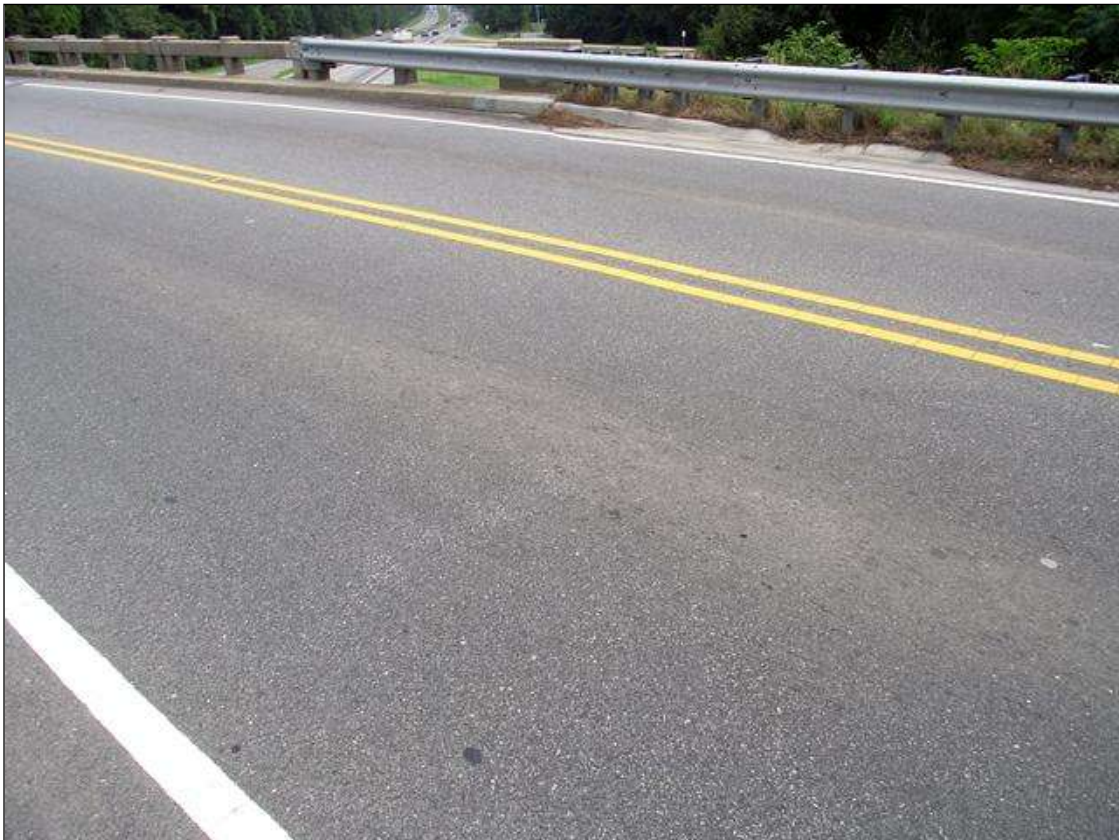
WEARING SURFACE OVER END BENT 1

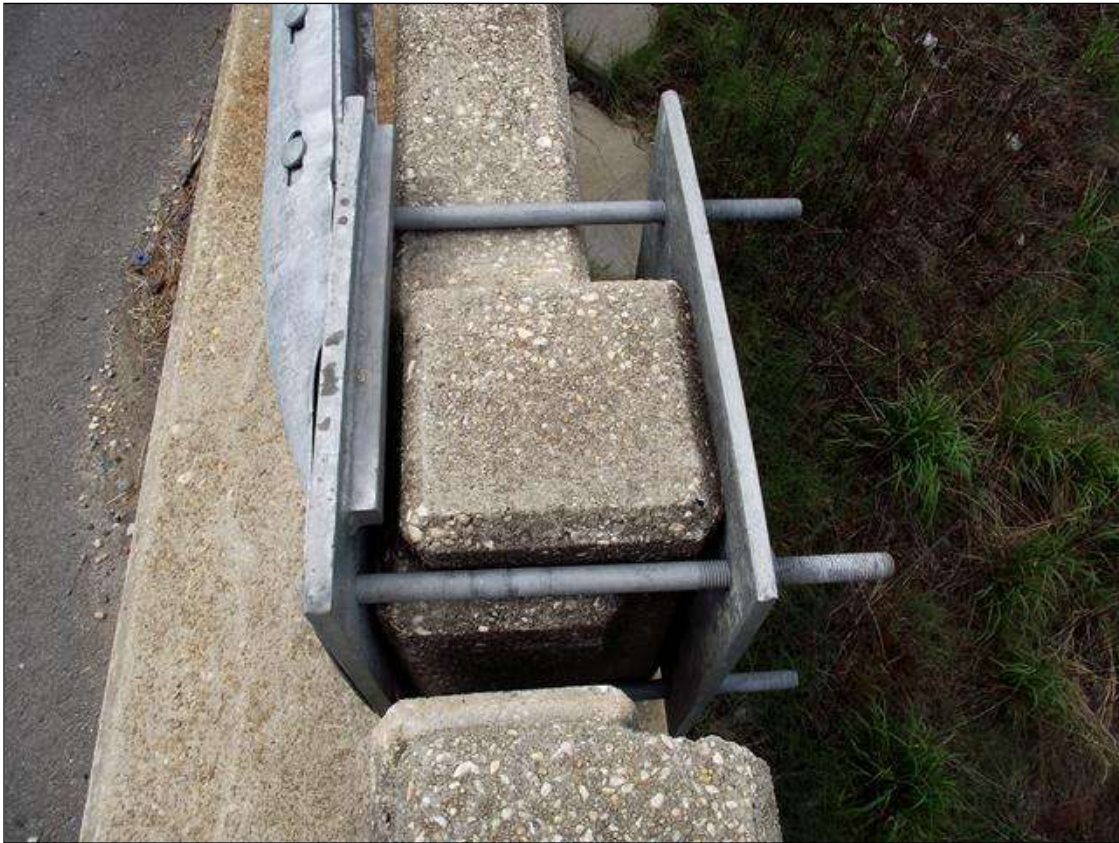
LEFT SIDE GUARDRAIL CONNECTION IN SPAN 1 - OTHERS SIMILAR

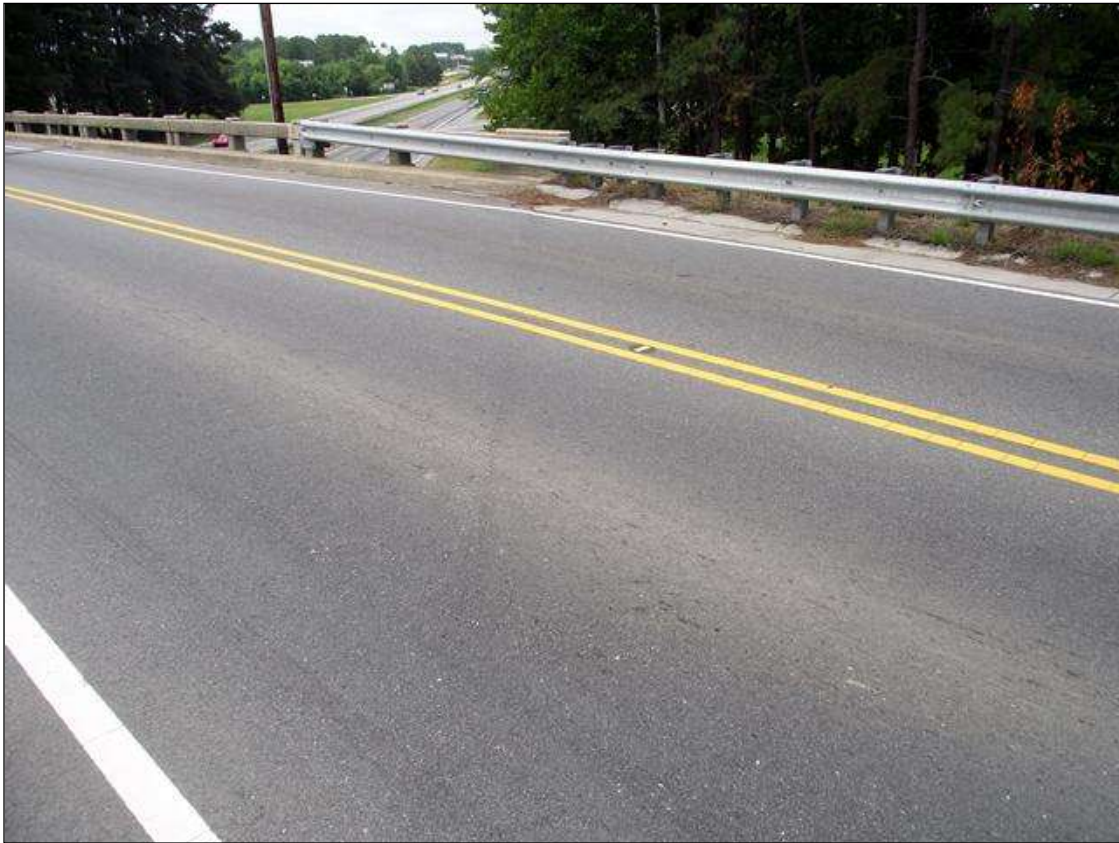
WEARING SURFACE OVER END BENT 2

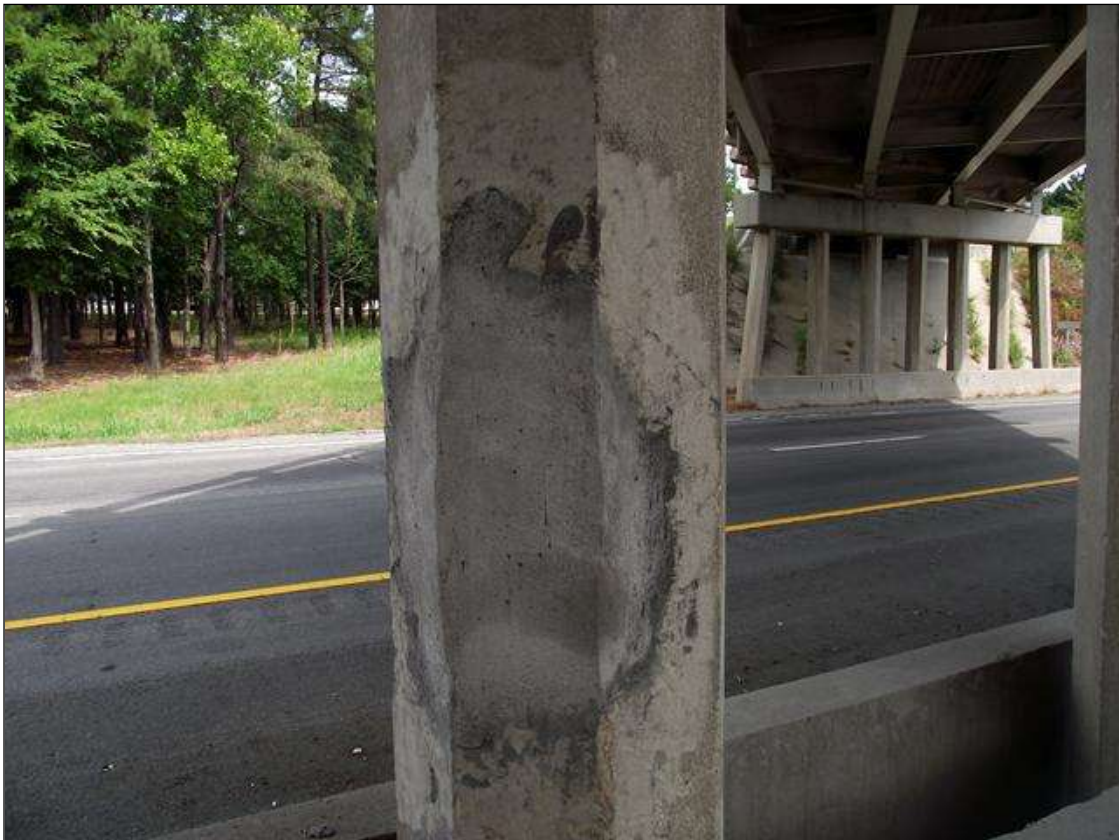
SPALL REPAIR IN FACES 1, 2 & 3 OF PILE NO.2 AT BENT 2

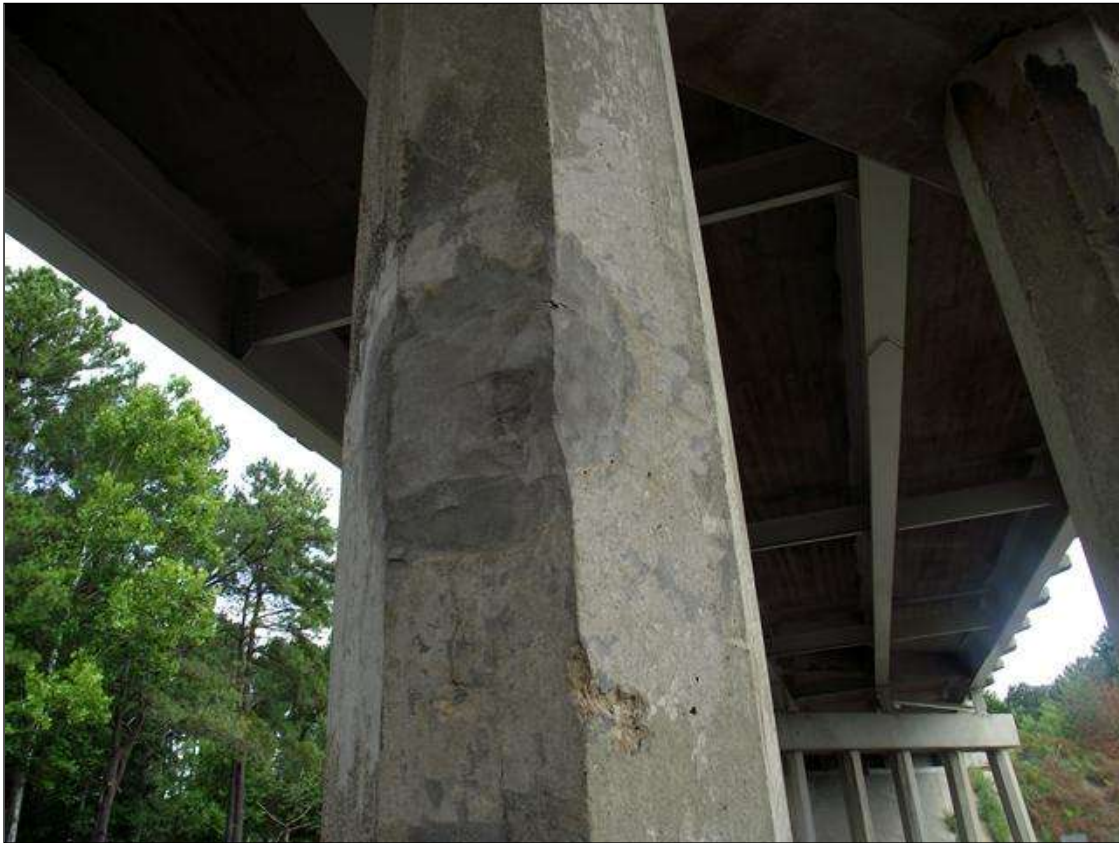
SPALL REPAIR IN FACES 1 & 2 OF PILE NO.4 AT BENT 2

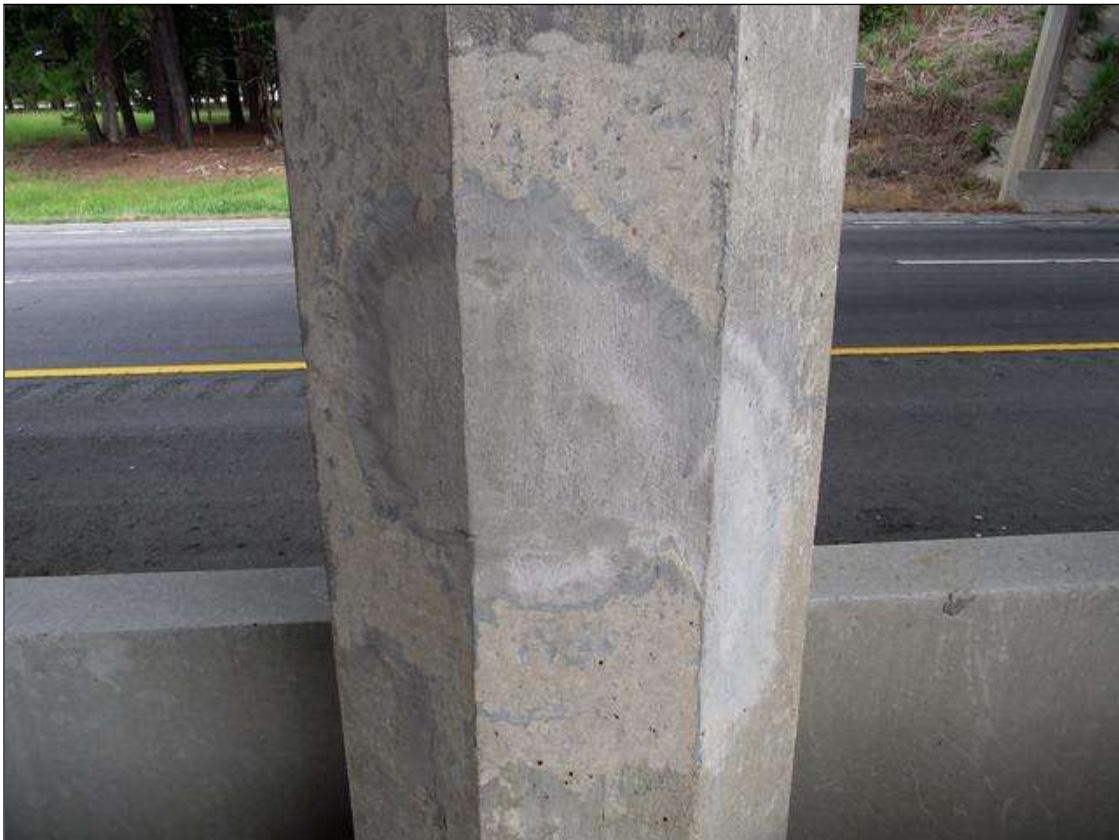
SPALL REPAIR IN FACES 1, 2 & 8 IN PILE NO.4 AT BENT 2

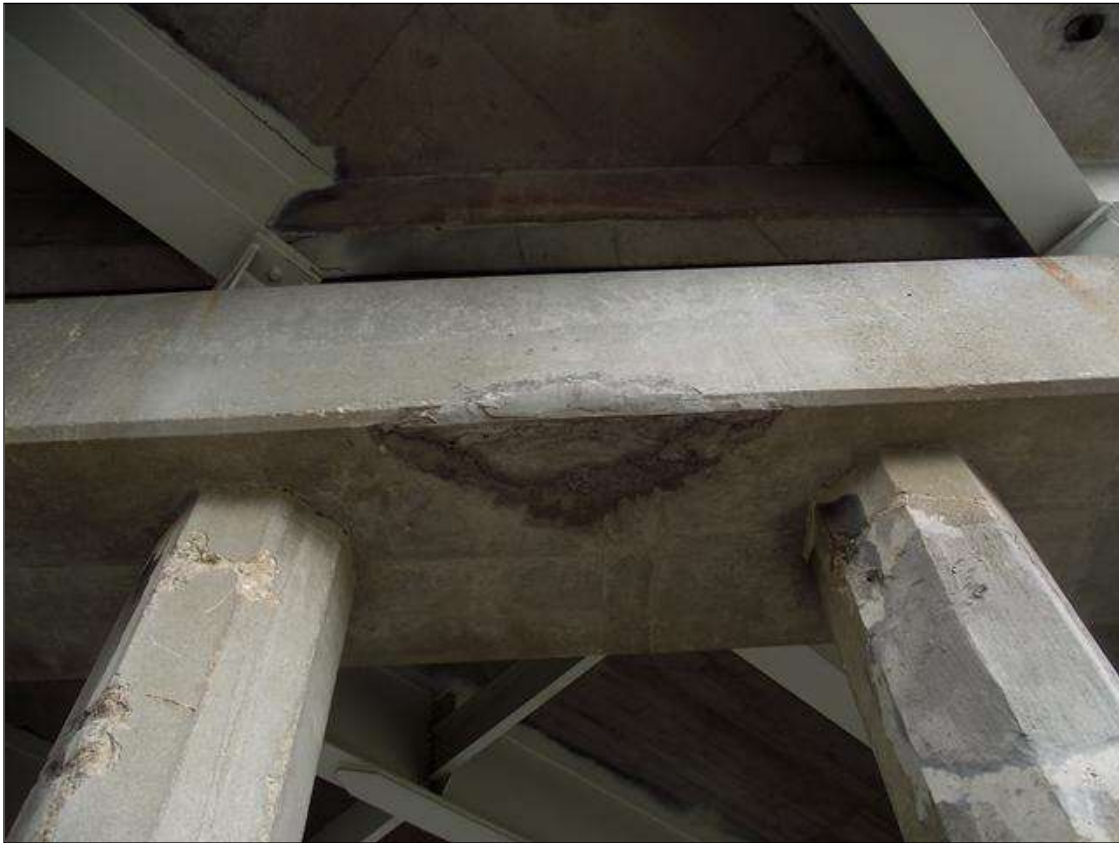
REPAIR PATCH IN THE BOTTOM EDGE OF BENT 2 CAP SPAN 2 SIDE UNDER BAY 3
