NC DEPARTMENT OF TRANSPORTATION ATTENTION
 DIVISION OF HIGHWAYS
 BRIDGE MANAGEMENT UNIT

BRIDGE INSPECTION REPORT

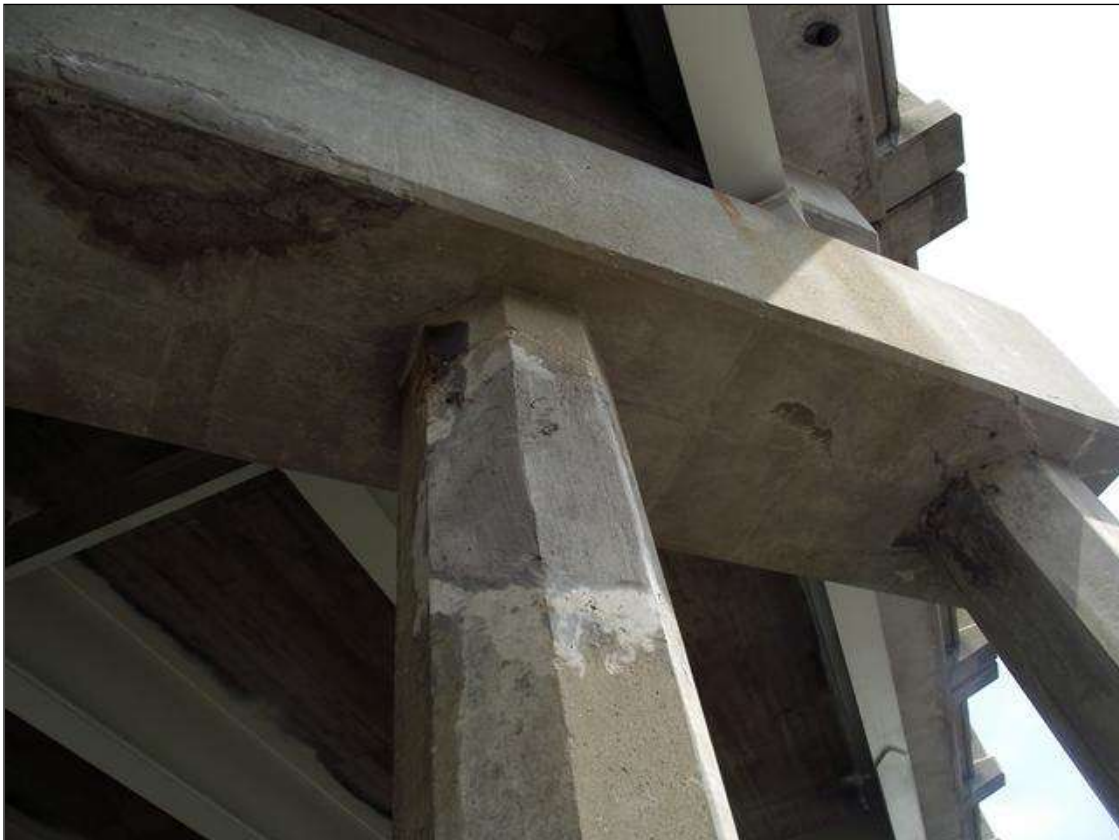
SPALL REPAIR IN FACES 1, 2, 3 & 8 IN PILE NO.6 AT BENT 2

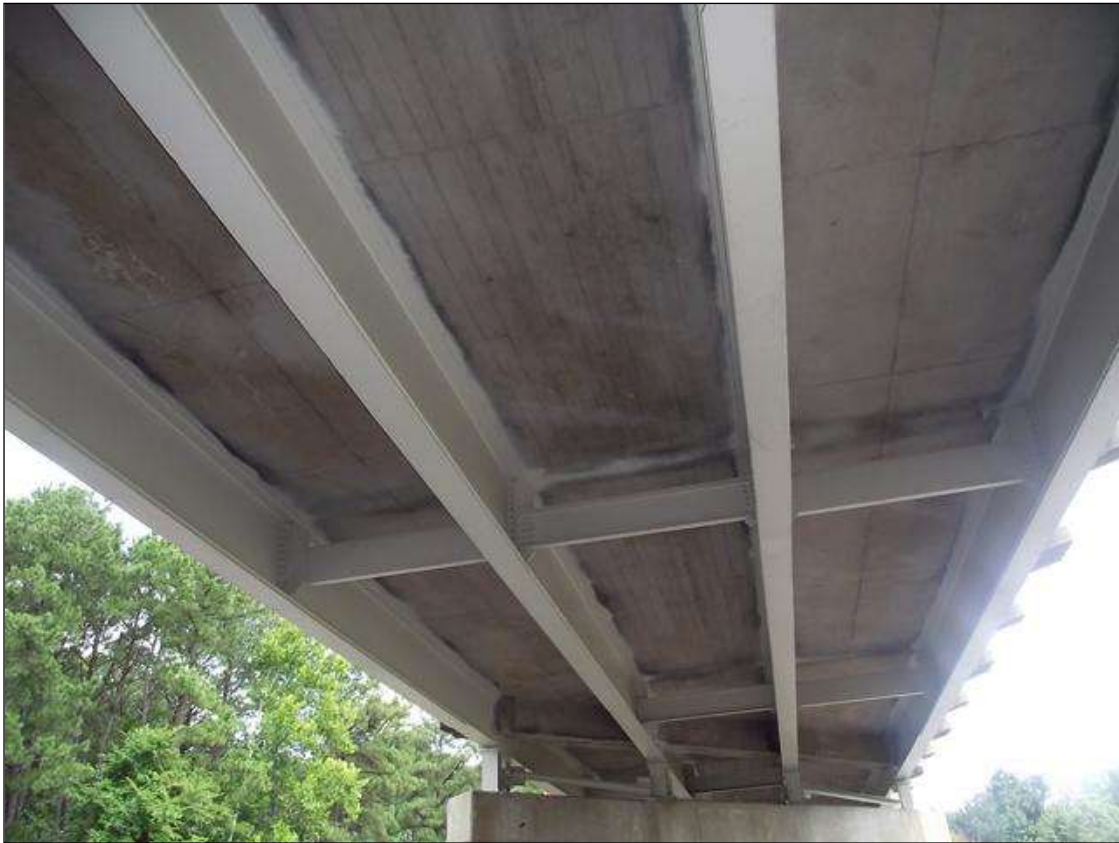
SUPERSTRUCTURE OVERVIEW - ALL SPANS SIMILAR

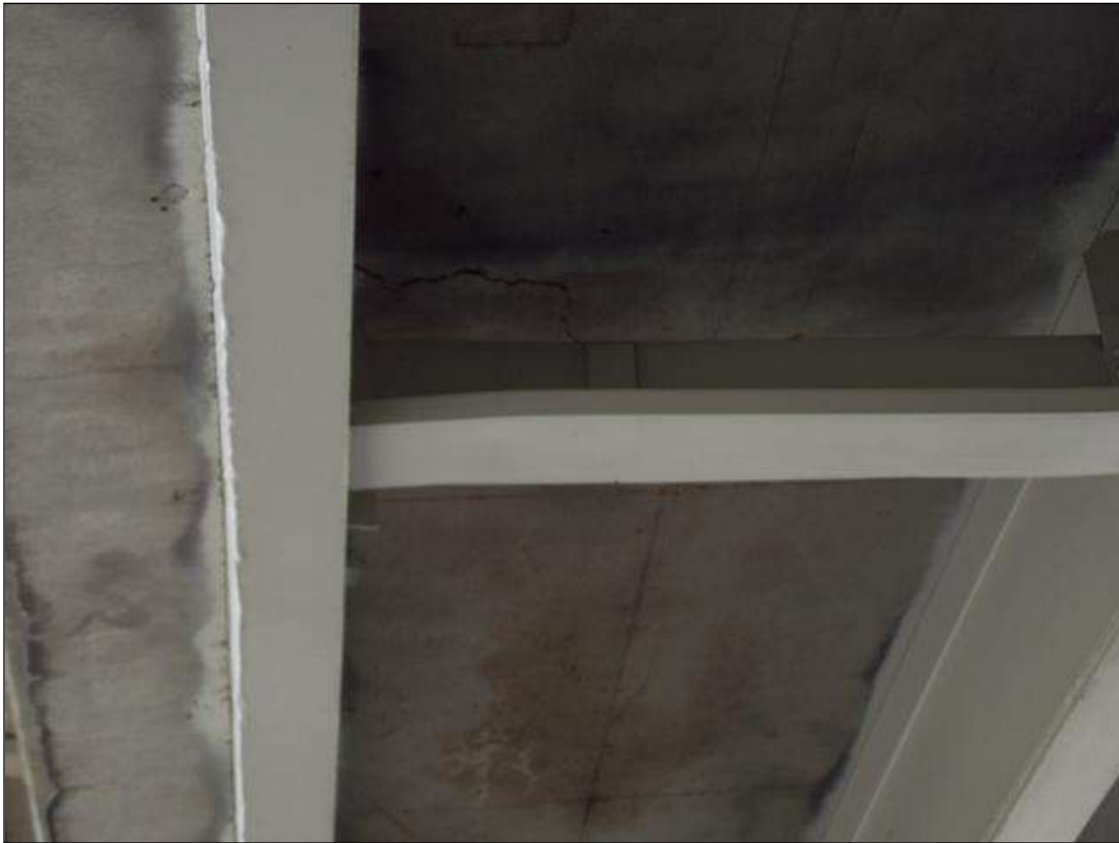
INTERIOR DIAPHRAGM IN SPAN 2 BAY 1 AT 1/3 POINT IS BENT FROM PREVIOUS IMPACT DAMAGE
