NC DEPARTMENT OF TRANSPORTATION
DIVISION OF HIGHWAYS
BRIDGE MANAGEMENT UNIT

PRIORITY MAINTENANCE ISSUED ON BROKEN ANCHOR BOLTS AND SPALLED CAP

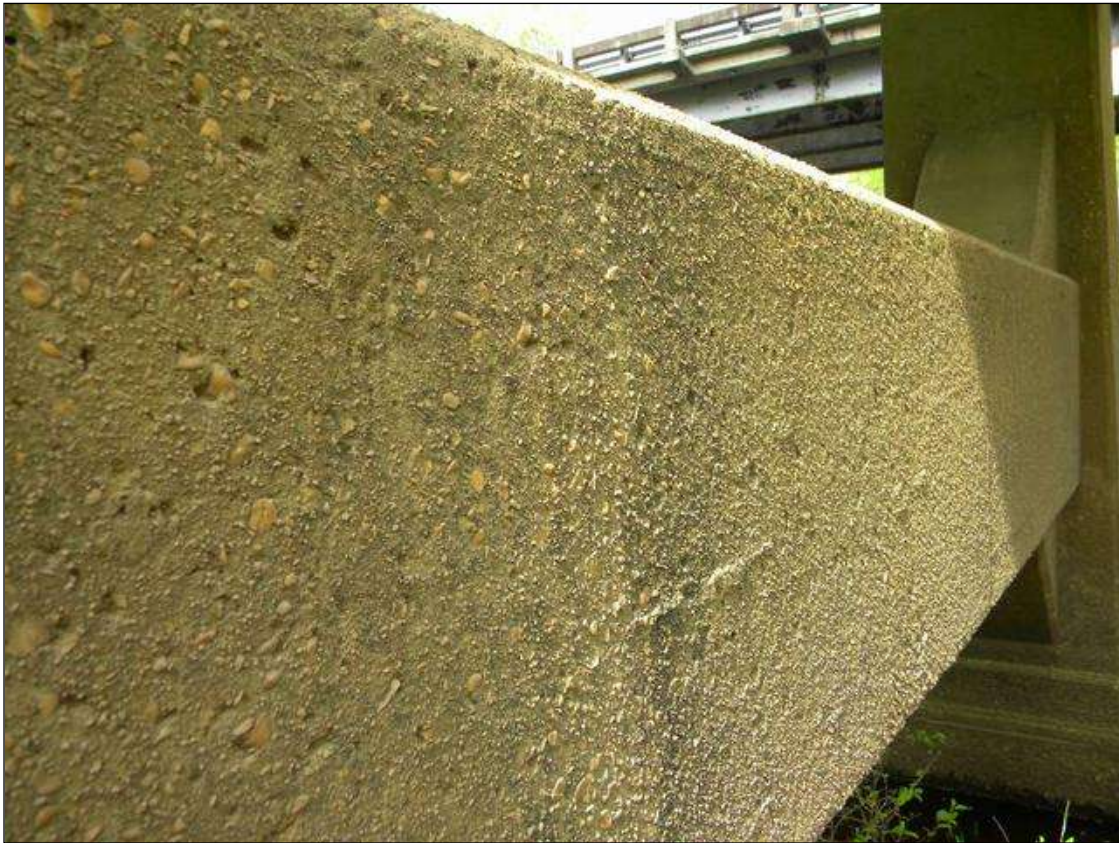
BENT STRUTS SCALED WITH COARSE AGGREGATE EXPOSED

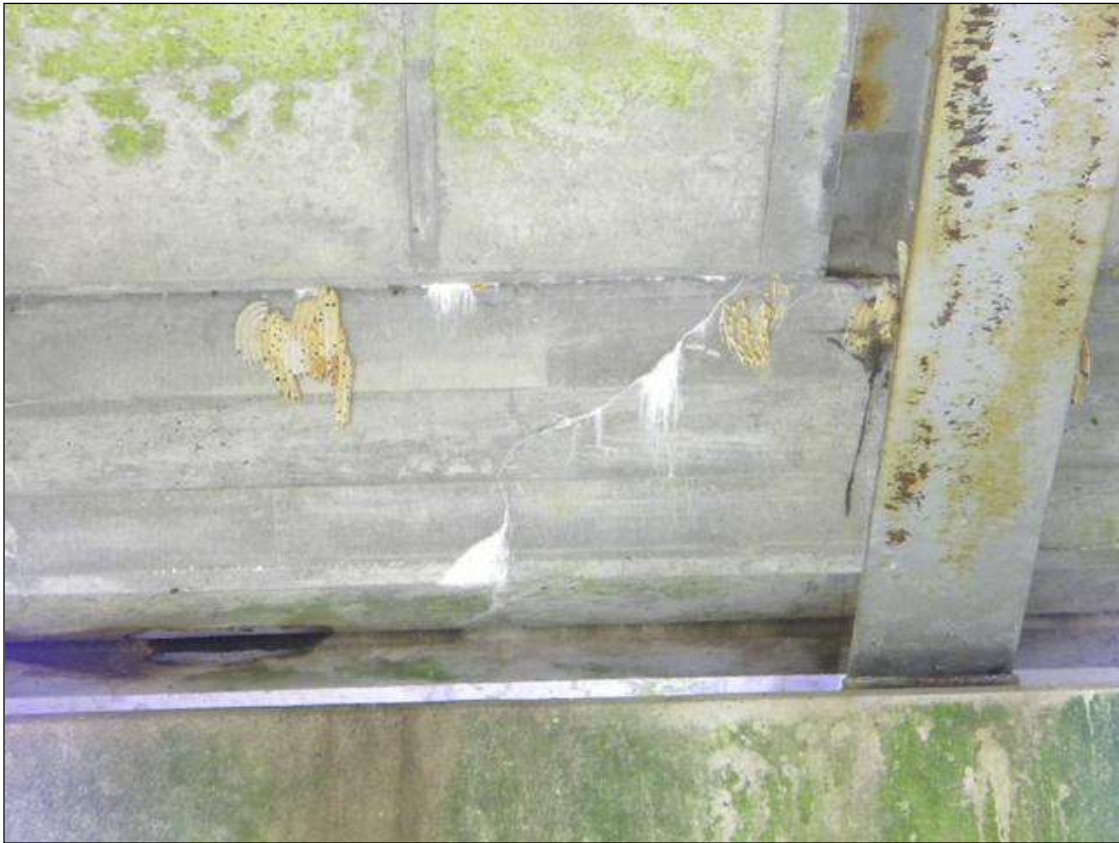
HAIRLINE VERTICAL AND DIAGONAL CRACKS WITH EFFLORESCENCE IN SPAN 3 END DIAPHRAGM AT BENT
2

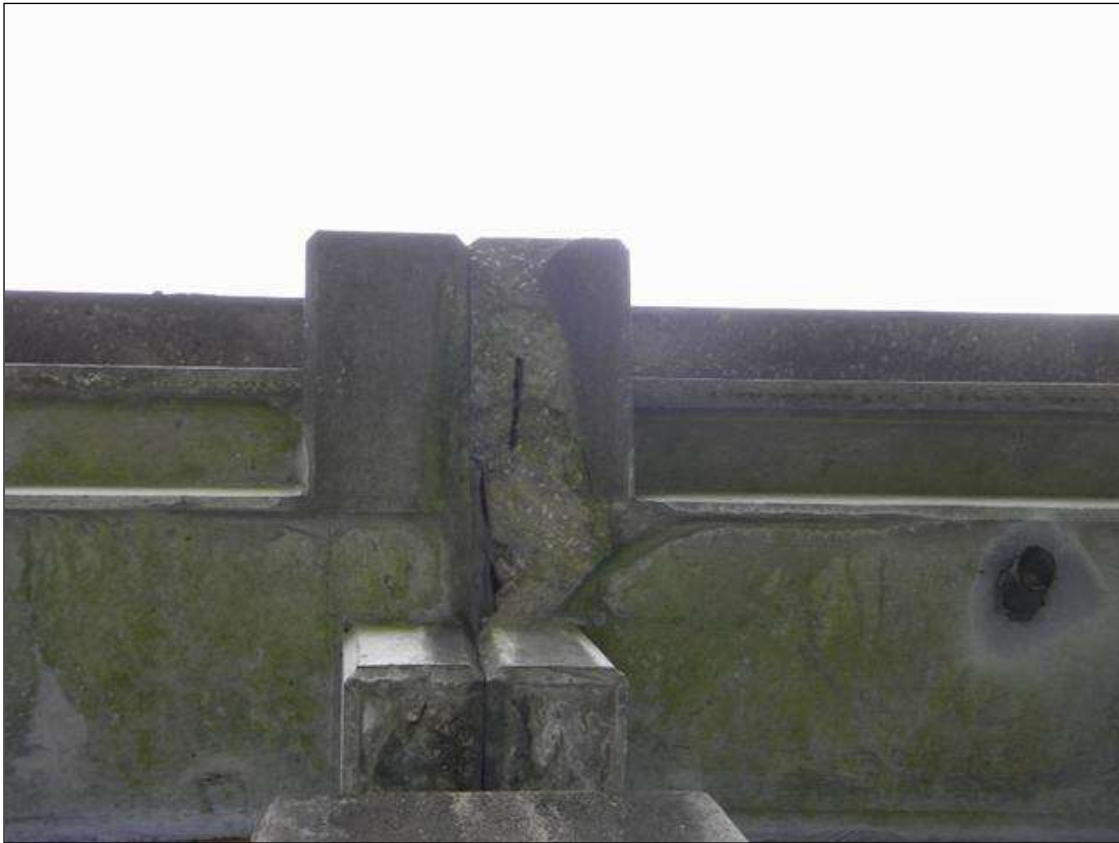
SPALLING WITH EXPOSED REBAR IN GUARDRAIL END POST BASE AT THE LEFT SIDE OF BENT 3 SPAN 3
SIDE

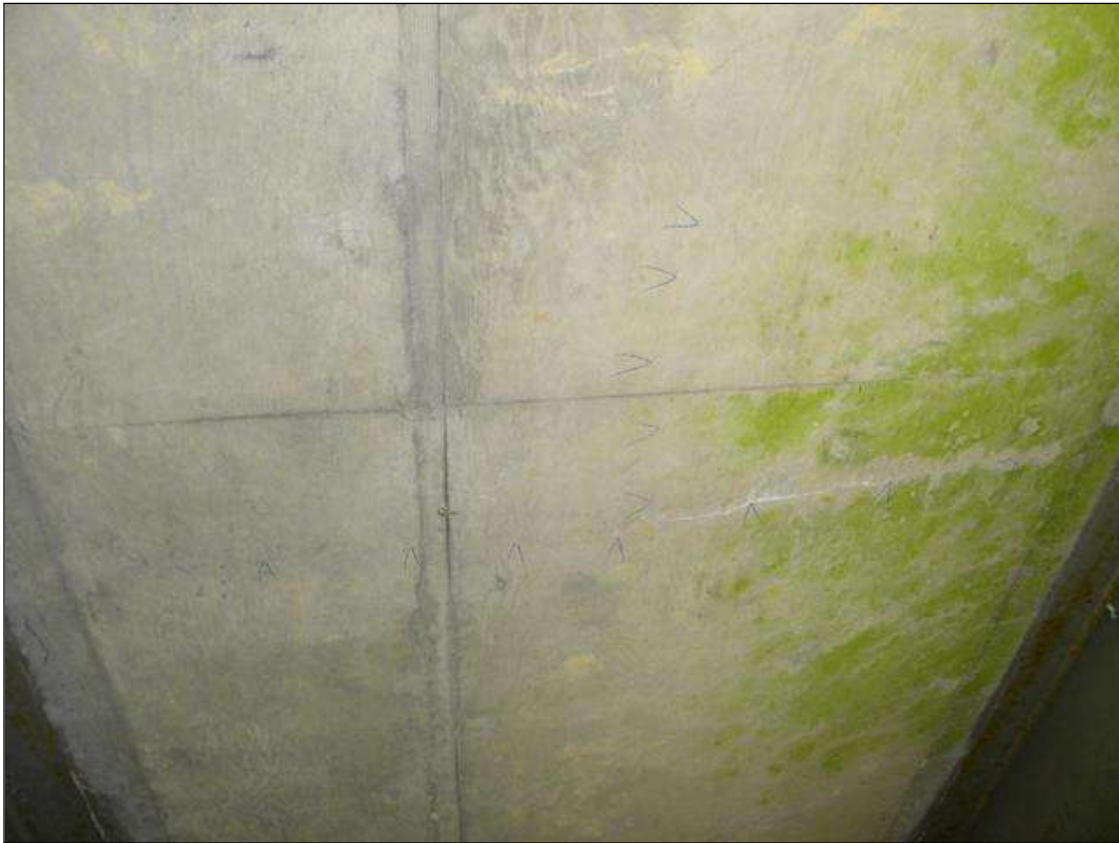
HAIRLINE LONGITUDINAL AND TRANSVERSE CRACKS IN BOTTOM OF DECK OF SPAN 4

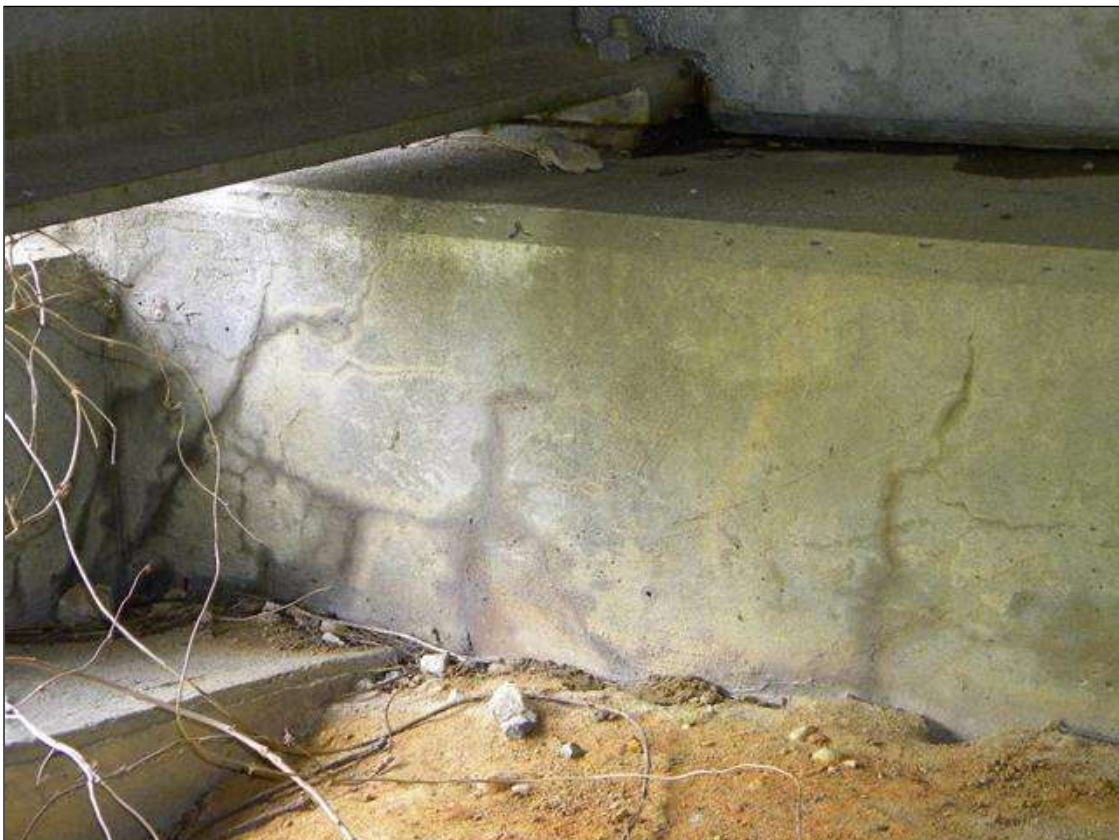
HAIRLINE MAP CRACKING IN FACE OF CAP AT END BENT 2 UNDER BEAM 1

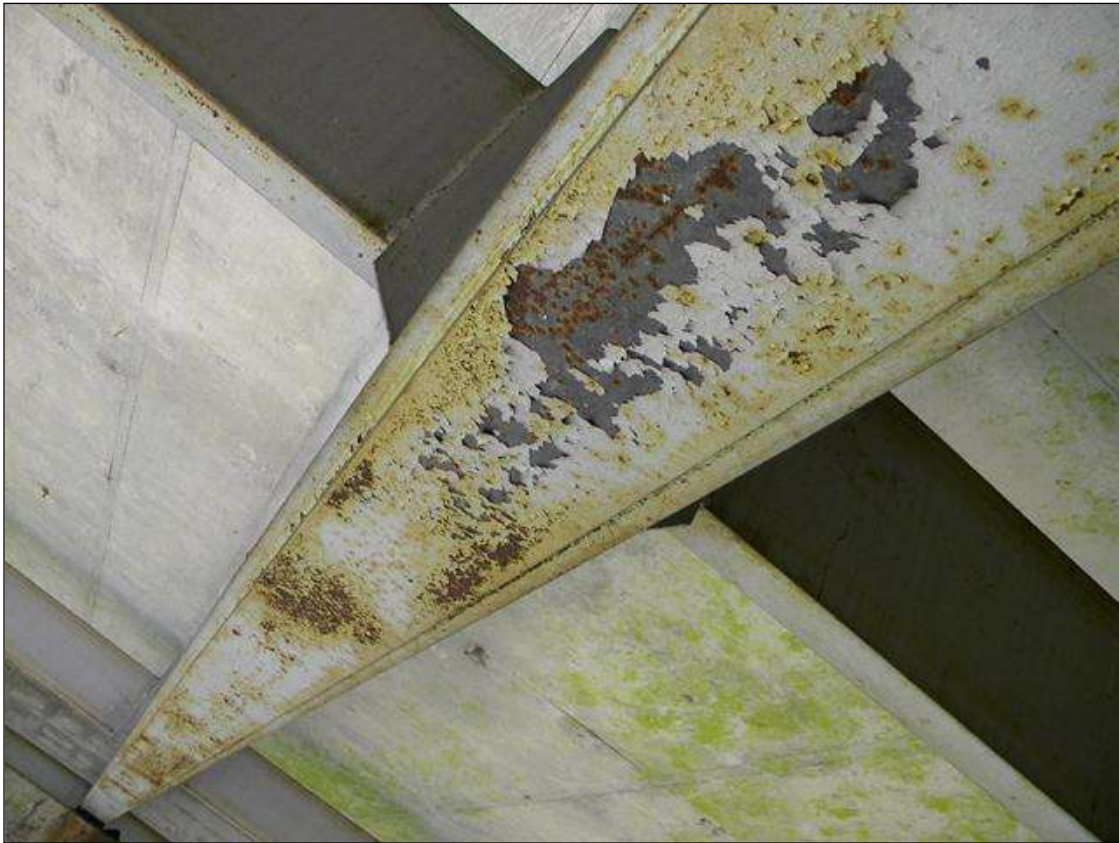
PEELING PAINT & SURFACE RUST IN THE BOTTOM OF COVER PLATES FOR BEAMS 2 & 3 IN SPAN 4

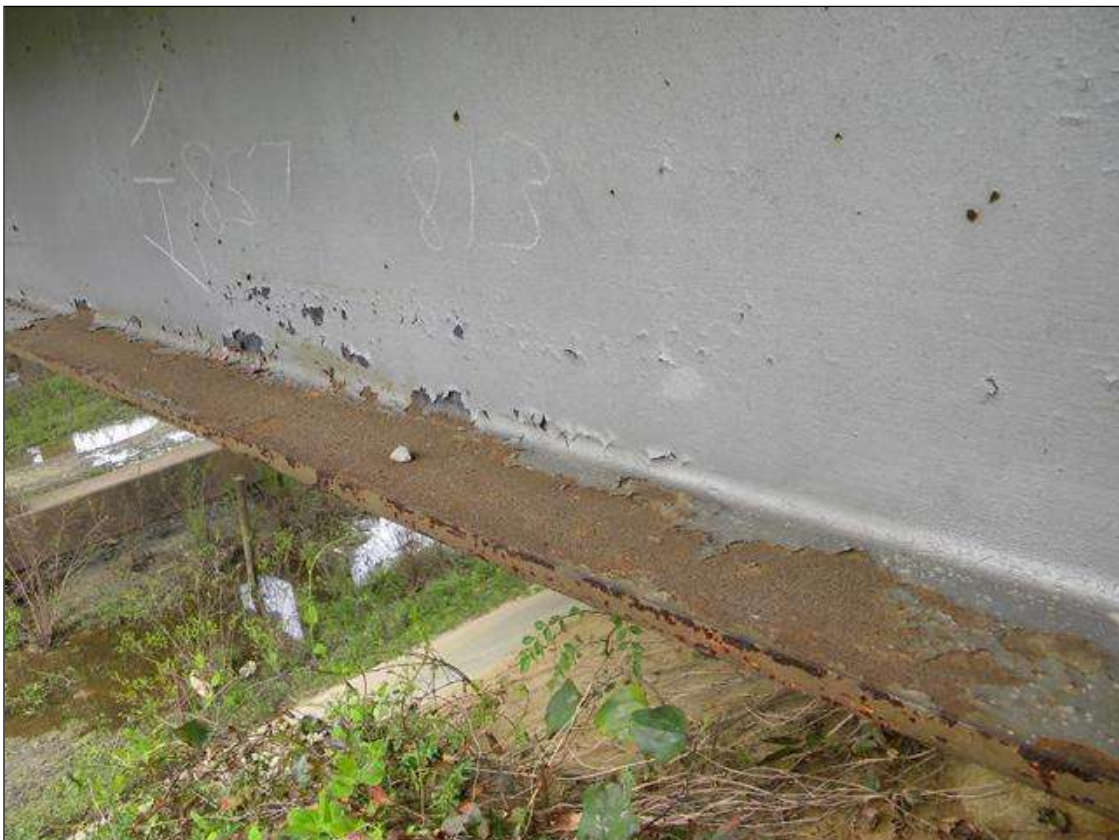
PEELING PAINT & SURFACE RUST IN THE RIGHT SIDE BOTTOM FLANGE OF BEAM 4 IN SPAN 4 OUT 10 FT. FROM END BENT 2

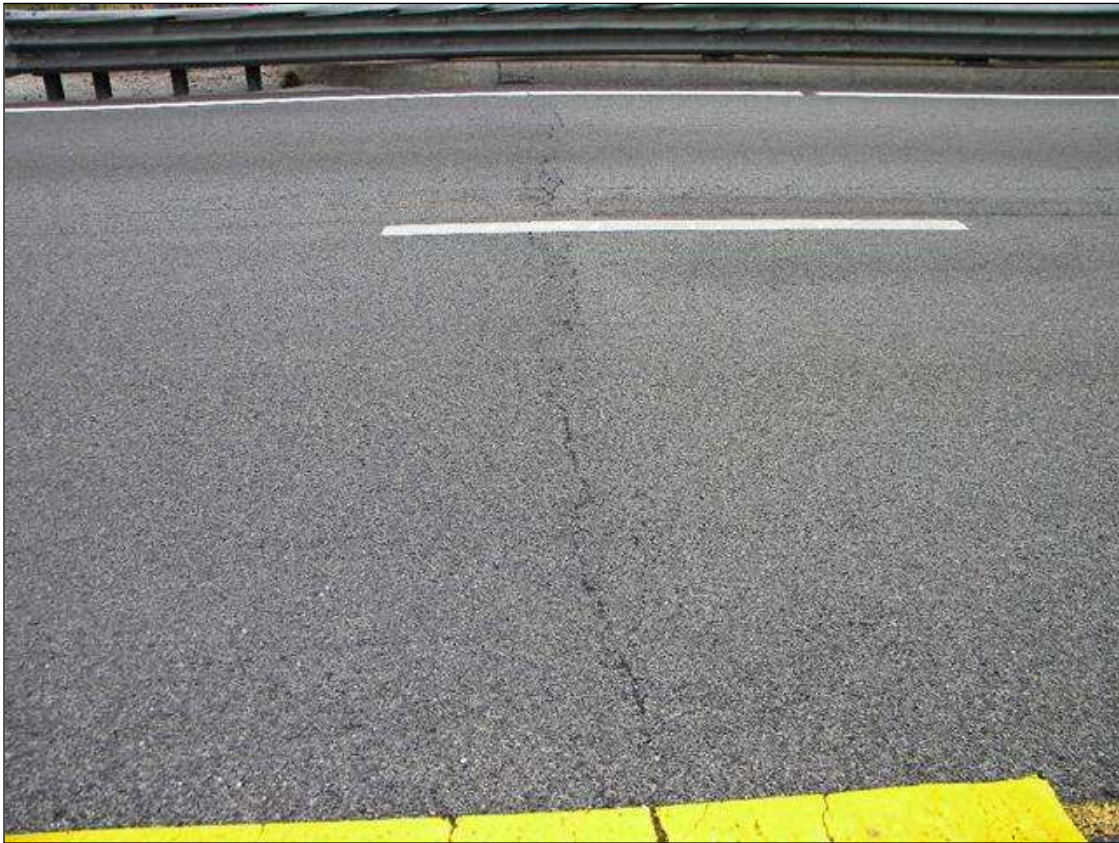
TRANSVERSE CRACK IN WEARING SURFACE OVER END BENT 2

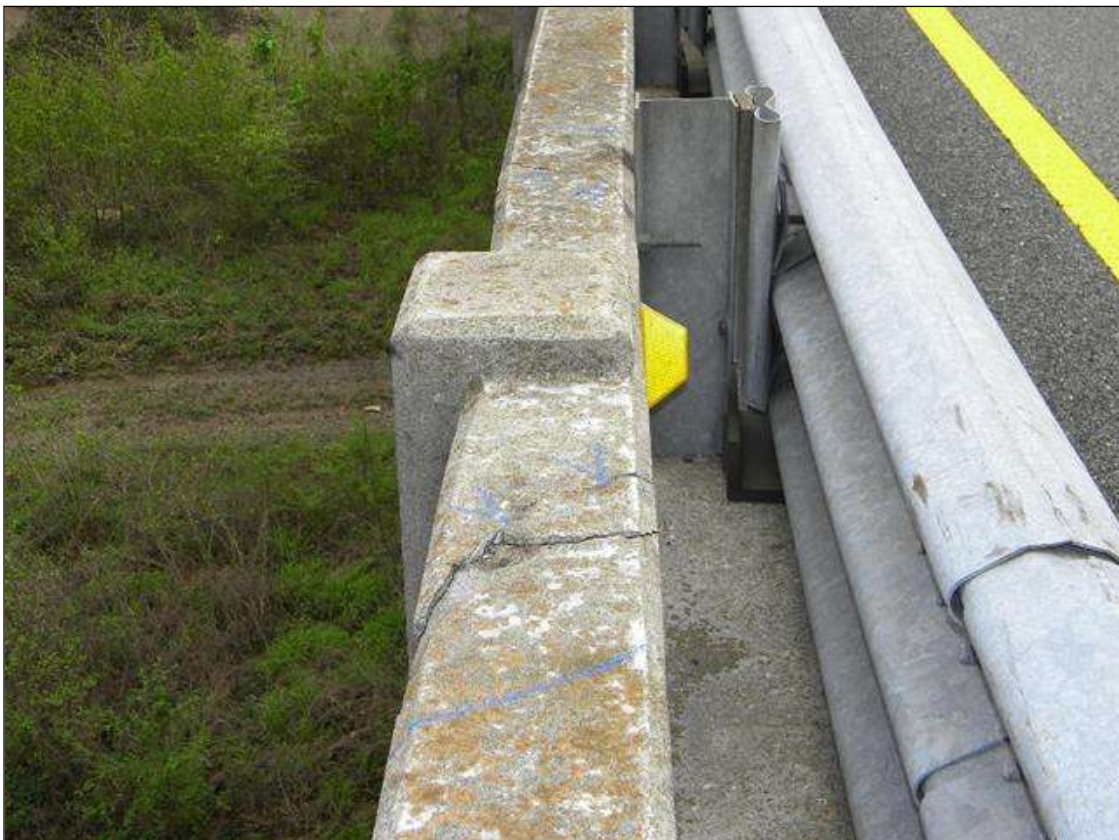
LEFT SIDE GUARDRAIL IN SPAN 2 IS CRACKED AND SPALLING FROM IMPACT DAMAGE

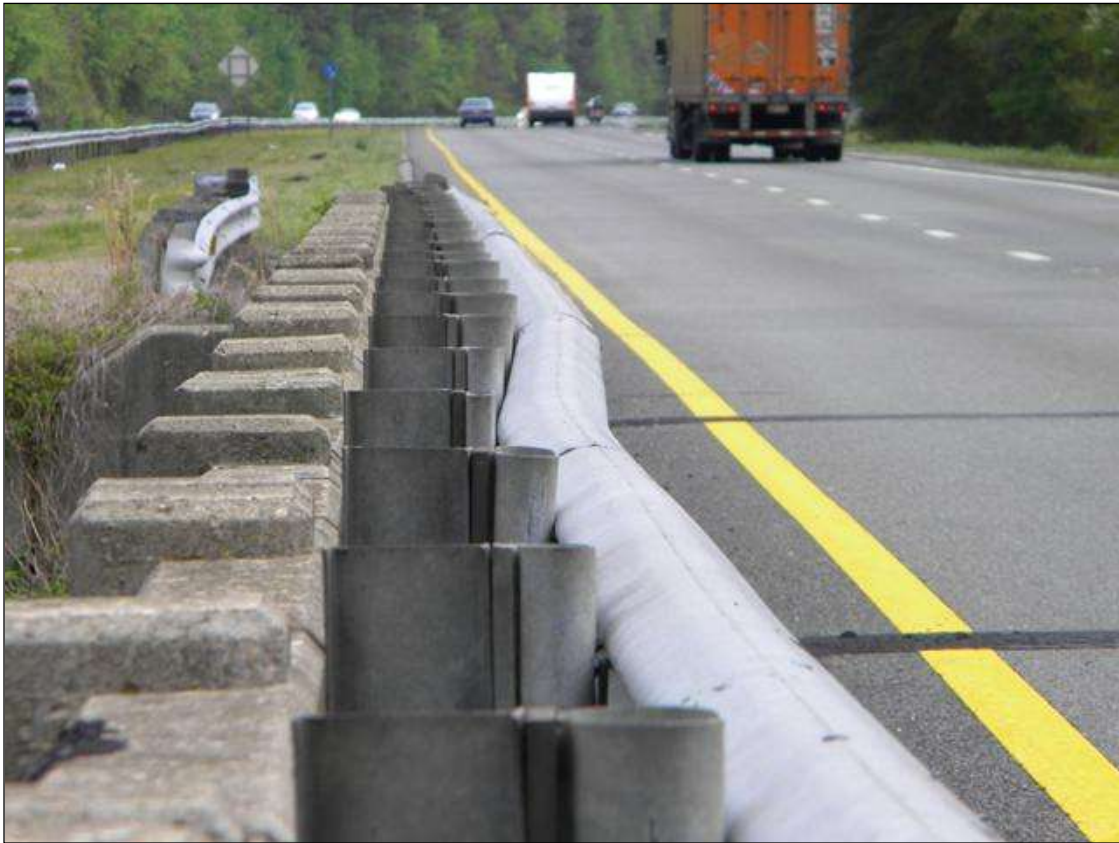
IMPACT DAMAGE ALONG THE LEFT SIDE STEEL GUARDRAIL OF SPAN 2

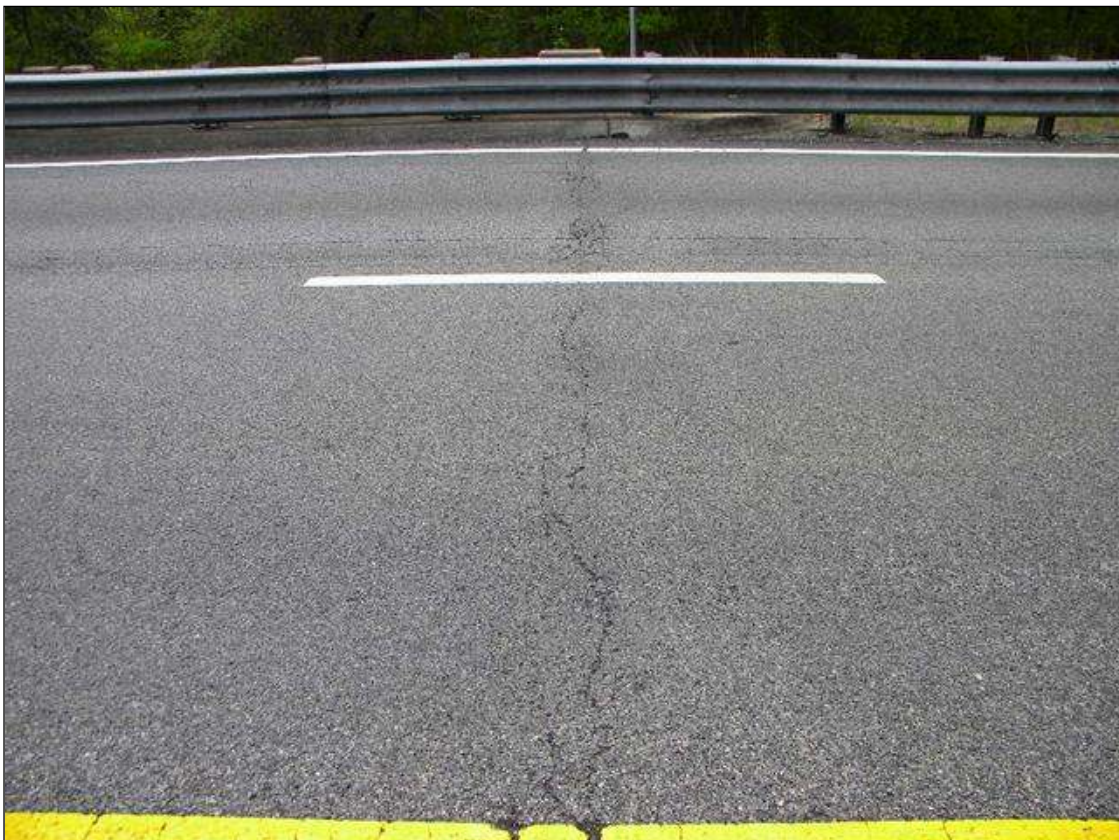
TRANSVERSE CRACK IN WEARING SURFACE OVER END BENT 1

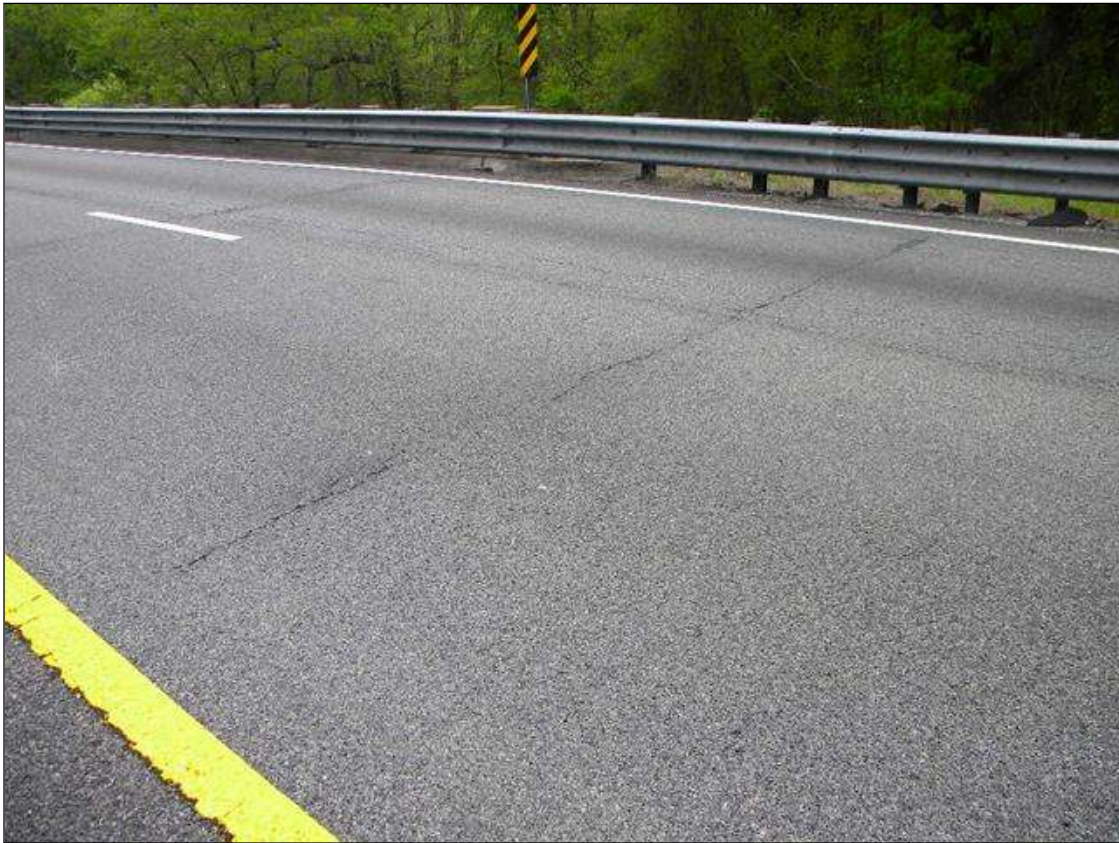
TRANSVERSE CRACK IN APPROACH 1

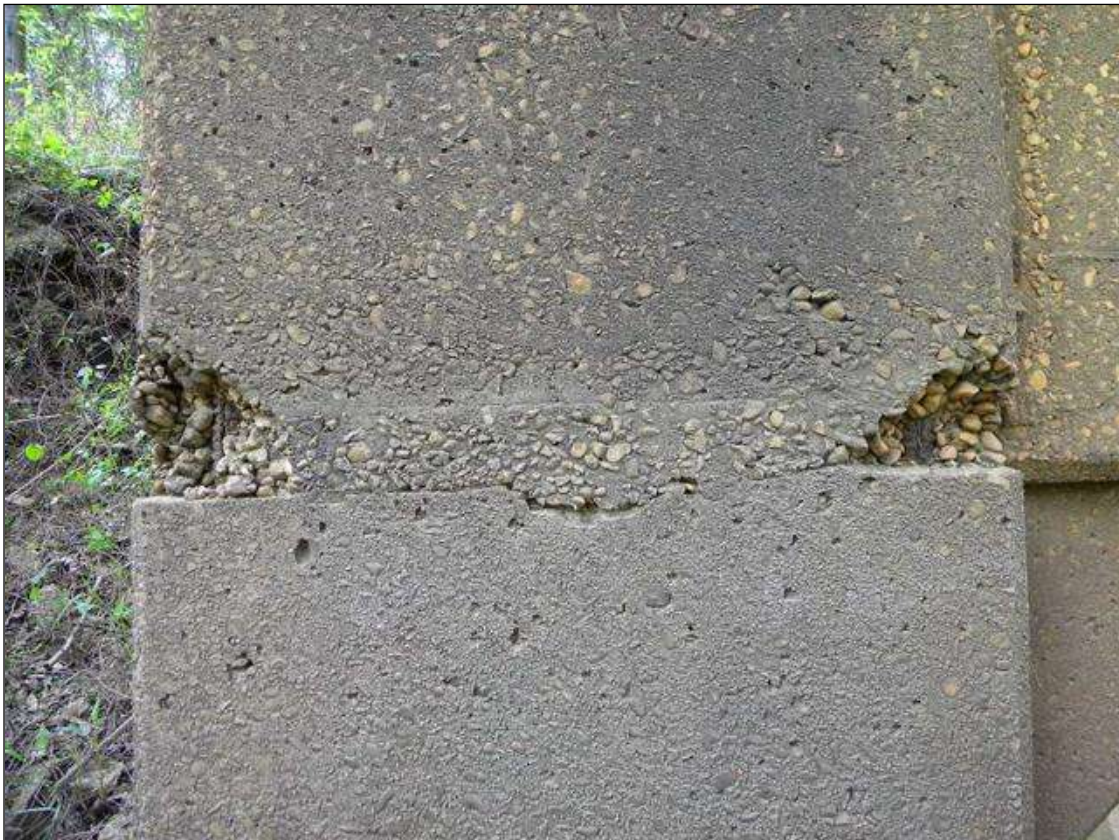
TWO "HONEYCOMBED" AREAS WITH EXPOSED REBAR IN COLUMN 2 AT BENT 1 SPAN 2 SIDE

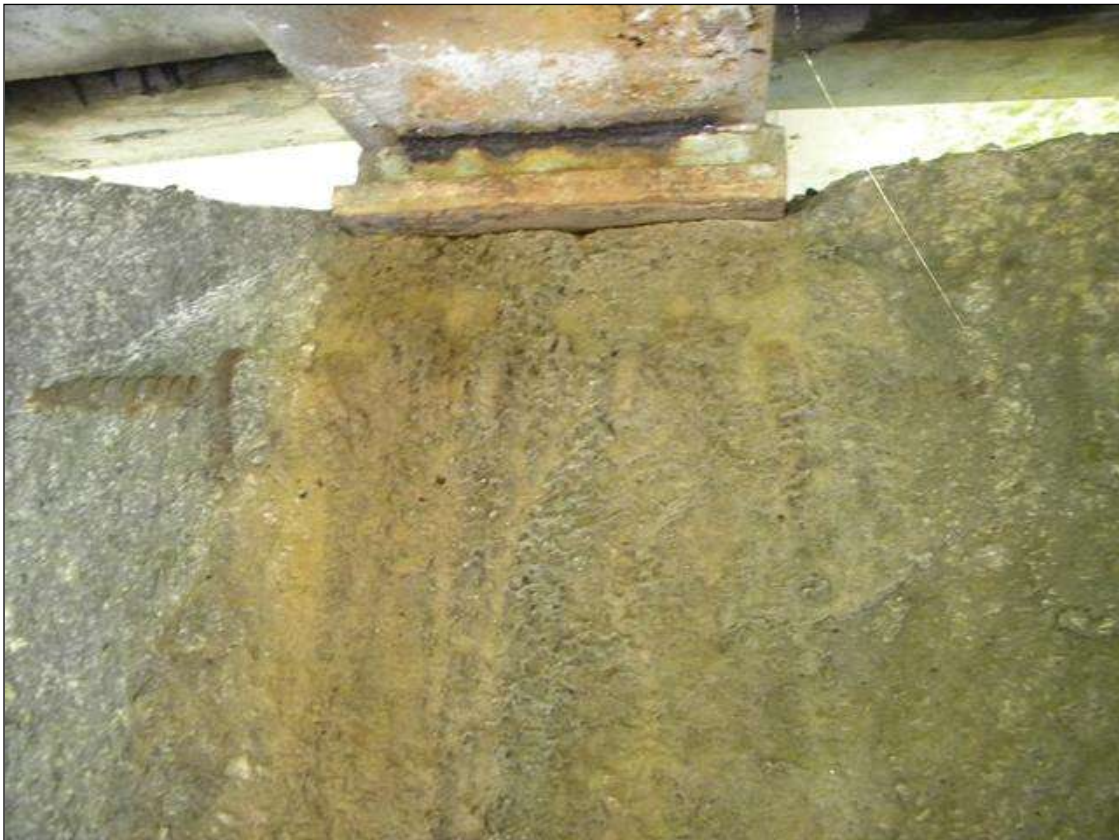
SPALL IN BENT 1 CAP SPAN 2 SIDE AT BEAM 3, PHOTO 1 OF 2 (PRIORITY MAINTENACNE ISSUED)

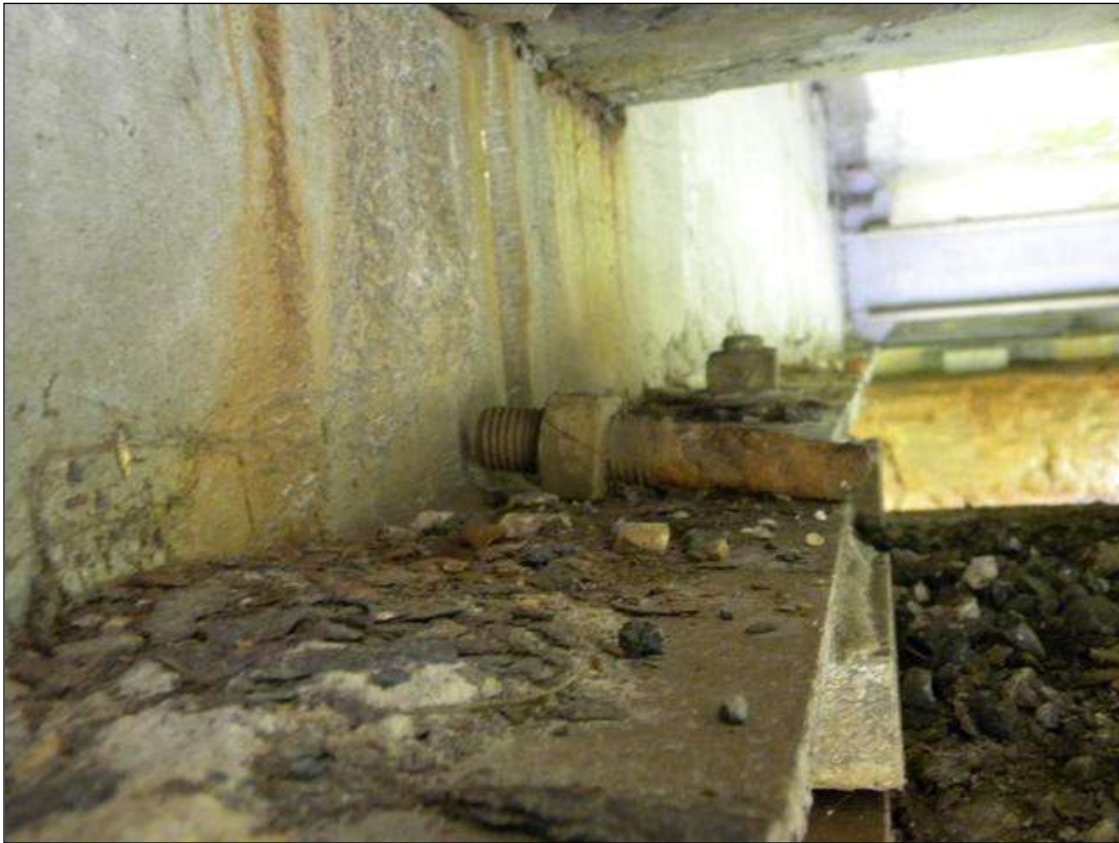
BROKEN ANCHOR BOLT IN THE LEFT SIDE OF BEAM 3 BEARING ASSEMBLY AT BENT 1 SPAN 2 (PRIORITY MAINTENACNE ISSUED)

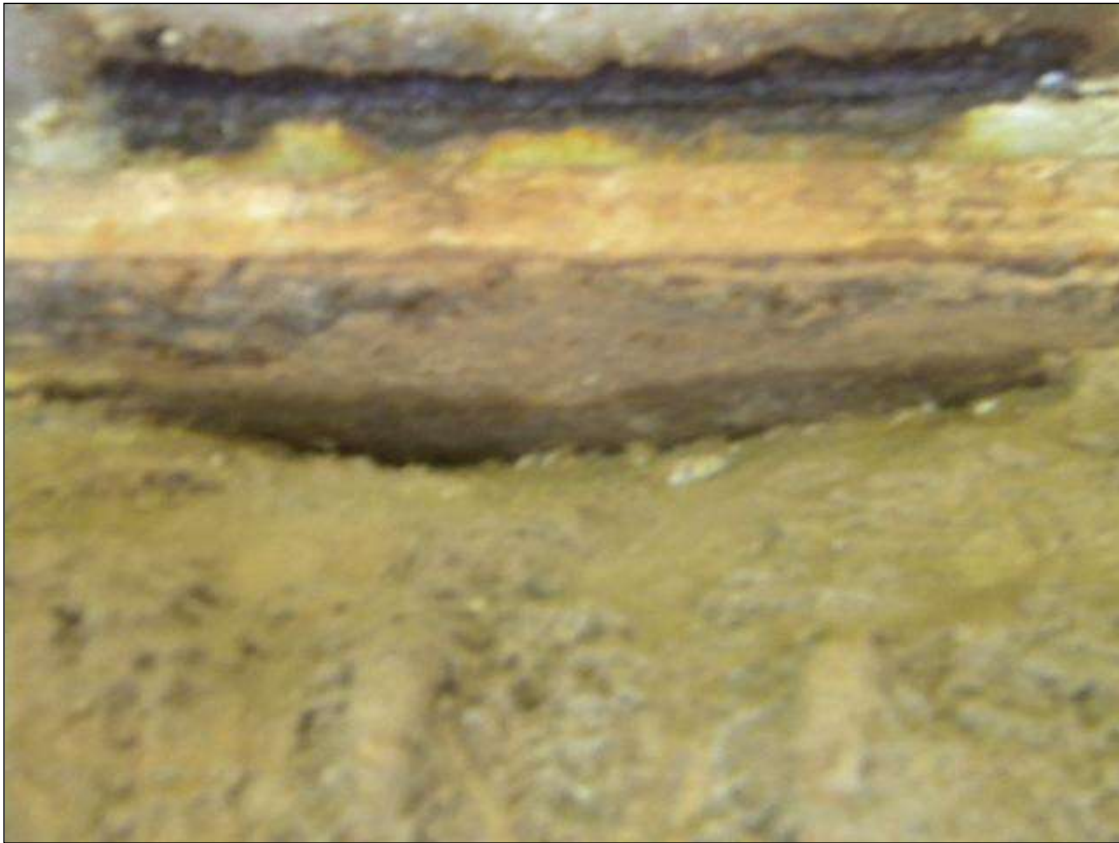
LAREG SPALL WITH EXPOSED MASONRY PLATE AT BEAM 3 BENT 1 SPAN 2 SIDE, PHOTO 2 OF 2 (PRIORITY MAINTENACNE ISSUED)

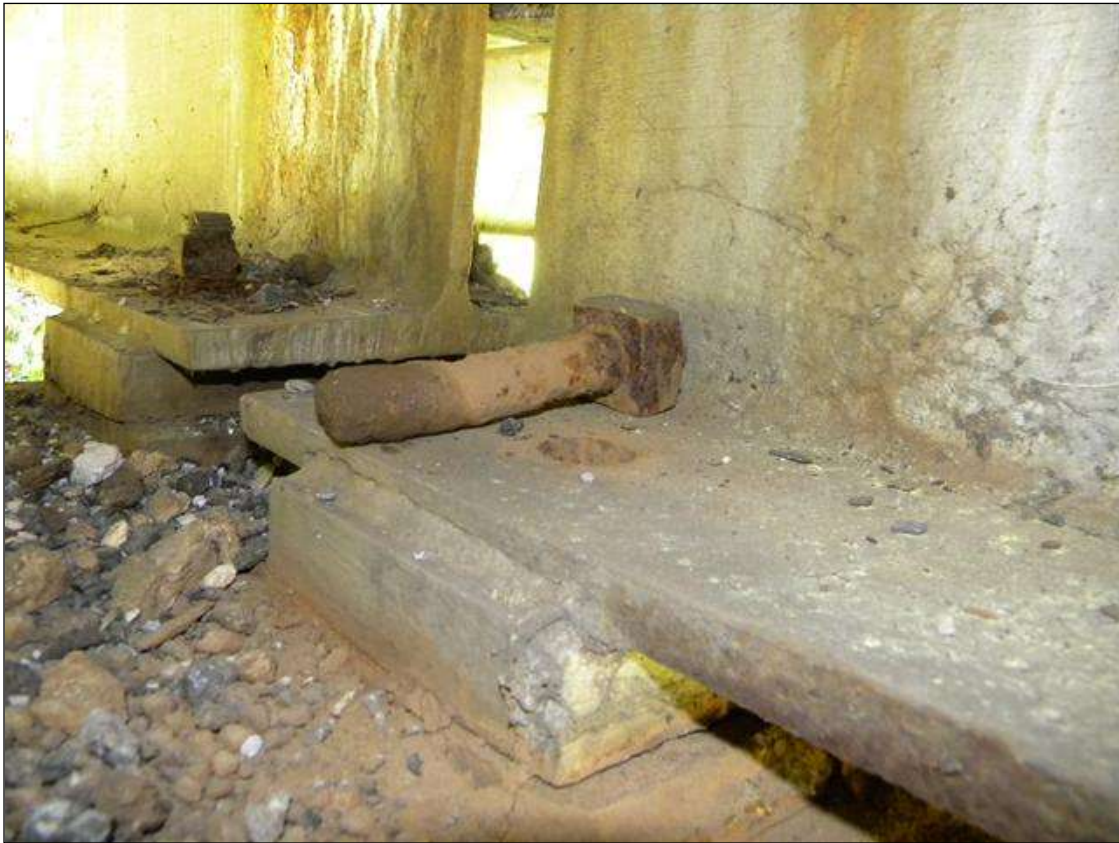
BROKEN ANCHOR BOLT IN THE RIGHT SIDE OF BEAM 2 BEARING ASSEMBLY AT BENT 1 SPAN 2 (PRIORITY MAINTENACNE ISSUED)

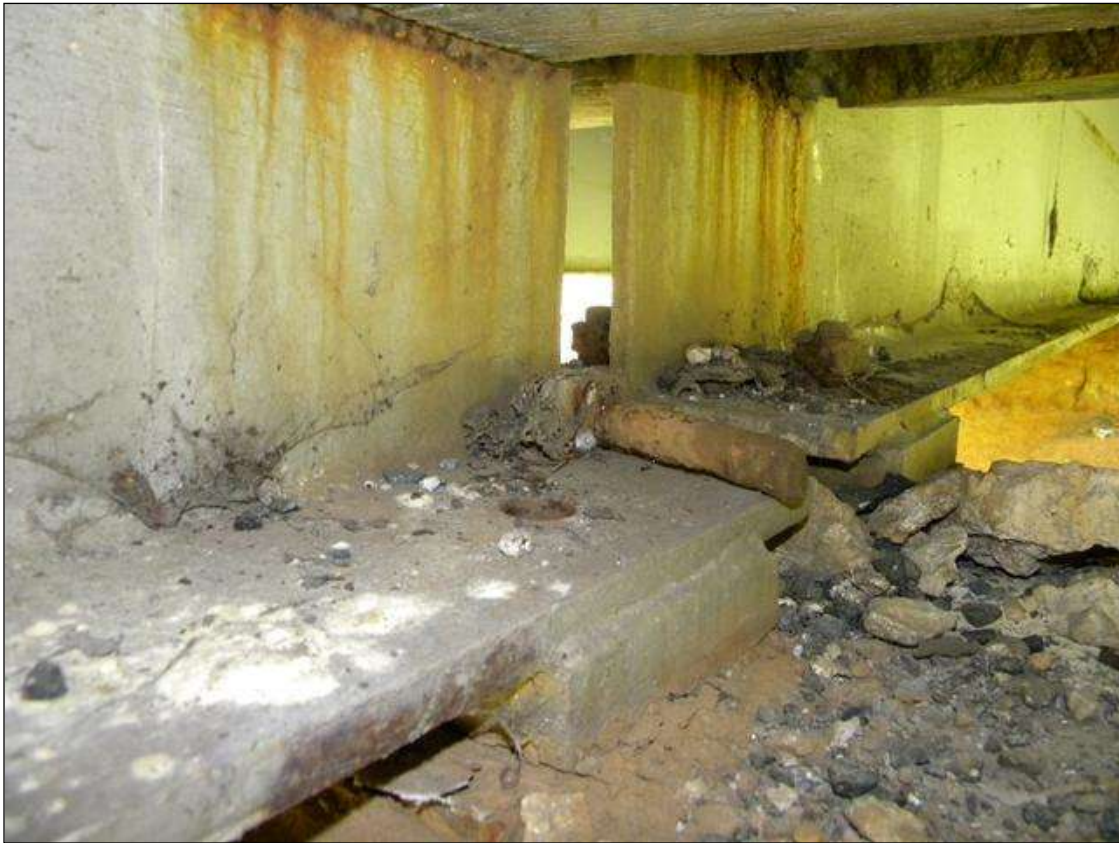
BROKEN ANCHOR BOLT IN THE LEFT SIDE OF BEAM 2 BEARING ASSEMBLY AT BENT 1 SPAN 2 (PRIORITY MAINTENACNE ISSUED)

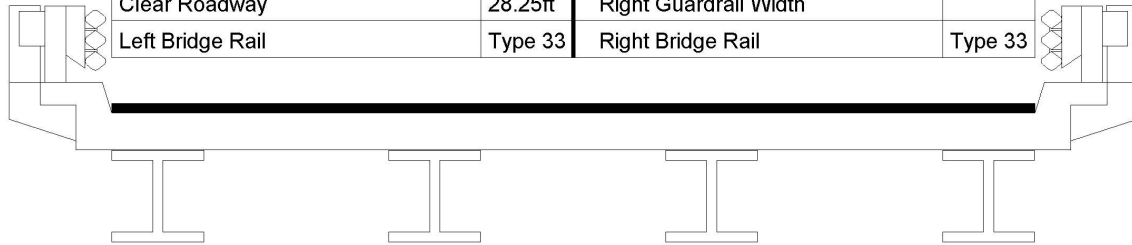
Measurements for Span #	1		
Deck Thickness	0.583	Left Overhang	3.75
Top of Rail to Bottom of Beam	6	Right Overhang	3.75
