NC DEPARTMENT OF TRANSPORTATION
 DIVISION OF HIGHWAYS
 BRIDGE MANAGEMENT UNIT

PRIORITY MAINTENANCE ISSUED ON ANCHOR BOLT

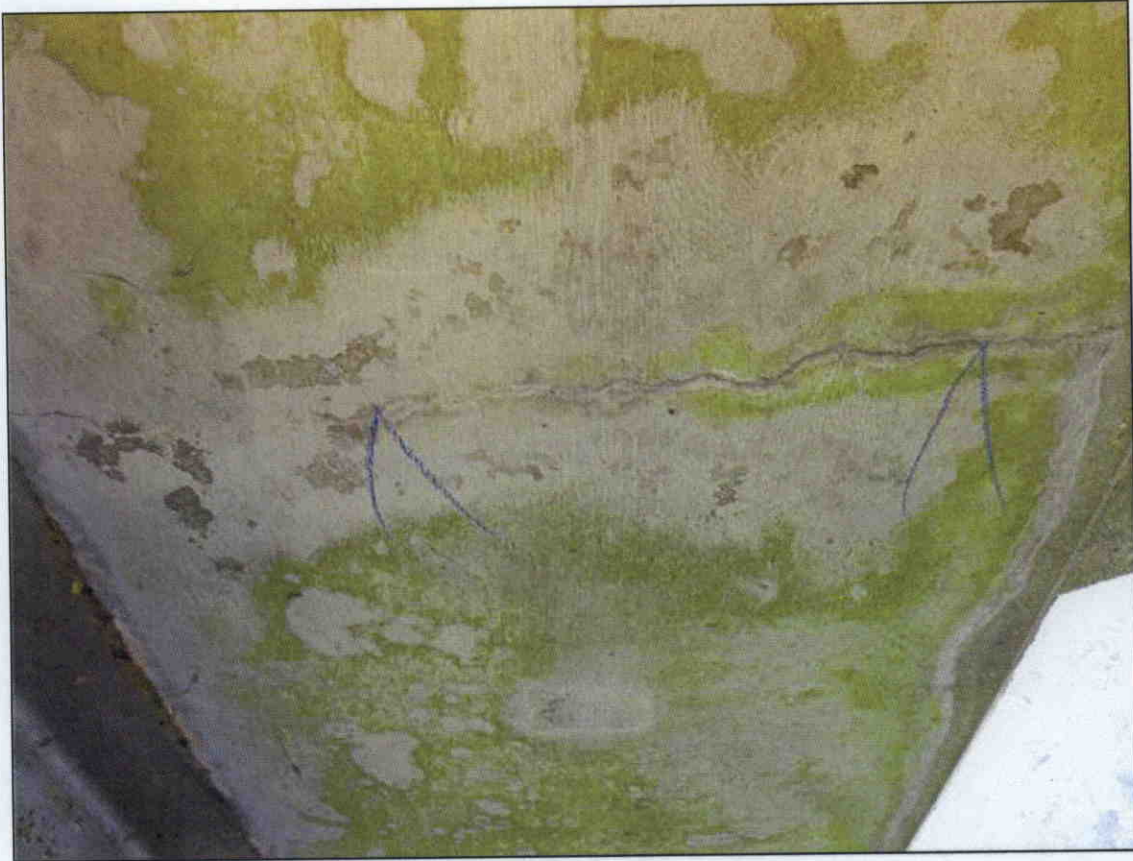
RANDOM HAIRLINE TRANSVERSE CRACKS WITH EFFLORESCENCE IN DECK OVERHANGS

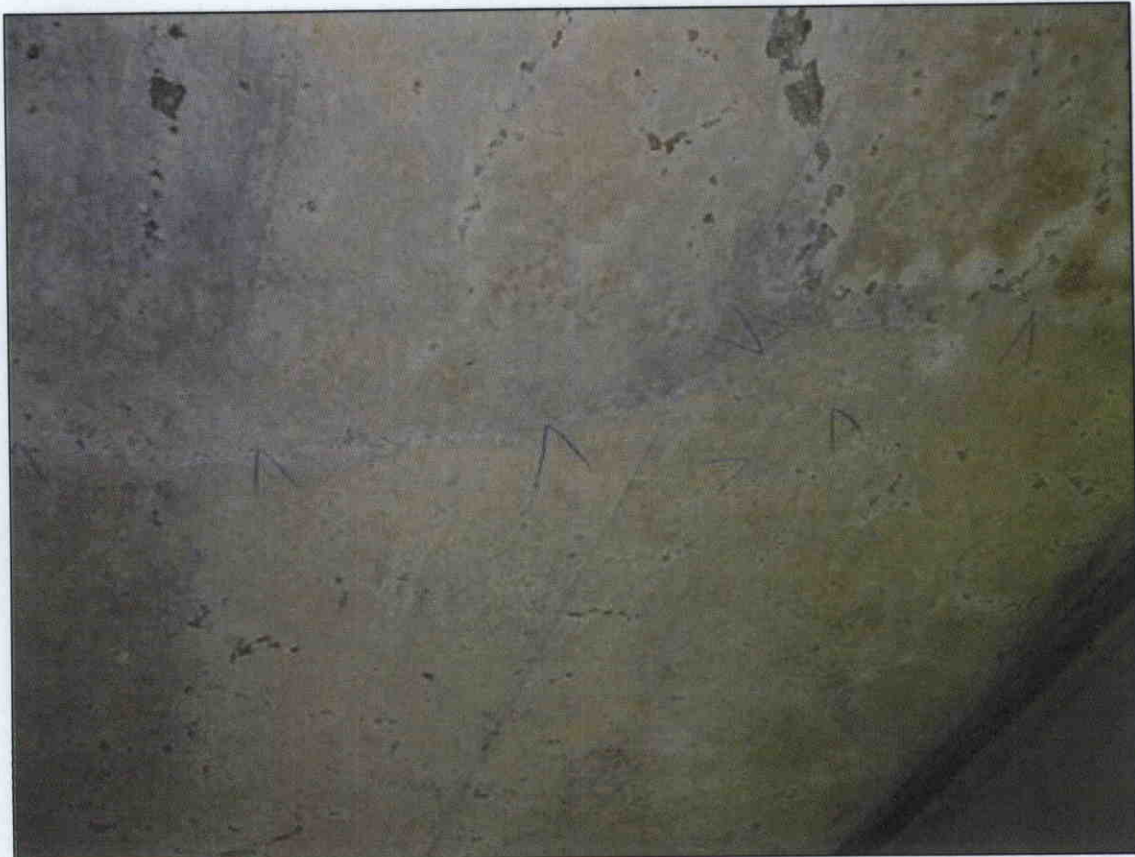
HAIRLINE MAP CRACKING IN BOTTOM OF DECK SPAN 1

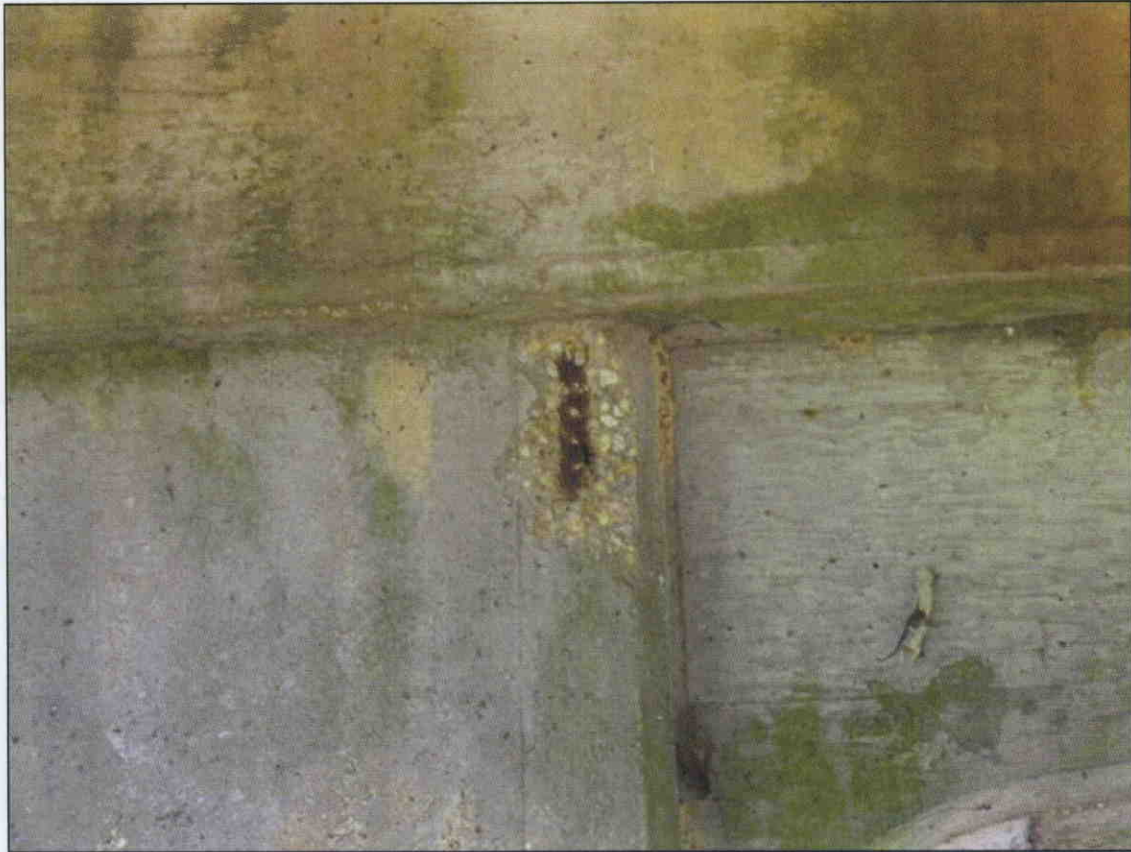
SURFACE SPALL WITH EXPOSED REBAR IN COLUMN 1 AT BENT 1 SPAN 1 SIDE JUST UNDER CAP

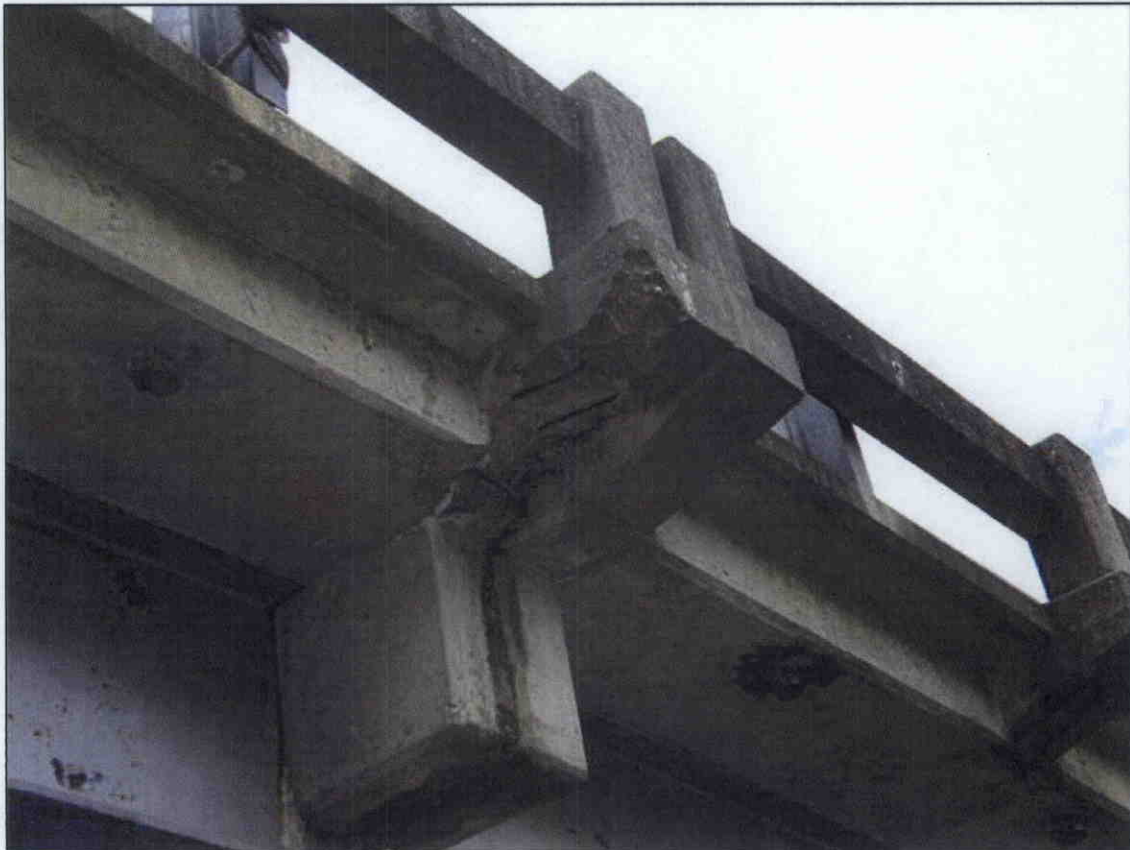
GUARDRAIL END POST BASE AT THE RIGHT SIDE OF BENT 1 SPAN 1 SIDE IS SPALLED WITH EXPOSED REBAR

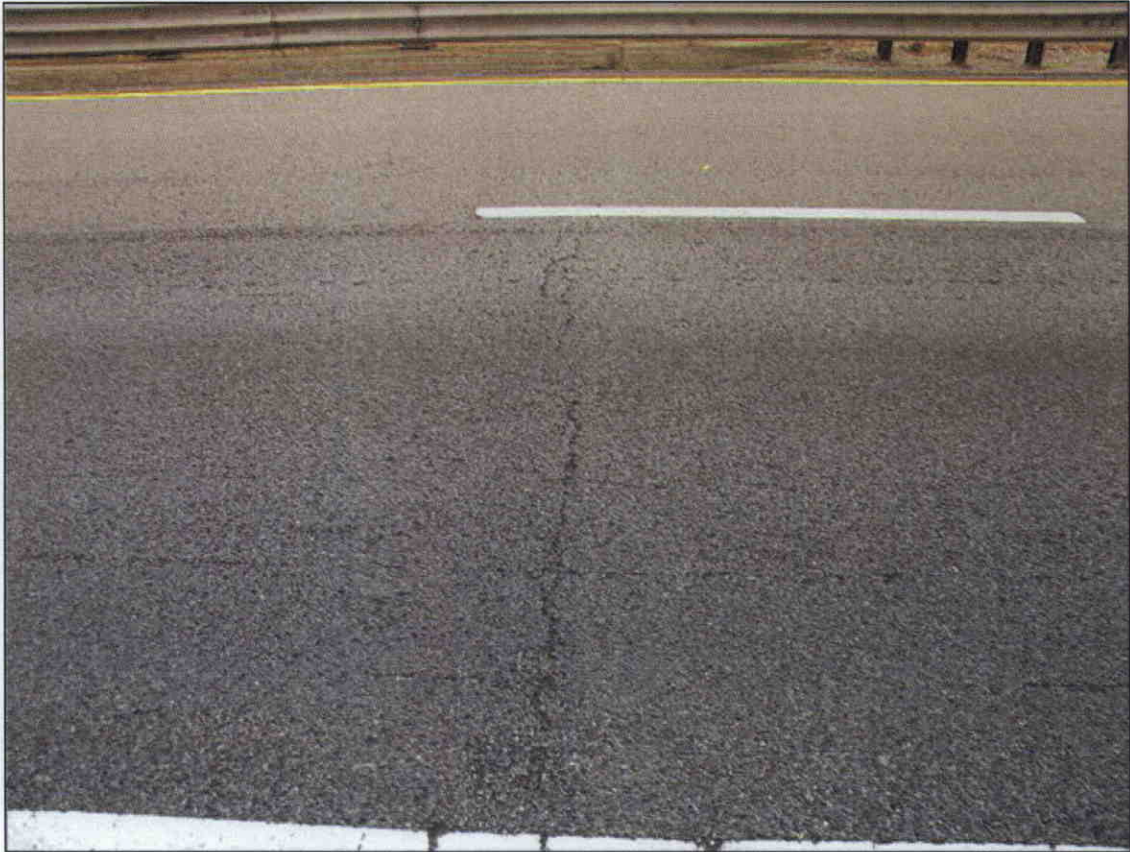
TRANSVERSE CRACK IN WEARING SURFACE OVER END BENT 1

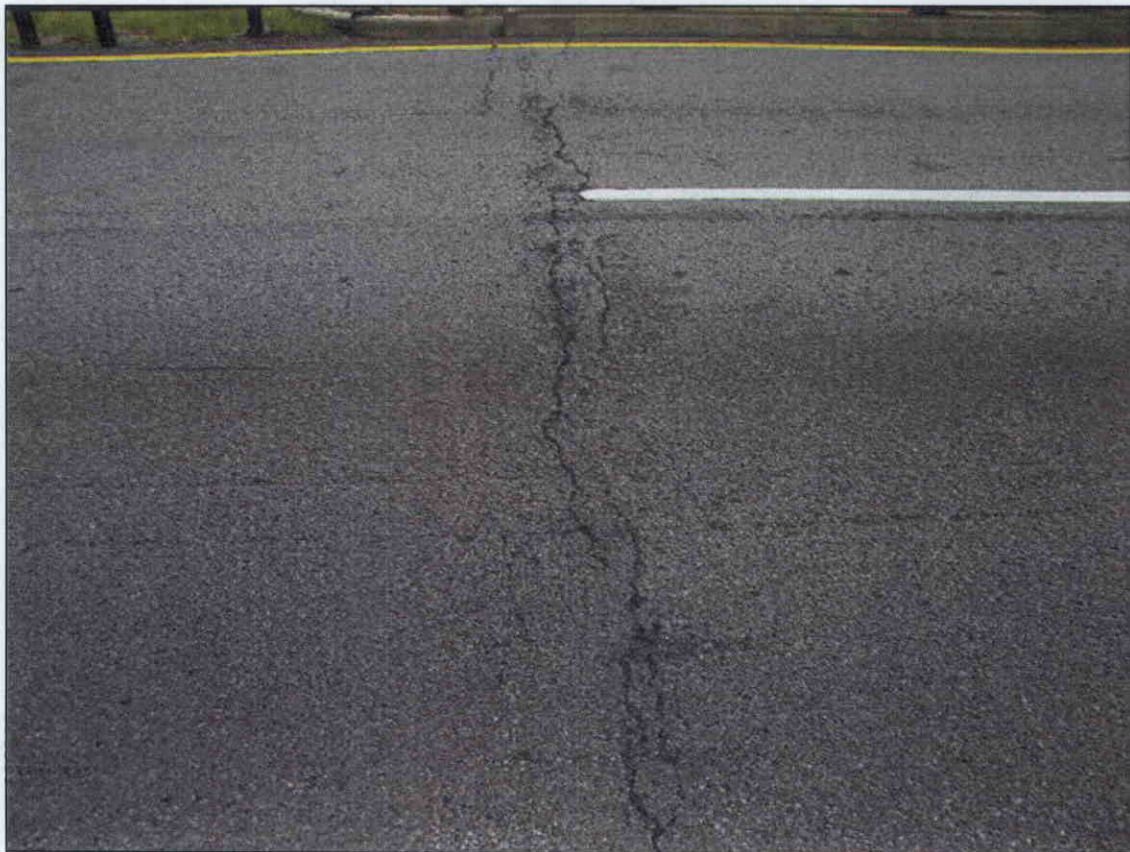
TRANSVERSE CRACKS IN WEARING SURFACE OVER END BENT 2

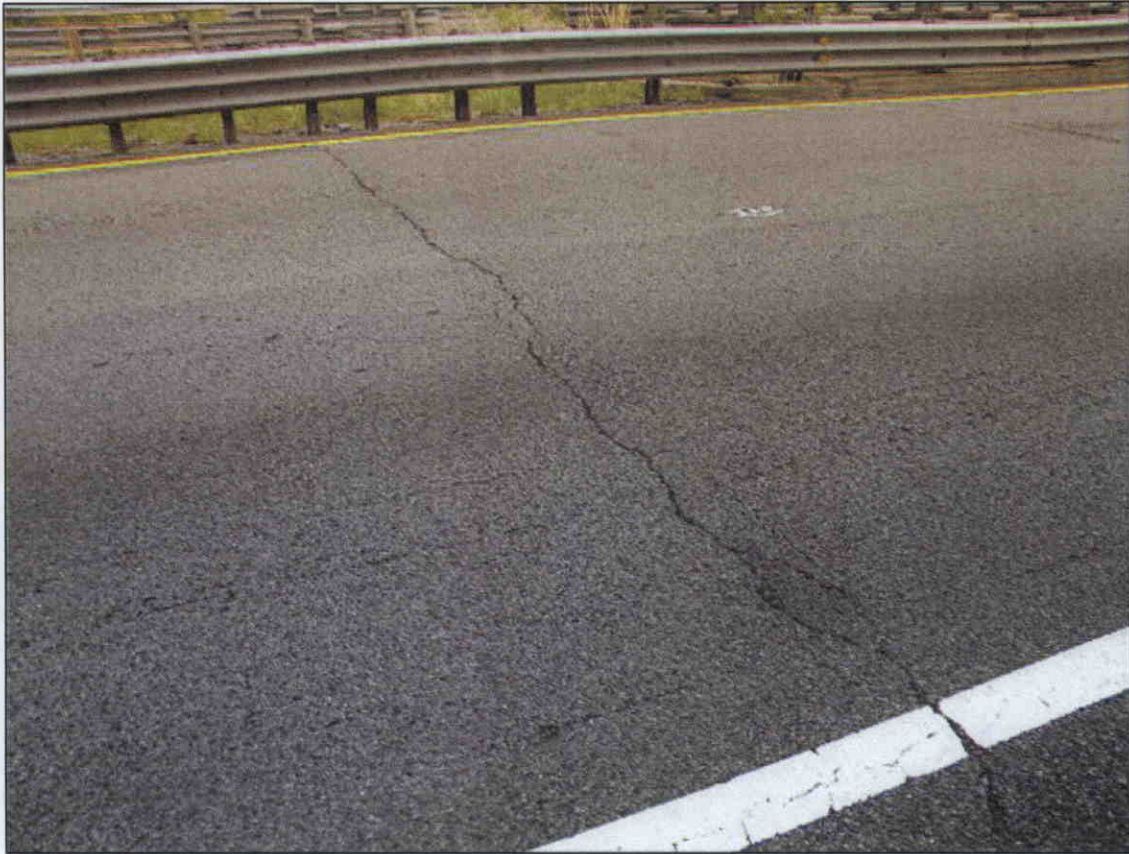
TRANSVERSE CRACK IN APPROACH 2

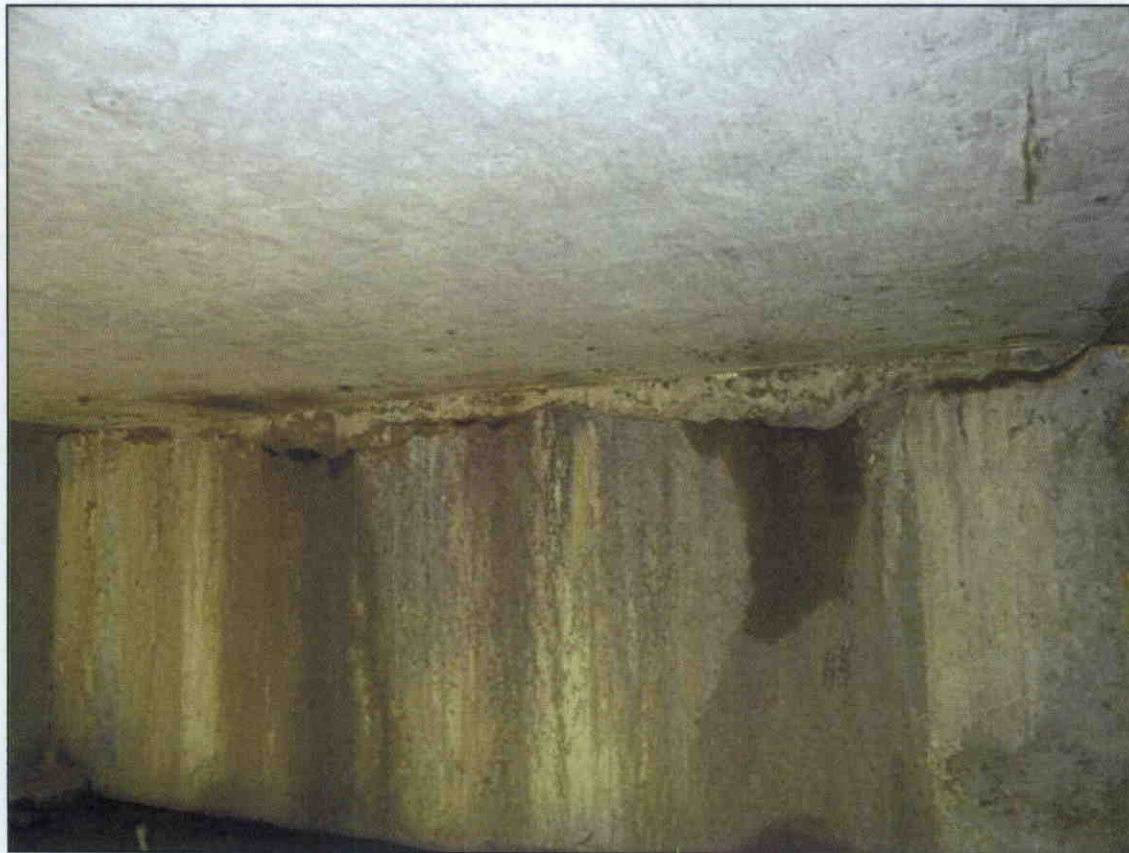
DELAMINATION ALONG THE TOP OF BACKWALL AT END BENT 2 BAY 1

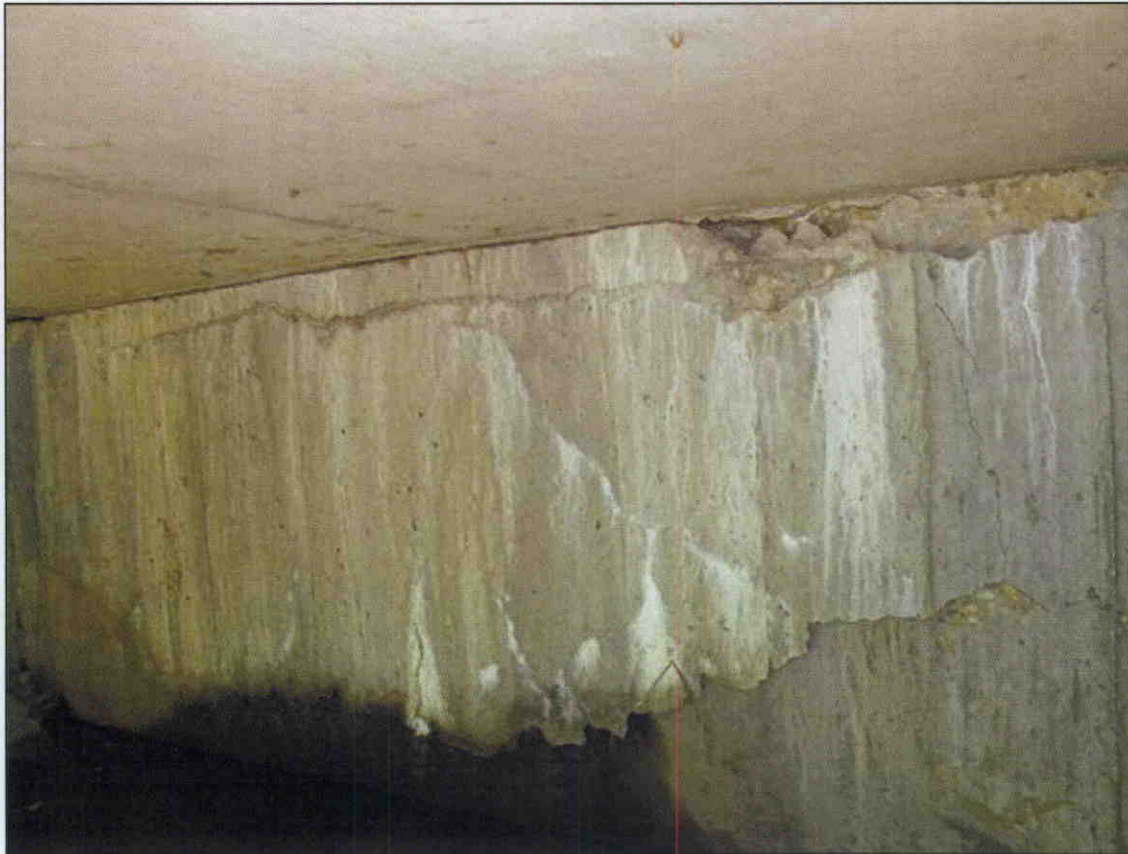
BACKWALL AT END BENT 2 BAY 2 CRACKED, SPALLED AND DELAMINATING

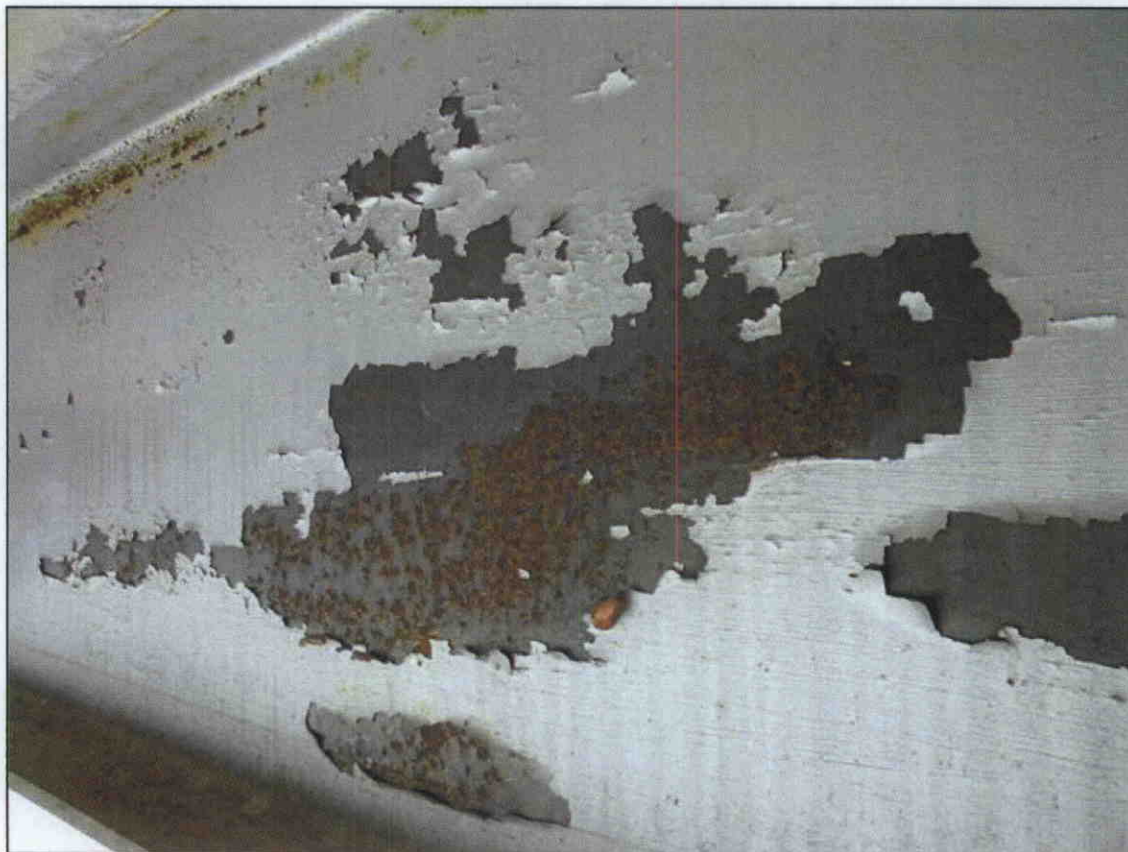
RANDOM SPOTS OF PEELING PAINT AND SURFACE RUST IN BEAM WEBS

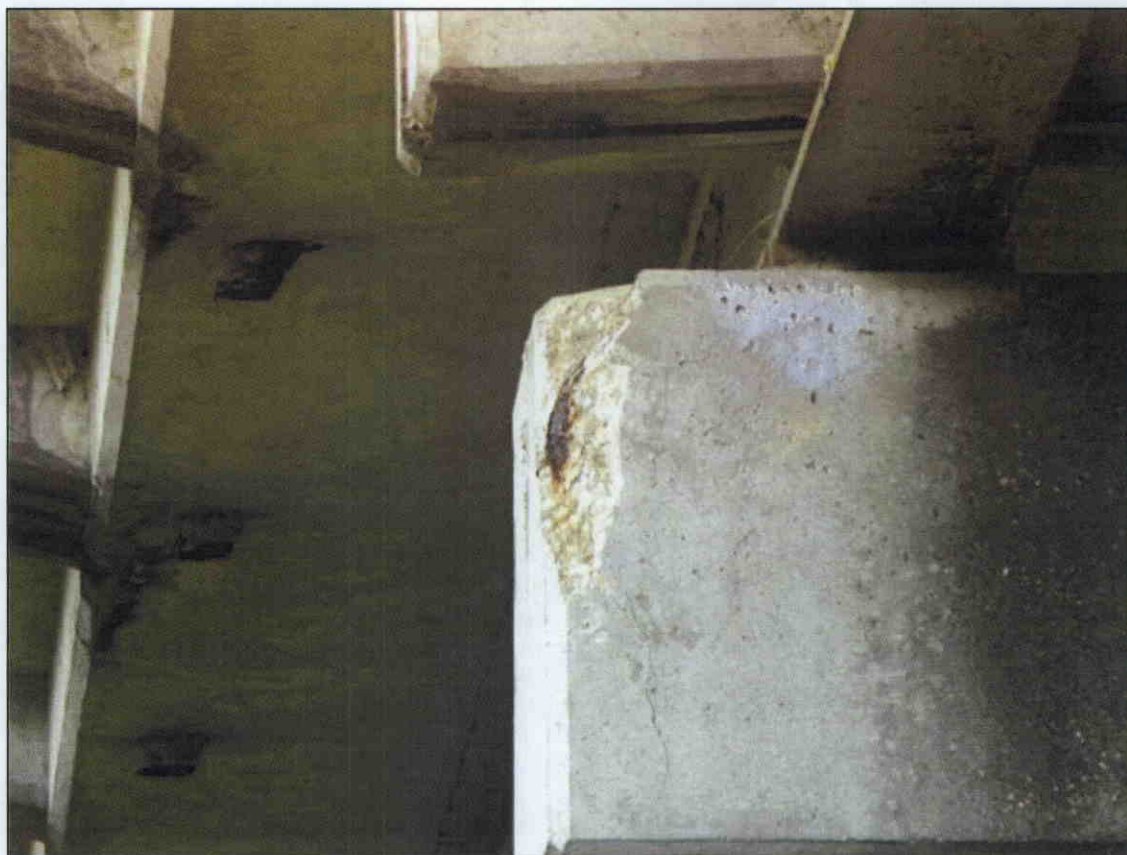
CORNER SPALL WITH EXPOSED REBAR AT BENT 1 RIGHT END OF CAP

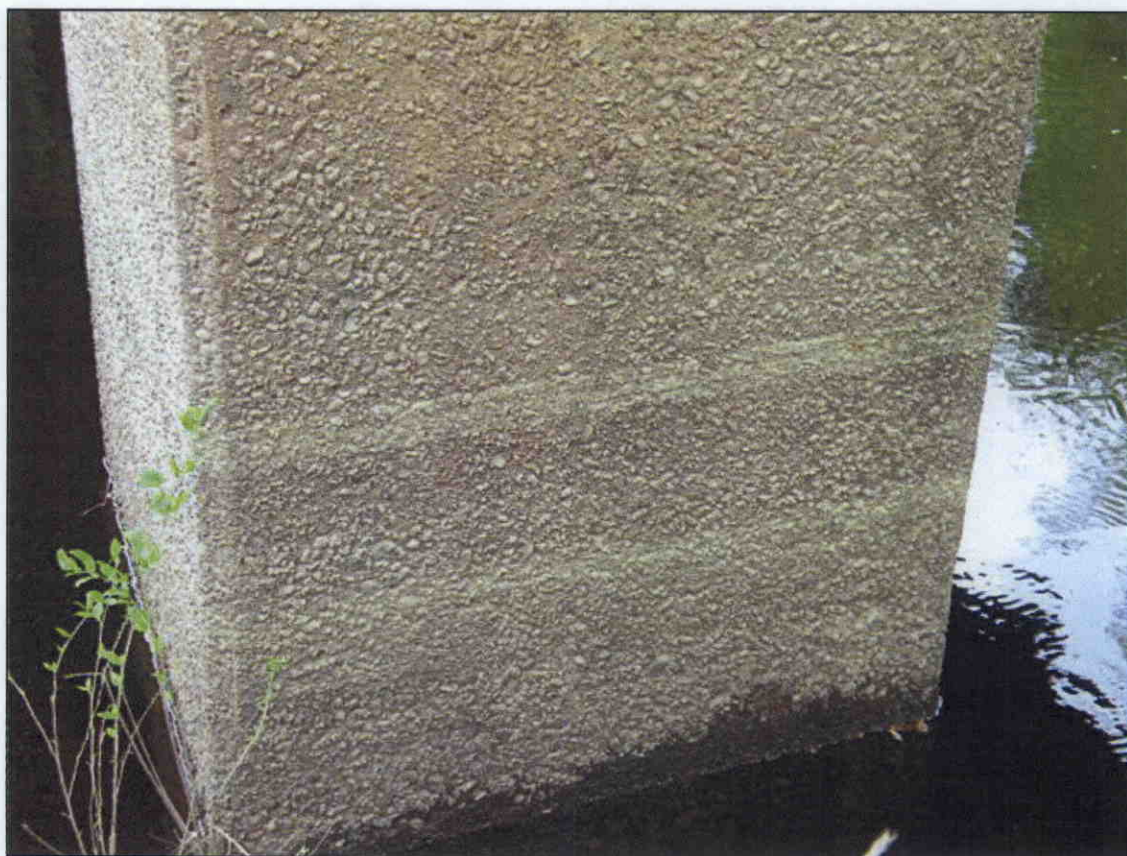
BENT COLUMNS SCALED WITH COARSE AGGREGATE EXPOSED UP TO HIGH WATER MARK

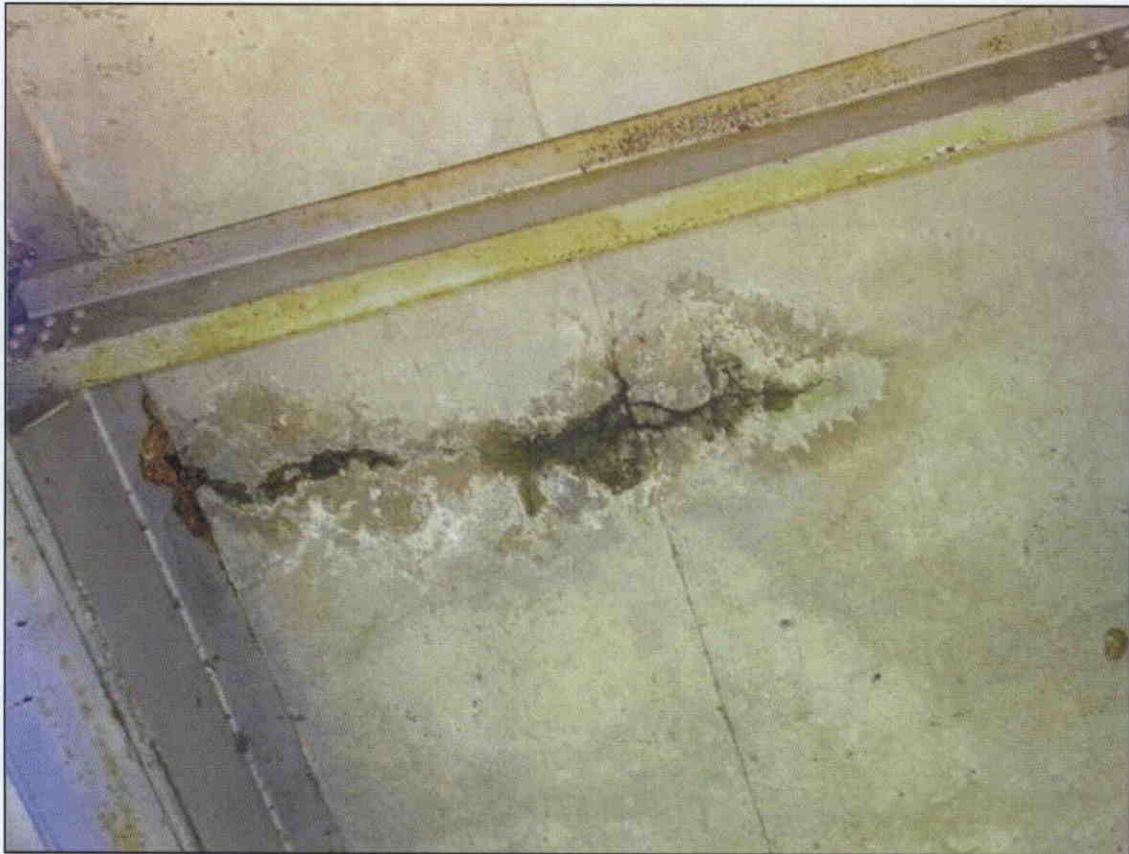
TRANSVERSE CRACK WITH WATER SEEPAGE IN BOTTOM OF DECK SPAN 3 BAY 2 AT 1/3 POINT FROM BENT
2

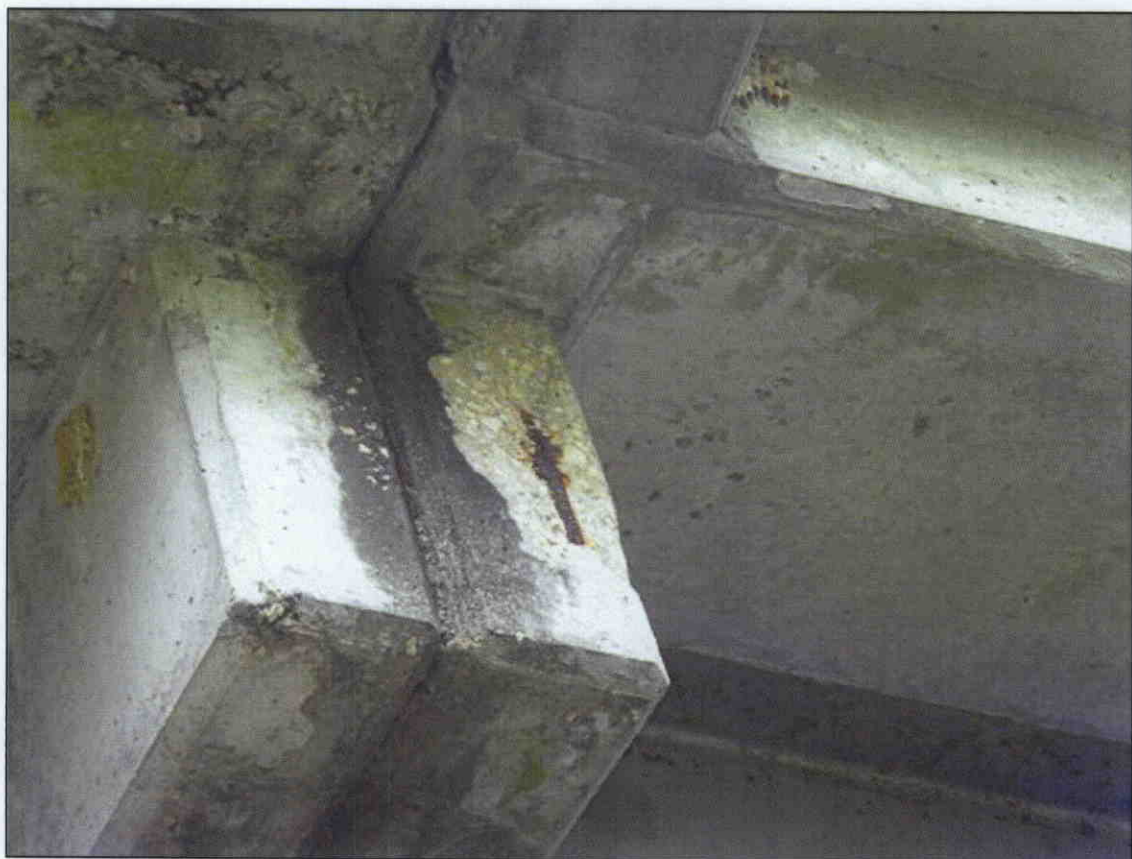
SPALL WITH EXPOSED REBAR IN LEFT EXTERIOR DIAPHRAGM AT BENT 2 SPAN 2 SIDE

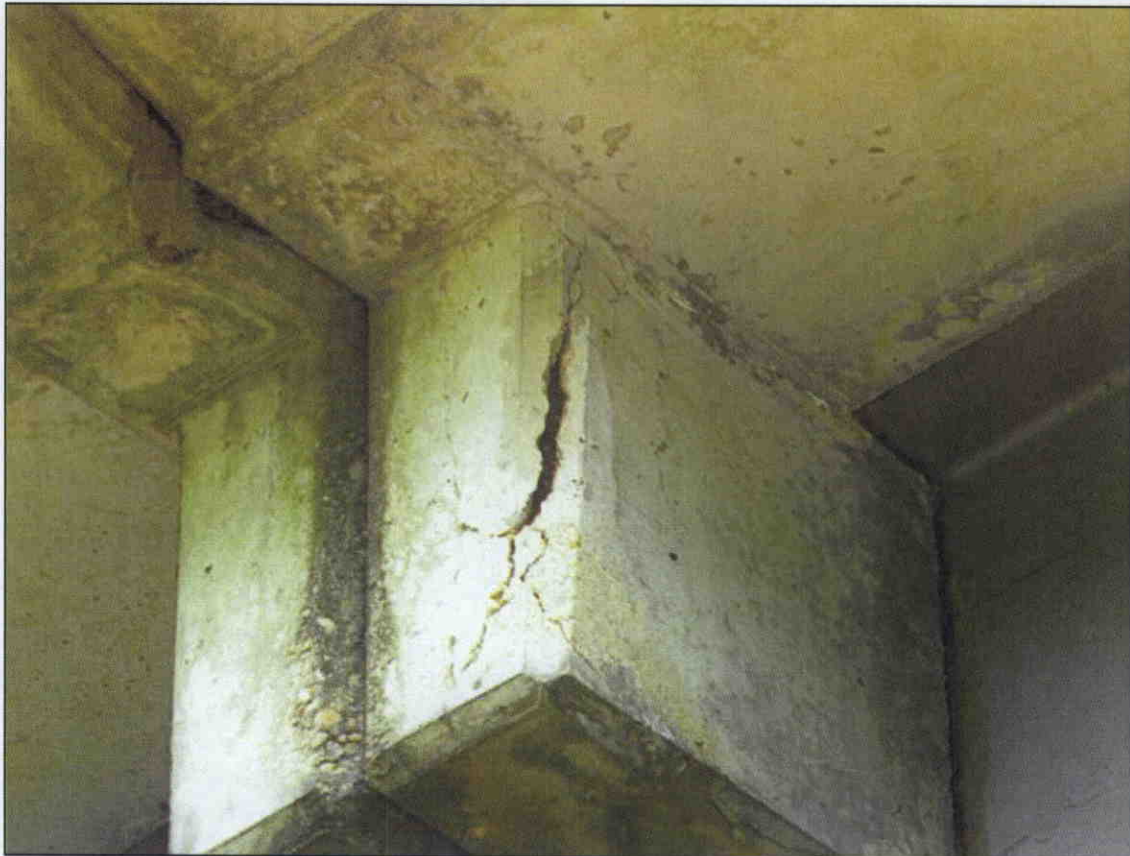
LEFT EXTERIOR DIAPHRAGM AT BENT 3 SPAN 3 SIDE CRACKED AND DELAMINATING

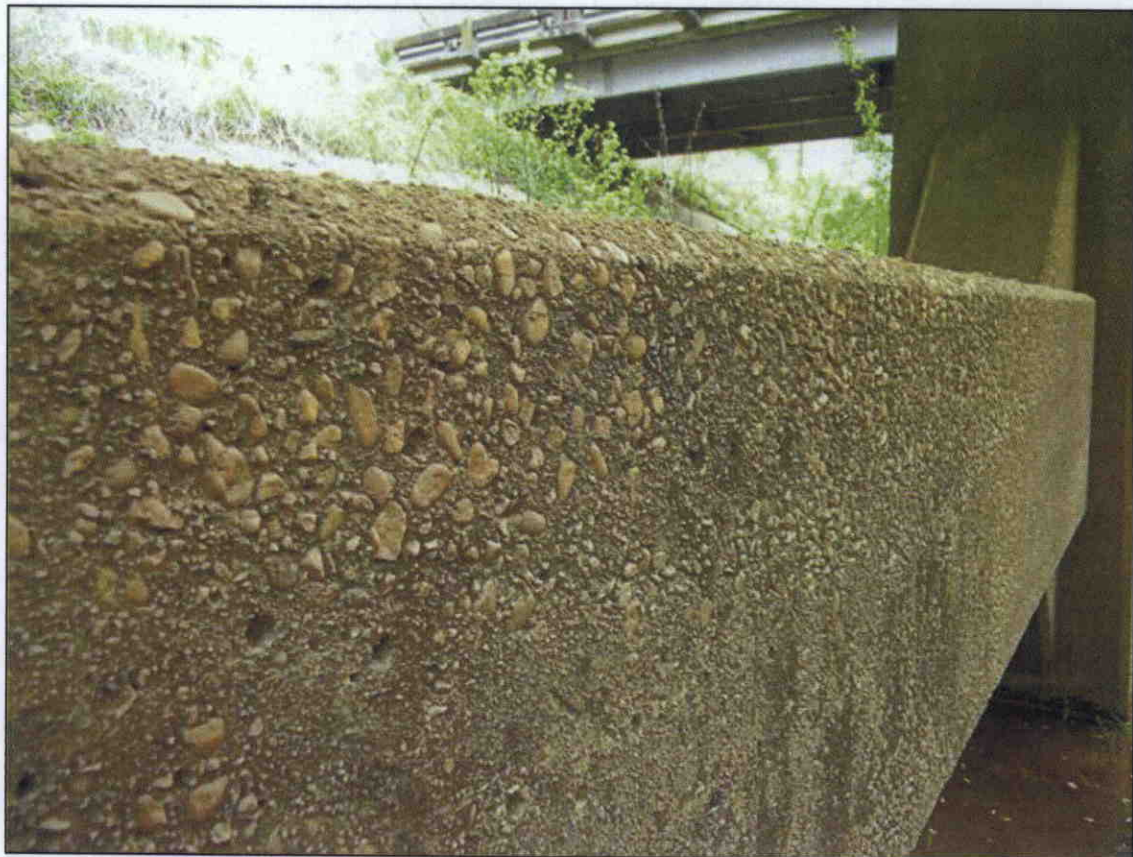
BENT STRUTS SCALED WITH COARSE AGGREGATE EXPOSED

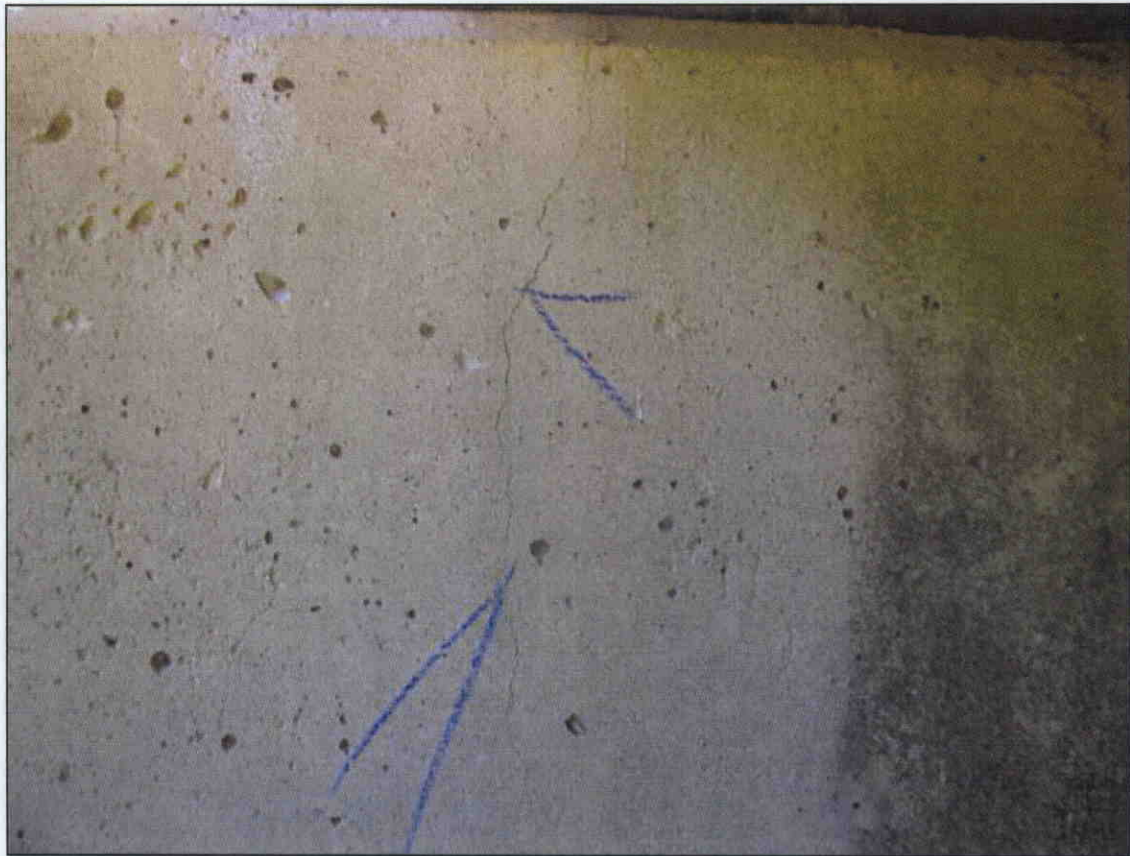
HAIRLINE VERTICAL CRACK IN FACE OF CAP AT BENT 2 SPAN 3 SIDE UNDER BEAM 4

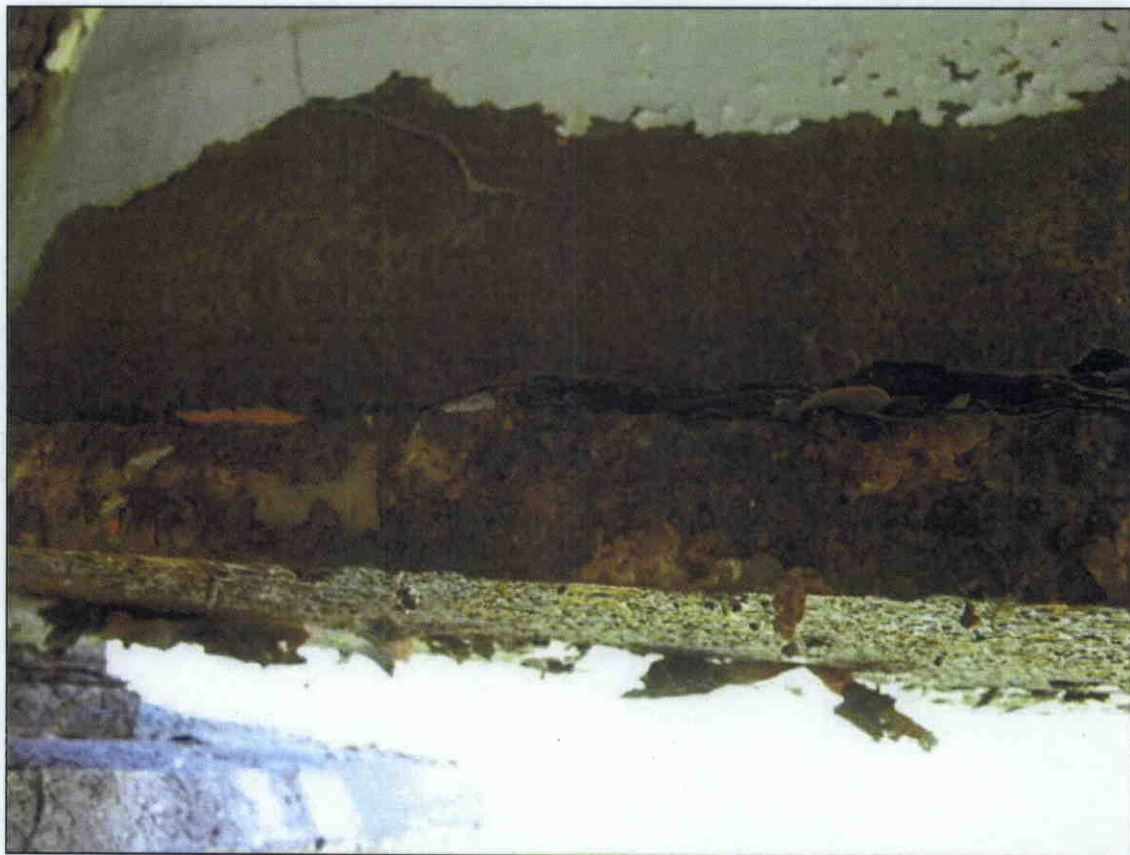
SECTION LOSS IN THE RIGHT SIDE BOTTOM FLANGE AND WEB OF BEAM 1 IN SPAN 3 OVER BENT 2

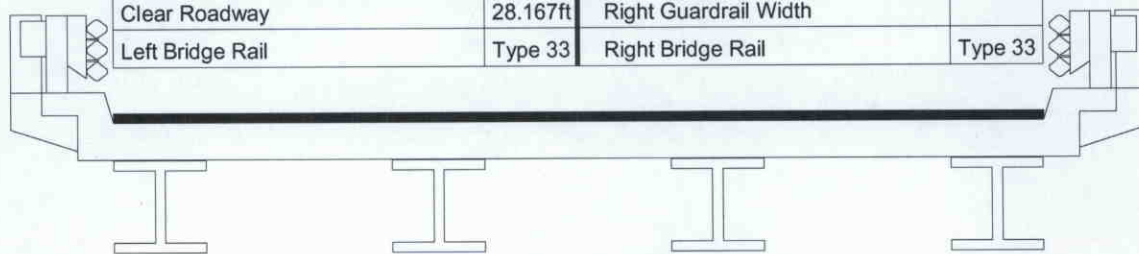
Measurements for Span #	1		
Deck Thickness	.583	Left Overhang	2.917
Top of Rail to Bottom of Beam	5.833	Right Overhang	2.917

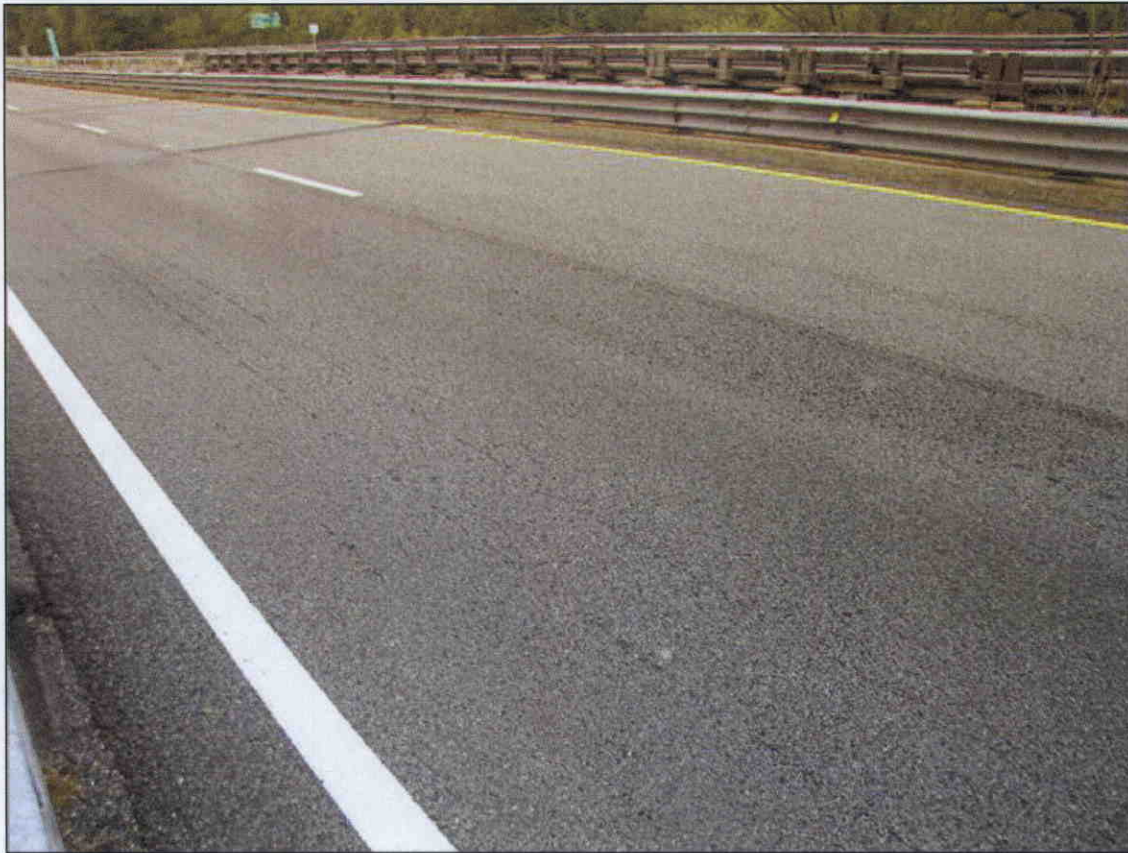
ASPHALT WEARING SURFACE OF SPAN 1 OTHERS SIMILAR
