NC DEPARTMENT OF TRANSPORTATION ATTENTION
 DIVISION OF HIGHWAYS
 BRIDGE MANAGEMENT UNIT

BRIDGE INSPECTION REPORT

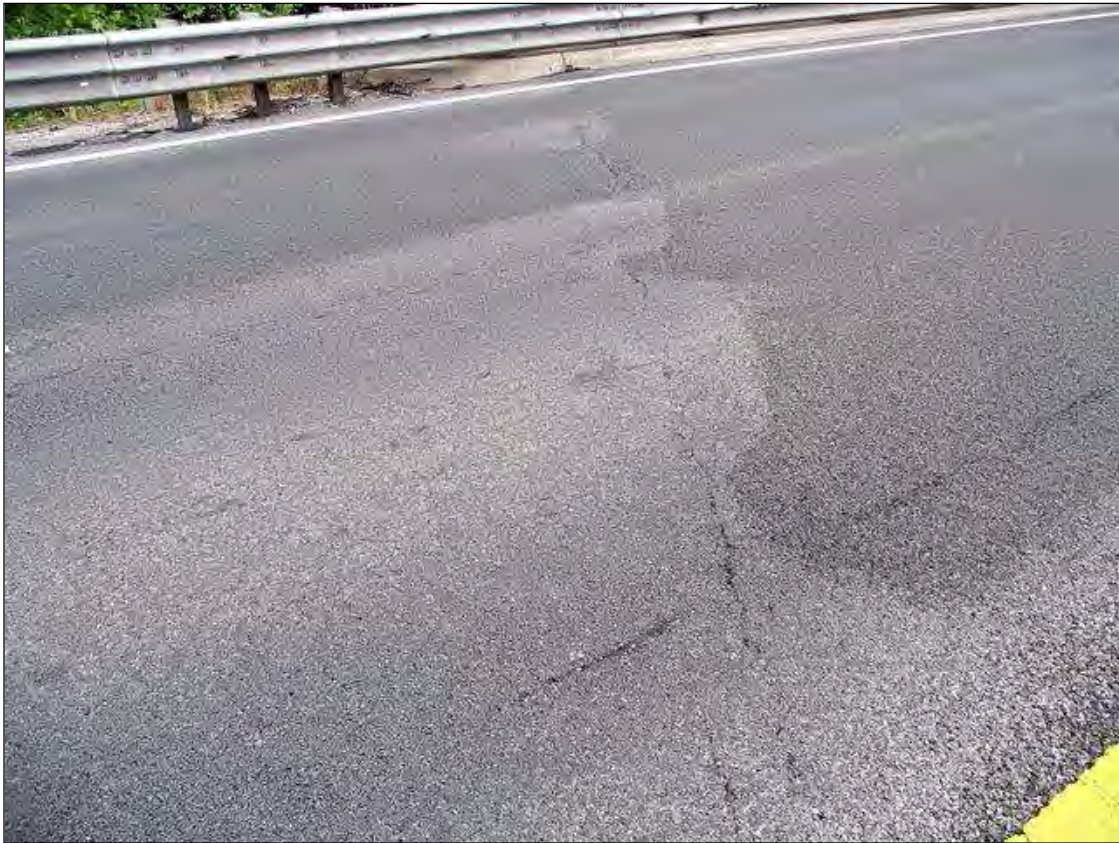
TRANSVERSE CRACK IN WEARING SURFACE OVER END BENT 1

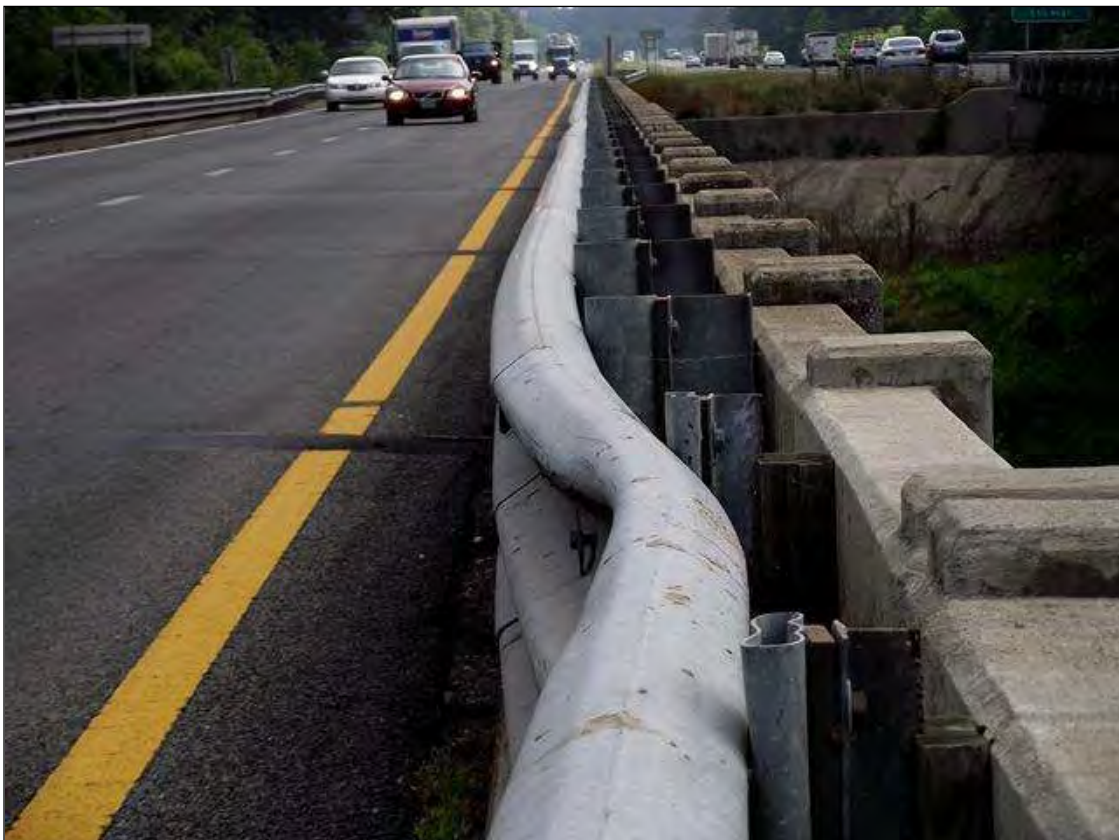
IMPACT DAMAGE TO THE RIGHT SIDE GUARDRAIL IN SPAN 1

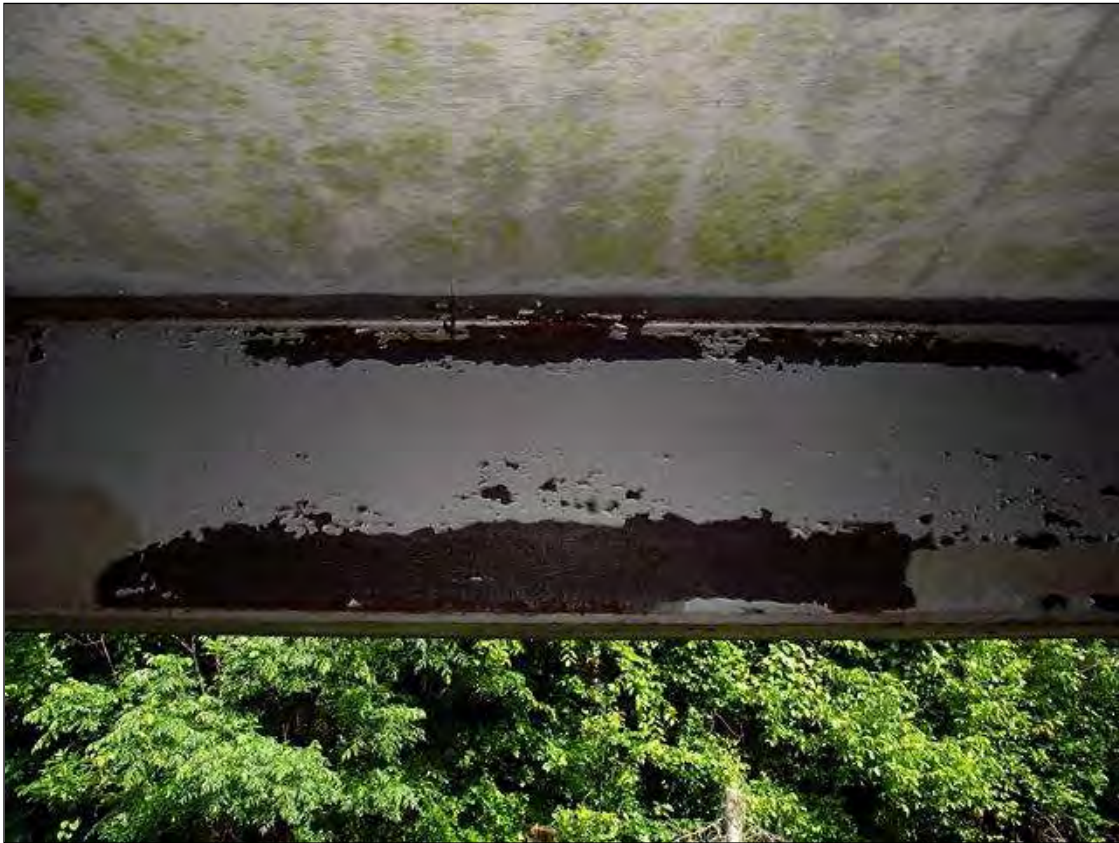
RANDOM AREAS OF PEELING PAINT & SURFACE RUST IN BEAM WEBS THROUGHOUT STRUCTURE

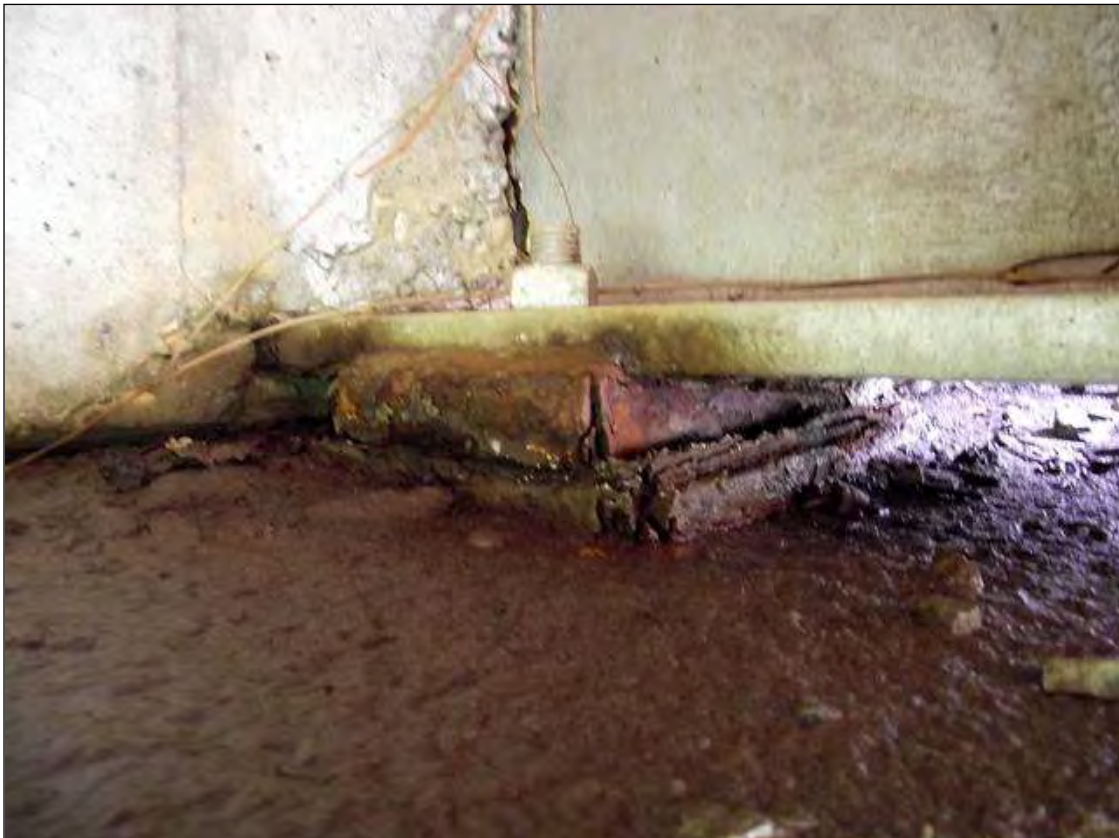
EXTERIOR BEARING ASSEMBLIES AT END BENT 2 ARE RUSTY AND FLAKING

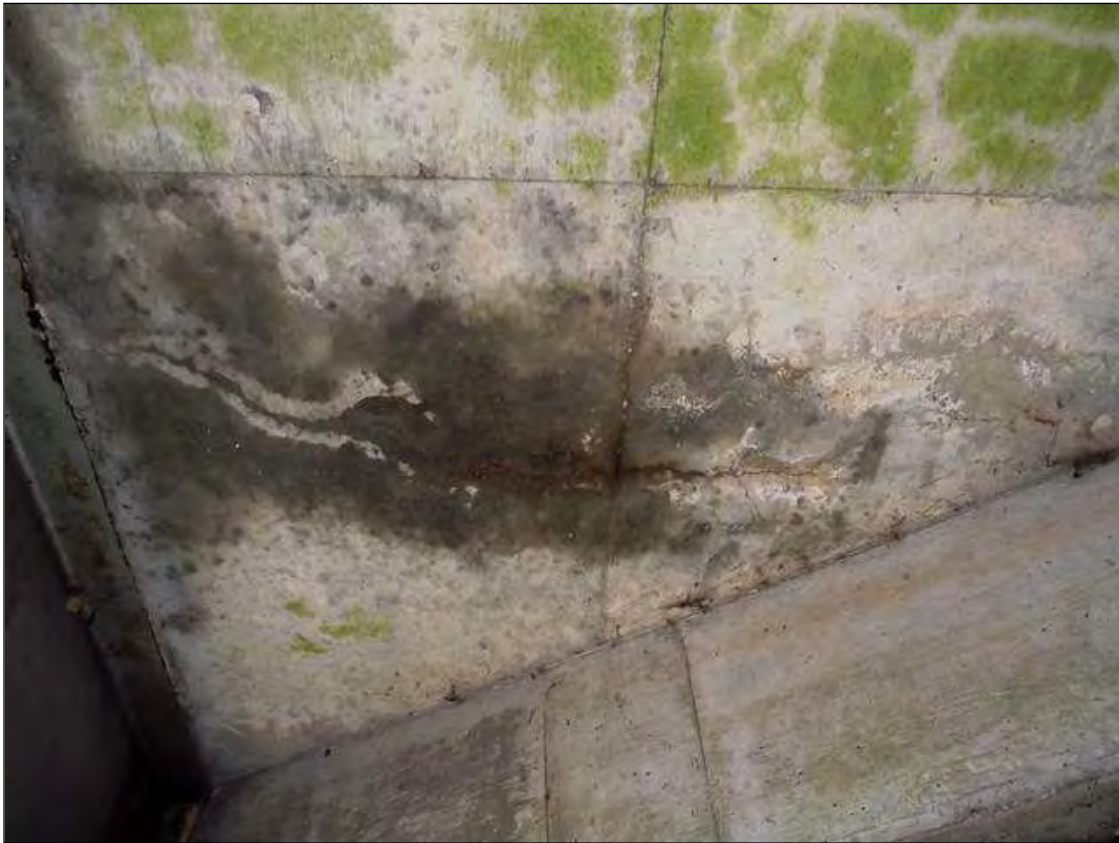
HAIRLINE DIAGONAL CRACK WITH EFFLORESCENCE IN BOTTOM OF DECK OF SPAN 8 BAY 3 NEAR BENT 7

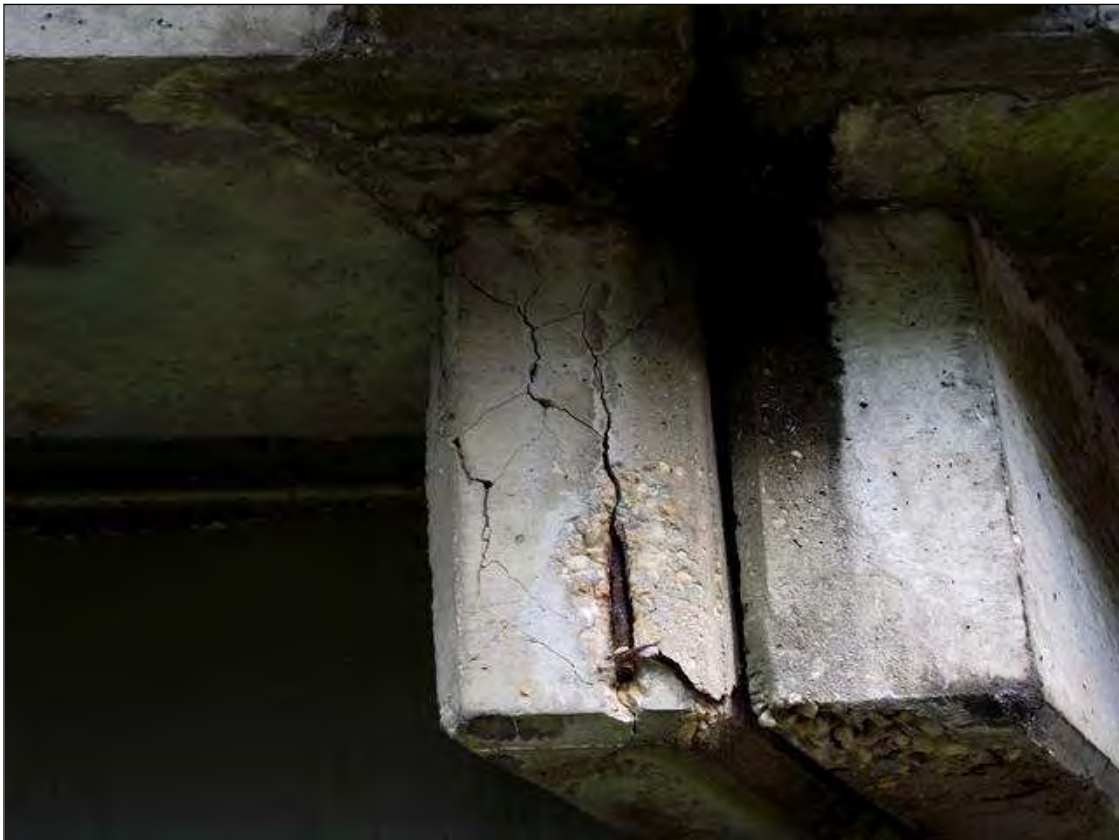
CRACKED AND SPALLED AREA WITH EXPOSED REBAR THE RIGHT EXTERIOR DIAPHRAGM OF SPAN 7 AT BENT 7

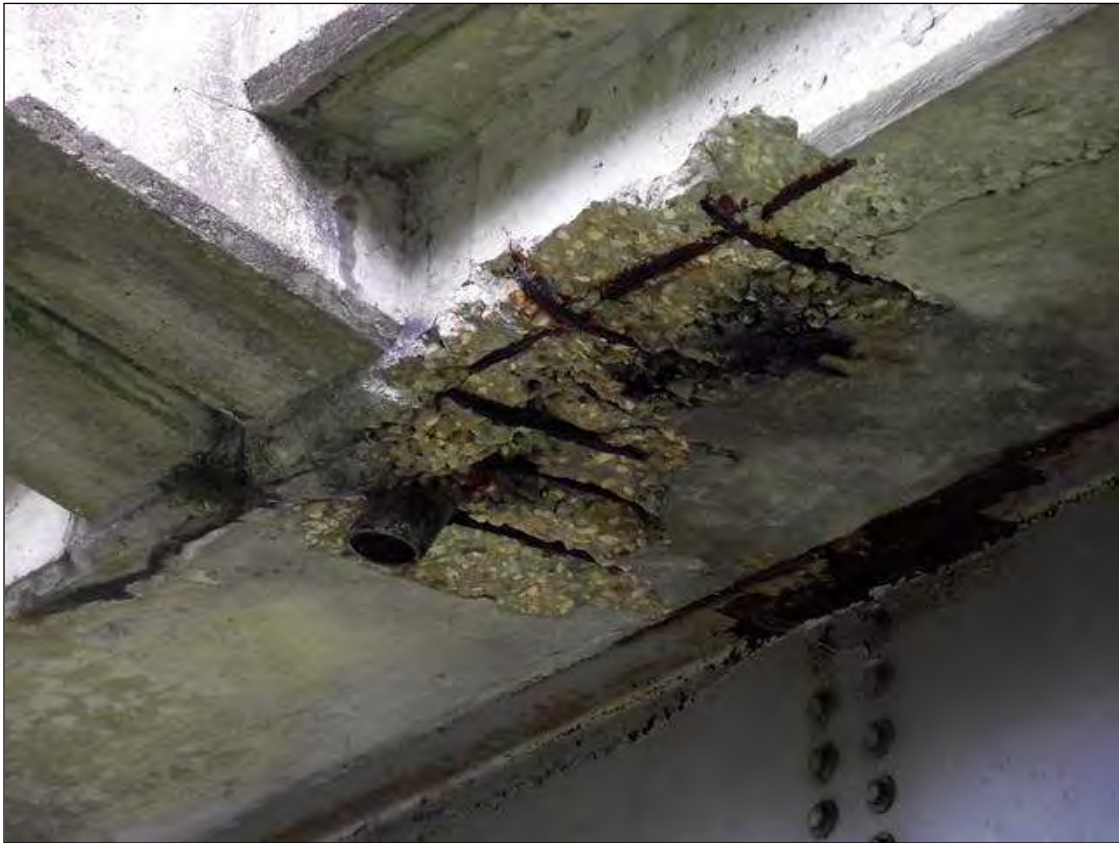
SPALLED AREA WITH SECTION LOSS TO EXPOSED REBAR IN THE RIGHT SIDE OVERHANG OF SPAN 7 AT 1/3 POINT FROM BENT 6

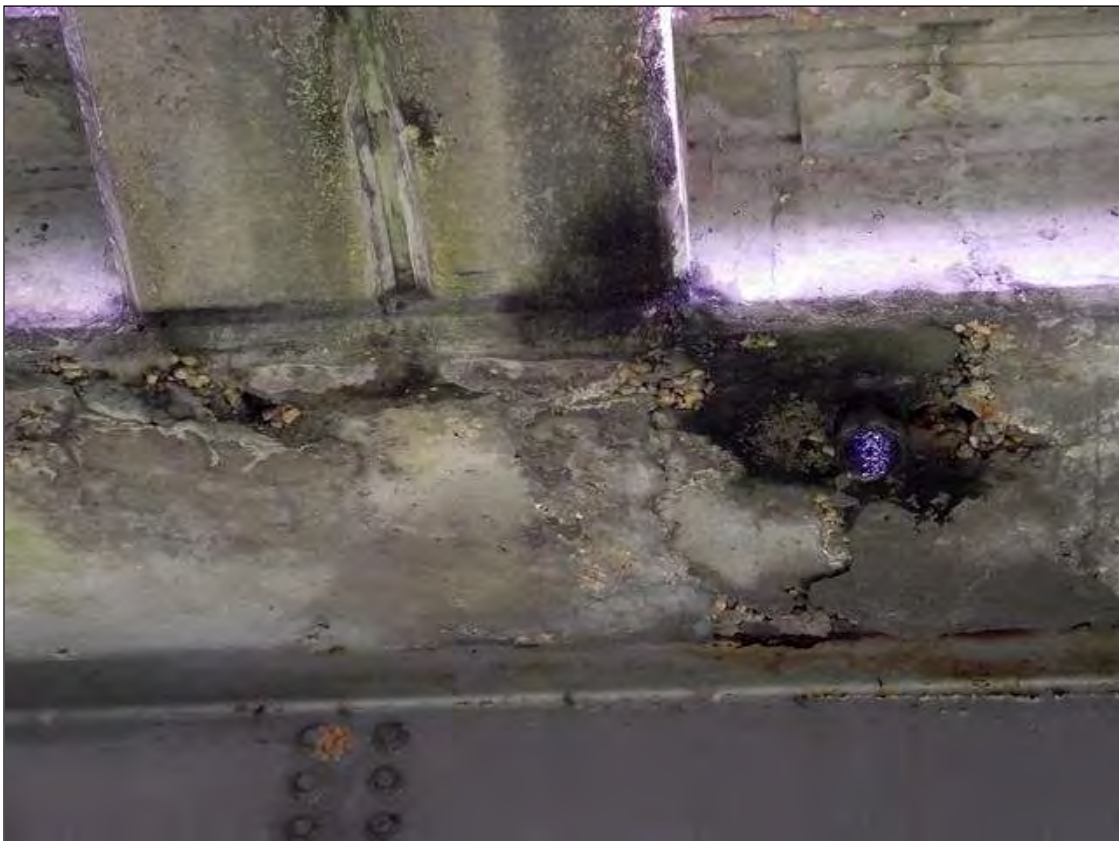
CRACKED AND DELAMINATED AREA IN THE RIGHT SIDE OVERHANG OF SPAN 7 AT MID-SPAN

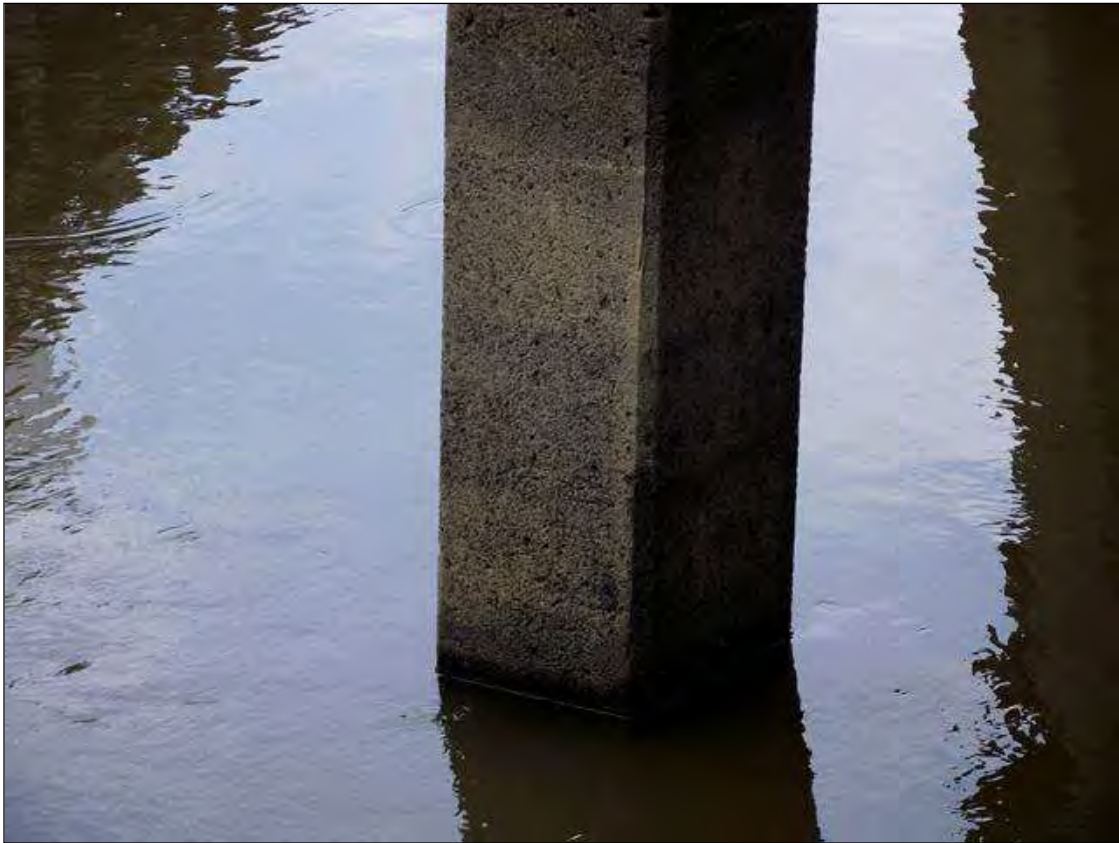
ABRASION WITH EXPOSED COARSE AGGREGATE IN FACES OF PILES IN WATERWAY

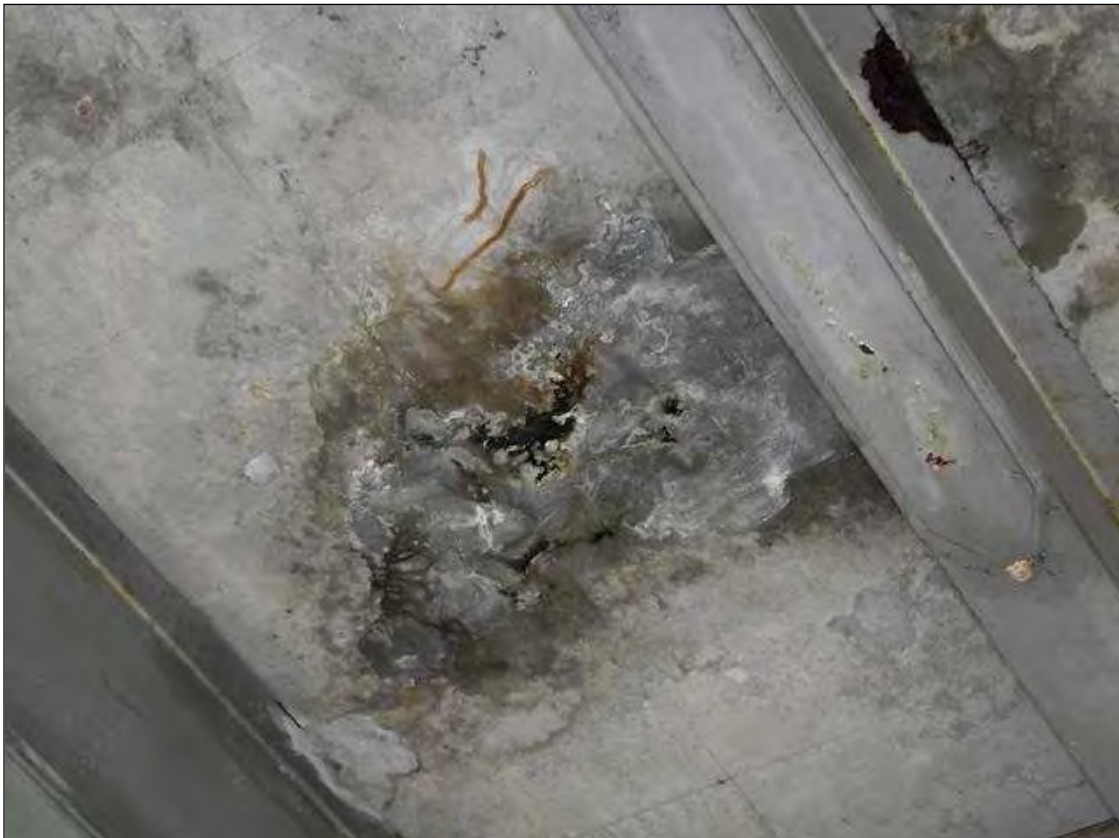
AREA OF MAP CRACKING WITH EFFLORESCENCE IN BOTTOM OF DECK OF SPAN 7 BAY 2 BETWEEN INTERIOR DIAPHRAGMS

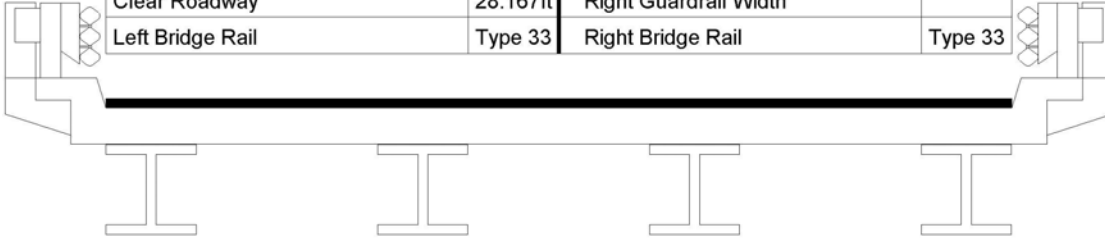
Measurements for Span #	1	ALL SPANS SIMILAR	
Deck Thickness	0.562	Left Overhang	3.708
Top of Rail to Bottom of Beam	5.875	Right Overhang	3.708

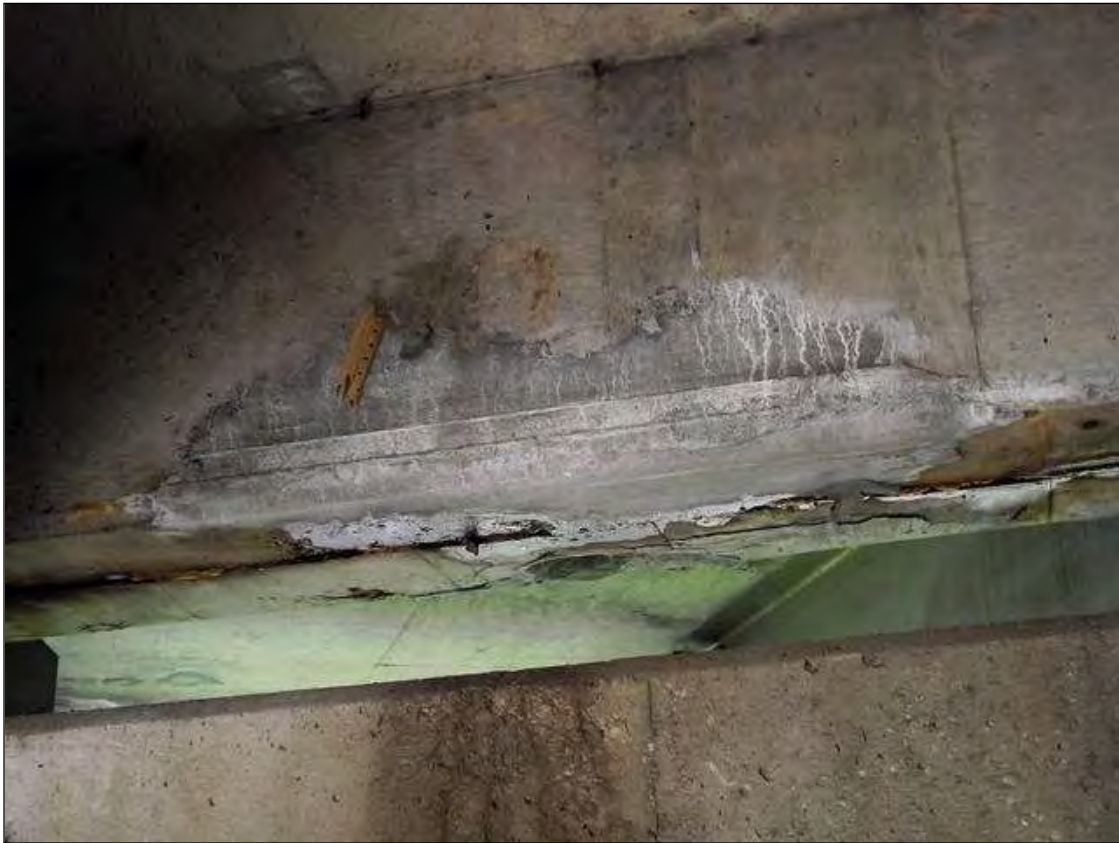
SPALL REPAIR IN SPAN 8 END DIAPHRAGM AT BENT 7 BAY 2

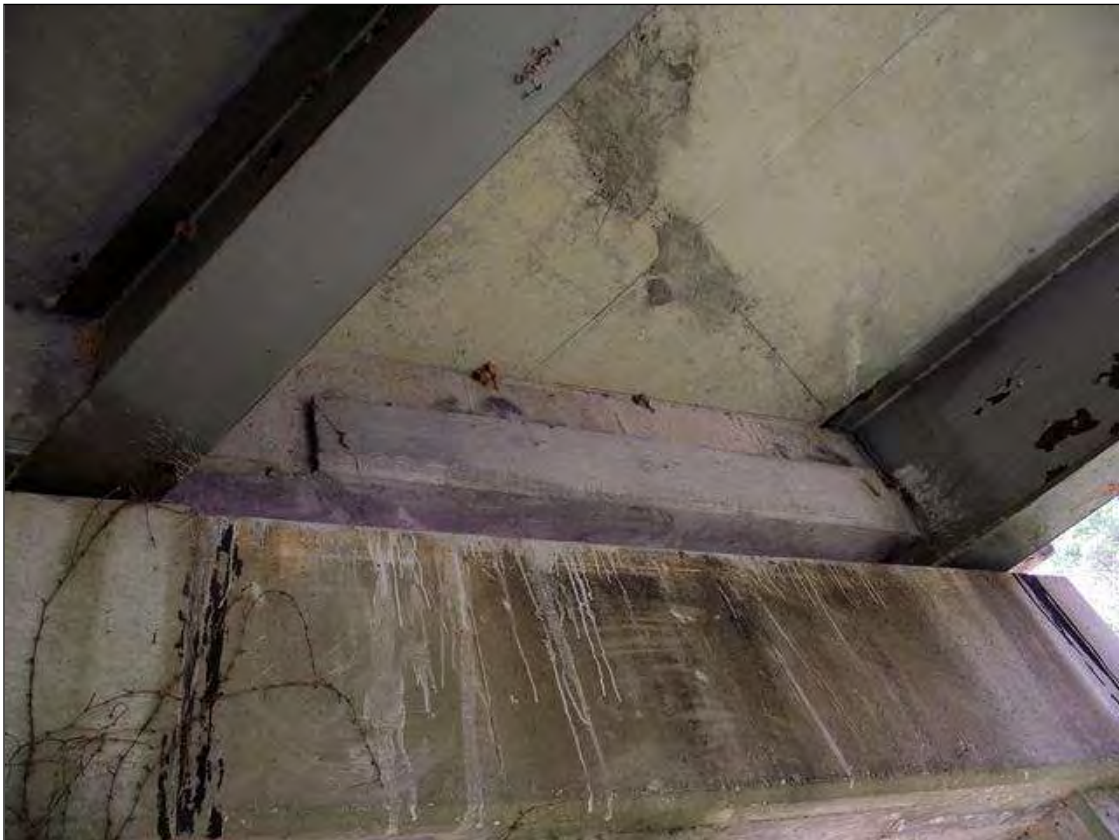
SPALL REPAIR IN SPAN 7 END DIAPHRAGM AT BENT 7 BAY 3

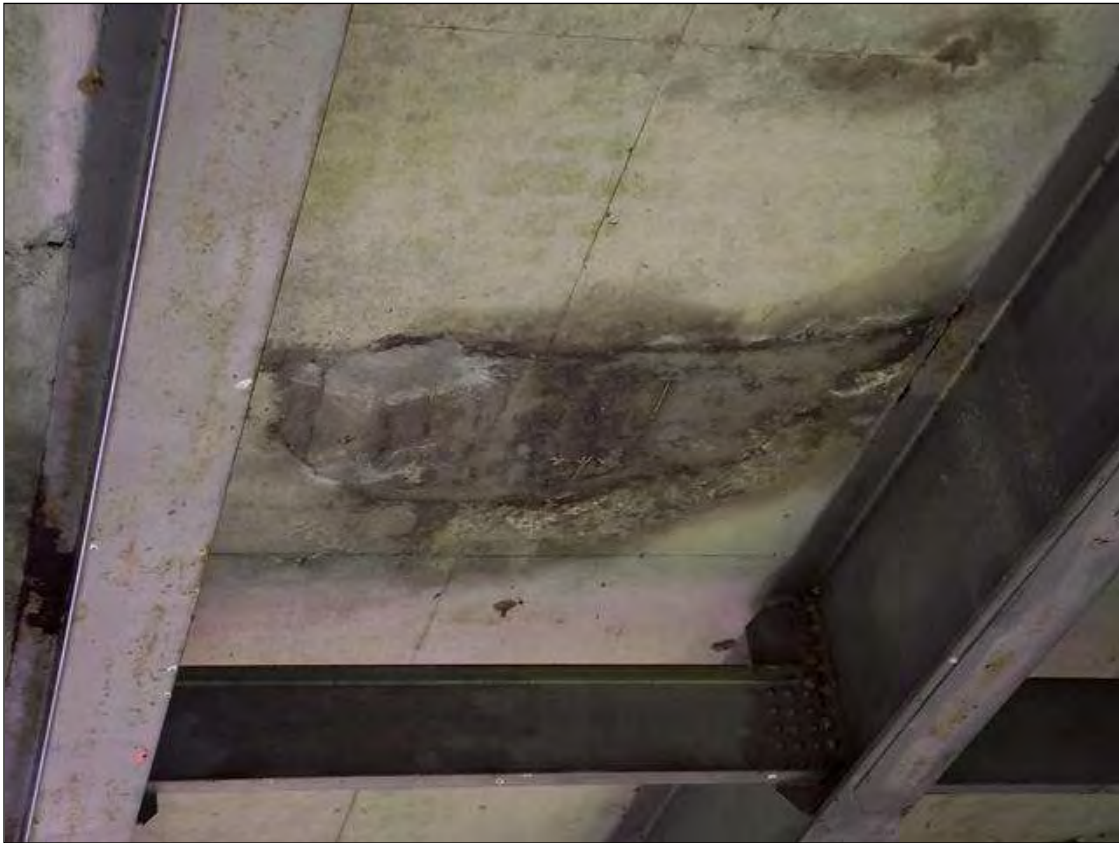
REPAIR PATCHES IN BOTTOM OF DECK OF SPAN 7 BAY 3 AT 1/3 POINT - SIMILAR PATCHES THROUGHOUT SPAN

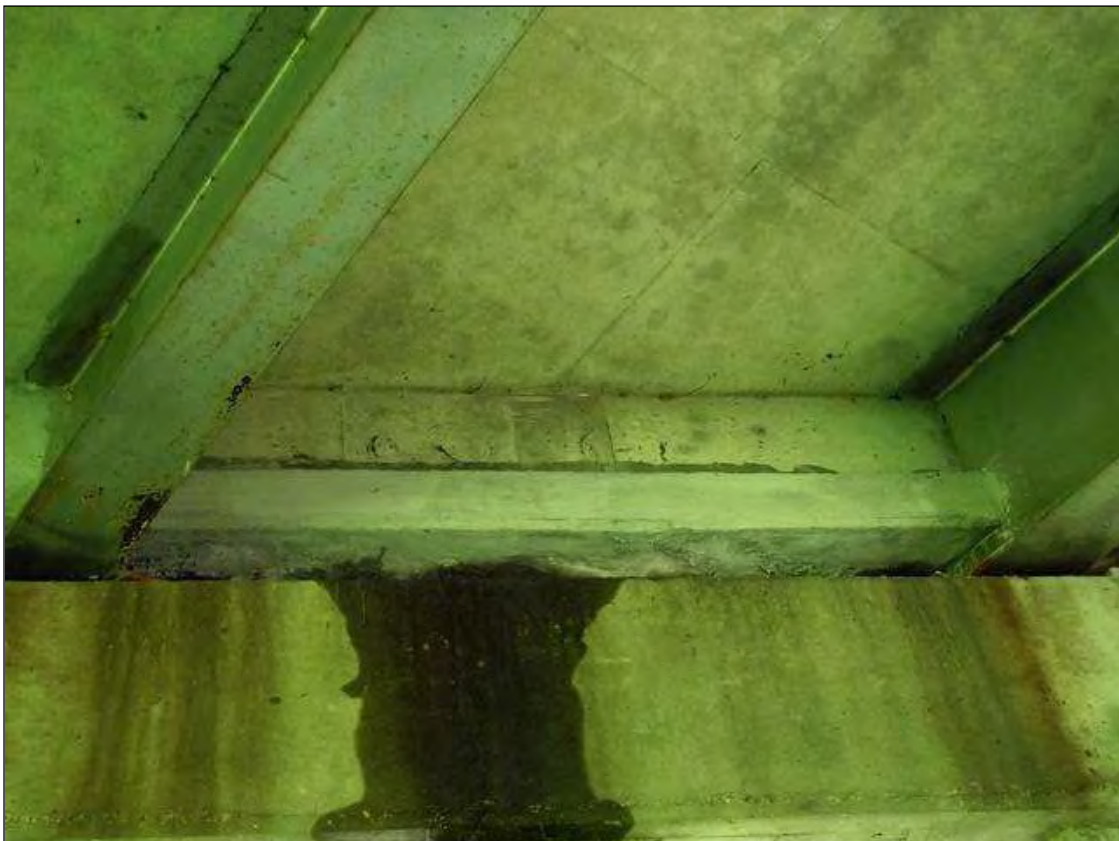
SPALL REPAIR IN SPAN 2 END DIAPHRAGM AT BENT 2 BAY 2 - BAY 3 SIMILAR

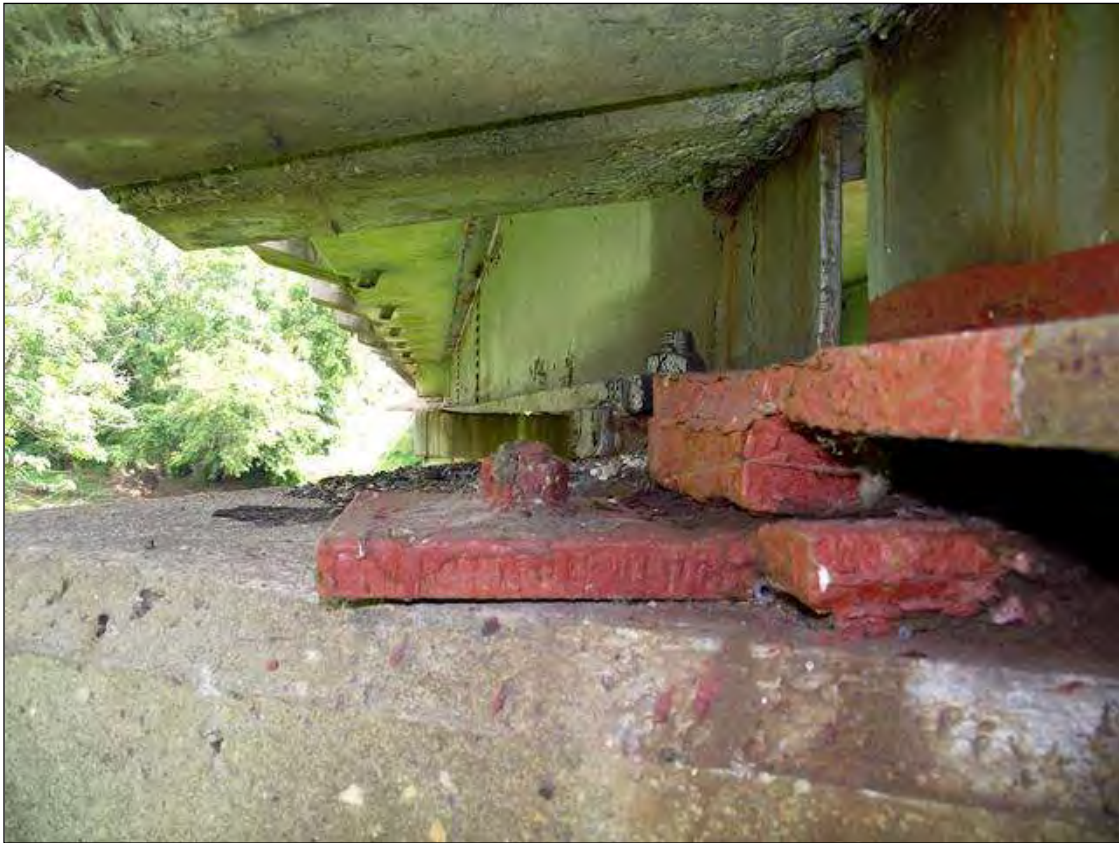
ANCHOR BOLT REPAIR FOR BEAM 1 AT BENT 1 (PLATES ADDED ADJACENT TO BEARING ASSEMBLIES) - OTHER REPAIRS SIMILAR THROUGHOUT STRUCTURE

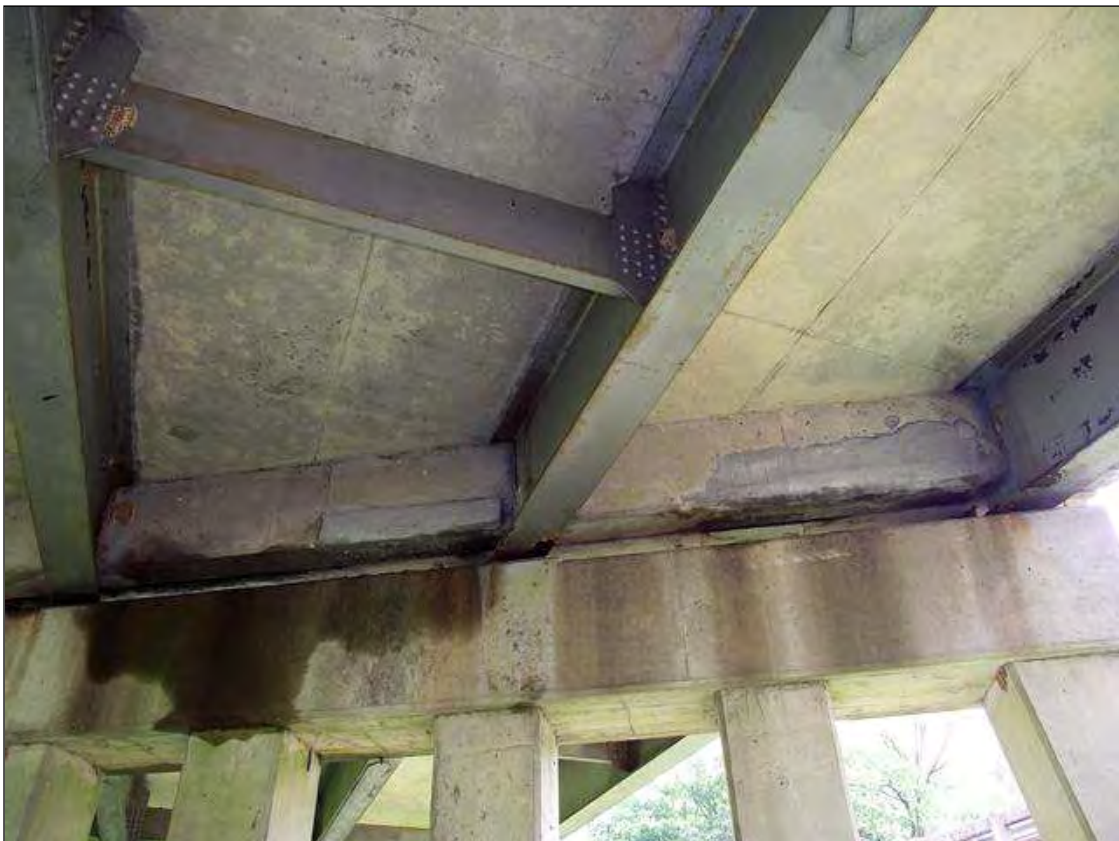
SPAN 1 END DIAPHRAGMS PATCHED AT BENT 1 BAYS 2 & 3

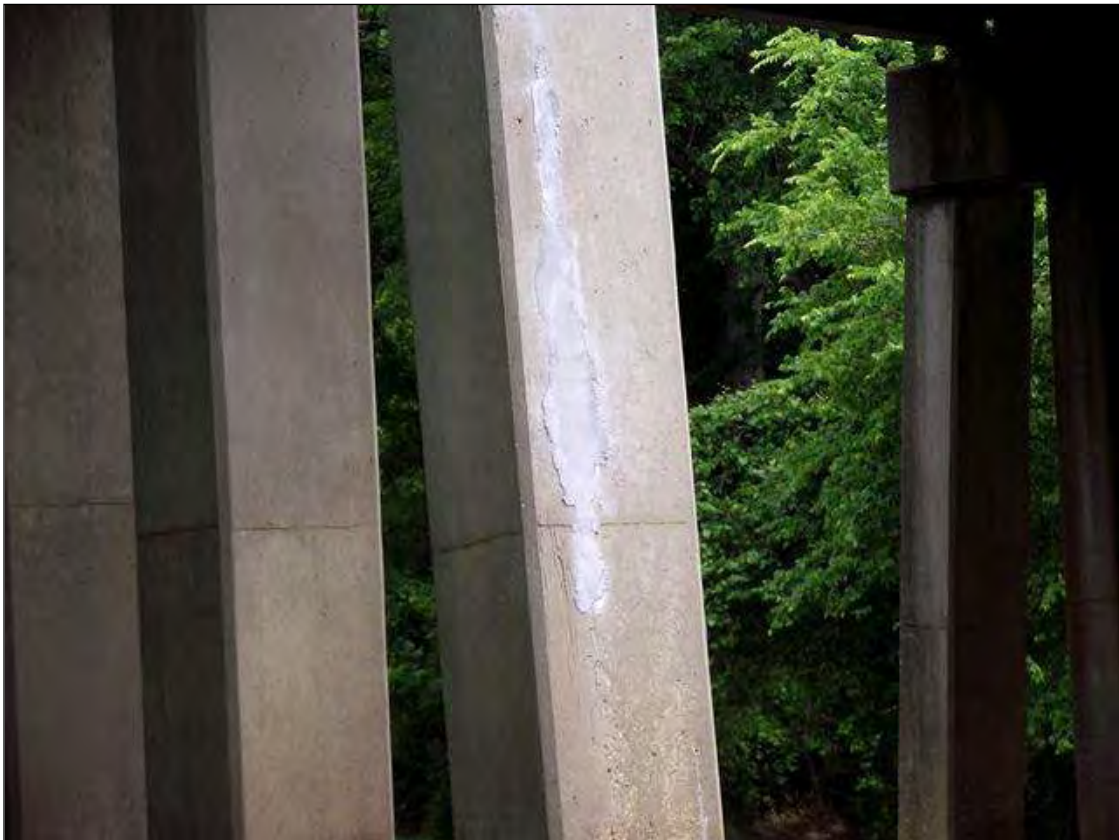
REPAIR PATCH IN THE RIGHT SIDE FACE OF PILE 7 AT BENT 3

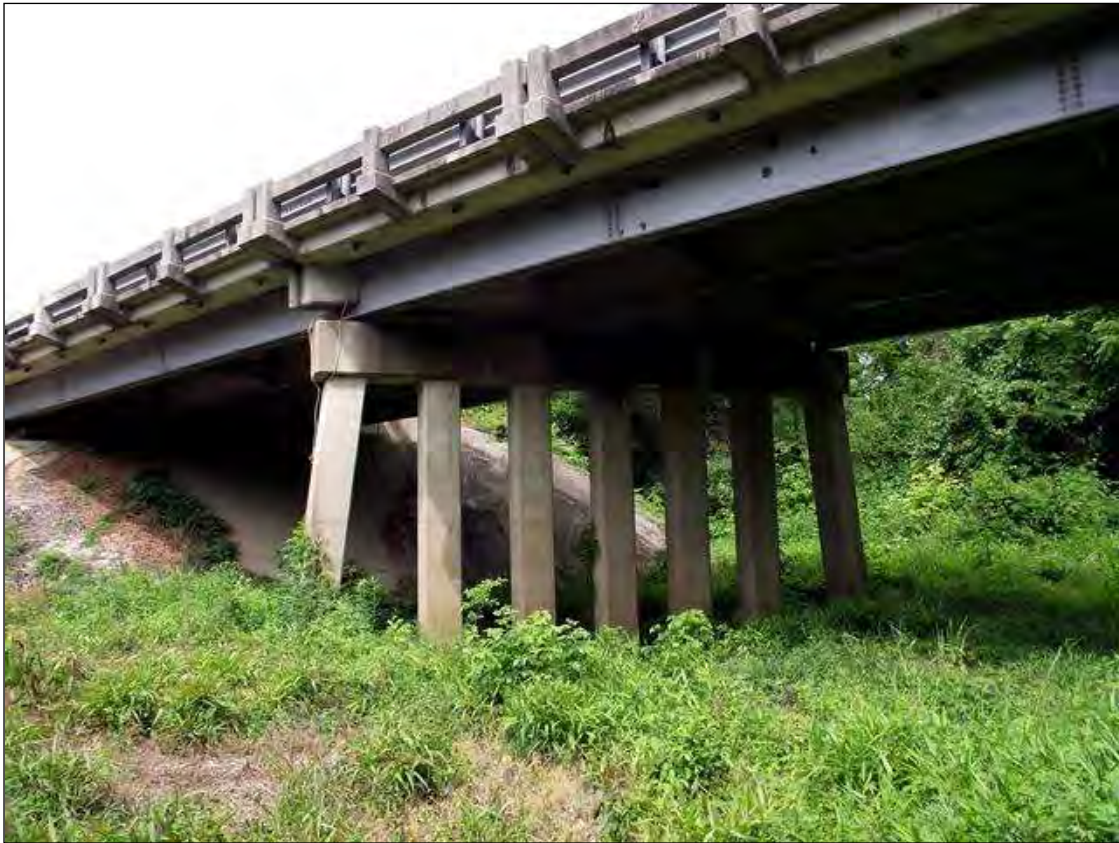
BENT 1 SPAN 2 SIDE - ALL BENTS SIMILAR
