PROJECT: 17BP.11.R.155 REFERENCE: SF-960436

**STRUCTURE  
SUBSURFACE INVESTIGATION**

COUNTY WILKES  
SITE DESCRIPTION BRIDGE NO. 436 ON SR 1943  
(BREWER MILL RD.) OVER EAST PRONG ROARING  
RIVER

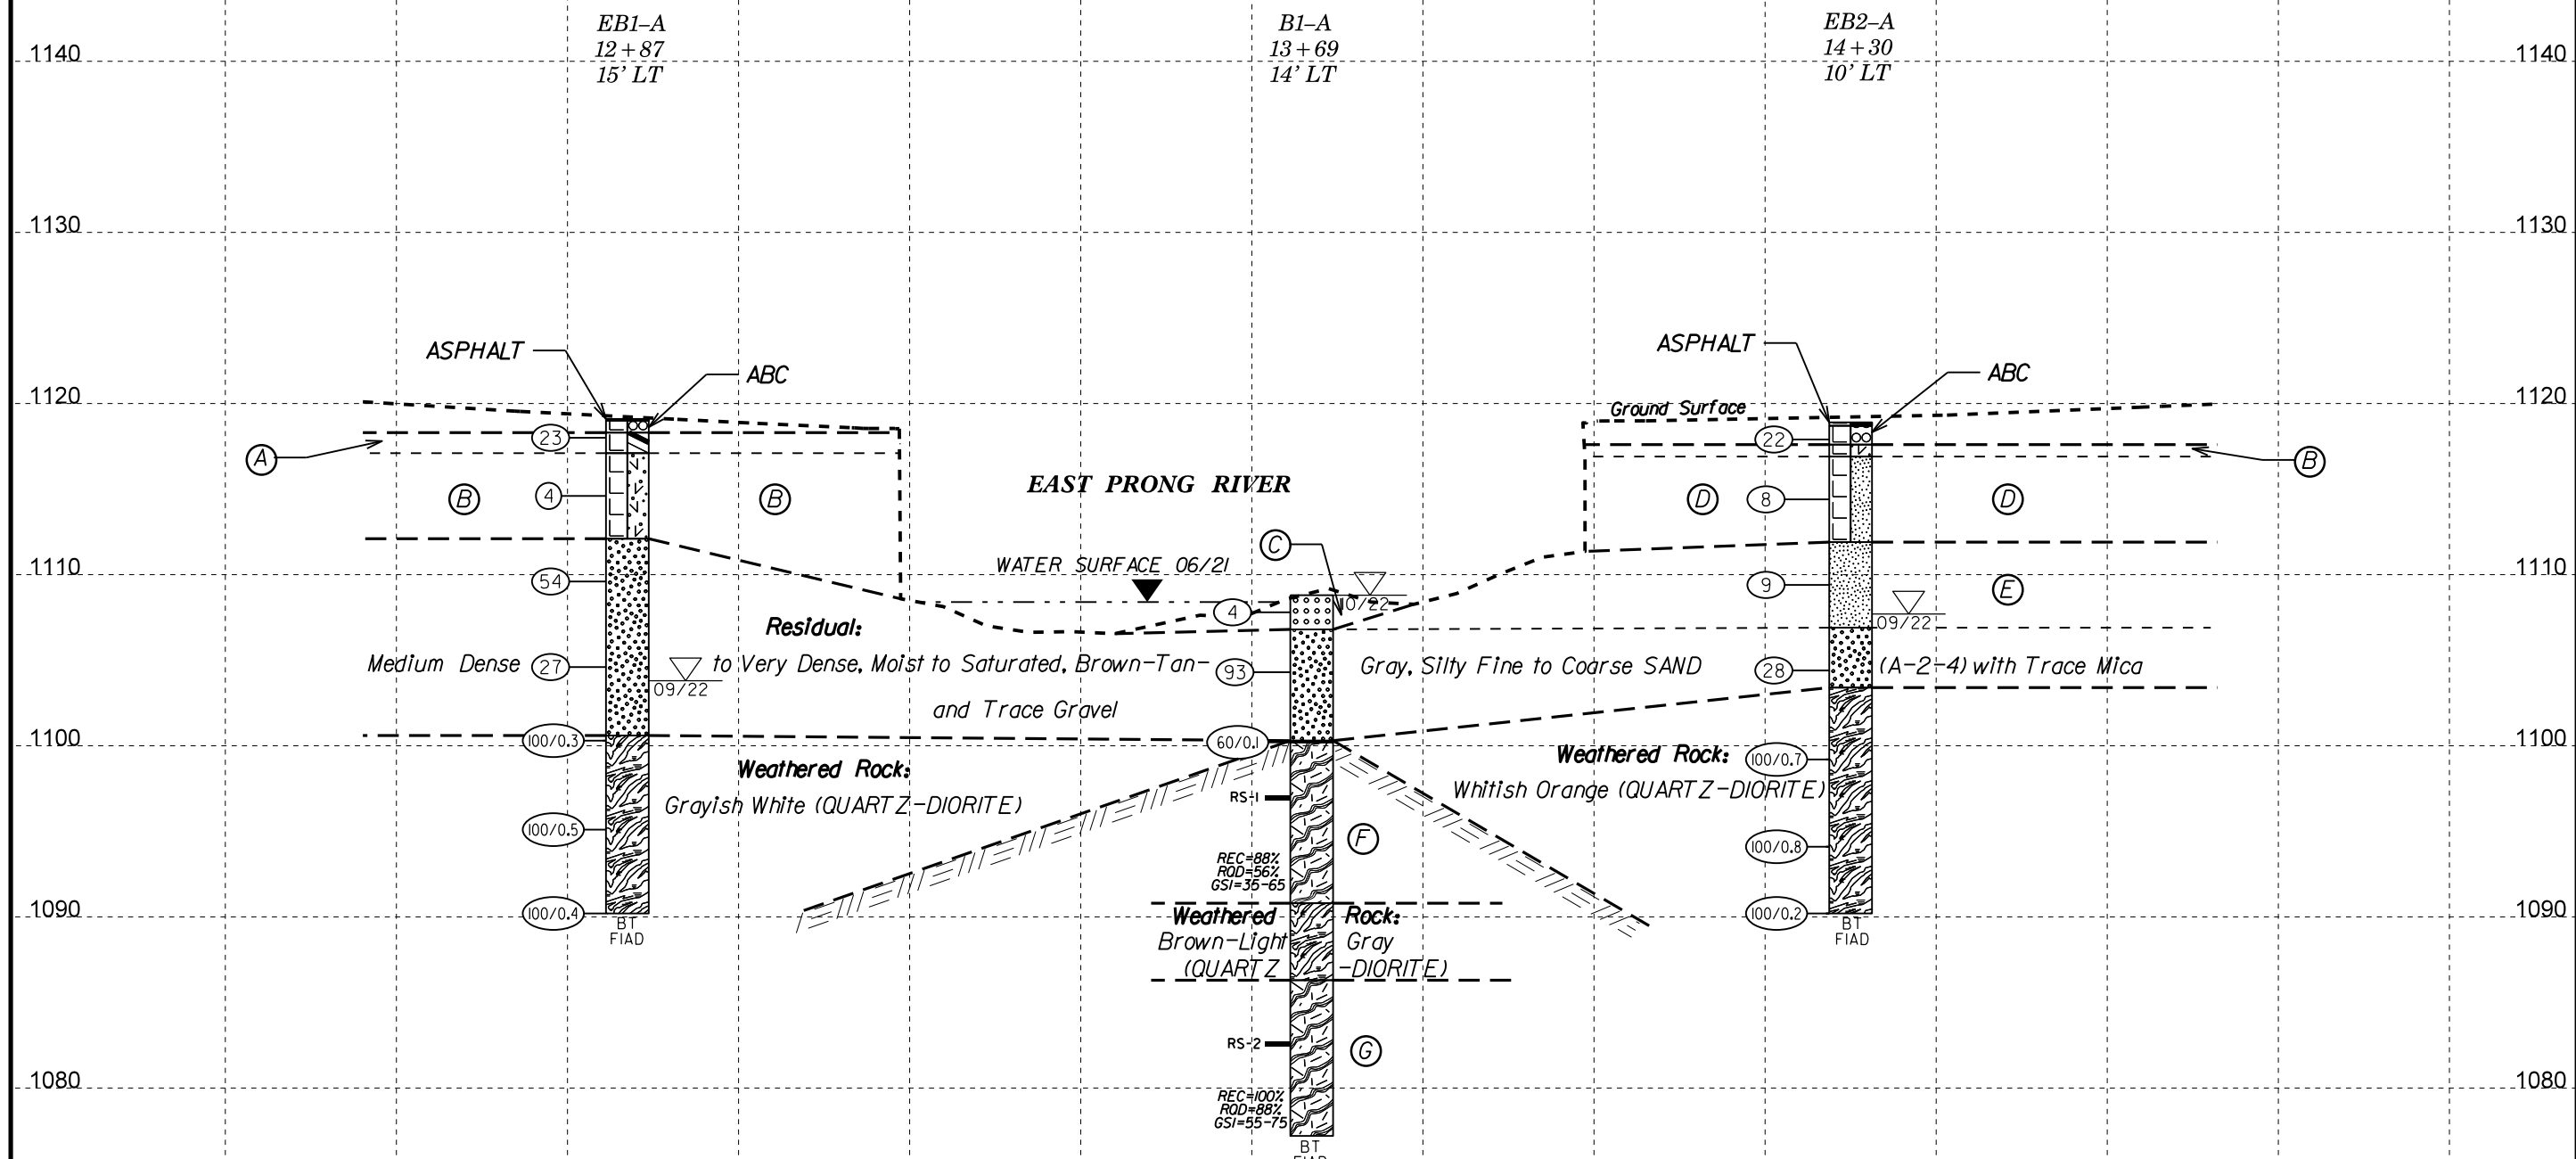
<b>PROJECT REFERENCE NO.</b>	<b>SHEET NO.</b>
SF-960436	4
<b>PROFILE BORINGS PROJECTED ALONG CENTERLINE OF -L-</b>

- (A) **Roadway Embankment:** Very Stiff, Moist, Brown-Gray, Fine Sandy CLAY (A-6) with Trace Mica
- (B) **Roadway Embankment:** Soft to Very Stiff, Moist to Wet, Brown-Gray-Orange, Fine to Coarse Sandy Clayey SILT (A-5) with Trace Mica, Gravel, and Roots
- (C) **Alluvial:** Loose, Tan, Gravelly Fine to Coarse SAND (A-3)
- (D) **Roadway Embankment:** Medium Stiff to Stiff, Moist, Gray-Orange-Brown, Fine to Coarse Sandy SILT (A-4) with Trace Mica and Gravel
- (E) **Residual:** Stiff, Moist, Tan-Brown, Fine Sandy SILT (A-4) with Trace Mica and Gravel
- (F) **Crystalline Rock:** Brown-White-Light Gray, Fresh to Moderate Weathering, Very Hard to Moderately Hard, (QUARTZ-DIORITE) with Moderately Close to Very Close Fracture Spacing
- (G) **Crystalline Rock:** Light Gray to Dark Gray, Fresh to Slight Weathering, Very Hard to Hard (QUARTZ-DIORITE) with Moderately Close to Close Fracture Spacing

GROUNDLINE TAKEN FROM .TIN FILE RECEIVED FROM KCA ON 09/23/2022.  
INFERRED STRATIGRAPHY IS DRAWN THROUGH THE BORINGS WITH BOTH  
PROJECTED ONTO THE PROFILE

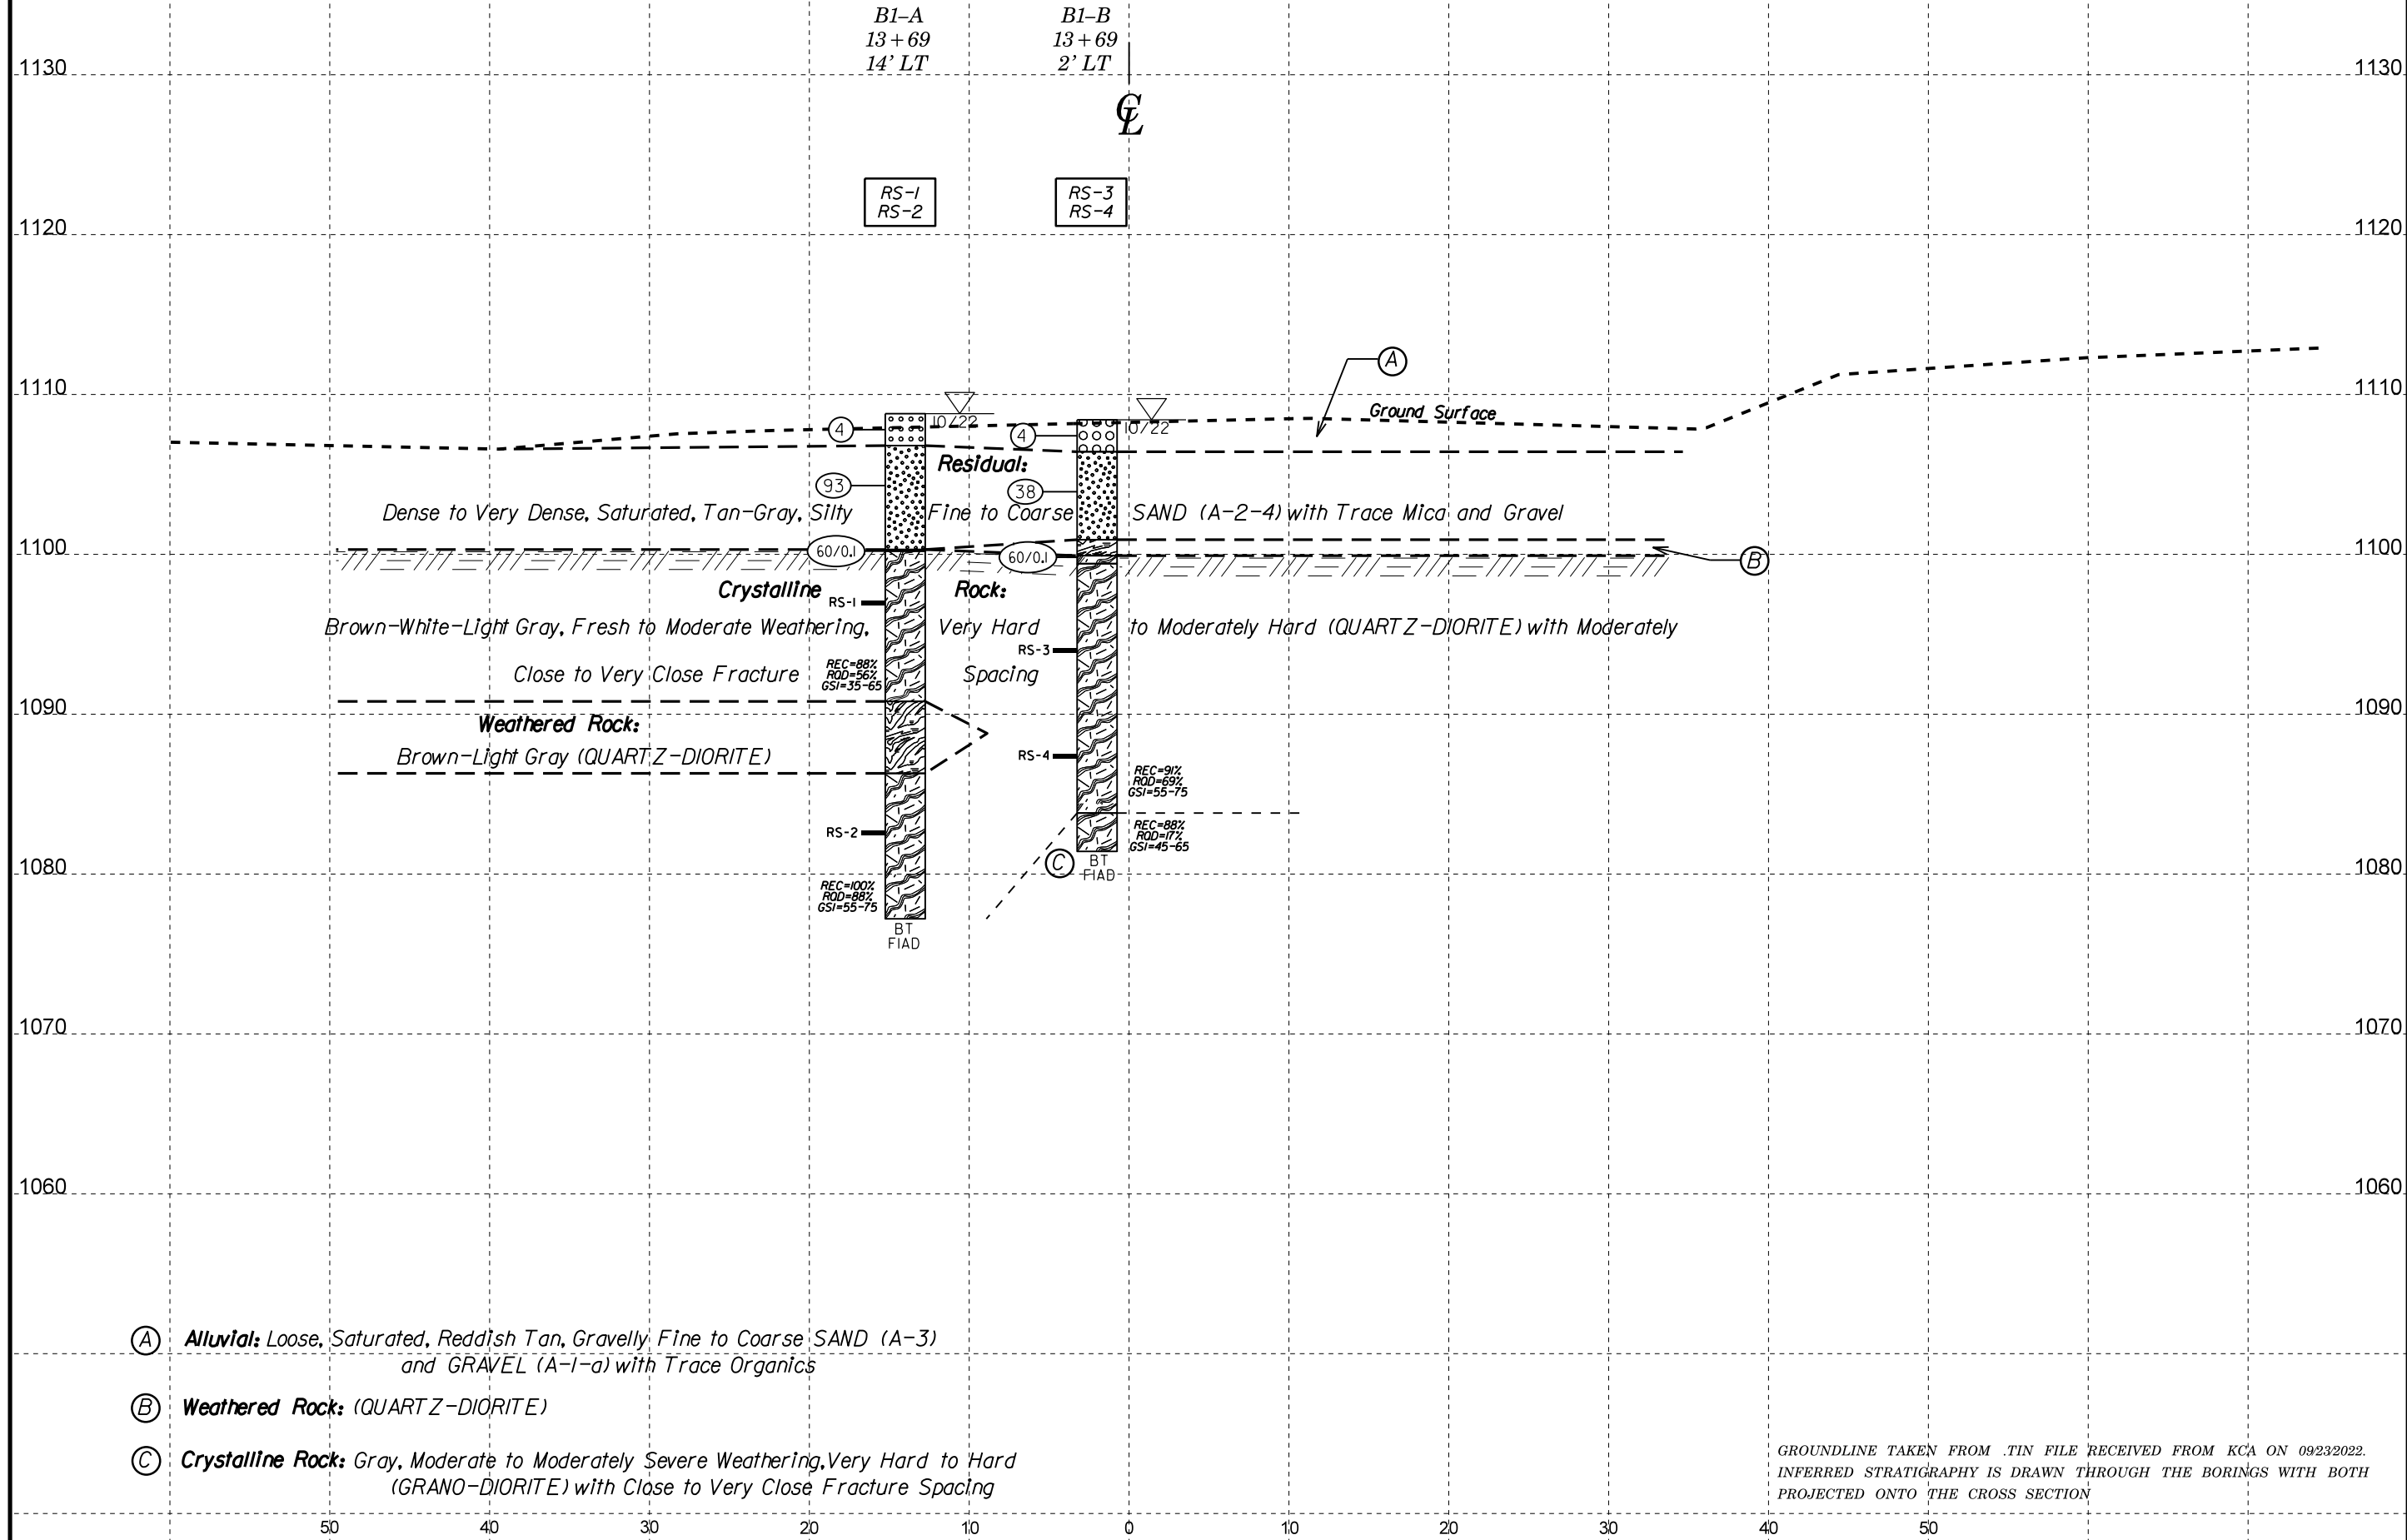
PROJECT REFERENCE NO.	SHEET NO.
SF-960436	6
CROSS SECTION THROUGH BENT 1 AT -L- STATION 13+67.00 SKEW=90°

- (A) **Alluvial:** Loose, Saturated, Reddish Tan, Gravelly Fine to Coarse SAND (A-3) and GRAVEL (A-1-a) with Trace Organics
- (B) **Weathered Rock:** (QUARTZ-DIORITE)
- (C) **Crystalline Rock:** Gray, Moderate to Moderately Severe Weathering, Very Hard to Hard (GRANO-DIORITE) with Close to Very Close Fracture Spacing

GROUNDLINE TAKEN FROM .TIN FILE RECEIVED FROM KCA ON 09/23/2022.  
INFERRED STRATIGRAPHY IS DRAWN THROUGH THE BORINGS WITH BOTH  
PROJECTED ONTO THE CROSS SECTION

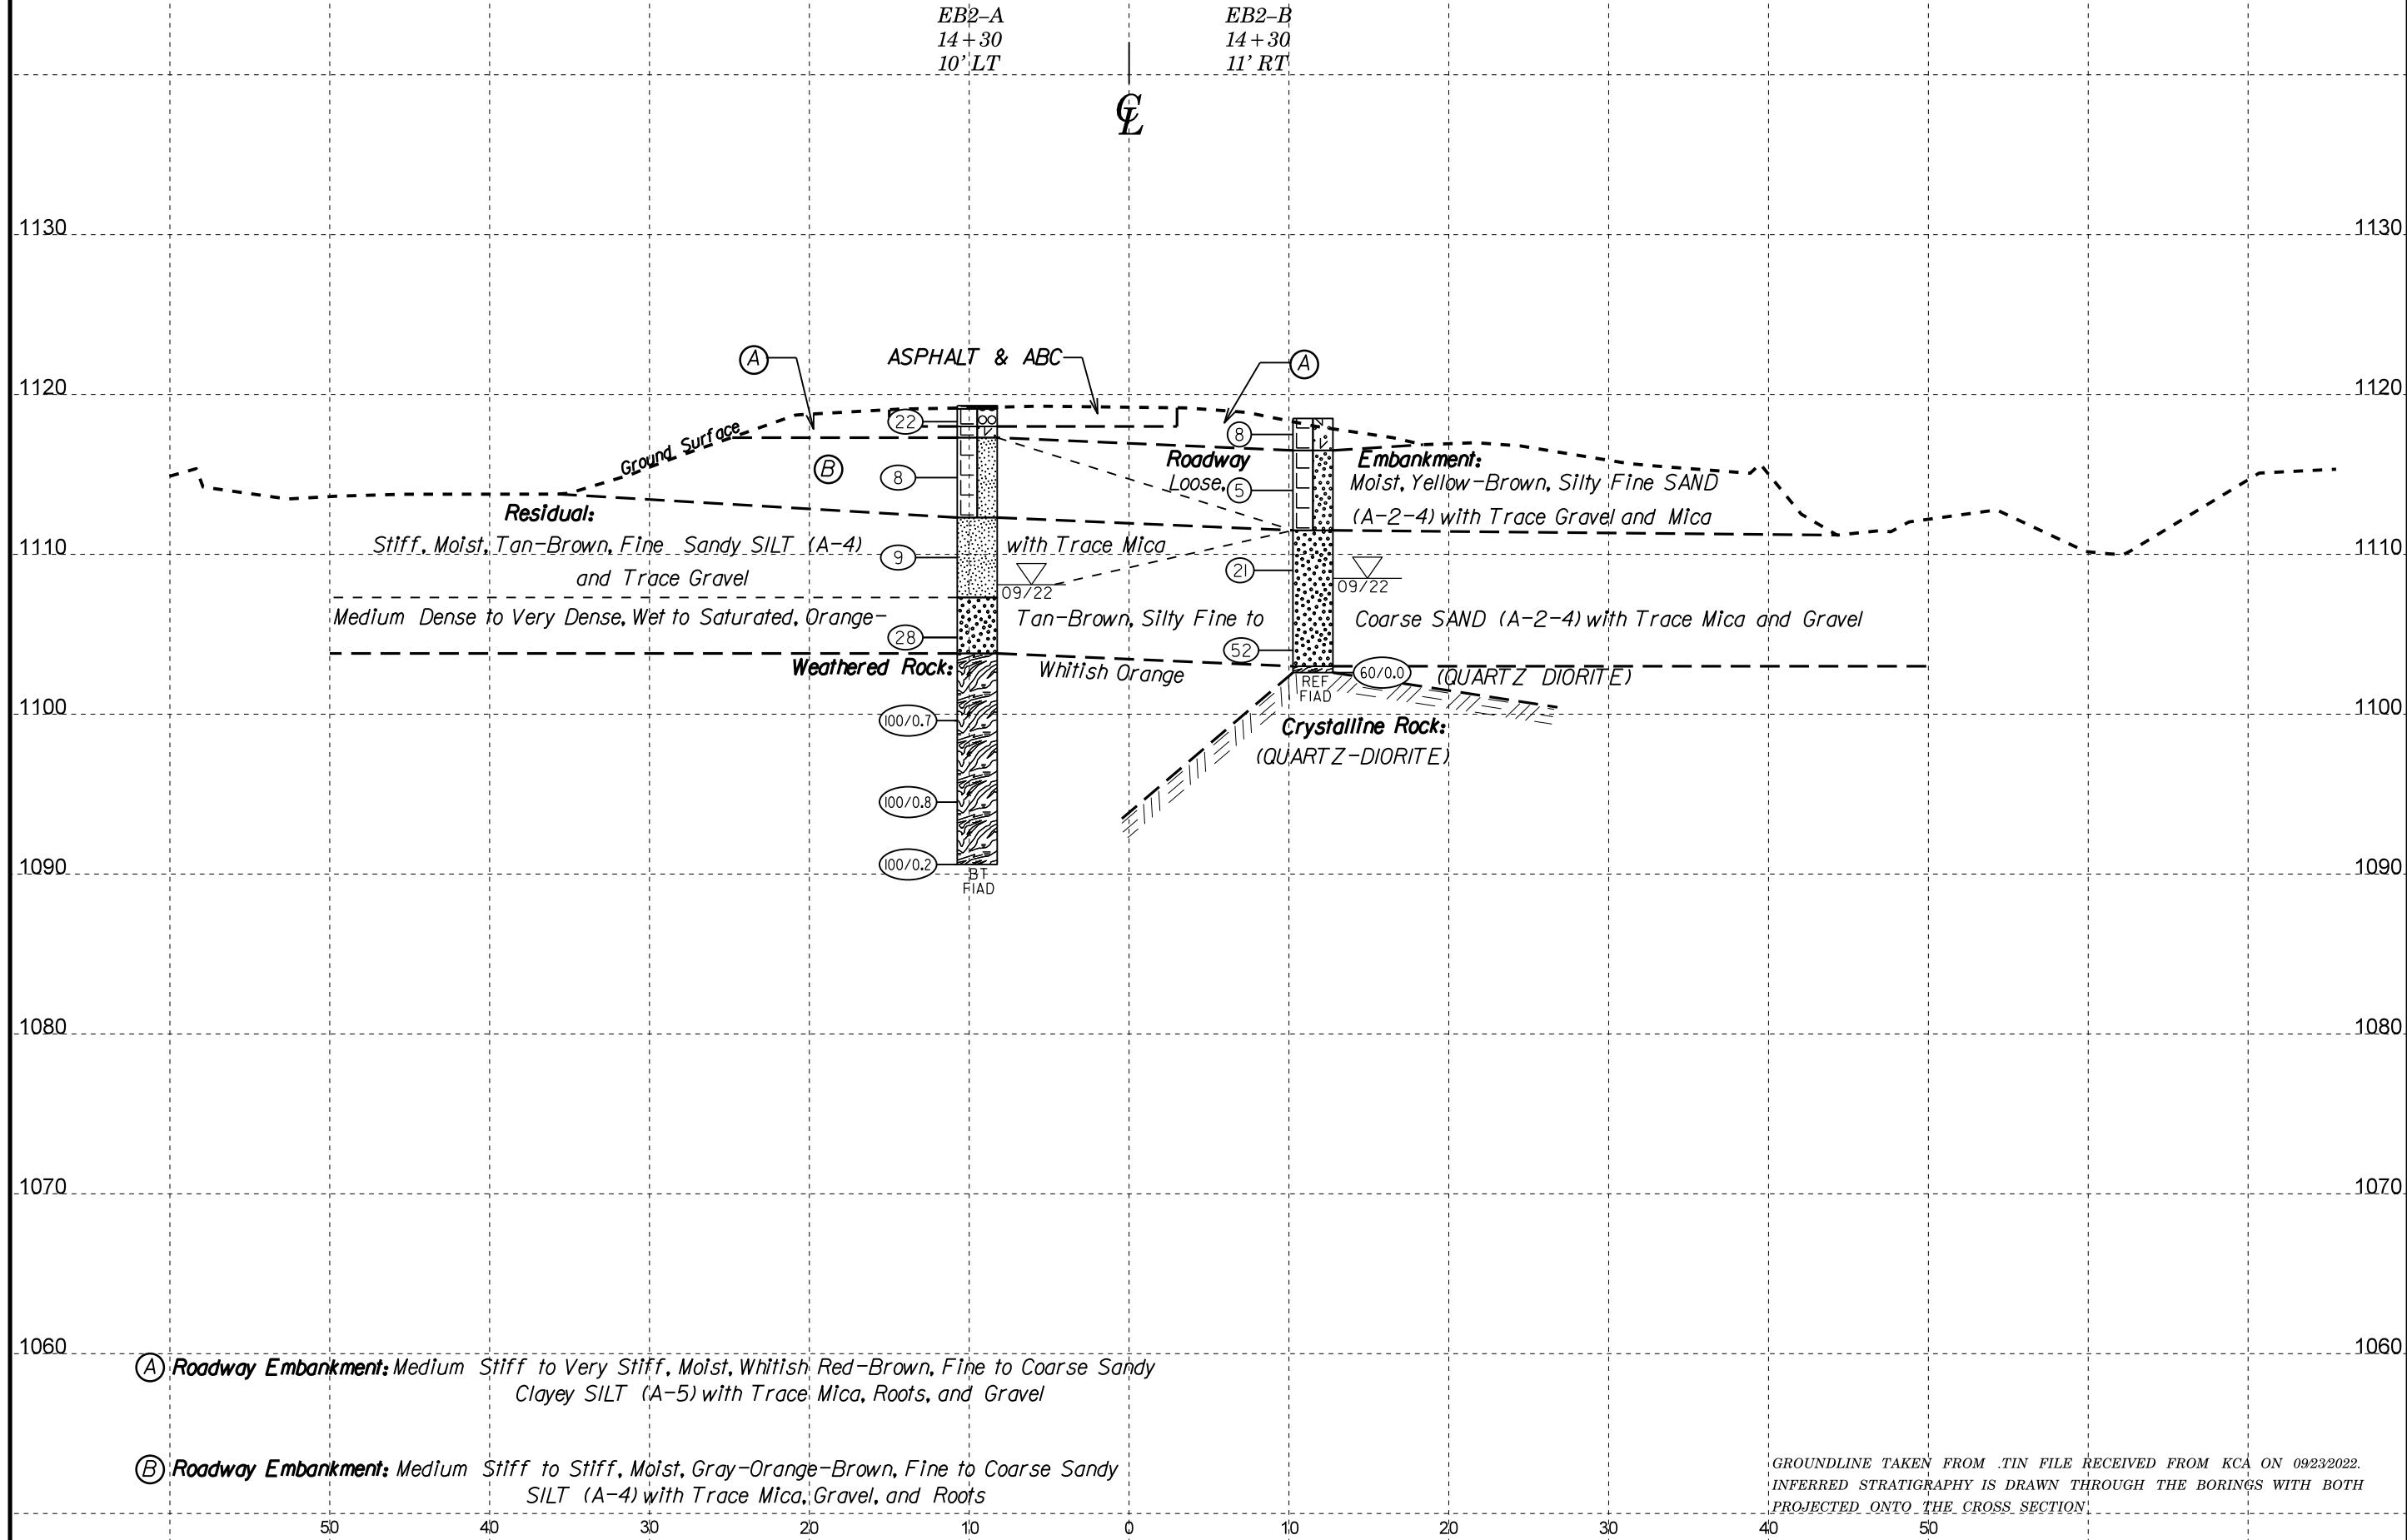
<b>PROJECT REFERENCE NO.</b>	<b>SHEET NO.</b>
SF-960436	7
<b>CROSS SECTION THROUGH END BENT 2</b>	
AT -L- STATION 14+28.19	
SKEW=90°

(A) **Roadway Embankment:** Medium Stiff to Very Stiff, Moist, Whitish Red-Brown, Fine to Coarse Sandy Clayey SILT (A-5) with Trace Mica, Roots, and Gravel

(B) **Roadway Embankment:** Medium Stiff to Stiff, Moist, Gray-Orange-Brown, Fine to Coarse Sandy SILT (A-4) with Trace Mica, Gravel, and Roots

GROUNDLINE TAKEN FROM .TIN FILE RECEIVED FROM KCA ON 09/23/2022.  
INFERRED STRATIGRAPHY IS DRAWN THROUGH THE BORINGS WITH BOTH  
PROJECTED ONTO THE CROSS SECTION.

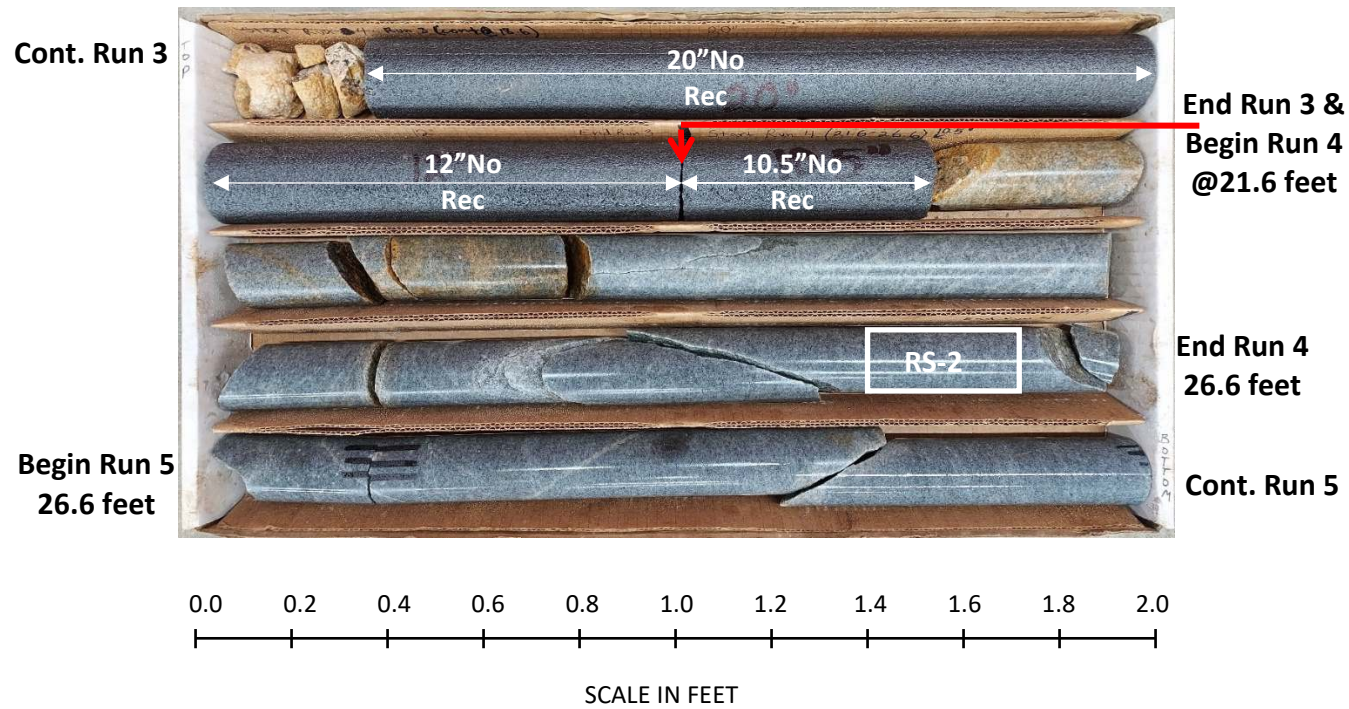
**CORE PHOTOGRAPHS:  
SF-960436 | 17BP.11.R.155  
B1-A: -L- 13+69, 14' LT**

WBS 17BP.11.R.155		TIP SF-960436		COUNTY WILKES		GEOLOGIST C. Ranieri						
SITE DESCRIPTION Bridge No. 436 on SR 1943 (Brewer Mill Rd.) over East Prong Roaring River							GROUND WTR (ft)					
BORING NO. B1-A		STATION 13+69		OFFSET 14 ft LT		ALIGNMENT -L-						
COLLAR ELEV. 1,108.8 ft		TOTAL DEPTH 31.6 ft		NORTHING 940,893		EASTING 1,395,887						
DRILL RIG/HAMMER EFF/DATE F&R2175 CME-55 92% 05/20/2022				DRILL METHOD NW Casing W/SPT & Core		HAMMER TYPE Automatic						
DRILLER D. Tignor		START DATE 10/03/22		COMP. DATE 10/04/22		SURFACE WATER DEPTH N/A						
CORE SIZE		TOTAL RUN		RUN		SAMP. NO.		STRATA		LOG	DESCRIPTION AND REMARKS	
ELEV (ft)	RUN ELEV (ft)	DEPTH (ft)	RUN (ft)	DRILL RATE (Min/ft)	REC. (ft) %	RQD (ft) %	NO.	REC. (ft) %	RQD (ft) %			ELEV. (ft)
1100.2	1,100.2	8.6	3.0	3:21/1.0 2:32/1.0 2:30/1.0	(2.7) 90%	(2.3) 77%		(8.3) 88%	(5.3) 56%		1,100.2	8.6
	1,097.2	11.6	5.0	2:22/1.0 2:11/1.0 2:08/1.0 2:13/1.0 2:01/1.0	(4.2) 84%	(2.6) 52%	RS-1

1095	1,092.2	16.6	5.0	2:37/1.0 2:46/1.0 3:13/1.0 2:35/1.0 2:04/1.0	(1.7) 34%	(0.4) 8%					1,090.8	18.0
1090	1,087.2	21.6	5.0	2:04/1.0 2:08/1.0 2:57/1.0 2:30/1.0 3:28/1.0	(4.1) 82%	(3.0) 60%		(9.1) 100%	(8.0) 88%		1,086.3	22.5
1085	1,082.2	26.6	5.0	3:36/1.0 2:32/1.0 3:01/1.0 3:28/1.0	(5.0) 100%	(5.0) 100%	RS-2				1,077.2	31.6
1080	1,077.2	31.6										
Boring Terminated at Elevation 1,077.2 ft in Crystalline Rock (QUARTZ-DIORITE) Notes: 1. Auger Refusal and Start Coring Rock at 8.6'
