REFERENCE: B-5846

PROJECT: 45799

STRUCTURE
SUBSURFACE INVESTIGATION

COUNTY IREDELL
 PROJECT DESCRIPTION REPLACE BRIDGE NO. 189 ON
SR 1892 (JENNINGS ROAD) OVER SOUTH YADKIN
RIVER

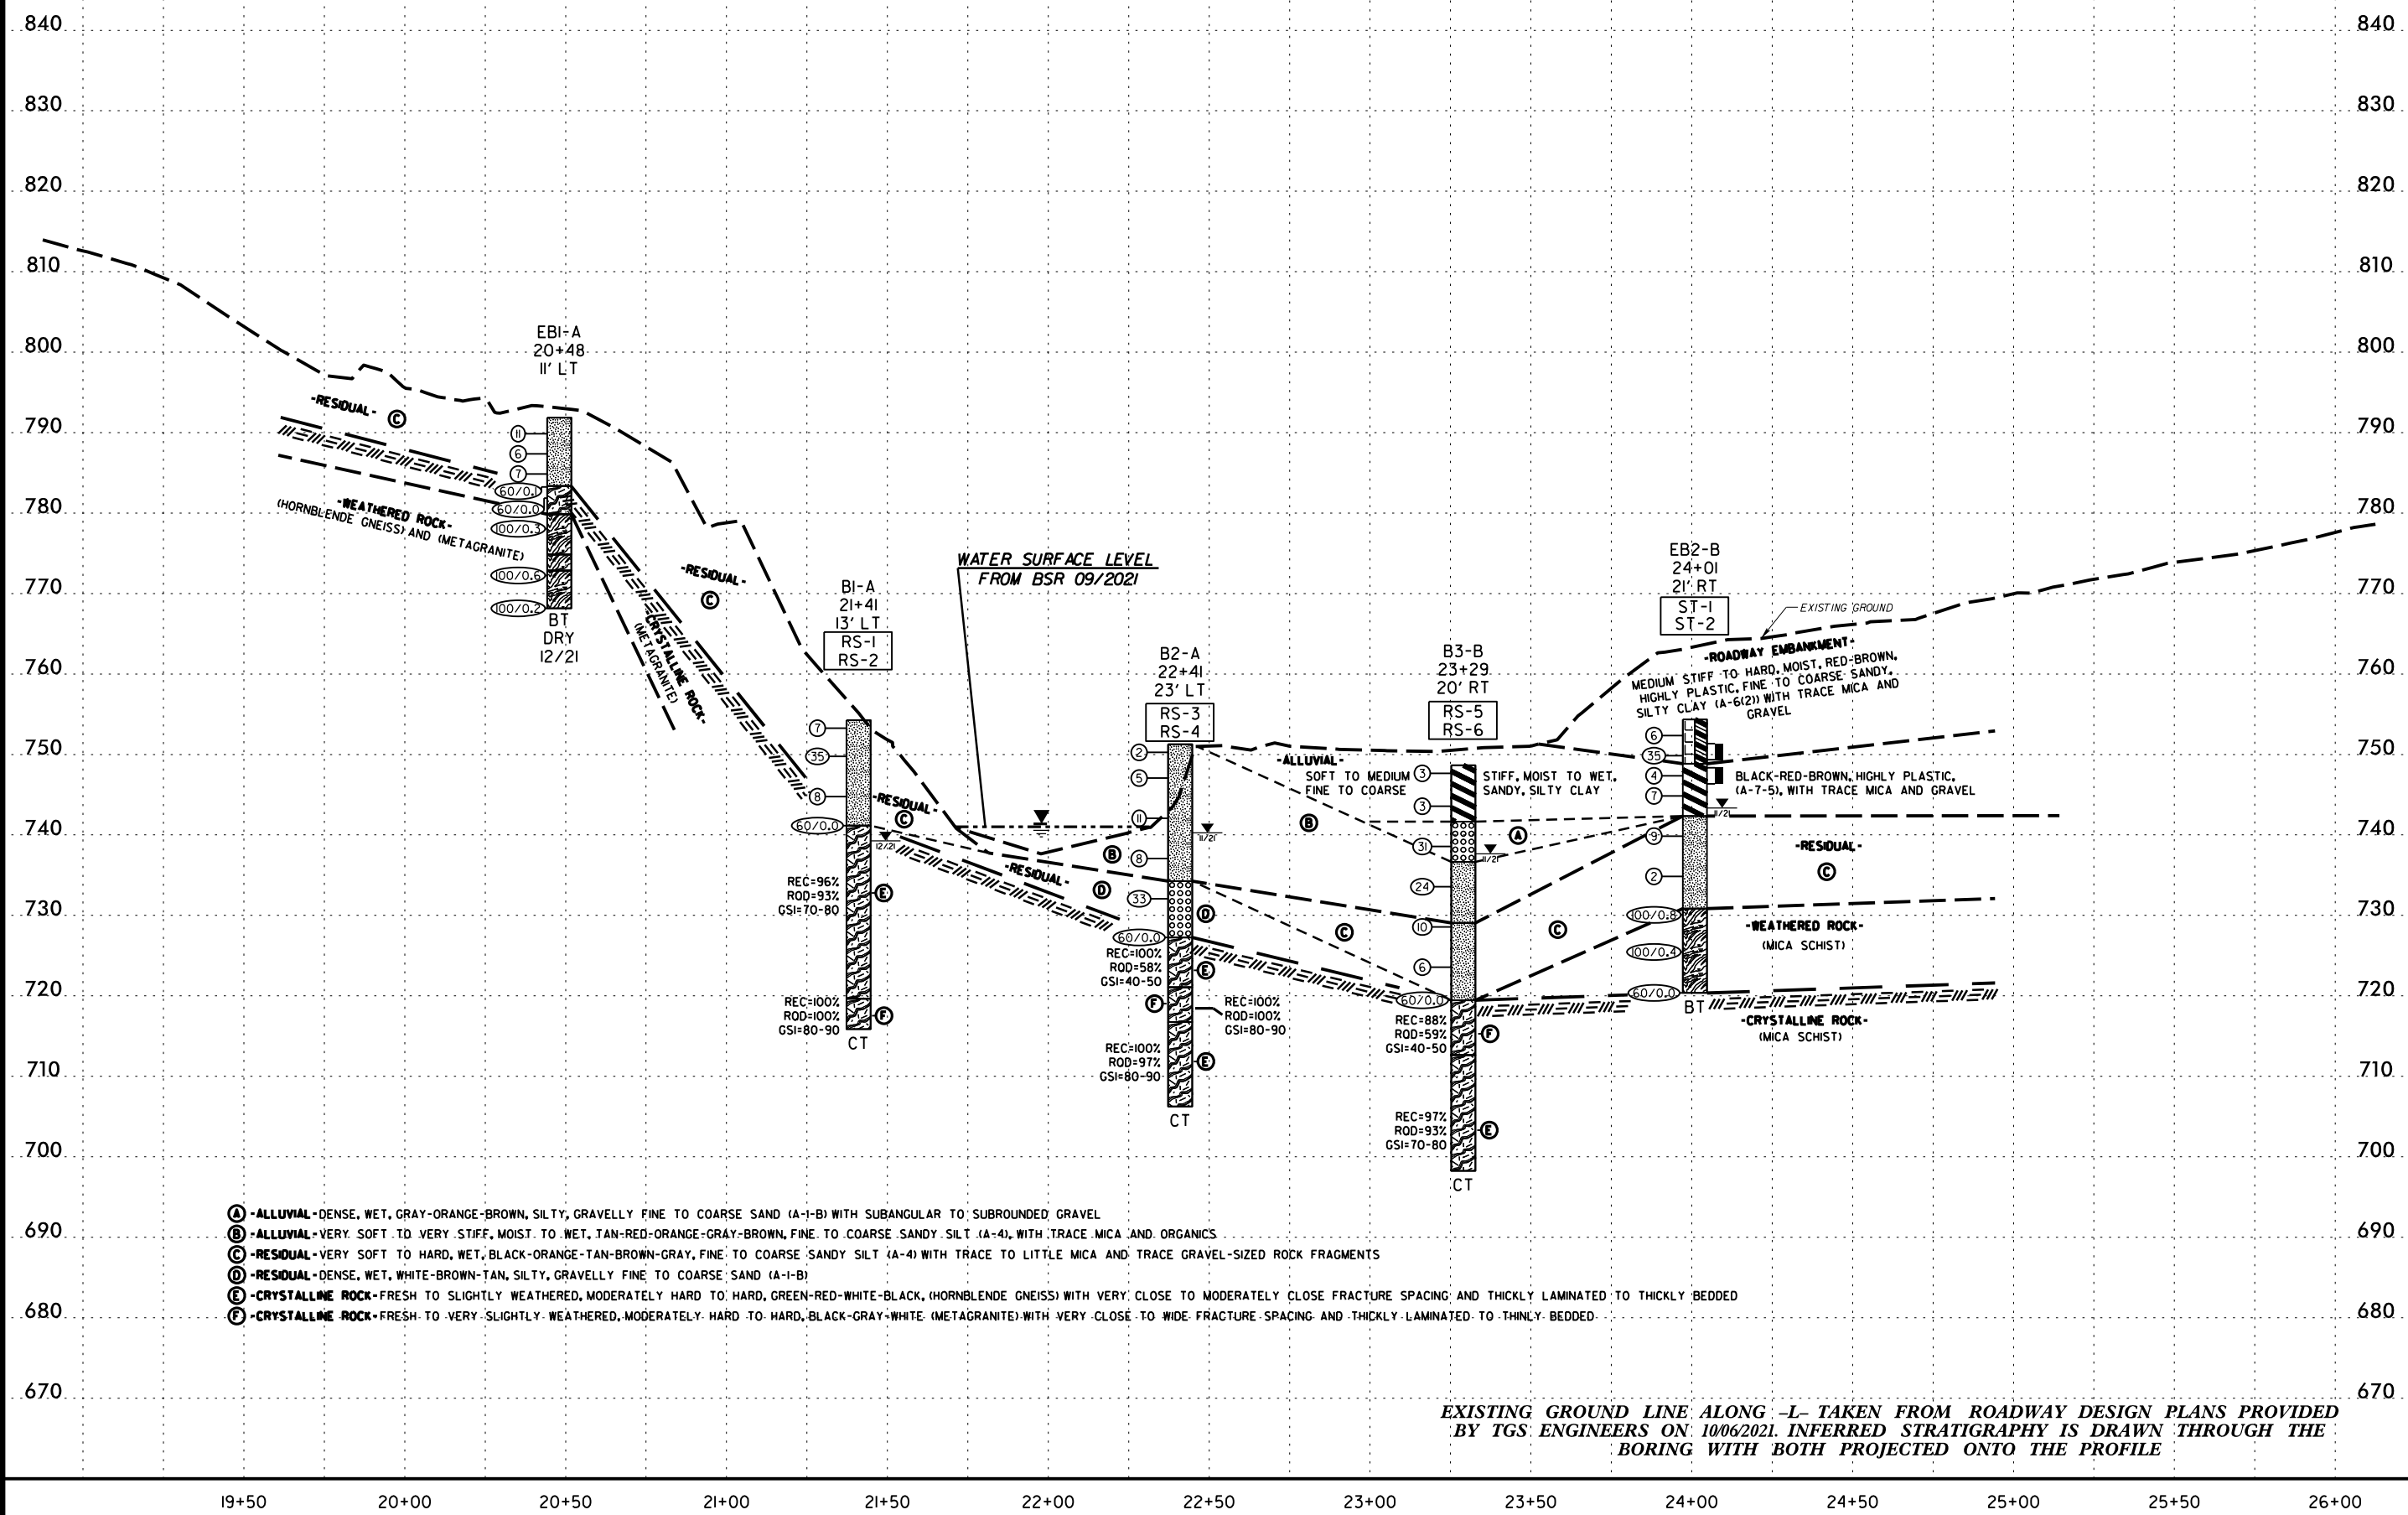
- A** - ALLUVIAL - DENSE, WET, GRAY-ORANGE-BROWN, SILTY, GRAVELLY FINE TO COARSE SAND (A-1-B) WITH SUBANGULAR TO SUBROUNDED GRAVEL
- B** - ALLUVIAL - VERY SOFT TO VERY STIFF, MOIST TO WET, TAN-RED-ORANGE-GRAY-BROWN, FINE TO COARSE SANDY SILT (A-4), WITH TRACE MICA AND ORGANICS

- C** - RESIDUAL - VERY SOFT TO HARD, WET, BLACK-ORANGE-TAN-BROWN-GRAY, FINE TO COARSE SANDY SILT (A-4) WITH TRACE TO LITTLE MICA AND TRACE GRAVEL-SIZED ROCK FRAGMENTS

- D** - RESIDUAL - DENSE, WET, WHITE-BROWN-TAN, SILTY, GRAVELLY FINE TO COARSE SAND (A-1-B)
- E** - CRYSTALLINE ROCK - FRESH TO SLIGHTLY WEATHERED, MODERATELY HARD TO HARD, GREEN-RED-WHITE-BLACK, (HORNBLende GNEISS) WITH VERY CLOSE TO MODERATELY CLOSE FRACTURE SPACING AND THICKLY LAMINATED TO THICKLY BEDDED

- F** - CRYSTALLINE ROCK - FRESH TO VERY SLIGHTLY WEATHERED, MODERATELY HARD TO HARD, BLACK-GRAY-WHITE (METAGRANITE) WITH VERY CLOSE TO WIDE FRACTURE SPACING AND THICKLY LAMINATED TO THINLY BEDDED

EXISTING GROUND LINE ALONG -L- TAKEN FROM ROADWAY DESIGN PLANS PROVIDED BY TGS ENGINEERS ON 10/06/2021. INFERRED STRATIGRAPHY IS DRAWN THROUGH THE BORING WITH BOTH PROJECTED ONTO THE PROFILE

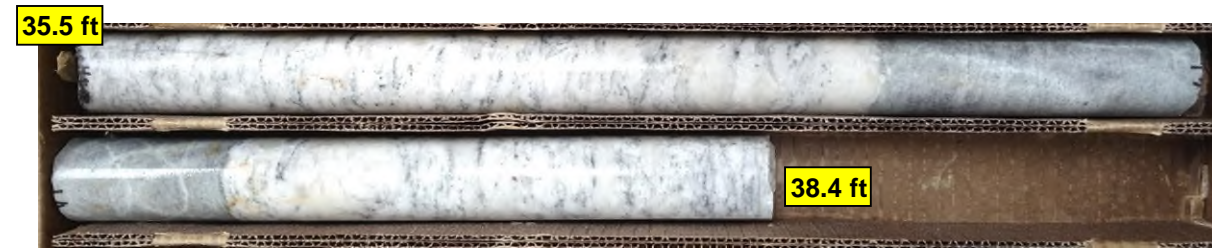
Rock Core Photographs

Replace Bridge 189 on SR 1892 (Jennings Road) over South Yadkin River, Iredell County, NC

Boring: B1-A

13.1 to 38.4 Feet

741.2	741.2	13.1	1.5	N=60/0.0 6:56/1.5	(1.1) 73%	(1.0) 67%		(20.6) 96%	(20.0) 93%			Begin Coring @ 13.1 ft
740	739.7	14.6	5.0	4:01/1.0 4:05/1.0 4:21/1.0 3:48/1.0 4:23/1.0	(4.5) 90%	(4.2) 84%	RS-1					CRYSTALLINE ROCK Fresh to Very Slightly Weathered, Moderately Hard to Hard, Green-Red-White-Black, (HORNBLLENDE GNEISS), with Very Close to Close Fracture Spacing and Thickly Laminated to Thinly Bedded
735	734.7	19.6	5.0	3:14/1.0 3:45/1.0 3:11/1.0 3:35/1.0 3:39/1.0	(4.9) 98%	(4.9) 98%	RS-2					RS-1: 17.4 - 17.9' Unit Weight: 176.5 pcf Unconfined Compressive Strength: 8,030 psi (1,156 ksf)
730	729.7	24.6	5.1	4:05/1.0 3:59/1.0 4:16/1.0 3:53/1.0 4:36/1.1	(5.1) 100%	(4.9) 96%						RS-2: 22.2 - 22.8' Unit Weight: 178.1 pcf Unconfined Compressive Strength: 11,110 psi (1,600 ksf) GSI=70-80
725	724.6	29.7	5.2	4:54/1.0 4:48/1.0 4:47/1.0 2:41/1.0 2:54/1.2	(5.2) 100%	(5.2) 100%						
720	719.4	34.9	3.5	5:55/1.0 9:58/1.0 15:51/1.0 42:06/0.5	(3.5) 100%	(3.5) 100%		(3.8) 100%	(3.8) 100%			Fresh, Hard, Gray-White (METAGRANITE), with Wide Fracture Spacing and Thickly Laminated to Thinly Bedded

715.9	38.4										GSI=80-90 Boring Terminated at Elevation 715.9 ft In Crystalline Rock (METAGRANITE)

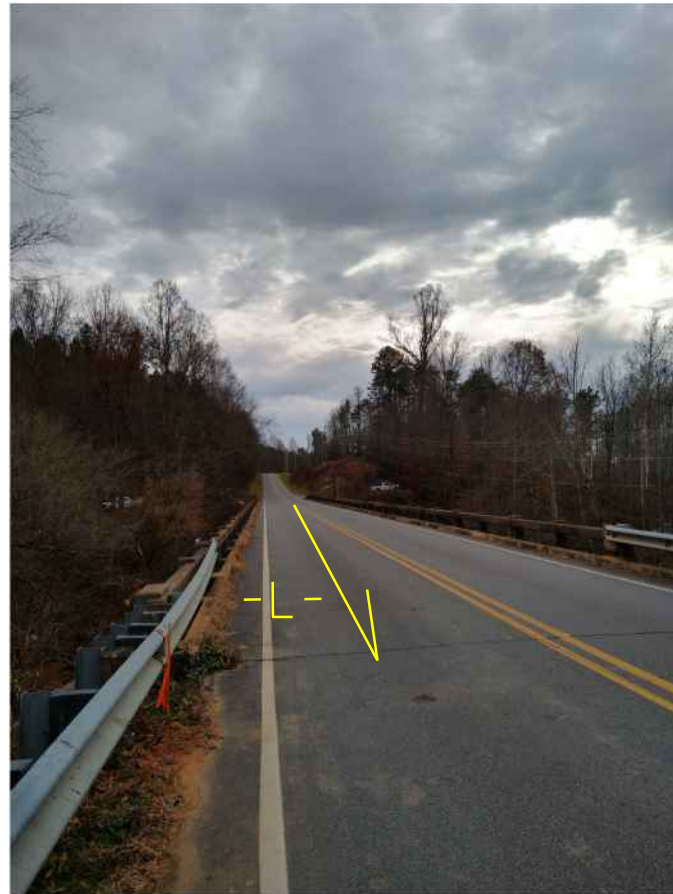
Photo #1: End Bent 2 looking south (downstation)

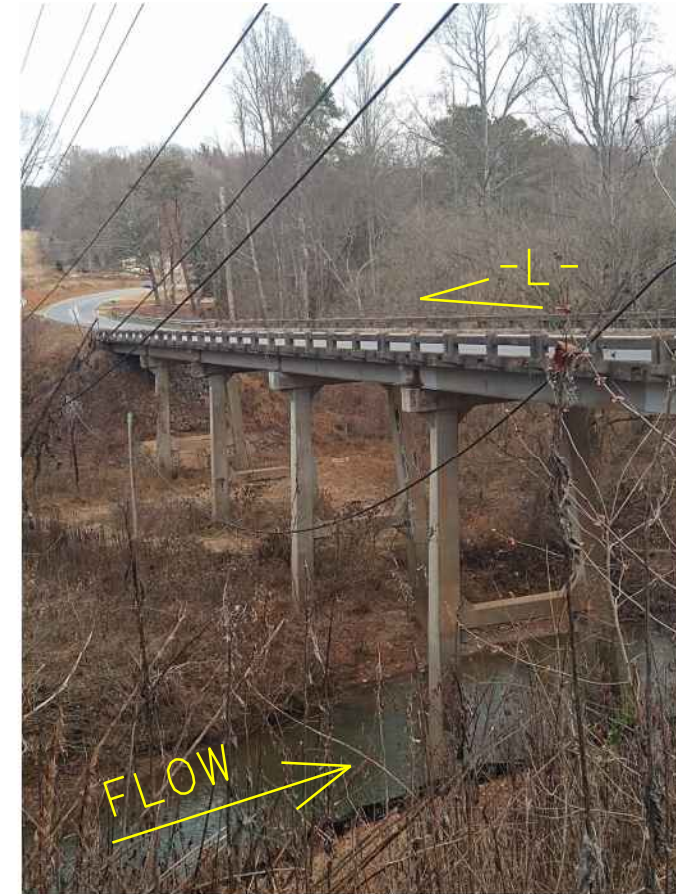
Photo #2: End Bent 1 looking north/northeast (upstation)

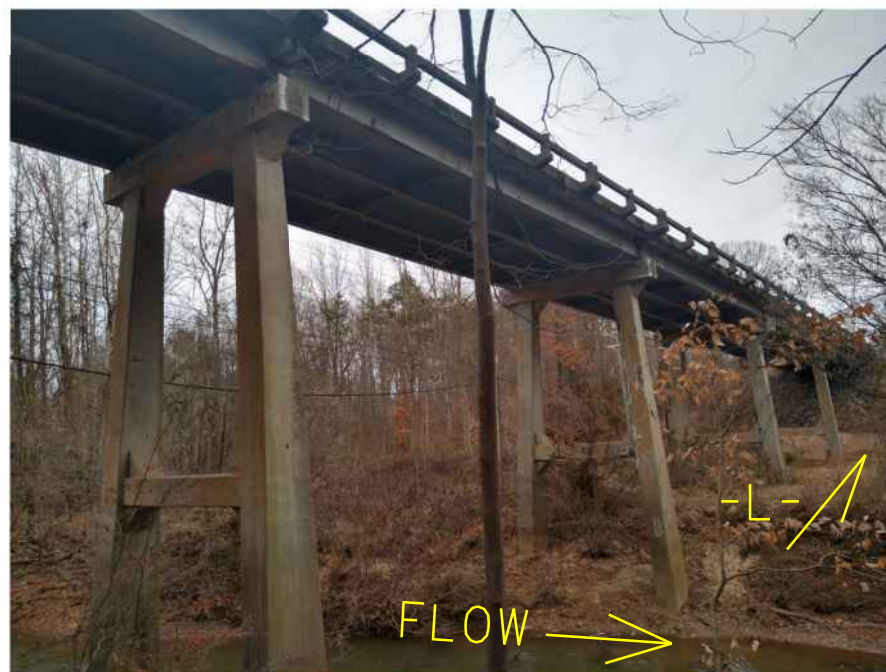
Photo #3: Right side of existing bridge looking north/northwest (upstation)
