**North Carolina Emergency Management – Private Roads and Bridges**  
Site Information Form

# BRIDGE SURVEY & HYDRAULIC DESIGN REPORT

NC DEPARTMENT OF EMERGENCY MANAGEMENT  
PRIVATE ROADS AND BRIDGES PROGRAM

# GEOTECHNICAL BORING REPORT

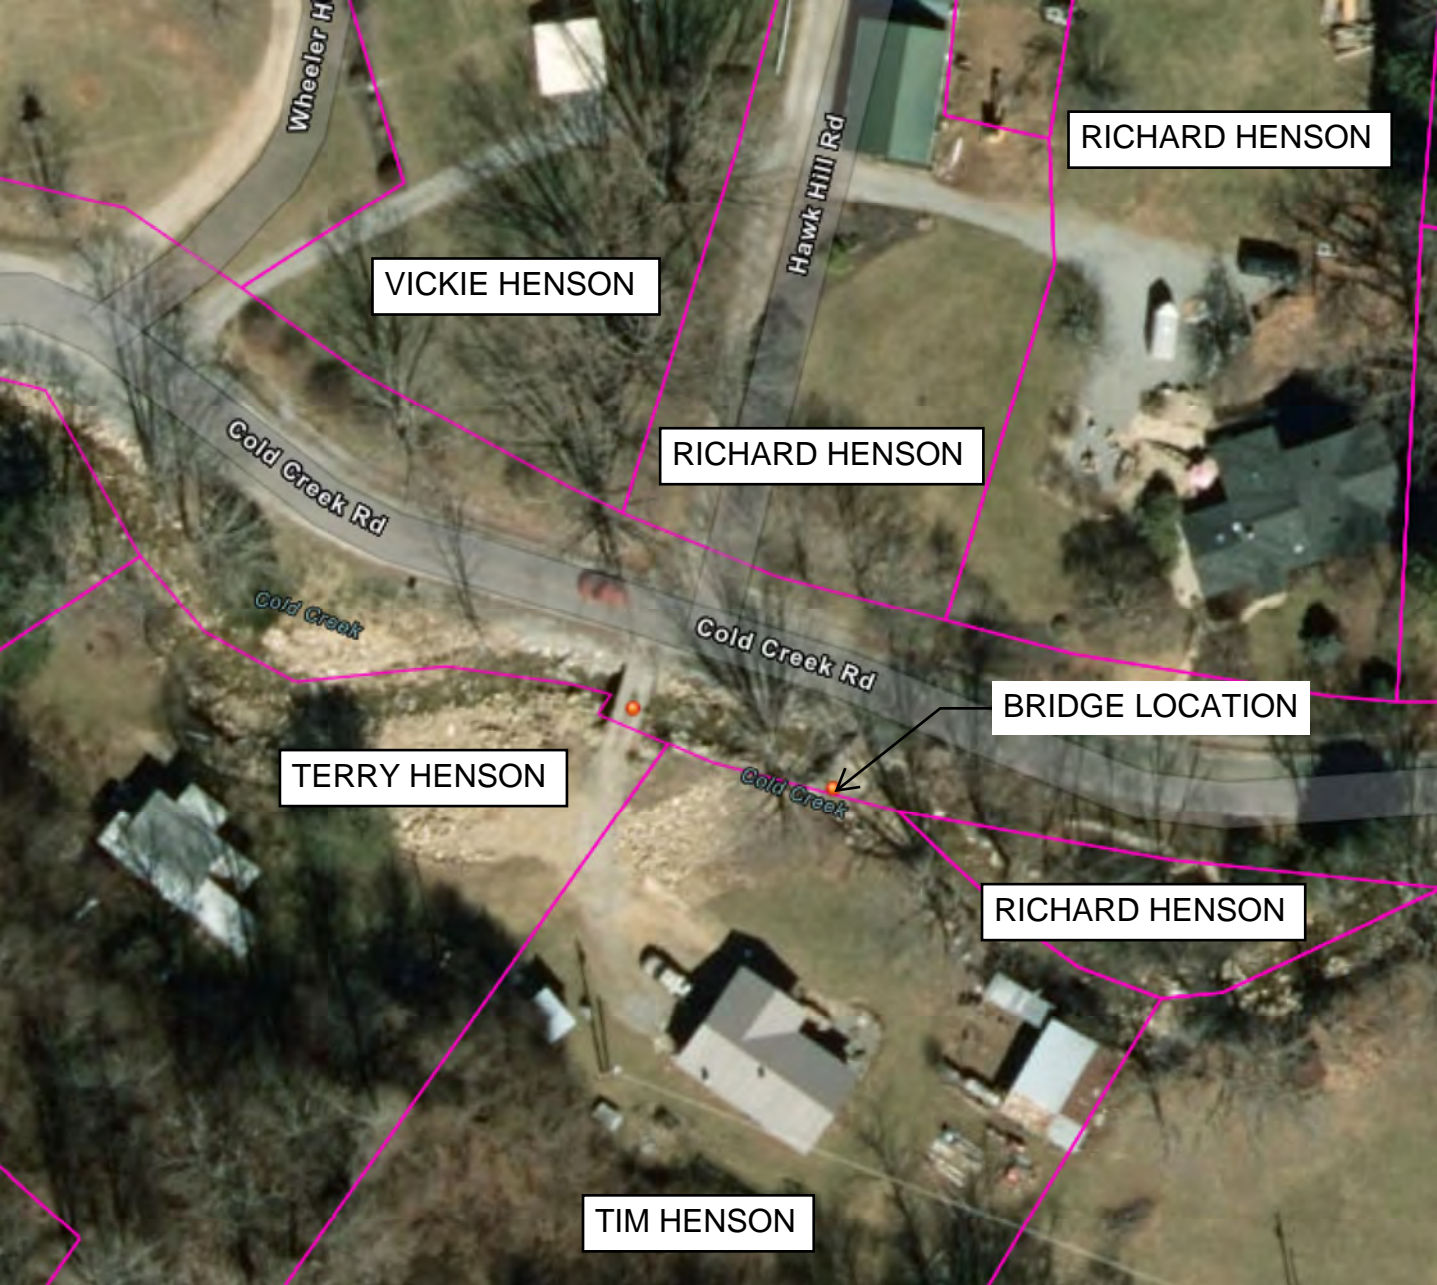
BRIDGE LOCATION

SITE ID: 044-01-f60bd

SITE ADDRESS: 85 COLD CREEK RD.,  
CANTON, NC 28716

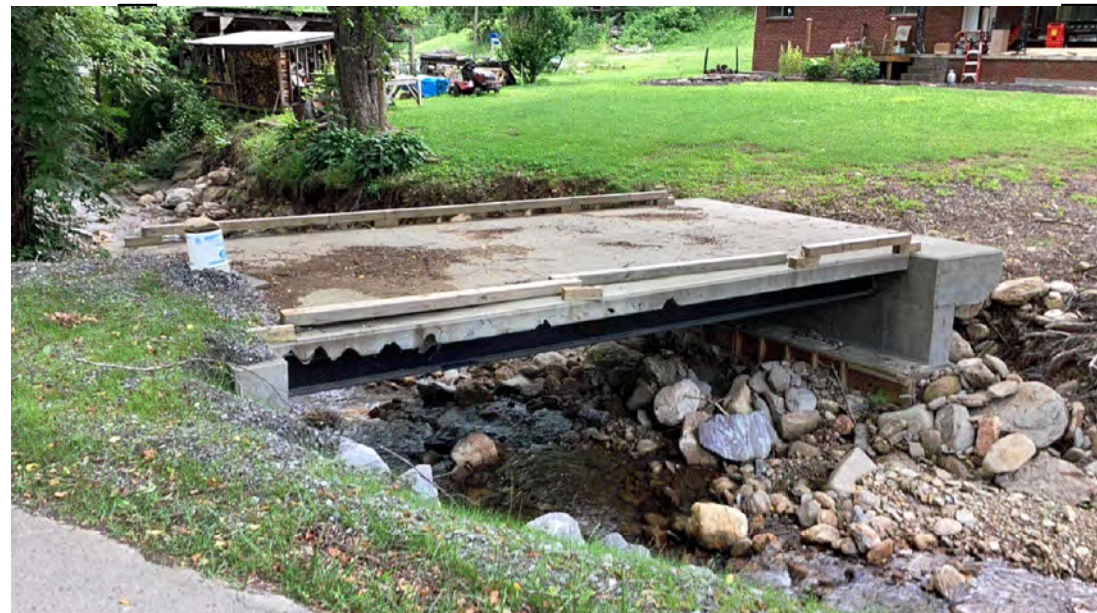
Site Number 044-01-f60bd Latitude 35.425335 Longitude -82.814606  
 County Haywood Address 85 Cold Creek Road  
 City Canton Zip Code 28716  
 Recommended Structure 1 @ 30' Steel Girder Bridge with 2'-6" Pier Caps  
 Recommended Width of Roadway 12' Skew Match existing  
 Recommended Location is (A) Upstream, Downstream) of Existing Crossing  
 Temporary Crossing Sitting on exposed abutments, foundations undermined

I hereby certify that I have reviewed the existing hydraulic conveyance at this site which was a 24 ft existing bridge with the proposed conveyance provided by a 30 ft span bridge.
