# North Carolina Emergency Management – Private Roads and Bridges

## Site Information Form

NC DEPARTMENT OF EMERGENCY MANAGEMENT  
PRIVATE ROADS AND BRIDGES PROGRAM

BRIDGE SURVEY & HYDRAULIC DESIGN REPORT

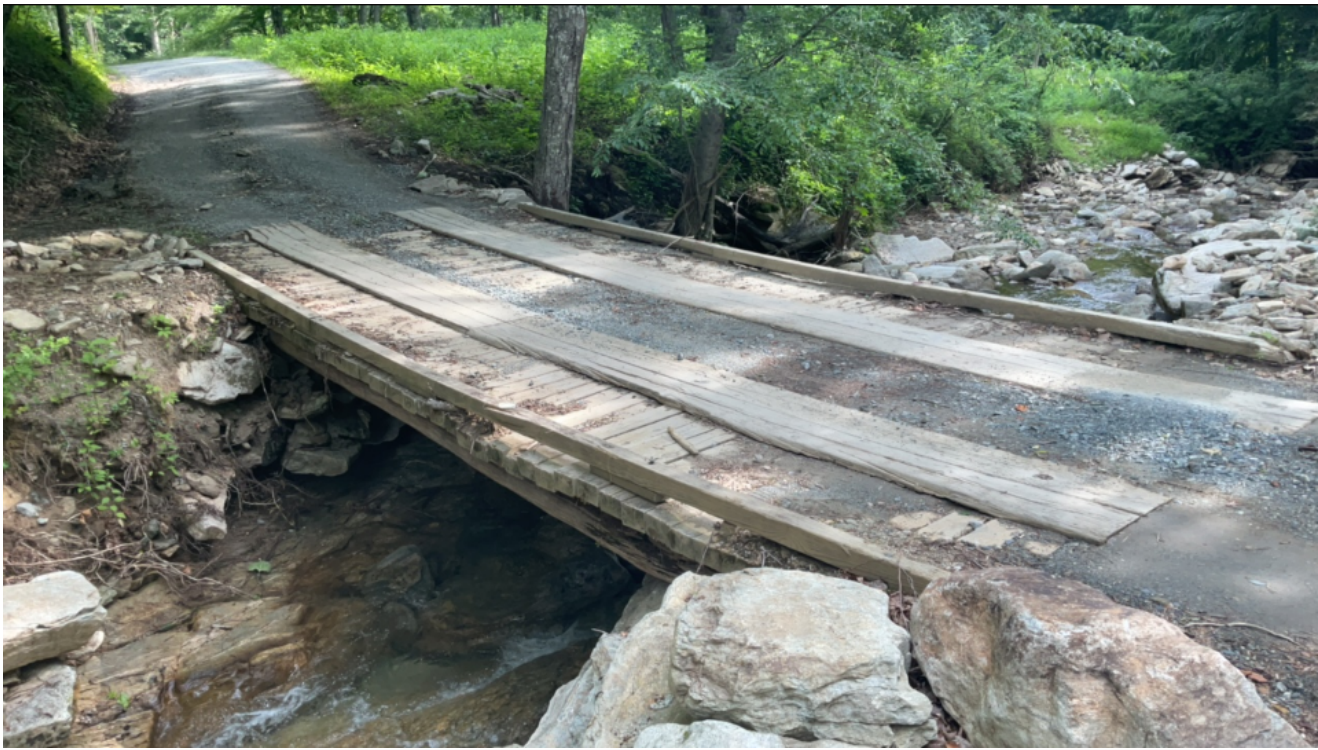
1 @ 40' Steel Modular Bridge (30' effective flow length)

I hereby certify that that I have reviewed the existing hydraulic conveyance at this site which was approximately a 25 ft timber bridge with the proposed conveyance provided by the proposed 40 ft. span bridge.

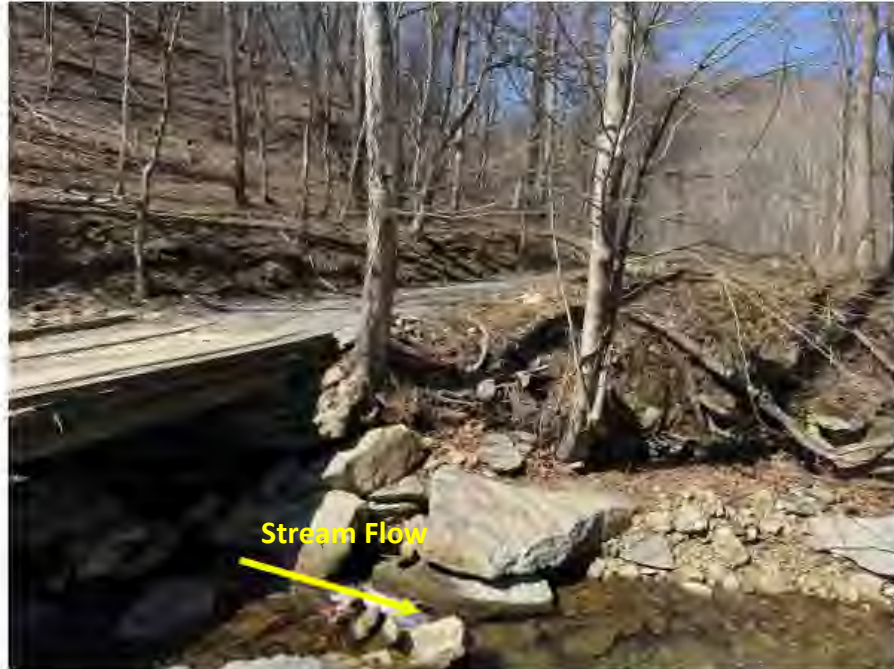
**Photograph No. 1: View looking North**

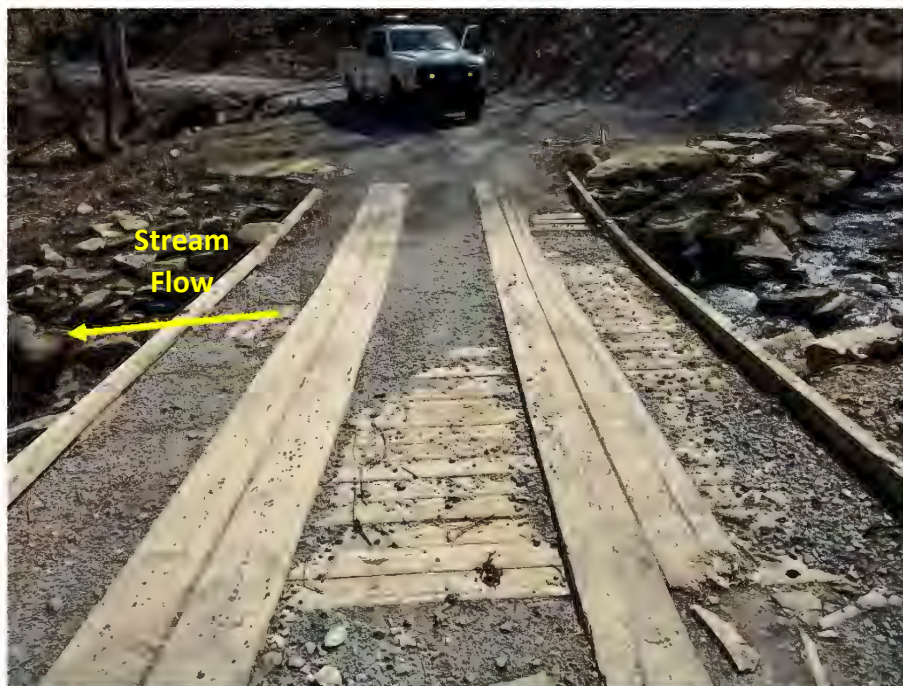
**Photograph No. 2: View looking South**

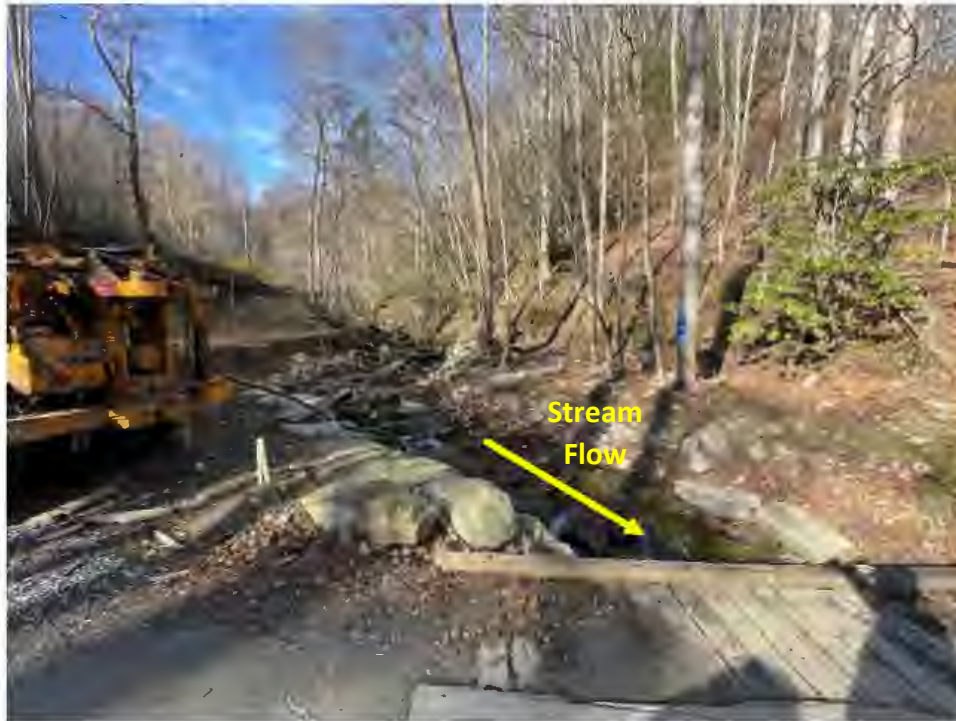
**Photograph No. 3:** View looking upstream

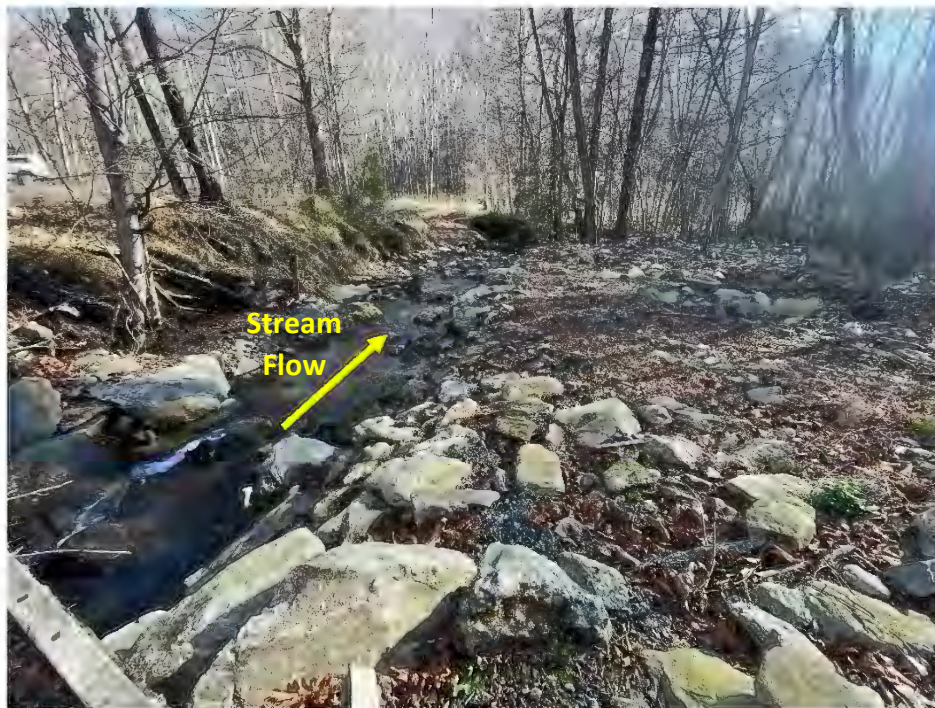
**Photograph No. 4:** View looking downstream

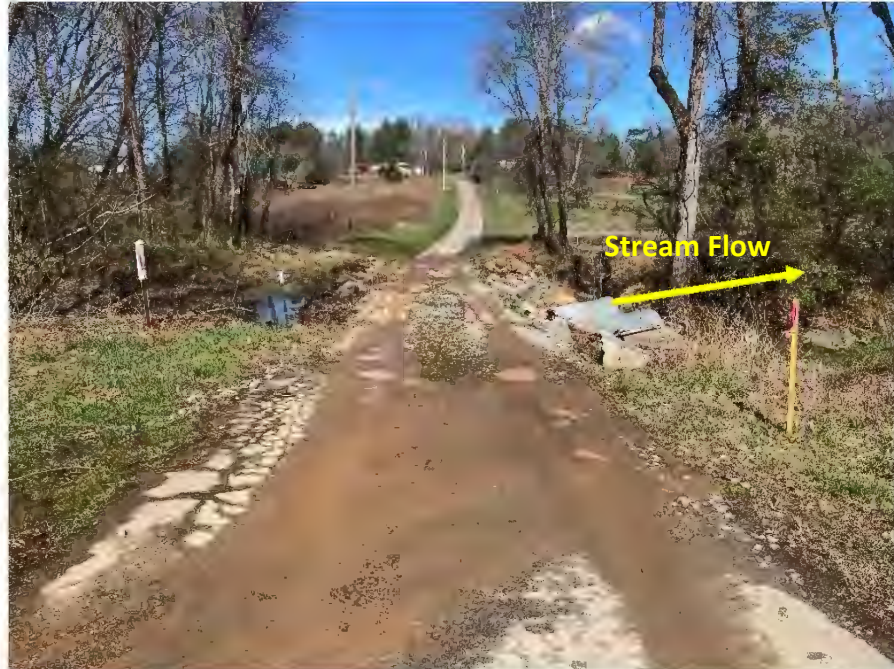
**Photograph No. 1: View looking North**

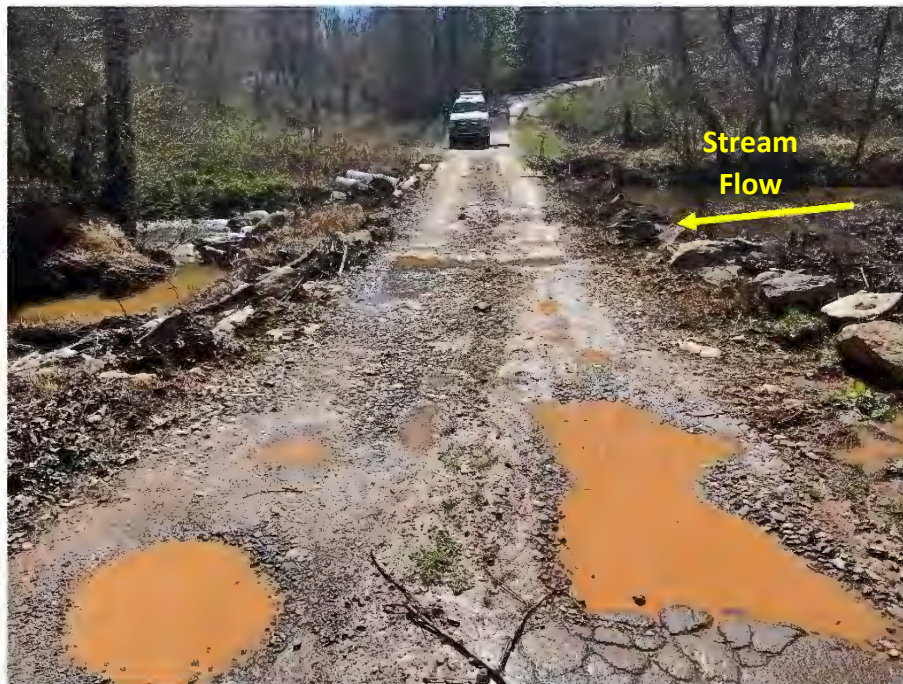
**Photograph No. 2: View looking South**

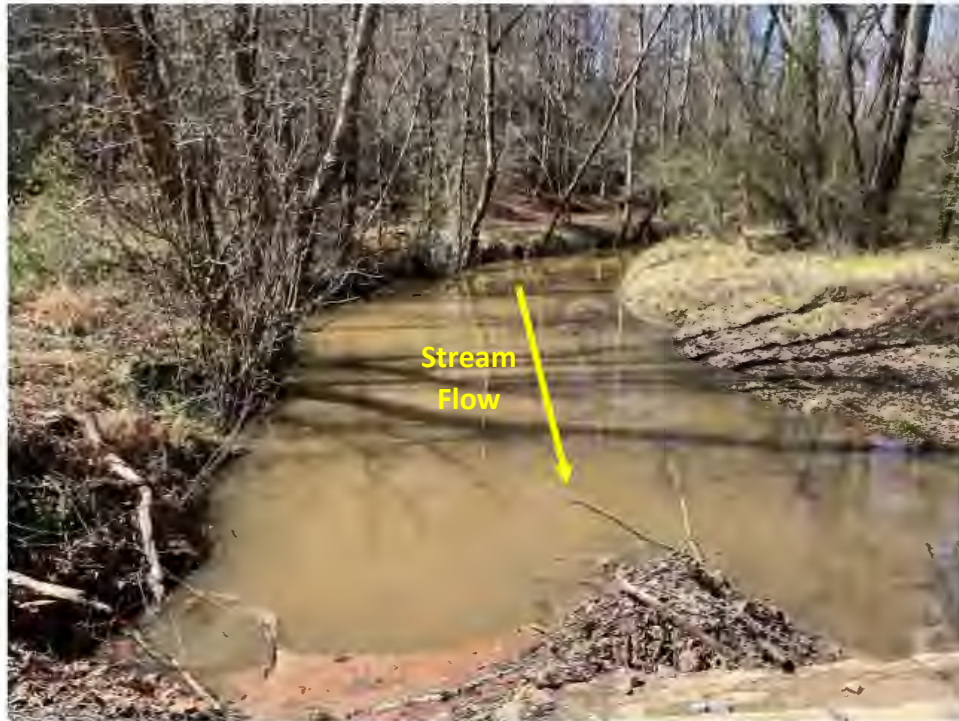
**Photograph No. 3:** View looking upstream

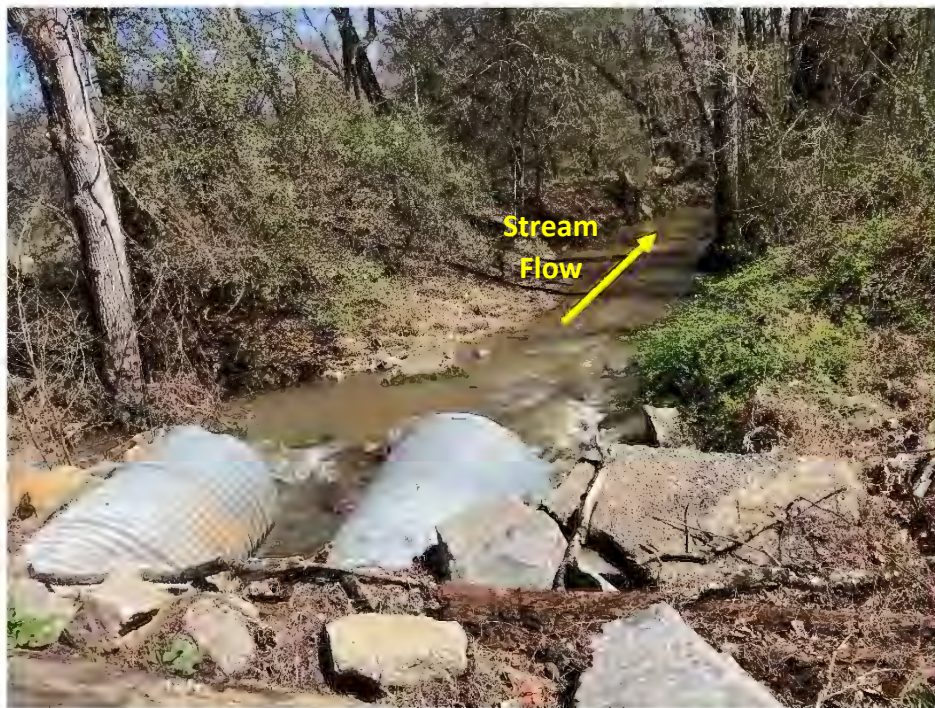
**Photograph No. 4:** View looking downstream
