SITE ID: 057-01-b1b42

# North Carolina Emergency Management – Private Roads and Bridges

BRIDGE SURVEY & HYDRAULIC DESIGN REPORT

NC DEPARTMENT OF EMERGENCY MANAGEMENT  
PRIVATE ROADS AND BRIDGES PROGRAM

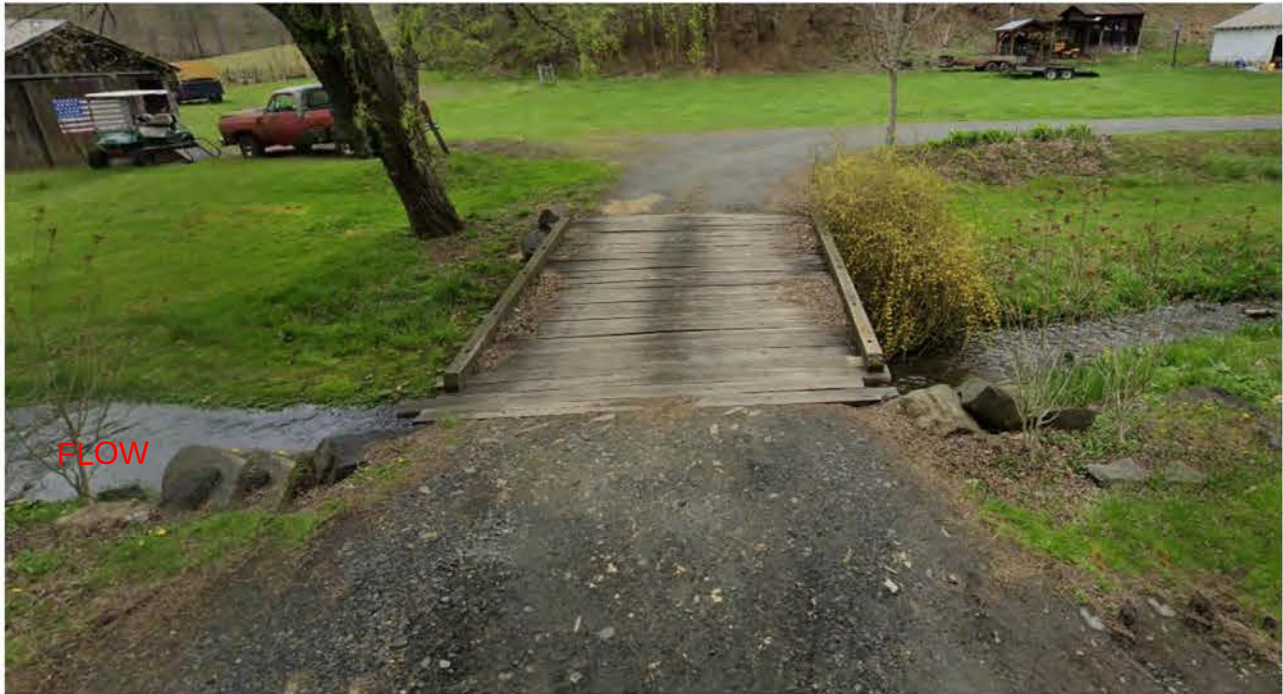
Note: Bridge was destroyed by Helene. Picture shown is a historical image from April 2024.
