**North Carolina Emergency Management – Private Roads and Bridges**  
Site Information Form

BRIDGE SURVEY & HYDRAULIC DESIGN REPORT

NC DEPARTMENT OF EMERGENCY MANAGEMENT  
PRIVATE ROADS AND BRIDGES PROGRAM

# GEOTECHNICAL BORING REPORT

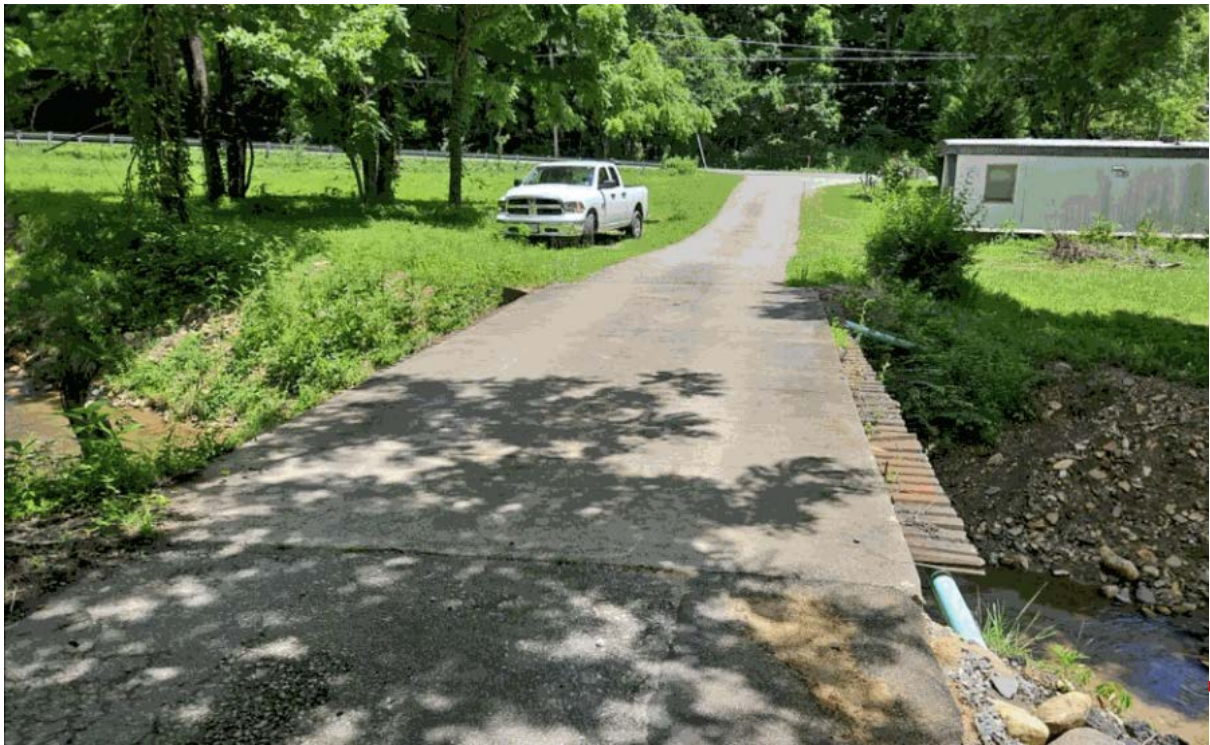
I hereby certify that I have reviewed the existing hydraulic conveyance at this site which was a 27 ft. timber bridge with the proposed conveyance provided by the proposed 50 ft. bridge.

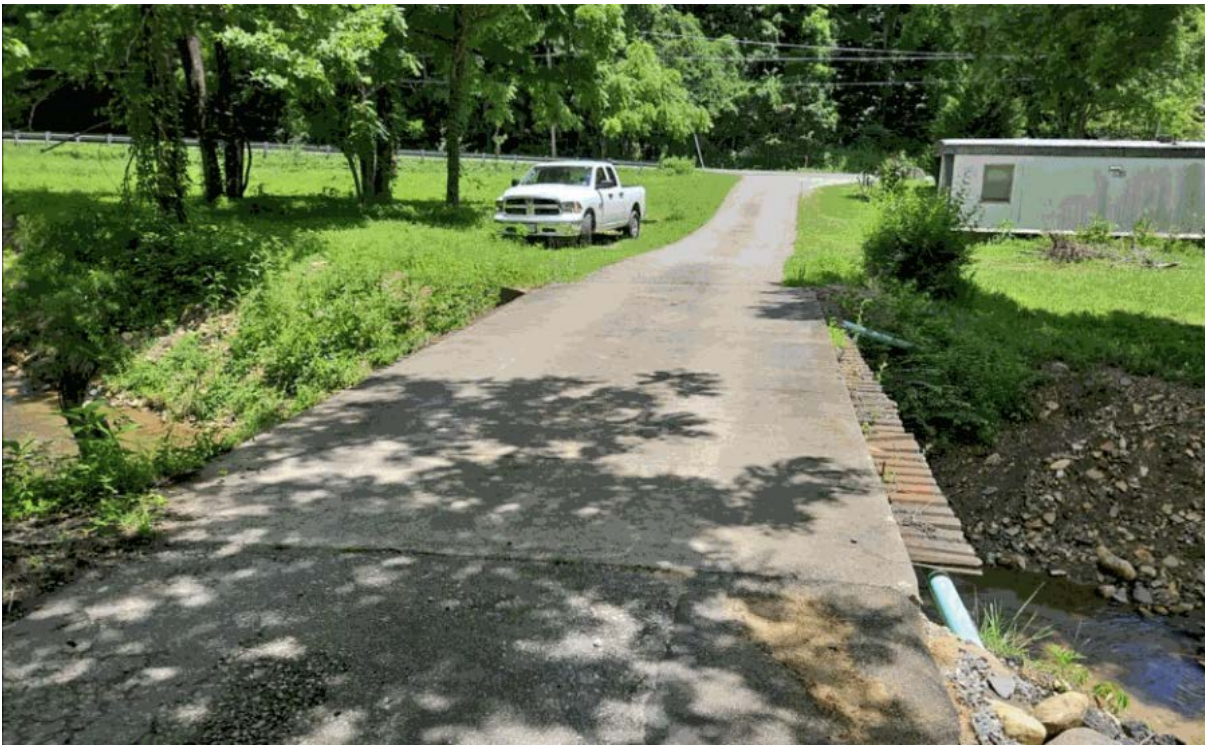
I hereby certify that that I have reviewed the existing hydraulic conveyance at this site which was a 27 ft. timber bridge with the proposed conveyance provided by the proposed 40 ft. bridge.
